(54) **REPAIR OF INTEGRALLY BLADED ROTORS**

A method is provided for repairing a damaged rotor blade on an integrally bladed rotor by removing a damaged portion of a damaged blade leaving a blade stub extending outwardly from the disk and performing a linear friction welding operation to attach a replacement blade segment to the blade stub. The rotor may be disposed operation using a linear friction welding apparatus. The method includes disposing a support collar about the blade stub and securing the support collar to the linear friction welding apparatus prior to a commencement of the bonding operation. A lower surface of the support collar is contoured to mate with a portion of an outer circumference surface of the rotor disk.

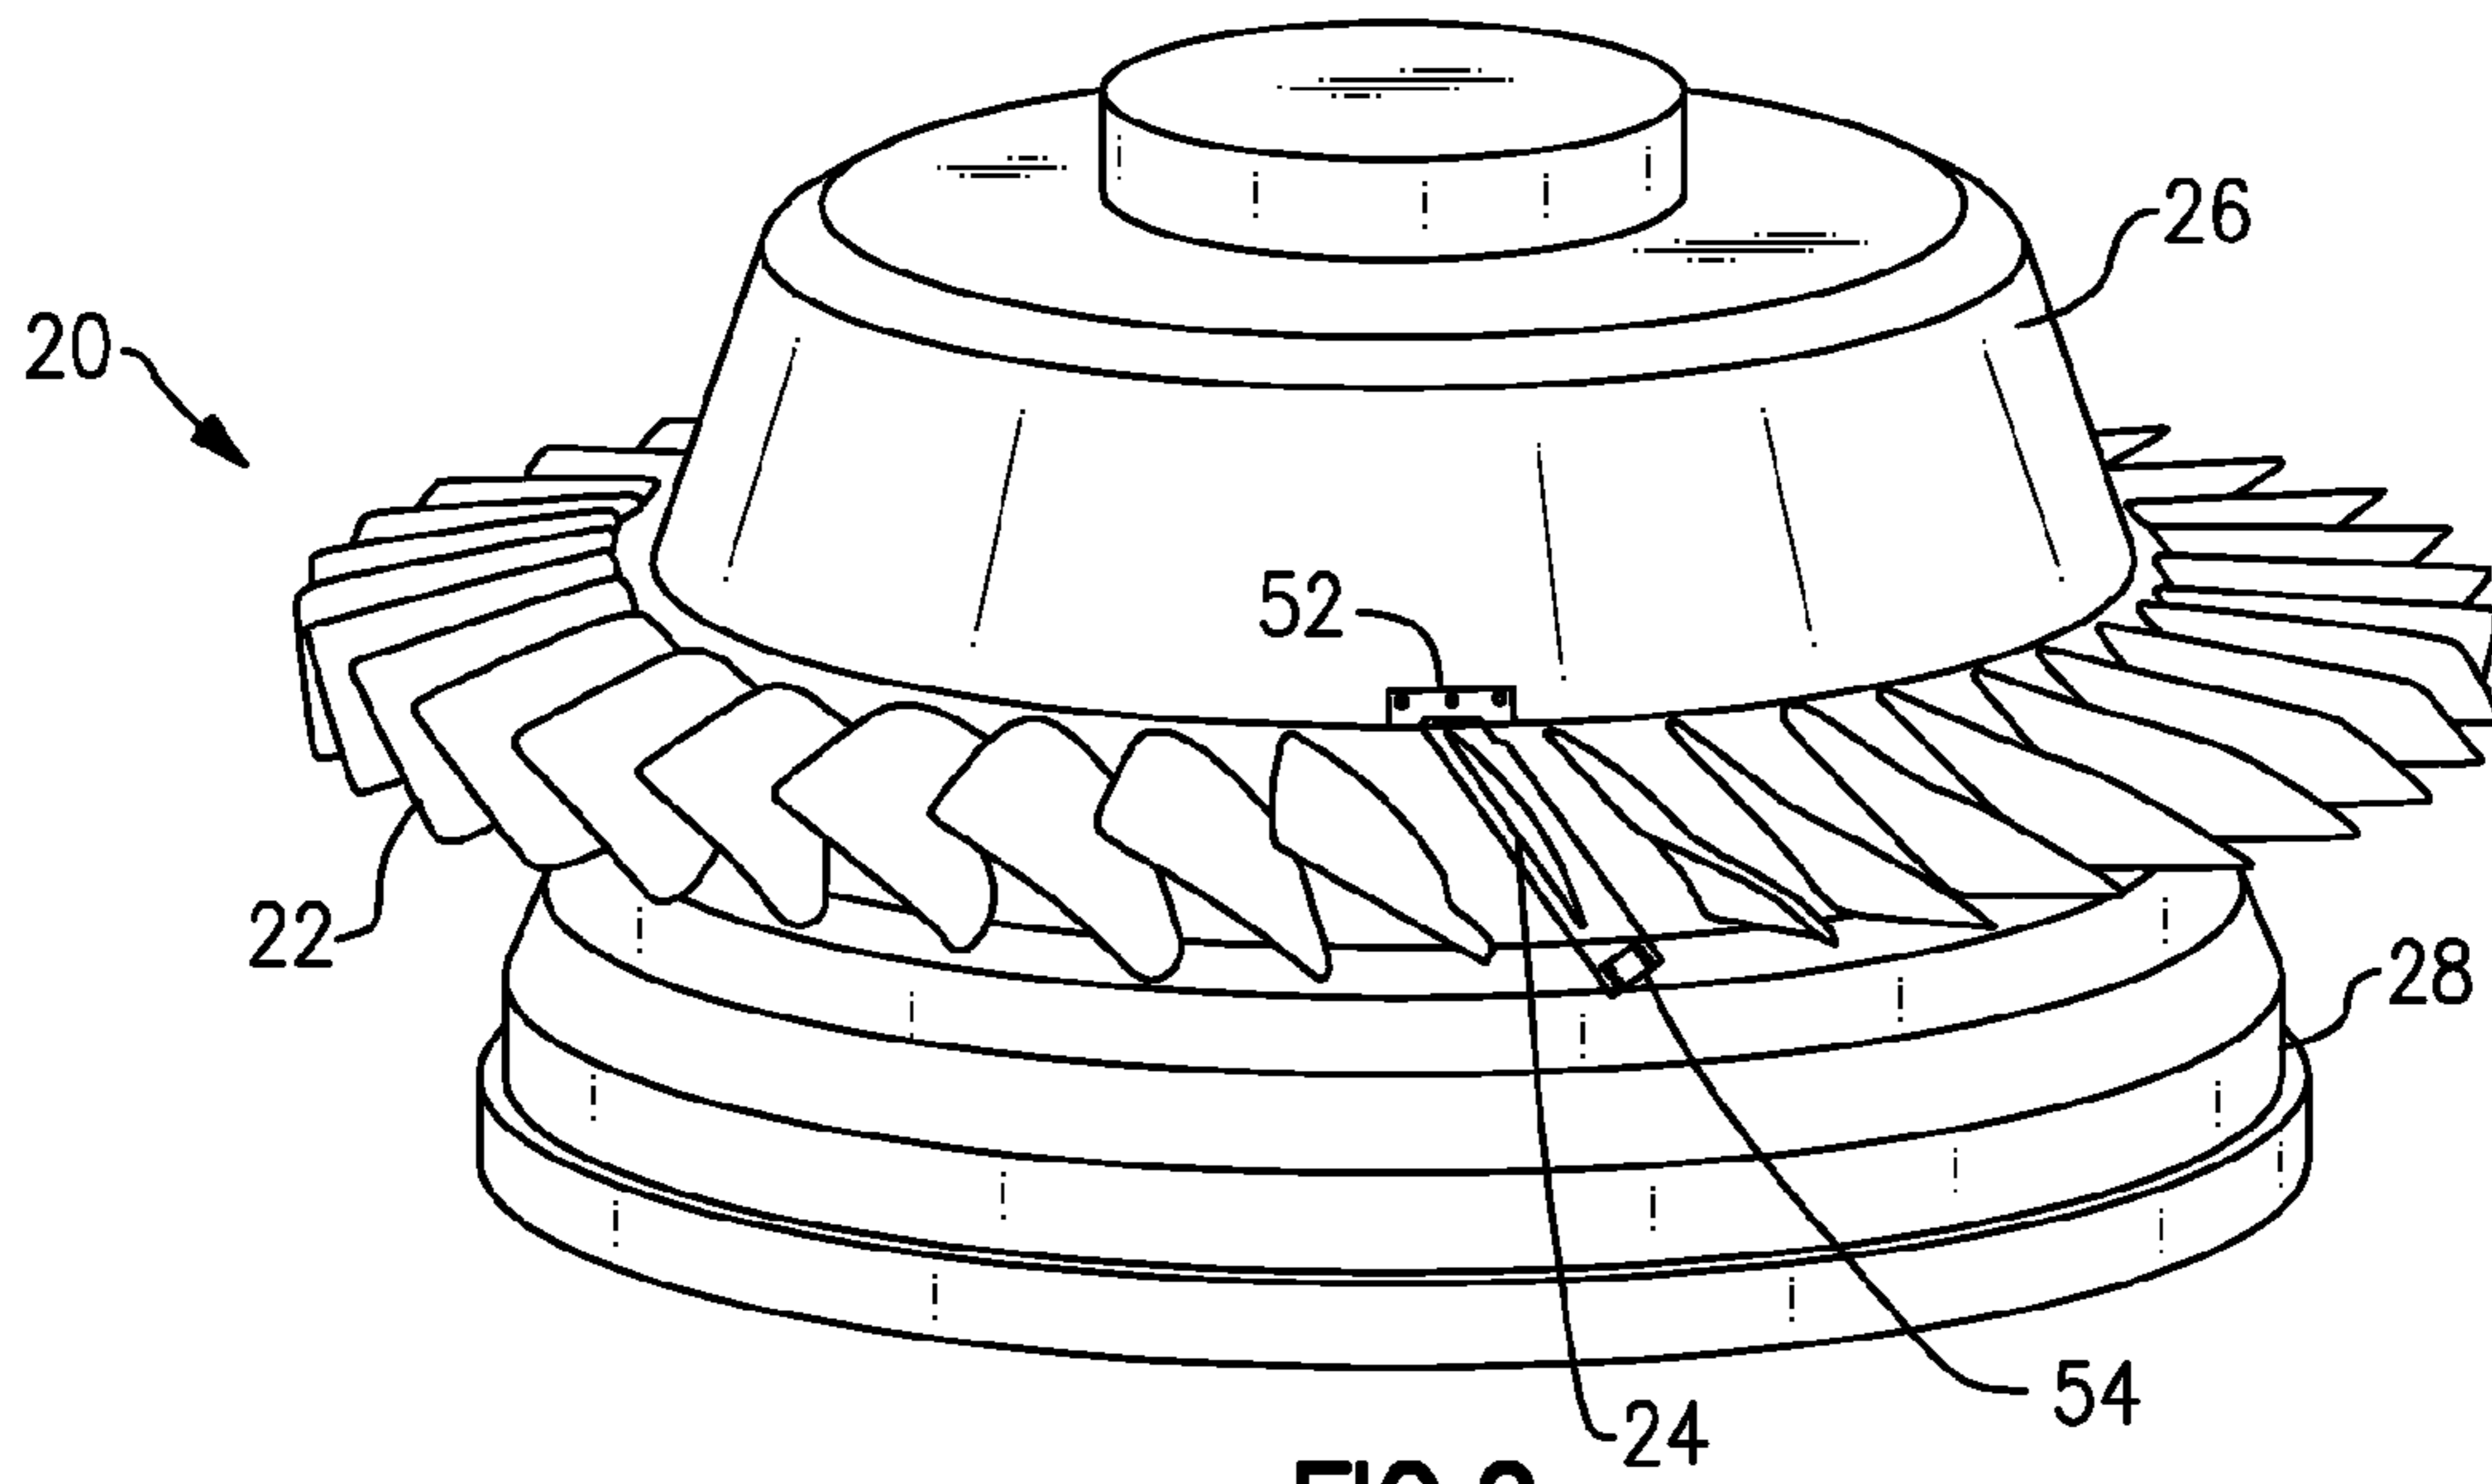
**FIG. 2**

FIG. 2 shows a linear friction welding apparatus for repairing an integrally bladed rotor;

Referring now to FIG. 2, there is depicted a linear friction welding apparatus **10** for repairing an integrally bladed rotor **20** including operational blades **22**, and a blade stub **24** of a damaged blade from which the damaged airfoil section of the blade has been removed. The damaged blade stub **24** is to be repaired by bonding a replacement blade segment, i.e. a new airfoil section (not shown in FIG. 2), to the blade stub **24**. The integrally blade rotor **20** is shown mounted in the linear friction welding apparatus **10** in position between a first holding portion **26** and a second holding portion **28**, both of which are part of the superstructure of the linear friction welding apparatus **10**. Generally, prior to placement of the integrally bladed rotor in the linear friction welding apparatus **10** the first step is to remove the damaged blade to a prescribed cut plane so as to remove the damaged segment of the blade airfoil and leave behind the blade stub **24**. The segment of the blade to be removed may be removed by any non-abusive machining technique or combination of techniques, such as for example cutting, grinding, finishing, or other technique that does not damage the blade stub **24** and that leaves a prepared outboard surface on the blade stub **24** to which the replacement blade airfoil segment may be suitably bonded using the linear friction welding apparatus **10**.

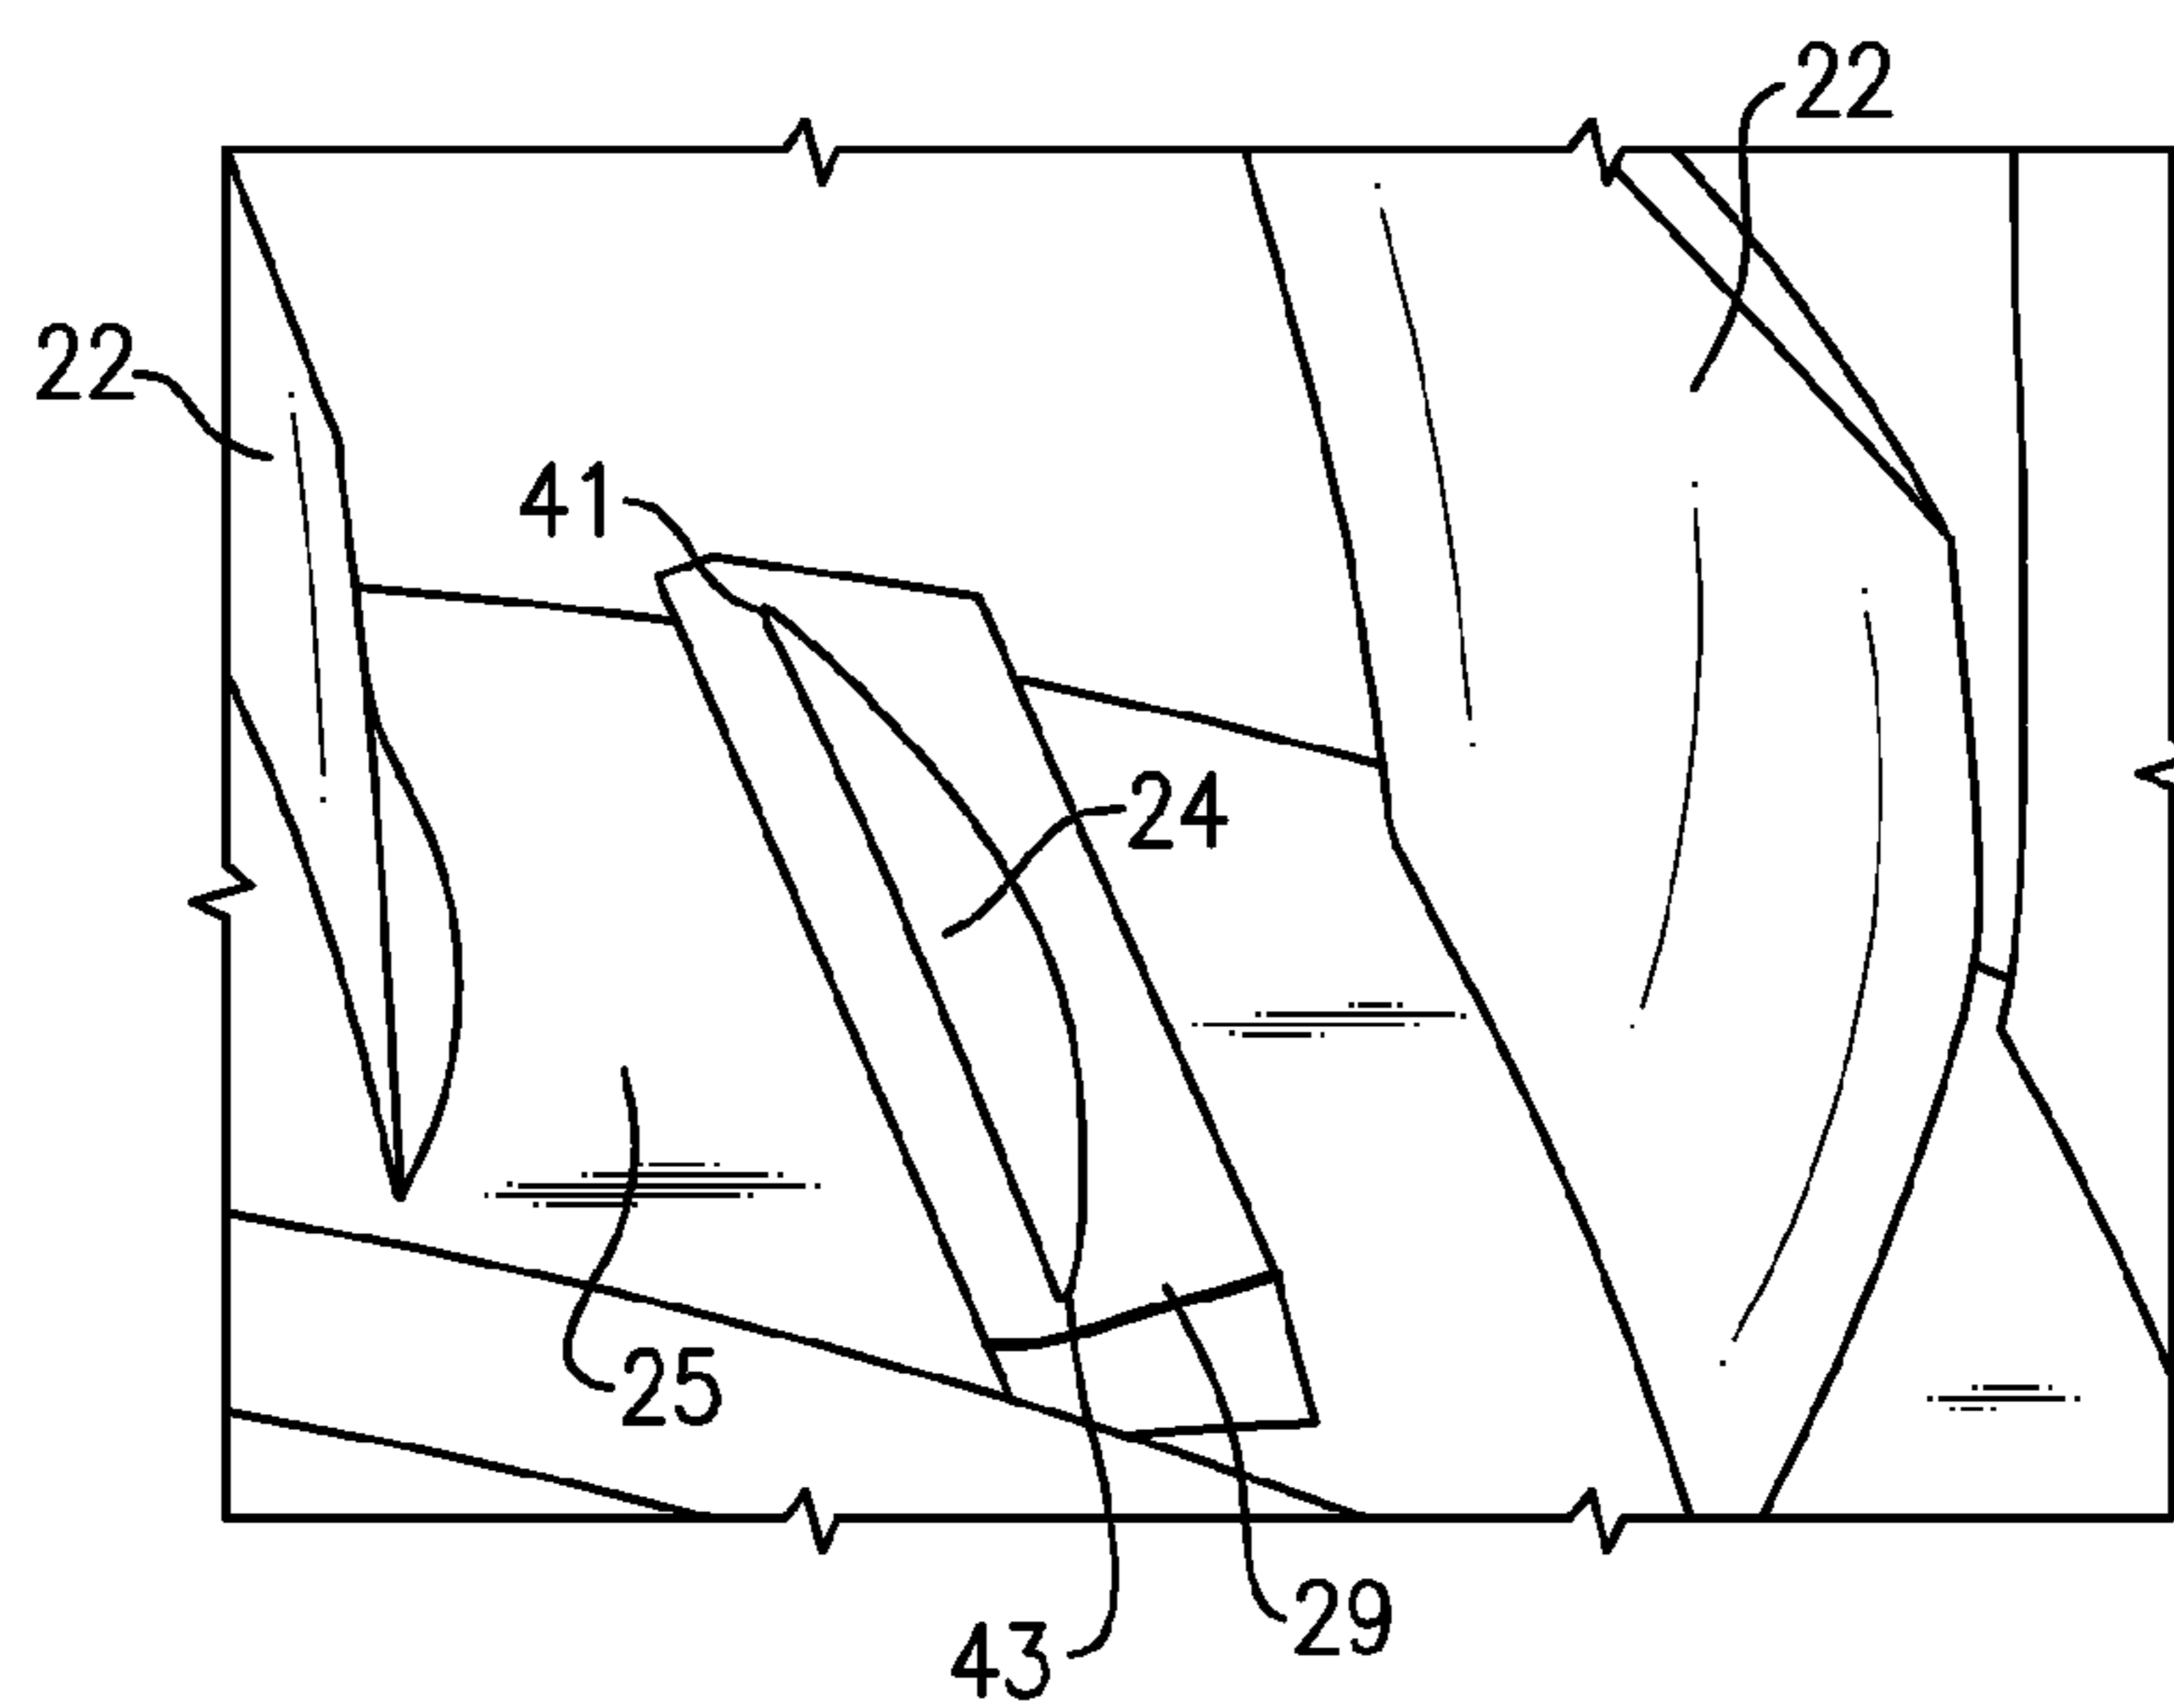
**FIG. 3**

FIG. 3 shows a detail of the FIG. 1 system;

As shown in FIG. 3, the stub **24** is provided with a consumable collar **29**. The consumable collar may be made of the same material as the rotor and blade, and is formed to have an internal cavity that is about the same size and shape of the blade stub in question. Rather than being formed of the same material, the collar could also be made of a different material, depending on engineering requirements. It is desirable that the maximum gaps between the cavity in the collar and the outer periphery of the blade be small (e.g., 0.04 inch, 1.02 mm, or less).

As shown in FIG. 3, the collar **29** is mounted on the blade stub **24**. The blade stub **24** extends between a leading edge **41** and a trailing edge **43**. The collar **29** supports the blade stub **24** as a linear friction welding operation, explained schematically with reference to FIG. 4, is performed. In particular, as shown in FIG. 4, the linear friction welding includes moving a replacement blade segment, for example new airfoil blank **60** (having a leading edge **63** and a trailing edge **61**), rapidly relative to the blade stub **24**, with an axial compressive force, and in a direction generally parallel to a dimension between the leading and trailing edges. By moving the airfoil **60** and blade stub **24** rapidly relative to each other, heat is built up, and the two sections weld together in the solid state. Generally, the replacement blade segment is wrought, as opposed to cast, as a wrought replacement blade segment has a more desired grain structure and wrought OEM (original equipment manufacture) properties. The linear friction welding technique is known.

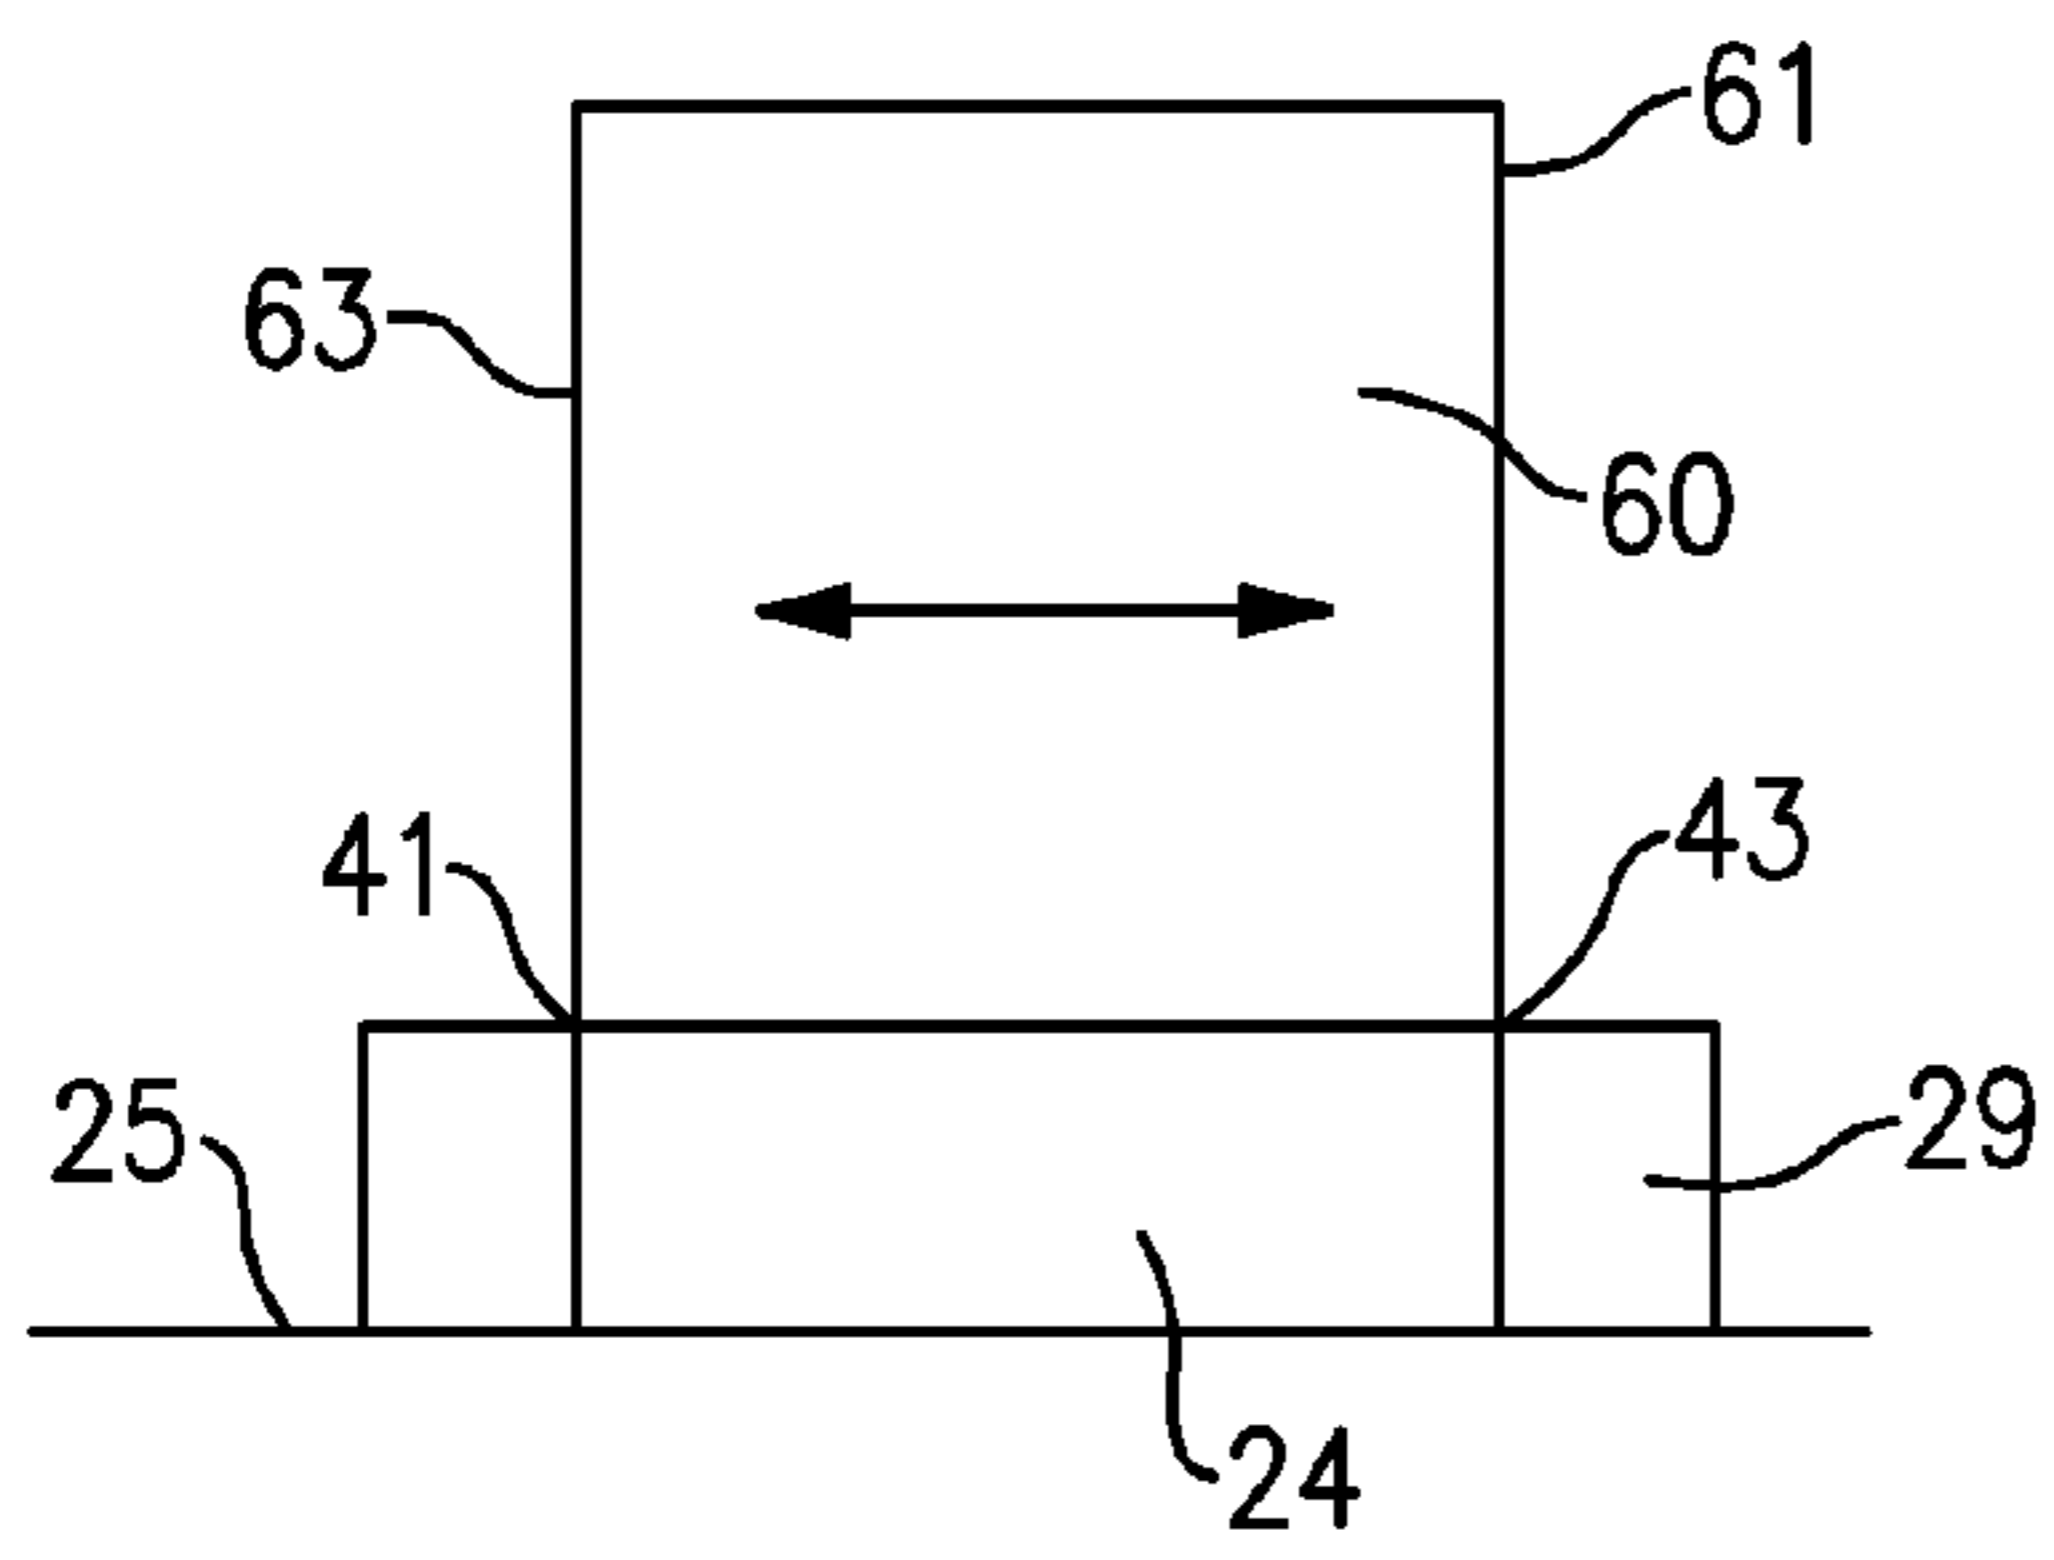
**FIG. 4**

FIG. 4 schematically shows a linear friction welding operation;

As can be appreciated from FIG. 4, the collar 29 provides additional structural support during the linear friction welding, and thus results in a robust reliable bond being formed between the airfoil 60 and the blade stub 24. To provide additional radial support during the linear friction welding process, the lower surface 31 of the collar 29 may be con-  
5

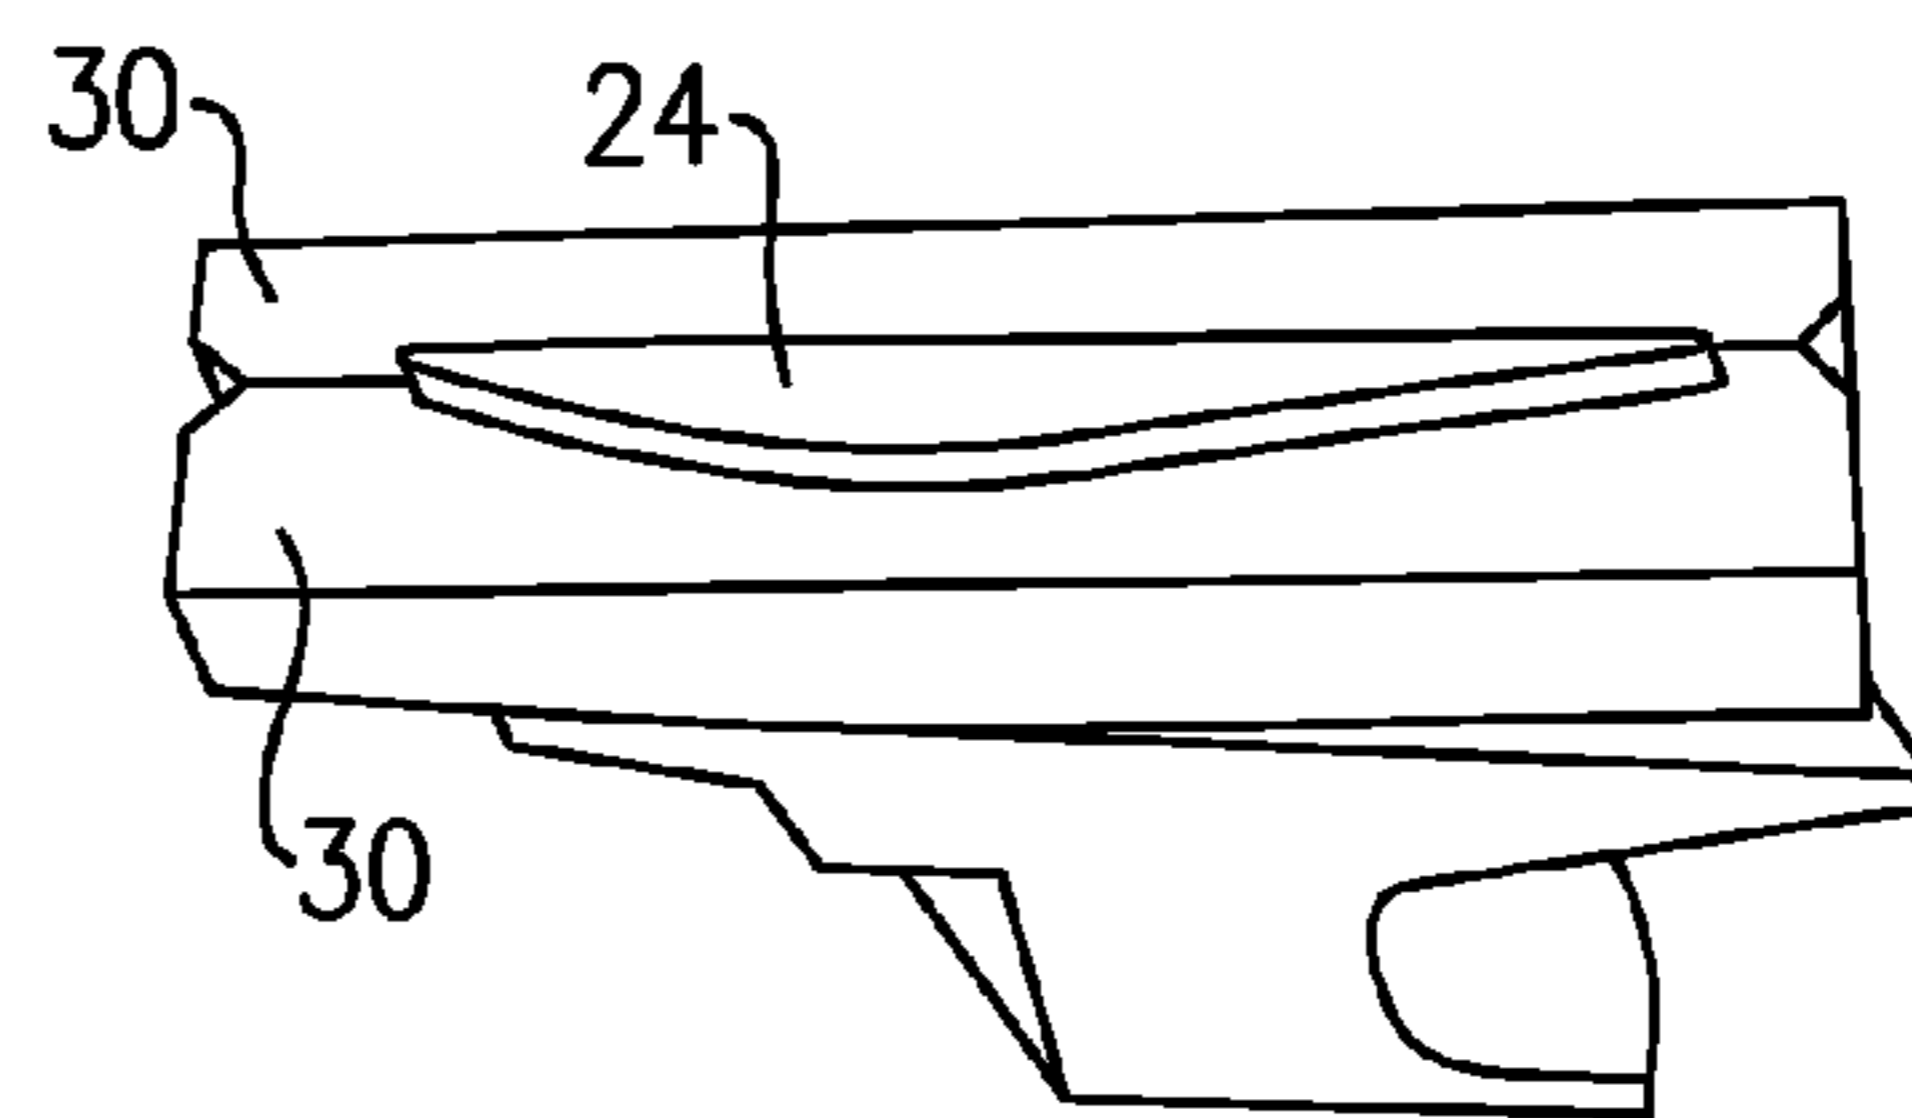
**FIG. 5**

FIG. 5 shows an embodiment of a collar according to this application;

toured to fit and mate with a portion of the outer circumferential surface 25 of the integrally bladed rotor 20. As shown in FIG. 5, the collar can be provided by two separate portions 30 which when assembled fit around the blade stub 24. As shown in FIG. 6, the collar may have portions 35 with an internal cavity 37 that actually extends above the blade stub 24. In this embodiment, there will be material from the collar actually sitting between the blade stub and the airfoil blank in the final repaired rotor. It is to be understood, however, that, if the design of the blade permits, the collar 29 may be a single-piece collar defining an internal cavity, having a continuous inner perimeter surface, that can be slipped over the blade stub 24 prior to commencement of the bonding step and can also be removed from the repaired blade.

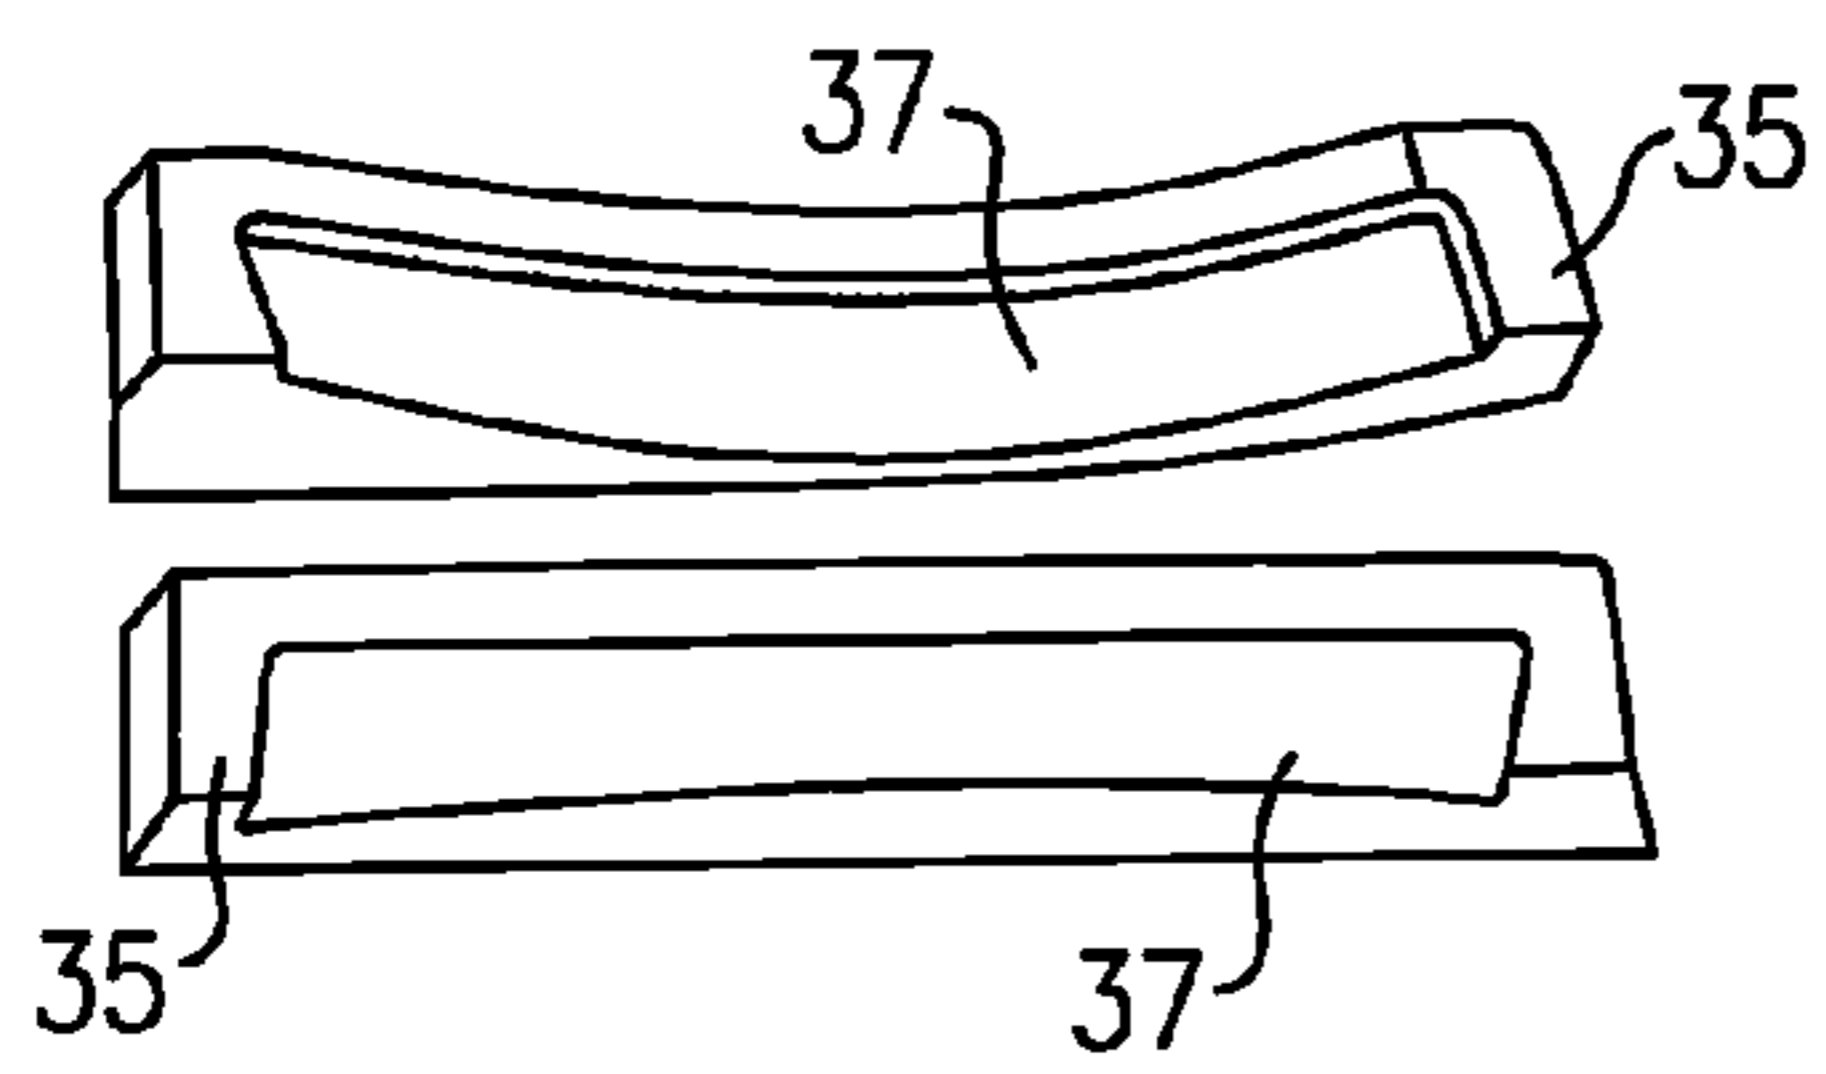
**FIG. 6**

FIG. 6 shows another embodiment;

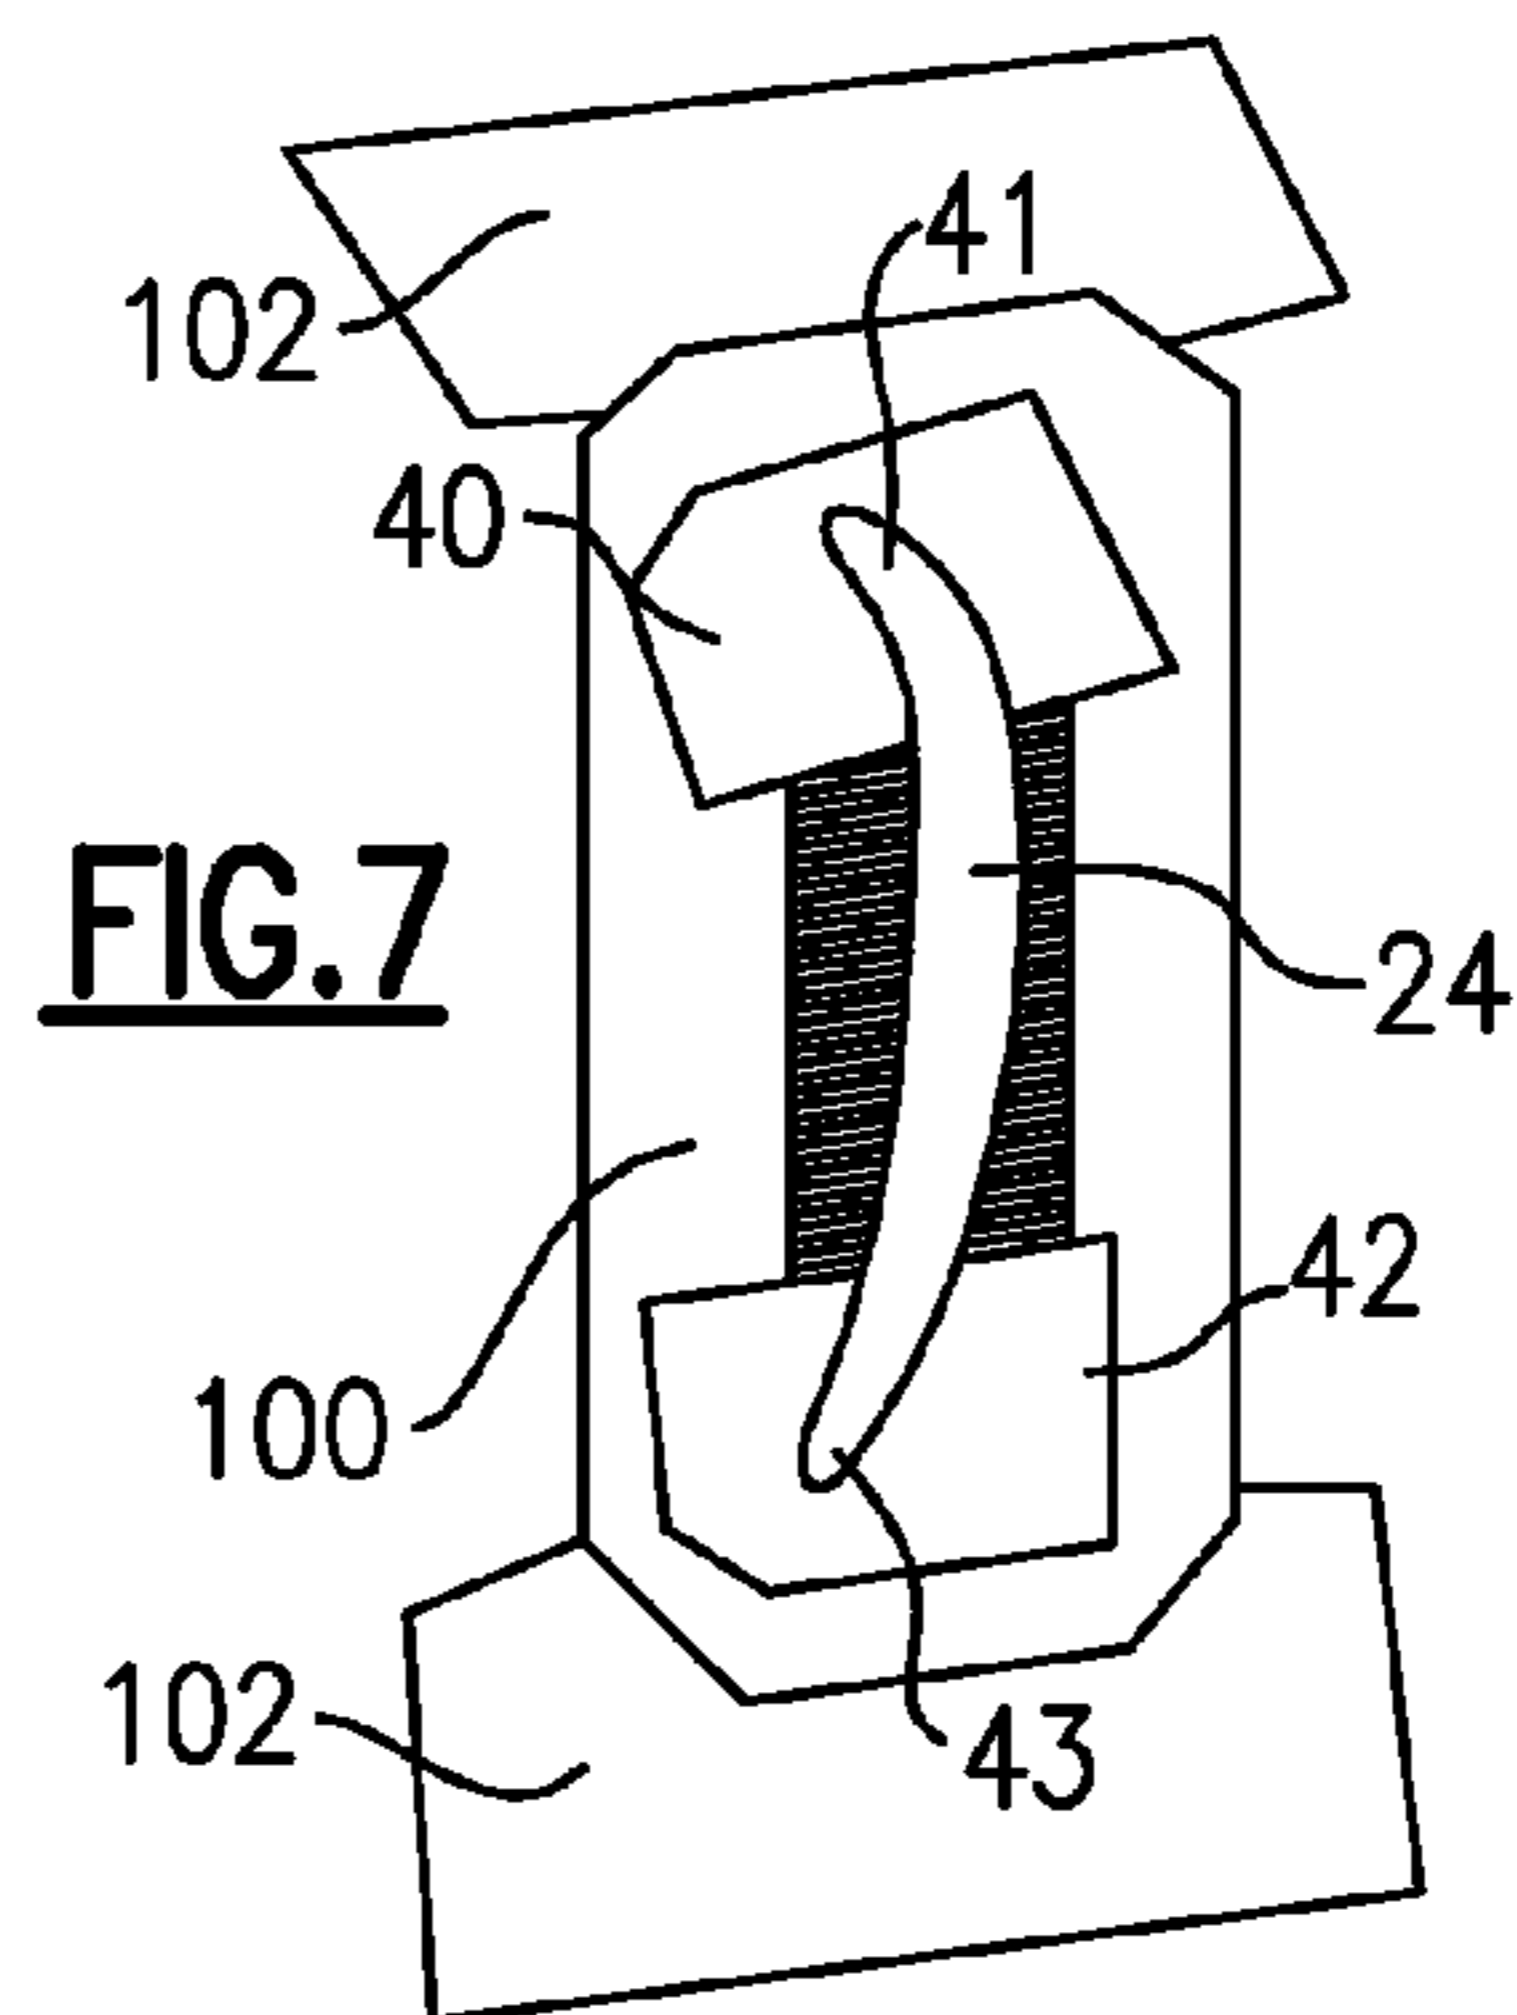
**FIG. 7**

FIG. 7 shows yet another embodiment; and

As shown in FIG. 7, it is also possible for the collar to be formed of separate portions 40 and 42 only supporting the leading and trailing edges 41 and 43. As shown, the two sub-collars support the edges, with unsupported portions at the outer circumference of the stub allowed between the two sub-collar portions 40 and 42. Thus, a collar holder 100 connects the leading and trailing edge sub-collar portions 40 and 42. In addition, tooling 102 may be provided to hold the collar support 100.

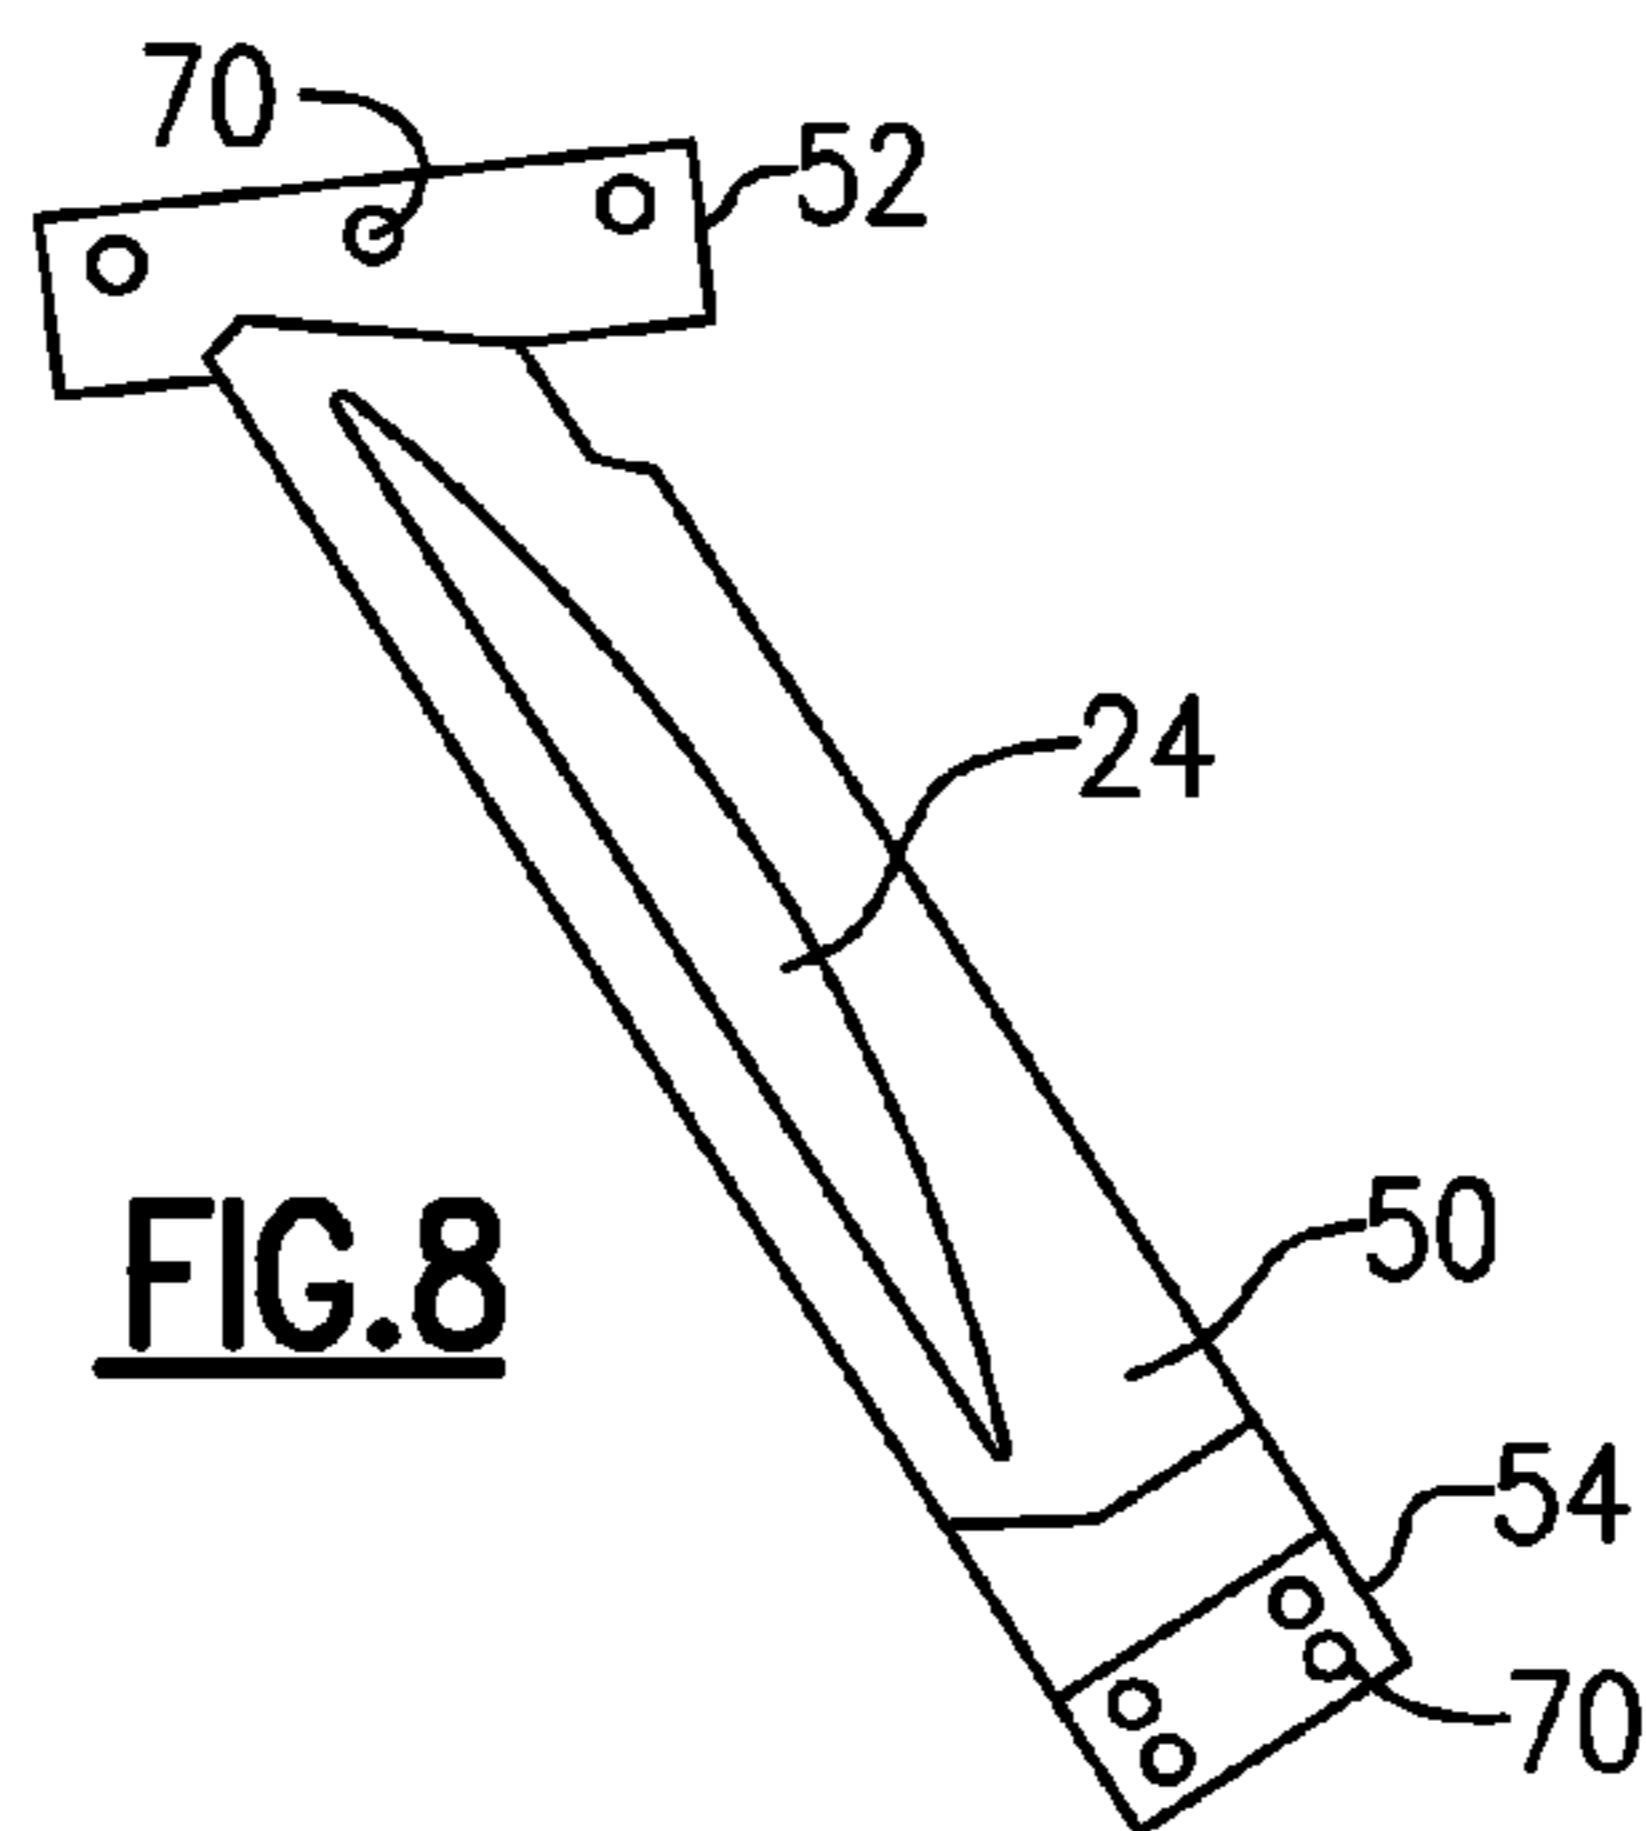
**FIG. 8**

FIG. 8 shows a collar secured to the linear friction welding machine apparatus.
