US008720056B2

(54) **TURBINE ROTOR BLADE REPAIR METHOD**

(73) Assignee: **Mitsubishi Heavy Industries, Ltd.**, Tokyo (JP)

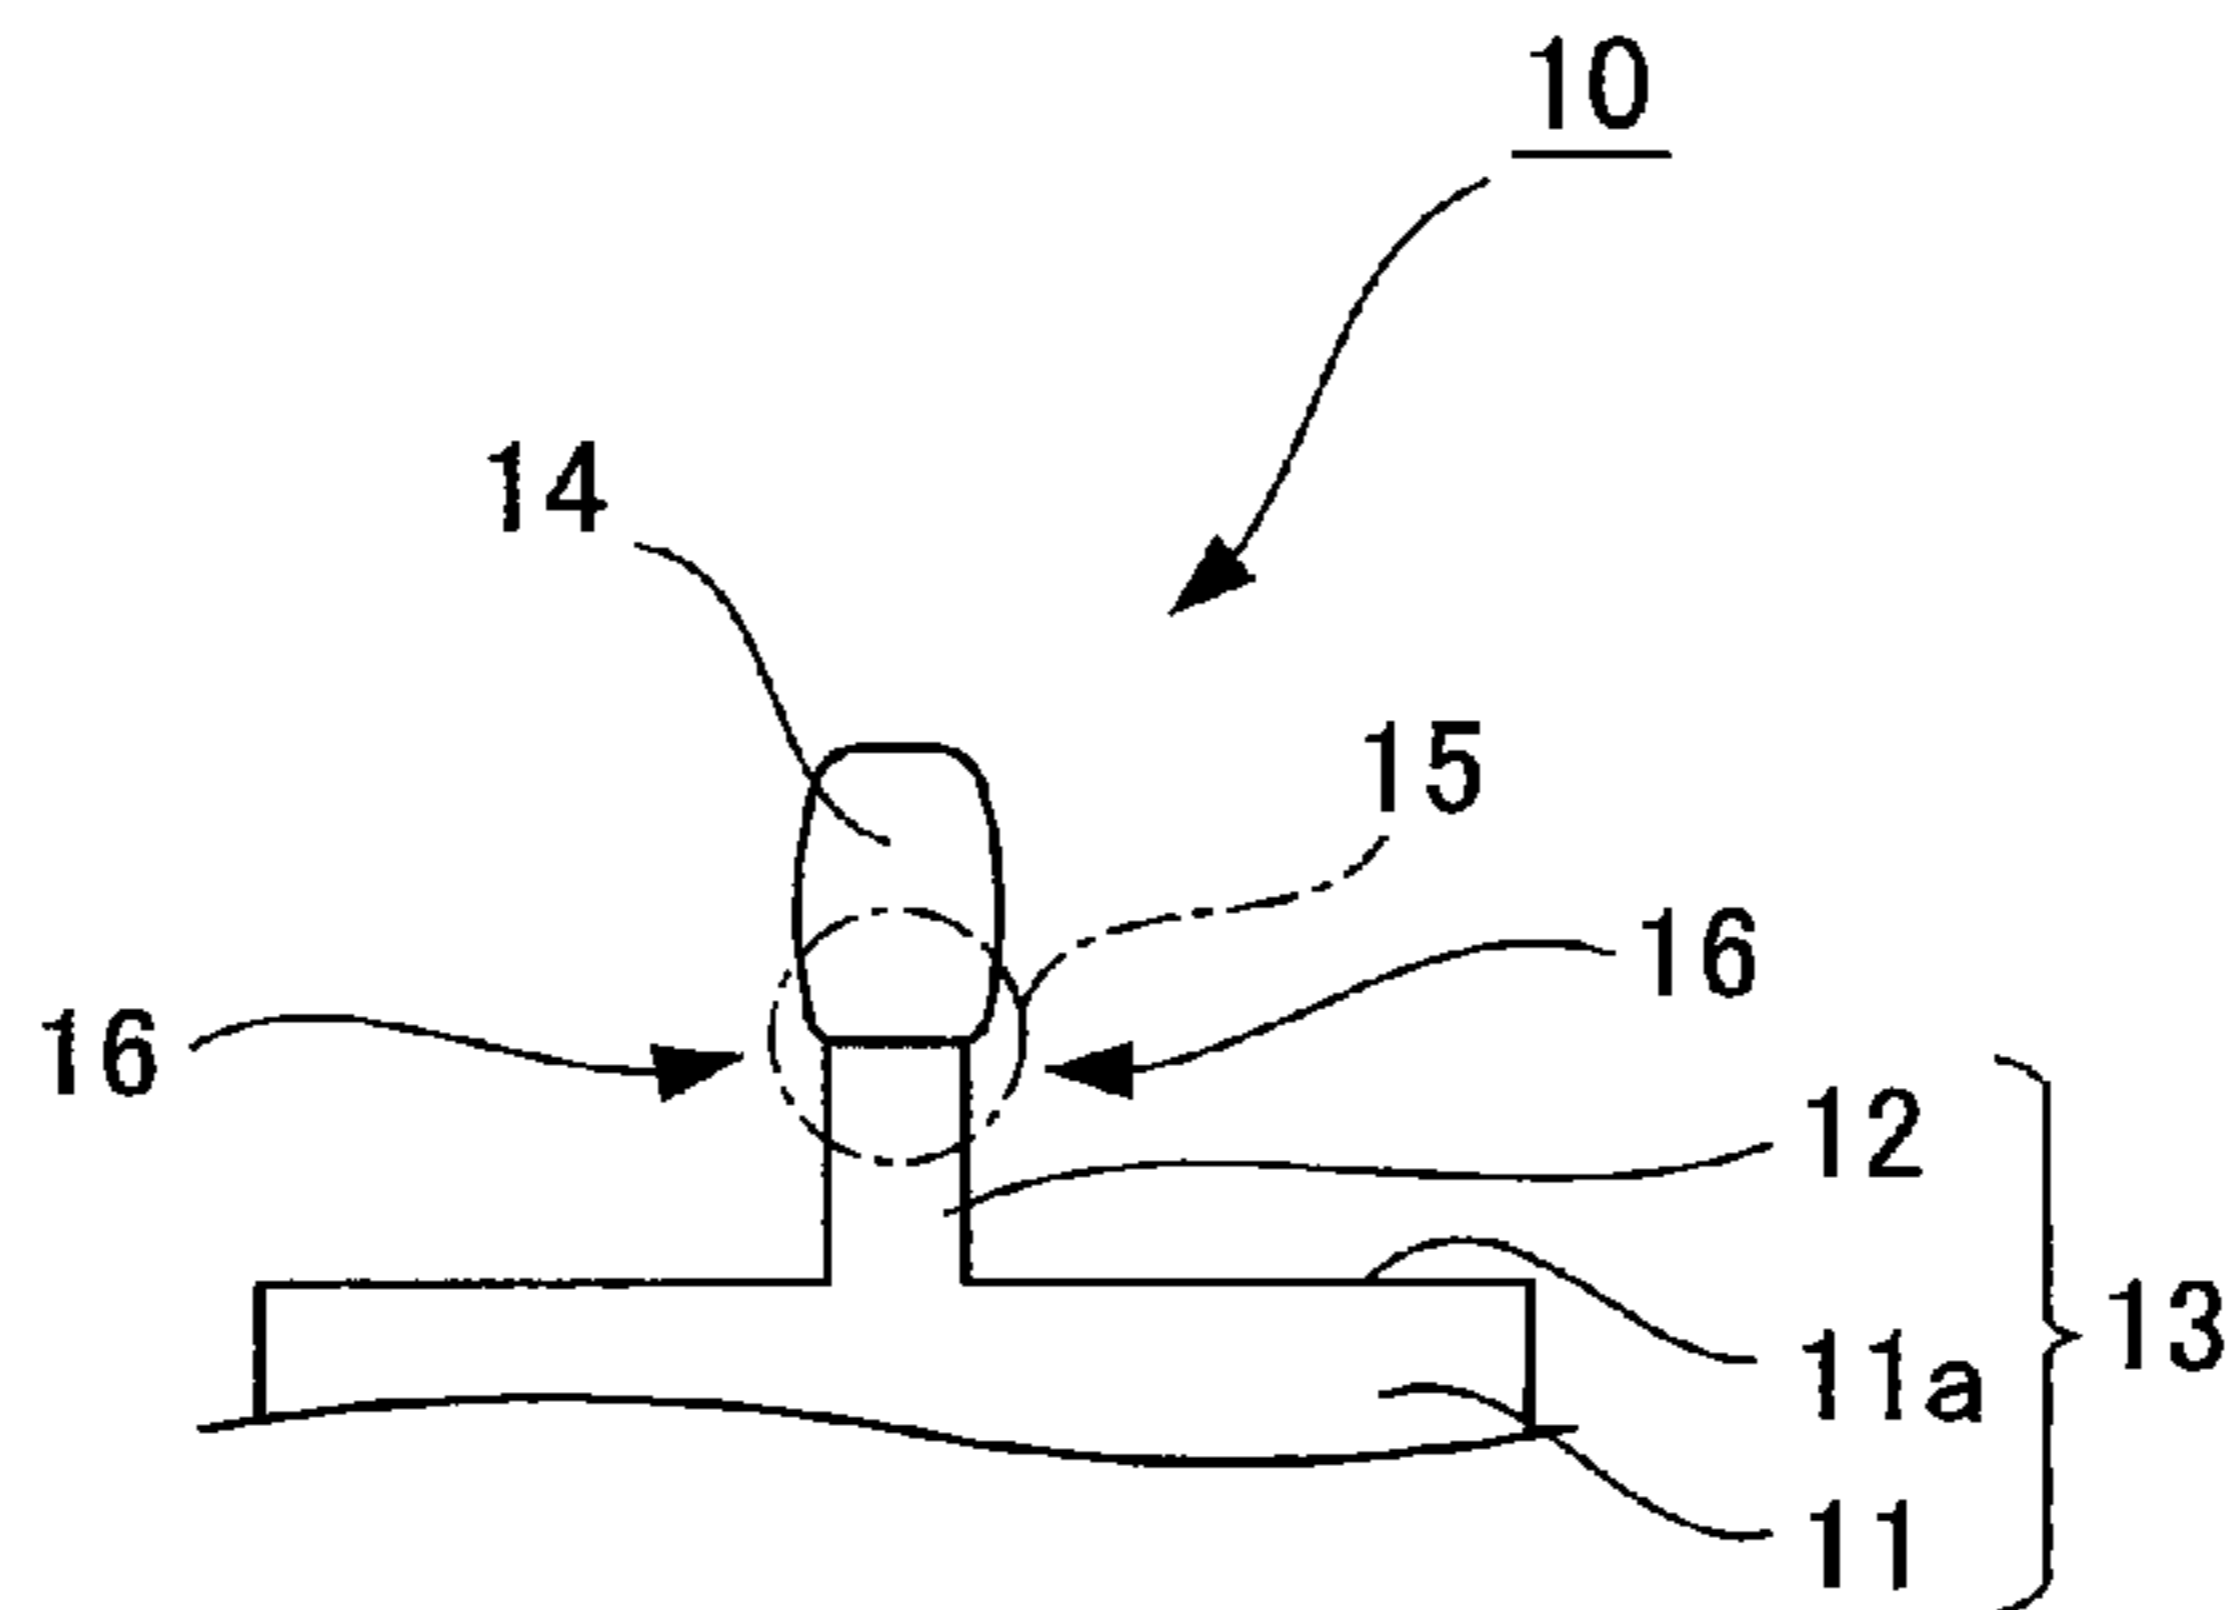
**Fig. 2**

FIG. 2 is a view for explaining peening of the first embodiment of the turbine rotor blade repair method according to the present invention.

Then, in step S4, peening is performed. The peening is performed by a peening hammer. As shown in FIG. 2, this treatment is performed on both side portions of the heat-affected zone 15 affected by the heat of the overlay welding. Thus, compressive residual stresses are produced in the boundary region between the fin and the overlaying metal. Accordingly, as shown in FIG. 3(b), tensile residual stresses 22a and 22b in the boundary region between the fin and the overlaying metal are reduced compared to the tensile residual stresses 21a and 21b produced during welding.

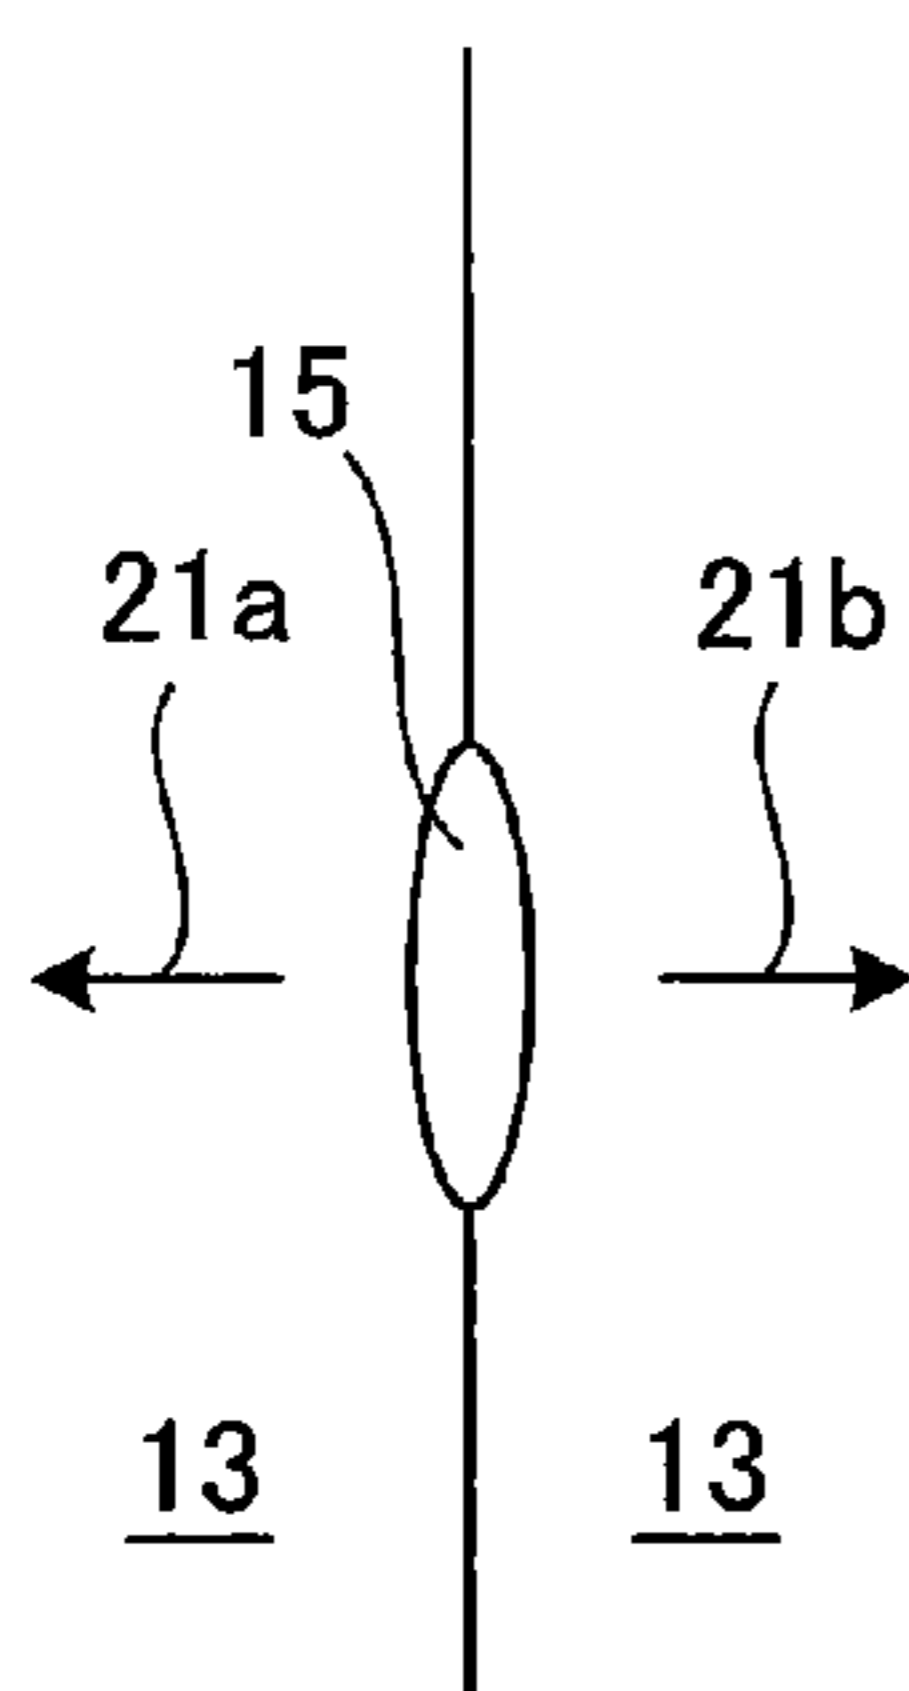
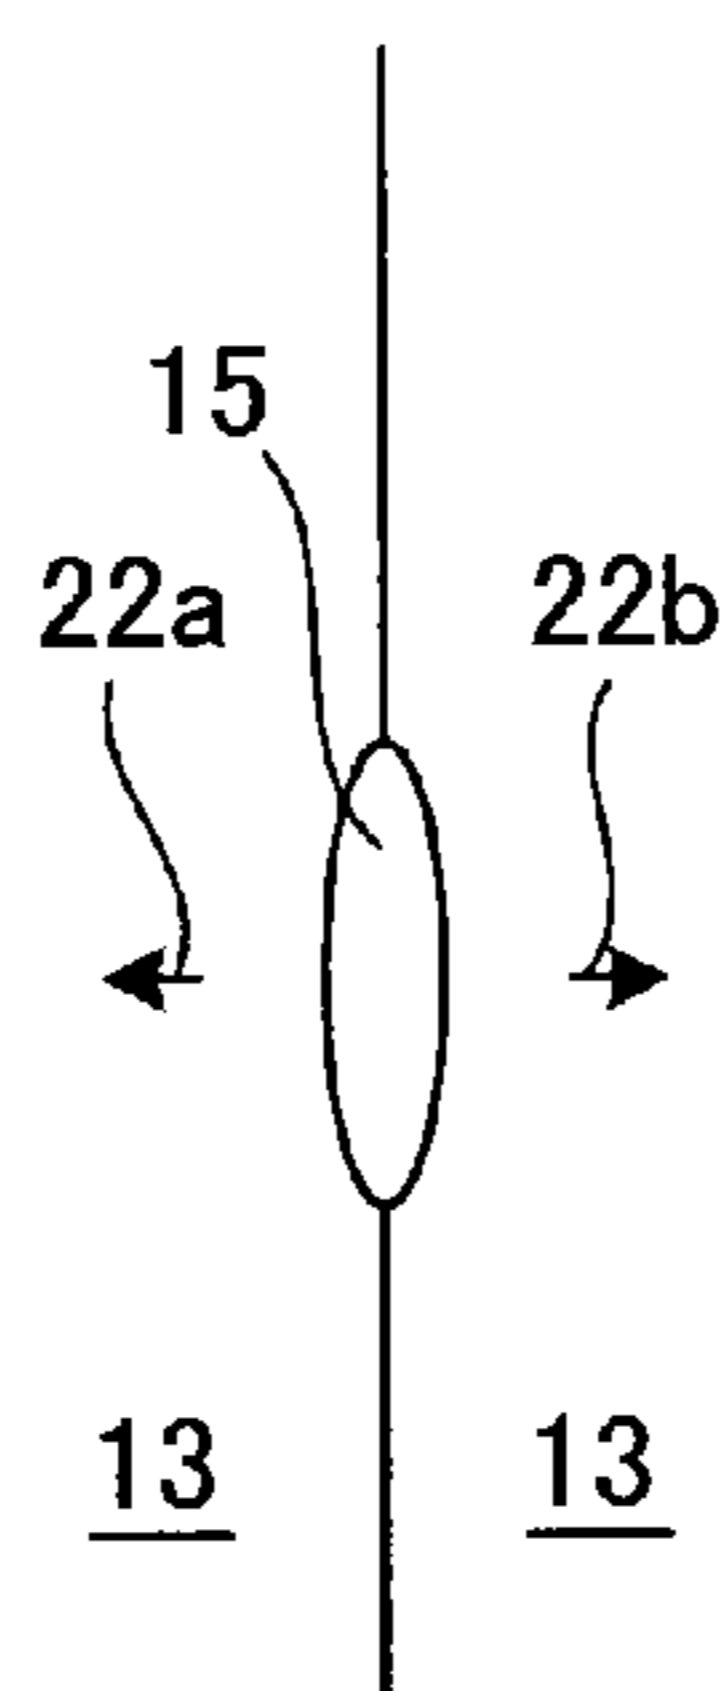
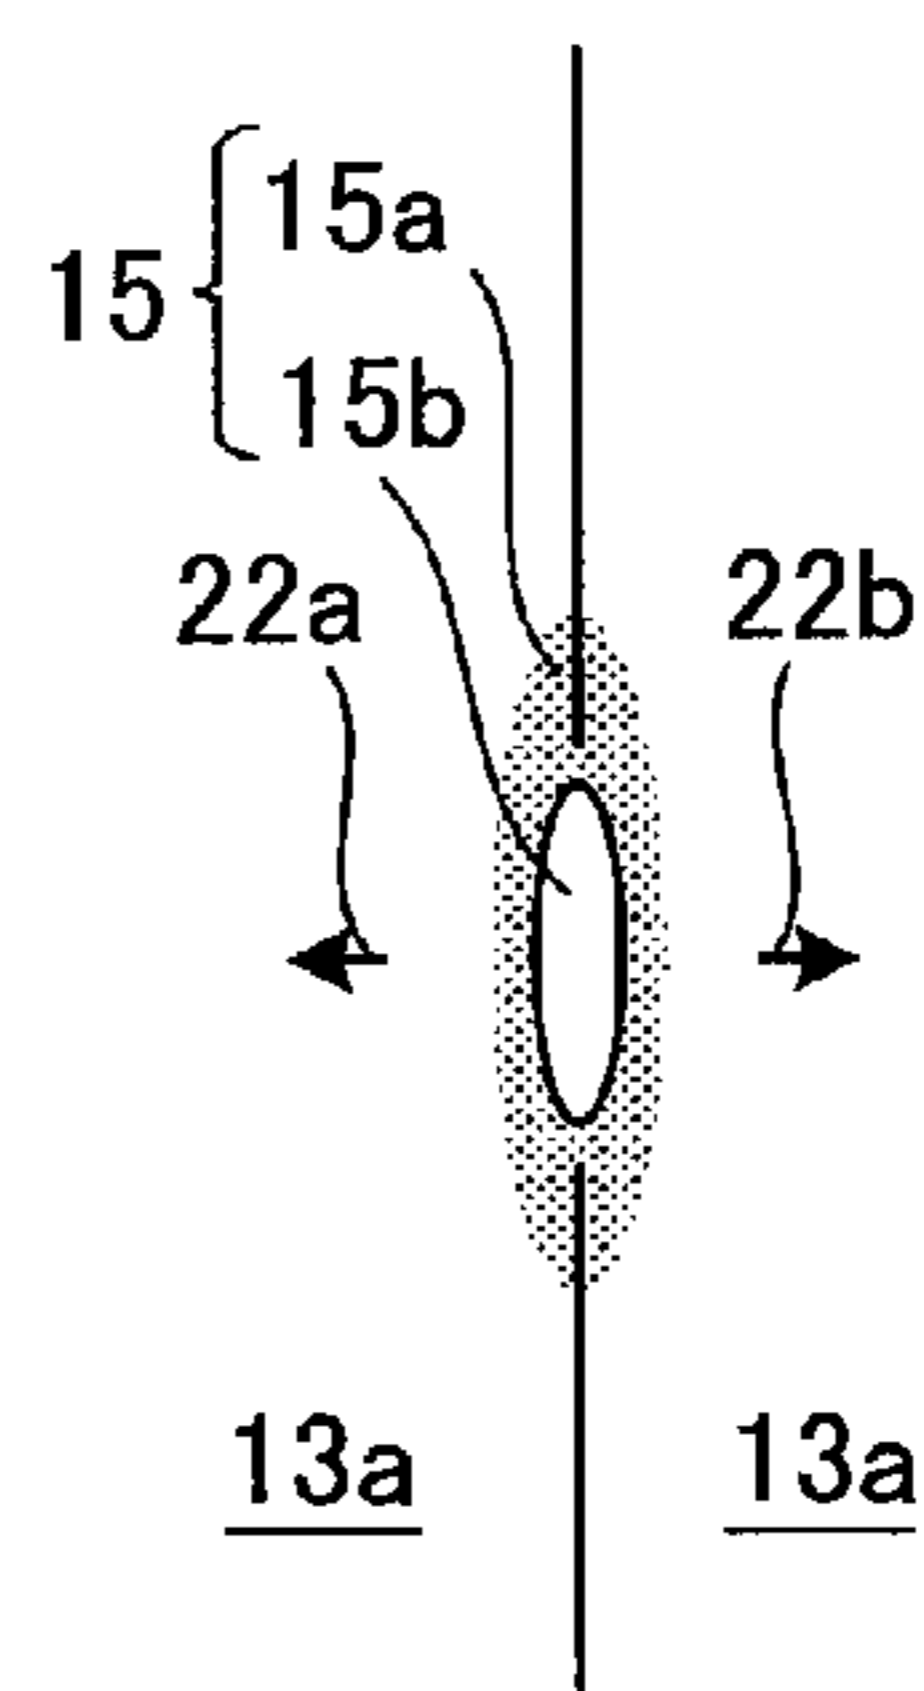
**Fig. 3(a)**

**Fig. 3(b)**

**Fig. 3(c)**

FIGS. 3(a) to 3(c) are views for explaining a boundary region produced by overlay welding of the first embodiment of the turbine rotor blade repair method according to the present invention.

A first embodiment in which the turbine rotor blade repair method according to the present invention is applied to a repair of a flat fin of a gas turbine rotor blade will be described with reference to FIGS. 1 to 3. FIG. 1 is a flowchart of the turbine rotor blade repair method. FIG. 2 is a view for explaining peening. FIGS. 3(a) to 3(c) are views for explaining a boundary region produced by overlay welding. It should be noted that in FIGS. 3(a) to 3(c), the lengths of arrows indicate the magnitudes of tensile residual stresses.

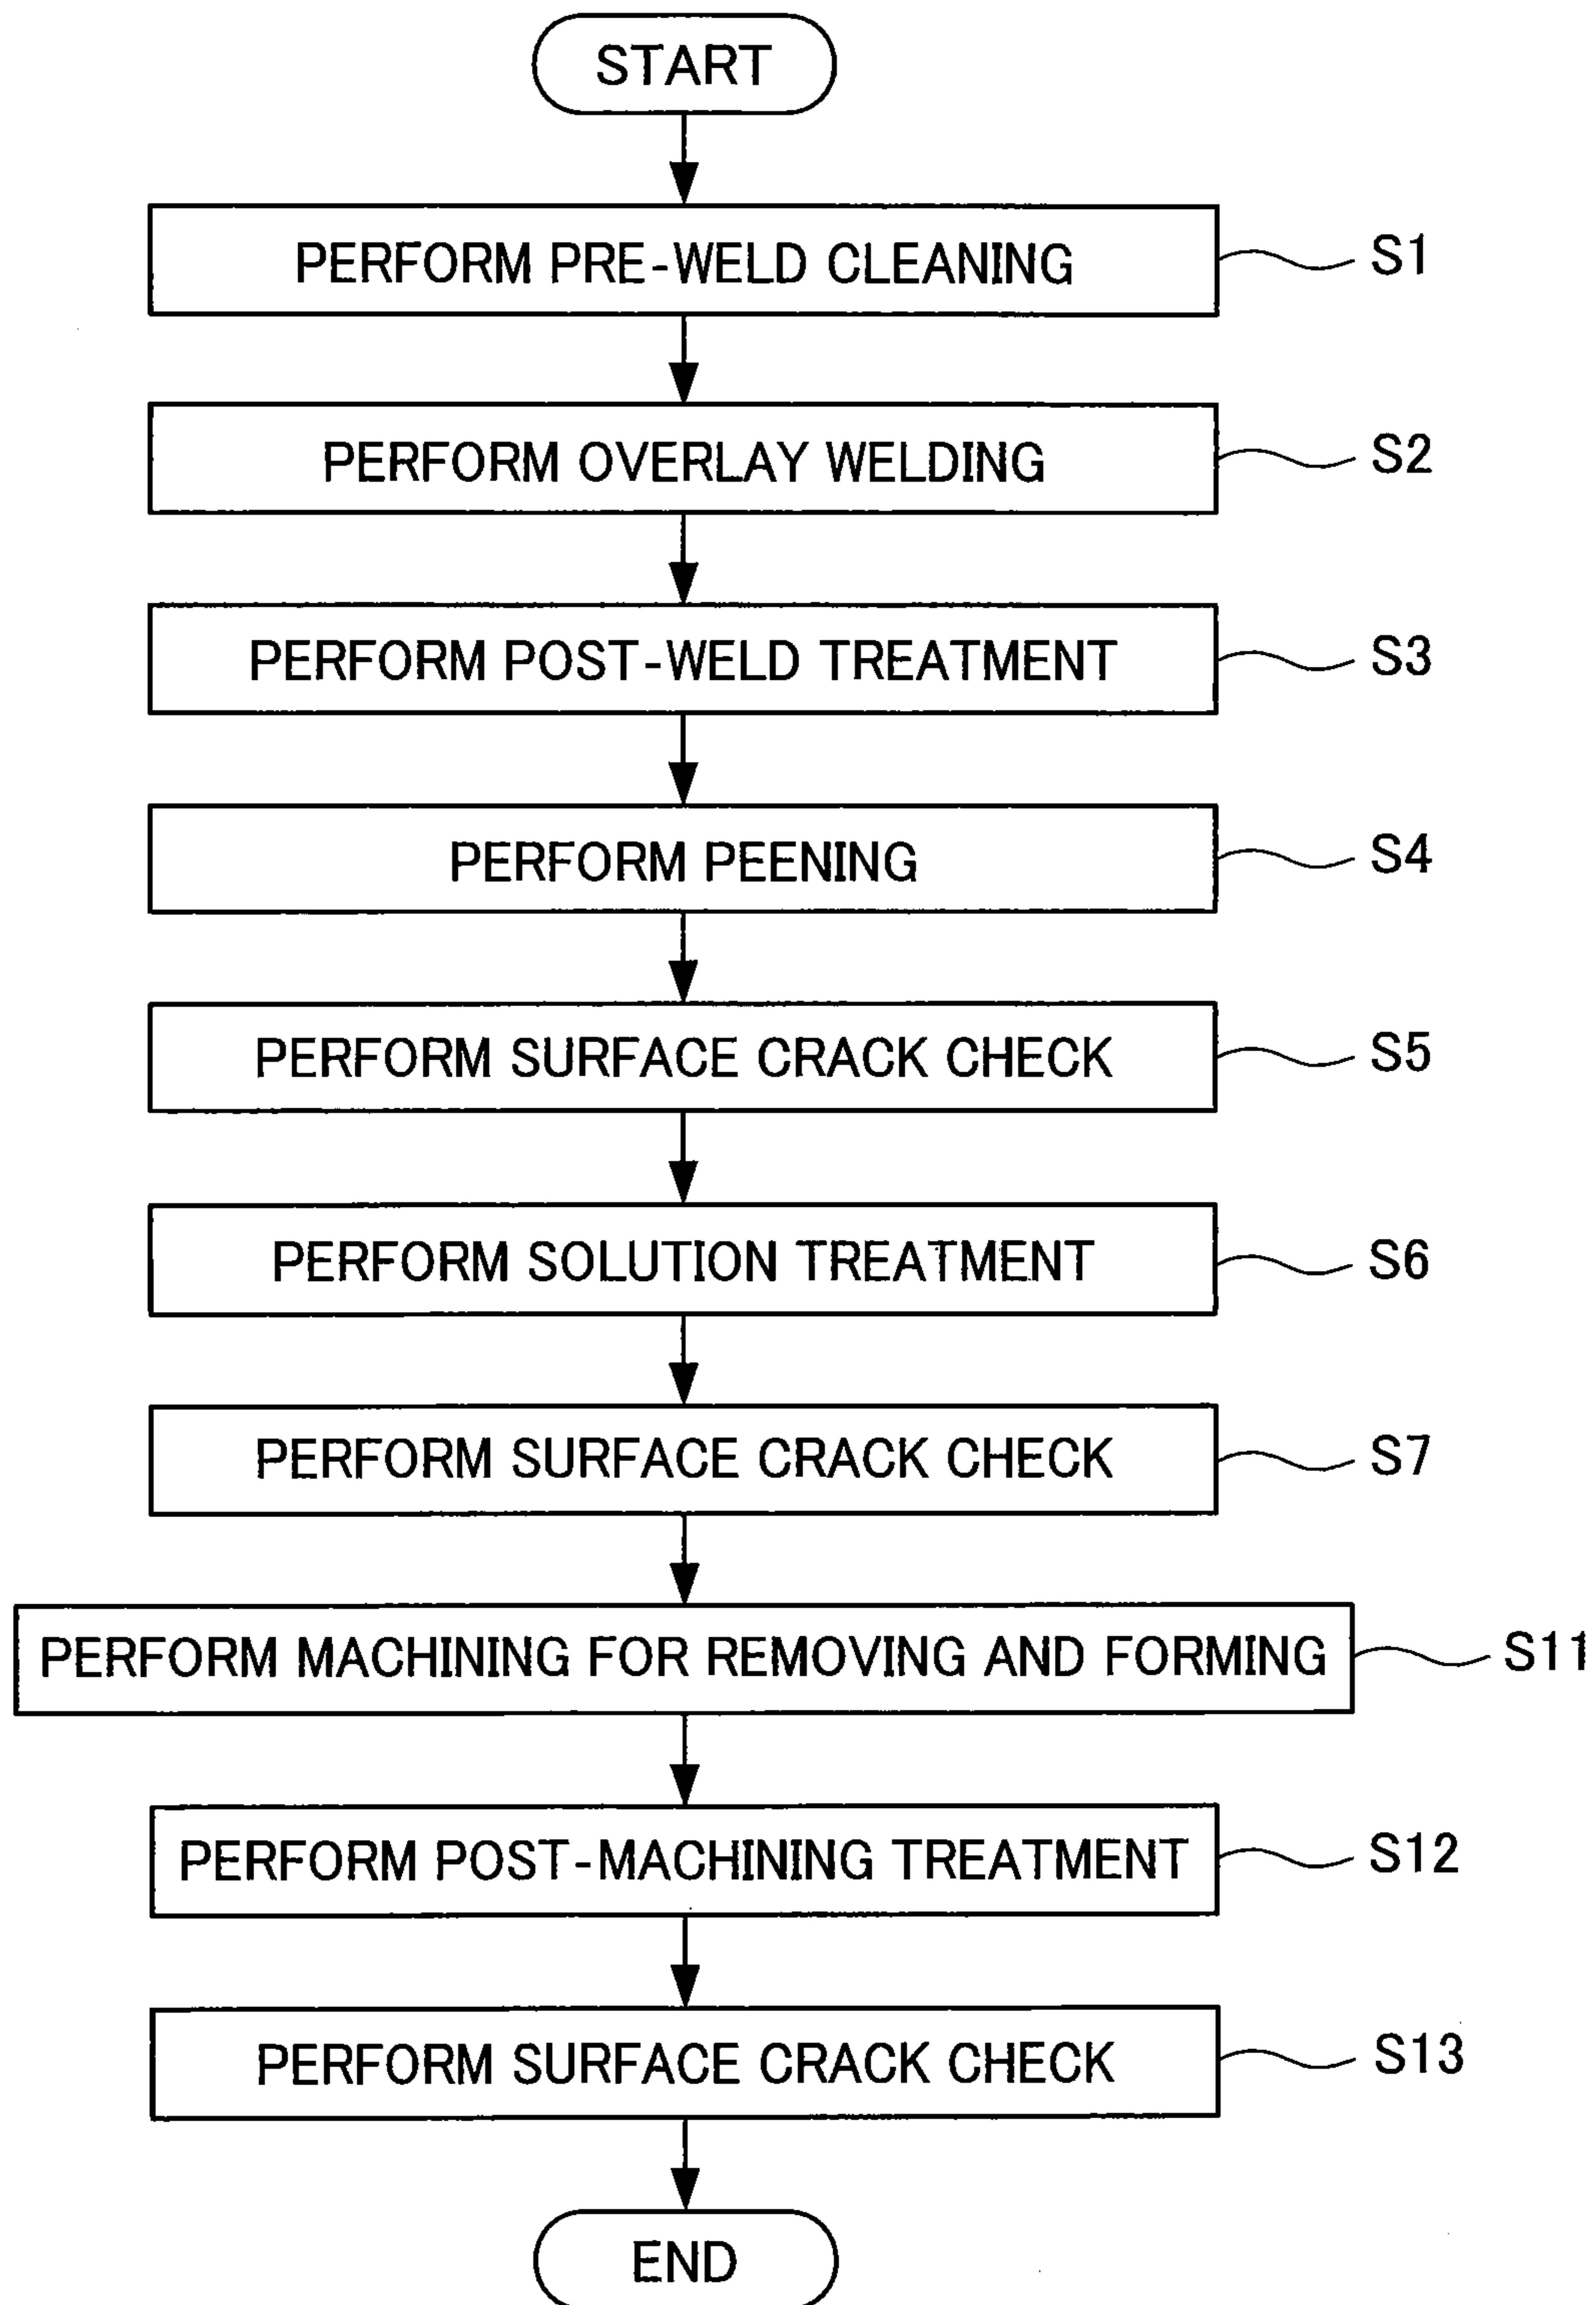
*Fig. 4*

FIG. 4 is a flowchart of a second embodiment of the turbine rotor blade repair method according to the present invention.

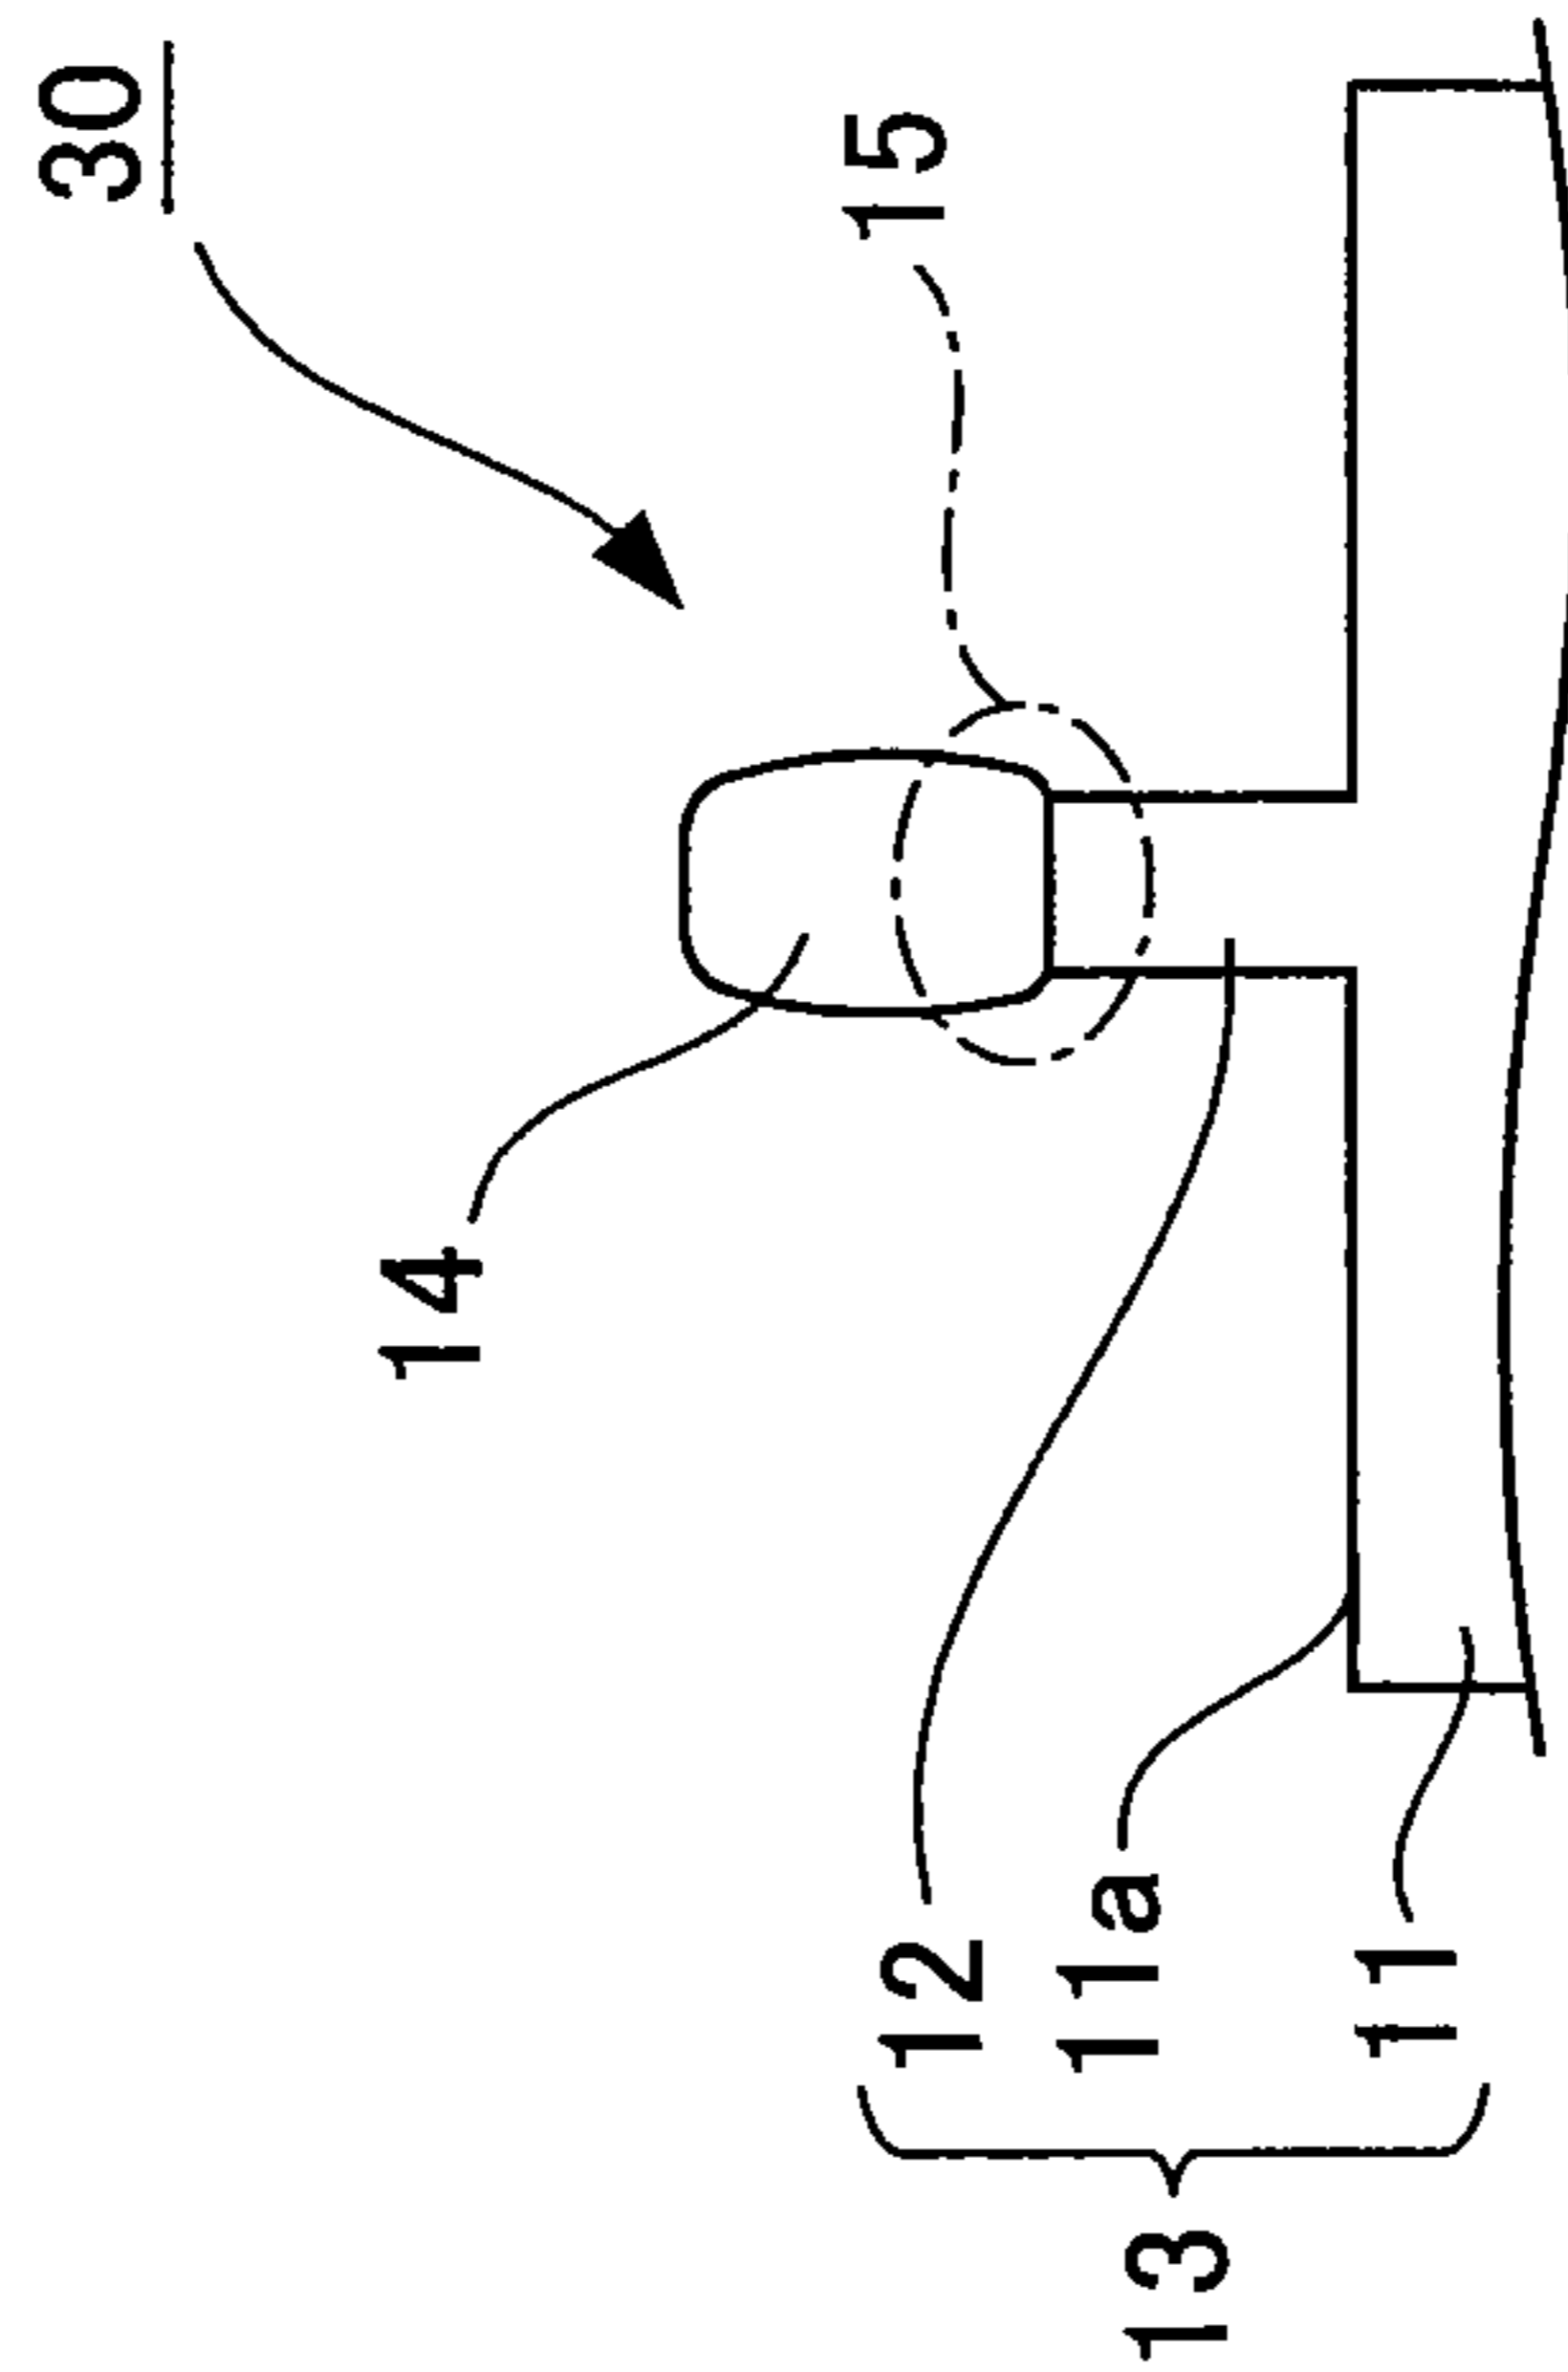
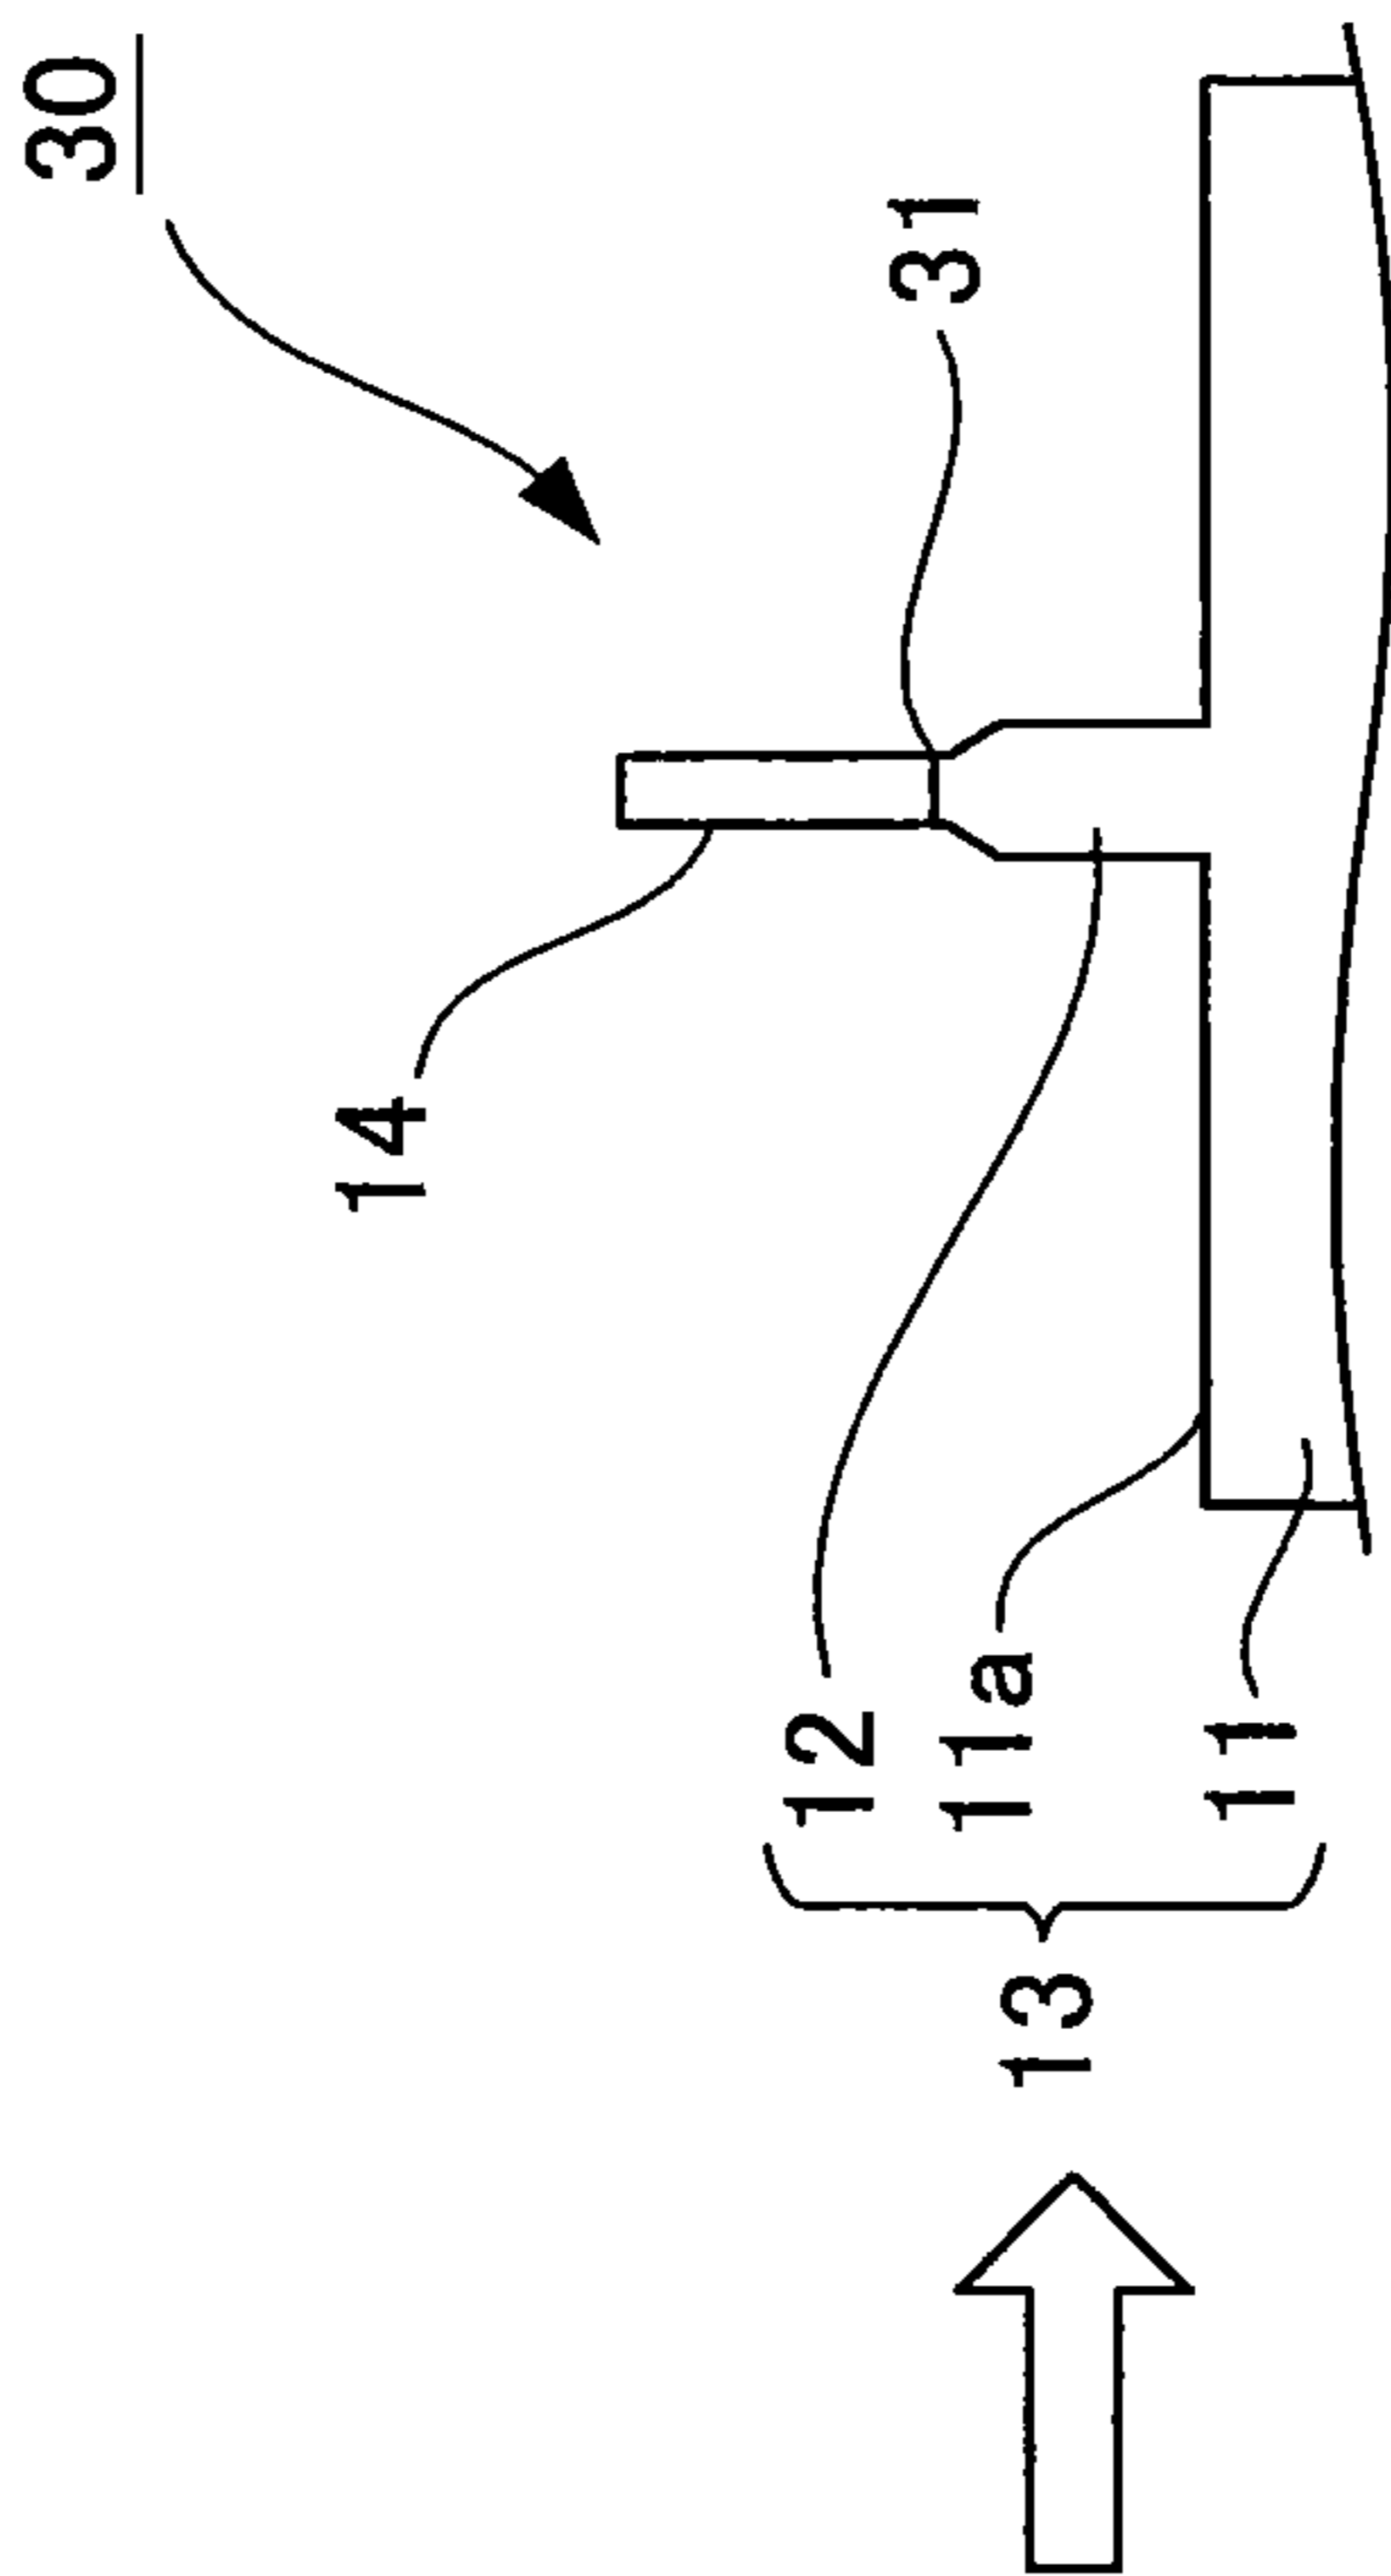
*Fig. 5(a)*

*Fig. 5(b)*

FIGS. 5(a) and 5(b) are views for explaining machining for removing and forming of the second embodiment of the turbine rotor blade repair method according to the present invention.

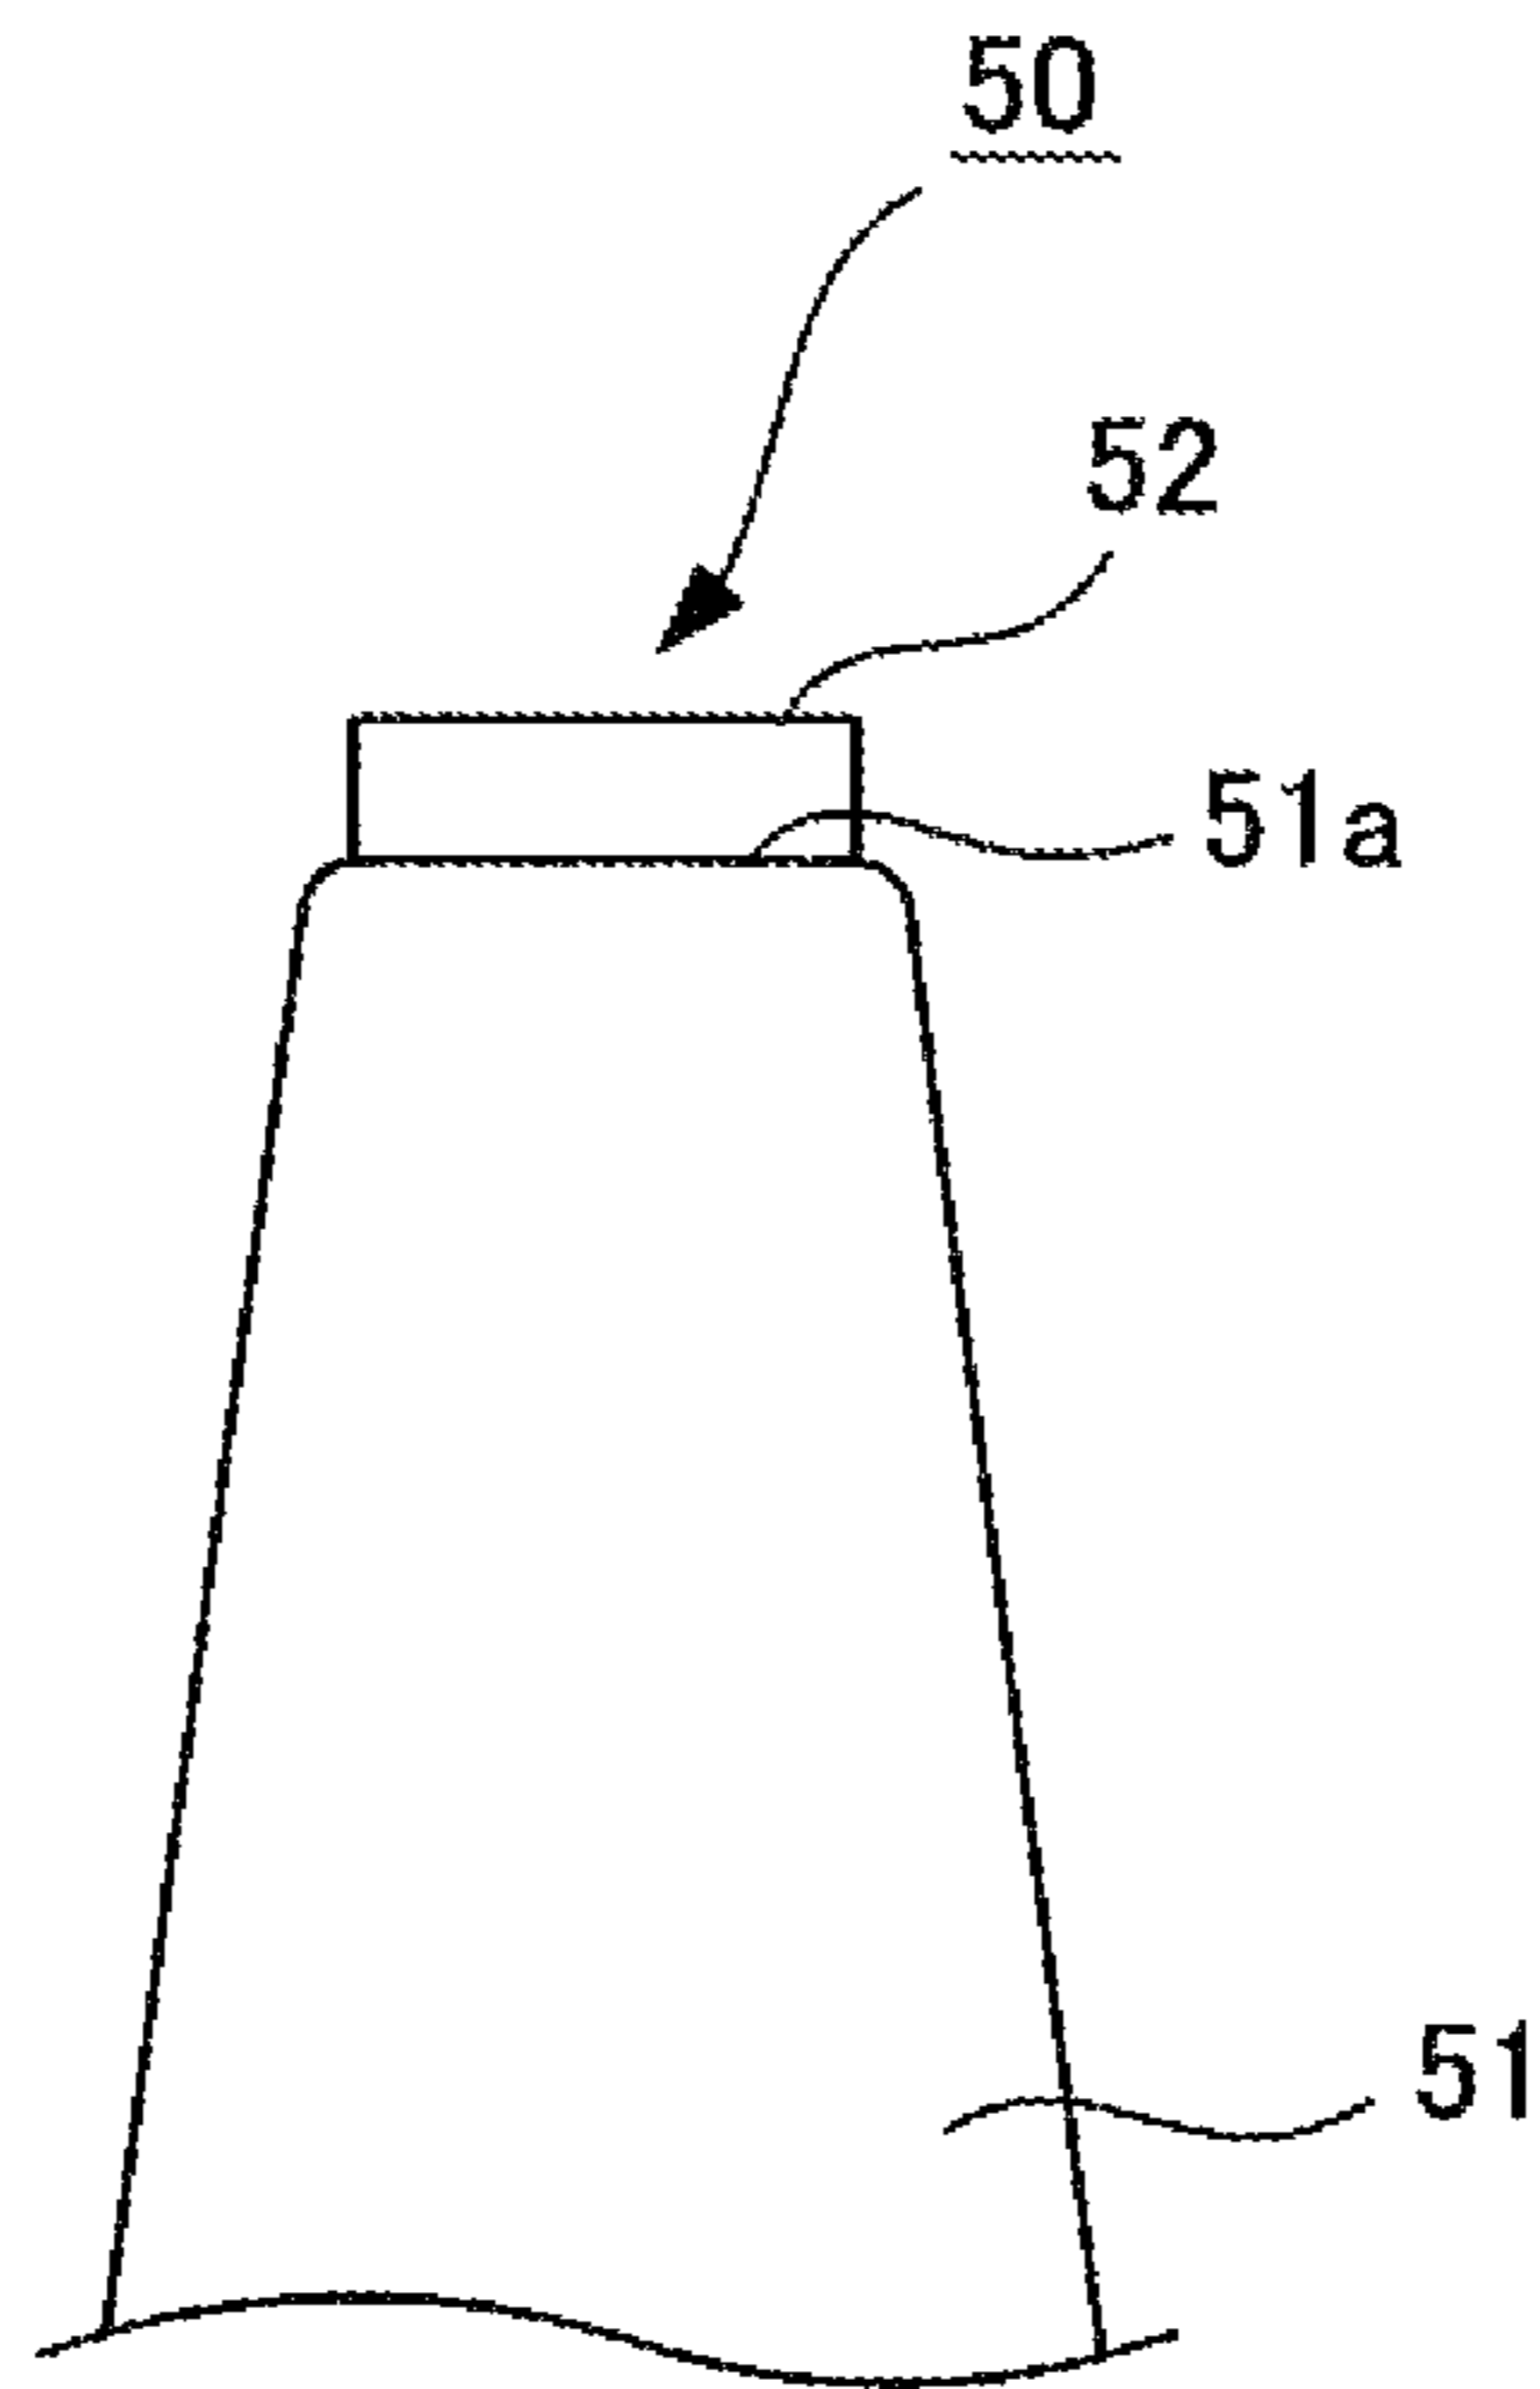
*Fig. 6*

FIG. 6 is a view showing one example of a turbine rotor blade.
