US008720056B2

(54) **TURBINE ROTOR BLADE REPAIR METHOD**

(73) Assignee: **Mitsubishi Heavy Industries, Ltd.**, Tokyo (JP)

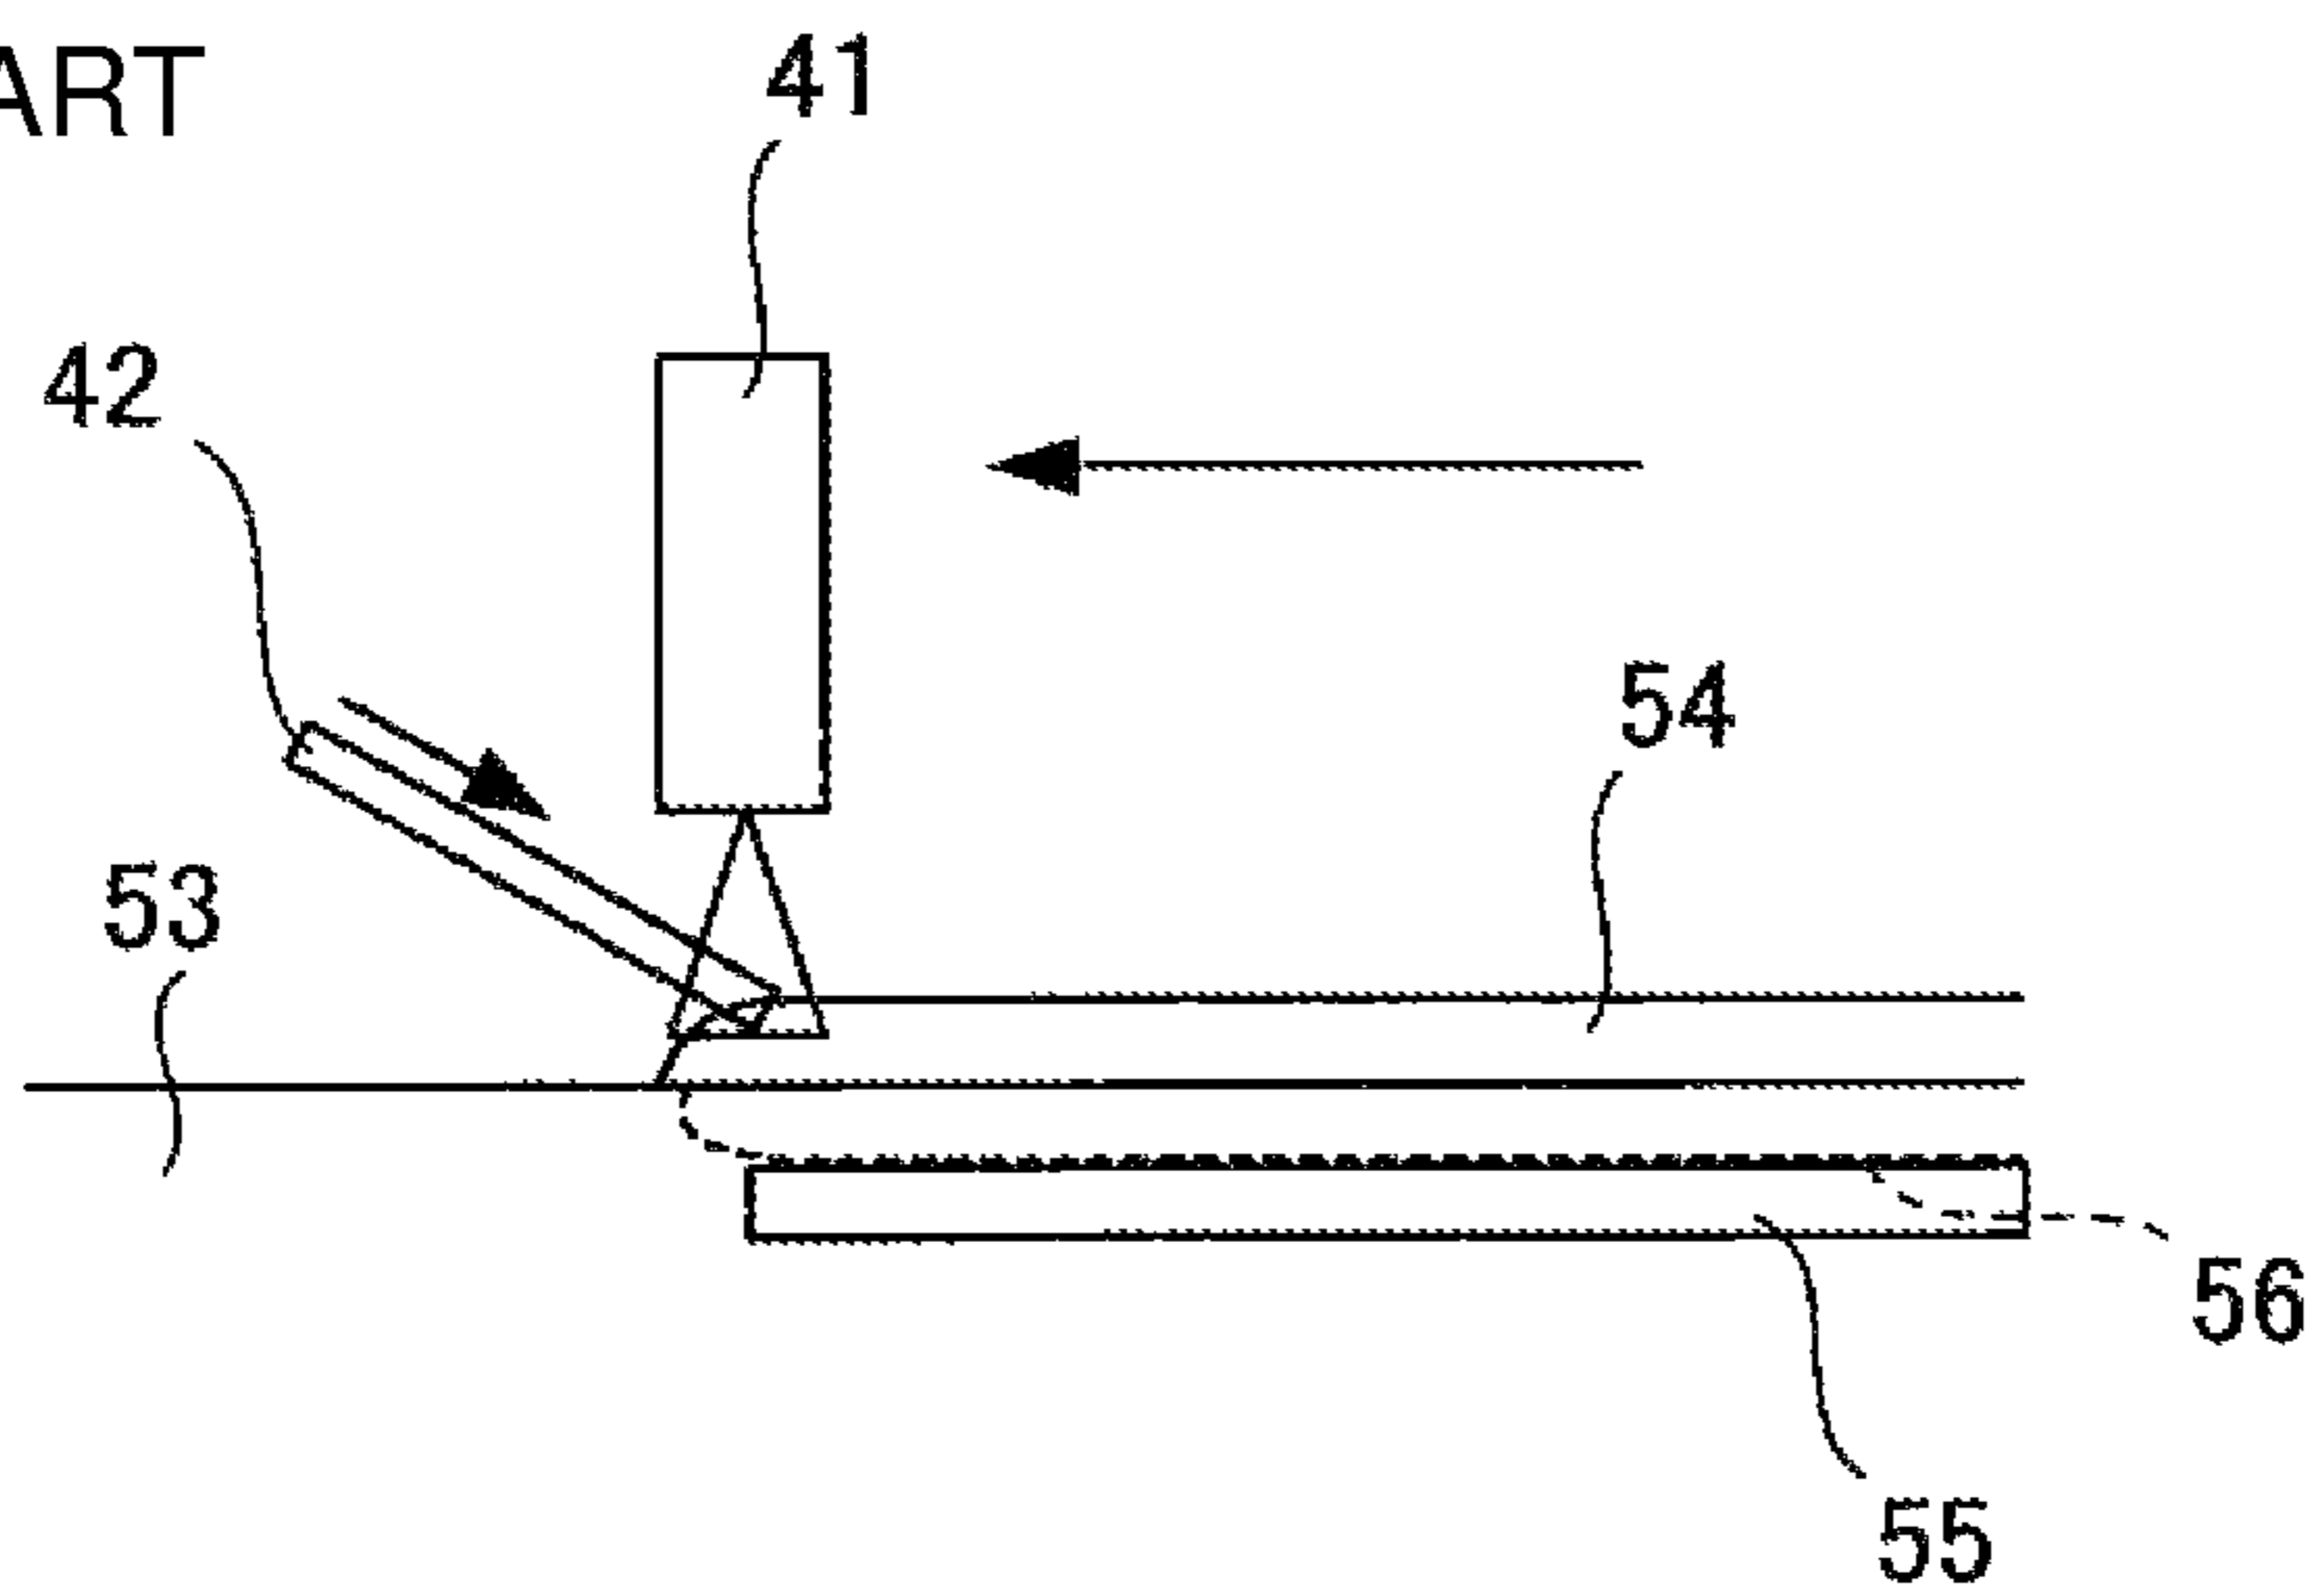
*Fig. 7*

PRIOR ART

FIG. 7 is a view for explaining a conventional turbine rotor blade repair method.

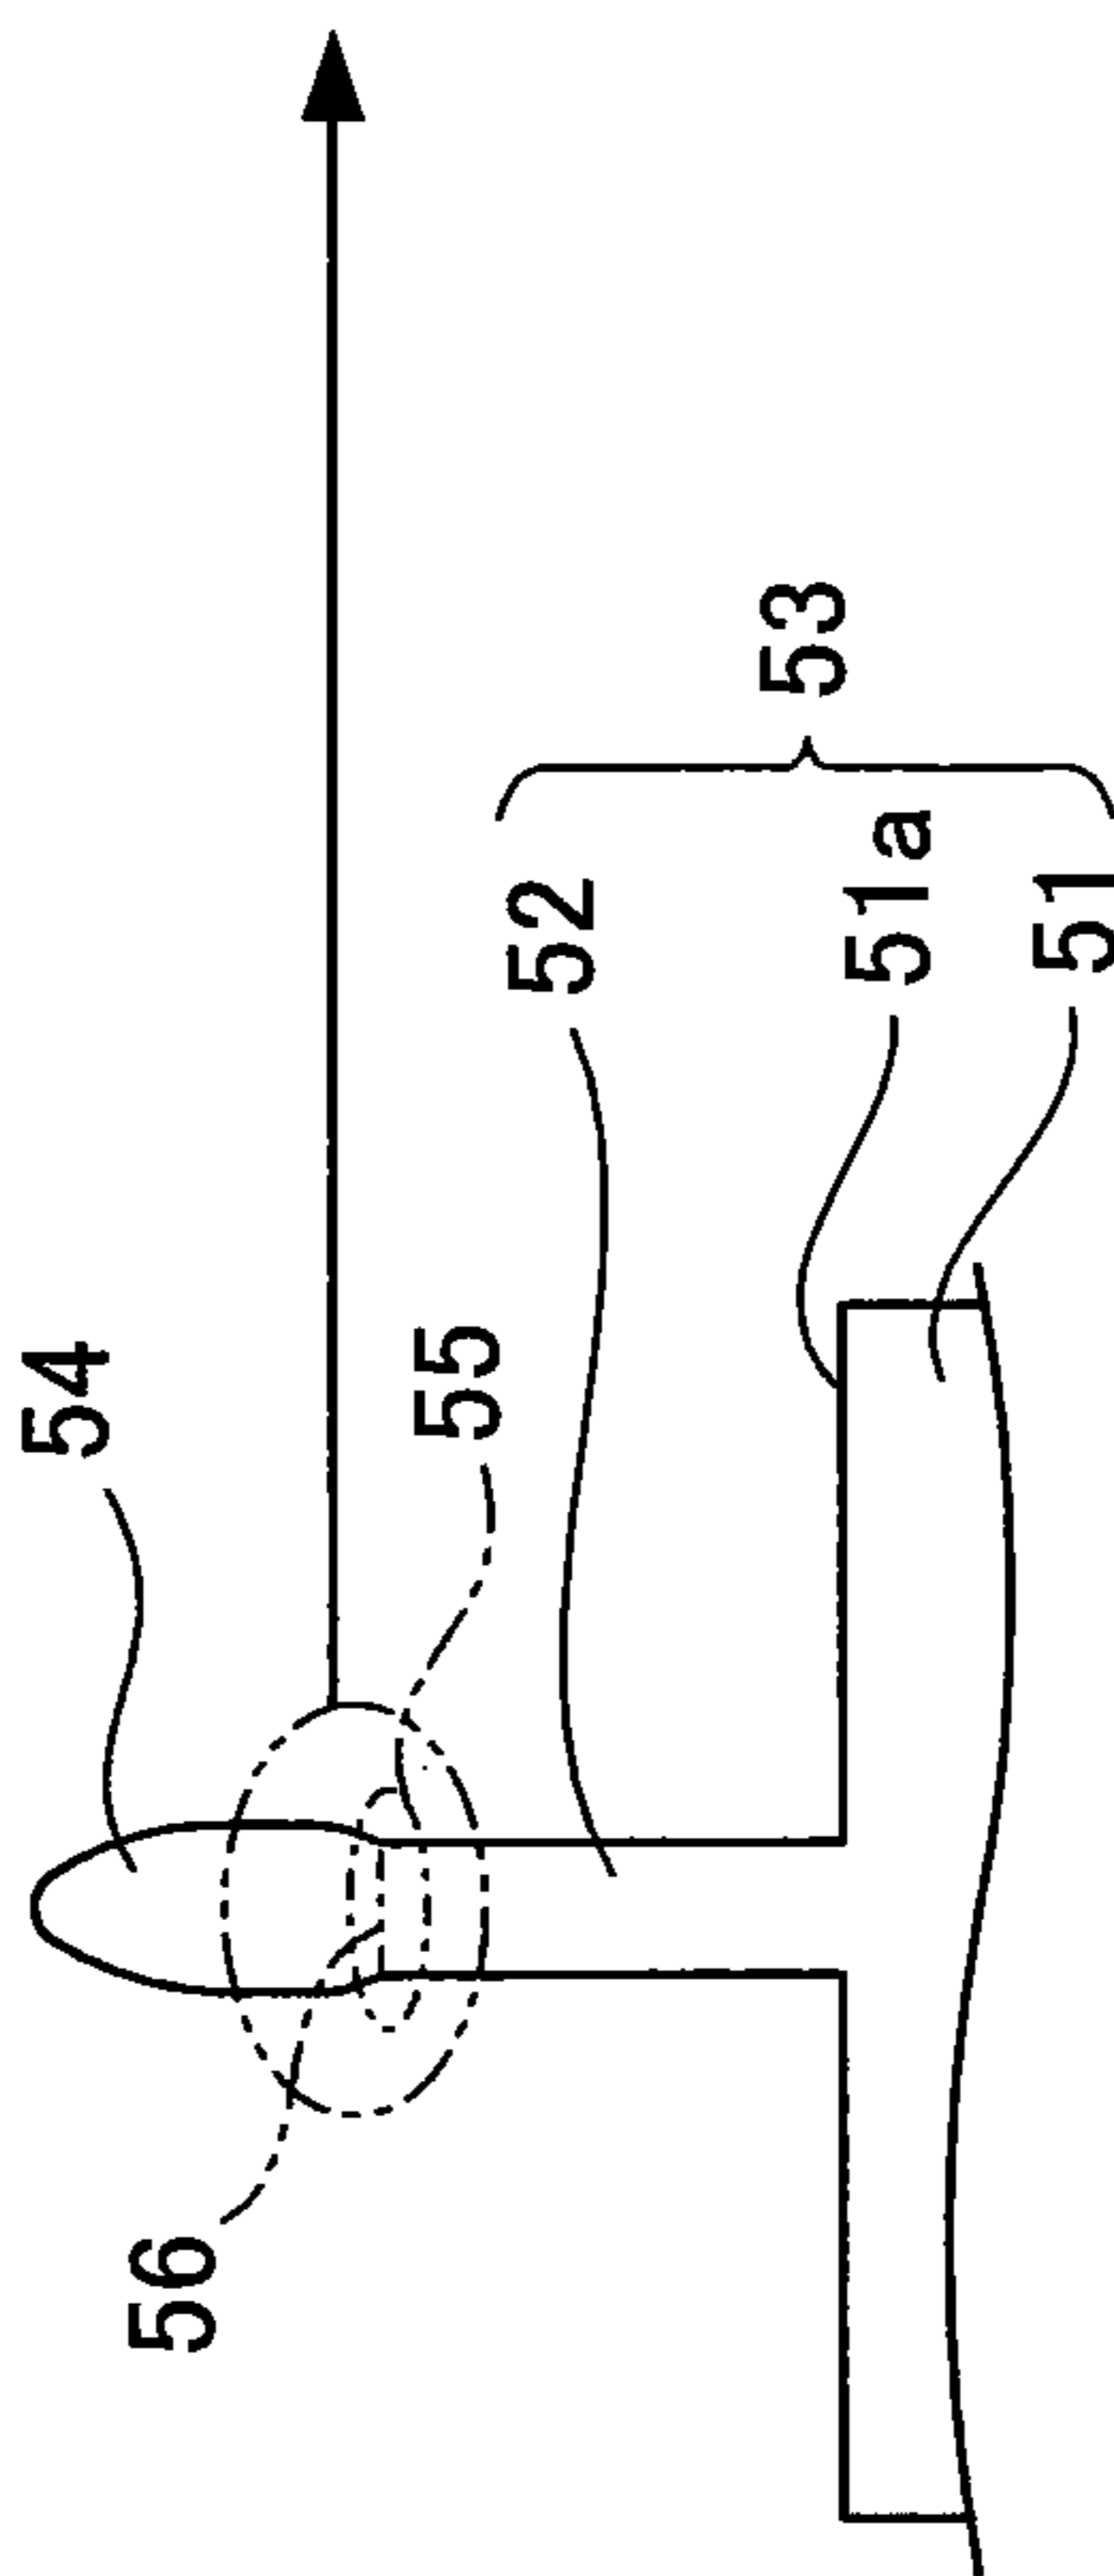
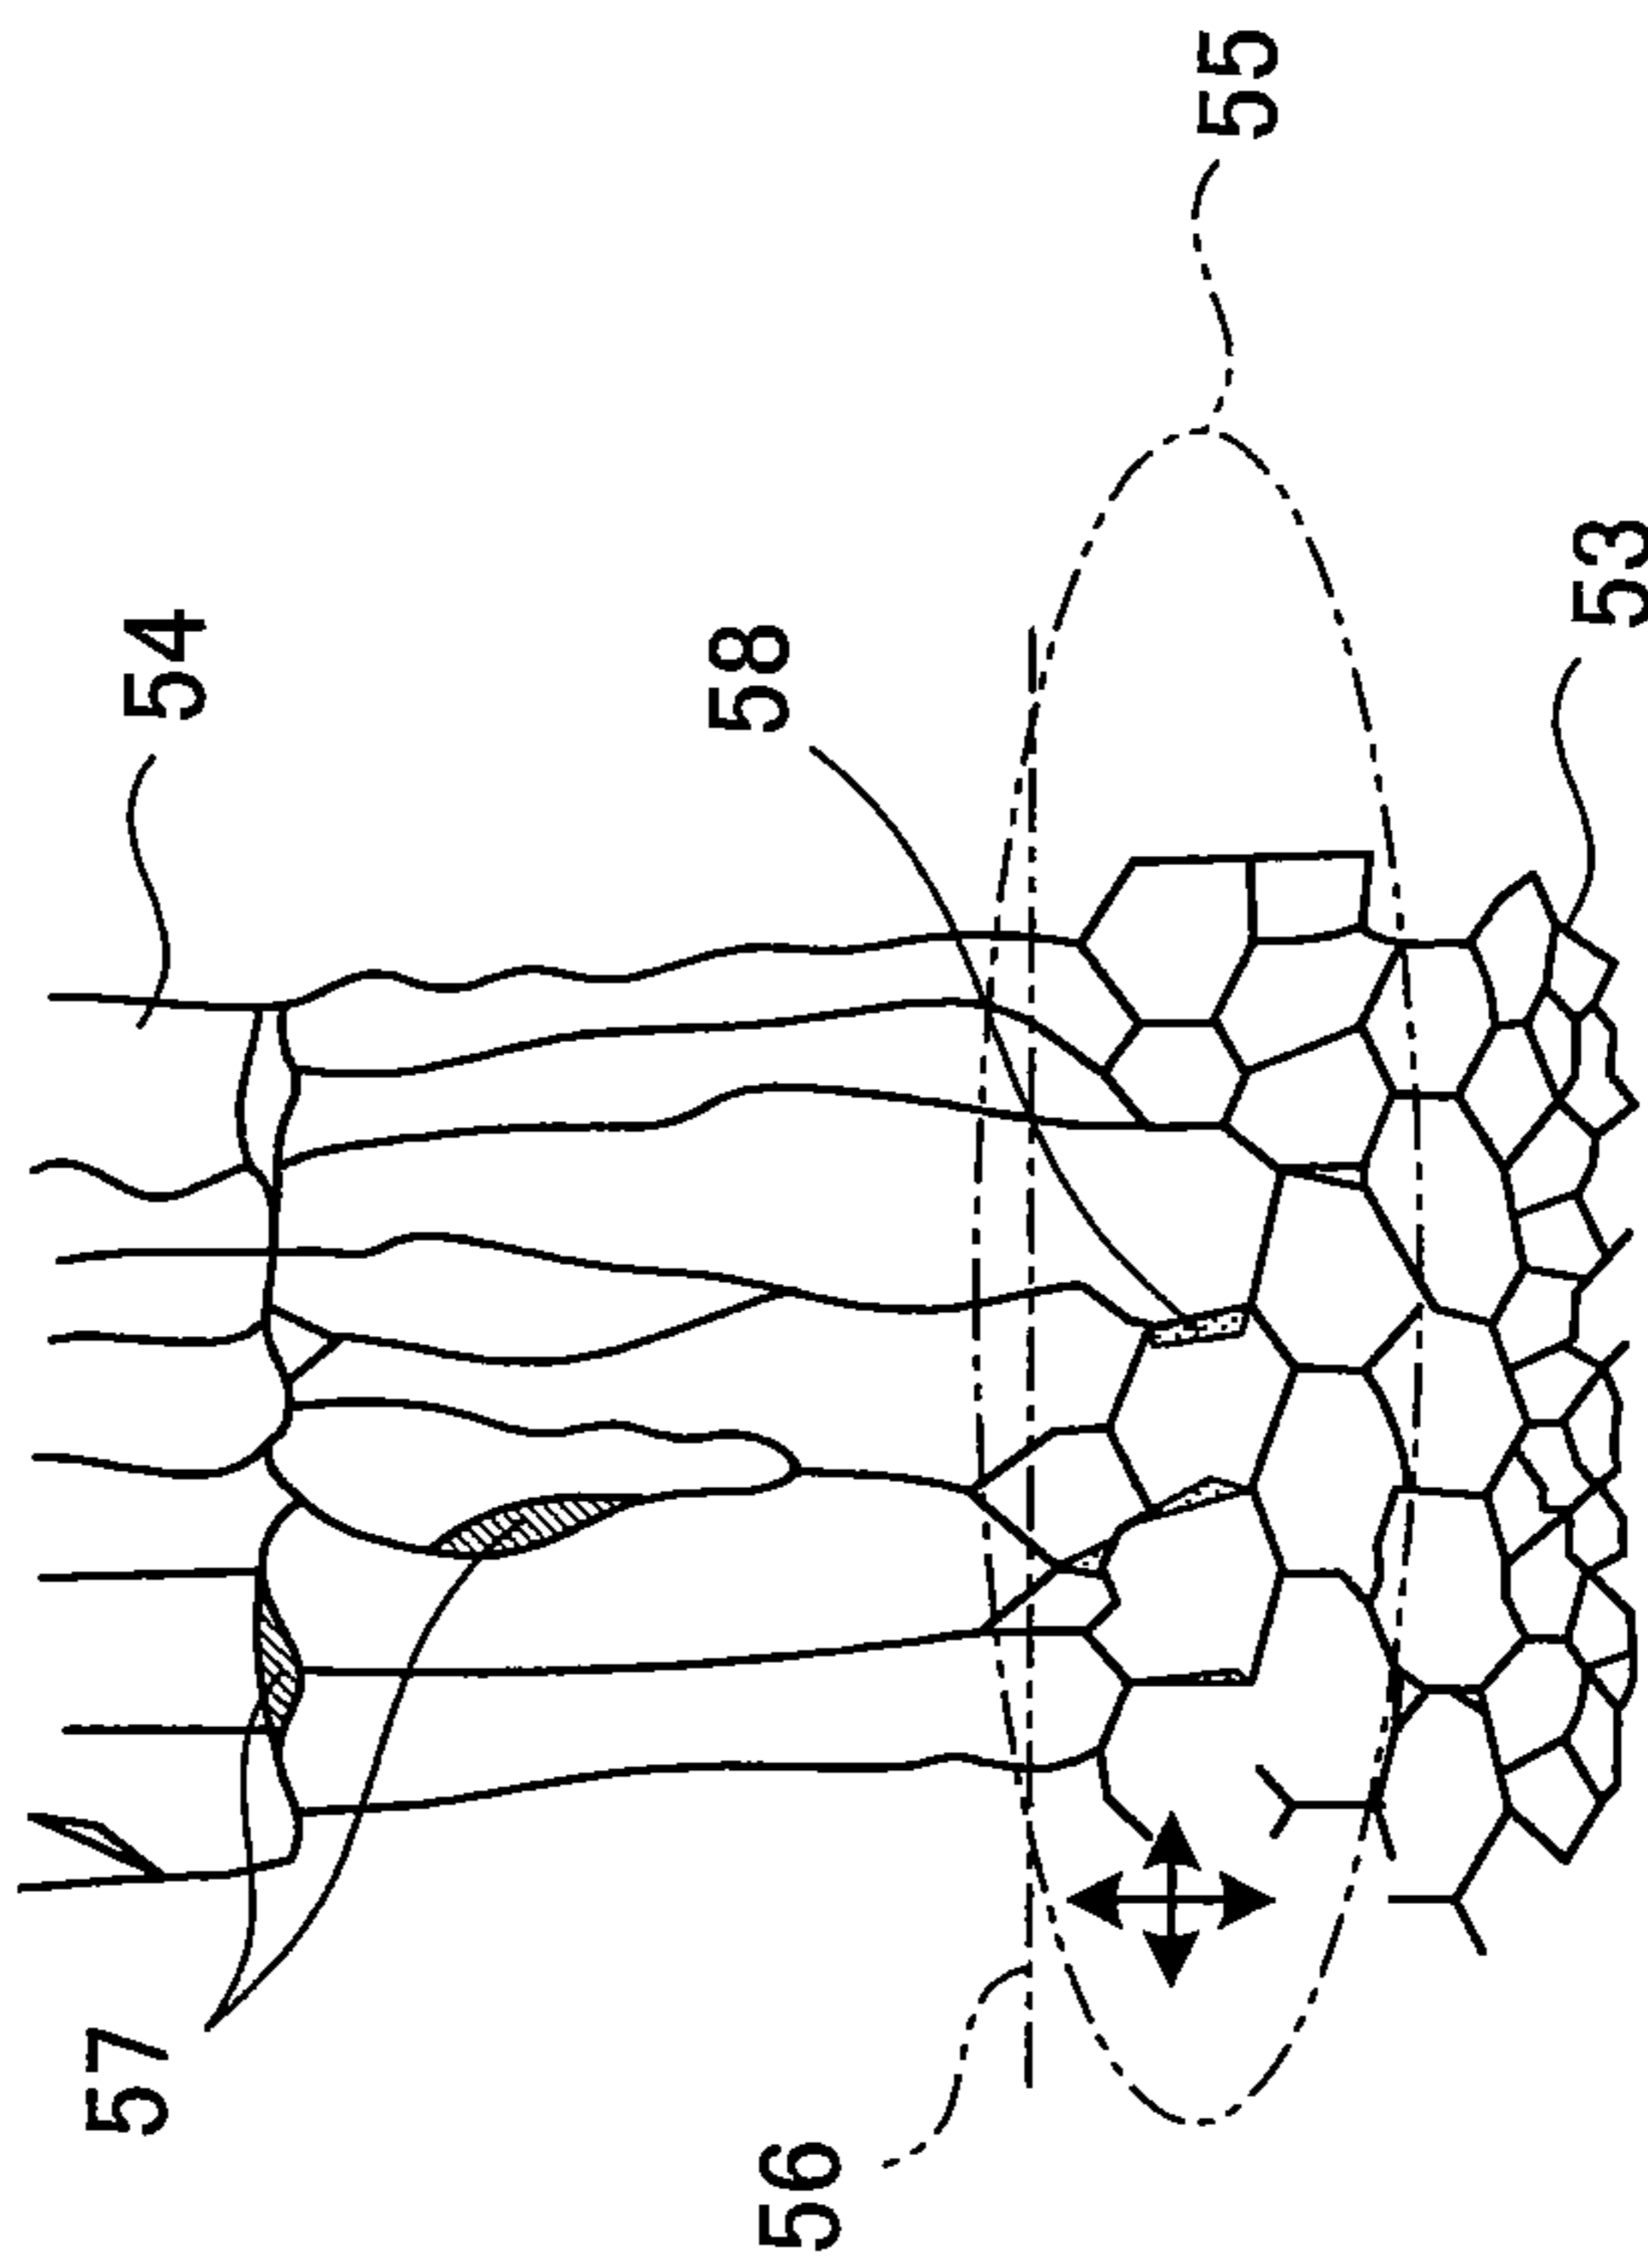
Fig. 8(a)

Fig. 8(b)

FIGS. 8(a) and 8(b) are views for explaining a boundary region produced by overlay welding of the conventional turbine rotor blade repair method.

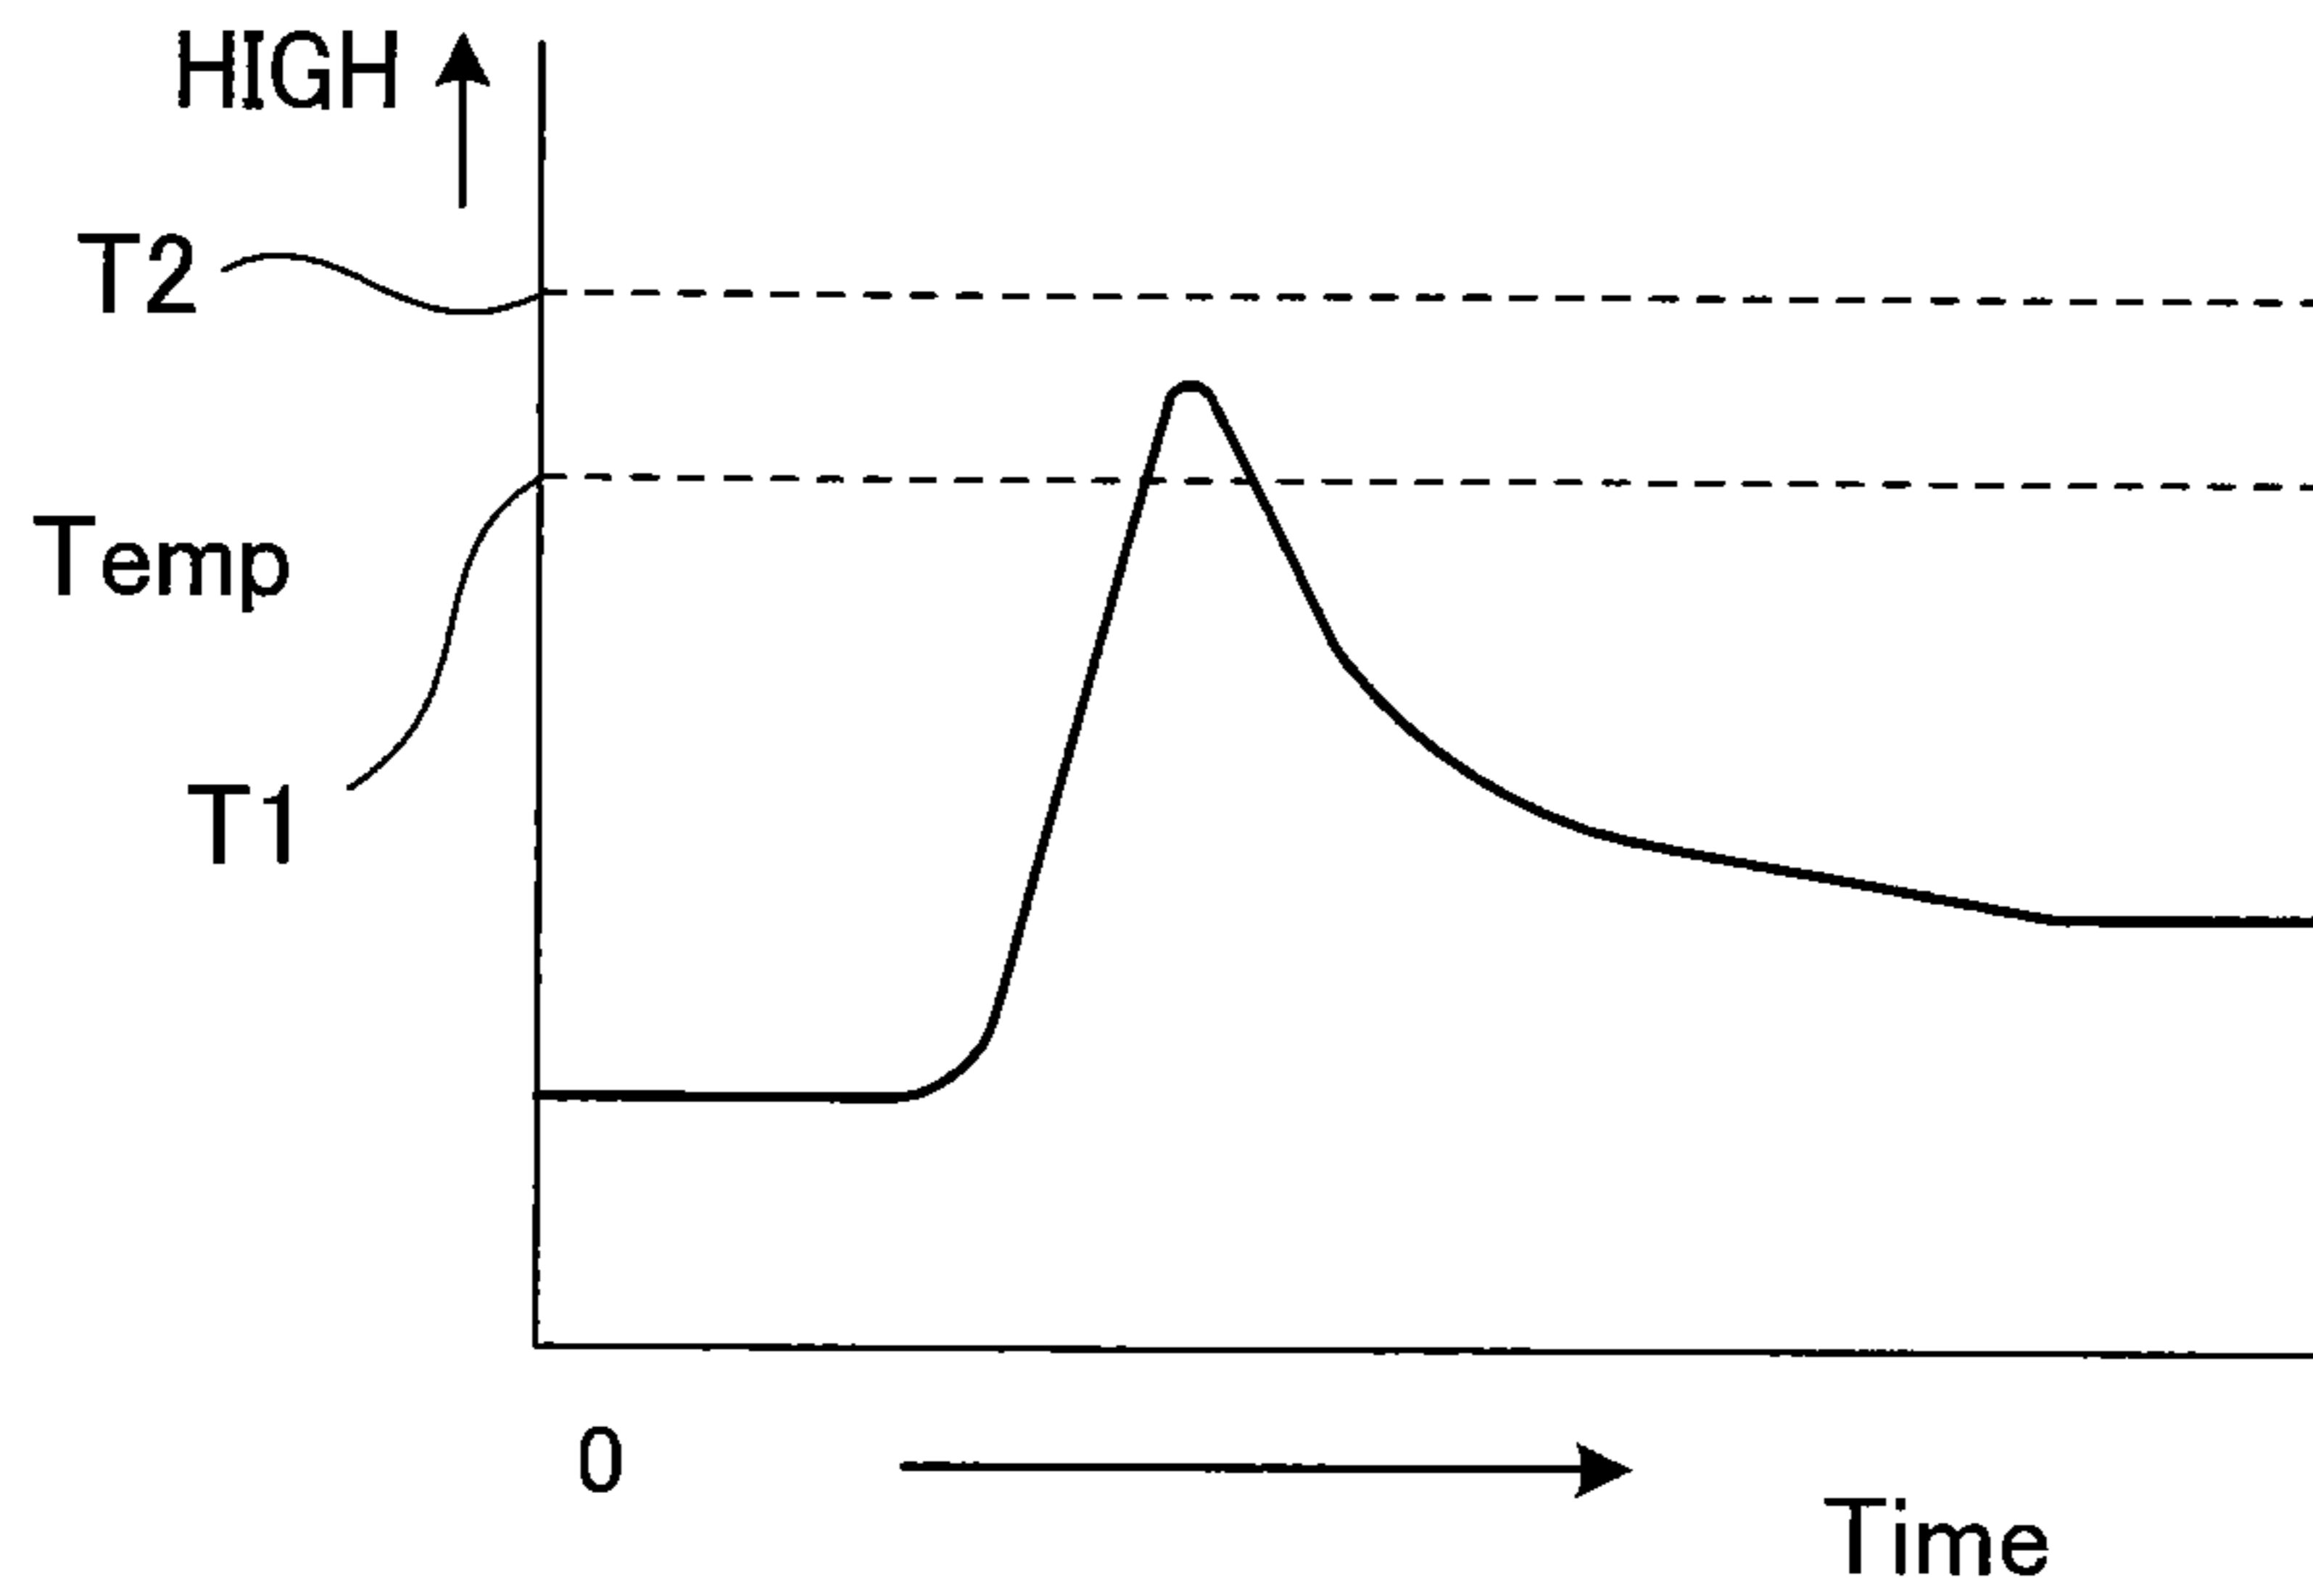
**Fig. 9**

FIG. 9 is a graph showing a temperature history during heat treatment in the conventional turbine rotor blade repair method.

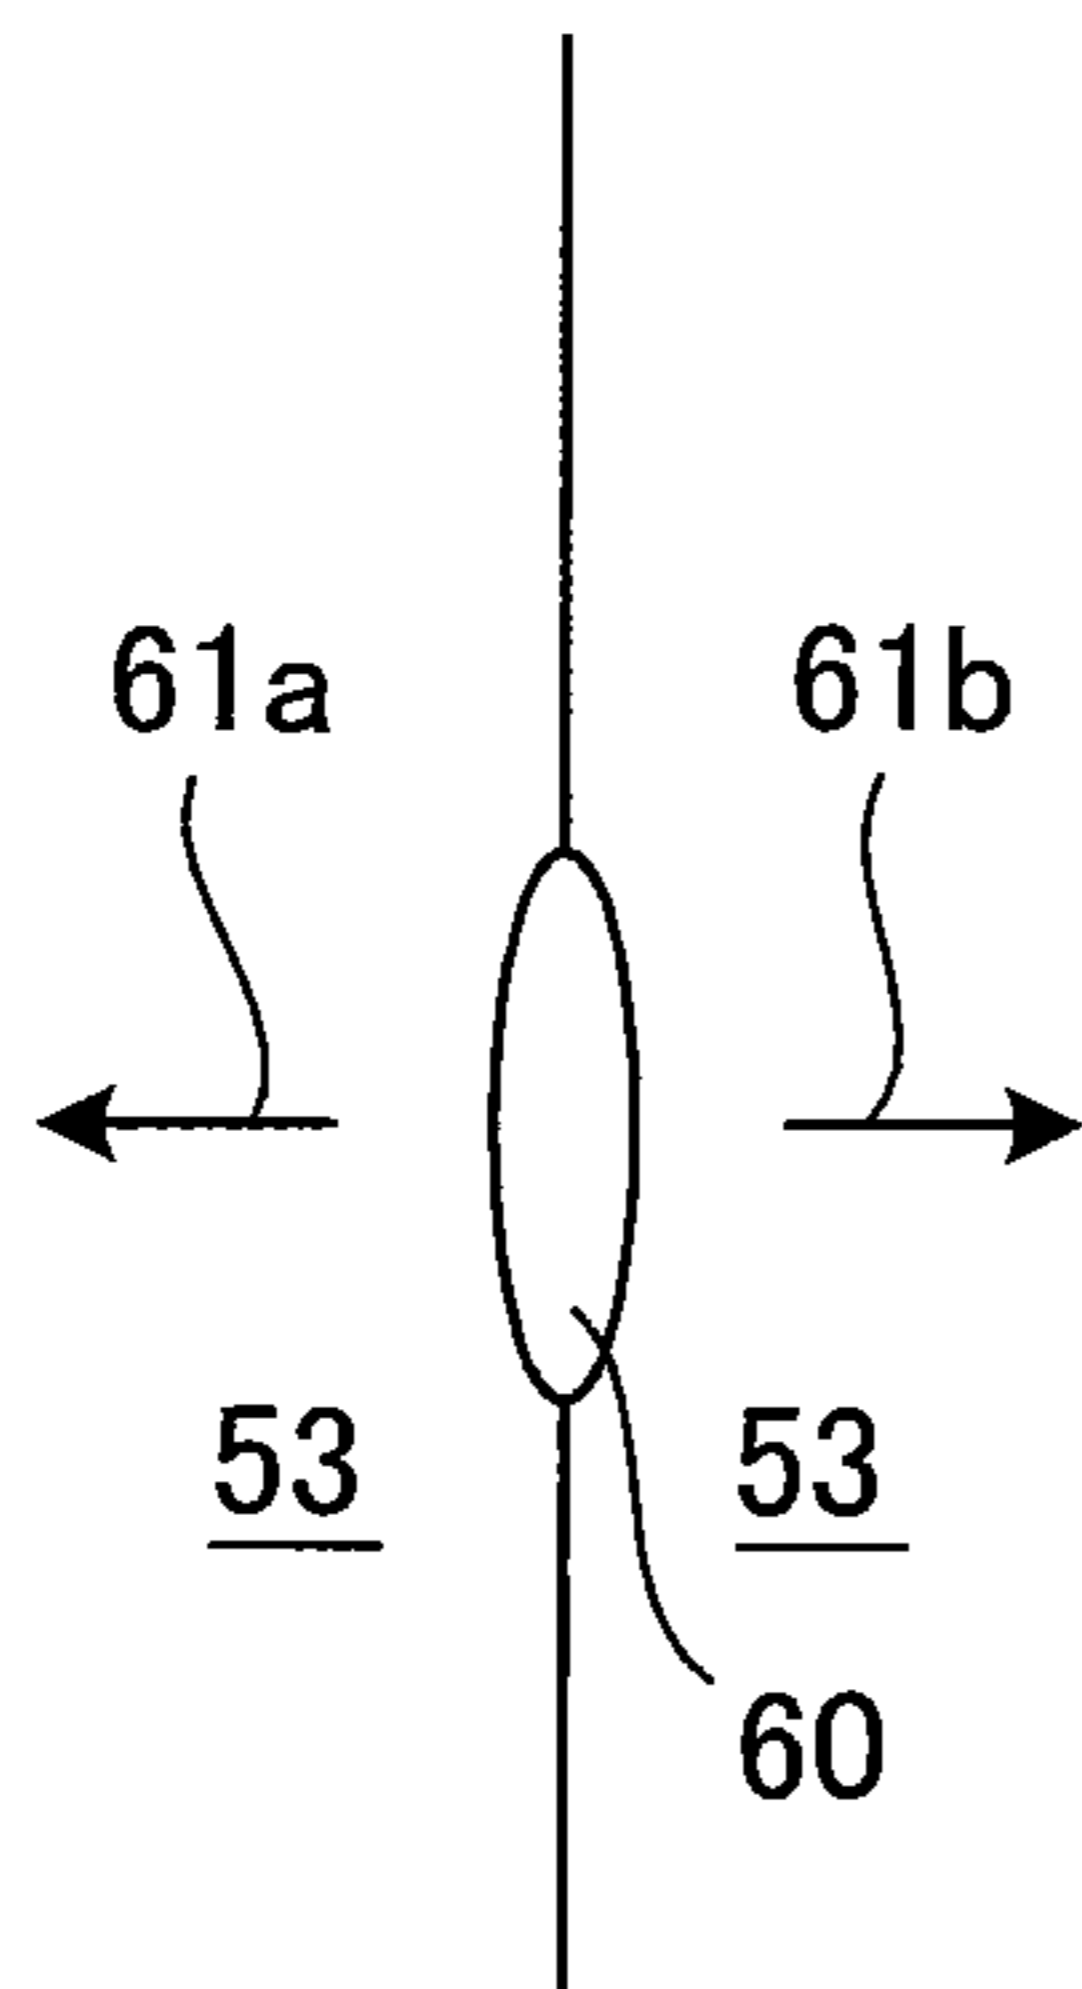
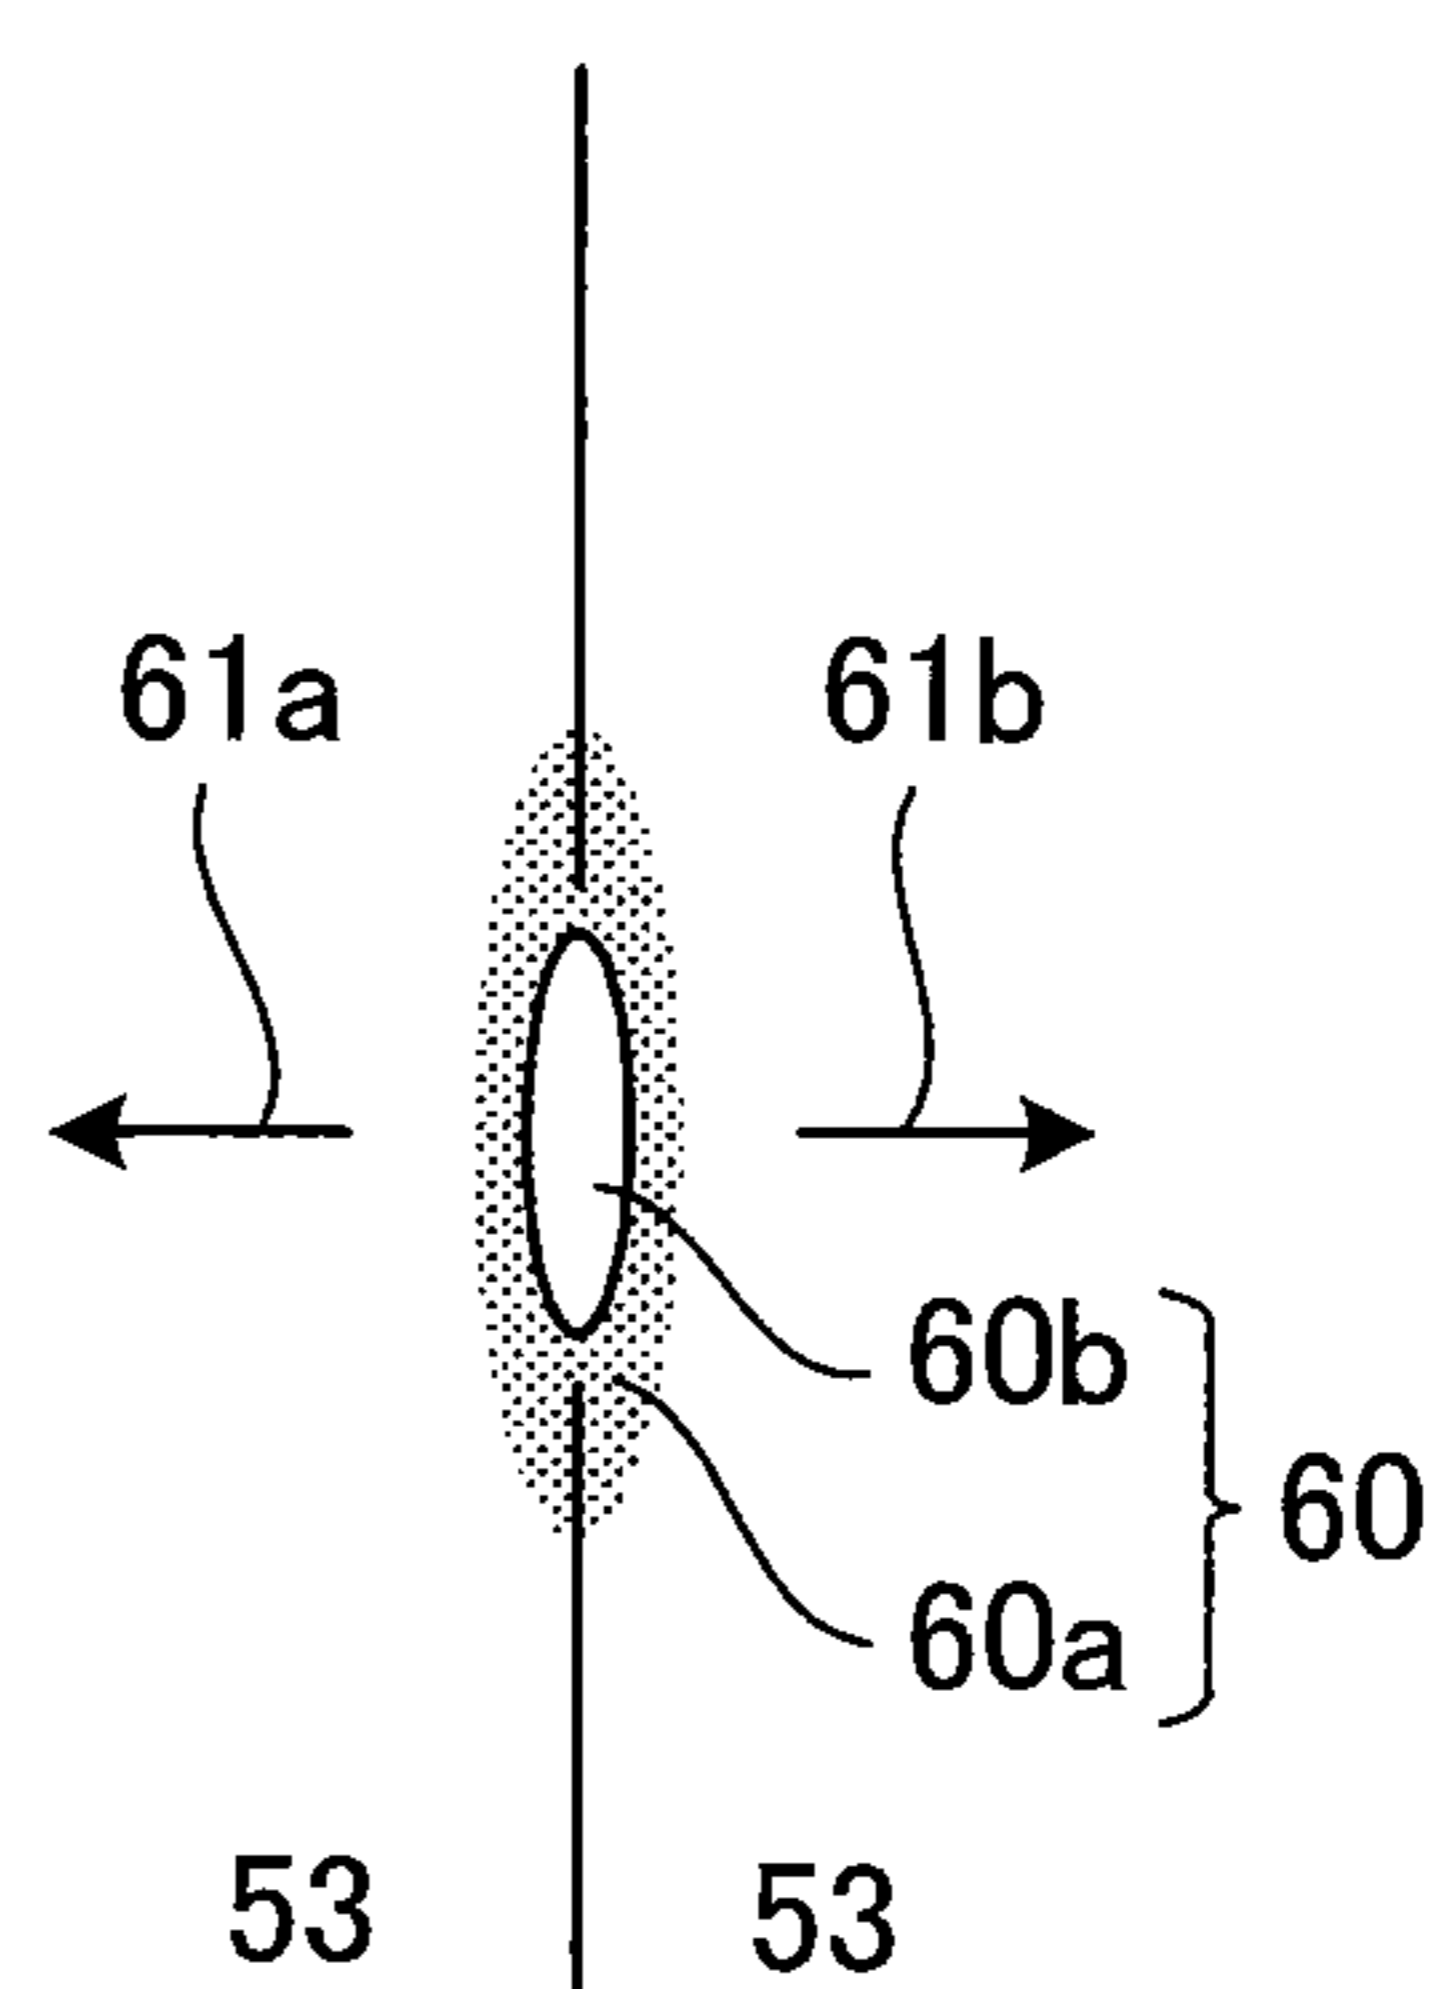
**Fig. 10(a)**

**Fig. 10(b)**

FIGS. 10(a) and 10(b) are views for explaining a boundary region produced by overlay welding of the conventional turbine rotor blade repair method.
