(12) **United States Patent**
Raiche et al.

(54) **METHOD FOR REPAIR OF A COMPONENT OF A TURBOMACHINE AND A COMPONENT REPAIRED ACCORDING TO THIS METHOD**

(71) Applicant: **MTU Aero Engines GmbH**, Munich (DE)

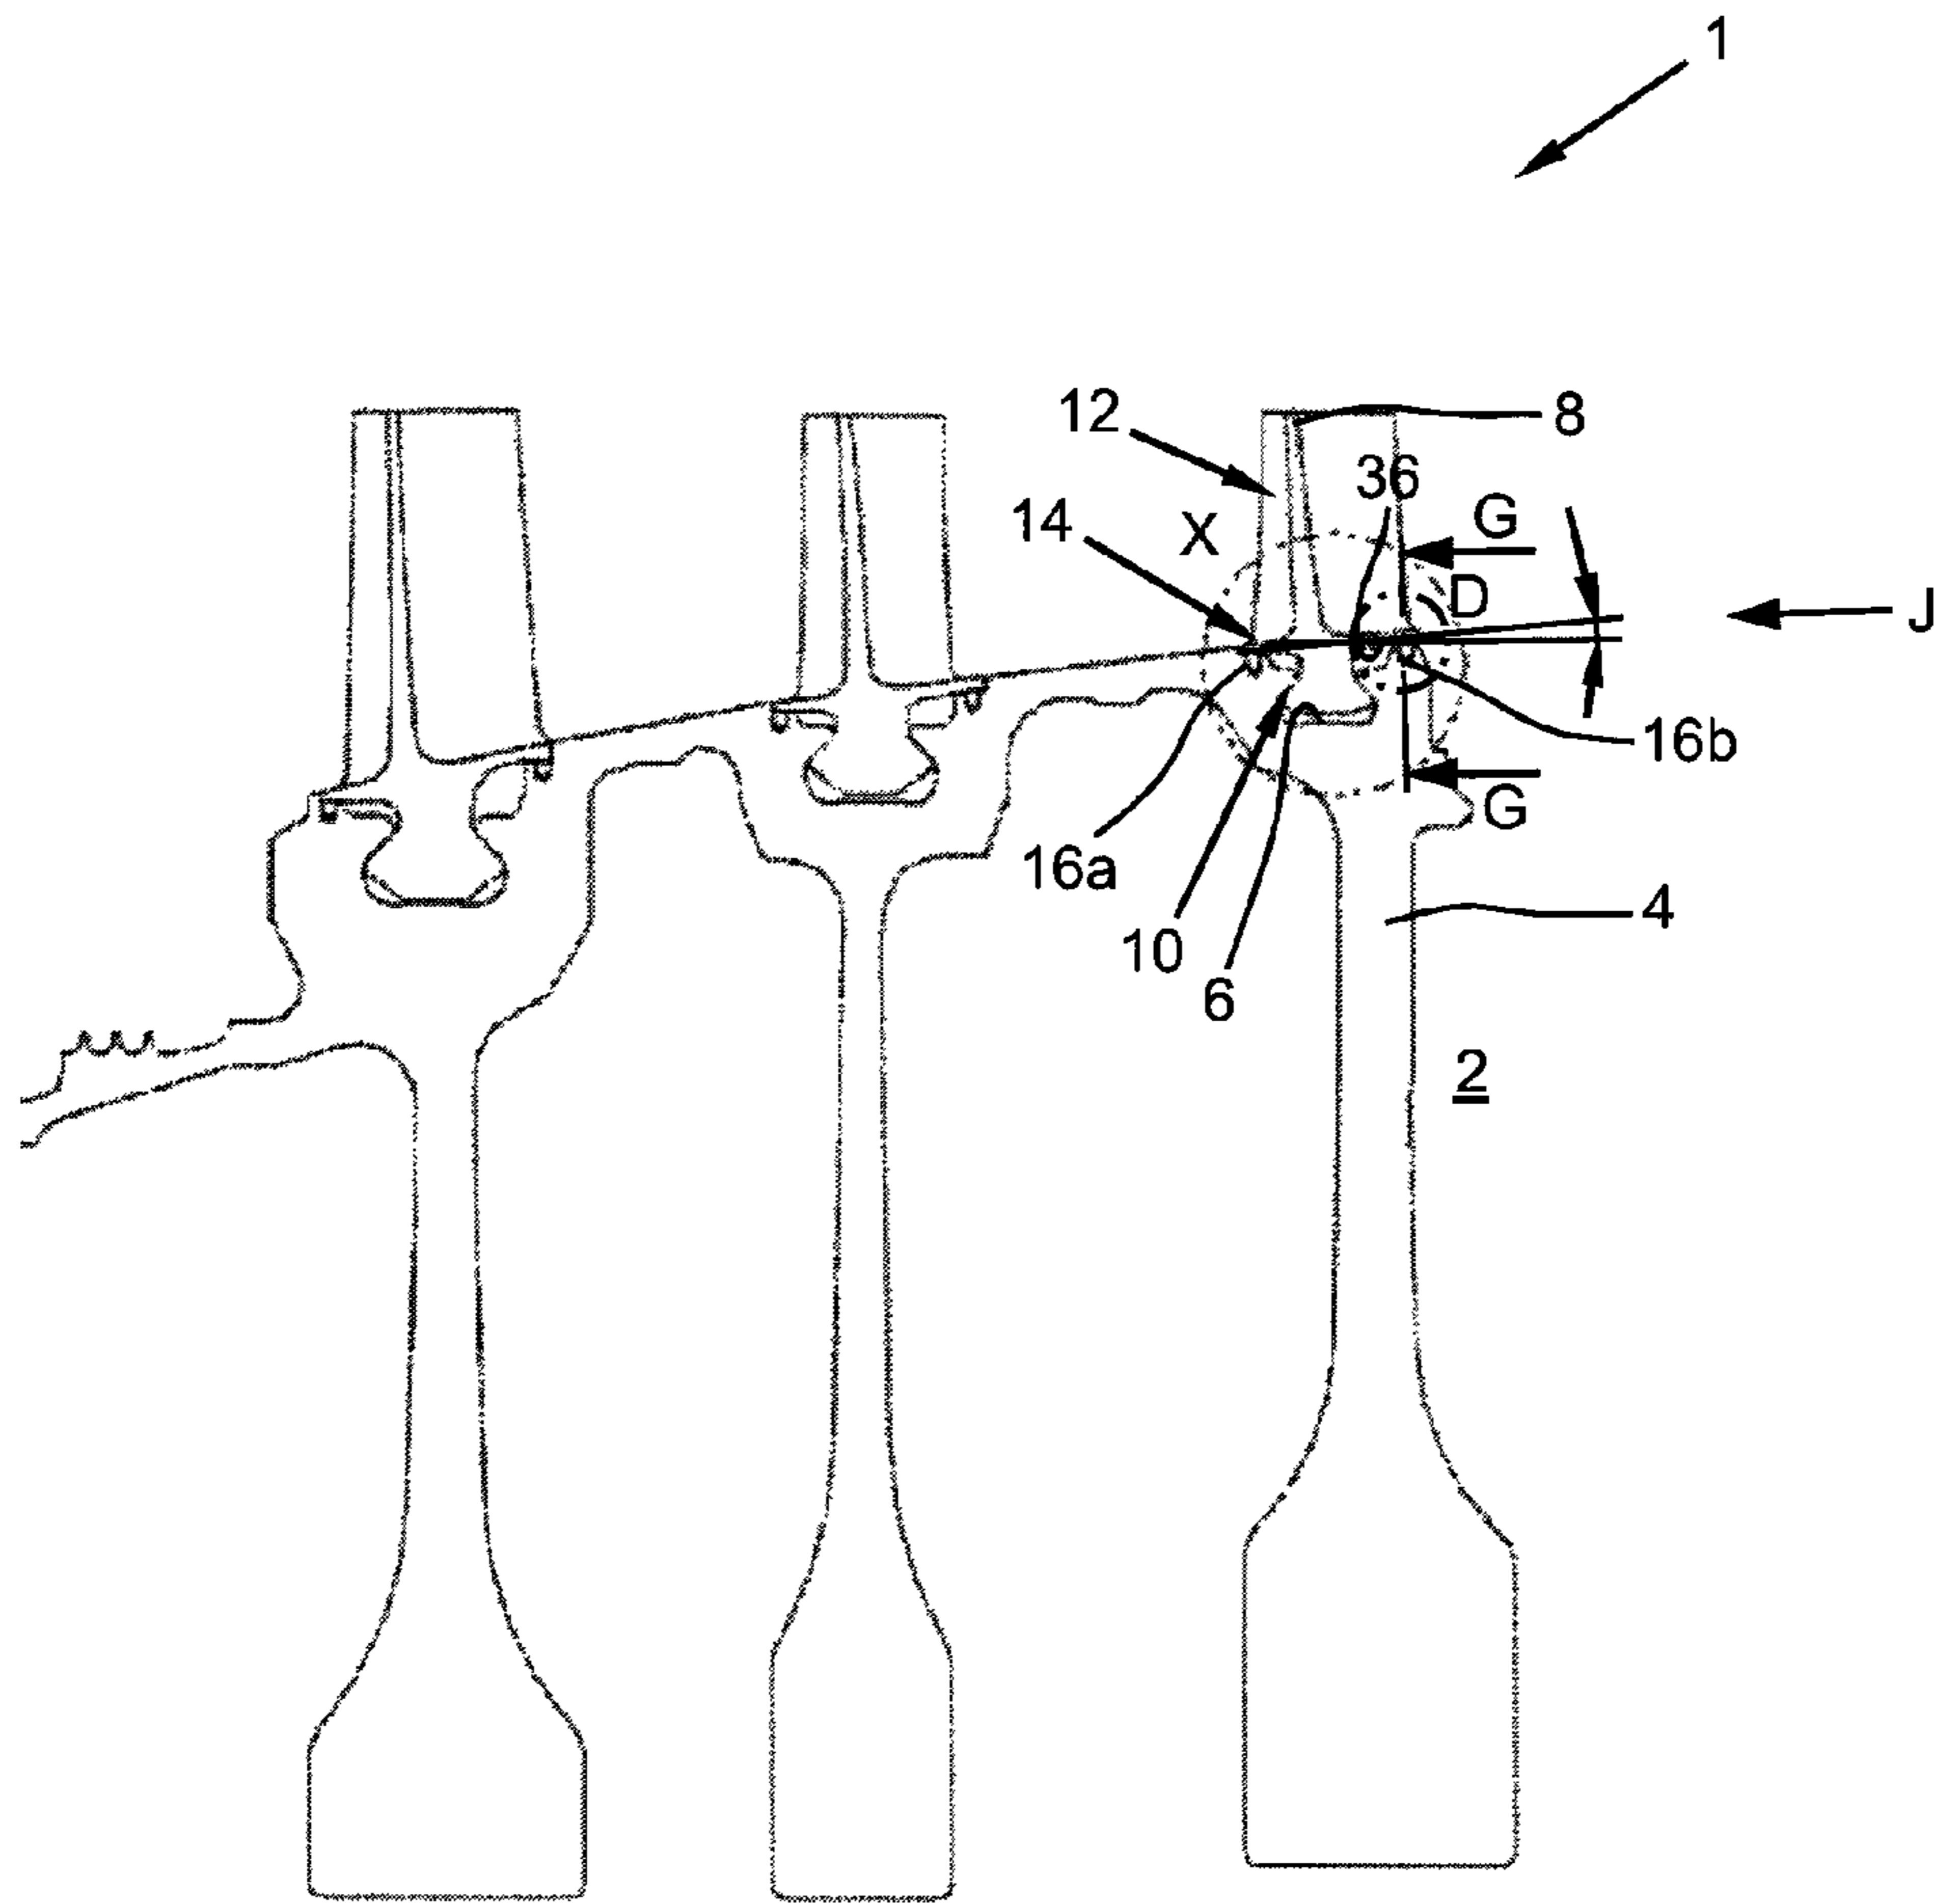
Fig. 1

FIG. 1 shows a sectional view of an aircraft gas turbine in the region of the high-pressure compressor;

FIG. 1 shows by way of example the application of the repair method according to the invention in the region of a high-pressure compressor 1 of an aircraft gas turbine 2. The invention, however, is not limited to repair applications in this region; rather the method can also be used advantageously in other regions.

The high-pressure compressor 1 has a compressor rotor 4 with compressor blades 8 taken up in rotor grooves 6. This is explained by way of example based on the third compressor stage in FIG. 1 of three sequential compressor stages in axial construction of high-pressure compressor 1.

Compressor blades 8 each have a form-fitted blade root 10, which is taken up in rotor groove 6, a blade surface 12, and a blade platform 14 disposed in the transition region between blade root 10 and blade surface 12. Ring elements 16 formed as damping rings are disposed between the compressor rotor 4 and the blade platforms 14, whereby to each compressor stage is assigned a damping ring 16a axially in front in a series of blades of the compressor blading and a damping ring 16b is assigned axially in back in the series of blades of the compressor blading. This can be further derived from FIG. 2, which shows an enlarged detail view of the excerpt X of FIG. 1.

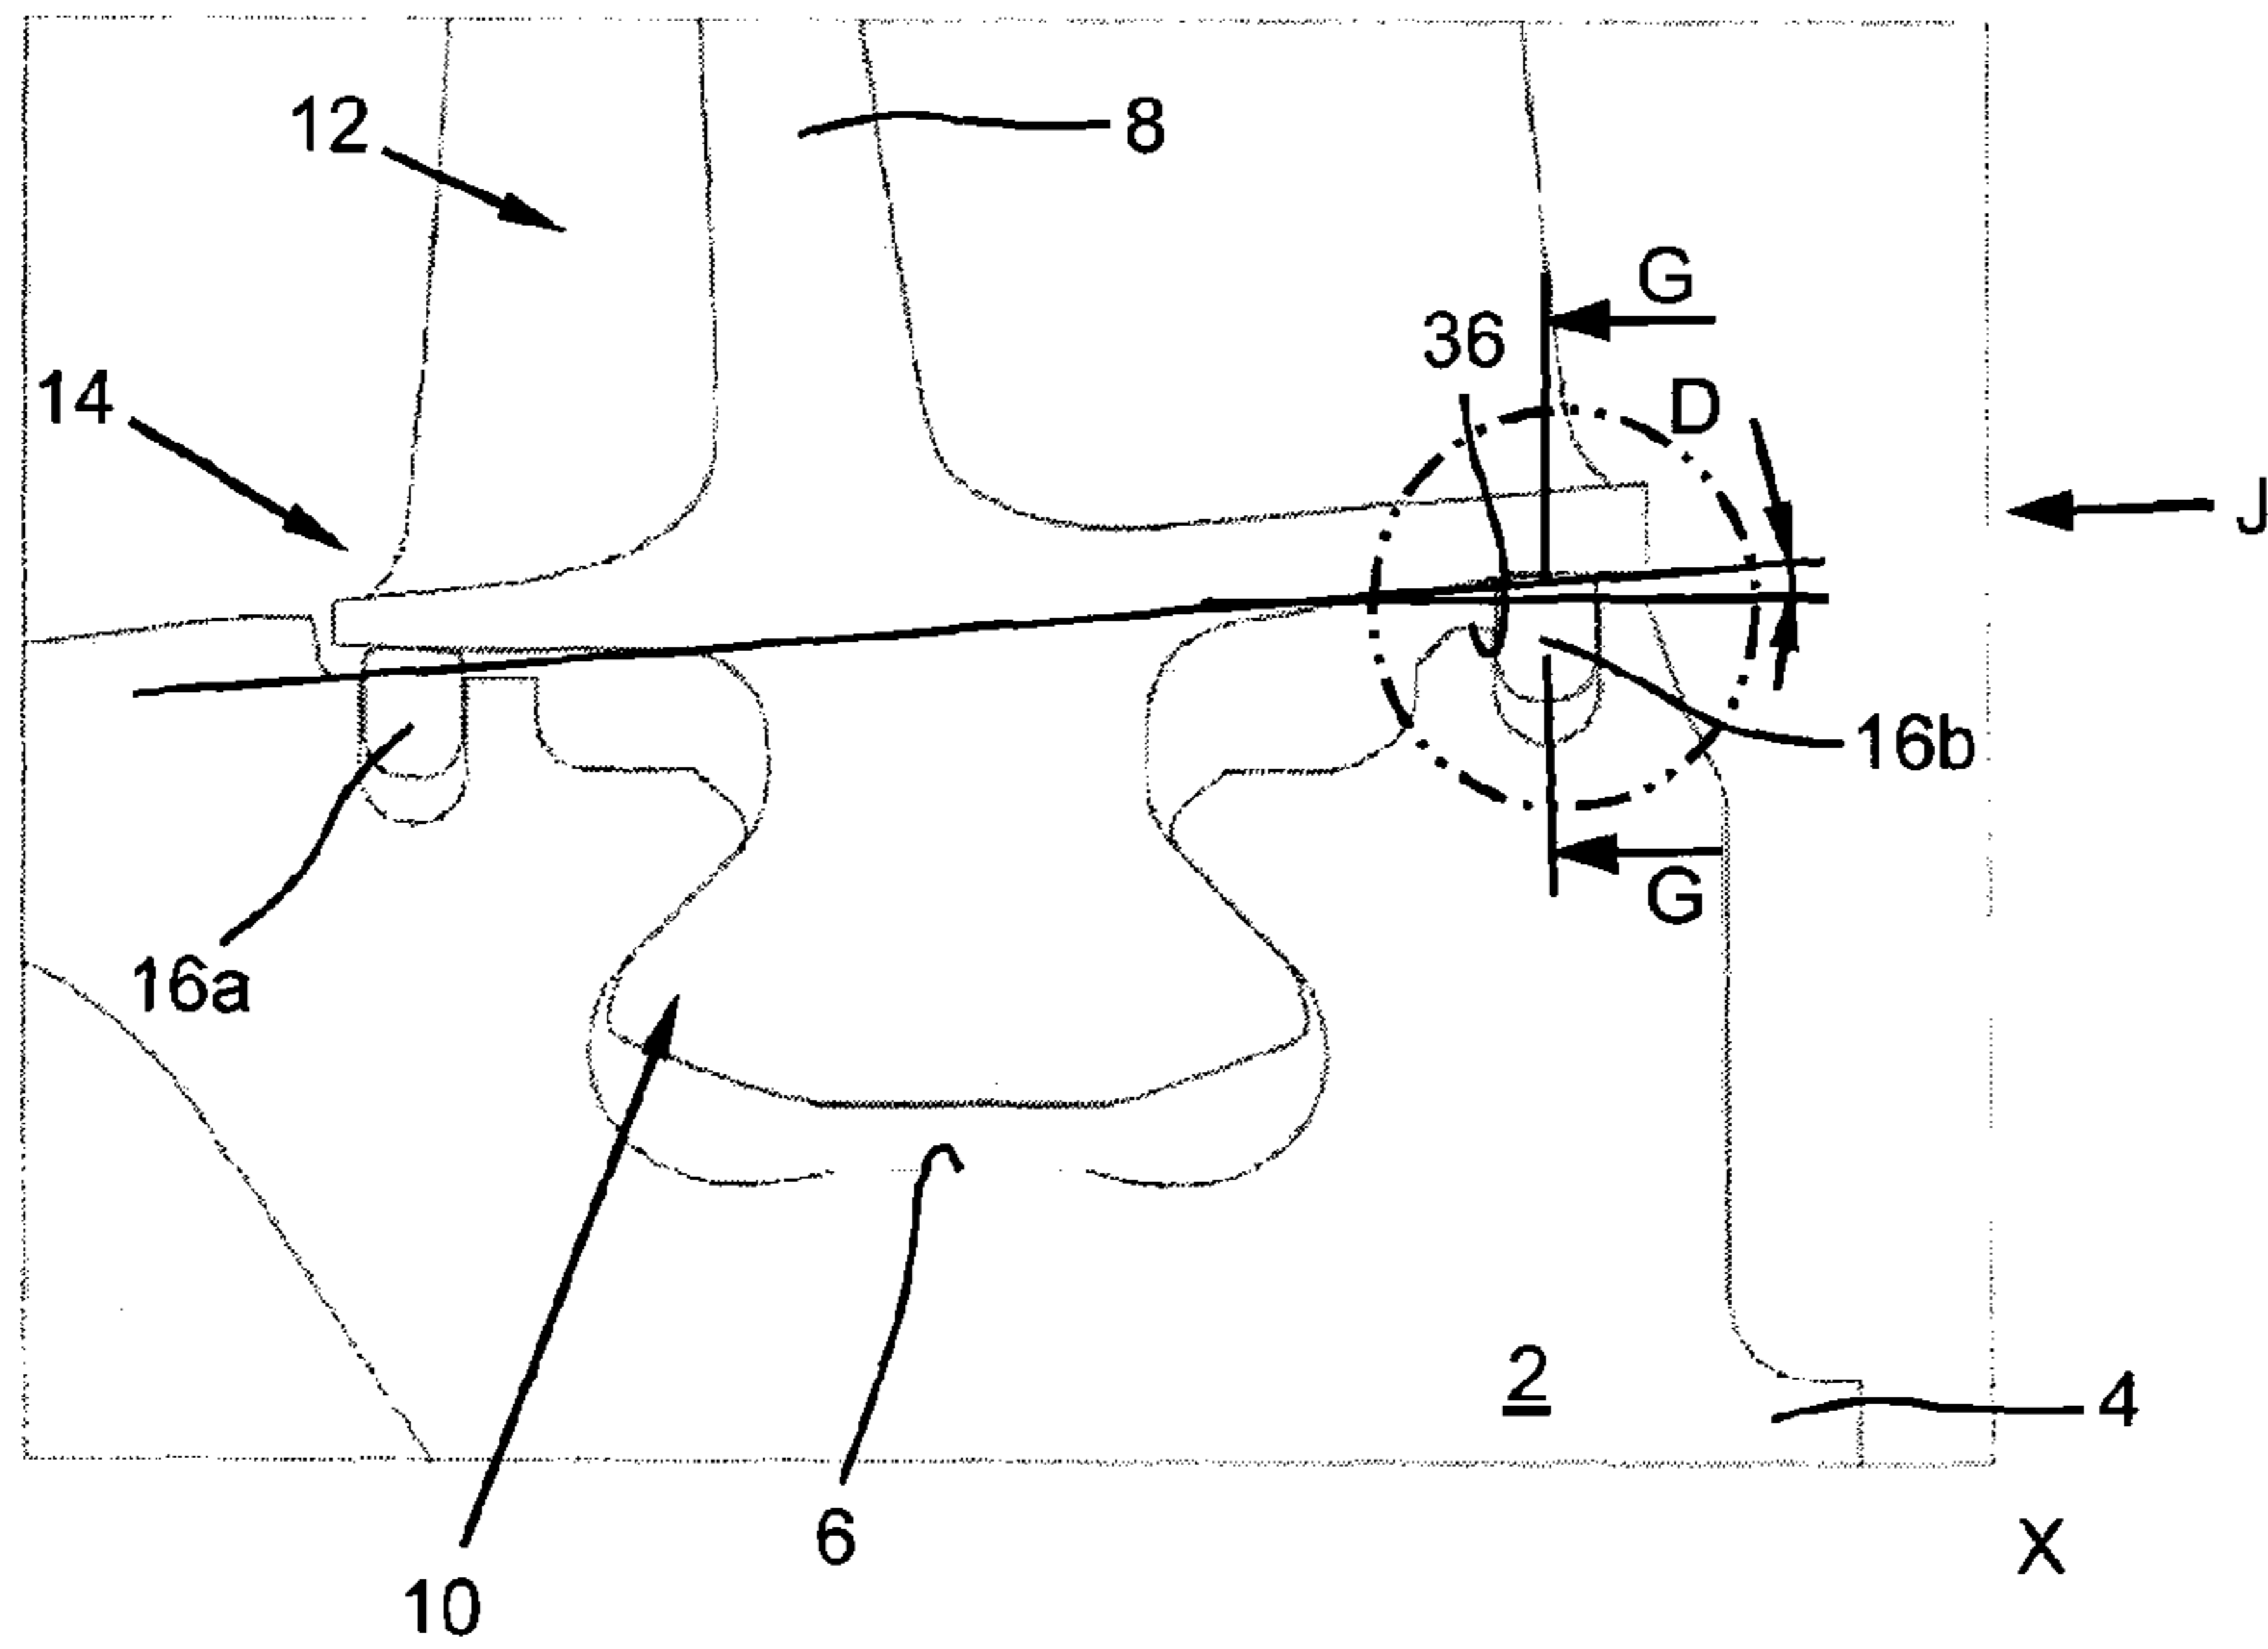
Fig. 2

FIG. 2 shows an enlarged detail view of the excerpt X of FIG. 1;

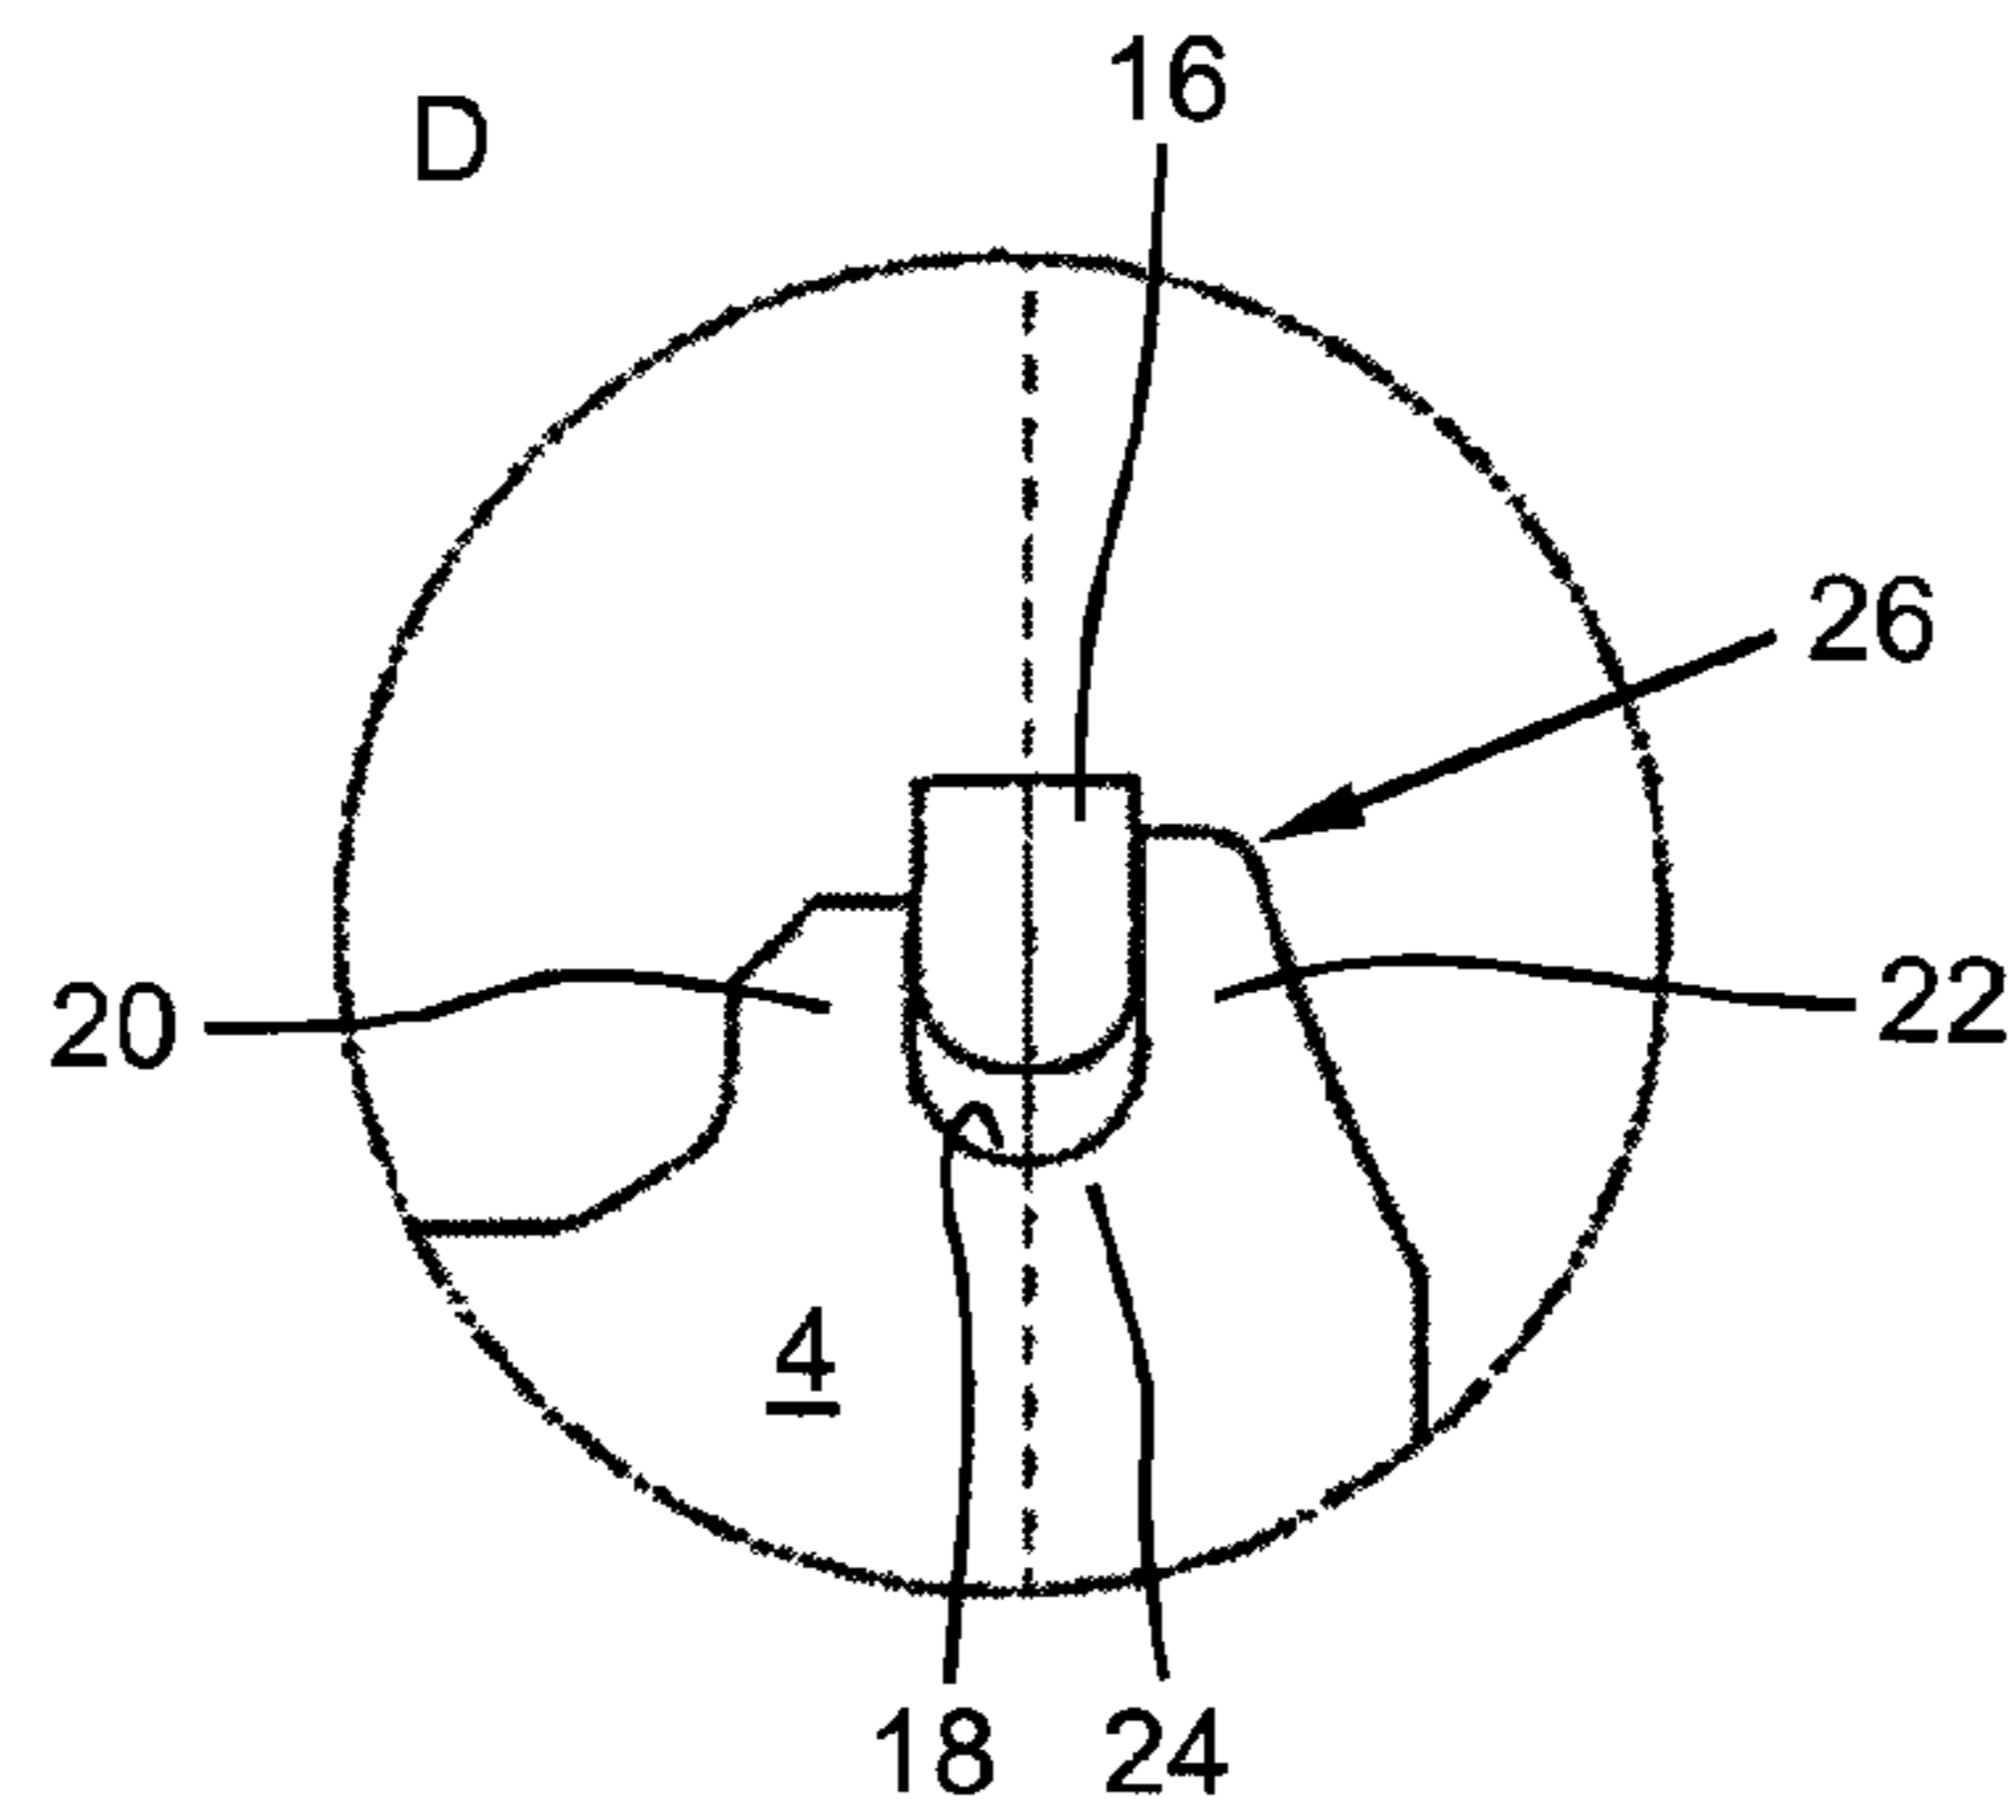
Fig. 3

FIG. 3 shows an enlarged detail view of the excerpt D of FIG. 2;

As can be particularly derived from FIG. 3, which shows an enlarged detail view of excerpt D of FIG. 2, the damping rings 16 are each disposed in an approximately U-shaped annular groove 18, which is radially open to the outside, of compressor rotor 4. The damping rings 16 have a circular damping-ring base body with a roughly rectangular cross section and rounded corner regions as well as two adjacent ring ends, which are not shown. The annular groove 18 is bounded by two parallelly extending side walls 20, 22 and a bottom wall 24. A front side wall 20 on the inlet side is set back radially opposite a back side wall 22 on the turbine side, so that the back side wall 22 projects radially and forms a support region 26 for the blade platforms 14 of the compressor blades 8 (see FIG. 1).

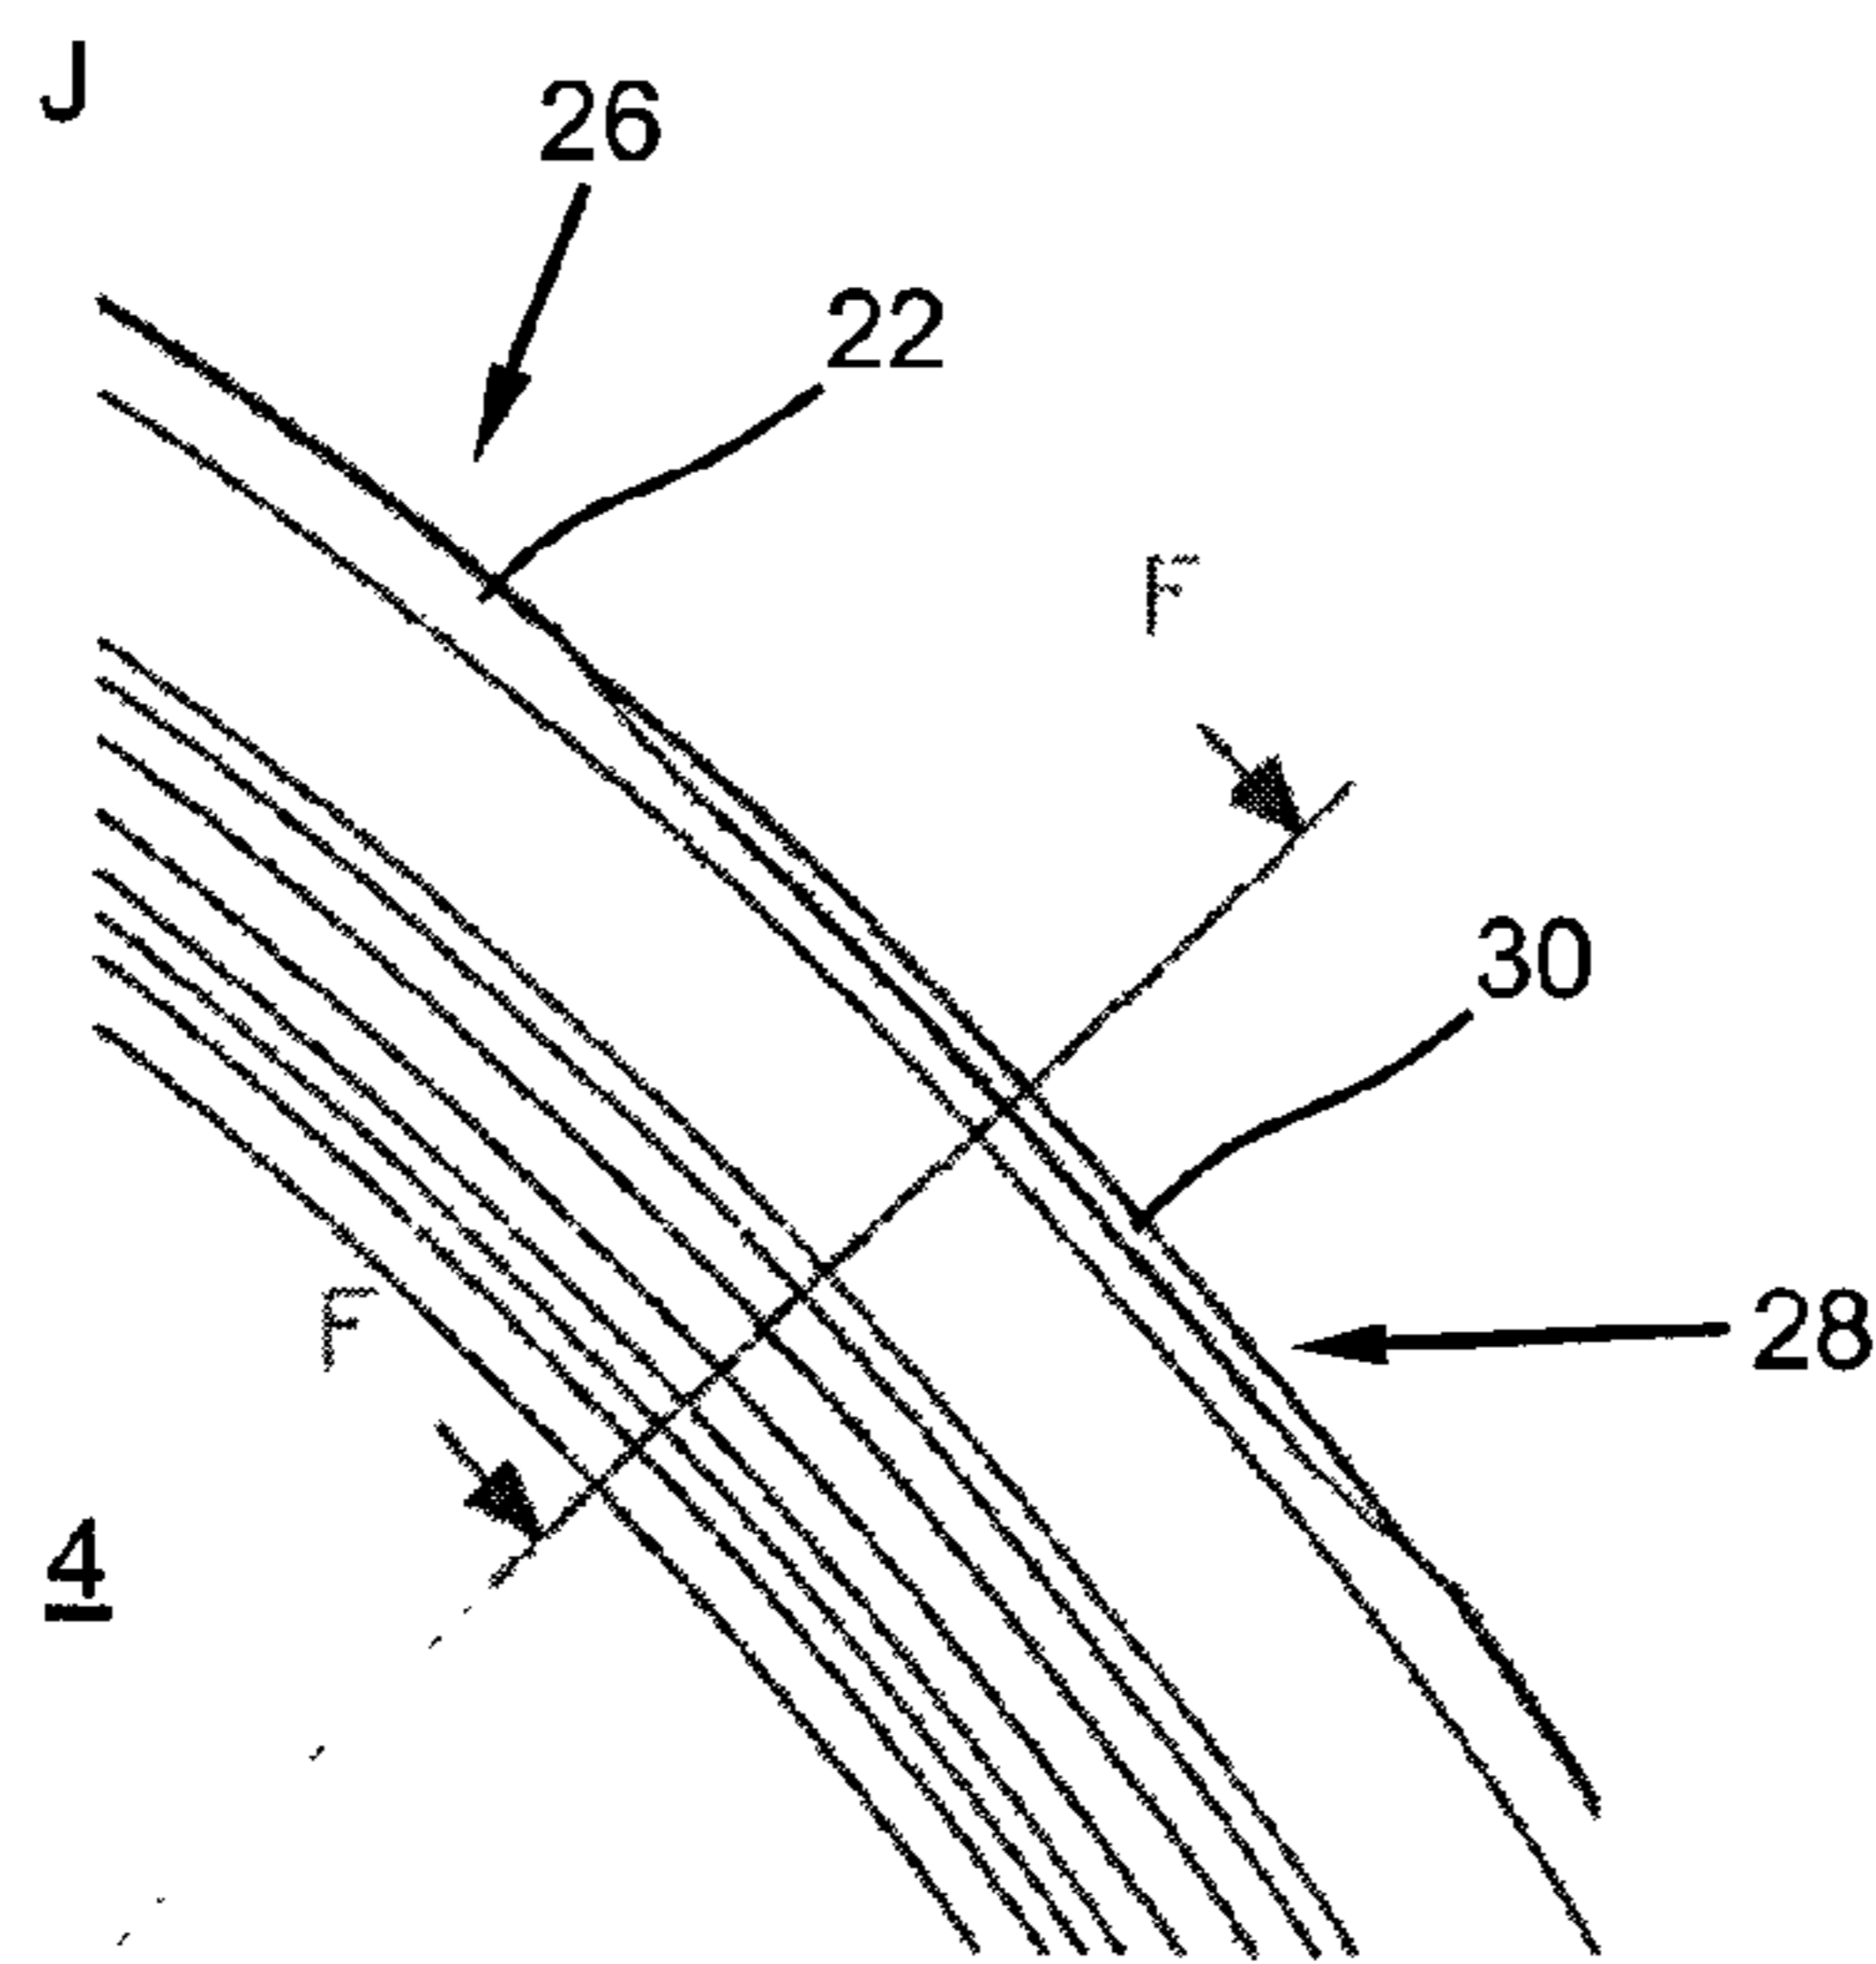
Fig. 4

FIG. 4 shows a detail view of the compressor rotor in the direction of view J of FIG. 2;

In the example of embodiment shown, the repair is made in a damaged region of the back side wall 22 on the turbine side. For this purpose, as can be derived in particular from FIGS. 4 and 5, which show a detail view of the compressor rotor 4 in the direction of view J of FIG. 2 and a sectional view of compressor rotor 4 along line G-G of FIG. 2, a section 28 of back side wall 22 which has been subjected to wear, i.e., of the support region 26 of compressor rotor 4, is removed in a first method step. With the removal of the worn segment 28, a depression or notching or rounding out 30 is formed, which satisfies the highest requirements with respect to the resulting component strength.

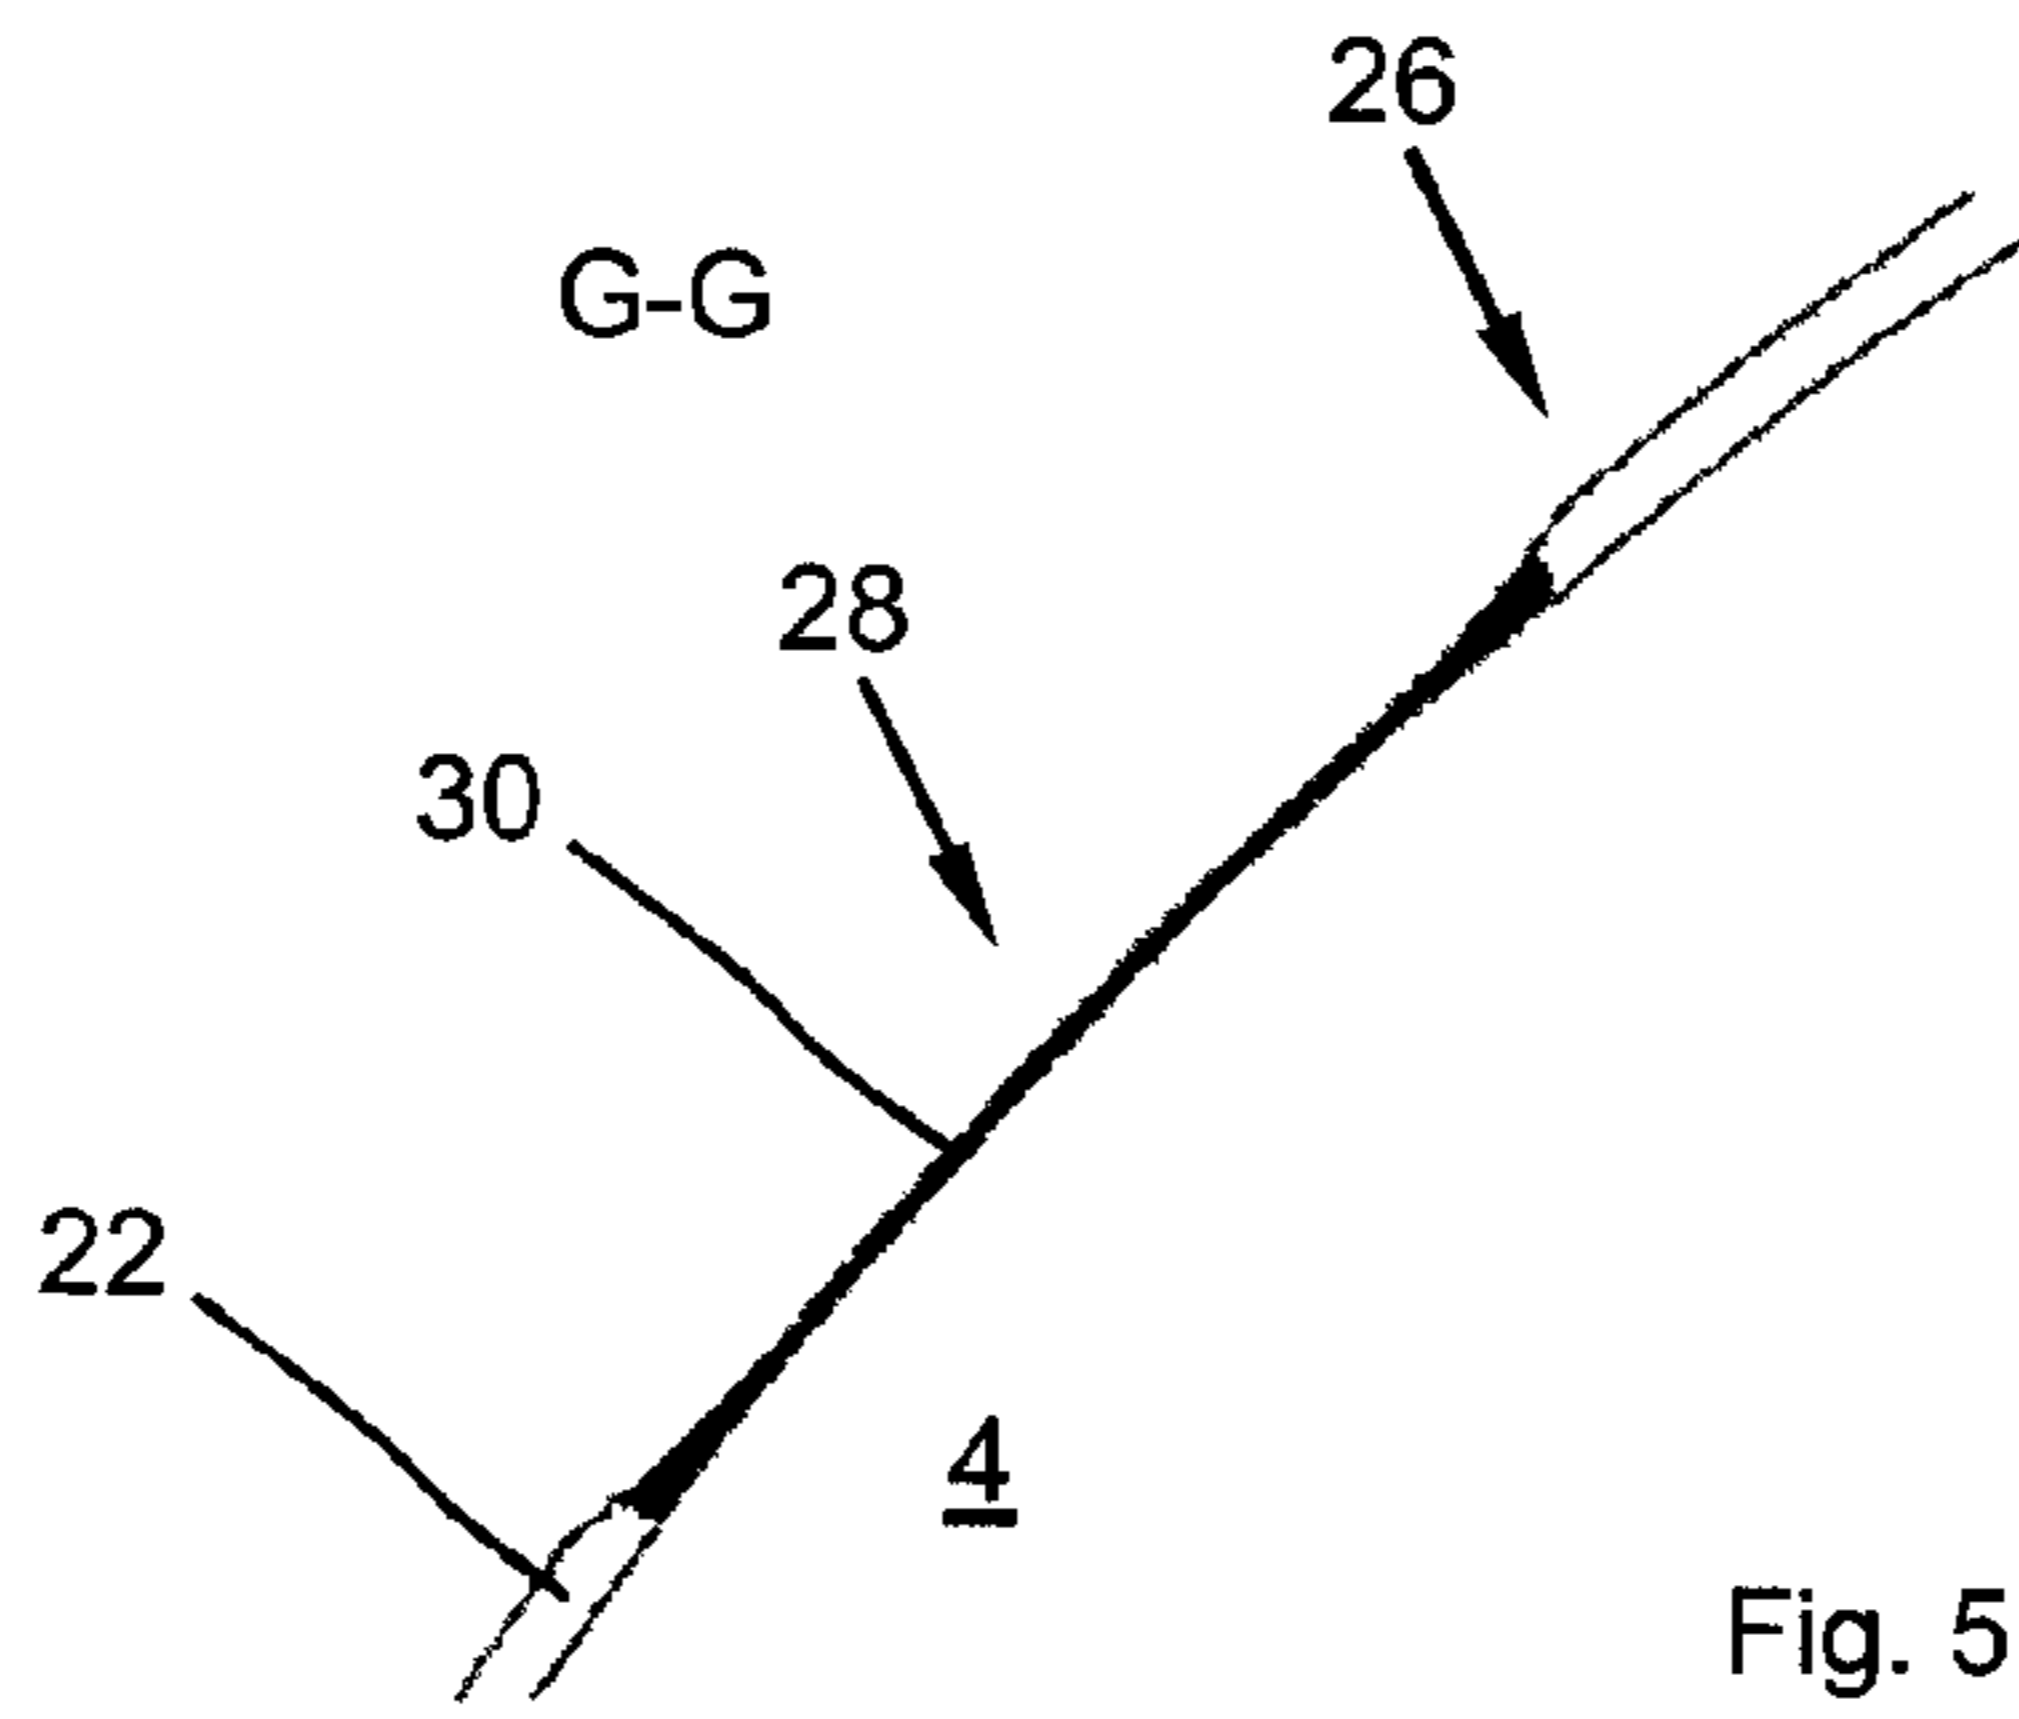
FIG. 5 shows a sectional view of the compressor rotor along line G-G of FIG. 2;

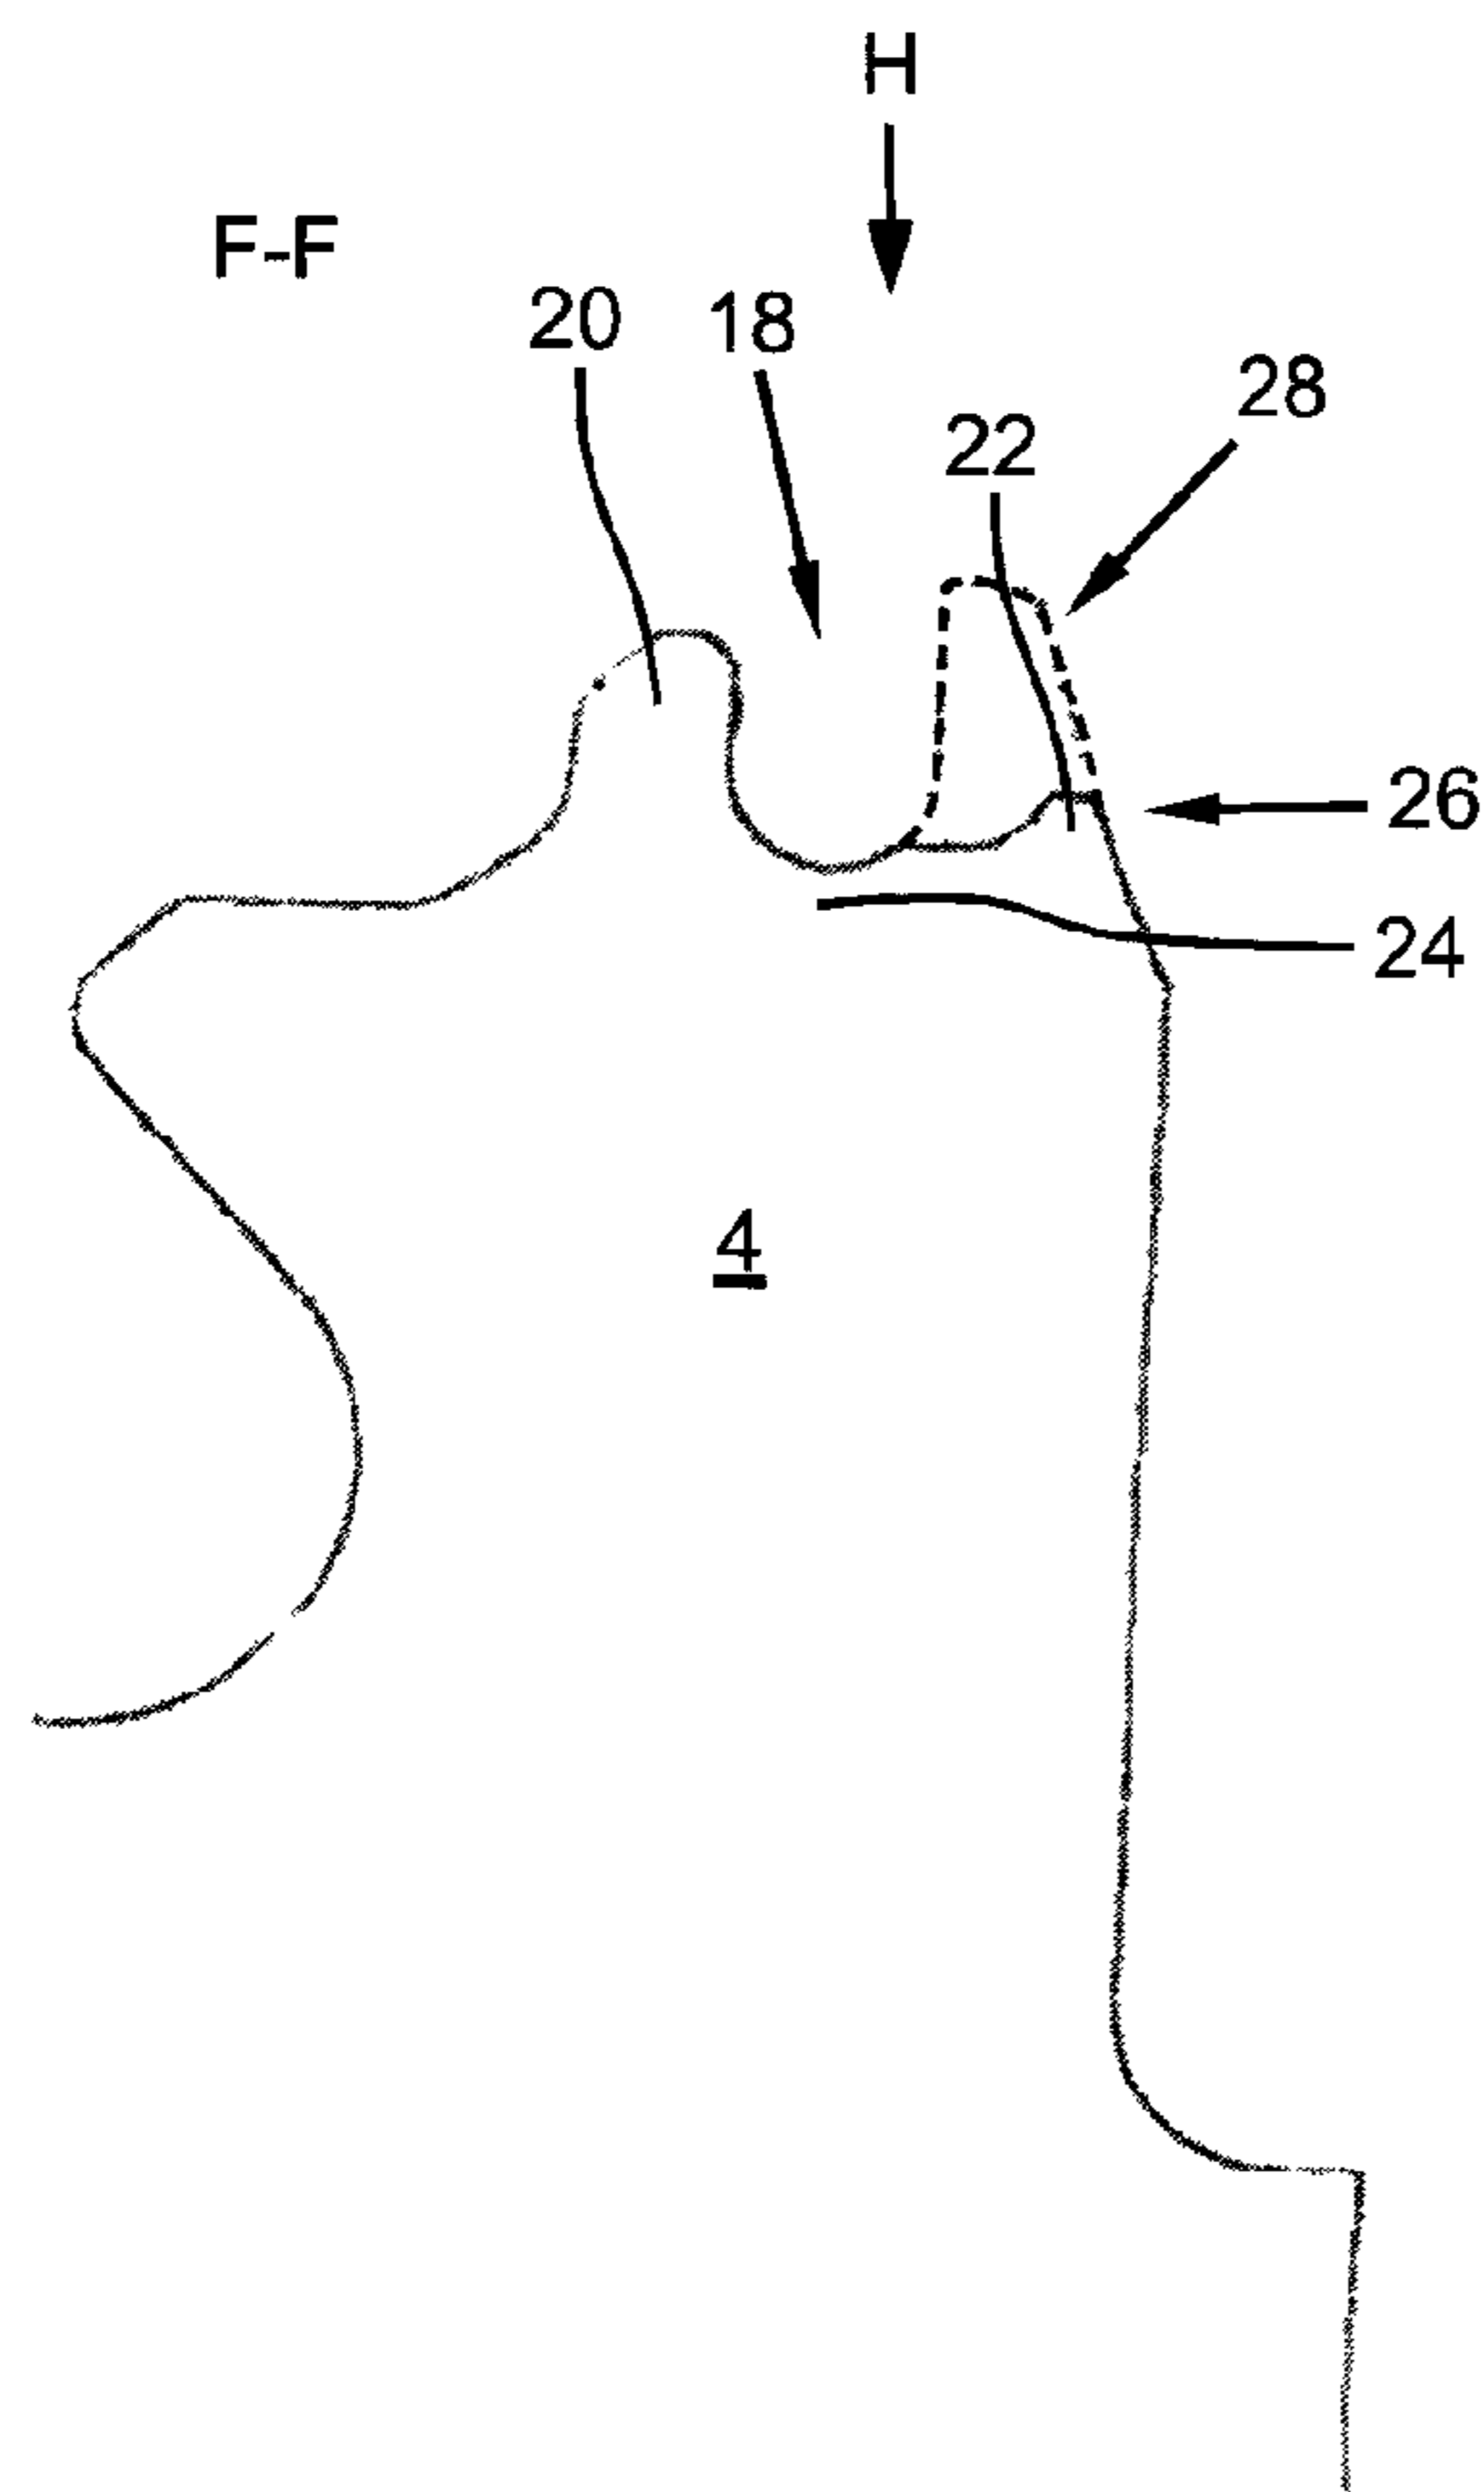
FIG. 6 shows a sectional view of the compressor rotor along line F-F of FIG. 4;

As can be derived from FIG. 6, which shows a sectional view of the compressor rotor 4 along line F-F of FIG. 4, the
