(12) **United States Patent**
Raiche et al.

(54) **METHOD FOR REPAIR OF A COMPONENT OF A TURBOMACHINE AND A COMPONENT REPAIRED ACCORDING TO THIS METHOD**

(71) Applicant: **MTU Aero Engines GmbH**, Munich (DE)

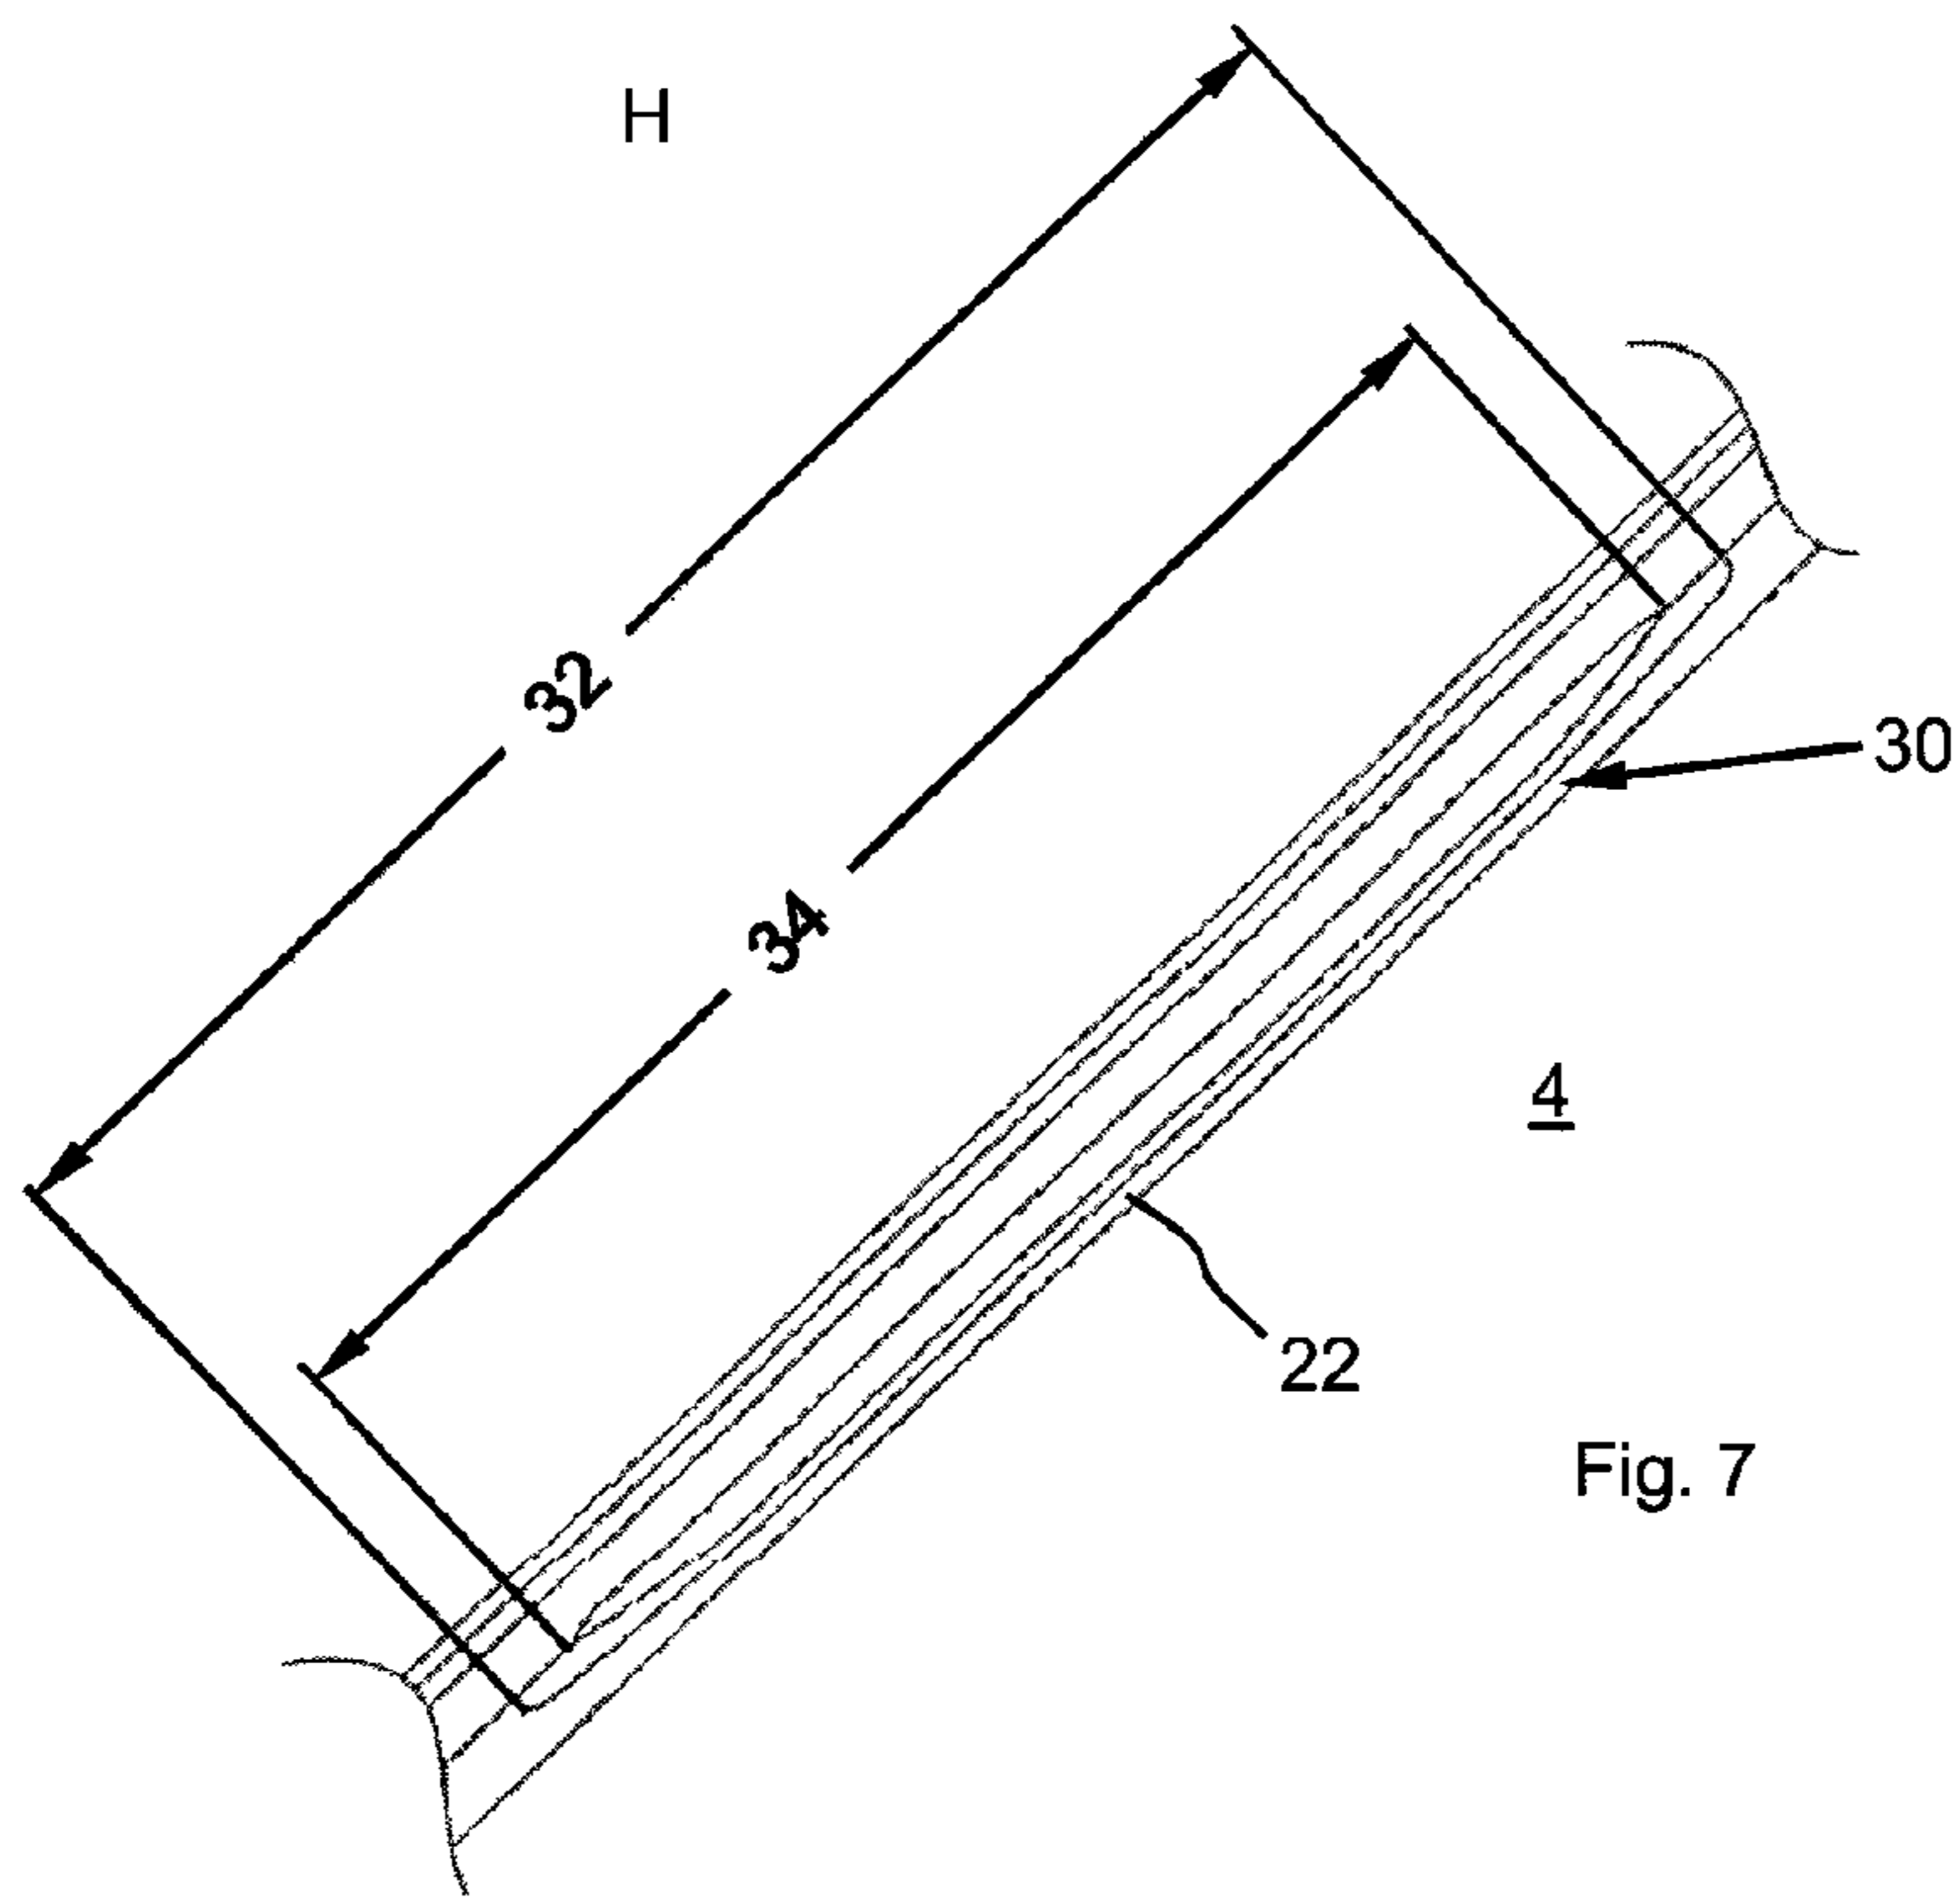
Fig. 7

FIG. 7 shows a top view H of FIG. 6;

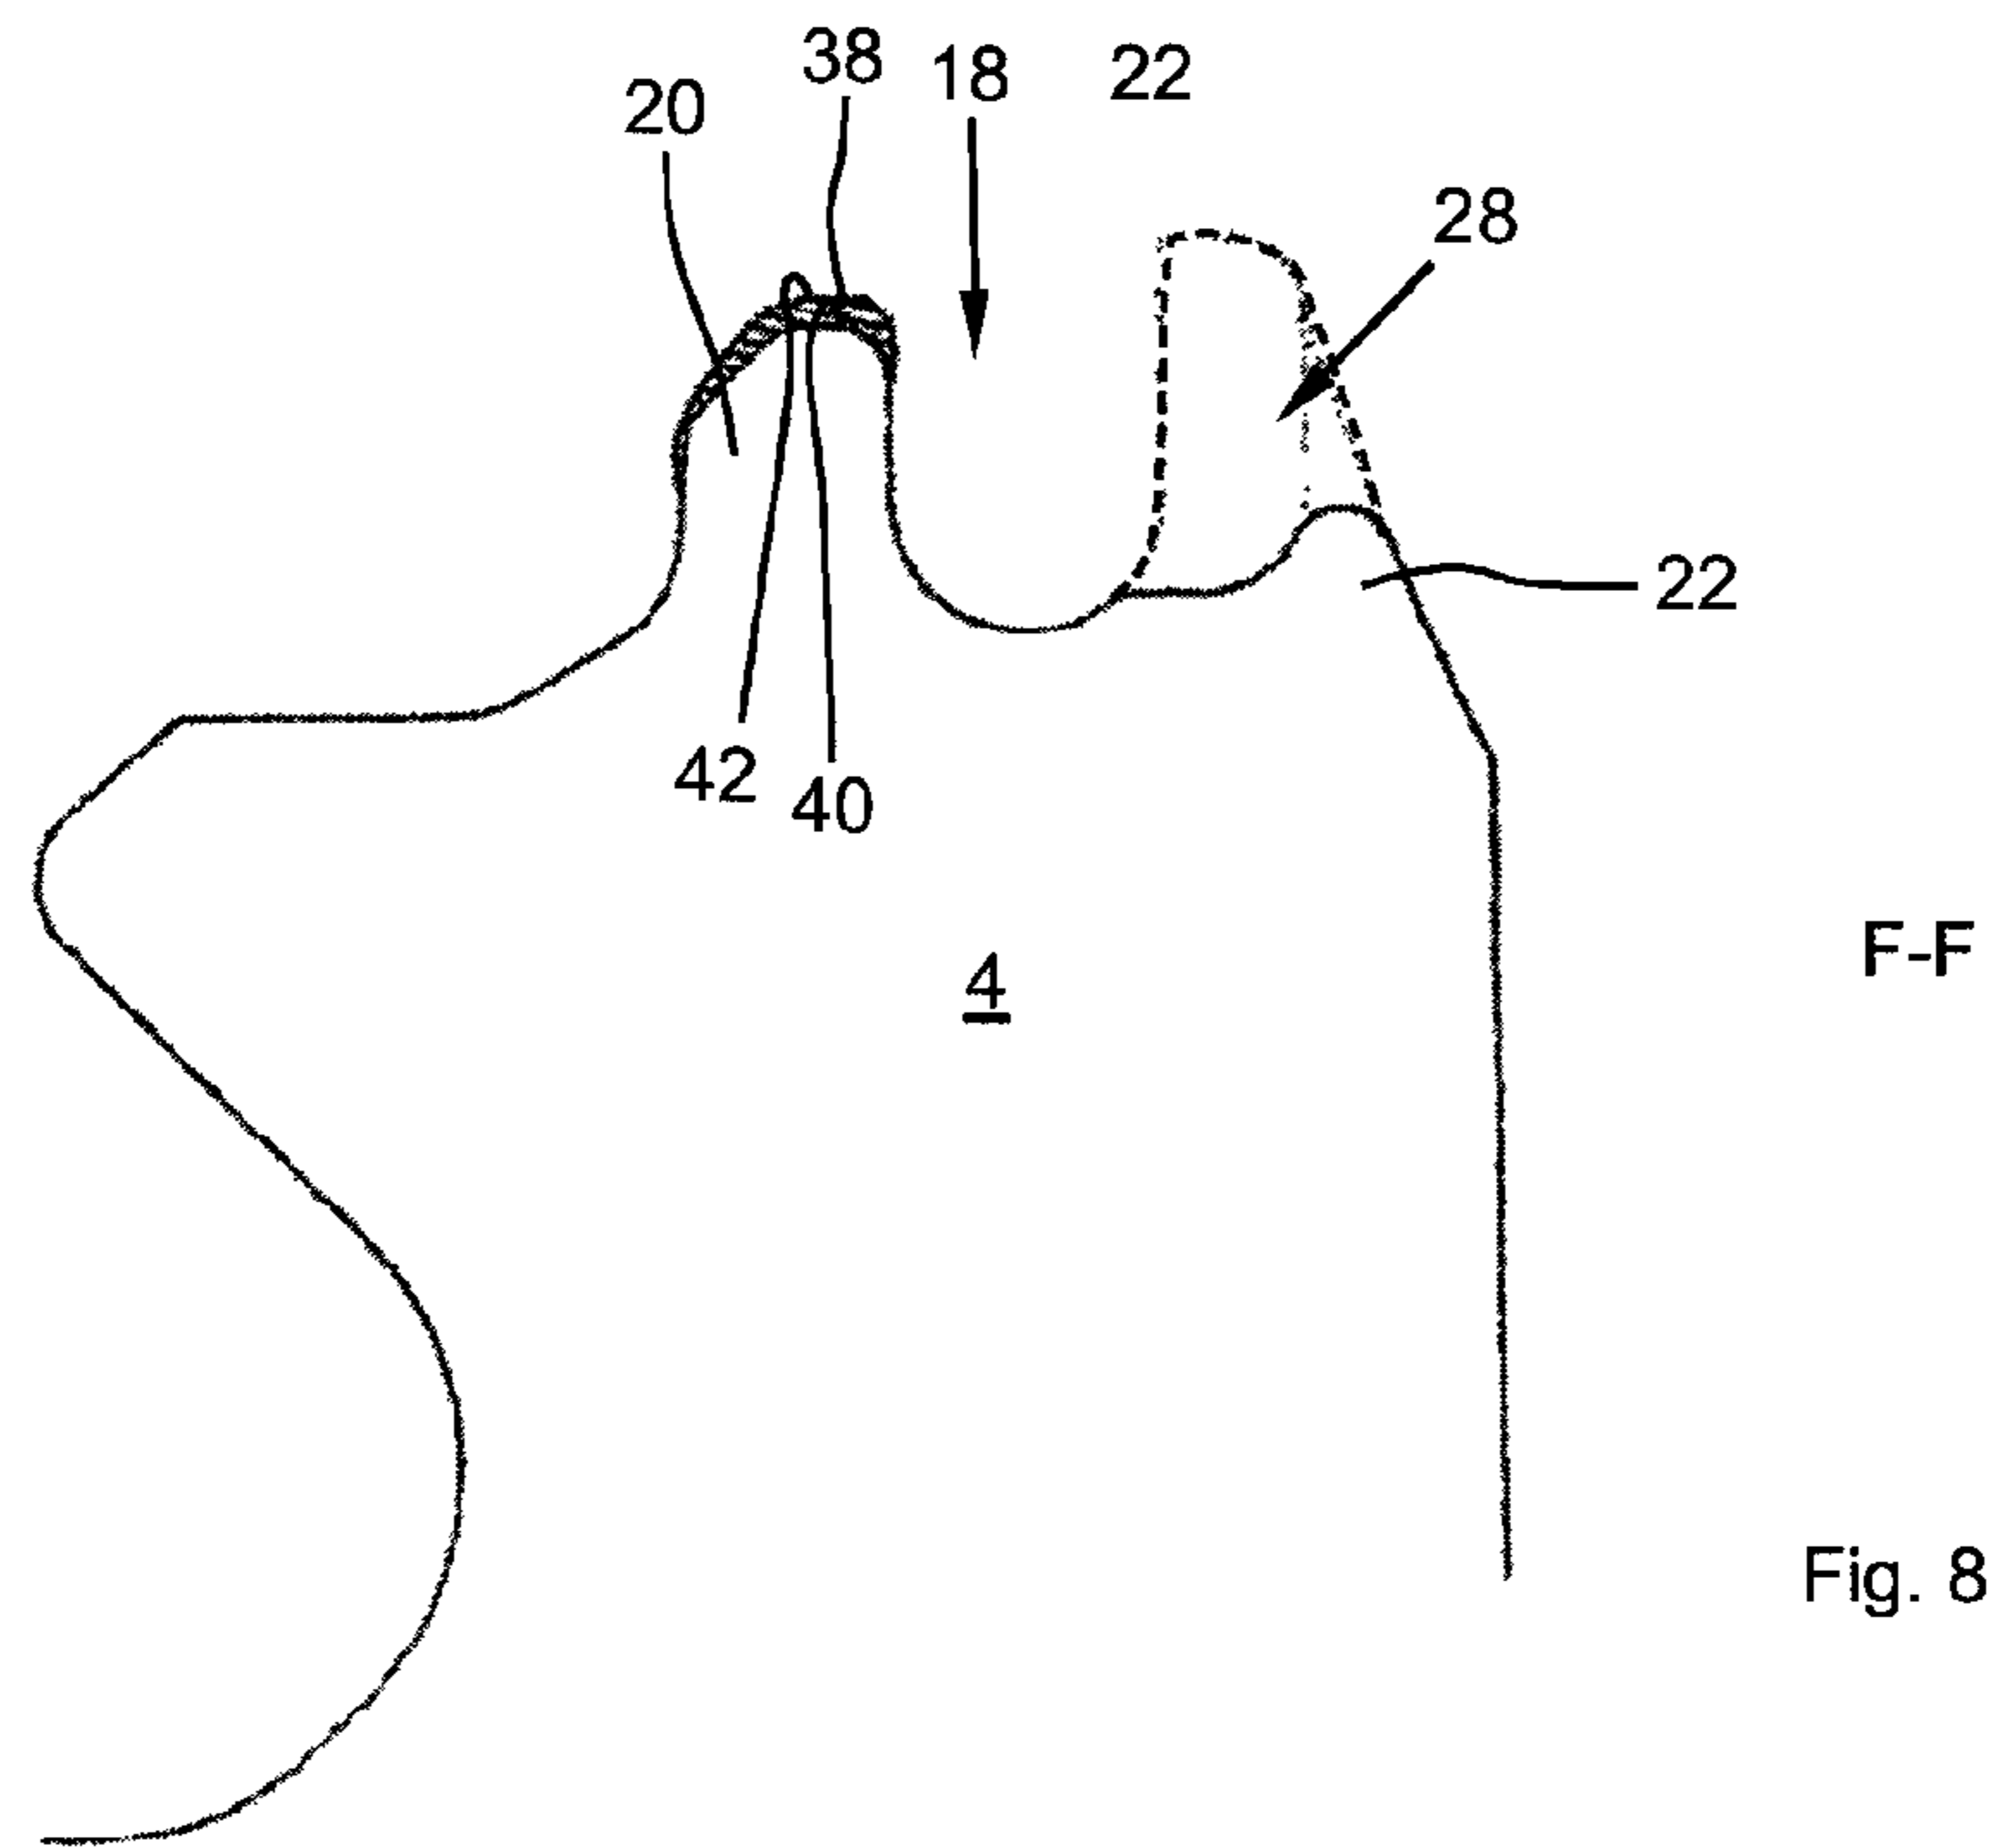
Fig. 8

FIG. 8 shows a sectional view of the compressor rotor along line F-F of FIG. 4 after the repair; and

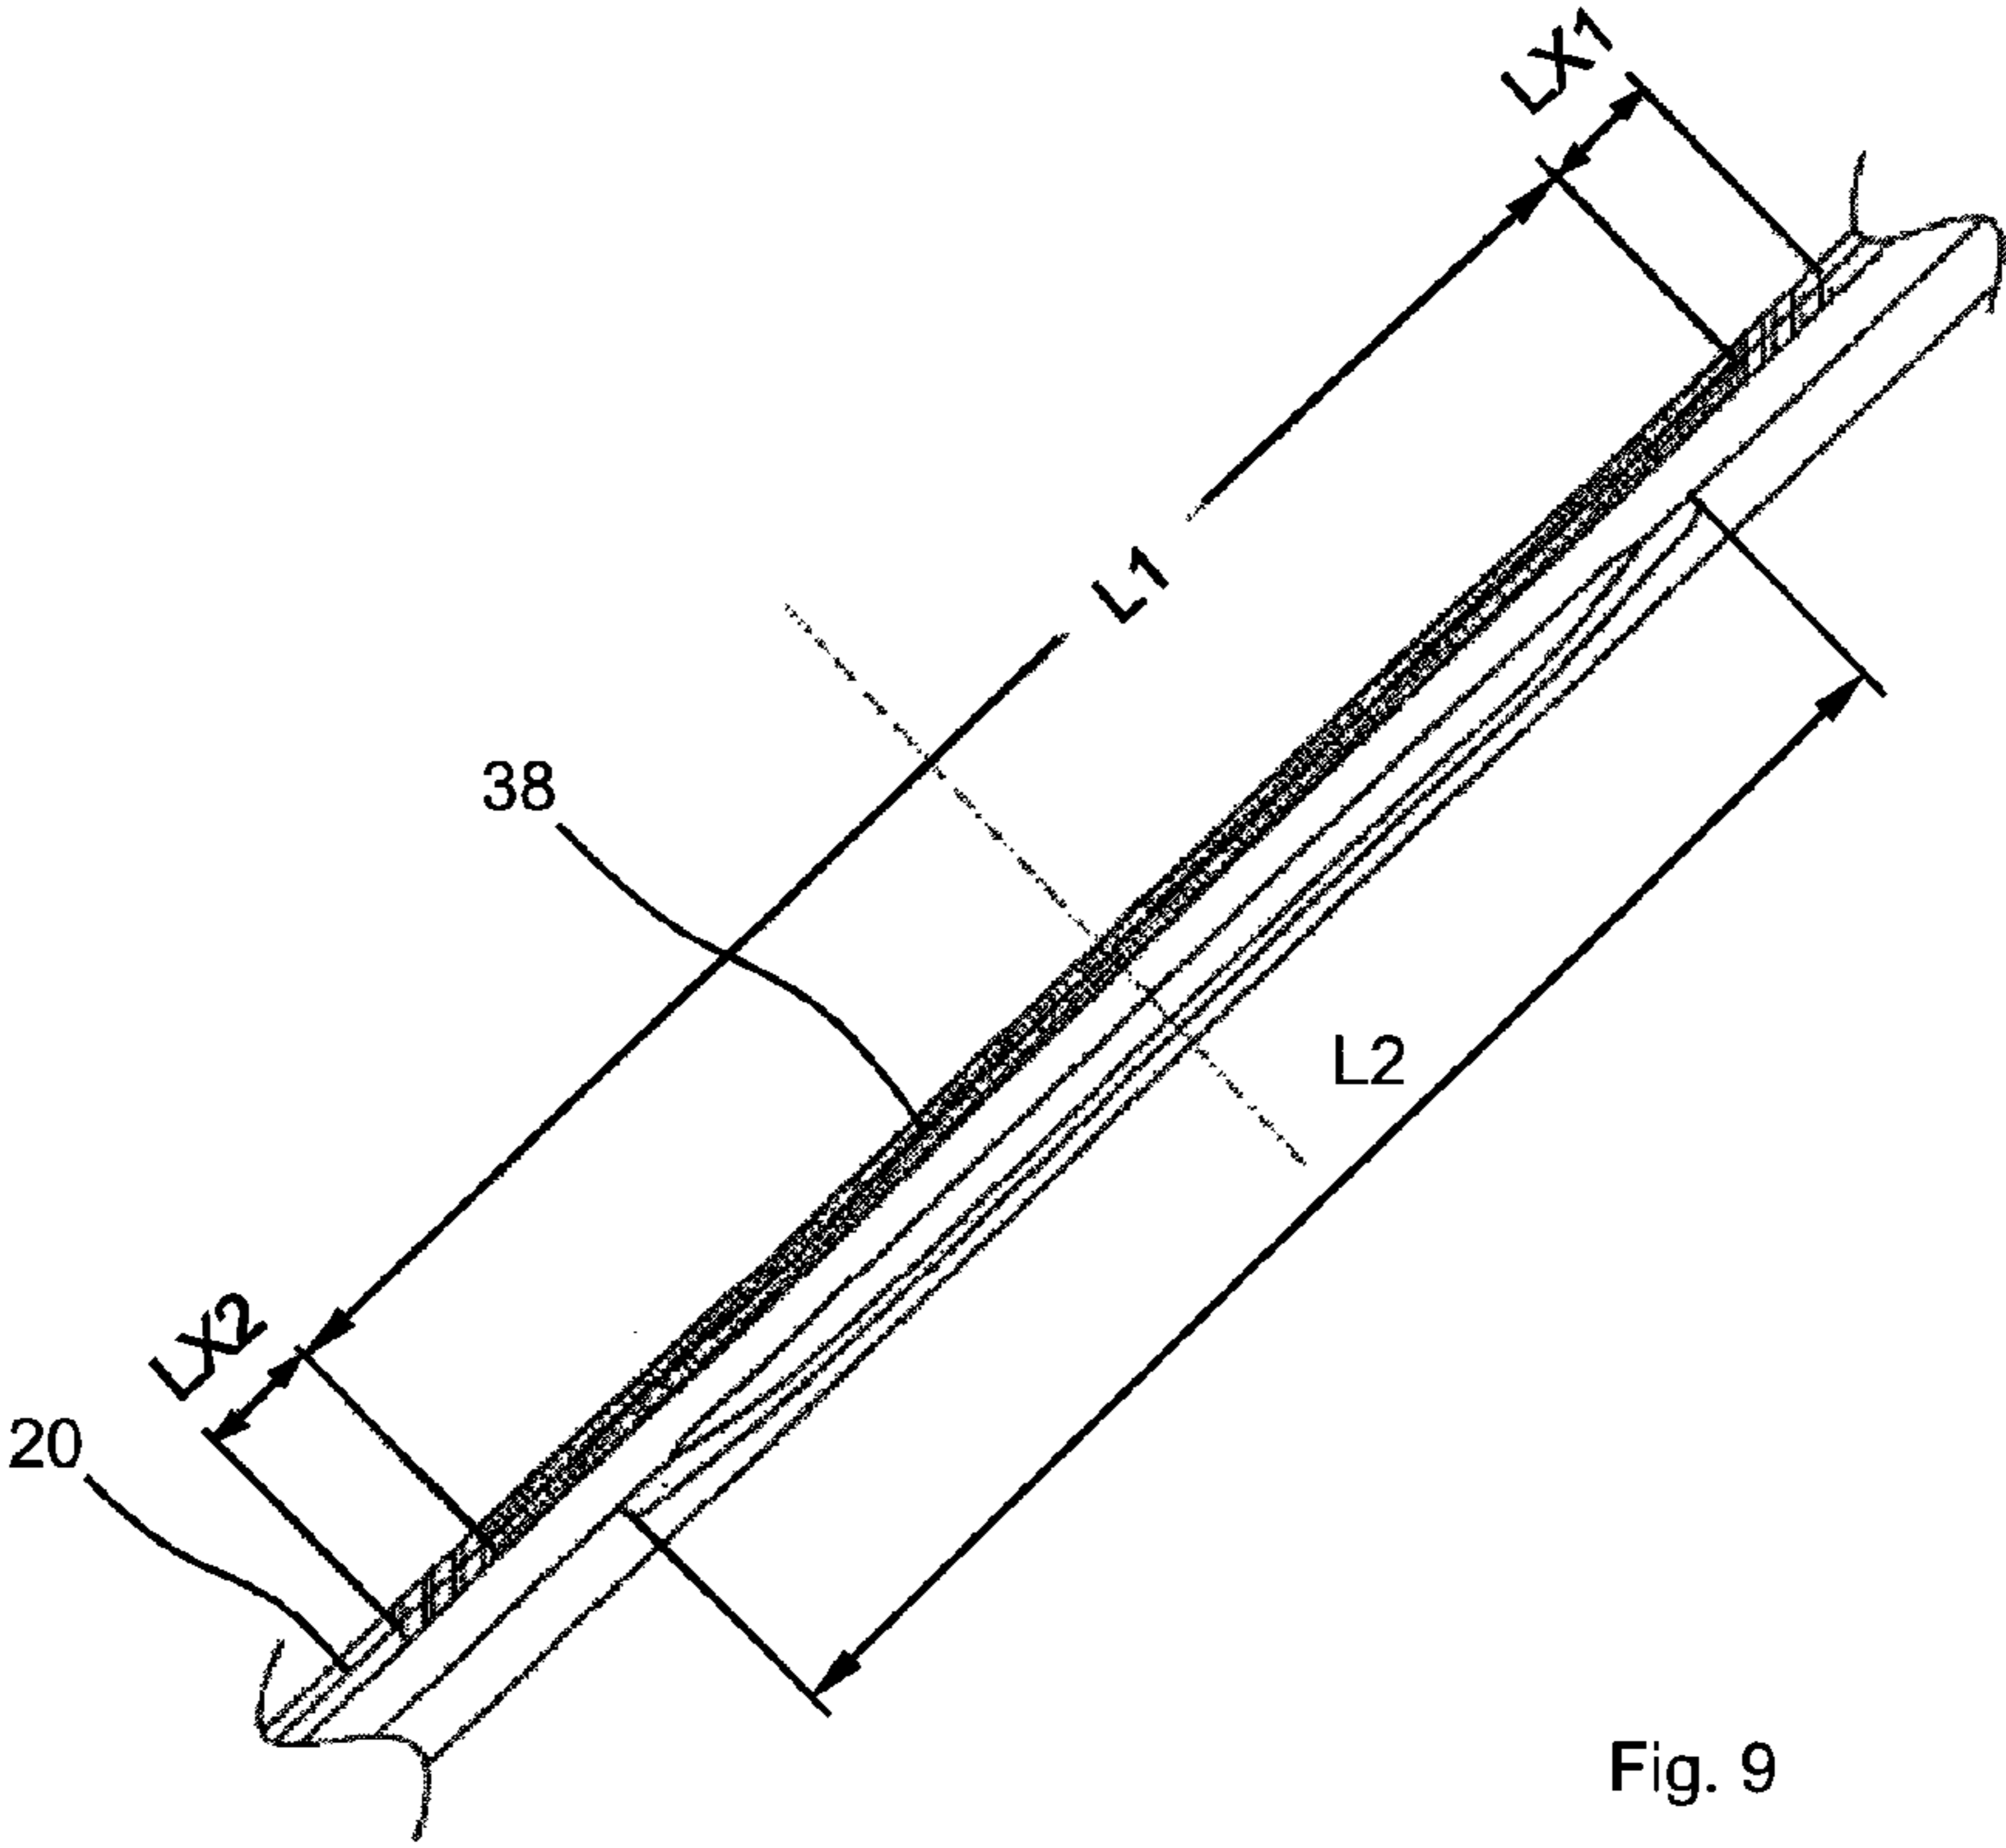
Fig. 9

FIG. 9 shows a top view H of FIG. 6 after the repair.
