(12) **United States Patent**
Cappelli et al.

(54) **ROTOR BLADE REPAIR STRUCTURE AND METHOD**

(73) Assignee: **Sikorsky Aircraft Corporation**, Stratford, CT (US)

A method of repairing a damaged portion of a rotor blade includes filling the damaged portion with a filler material. A pre-cured patch assembly is applied over the damaged portion, the patch assembly including one or more laminate packs positionable at at least one of an upper rotor blade surface and a lower rotor blade surface and one or more overwrap plies positionable over the upper rotor blade surface and the lower blade surface. A repair structure for a damaged portion of a rotor blade includes a volume of fill material disposed at the damaged portion.

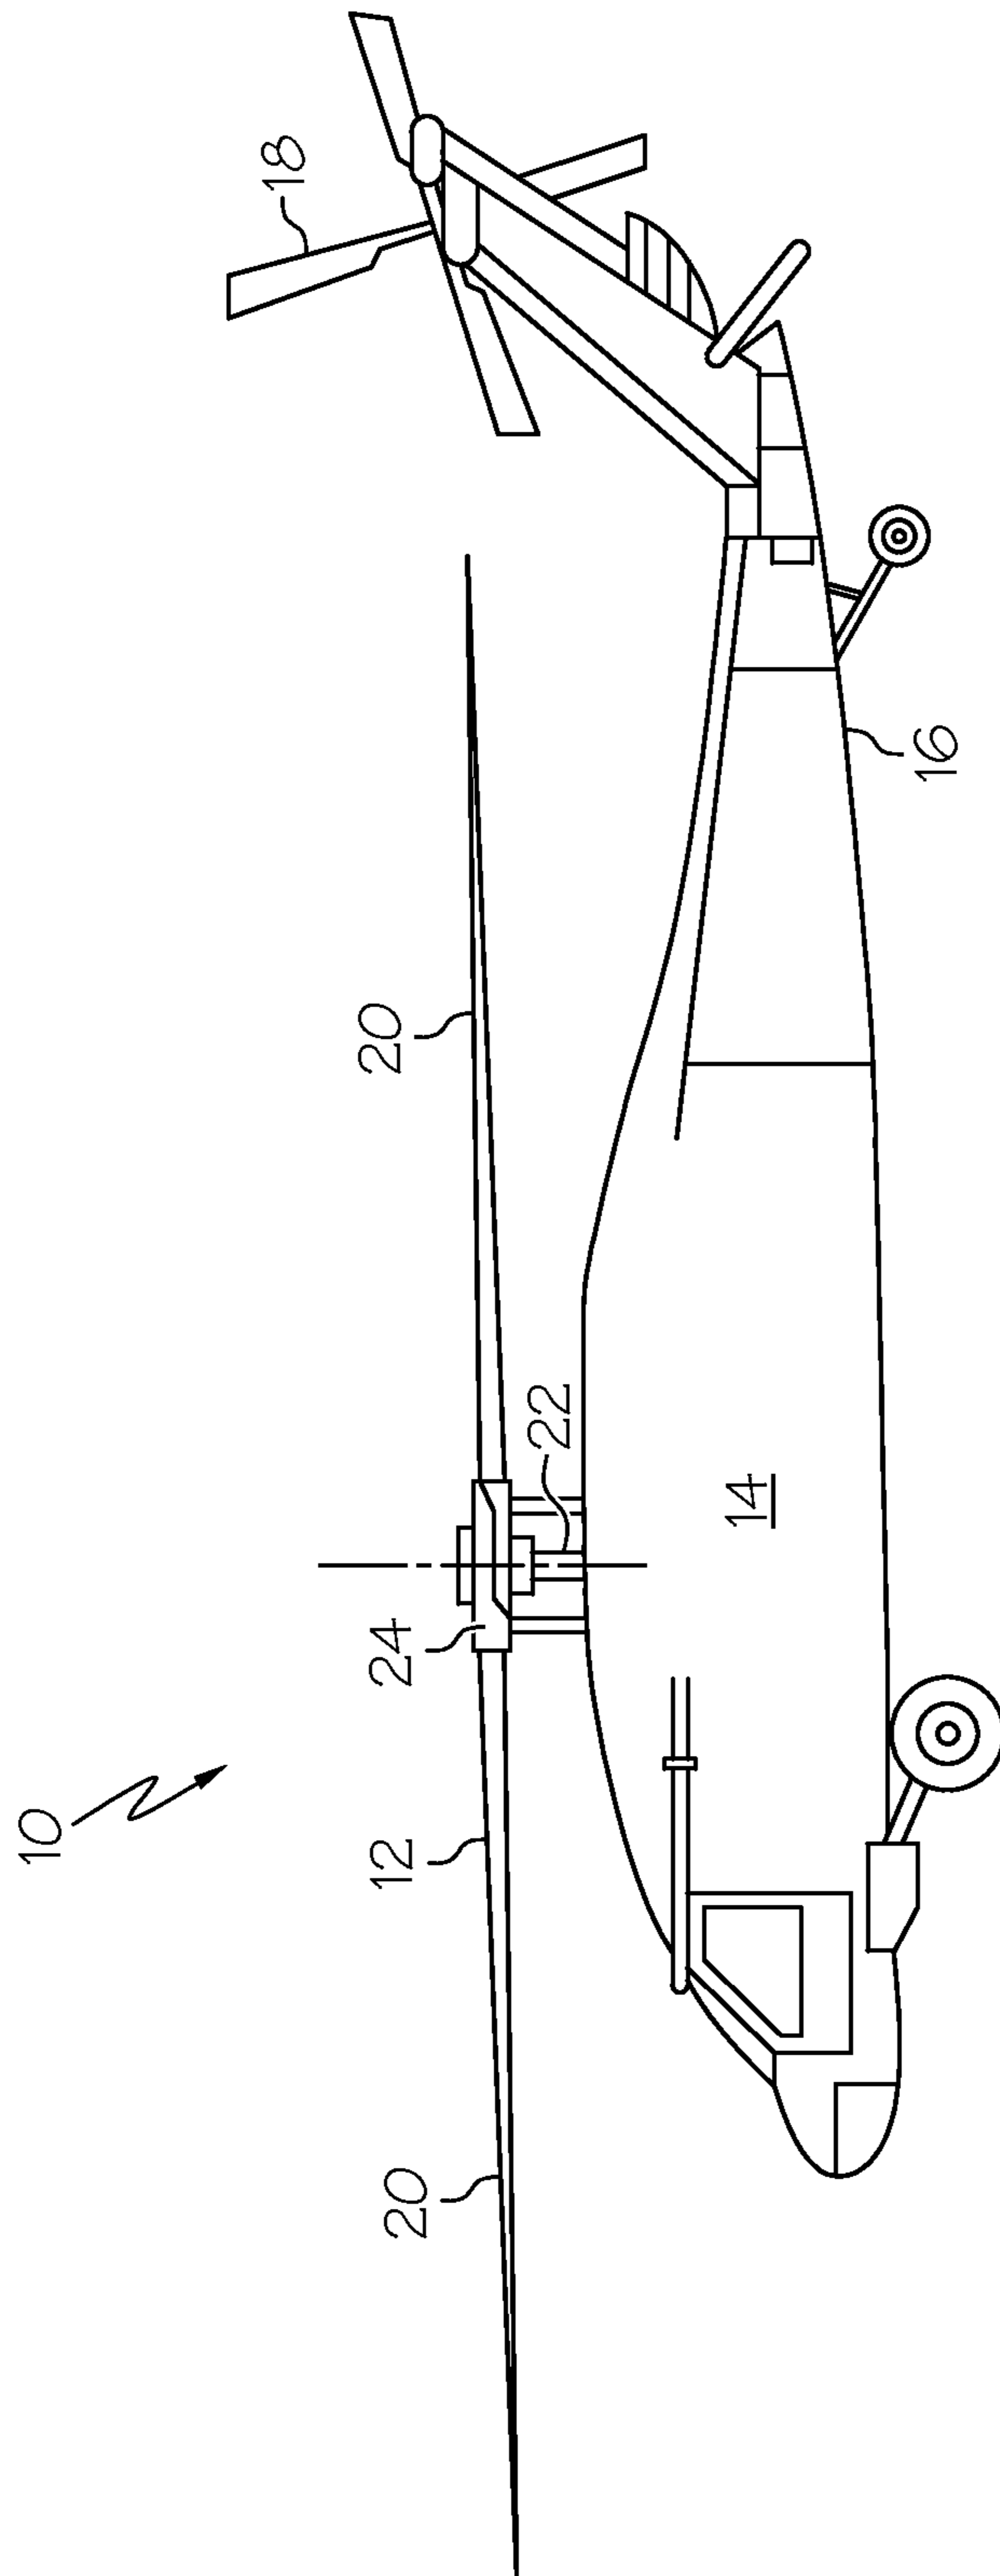
FIG. 1 is a schematic view of an embodiment of a helicopter;

Shown in FIG. 1 is a schematic of a rotary wing aircraft, in this embodiment, a helicopter 10. The helicopter 10 includes a main rotor assembly 12, and an airframe 14 having an extending tail 16 at which is mounted an anti-torque rotor 18. Although the aircraft illustrated is a helicopter 10, it is to be appreciated that other machines, such as turbo props, tilt-rotor aircraft, or wind turbines may also benefit from the system of the present disclosure. Further, while the description herein is of the system applied to the main rotor assembly 12 if a helicopter 10, it may also be applied to the anti-torque rotor 18. The main rotor assembly 12 includes a plurality of blade assemblies 20 located about a rotor shaft 22 via a swashplate 24.

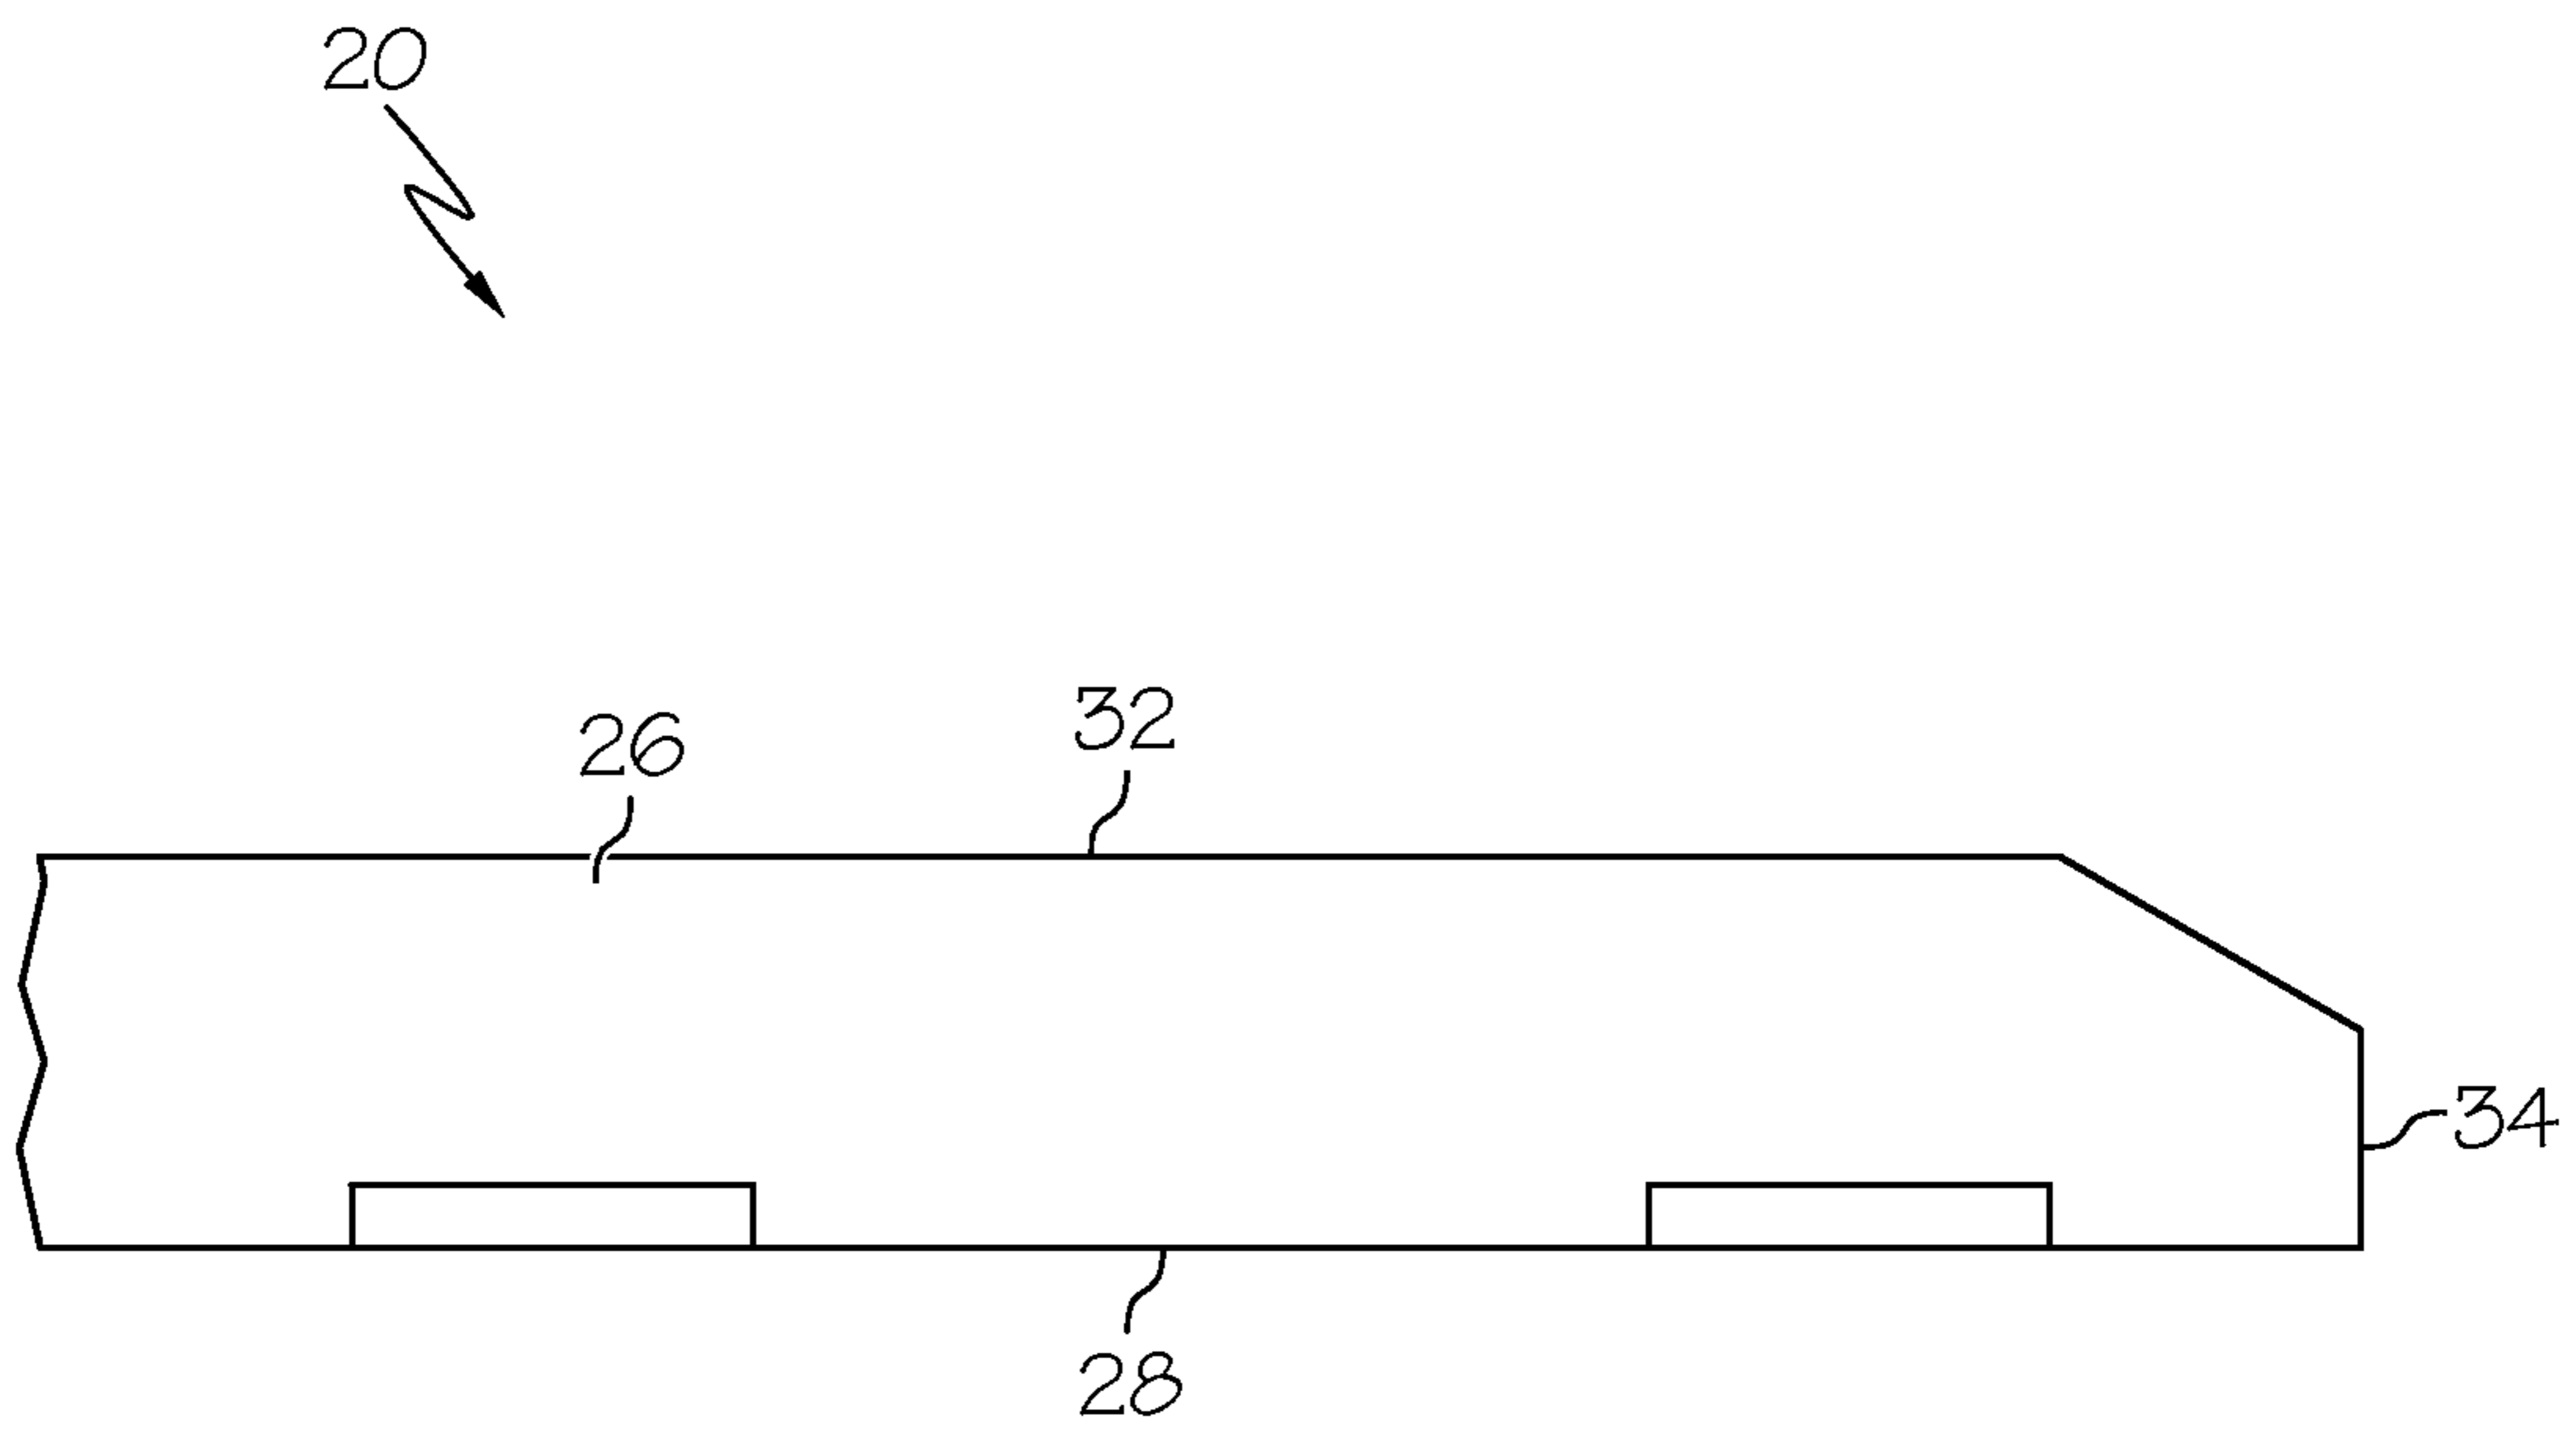
FIG. 2 is a plan view of an embodiment of a rotor blade for a helicopter;

Referring now to FIG. 2, each blade assembly 20 includes a rotor blade 26 with a leading edge 32 and a trailing edge 28. The trailing edge 28 is formed of a plurality of material plies 30 (best shown in FIG. 3), in some embodiments, a graphite material, which are bonded together. While the structure and method described below is directed toward repair of the trailing edge 28, it is to be appreciated that the repair may be utilized at other portions of the rotor blade 26, for example, the leading edge 32 or a blade tip 34.

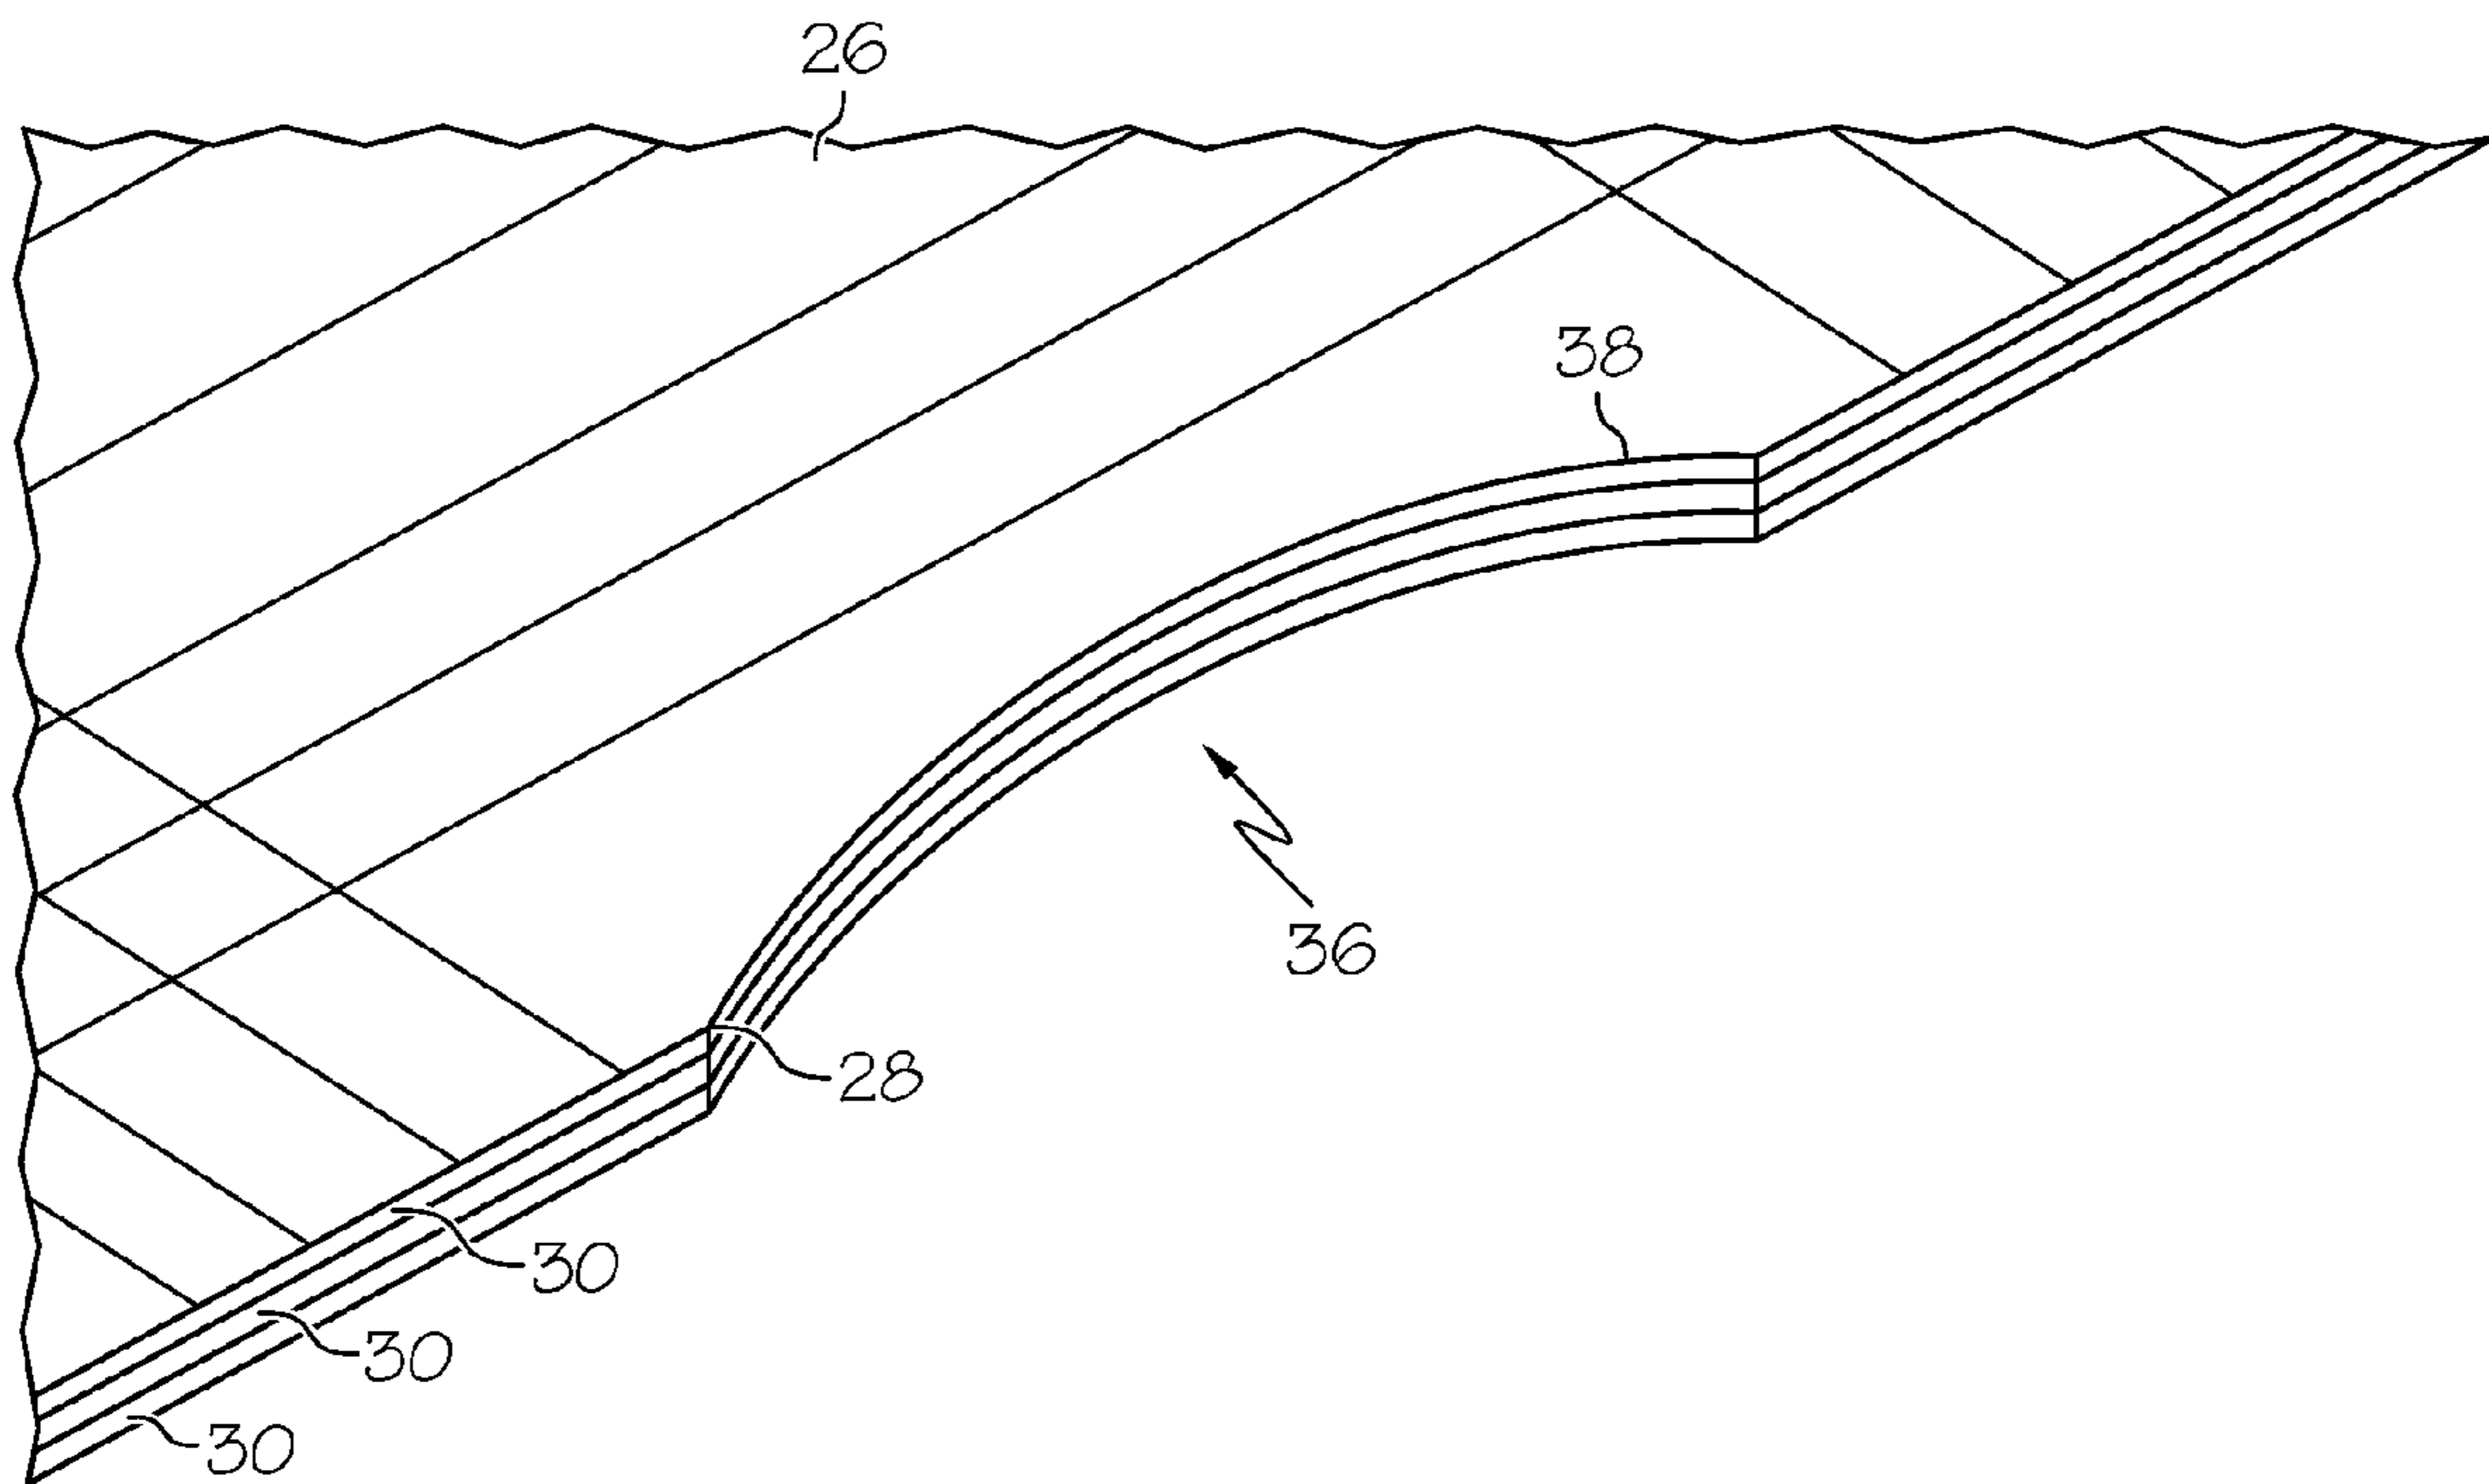
FIG. 3 is a perspective view of a trailing edge portion of a rotor blade; and

Referring to FIG. 3, during operation of the helicopter 10, the blade assembly 20 may become damaged, as indicated by damaged area 36. The damaged area 36 is removed from the trailing edge 28 leaving a specified repair shape 38, determined by limit loads of the blade assembly 20. In some embodiments, as shown, the repair shape 38 is an arc or a segmented arc (having a flat portion interposed between two arc segments), and in some embodiments the repair shape has a width that is about 10 times the depth.

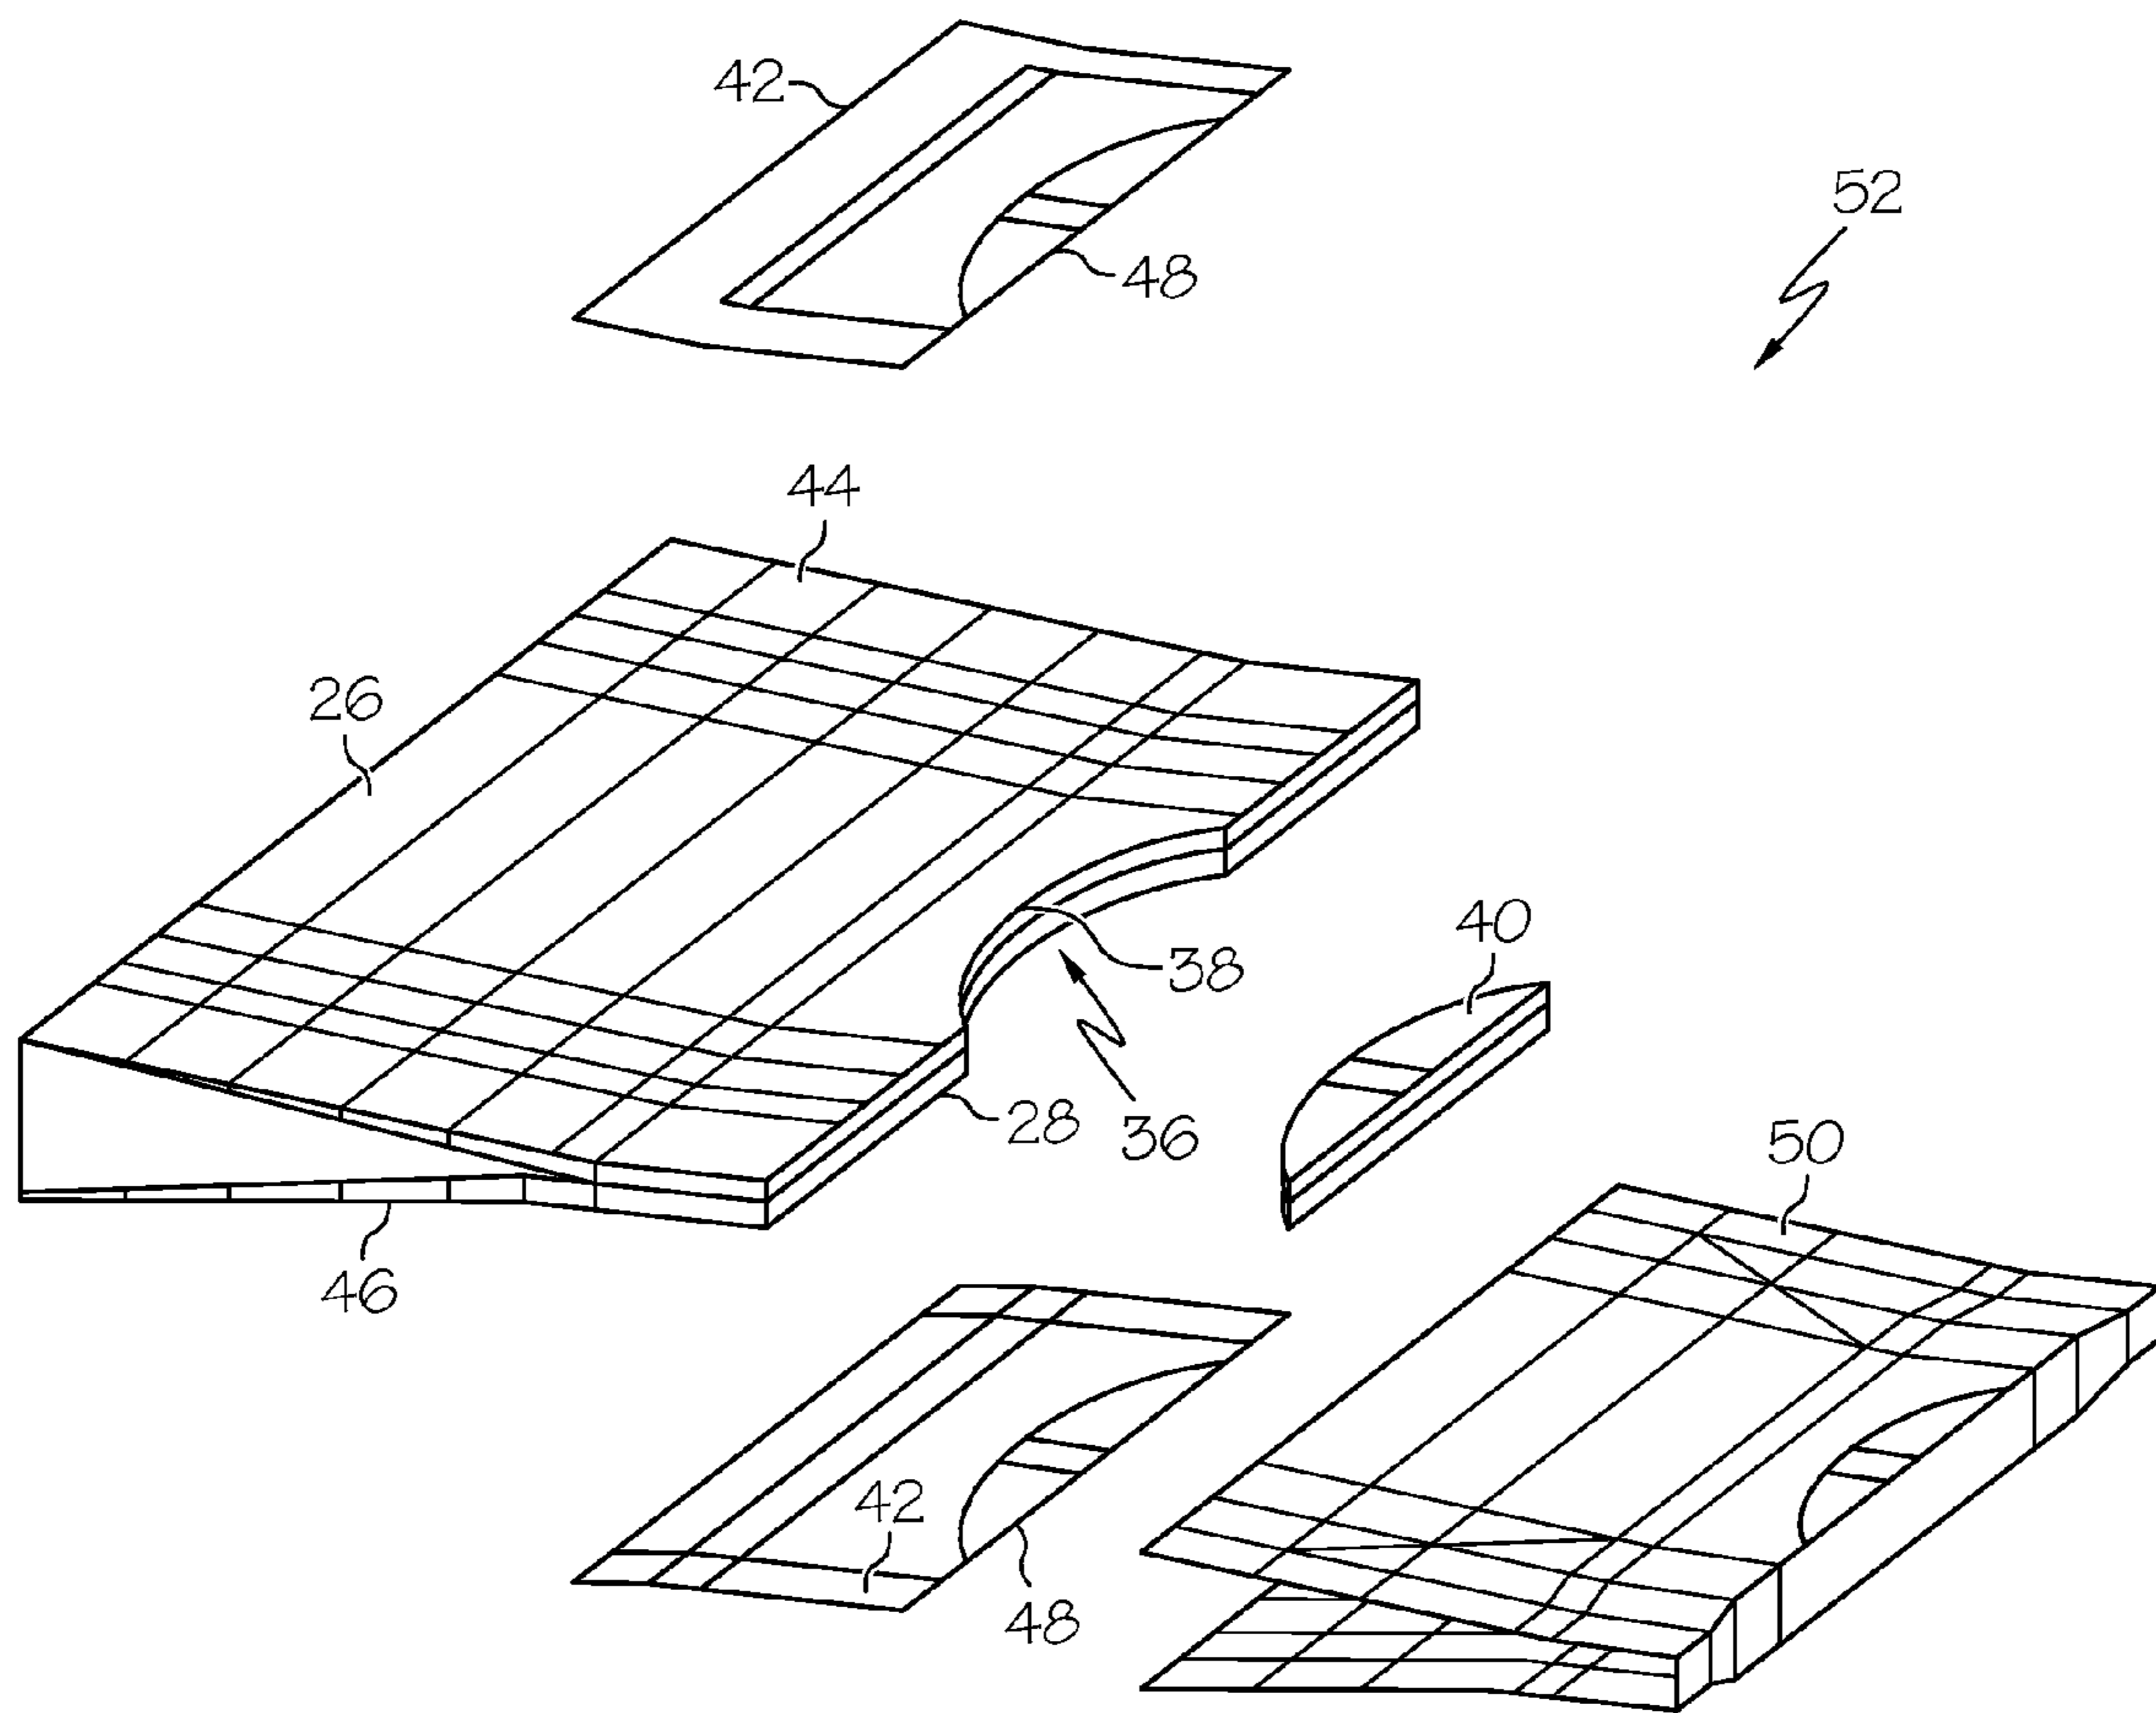
FIG. 4 is an exploded view of an embodiment of a repair structure for a rotor blade.

Referring now to FIG. 4, the repair shape 38 is filled with a filler material 40, which may be a mixture of adhesive and fiberglass powder, fiberglass whisker or other suitable material. Once the filler material 40 is applied, it is cured in position and sanded to a desired finish. In an alternative embodiment, a precured filler material 40 is bonded into the damaged area 36 with an adhesive. For example, a foaming adhesive or fiberglass material cut to a selected shape may be used. Further, in some embodiments, the damaged area is not removed 36 to leave a repair shape or prepared damage area 38, and the filler material 40 is applied directly to the damaged area 36.
