(12) **United States Patent**
Cappelli et al.

(54) **ROTOR BLADE REPAIR STRUCTURE AND METHOD**

A method of repairing a damaged portion of a rotor blade includes filling the damaged portion with a filler material. A pre-cured patch assembly is applied over the damaged portion, the patch assembly including one or more laminate packs positionable at at least one of an upper rotor blade surface and a lower rotor blade surface and one or more overwrap plies positionable over the upper rotor blade surface and the lower blade surface. A repair structure for a damaged portion of a rotor blade includes a volume of fill material disposed at the damaged portion.

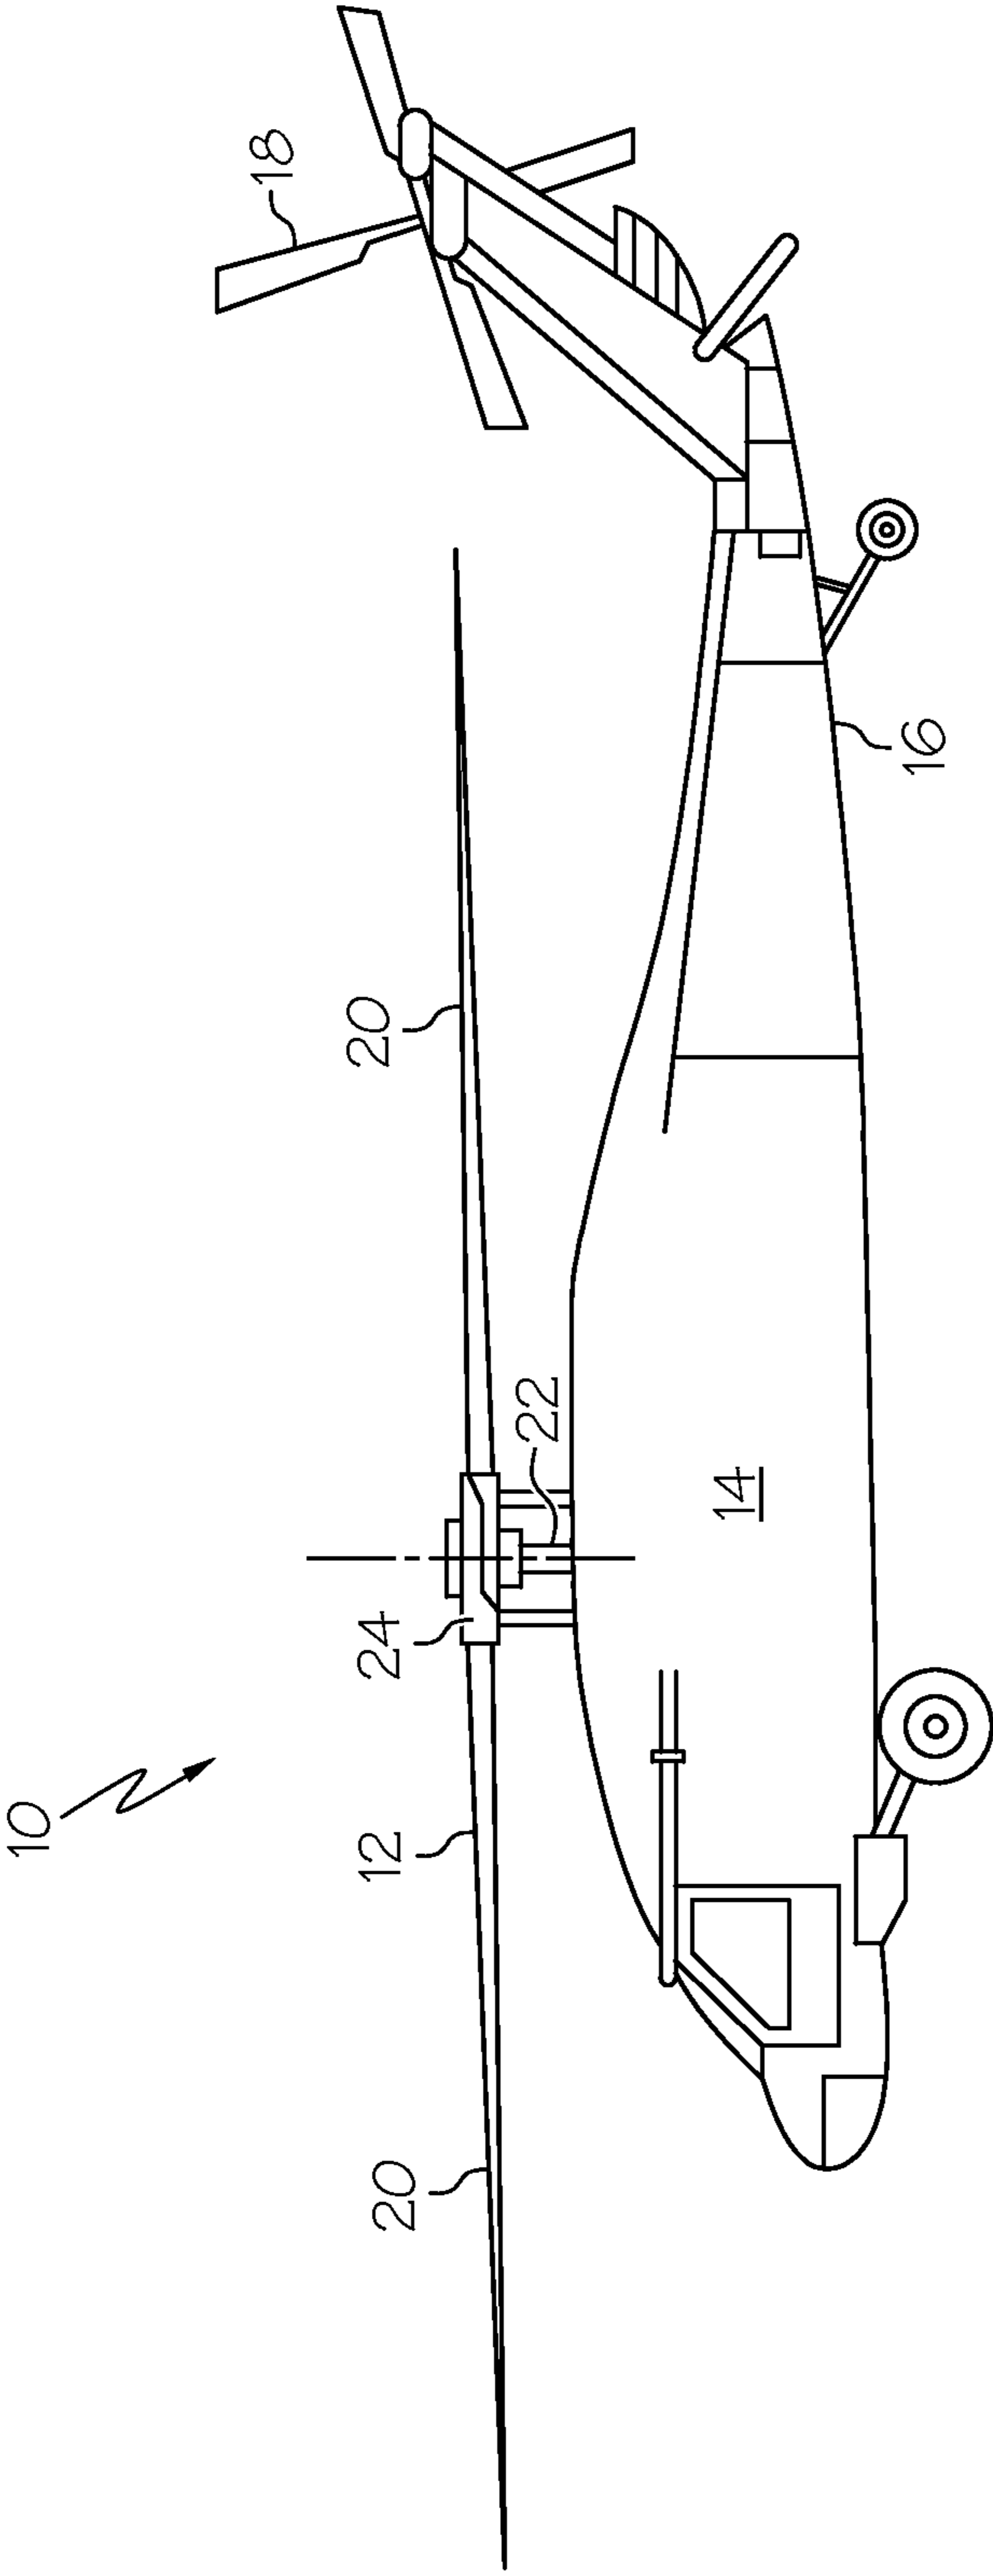
FIG. 1 is a schematic view of an embodiment of a helicopter;

Shown in FIG. 1 is a schematic of a rotary wing aircraft, in this embodiment, a helicopter 10. The helicopter 10 includes a main rotor assembly 12, and an airframe 14 having an extending tail 16 at which is mounted an anti-torque rotor 18. Although the aircraft illustrated is a helicopter 10, it is to be appreciated that other machines, such as turbo props, tilt-rotor aircraft, or wind turbines may also benefit from the system of the present disclosure. Further, while the description herein is of the system applied to the main rotor assembly 12 if a helicopter 10, it may also be applied to the anti-torque rotor 18. The main rotor assembly 12 includes a plurality of blade assemblies 20 located about a rotor shaft 22 via a swashplate 24.

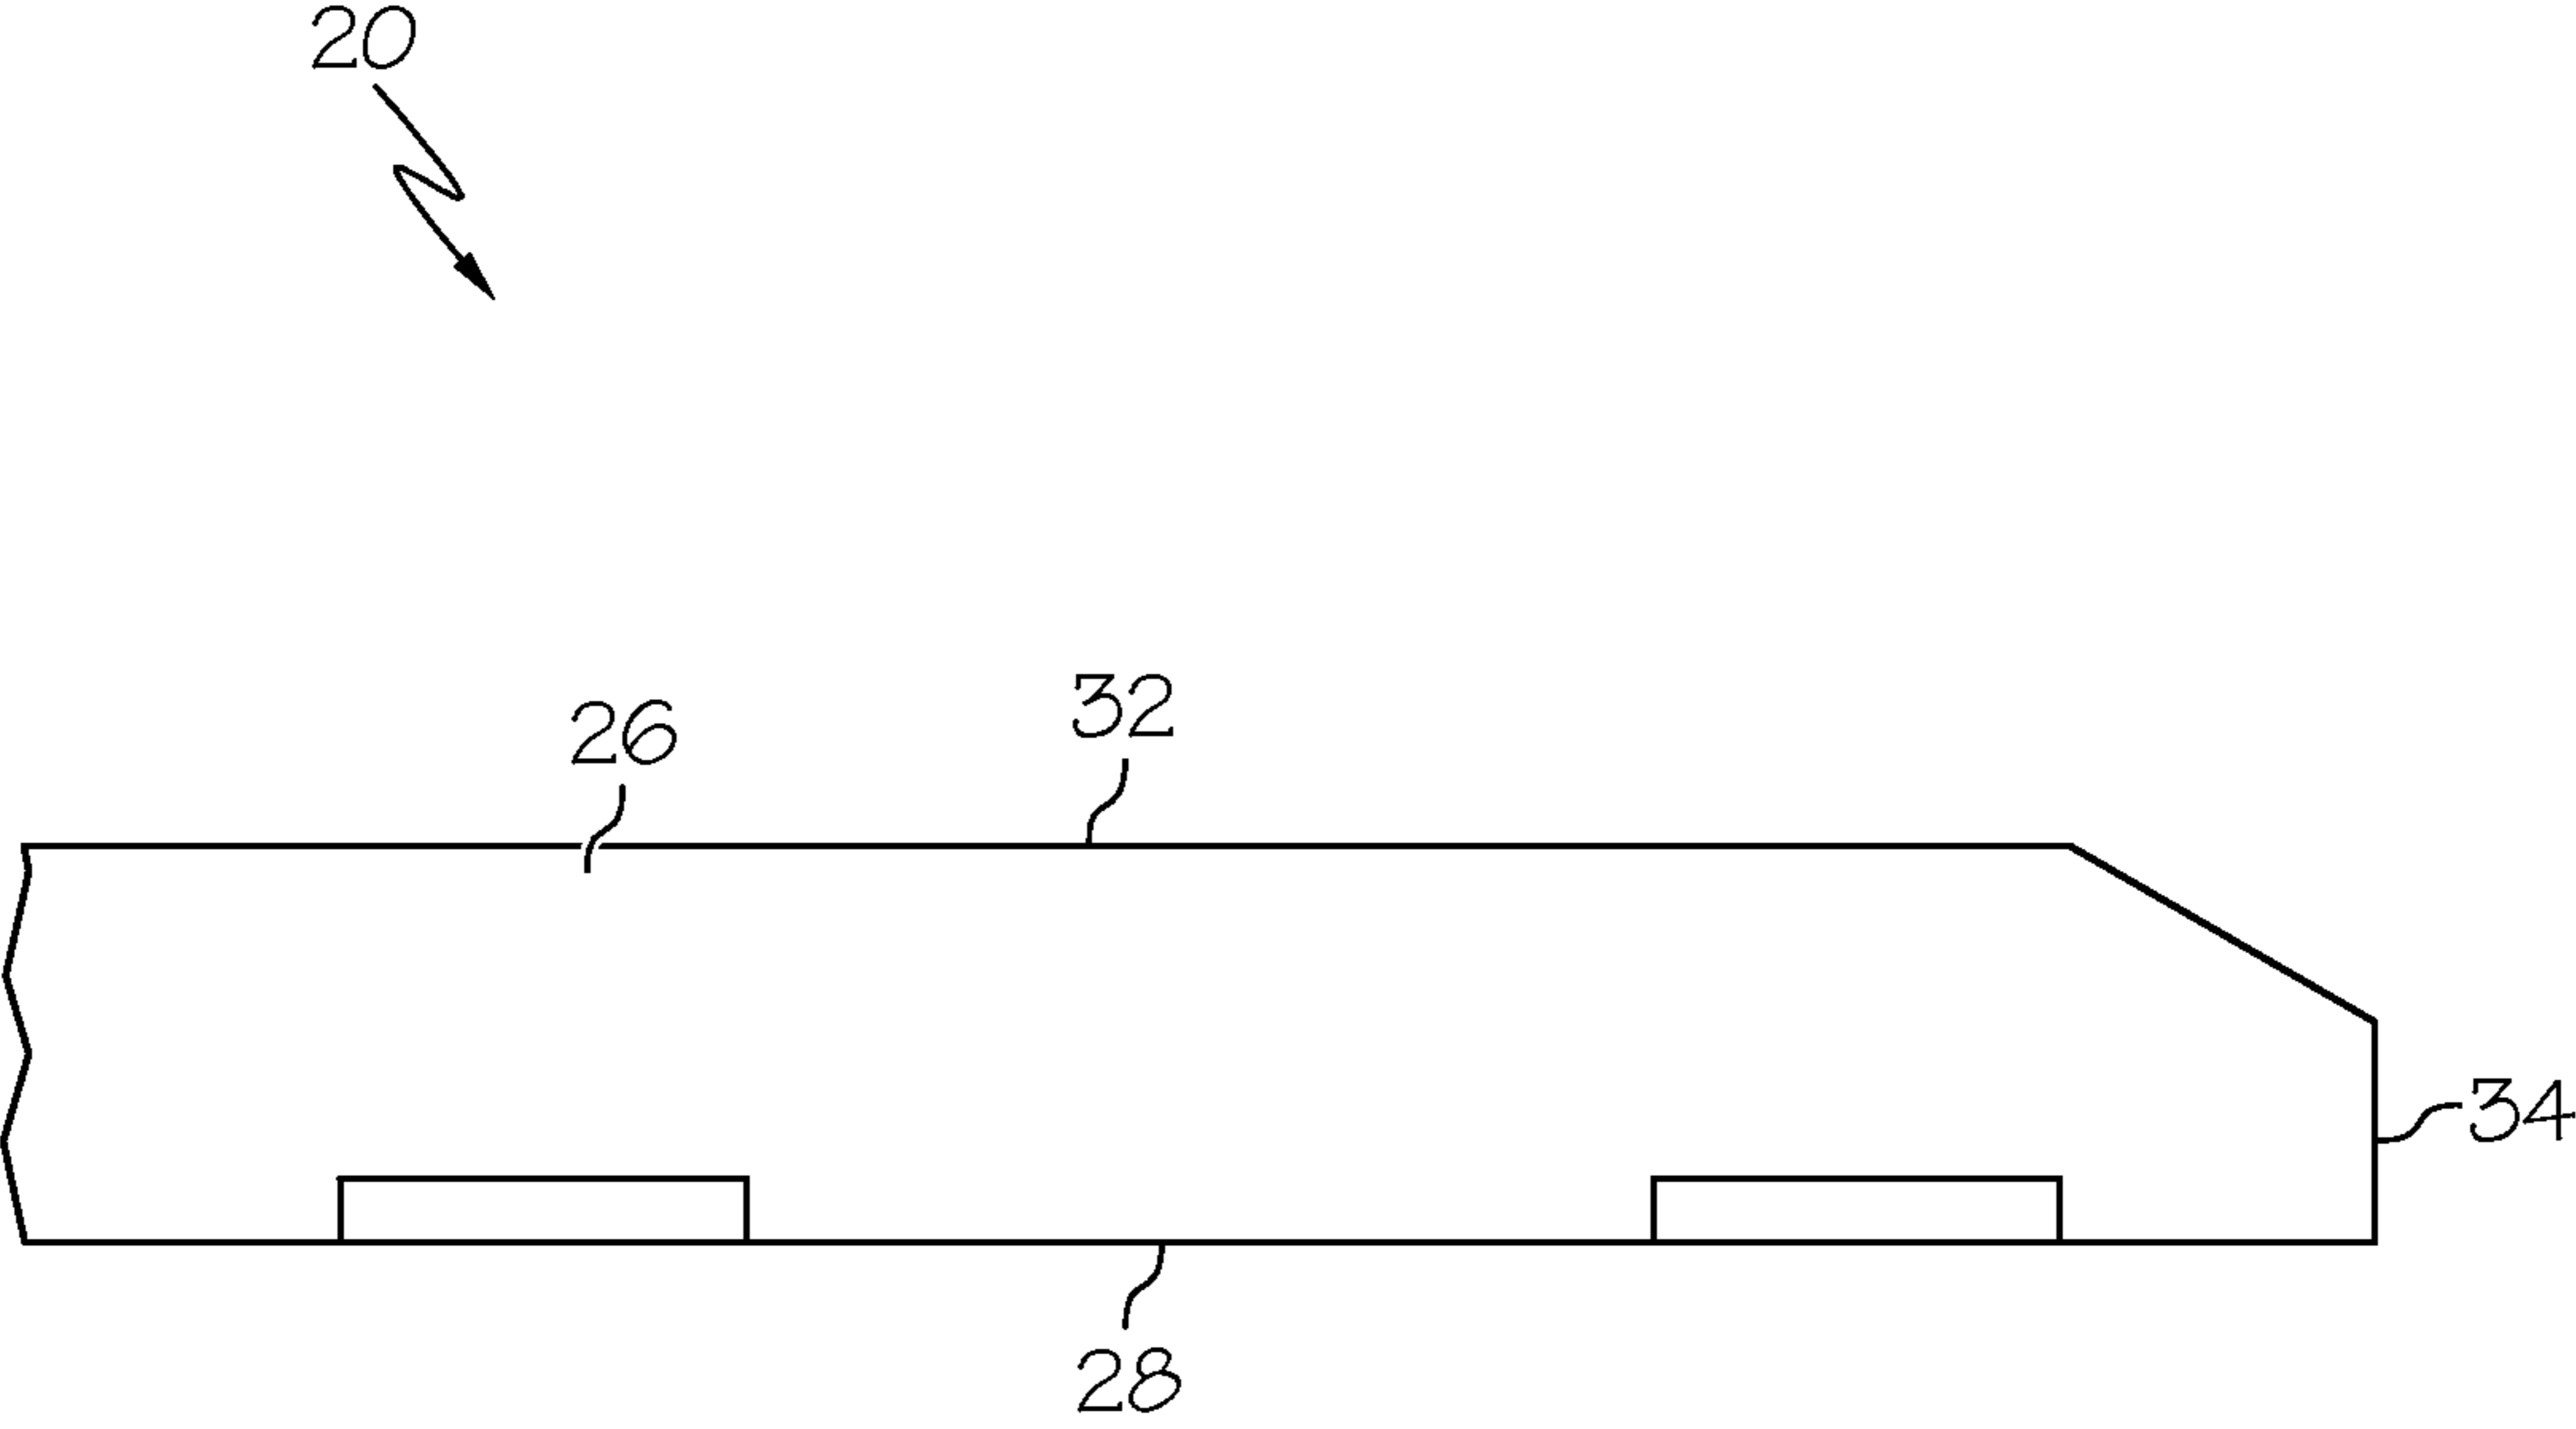
FIG. 2 is a plan view of an embodiment of a rotor blade for a helicopter;

Referring now to FIG. 2, each blade assembly 20 includes a rotor blade 26 with a leading edge 32 and a trailing edge 28. The trailing edge 28 is formed of a plurality of material plies 30 (best shown in FIG. 3), in some embodiments, a graphite material, which are bonded together. While the structure and method described below is directed toward repair of the trailing edge 28, it is to be appreciated that the repair may be utilized at other portions of the rotor blade 26, for example, the leading edge 32 or a blade tip 34.

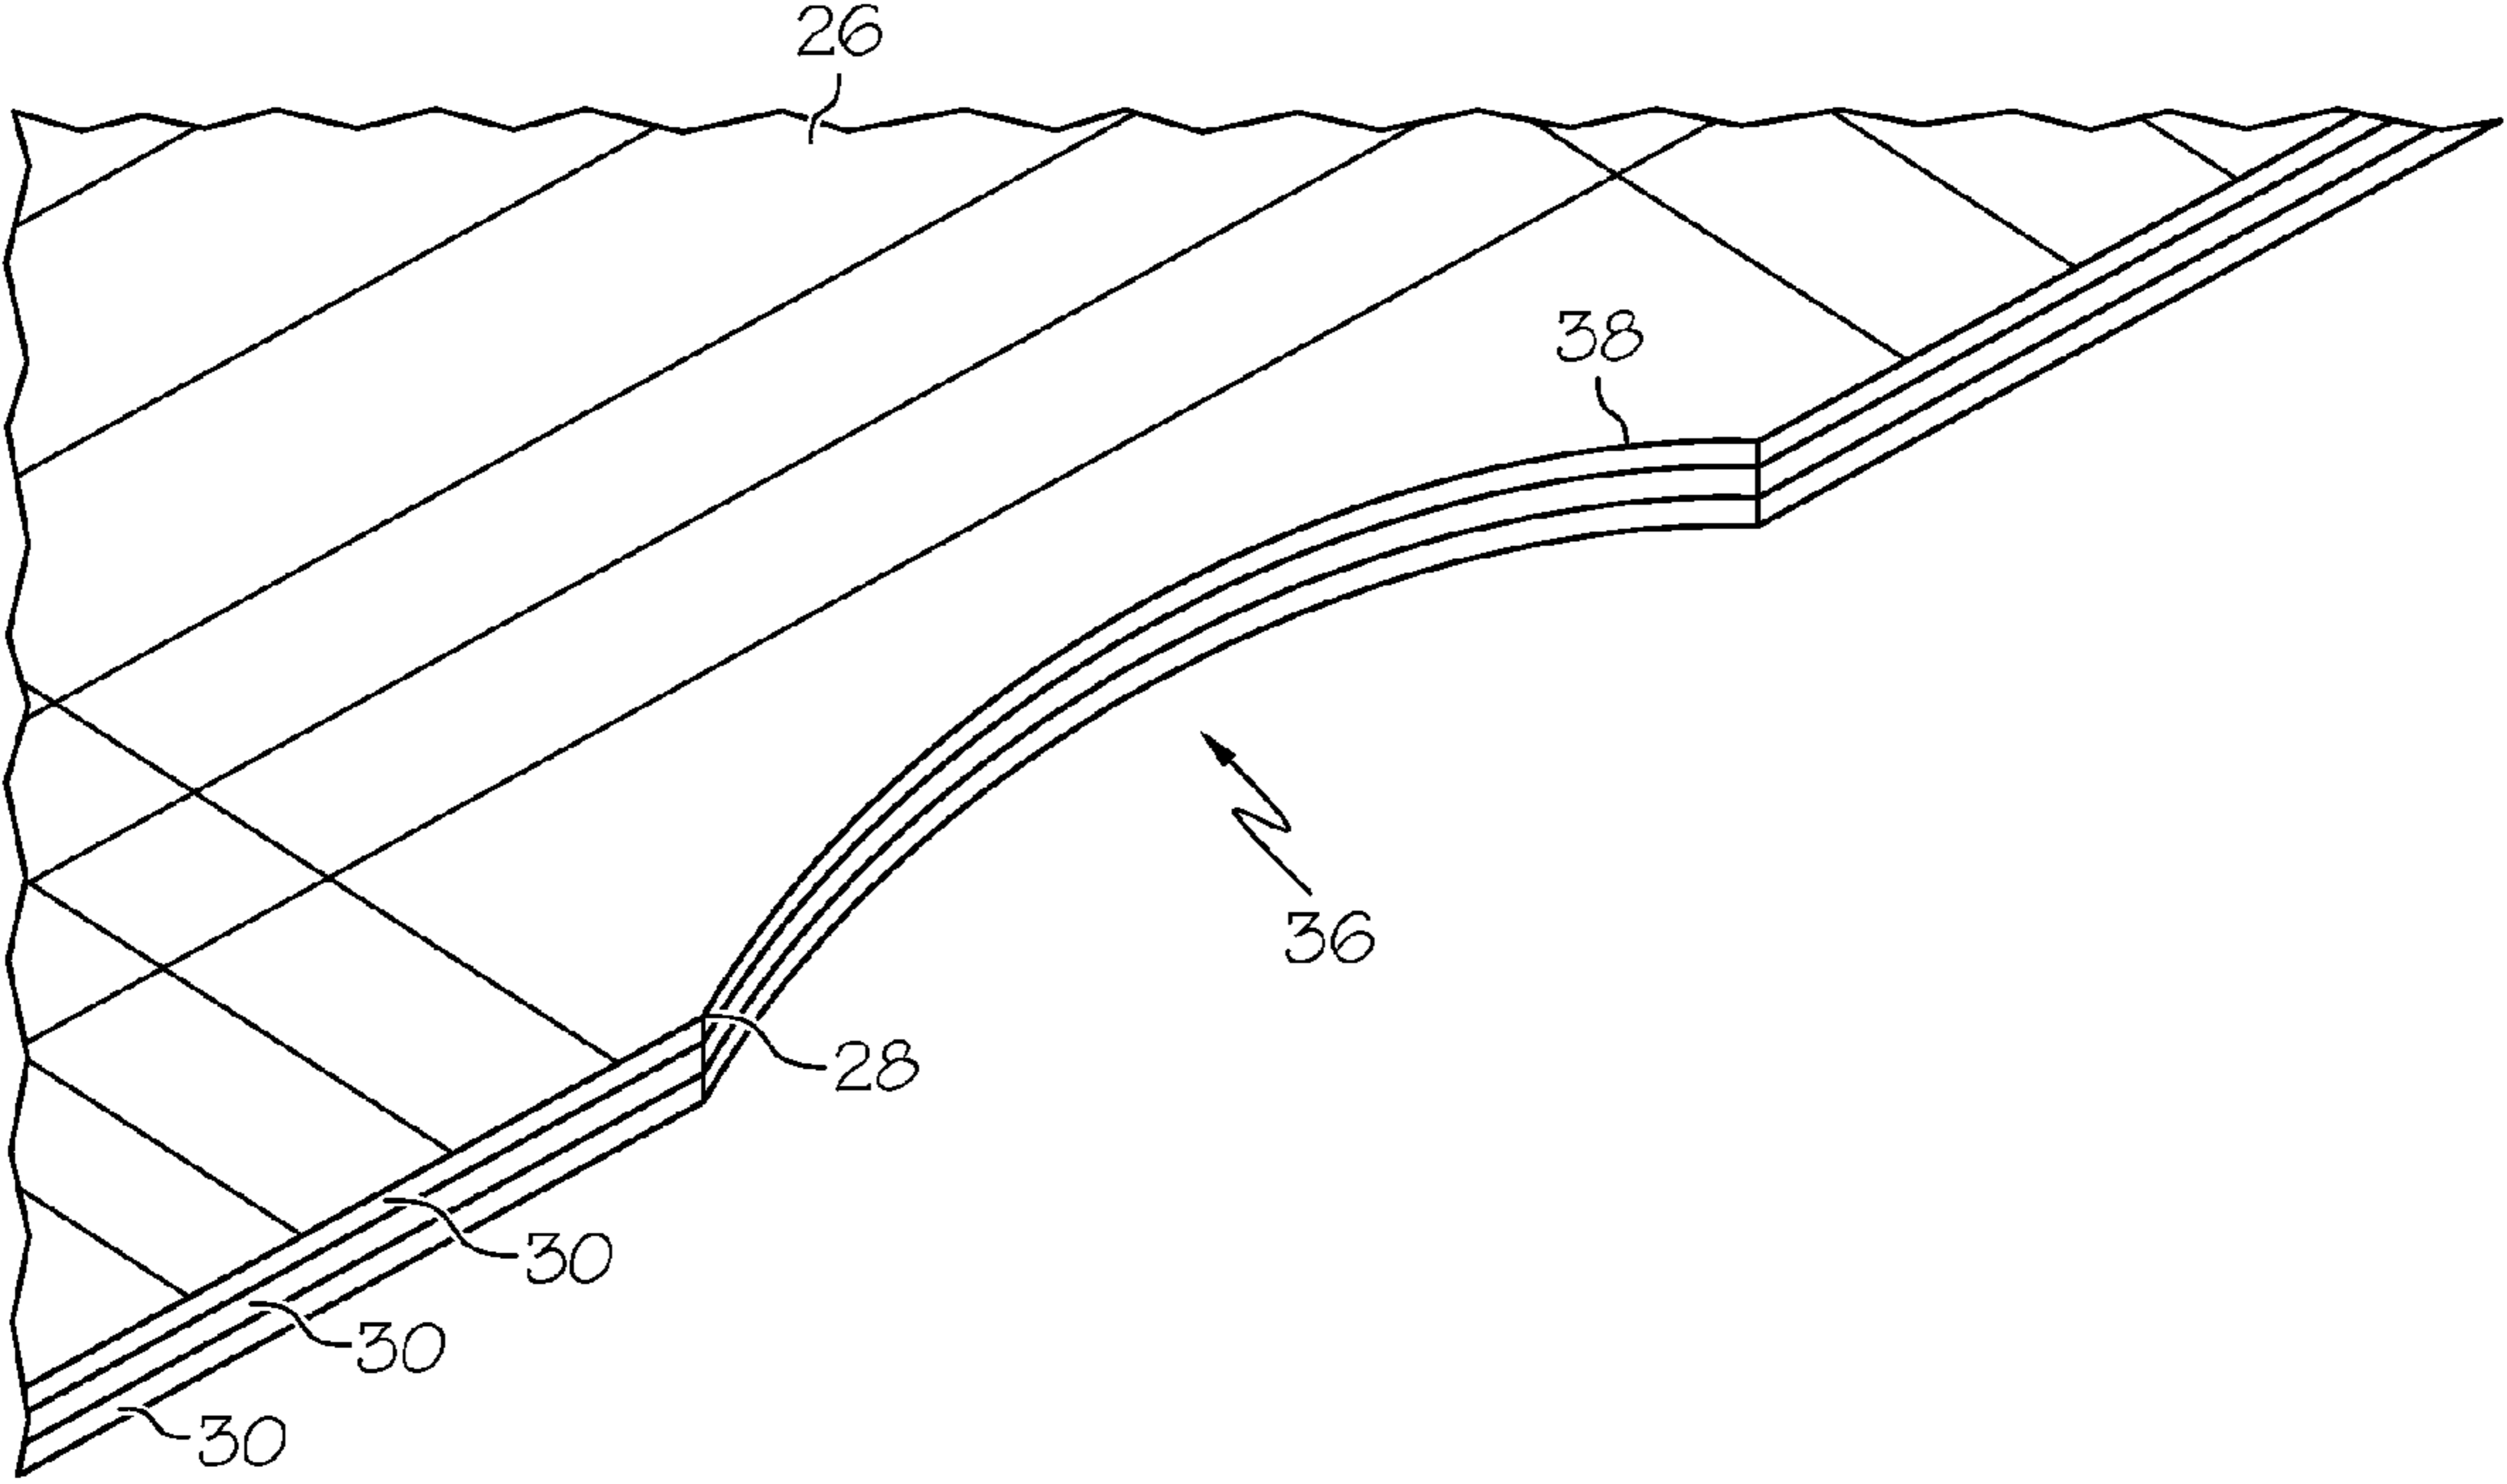
FIG. 3 is a perspective view of a trailing edge portion of a rotor blade; and

Referring to FIG. 3, during operation of the helicopter 10, the blade assembly 20 may become damaged, as indicated by damaged area 36. The damaged area 36 is removed from the trailing edge 28 leaving a specified repair shape 38, determined by limit loads of the blade assembly 20. In some embodiments, as shown, the repair shape 38 is an arc or a segmented arc (having a flat portion interposed between two arc segments), and in some embodiments the repair shape has a width that is about 10 times the depth.

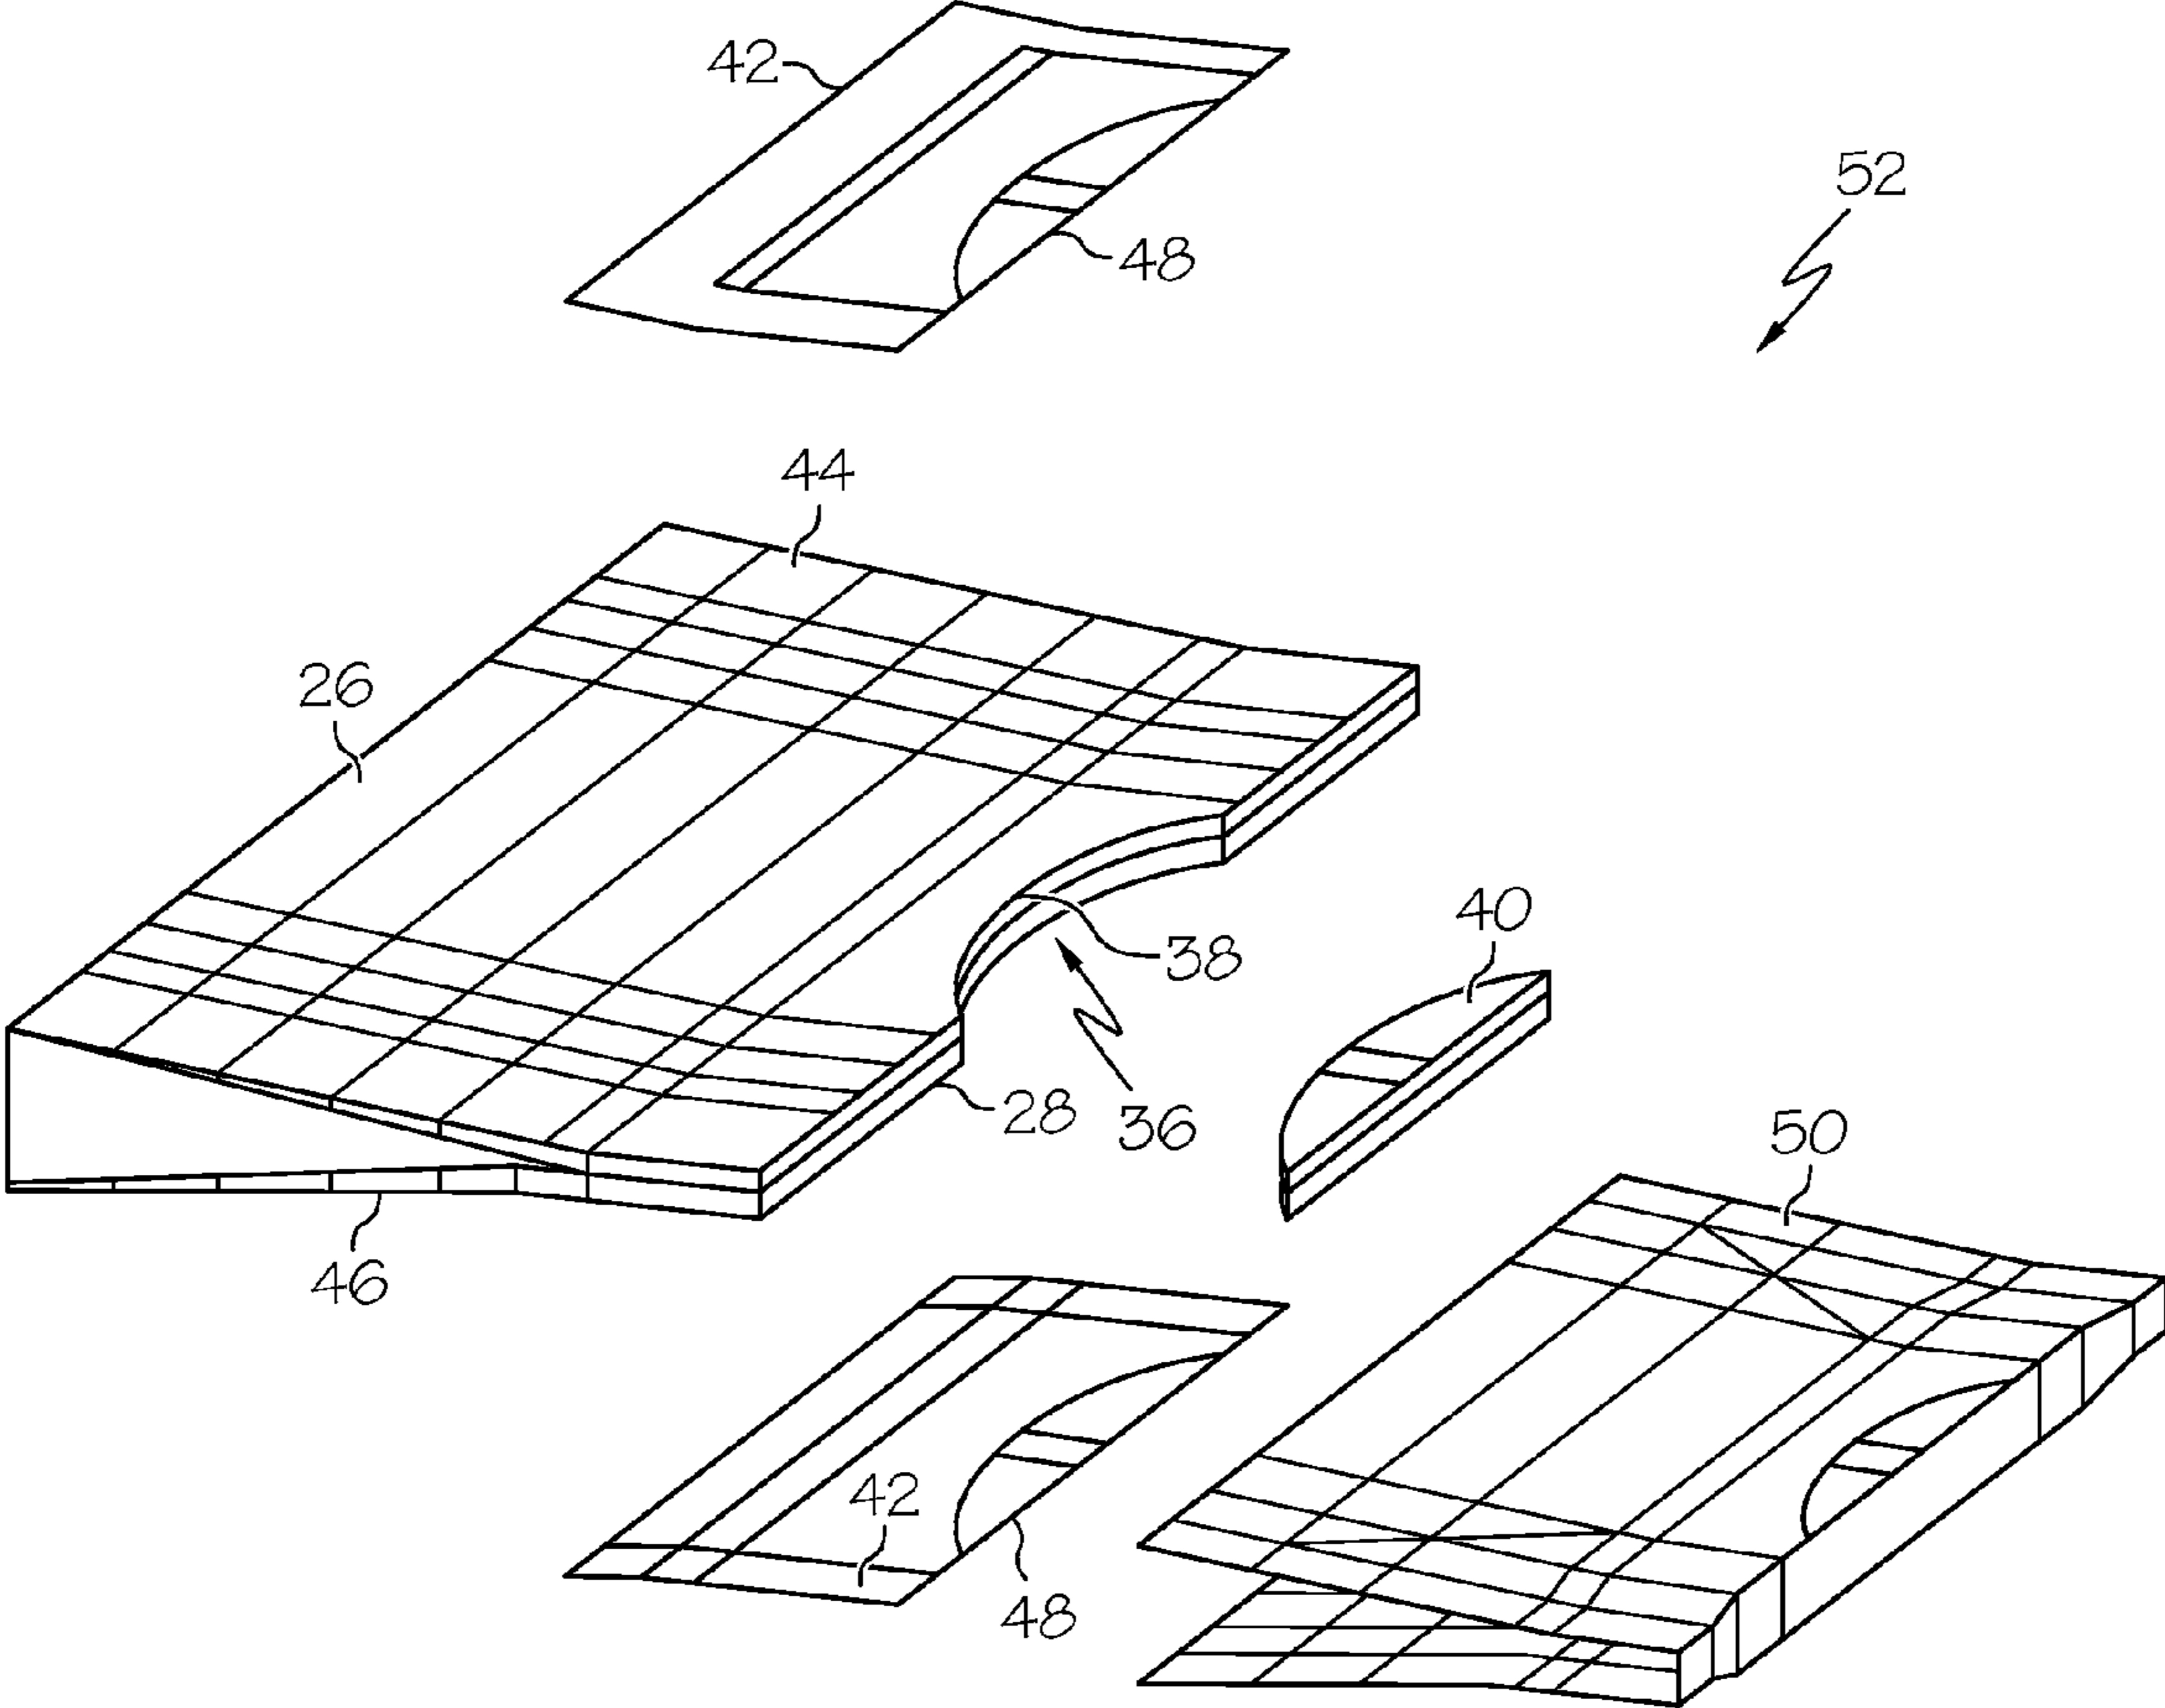
FIG. 4 is an exploded view of an embodiment of a repair structure for a rotor blade.

Referring now to FIG. 4, the repair shape 38 is filled with a filler material 40, which may be a mixture of adhesive and fiberglass powder, fiberglass whisker or other suitable material. Once the filler material 40 is applied, it is cured in position and sanded to a desired finish. In an alternative embodiment, a precured filler material 40 is bonded into the damaged area 36 with an adhesive. For example, a foaming adhesive or fiberglass material cut to a selected shape may be used. Further, in some embodiments, the damaged area is not removed 36 to leave a repair shape or prepared damage area 38, and the filler material 40 is applied directly to the damaged area 36.
