(10) **Patent No.:** **US 8,918,995 B2**
(45) **Date of Patent:** ***Dec. 30, 2014**

(54) **METHOD OF REPAIRING SHROUDED
TURBINE BLADES WITH CRACKS IN THE
VICINITY OF THE OUTER SHROUD NOTCH**

A method of repairing a damaged notch fillet radius of a
turbine blade shroud includes a replacement notch fillet
radius and a hardface nugget. The damaged notch fillet radius
is blended out and a hardface structure positioned proximate
the damaged notch fillet radius is removed. A replacement
notch fillet radius is formed with weld filler and the hardface
nugget is welded to at least a portion of the replacement notch
fillet radius.

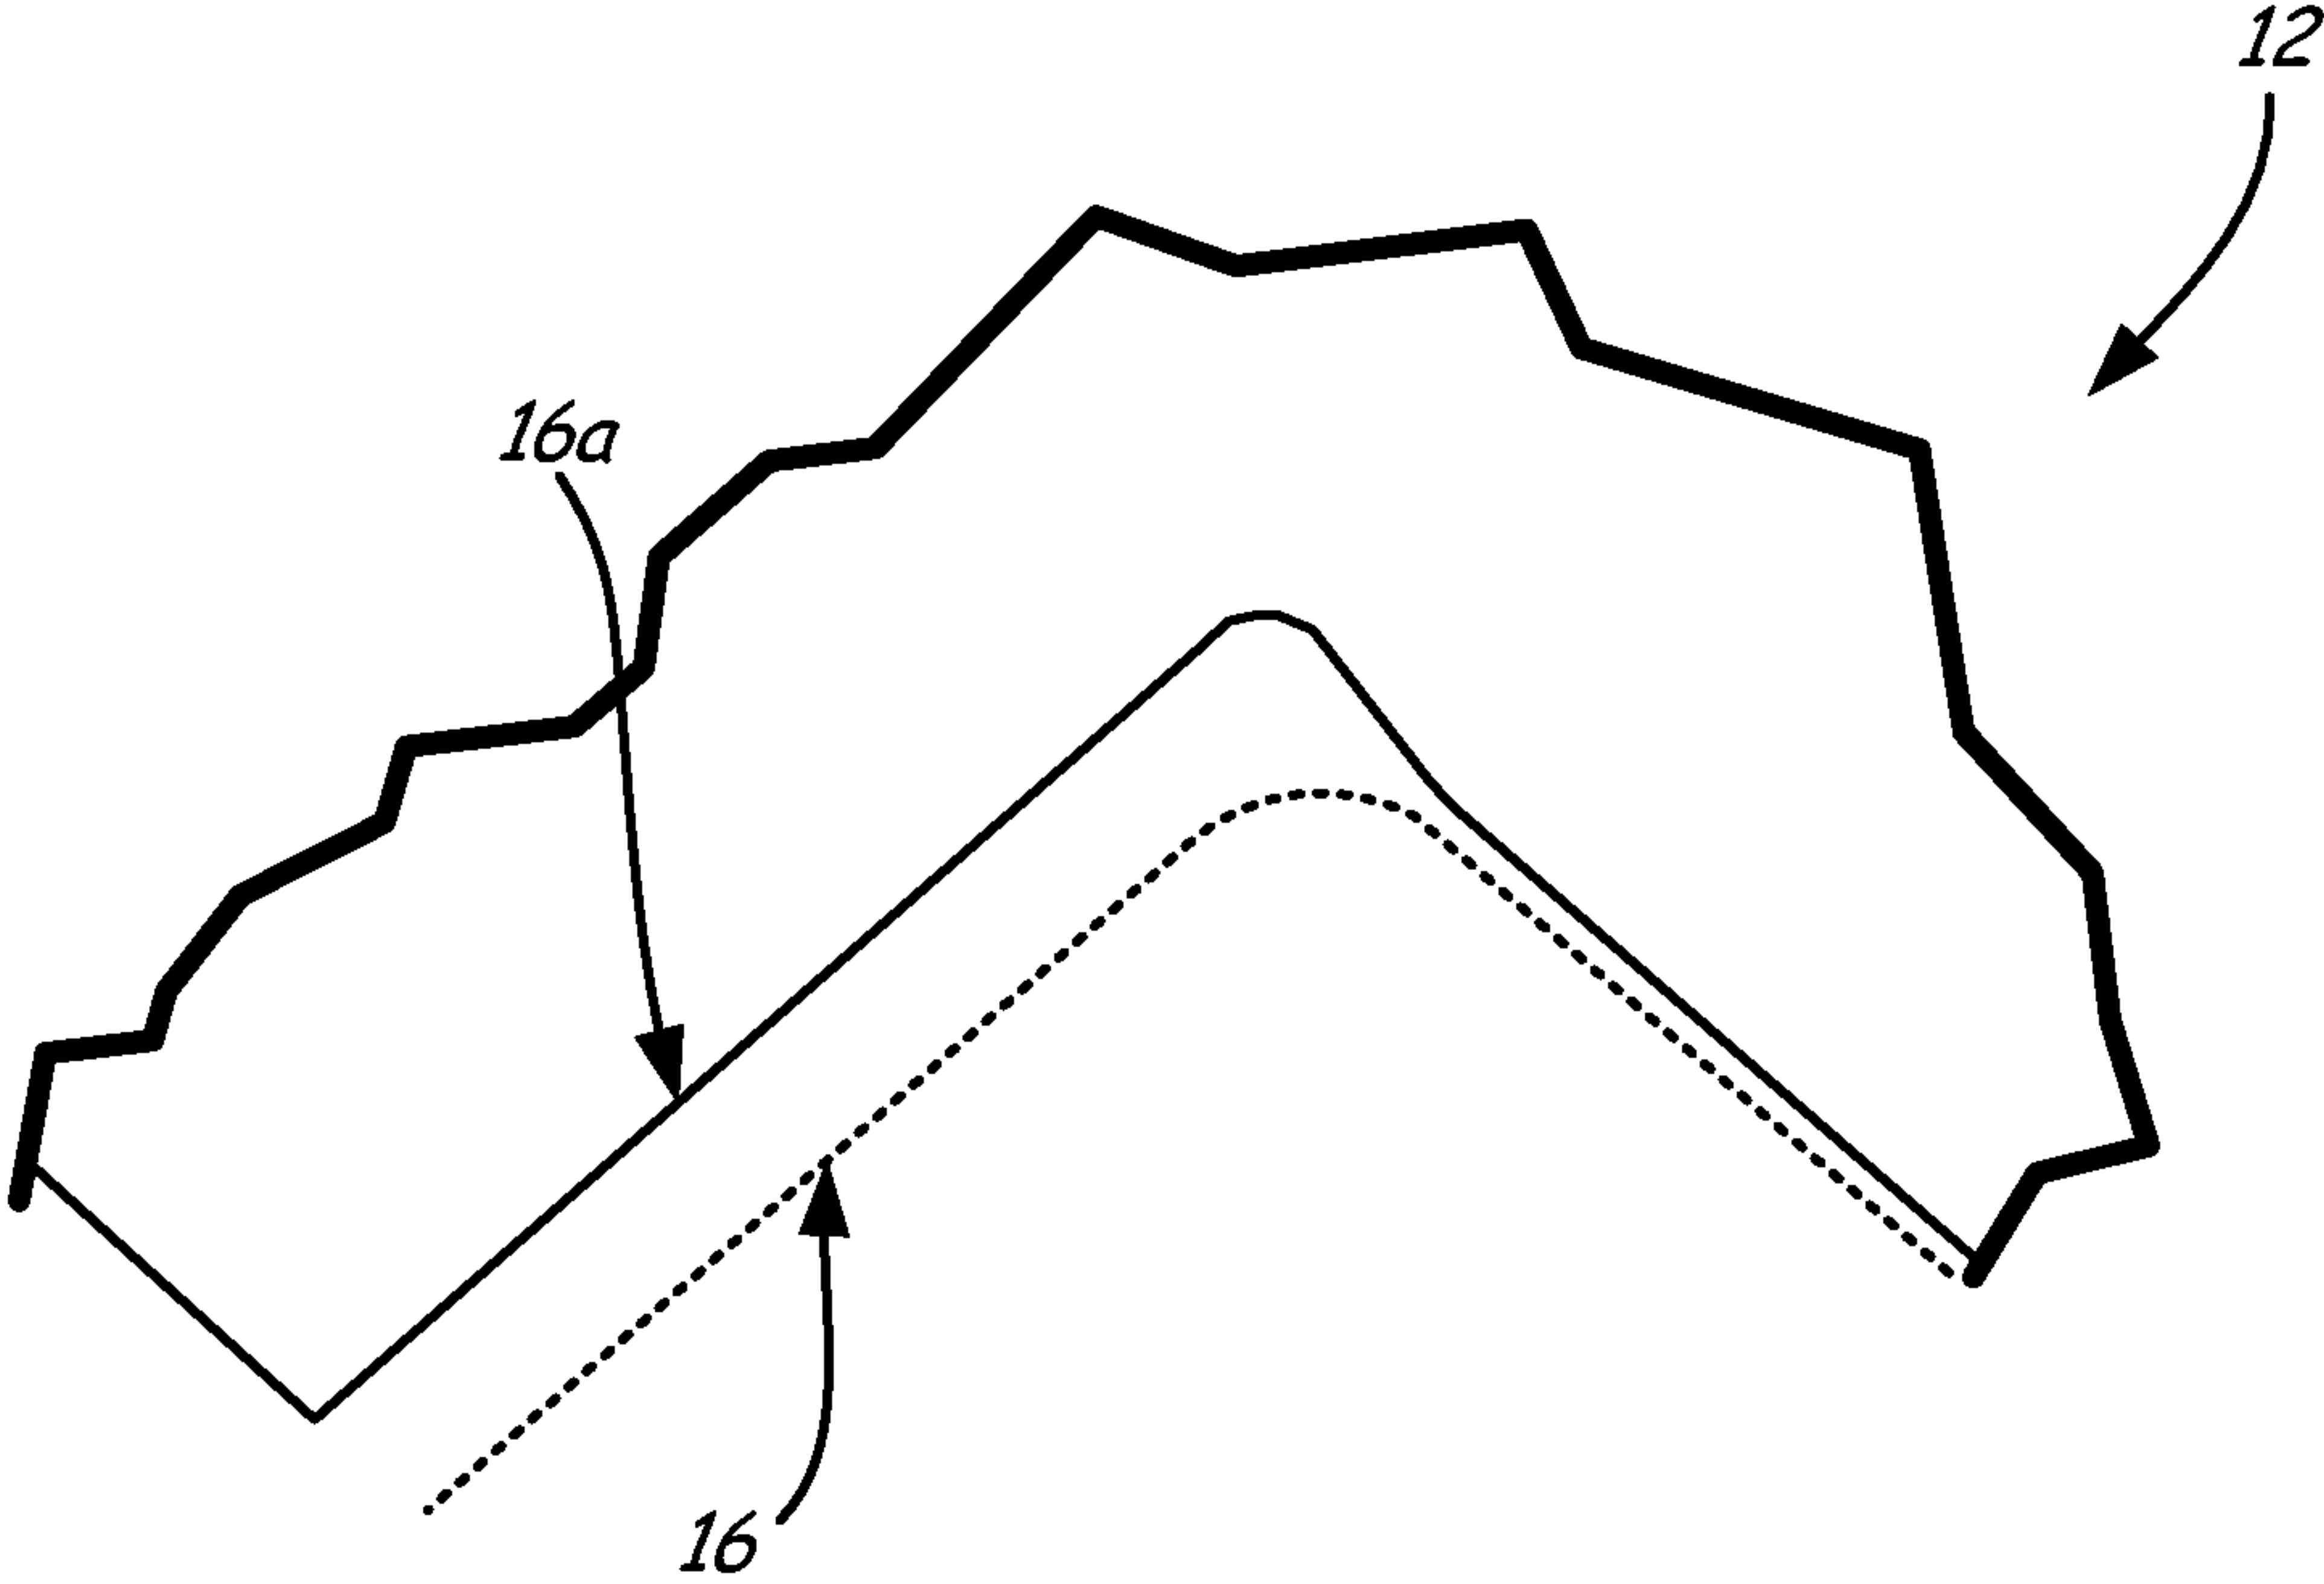
FIG. 5 is an enlarged view of the notch fillet radius with a hardface structure of the turbine blade removed.

FIG. 5 shows an enlarged view of new edge 16a after notch fillet radius 20 and hardface structure 22 have been removed from shroud 12. After crack 24 (shown in FIG. 3) and the area proximate crack 24 have been blended out from shroud 12, hardface structure 22 (shown in FIG. 4) is also removed from shroud 12. Hardface structure 22 may be removed in any suitable manner, such as by machining or grinding hardface structure 22 from shroud 22. Removal of crack 24, the area proximate crack 24, and hardface structure 22 essentially entirely eliminates original edge 16 (shown in FIG. 3) and forms new edge 16a as the new perimeter of shroud 12.

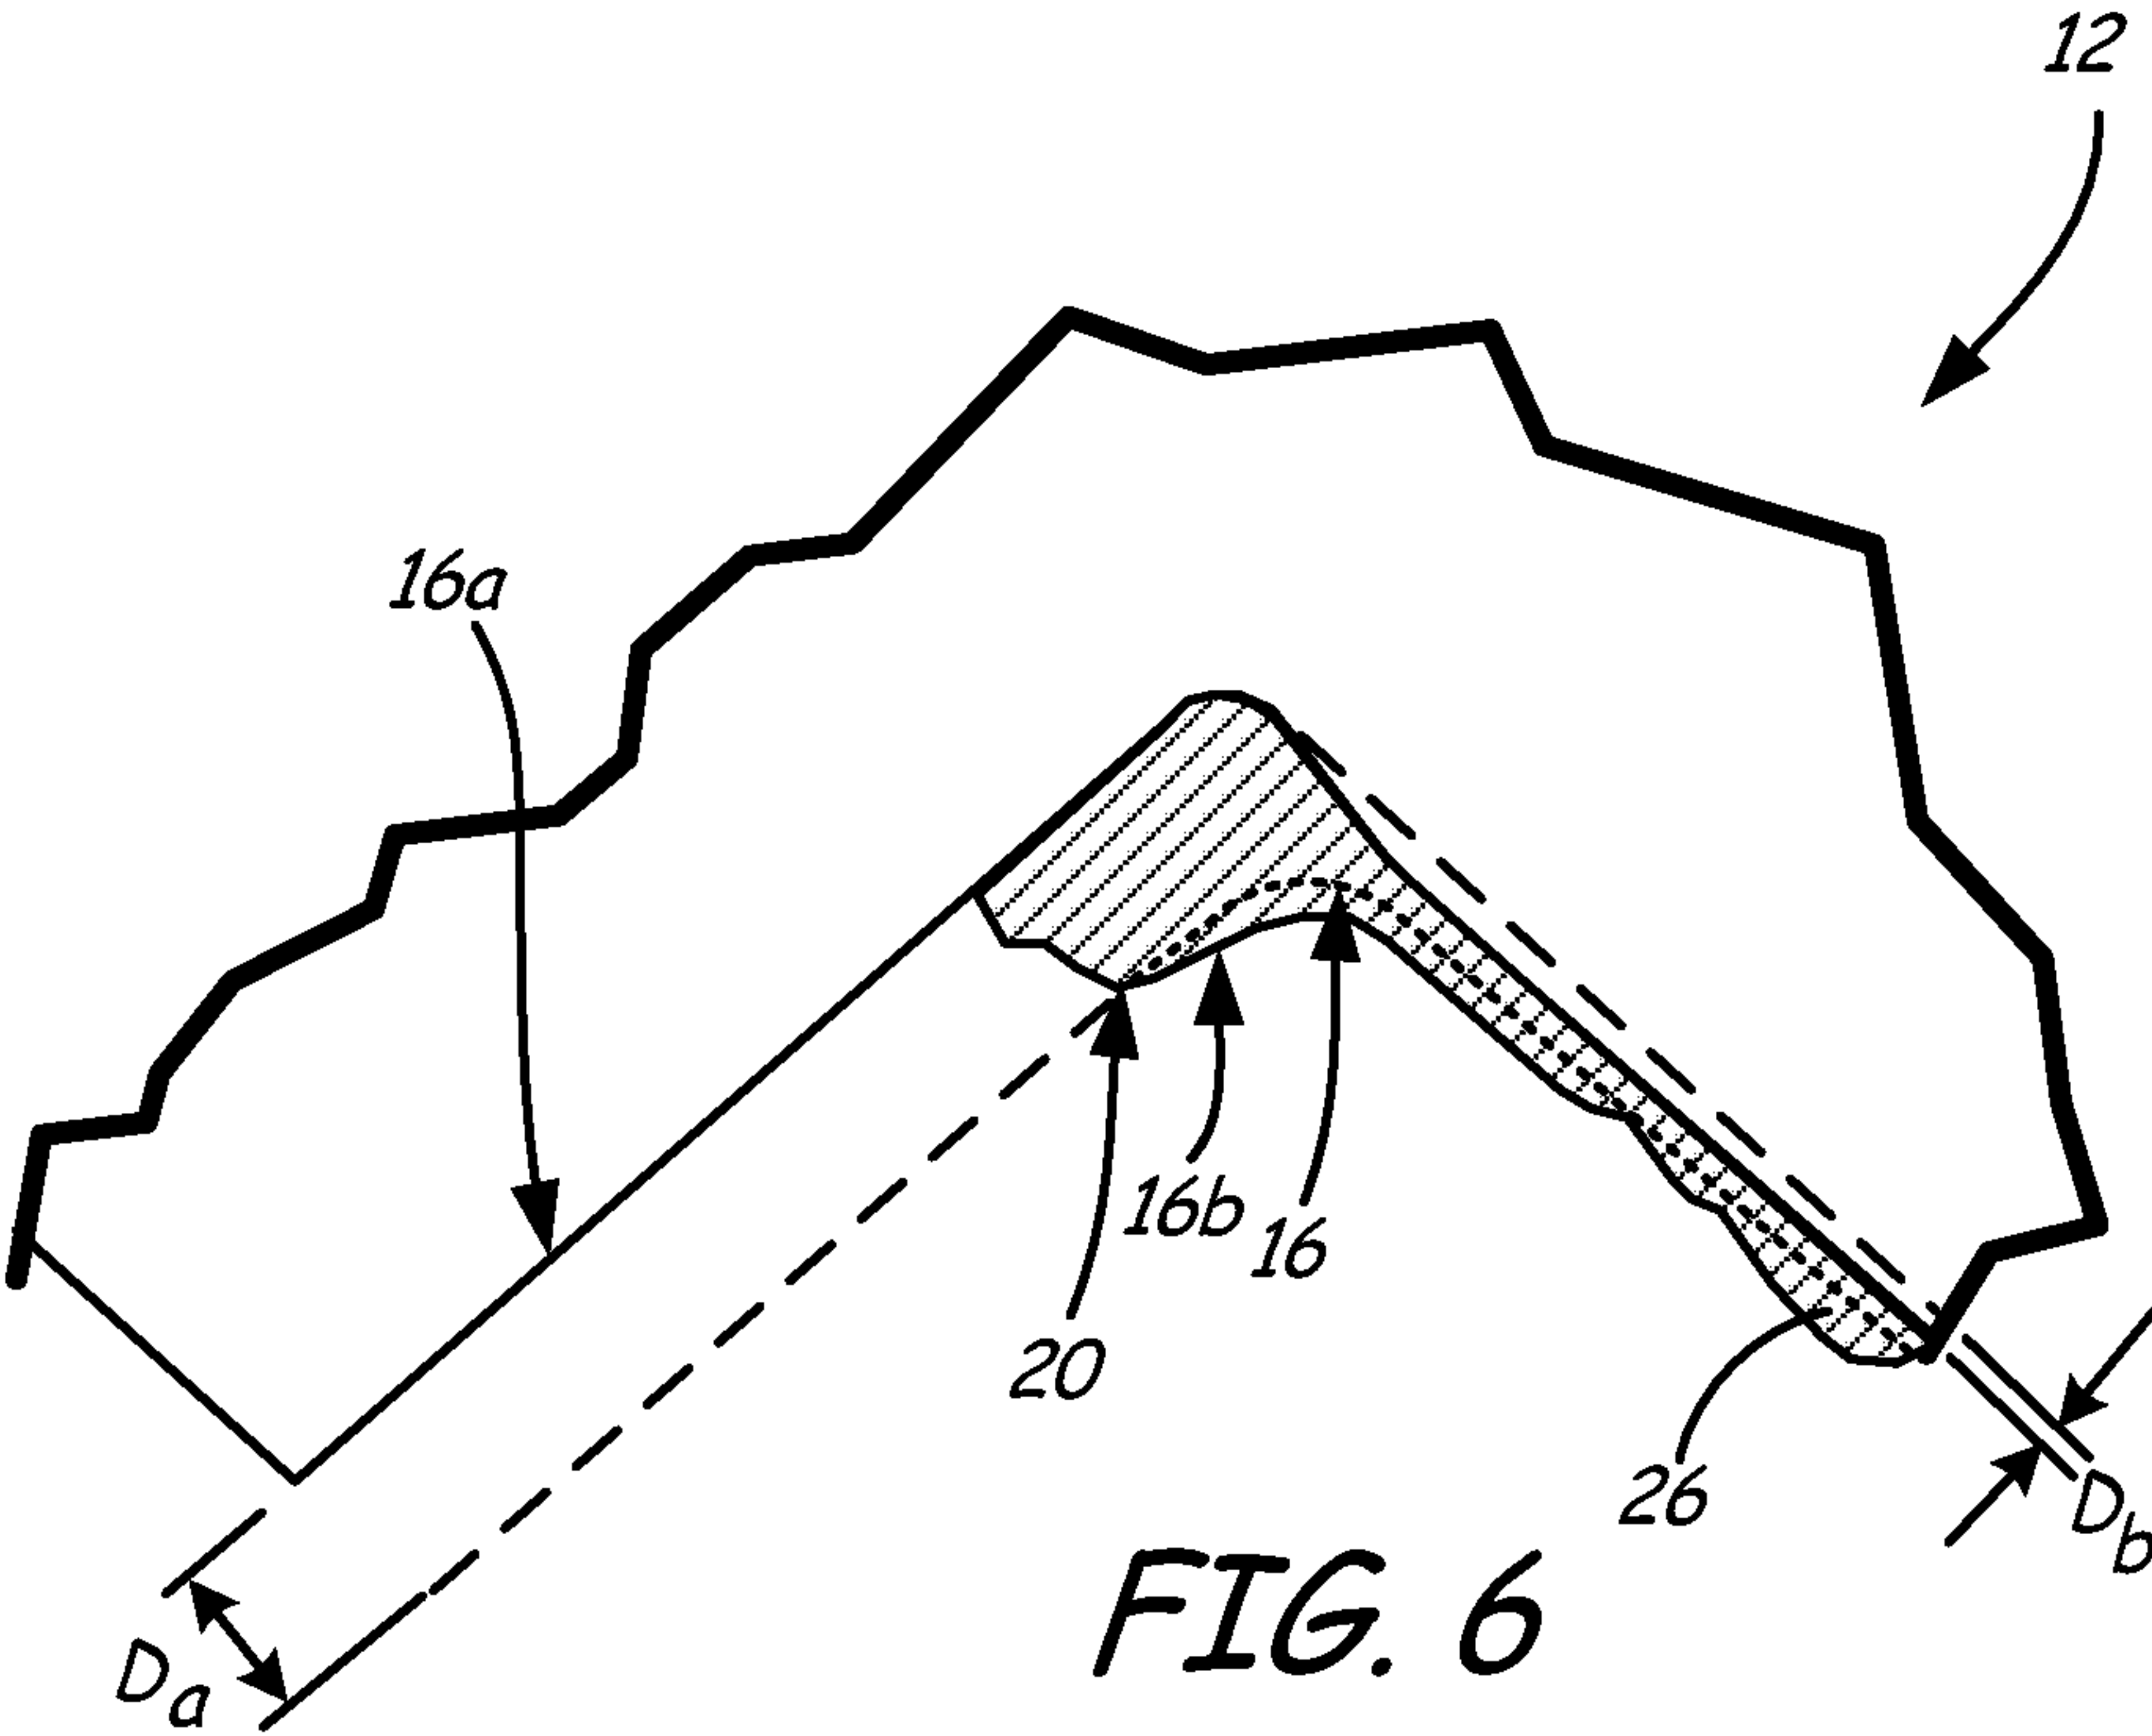
FIG. 6 is an enlarged view of the notch fillet radius with a replacement weld.

FIG. 6 shows an enlarged view of new edge 16a and notch fillet radius 20 with replacement weld 26. Once crack 24 and hardface structure 22 (shown in FIG. 3) have been removed from shroud 12, replacement weld 26 is formed with a weld filler along a portion of new edge 16a. Replacement weld 26 is formed to fill in the notch fillet radius removed by blending out crack 24 and has a height of at least depth D_a and a width of at least depth D_b . Replacement weld 26 thus takes the shape of notch fillet radius 20 that was previously removed and extends new replacement weld edge 16b back to at least original edge 16 at notch fillet radius 20. While any suitable weld filler material may be used, in one embodiment, a suitable weld filler is a nickel-based alloy known as Inconel 625, available from International Nickel, Inc., Saddle Brook, N.J.

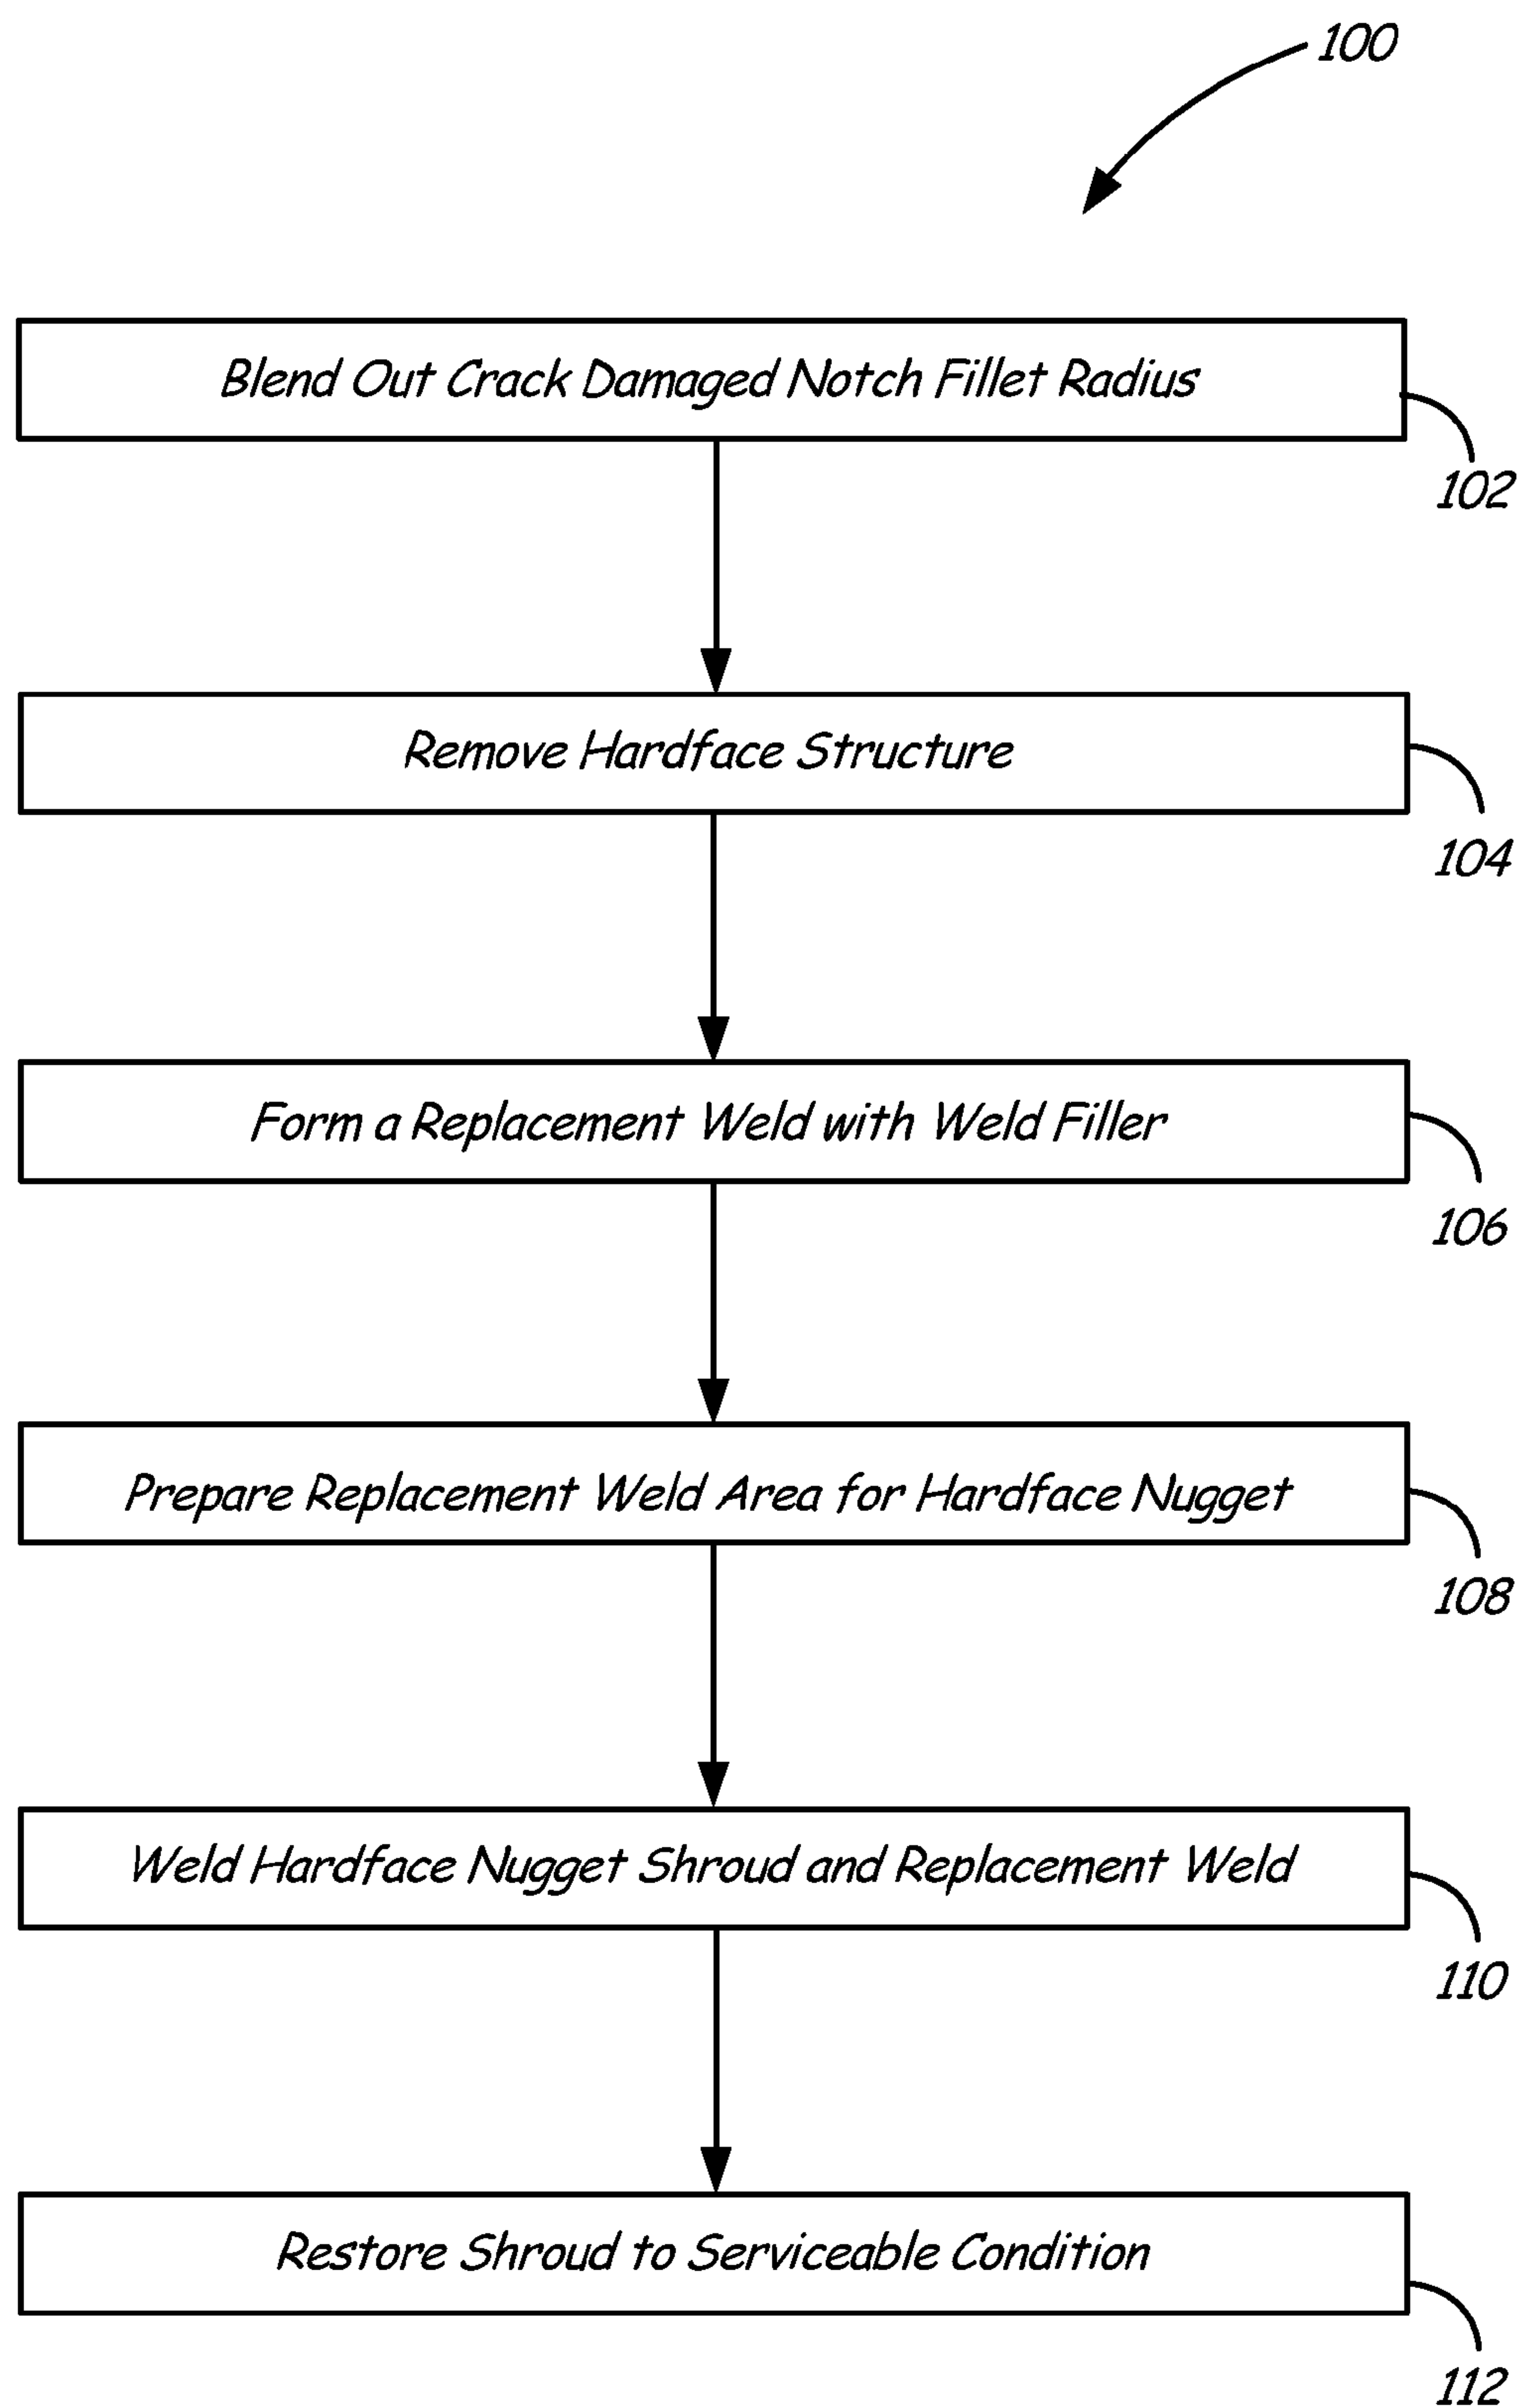
**FIG. 9**

FIG. 9 is a block diagram of a method of repairing a damage site of a notch fillet radius of a turbine blade. text]

FIG. 9 shows a block diagram of an exemplary, non-limiting method 100 of repairing shroud 12 with crack 24 located at notch fillet radius 20. Conventional blending techniques can repair cracks only up to a depth of approximately 0.03 inches. Method 100 allows the repair of cracks having a depth of up to approximately 0.1 inches. Conventional blending techniques can repair cracks only up to a depth of approximately 0.03 inches. As shown in Box 102, crack 24 and the surrounding damaged area of notch fillet radius 20 are blended out locally. Hardface structure 22 is then either machined or ground off of shroud 12, as represented by Box 104. As described in Box 106, replacement weld 26 is formed at new edge 16a and notch fillet radius 20 with a weld filler to fill in the area previously removed in Box 102. After replacement weld 26 has been formed on shroud 12, shroud 12 is prepared to accept hardface nugget 30 by machining edge portion 28 of replacement weld 26, as represented by Box 108. Hardface nugget 30 is welded to shroud 12 and replacement weld 26 at the same location that hardface structure 22 was located, as represented by Box 110. As depicted in Box 112, after hardface nugget 30 has been welded onto shroud 12, shroud 12 is restored to serviceable condition using conventional notch repair procedures, which can include, for example: grinding, degreasing, stress-relieving, shot peening, and the like.
