US008918995B2

(10) **Patent No.:** **US 8,918,995 B2**
(45) **Date of Patent:** ***Dec. 30, 2014**

(54) **METHOD OF REPAIRING SHROUDED
TURBINE BLADES WITH CRACKS IN THE
VICINITY OF THE OUTER SHROUD NOTCH**

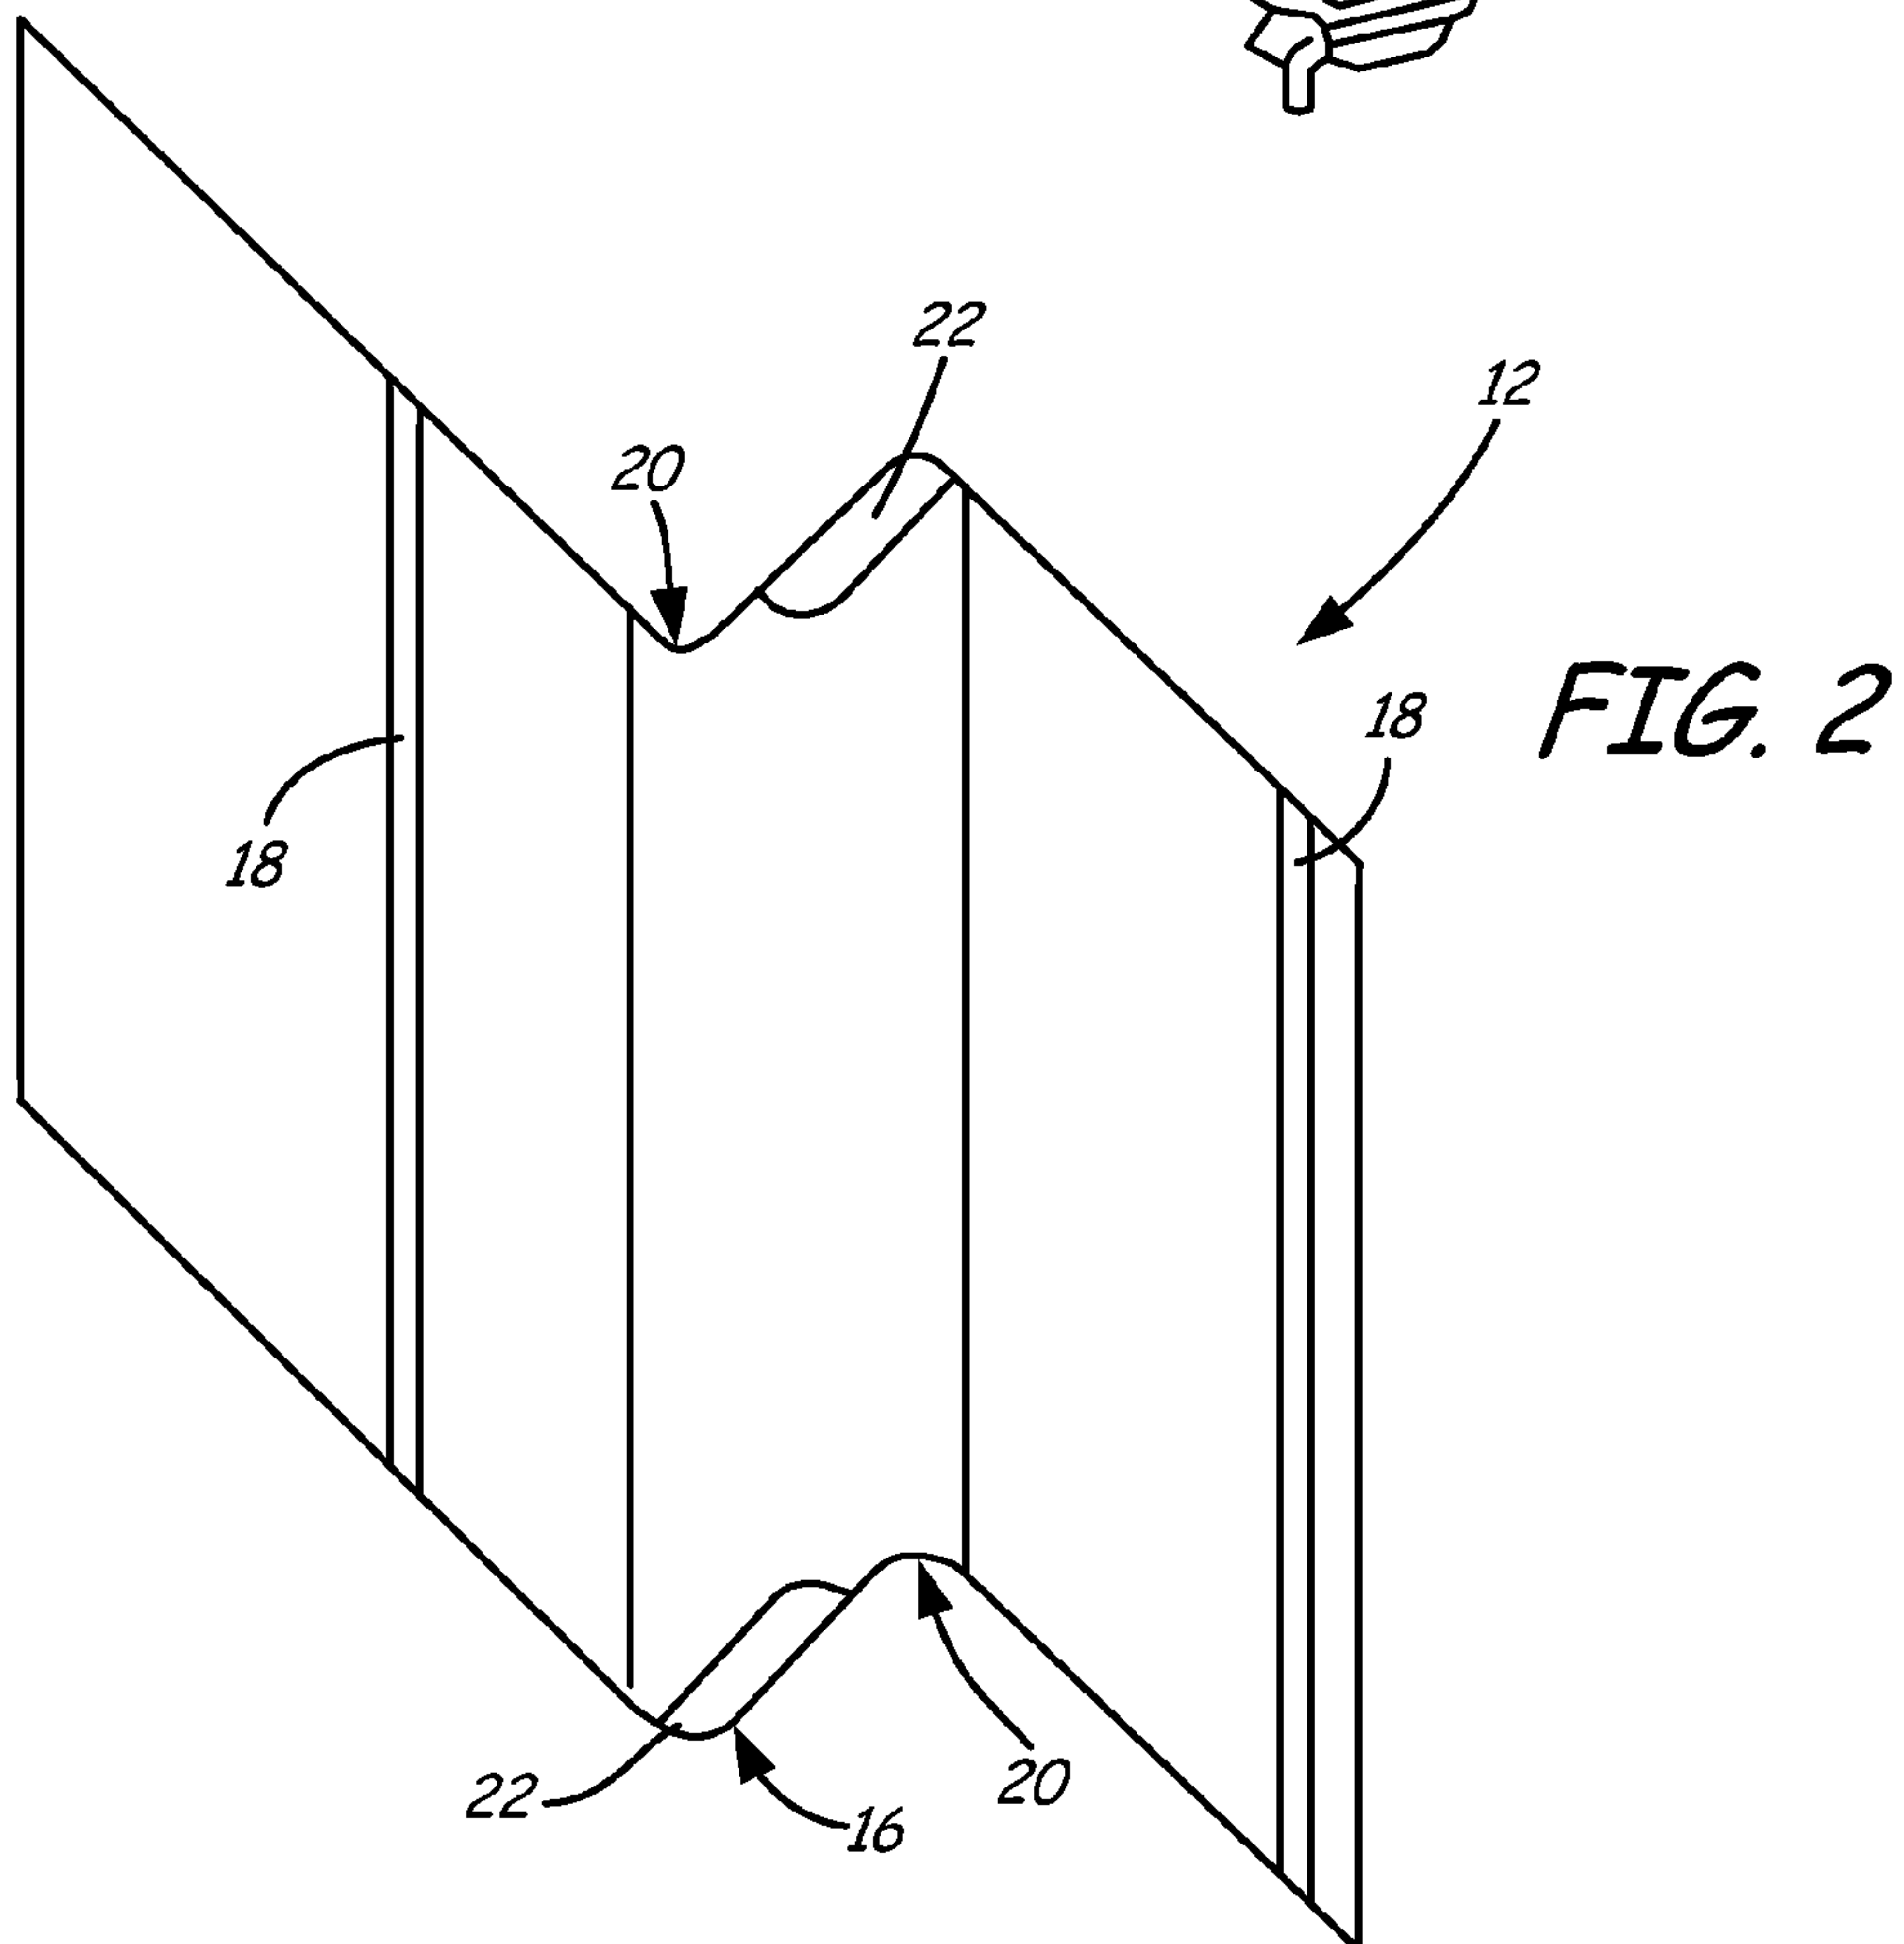
FIG. 1 is a perspective view of a turbine blade.

FIGS. 1 and 2 show a perspective view of turbine blade 10 and a top view of shroud 12 of turbine blade 10, respectively, and will be discussed in conjunction with one another. Turbine blade 10 generally includes shroud 12 positioned at a top end 14 of turbine blade 10. Shroud 12 has an original edge 16 and generally includes air seals 18, notch fillet radius 20, and hardface structures 22. Notch fillet radius 20 is formed at original edge 16 of shroud 12. Hardface structure 22 is welded to original edge 16 adjacent notch fillet radius 20 and functions to dissipate the vibration energy when hardface structure 22 rubs against adjacent blade hardfaces. In operation, the shrouds of adjacent turbine blades are positioned next to each other such that each notch fillet radius 20 of shroud 12 abuts a hardface structure of an adjacent shroud on either side of shroud 12. Turbine blade 10 is exposed to high temperatures and vibratory stresses present in jet turbine engines with loads constantly exerted on original edge 16 of shroud 12, and particularly notch fillet radius 20. Thus, notch fillet radius 20 and the area proximate notch fillet radius 20 can crack, with the crack typically radiating inward. Whereas current repair techniques only allow cracks of up to approximately 0.03 inches deep to be repaired, the new methods of repairing cracks described herein allow cracks up to approximately 0.1 inches deep to be repaired. This allows many parts to be repaired instead of being scrapped.

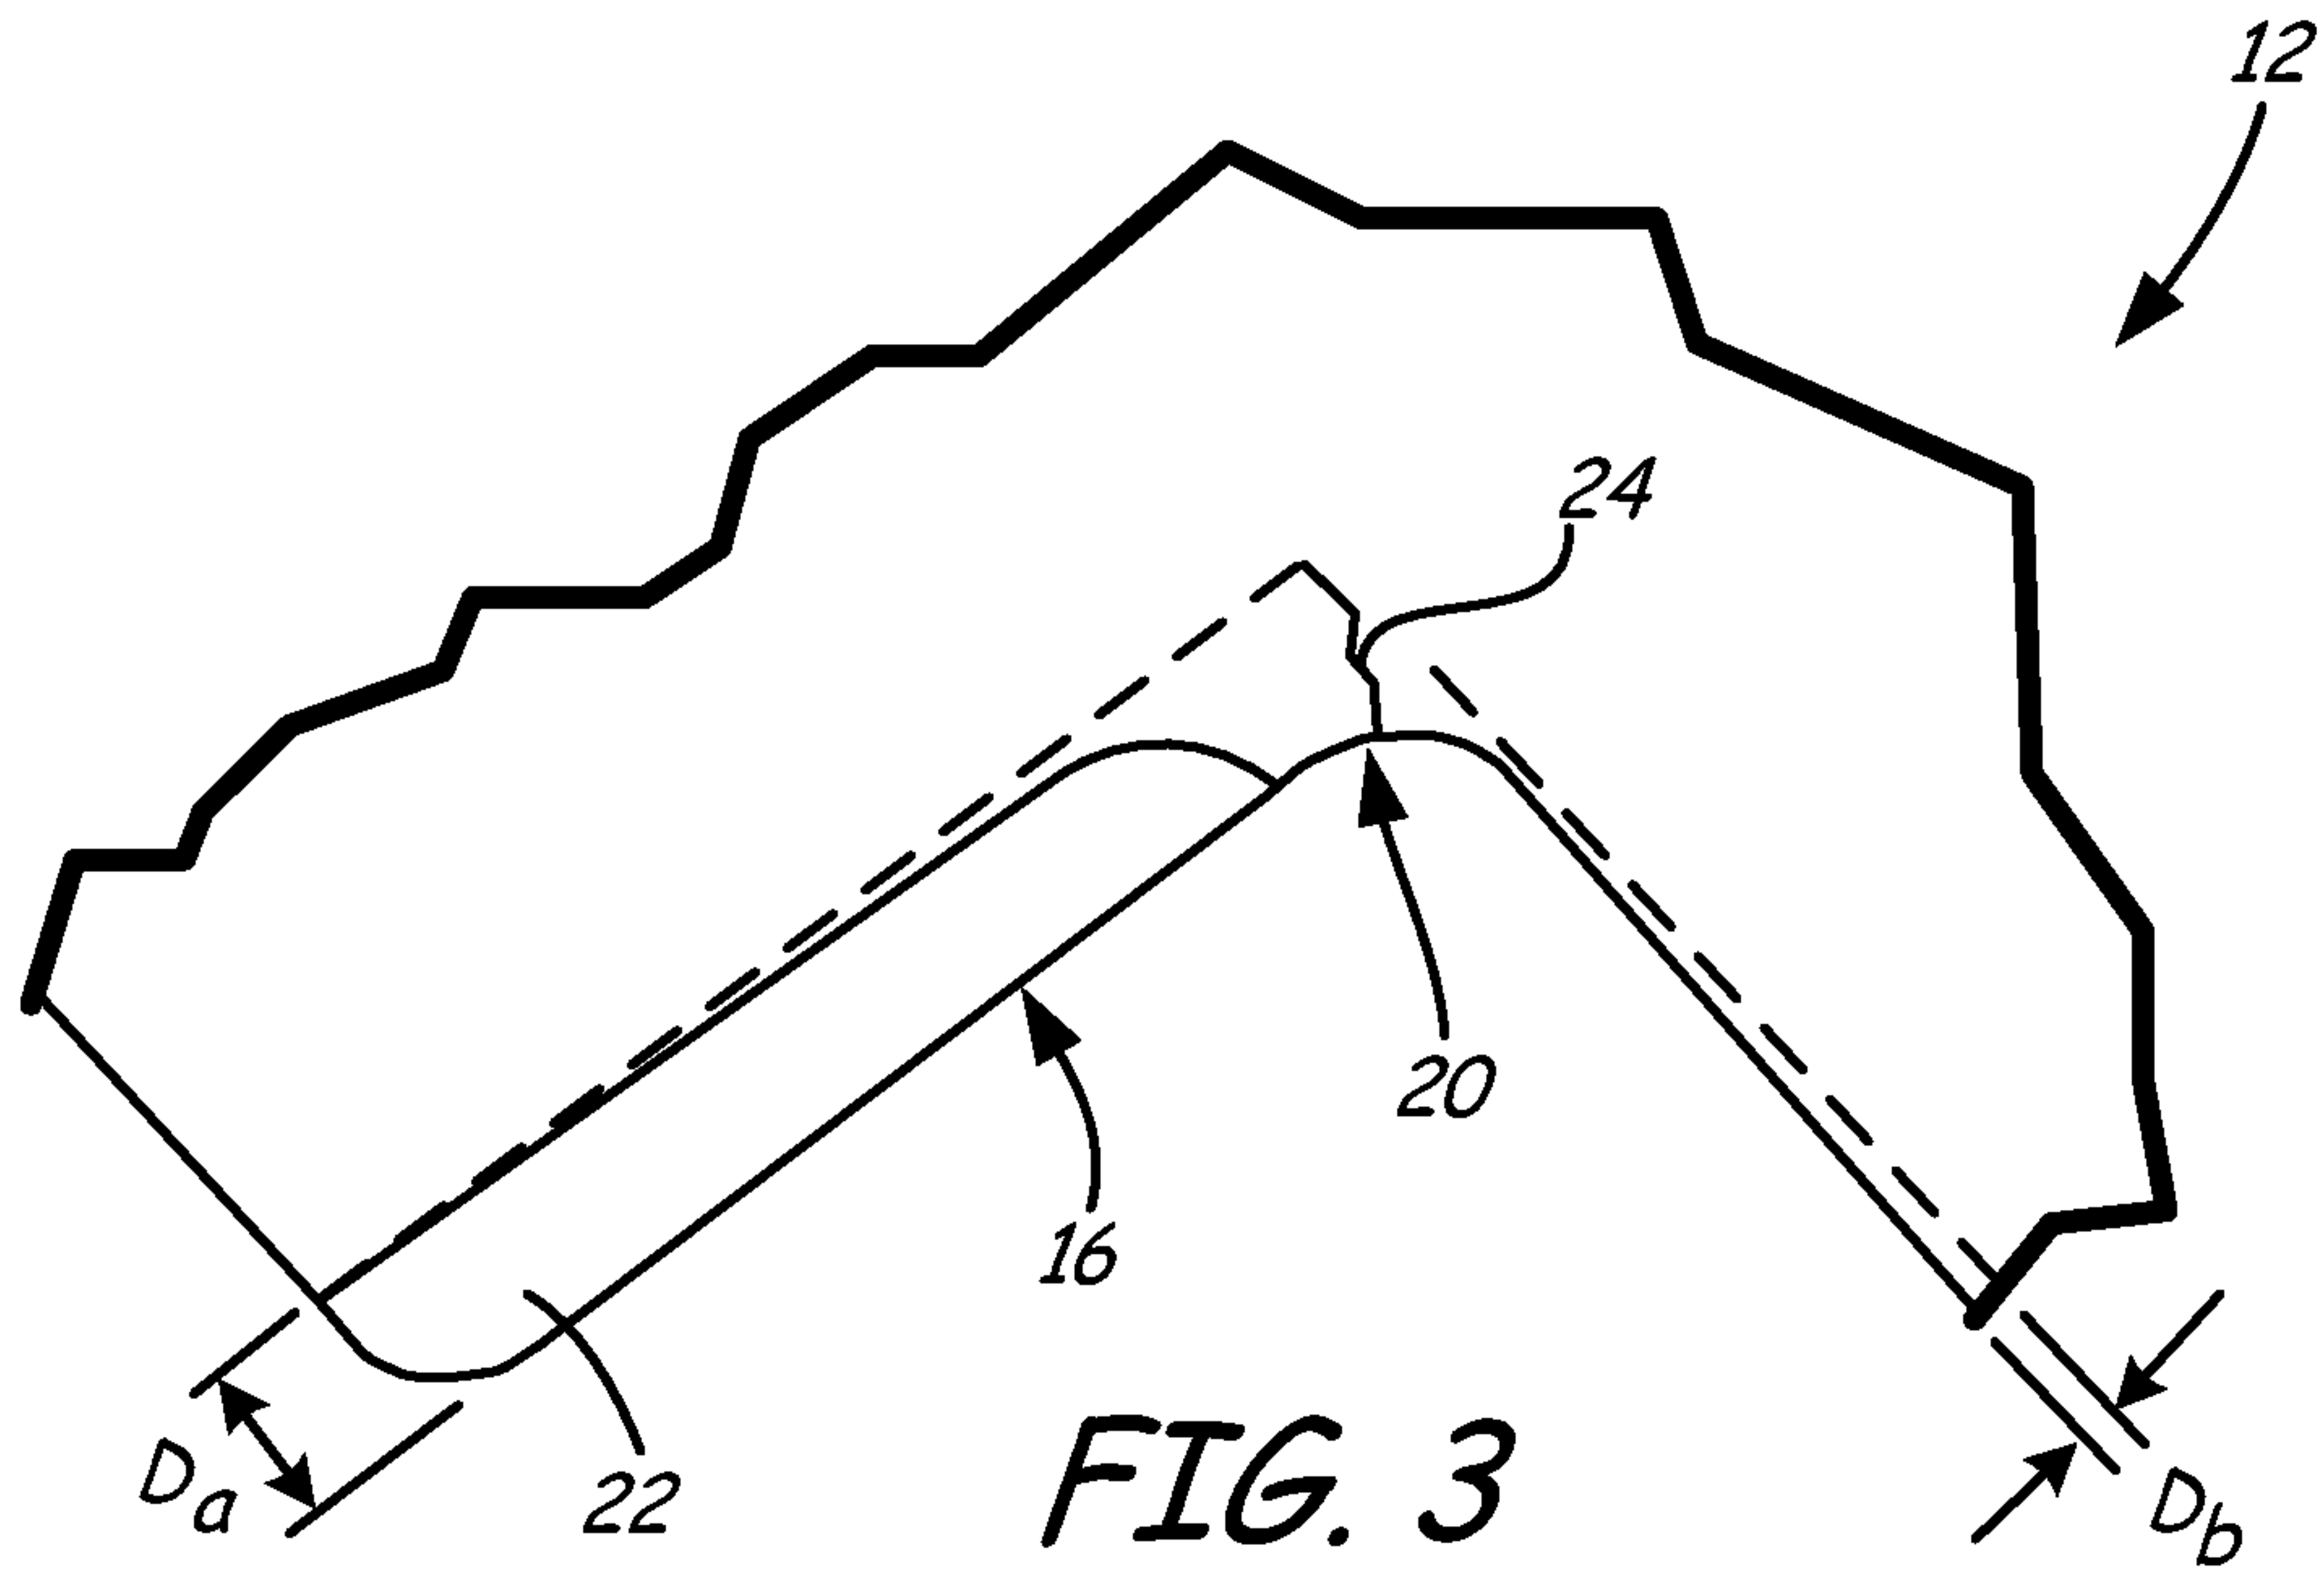
FIG. 2 is an enlarged top view of a shroud of the turbine blade.
