(12) **United States Patent**
Krizansky et al.

(10) **Patent No.:** **US 9,018,560 B2**
(45) **Date of Patent:** **Apr. 28, 2015**

(54) **REPAIR ALIGNMENT METHOD AND APPARATUS FOR TURBINE COMPONENTS**

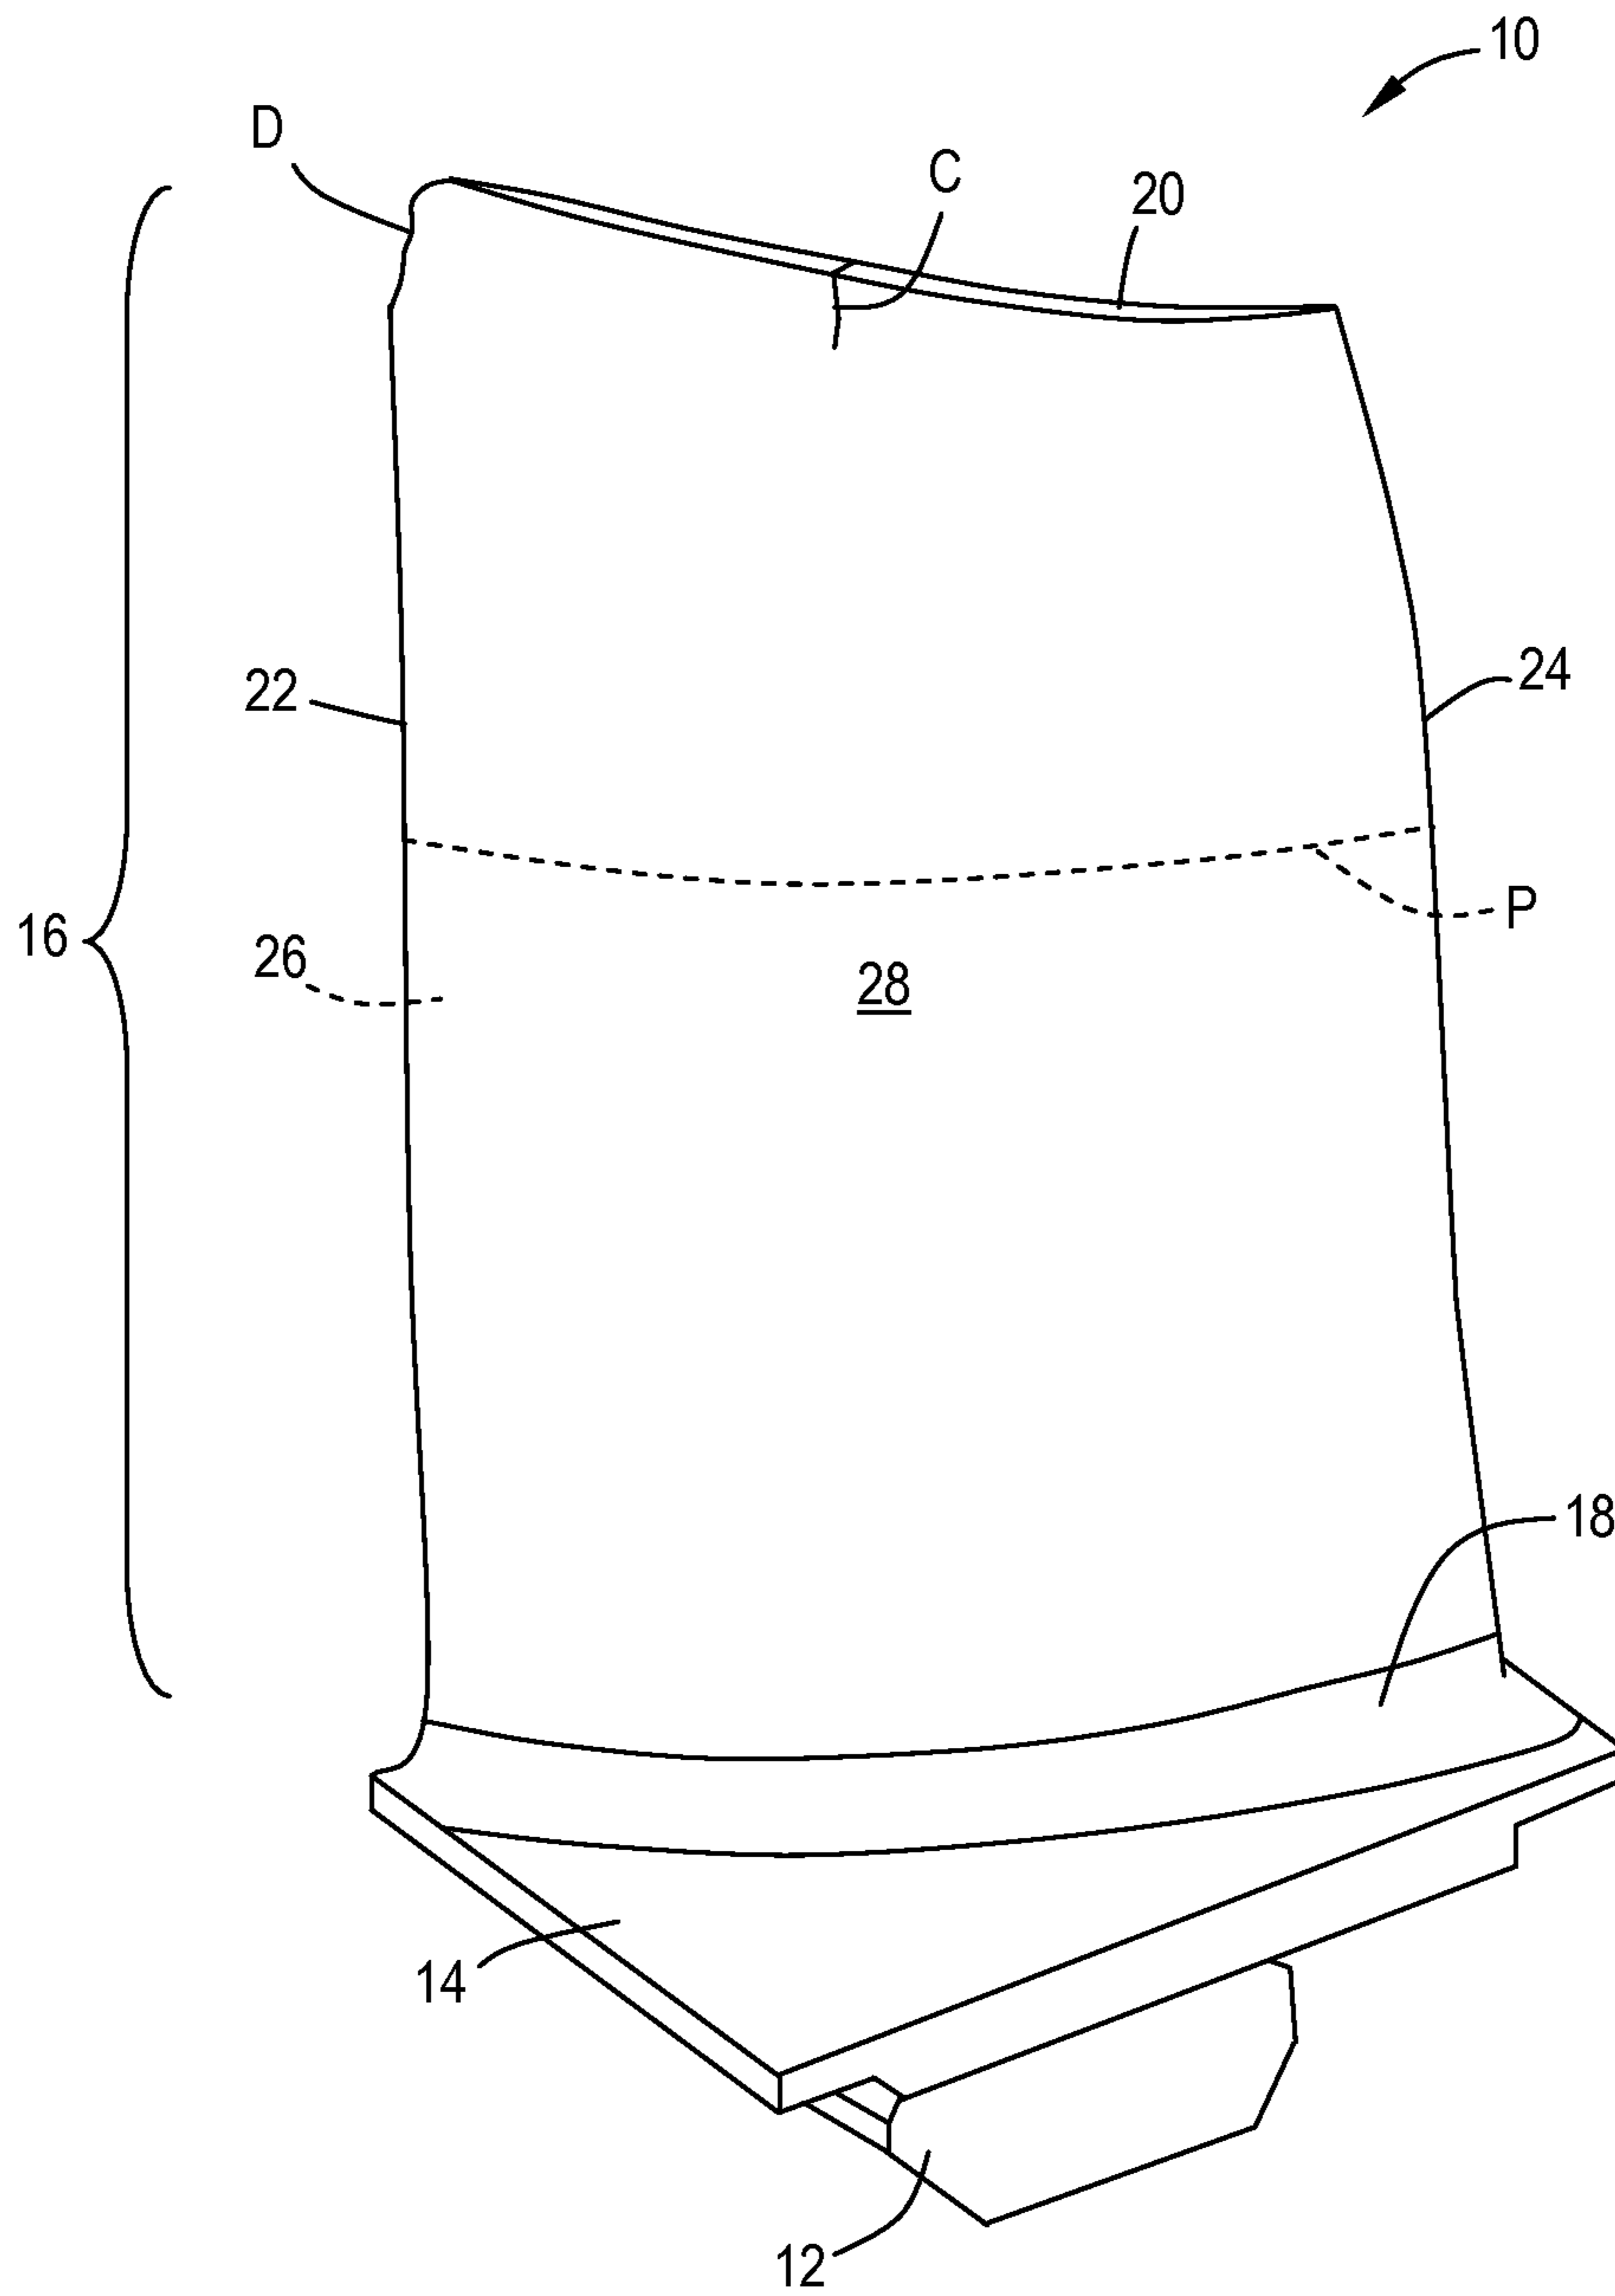
FIG. 1 is a perspective view of an engine-run turbine compressor blade, exhibiting damage from use;

views, FIG. 1 shows a compressor blade 10 of a gas turbine engine. It will be understood that the principles of the present invention are also applicable to other kinds of airfoils. The blade 10 includes a dovetail 12 used to mount the blade 10 to a compressor disk wheel (not shown), an arcuate platform 14, and an airfoil 16 having a root 18, a tip 20, a leading edge 22, a trailing edge 24, a concave pressure side 26 and a convex suction side 28.

In operation, the blade 10 is subject to damage, especially tip and erosion damage from abrasive materials and/or foreign object impacts. The blade 10 in FIG. 1 is shown to include both a crack "C" and a damaged area "D" where material is missing.

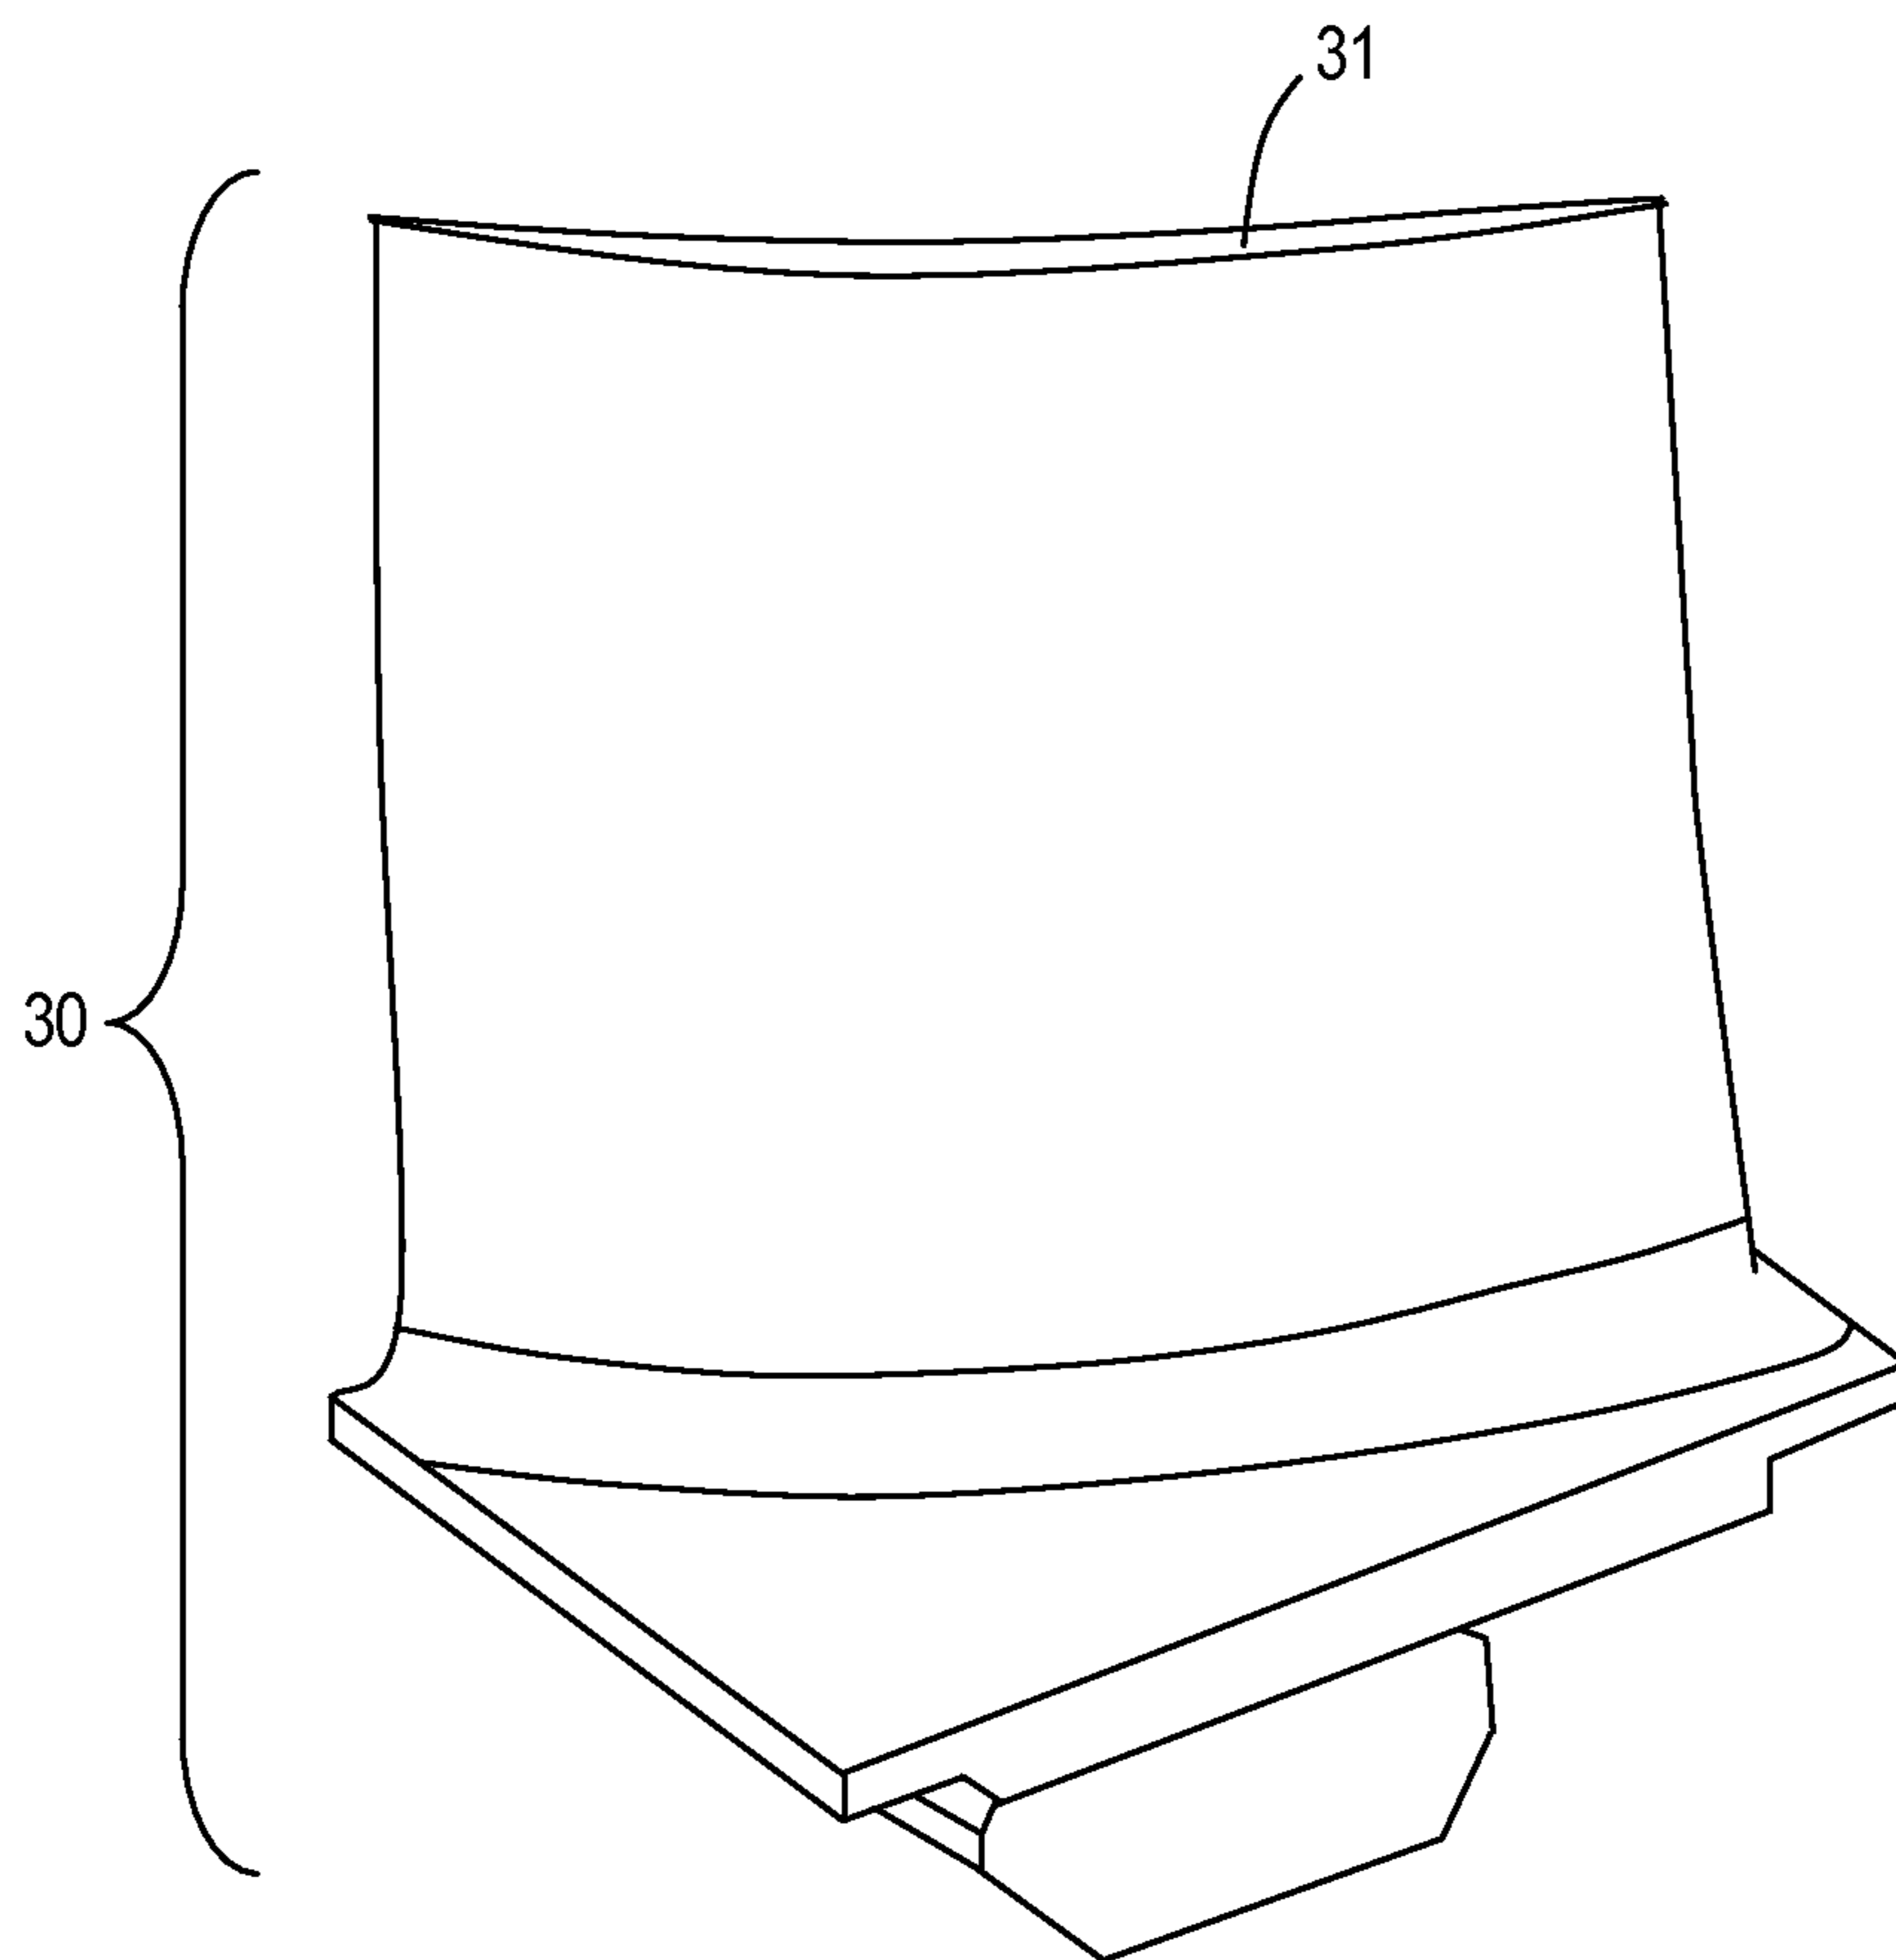
FIG. 2 is a perspective view of the blade of FIG. 1 after being prepared for a welding operation;

FIG. 2 shows the blade after it has been prepared for a subsequent welding process by cutting, grinding, machining, or otherwise working it to remove the spanwise outer portion along a predetermined cutting plane P (seen in FIG. 1). As thus prepared, the remaining portion of the blade 10 is referred to as a "field item" 30. The preparation process exposes a faying surface 31. The cutting plane P is selected so that pressure applied to on the field item 30 along its spanwise or stacking axis during a welding process will not end to cause misalignment. The remainder of the airfoil 16 is referred to herein as a "root portion".

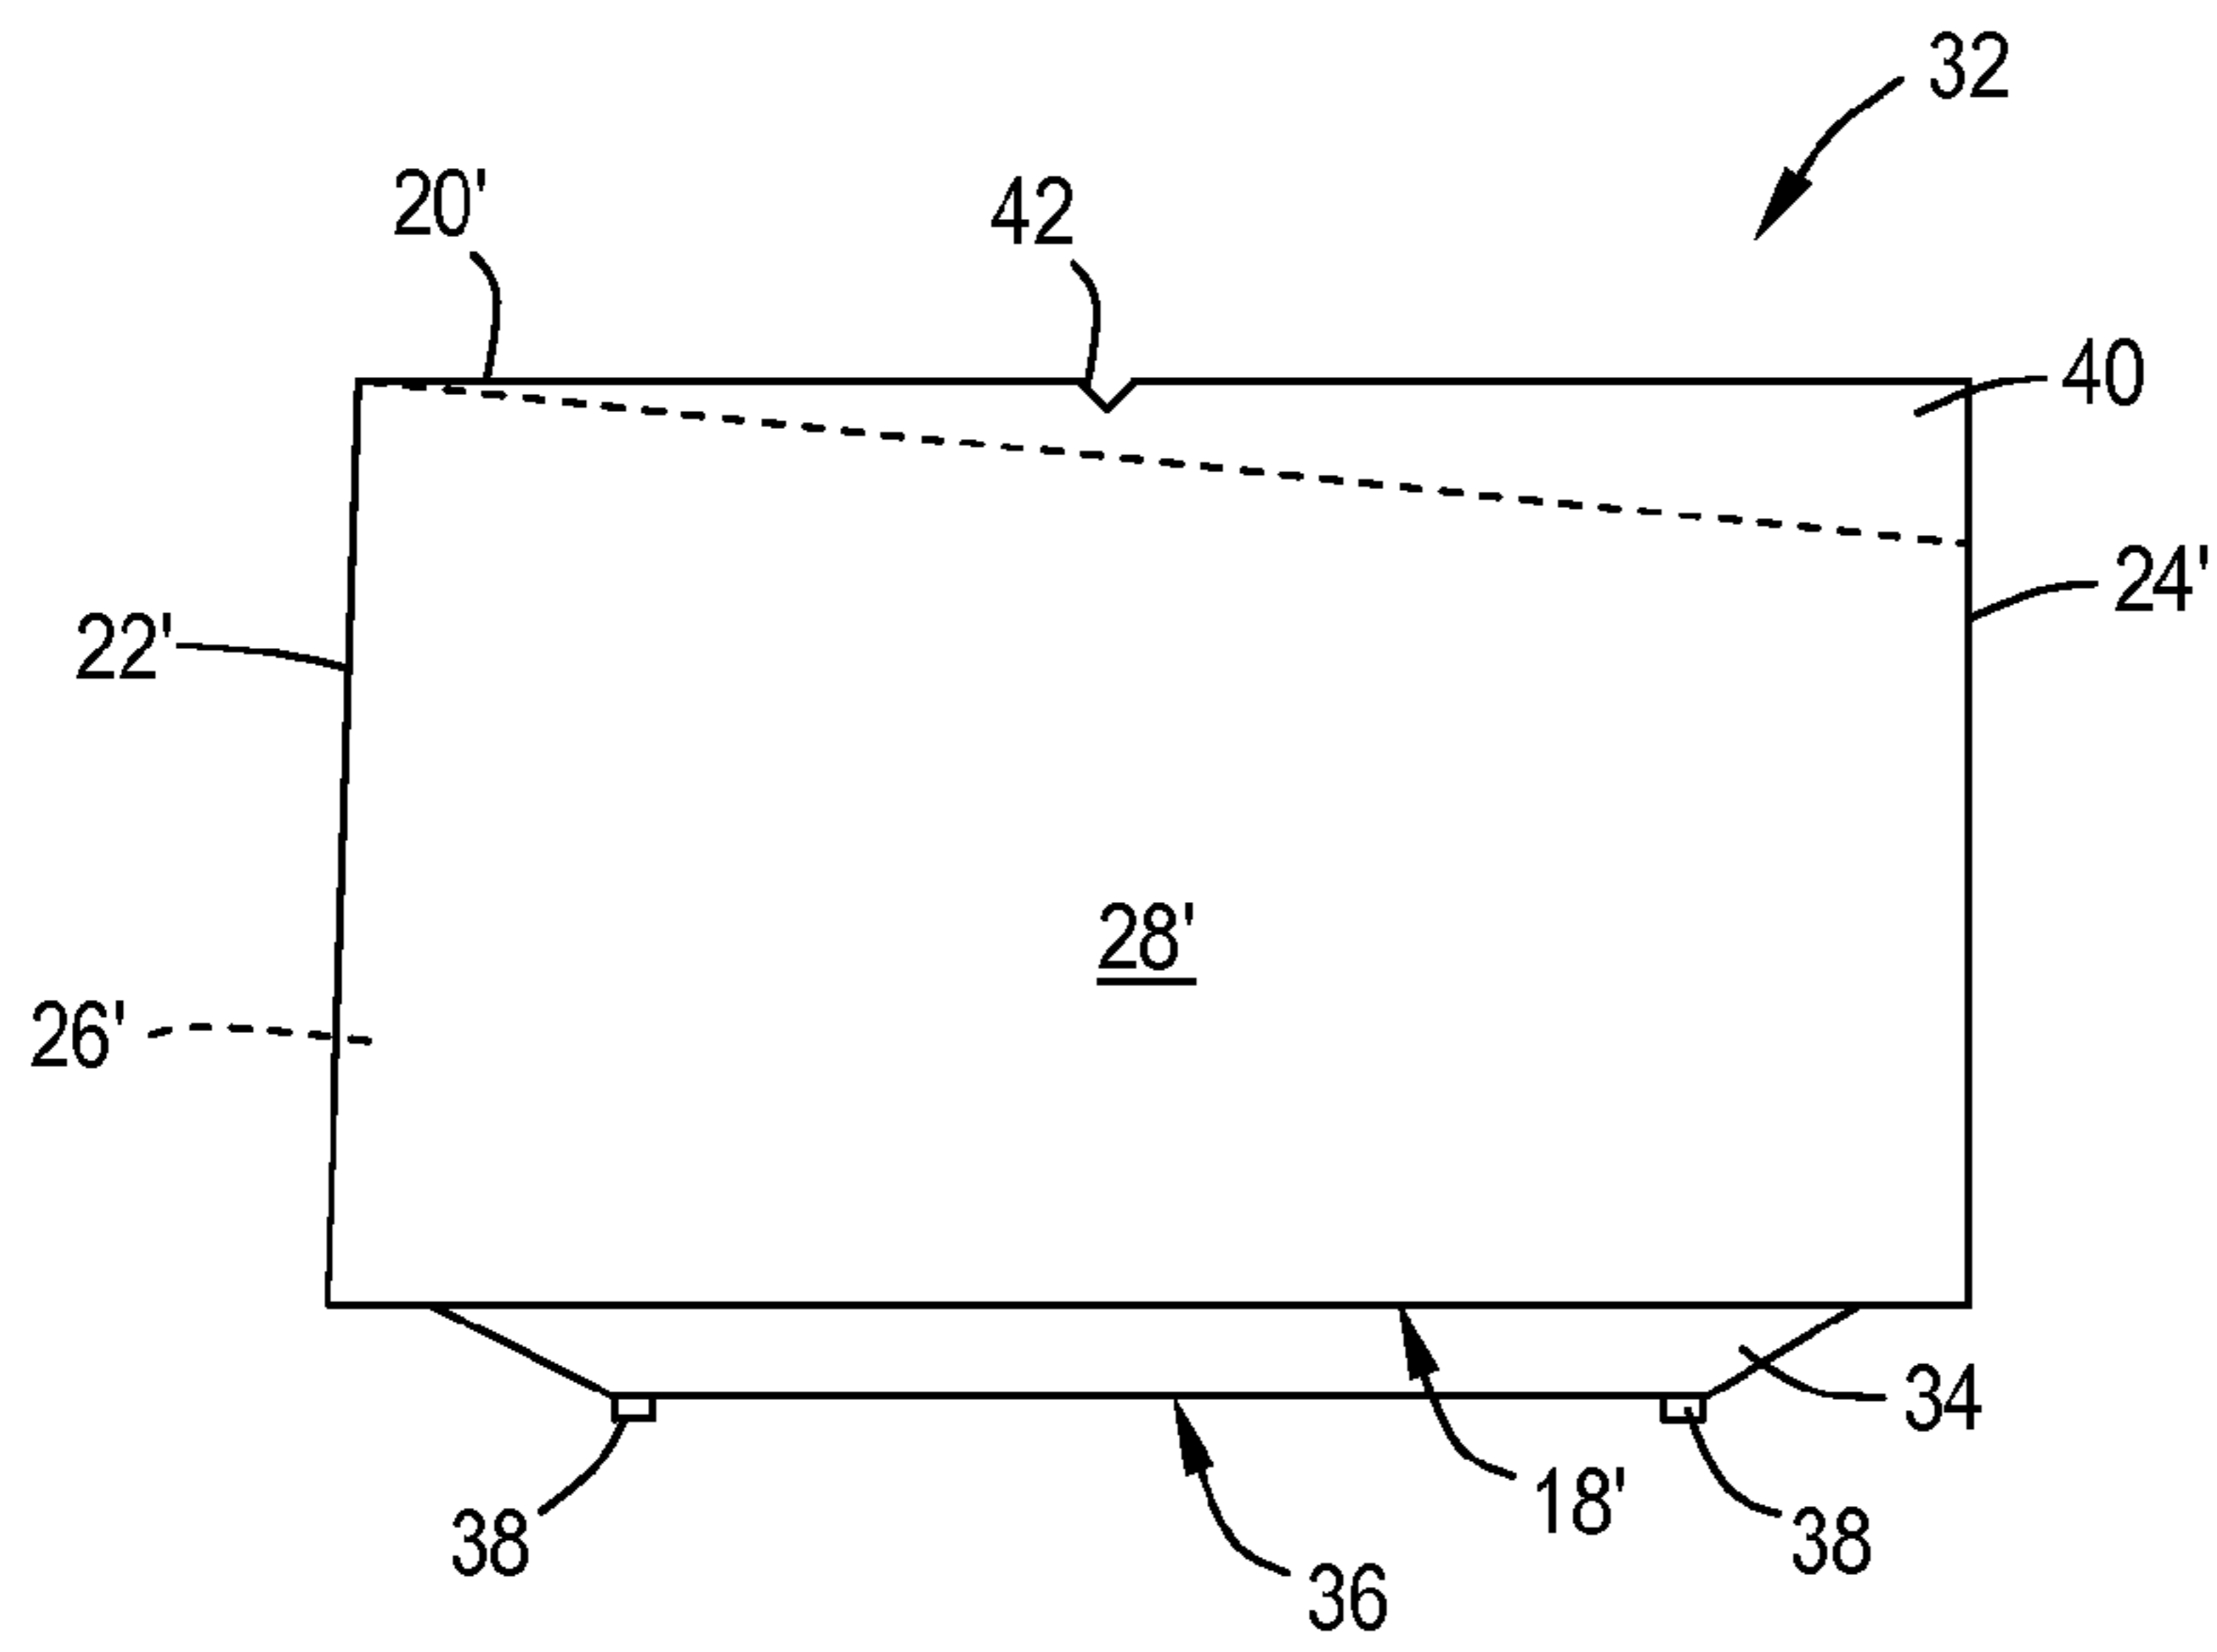
FIG. 3 is a side view of a repair section for use with the blade of FIG. 1;

FIGS. 3 and 4 illustrate a repair section 32 for use to replace the removed portion of the airfoil 16. This type of repair section may also be referred to as a "SPAD", from the term "spare part assembly detail" or "spare part assembly drawing". The repair section 32 mimics the spanwise outer portion of the airfoil 16 (referred to herein as a "tip portion") and includes a leading edge 22', a trailing edge 24', and opposed pressure and suction sides 26' and 28'. In the radial or spanwise direction, it extends between a tip 20' and a base 18'. An integral sacrificial projection 34 extends from the base 18'. The projection 34 is generally trapezoidal in shape, with its cross-sectional area being tapered down as it extends away from the rest of the base 18'. The projection 34 incorporates a faying surface 36 which is planar or otherwise complementary to the faying surface 31 of the field item 30, as is the base 18'. The dimensions and exact shape of the projection 34 are selected to provide for an appropriate amount of material extrusion for a specific application. A pair of small cross-section tabs 38, for example a few thousands of a inch in length, extend from the base 18' of the repair section 32. The repair section 32 may include a sacrificial portion 40 adjacent the tip 20'. The inner boundary of the sacrificial portion 40 coincides with the finished tip profile, and its outer boundary is parallel to the faying surface 36. A notch 42 is formed in the tip 20'. In the illustrated example the notch is V-shaped.

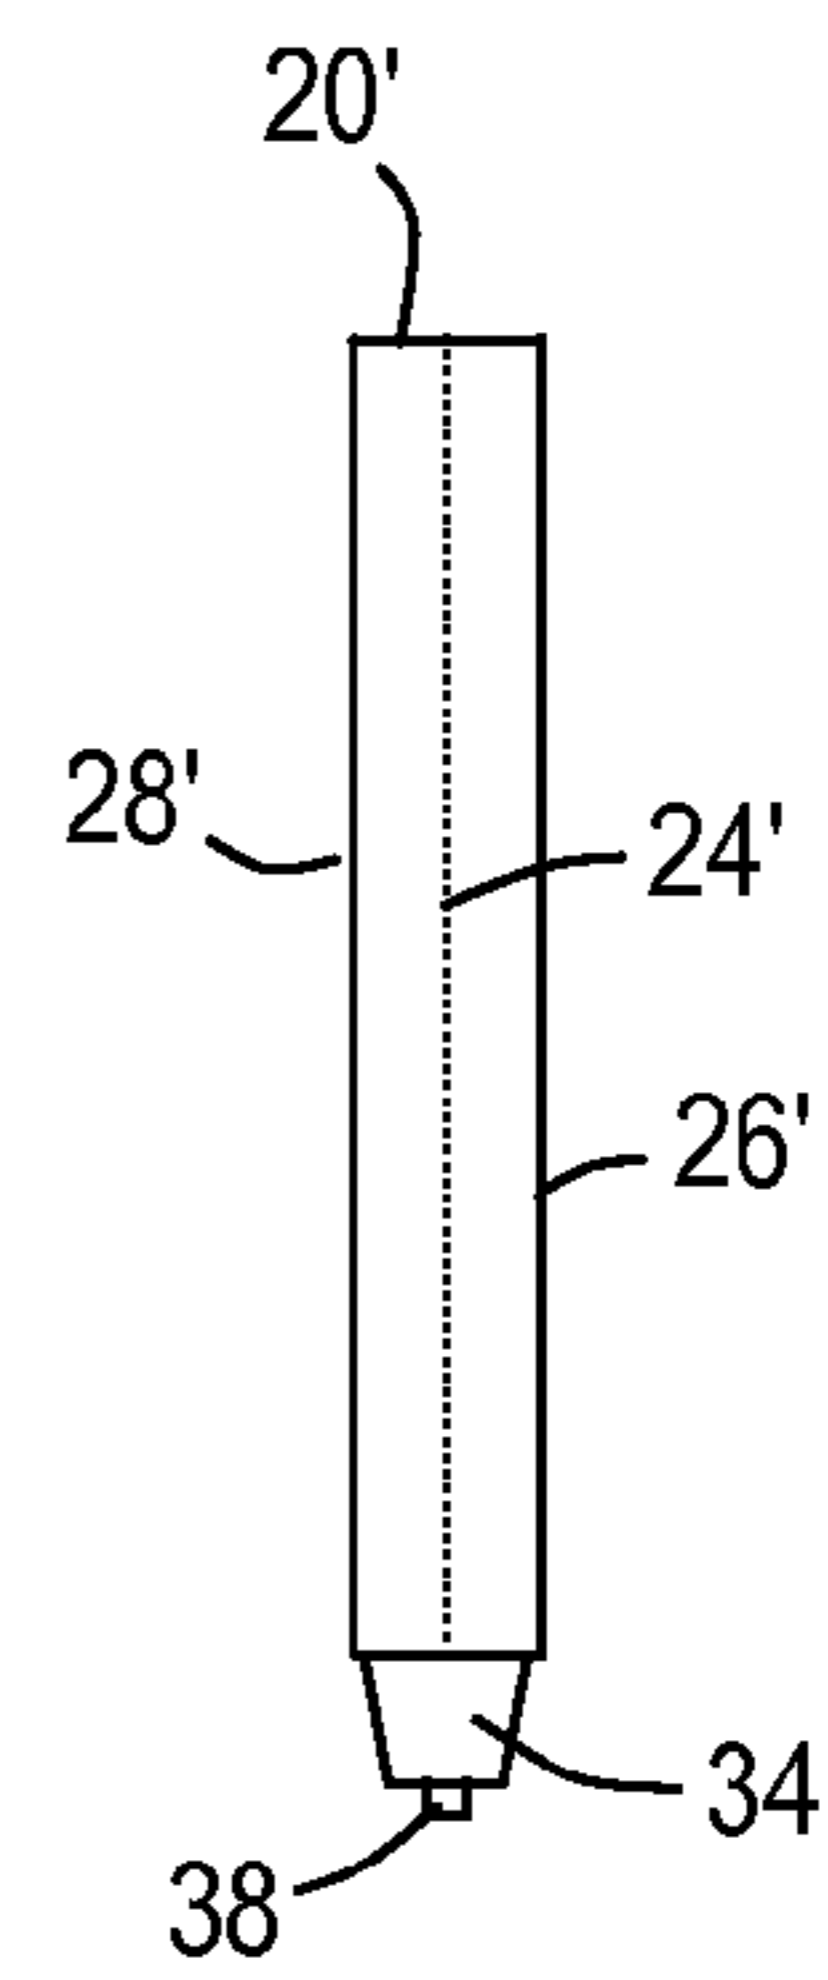
FIG. 4 is a rear elevational view of the repair section of FIG. 3;

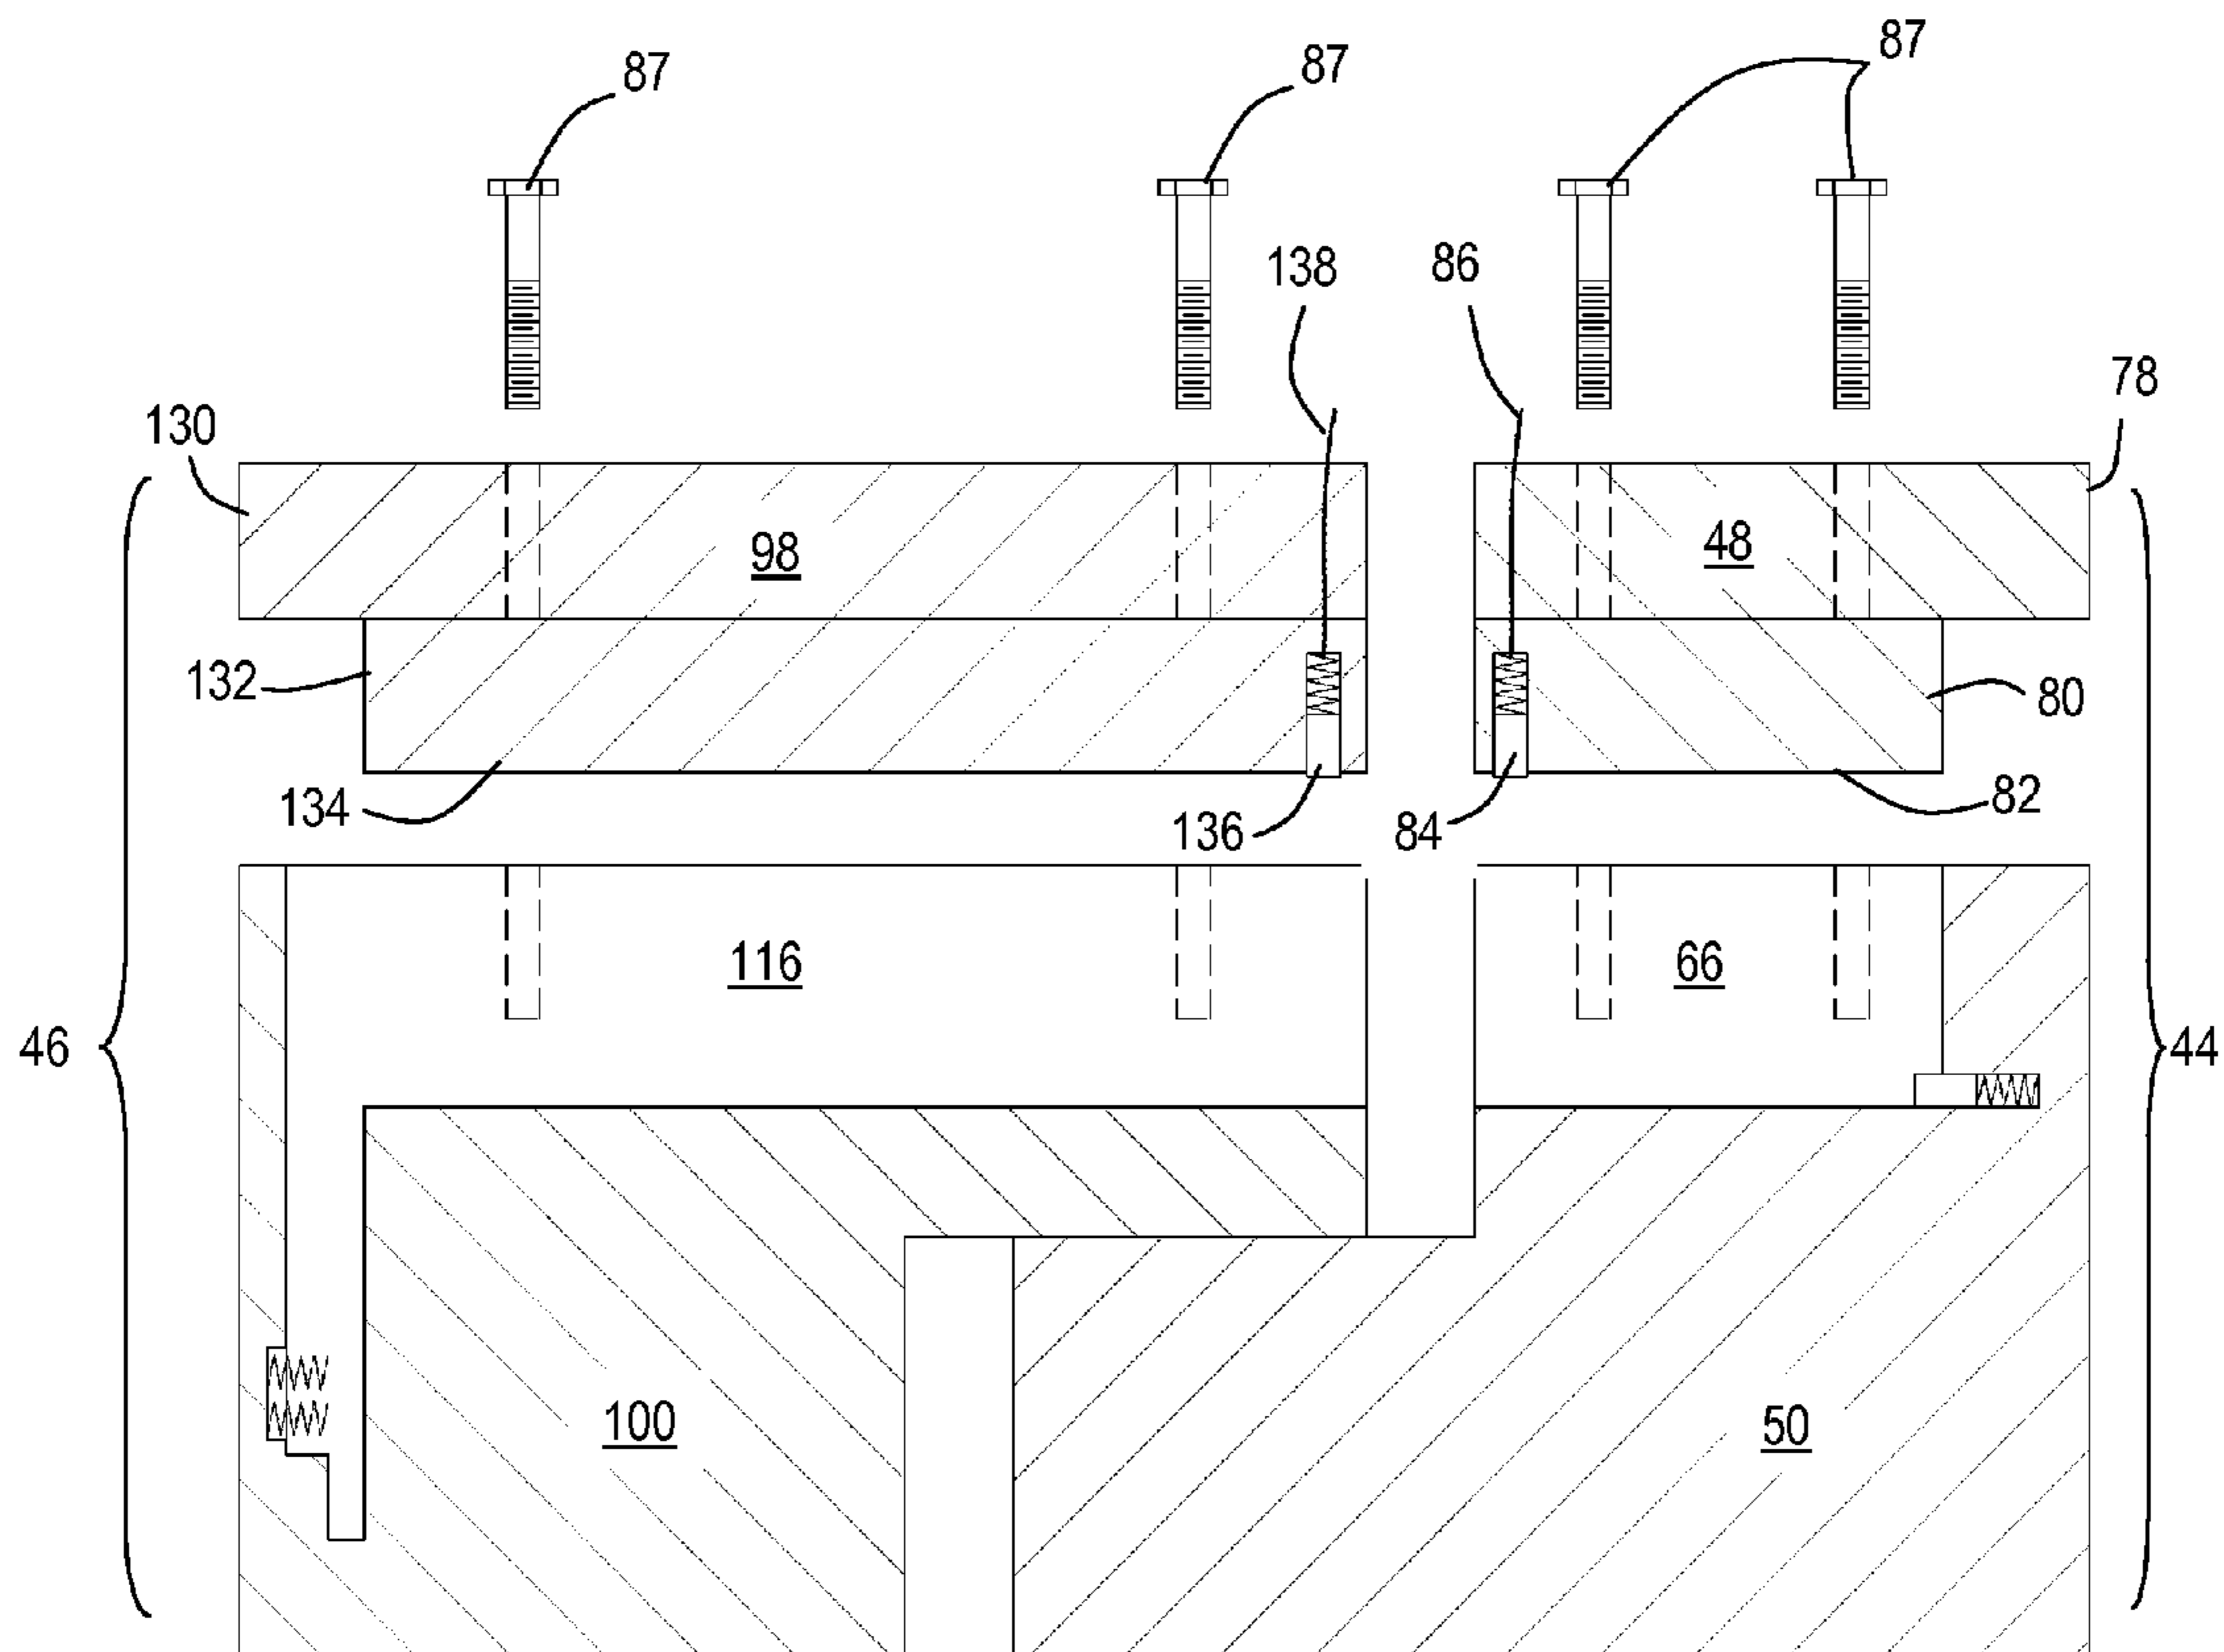
FIG. 5 is a cross-sectional view of a fixture constructed according to an aspect of the present invention;

FIG. 5 shows a fixture used to align and weld the repair section 32 and the field item 30 together. Its basic components are two, two-part dies, referred to as a repair section die 44 and a field item die 46, respectively.

The male half 48 (seen in FIG. 5) includes a body 78 which mates against the top face 54 of the female half 50, and a block 80 which is shaped to protrude into the recess 66. Its bottom face 82 is curved to match the repair section 32. A spring-loaded electrical contact 84 protrudes from the bottom face 82 of the block 80 and is coupled to an electrical lead 86. Means are provided for securing the male half 48 to the female half 50, such as the illustrated bolts 87.

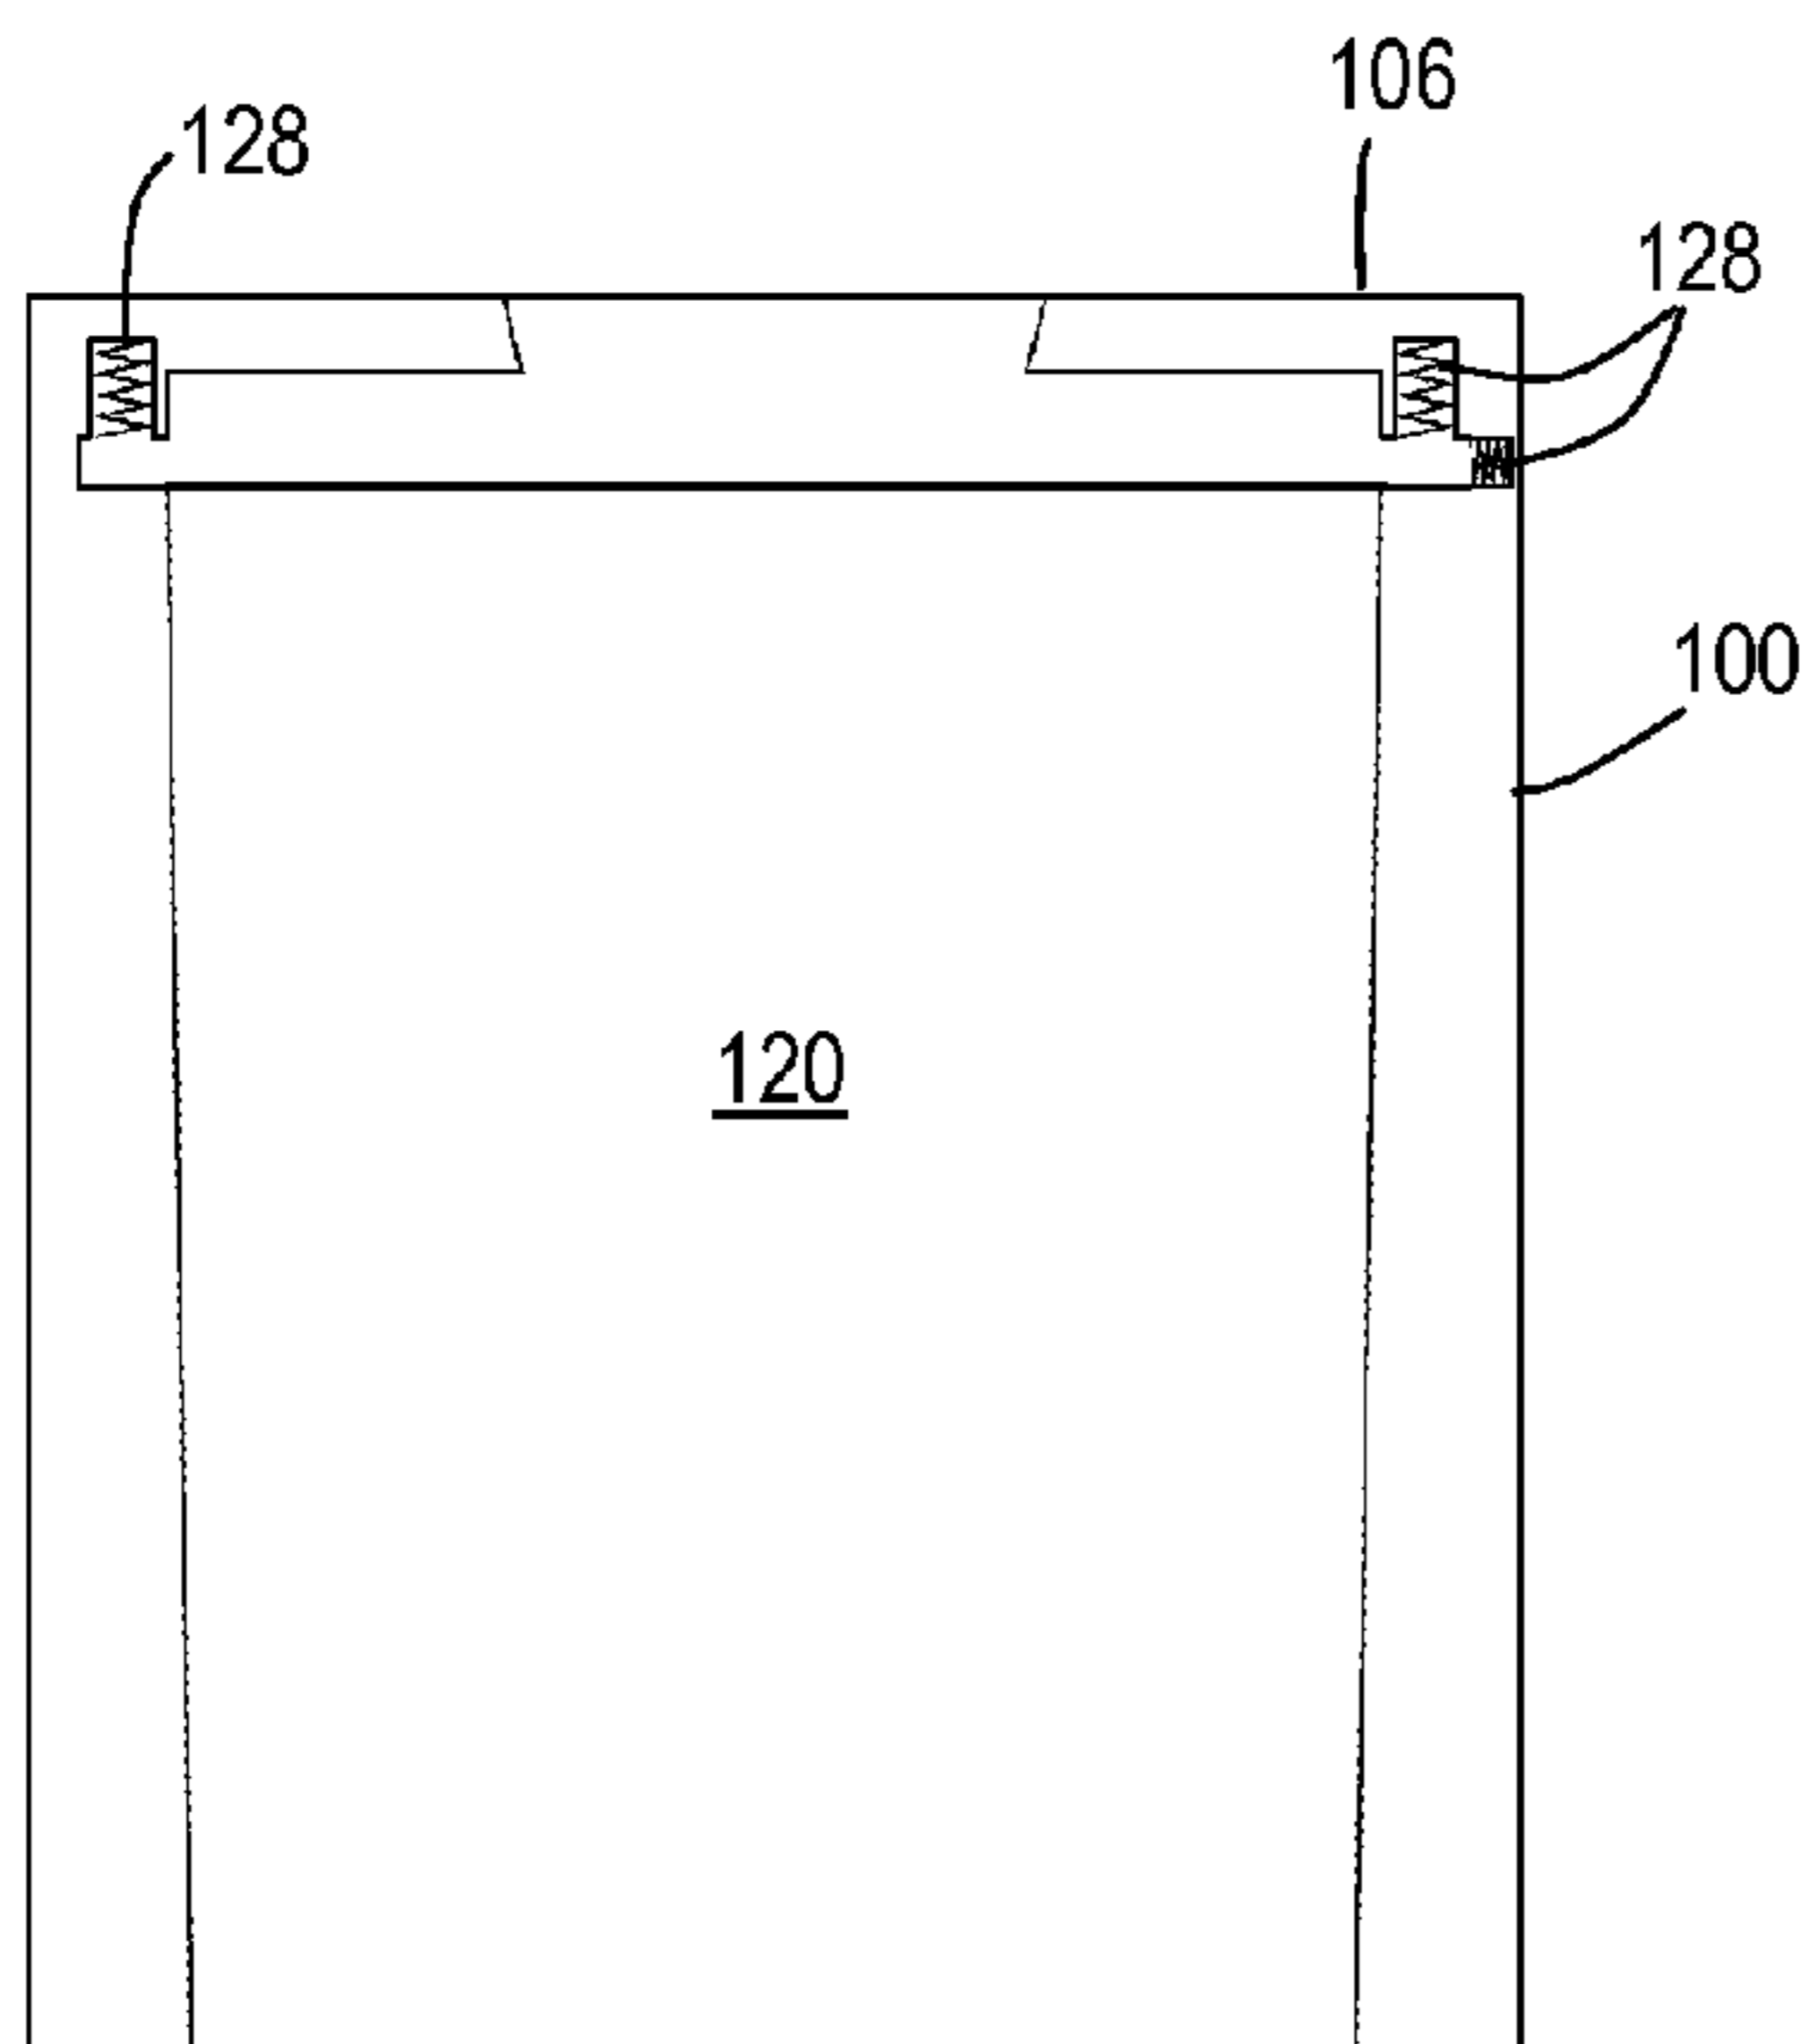
FIG. 11 is a top view of the die of FIG. 9; and
