(12) **United States Patent**
Krizansky et al.

(10) **Patent No.:** **US 9,018,560 B2**
(45) **Date of Patent:** **Apr. 28, 2015**

(54) **REPAIR ALIGNMENT METHOD AND APPARATUS FOR TURBINE COMPONENTS**

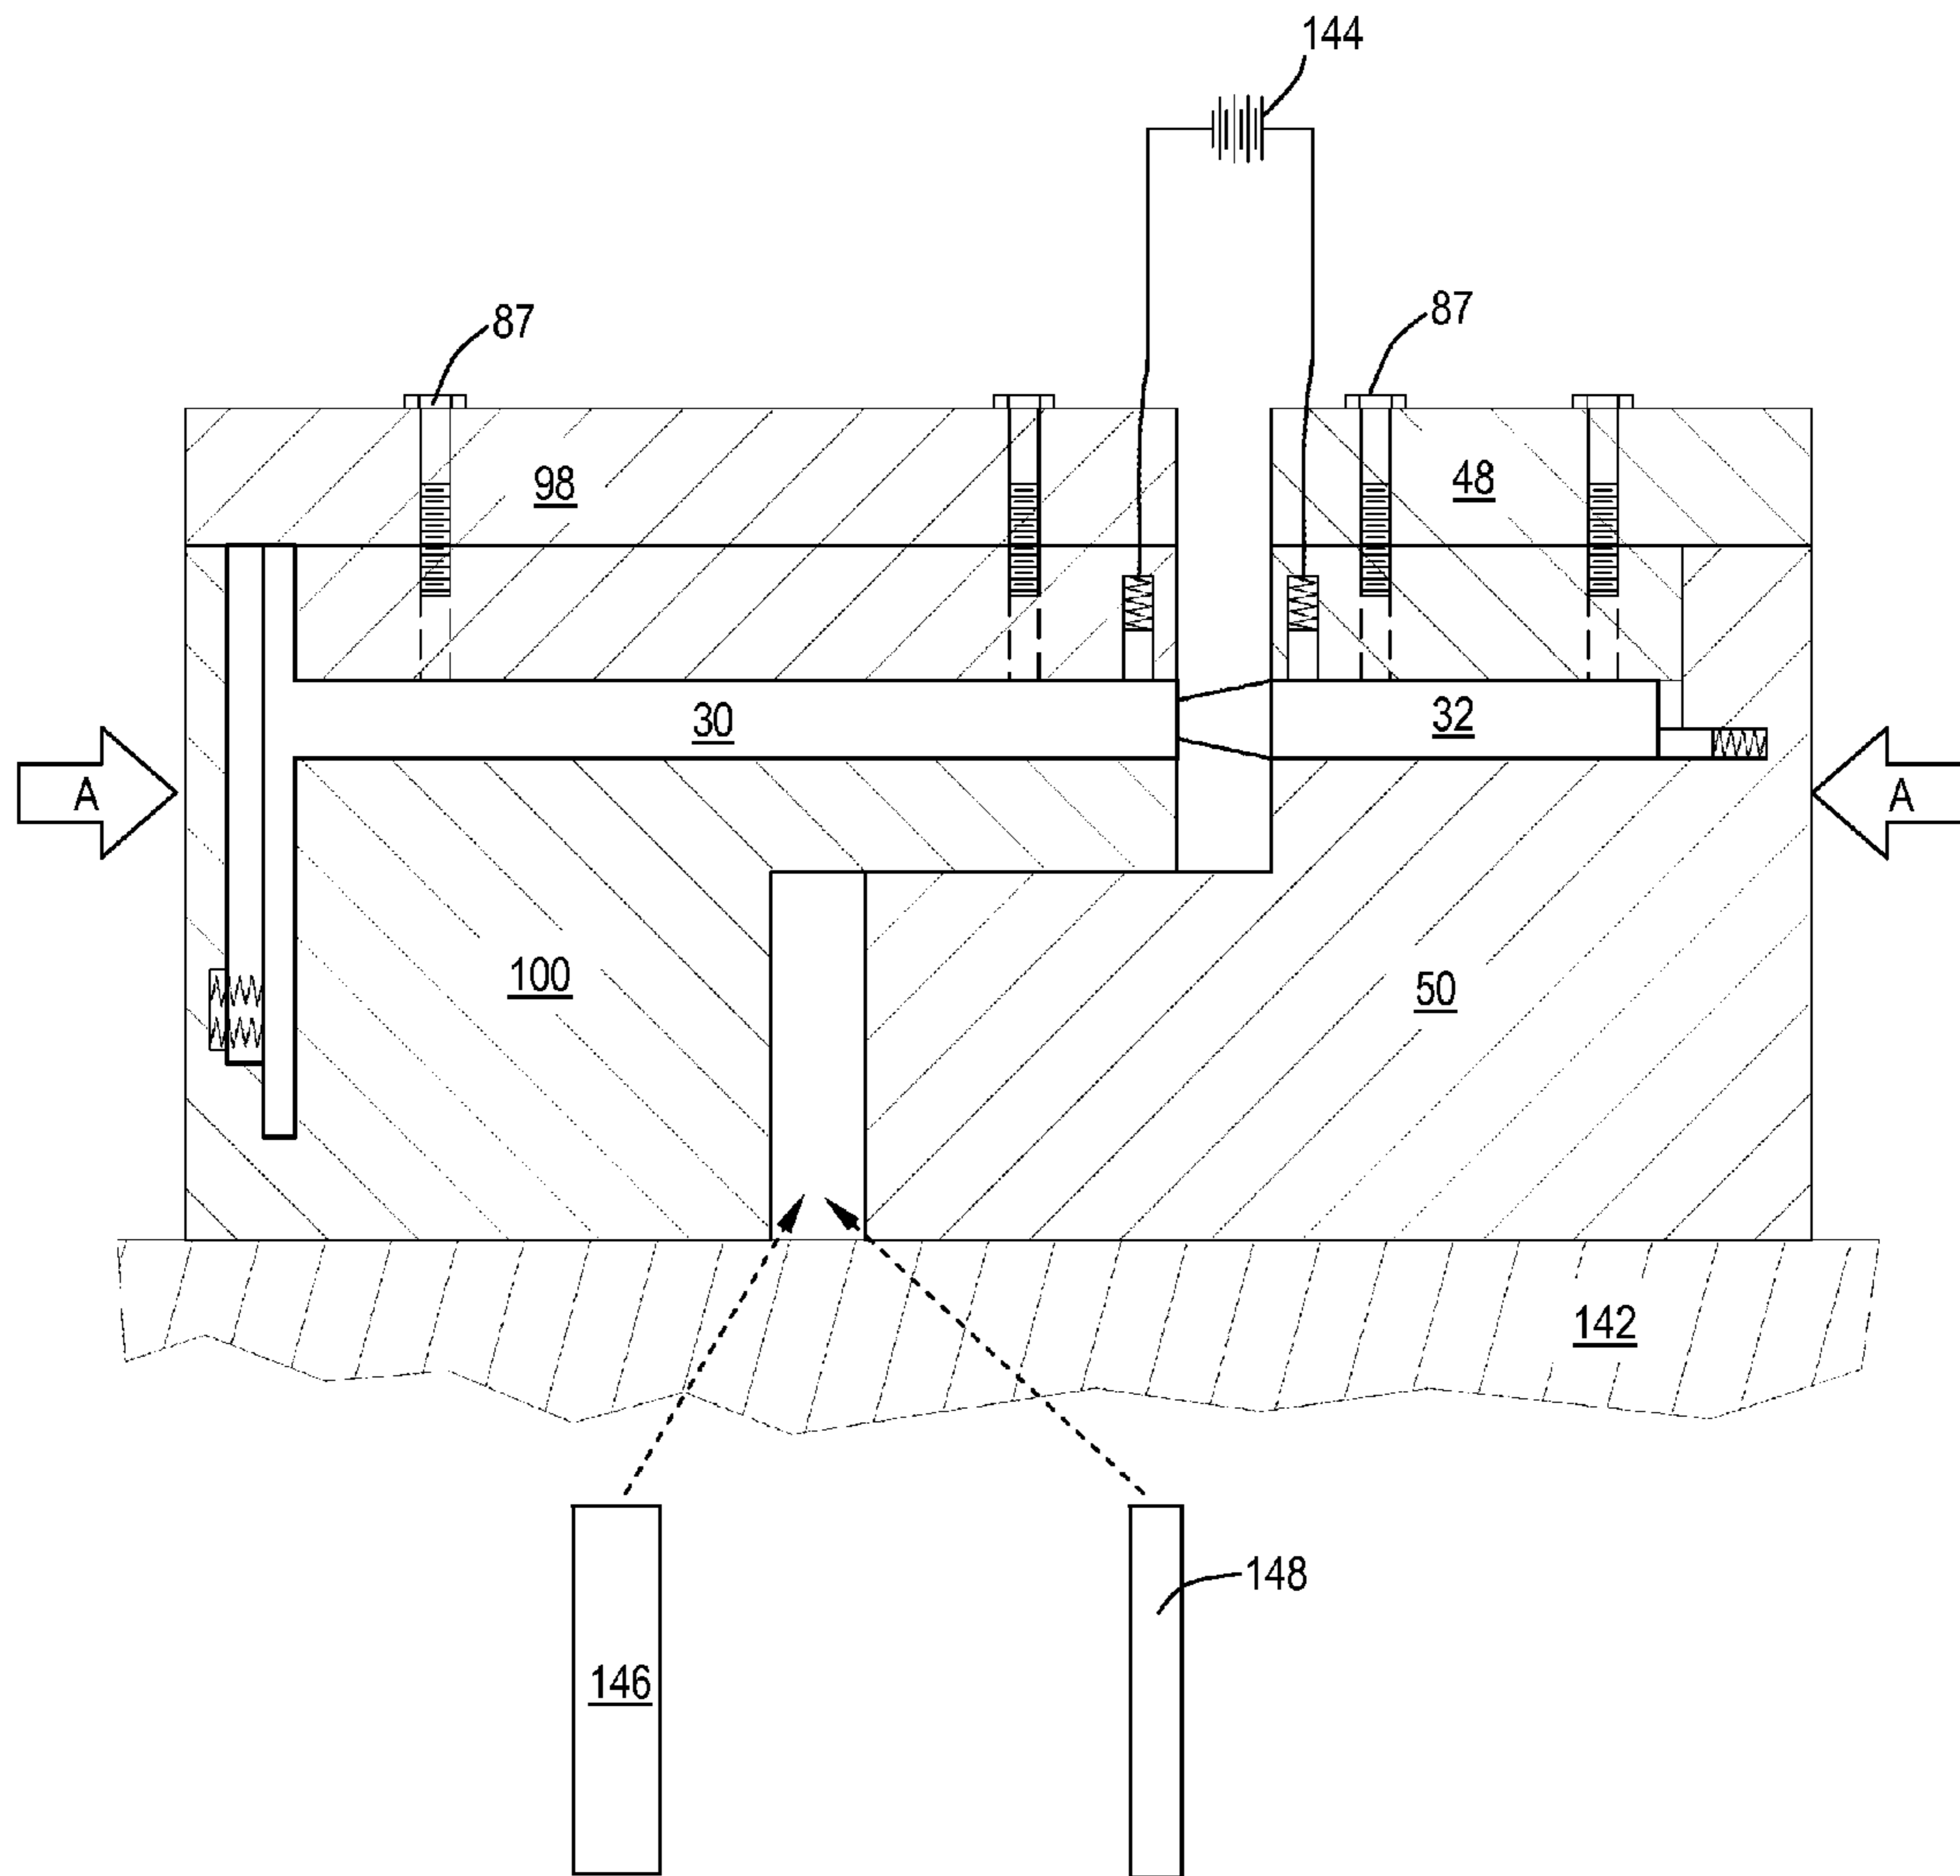
FIG. 12 is a cross-sectional view of the fixture assembled during a welding process.
