(54) **TRANSMISSION SYSTEM AND METHOD OF REPAIR**

A transmission system and method of repair having a transmission servo rod received within a transmission housing bore, the rod having an aperture disposed along an exterior surface of the rod, configured to receive transmission fluid from a port within the transmission housing bore, a first recessed groove in the exterior surface of the rod disposed above the aperture; a second recessed groove in the exterior surface of the rod disposed below the aperture; and a first and second resilient sealing member received within the first and second recessed grooves, respectively, the resilient sealing members configured to engage an inner surface of the transmission housing bore.

TRANSMISSION SYSTEM AND METHOD OF REPAIR

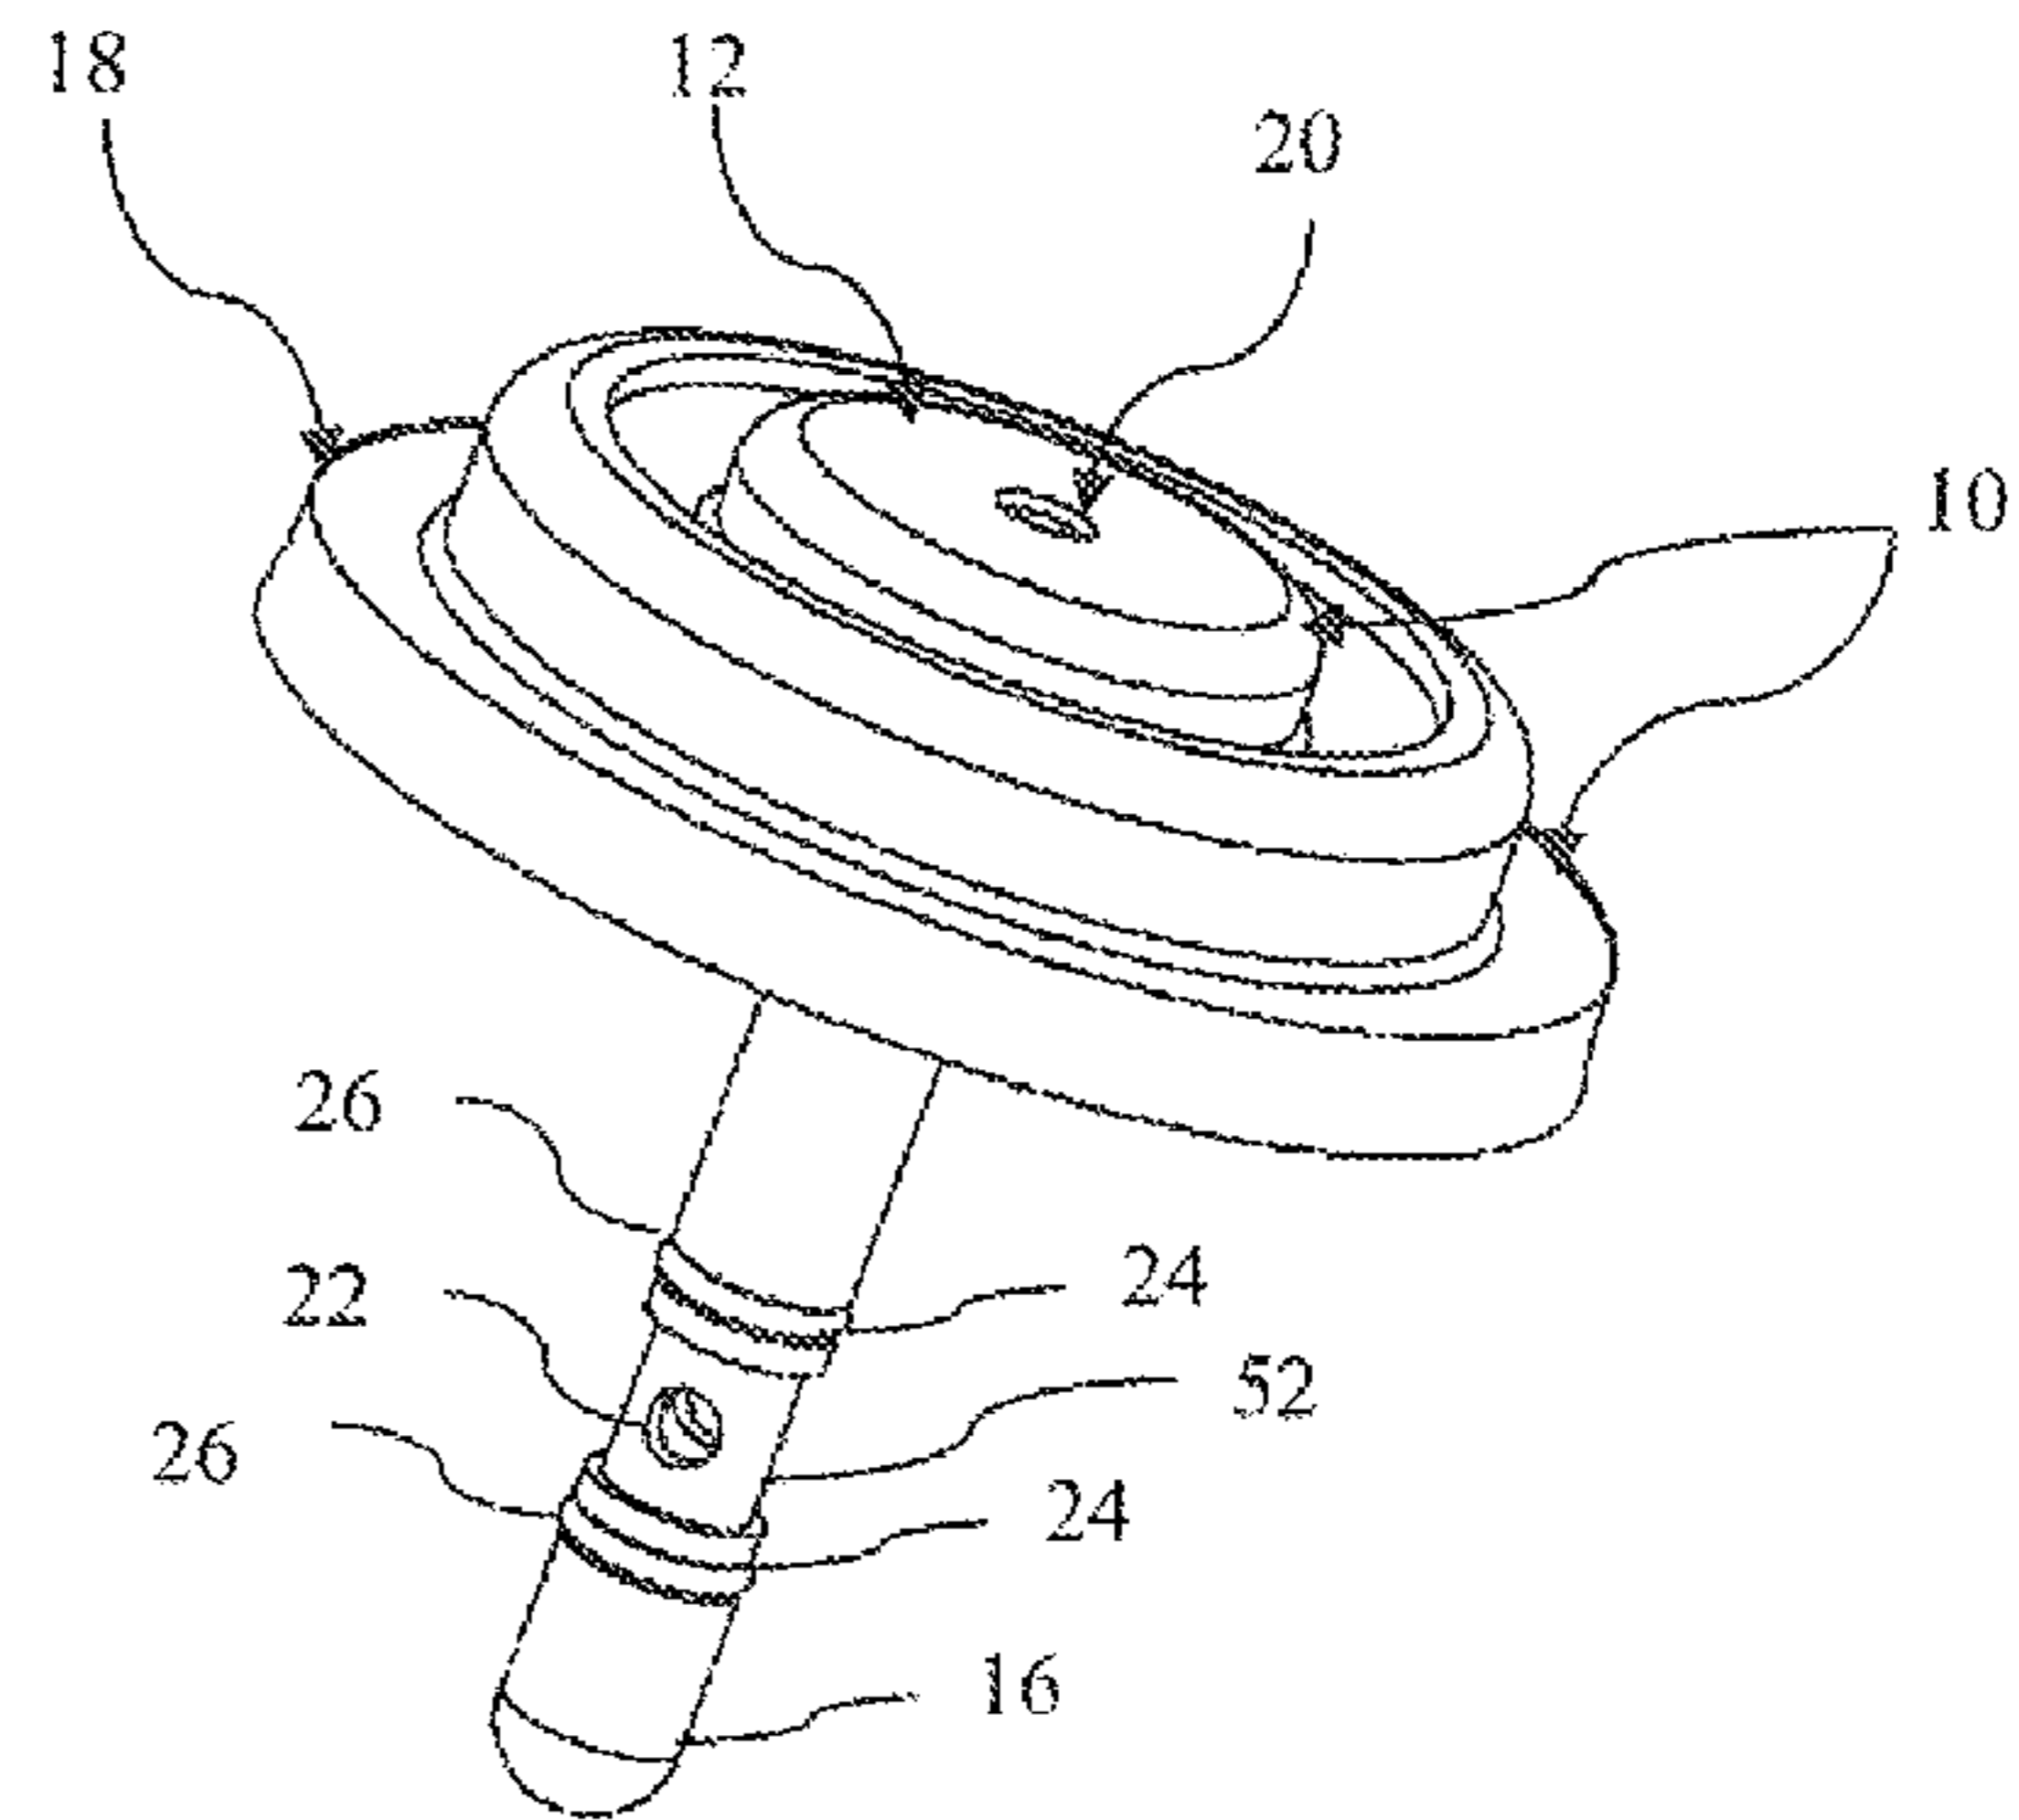
FIG. 2 is an isometric view of a modified OEM part with machined o-ring grooves and o-rings;

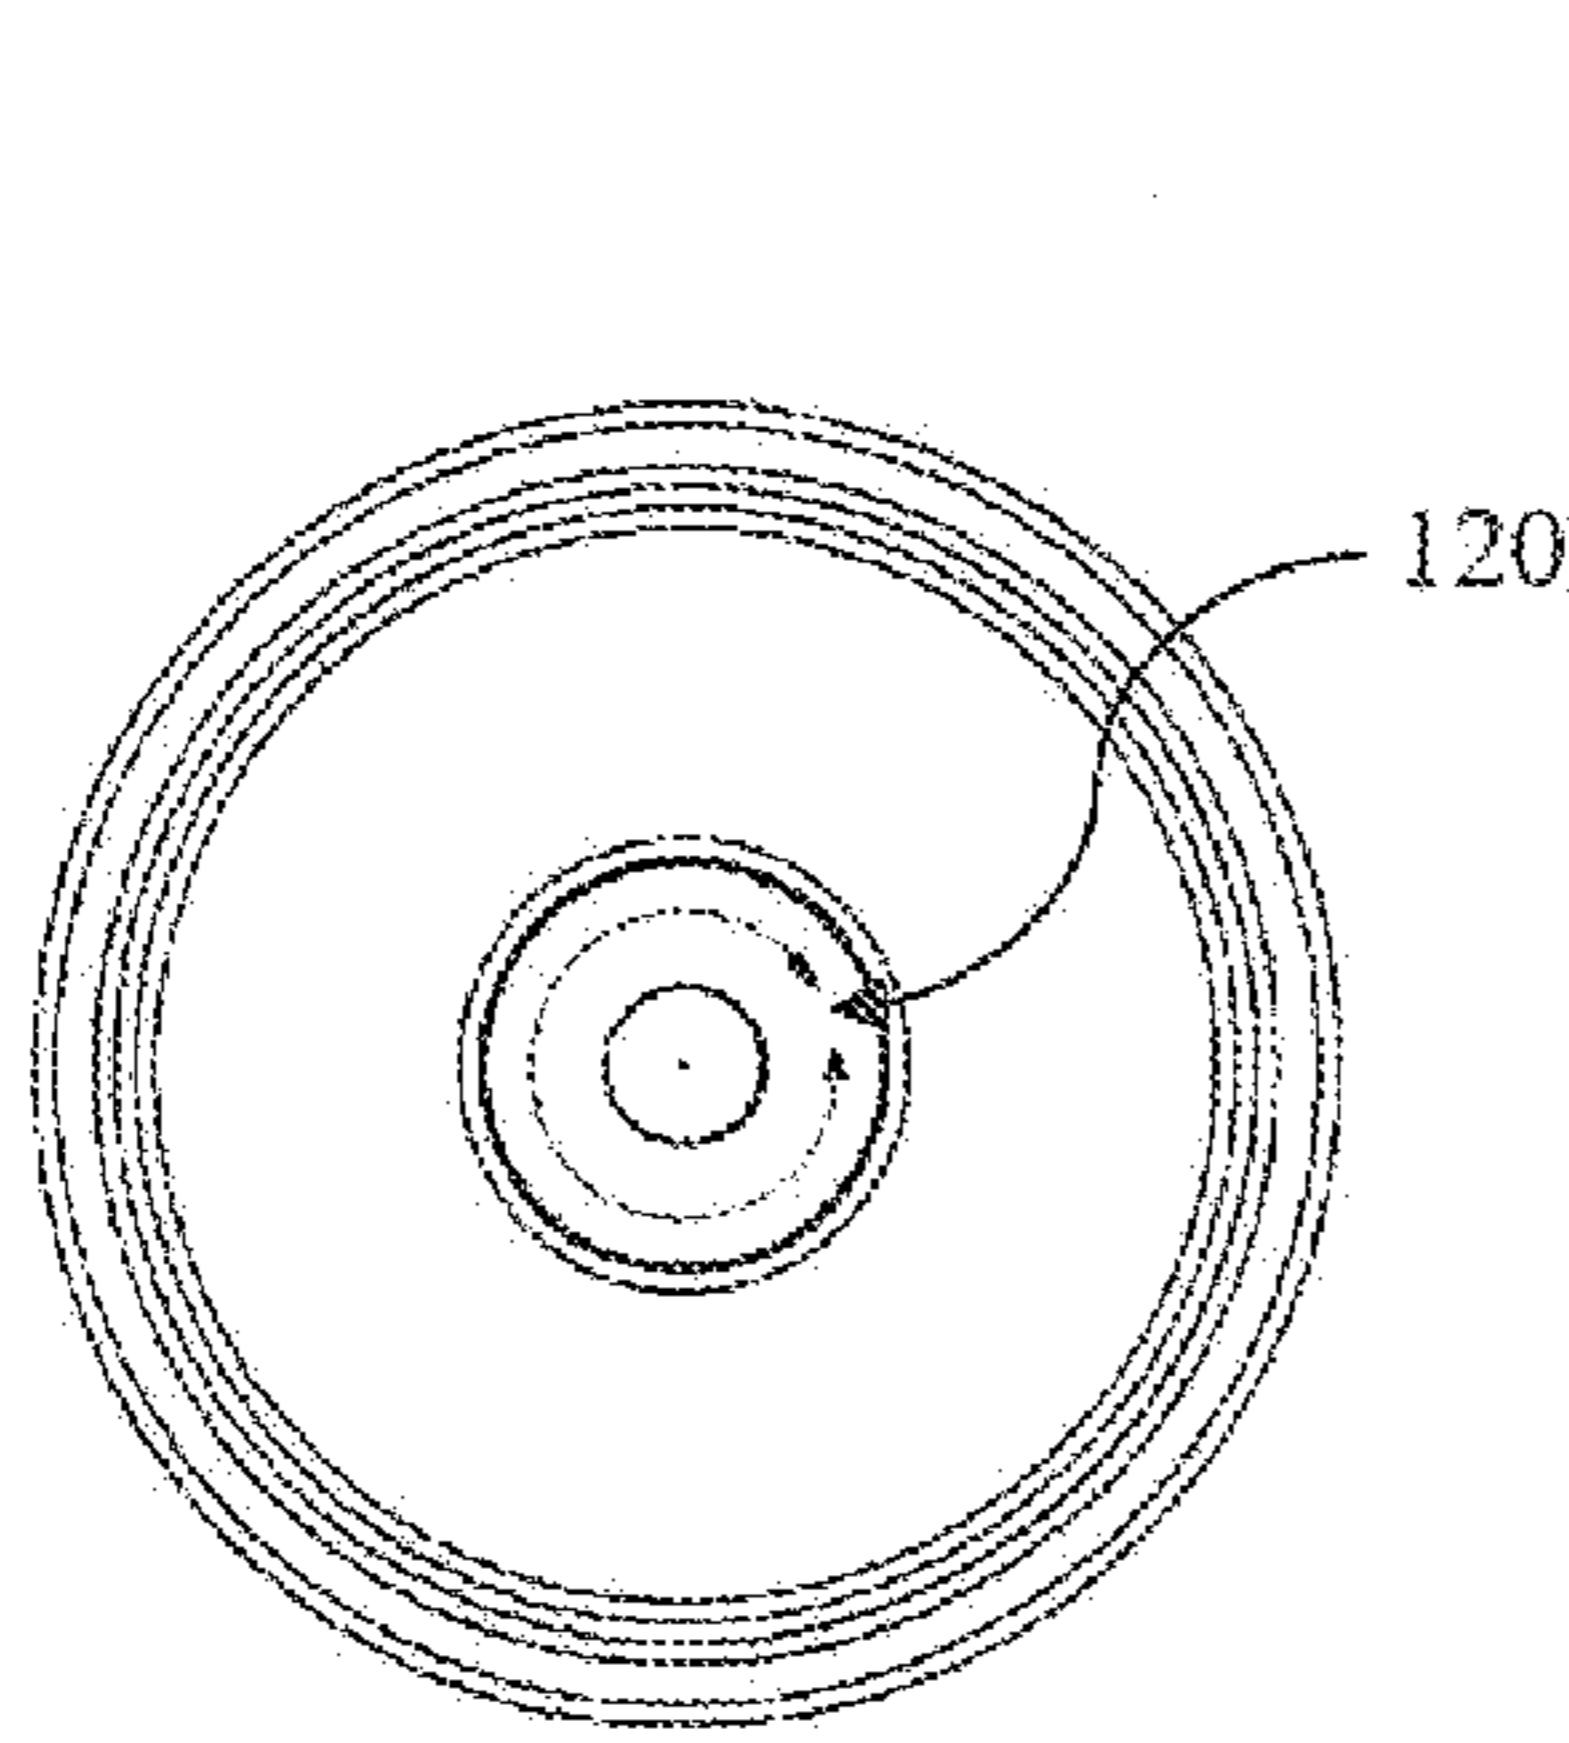
FIG. 3 is a bottom view of a core section of an intermediate servo as it would appear from inside a transmission looking out.

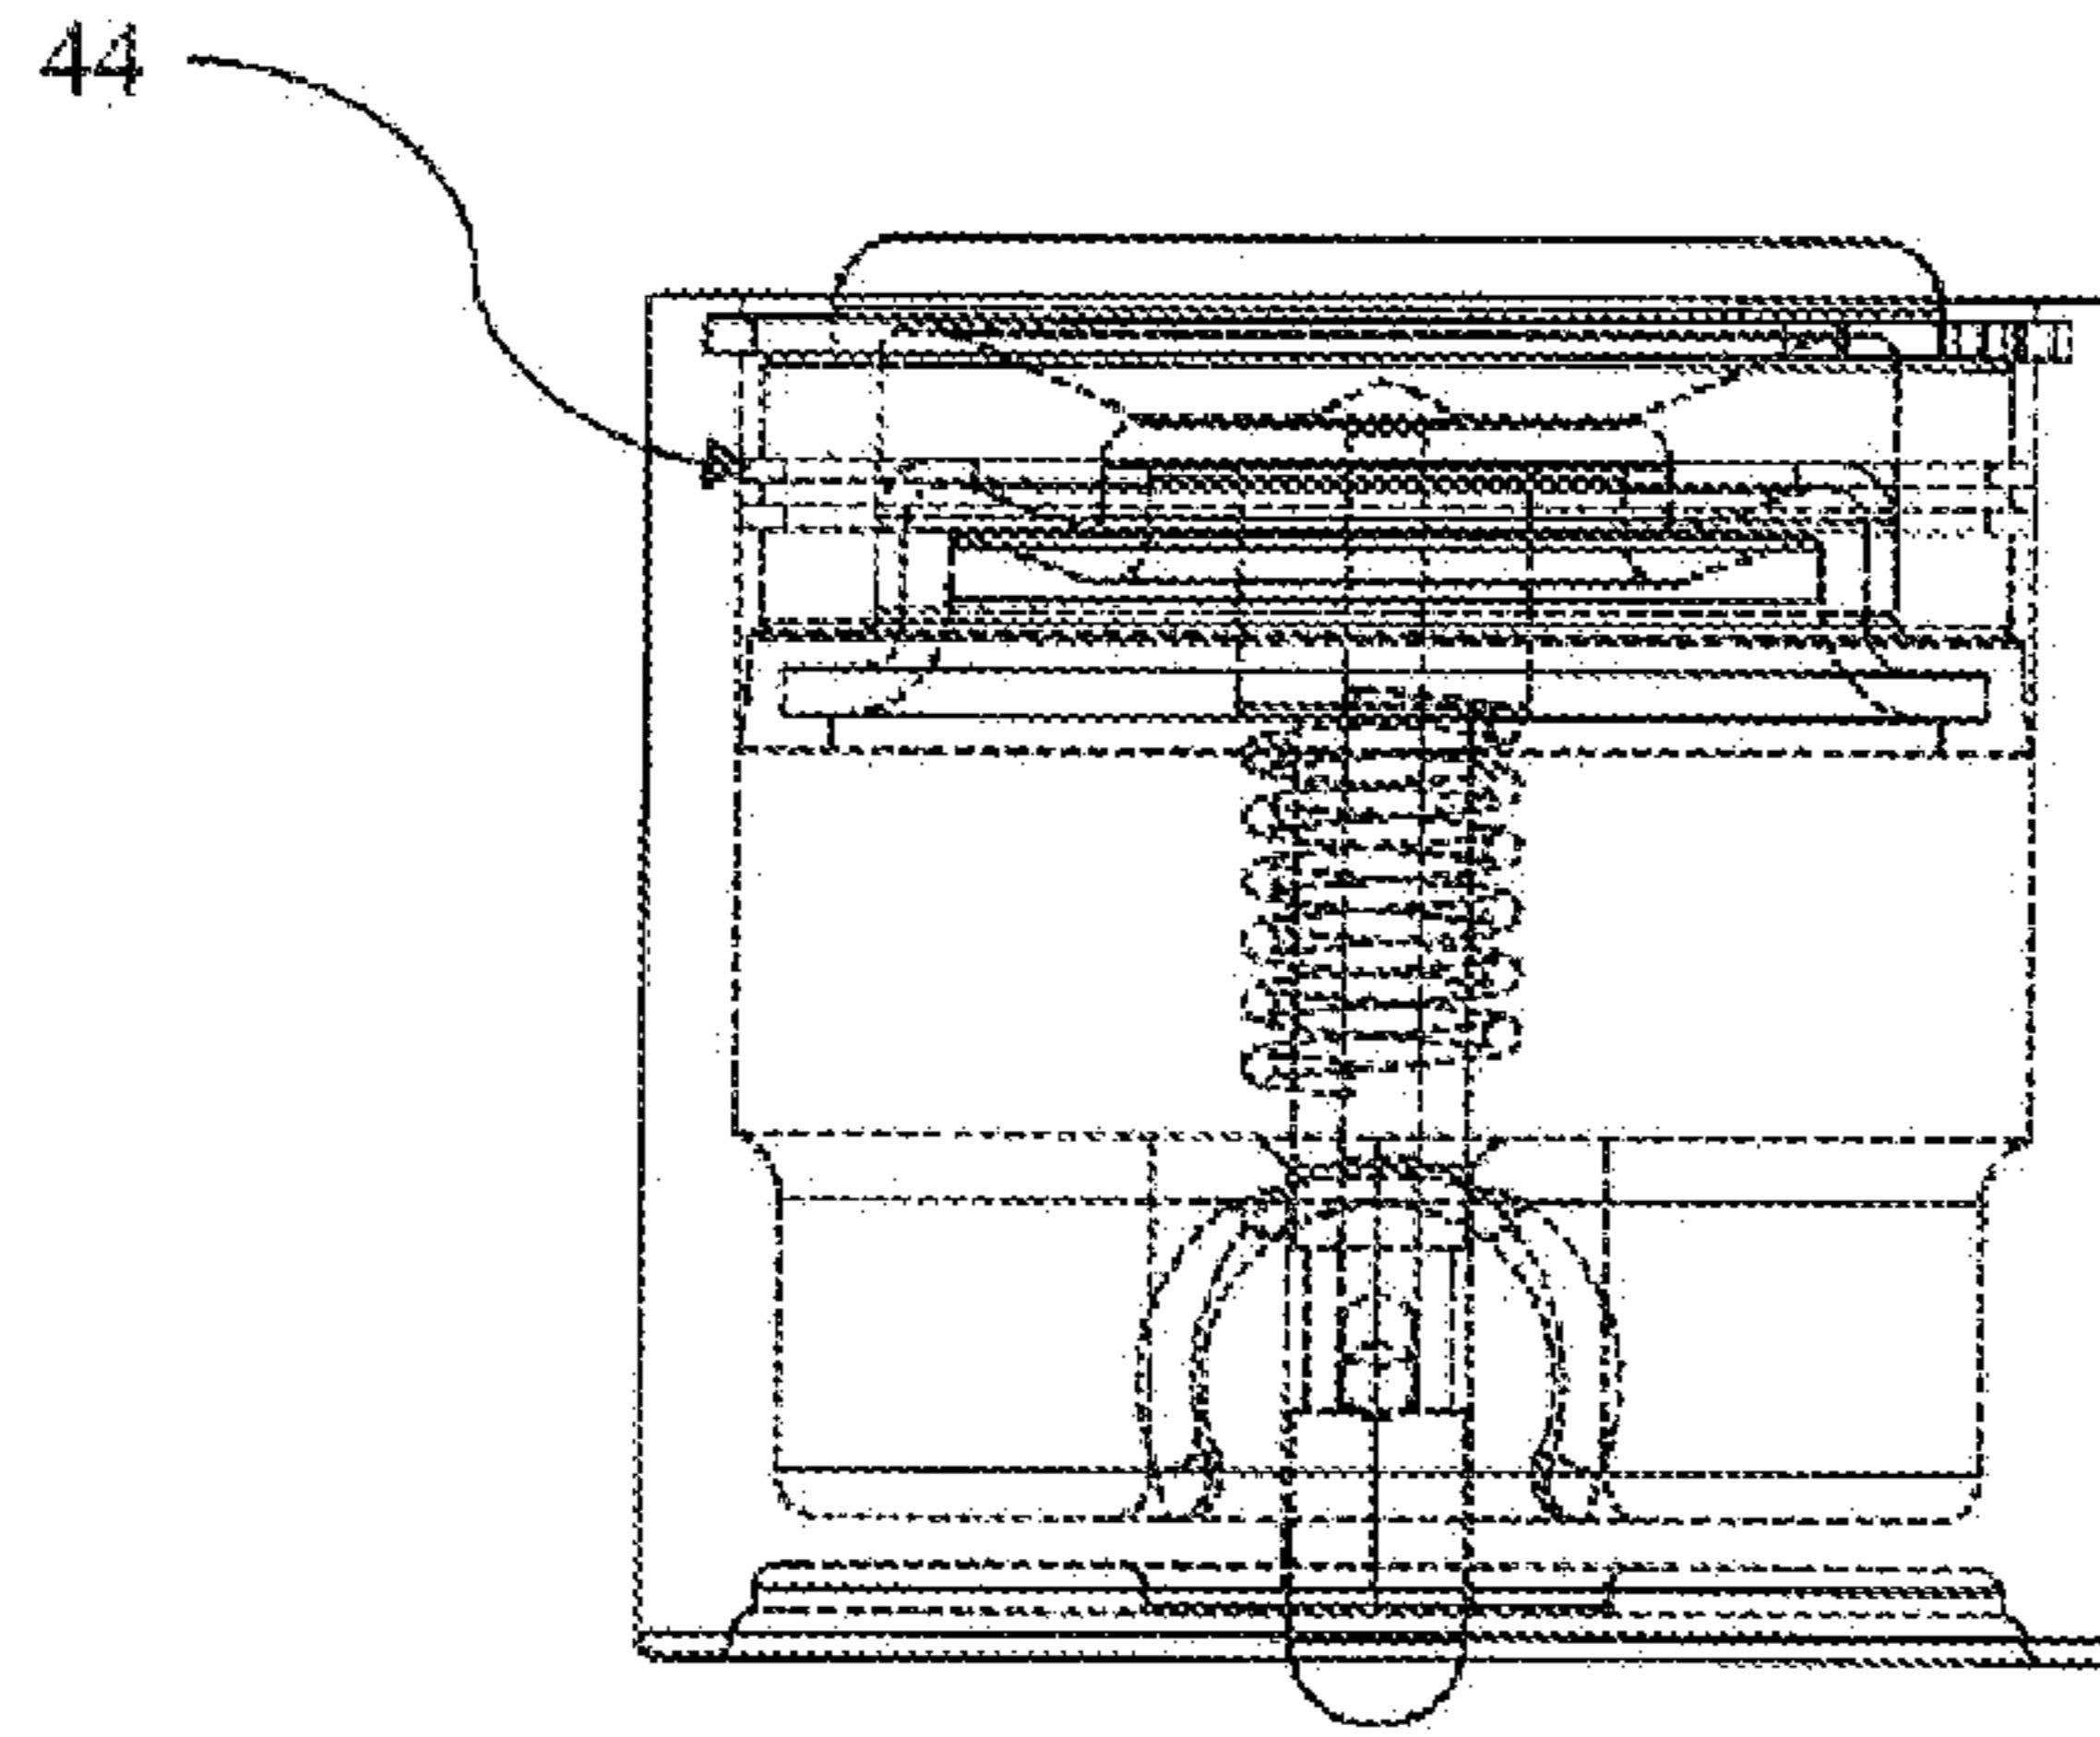
FIG. 4
PRIOR ART

FIG. 4 is a front view of a core section of the intermediate servo showing the servo, including the piston, bore the rod goes through, snap ring, and return spring;

5 The OEM servos consist of a rod 16 and piston 12 & 18 (see FIG. 1). The servos have a cross bore 22 that is centered on a wide groove 52 that is machined into the rod. The large groove allows for fluid to pass into the cross bore 22 while the servo is extending and retracting (see FIGS. 1, 4, 6, 7, and 21).
 10 The rod 16 on the servo has a bore 20 running through the center of the rod from the cross bore 22 to the top of the piston 12 (see FIGS. 1, 4, 6, 7 & 8). As part of the OEM design, when the solenoid (not shown) for that servo is activated, the pressurized transmission fluid passes through the cross bore 22 in the rod 16 up to the top side of the piston 12 between the piston 10 and the servo cap 36. Some fluid also passes to the bottom side of the piston 14 and to the reservoir 40 (See FIGS. 1 and 7). This is an inherent part of the OEM design. The system is designed such that the intermediate servo which

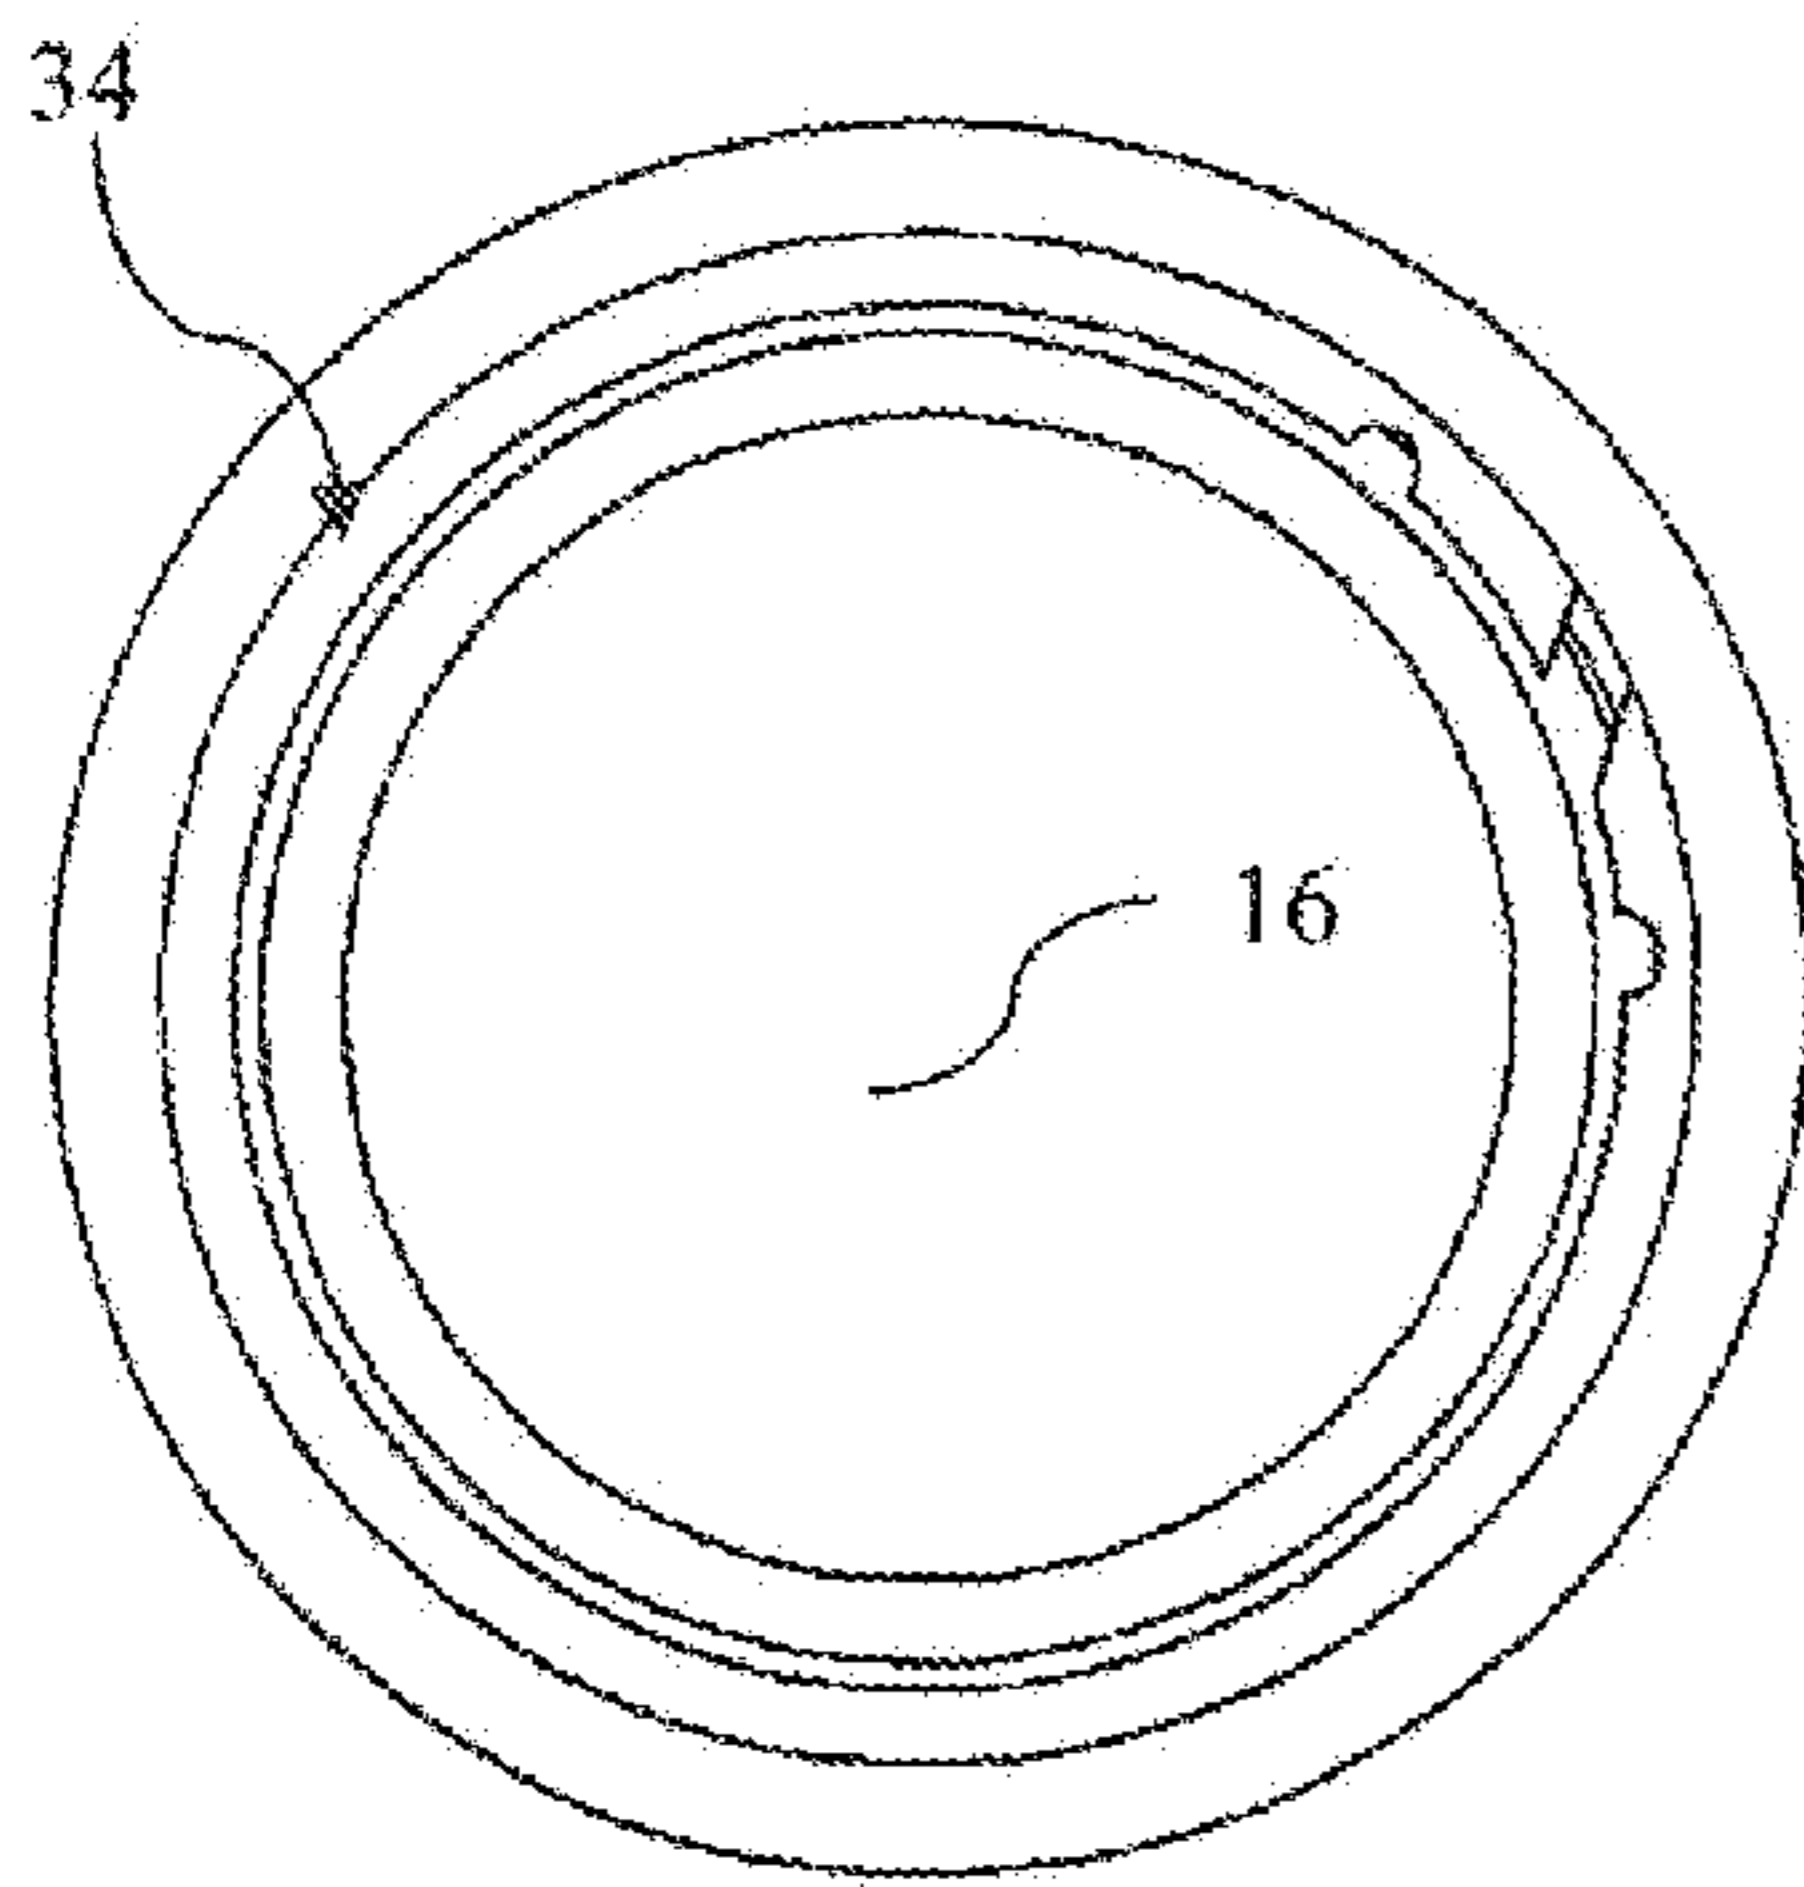
FIG. 5 is a top view of a bore section of the intermediate servo showing a cap and the snap ring that holds the cap in place;

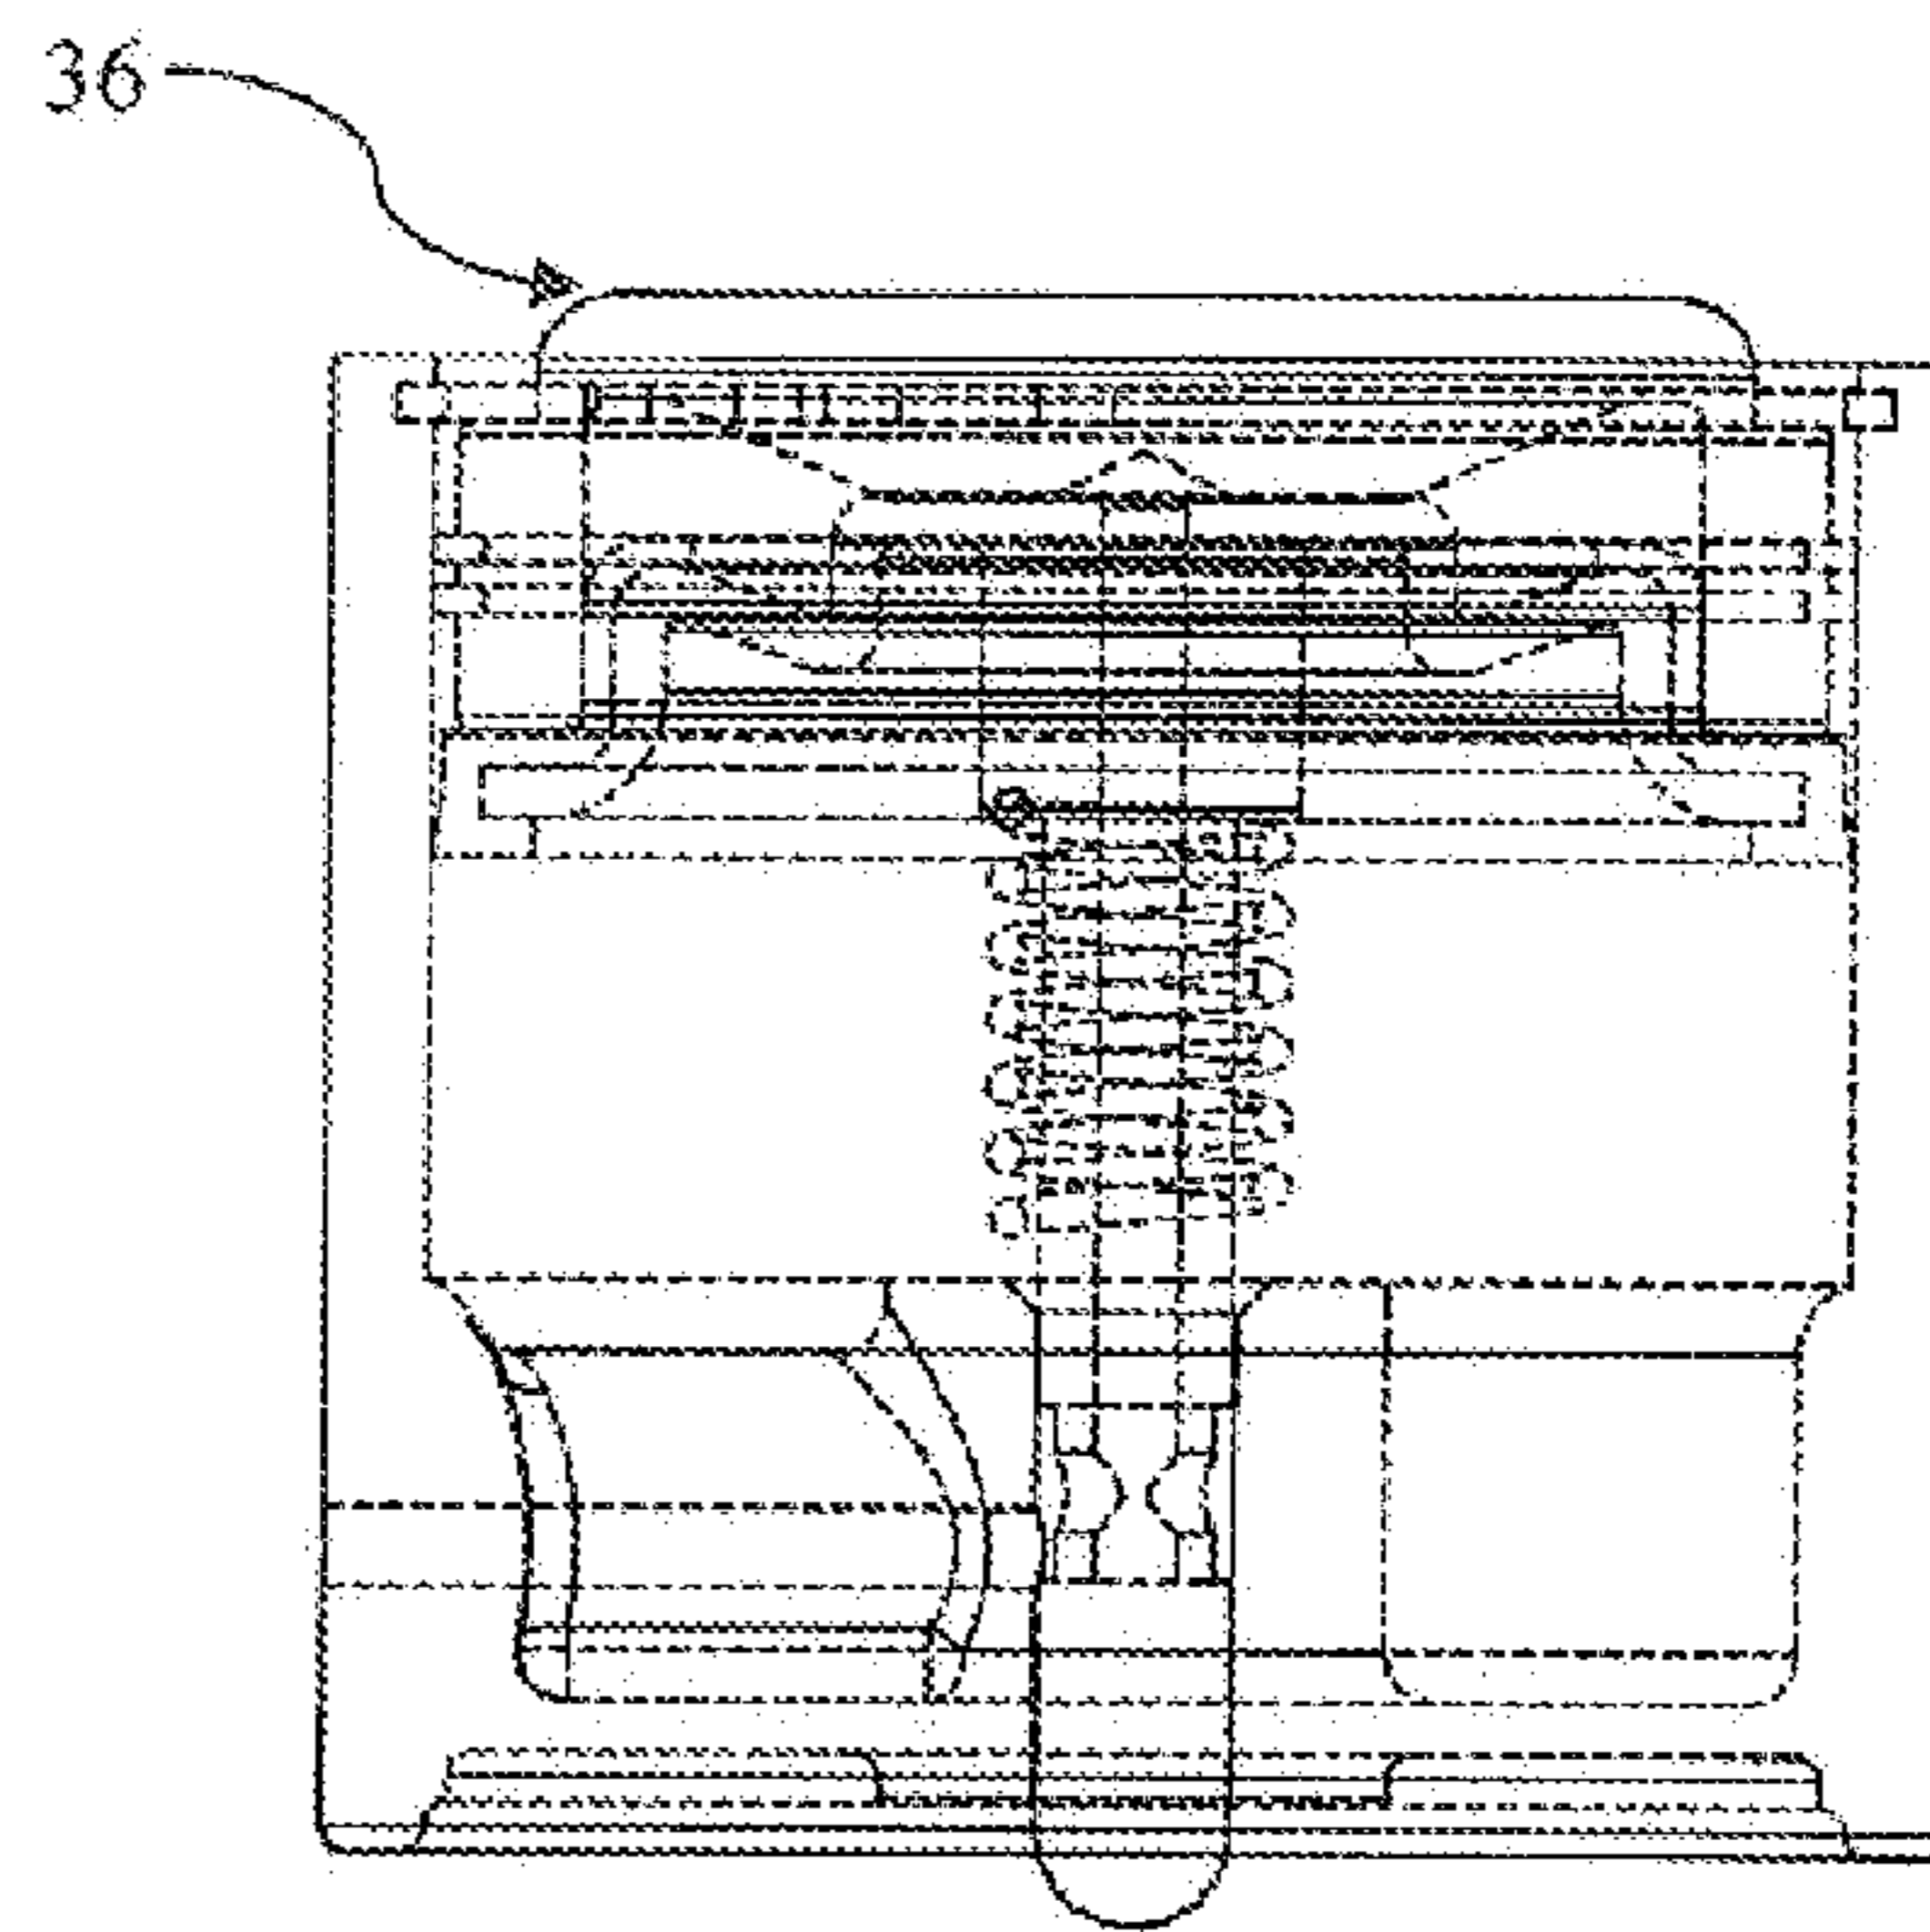
FIG. 6
PRIOR ART

FIG. 6 is a side view of the bore section of the intermediate servo showing a fluid port and the same components as in FIG. 5;

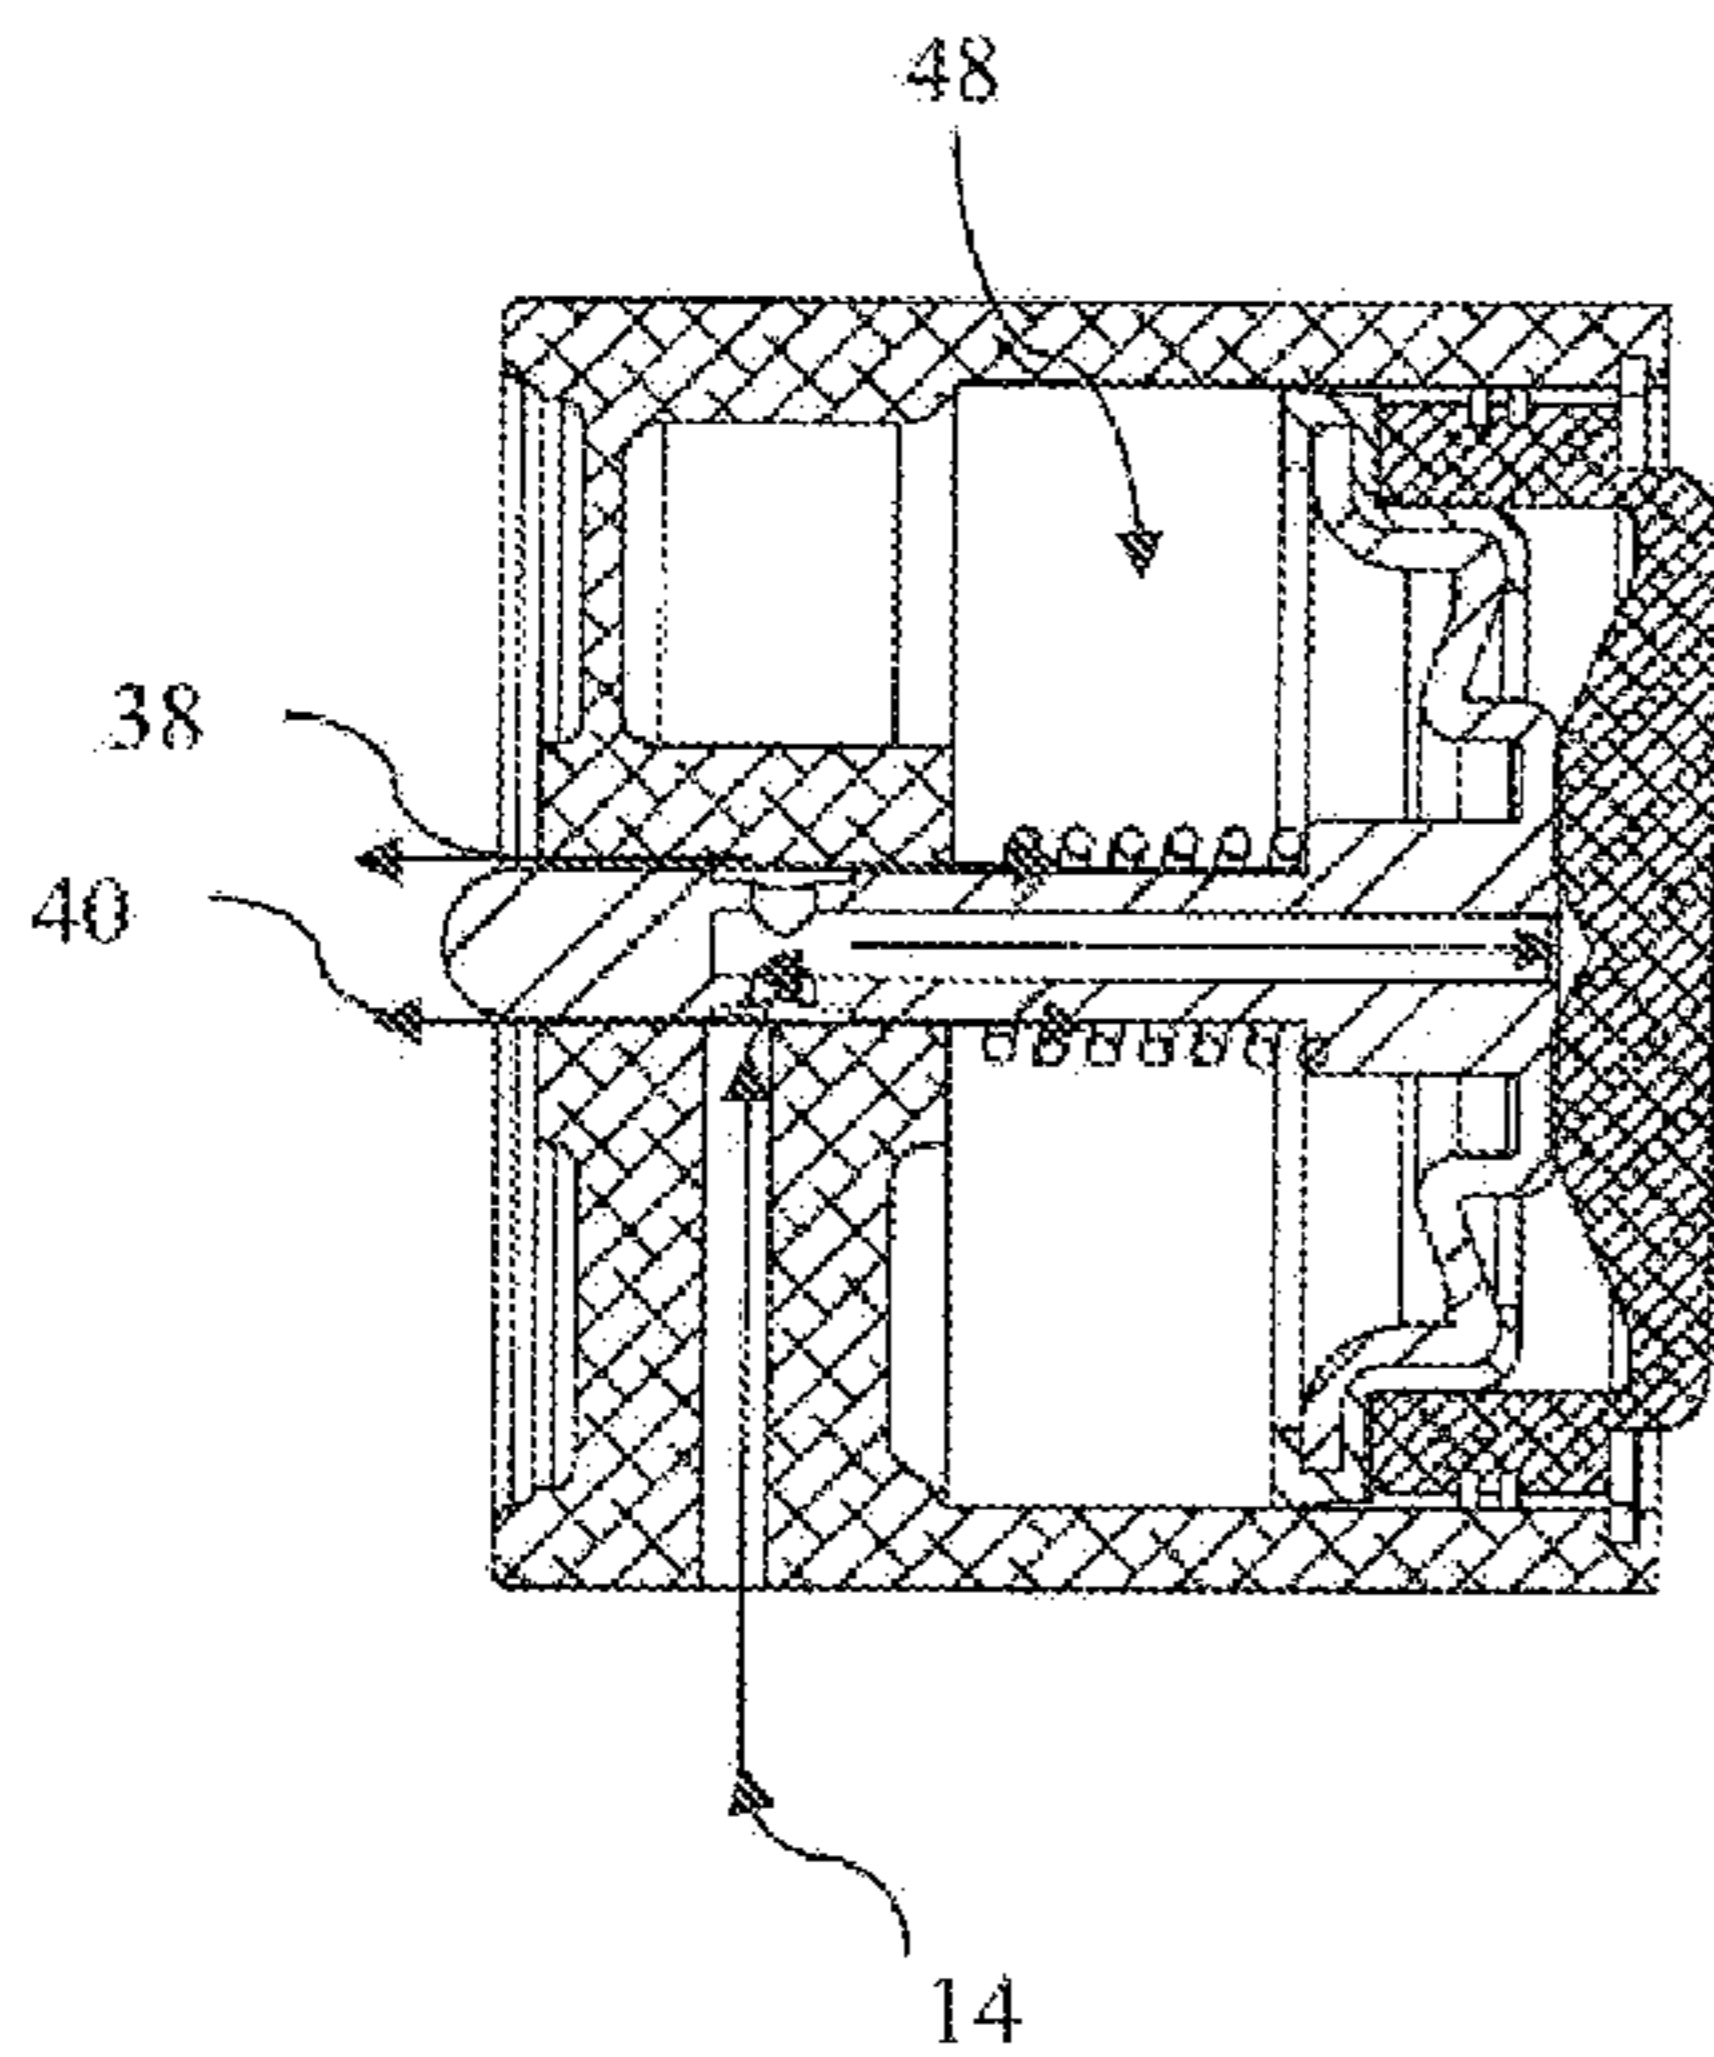
14
FIG. 11
PRIOR ART

FIGS. 11 & 12 are cross section views showing wear to a bore over the life of the vehicle and additional flow points of transmission fluid causing pressure loss;
