(54) **TRANSMISSION SYSTEM AND METHOD OF REPAIR**

A transmission system and method of repair having a transmission servo rod received within a transmission housing bore, the rod having an aperture disposed along an exterior surface of the rod, configured to receive transmission fluid from a port within the transmission housing bore, a first recessed groove in the exterior surface of the rod disposed above the aperture; a second recessed groove in the exterior surface of the rod disposed below the aperture; and a first and second resilient sealing member received within the first and second recessed grooves, respectively, the resilient sealing members configured to engage an inner surface of the transmission housing bore.

TRANSMISSION SYSTEM AND METHOD OF REPAIR

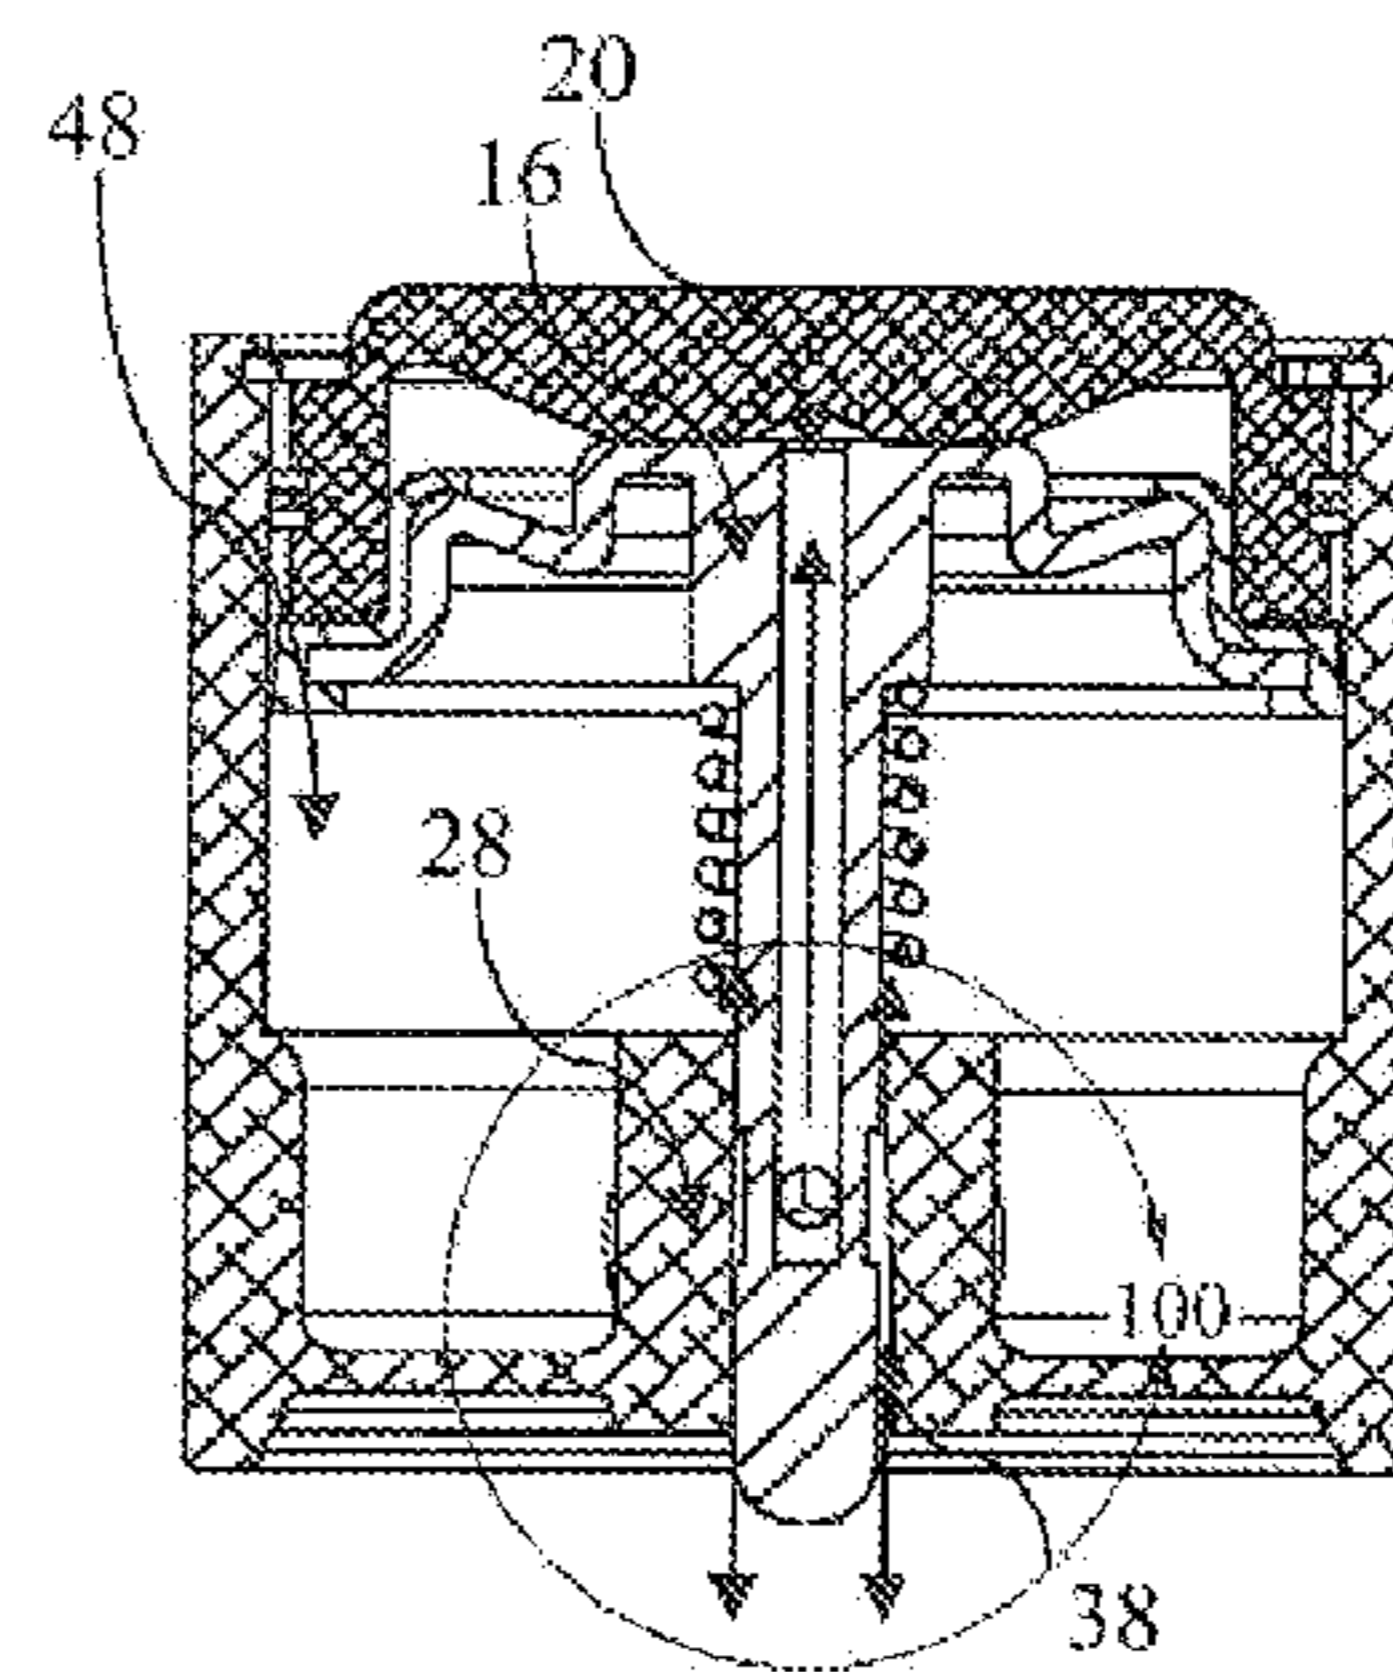
FIG. 12
PRIOR ART

FIGS. 11 & 12 are cross section views showing wear to a bore over the life of the vehicle and additional flow points of transmission fluid causing pressure loss;

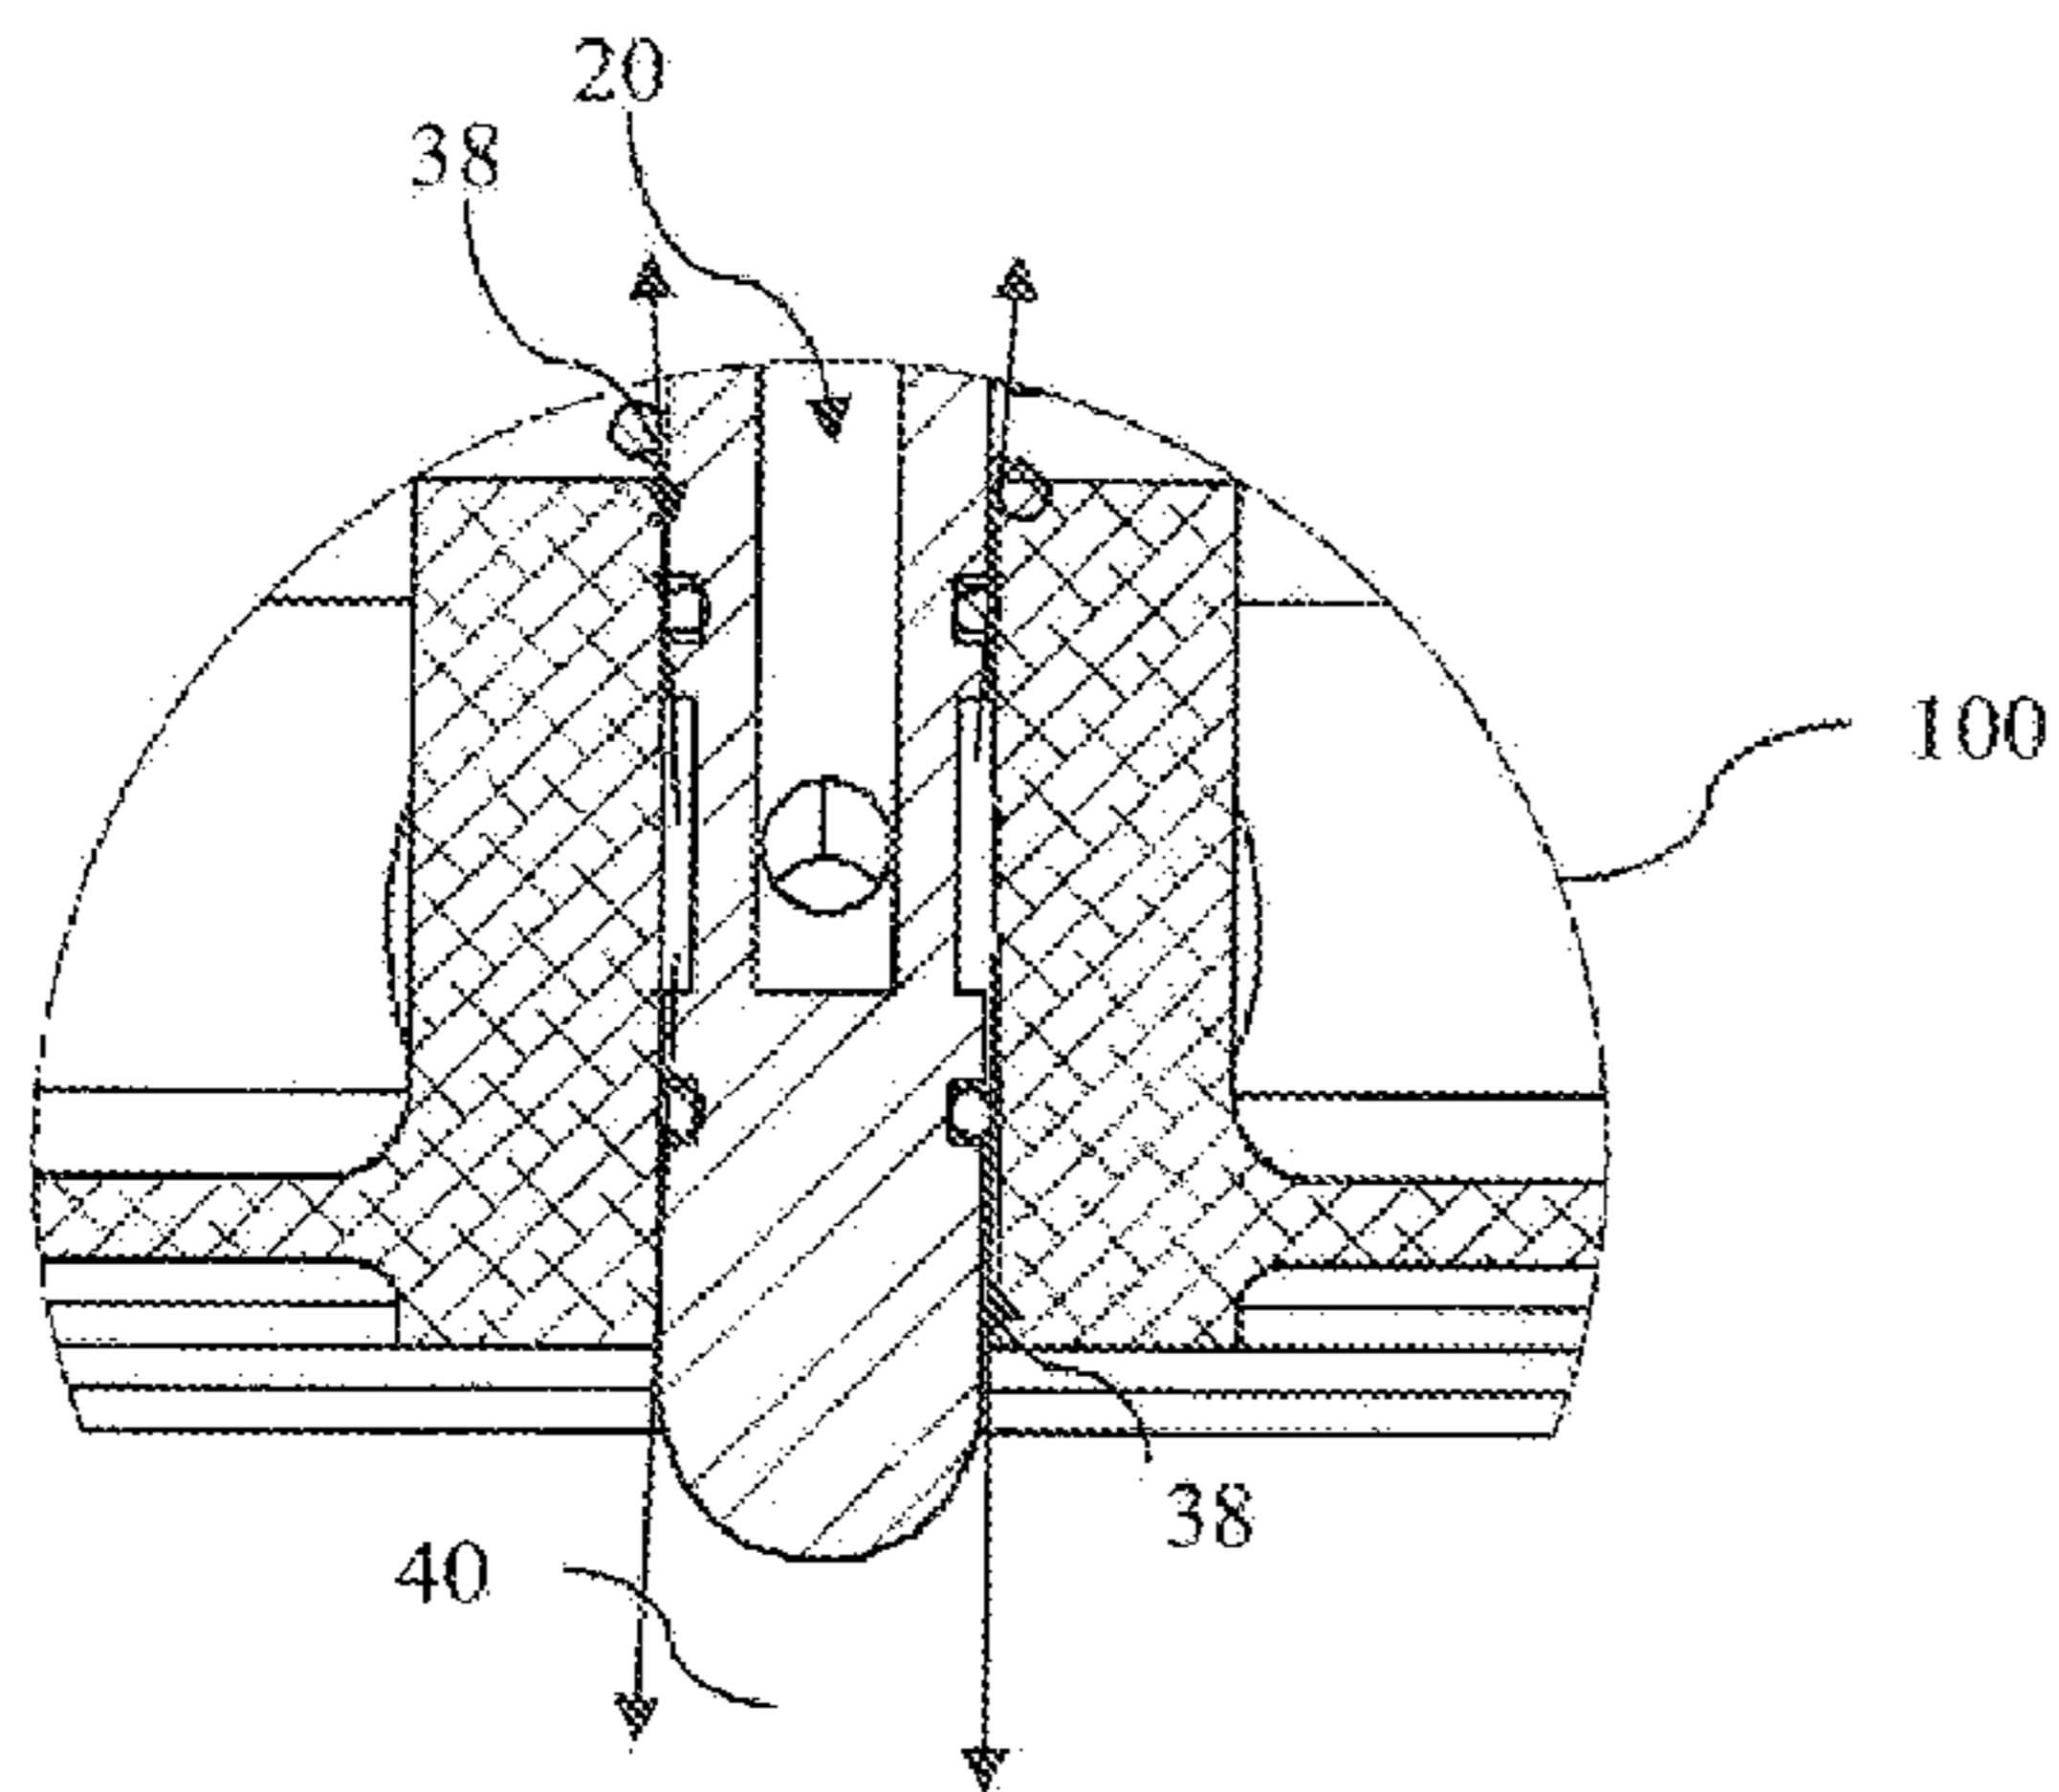
FIG. 13 is a scale 2:1 detailed view showing the increased clearance due to normal operating wear on a bore;

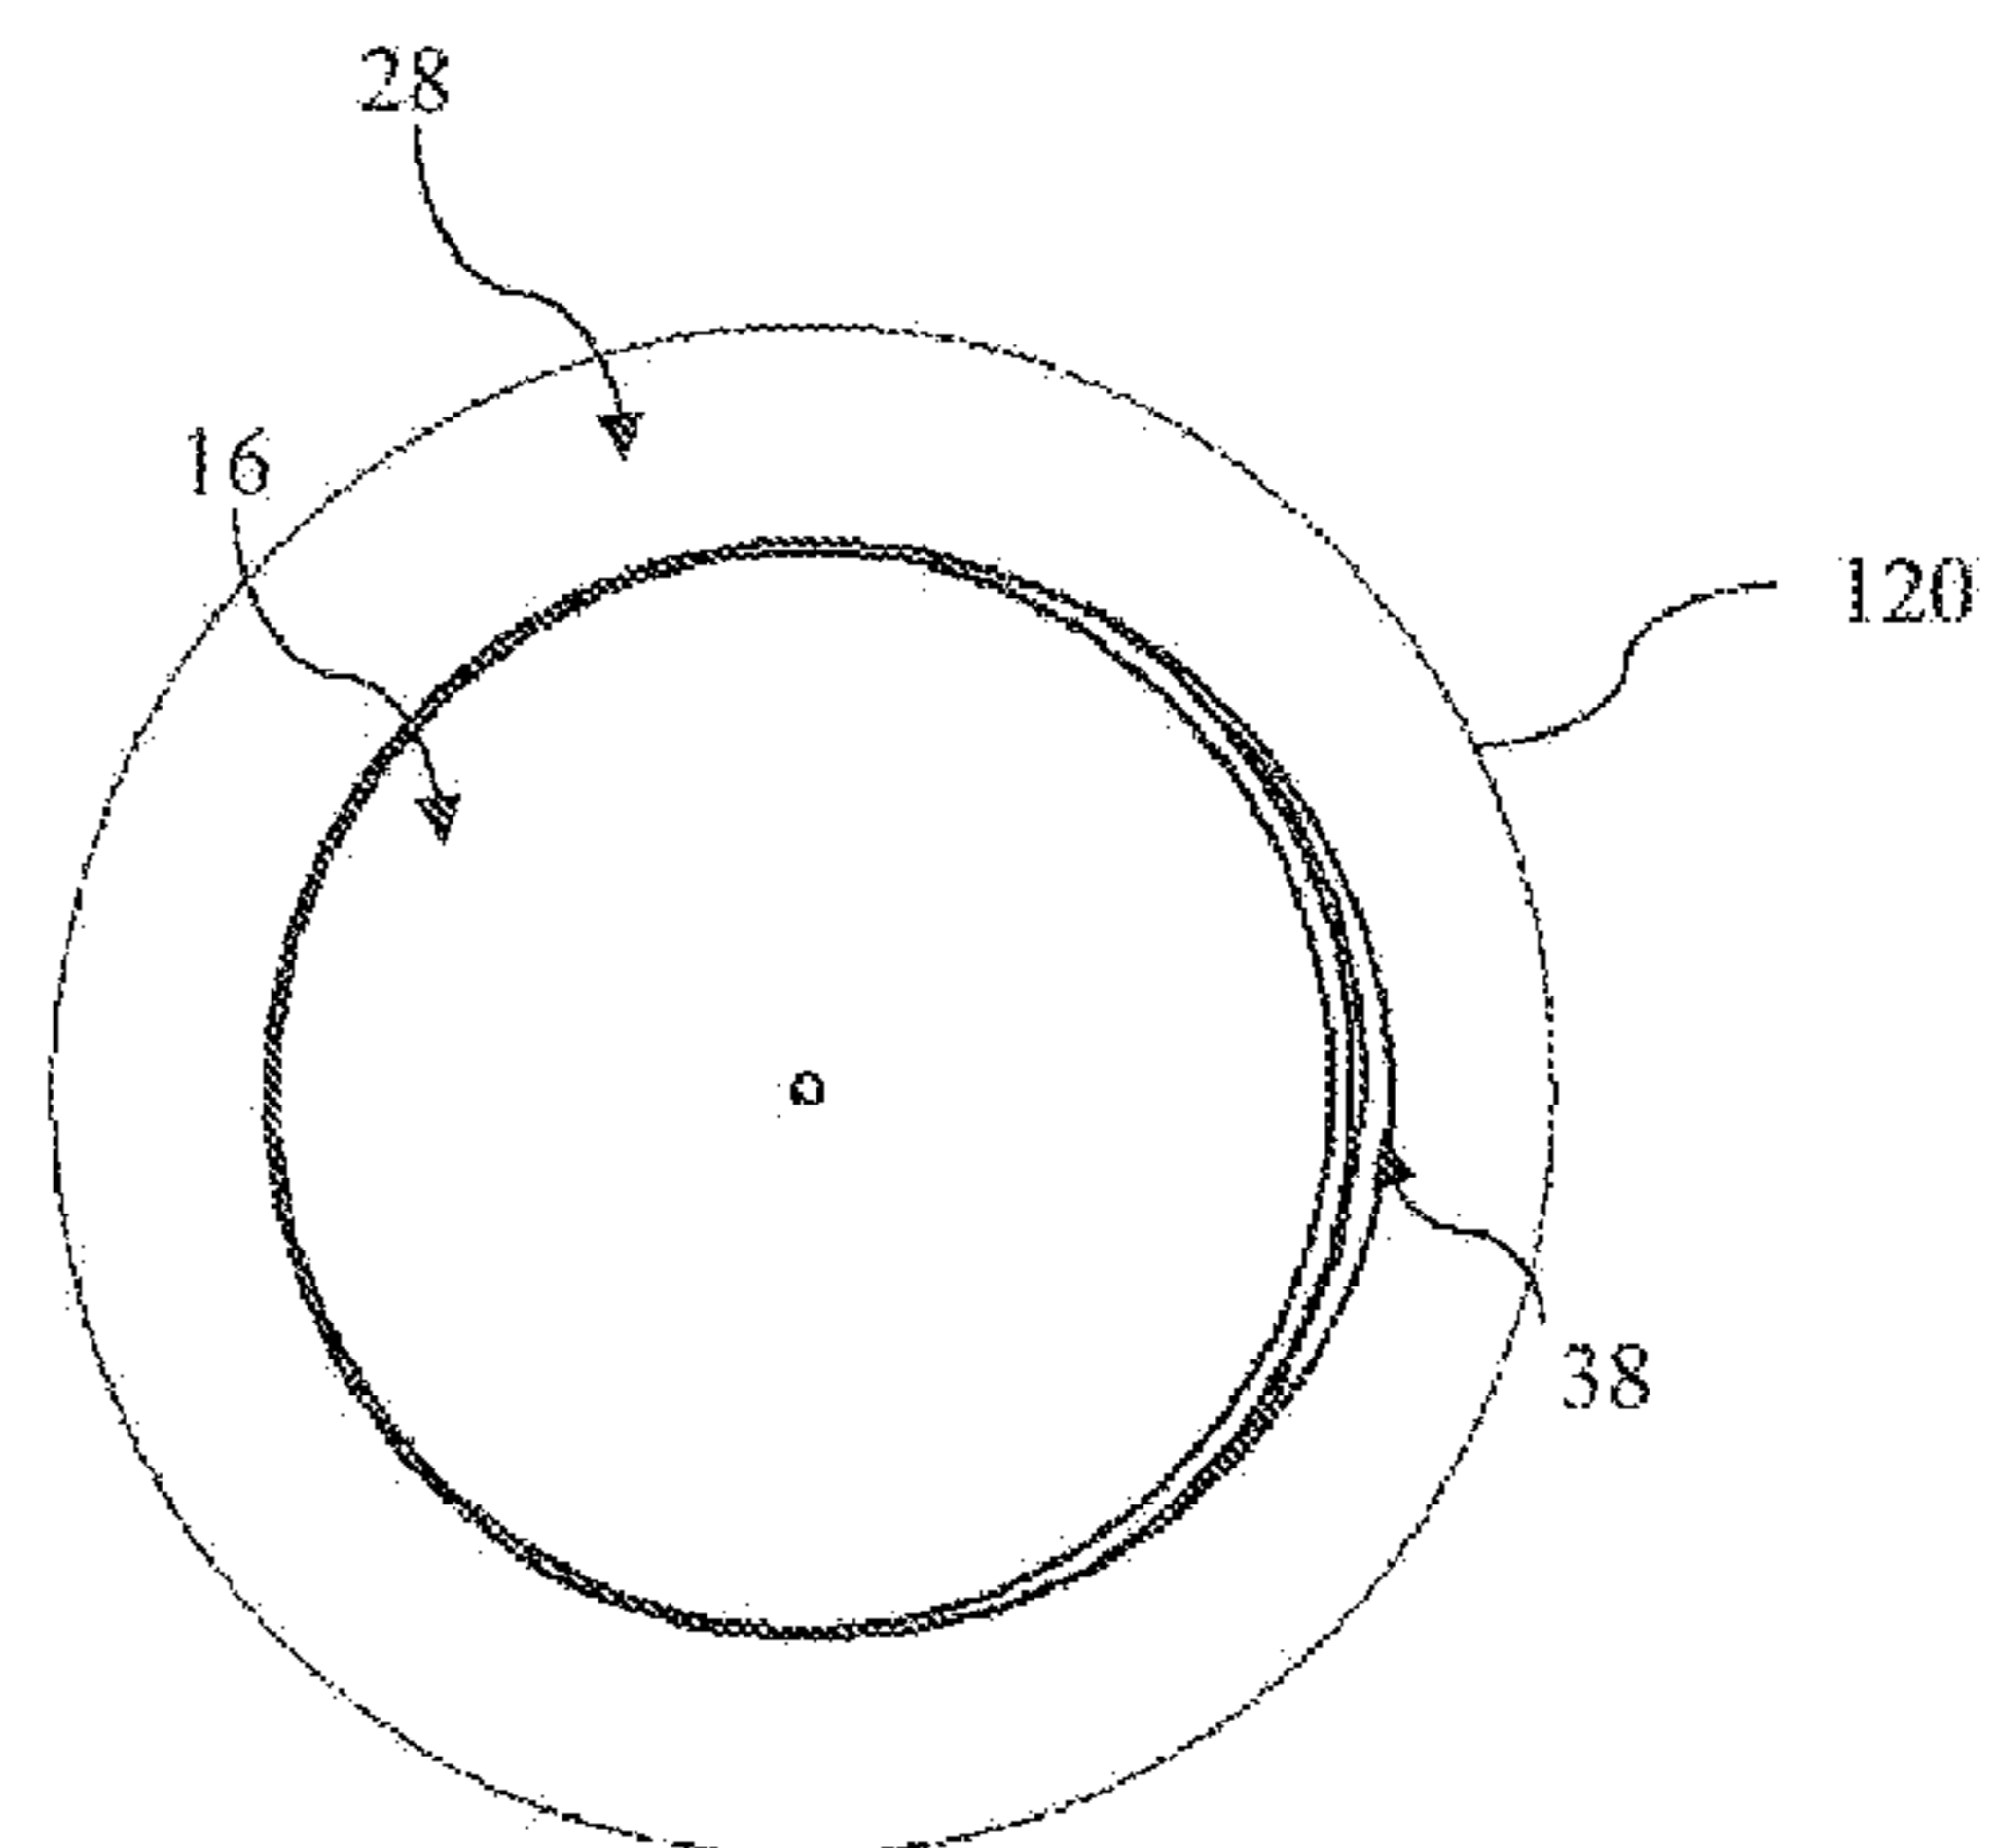
FIG. 14 is a scale 6:1 detailed view showing an ob-round shaped wear on a bore looking at the end view of a rod as it would appear from inside the transmission reservoir;

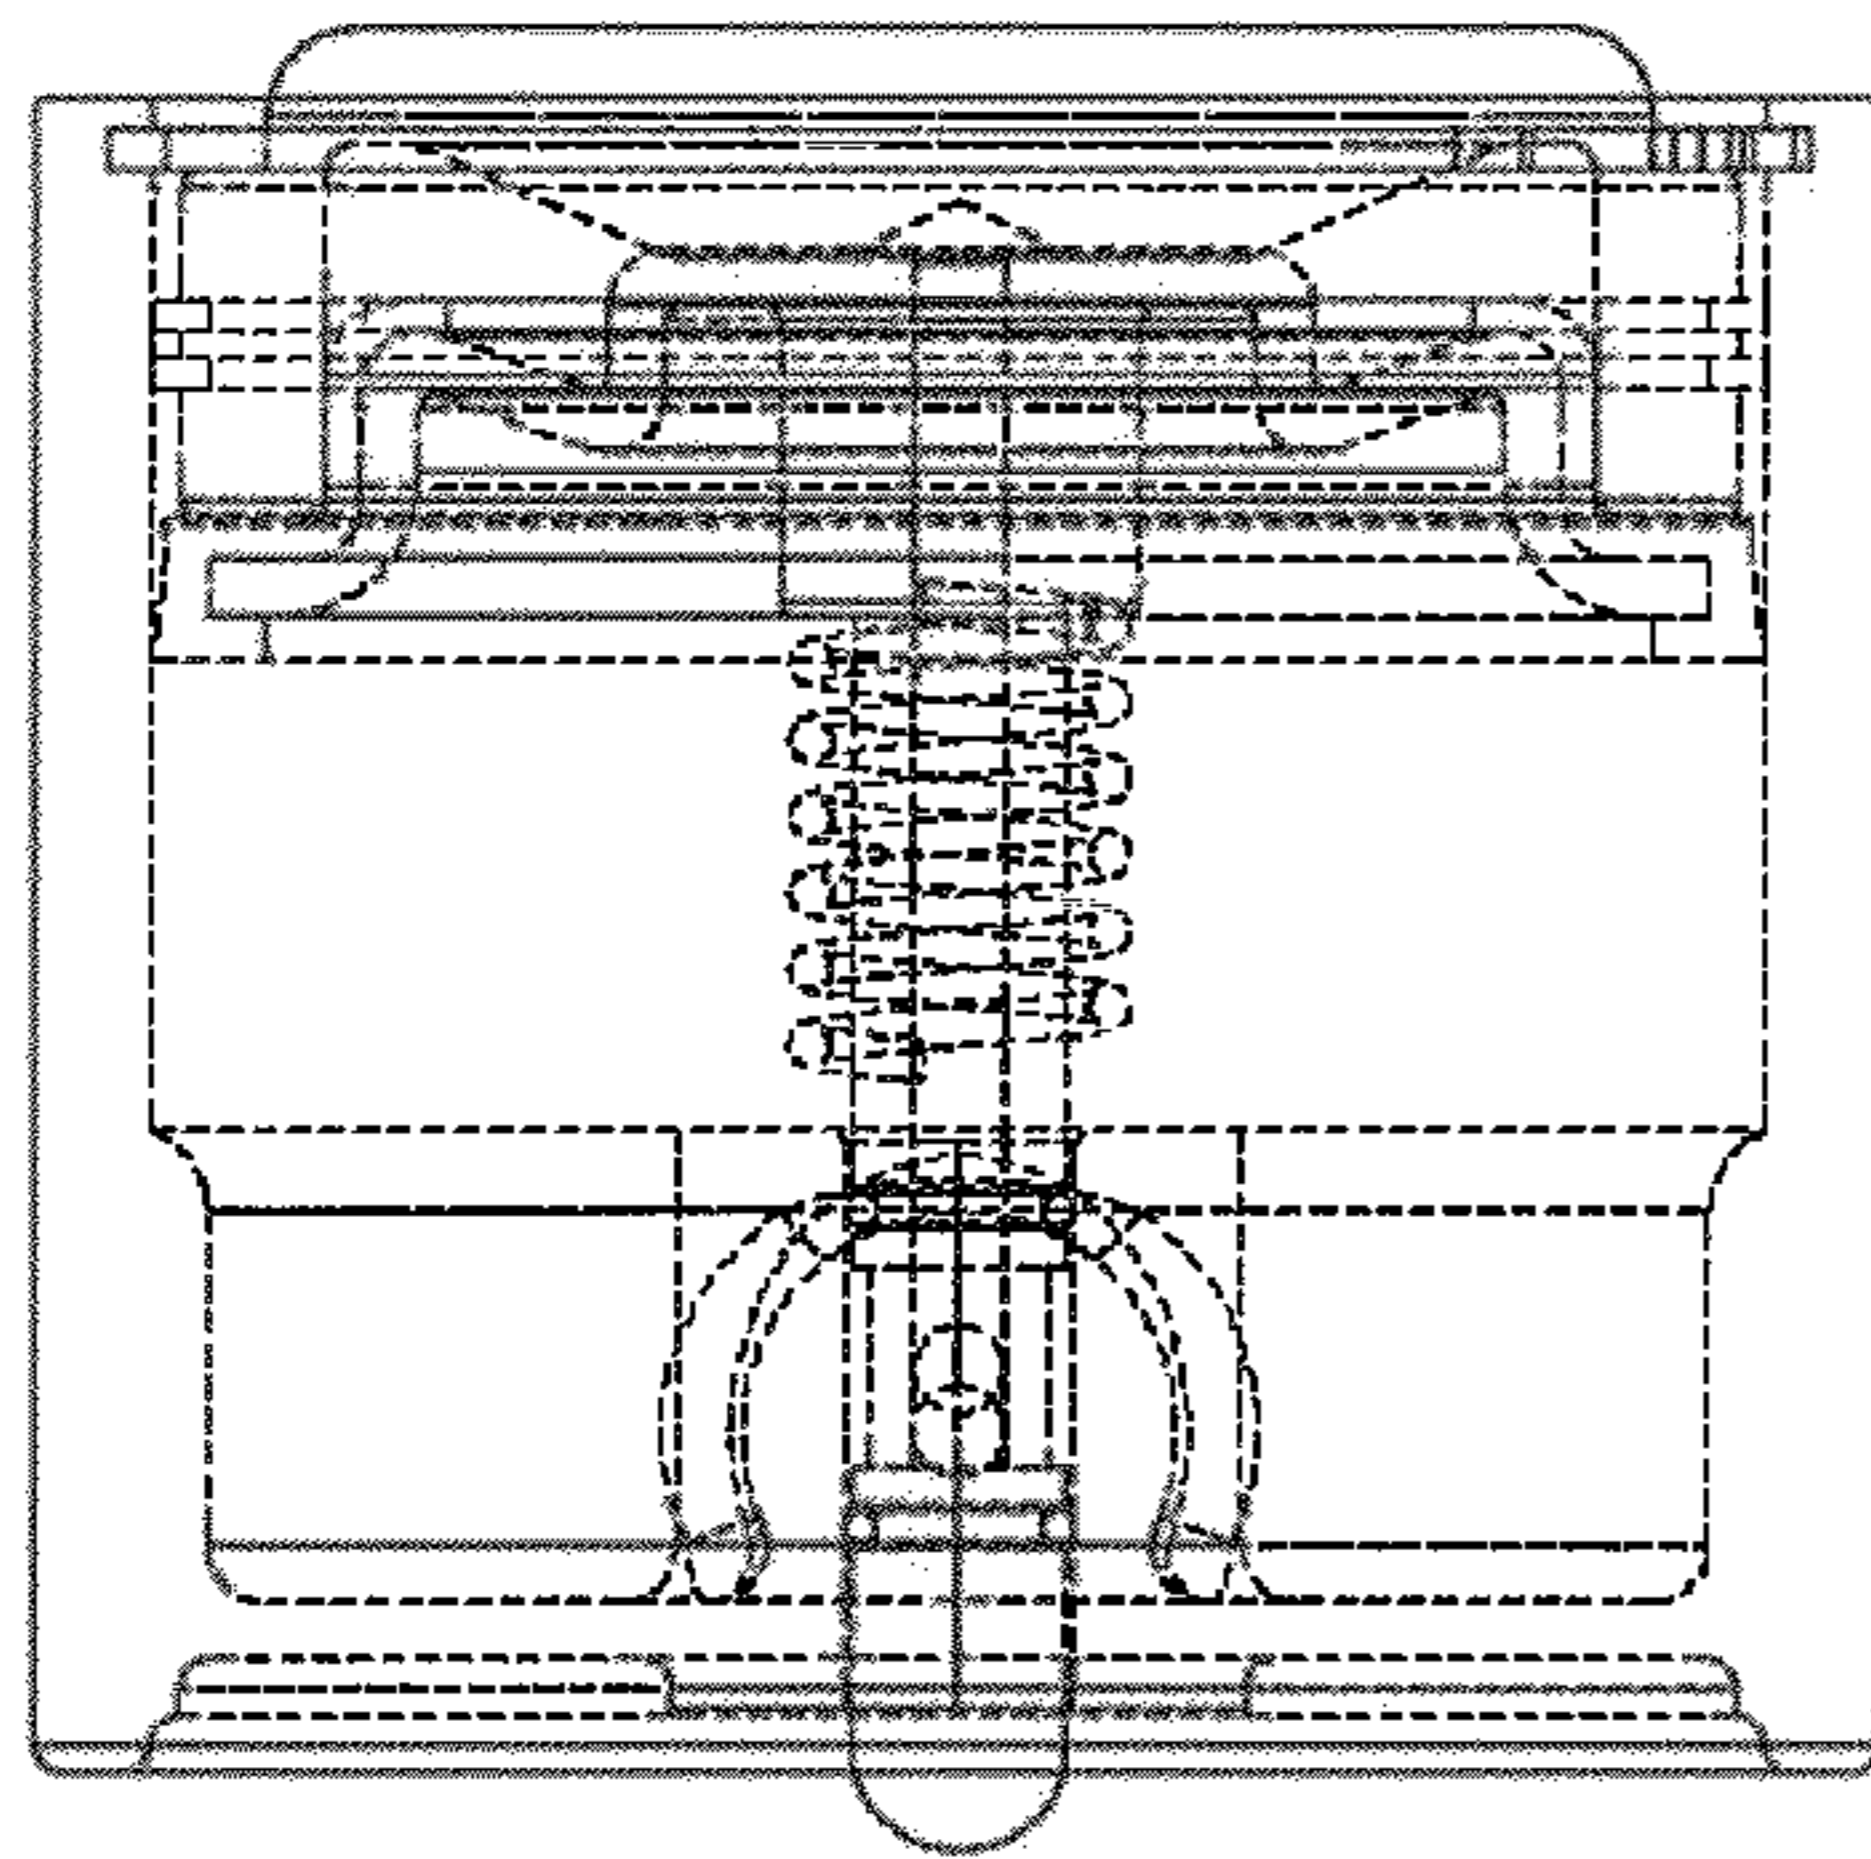
FIG. 15

FIGS. 15 & 16 are side and front views (hidden lines shown), showing the modified OEM parts with o-ring grooves and o-rings;

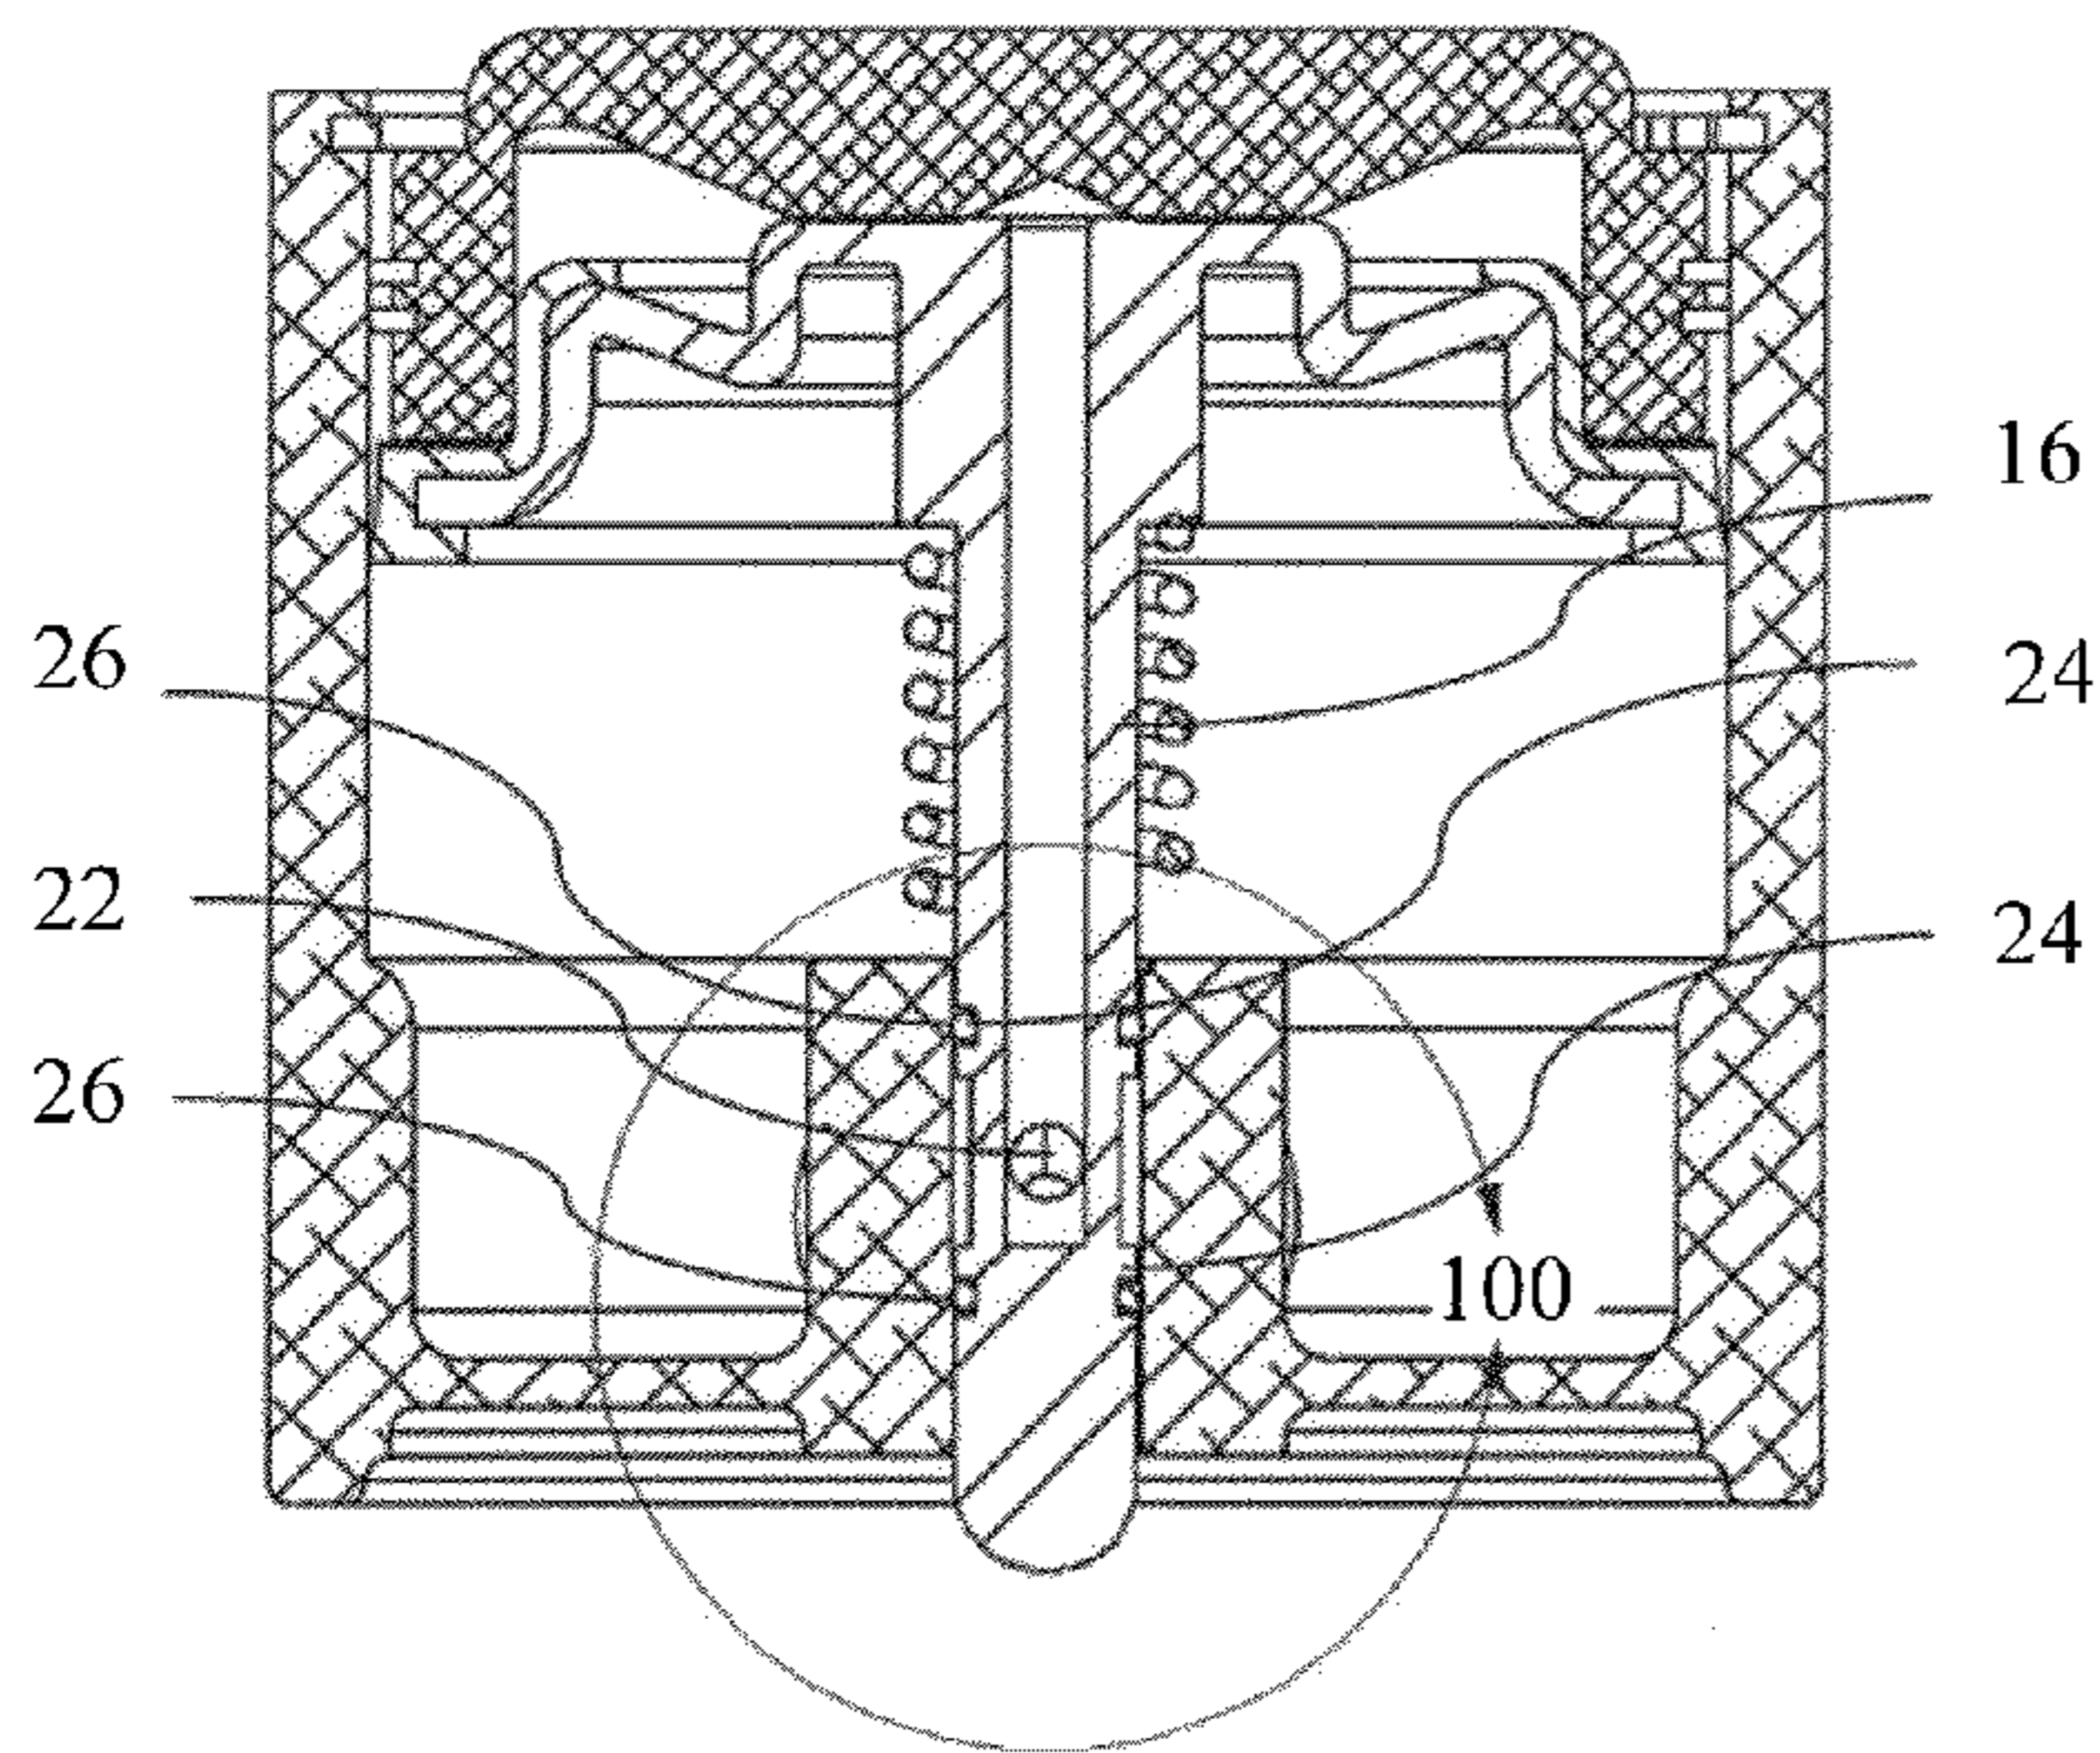
FIG. 17

FIGS. 17 & 18 are cross sections showing modified parts with o-ring grooves and o-rings sealing against the bore;

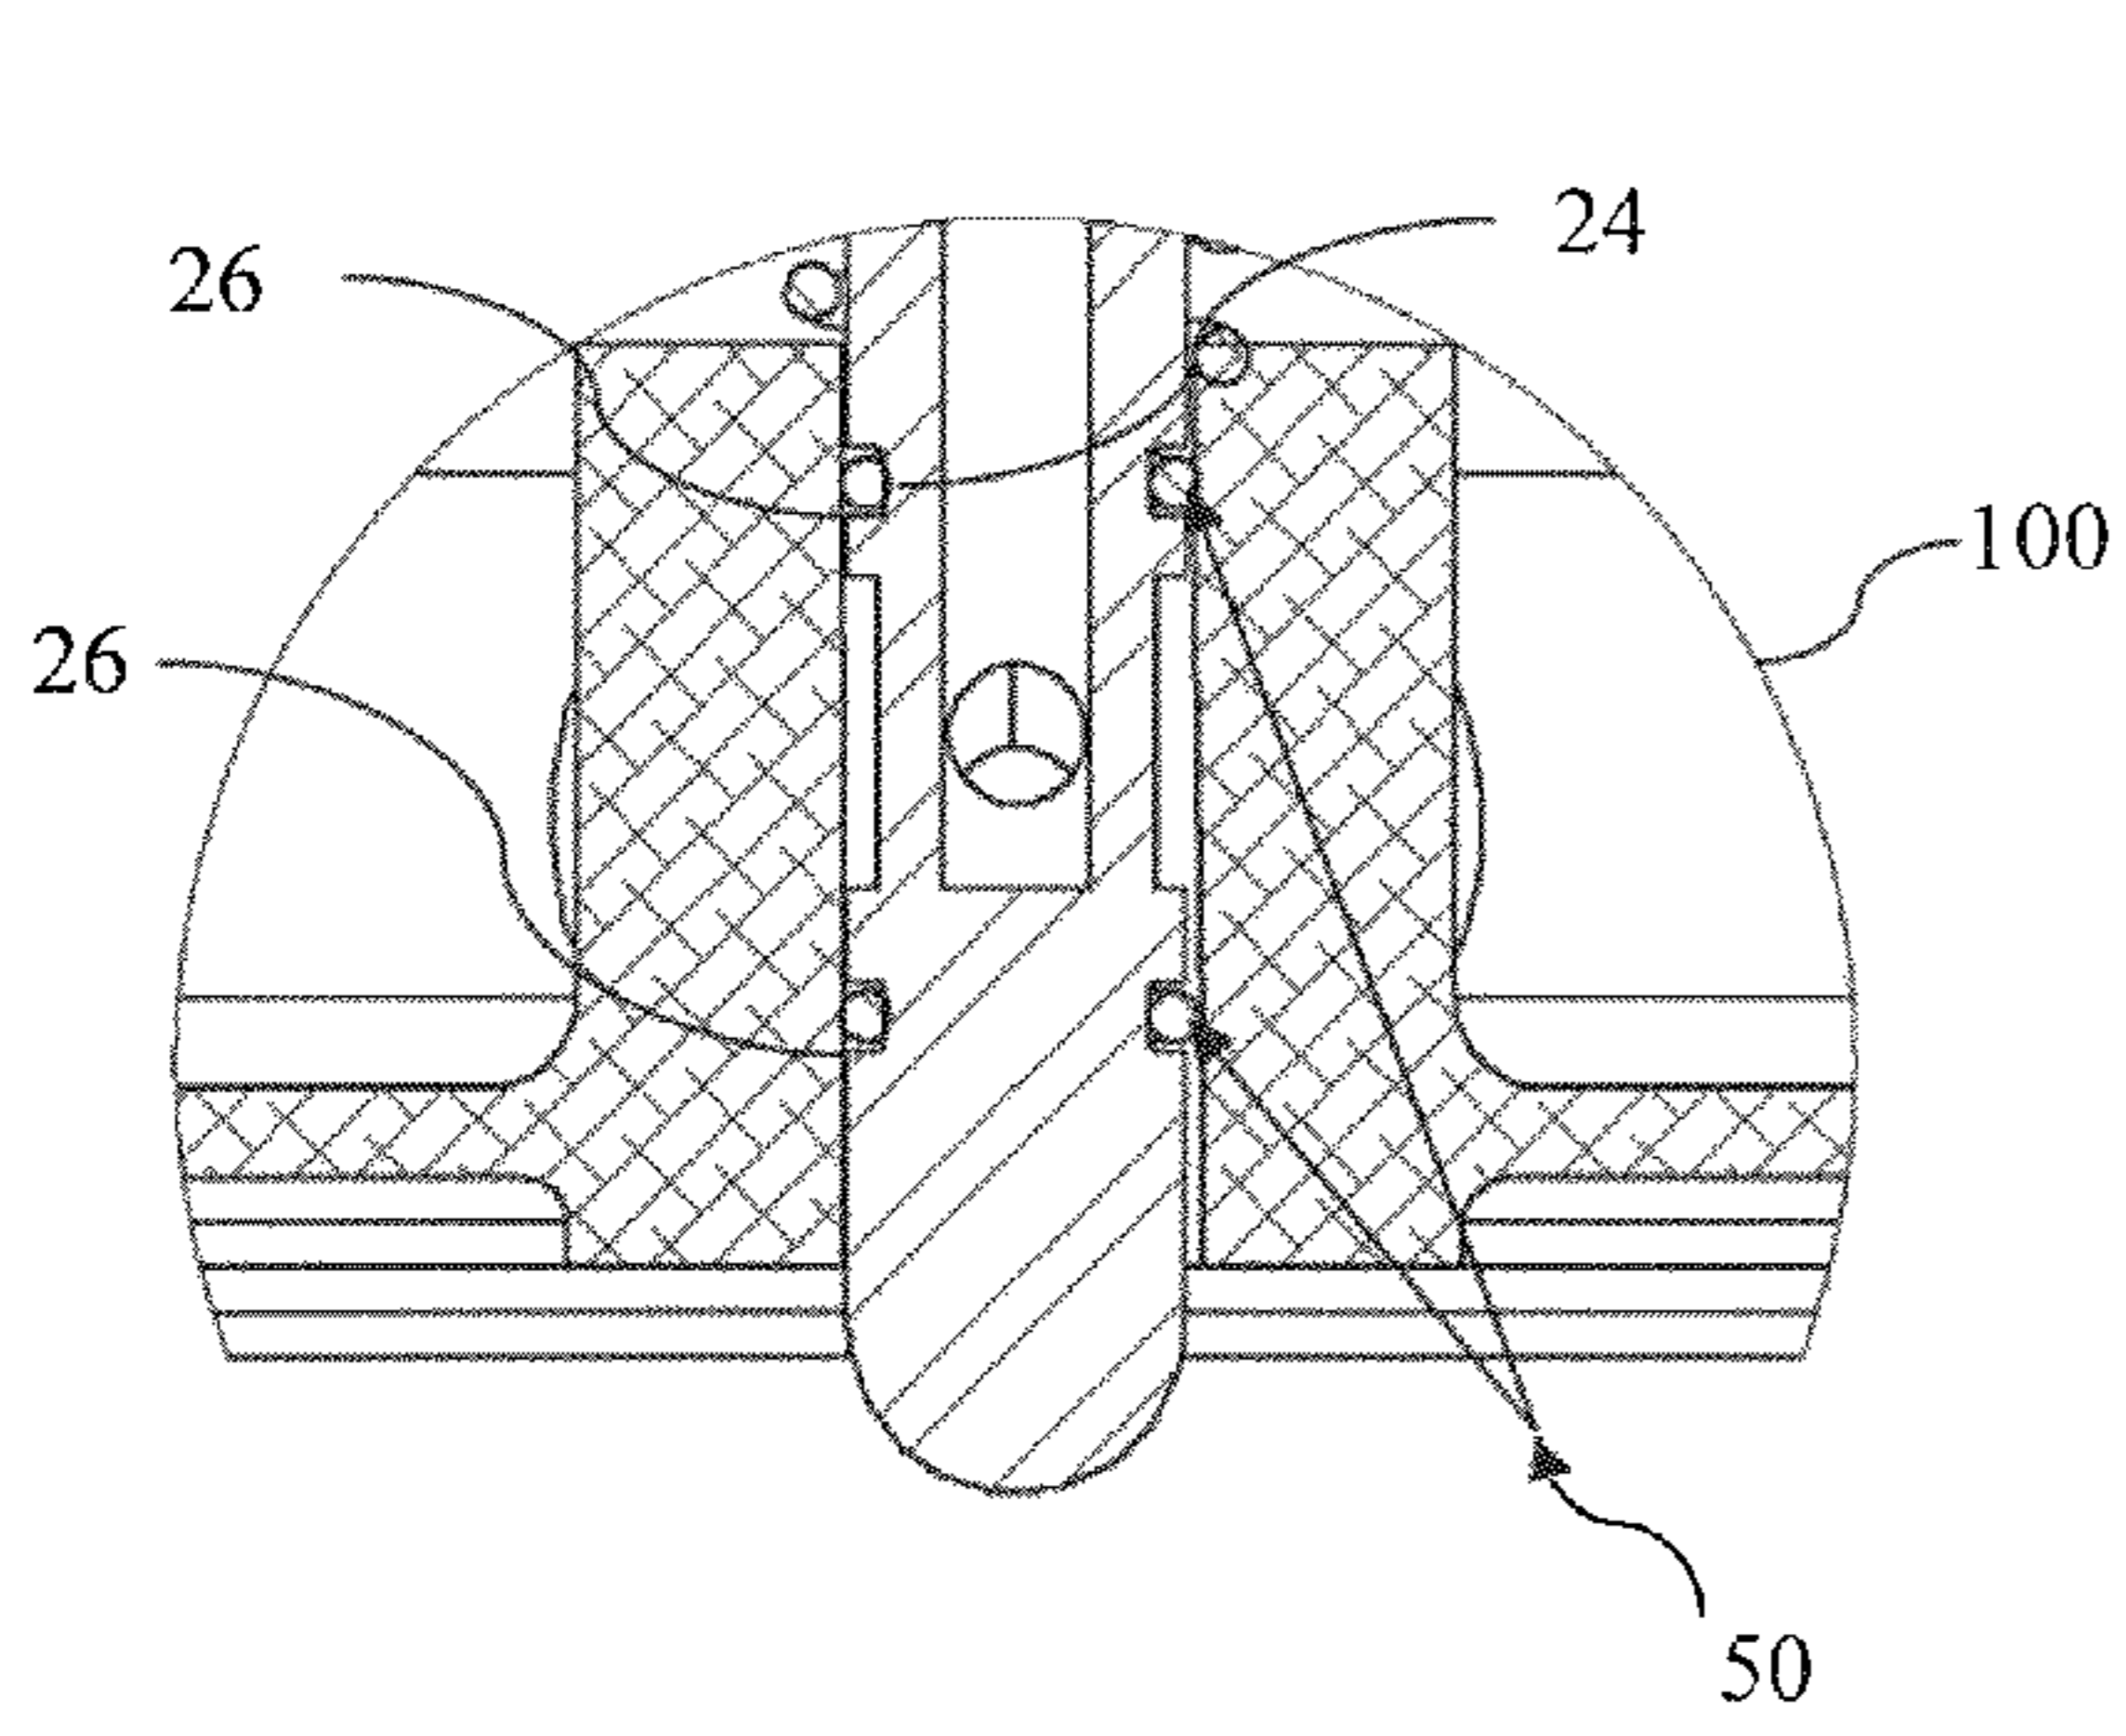
FIG. 19 is a scale 2:1 cross section showing o-ring grooves and o-rings, sealing a bore and directing fluid through a rod bore;
