(54) **TRANSMISSION SYSTEM AND METHOD OF REPAIR**

A transmission system and method of repair having a transmission servo rod received within a transmission housing bore, the rod having an aperture disposed along an exterior surface of the rod, configured to receive transmission fluid from a port within the transmission housing bore, a first recessed groove in the exterior surface of the rod disposed above the aperture; a second recessed groove in the exterior surface of the rod disposed below the aperture; and a first and second resilient sealing member received within the first and second recessed grooves, respectively, the resilient sealing members configured to engage an inner surface of the transmission housing bore.

TRANSMISSION SYSTEM AND METHOD OF REPAIR

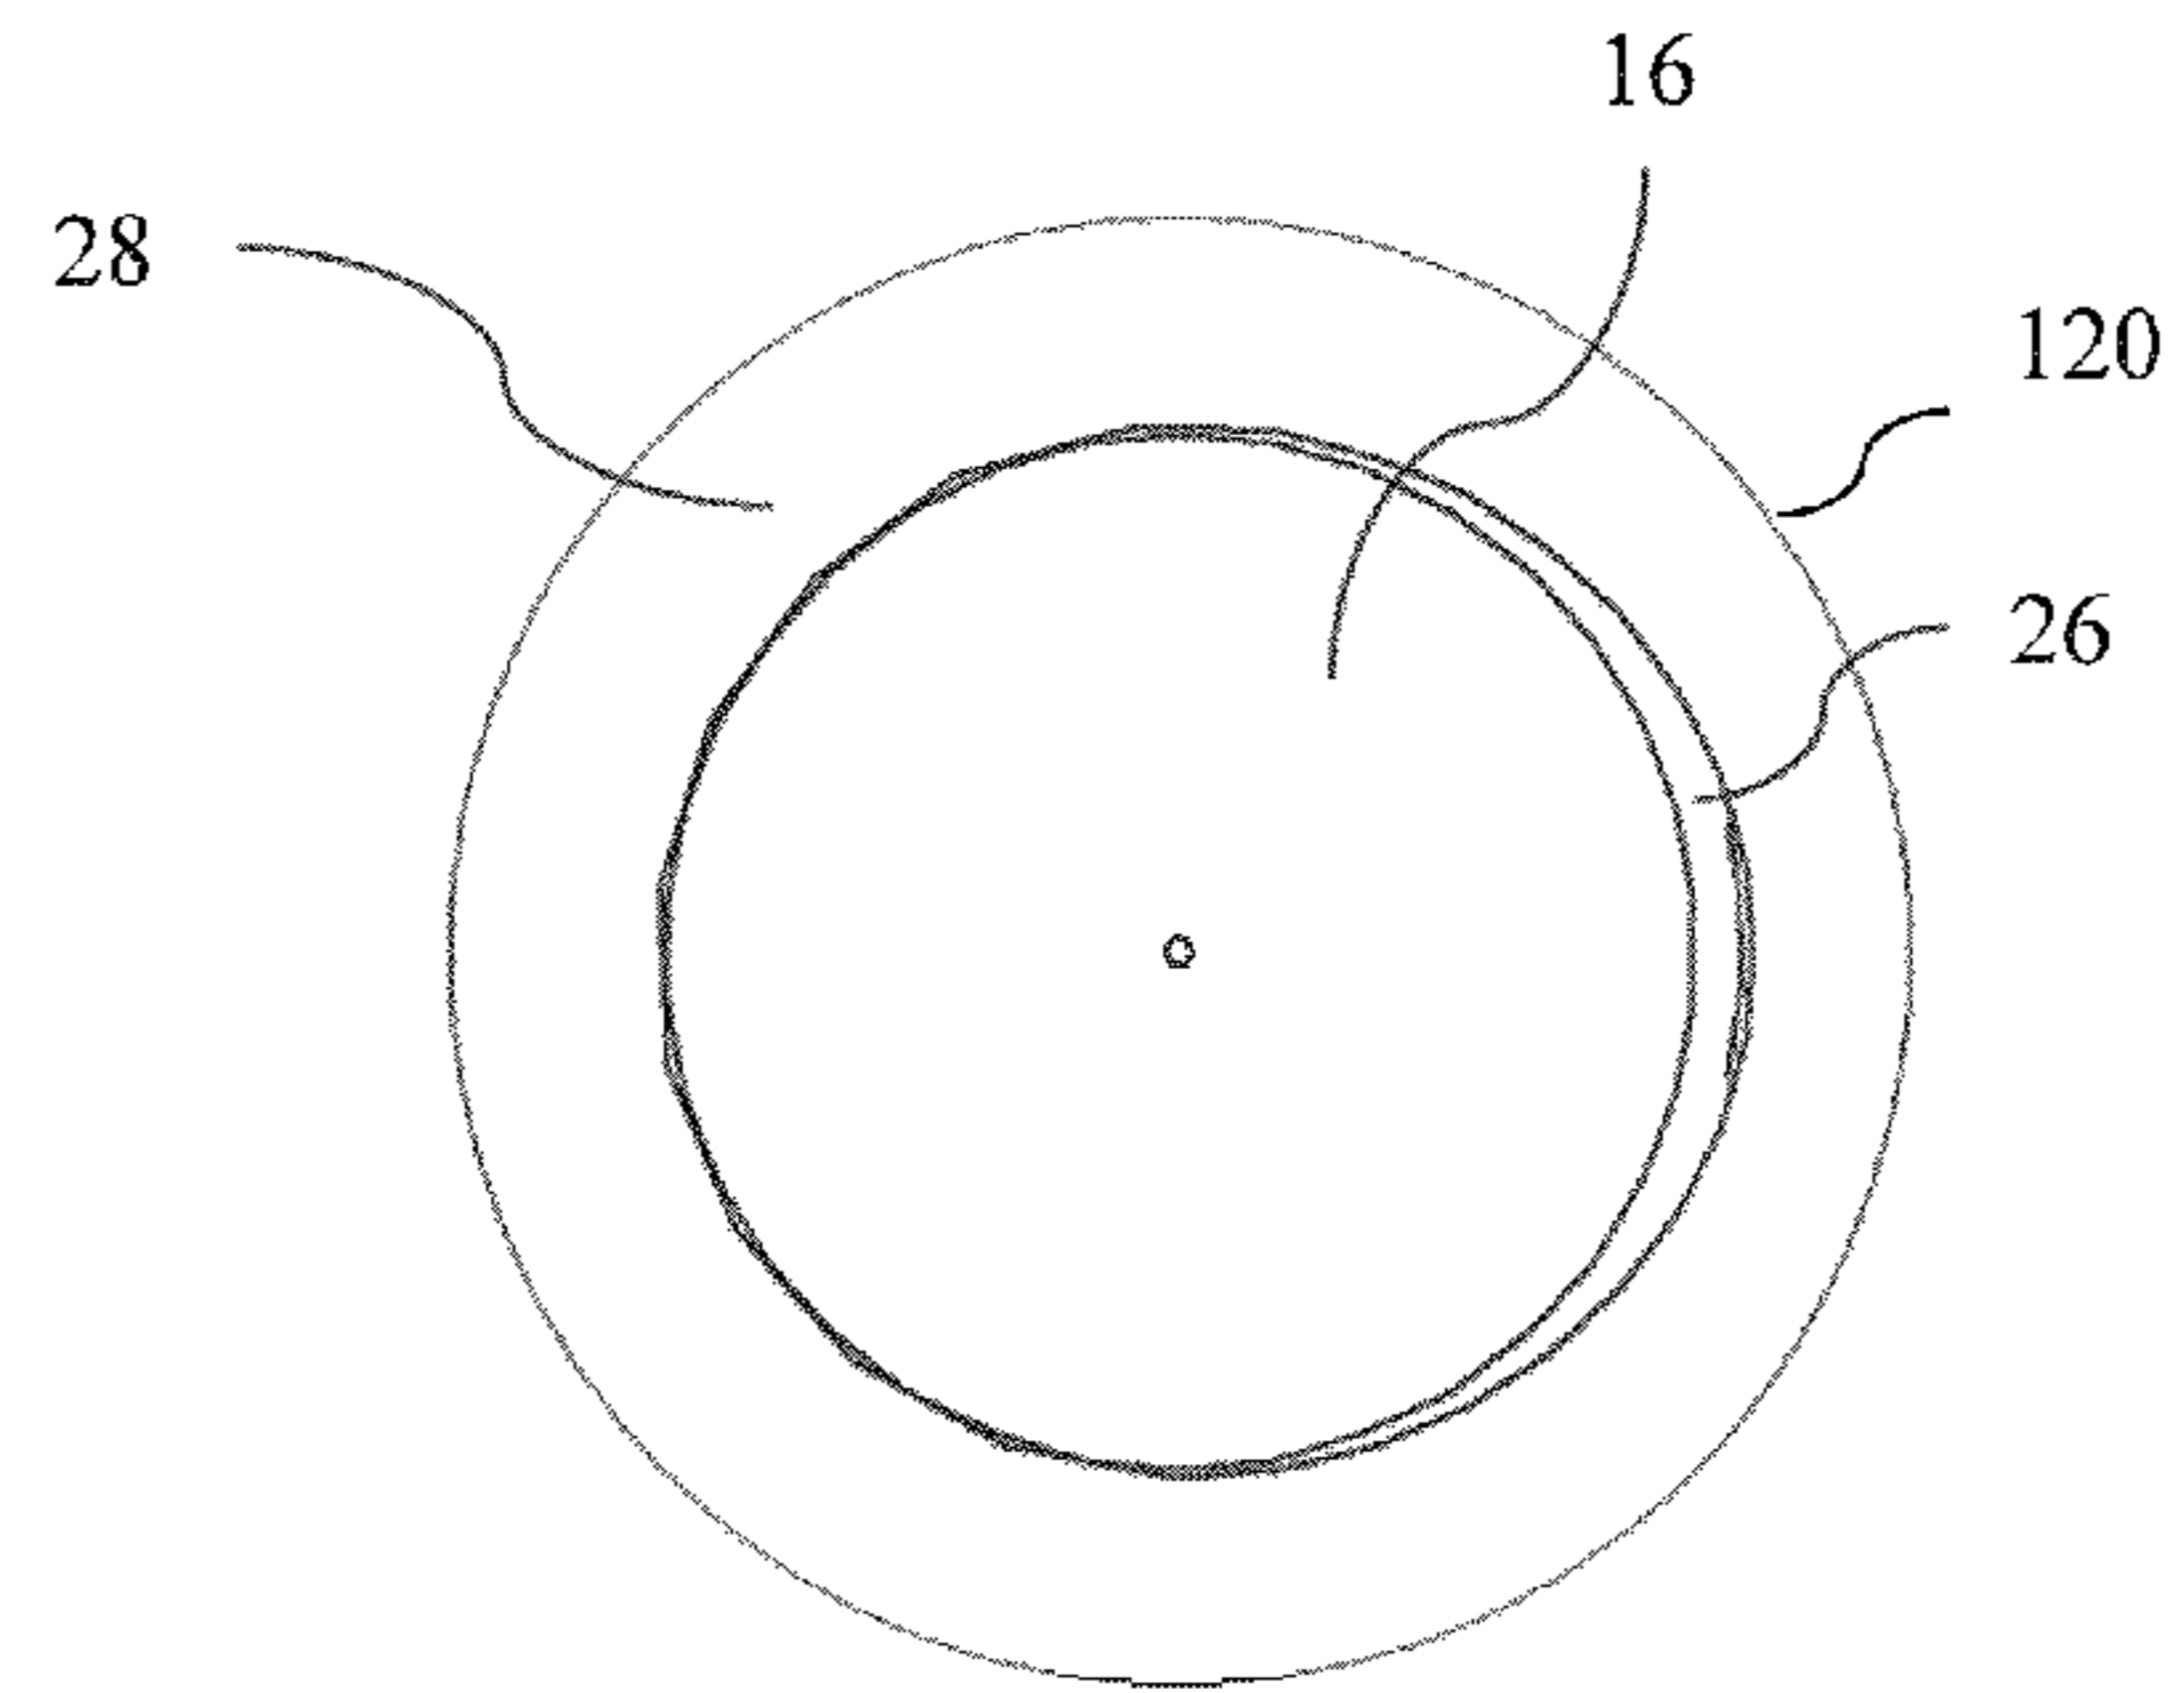
FIG. 20 is a scale 6:1 detailed view of the end of a rod and a bore showing the o-ring sealing an ob-round wear point;

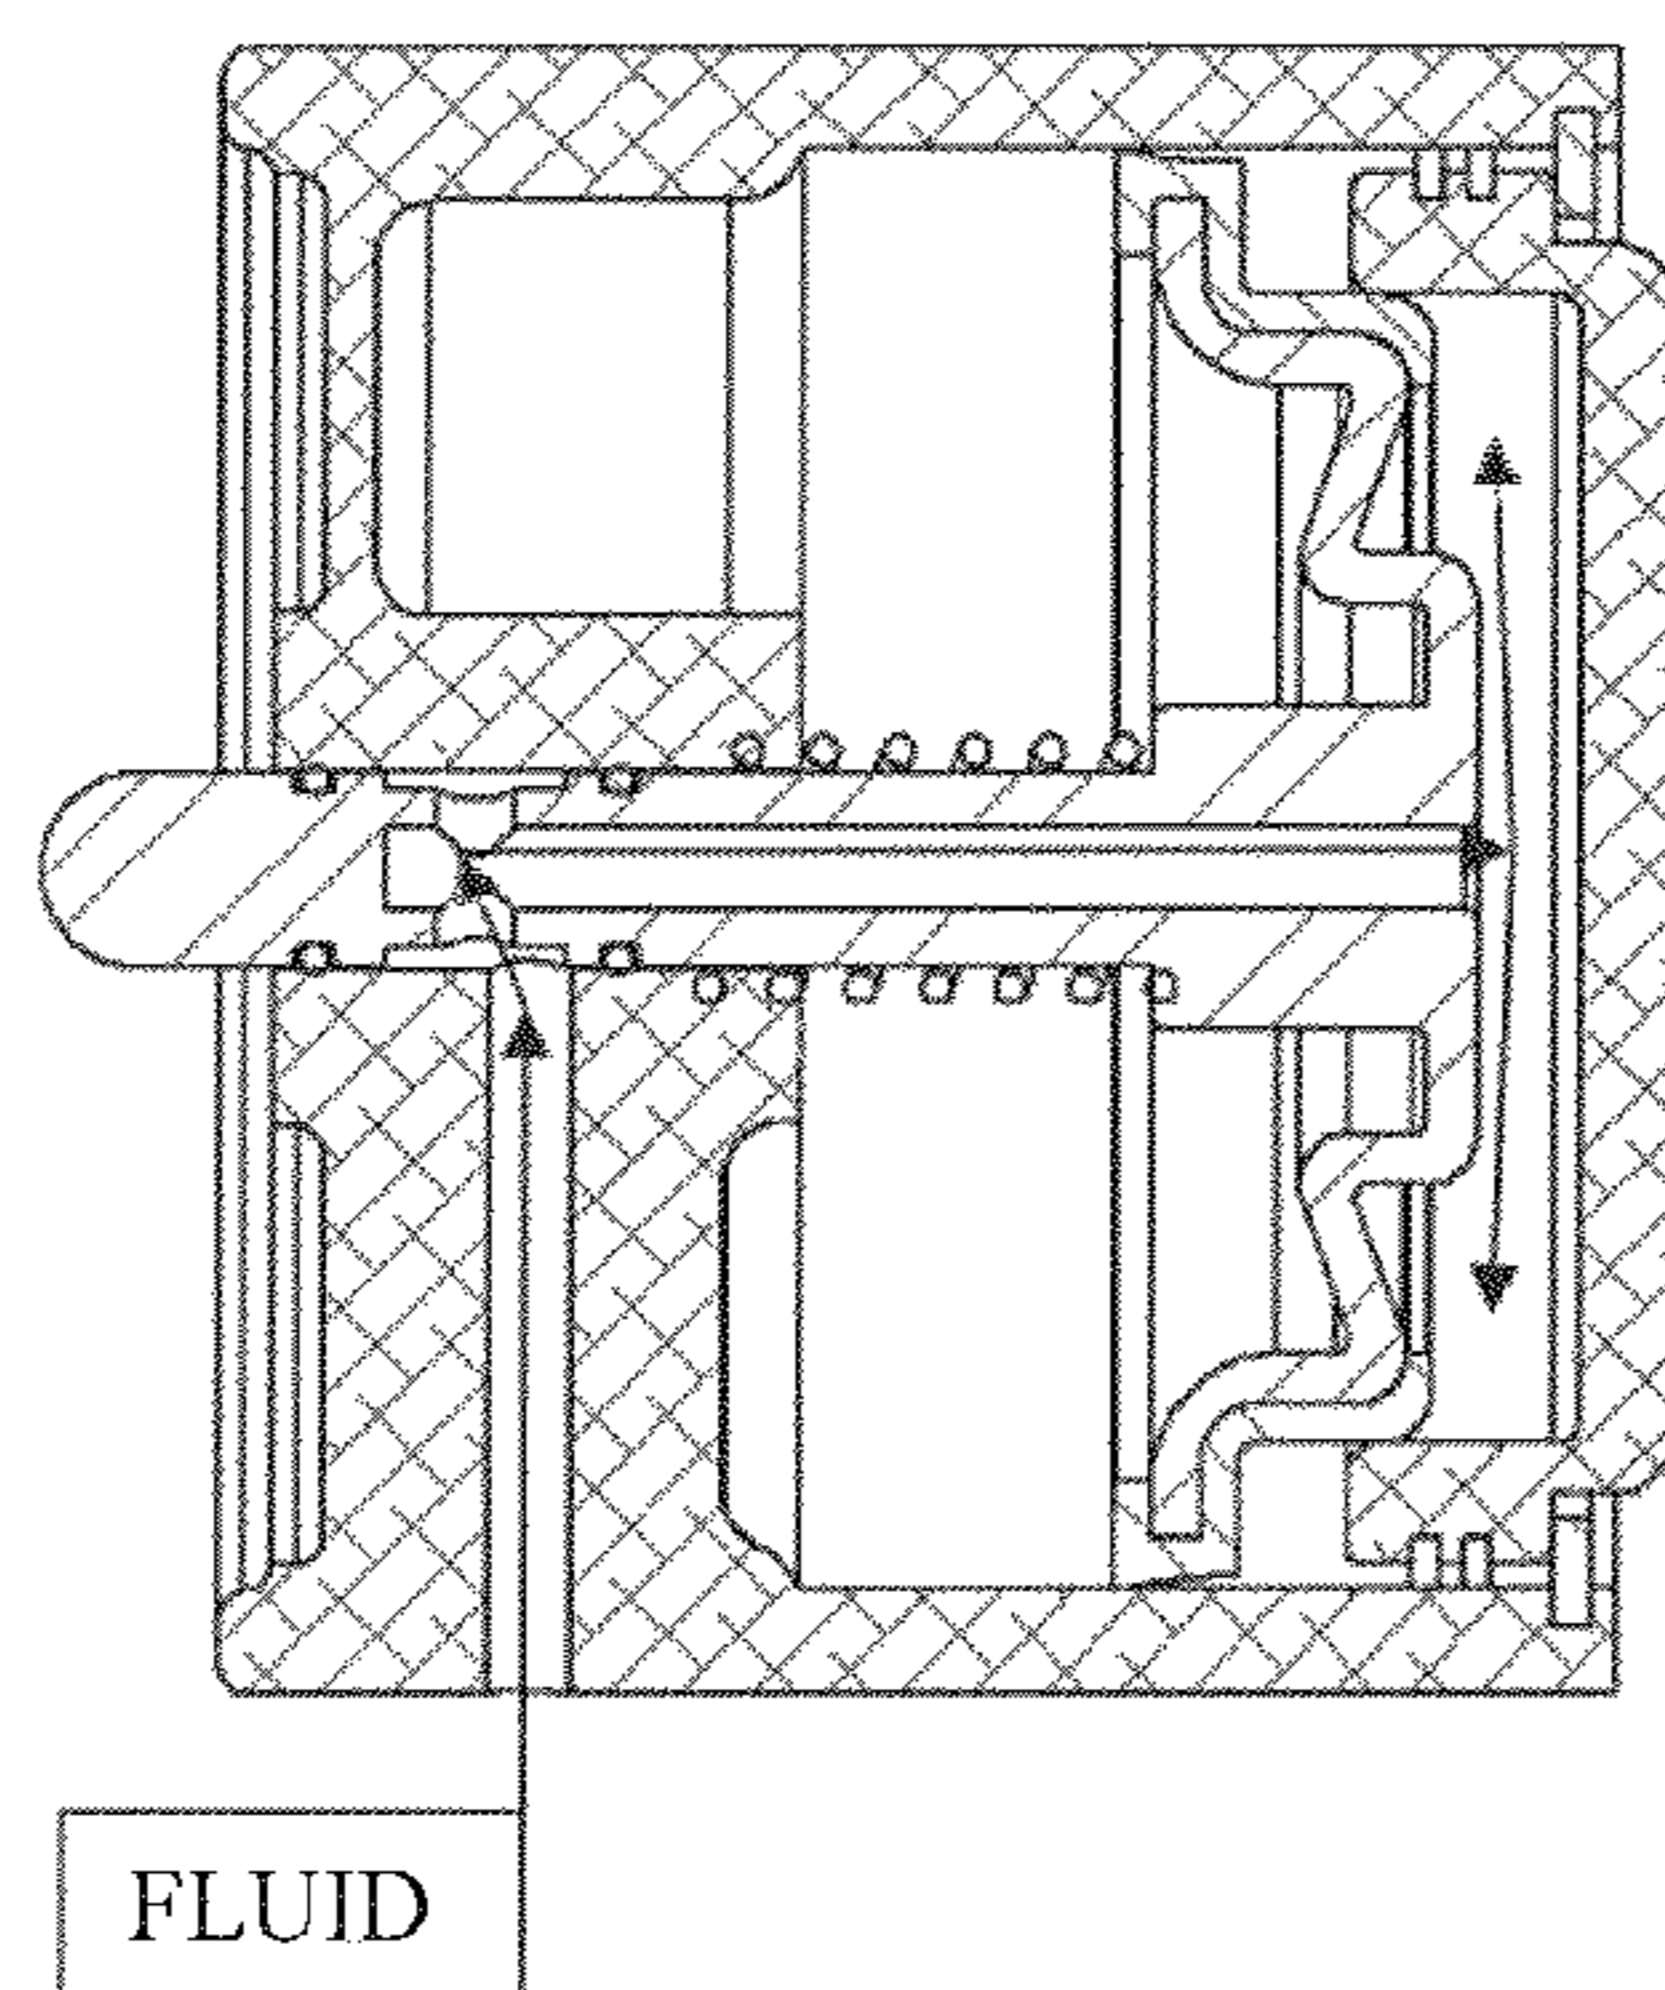
FIG. 21 is a section view showing a servo extended and the relative positions of o-rings with respect to the ends of a bore, as well as redirection of fluid flow;

5 The OEM servos consist of a rod 16 and piston 12 & 18 (see FIG. 1). The servos have a cross bore 22 that is centered on a wide groove 52 that is machined into the rod. The large groove allows for fluid to pass into the cross bore 22 while the servo is extending and retracting (see FIGS. 1, 4, 6, 7, and 21).
 10 The rod 16 on the servo has a bore 20 running through the center of the rod from the cross bore 22 to the top of the piston 12 (see FIGS. 1, 4, 6, 7 & 8). As part of the OEM design, when the solenoid (not shown) for that servo is activated, the pressurized transmission fluid passes through the cross bore 22 in the rod 16 up to the top side of the piston 12 between the piston 10 and the servo cap 36. Some fluid also passes to the bottom side of the piston 14 and to the reservoir 40 (See FIGS. 1 and 7). This is an inherent part of the OEM design. The system is designed such that the intermediate servo which

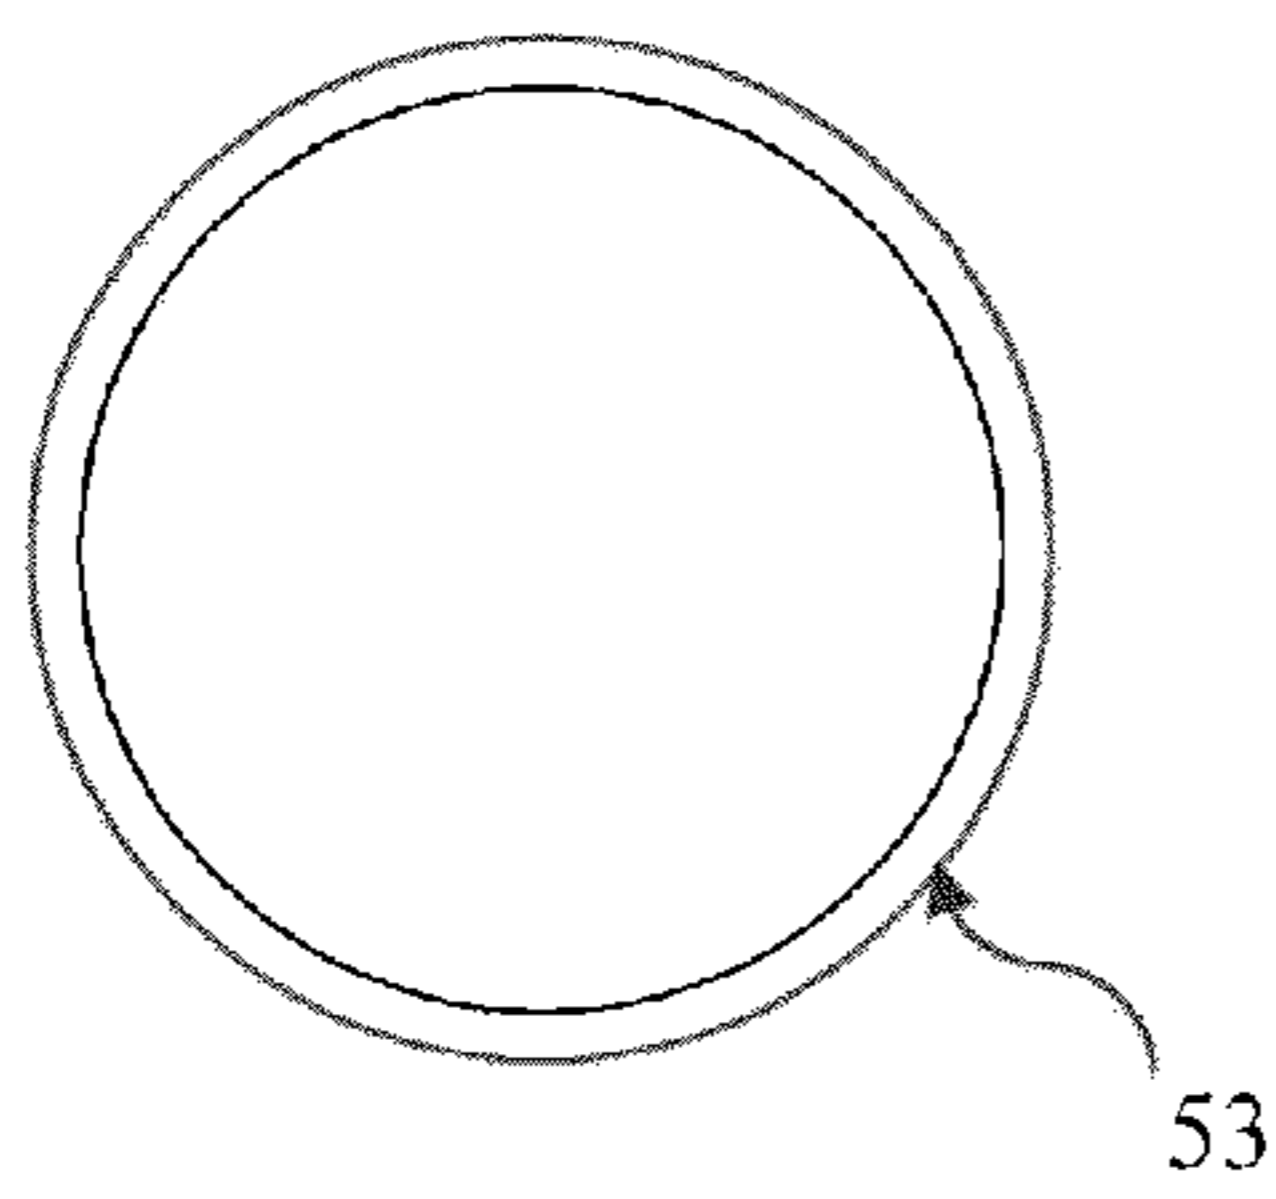
FIG. 22A is a two-dimensional top view of an assembly sleeve;

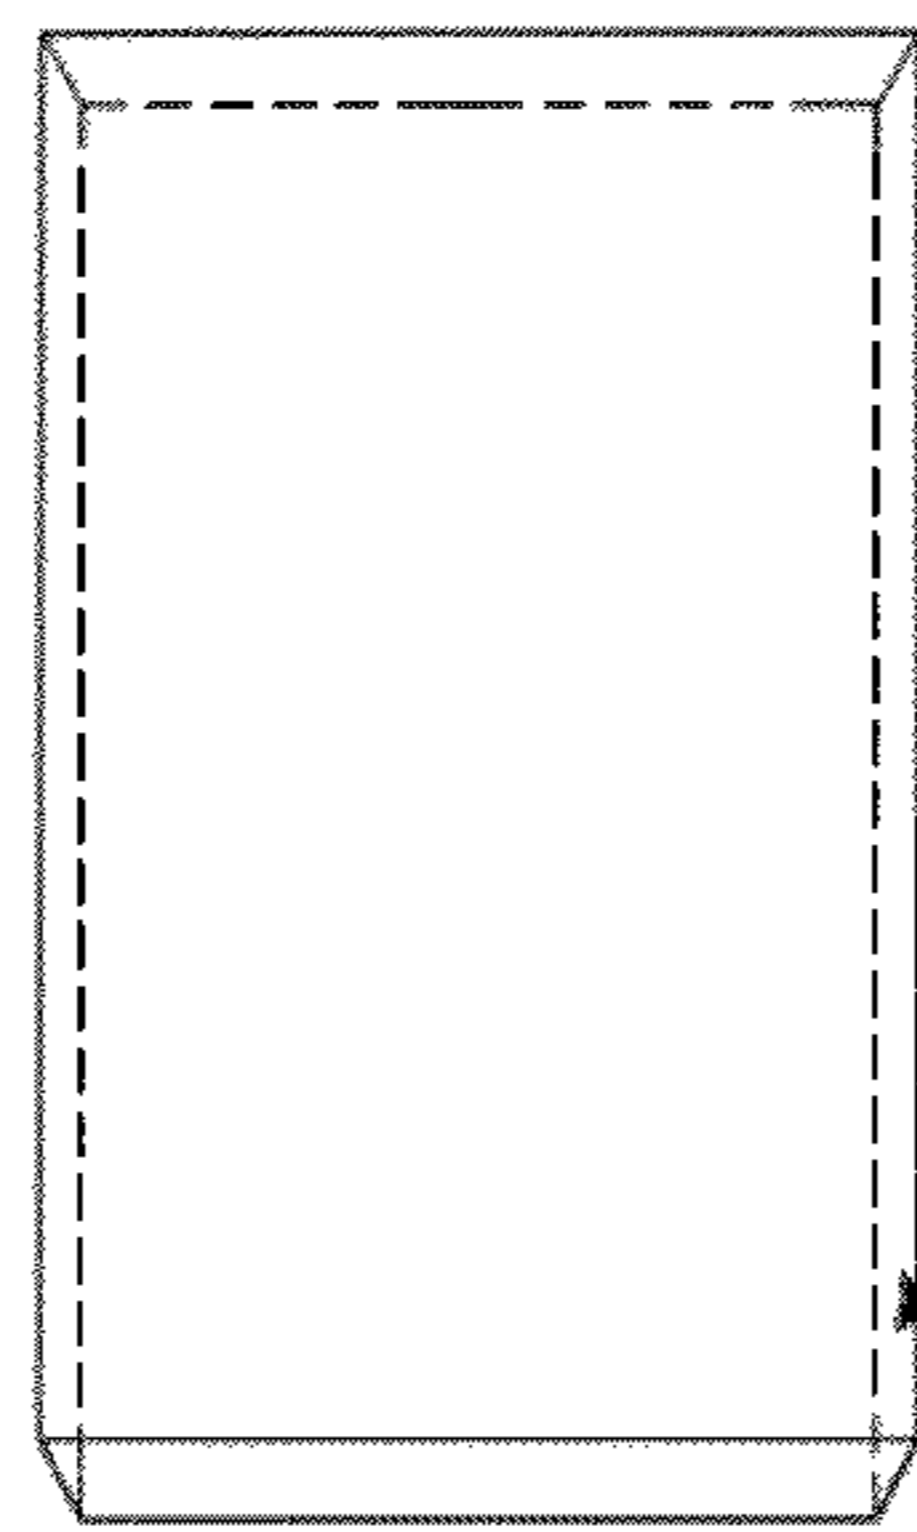
FIG. 22B is a two-dimensional front view of an assembly sleeve;

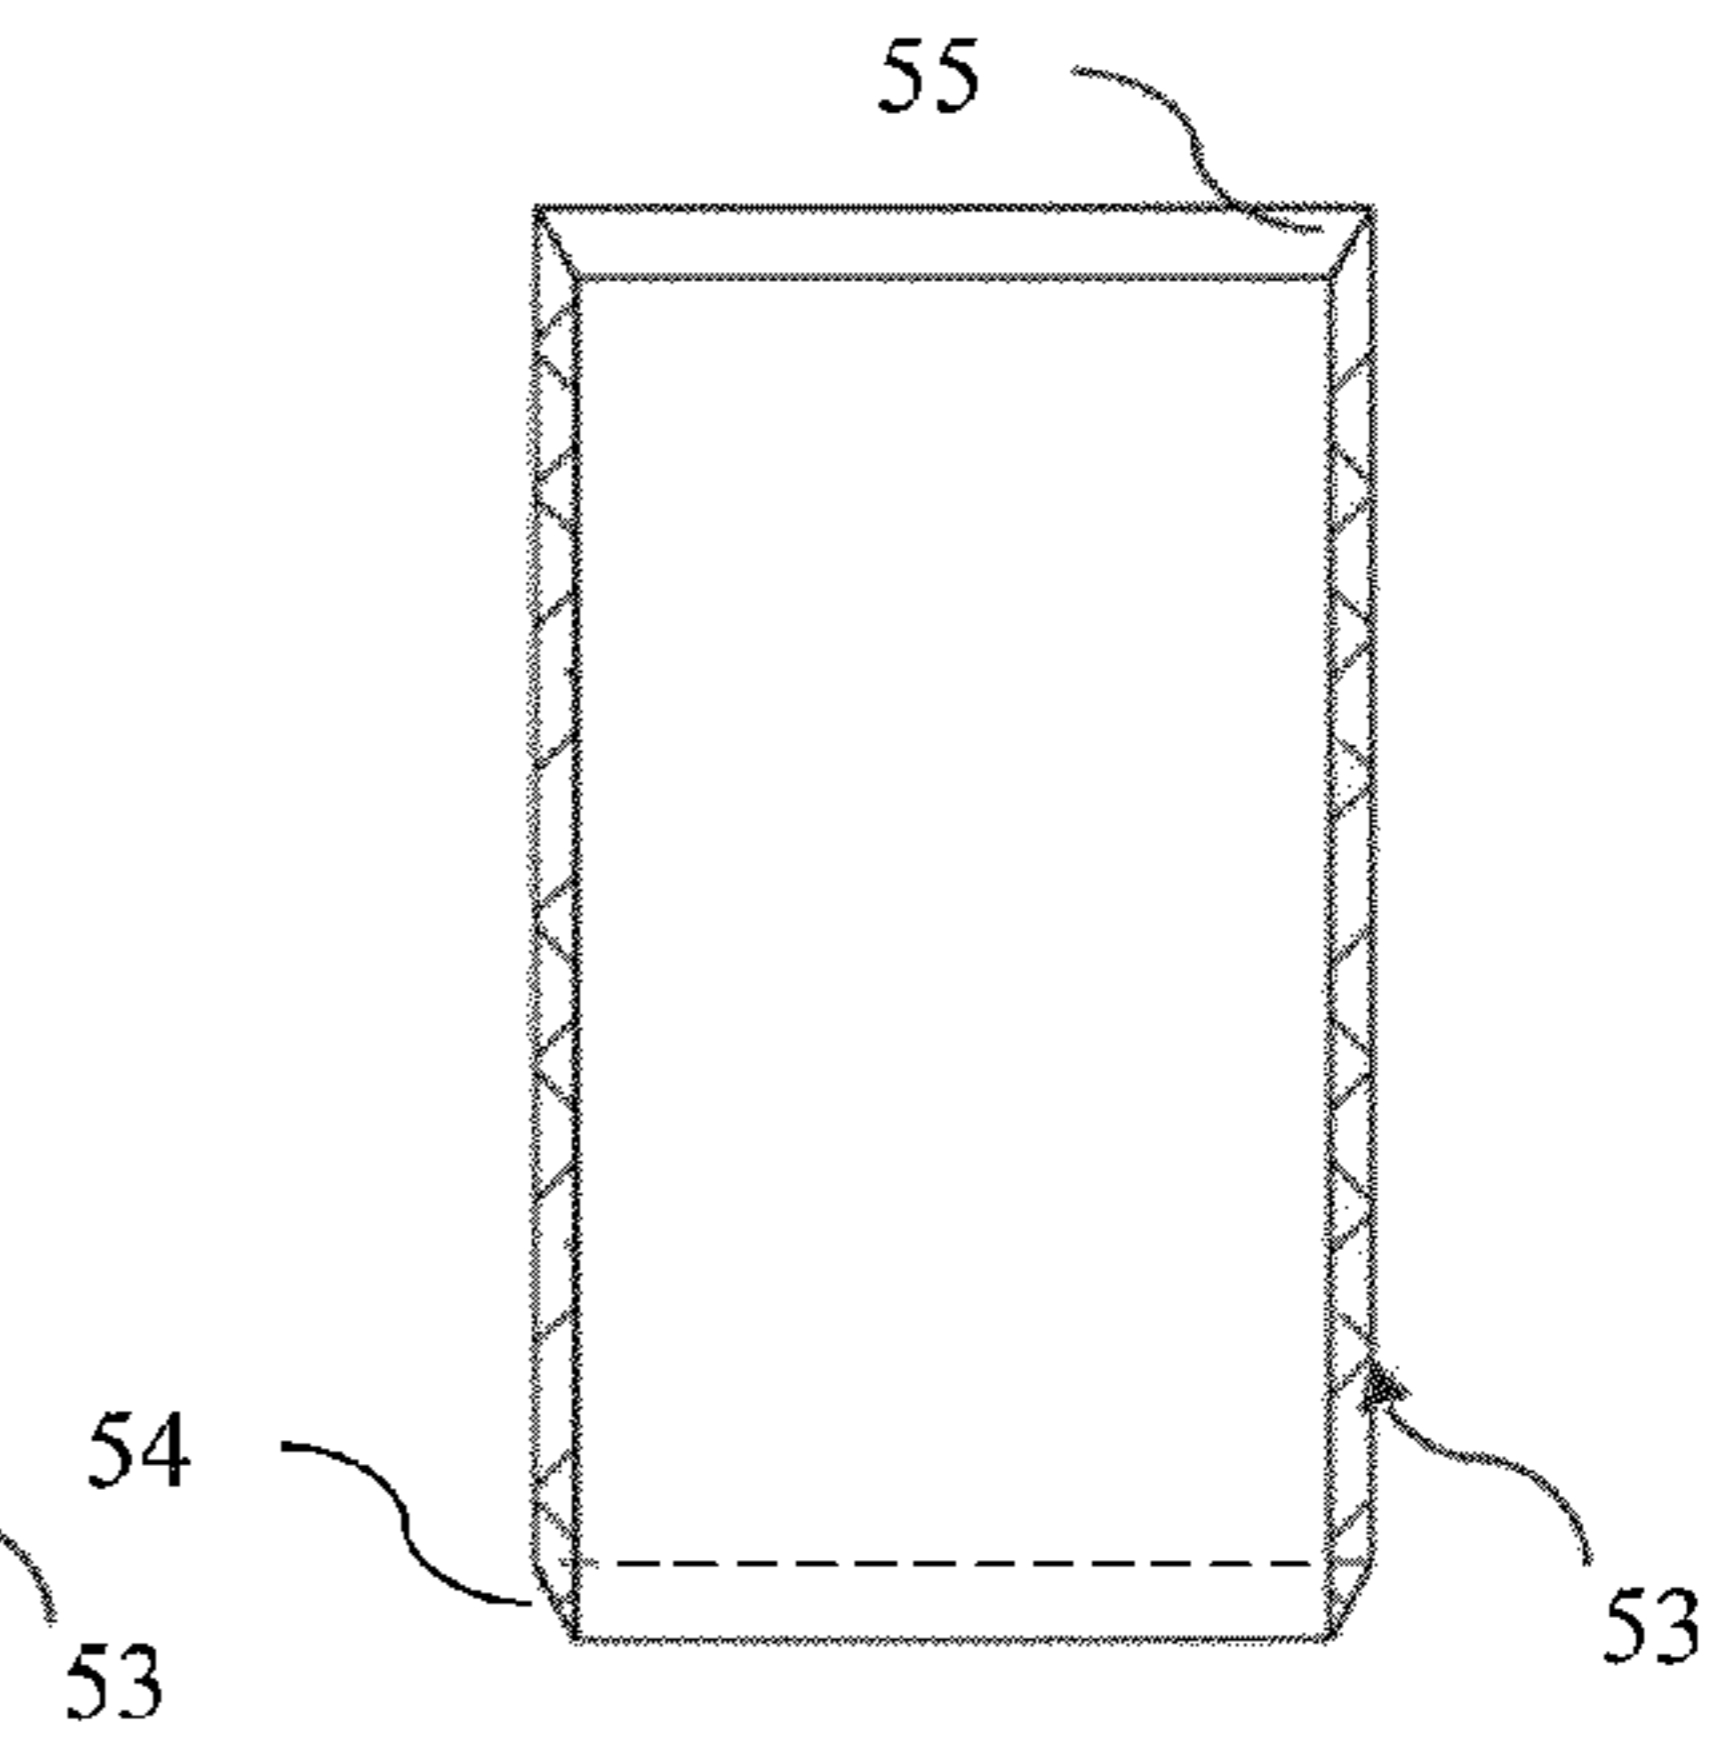
FIG. 22C is a two-dimensional cross section of an assembly sleeve;

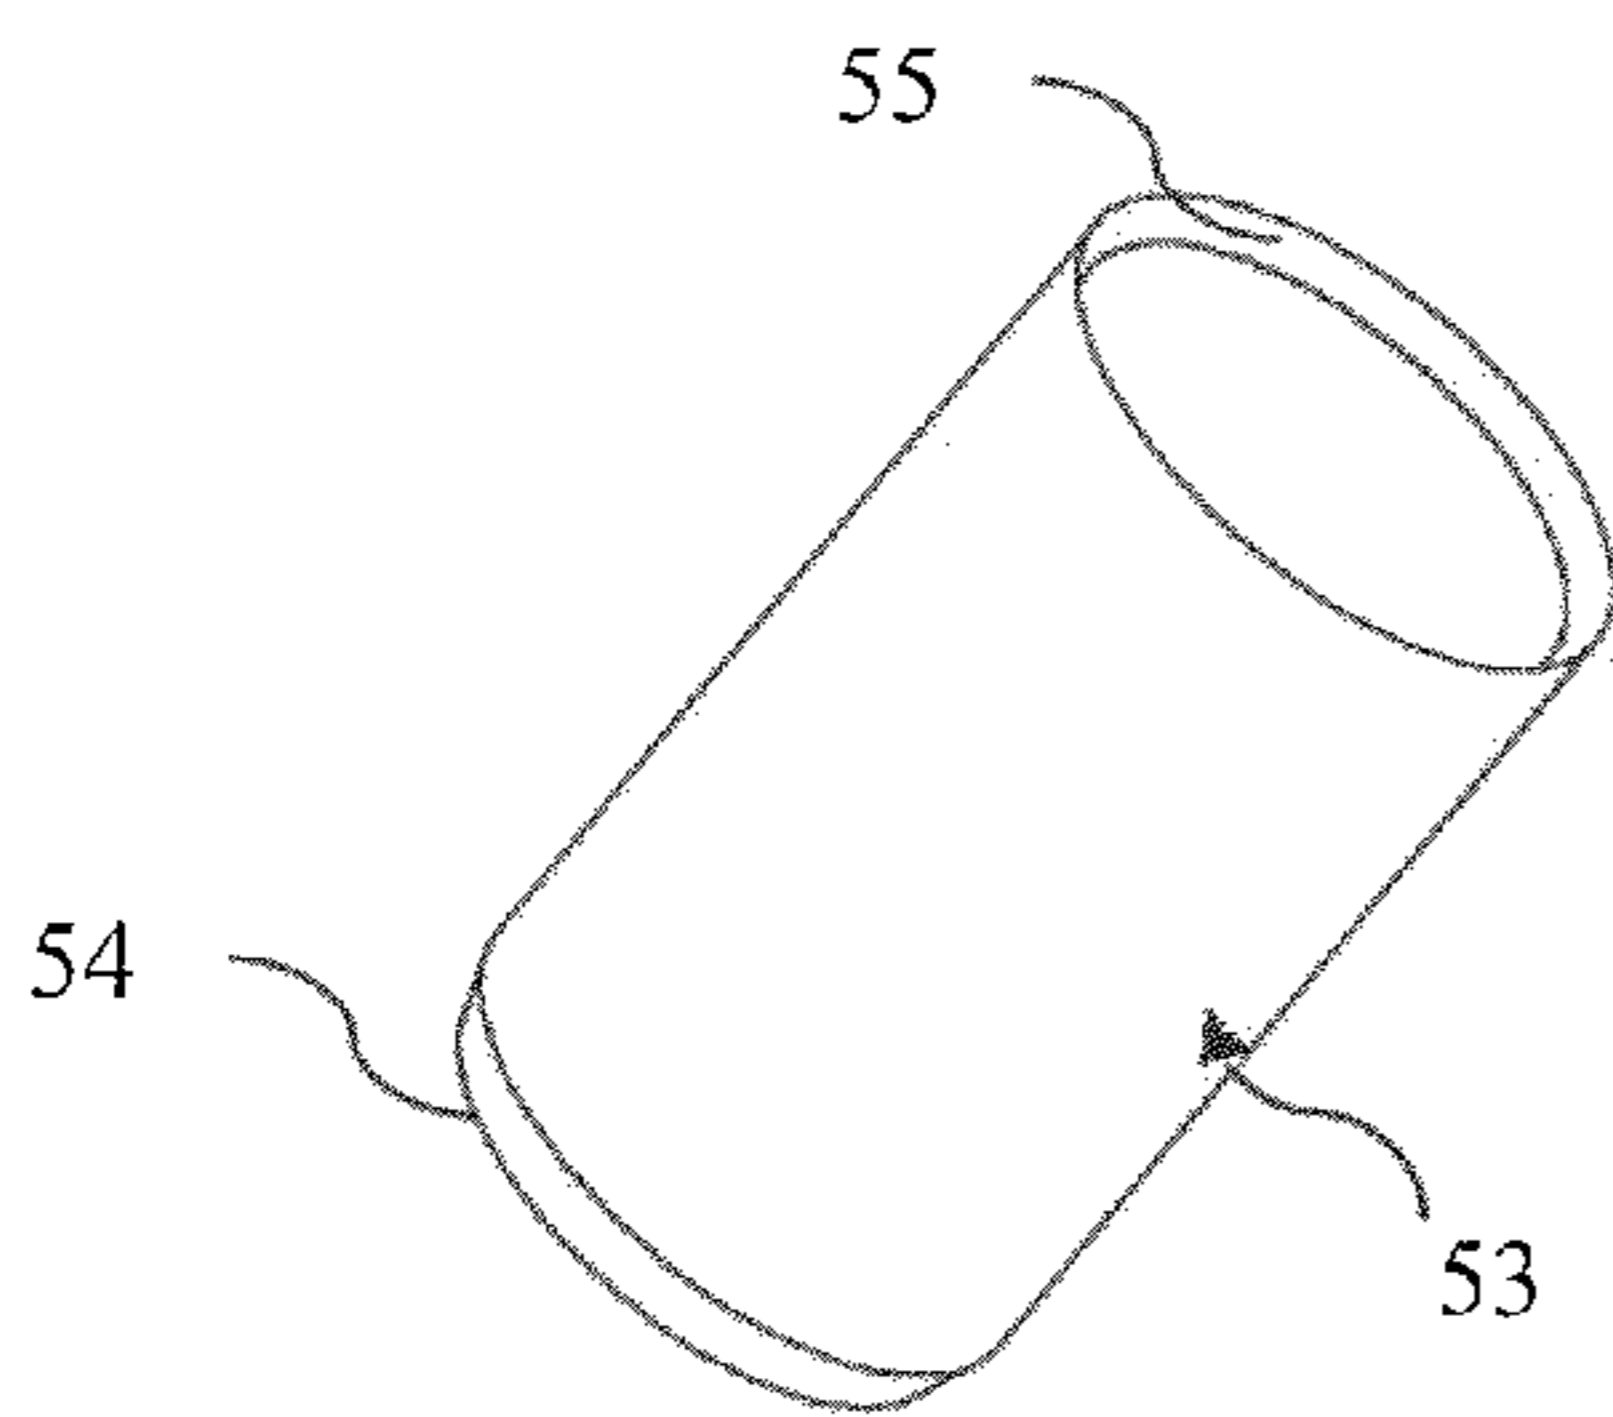
FIG. 22D is an isometric view of an assembly sleeve;

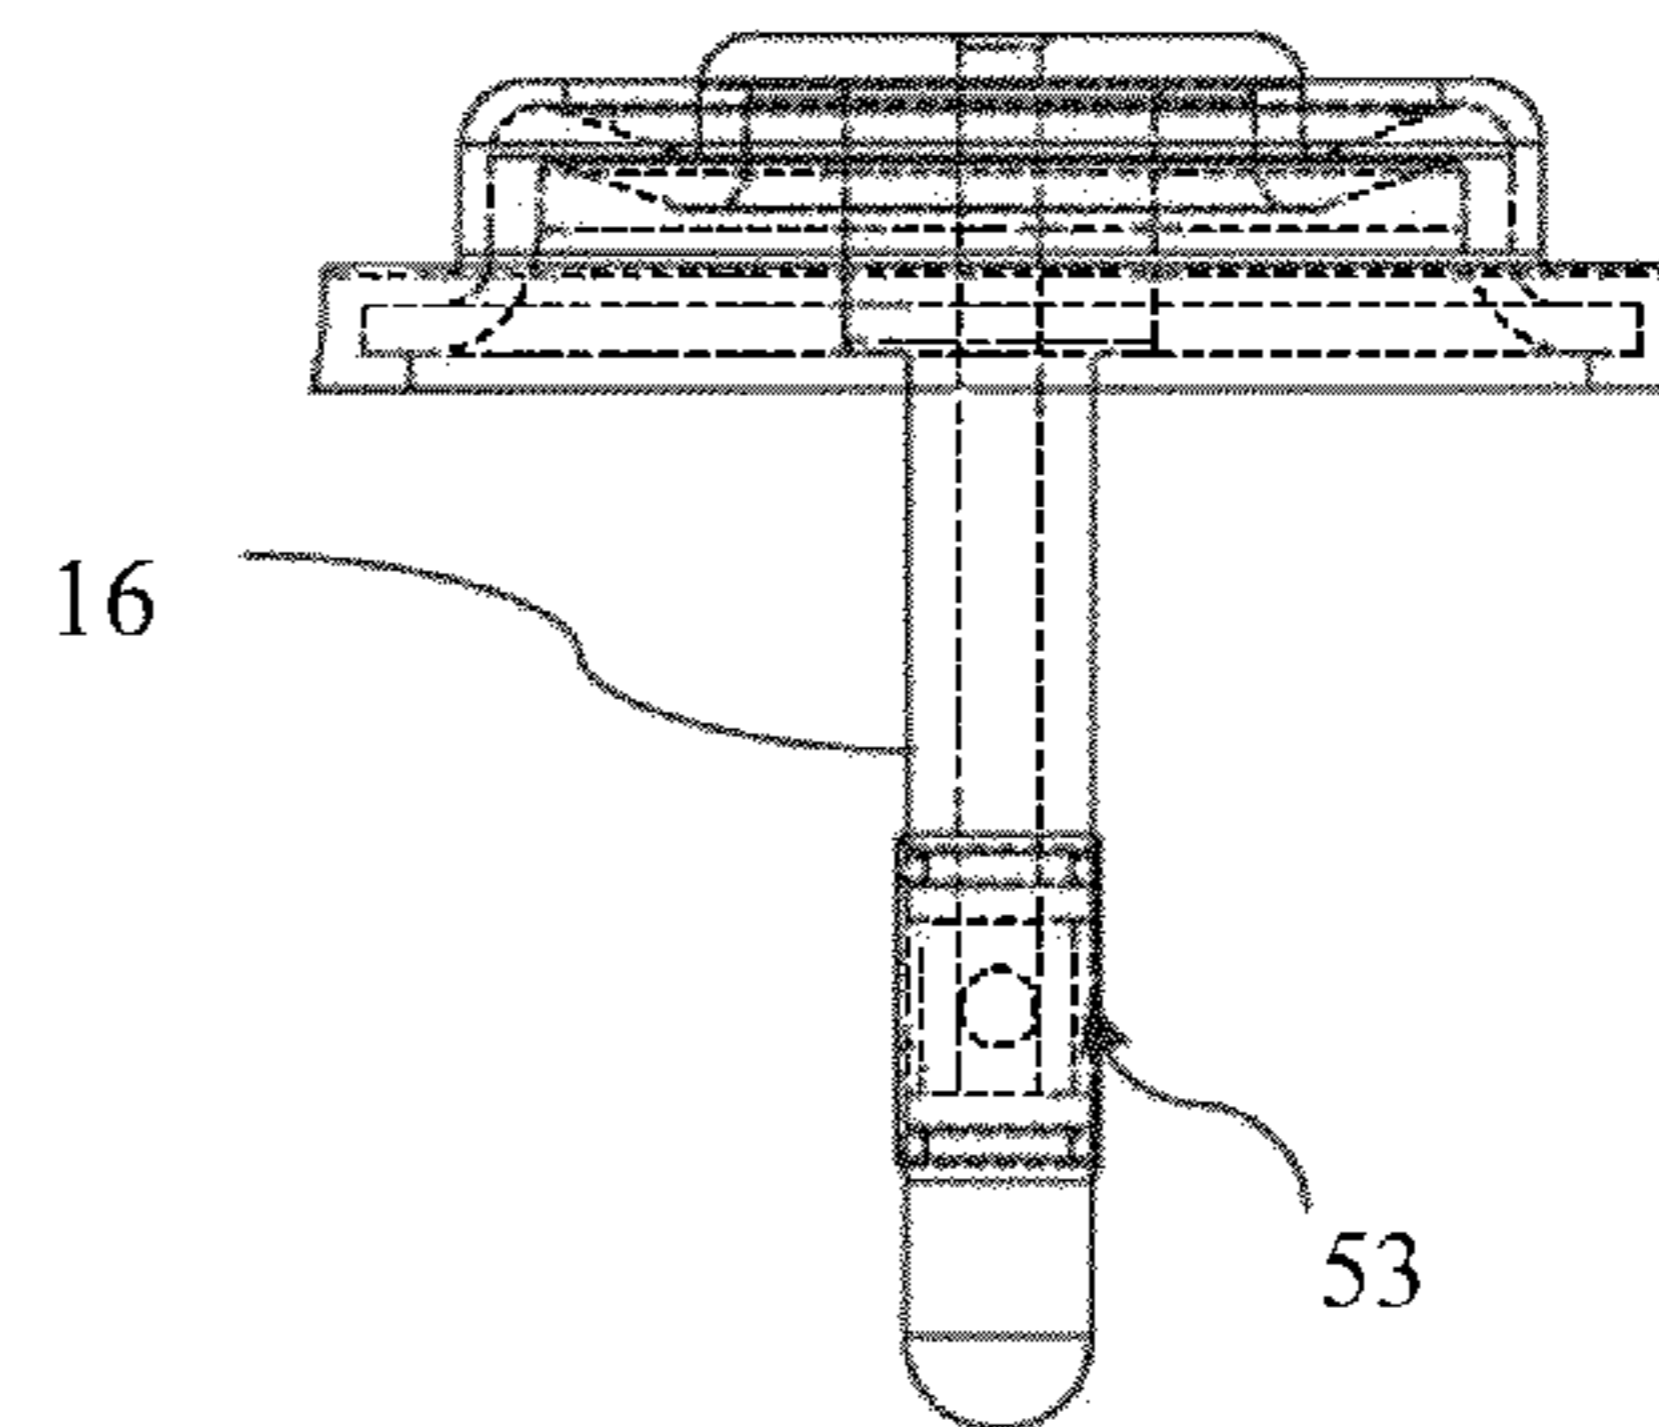
FIG. 23 is a two-dimensional view of an intermediate servo with an assembly sleeve shown in the installed position prior to installation of the servo into a bore.

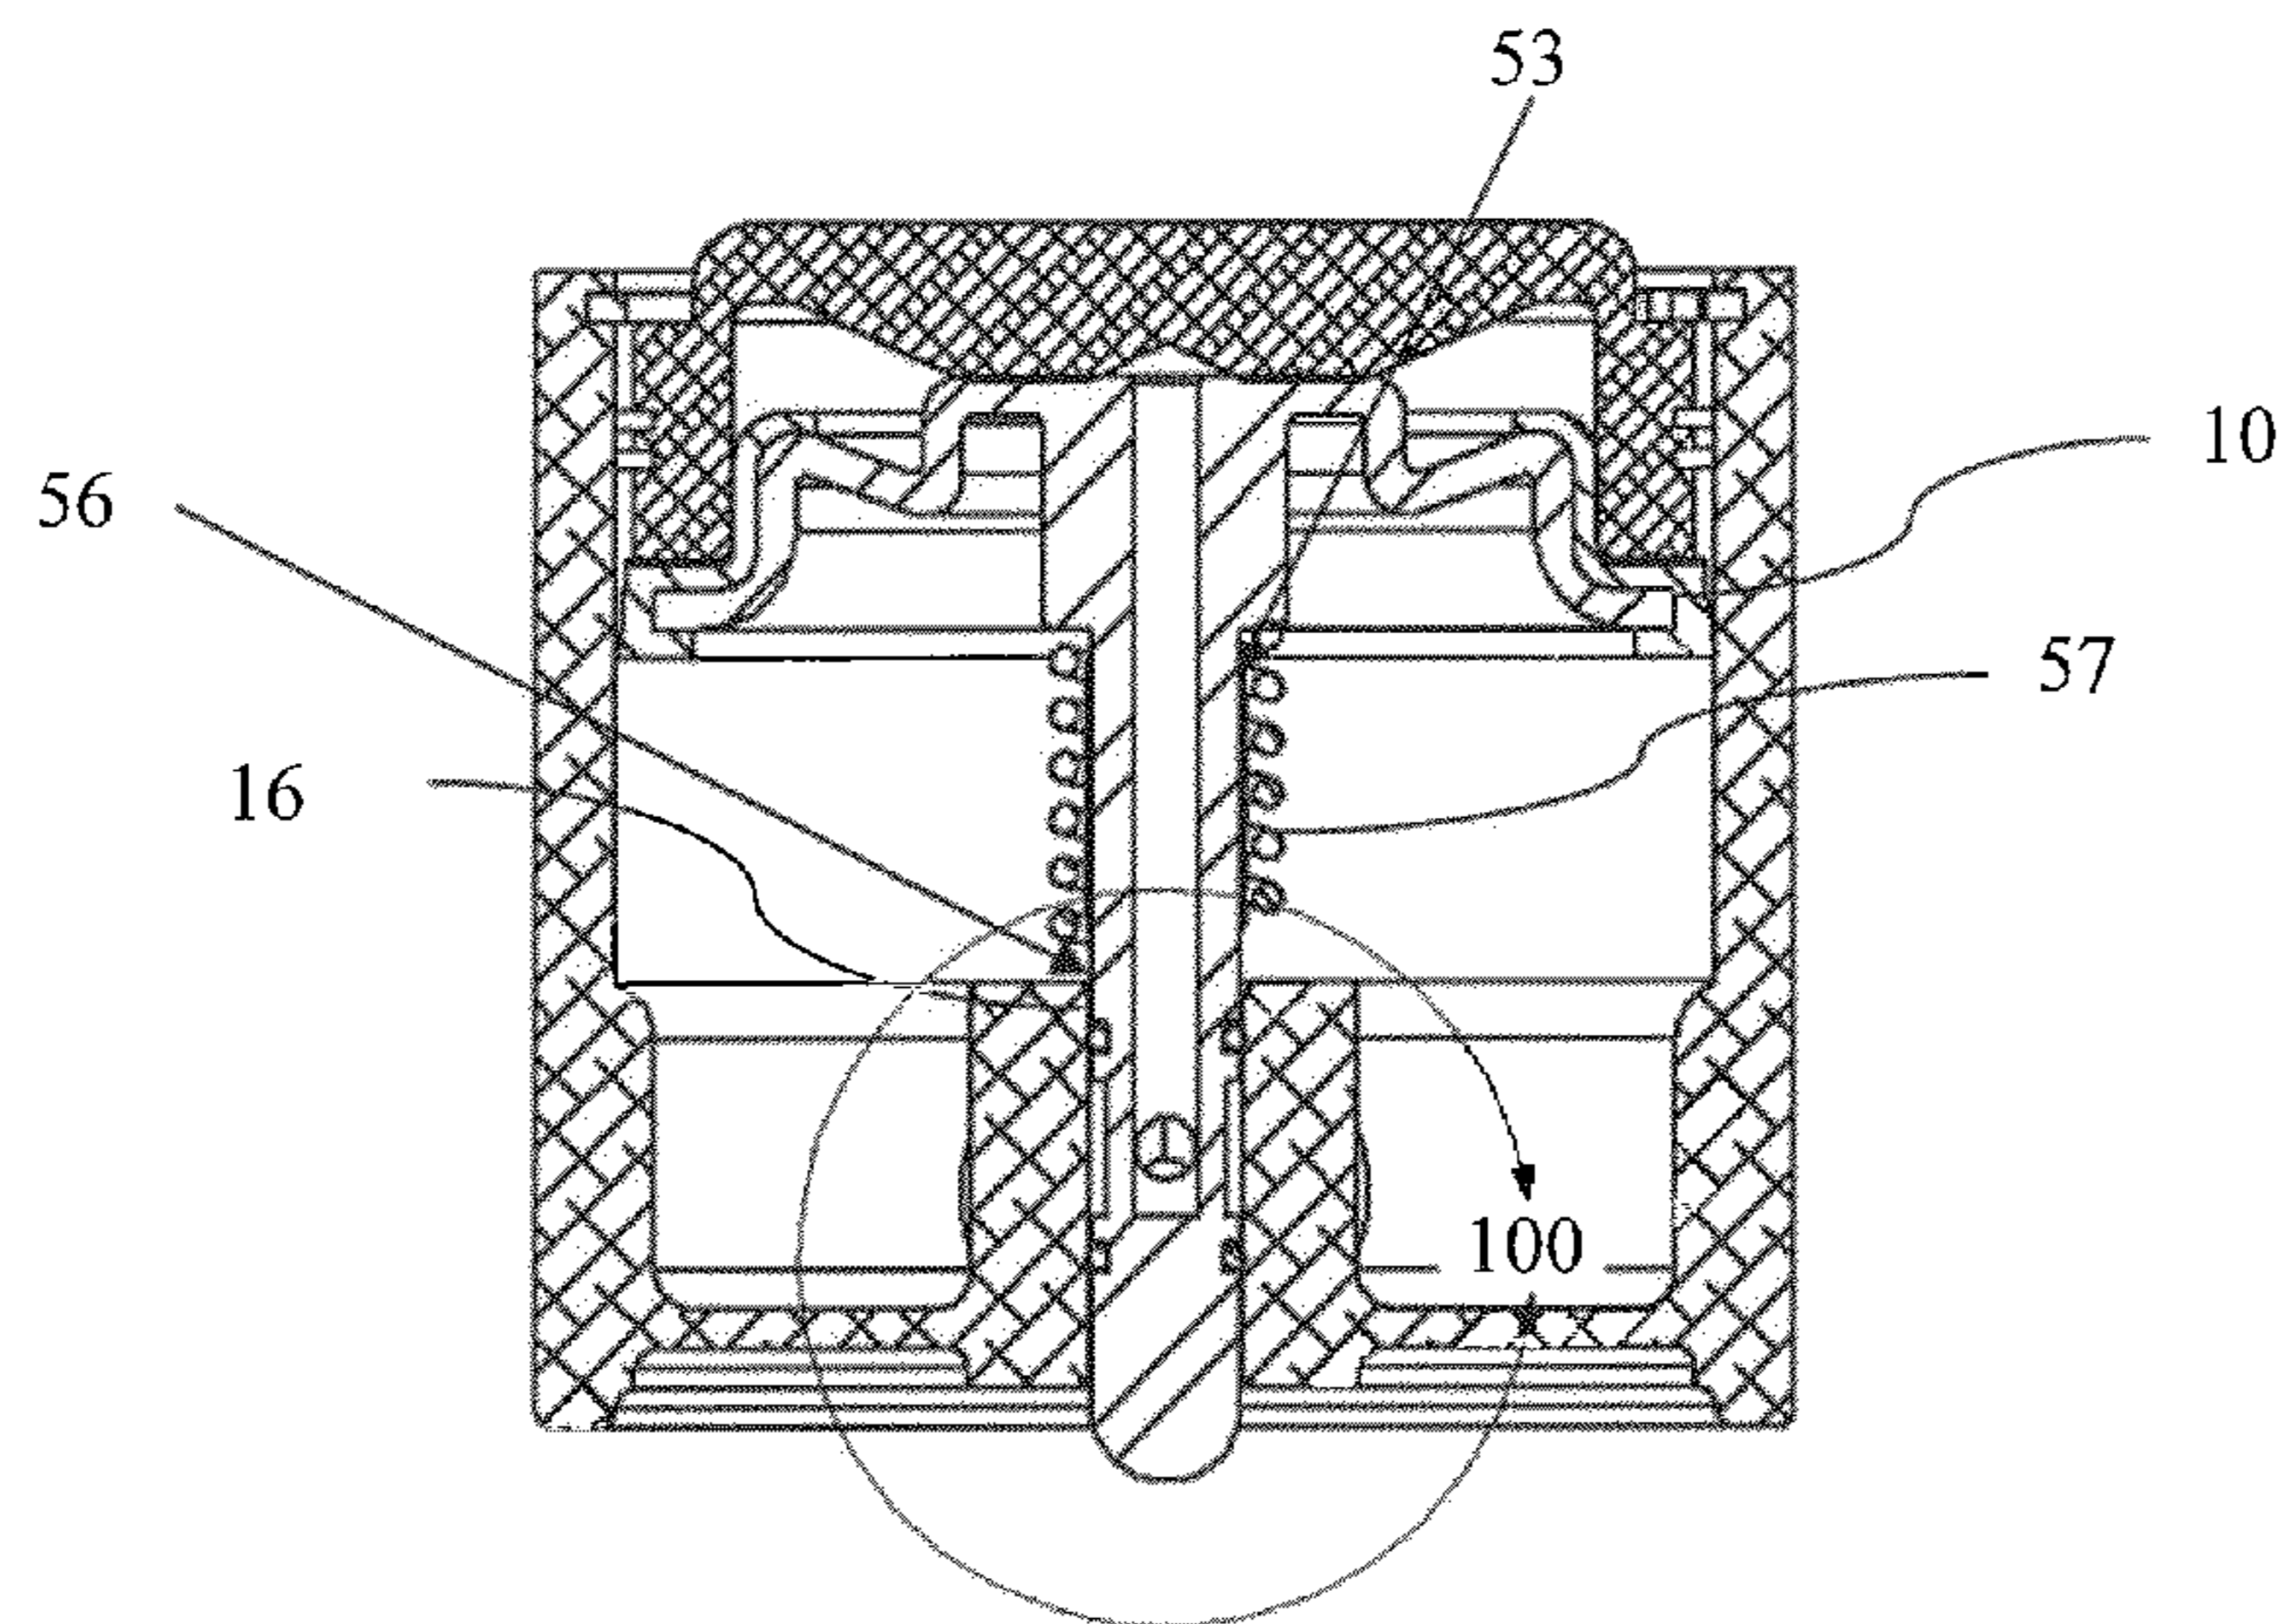
FIG. 24 is a cross section showing an assembly sleeve in the operating position after installation of the servo into a bore;
