(54) **TRANSMISSION SYSTEM AND METHOD OF REPAIR**

A transmission system and method of repair having a transmission servo rod received within a transmission housing bore, the rod having an aperture disposed along an exterior surface of the rod, configured to receive transmission fluid from a port within the transmission housing bore, a first recessed groove in the exterior surface of the rod disposed above the aperture; a second recessed groove in the exterior surface of the rod disposed below the aperture; and a first and second resilient sealing member received within the first and second recessed grooves, respectively, the resilient sealing members configured to engage an inner surface of the transmission housing bore.

TRANSMISSION SYSTEM AND METHOD OF REPAIR

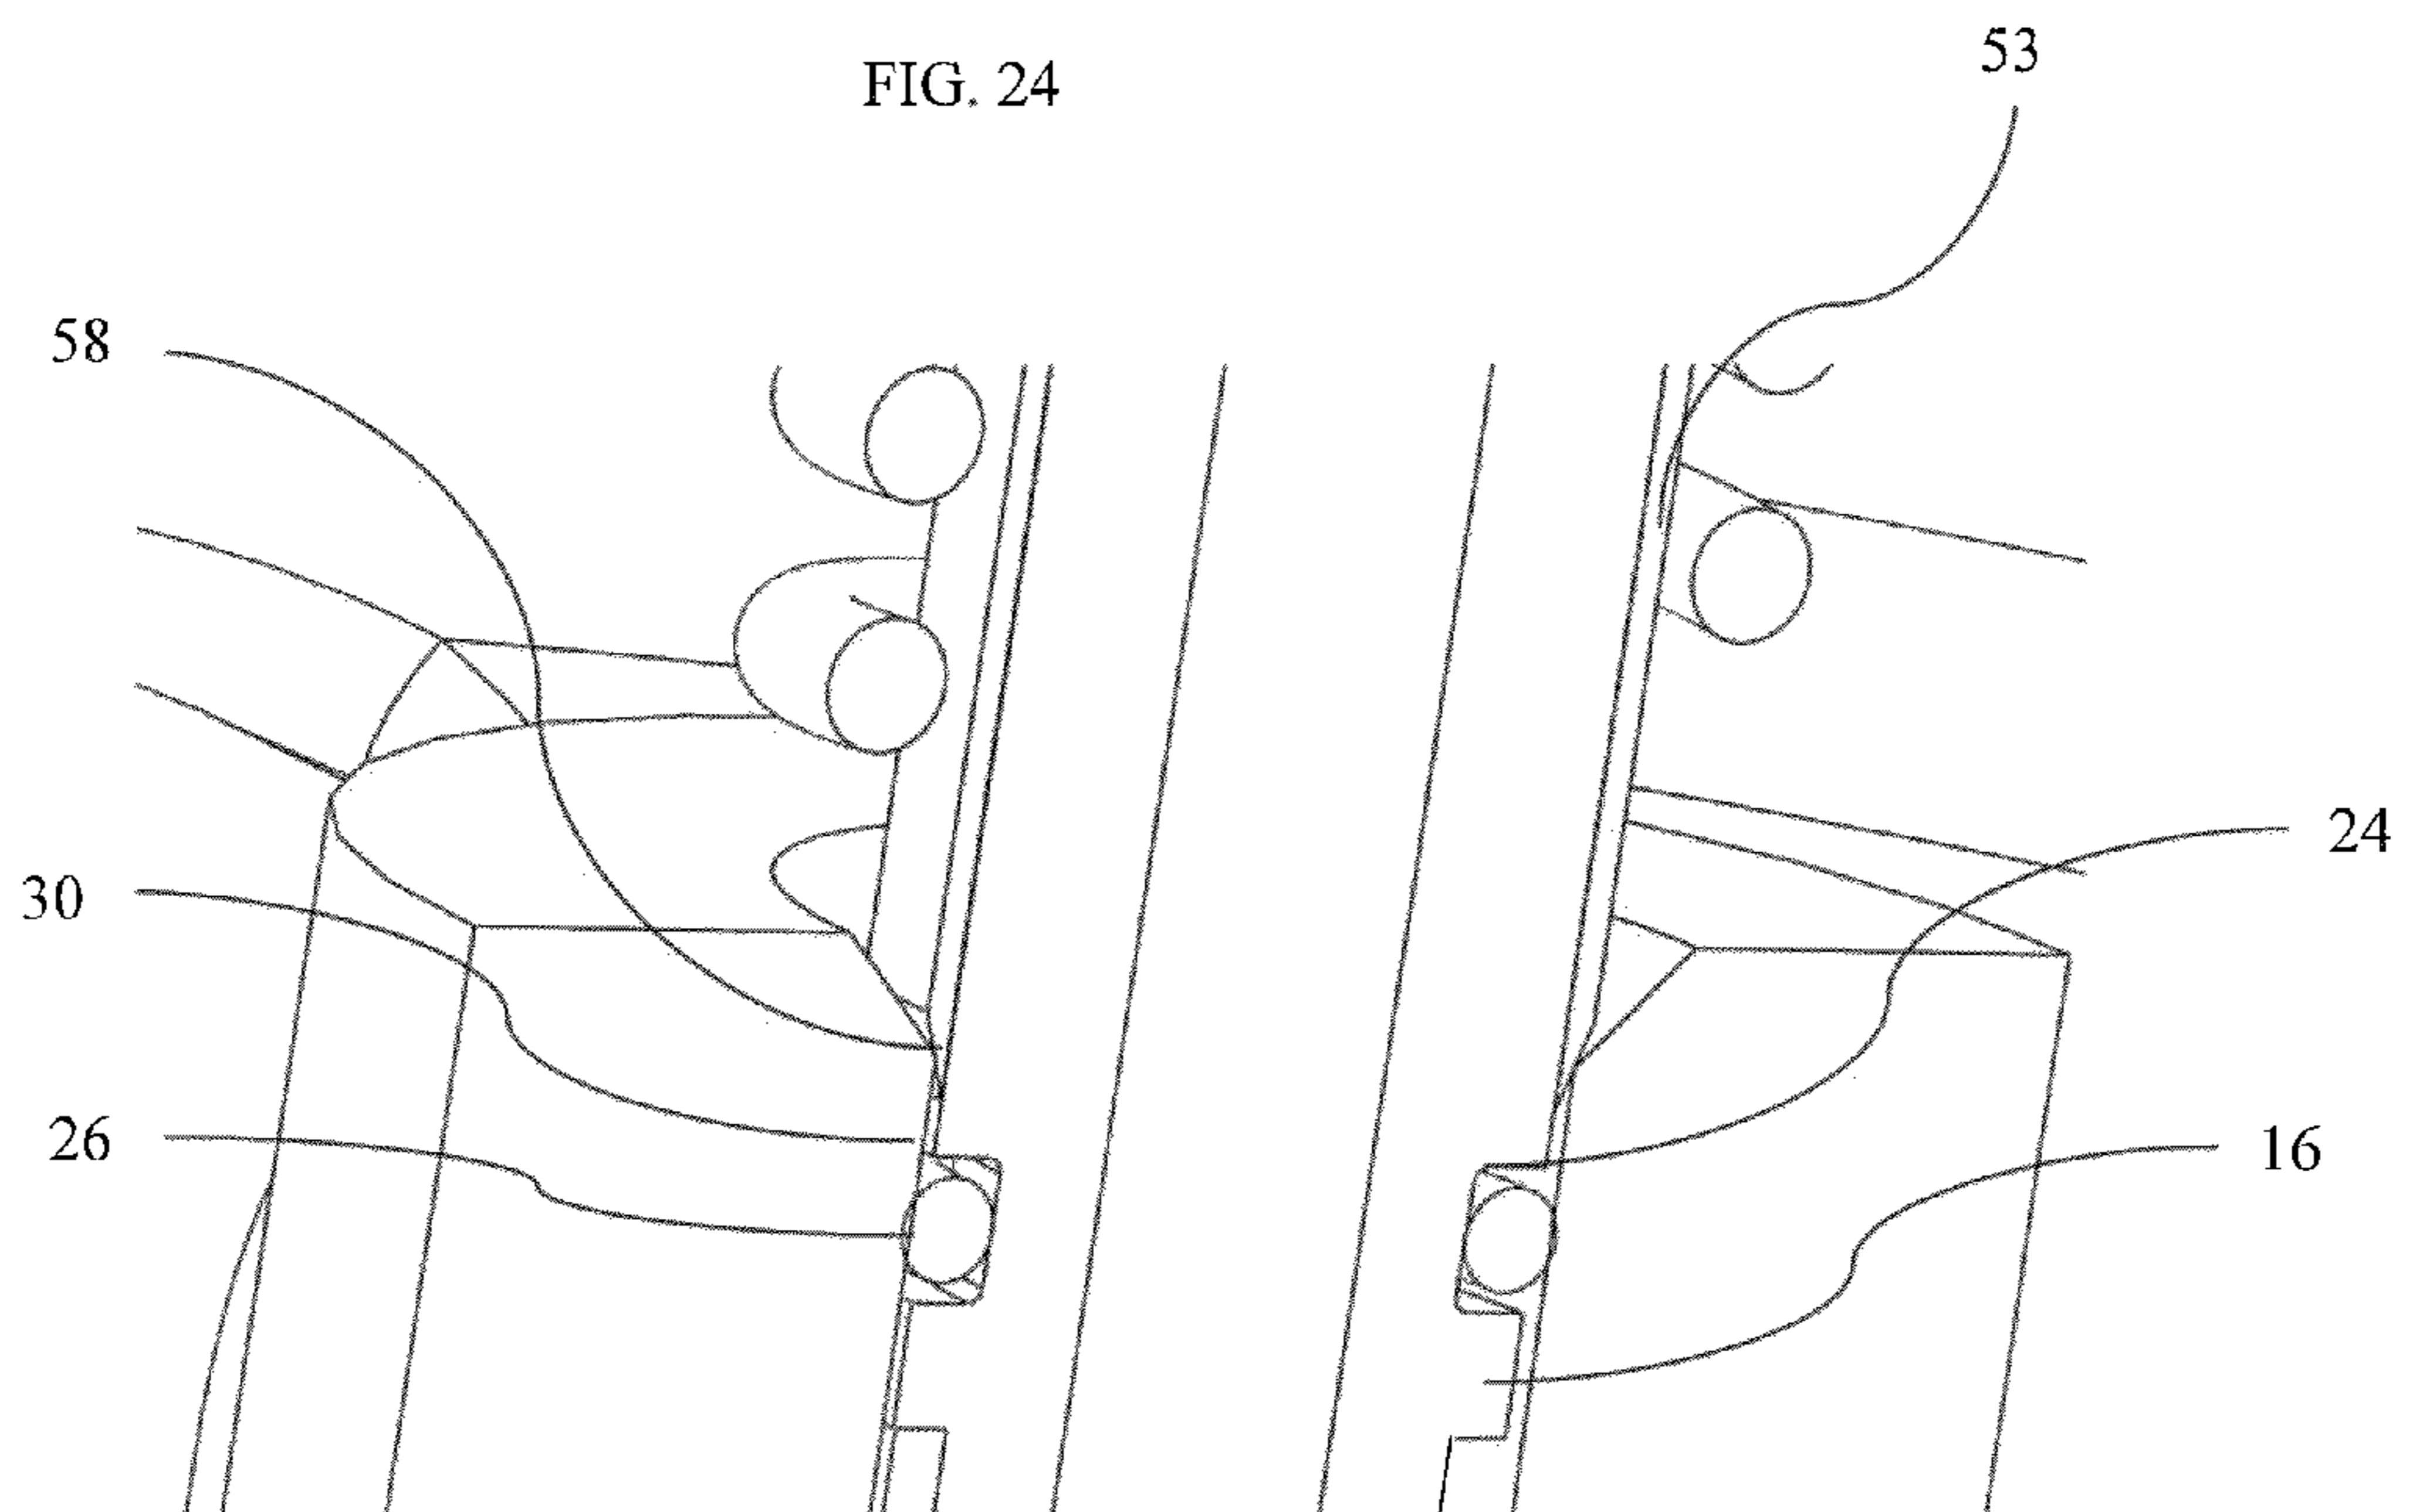
FIG. 25 is a cross section showing the contact of an assembly sleeve with an OEM chamfer allowing o-rings to slide directly into the bore.
