(54) **TRANSMISSION SYSTEM AND METHOD OF REPAIR**

A transmission system and method of repair having a transmission servo rod received within a transmission housing bore, the rod having an aperture disposed along an exterior surface of the rod, configured to receive transmission fluid from a port within the transmission housing bore, a first recessed groove in the exterior surface of the rod disposed above the aperture; a second recessed groove in the exterior surface of the rod disposed below the aperture; and a first and second resilient sealing member received within the first and second recessed grooves, respectively, the resilient sealing members configured to engage an inner surface of the transmission housing bore.

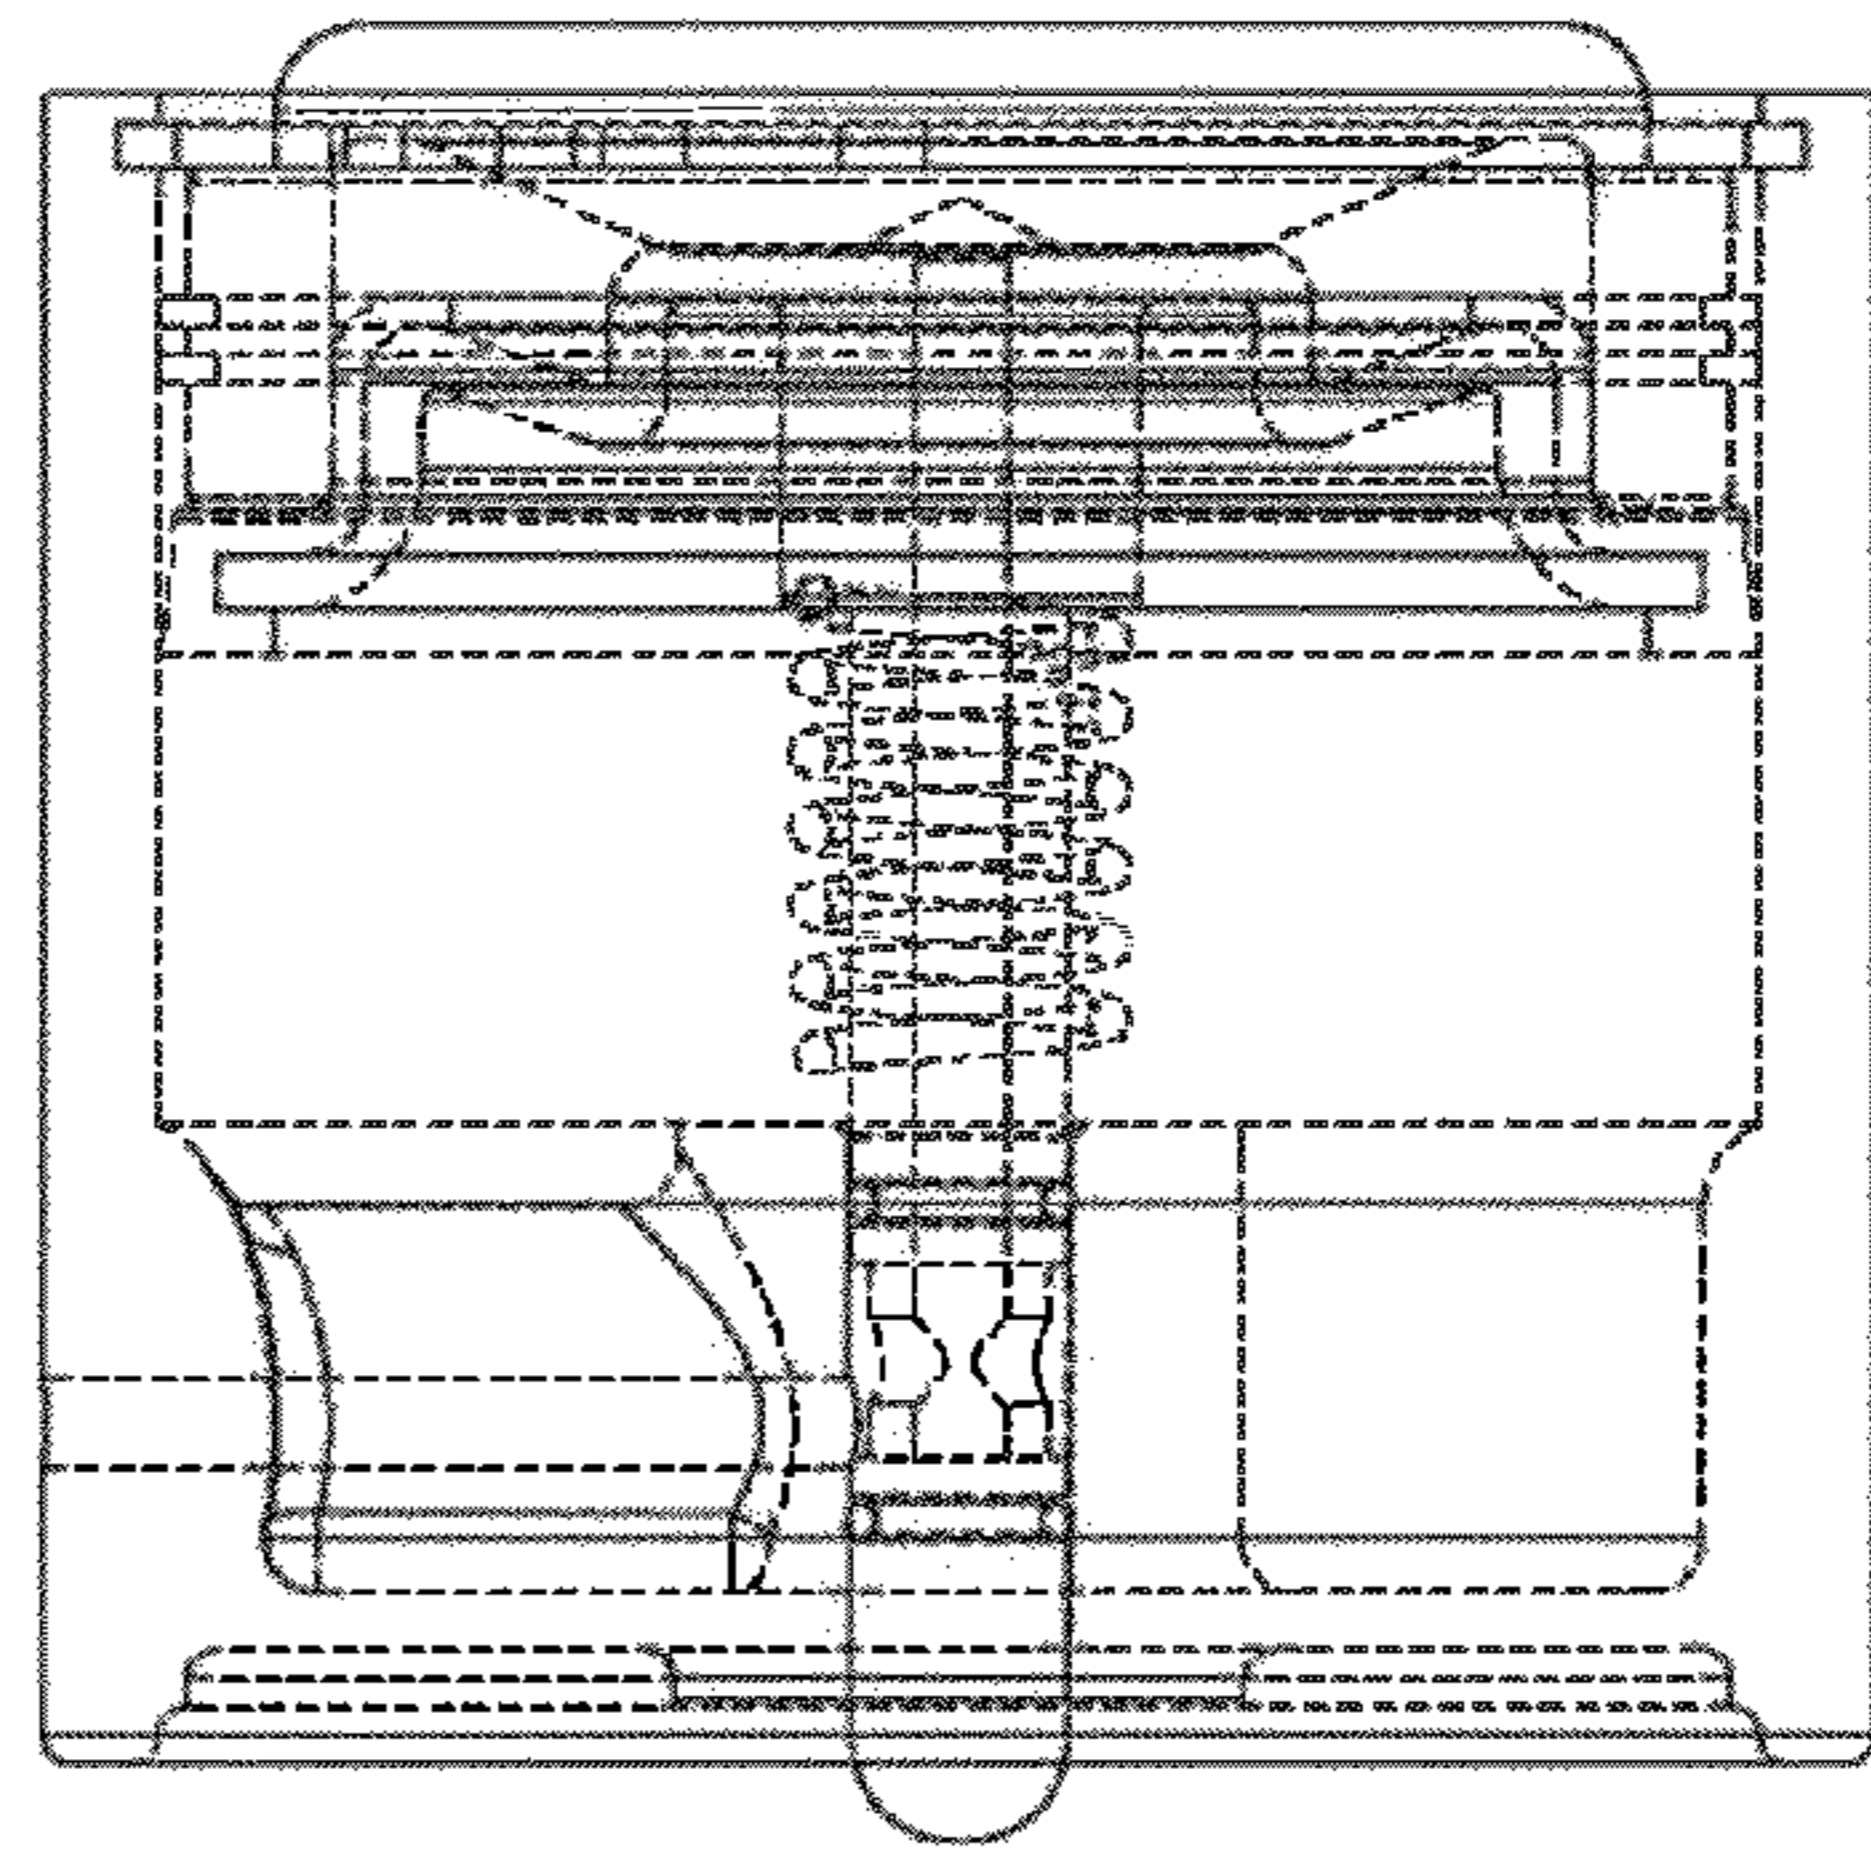
FIGS. 15 & 16 are side and front views (hidden lines shown), showing the modified OEM parts with o-ring grooves and o-rings;

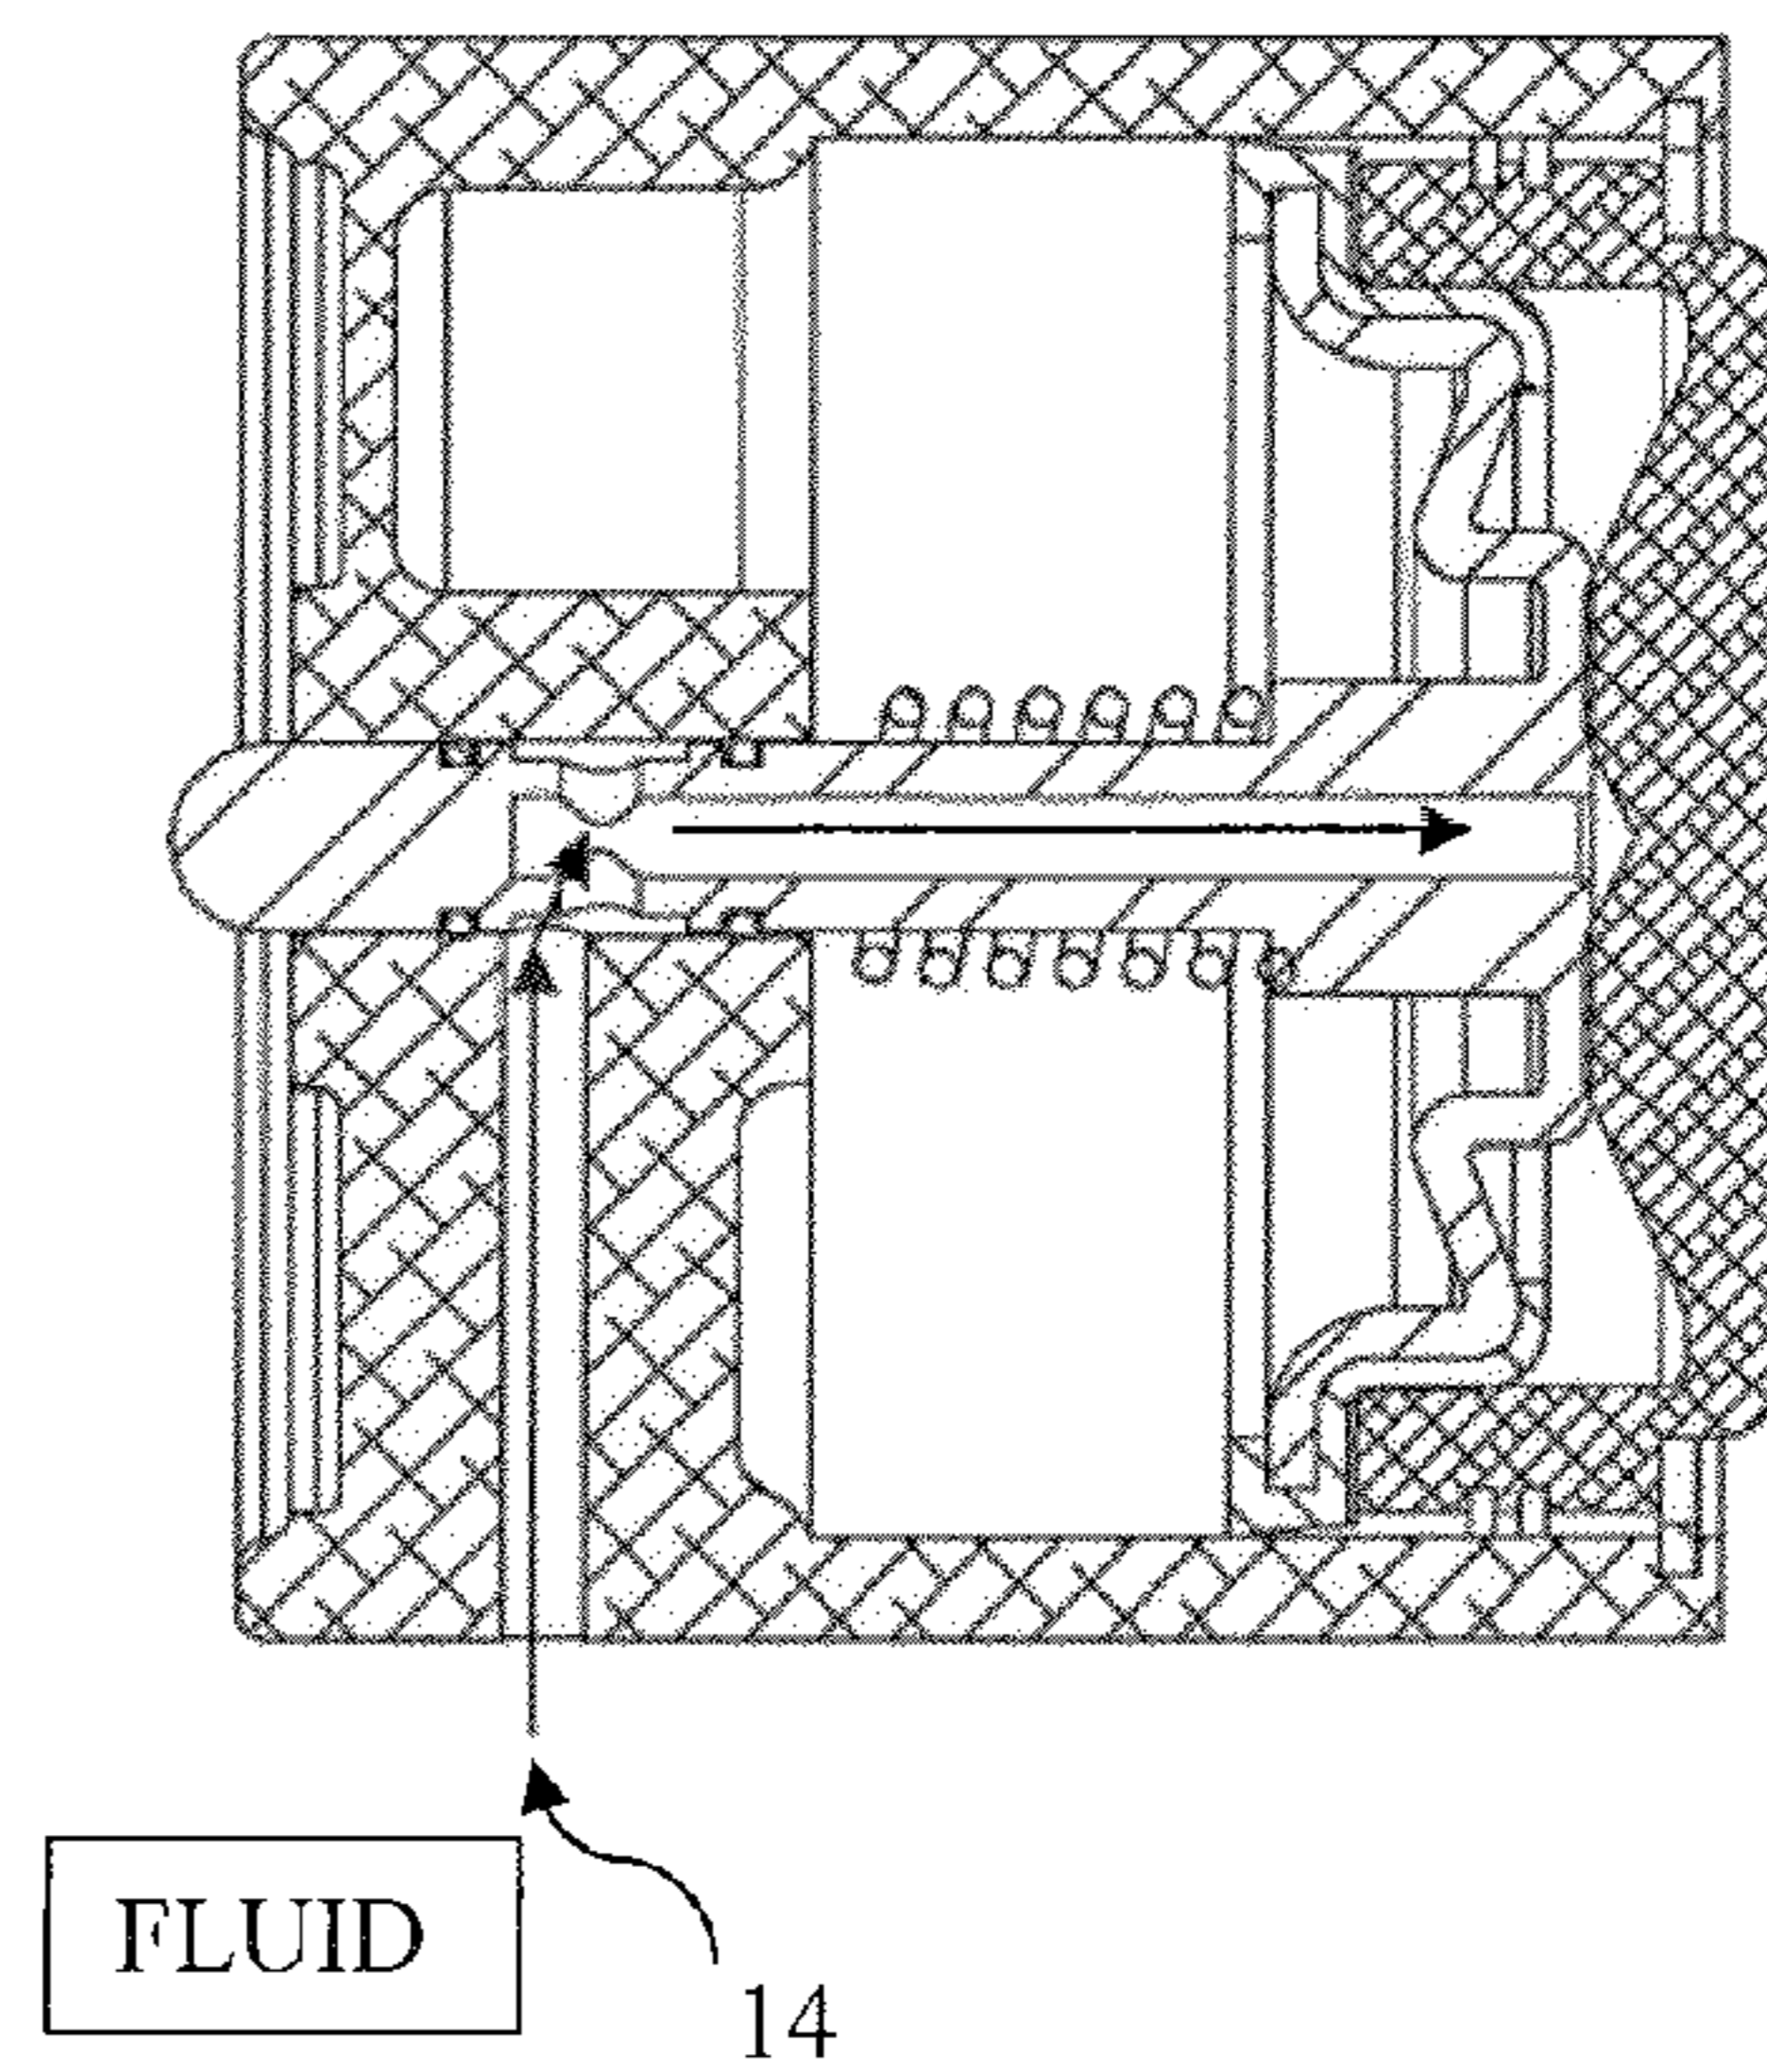
FIGS. 17 & 18 are cross sections showing modified parts with o-ring grooves and o-rings sealing against the bore;
