US009186757B2

(54) **METHOD OF PROVIDING A TURBINE
BLADE TIP REPAIR**

(73) Assignee: **Siemens Energy, Inc.**, Orlando, FL (US)

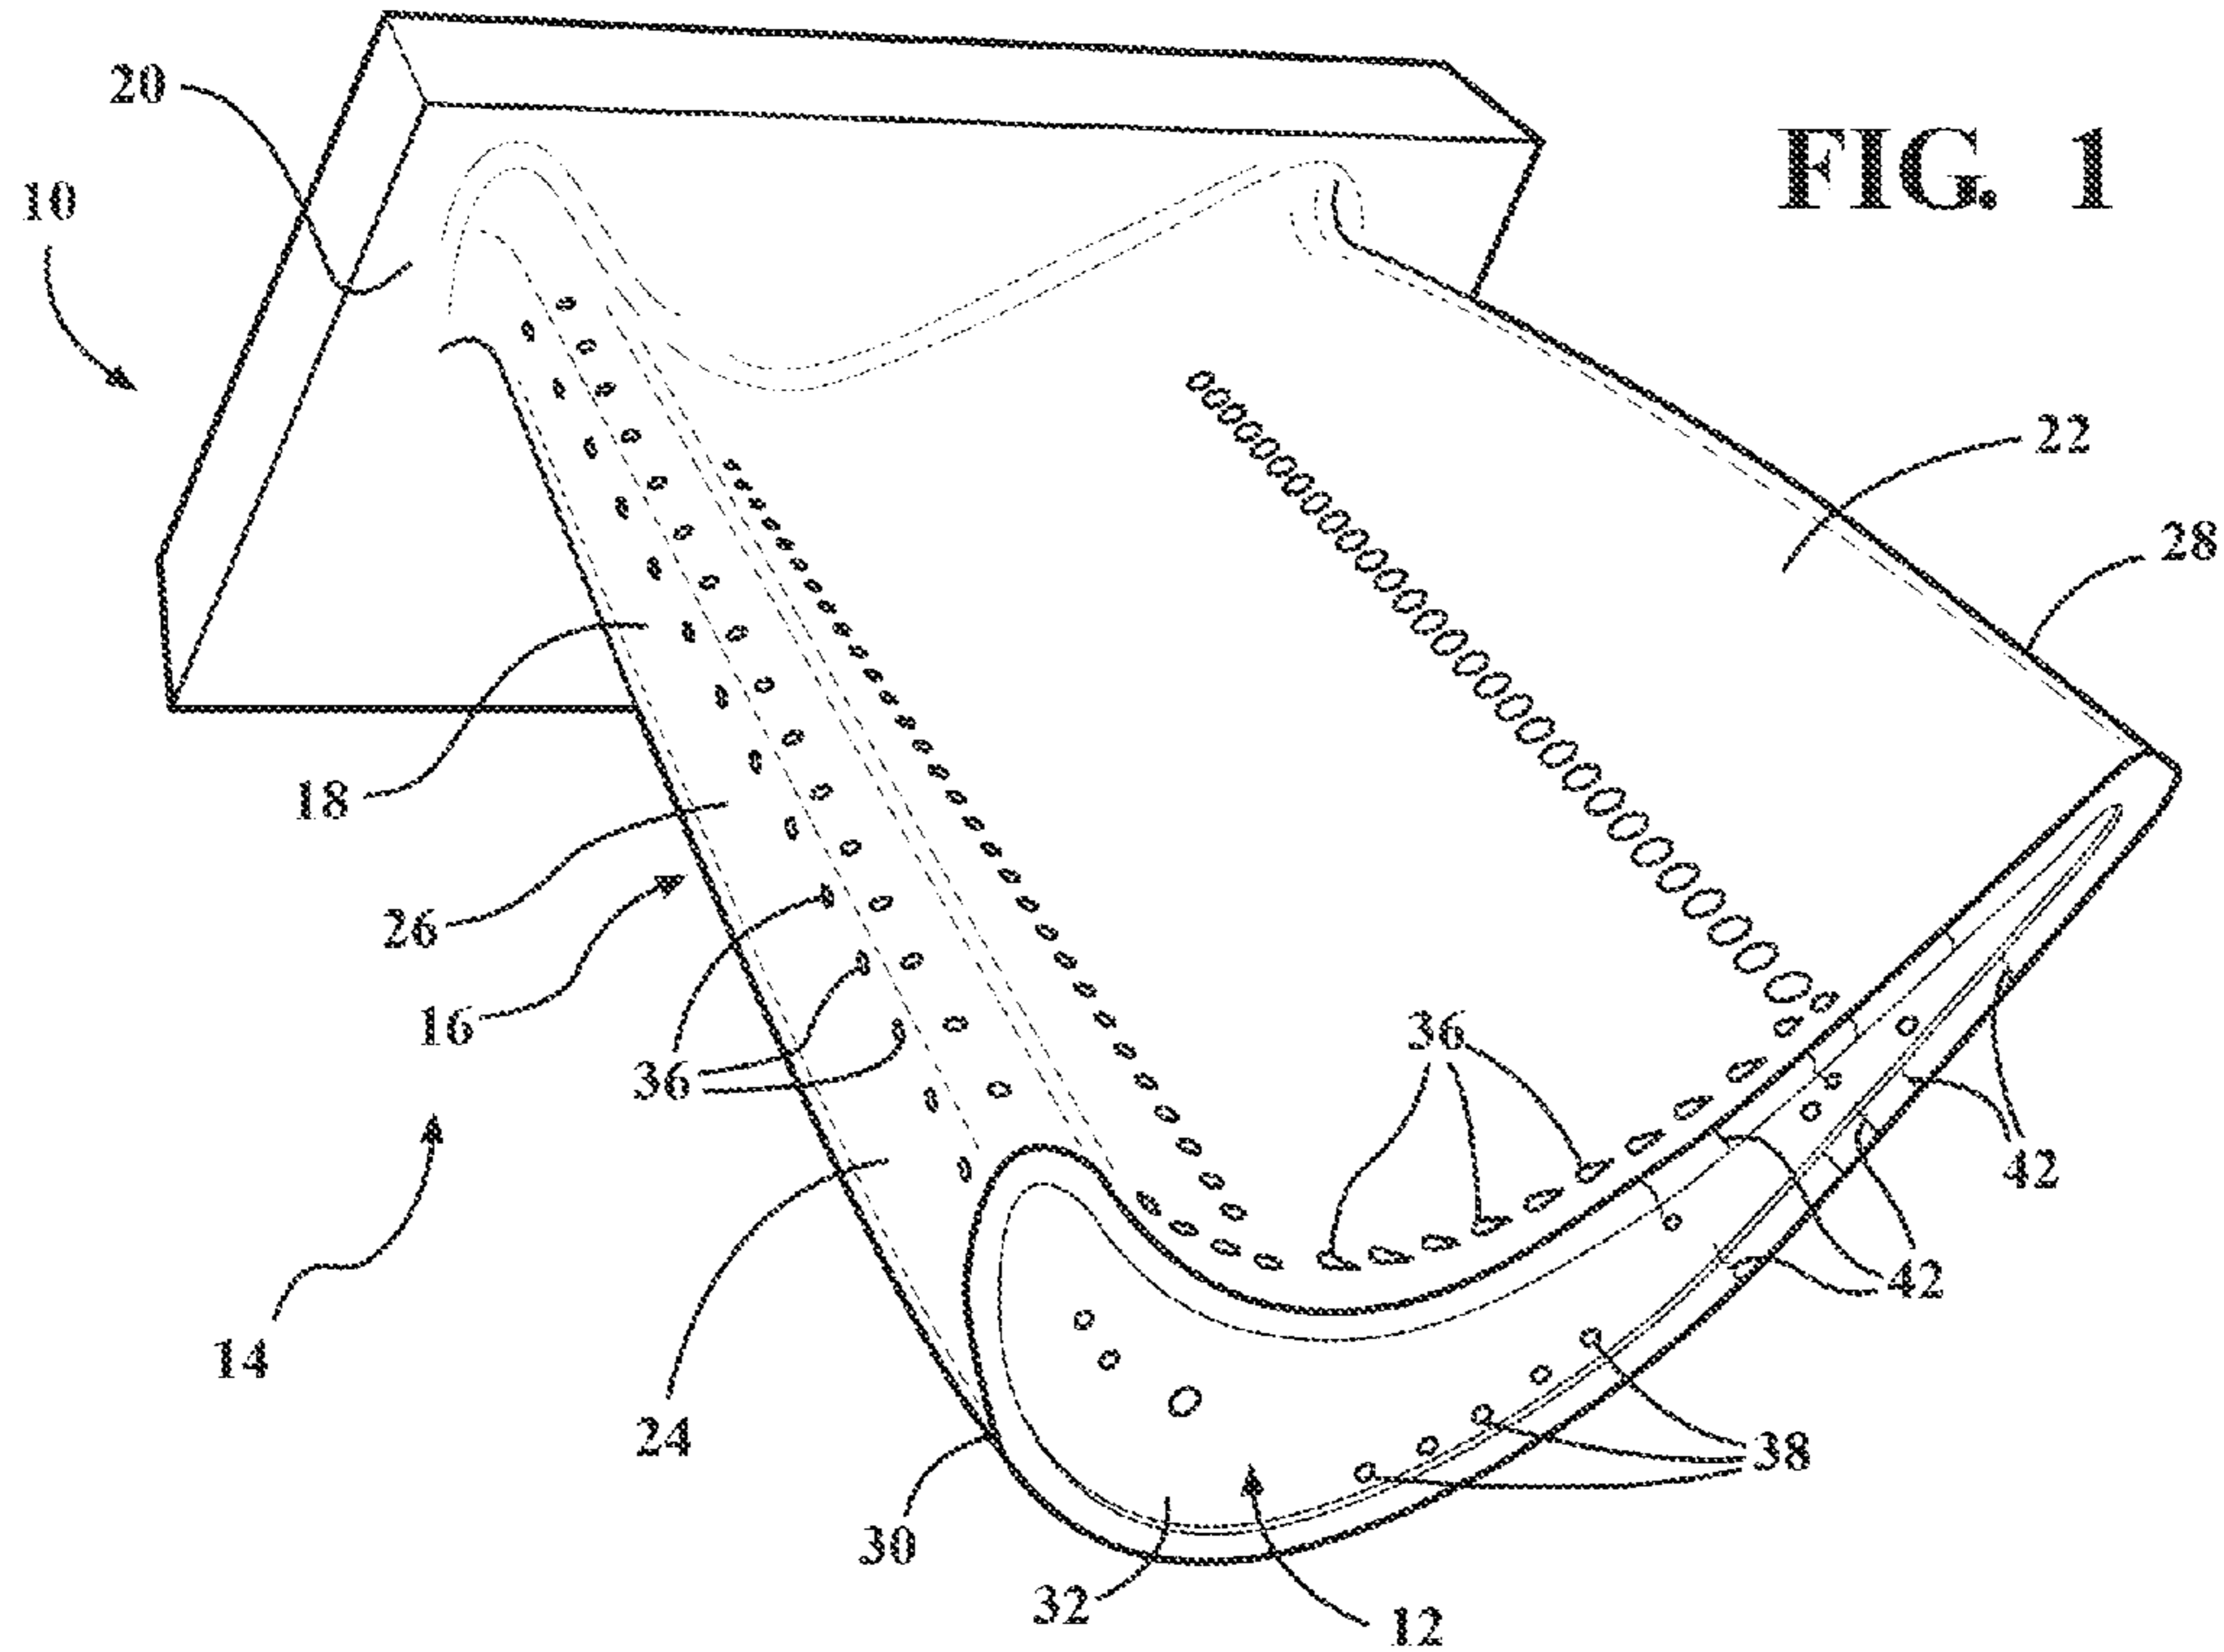
FIG. 1 is a perspective view of a prior art turbine blade having cracks formed in the blade tip;

Reference is now made to FIG. 1 which shows a turbine blade 10 in a gas turbine engine (not shown), wherein the blade 10 includes a damaged blade tip 12, such as may be identified during a routine maintenance inspection of the engine. The turbine blade 10 is one of a plurality of turbine blades 14 that are circumferentially aligned in the gas turbine engine. The turbine blade 10 comprises an airfoil 16 extending radially outwardly from a mounting location such as a rotor disk of a rotor assembly (not shown). The airfoil 16 includes an airfoil outer wall 18 extending in a radial direction from a blade platform 20. The outer wall 18 of the airfoil 16 is exposed to a high temperature working gas of the gas

turbine engine and comprises a pressure side wall 22 and an oppositely facing suction side wall 24. The pressure and suction side walls 22, 24 are joined together at chordally spaced apart leading and trailing edges 26, 28 of the airfoil 16. The blade tip 12 of the turbine blade 10 is located at a radially outer end of the outer wall 18, distal from the platform 20. The blade tip 12 includes a squealer portion 30 defining an outward extension of the airfoil outer wall 18. The blade tip 12 further comprises a tip cap 32 that is recessed from a radially outer end of the squealer portion 30, as shown in FIGS. 1 and 2A. The tip cap 32 defines a closure over an opening formed at a radially outer end of the airfoil outer wall 18 to define a closed internal cavity 34 at the blade tip 12, as shown in FIGS. 2A and 2C-G.

Referring again to FIG. 1, thermally and mechanically induced stresses, such as may be present during normal operation of the gas turbine engine, may result in damage to the squealer portion 30 and tip cap 32 of the turbine blade 10 in the form of cracks 42 at the blade tip 12. A turbine blade 10 exhibiting such cracks, such as may be observed during a routine inspection of the engine, is typically removed from the engine and repaired or refurbished for reinstallation in an engine. In accordance with aspects of the present invention, a method of repairing a turbine blade is described, including providing a durable tip cap structure that limits or reduces stress cracking in the tip cap, whereby the service life of the blade may be extended.
