US009186757B2

(54) **METHOD OF PROVIDING A TURBINE
BLADE TIP REPAIR**

(73) Assignee: **Siemens Energy, Inc.**, Orlando, FL (US)

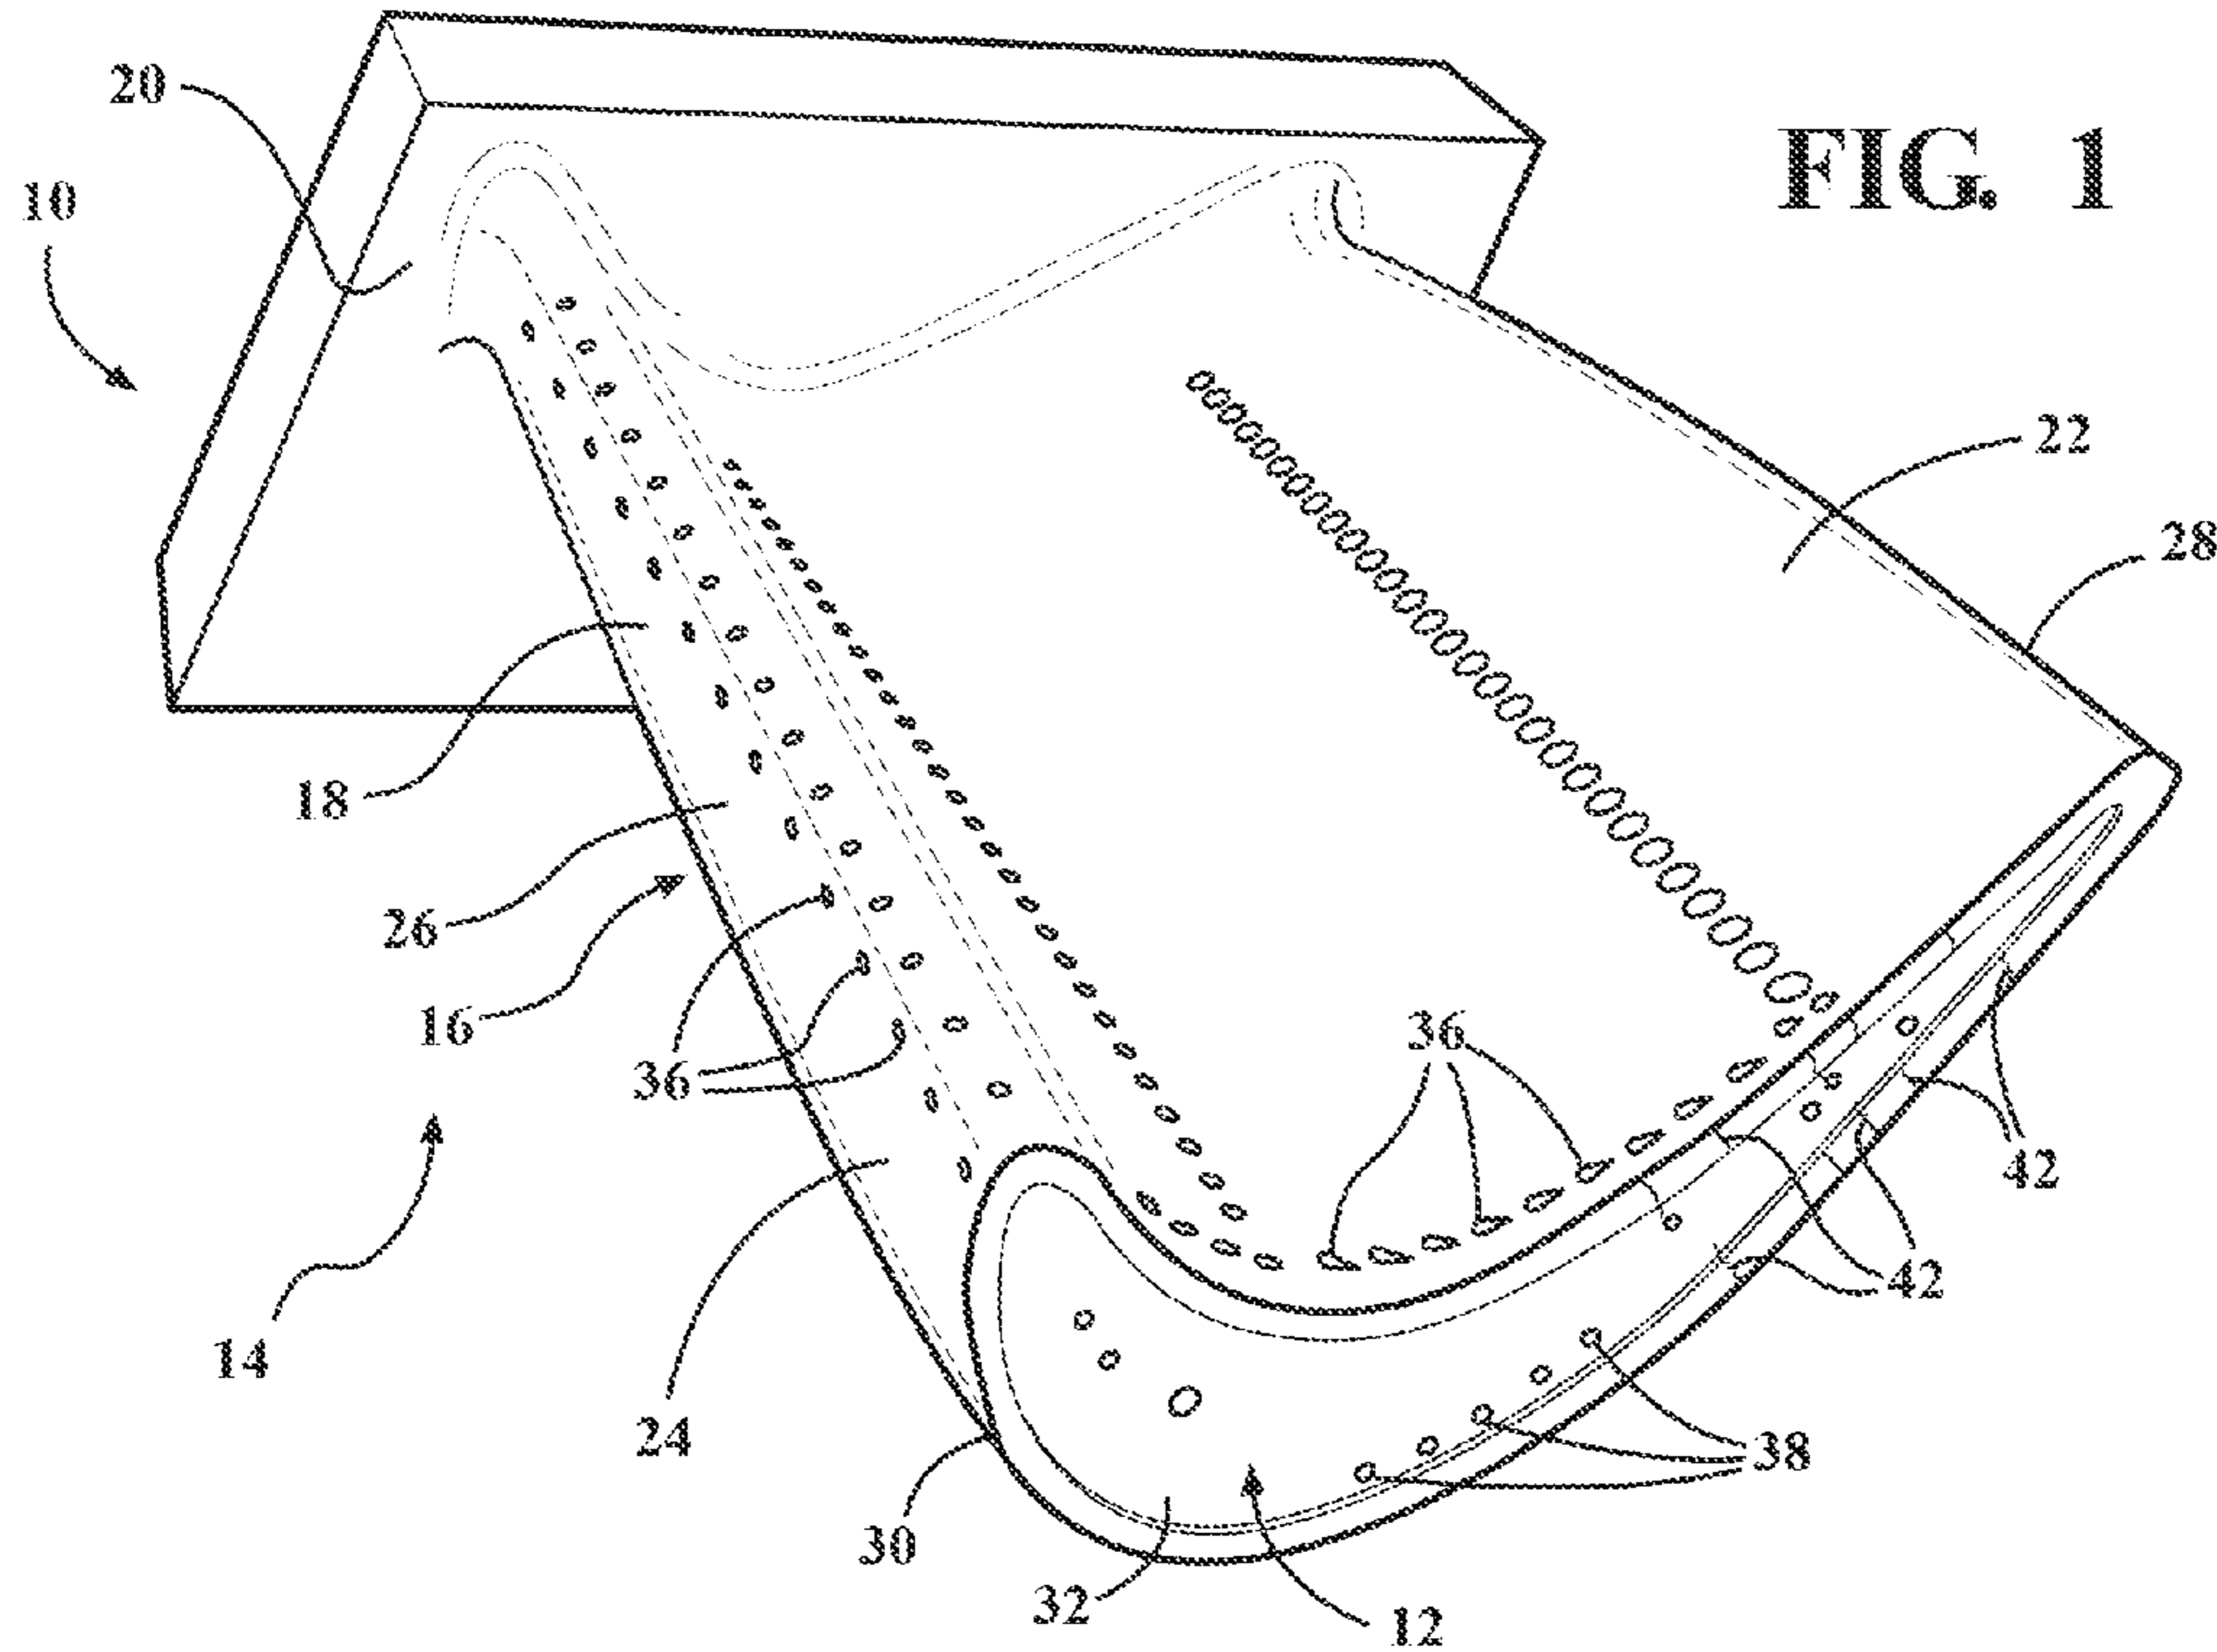
FIG. 1 is a perspective view of a prior art turbine blade having cracks formed in the blade tip;

Reference is now made to FIG. 1 which shows a turbine blade 10 in a gas turbine engine (not shown), wherein the blade 10 includes a damaged blade tip 12, such as may be identified during a routine maintenance inspection of the engine. The turbine blade 10 is one of a plurality of turbine blades 14 that are circumferentially aligned in the gas turbine engine. The turbine blade 10 comprises an airfoil 16 extending radially outwardly from a mounting location such as a rotor disk of a rotor assembly (not shown). The airfoil 16 includes an airfoil outer wall 18 extending in a radial direction from a blade platform 20. The outer wall 18 of the airfoil 16 is exposed to a high temperature working gas of the gas

Referring again to FIG. 1, thermally and mechanically induced stresses, such as may be present during normal operation of the gas turbine engine, may result in damage to the squealer portion 30 and tip cap 32 of the turbine blade 10 in the form of cracks 42 at the blade tip 12. A turbine blade 10 exhibiting such cracks, such as may be observed during a routine inspection of the engine, is typically removed from the engine and repaired or refurbished for reinstallation in an engine. In accordance with aspects of the present invention, a method of repairing a turbine blade is described, including providing a durable tip cap structure that limits or reduces stress cracking in the tip cap, whereby the service life of the blade may be extended.

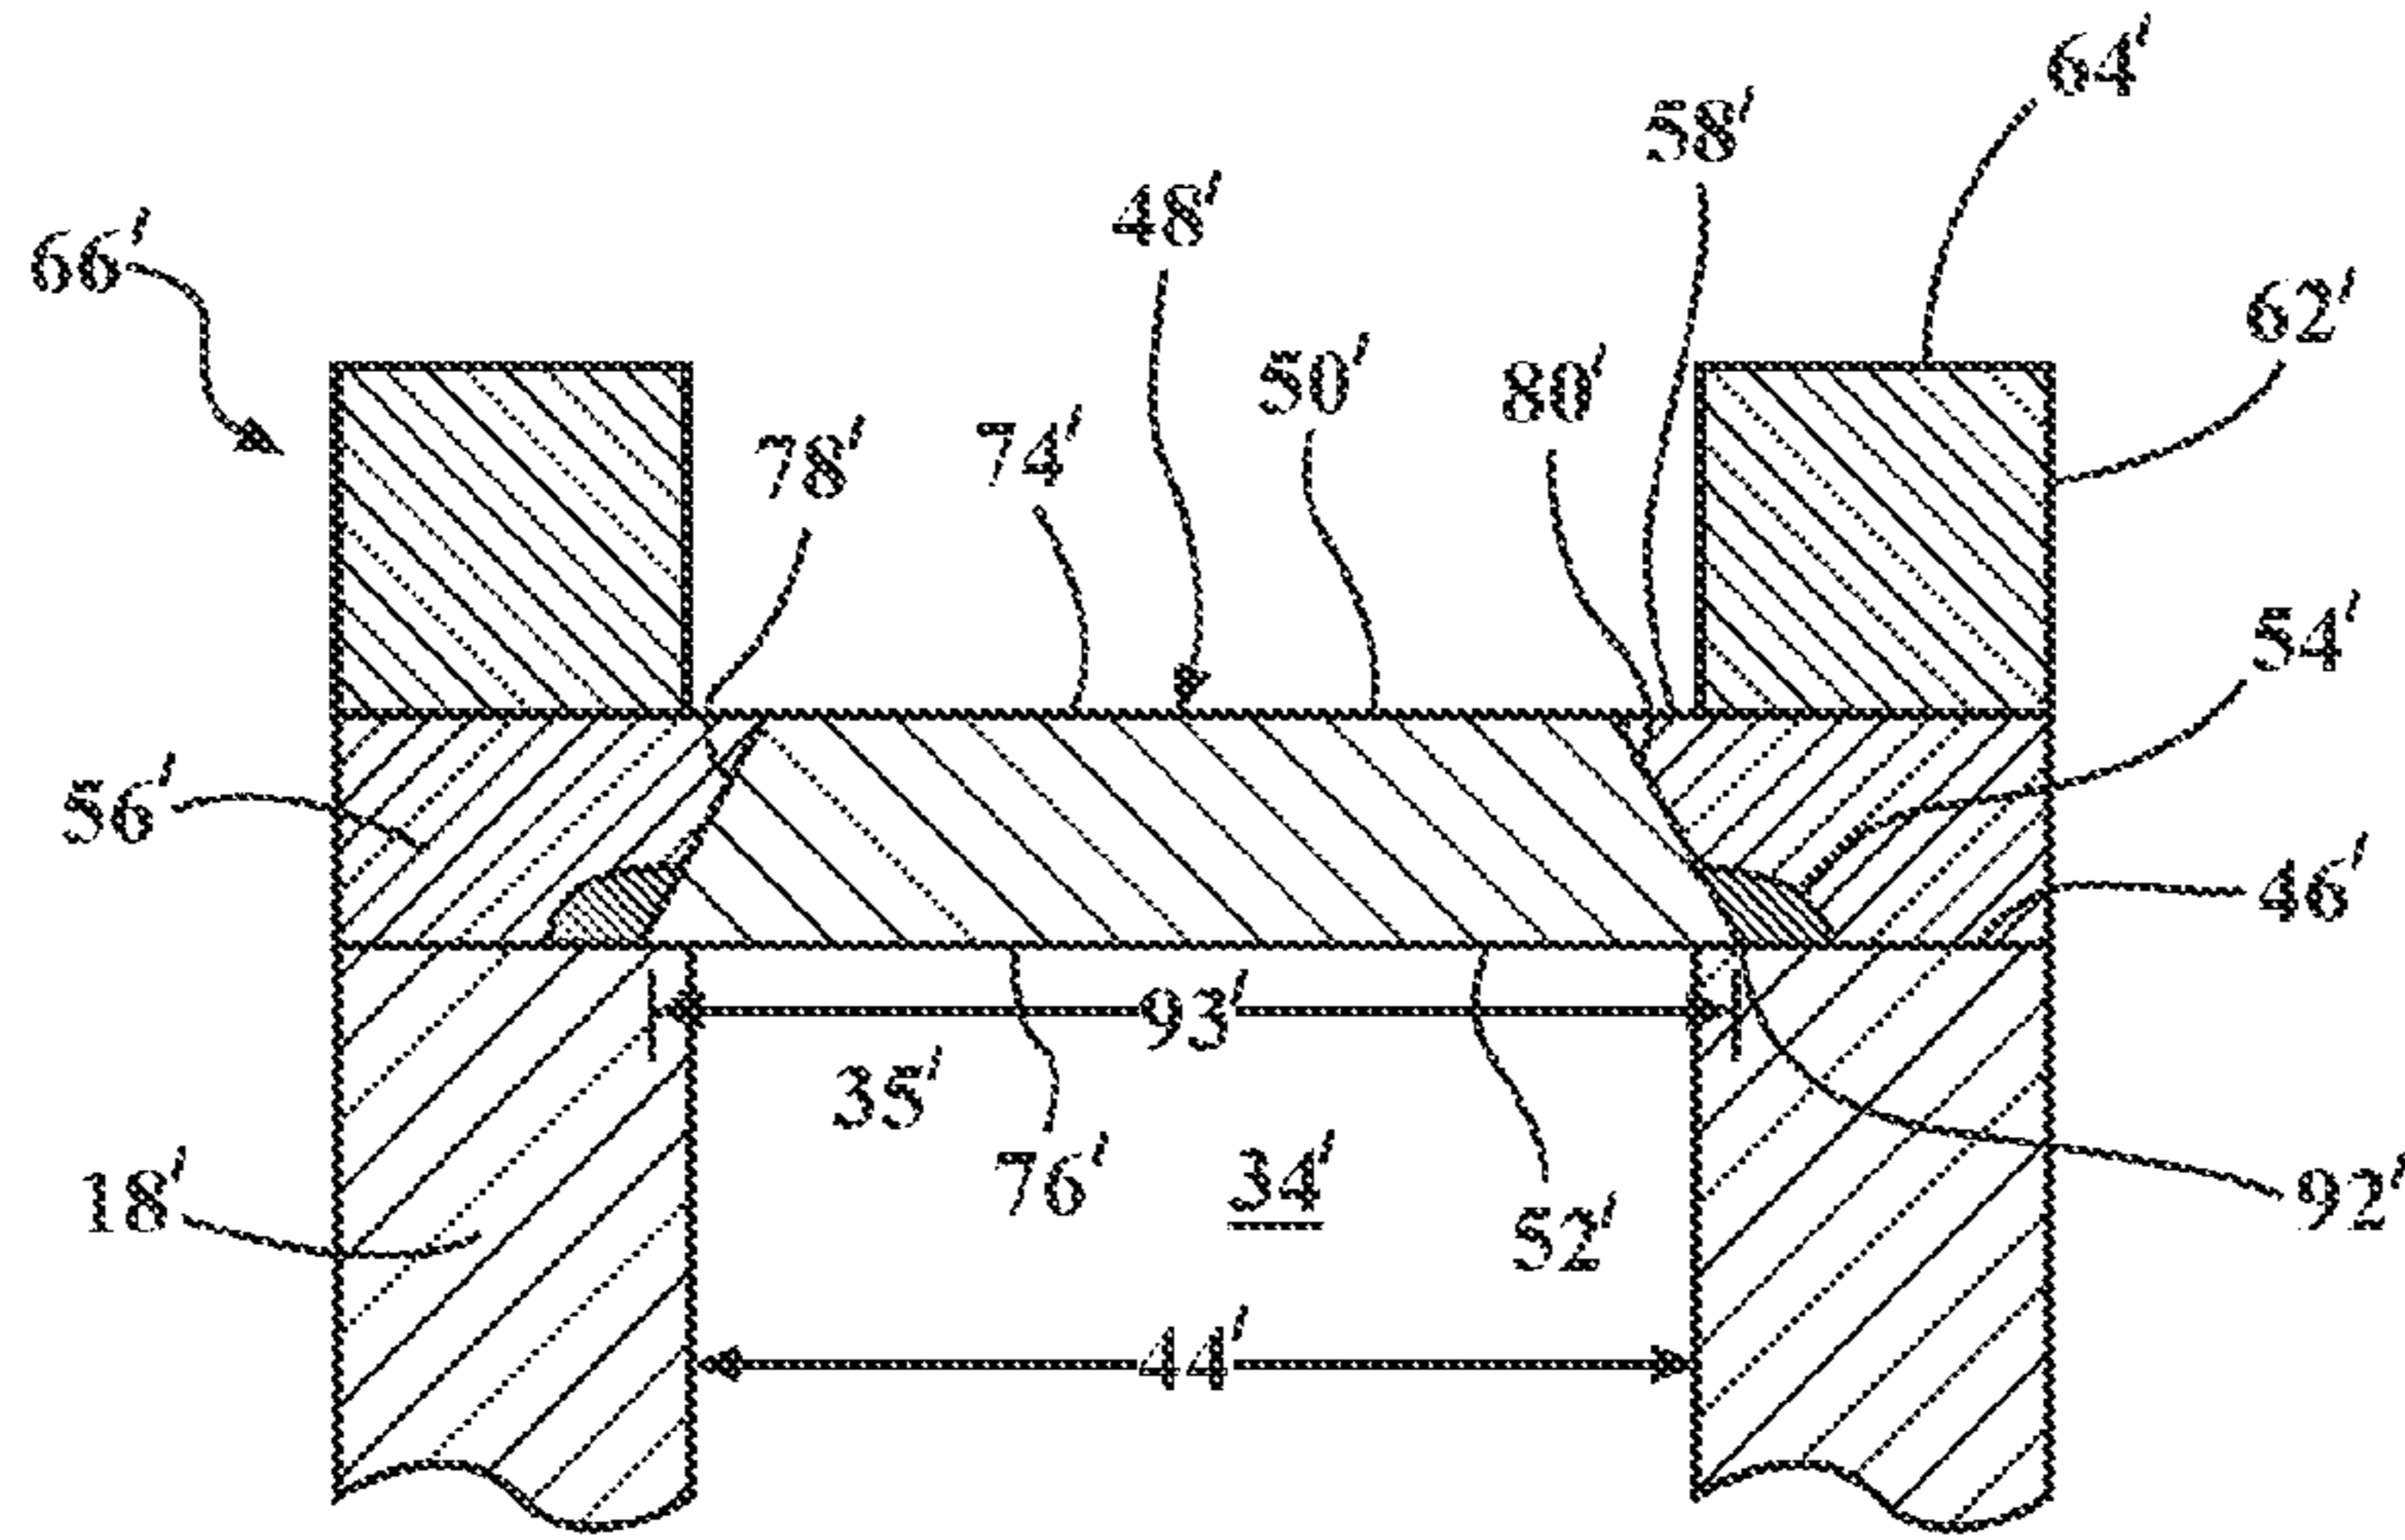
FIG. 3 is a cross-sectional view of a replacement turbine blade tip according to further aspects of the present invention;

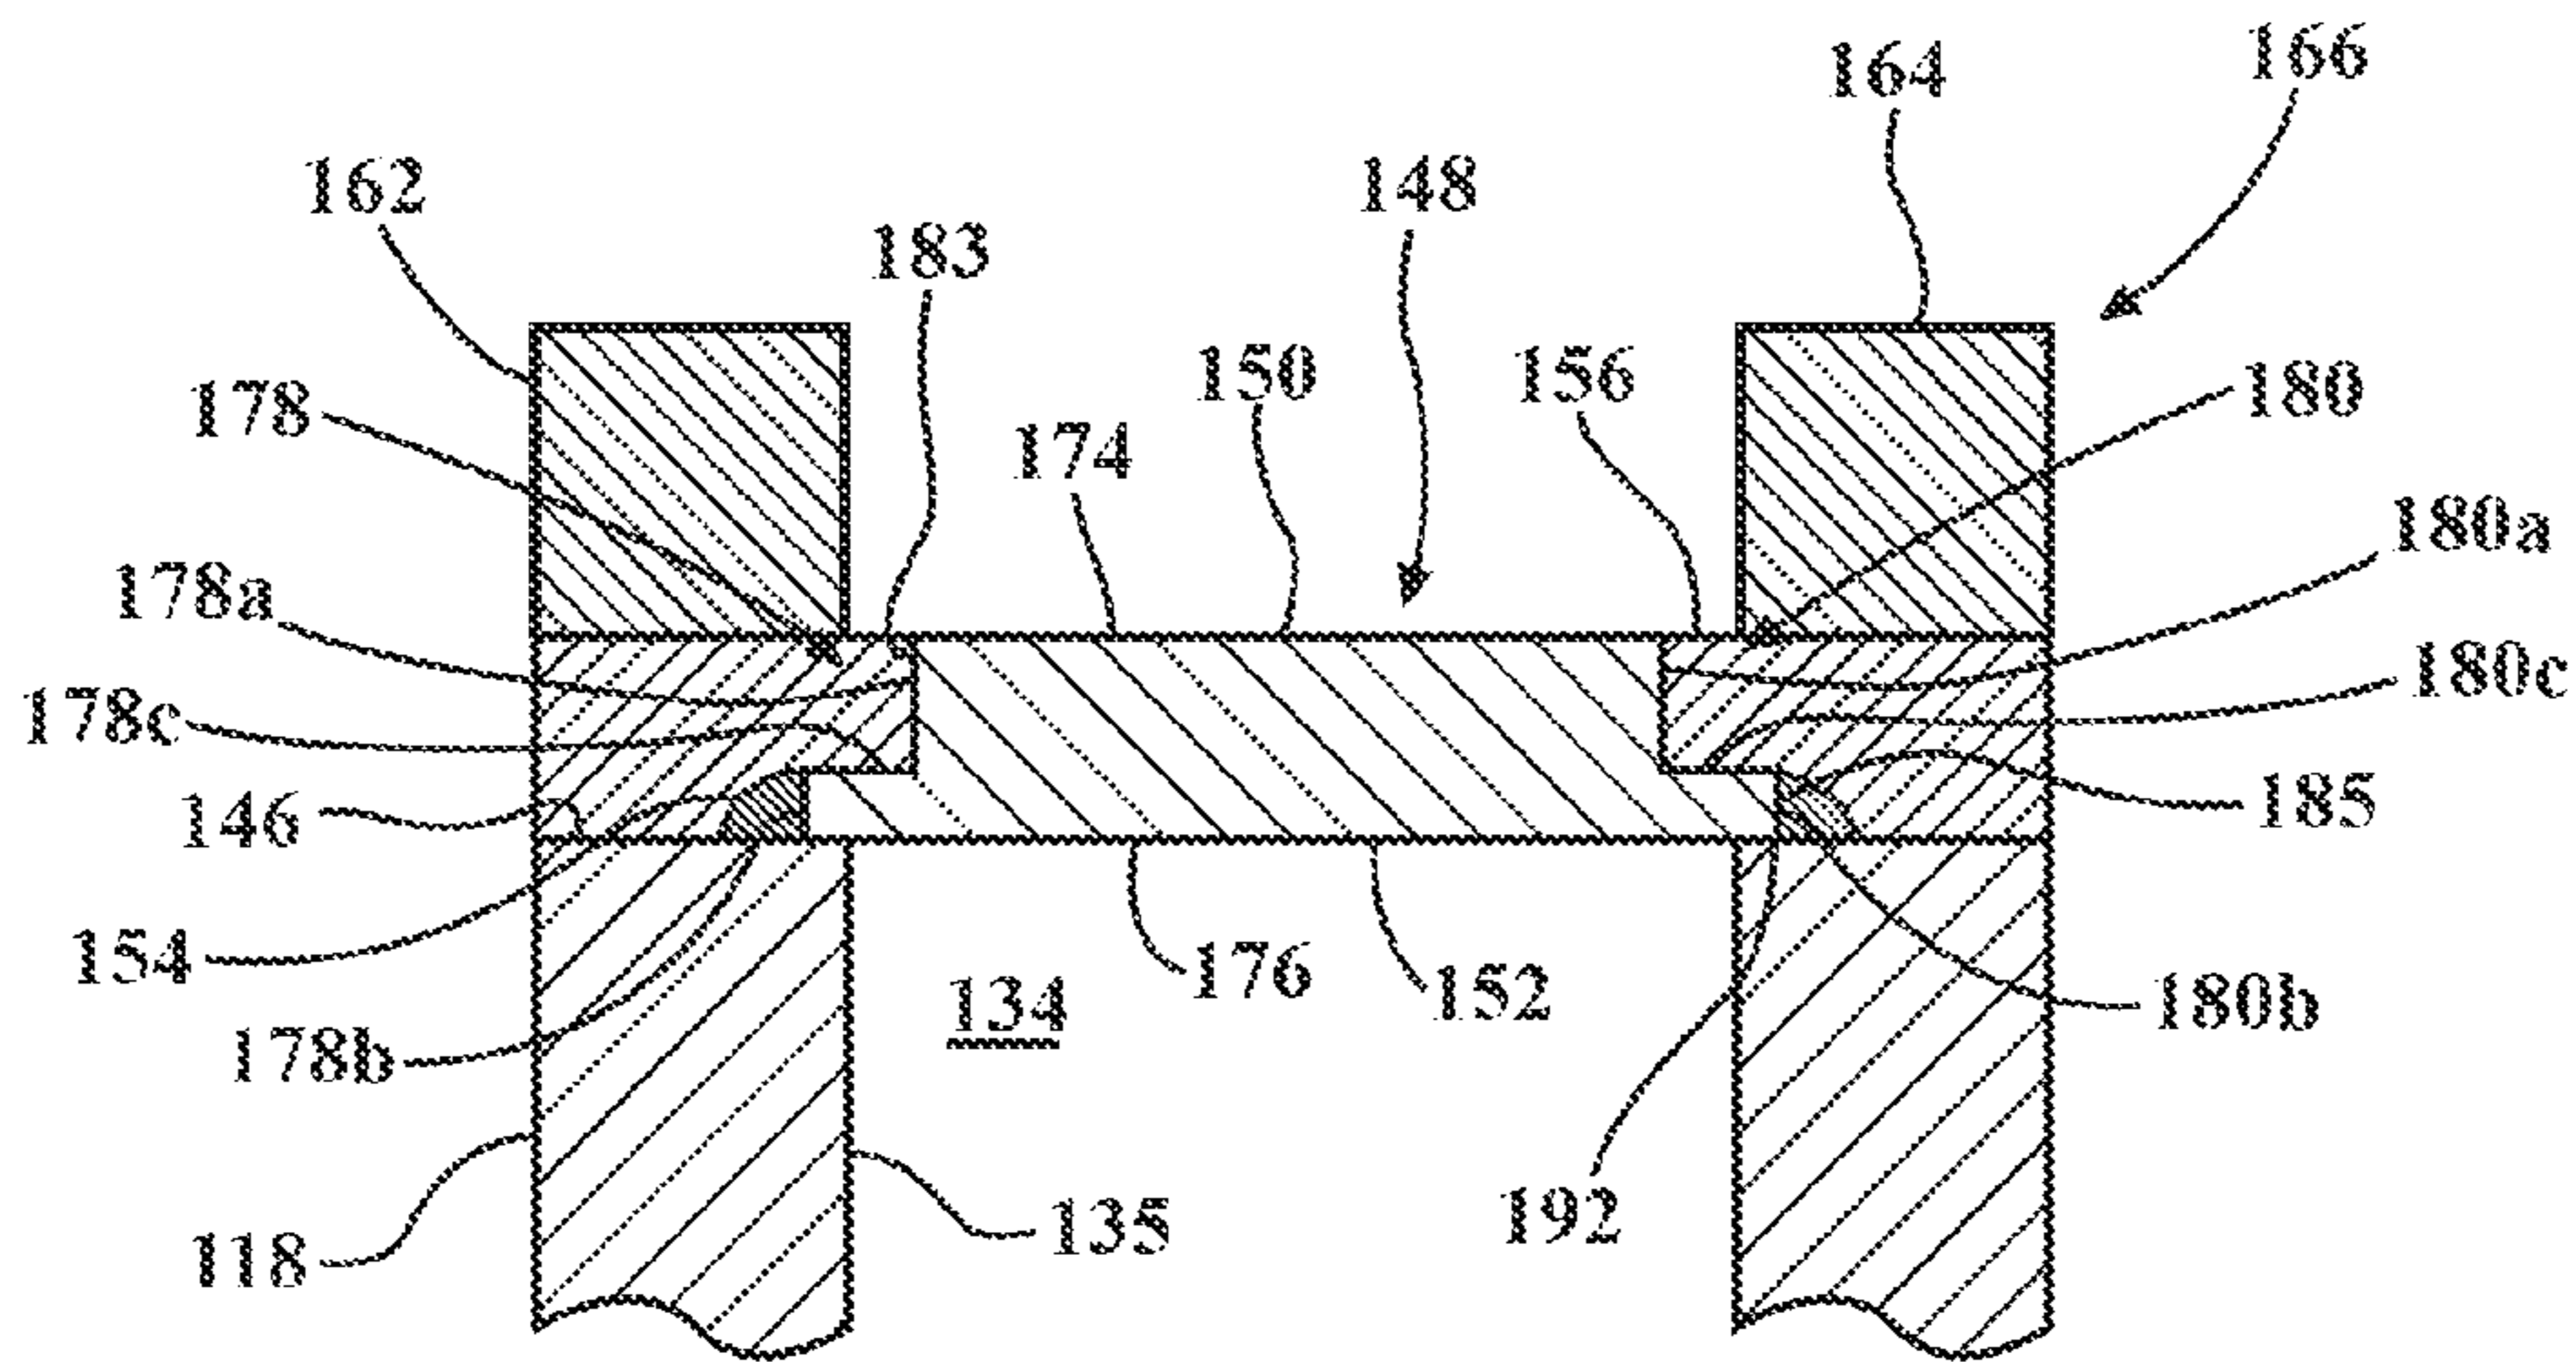
FIG. 4 is a cross-sectional view of a replacement turbine blade tip according to still further aspects of the present invention;

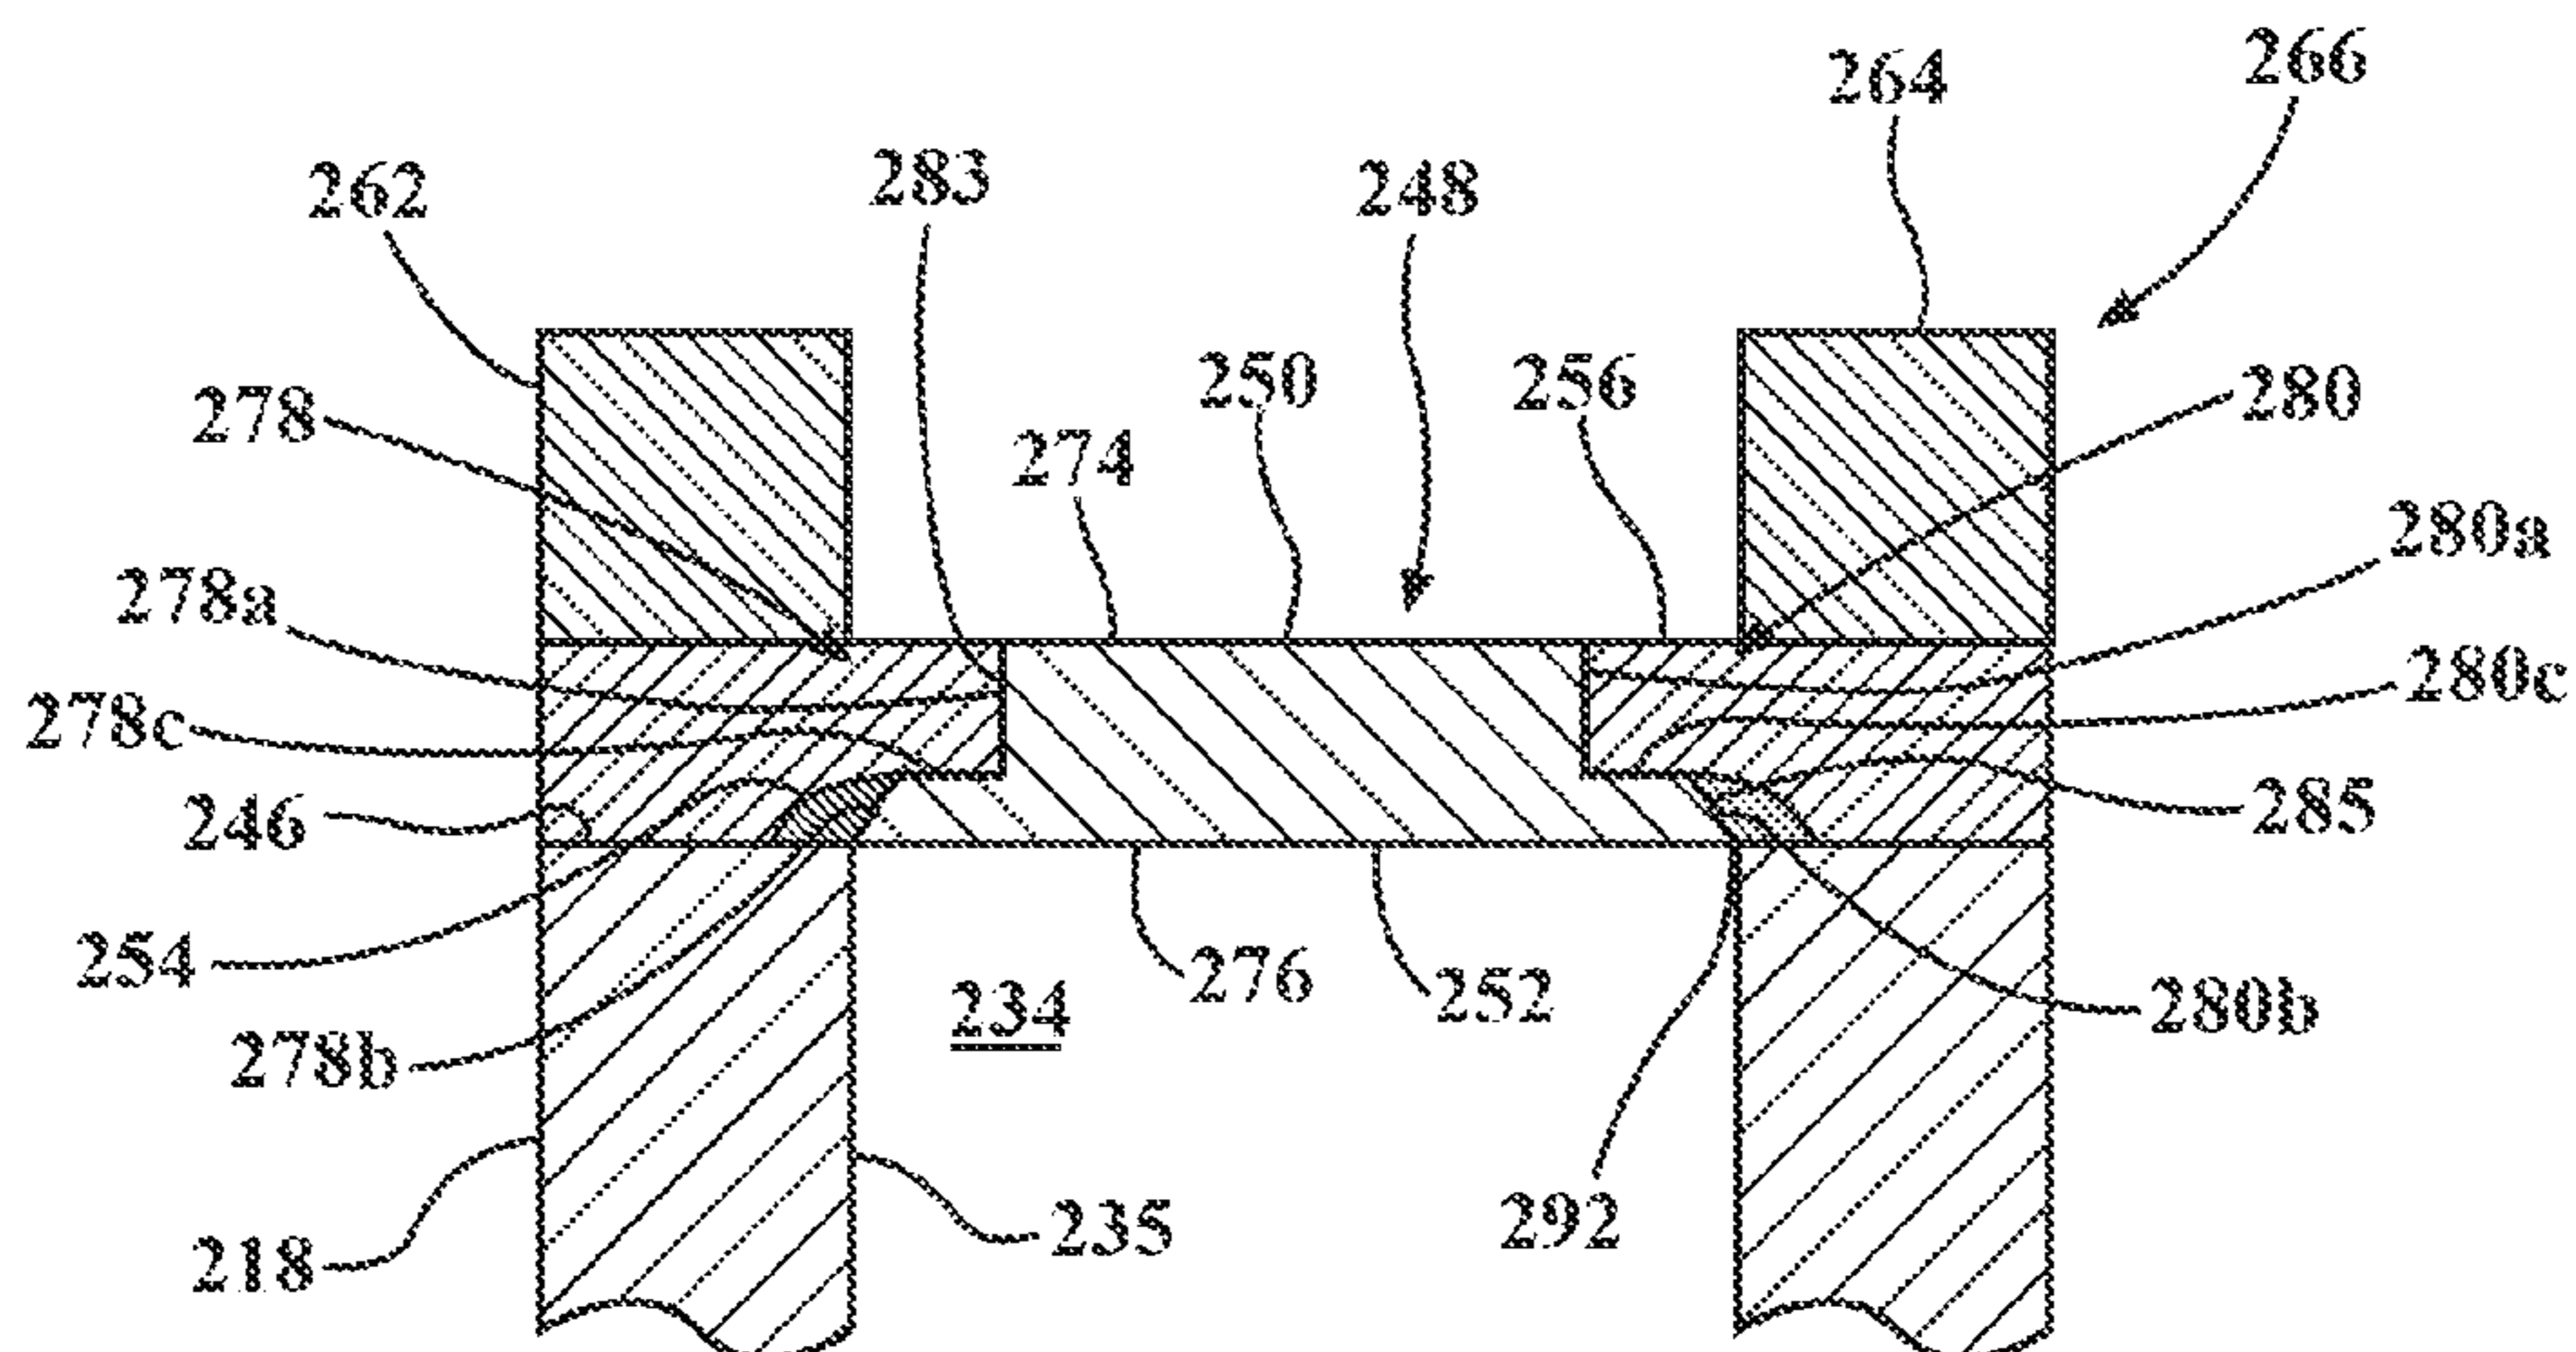
FIG. 5 is a cross-sectional view of a replacement turbine blade tip according to still further aspects of the present invention;

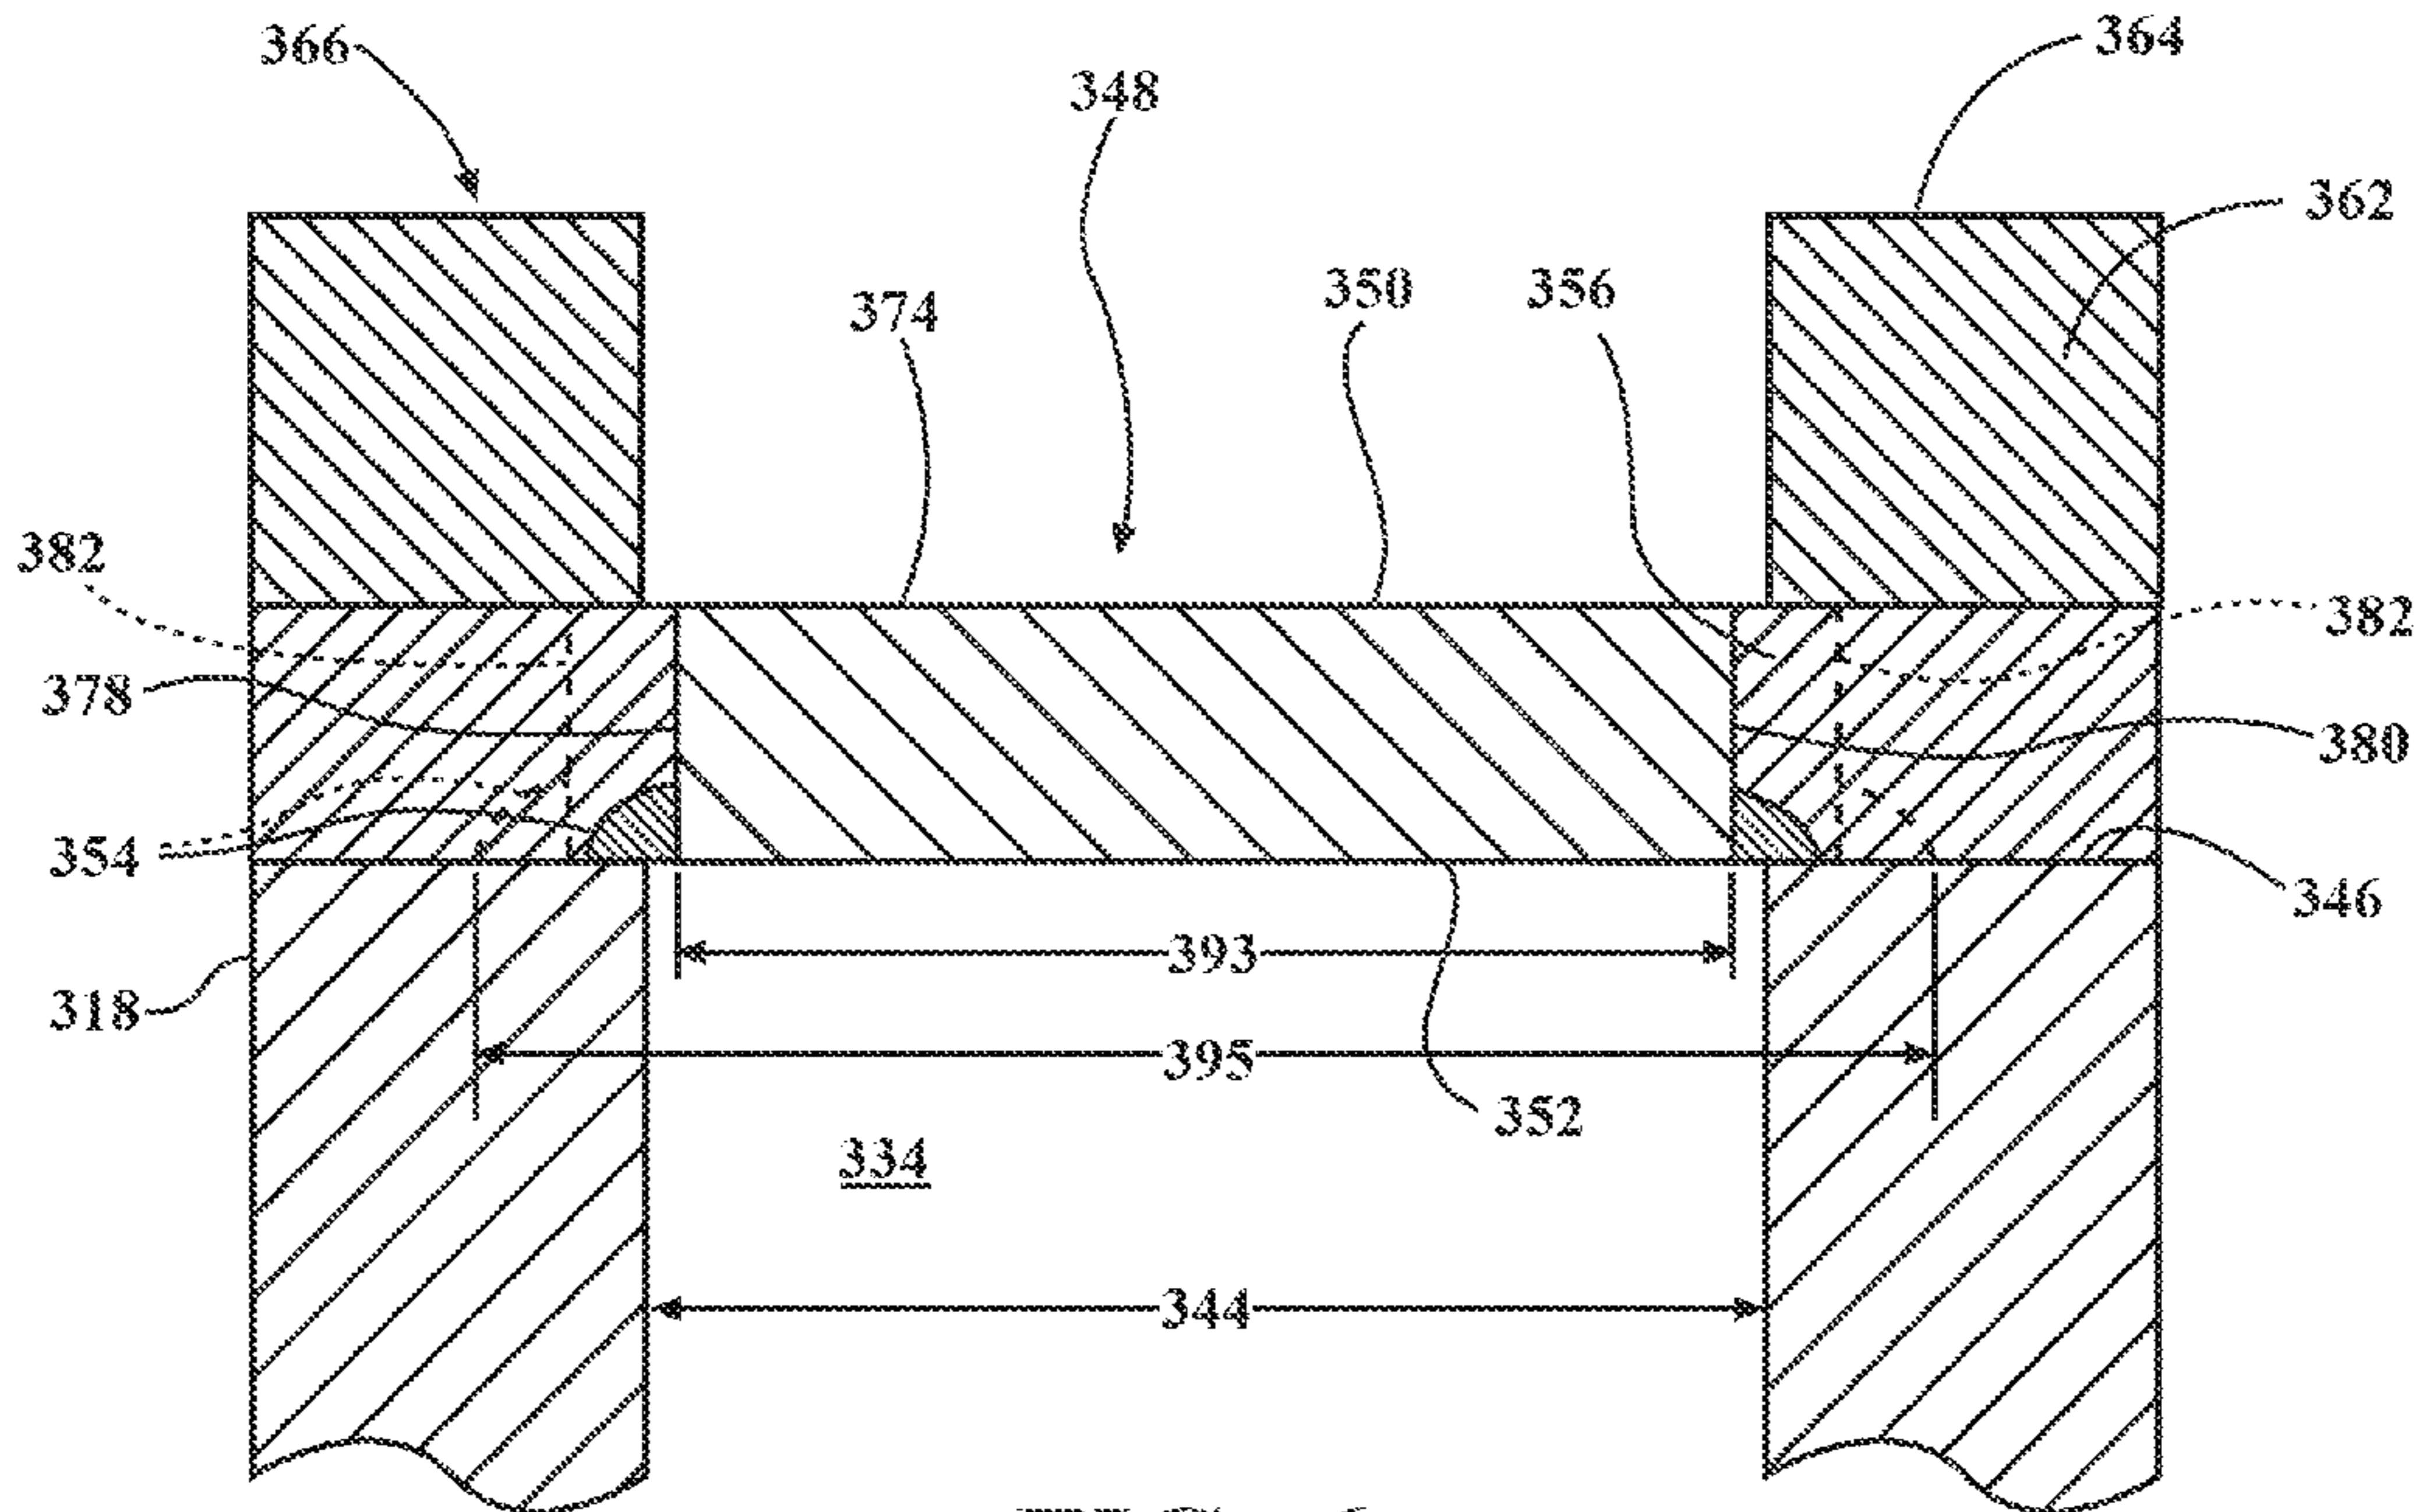
FIG. 6 is a cross-sectional view of a replacement turbine blade tip according to yet further aspects of the present invention;

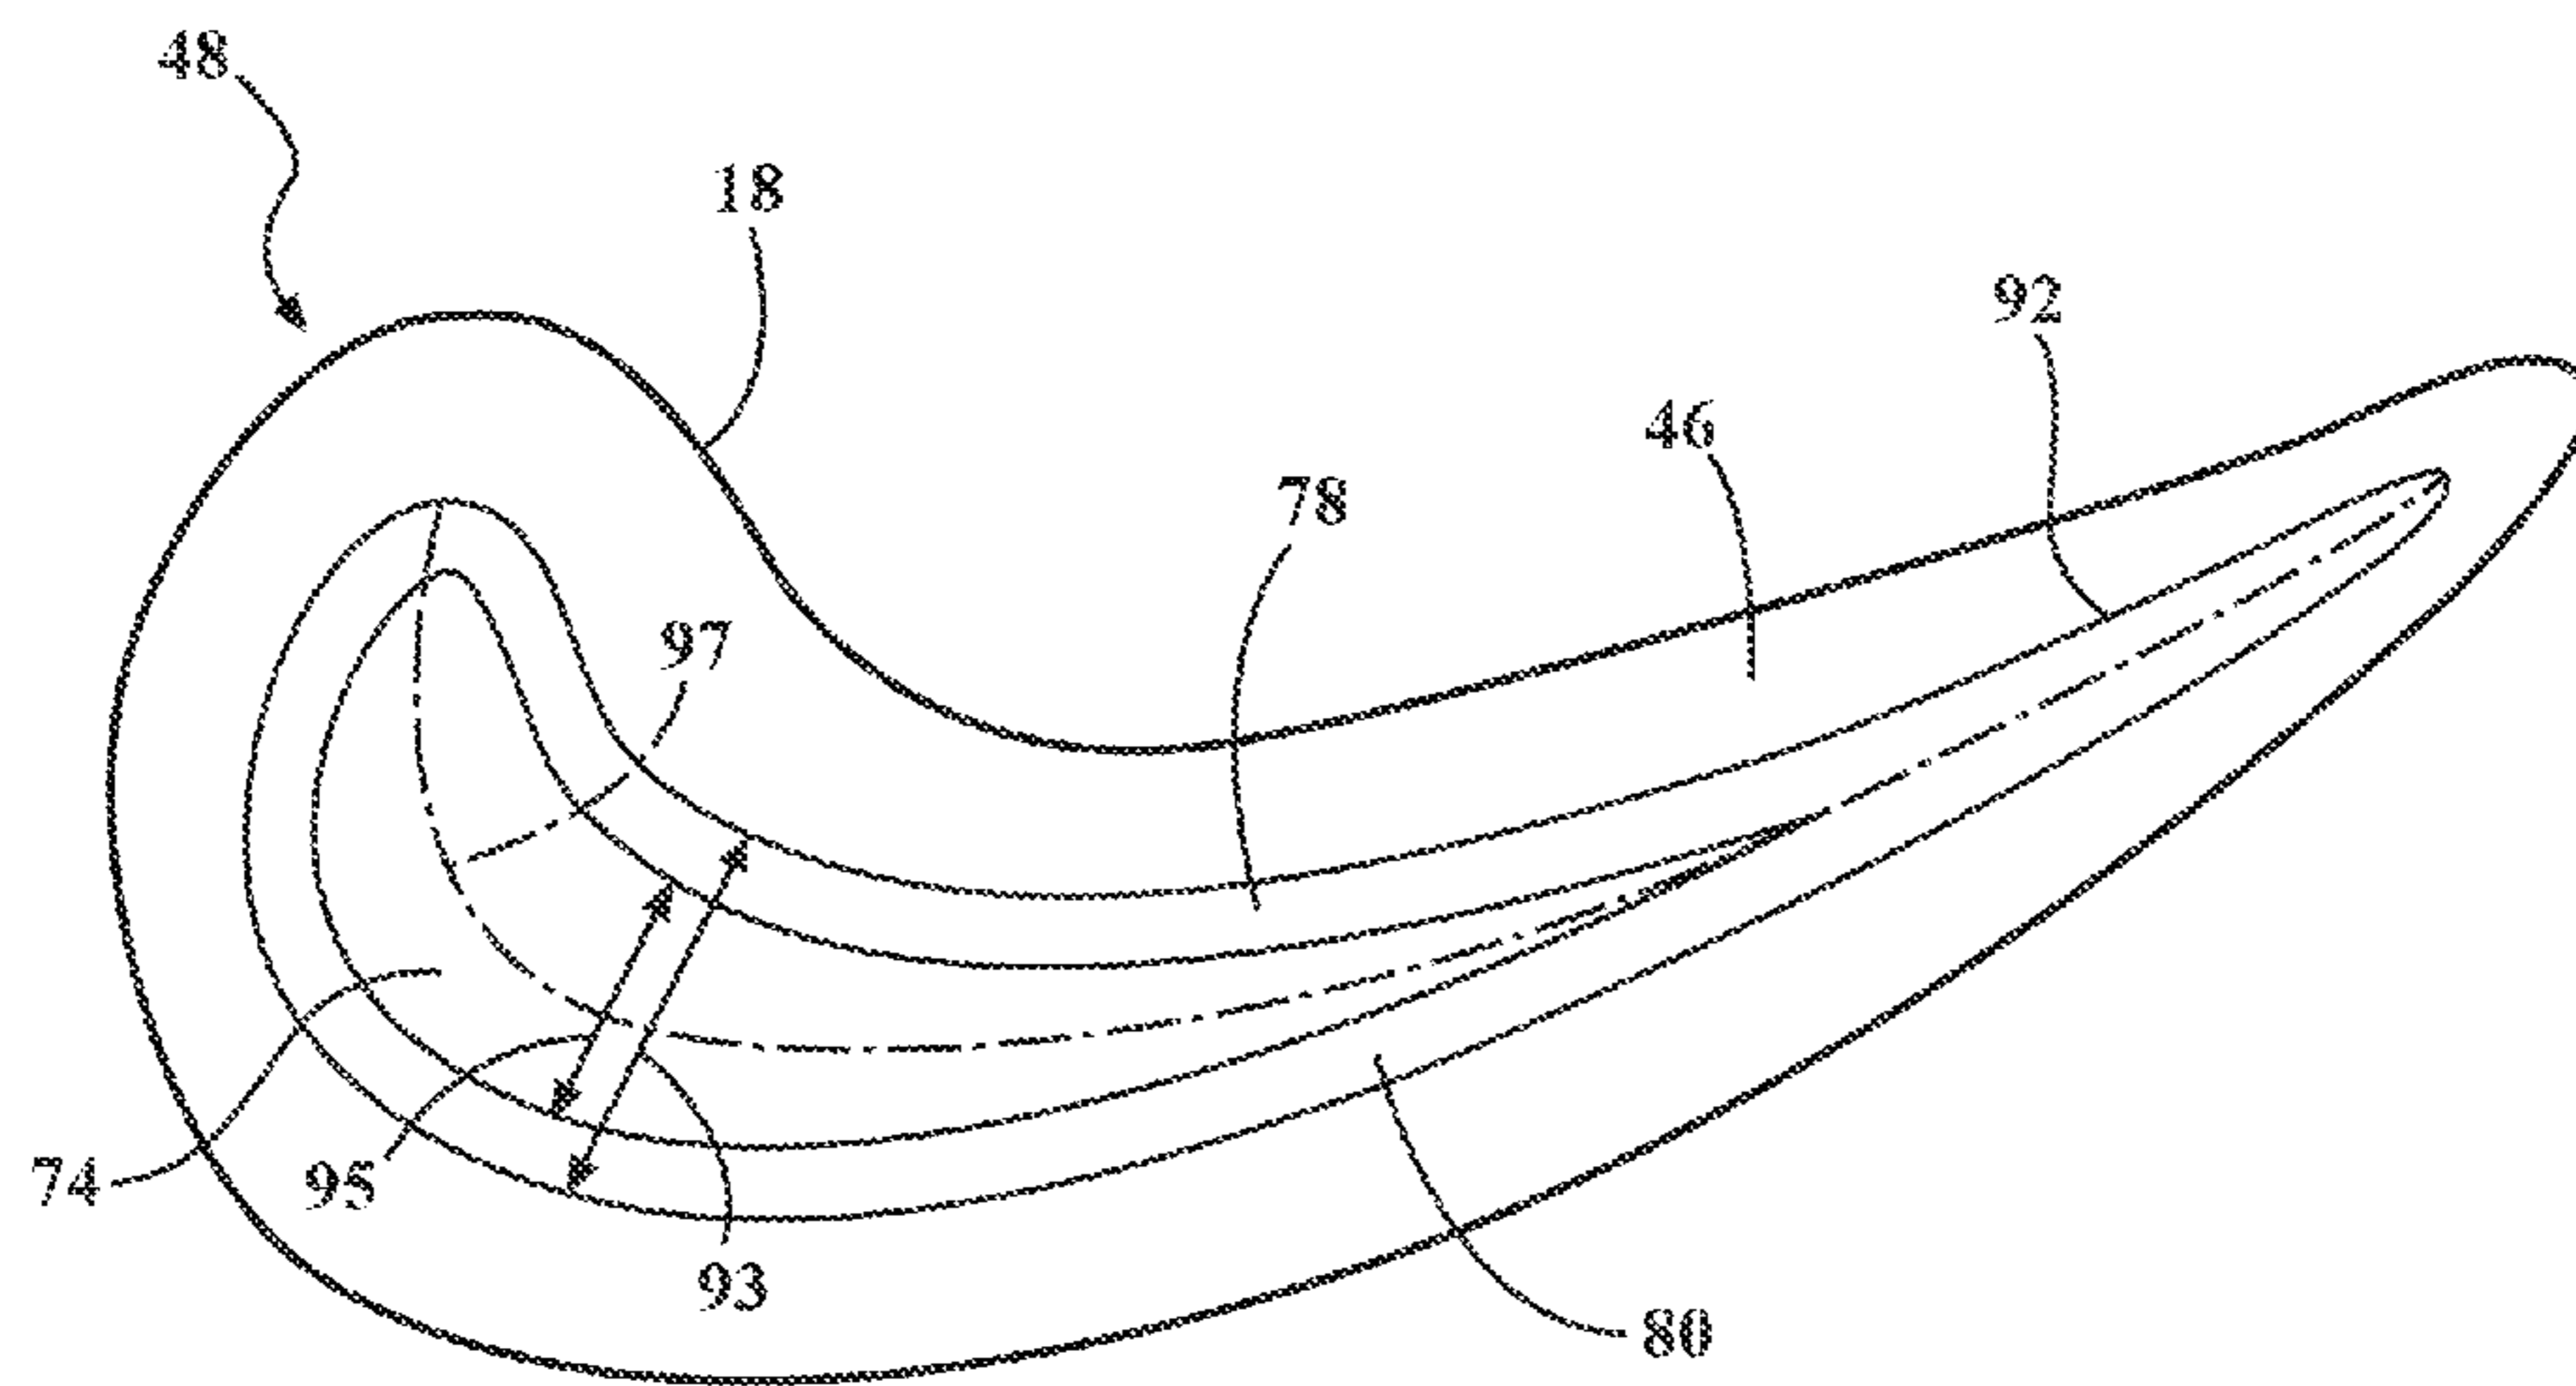
FIG. 7 is a plan view of a replacement tip cap corresponding to the replacement turbine blade tip shown in FIG. 2G, and shown in position on an outer wall of a turbine blade prior to attachment;

The replacement tip cap 48 defines a tip cap perimeter comprising an inner side perimeter 92 (FIG. 7) that is configured to generally correspond to an inner perimeter 35 of the internal cavity 34. In particular, the perimeter 92 of the replacement tip cap 48 may have an airfoil shape configured
