US009186757B2

(54) **METHOD OF PROVIDING A TURBINE
BLADE TIP REPAIR**

(73) Assignee: **Siemens Energy, Inc.**, Orlando, FL (US)

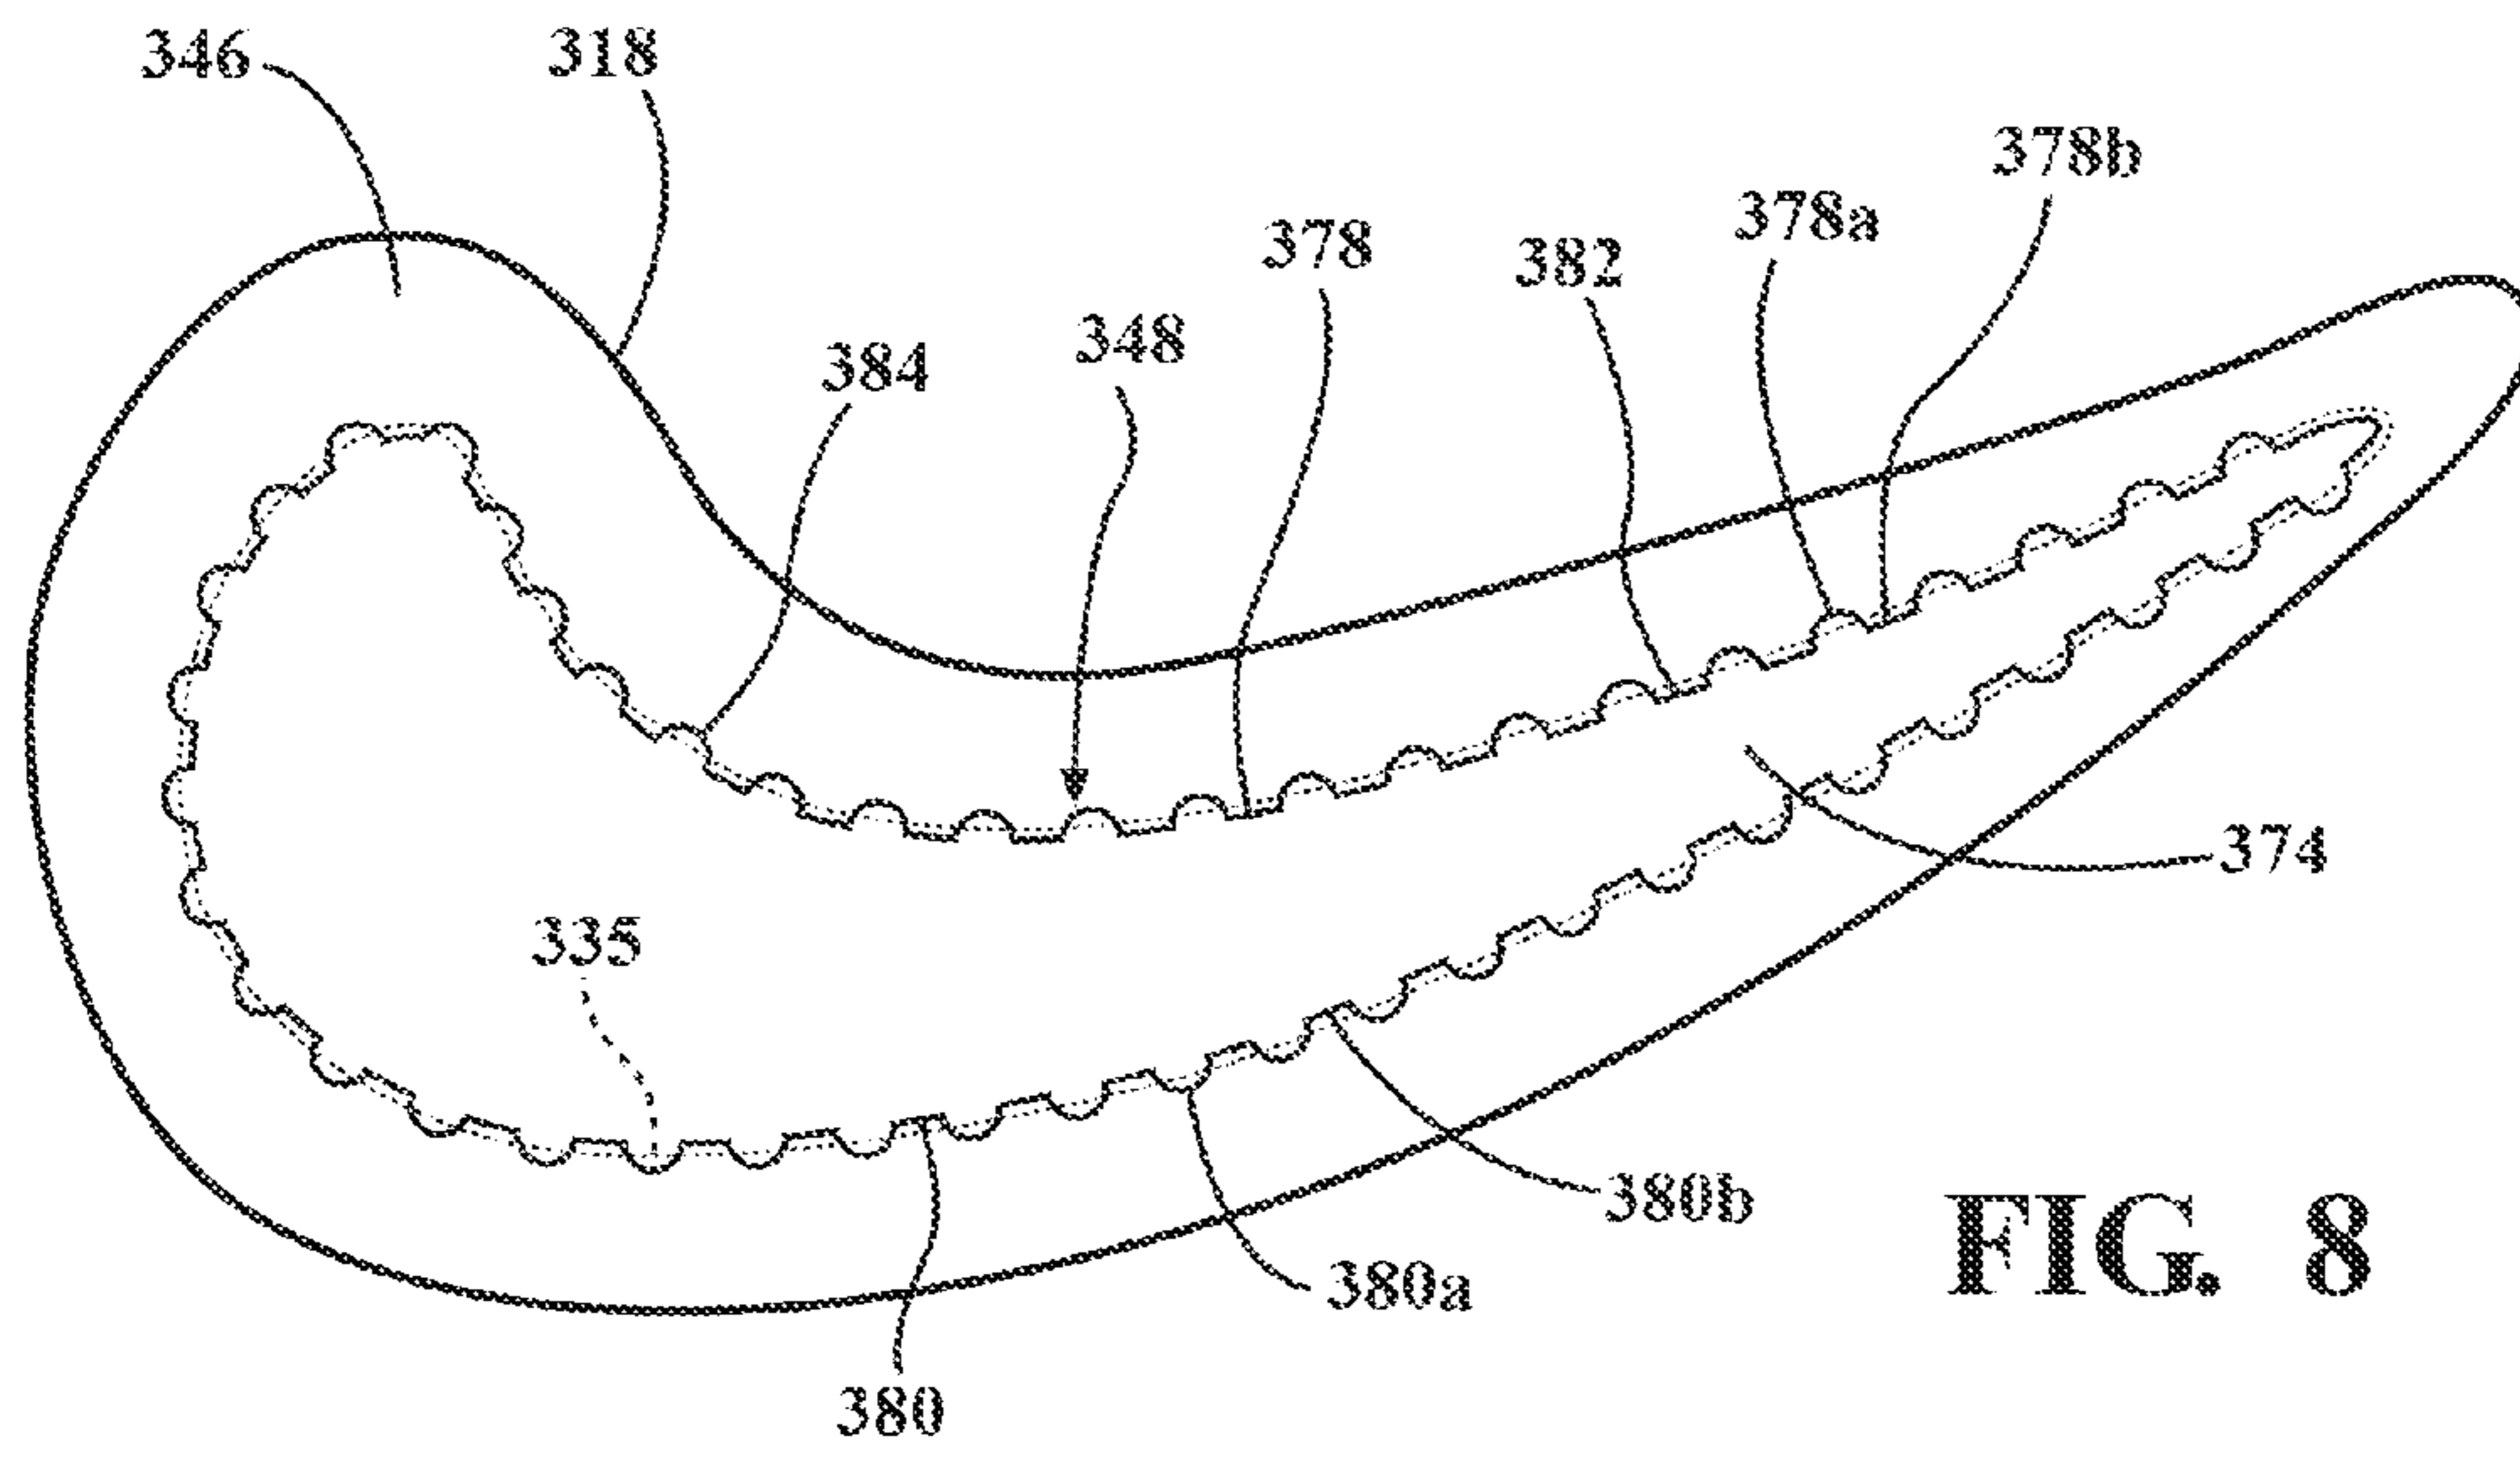
FIG. 8 is a plan view of a replacement tip cap corresponding to the replacement turbine blade tip shown in FIG. 6, and shown in position on an outer wall of a turbine blade prior to attachment; and

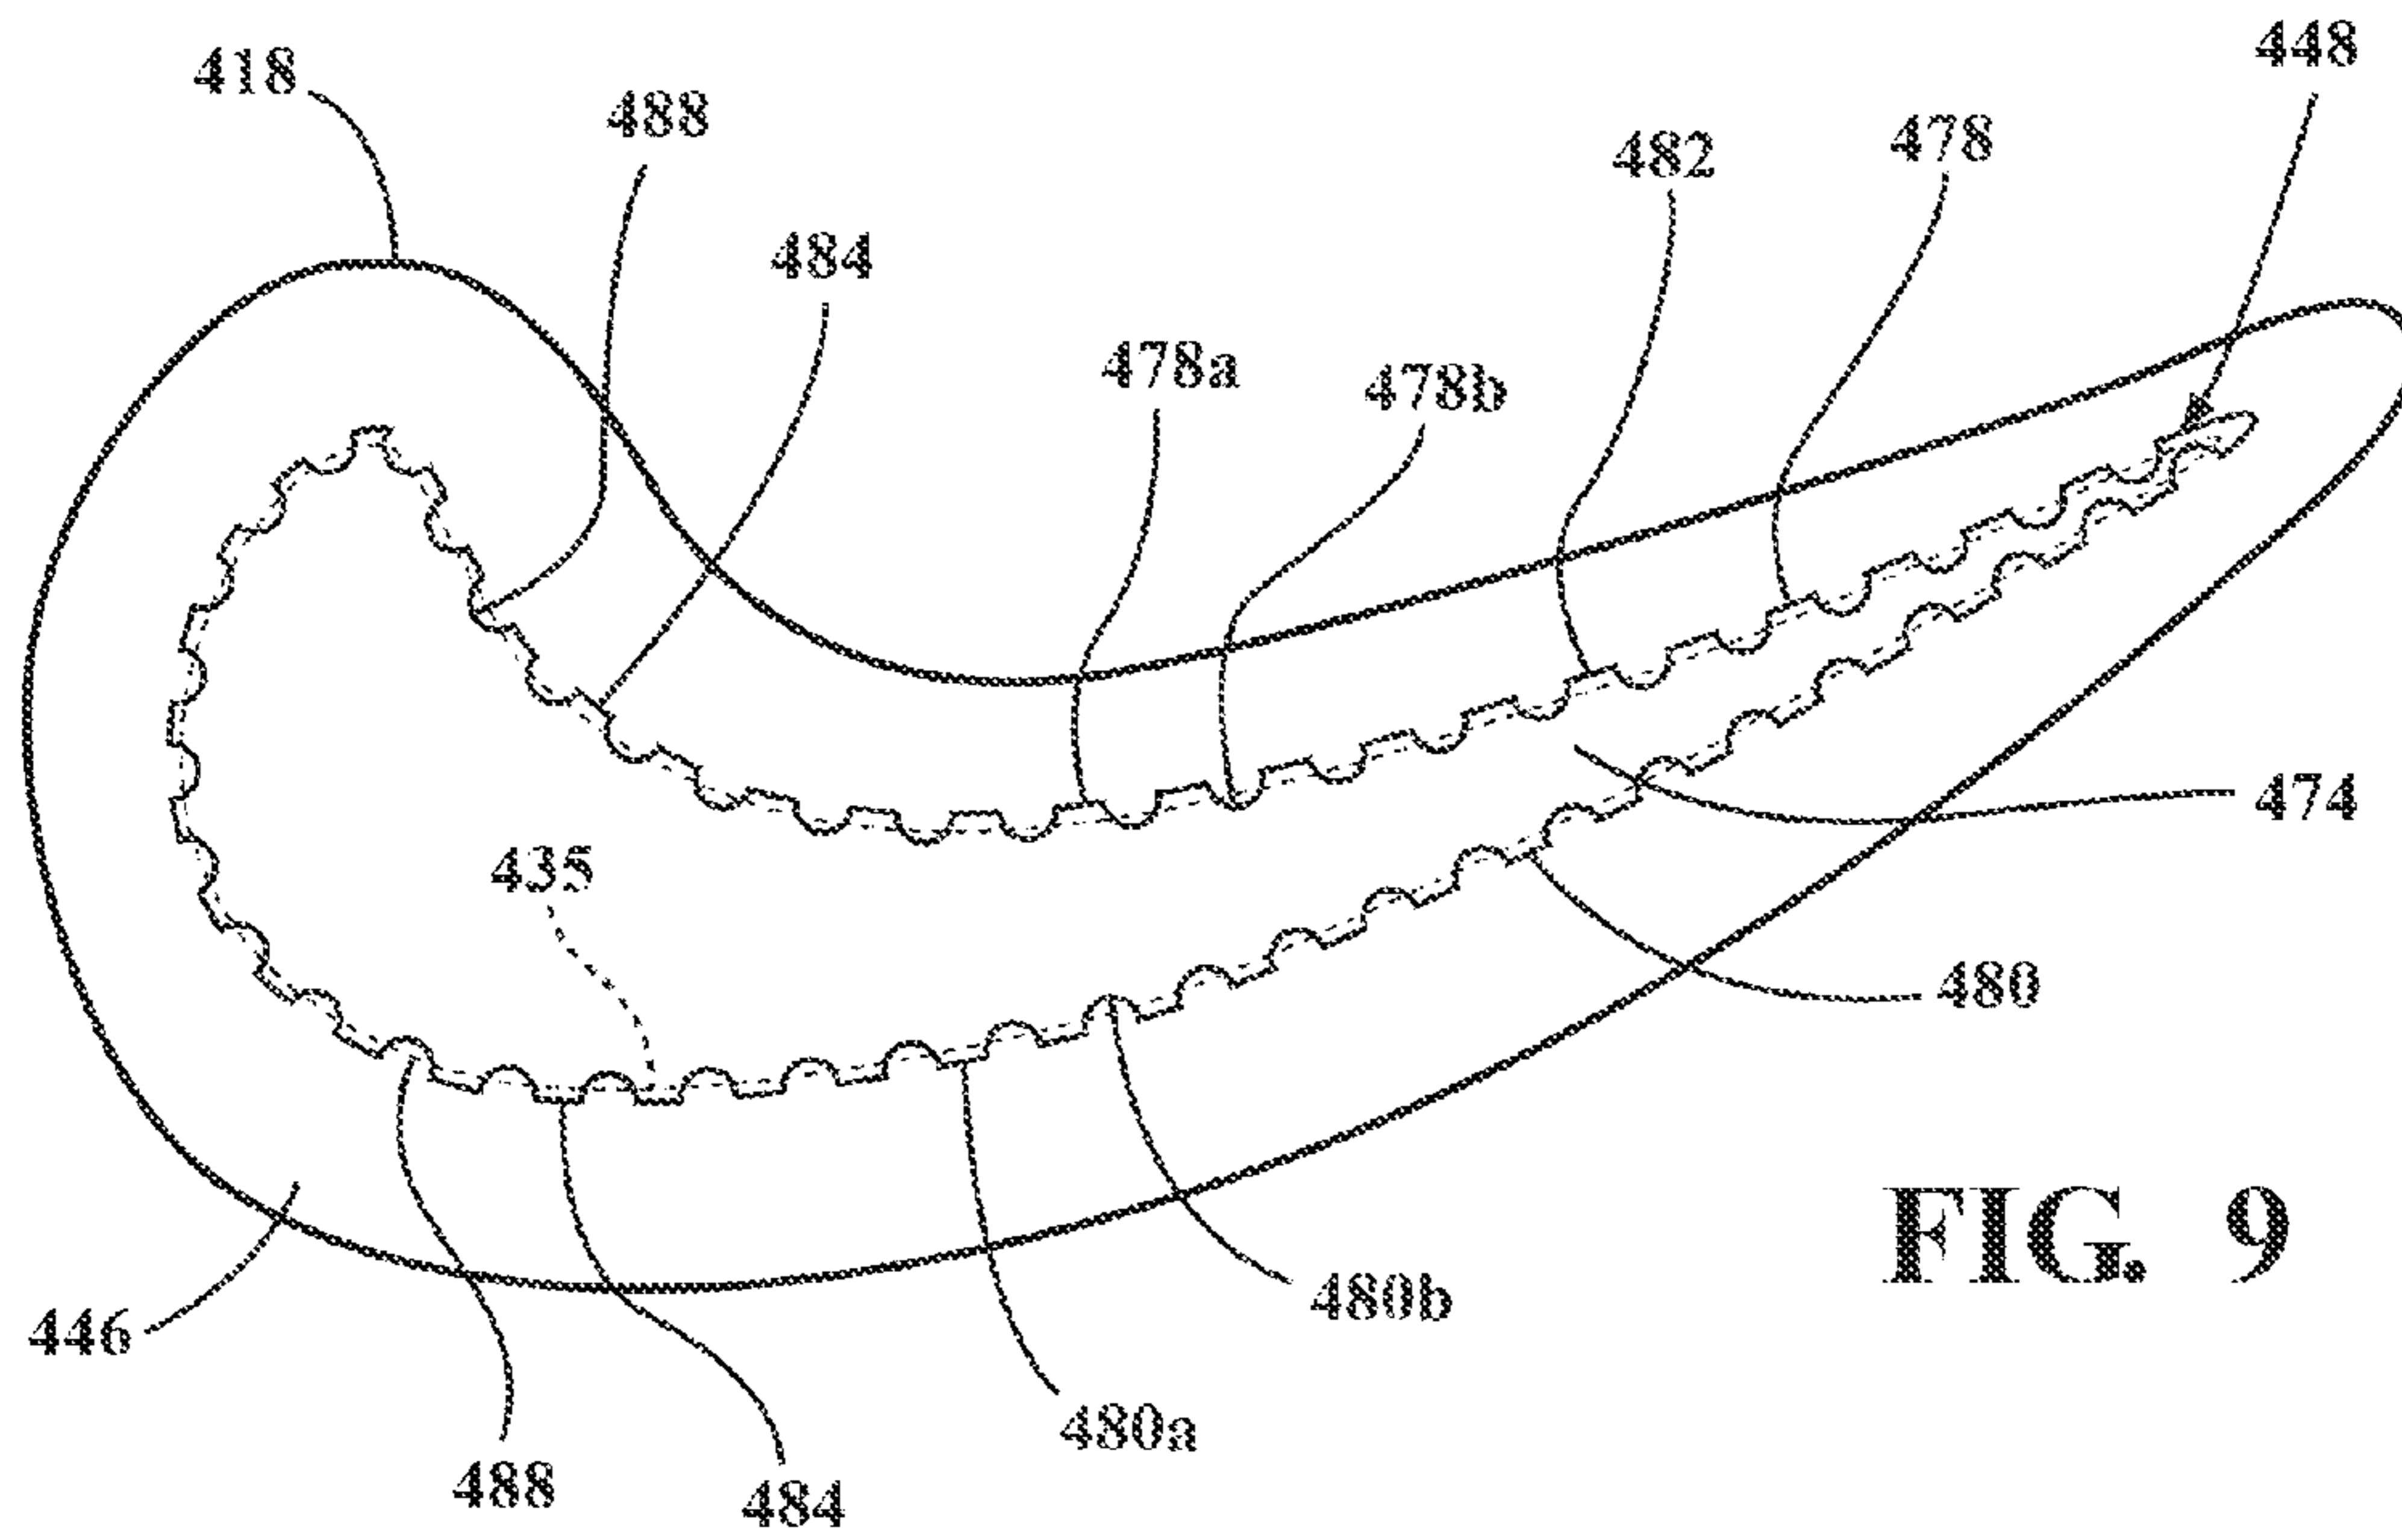
FIG. 9 is a plan view of a replacement tip cap that is a variation of the replacement tip cap shown in FIG. 8, and shown in position on an outer wall of a turbine blade prior to attachment.
