(54) **TURBOMACHINE DIAPHRAGM AND METHOD OF REPAIRING A TURBOMACHINE DIAPHRAGM**

## TURBOMACHINE DIAPHRAGM AND METHOD OF REPAIRING A TURBOMACHINE DIAPHRAGM

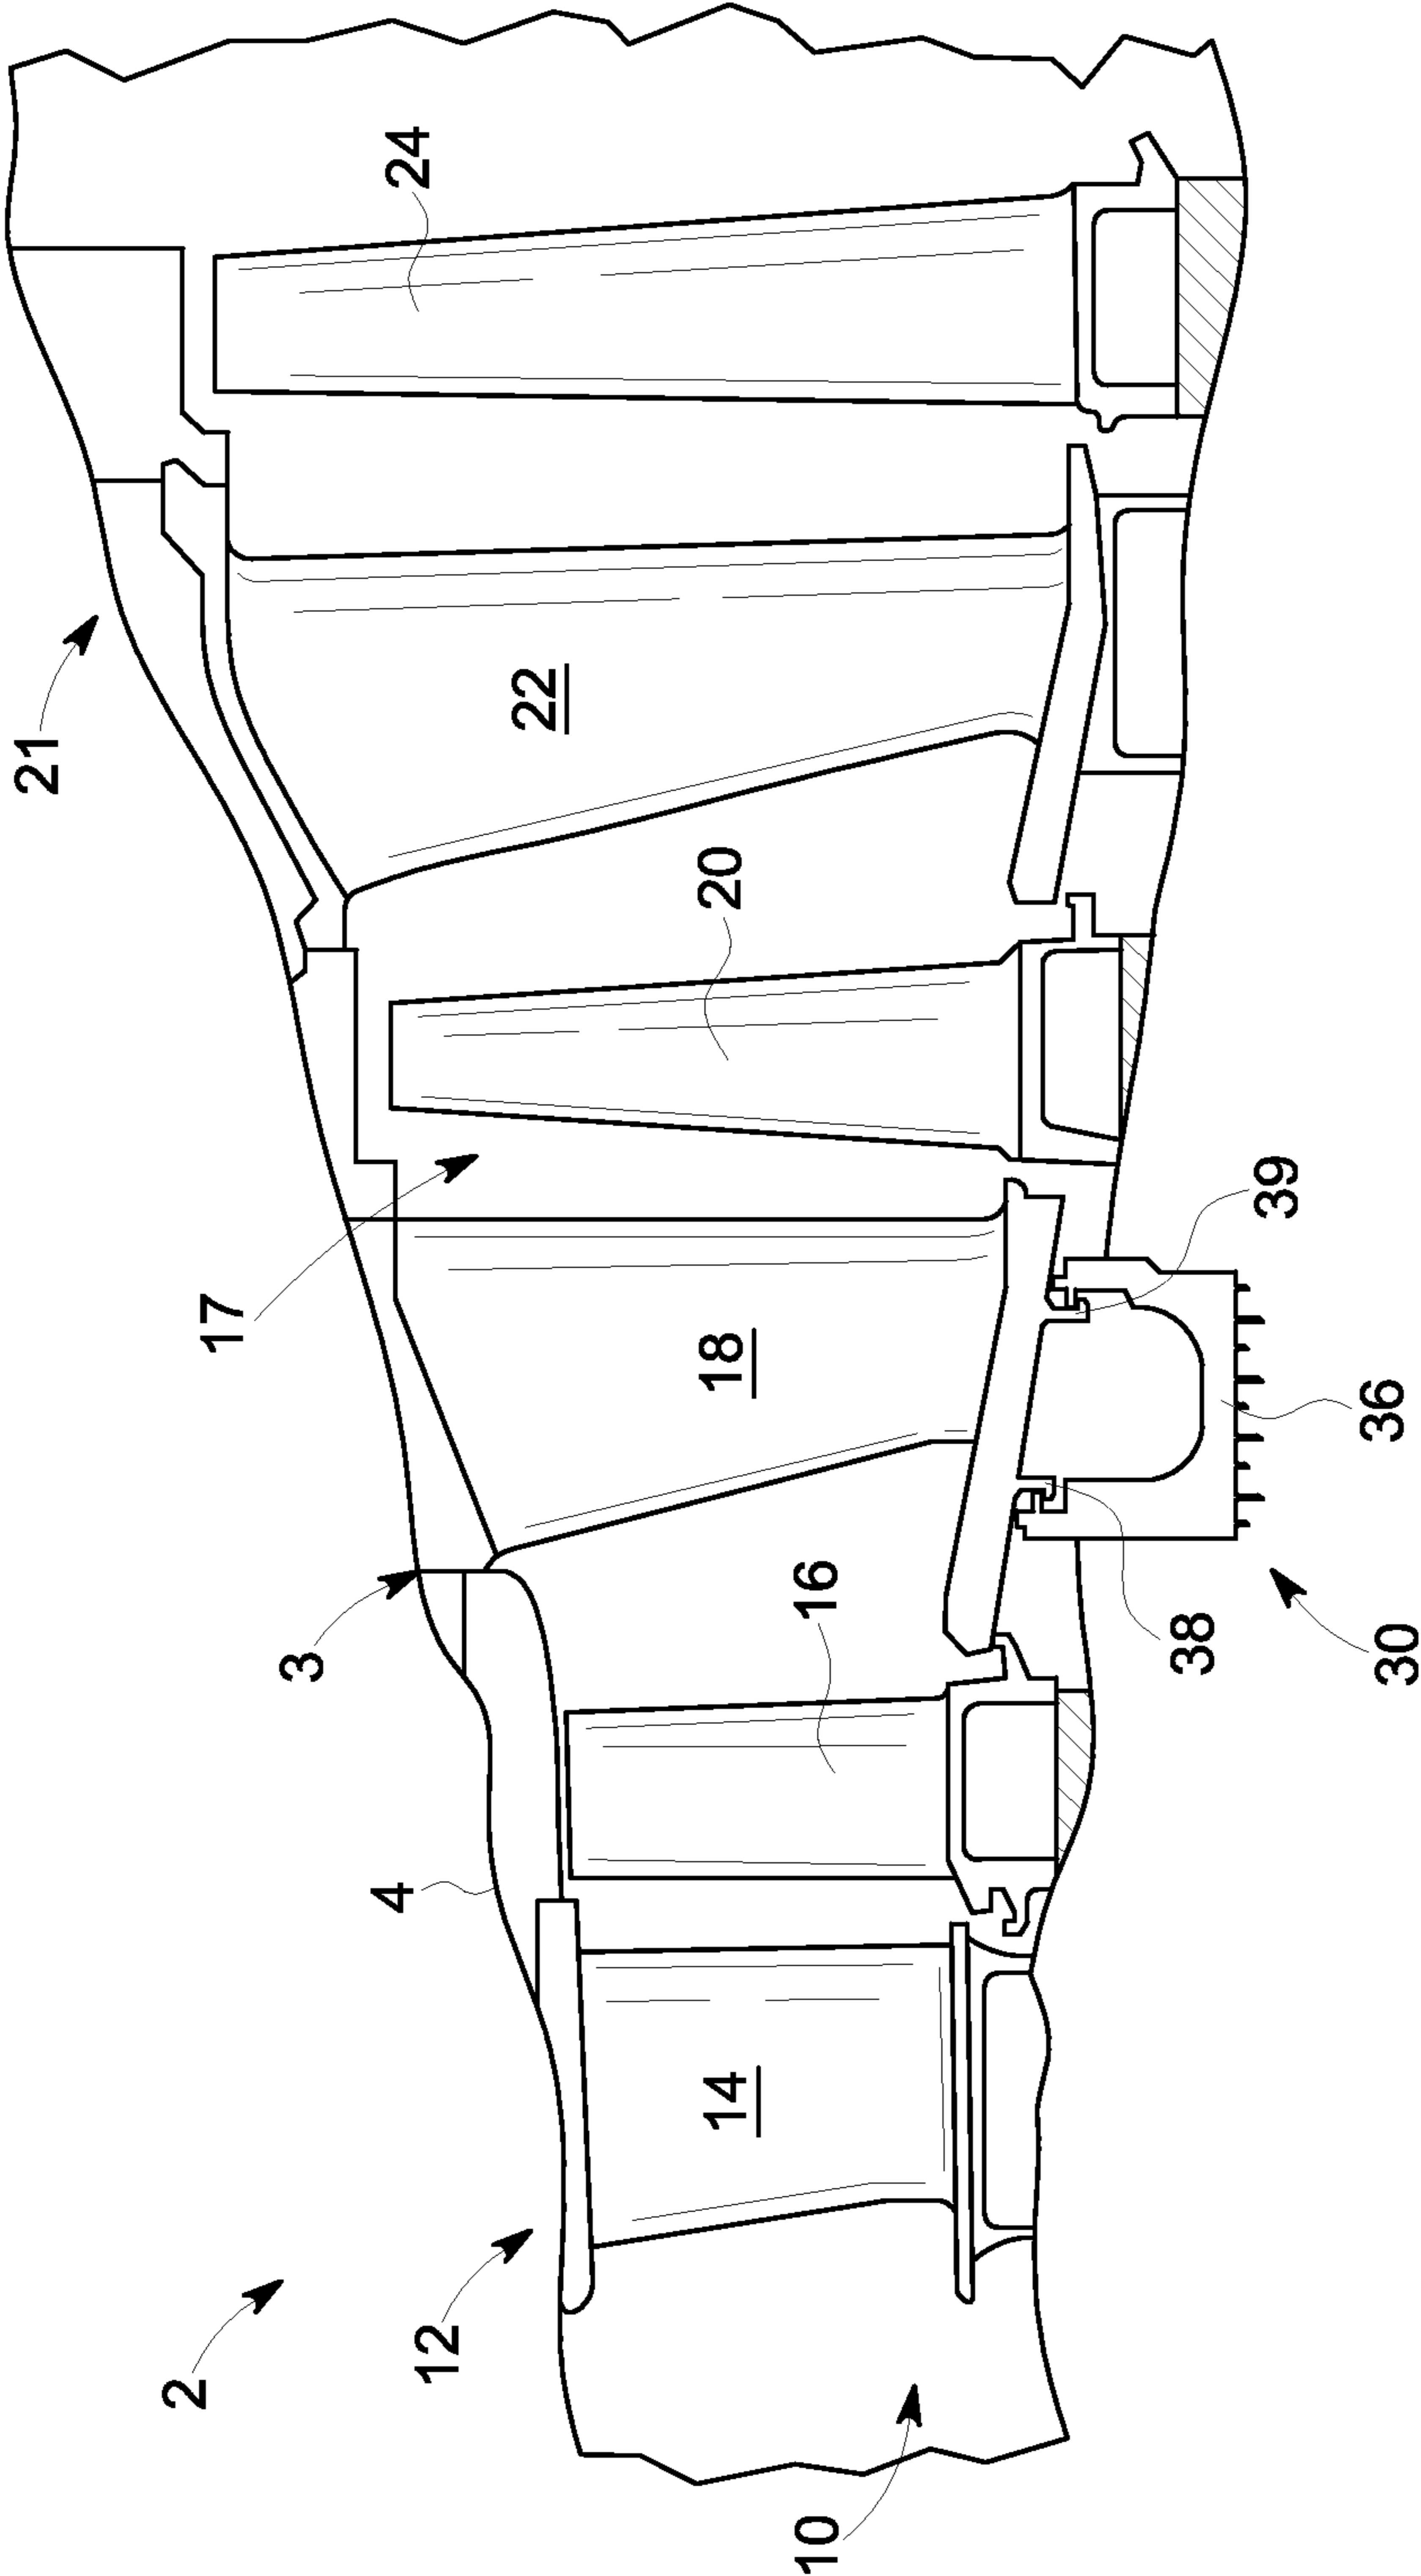
FIG. 1 is a schematic view of a turbomachine including a diaphragm in accordance with an exemplary embodiment;

Referring to FIG. 1, a turbomachine, in accordance with an exemplary embodiment, is indicated generally at 2. Turbomachine 2 includes a turbine portion 3 having a housing 4 that defines, at least in part, a hot gas path 10. Turbine portion 3 includes a first stage 12, having a plurality of first stage vanes or nozzles 14, and first stage buckets or blades 16; a second stage 17 having a plurality of second stage vanes or nozzles 18 and second stage buckets or blades 20; and a third stage 21 having a plurality of third stage vanes or nozzles 22 and third stage buckets or blades 24. Of course it should be understood that turbine portion 3 could also include additional stages (not shown).

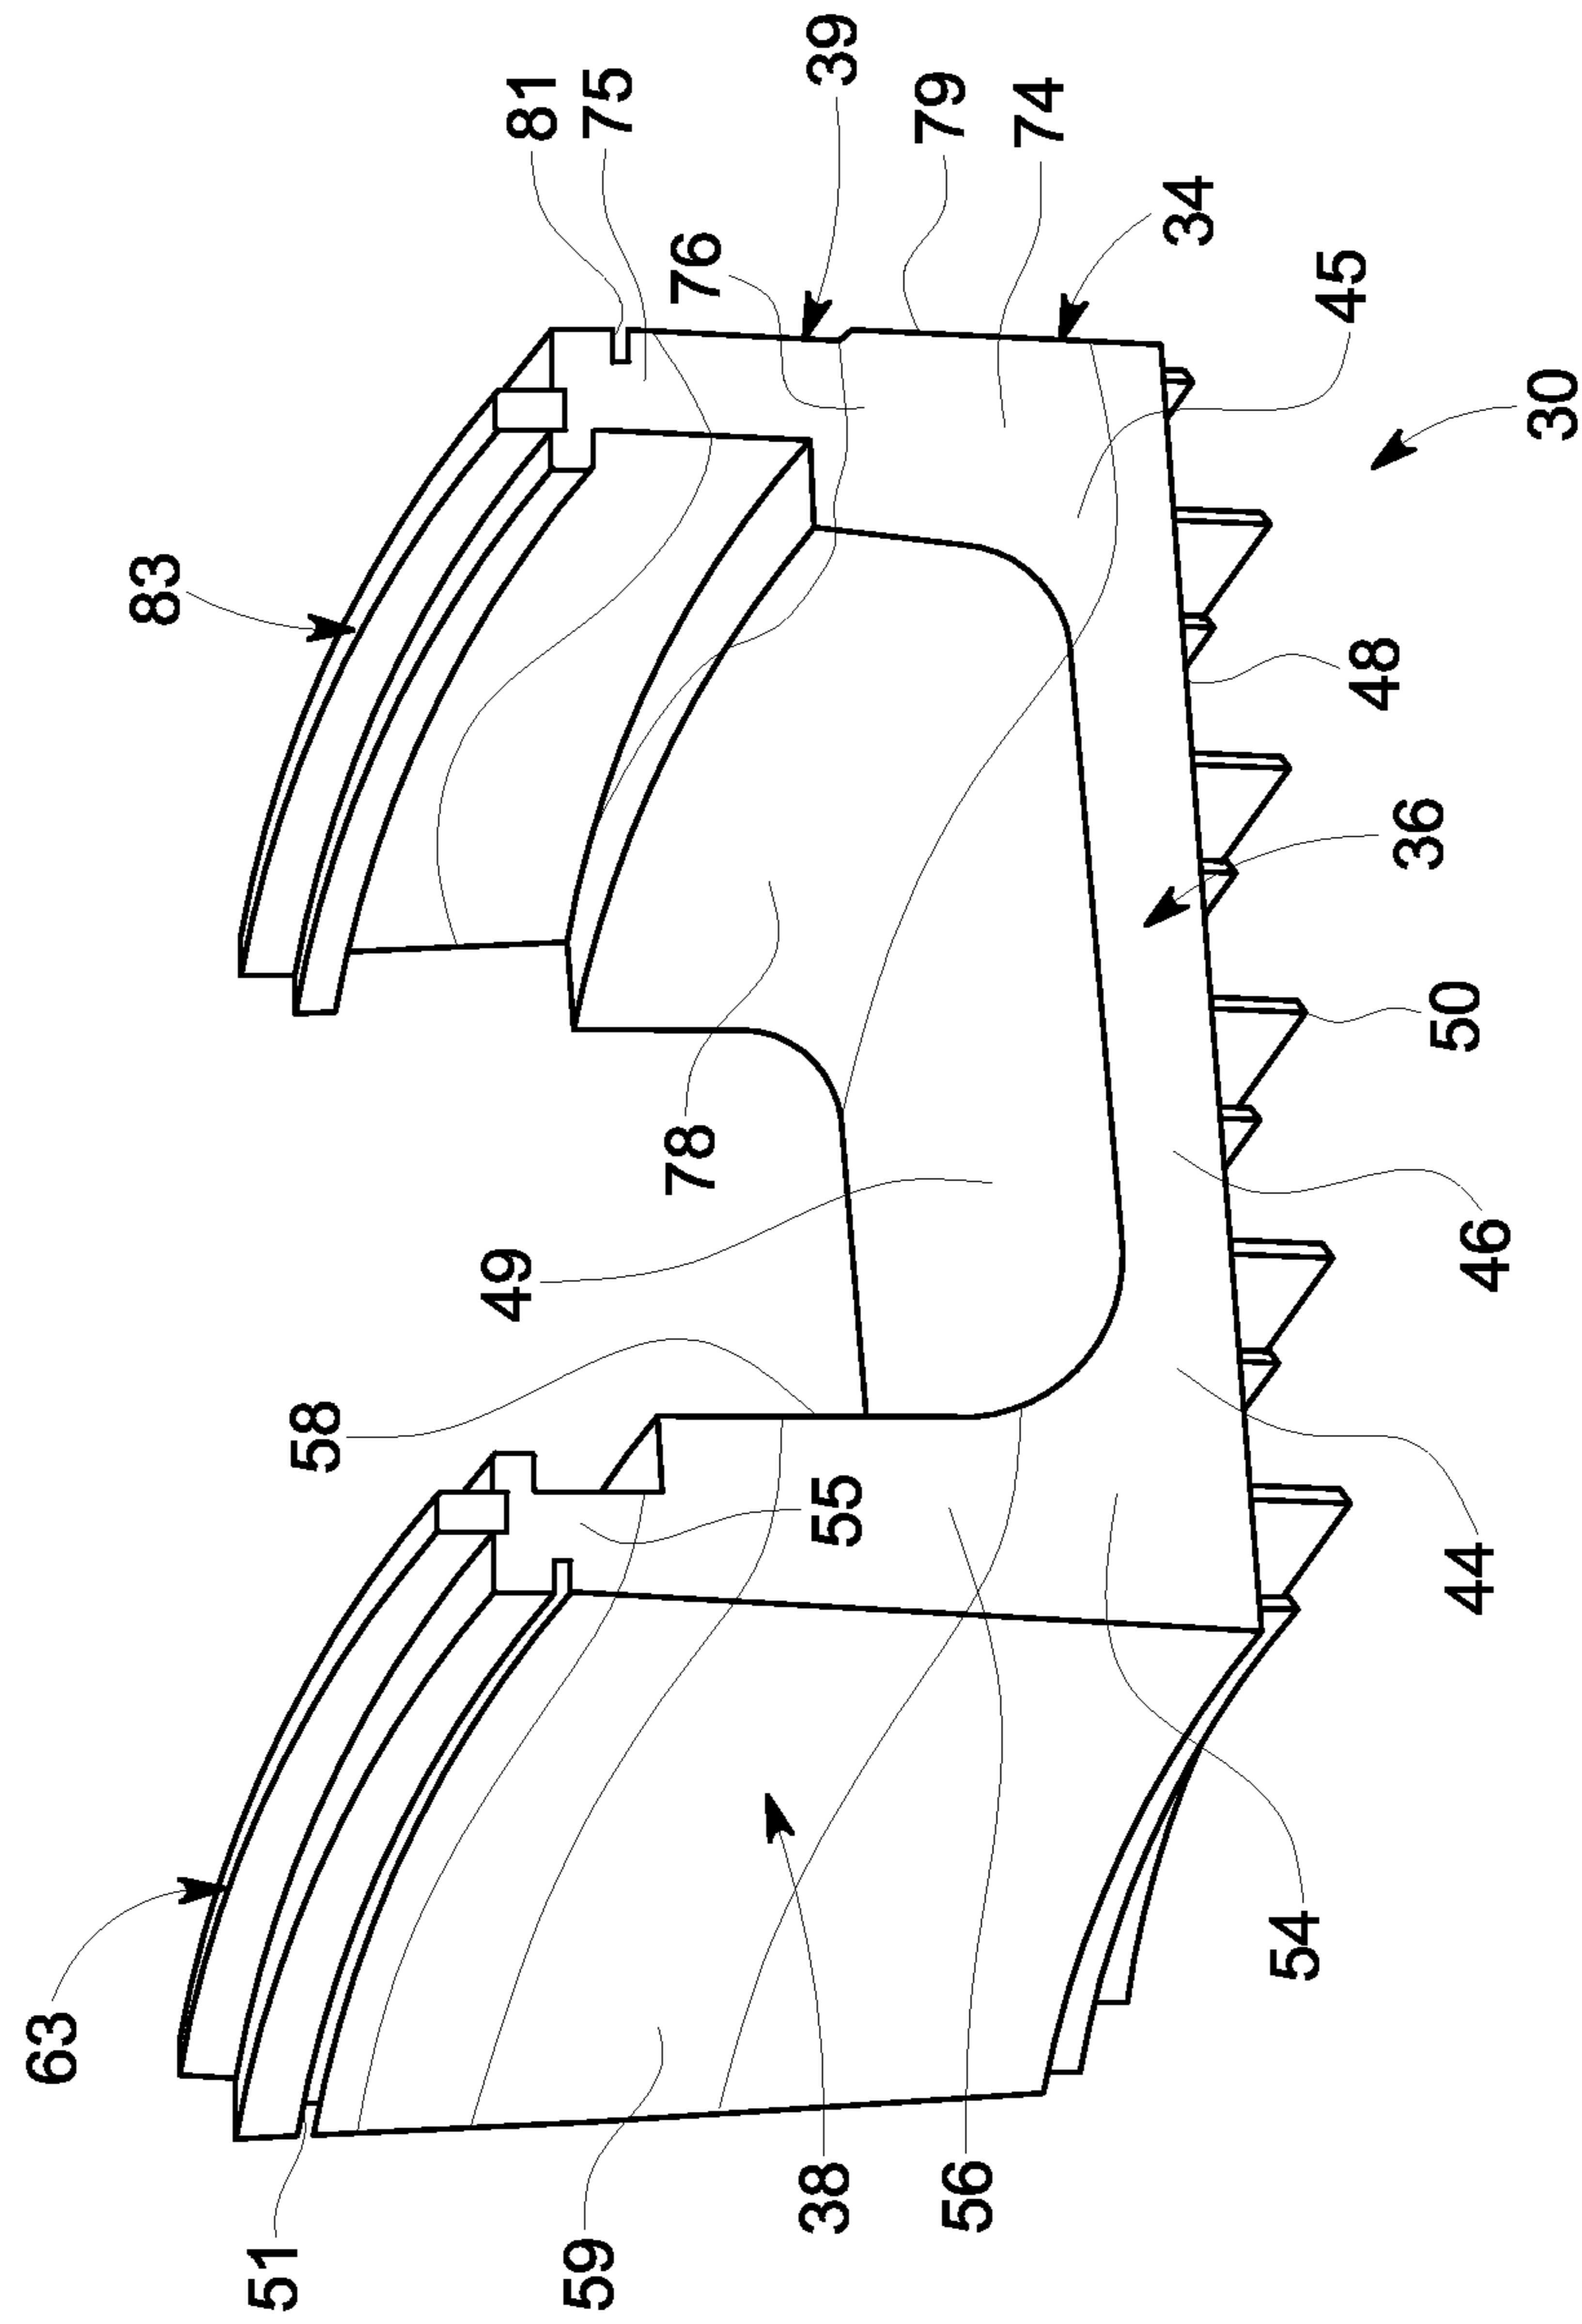
FIG. 2 is a perspective view of a diaphragm including a repair coupon in accordance with an exemplary embodiment;

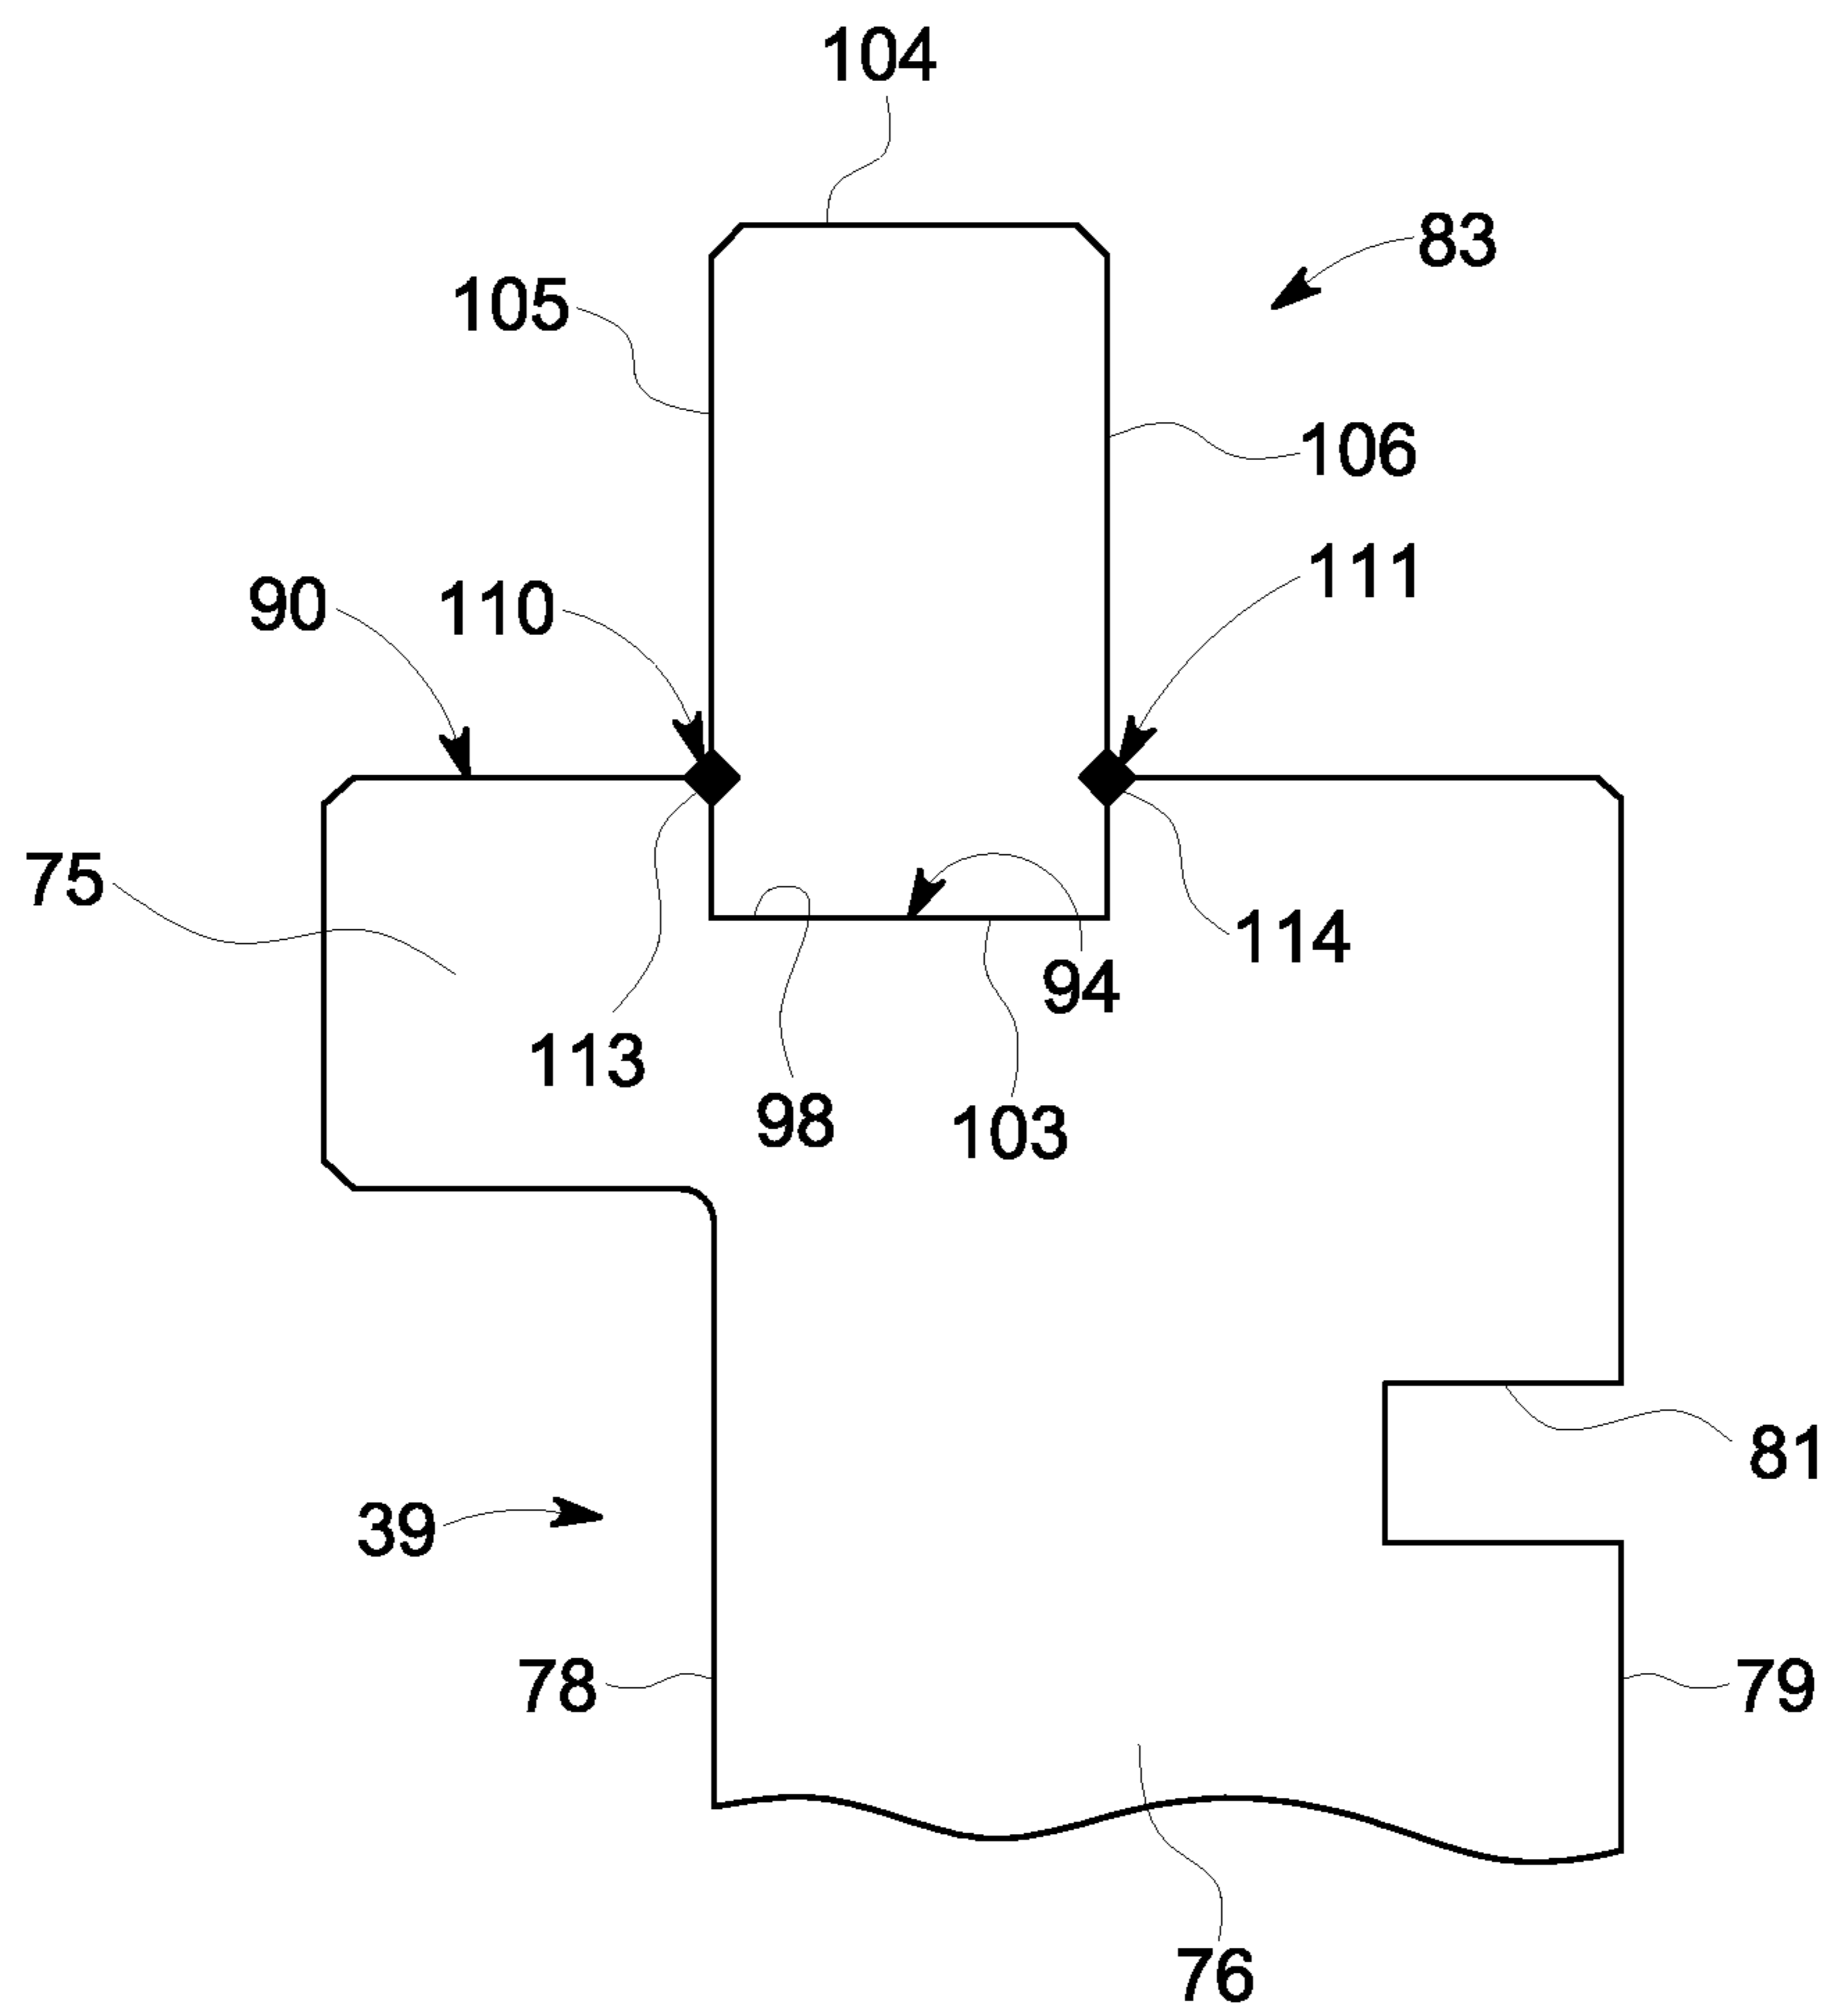
FIG. 3 is a partial plan view of a repair coupon mounted to a diaphragm rail member in accordance with one aspect of the exemplary embodiment;

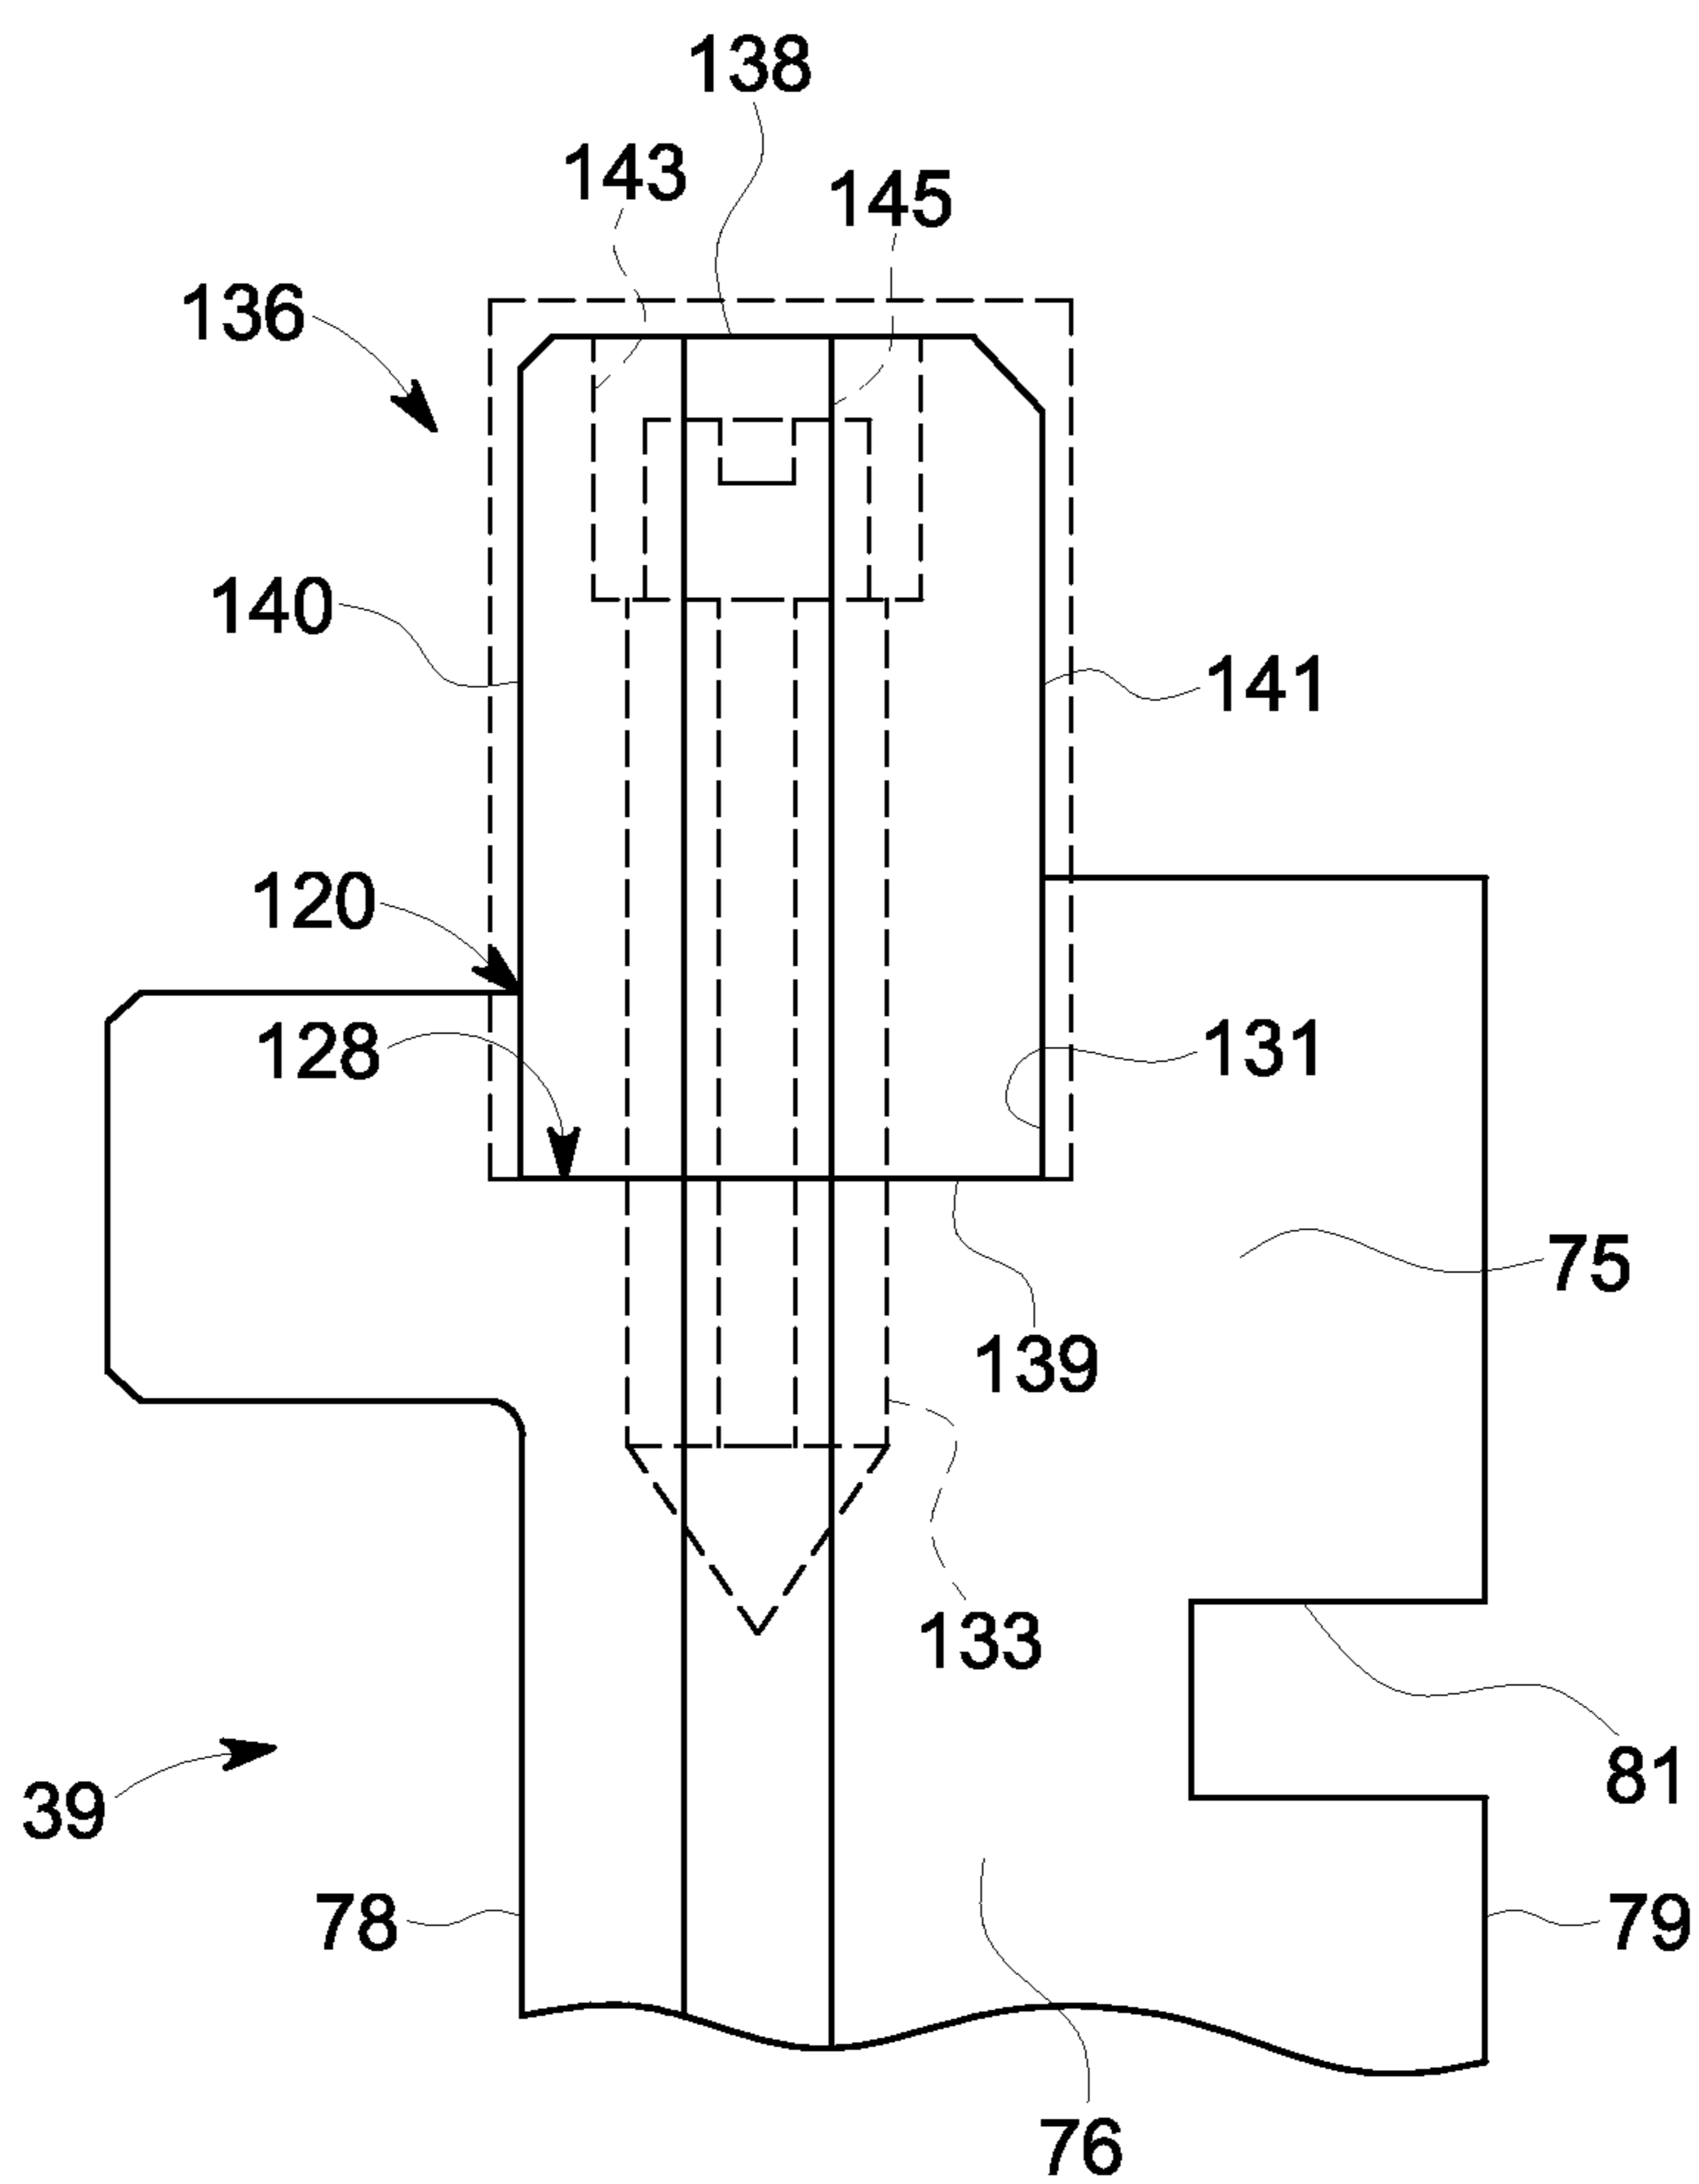
FIG. 4 is a partial plan view of a repair coupon mounted to a diaphragm rail member in accordance with another aspect of the exemplary embodiment;

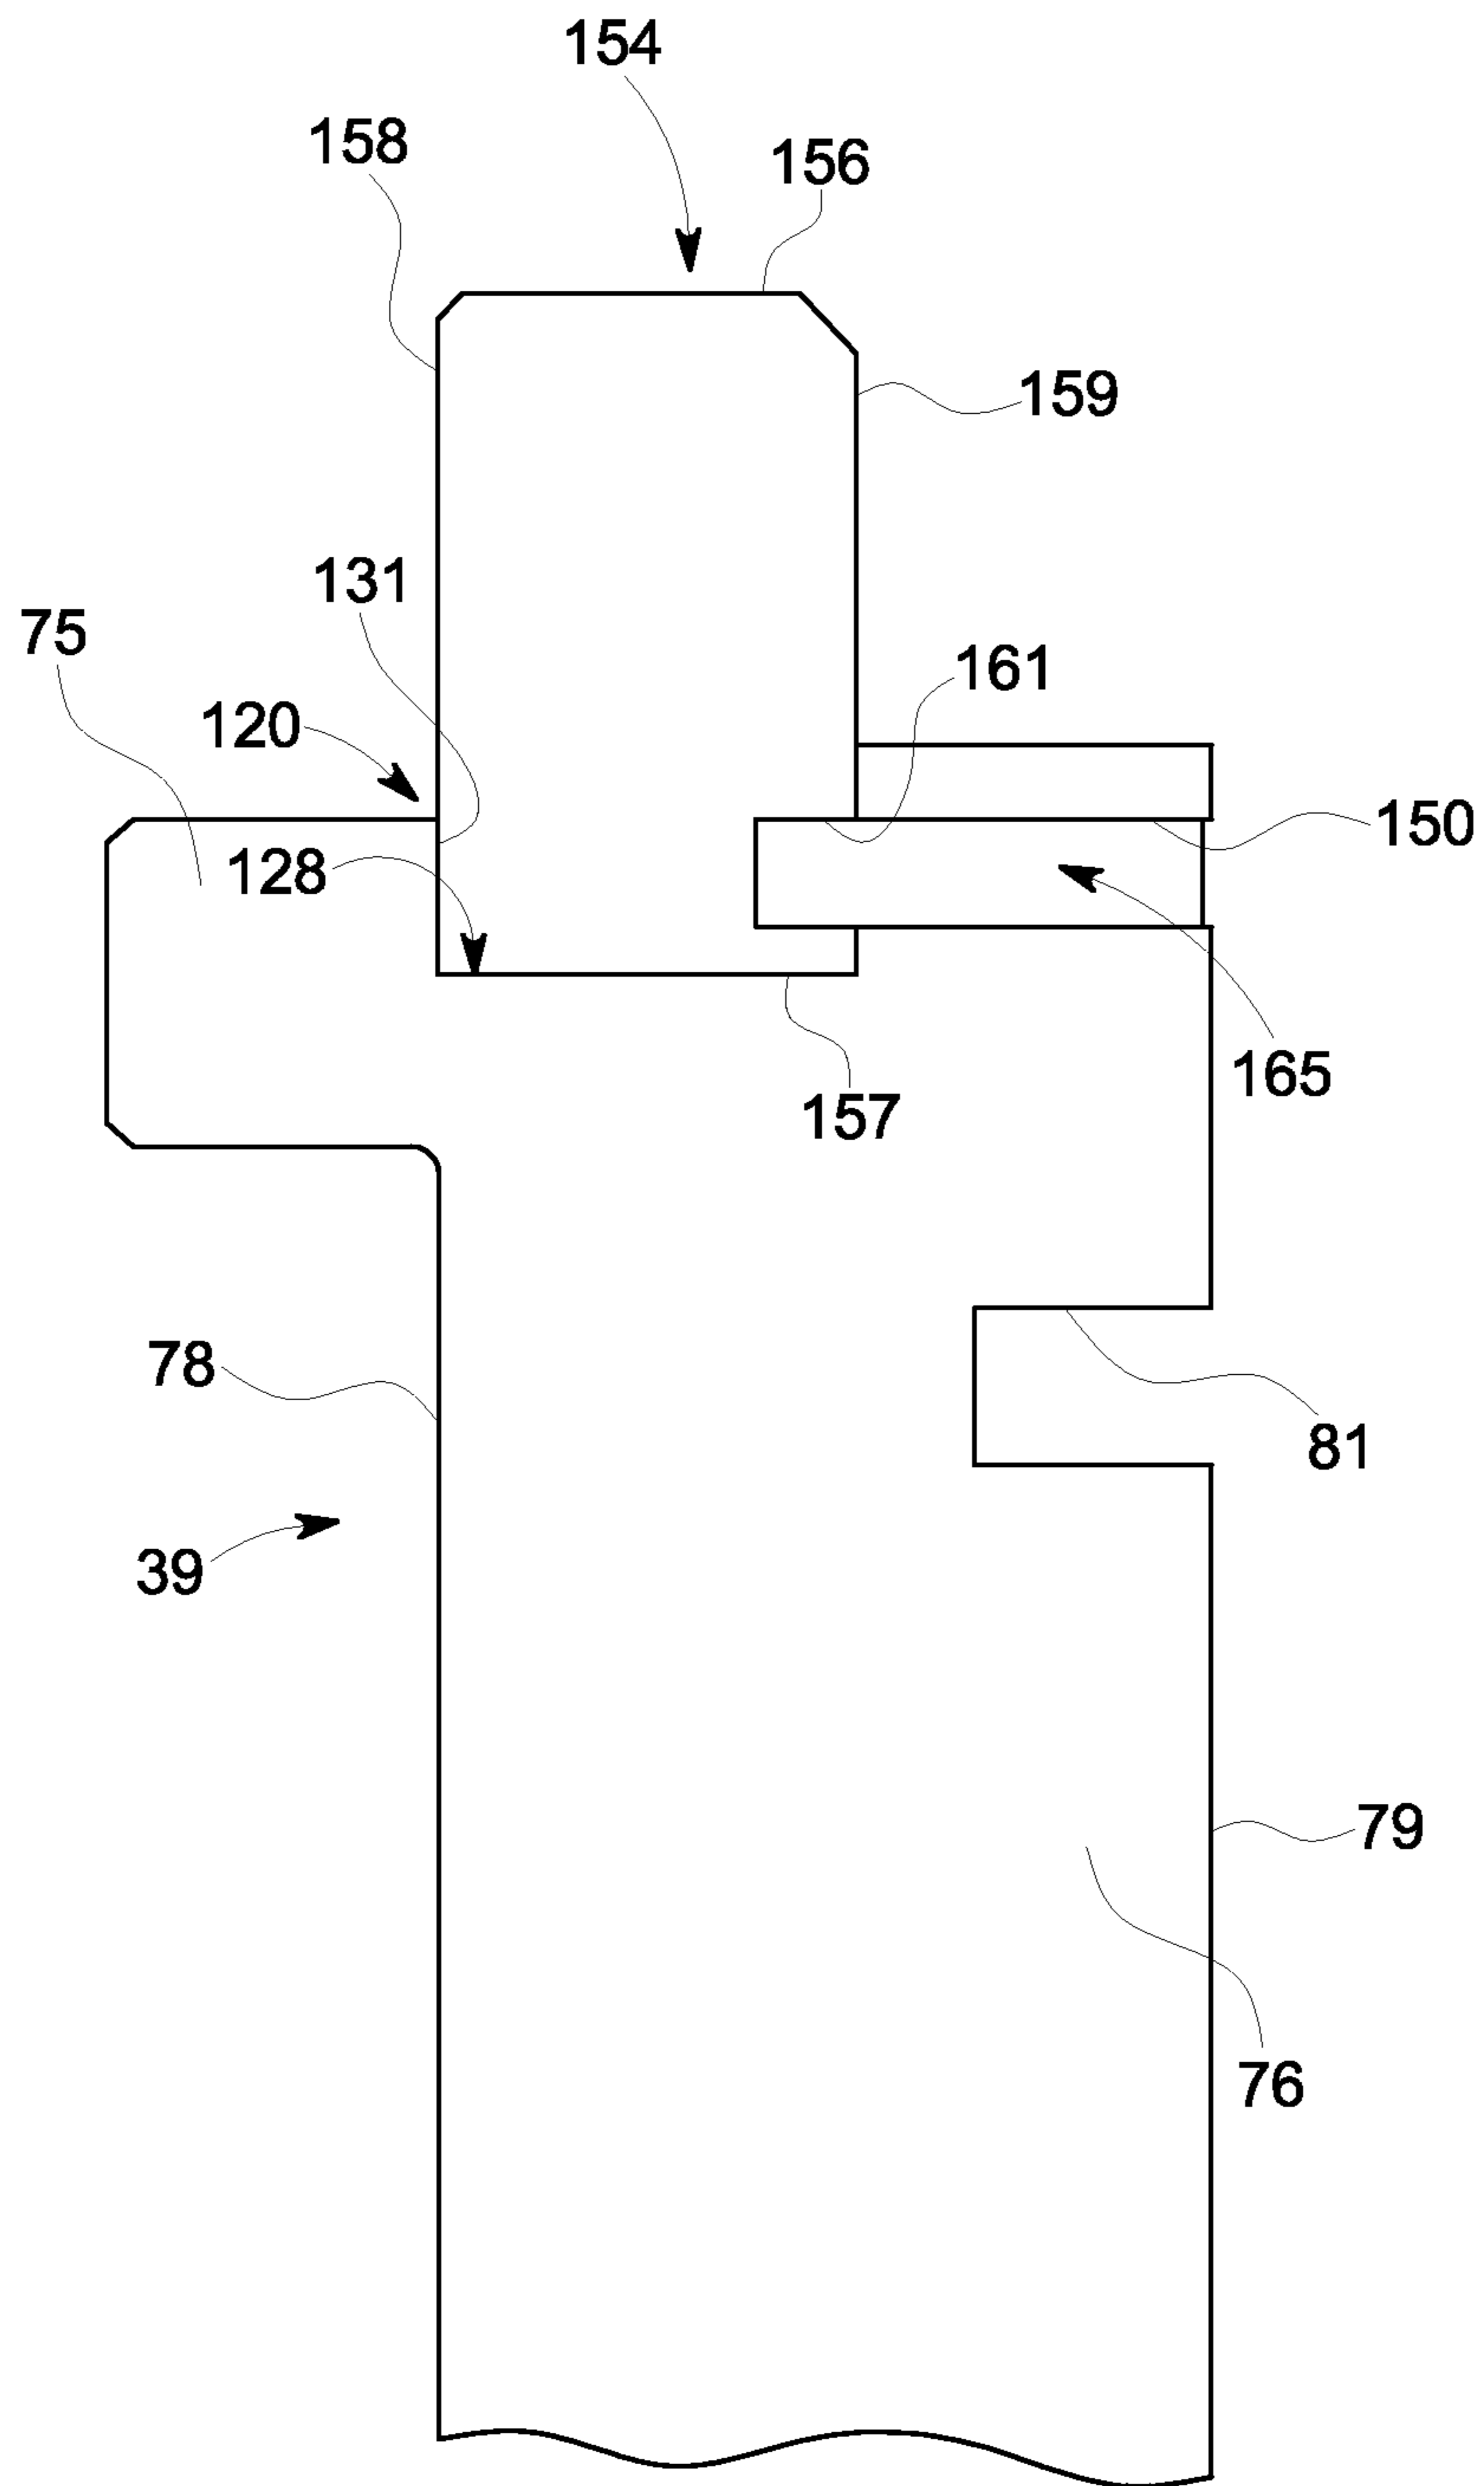
FIG. 5 is a partial plan view of a repair coupon mounted to a diaphragm rail member in accordance with yet another aspect of the exemplary embodiment;

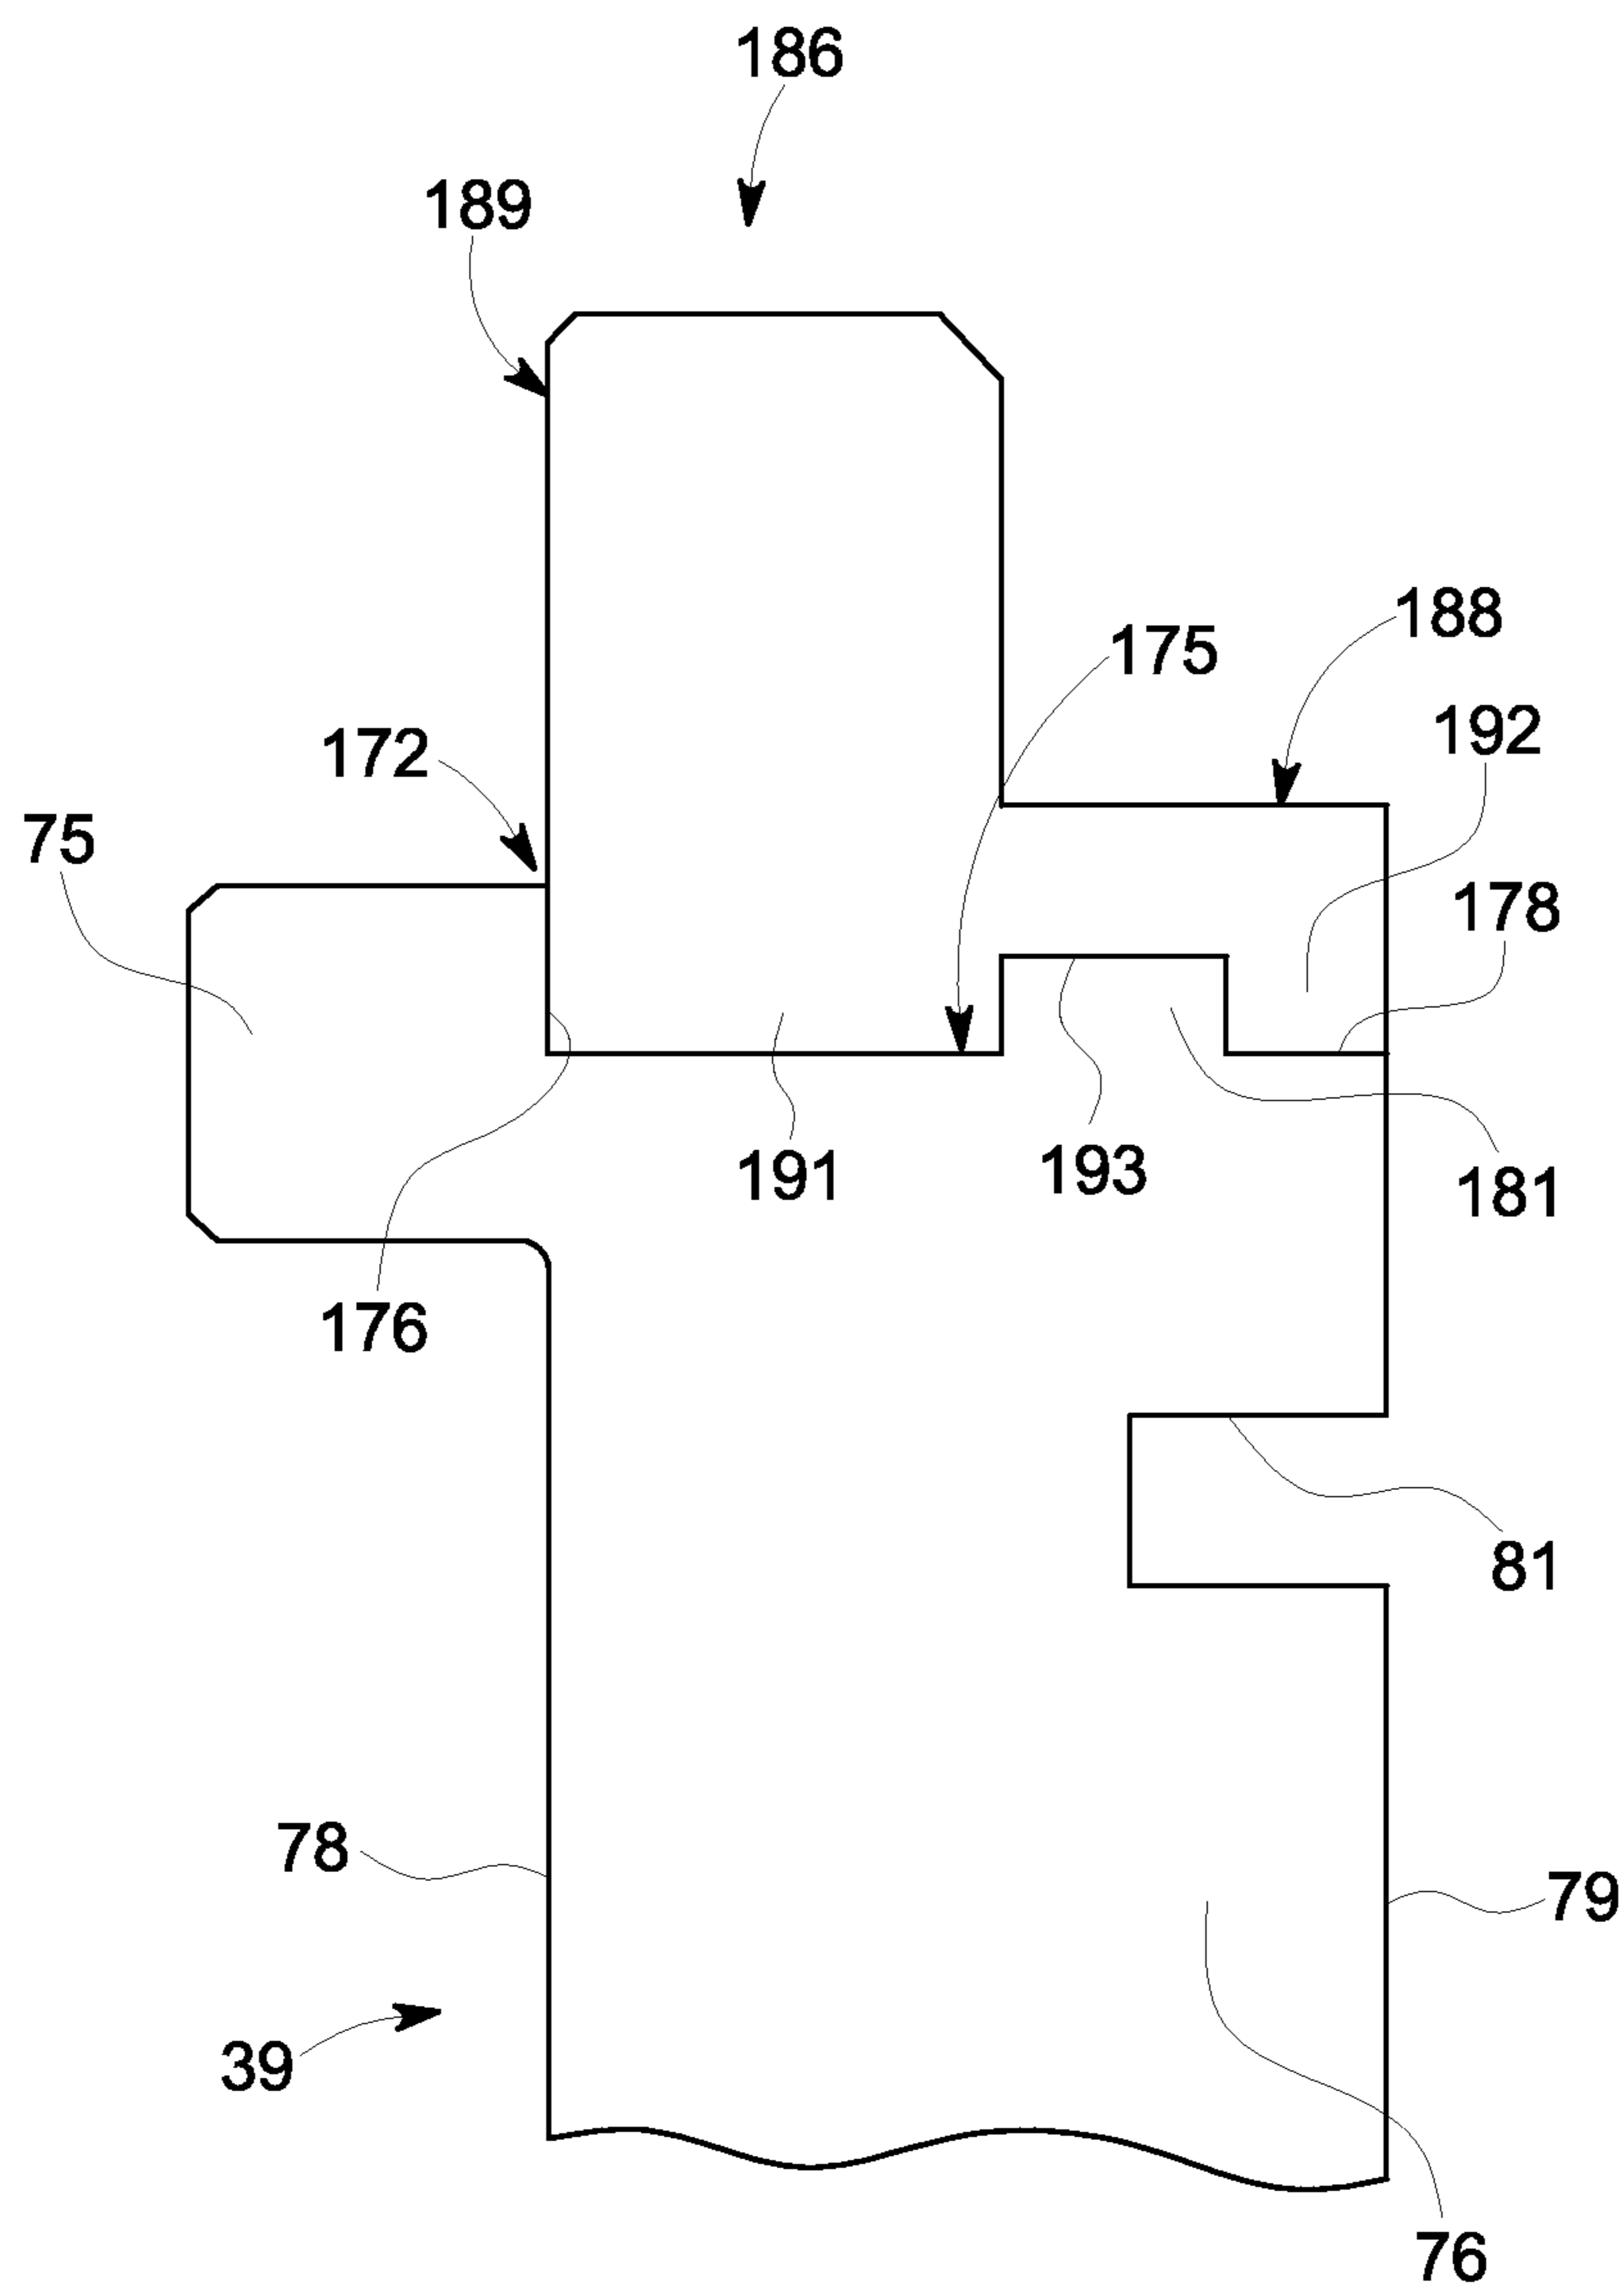
FIG. 6 is a partial plan view of a repair coupon mounted to a diaphragm rail member in accordance with still another aspect of the exemplary embodiment;
