(54) **TURBOMACHINE DIAPHRAGM AND METHOD OF REPAIRING A TURBOMACHINE DIAPHRAGM**

## TURBOMACHINE DIAPHRAGM AND METHOD OF REPAIRING A TURBOMACHINE DIAPHRAGM

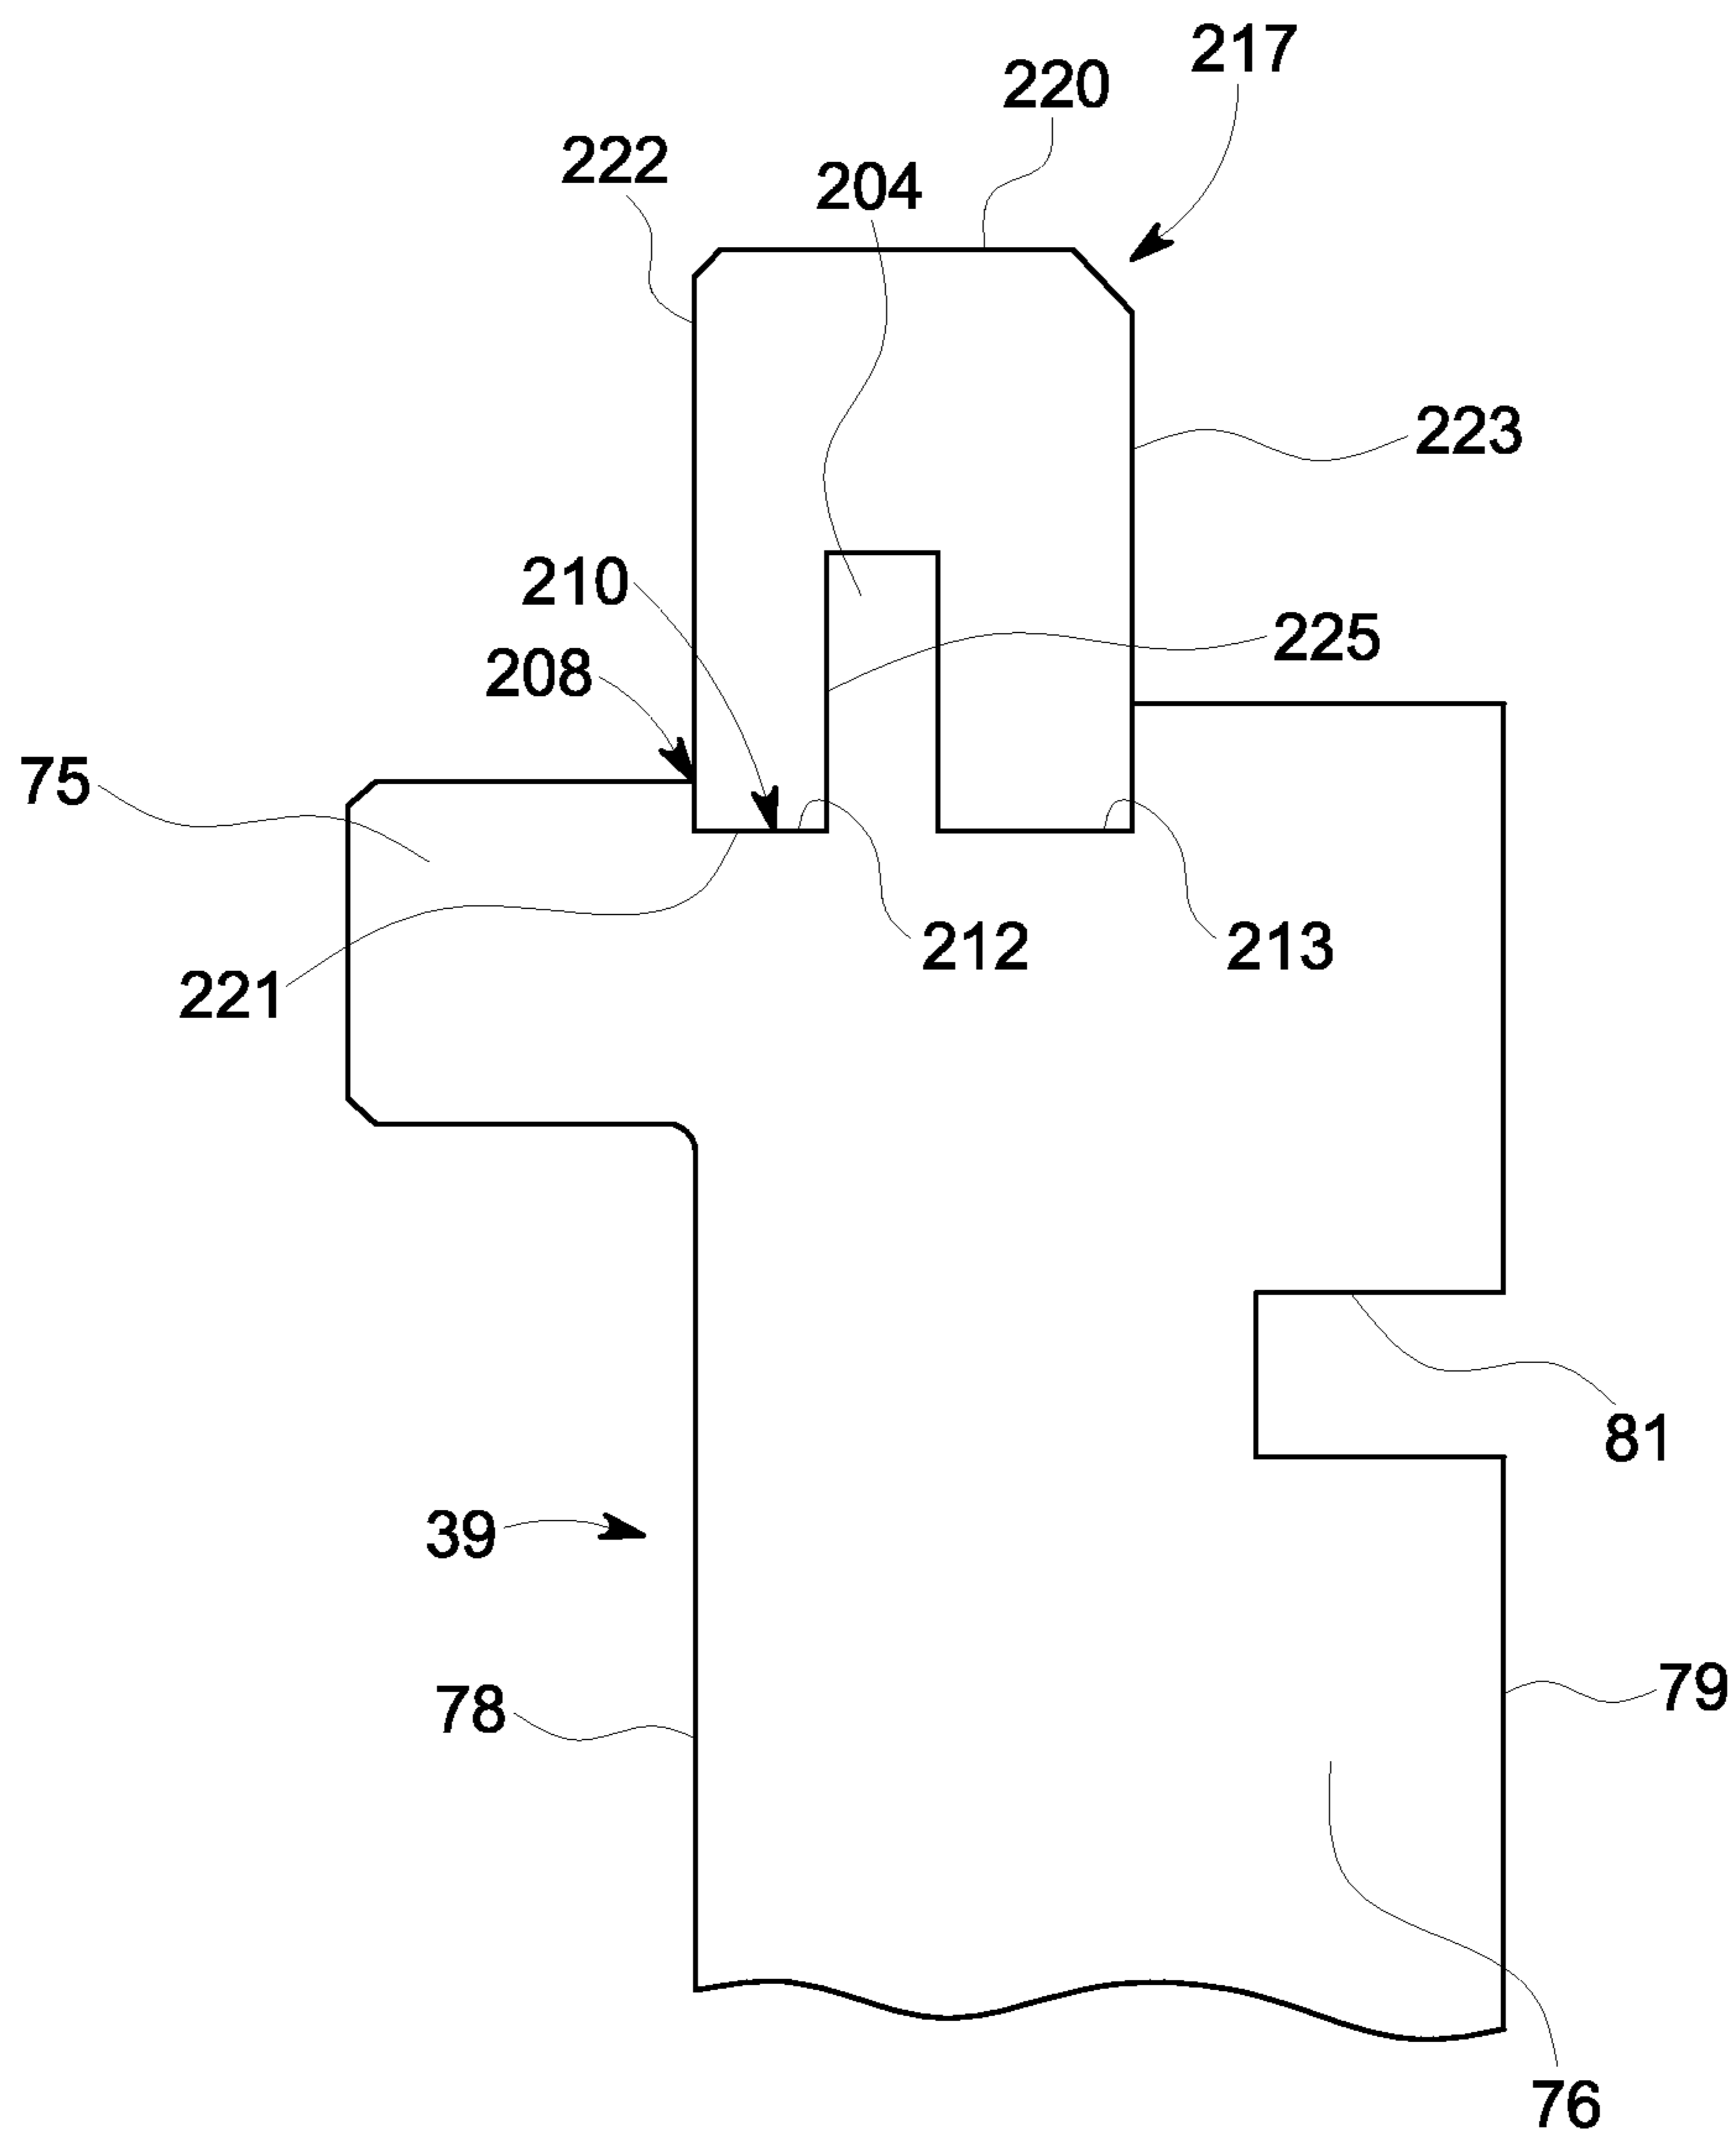
FIG. 7 is a partial plan view of a repair coupon mounted to a diaphragm rail member in accordance with still yet another aspect of the exemplary embodiment;

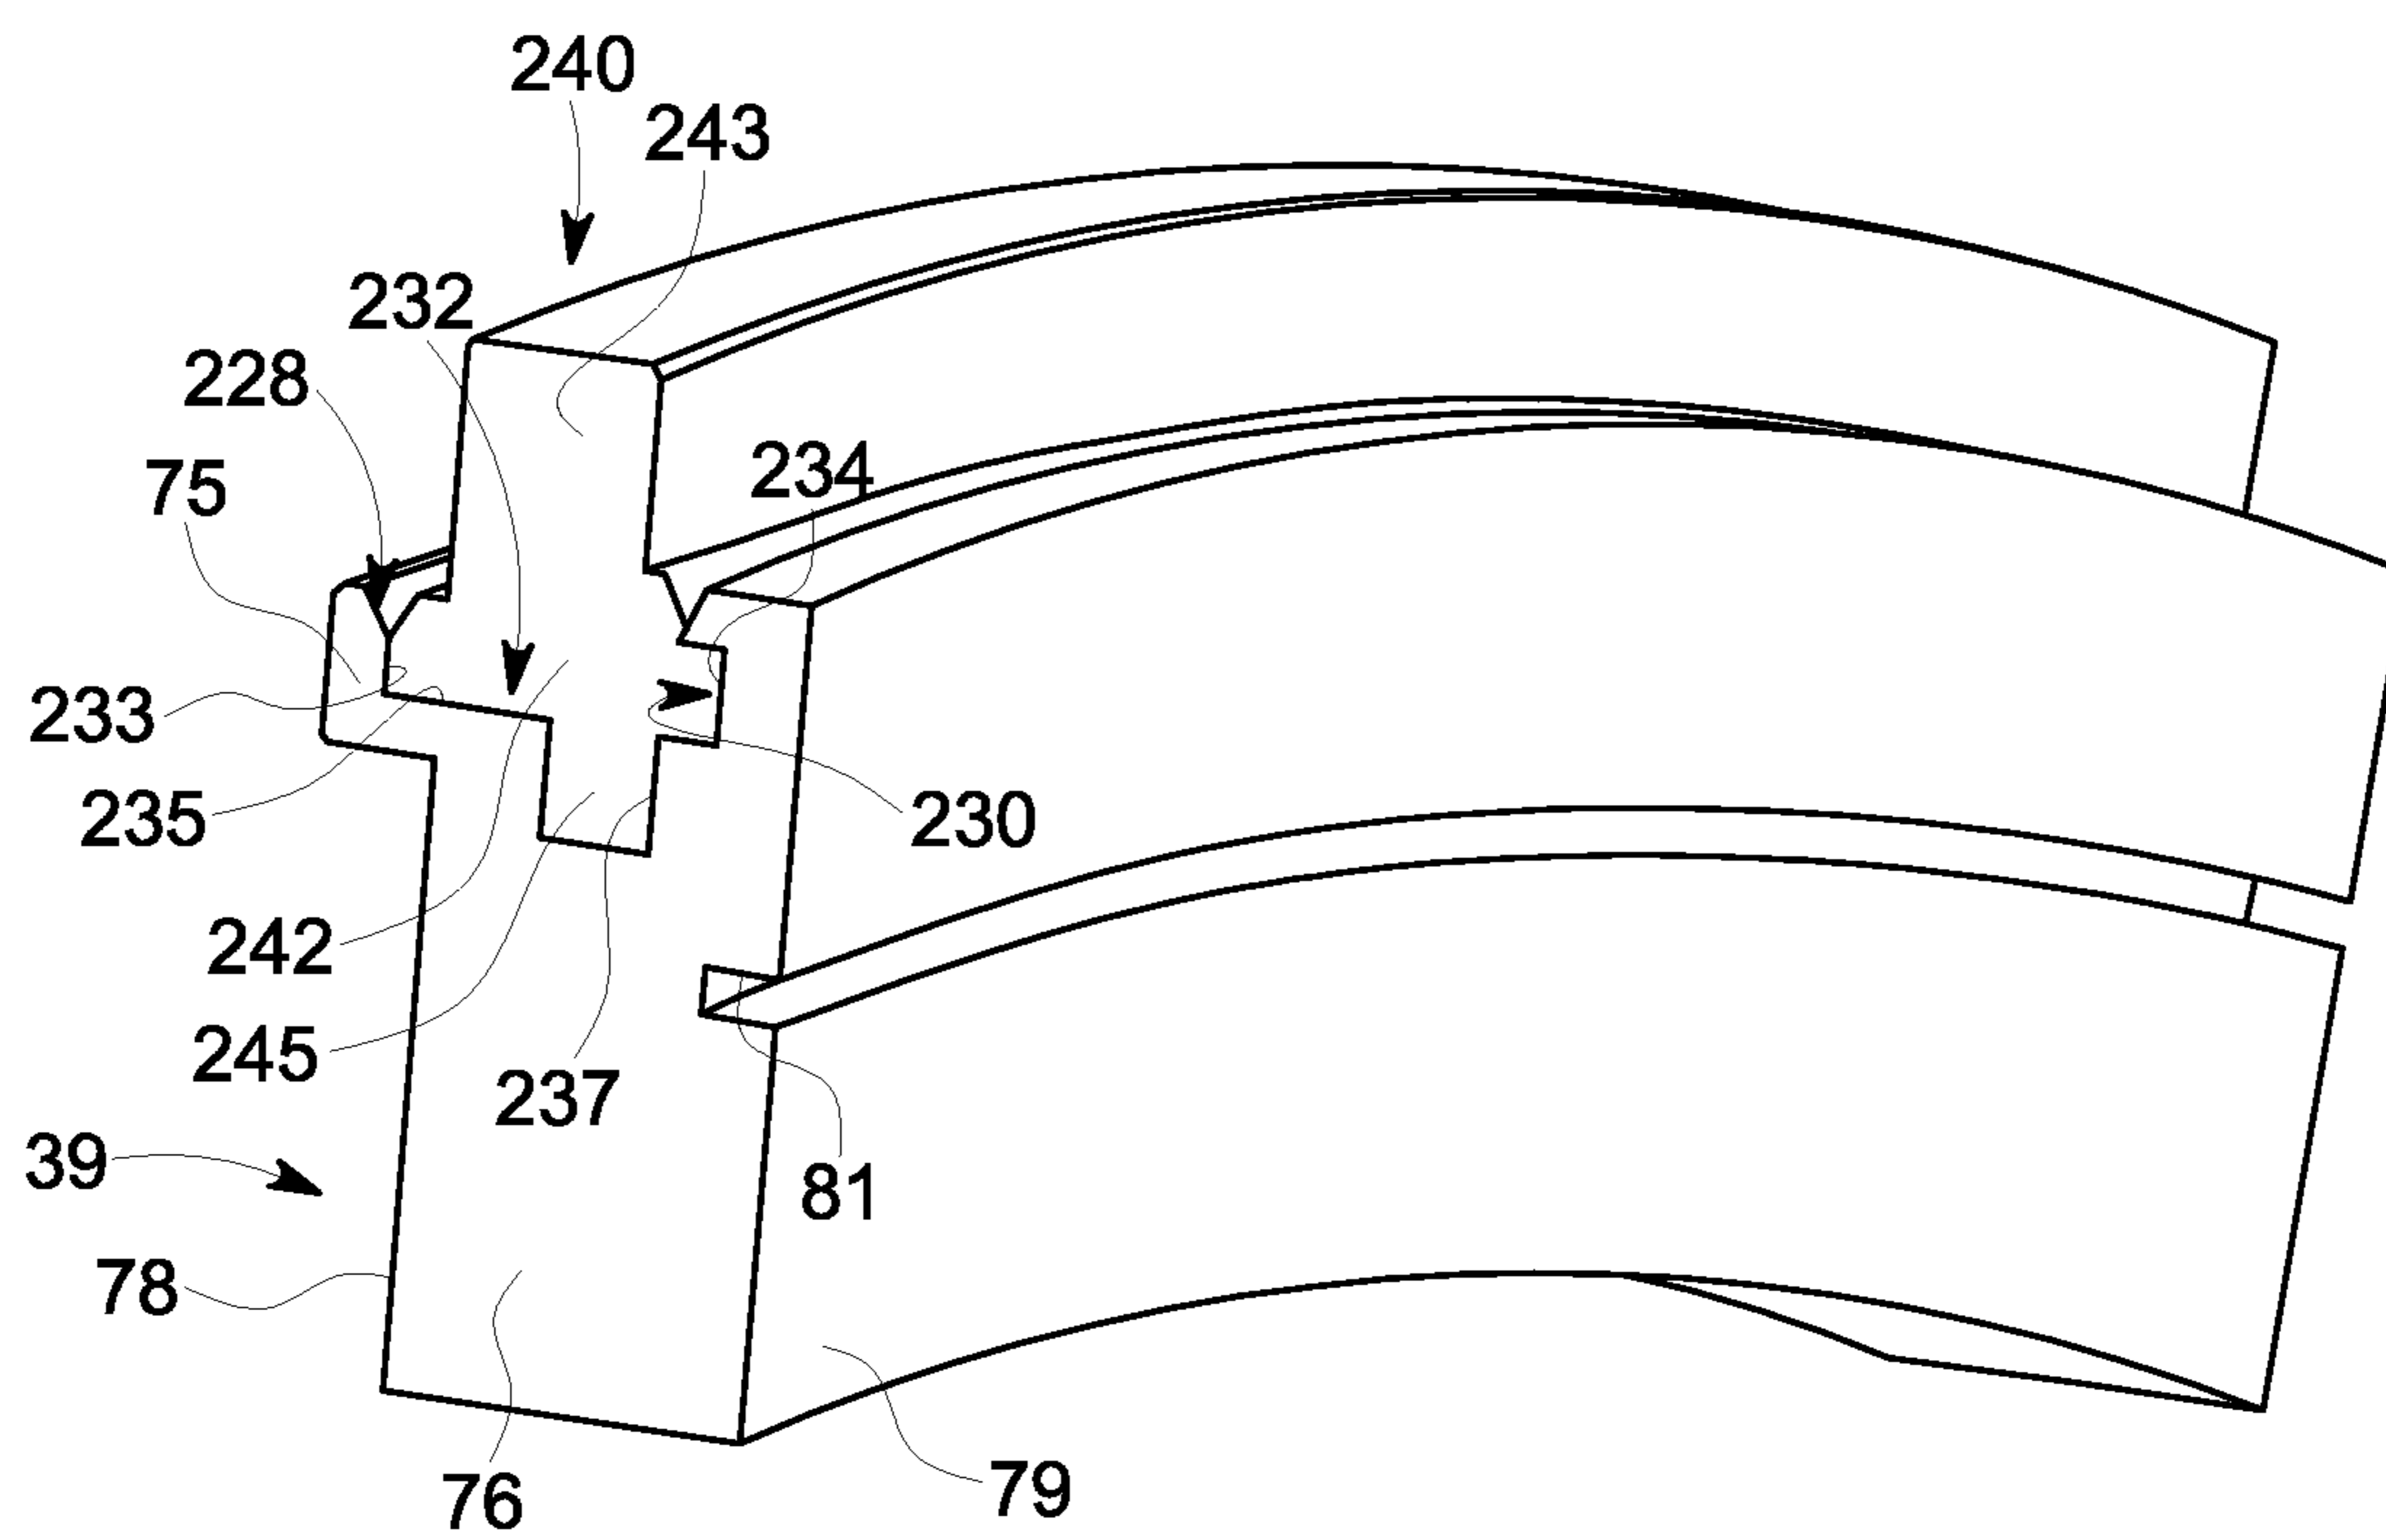
FIG. 8 is a partial plan view of a repair coupon mounted to a diaphragm rail member in accordance with yet still another aspect of the exemplary embodiment;

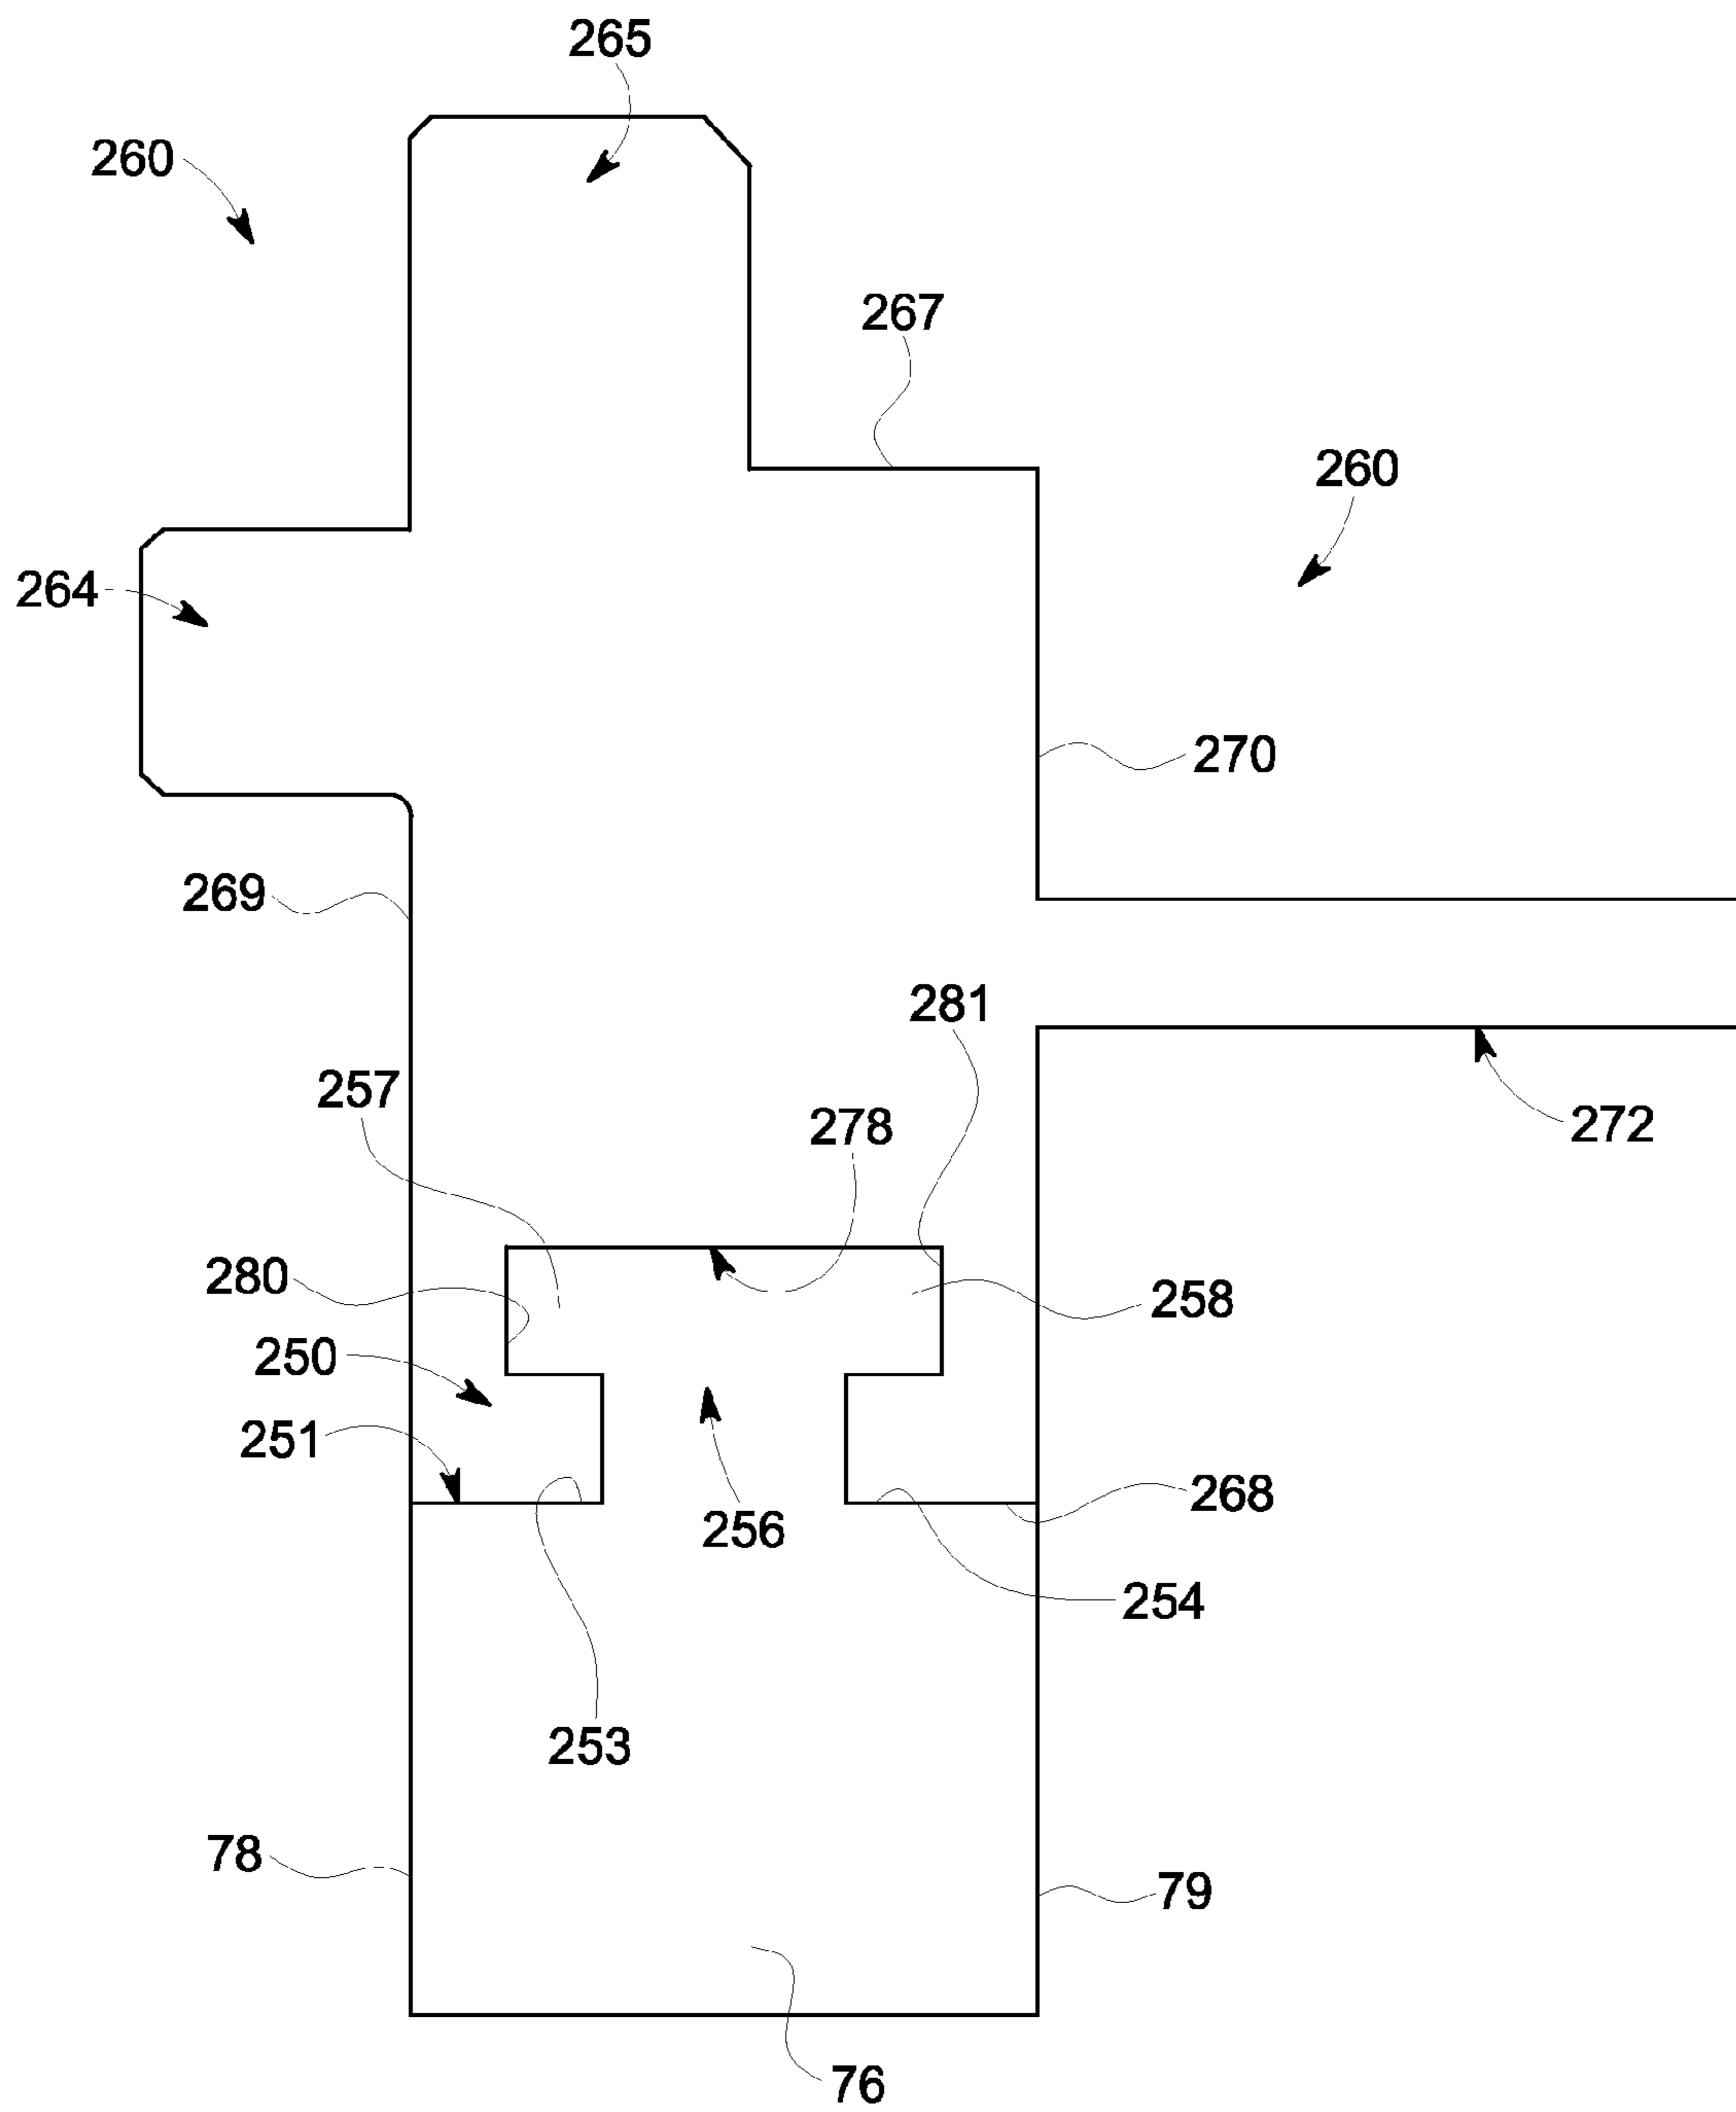
FIG. 9 is a partial plan view of a repair coupon mounted to a diaphragm rail member in accordance with still another aspect of the exemplary embodiment;

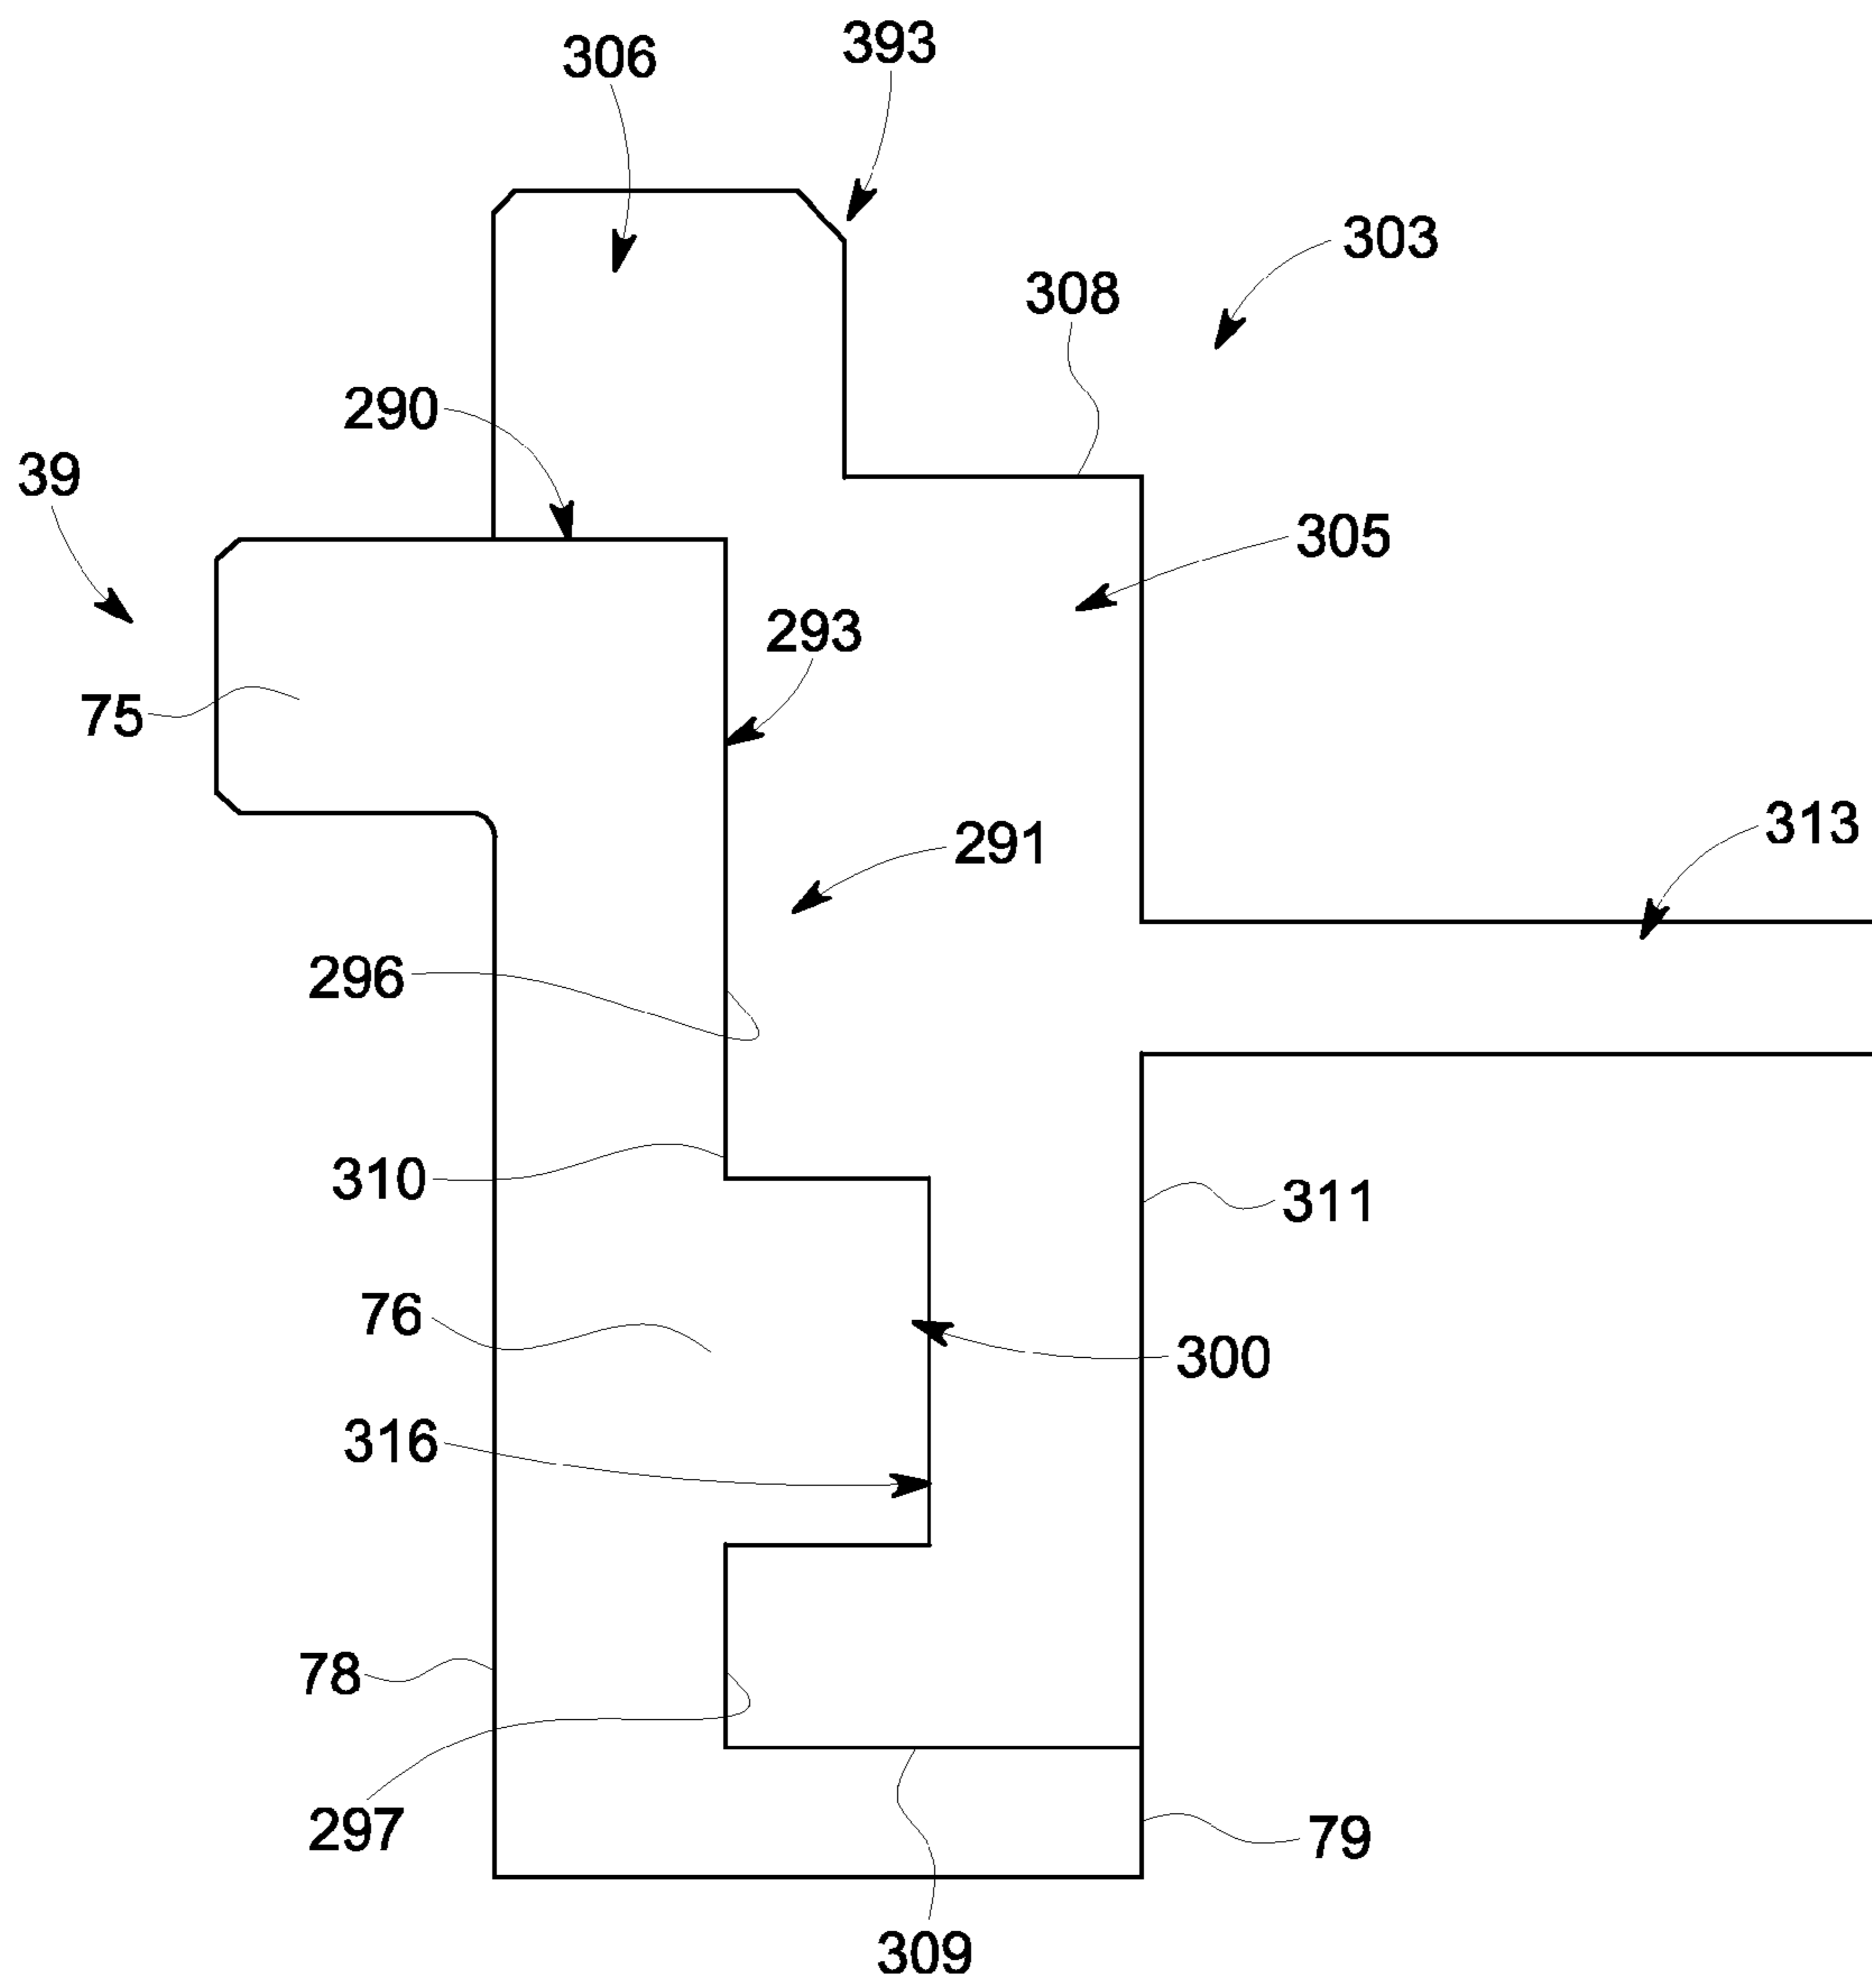
FIG. 10 is a partial plan view of a repair coupon mounted to a diaphragm rail member in accordance with yet another aspect of the exemplary embodiment;

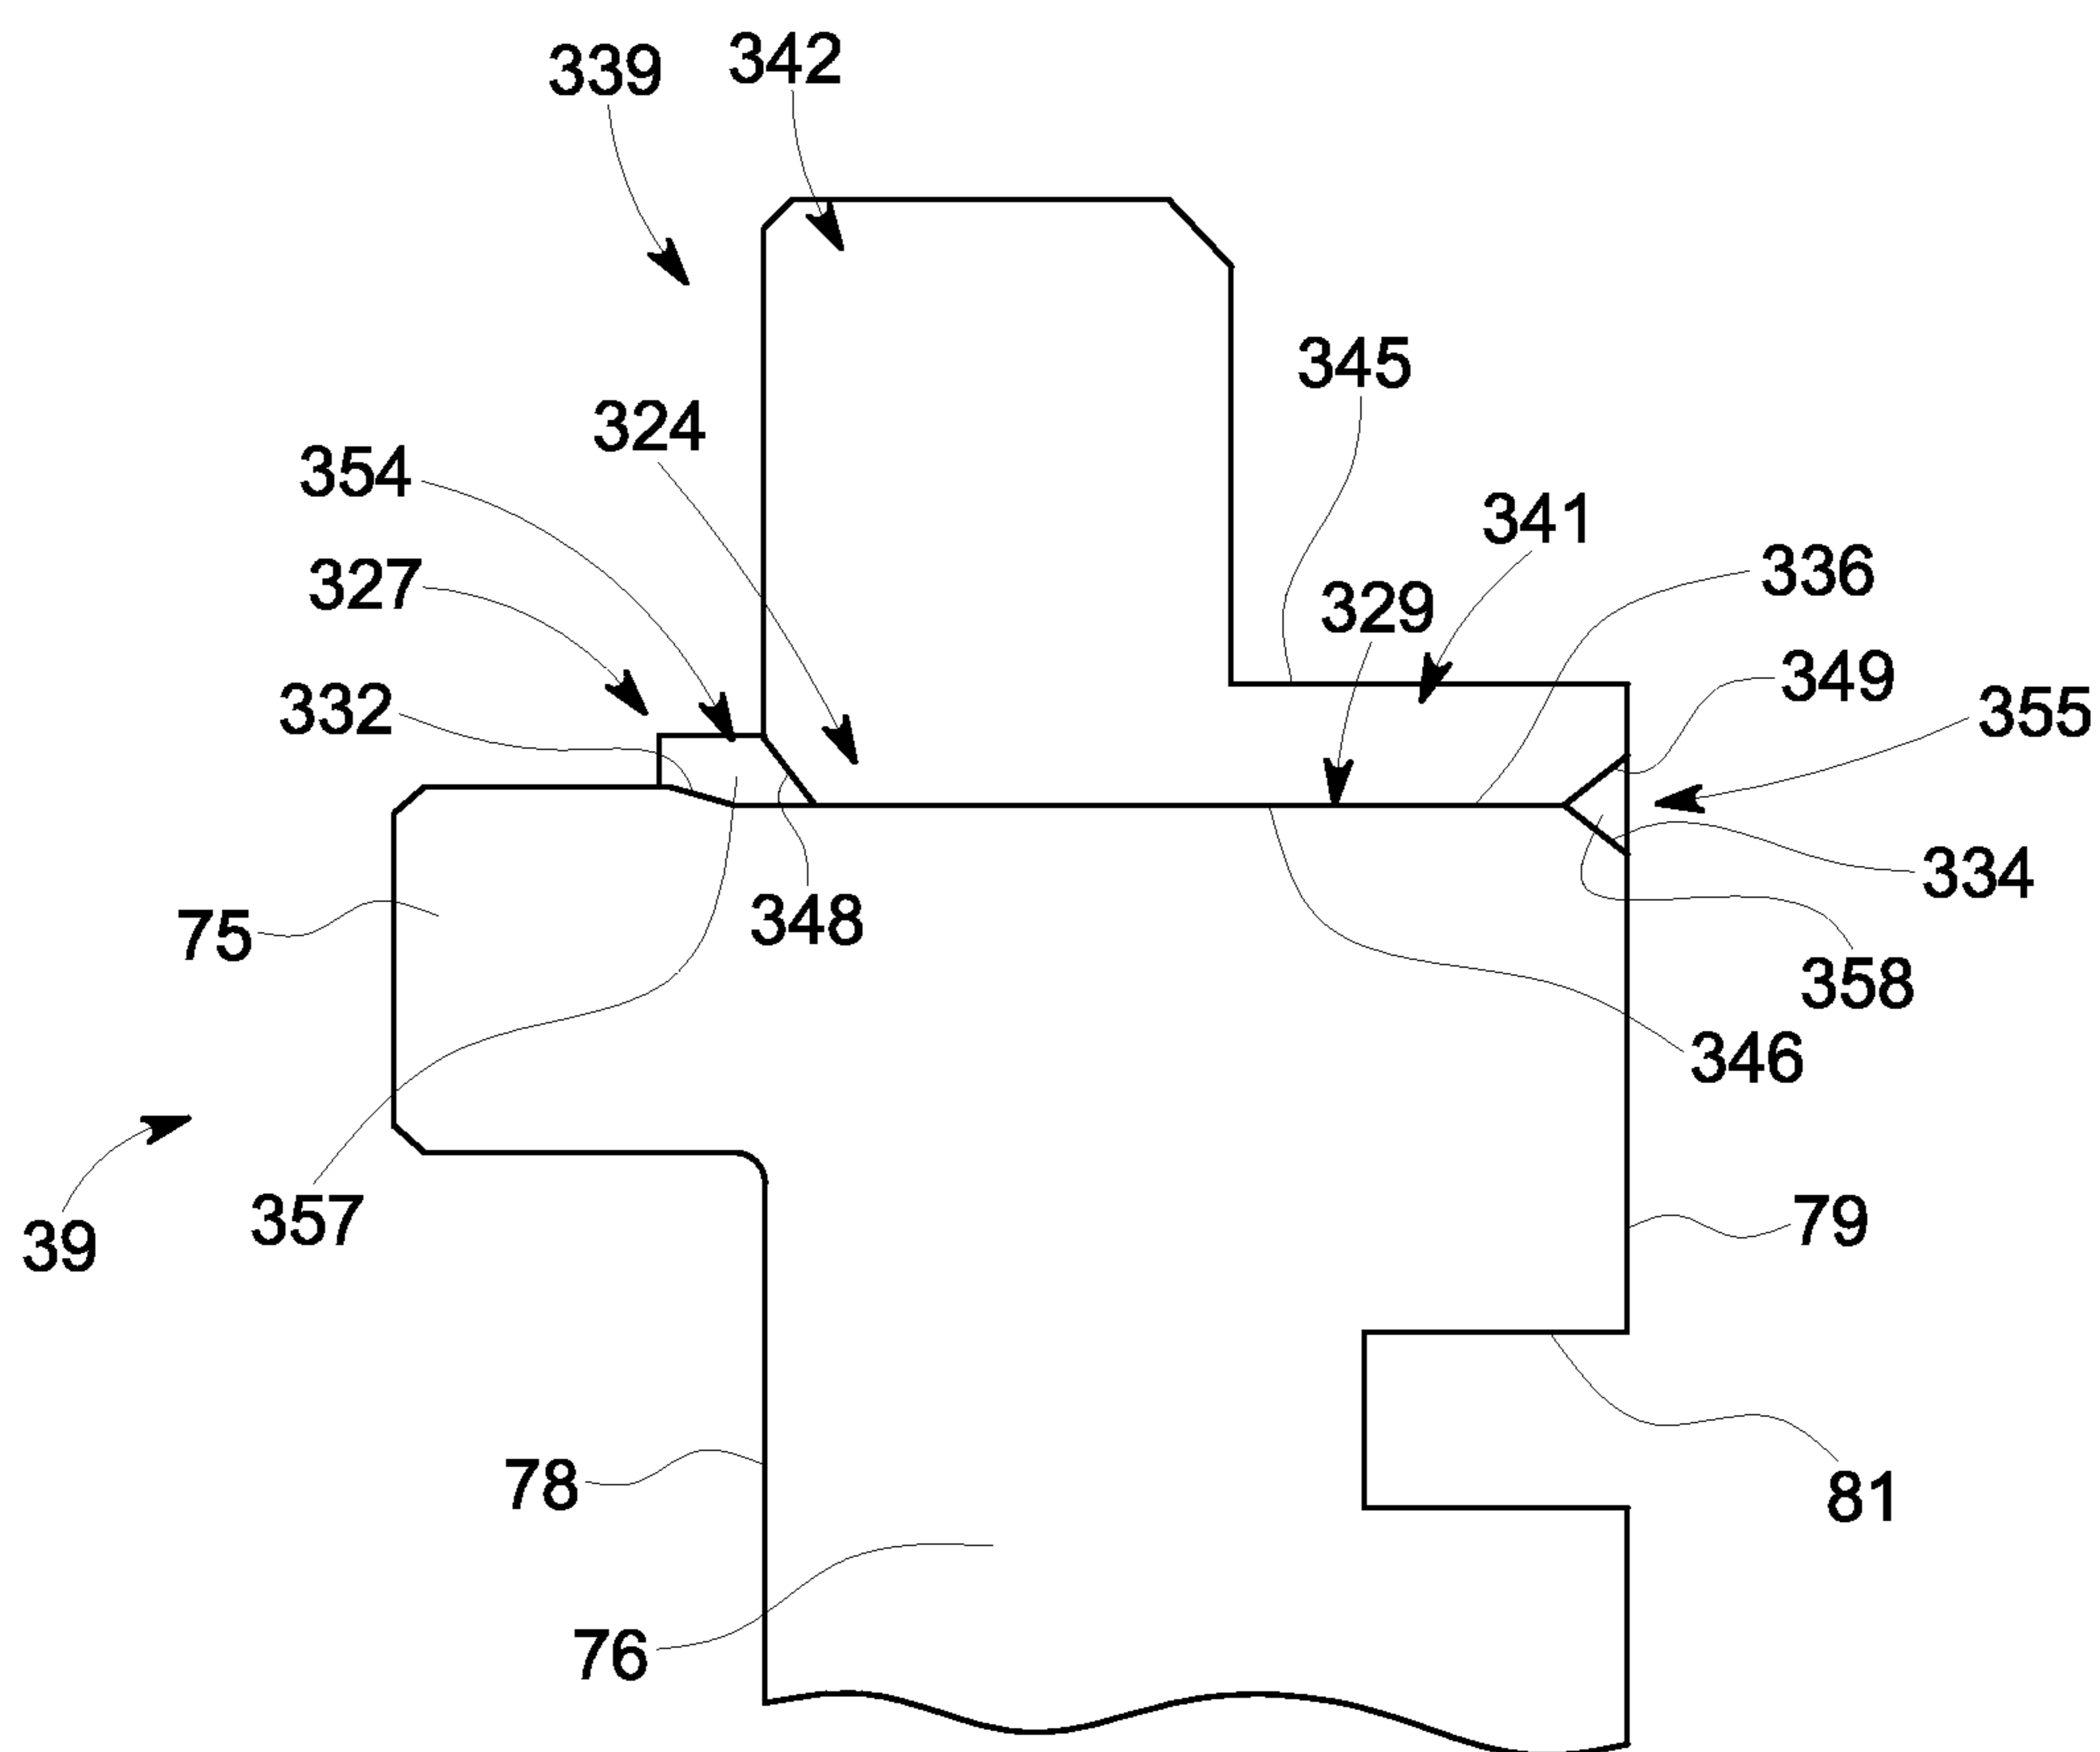
FIG. 11 is a partial plan view of a repair coupon mounted to a diaphragm rail member in accordance with another aspect of the exemplary embodiment;

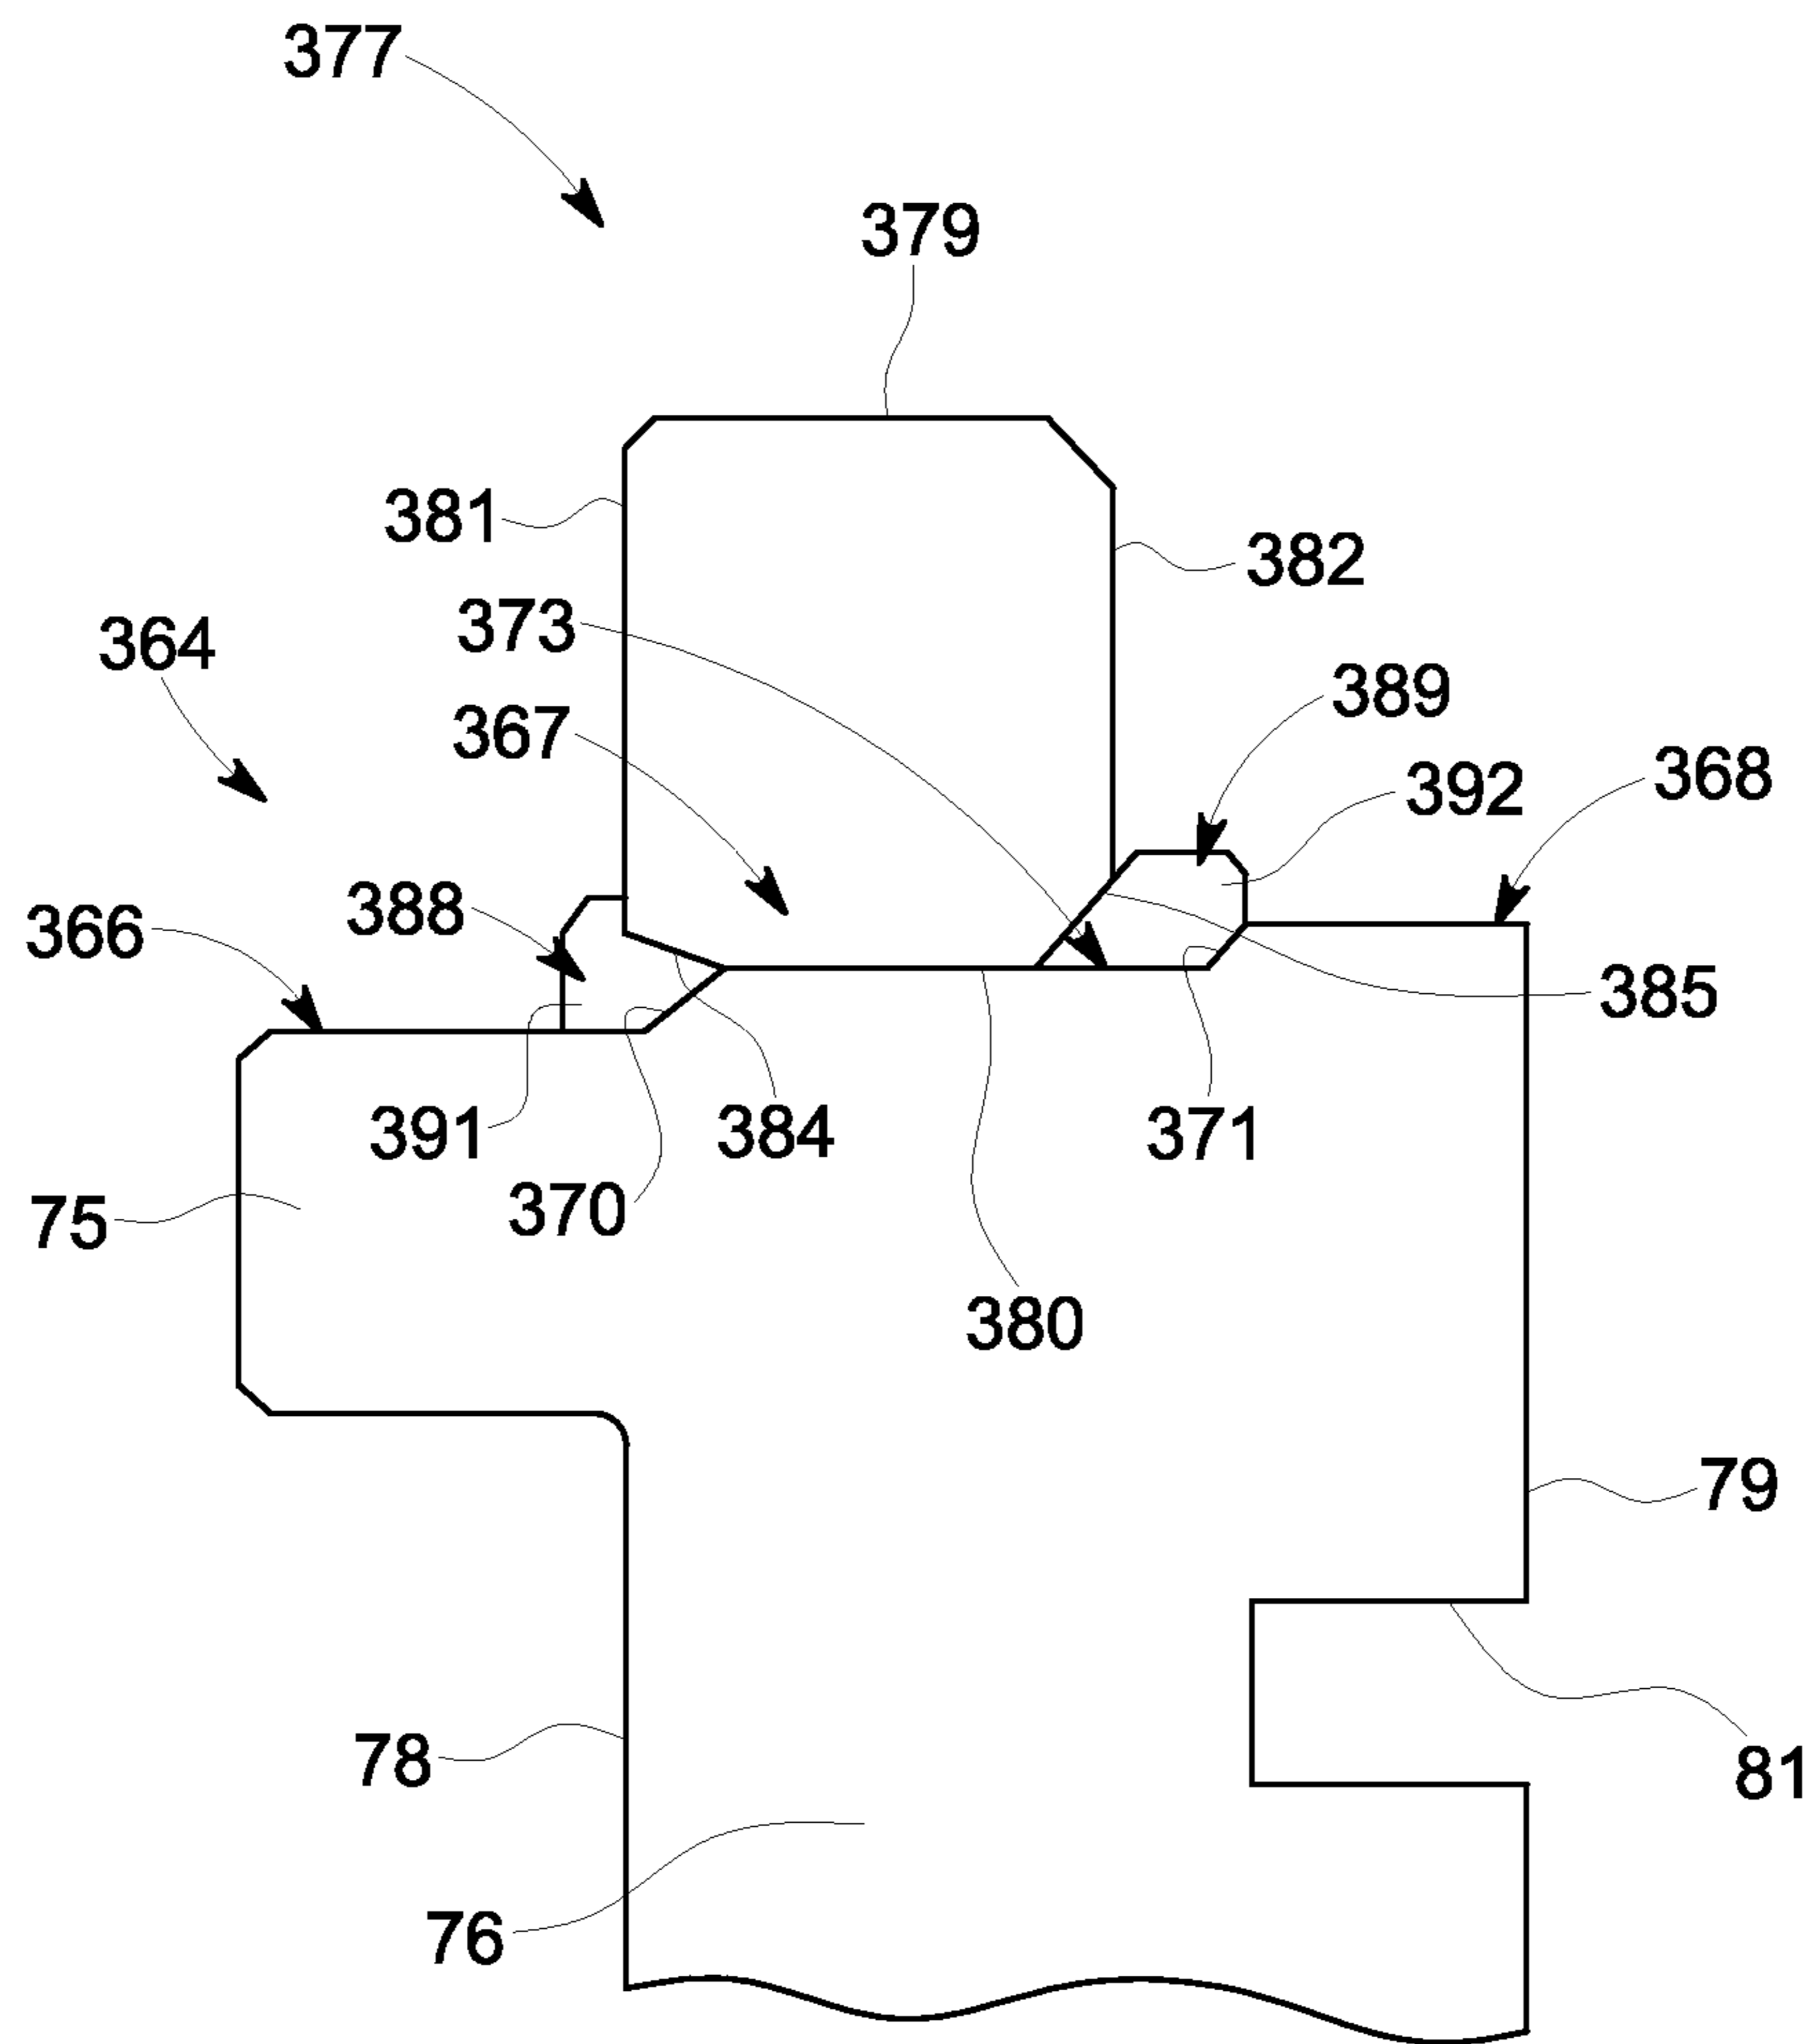
FIG. 12 is a partial plan view of a repair coupon mounted to a diaphragm rail member in accordance with yet still another aspect of the exemplary embodiment;
