(54) **TURBOMACHINE DIAPHRAGM AND METHOD OF REPAIRING A TURBOMACHINE DIAPHRAGM**

## TURBOMACHINE DIAPHRAGM AND METHOD OF REPAIRING A TURBOMACHINE DIAPHRAGM

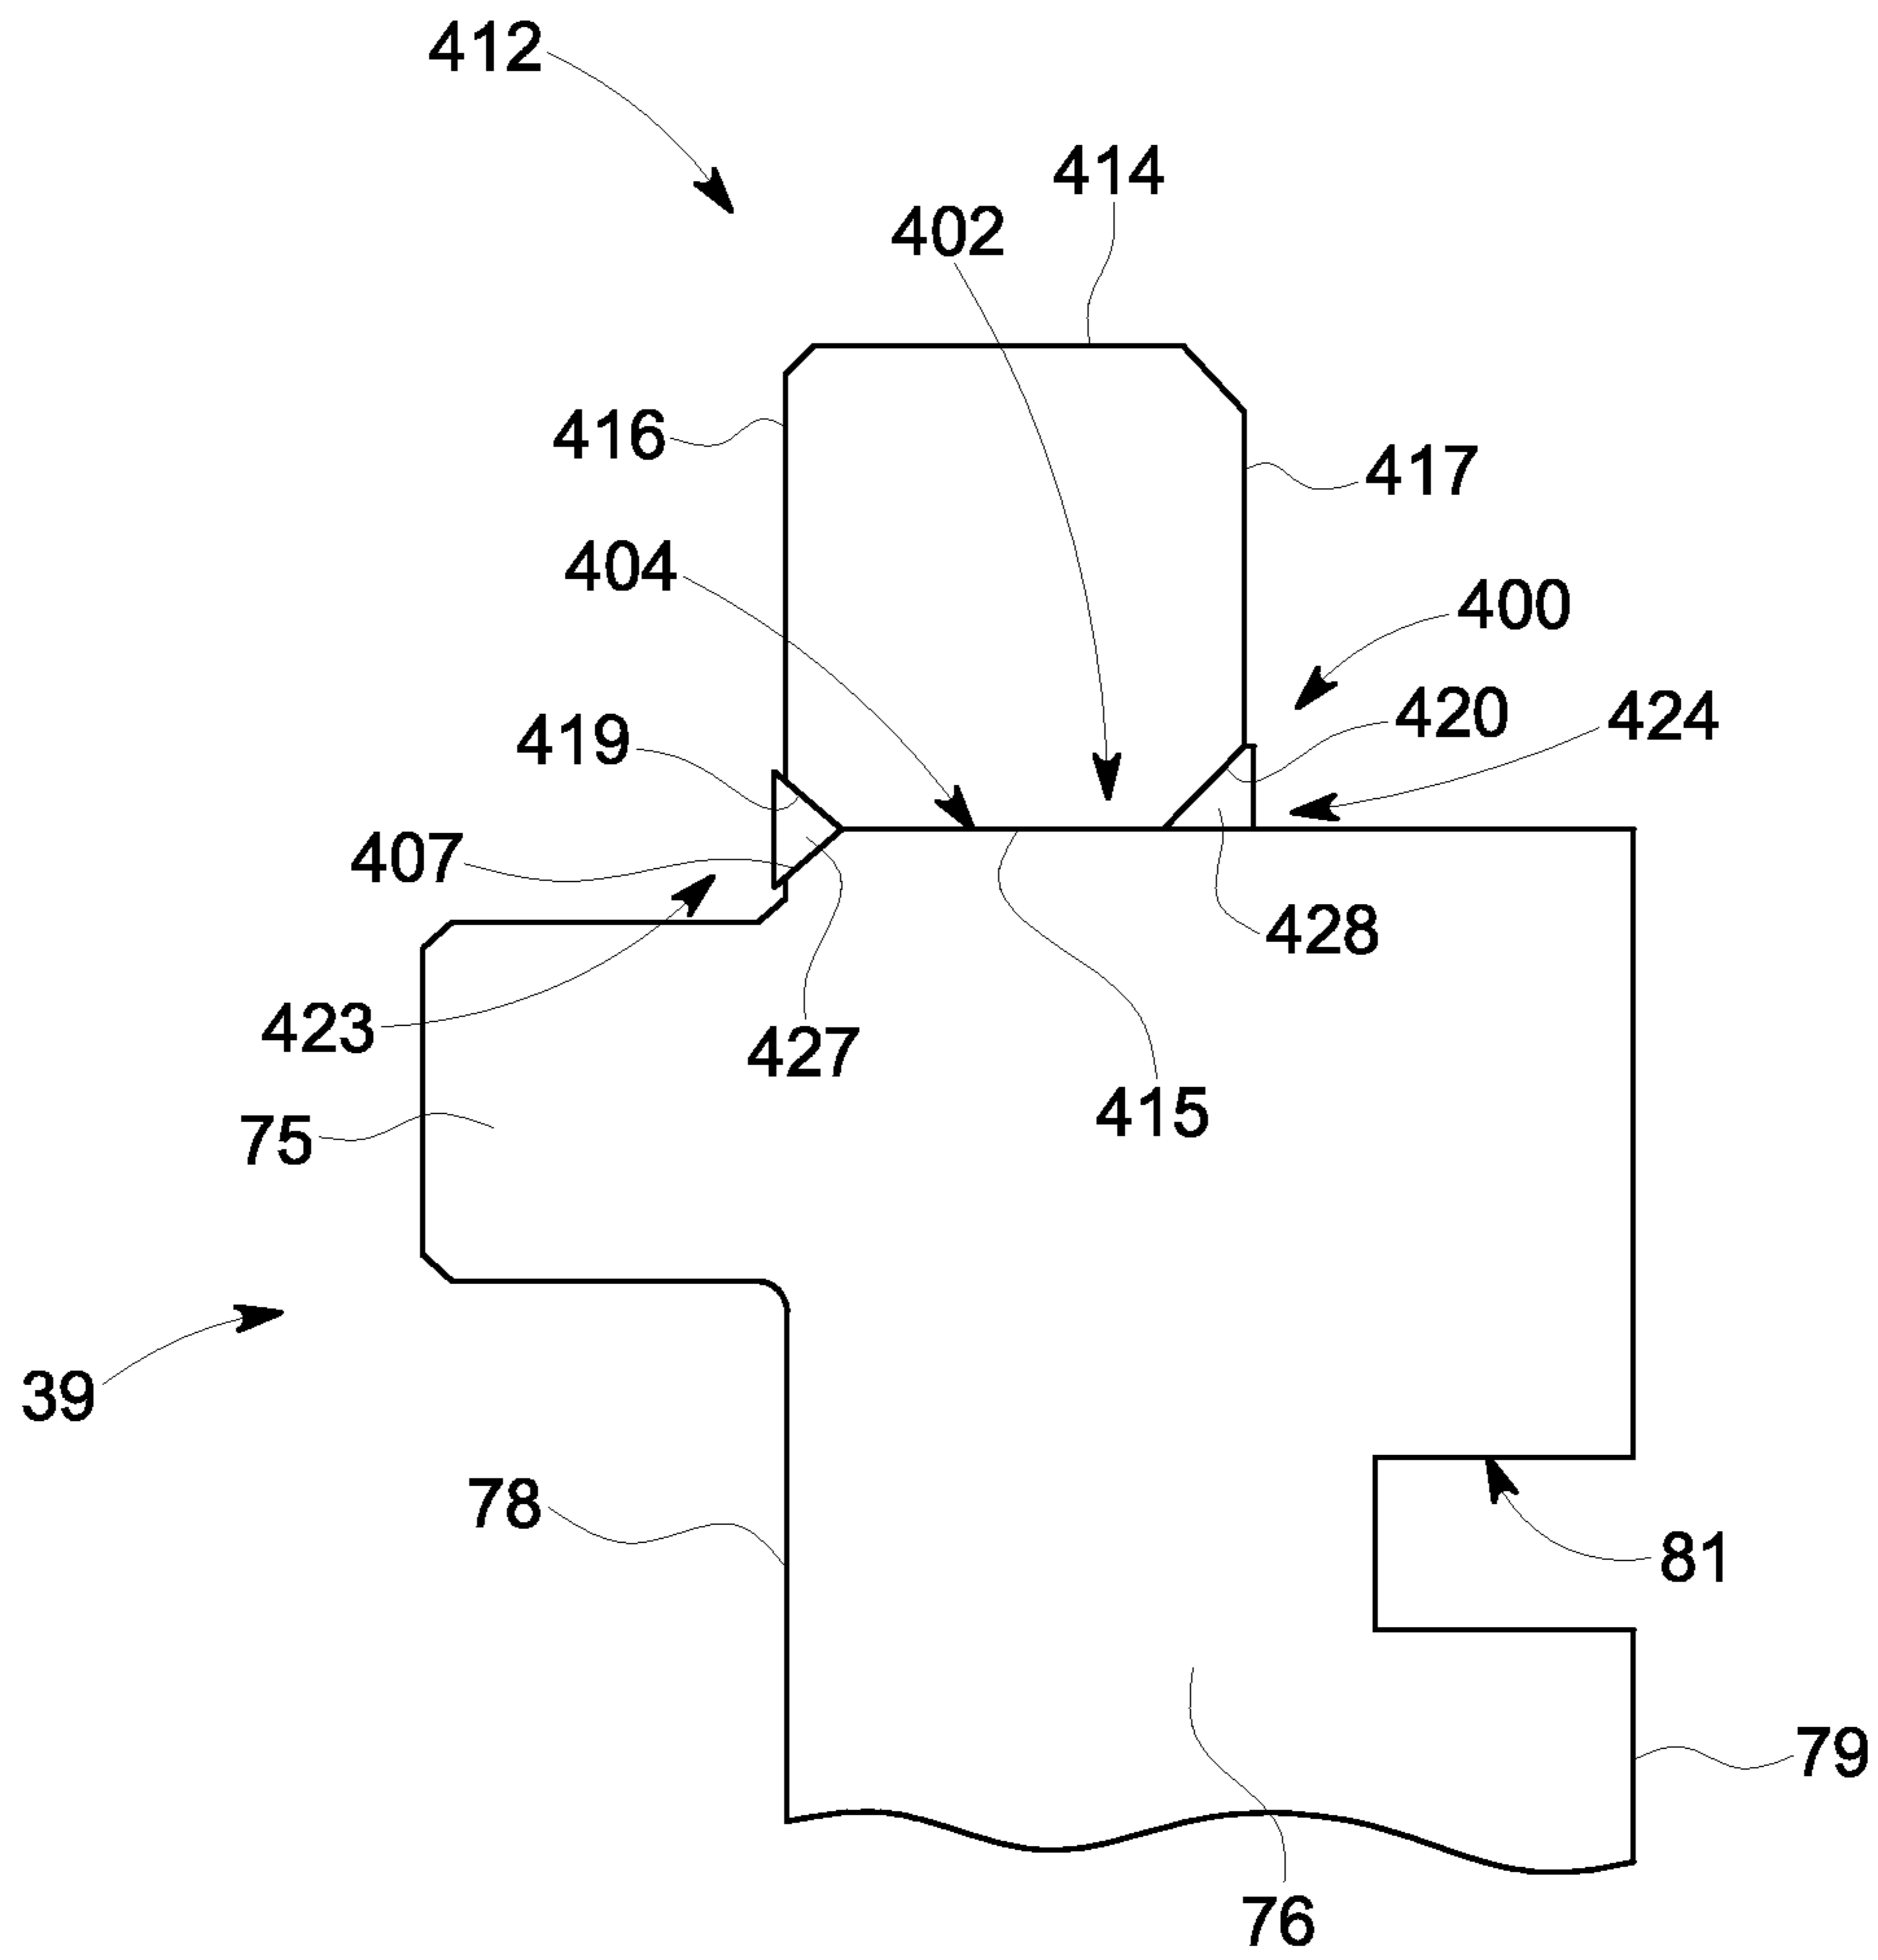
FIG. 13 is a partial plan view of a repair coupon mounted to a diaphragm rail member in accordance with yet another aspect of the exemplary embodiment;

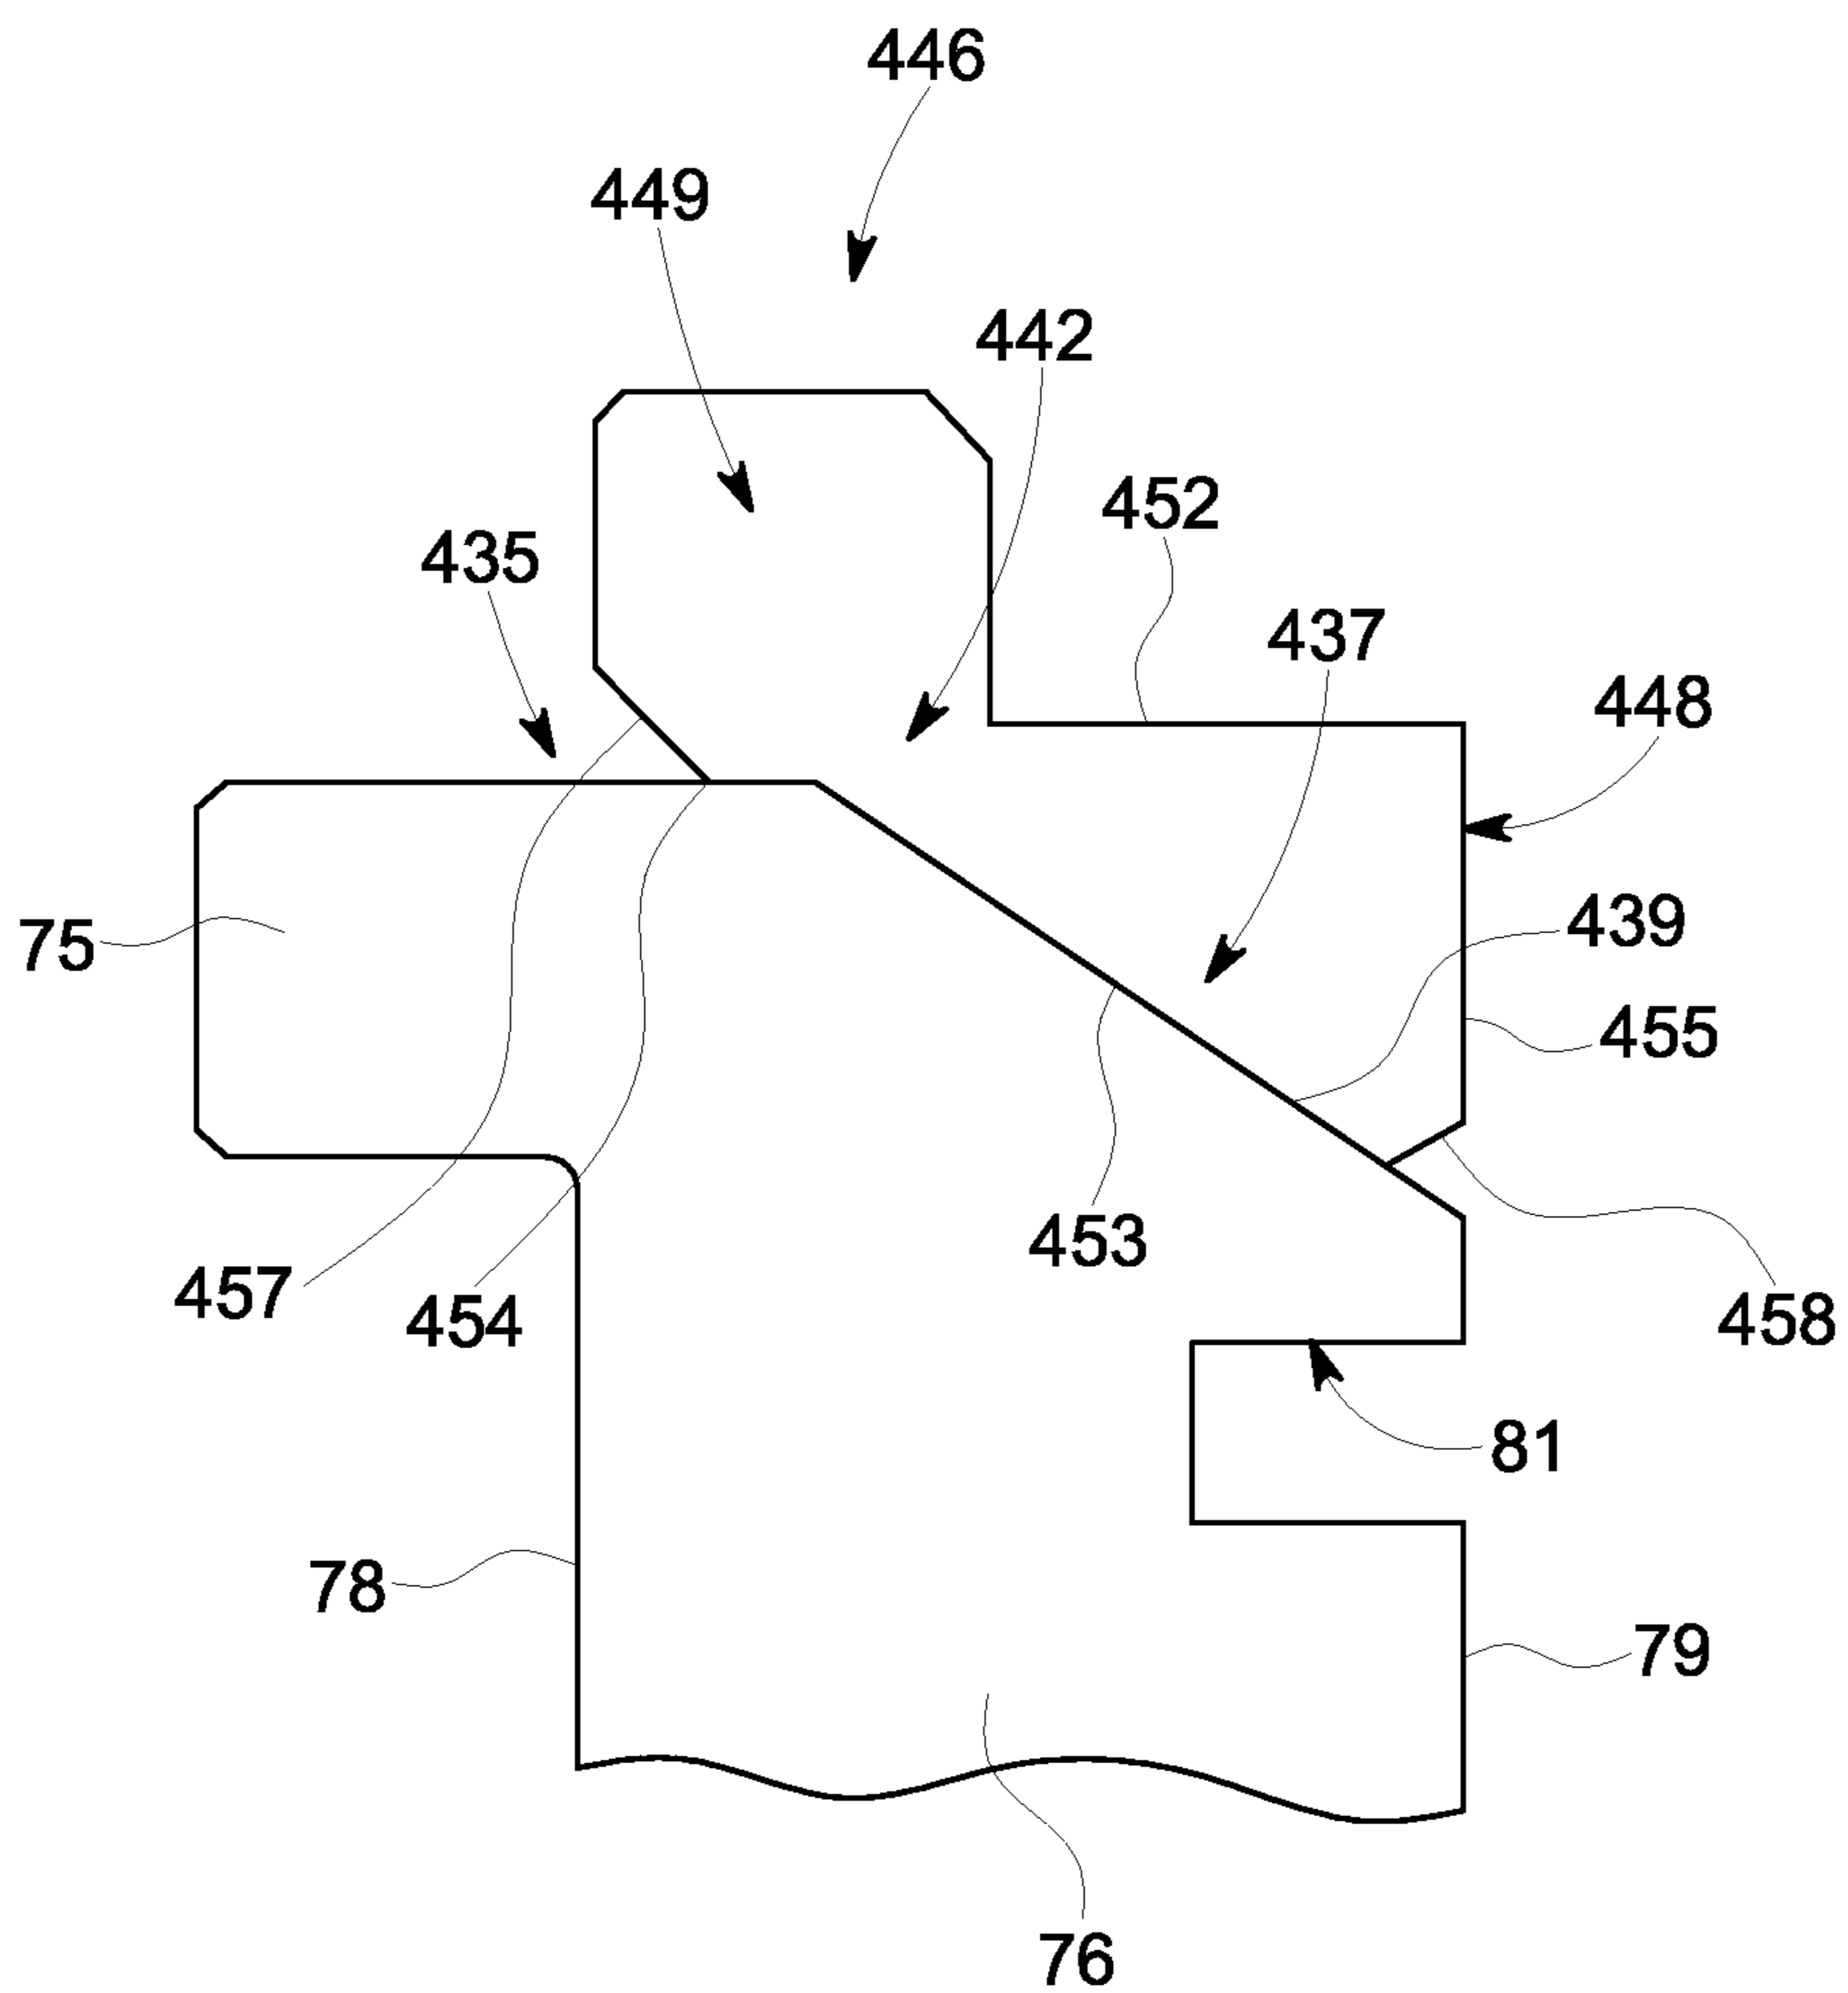
FIG. 14 is a partial plan view of a repair coupon mounted to a diaphragm rail member in accordance with still another aspect of the exemplary embodiment;

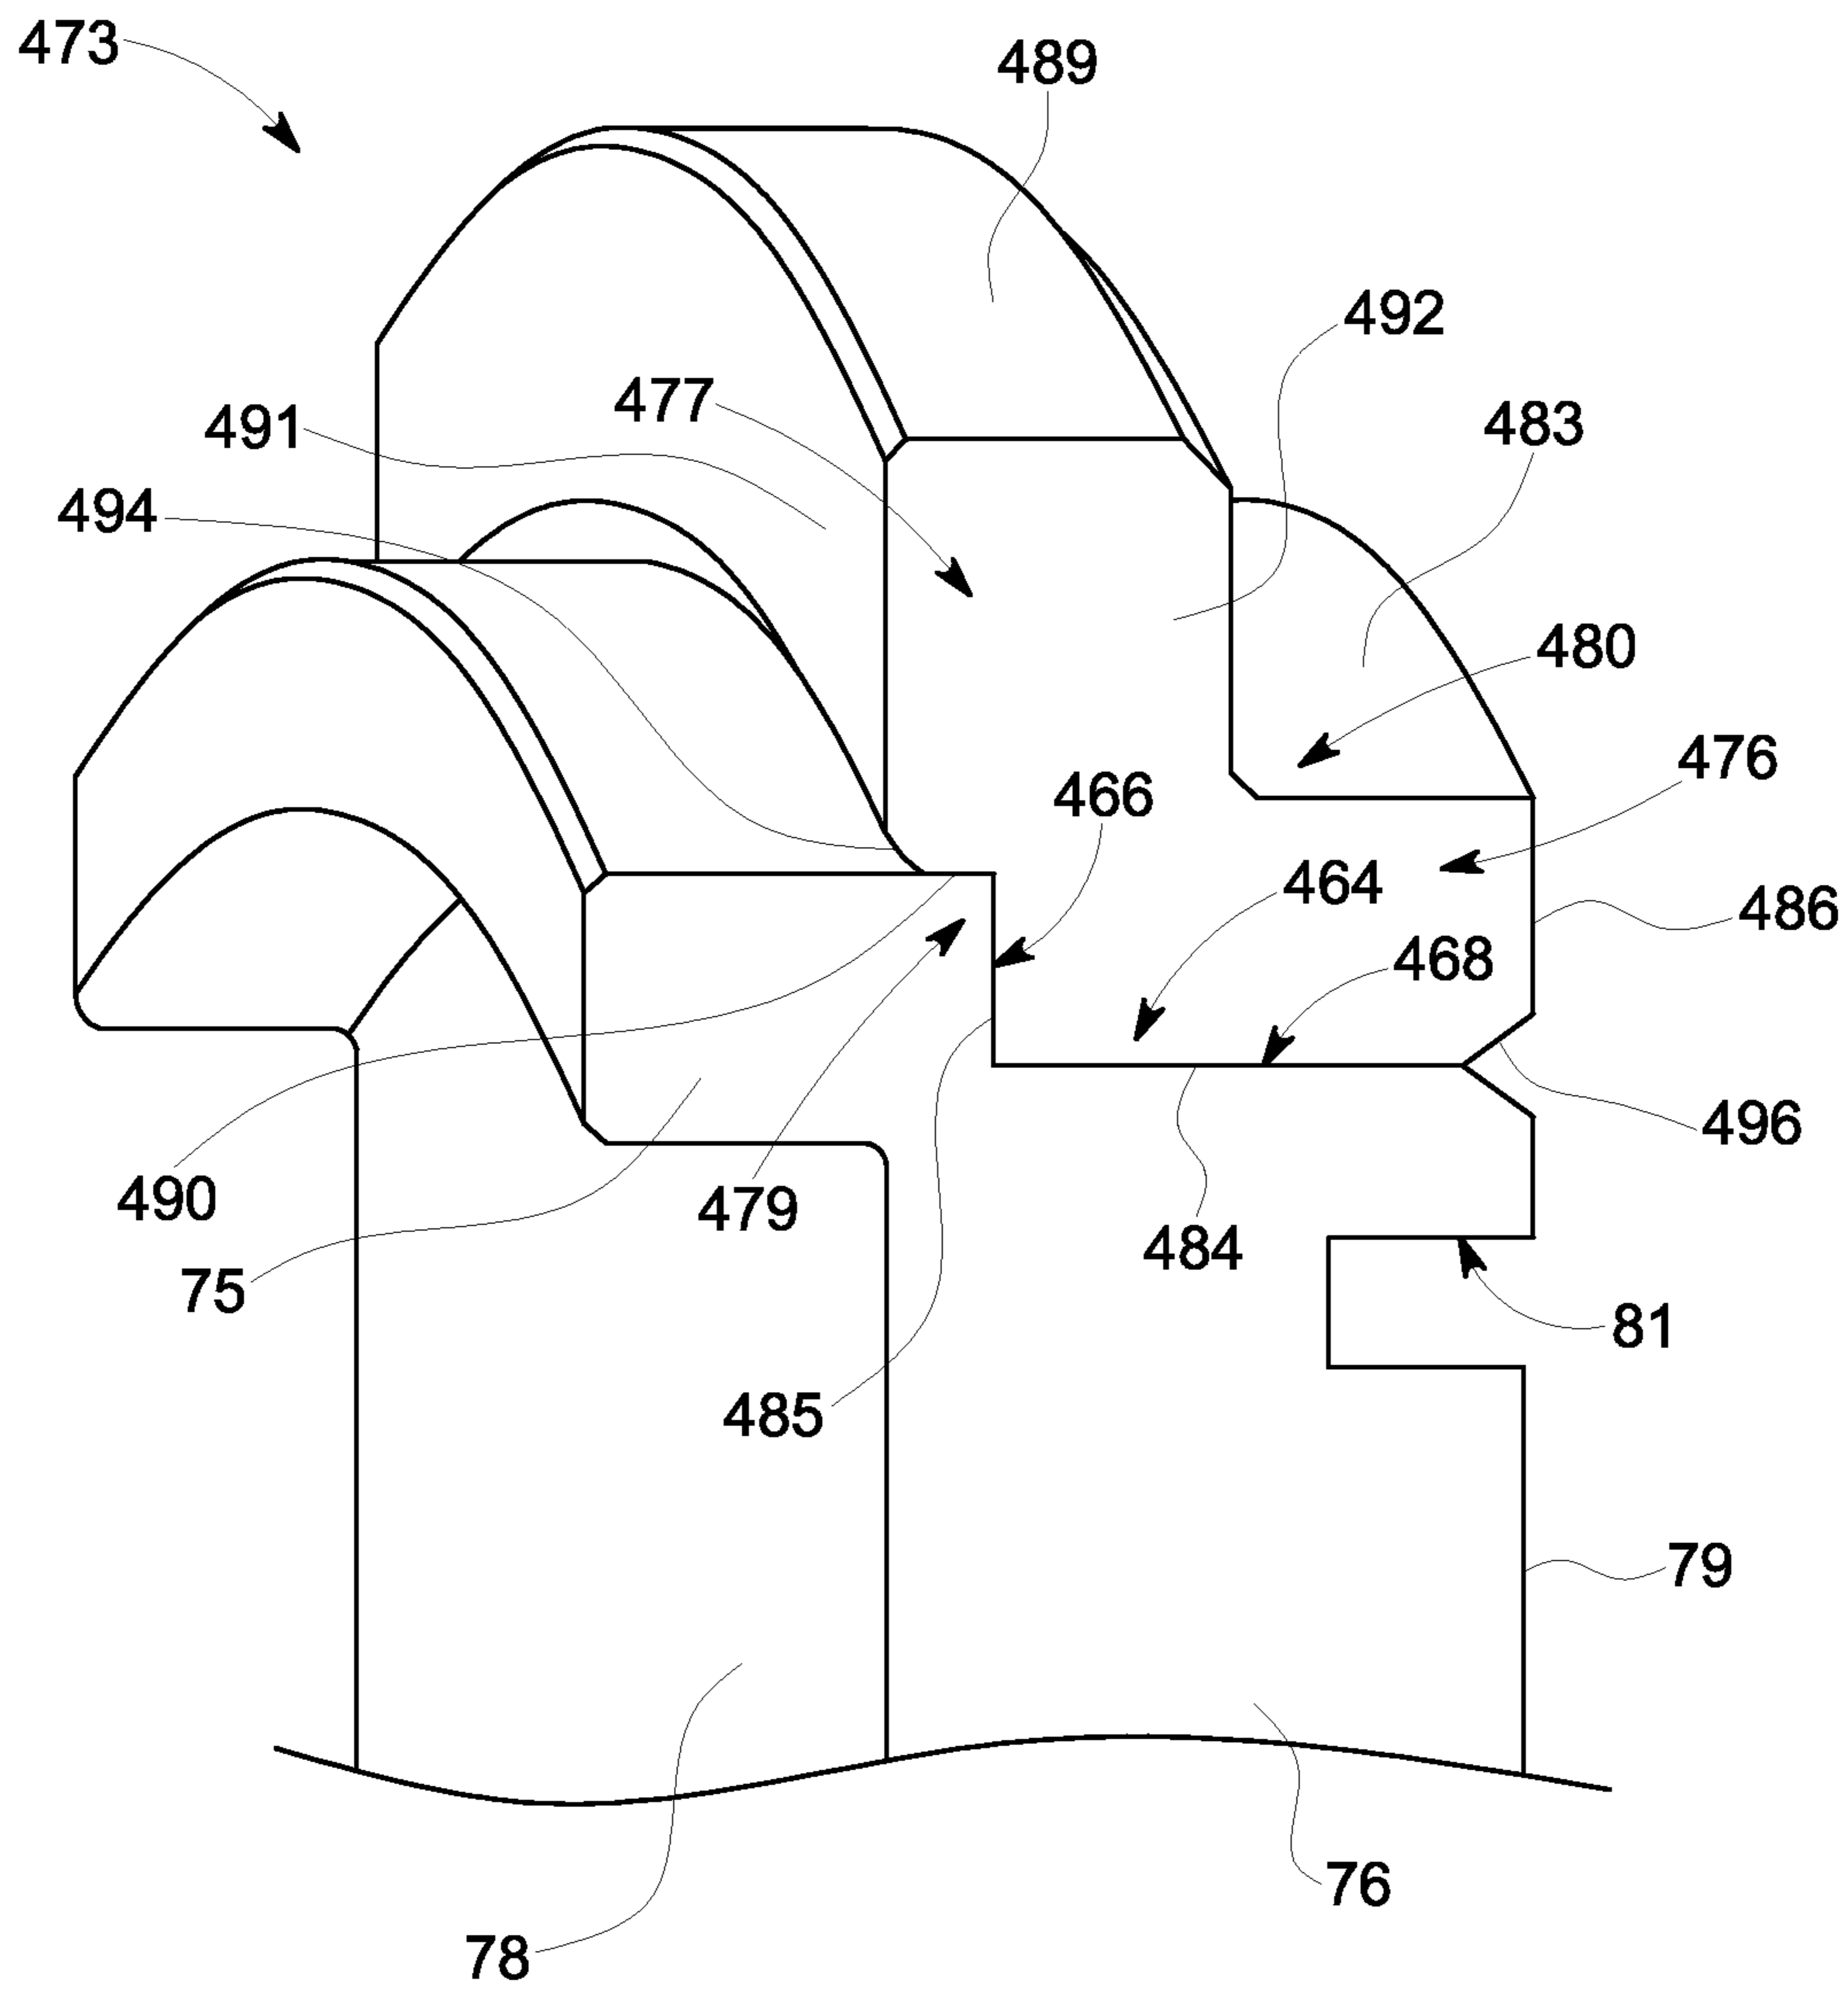
FIG. 15 is a partial plan view of a repair coupon mounted to a diaphragm rail member in accordance with another aspect of the exemplary embodiment;

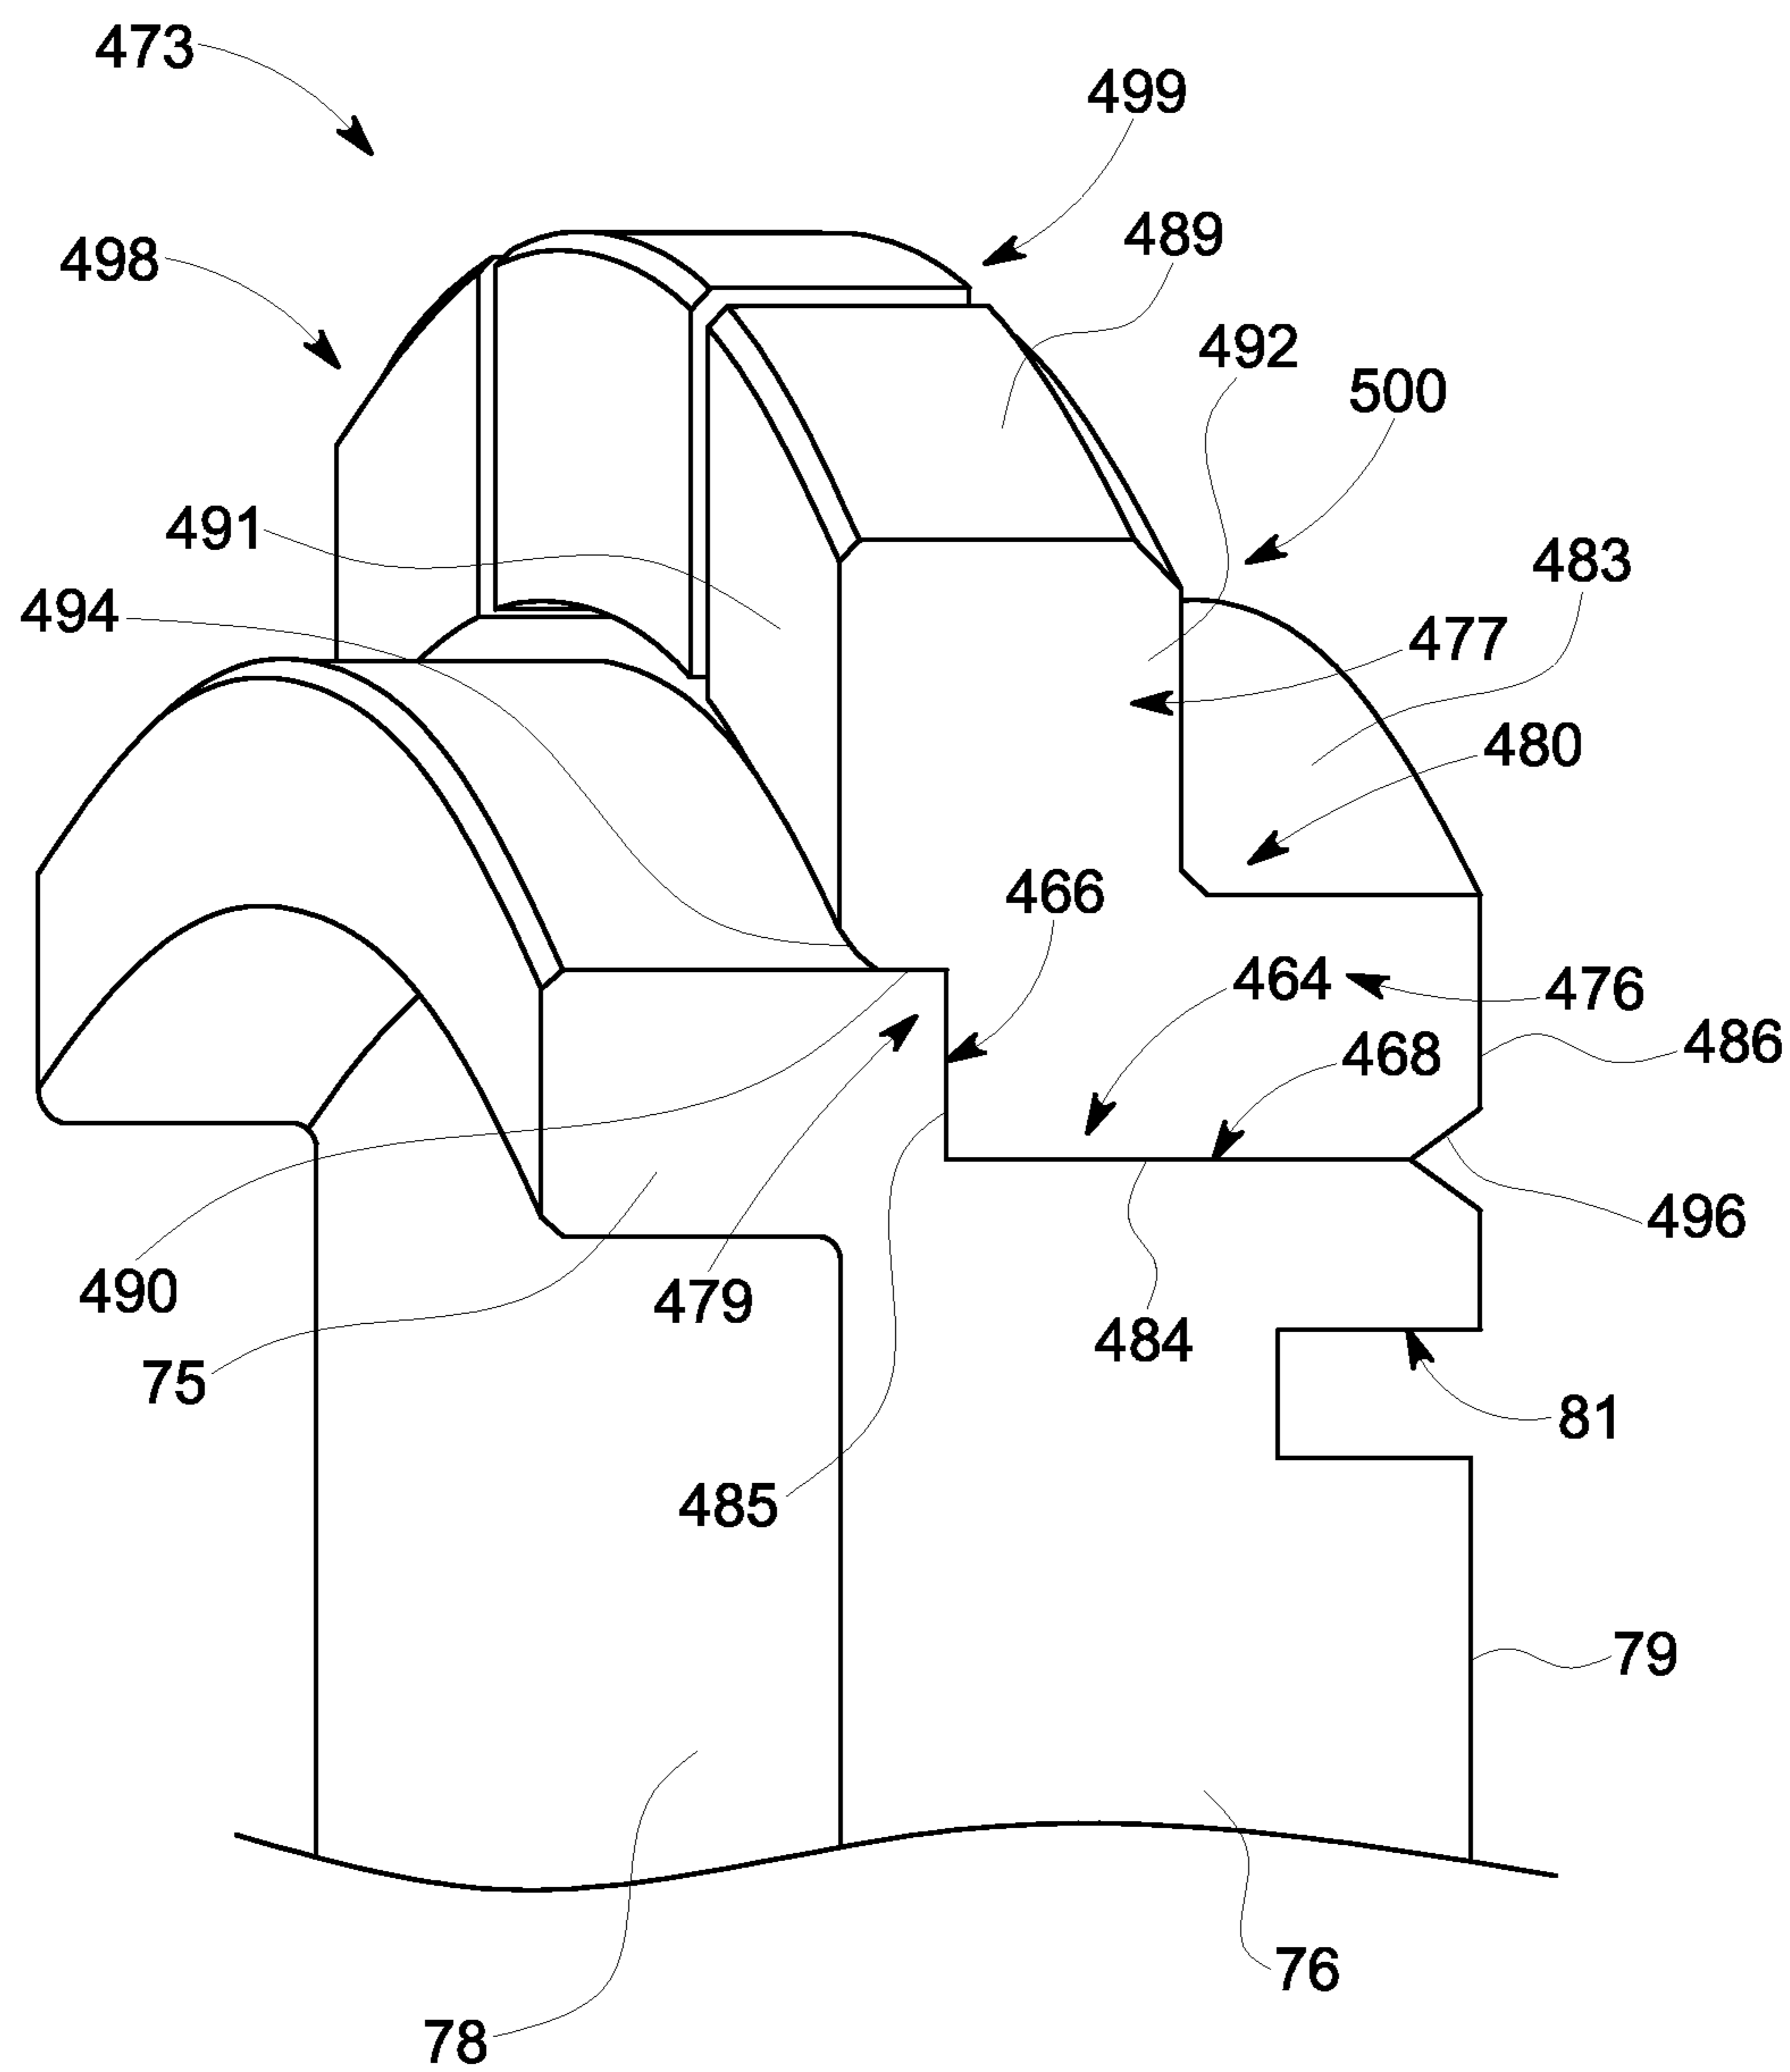
FIG. 16 is a partial plan view of a repair coupon mounted to a diaphragm rail member in accordance with still yet another aspect of the exemplary embodiment; and

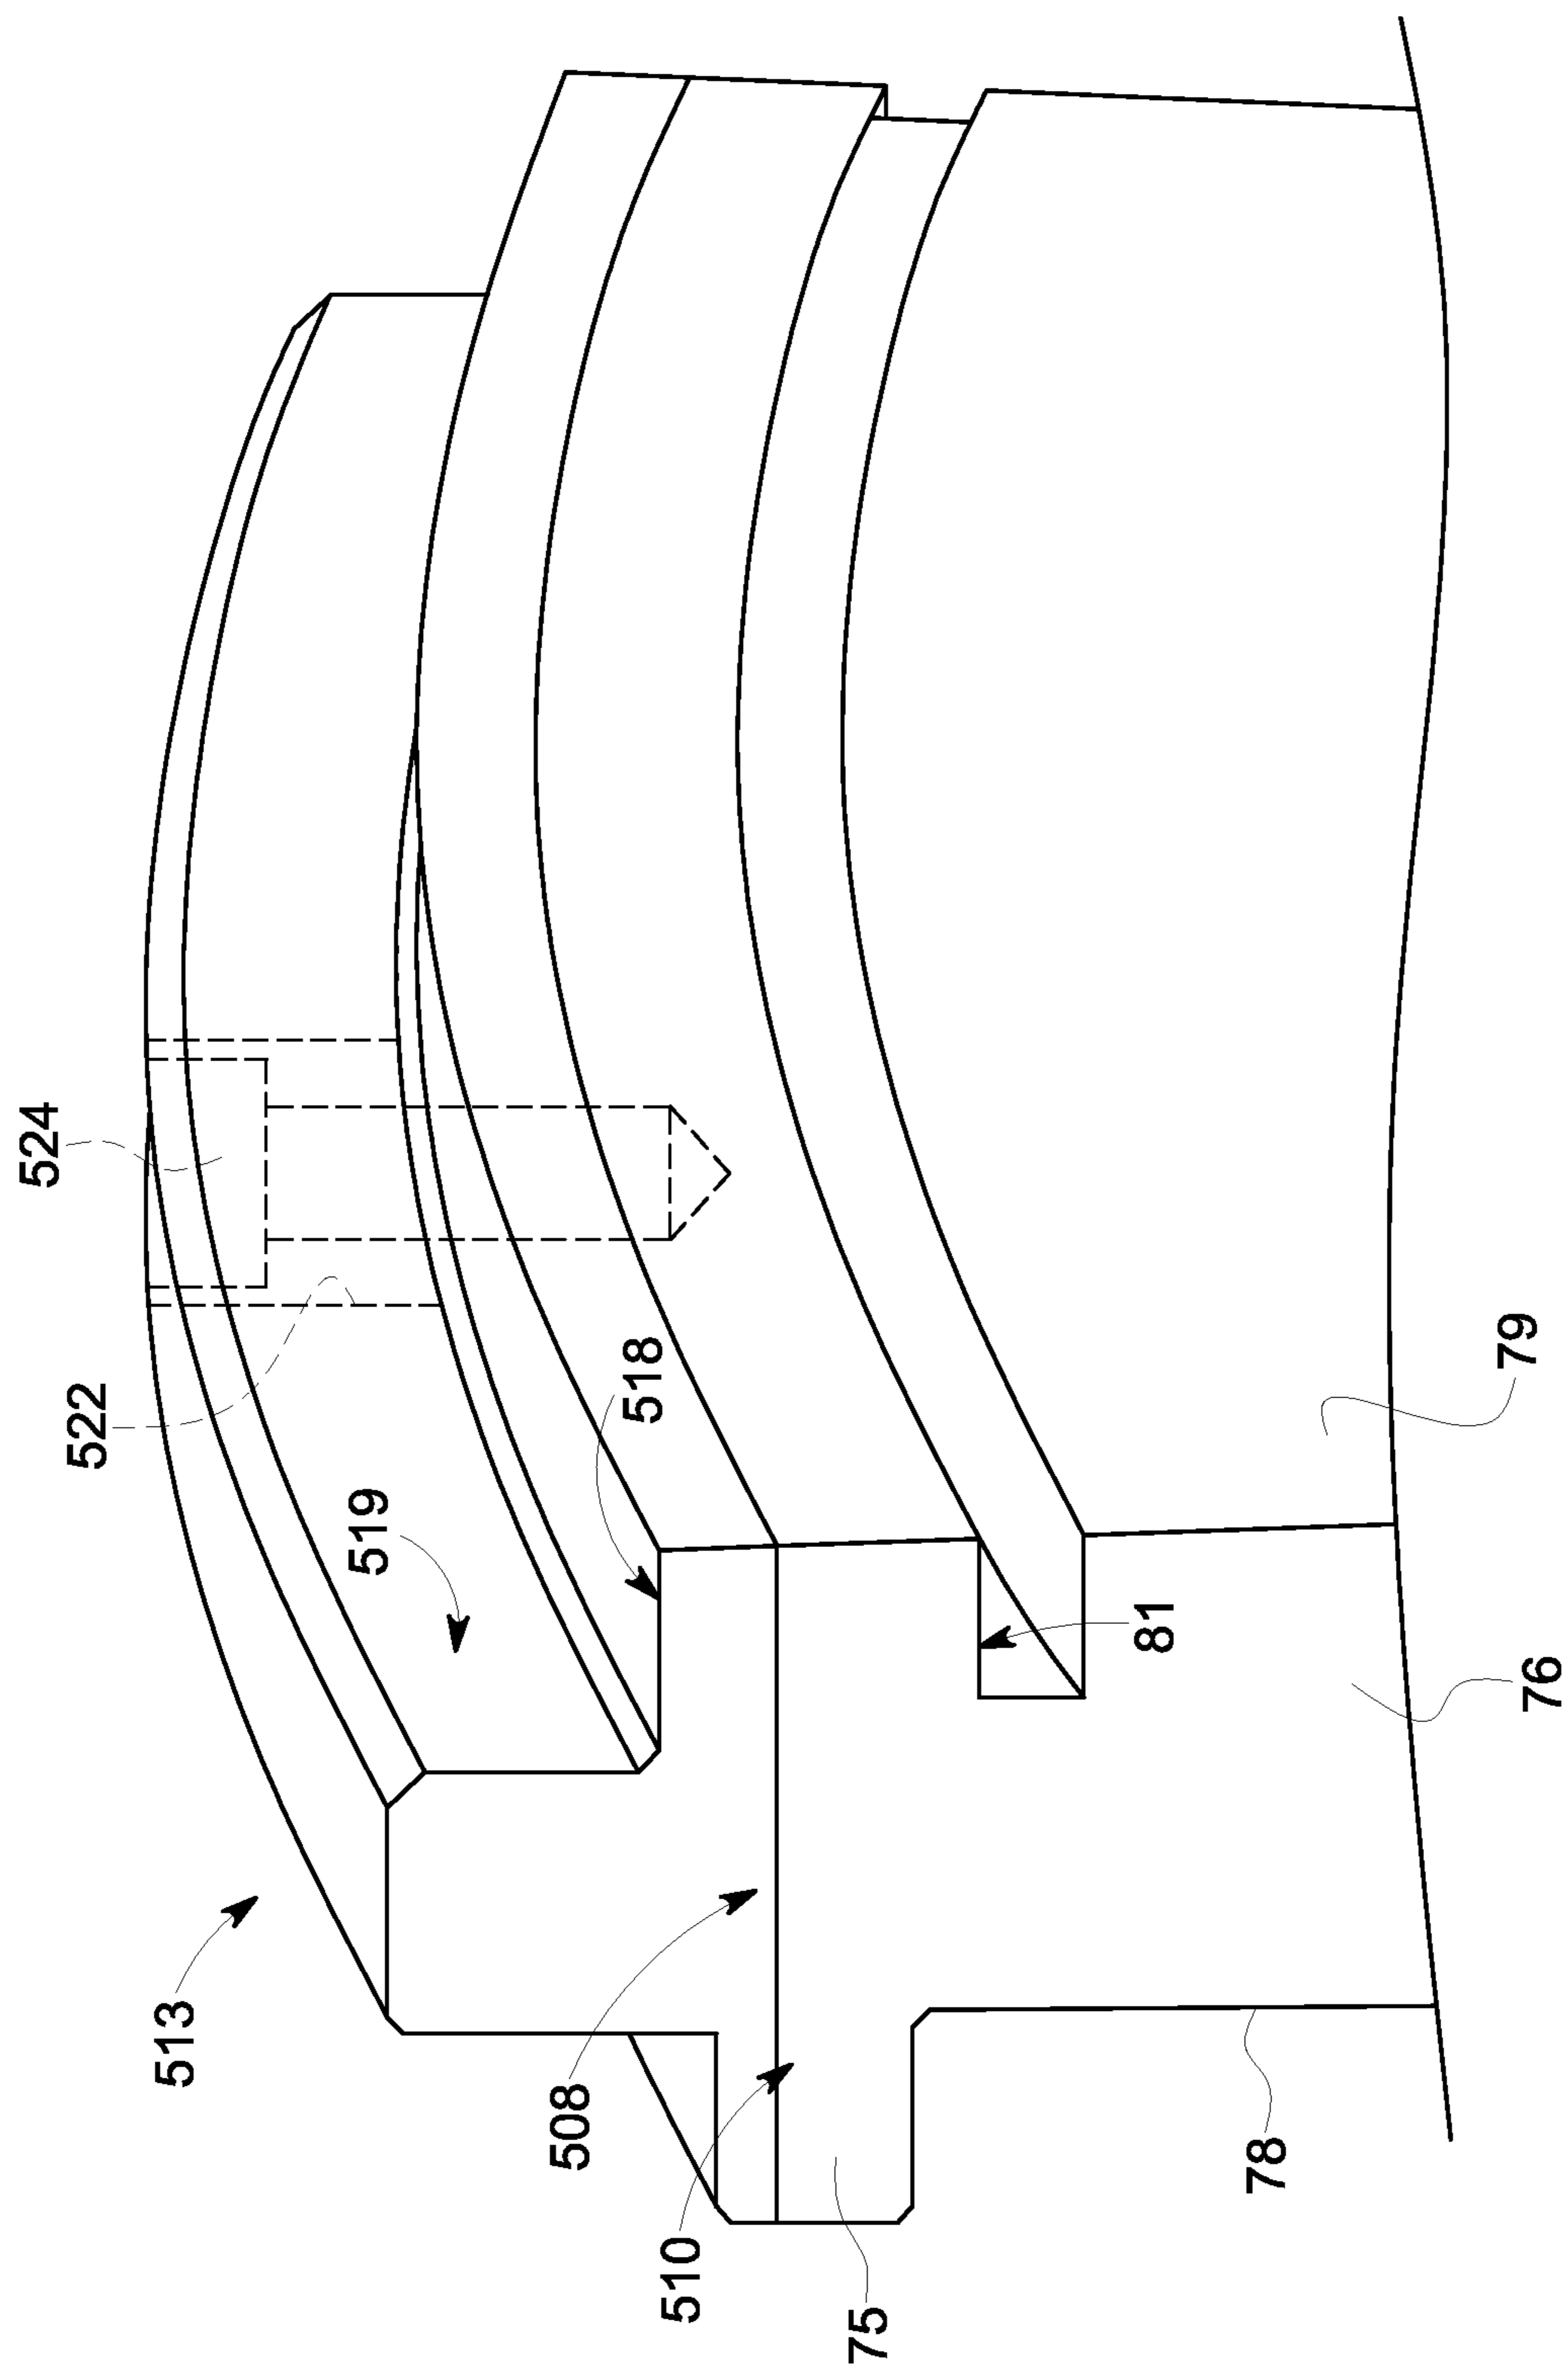
FIG. 17 is a partial plan view of a repair coupon mounted to a diaphragm rail member in accordance with yet still another aspect of the exemplary embodiment.
