(54) **METHOD FOR REPAIRING AN AIRCRAFT FUSELAGE**

(73) Assignee: **AIRBUS OPERATIONS S.A.S.**, Toulouse (FR)

A method for repairing damage to the coating of an aircraft fuselage, the coating being made of fiber-reinforced composite material. This method comprising making a cut-out in the fuselage with a substantially parallelepipedal outline around the damage and drilling a circular hole substantially centered on the intersection of the sides of the outline of the parallelepiped of the cut-out at each of the corners of the outline before the cutting out operation.

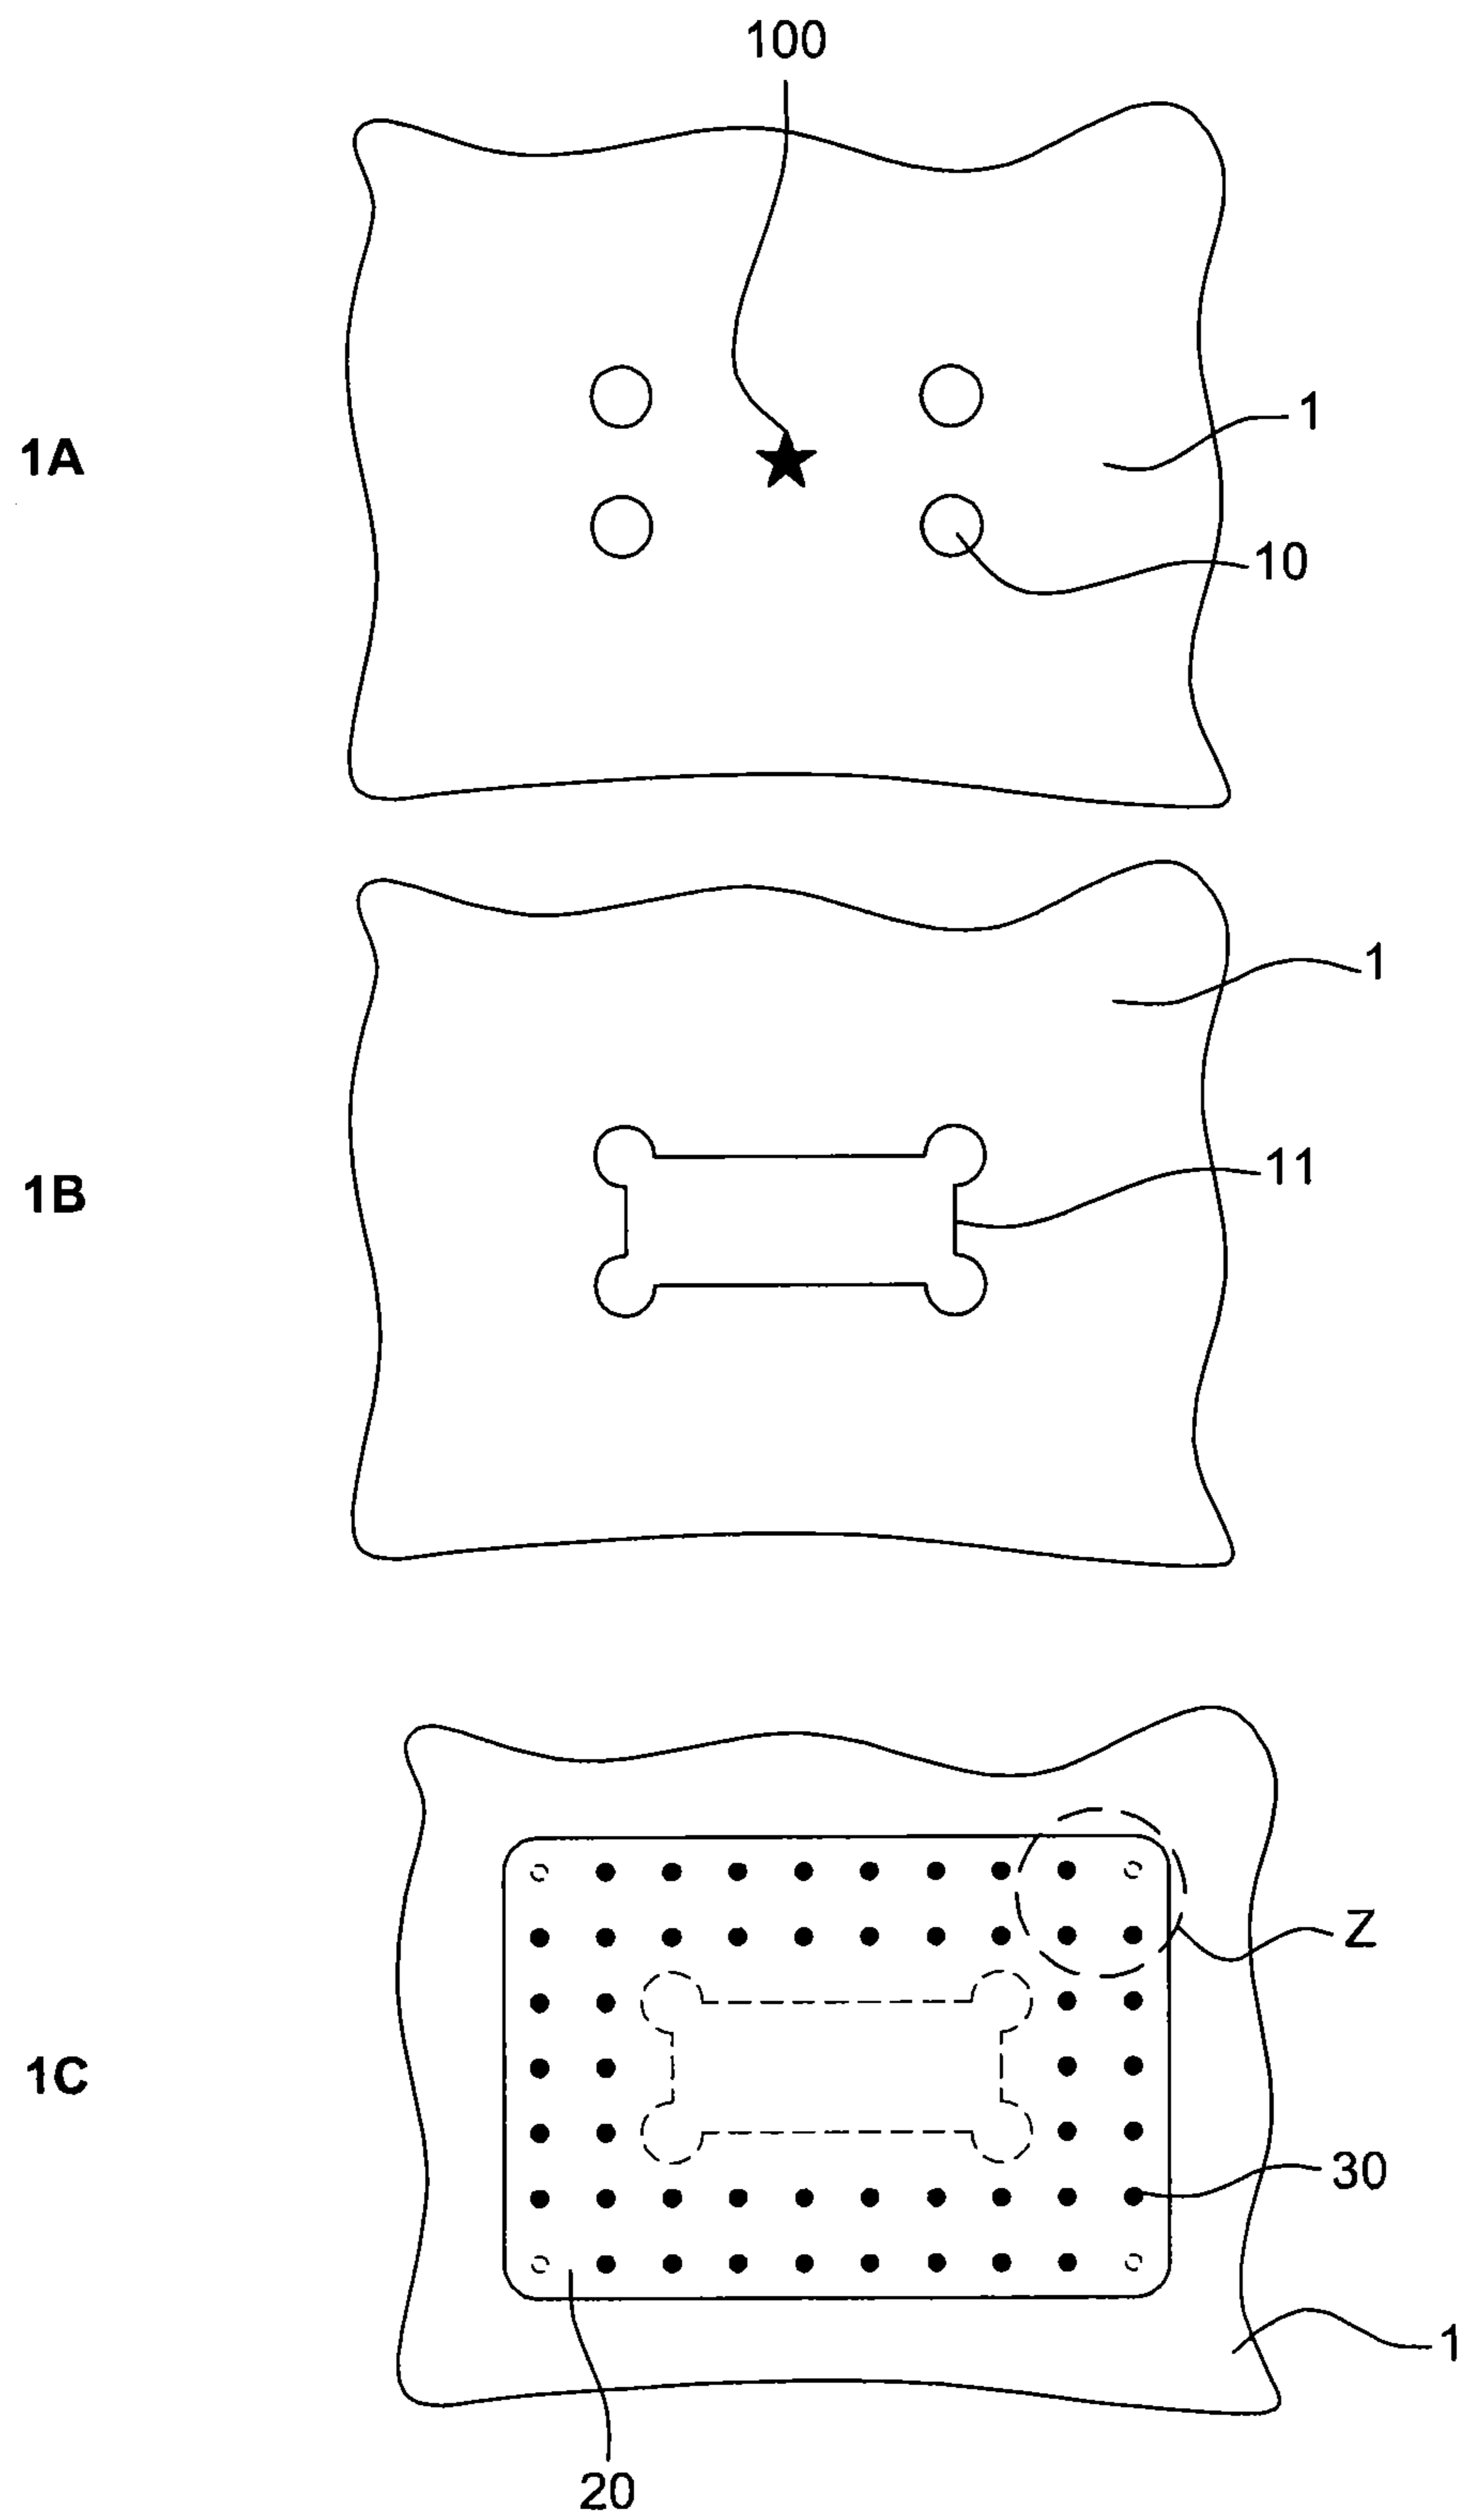
Fig. 1

FIG. 1 represents a synopsis of the repair principle which is the subject of the invention, with the drilling of the end holes in FIG. 1A, the cutting out in FIG. 1B and the fitting of the liner in FIG. 1C;

FIG. 1A: the coating of a composite fuselage (1) has been subjected to an impact (100). To perform the repair, the operator starts by drilling four holes (10) using an axial machining

FIG. 1B: from these holes, the operator realizes the cut-out lines (11) to extract the recommended rectangular area from the coating. This cut-out is realized with a radial advance movement tool, to which the advance movement is communicated manually by the operator. As an example, for a fiber reinforced composite coating, this tool can consist of an angle grinder, a jig-saw or a router such as a portable milling machine available under the brand name ONSRUD® manufactured by LMT Tools.

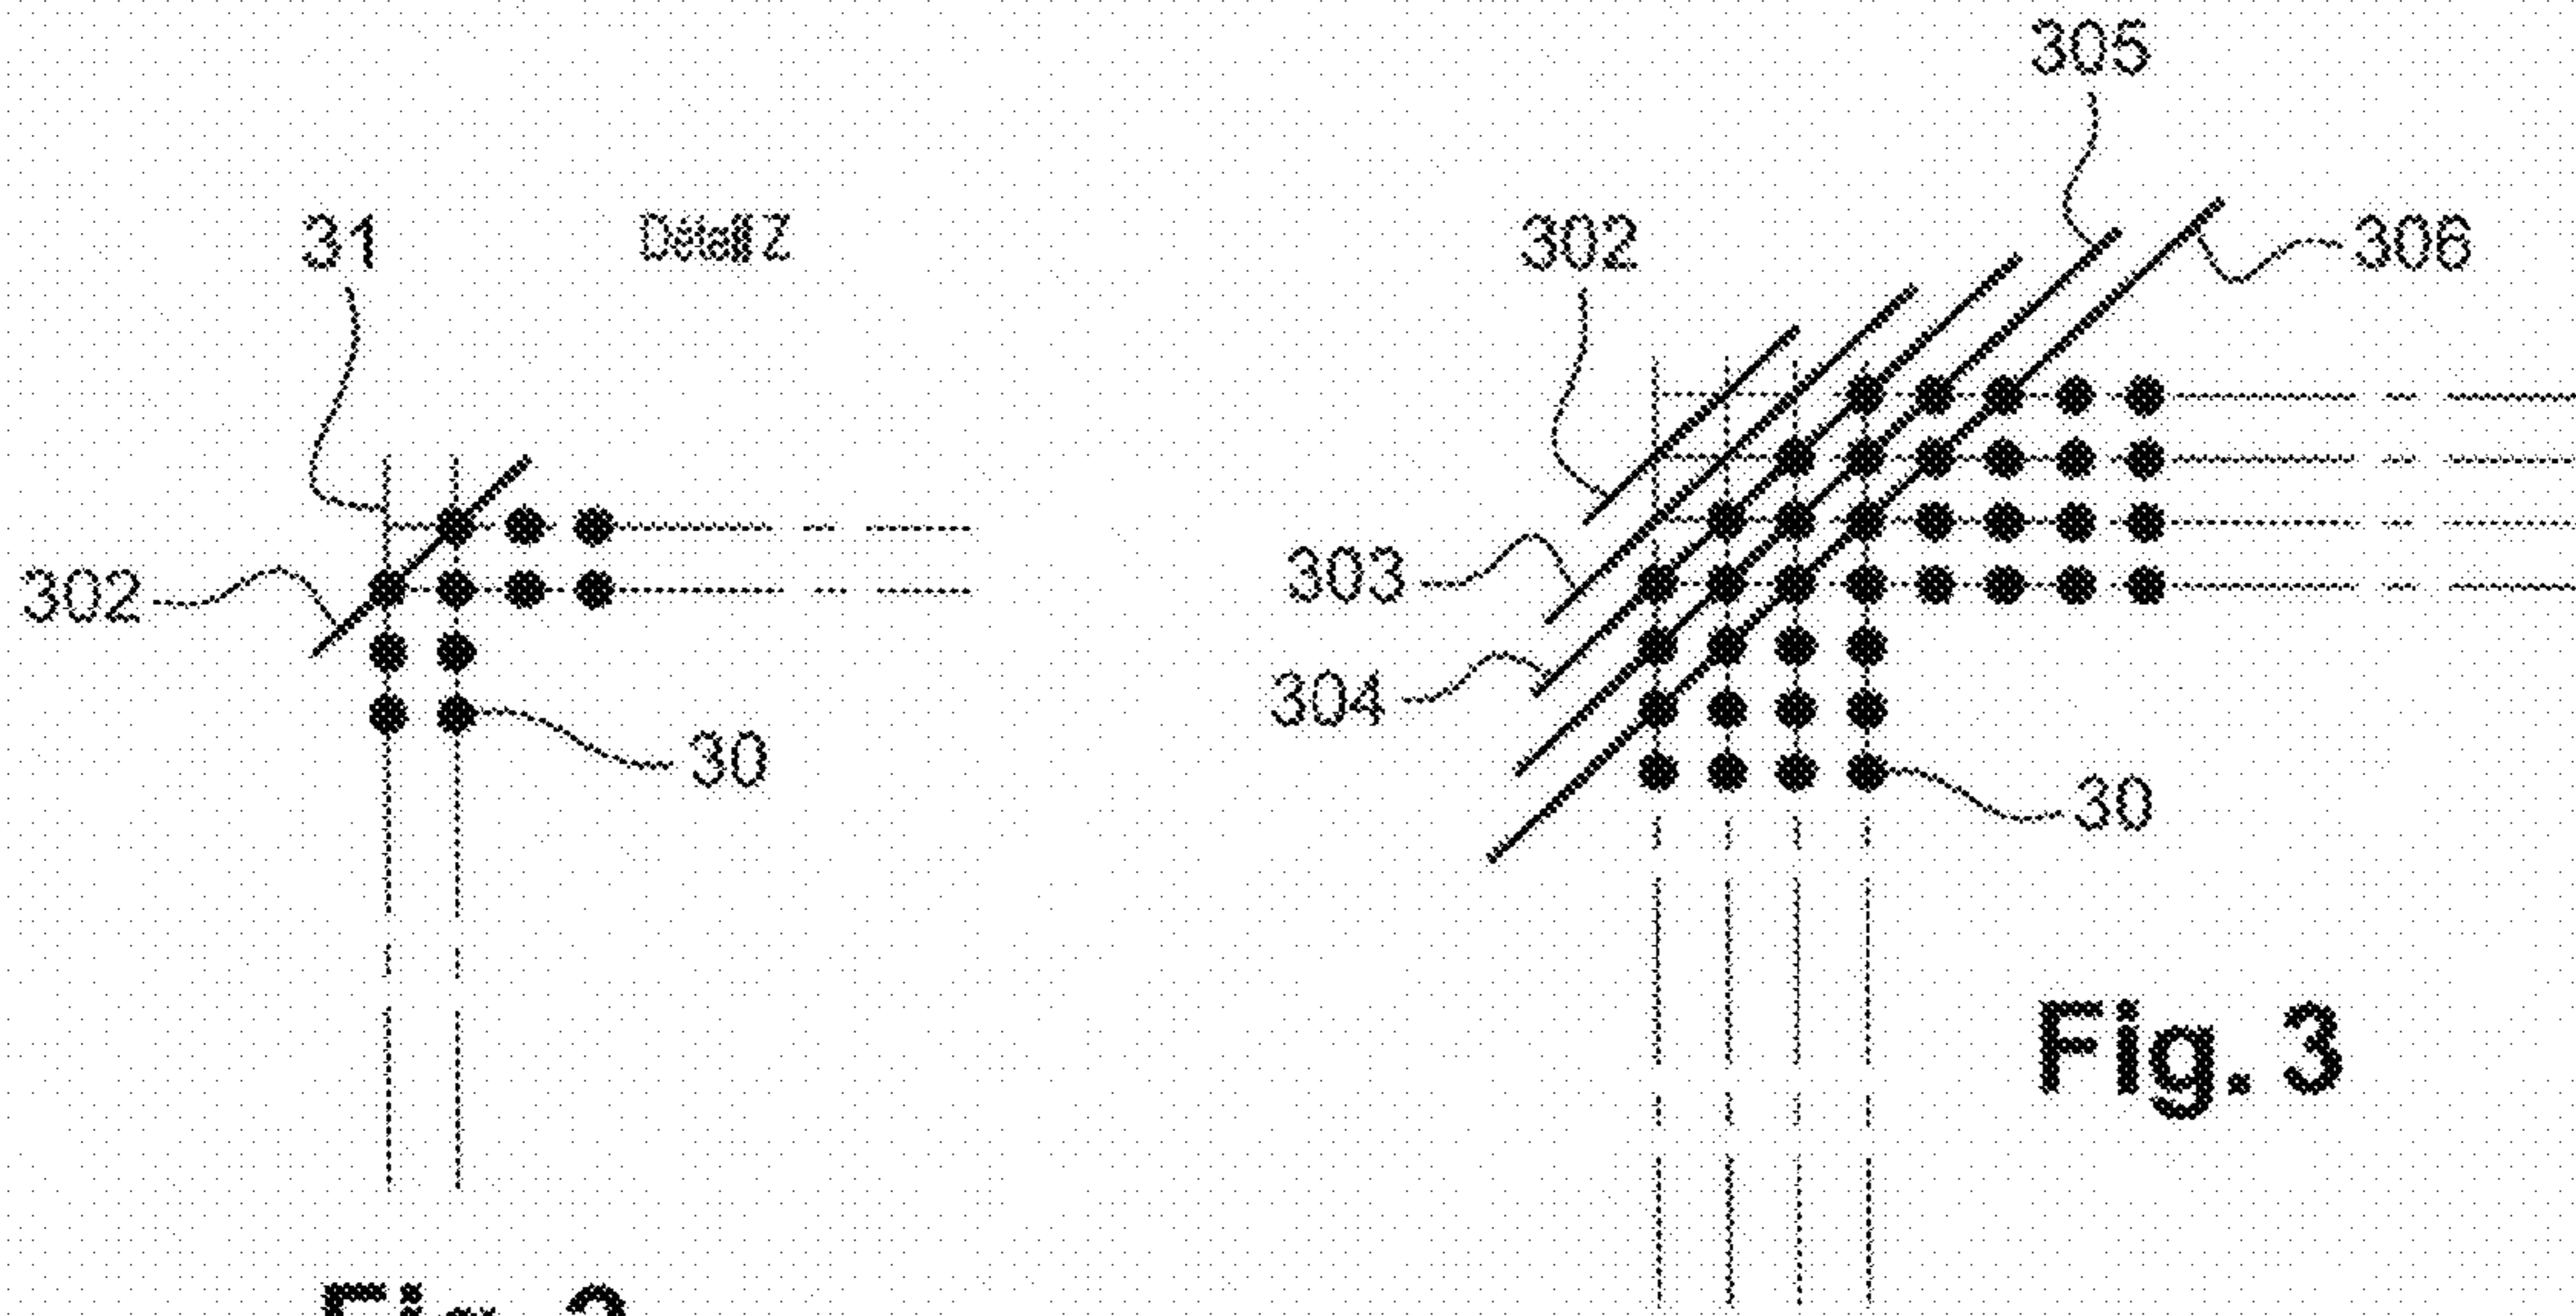
Fig. 2

FIG. 2 shows a detail of FIG. 1 C, which highlights the distribution of the fasteners at the corners of the liner;

FIG. 3 illustrates the distribution of the fasteners at the corners of the liner in a general case;

FIG. 2: $N=2$ and so as to distribute the dissipation of forces into the sound portion, the fastener provided for at position (31) located on the outside of the 2×2 diagonal (302) is not fitted at the corner of the liner. FIG. 3: generally, those fasteners located on the outer part of the corner of the liner are not fitted in one or several rows. In the example of FIG. 3, $N=4$, the fasteners are not fitted at the locations beyond the 4×4 diagonal (304) i.e. 6 fasteners not fitted including the 2×2 diagonal (302) and the 3×3 diagonal (303). The number of fasteners not fitted at the corner depends on the number of rows and on the intensity of the loading, i.e. of the surface area of the damaged area and its location on the fuselage. This configuration is determined by calculation and consigned in the maintenance and repair manual for the most frequent cases.

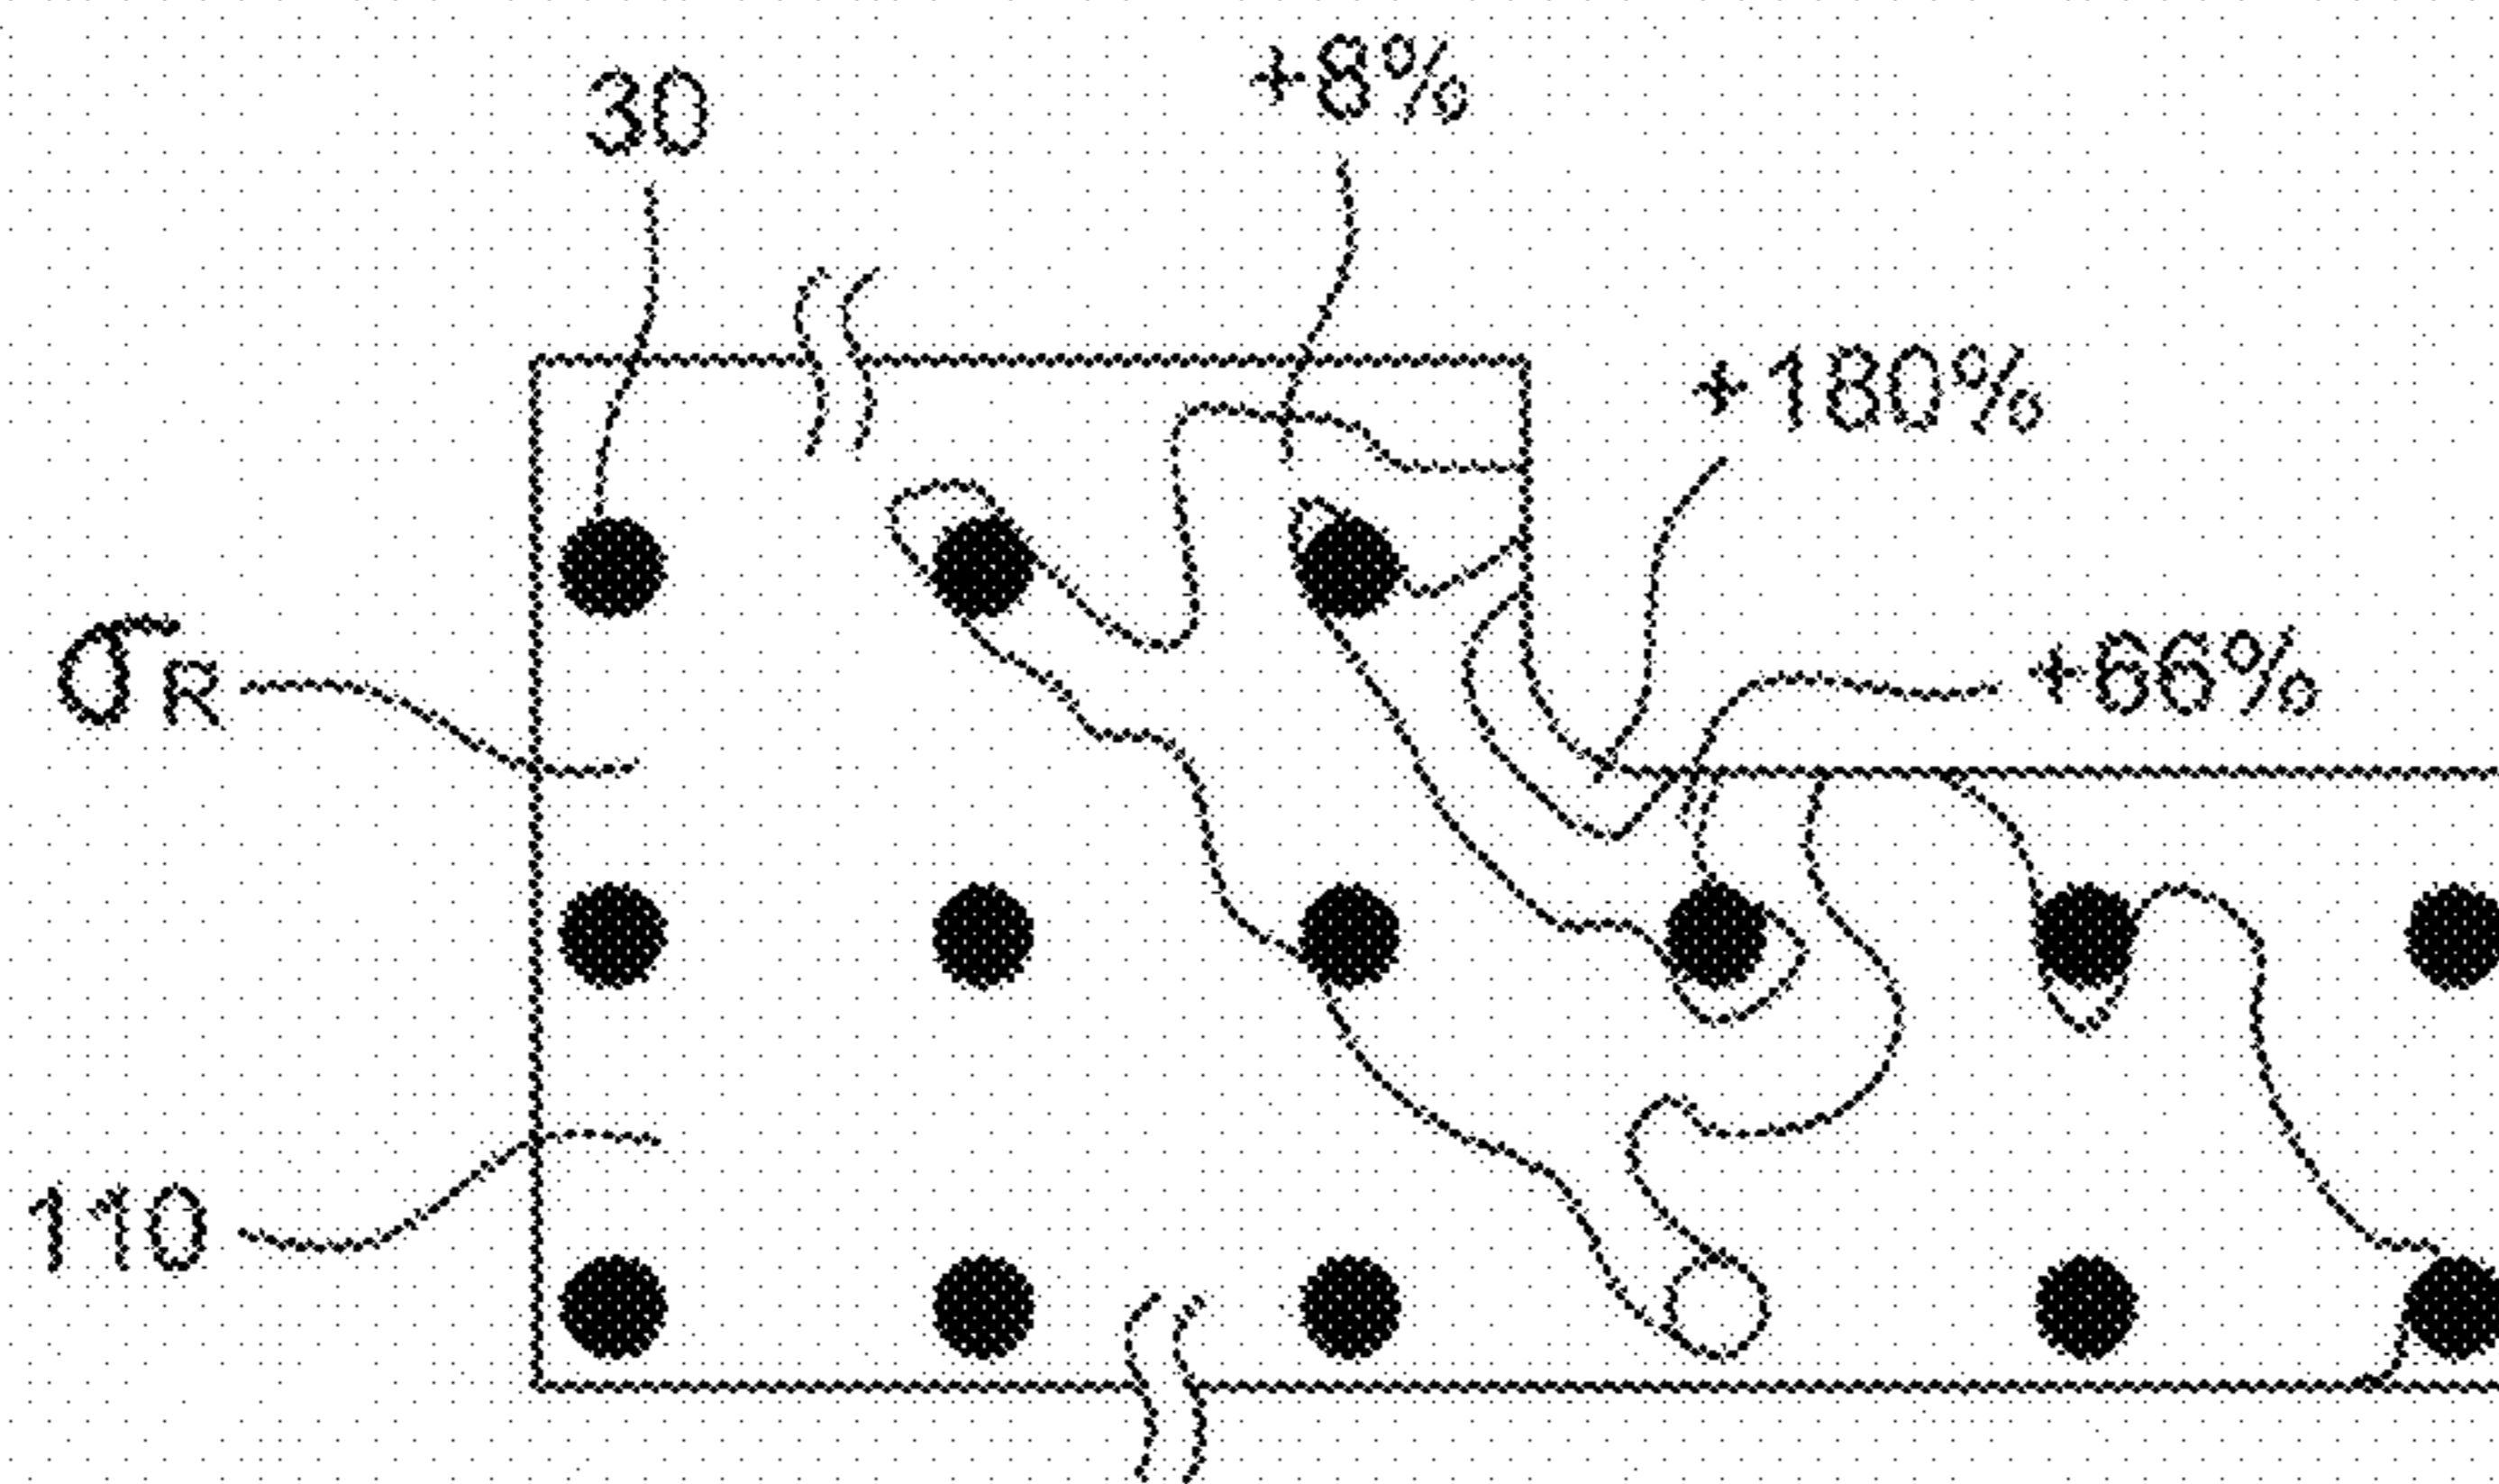
Fig. 4

FIG. 4 represents the distribution of the service stress in the fuselage in the vicinity of a repair according to the prior state of the art;

FIGS. 4 and 5: comparing the services loading at the edge of the cut-out can be performed using a finite element simulation. Both figures correspond to the same macroscopic loading conditions and give the Von Mises yield criterion in the repaired fuselage in the vicinity of the cut-out. The reference loading, which corresponds to areas distant from the cut-out (110), is the same in both cases. The loading level for the other areas is defined relative to this reference loading.

FIG. 4: by using the cutting out principle of the prior state of the art with skipped connections at the edges of the cut-out, the loading of the straight parts of the cut-out is between 60% and 100% of the reference loading.

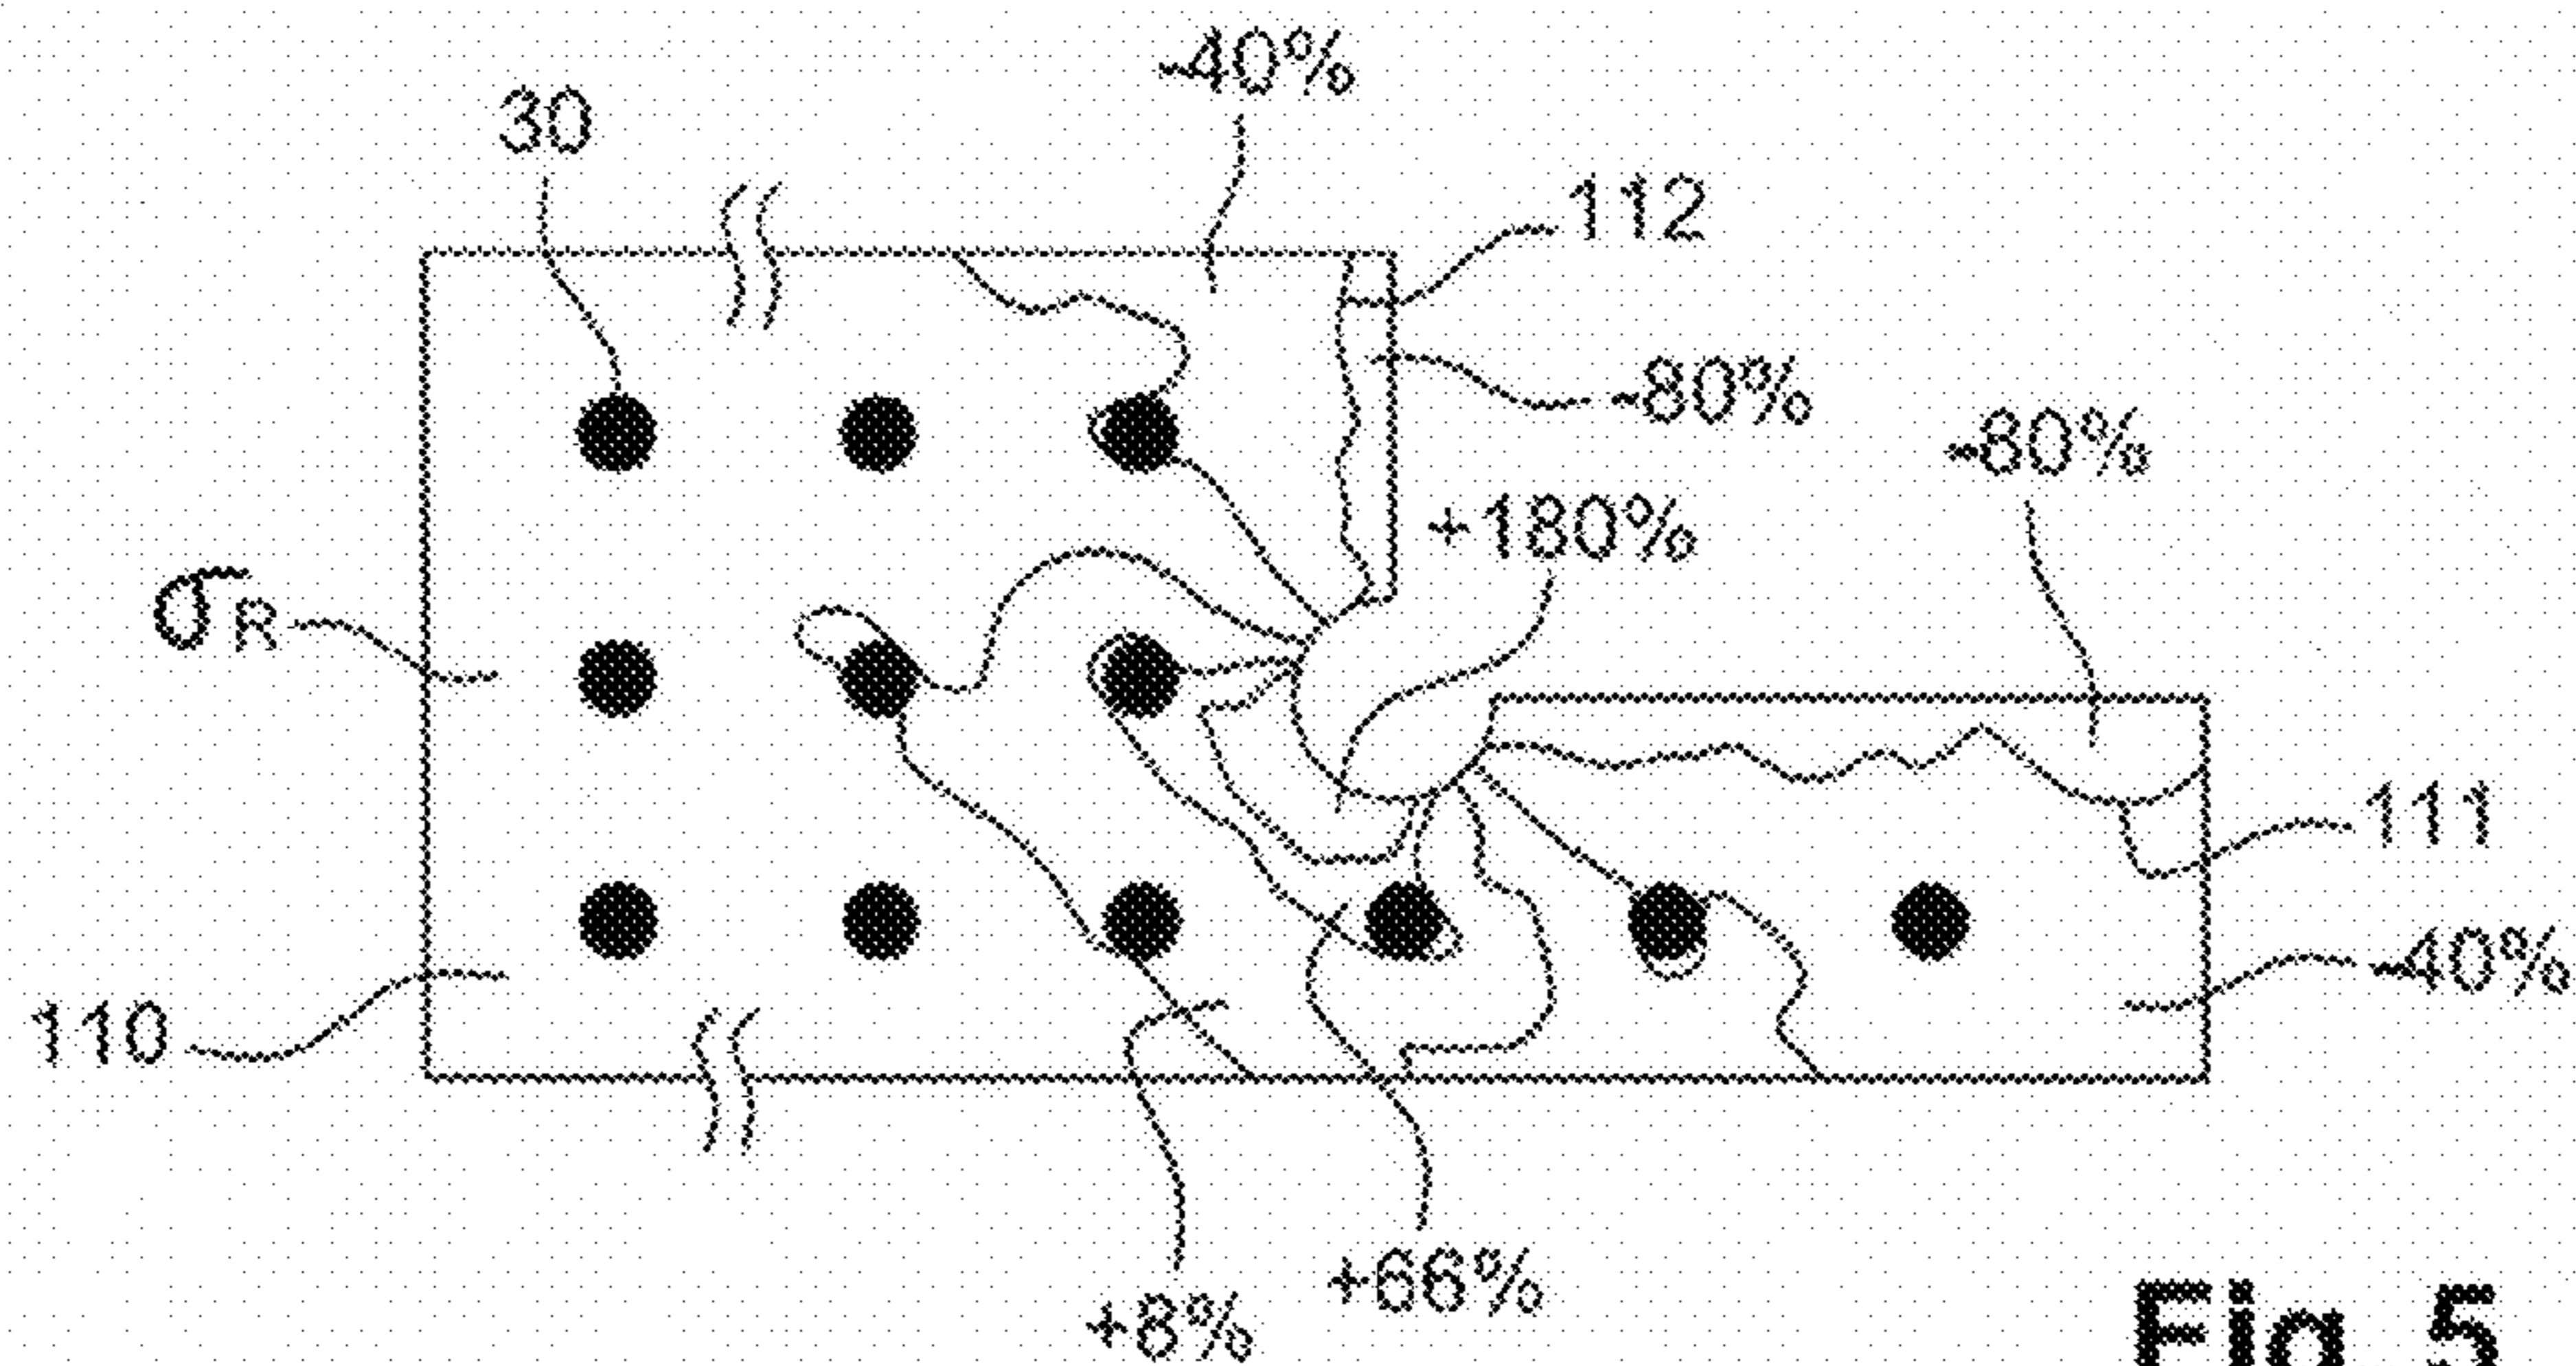
Fig. 5

FIG. 5 represents the distribution of the service stress in the fuselage in the vicinity of a repair according to an example of realization of the invention;

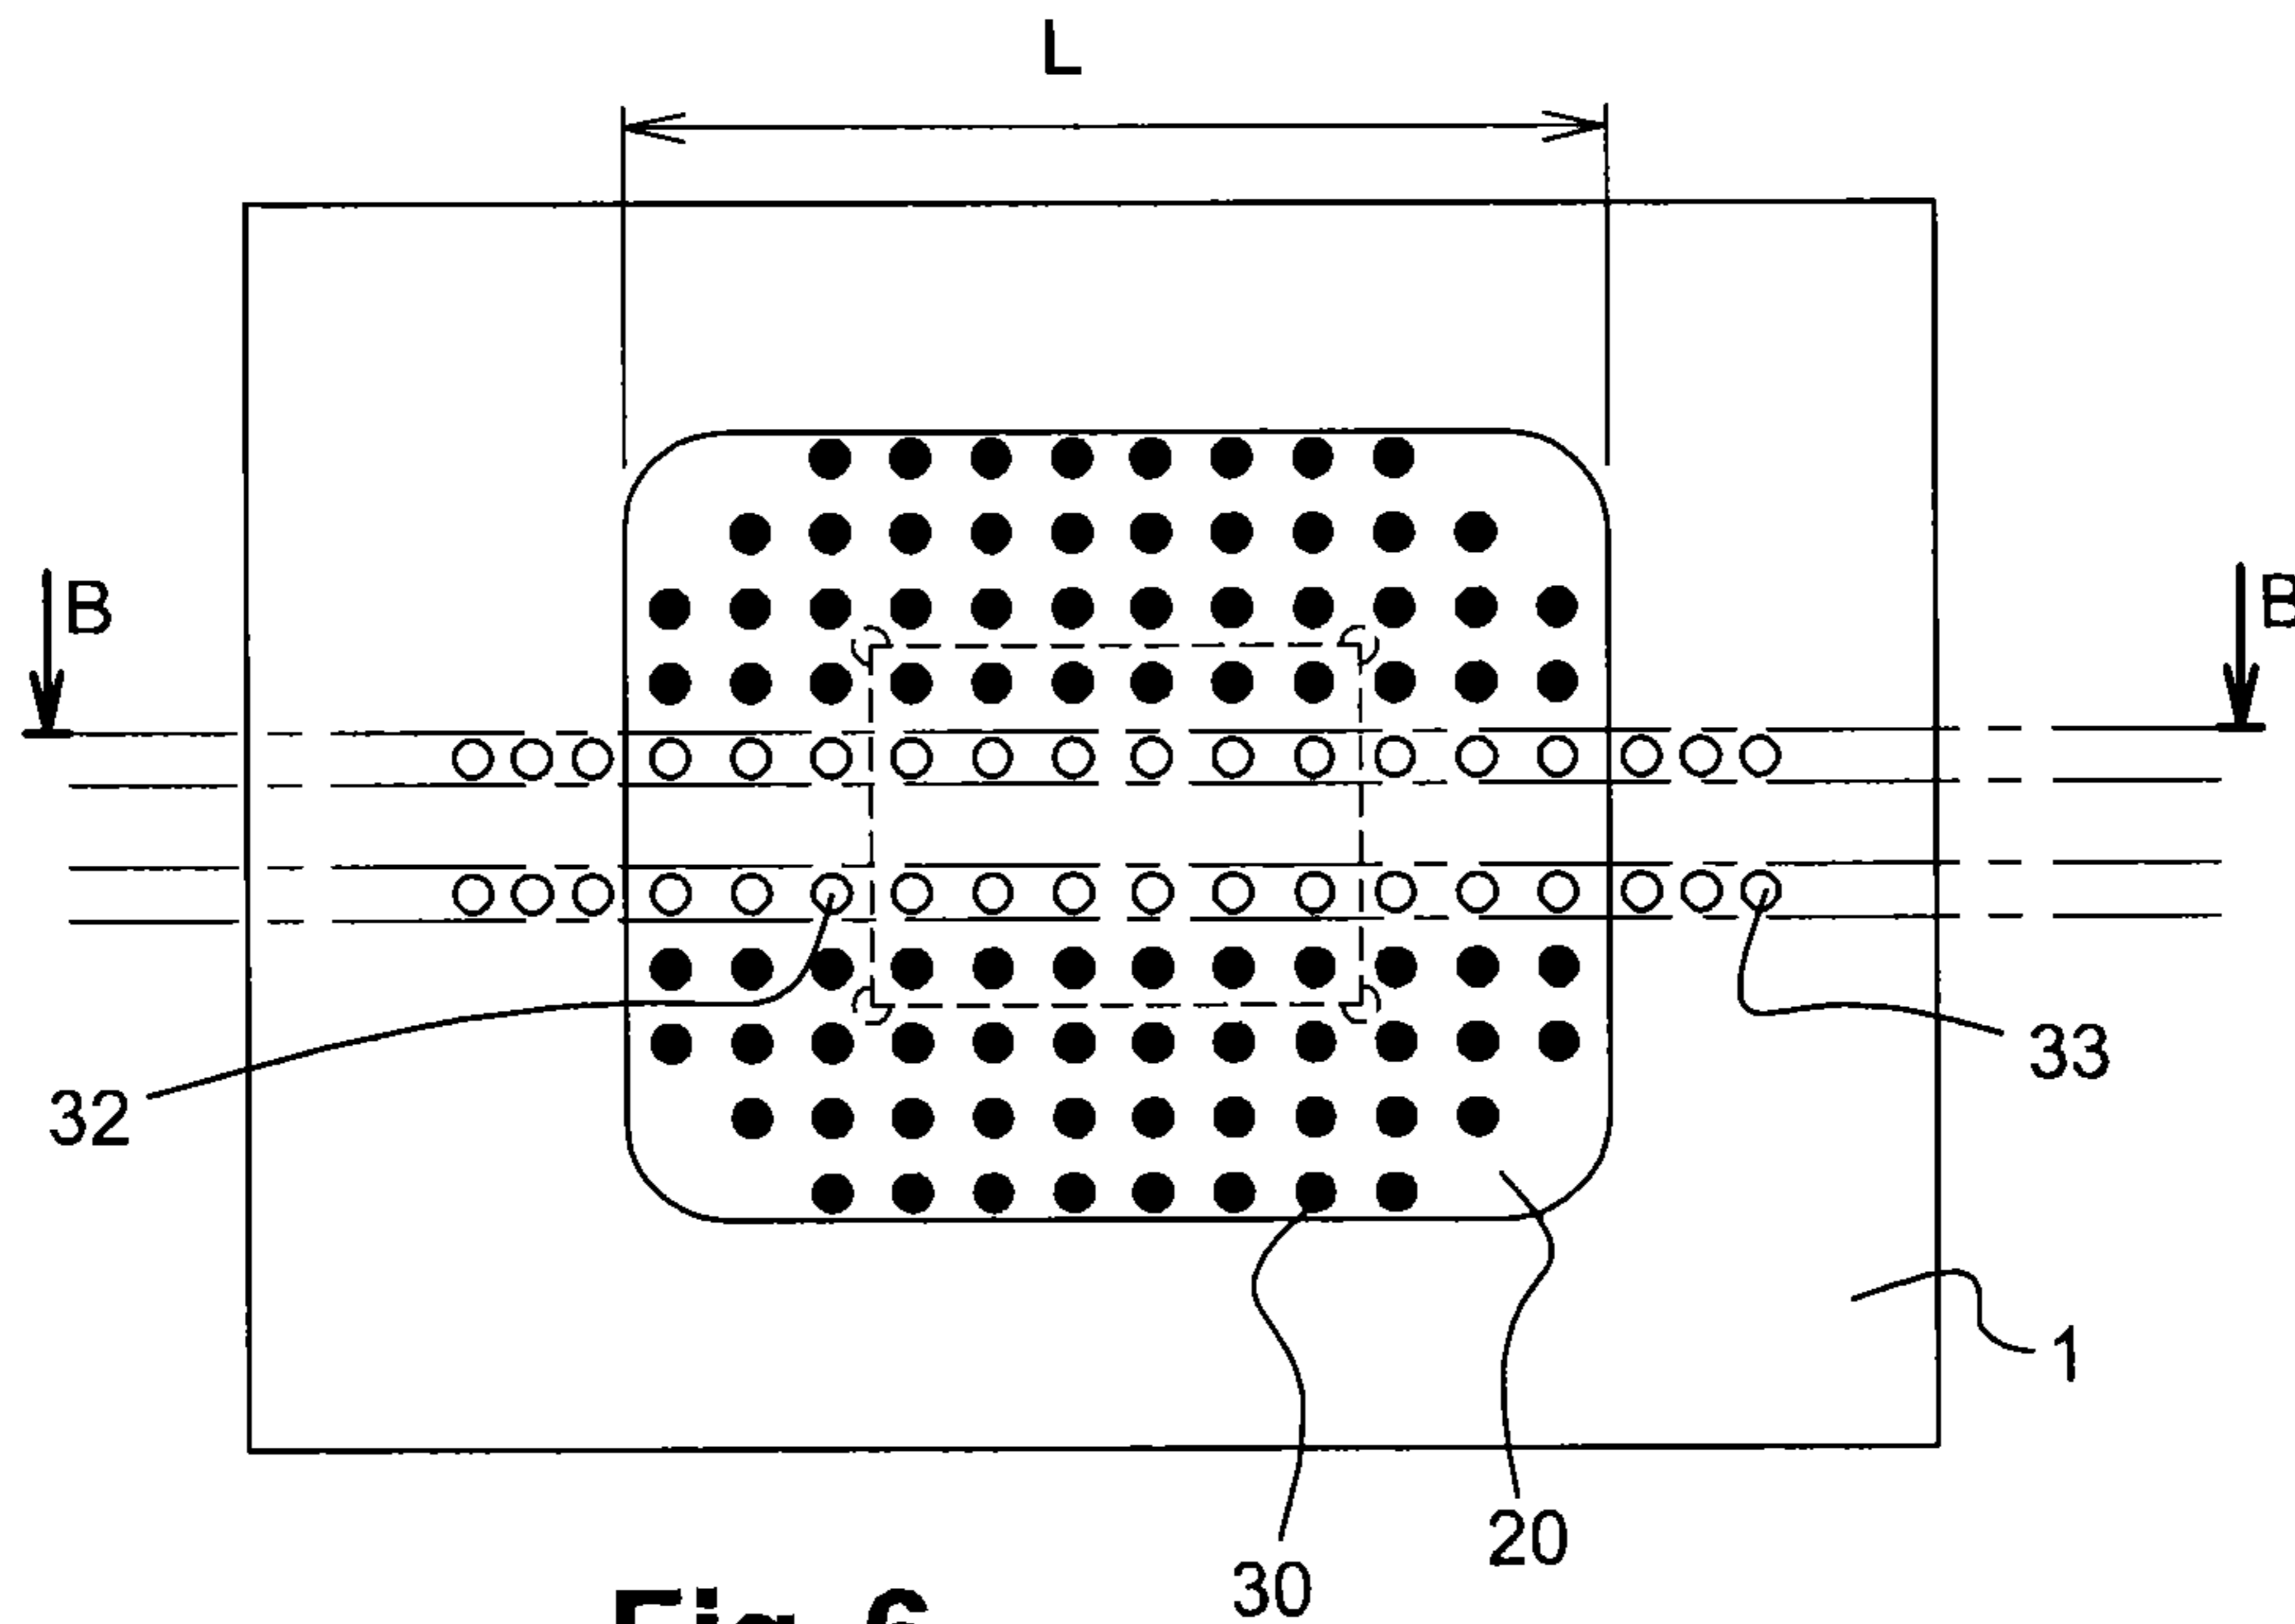
Fig. 6

FIG. 6 is an example of repair in a general case that requires cutting out a longitudinal stiffener in front view;

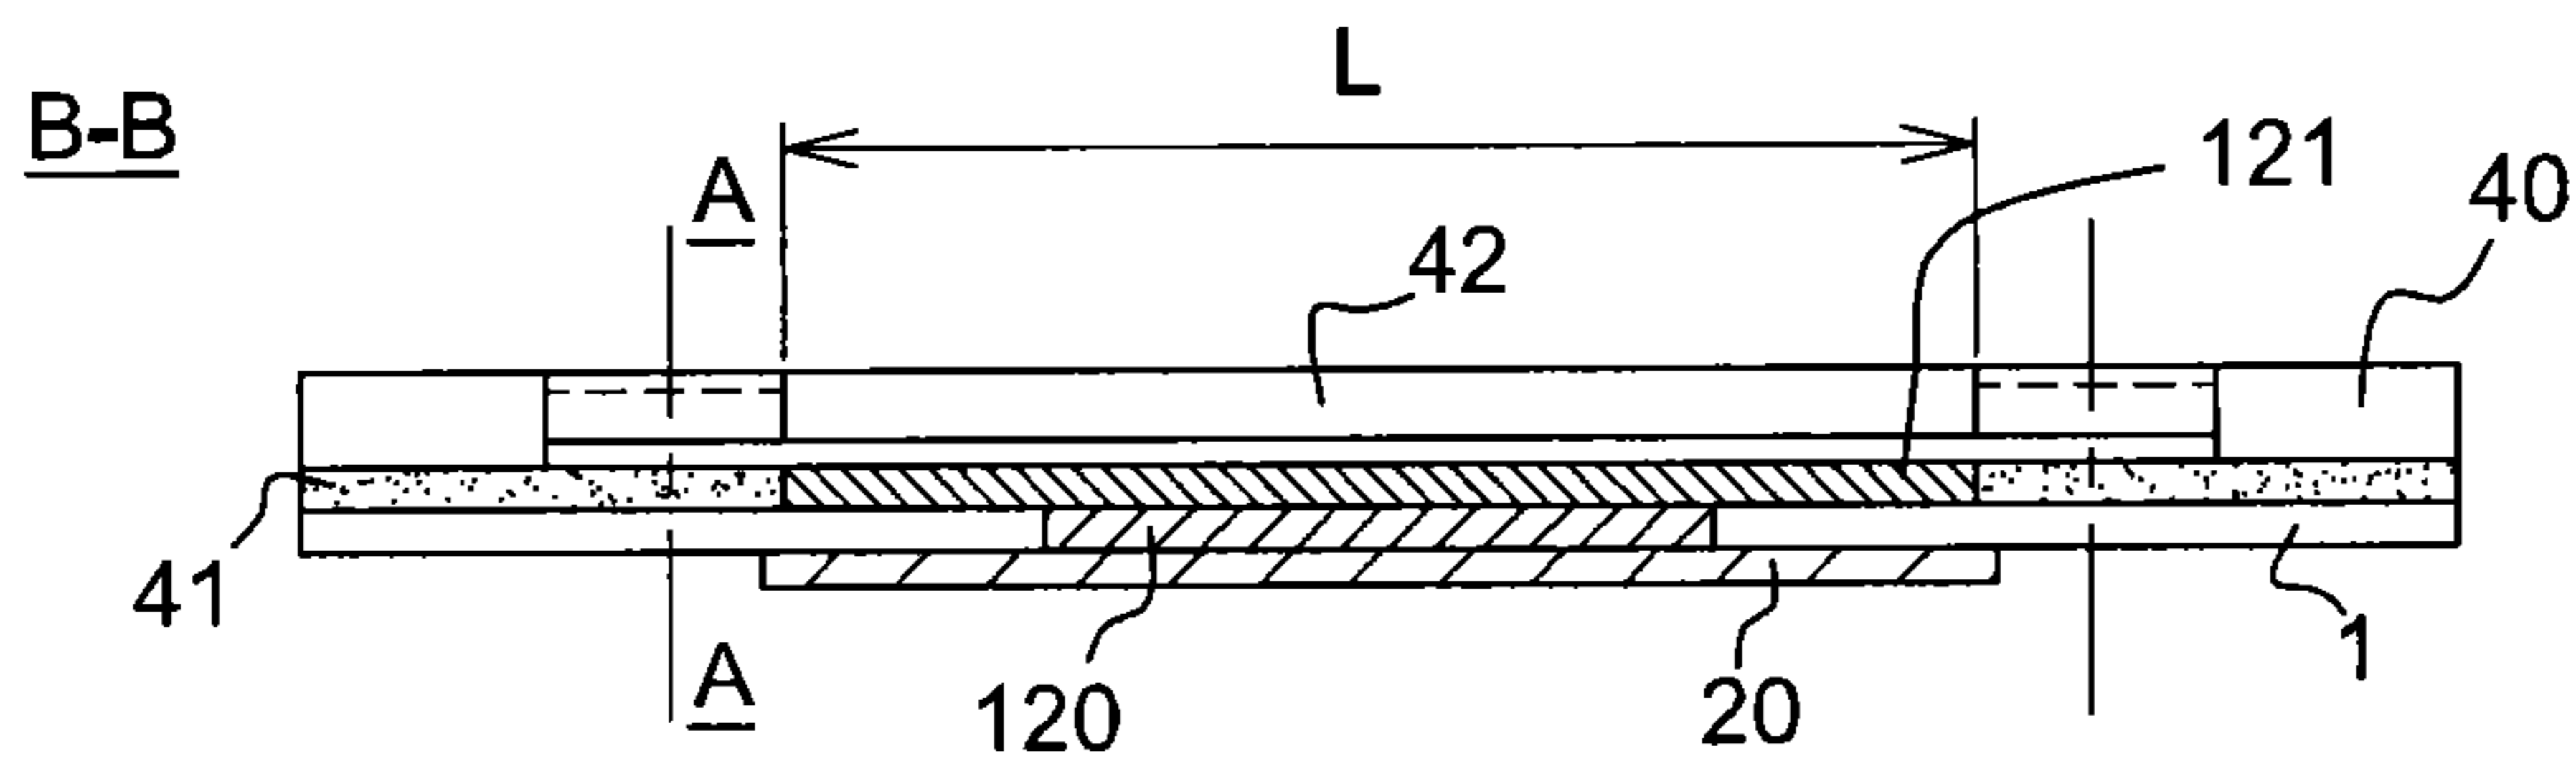
Fig. 7

FIG. 7 is a B-B cross-section view along the thickness of the repair shown in FIG. 6;

FIG. 7: a shim (120) whose thickness is equal to the thickness of the skin is placed in the cut-out. An inner liner (121) whose thickness is designed to compensate the thickness of the stringer's flange (41) and whose dimensions are substantially equal to those of the outer liner (20) is placed inside the

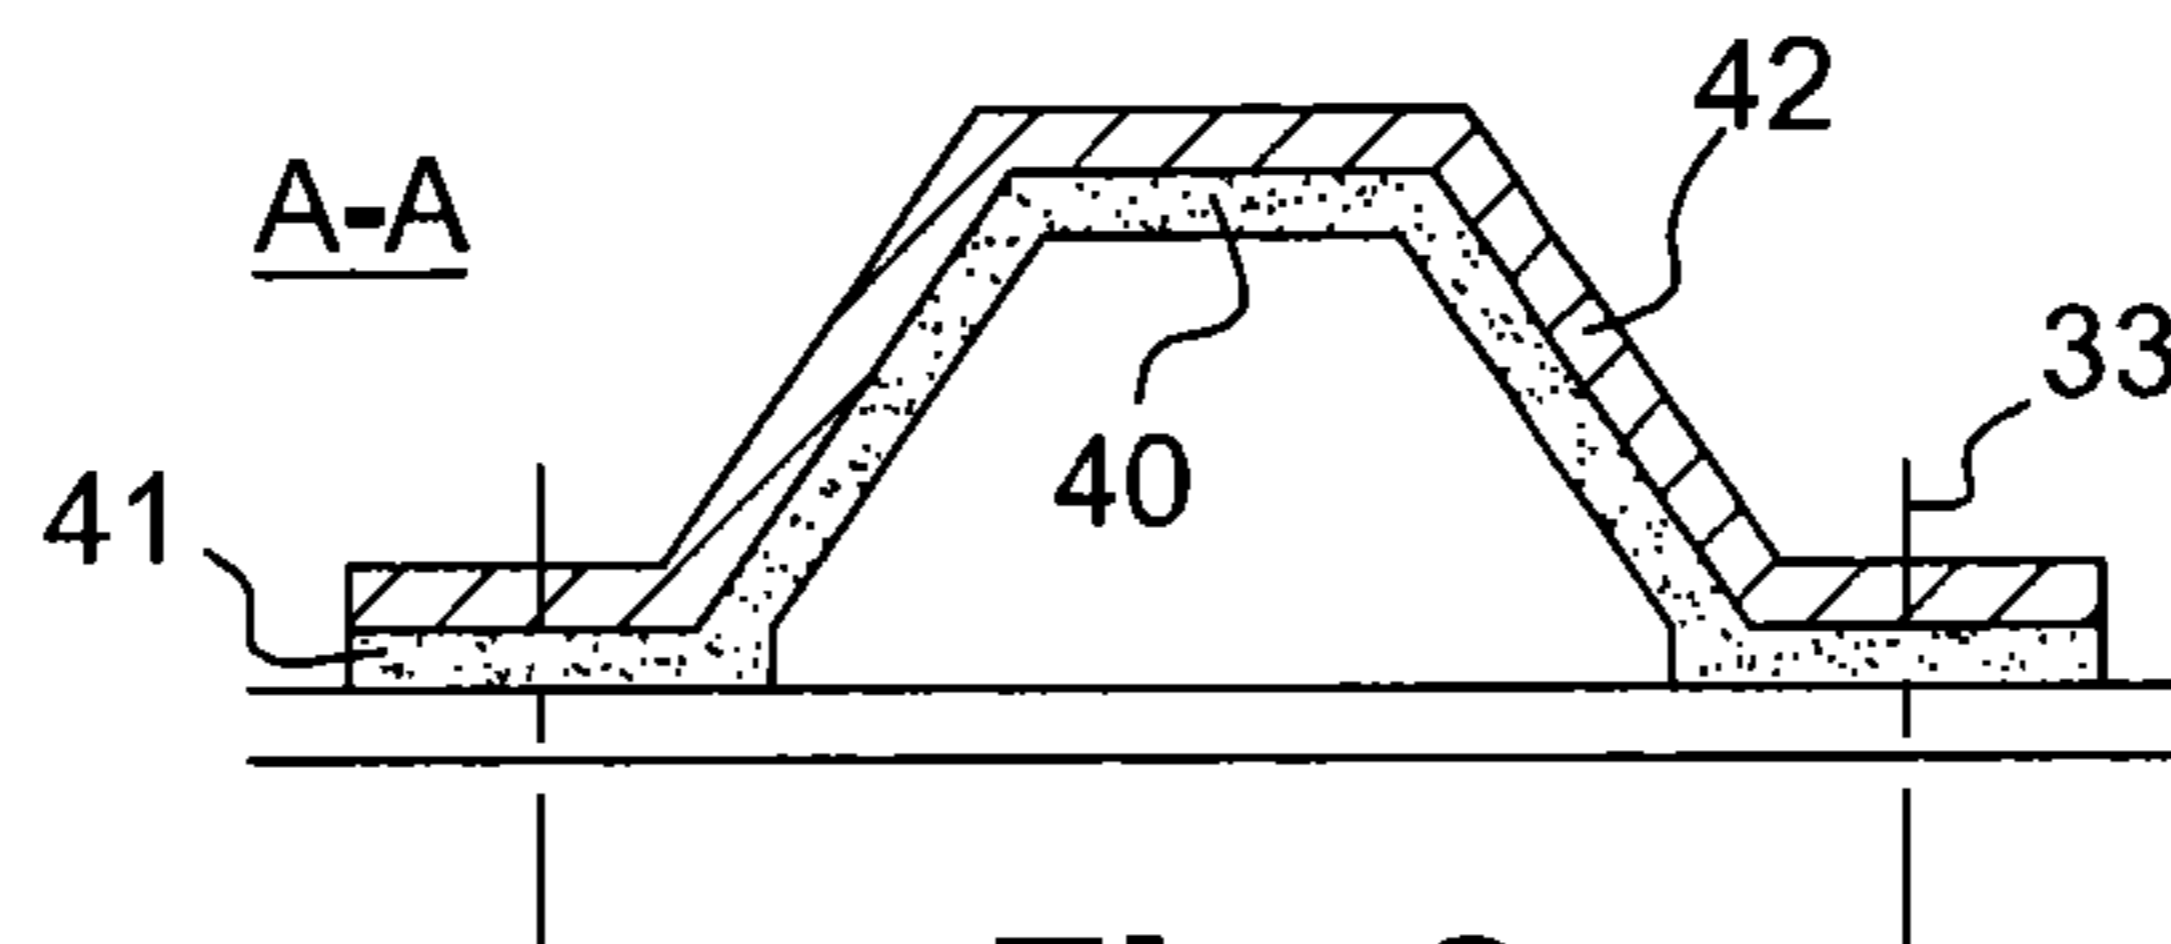
Fig. 8

FIG. 8 is a transversal A-A cross-section view of this same view in the immediate vicinity of the repair.
