(12) **United States Patent**  
**Newman**

(54) **METHOD AND APPARATUS FOR REMOTE FEATURE MEASUREMENT IN DISTORTED IMAGES**

(71) Applicant: **DIGITAL WIND SYSTEMS, INC.**,  
West Conshohocken, PA (US)

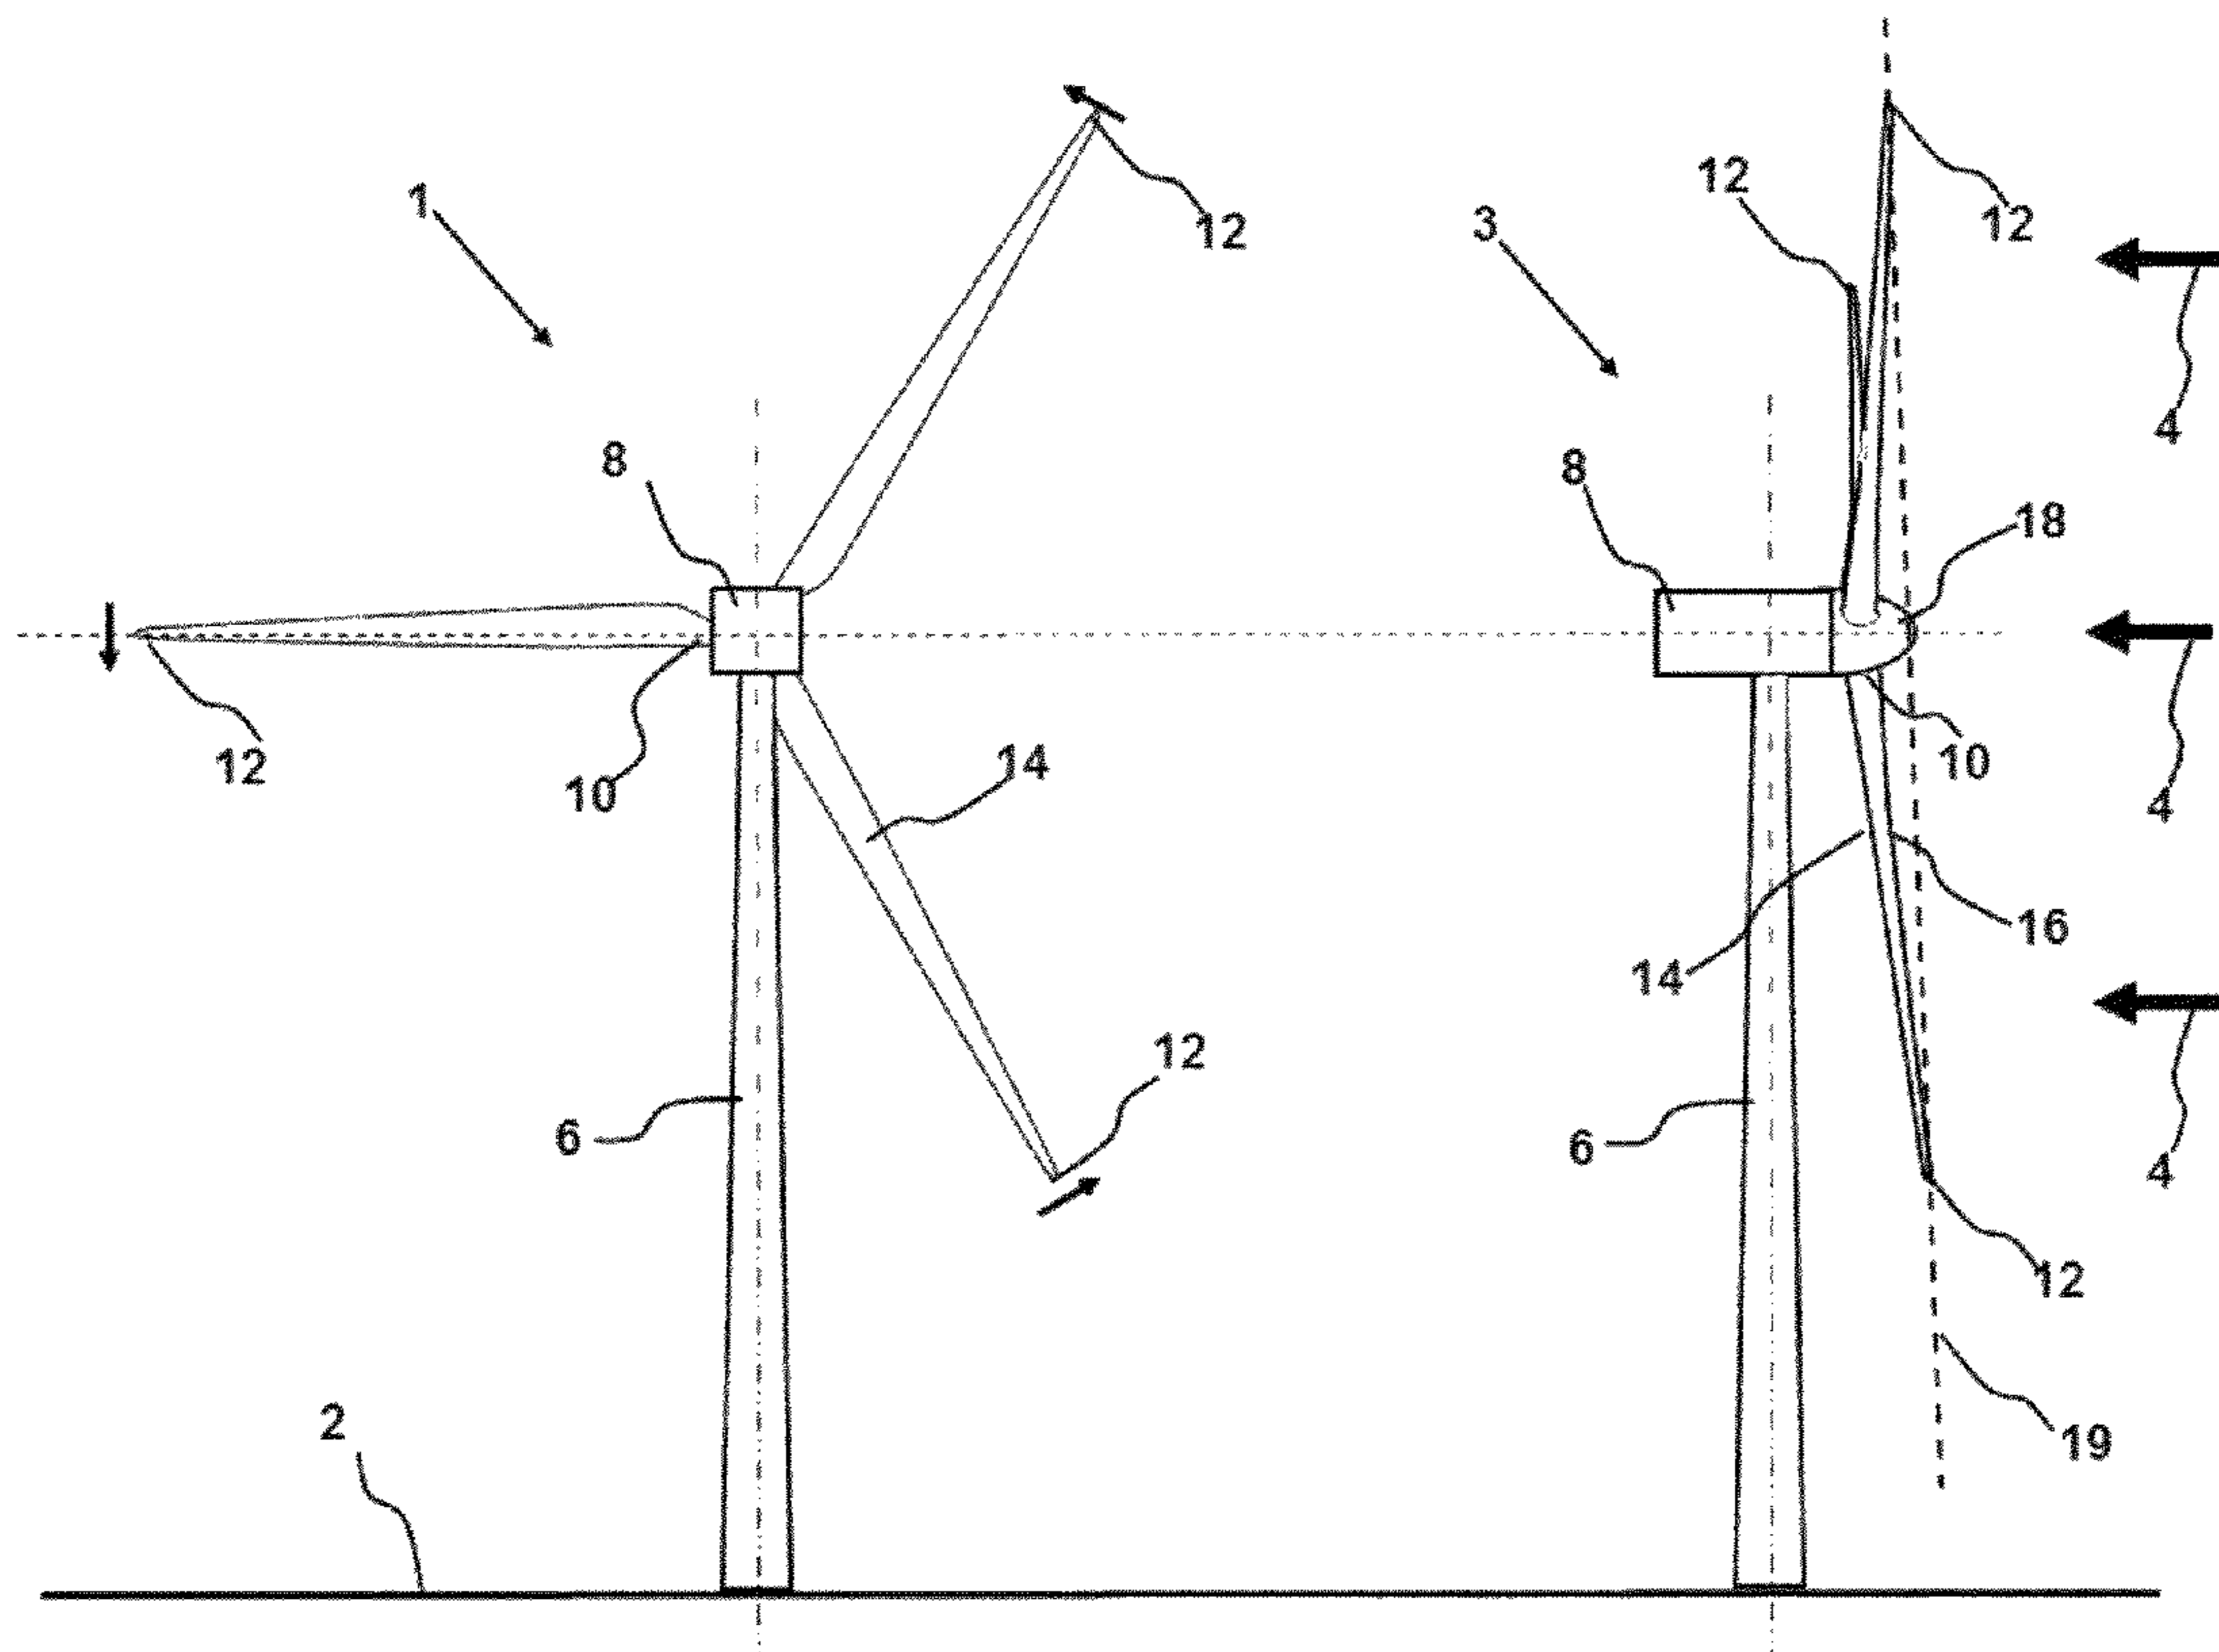
Fig. 1

FIG. 1 is a schematic representation of a utility scale, horizontal axis, wind turbine generator.

Referring now to the drawings, wherein like reference numerals indicate corresponding structure throughout, and referring in particular to FIG. 1, a schematic diagram of a HAWT is shown that that is typical of both land based and off-shore turbine generators. The view 1 from behind the turbine facing the wind includes tower 6 extending up from the ground or ocean surface 2 to support the nacelle 8 which contains the generator and gear reducers, unless it is a direct drive generator. There are typically three blades on a utility scale wind turbine having root ends 10 and blade tips 21. As seen from the side view 2, the blade root ends attach to the rotatable hub 18. Blade side 16 facing the wind 4 is often referred to as the high pressure side. The blade side 14, facing away from the wind is referred to as the low pressure or suction side. As the blade speed increases the blade pitch is adjusted to the optimal angle of attack to the wind to create the maximum lift and torque required to drive the electricity generator.

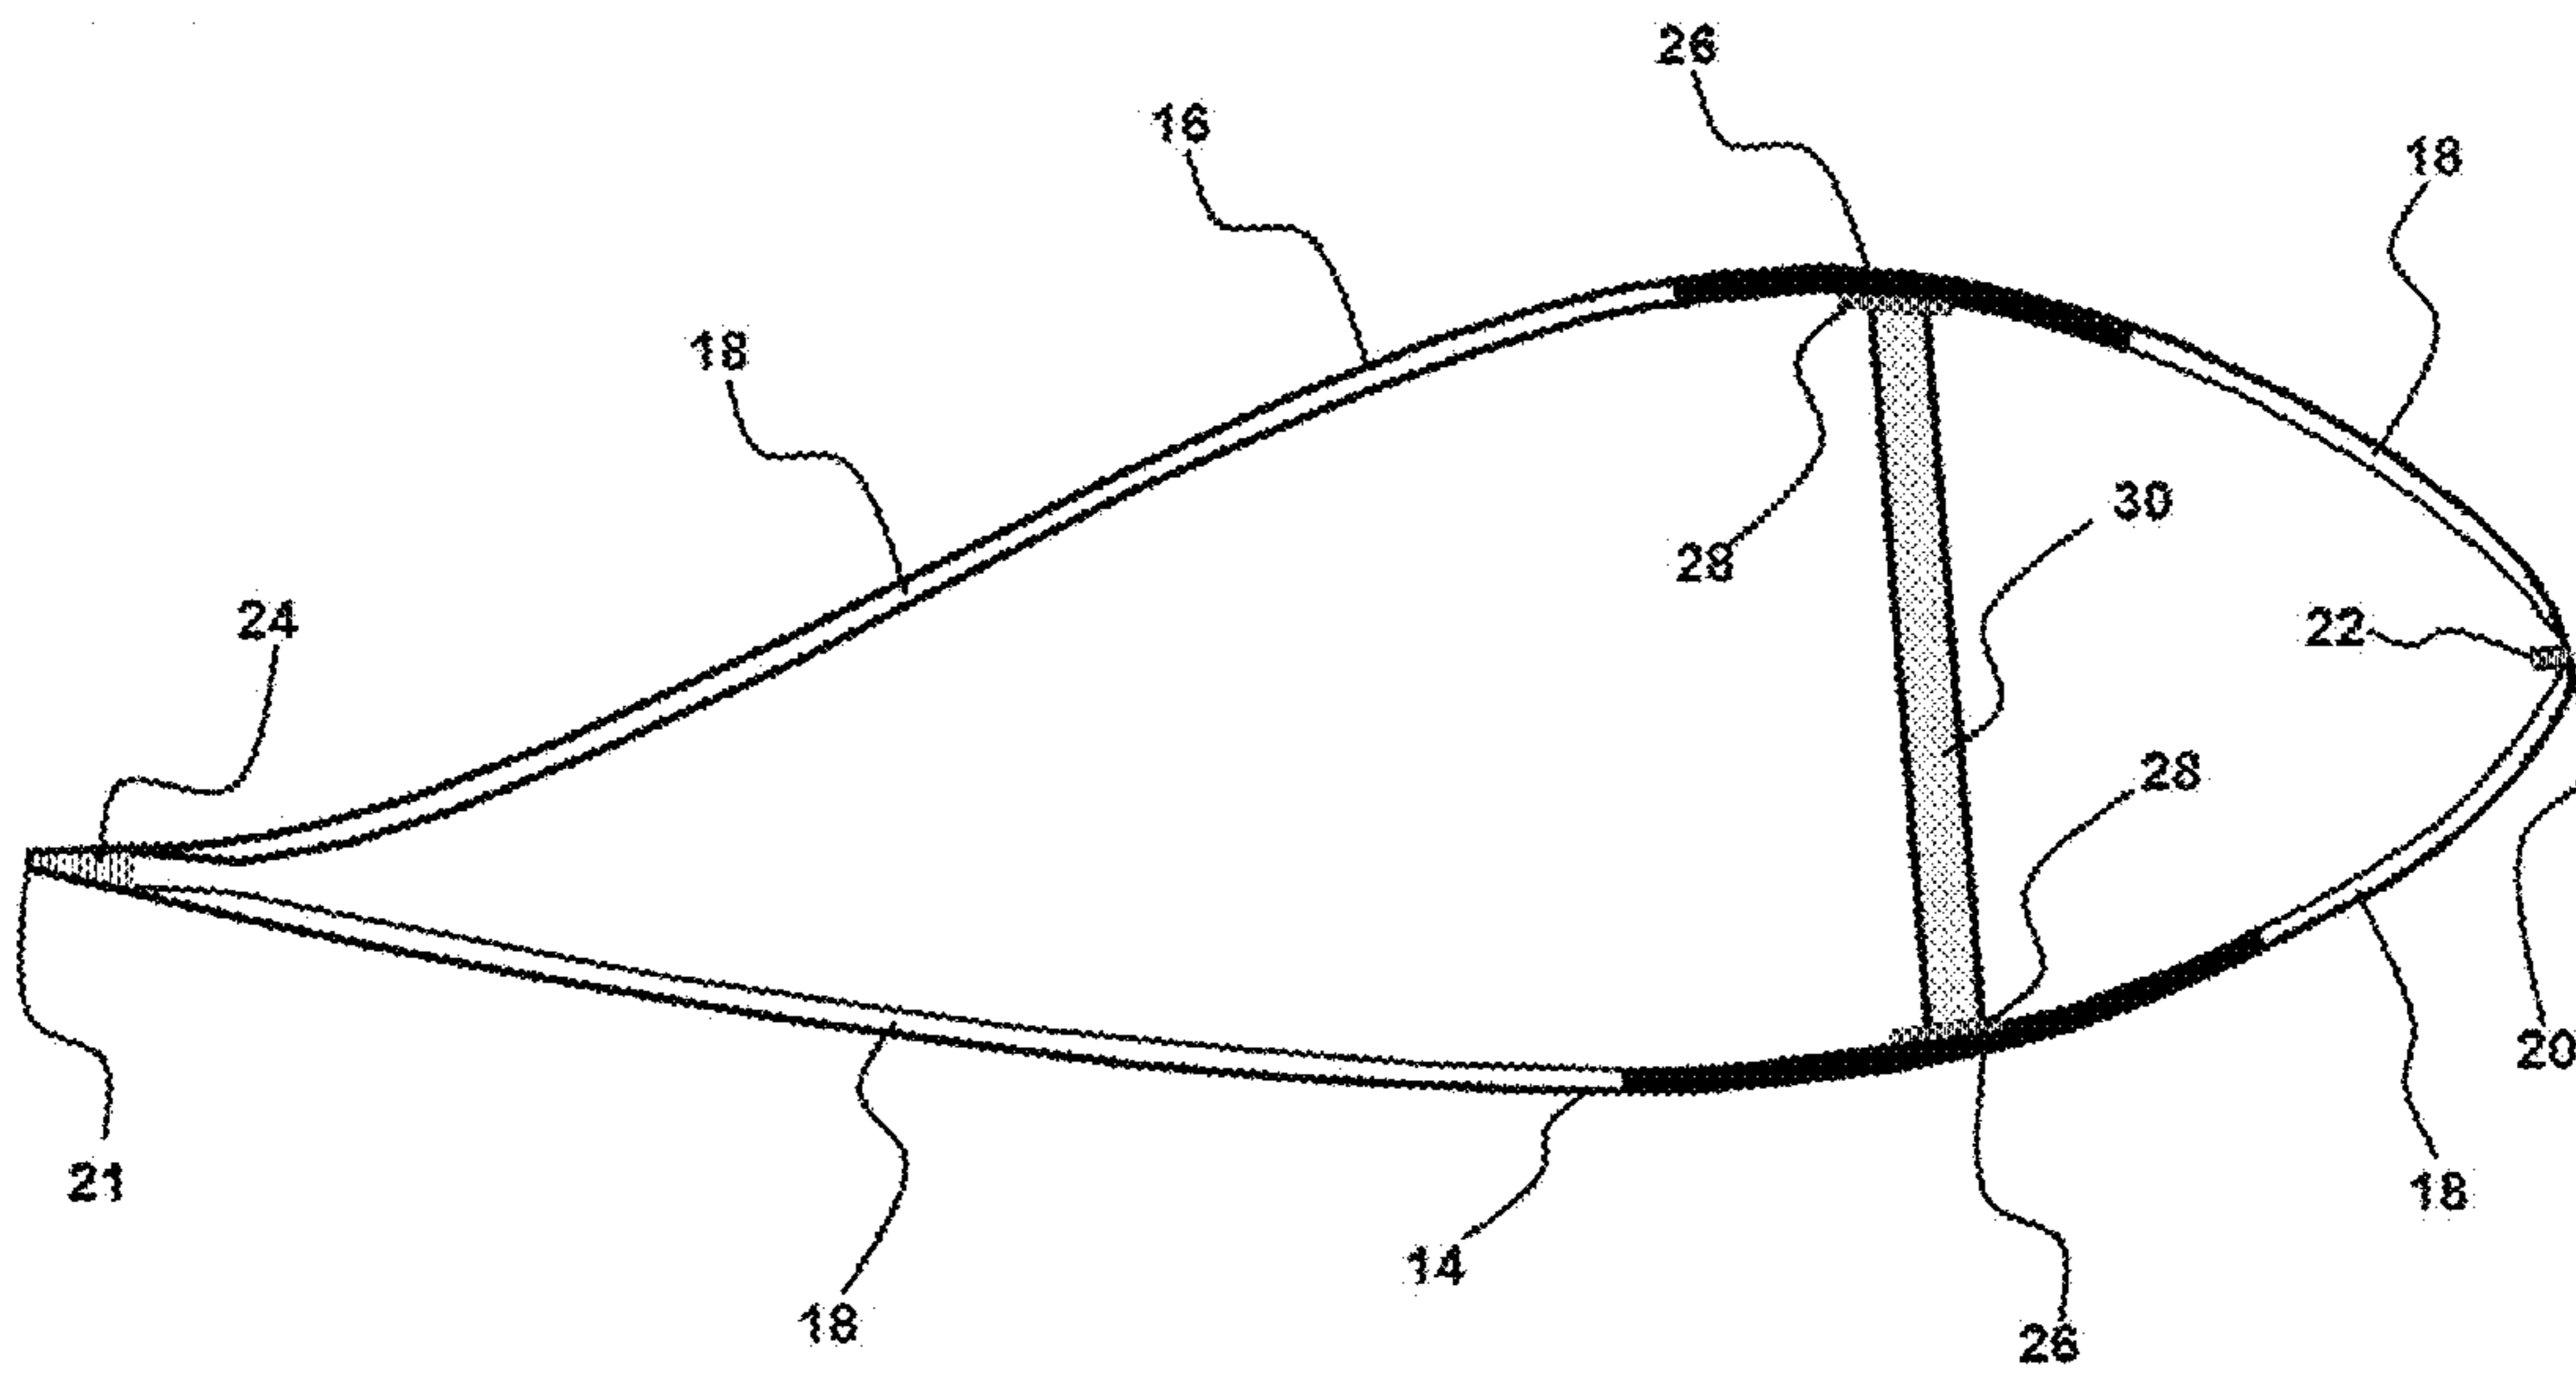
Fig. 2

FIG. 2 is a schematic representation of a wind turbine blade cross section.

FIG. 2 shows the construction cross section of a typical HAWT blade. Wind turbine blades are generally manufactured with adhesively bonded composite shells forming the high pressure side 16 and the low pressure side 14. The trailing edge 21 is adhesively bonded as is the leading edge 20, with adhesive bonding in some cases between two flanges 22 formed by the inner and outer fiberglass skins that make up sandwich panels 18. Two spar caps 26, which may be made from fiberglass or carbon fiber laminate are bonded to the edges of the sandwich panels 18. The blade spar web 30, which can be a solid fiberglass laminate or a sandwich construction with fiberglass or carbon fiber face sheets and a core material made with foam, balsa wood or other suitable material with high compressive strength. The spar web 30 is bonded with adhesive 28 to the spar caps 26 to form an I beam. Sometimes a second or even third spar web is present forming a box beam.

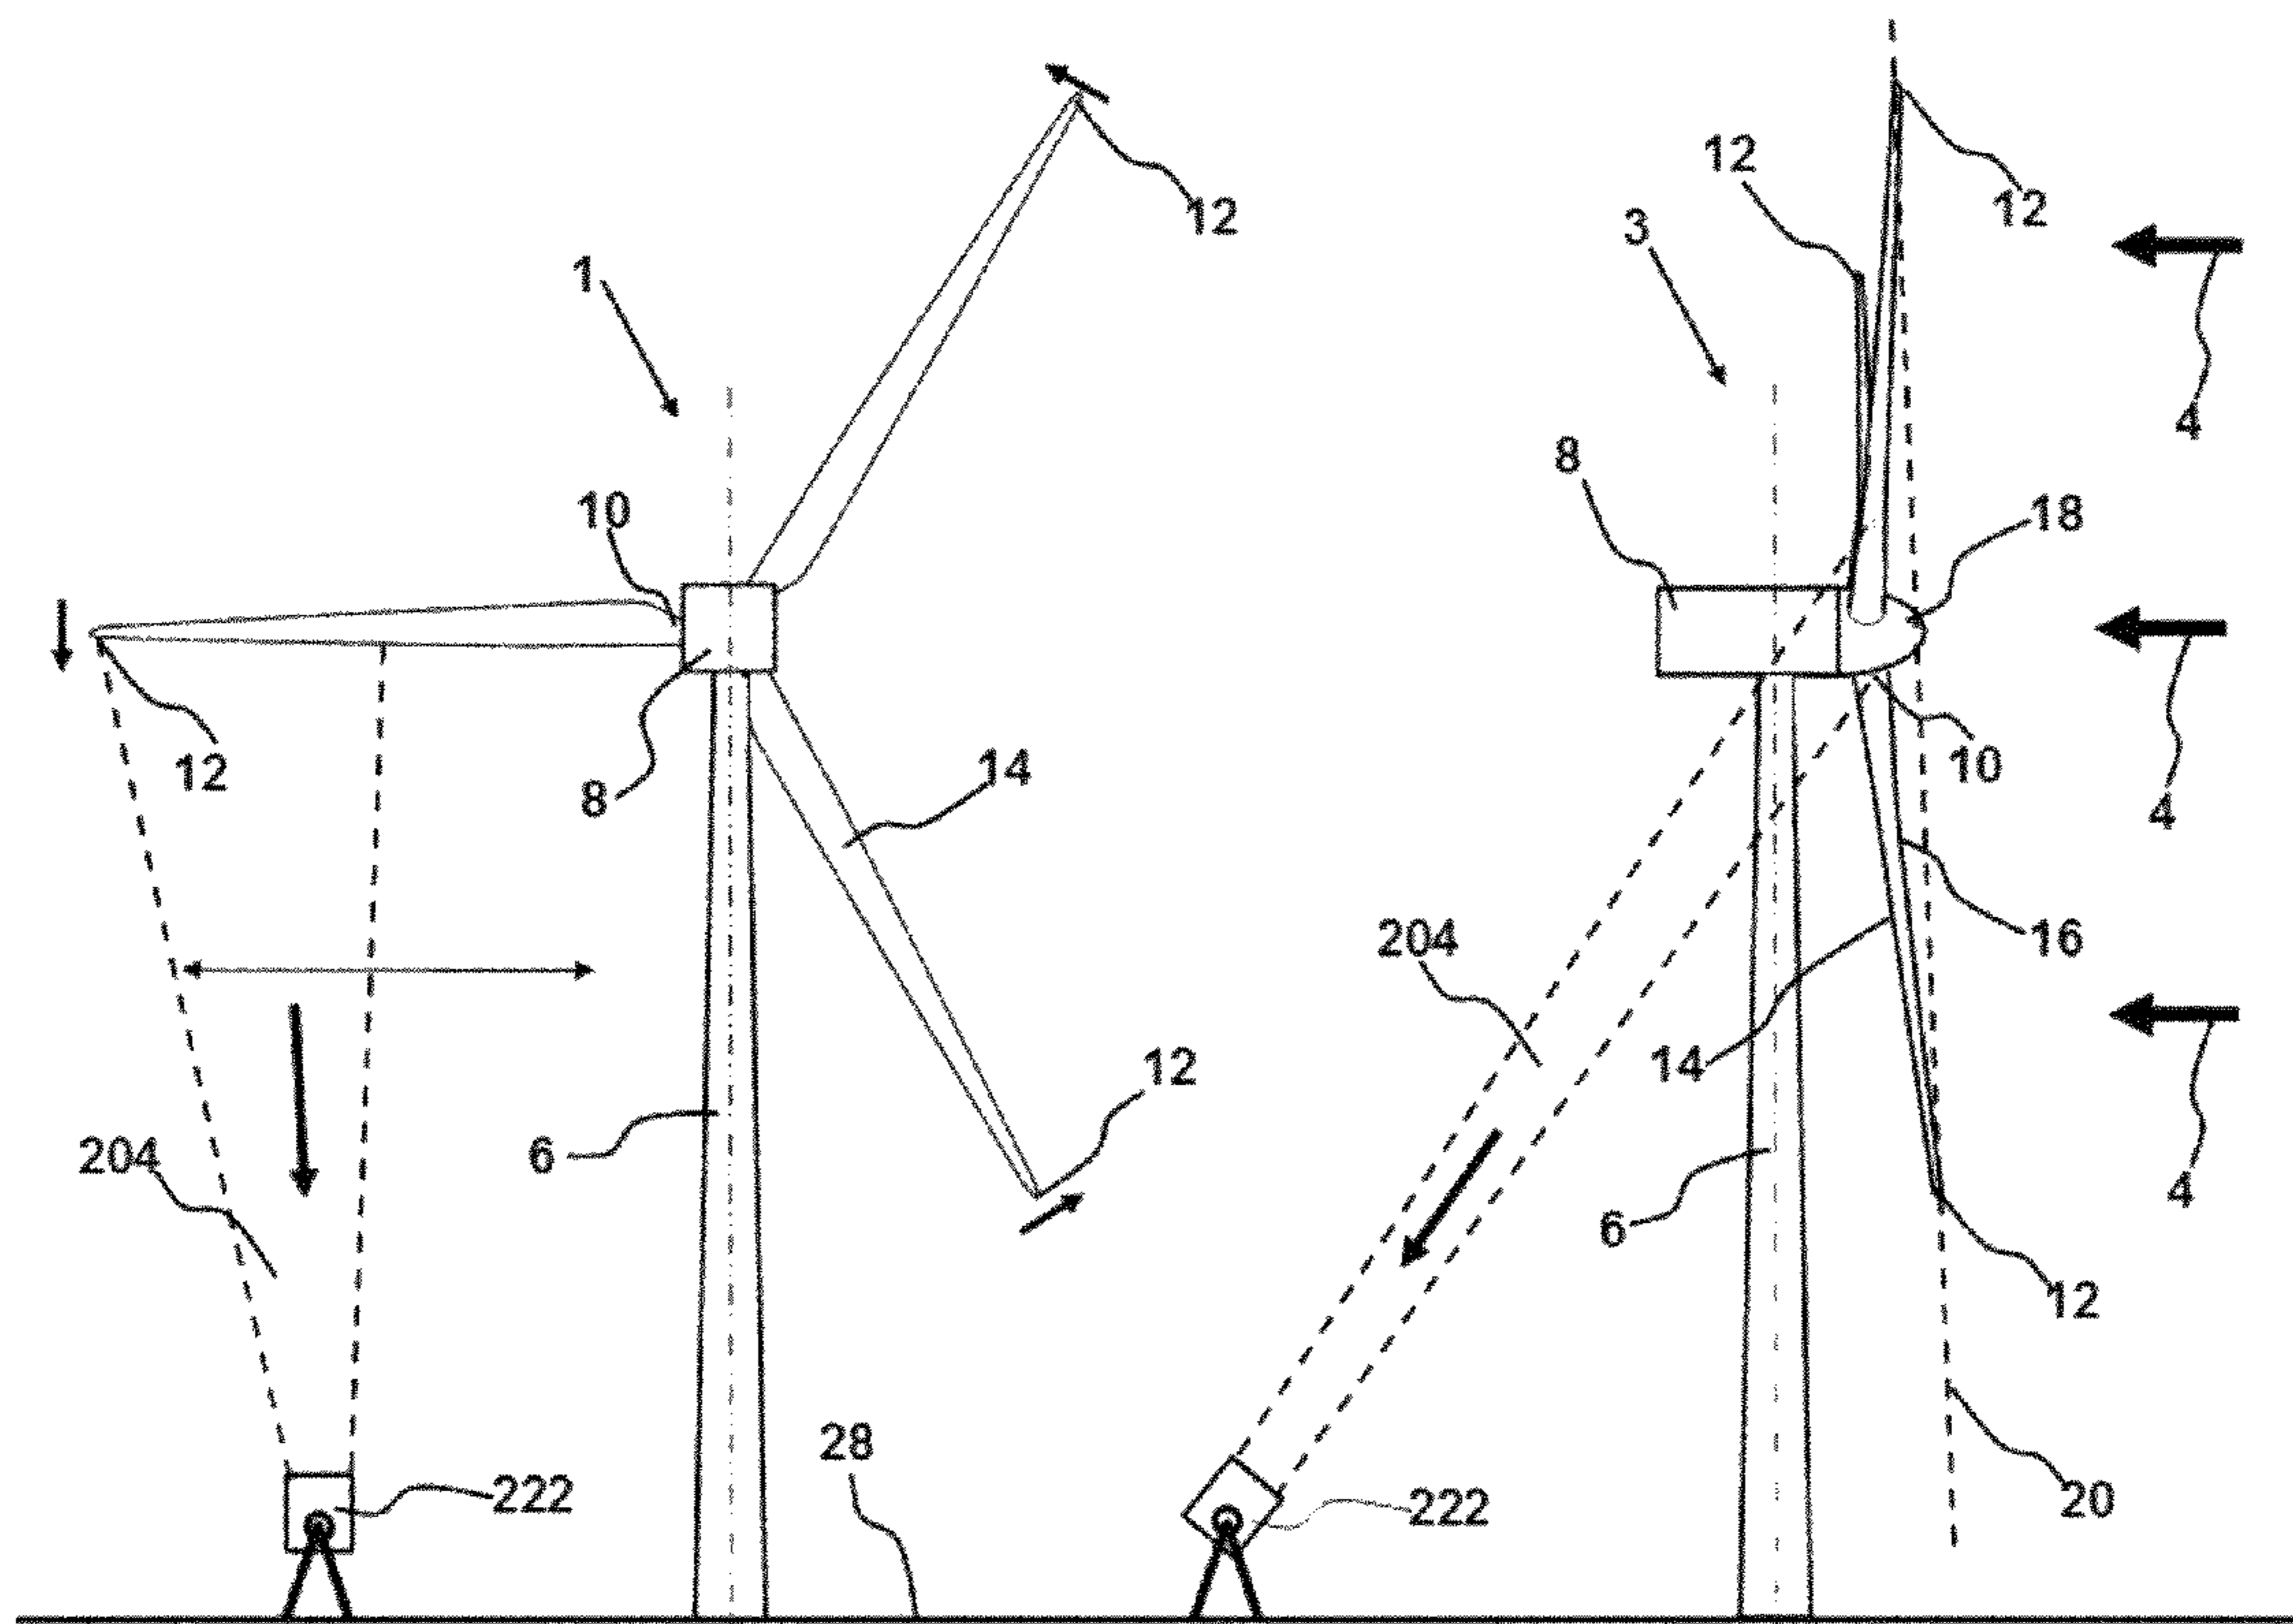
Fig. 3

FIG. 3 is a schematic diagram showing the relative location of a thermal camera for inspecting the wind turbine blades that are oriented so as to be substantially perpendicular with respect to the ground or sea level;

FIG. 3 is a schematic diagram showing the side view of thermal camera 222 at locations down wind of tower 6 for inspection of the low pressure side of the blade 11. Thermal

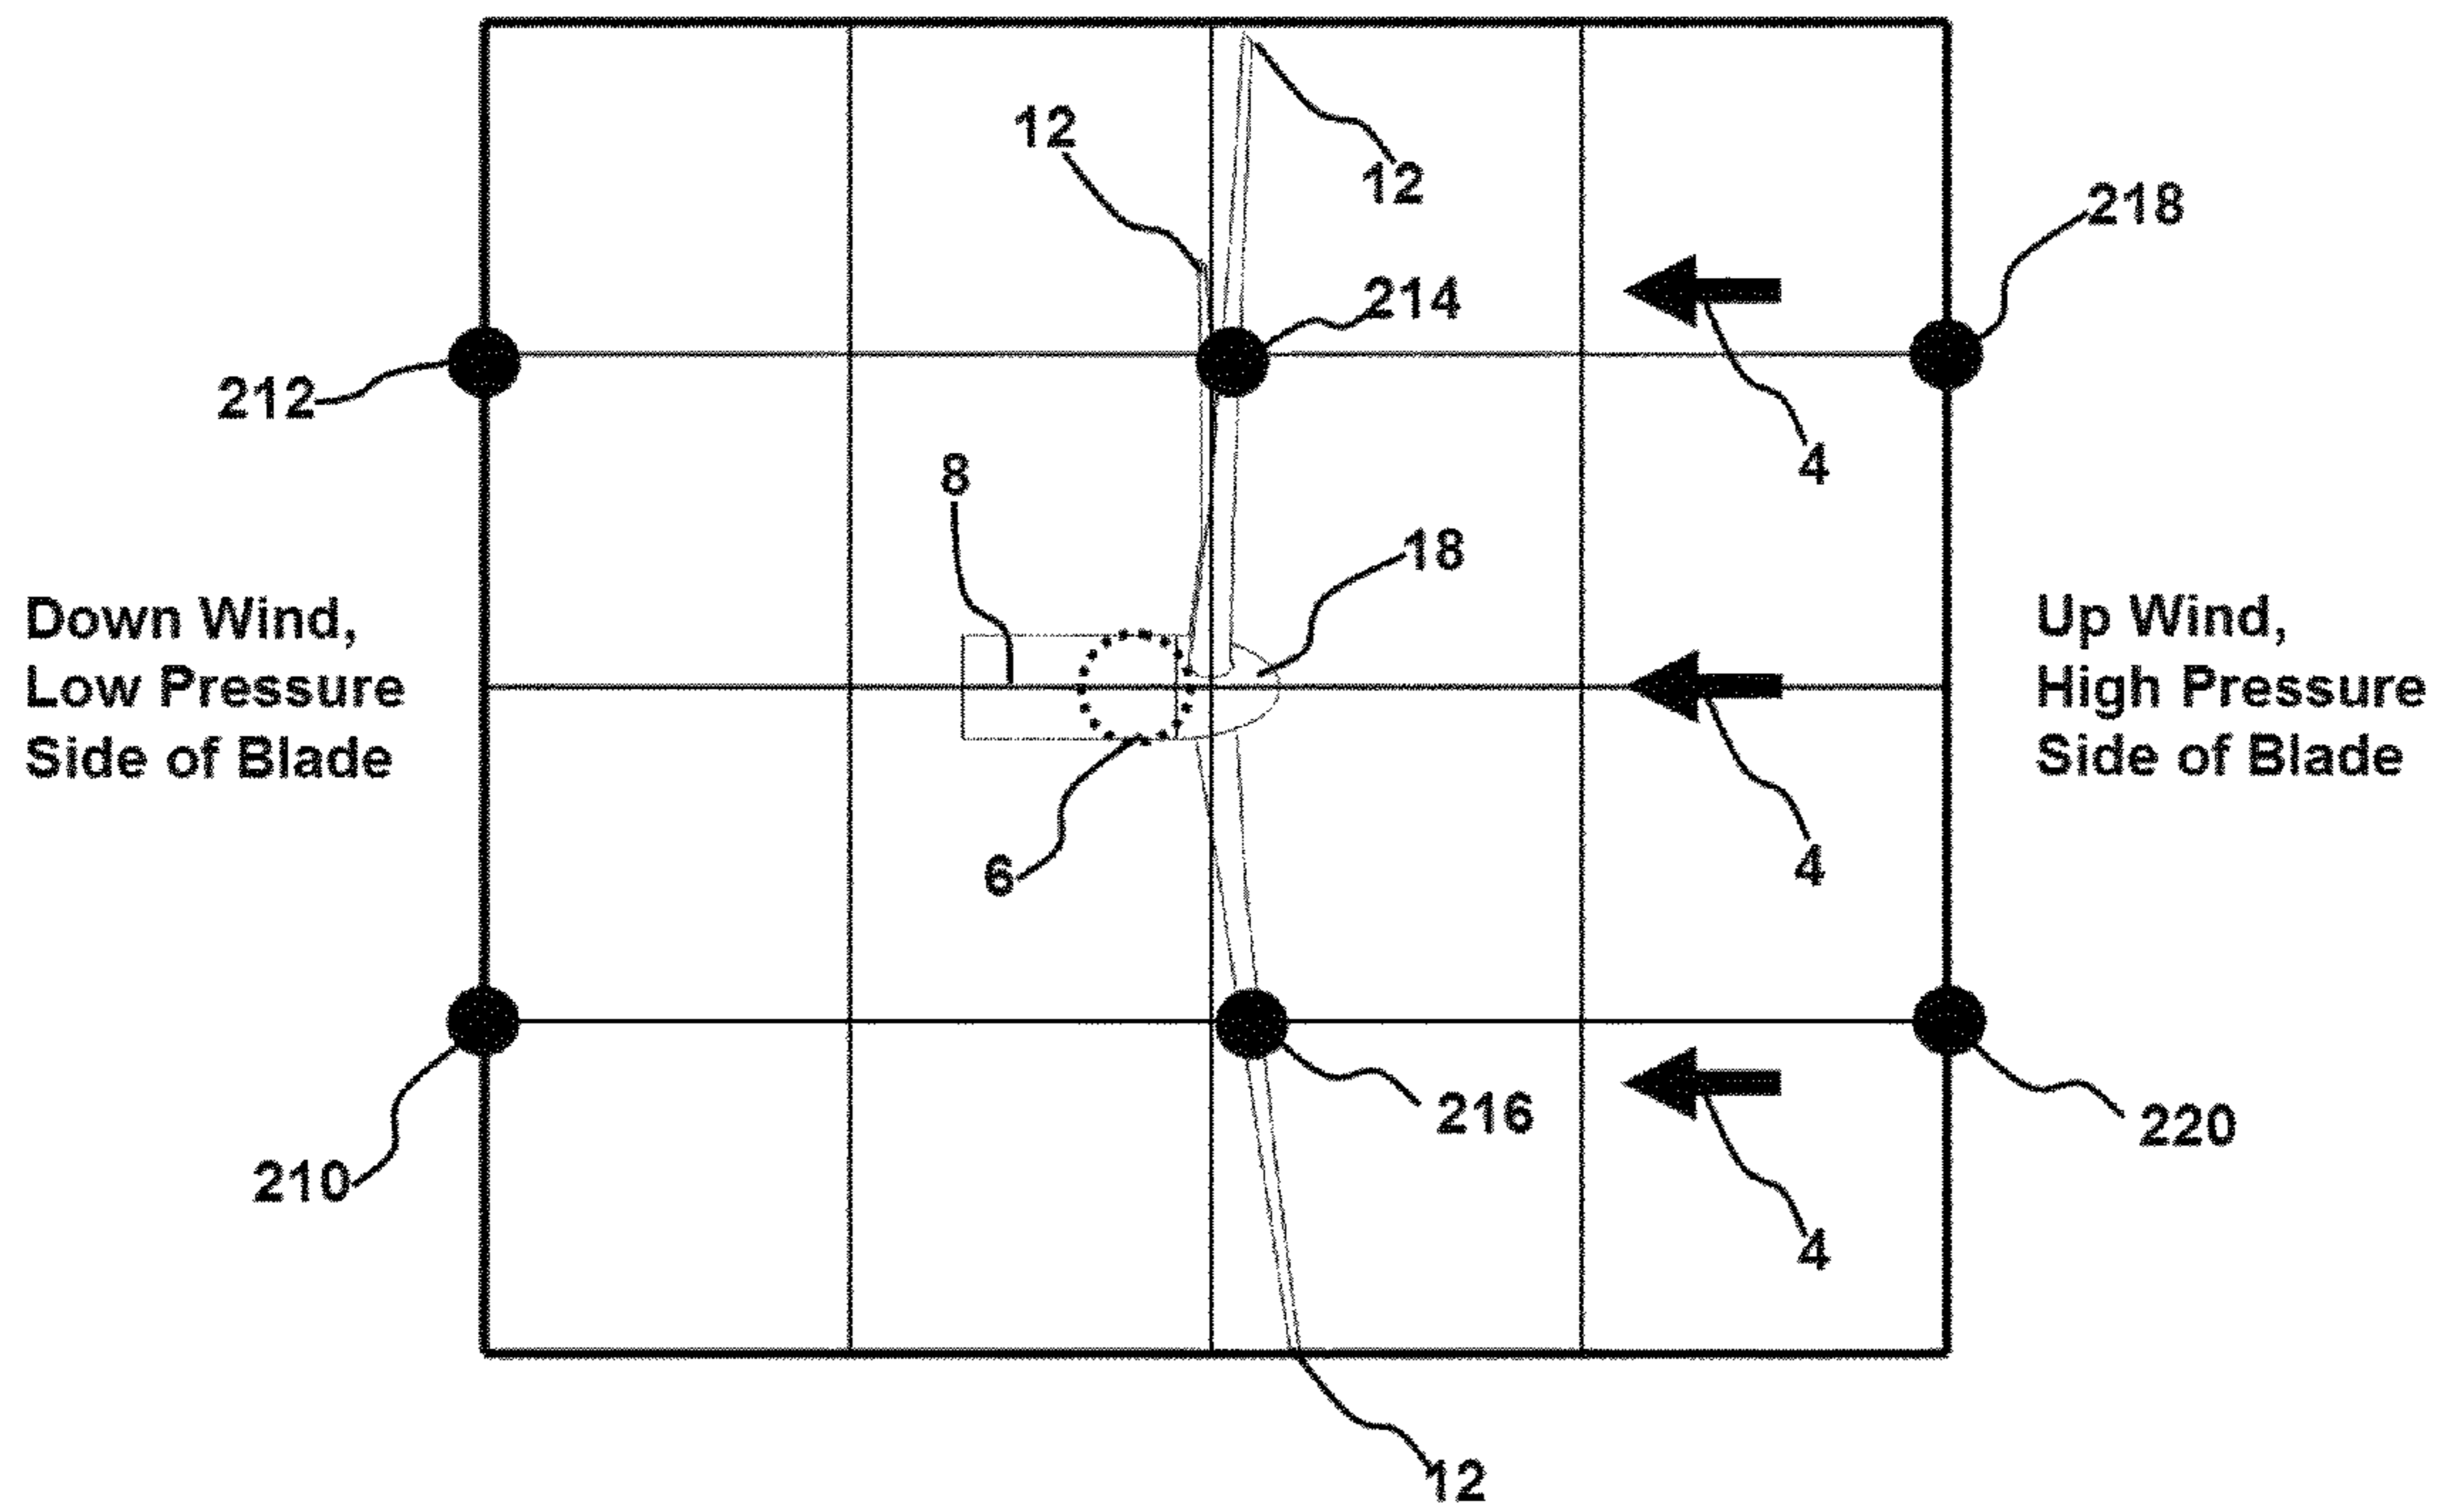
Fig. 4

FIG. 4 is a diagrammatical plan view of a wind turbine site with an indication of six placement locations for the thermal camera to view various locations on the blades;

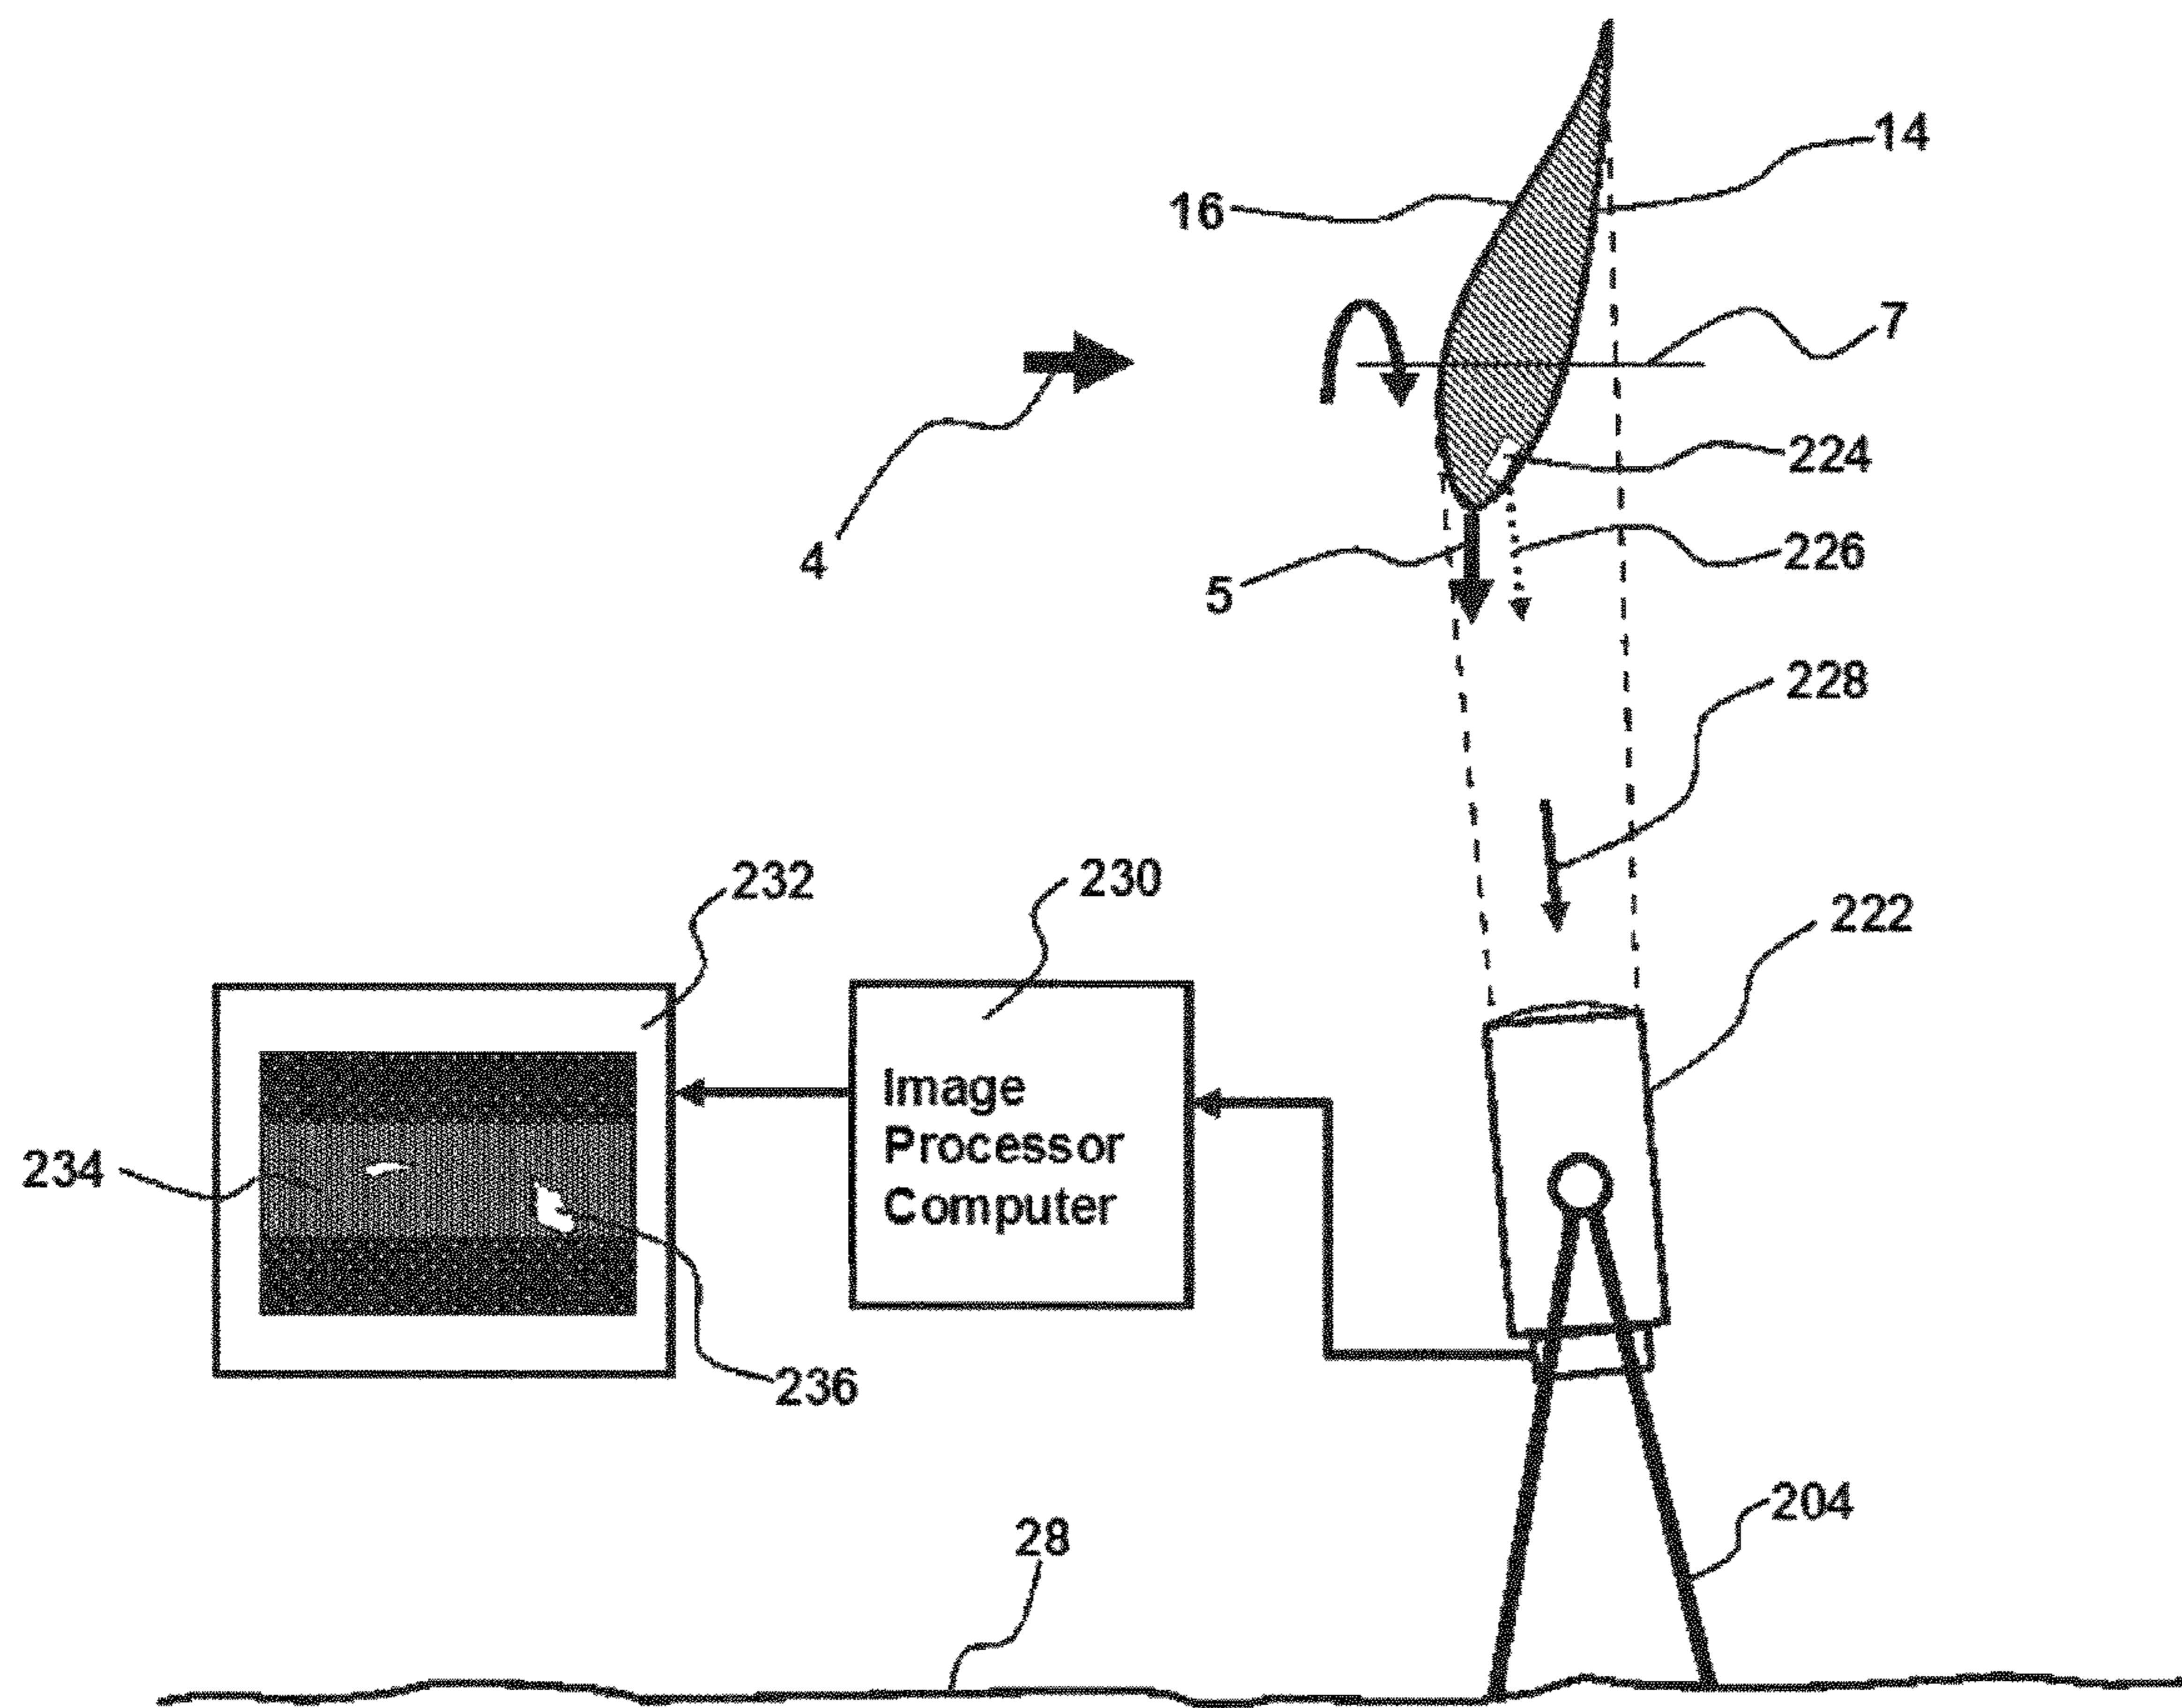
Fig. 5

FIG. 5 shows a basic thermal system including an image processing computer that is suitable for direct viewing and recording blade surfaces in or near a wind turbine site;

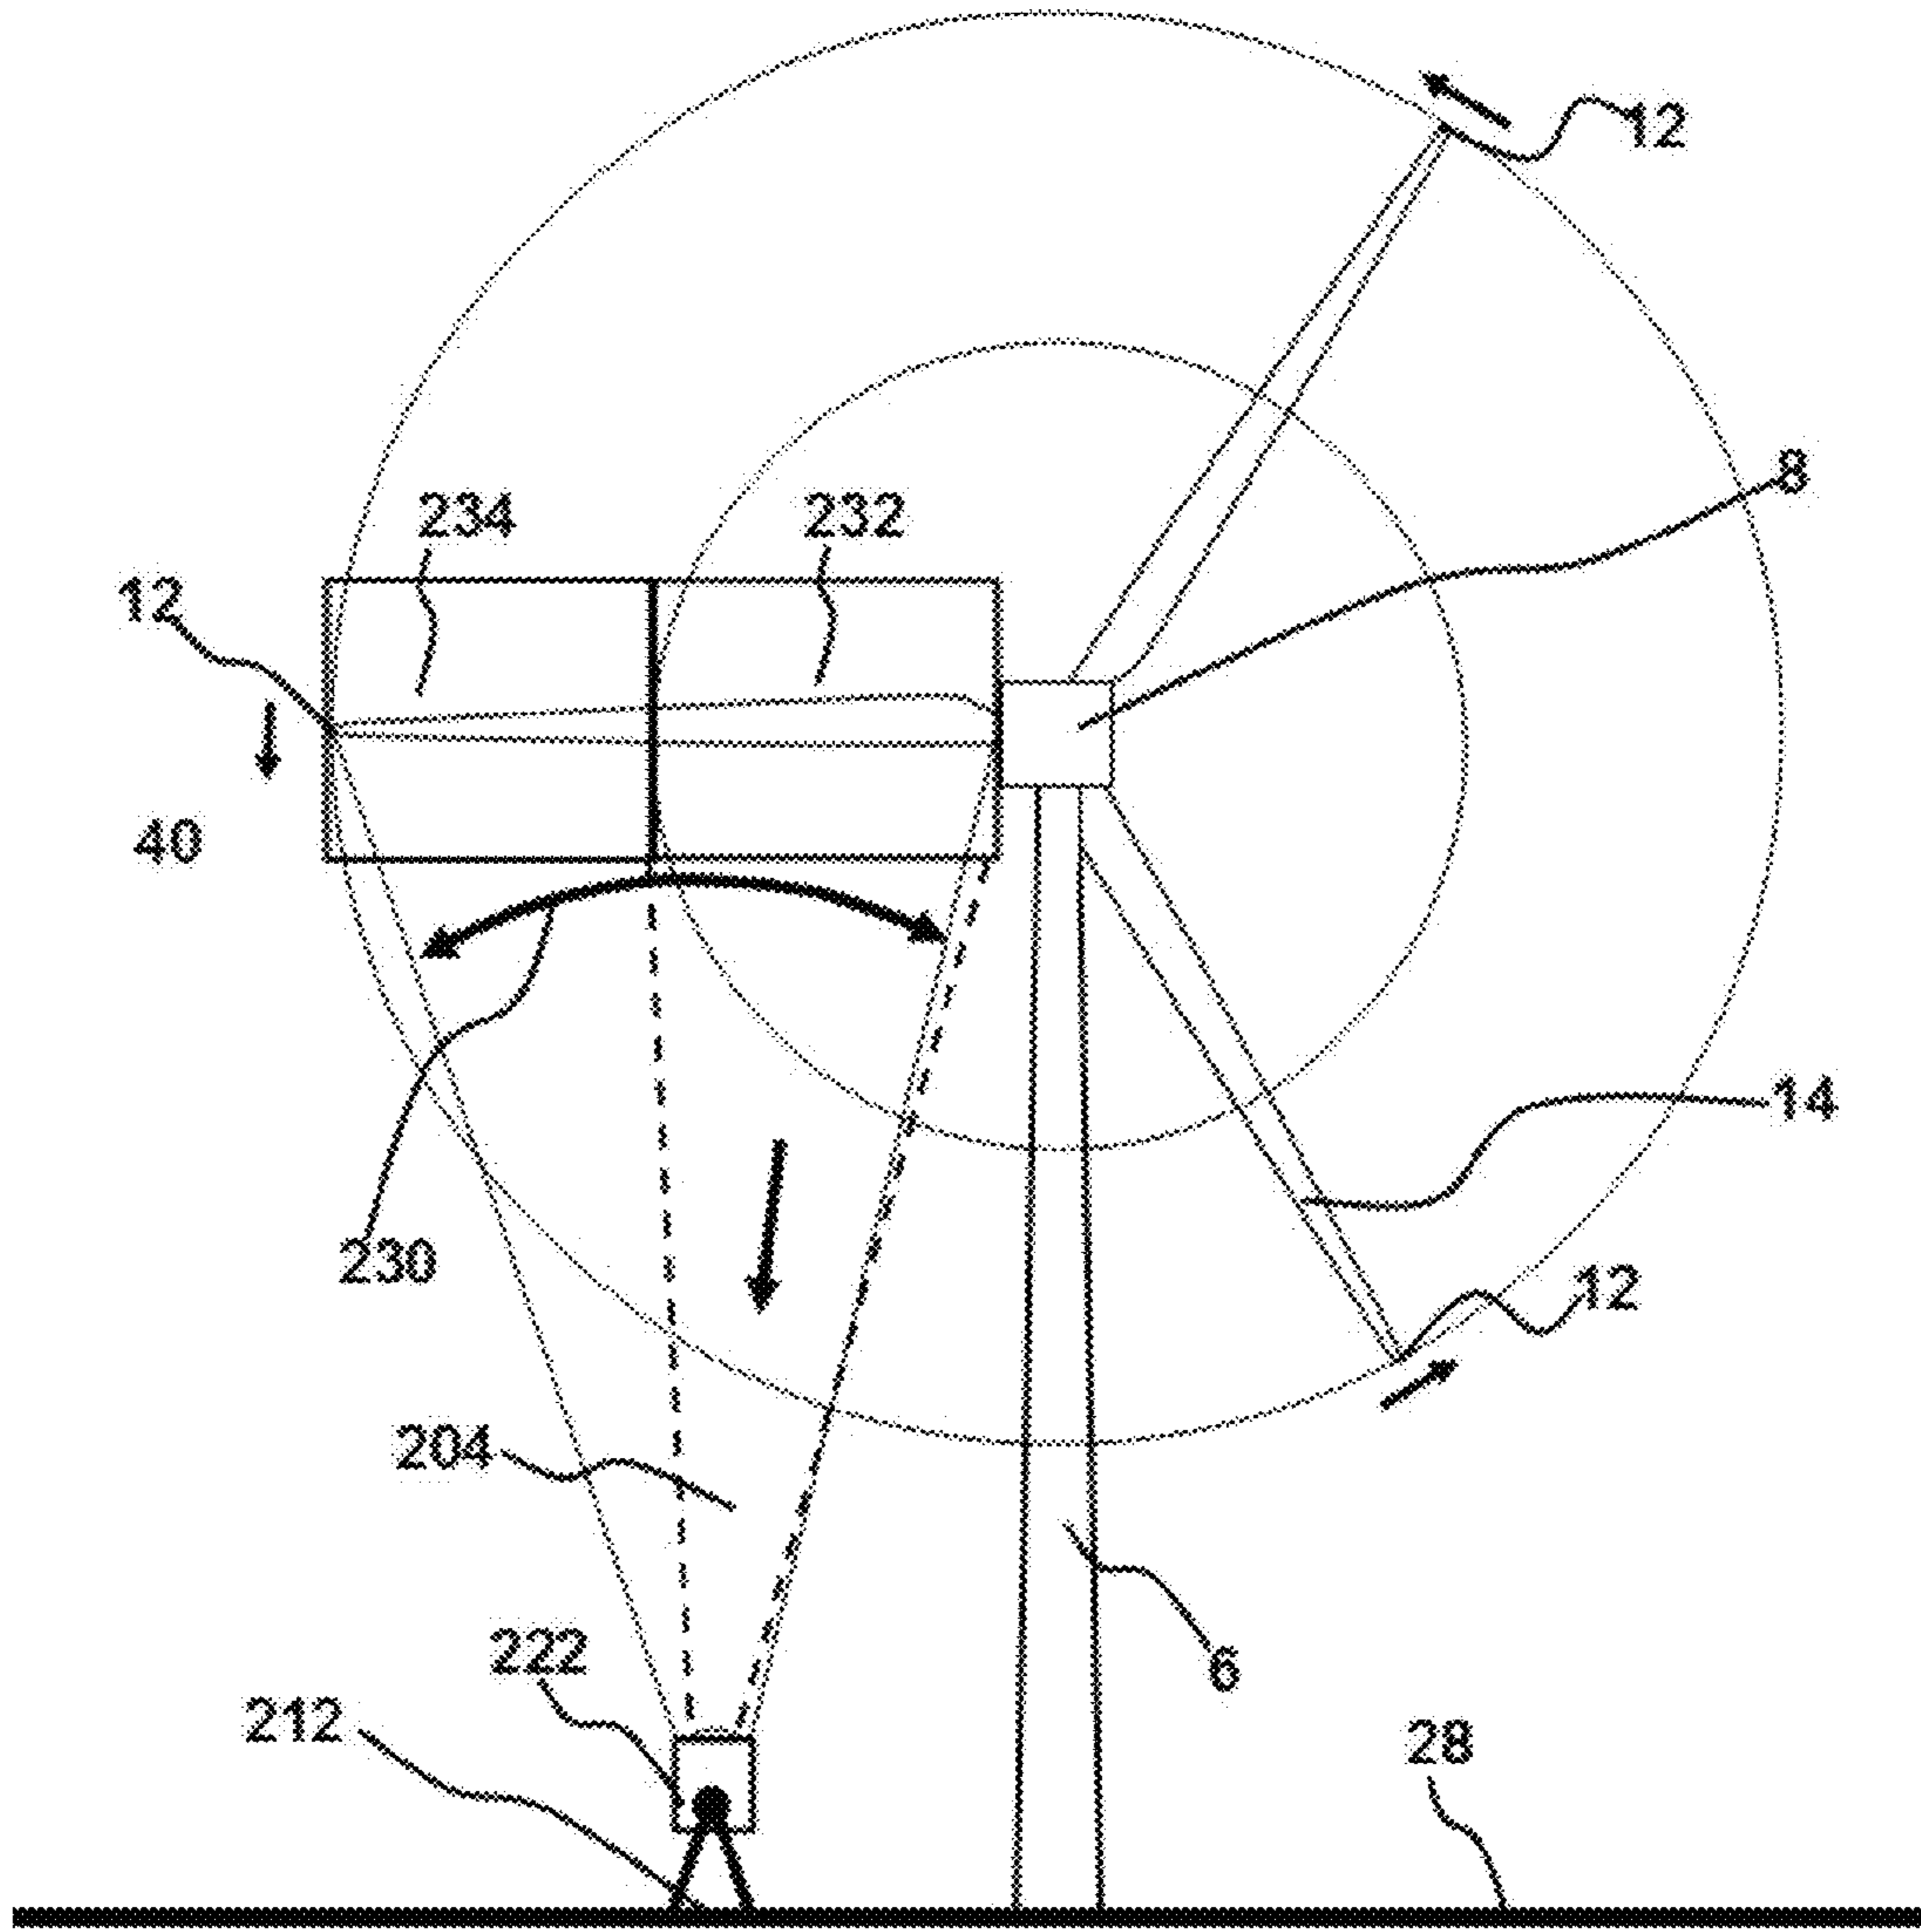
Fig. 6

FIG. 6 a schematic showing the thermal camera viewing a low pressure, or suction side of a blade in the horizontal position.
