(12) **United States Patent**  
**Newman**

(54) **METHOD AND APPARATUS FOR REMOTE FEATURE MEASUREMENT IN DISTORTED IMAGES**

(71) Applicant: **DIGITAL WIND SYSTEMS, INC.**,  
West Conshohocken, PA (US)

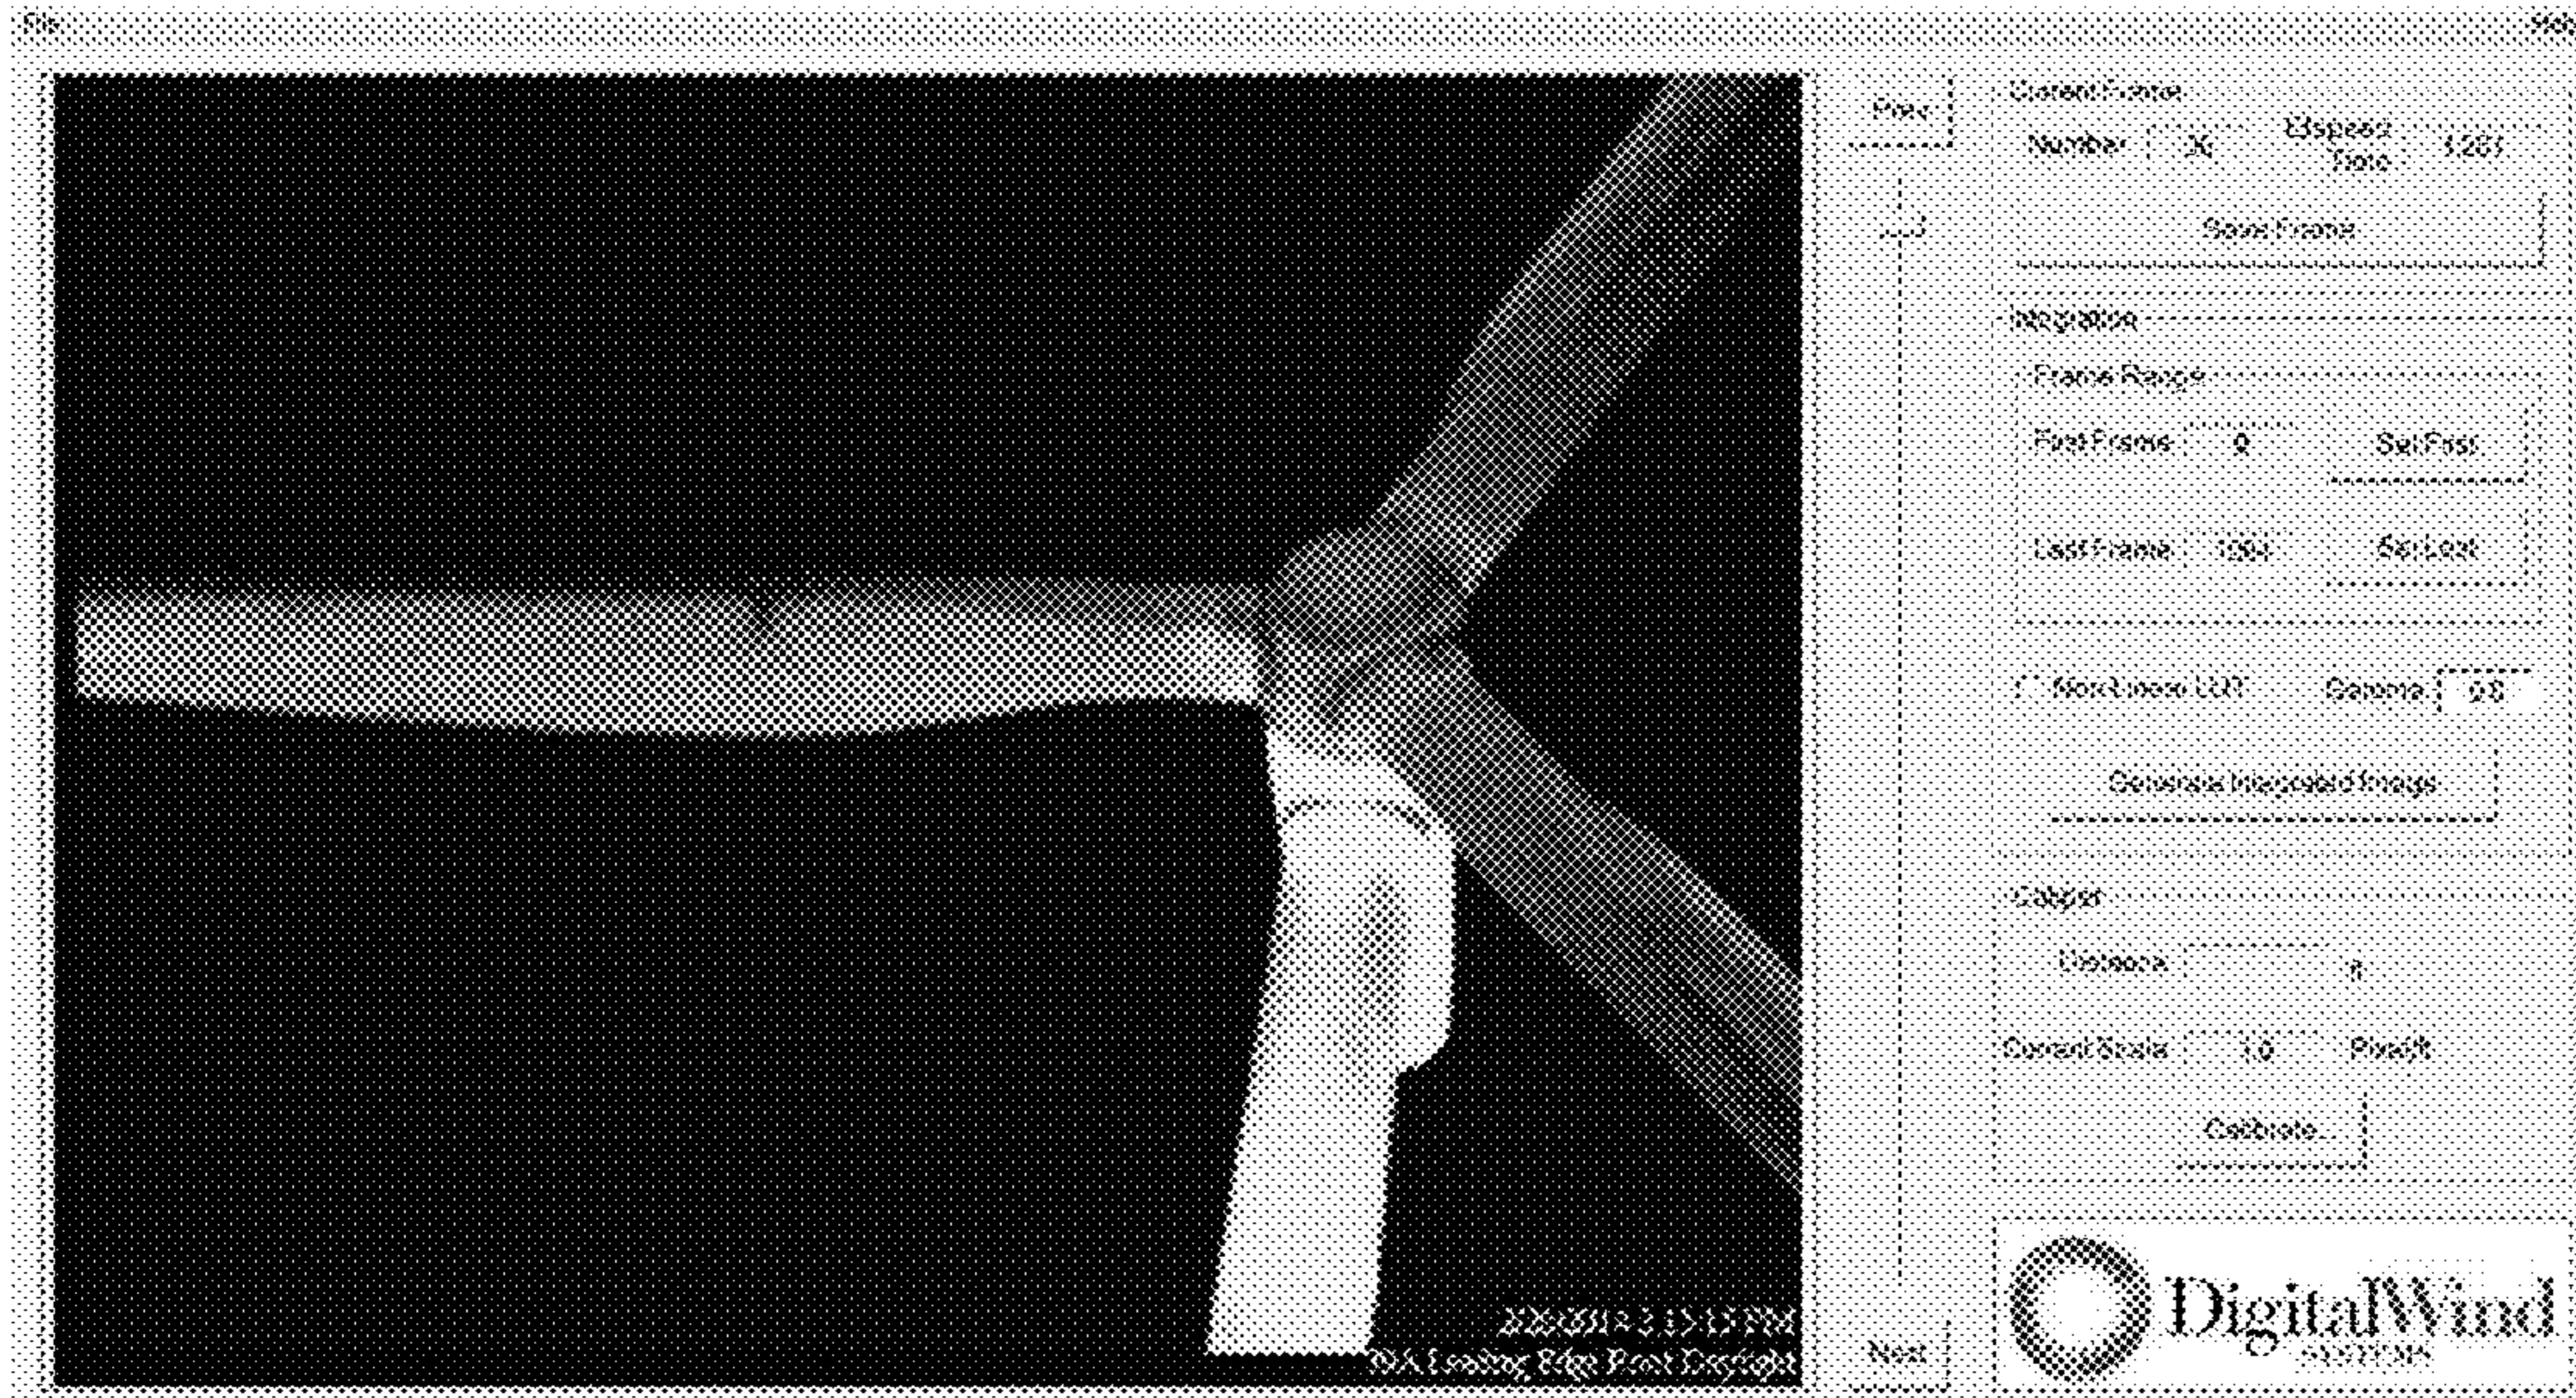
FIG 7

FIG. 7 is a screenshot of a display image generated by the image processing computer showing a thermal image of the high pressure side of an operating wind turbine rotator with a video frame selected with the blade positioned horizontally blade showing a dark defect during nighttime;

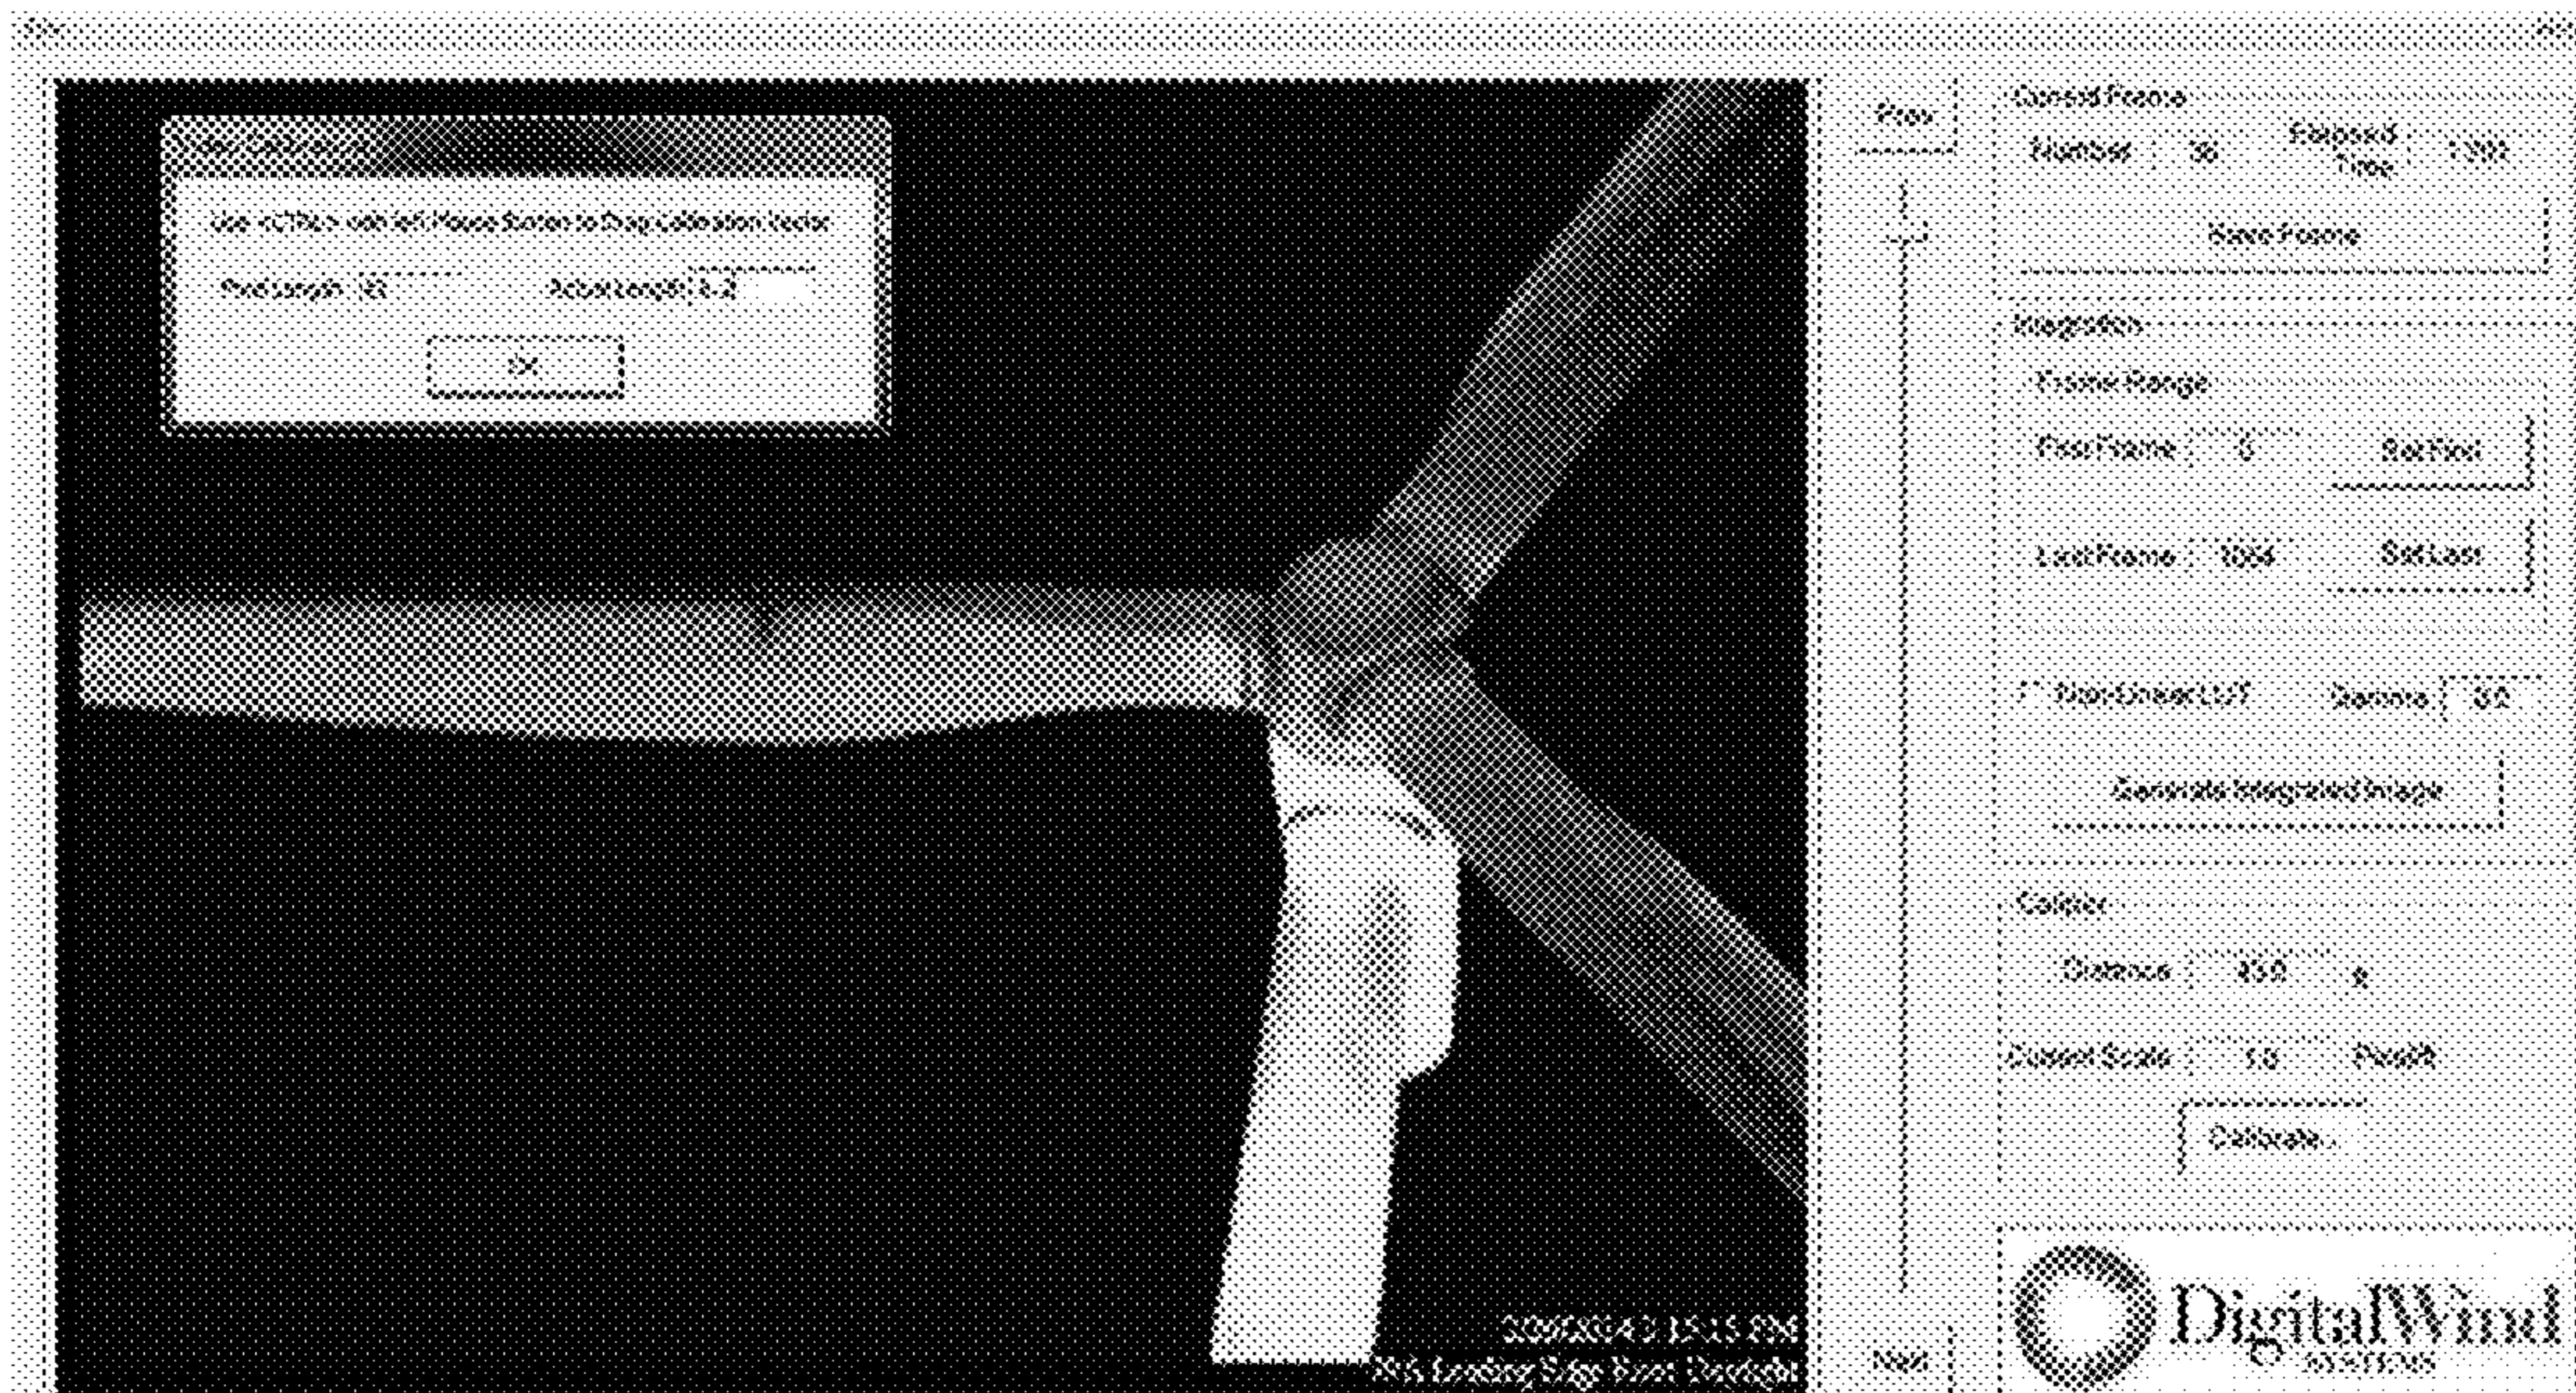
FIG 8

FIG. 8 is a screenshot of a display image generated by the image processing computer showing the use of a caliper overlay function to mark on the digital image the width or diameter of the cylindrical root end of a blade;

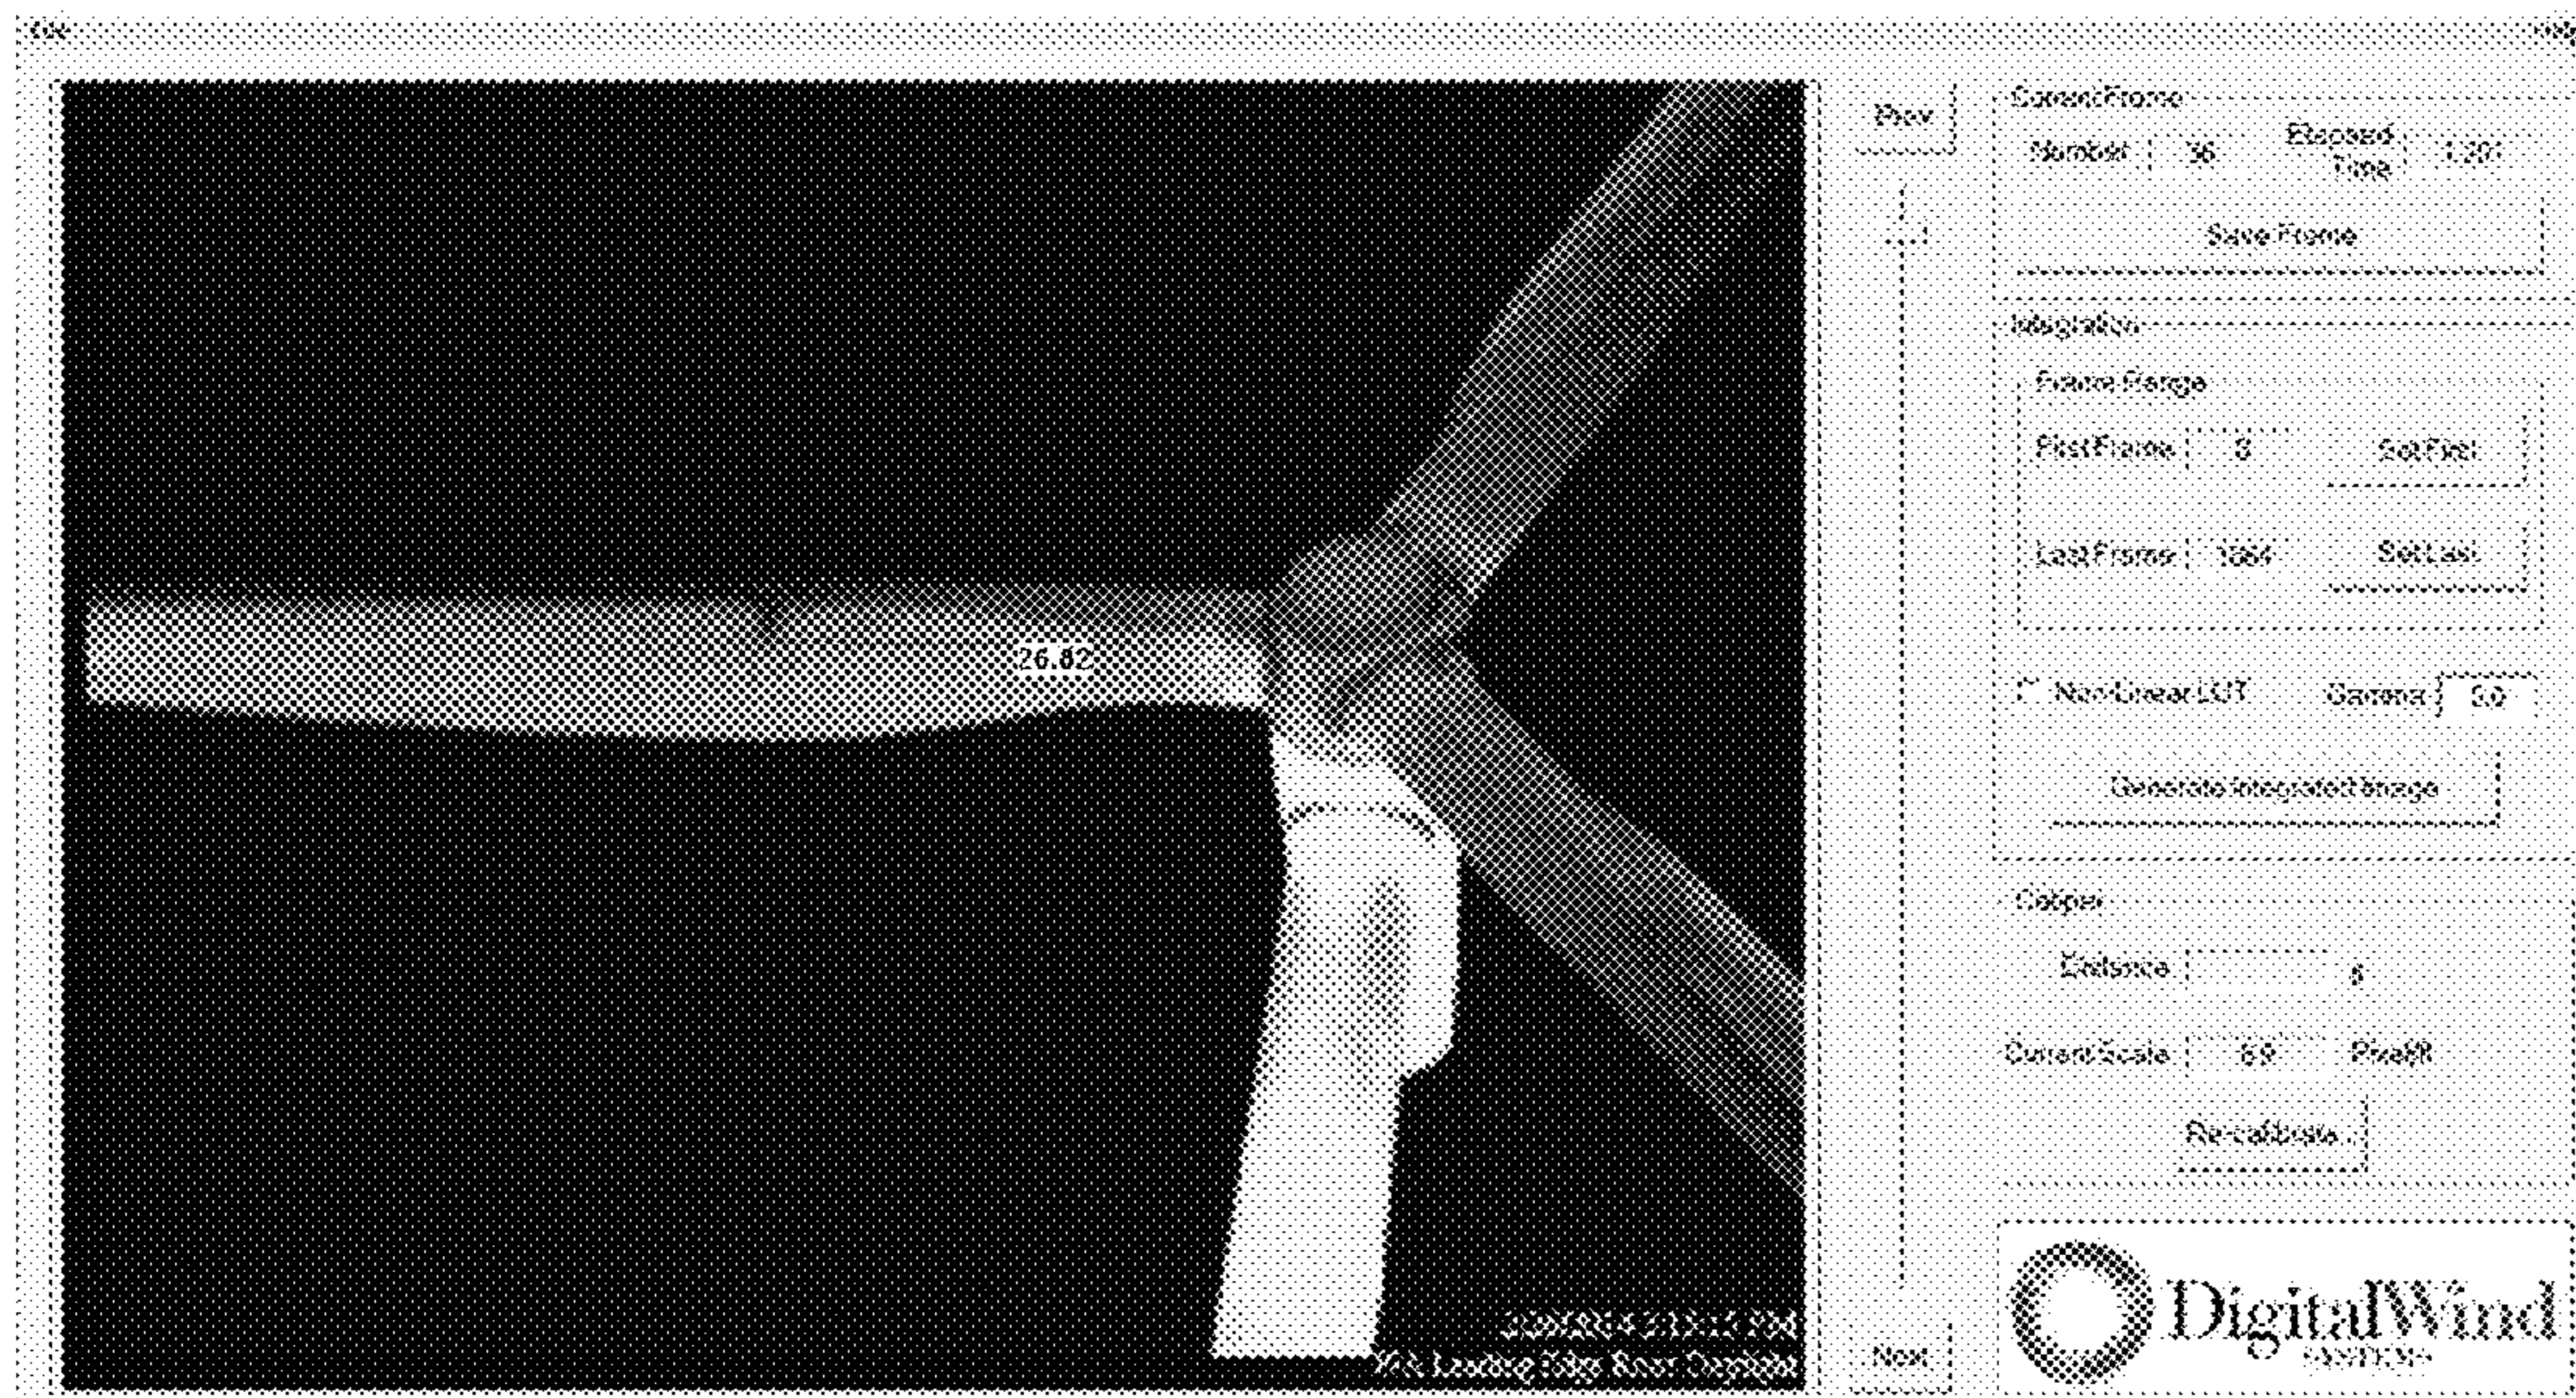
FIG 9

FIG. 9 is a screenshot of a display image generated by the image processing computer showing the use of the caliper overlay function to determine a distance between the blade root end and the black indication of a defect in a wind turbine blade;

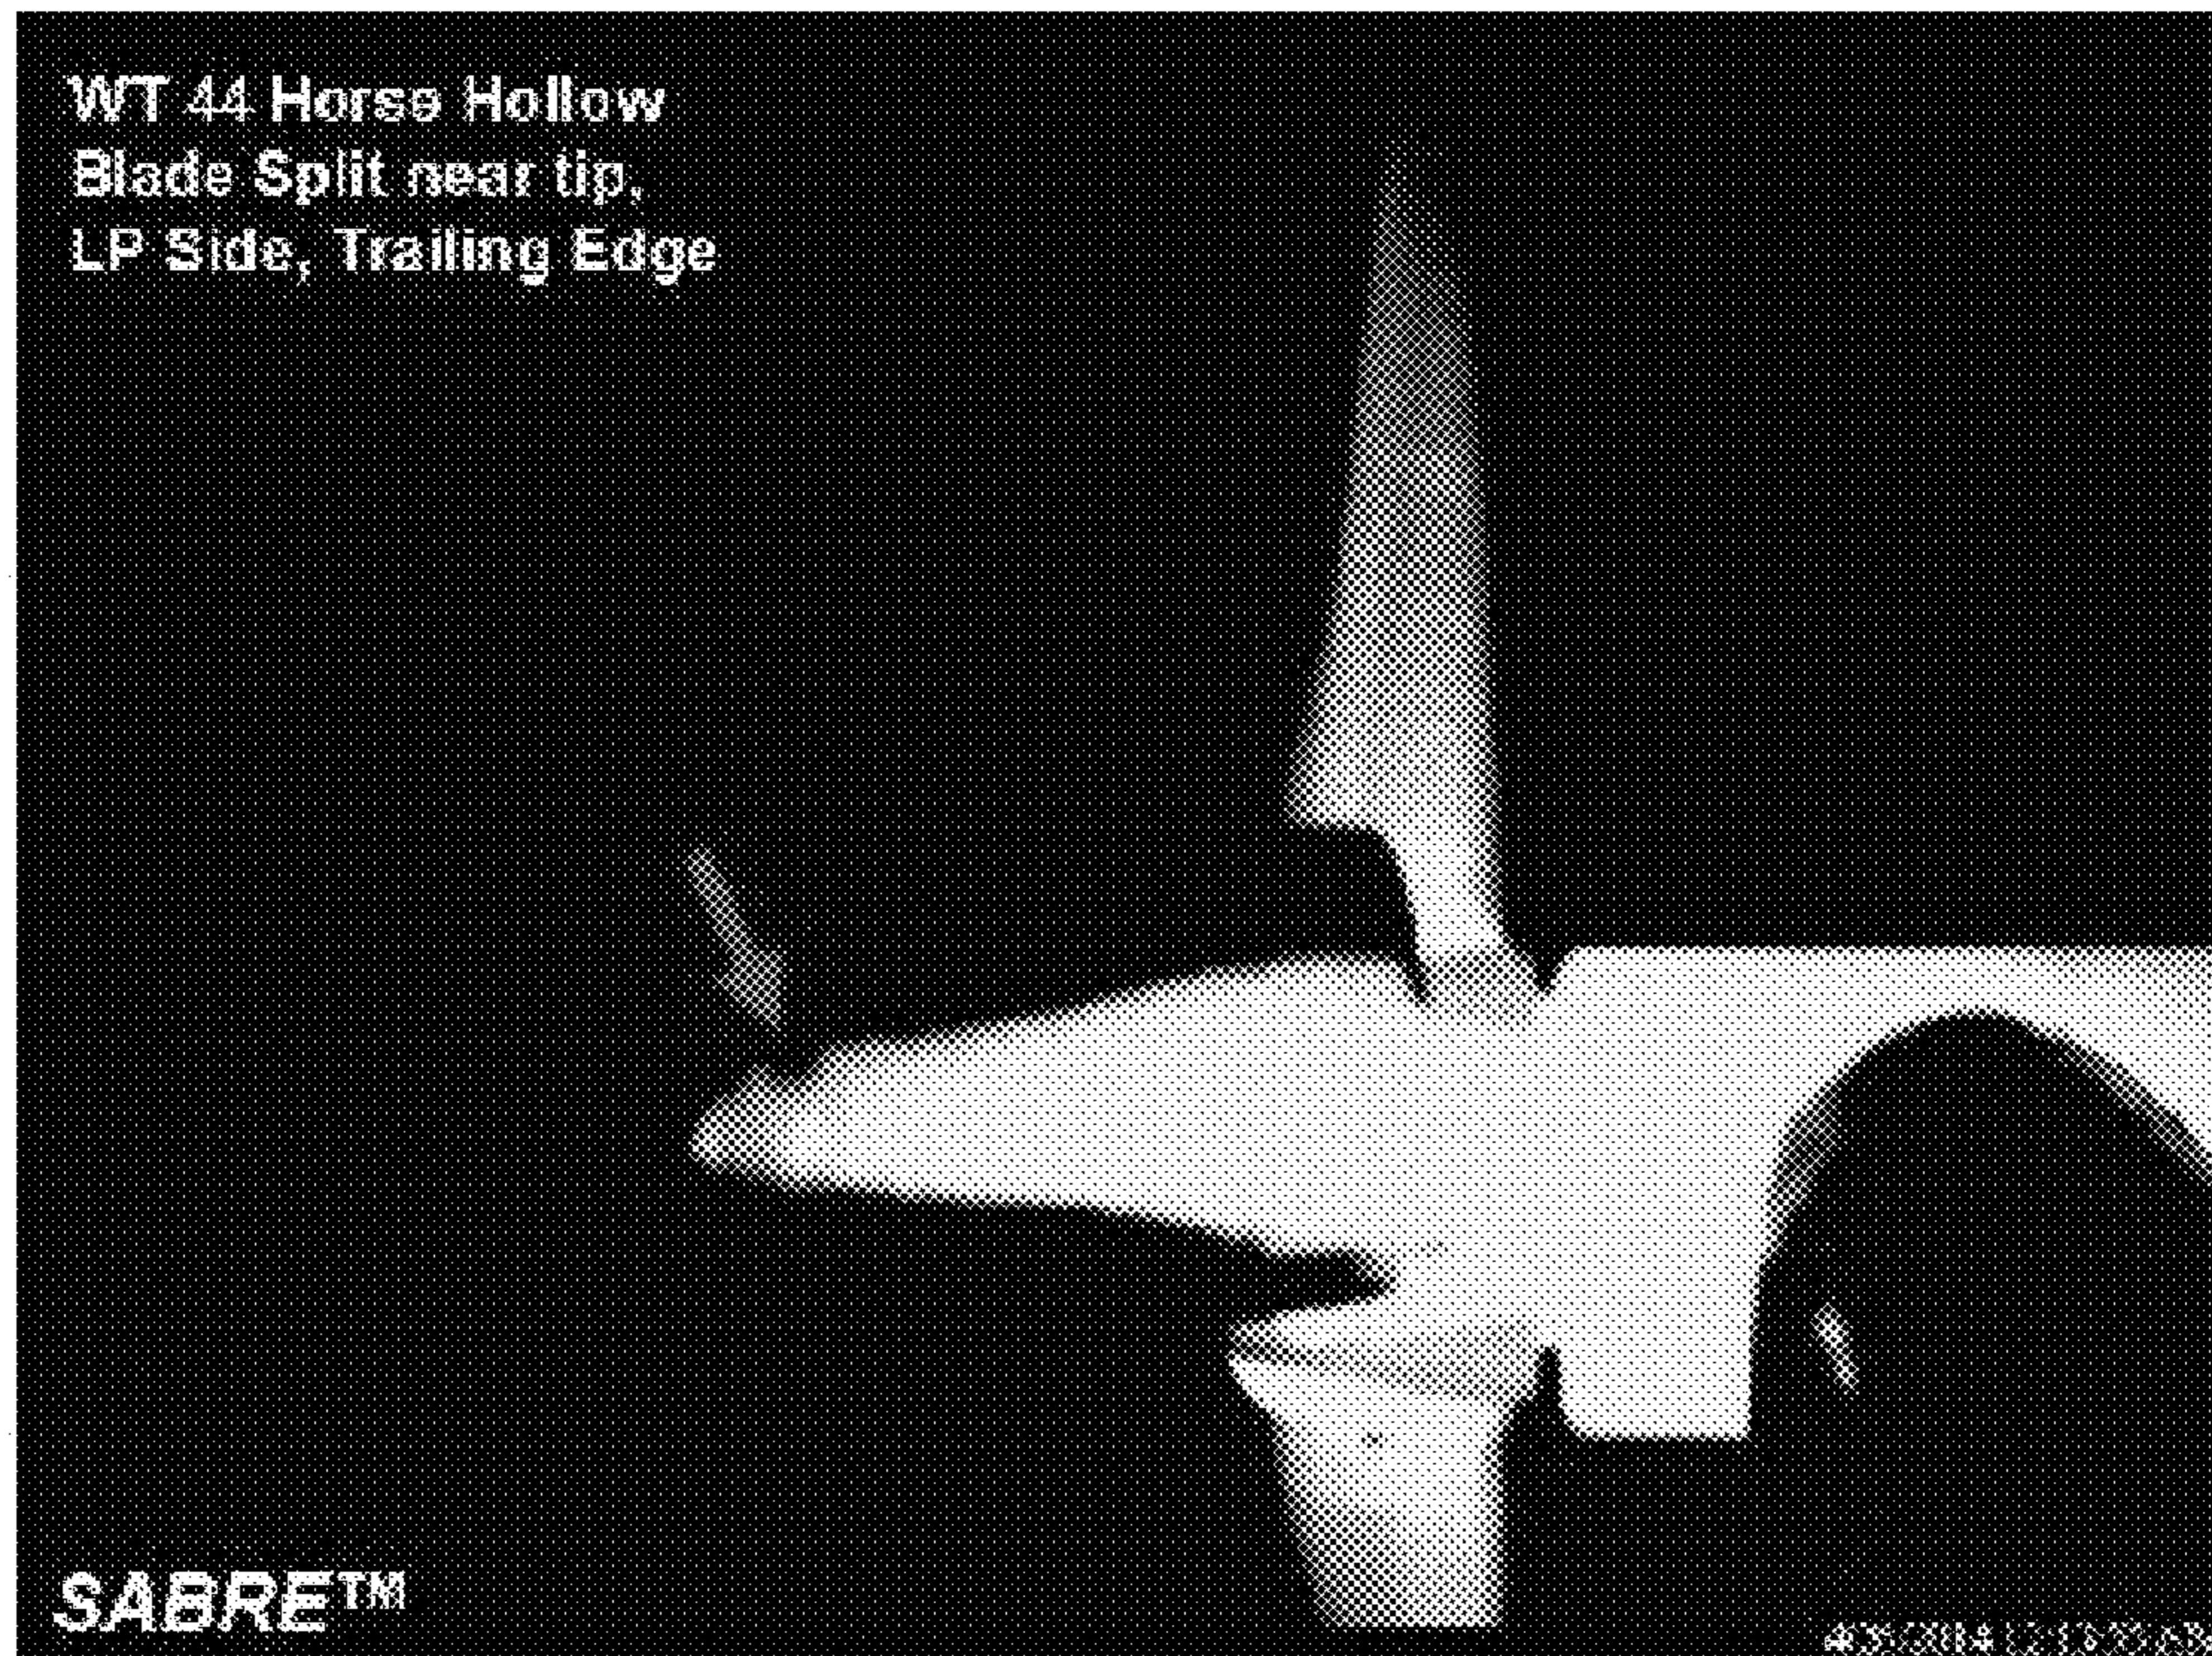
FIG 10

FIG. 10 is an infrared image showing a flaw in a wind turbine blade near the tip of the blade;

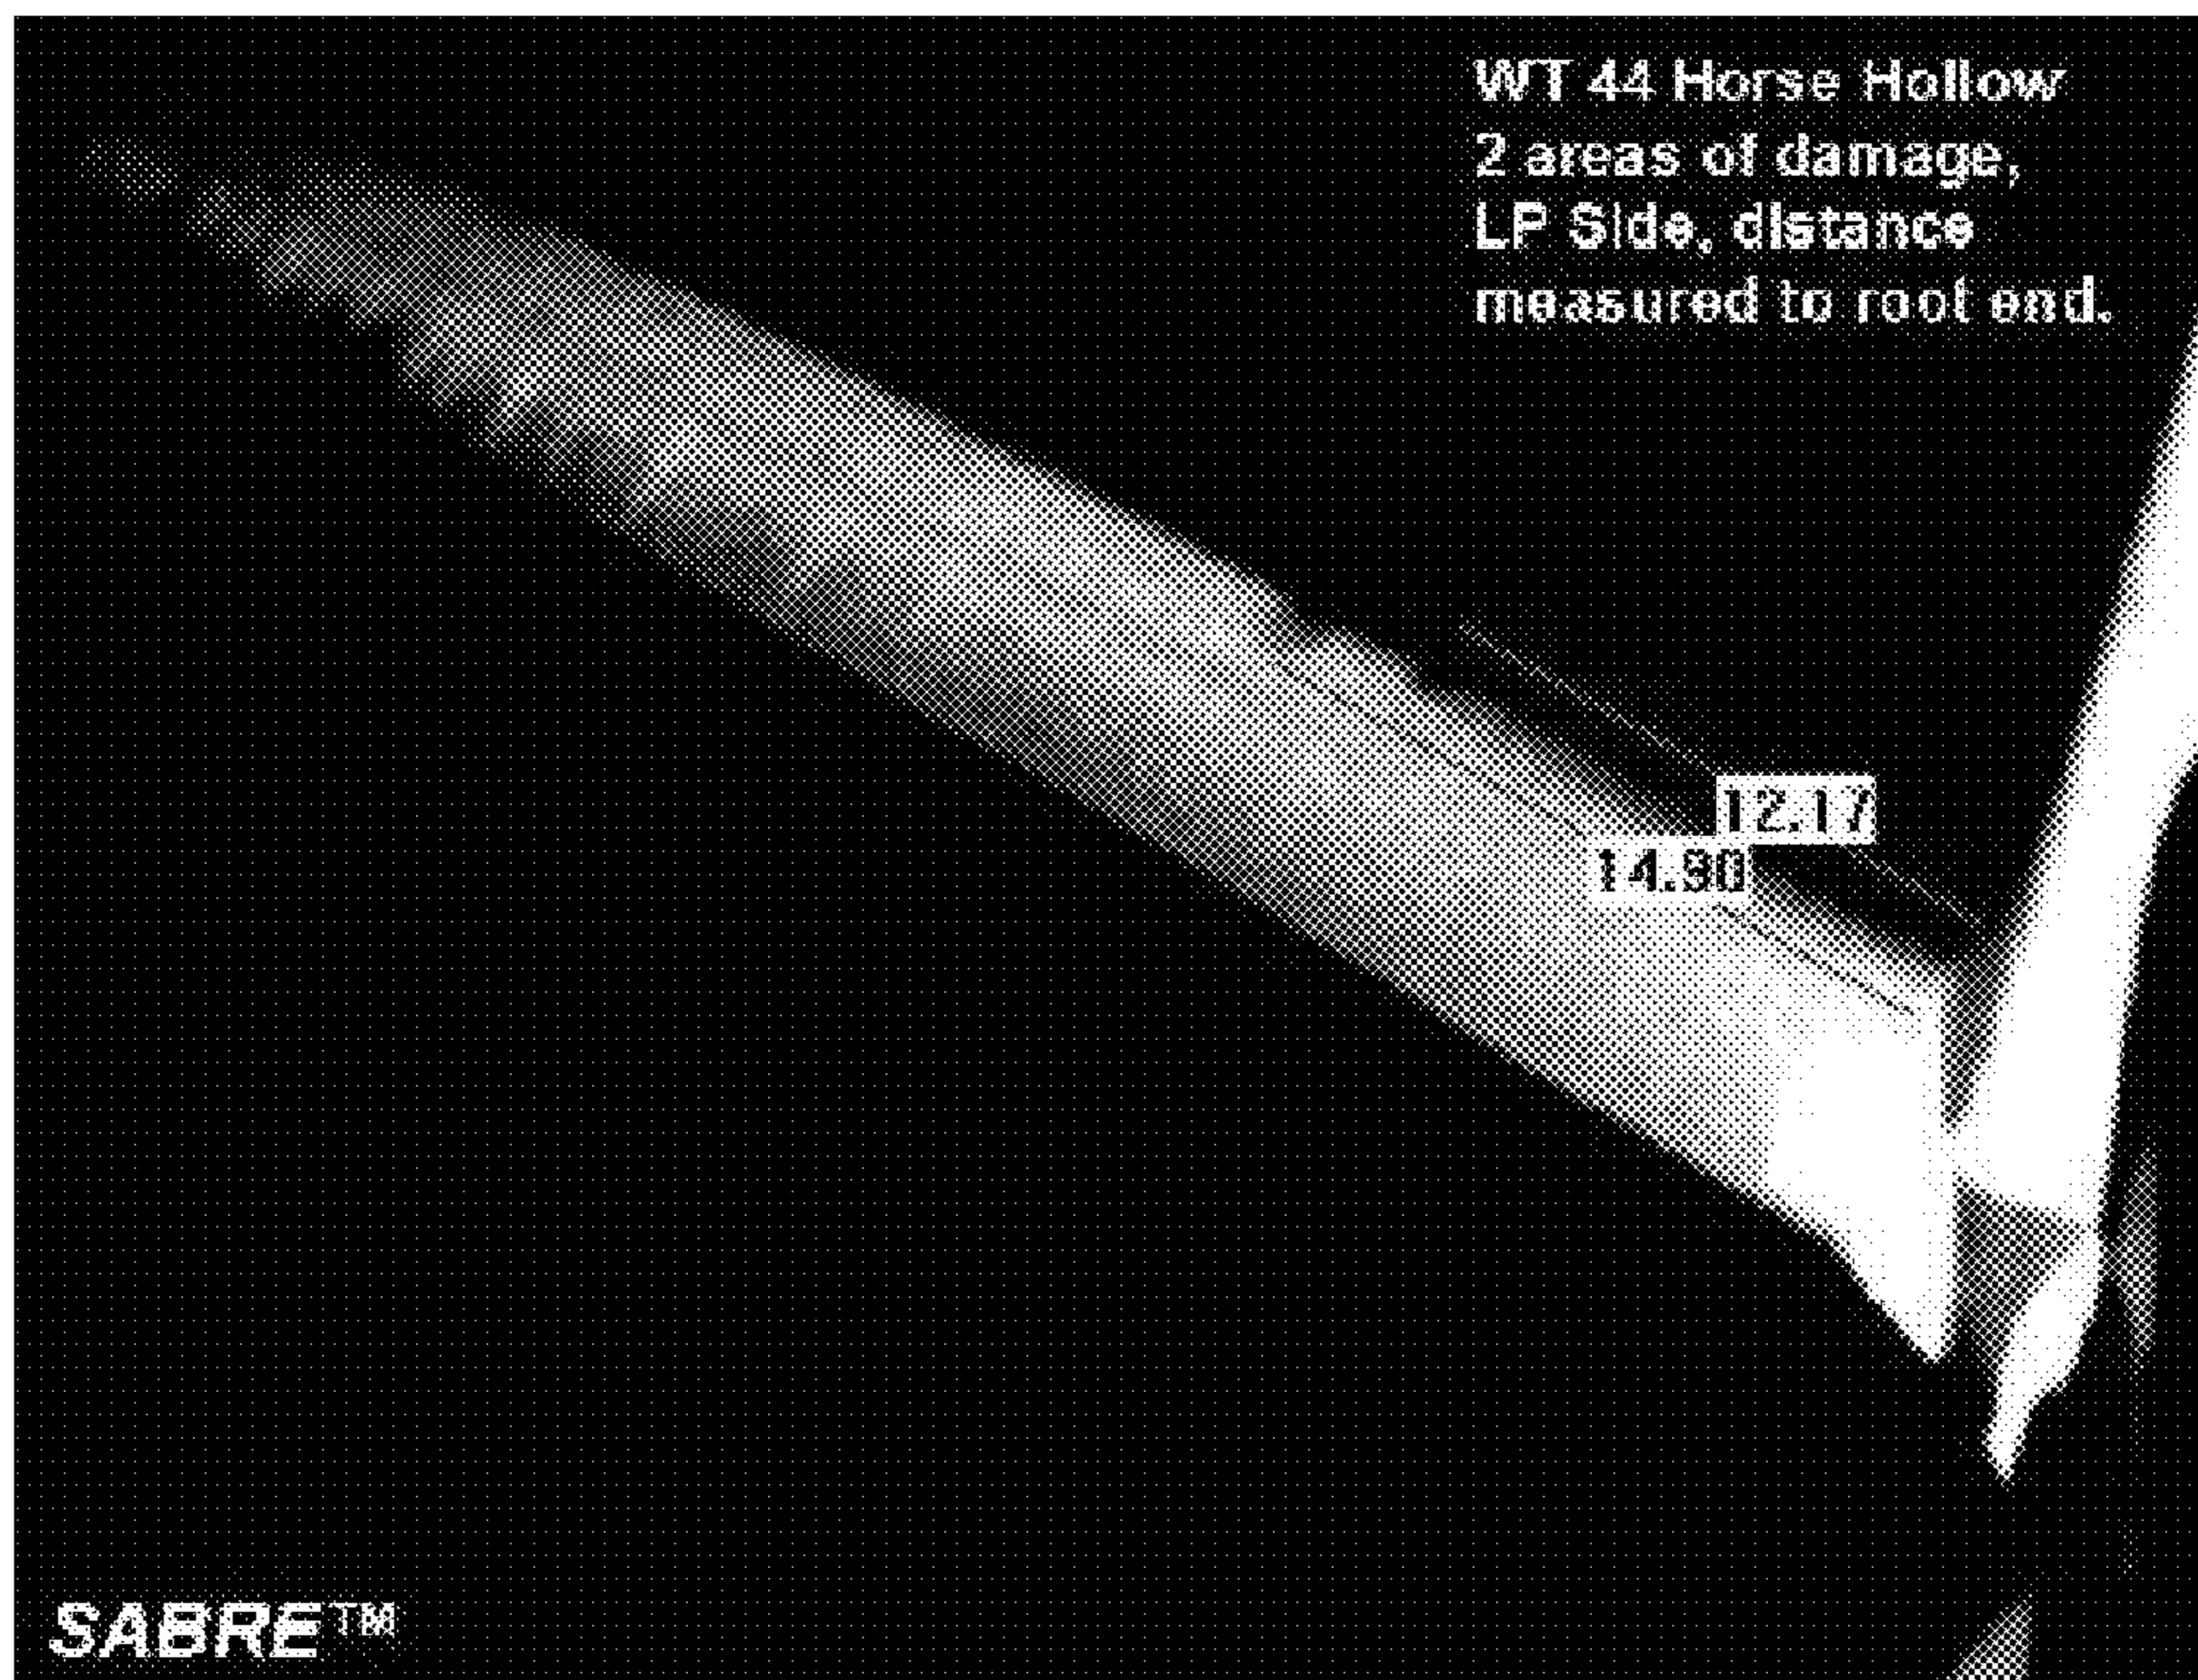
FIG 11

FIG. 11 is an infrared image showing the caliper overlay function being used to measure the location of two areas of damage on a wind turbine blade with respect to the blade root end; and
