(10) **Patent No.:** **US 9,488,053 B2**
(45) **Date of Patent:** **Nov. 8, 2016**

(54) **METHOD FOR REPAIRING A SINGLE CRYSTAL TURBINE BLADE**

A method is provided for repairing a single crystal turbine blade, which includes an airfoil with a tip having a tip cover plate, tip cooling air holes and a tip crown. The method includes removing the tip crown by manual grinding, thereby preserving the underlying tip cover plate; preparing the tip cooling air holes by manual grinding; closing said prepared tip cooling air holes by manual welding; and building-up a new tip crown by a LMF (Laser Metal Forming) process.

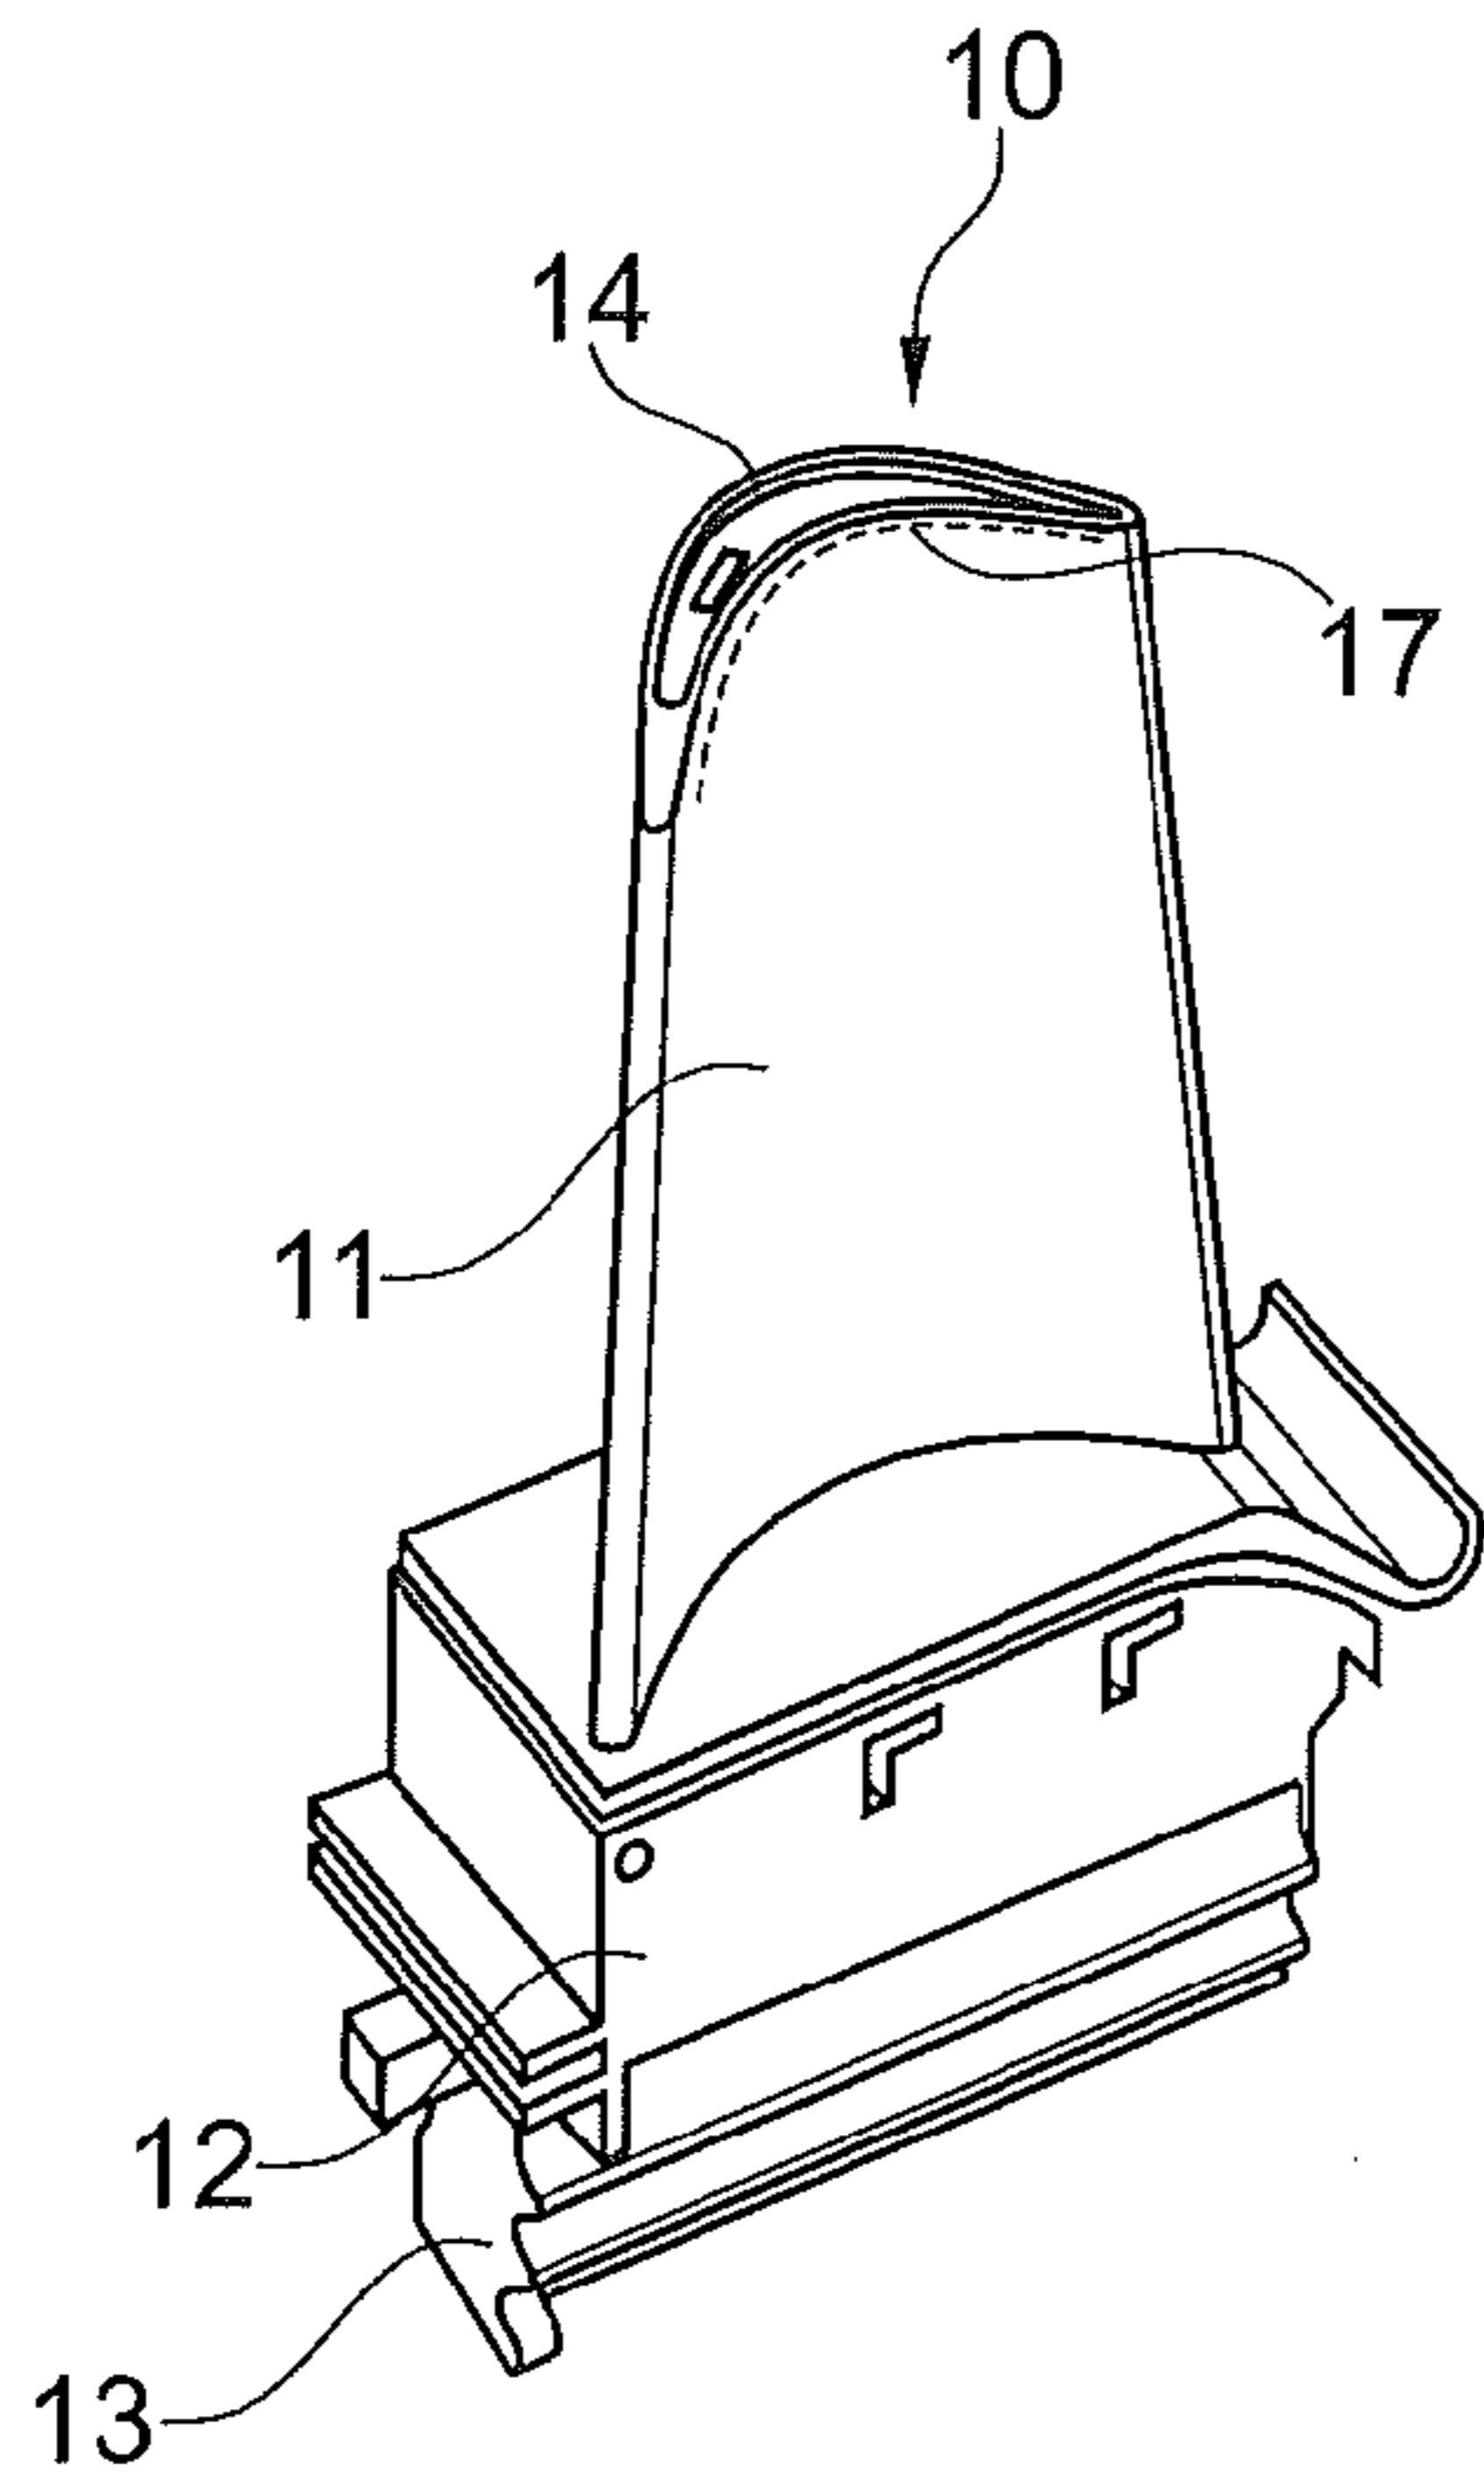
Fig. 1

FIG. 1 shows a photograph of a typical gas turbine blade in a perspective view;

FIG. 1 shows a photograph of a typical gas turbine blade **10** in a perspective view. The turbine blade **10** comprises an airfoil **11**, which extends in radial direction from a shaft and ends with a blade tip **14**. Below the shaft **12** a foot **13** of the fir-tree type is provided for mounting the blade in a respective groove of the rotor. Part of the blade tip **14** is a crown (**16** in FIG. 4), a circumferential rim. FIG. 2 is a side view of the blade **10**. FIG. 3 is a top view. Further features of the blade tip **14** are tip cooling air holes **17** and so-called letterboxes **15**, slots in the tip cover plate (**25** in FIG. 4), which are closed by brazed closing plates (**26** in FIG. 4).

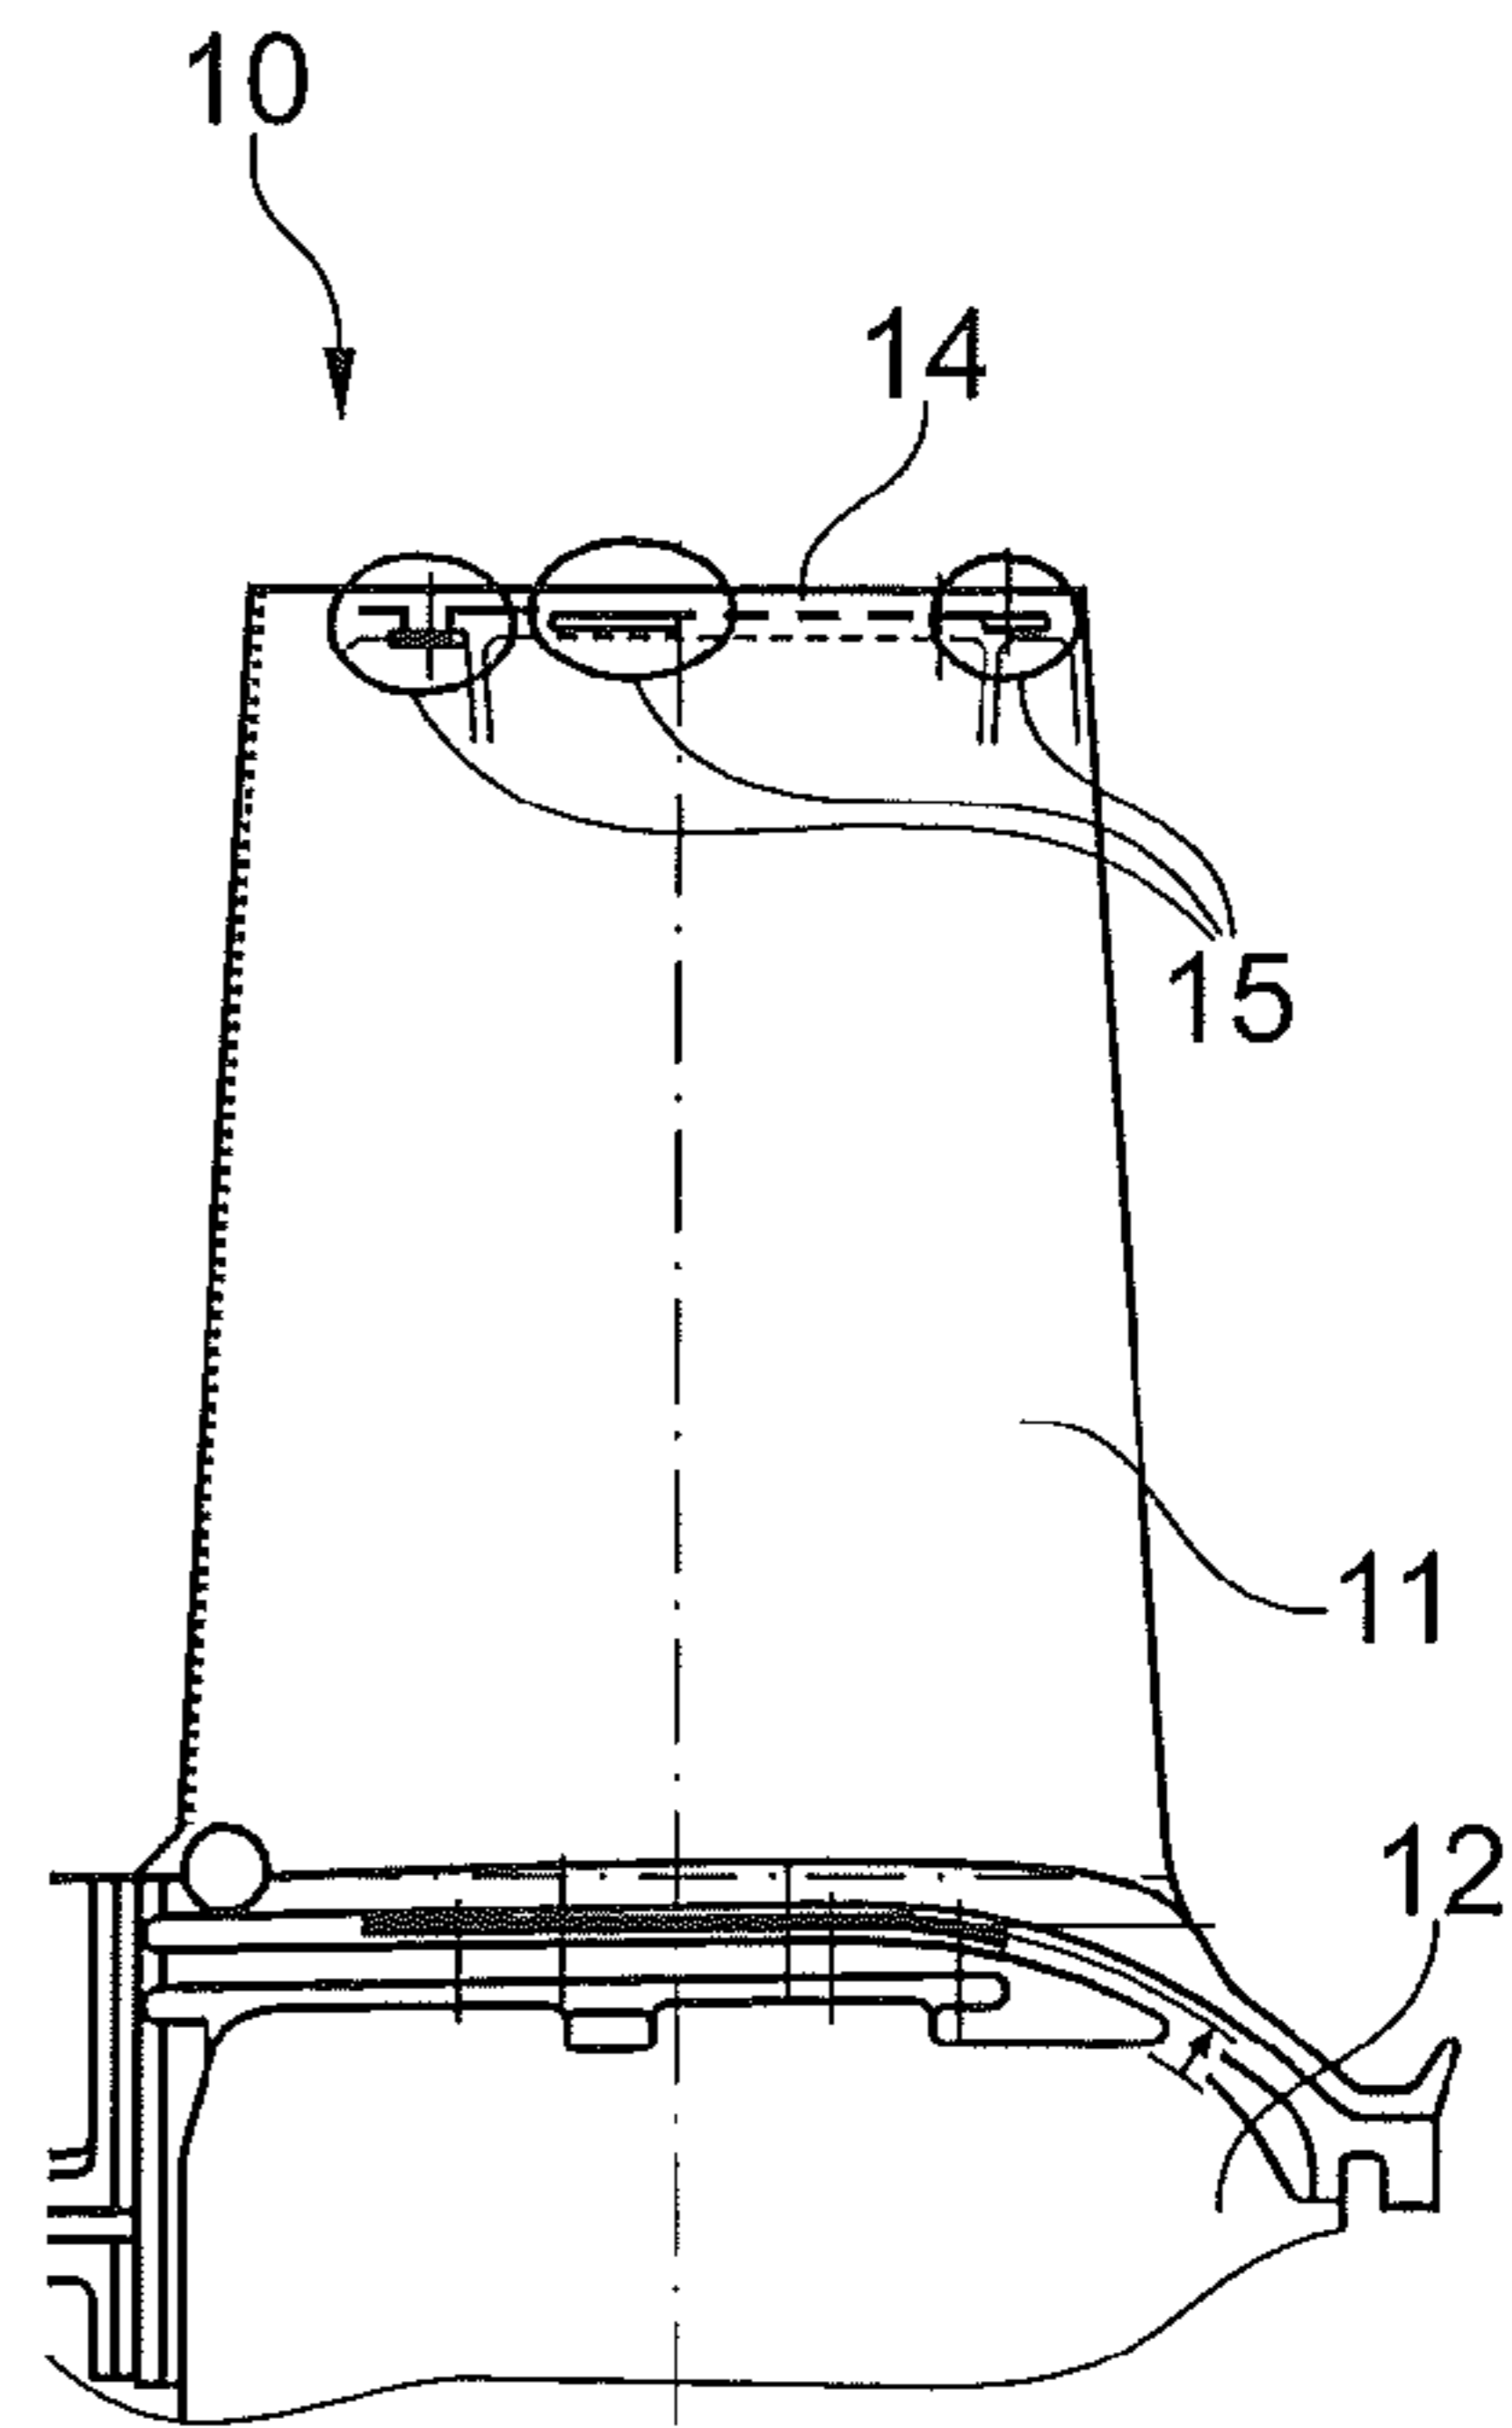
Fig. 2

FIG. 2 shows the turbine blade of FIG. 1 in a side view;

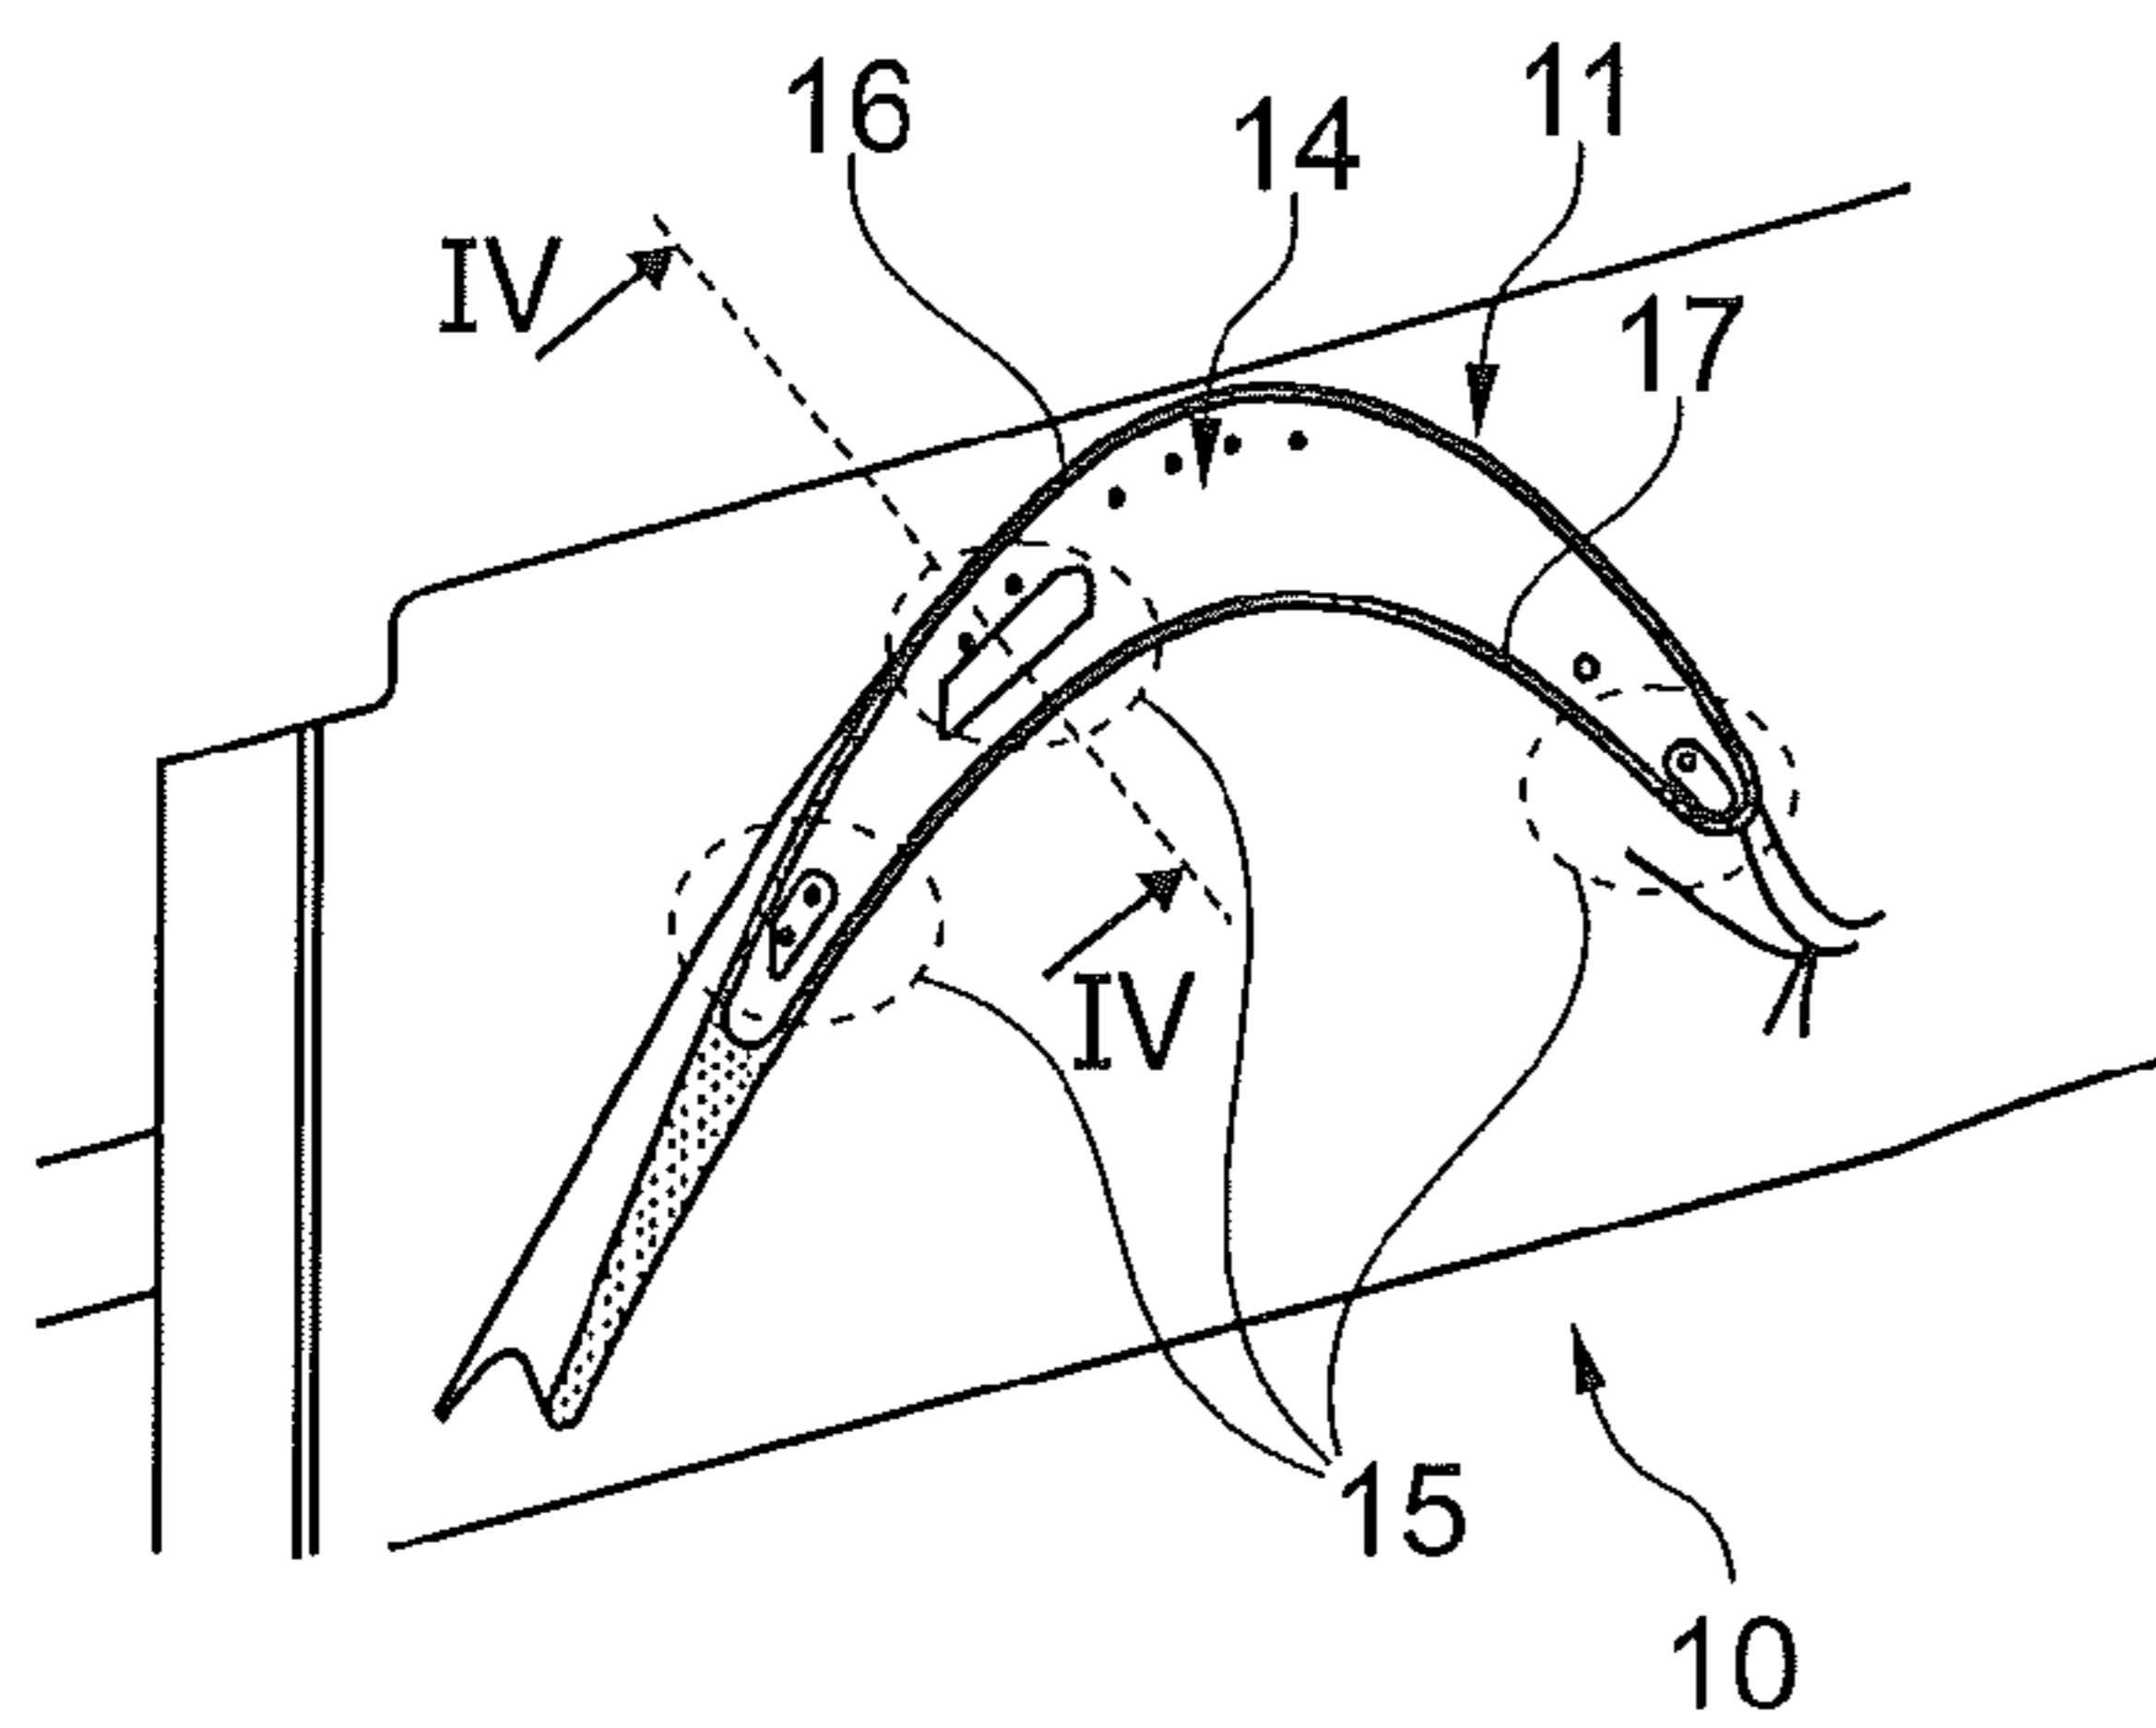
Fig. 3

FIG. 3 shows the turbine blade of FIG. 1 in a top view;

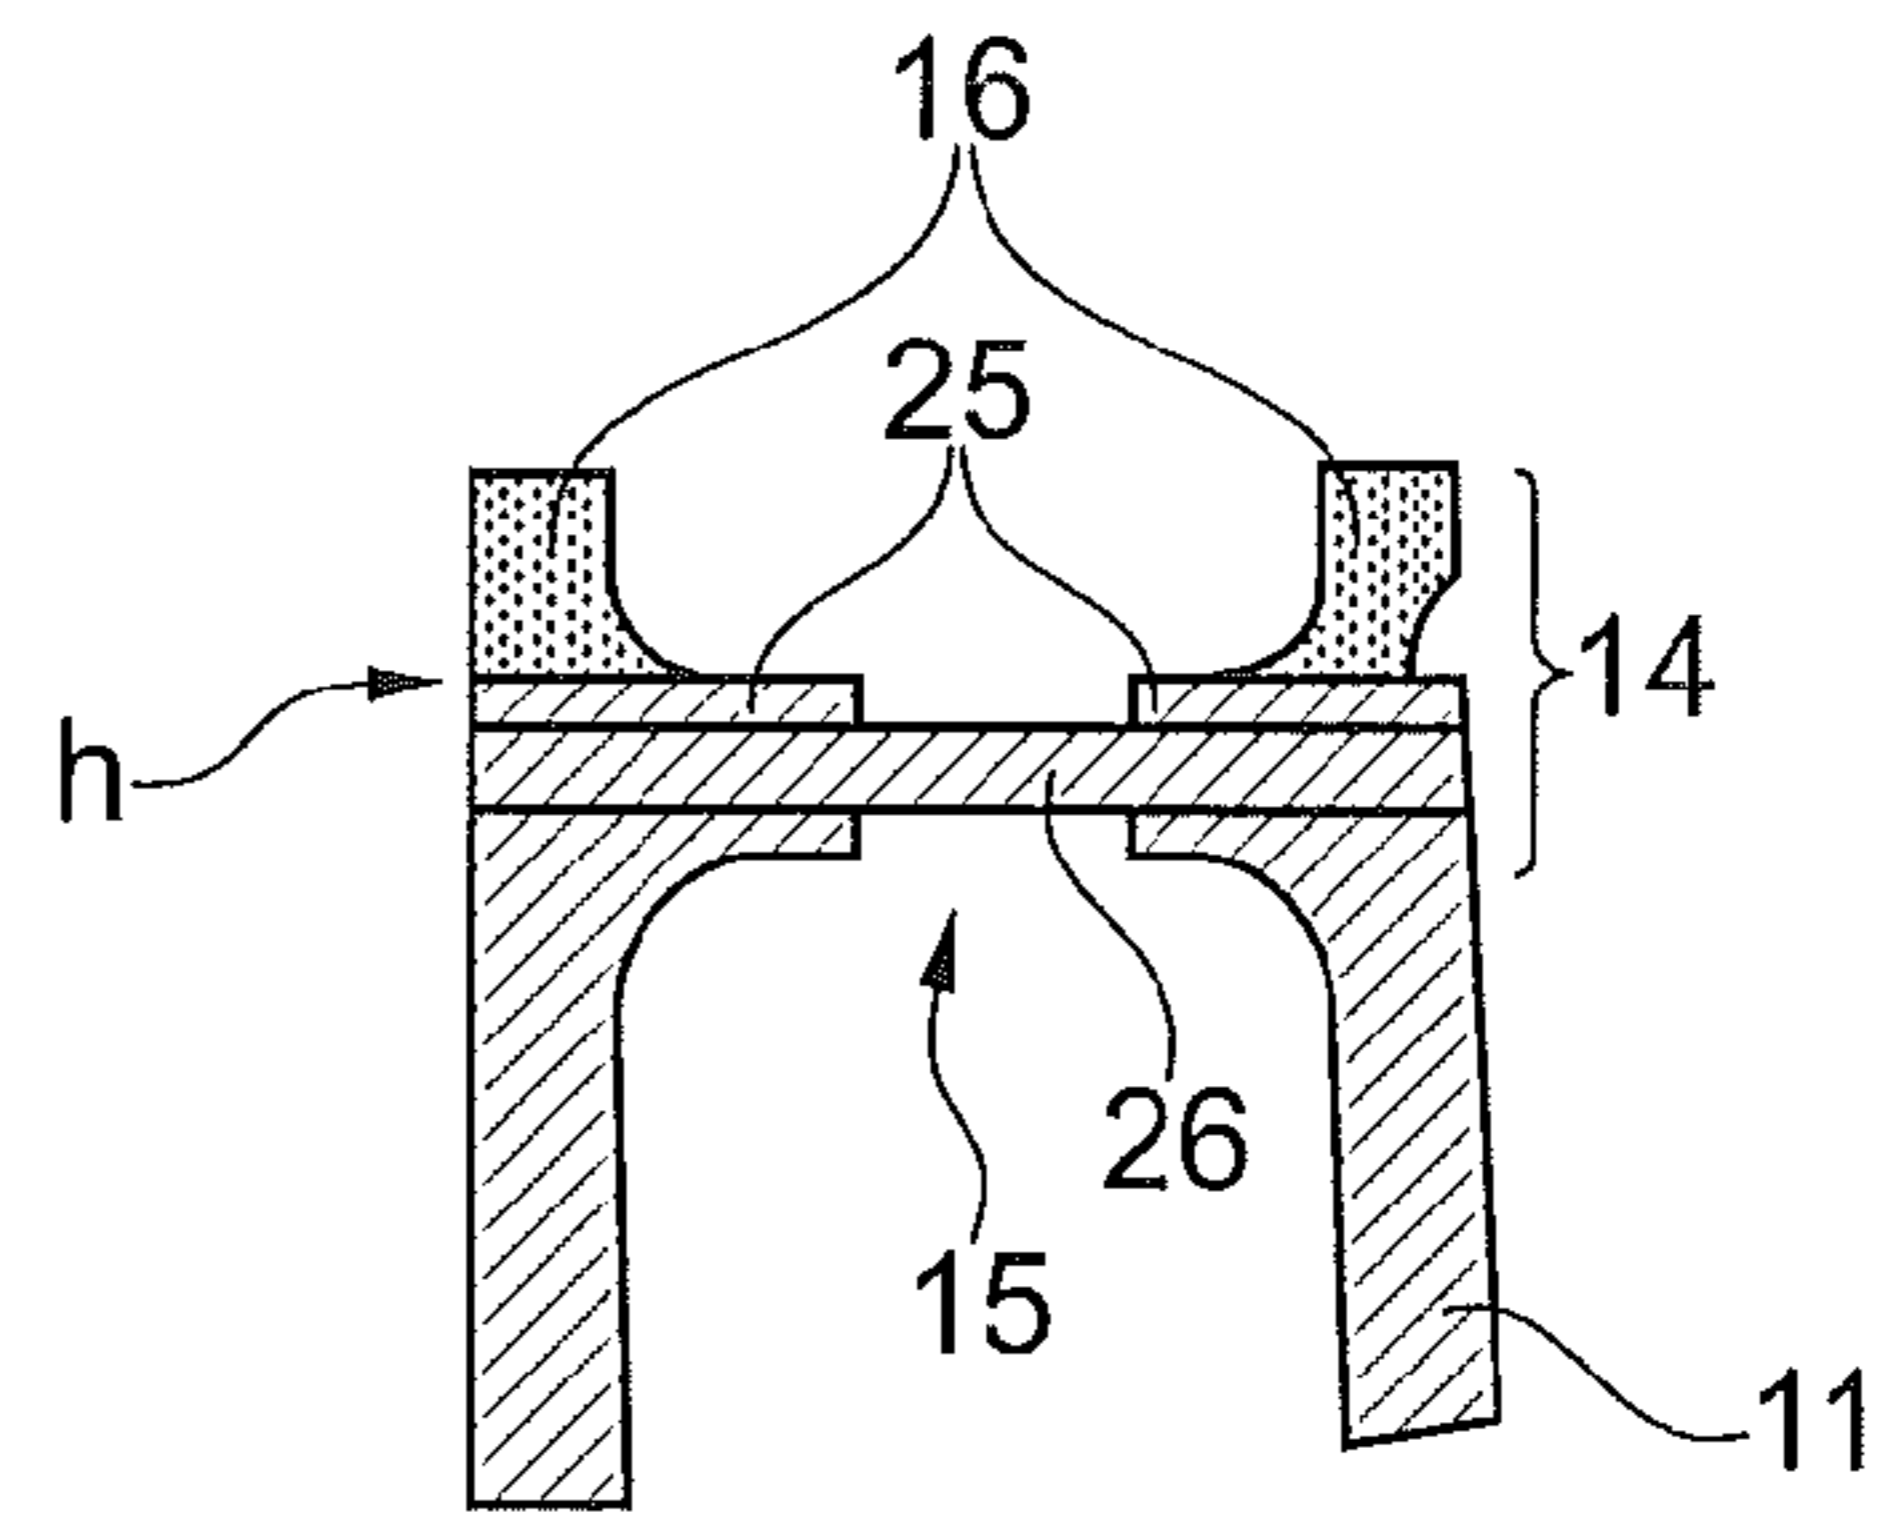
Fig. 4

FIG. 4 shows a sectional view of the blade tip along the line IV-IV in FIG. 3;

As shown in FIG. 4, the tip crown 16 is removed from the blade tip 14 to a height h by manual grinding. The tip cover plate 25 is thereby preserved.

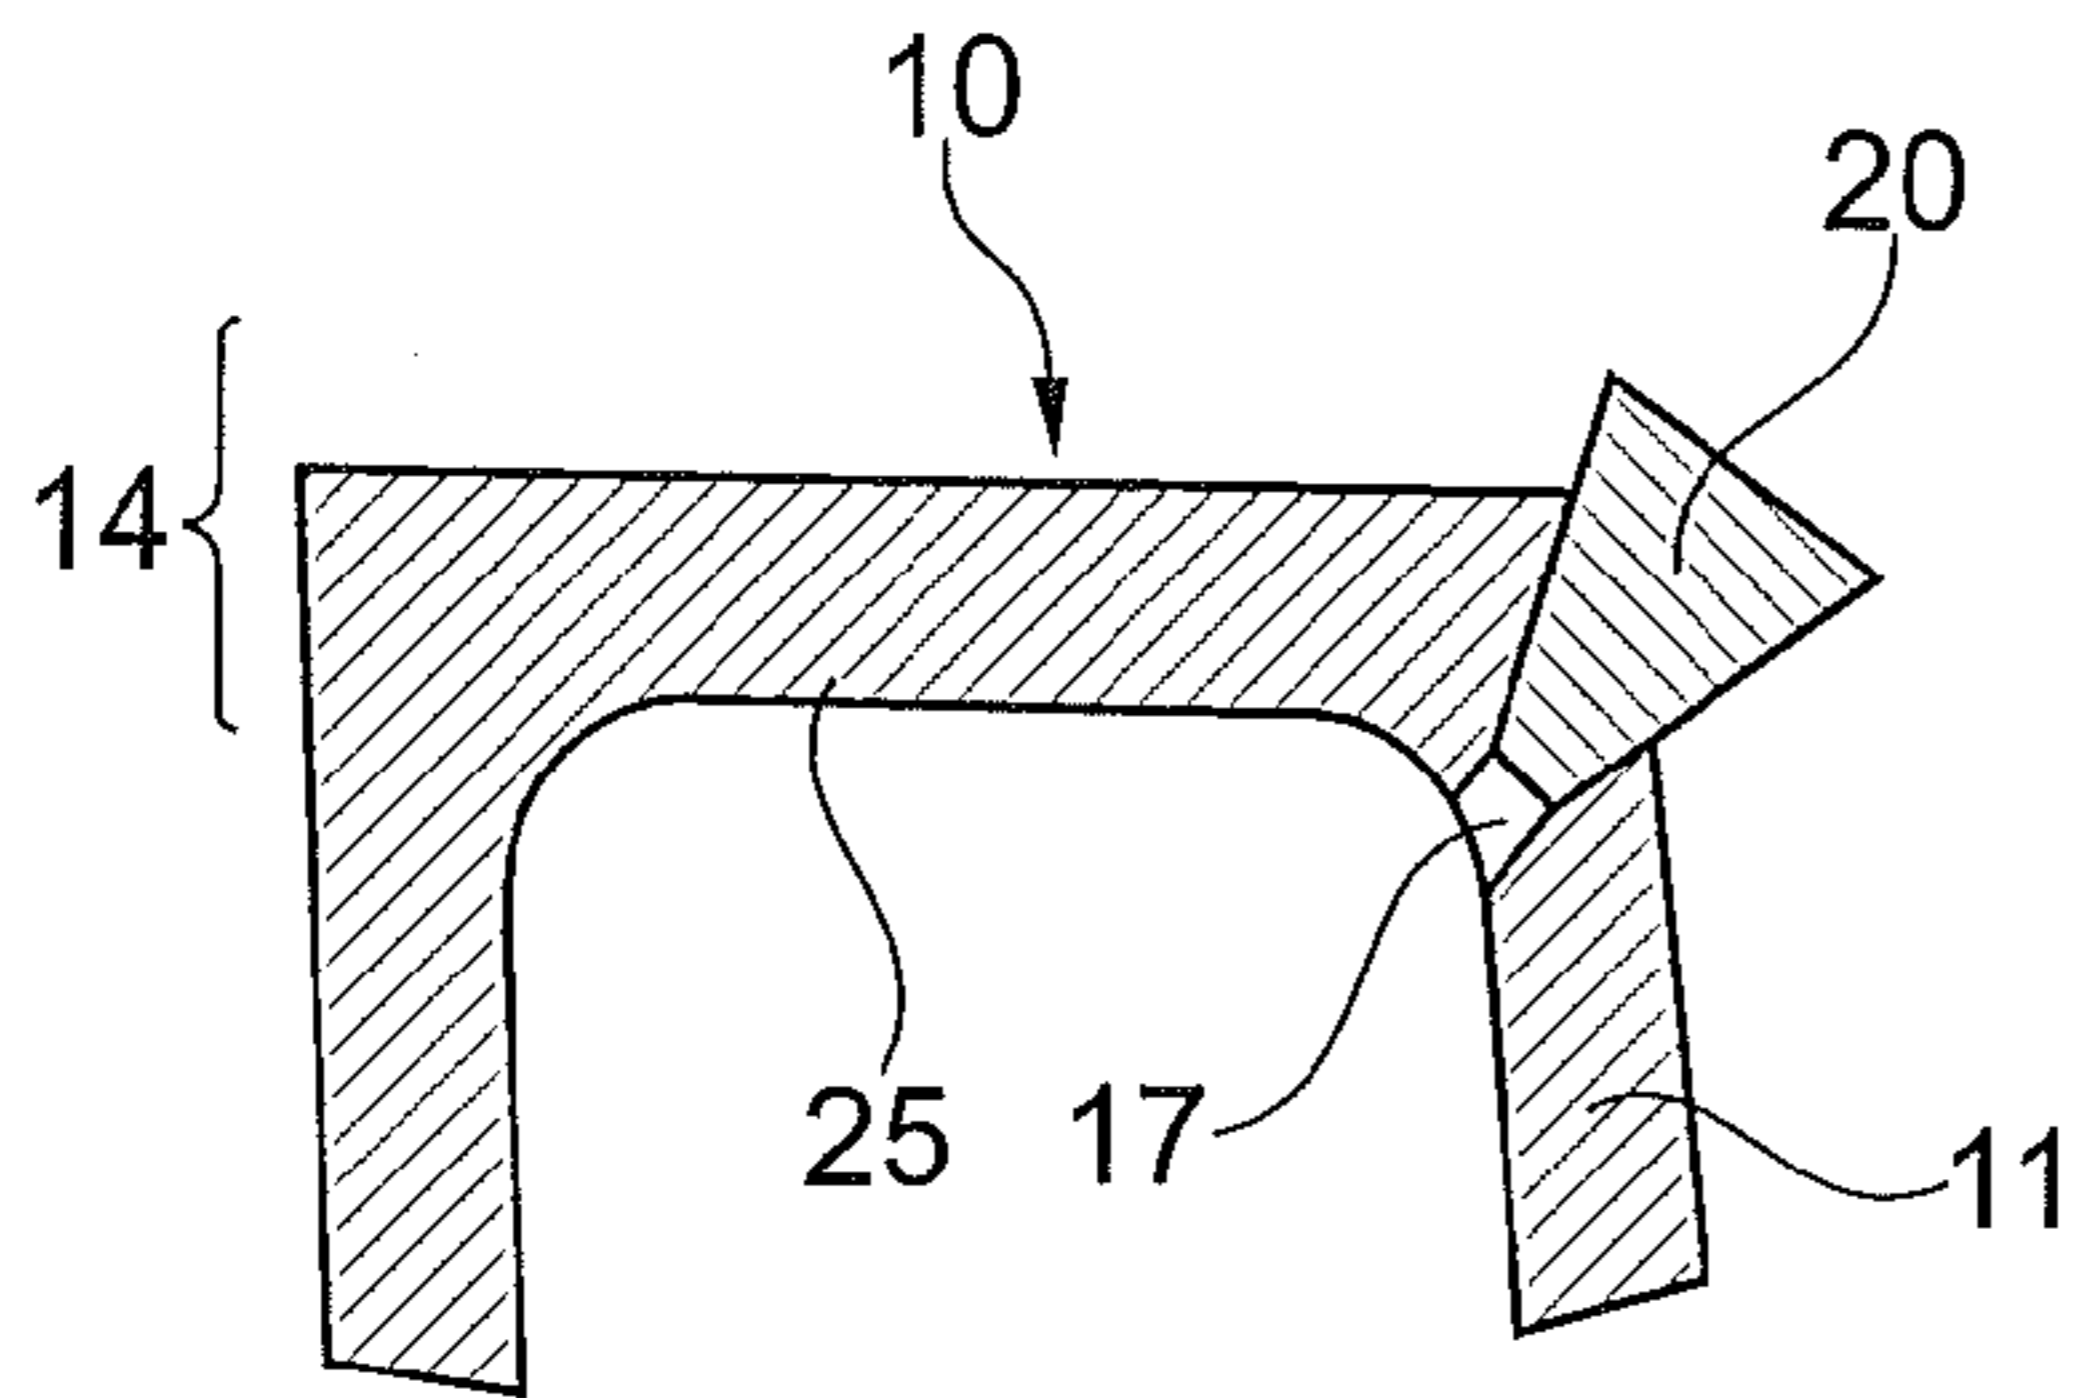
Fig. 5

FIG. 5 shows a sectional view of the blade tip through a tip cooling air hole to be prepared by manual grinding;

Then, according to FIGS. 5 and 7, the tip cooling air holes 17 and letterboxes 15 are prepared by manual grinding. For the preparation of the tip cooling air holes 17, a grinding tool 20 is used (FIG. 5). The preparation of the letterboxes 15 results in grinded recesses 18a and 18b (FIG. 7).

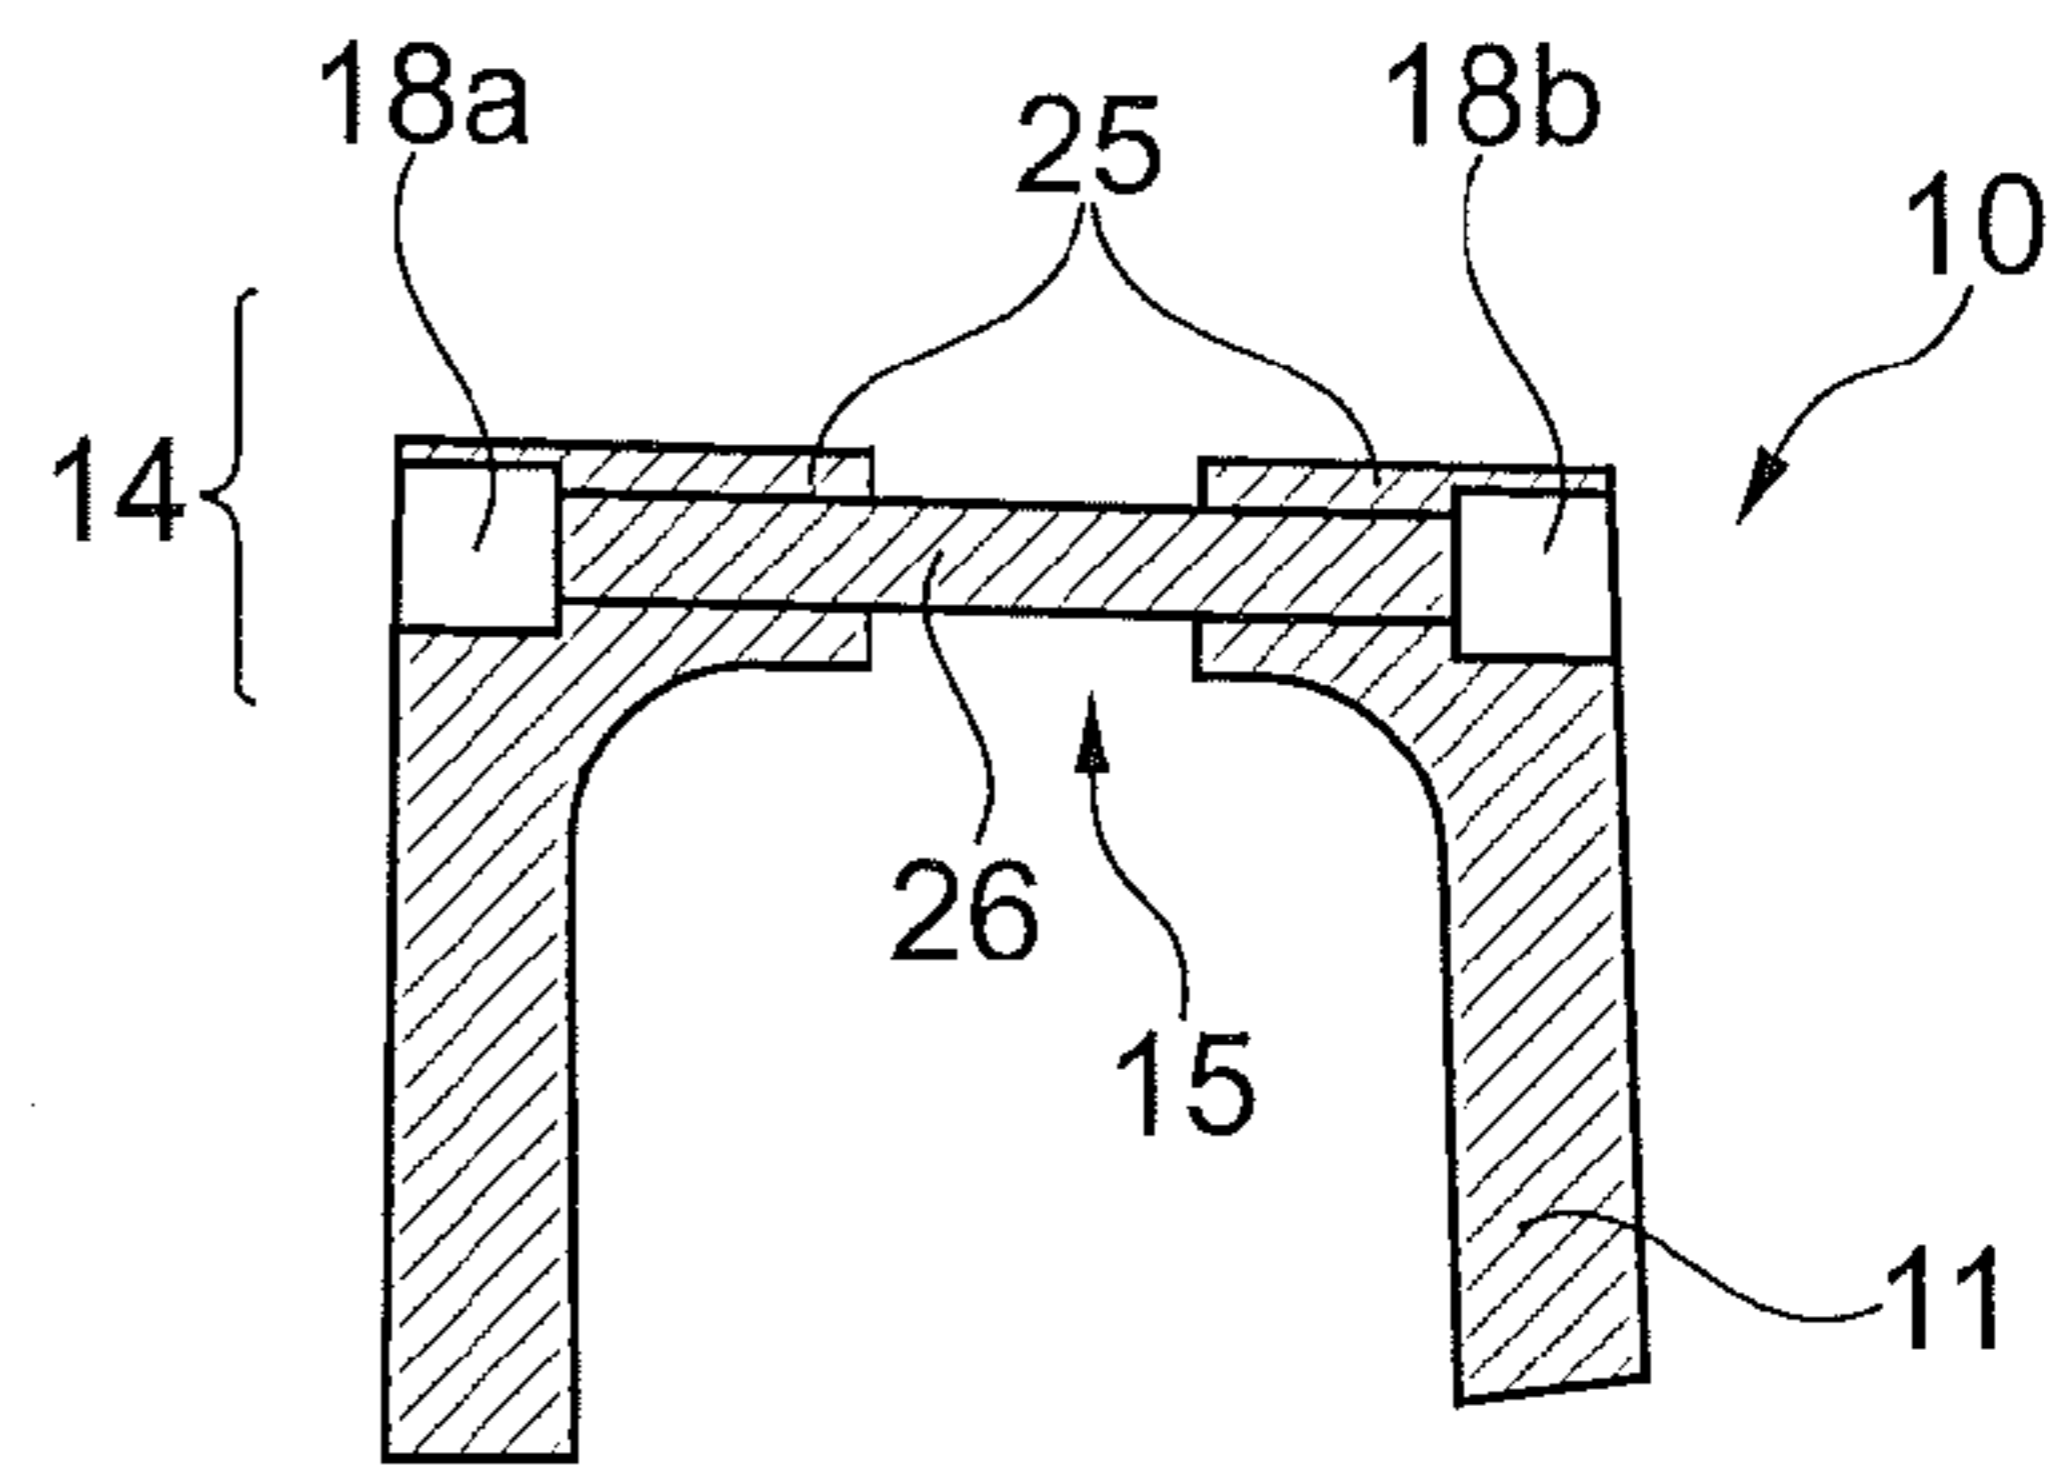
Fig. 7

FIG. 7 shows a sectional view of the blade tip similar to FIG. 4 with the letterbox being prepared by manual grinding;
