(10) **Patent No.:** **US 9,488,053 B2**
(45) **Date of Patent:** **Nov. 8, 2016**

(54) **METHOD FOR REPAIRING A SINGLE CRYSTAL TURBINE BLADE**

A method is provided for repairing a single crystal turbine blade, which includes an airfoil with a tip having a tip cover plate, tip cooling air holes and a tip crown. The method includes removing the tip crown by manual grinding, thereby preserving the underlying tip cover plate; preparing the tip cooling air holes by manual grinding; closing said prepared tip cooling air holes by manual welding; and building-up a new tip crown by a LMF (Laser Metal Forming) process.

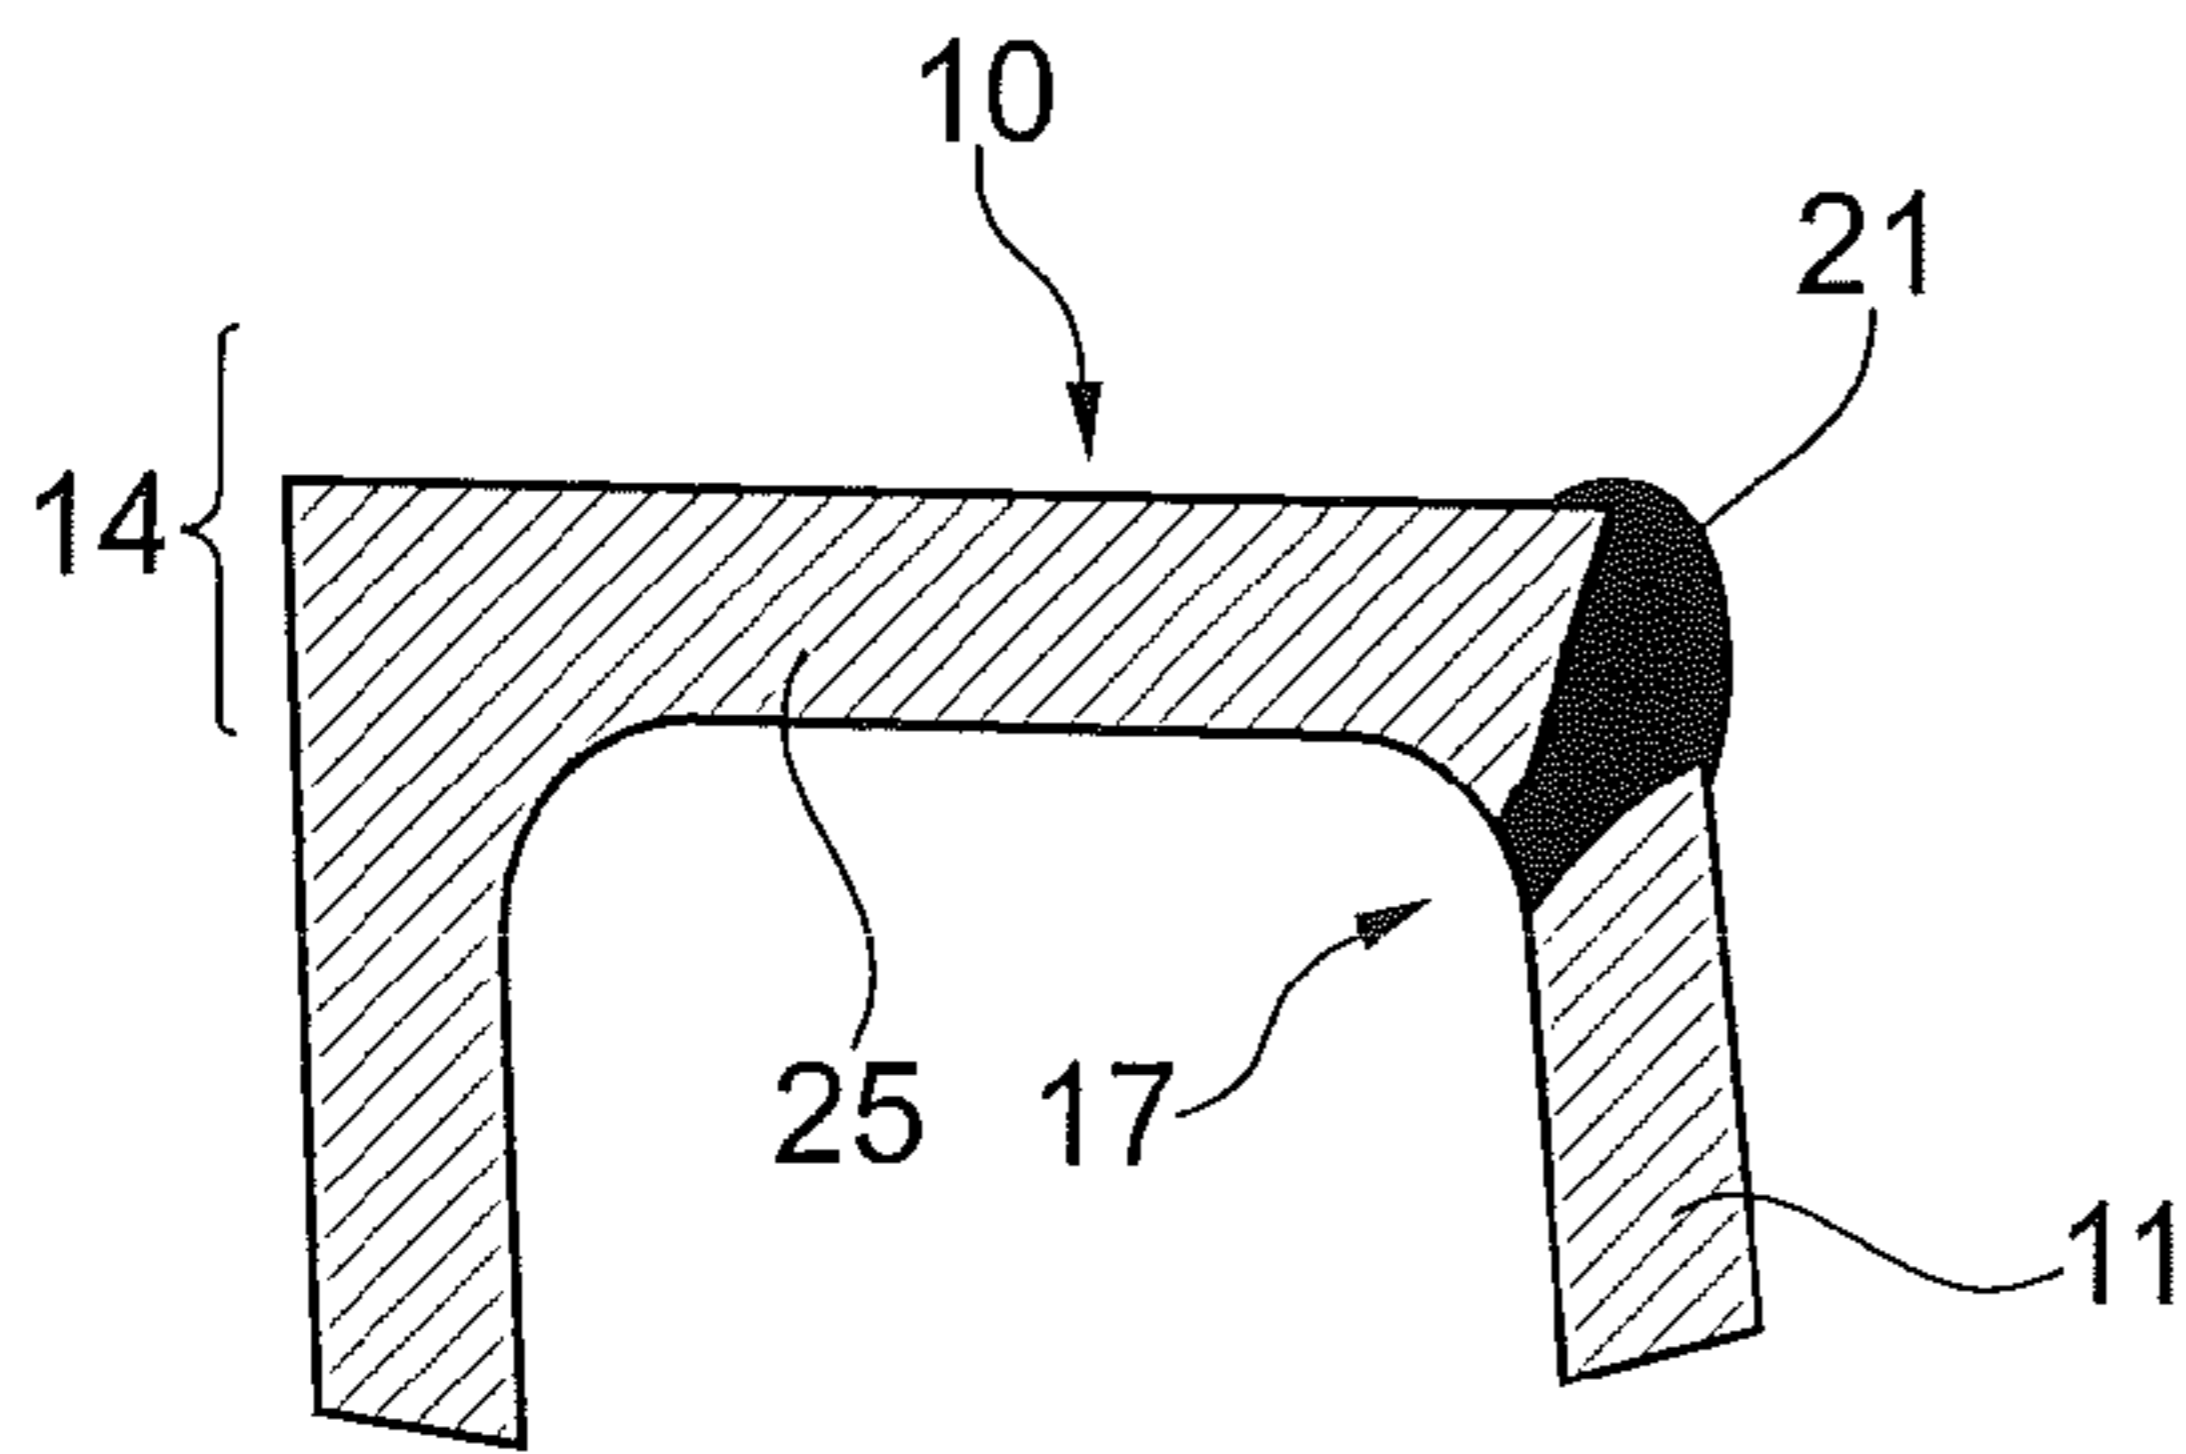
Fig. 6

FIG. 6 shows the view of FIG. 5 with the prepared tip cooling air hole closed by manual welding;

Manual TIG welding is then used to close the letterboxes 15 with fillings 19a-c (FIG. 8), and the tip cooling air holes with fillings 21 (FIG. 6).

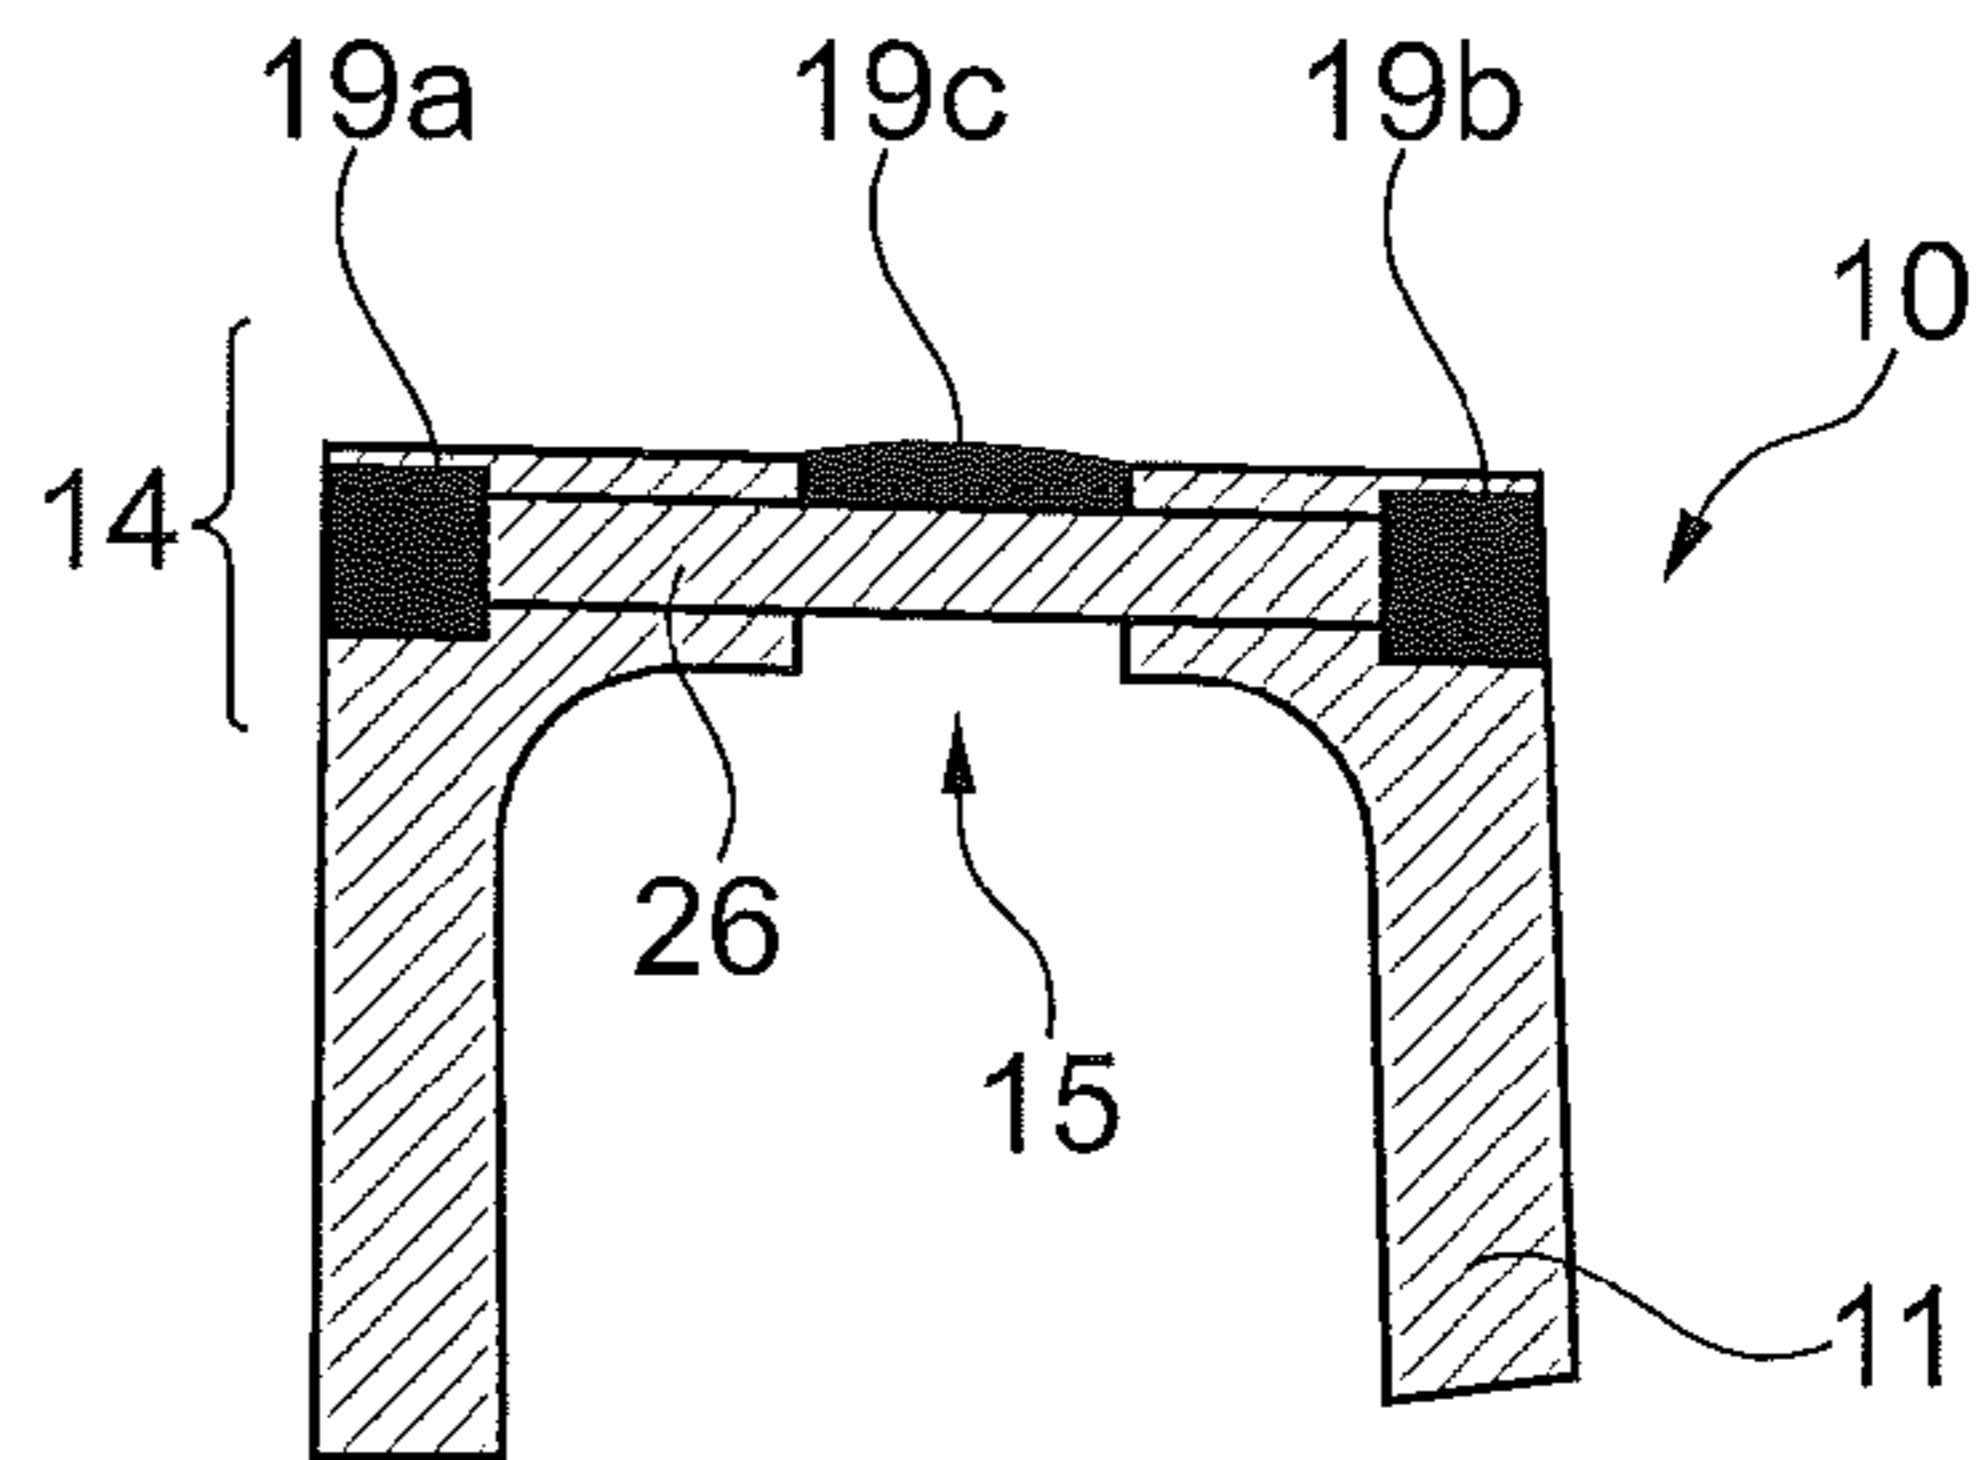
Fig. 8

FIG. 8 shows the view of FIG. 7 with the prepared letterbox closed by manual welding;

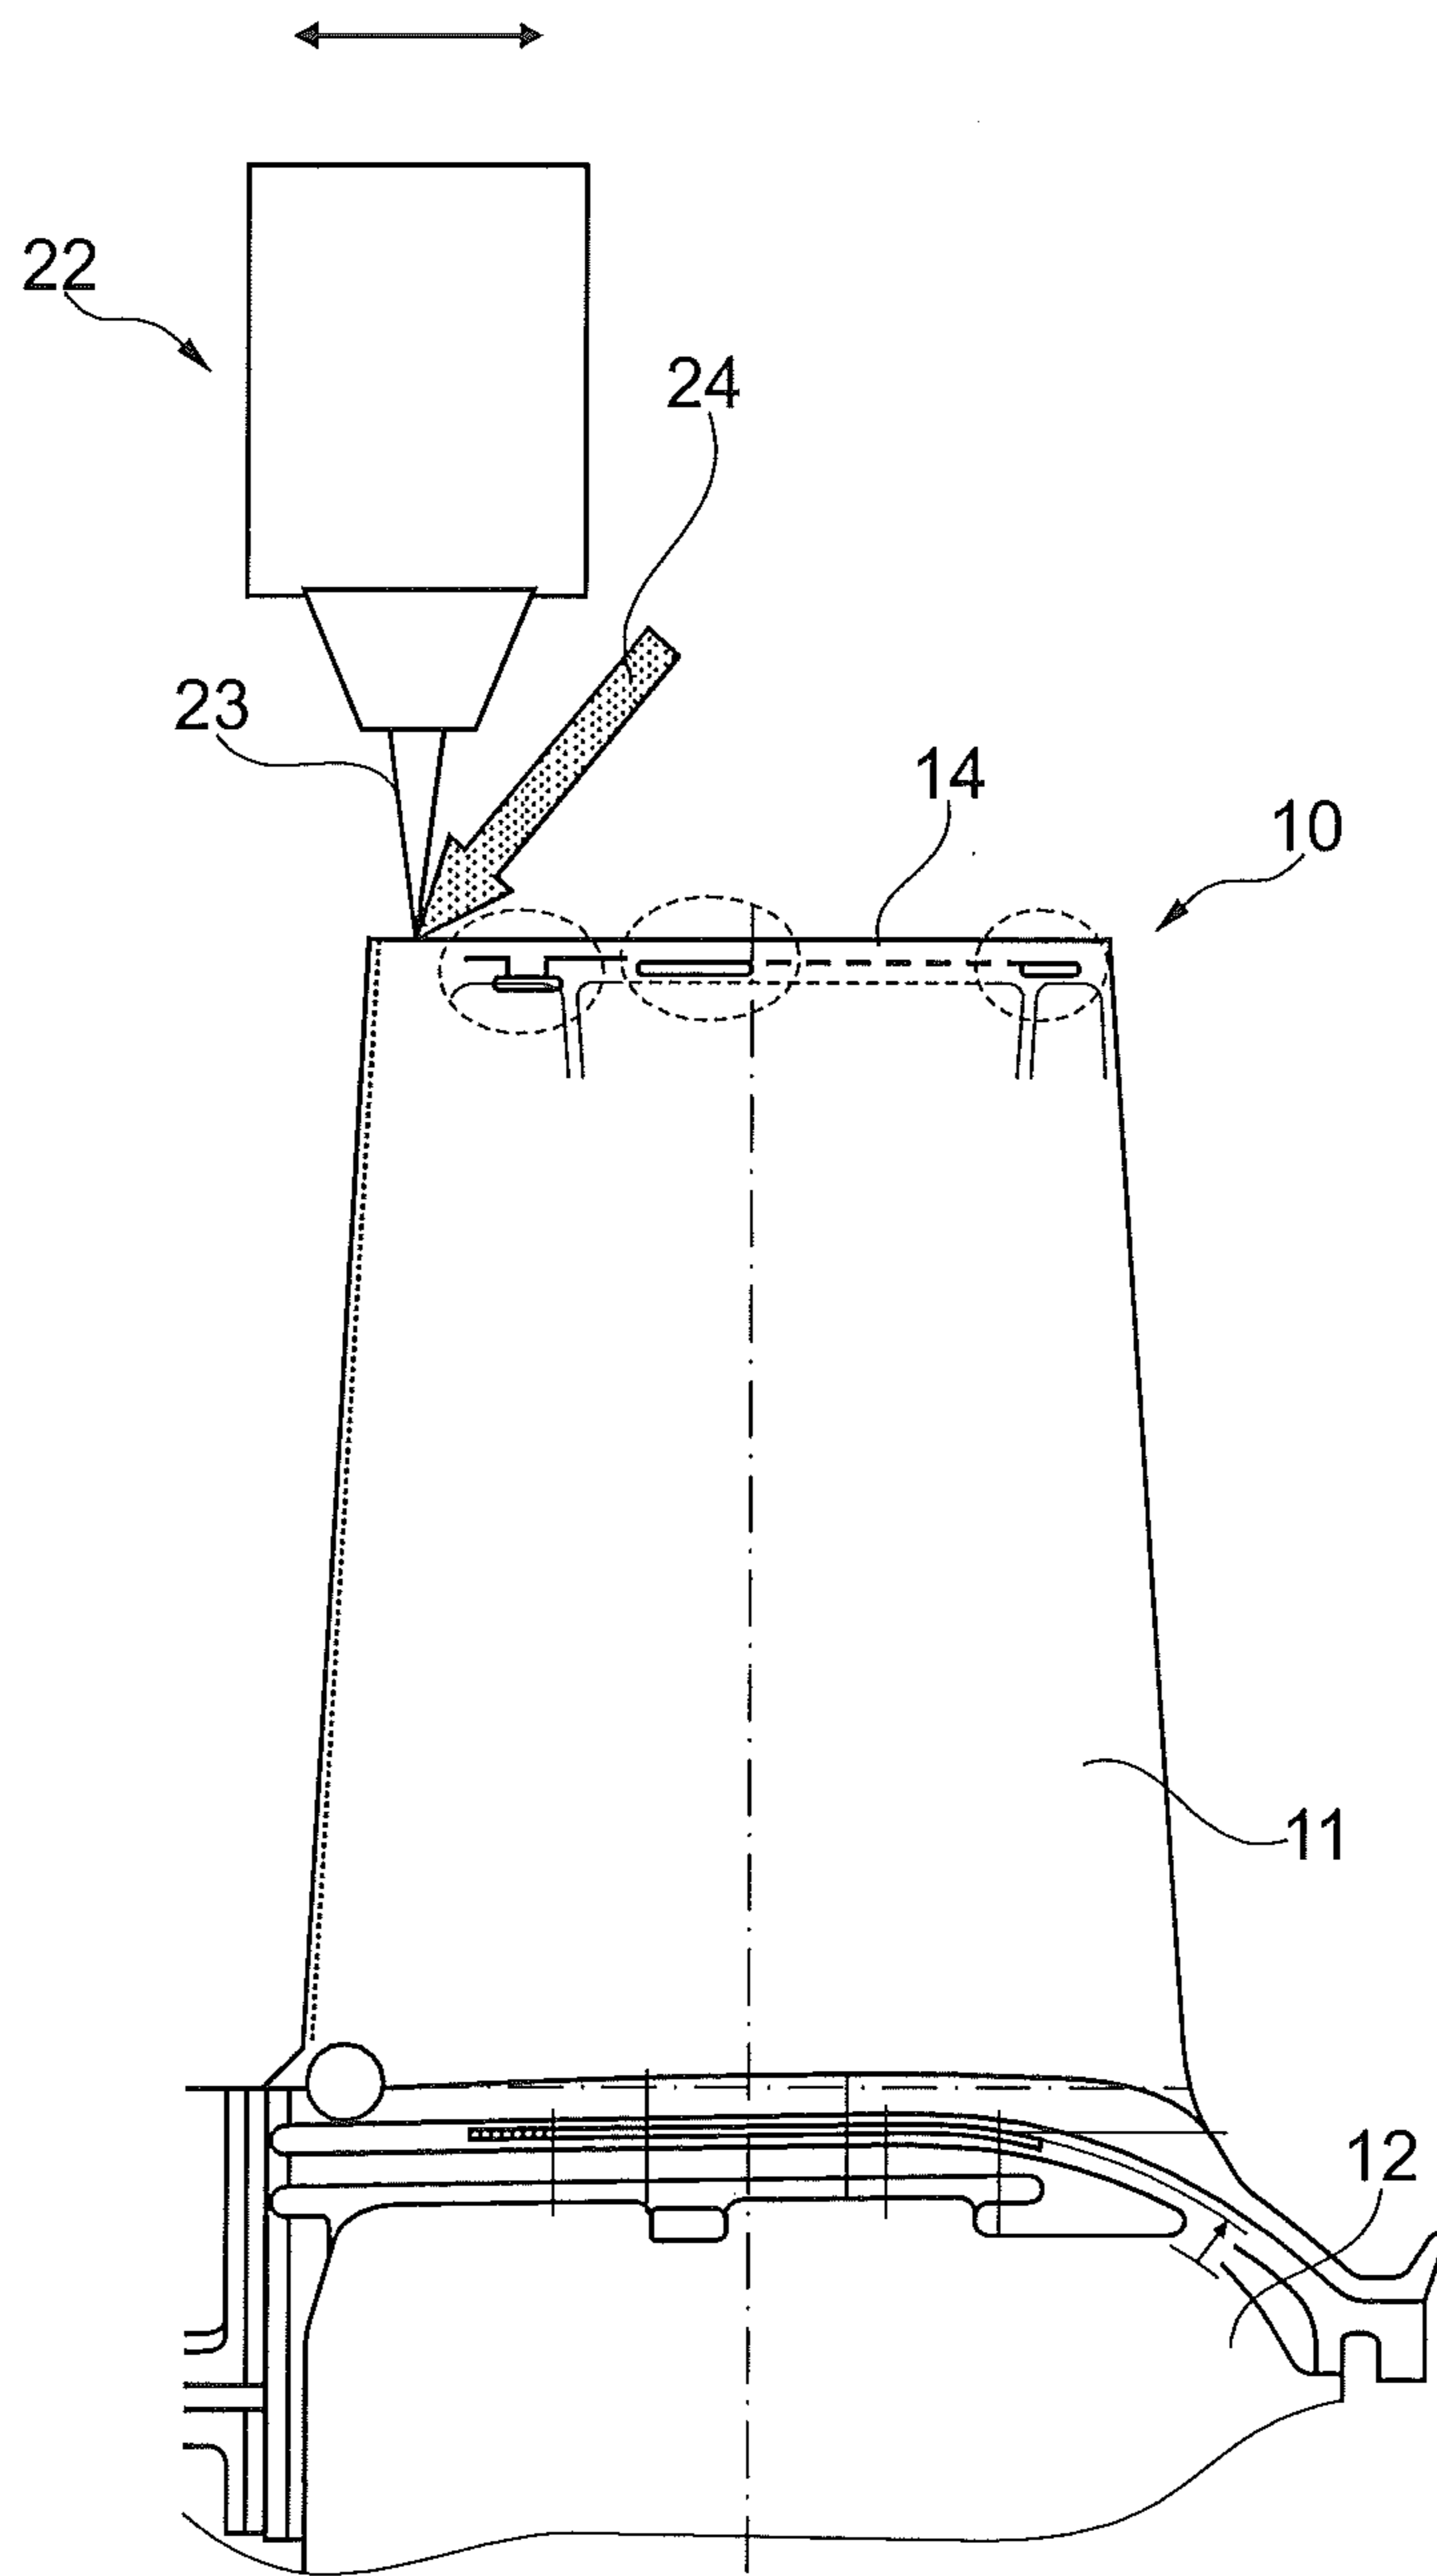
Fig. 9

FIG. 9 shows the process of LMF for building-up a new crown;

Then, a new tip crown (16' in FIG. 10) is built-up by LMF with a LMF device 22 (FIG. 9) by using a laser beam 23 and supplying a powder material 24. A special oscillating welding path at the trailing edge is used for optimum weld quality and heat transport during LMF process. It is advantageous to use same filler material as with TIG welding (wire used for TIG welding), for example Haynes® 230 alloy. A respective LMF process is for example disclosed in: M. B. Henderson et al., Nickel-Based Superalloy Welding Practises for Industrial Gas Turbine Applications.

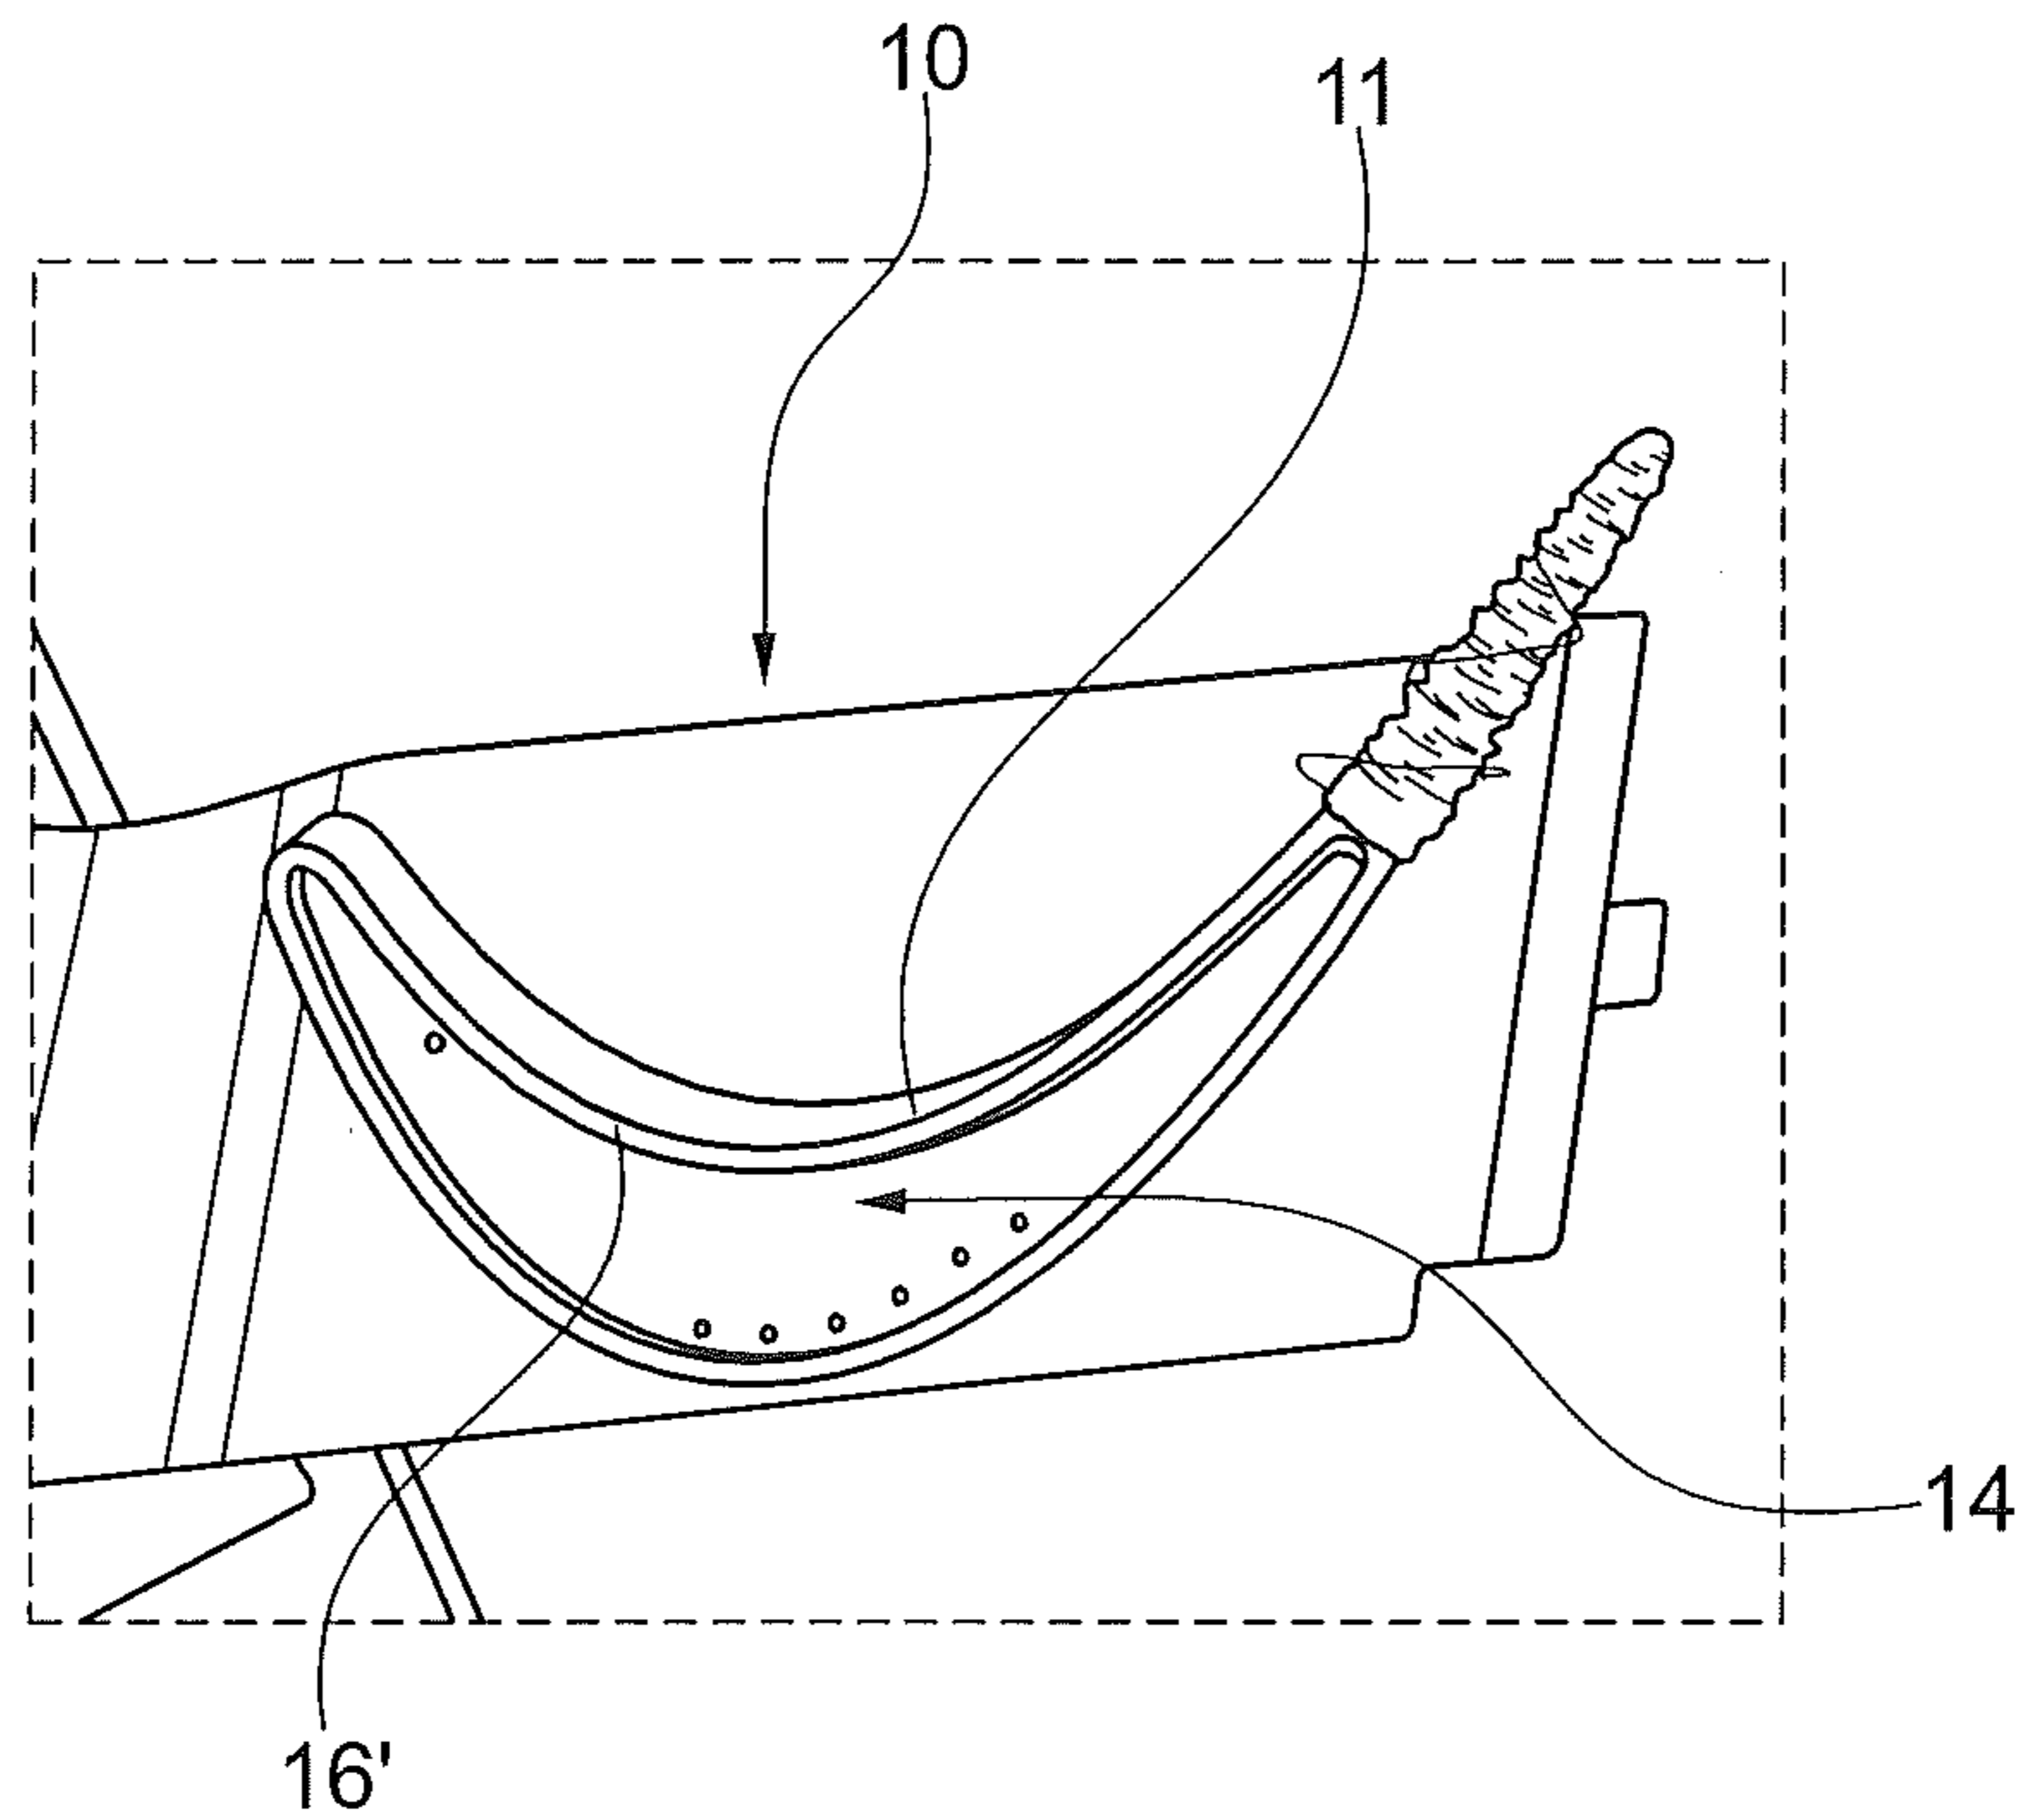
Fig. 10

FIG. 10 shows a photograph with a top view of a blade tip similar to FIG. 3, with a new crown built-up by LMF; and

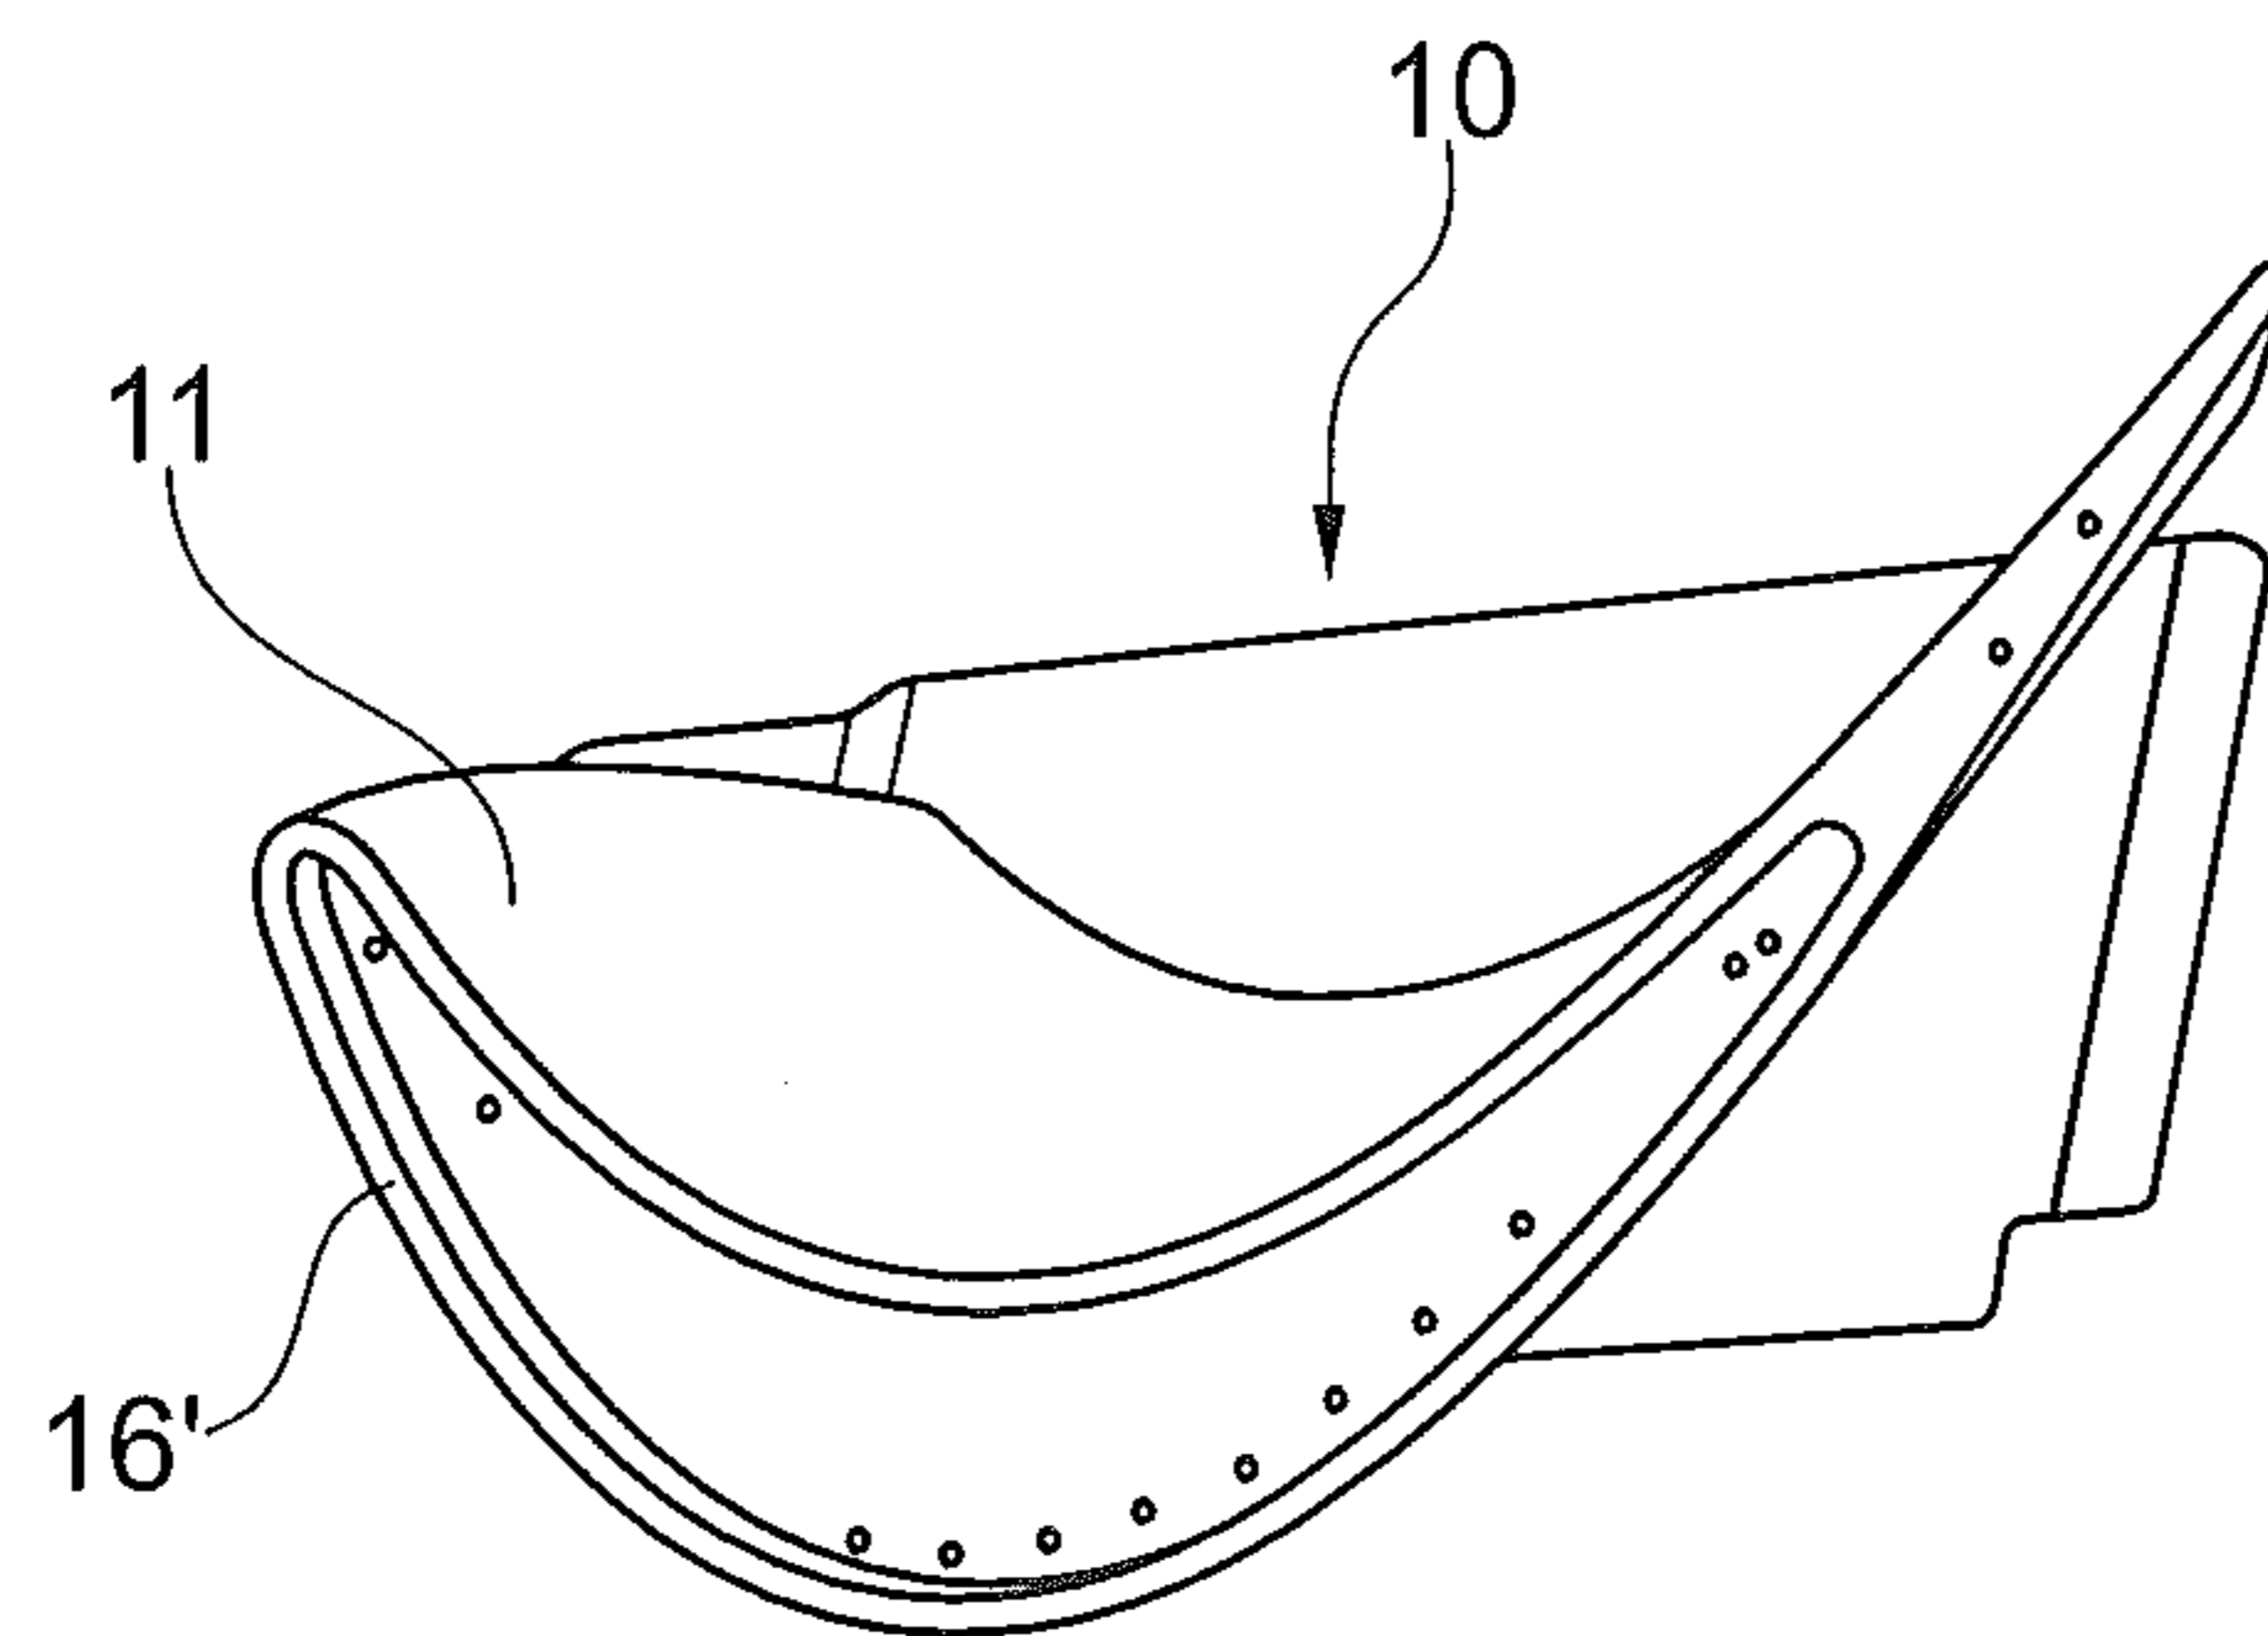
Fig. 11

FIG. 11 shows the blade tip of FIG. 10 after fine grit blasting and before coating.

A final contouring step of the tip area by manual grinding and a CNC tip height machining leads to a repaired blade tip as shown in FIG. 11.
