(10) **Patent No.:** **US 9,500,080 B2**
(45) **Date of Patent:** **Nov. 22, 2016**

(54) **METHOD OF REPLACING DAMAGED AEROFOIL**

(71) Applicants: **Rolls-Royce plc**, London (GB);
Rolls-Royce Corporation, Indianapolis, IN (US)

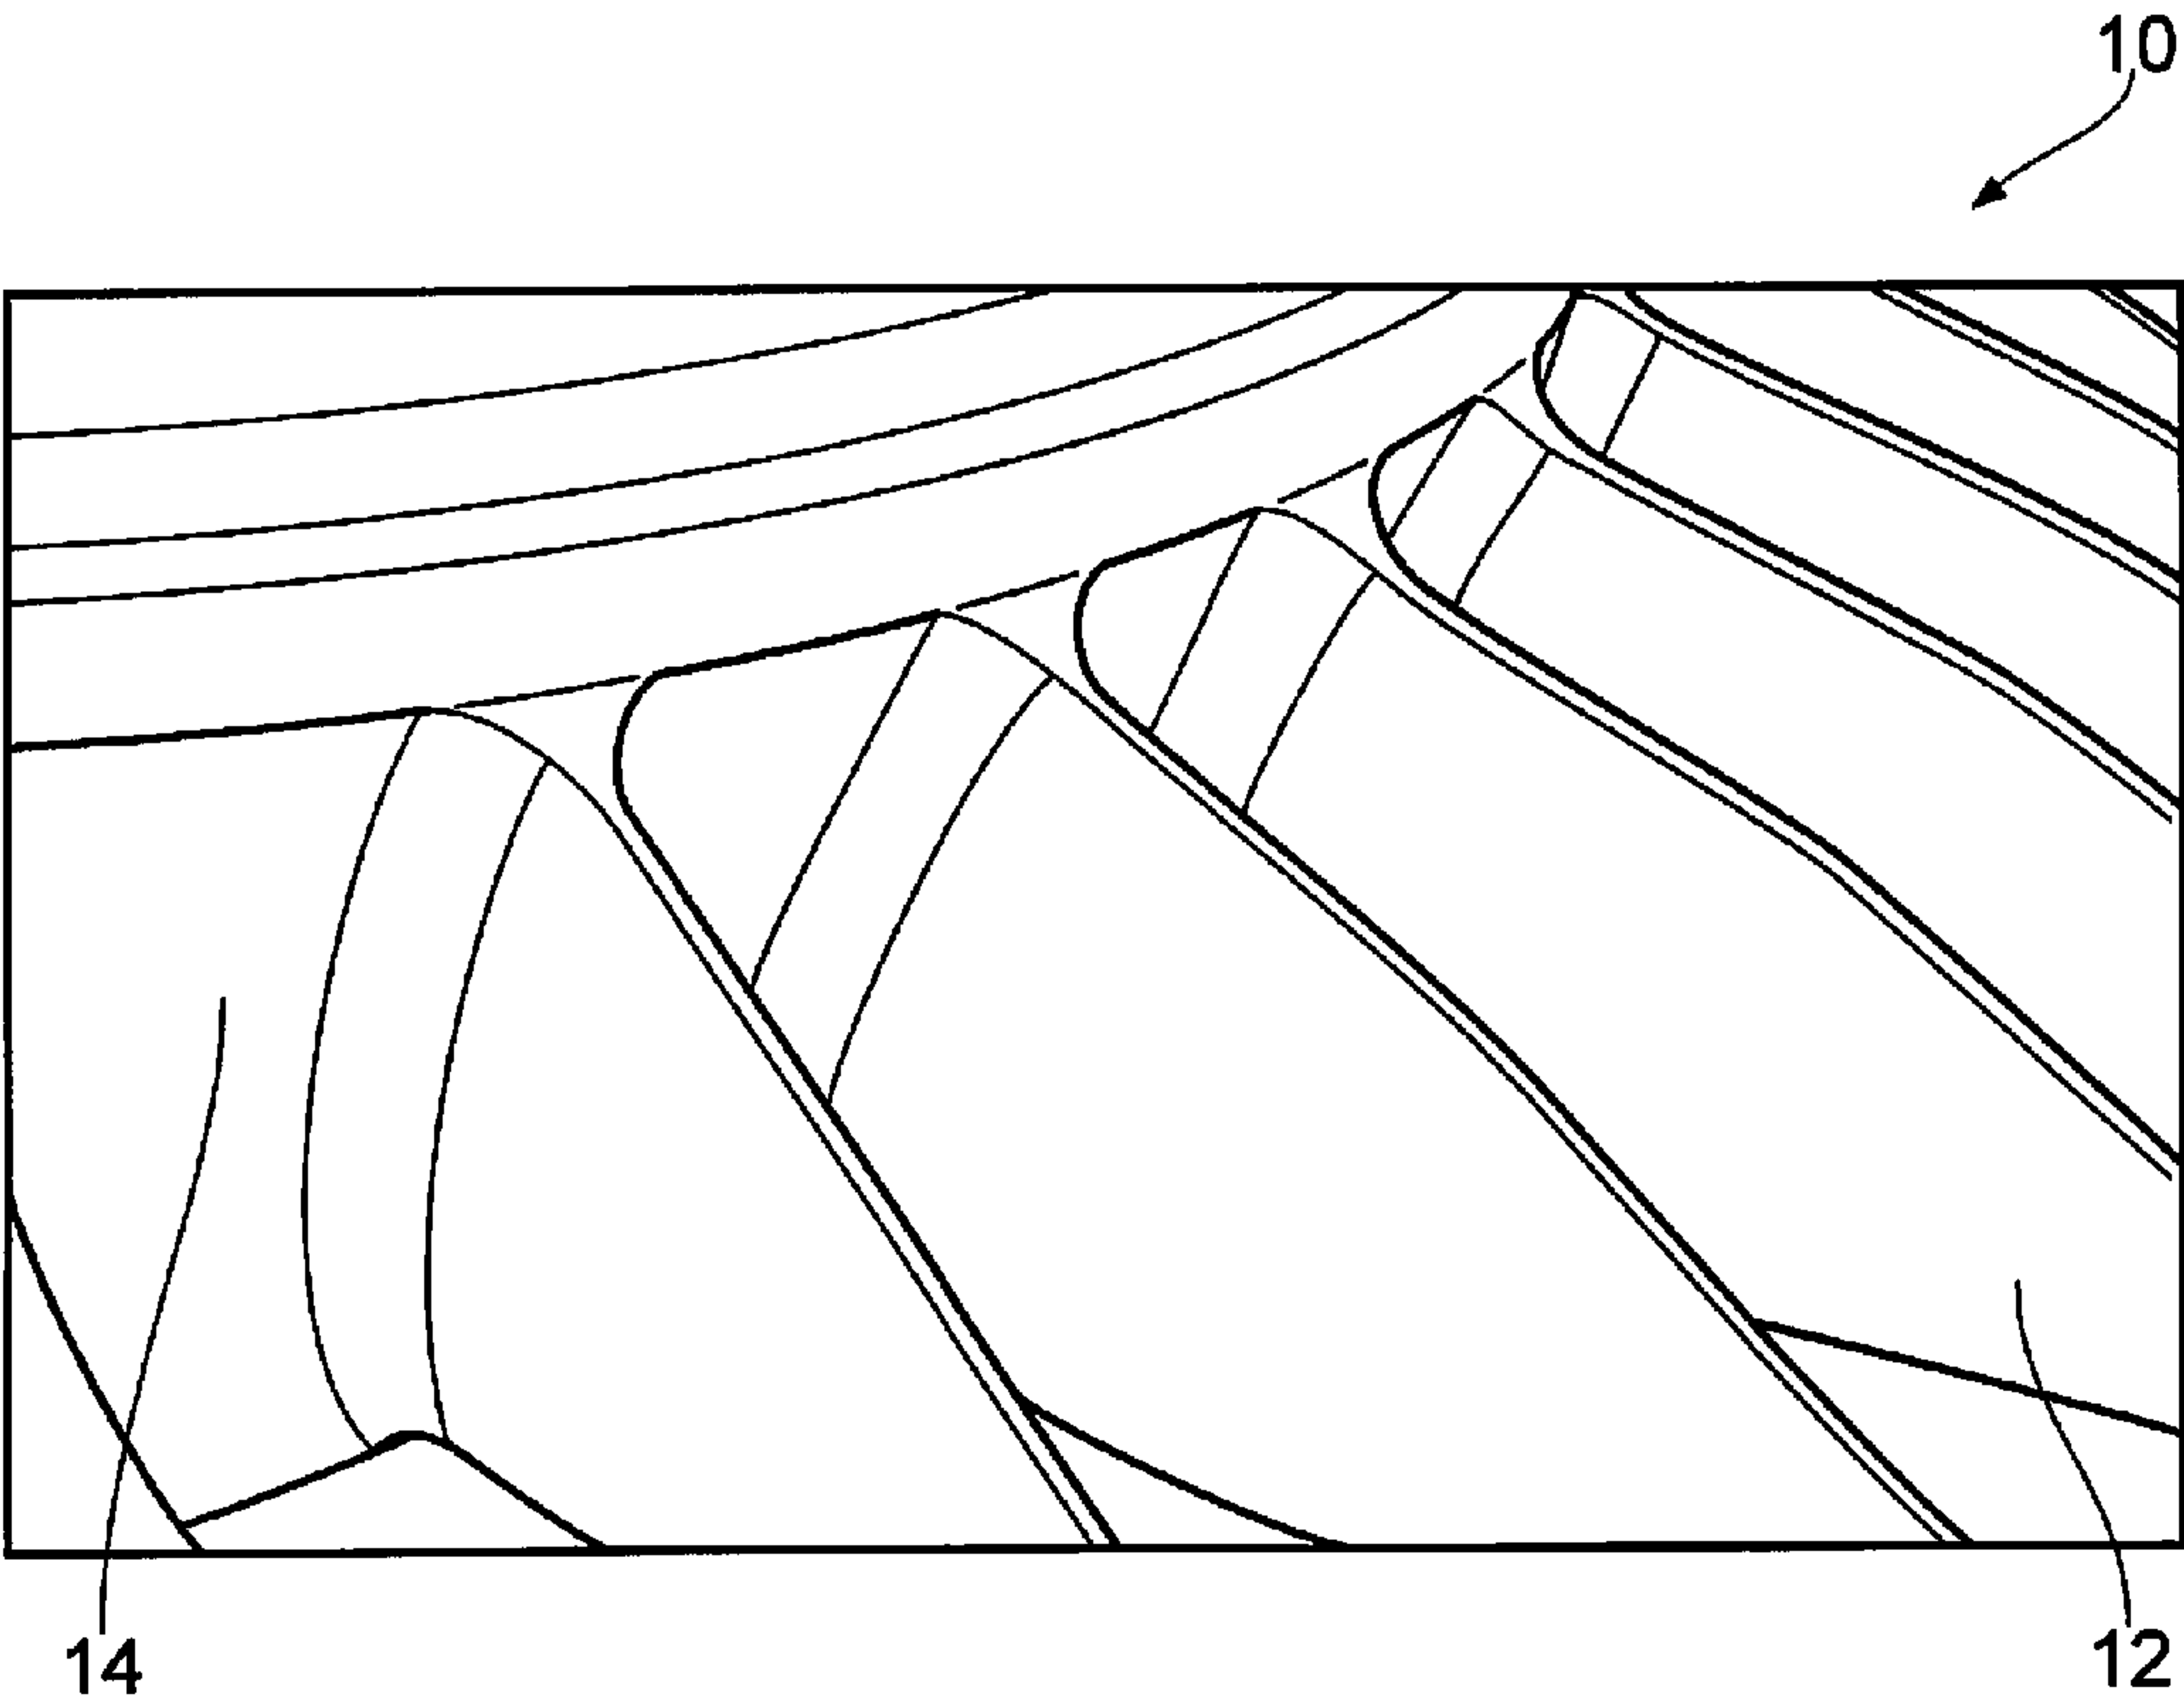
FIG. 1 is a perspective view of part of an integrally bladed rotor assembly;

Referring to FIG. 1, there is illustrated a part of an integrally bladed rotor assembly 10 which may be used in the compressor or turbine of an aero engine. The rotor assembly 10 includes a plurality of blades 12 attached to a rim 14 of a disc so as to extend radially outwardly therefrom. The blades 12 are typically of a titanium, nickel or steel alloy (a titanium 6-4 alloy commonly being used) and are attached to the rim 14 by LFW. This can involve holding the disc stationary while a blade member (comprising the as yet un-machined/unfinished blade) is oscillated against the rim 14 under a radial forge load. For example, the blade member may be oscillated axially against the rim. The heat generated by the oscillation together with the radial load results in the material of the blade member and rim becoming viscoplastic. When the material subsequently cools, bonds are formed and a weld is created between the rim 14 and the blade 12. During the friction welding process, upset material (“flash”) is extruded from the sides of the joint. The blade is subsequently machined into shape, the material at the edges of the weld being removed.

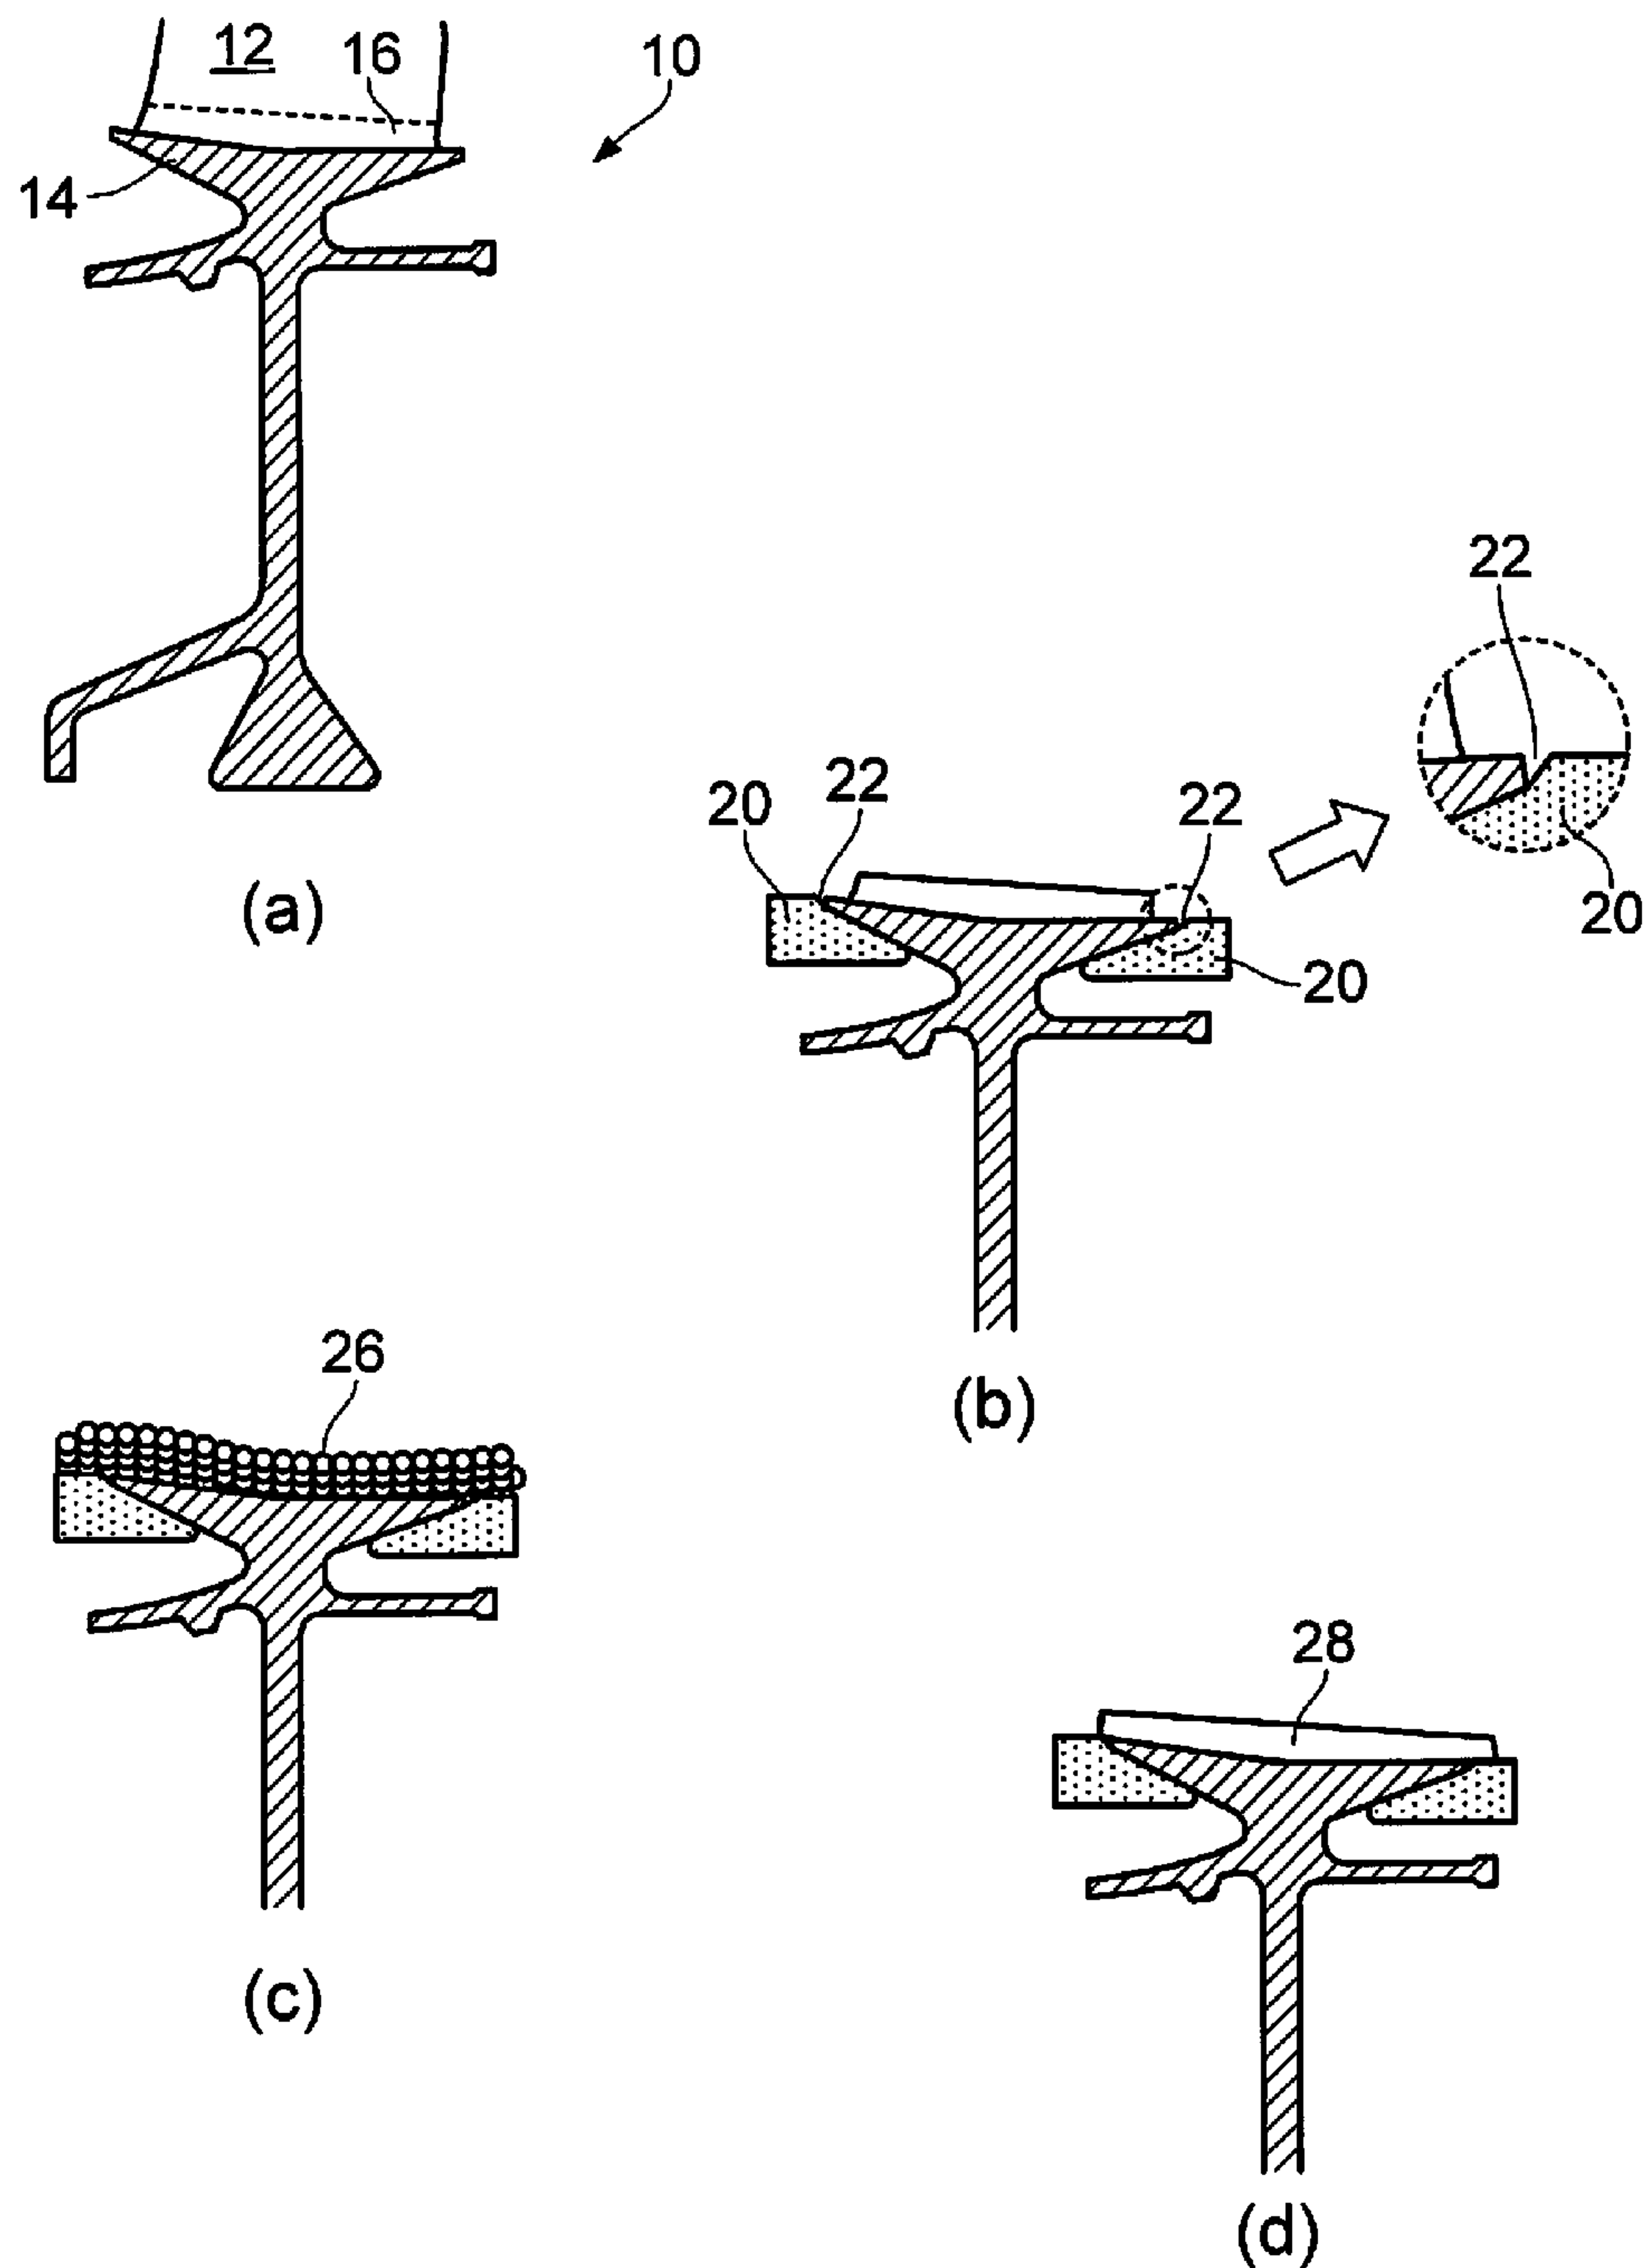
FIG. 2 shows schematically cross-sections through a bladed rotor assembly to illustrate stages (a)-(d) in a process for preparing the assembly for replacement of a damaged blade by LFW; and

FIG. 2 shows schematically cross-sections through a bladed rotor assembly to illustrate stages (a)-(d) in a process for preparing the assembly for replacement of a damaged blade by LFW.

Firstly, as shown in FIG. 2(a) a damaged blade 12 is removed at the position indicated by the dotted line, leaving a repair stub 16 having an aerofoil profile.

Sacrificial supports 20 are then inserted beneath the underside of the rim at the repair stub (FIG. 2(b)). The sacrificial supports are typically formed of a material that is softer than the metal of the assembly 10 to cushion the interface between the supports and the rim, and thereby prevent damage to the underside of the rim during LFW. For example, the supports can be formed of commercially pure titanium in the case of an assembly formed of formed from Ti—6Al—4V alloy. Another option, however, is to introduce soft layers between the rim and the supports.

The supports 20 project axially beyond the trailing and leading edges of the rim 14, and are typically shaped so that they form recesses 22 which extend along the trailing and leading edges of the rim adjacent the repair stub 16 (as shown in more detail in the close up view of the circled region of the trailing edge of the rim in FIG. 2(b)). Another option, however, is to shape the supports so that they do not form such recesses and e.g. simply abut the trailing and leading edges of the rim.

Next, as shown in FIG. 2(c), metal is deposited around the repair stub 16, for example by shaped metal deposition, plasma welding, laser powder welding or laser wire welding. In particular, the deposited metal 26, supported by the sacrificial supports 20, wraps around the trailing and leading edges of the stub and projects axially beyond the trailing and leading edges of the rim 14. Circumferentially extending lines of deposited metal also fill the recesses 22 (if present)

Finally, as shown in FIG. 2(d), and in FIG. 3 which shows schematically a perspective view of the assembly 10, the deposited metal 26 is machined to form an enlarged repair stub 28. For clarity in FIG. 3, none of the other blades of the assembly are shown.

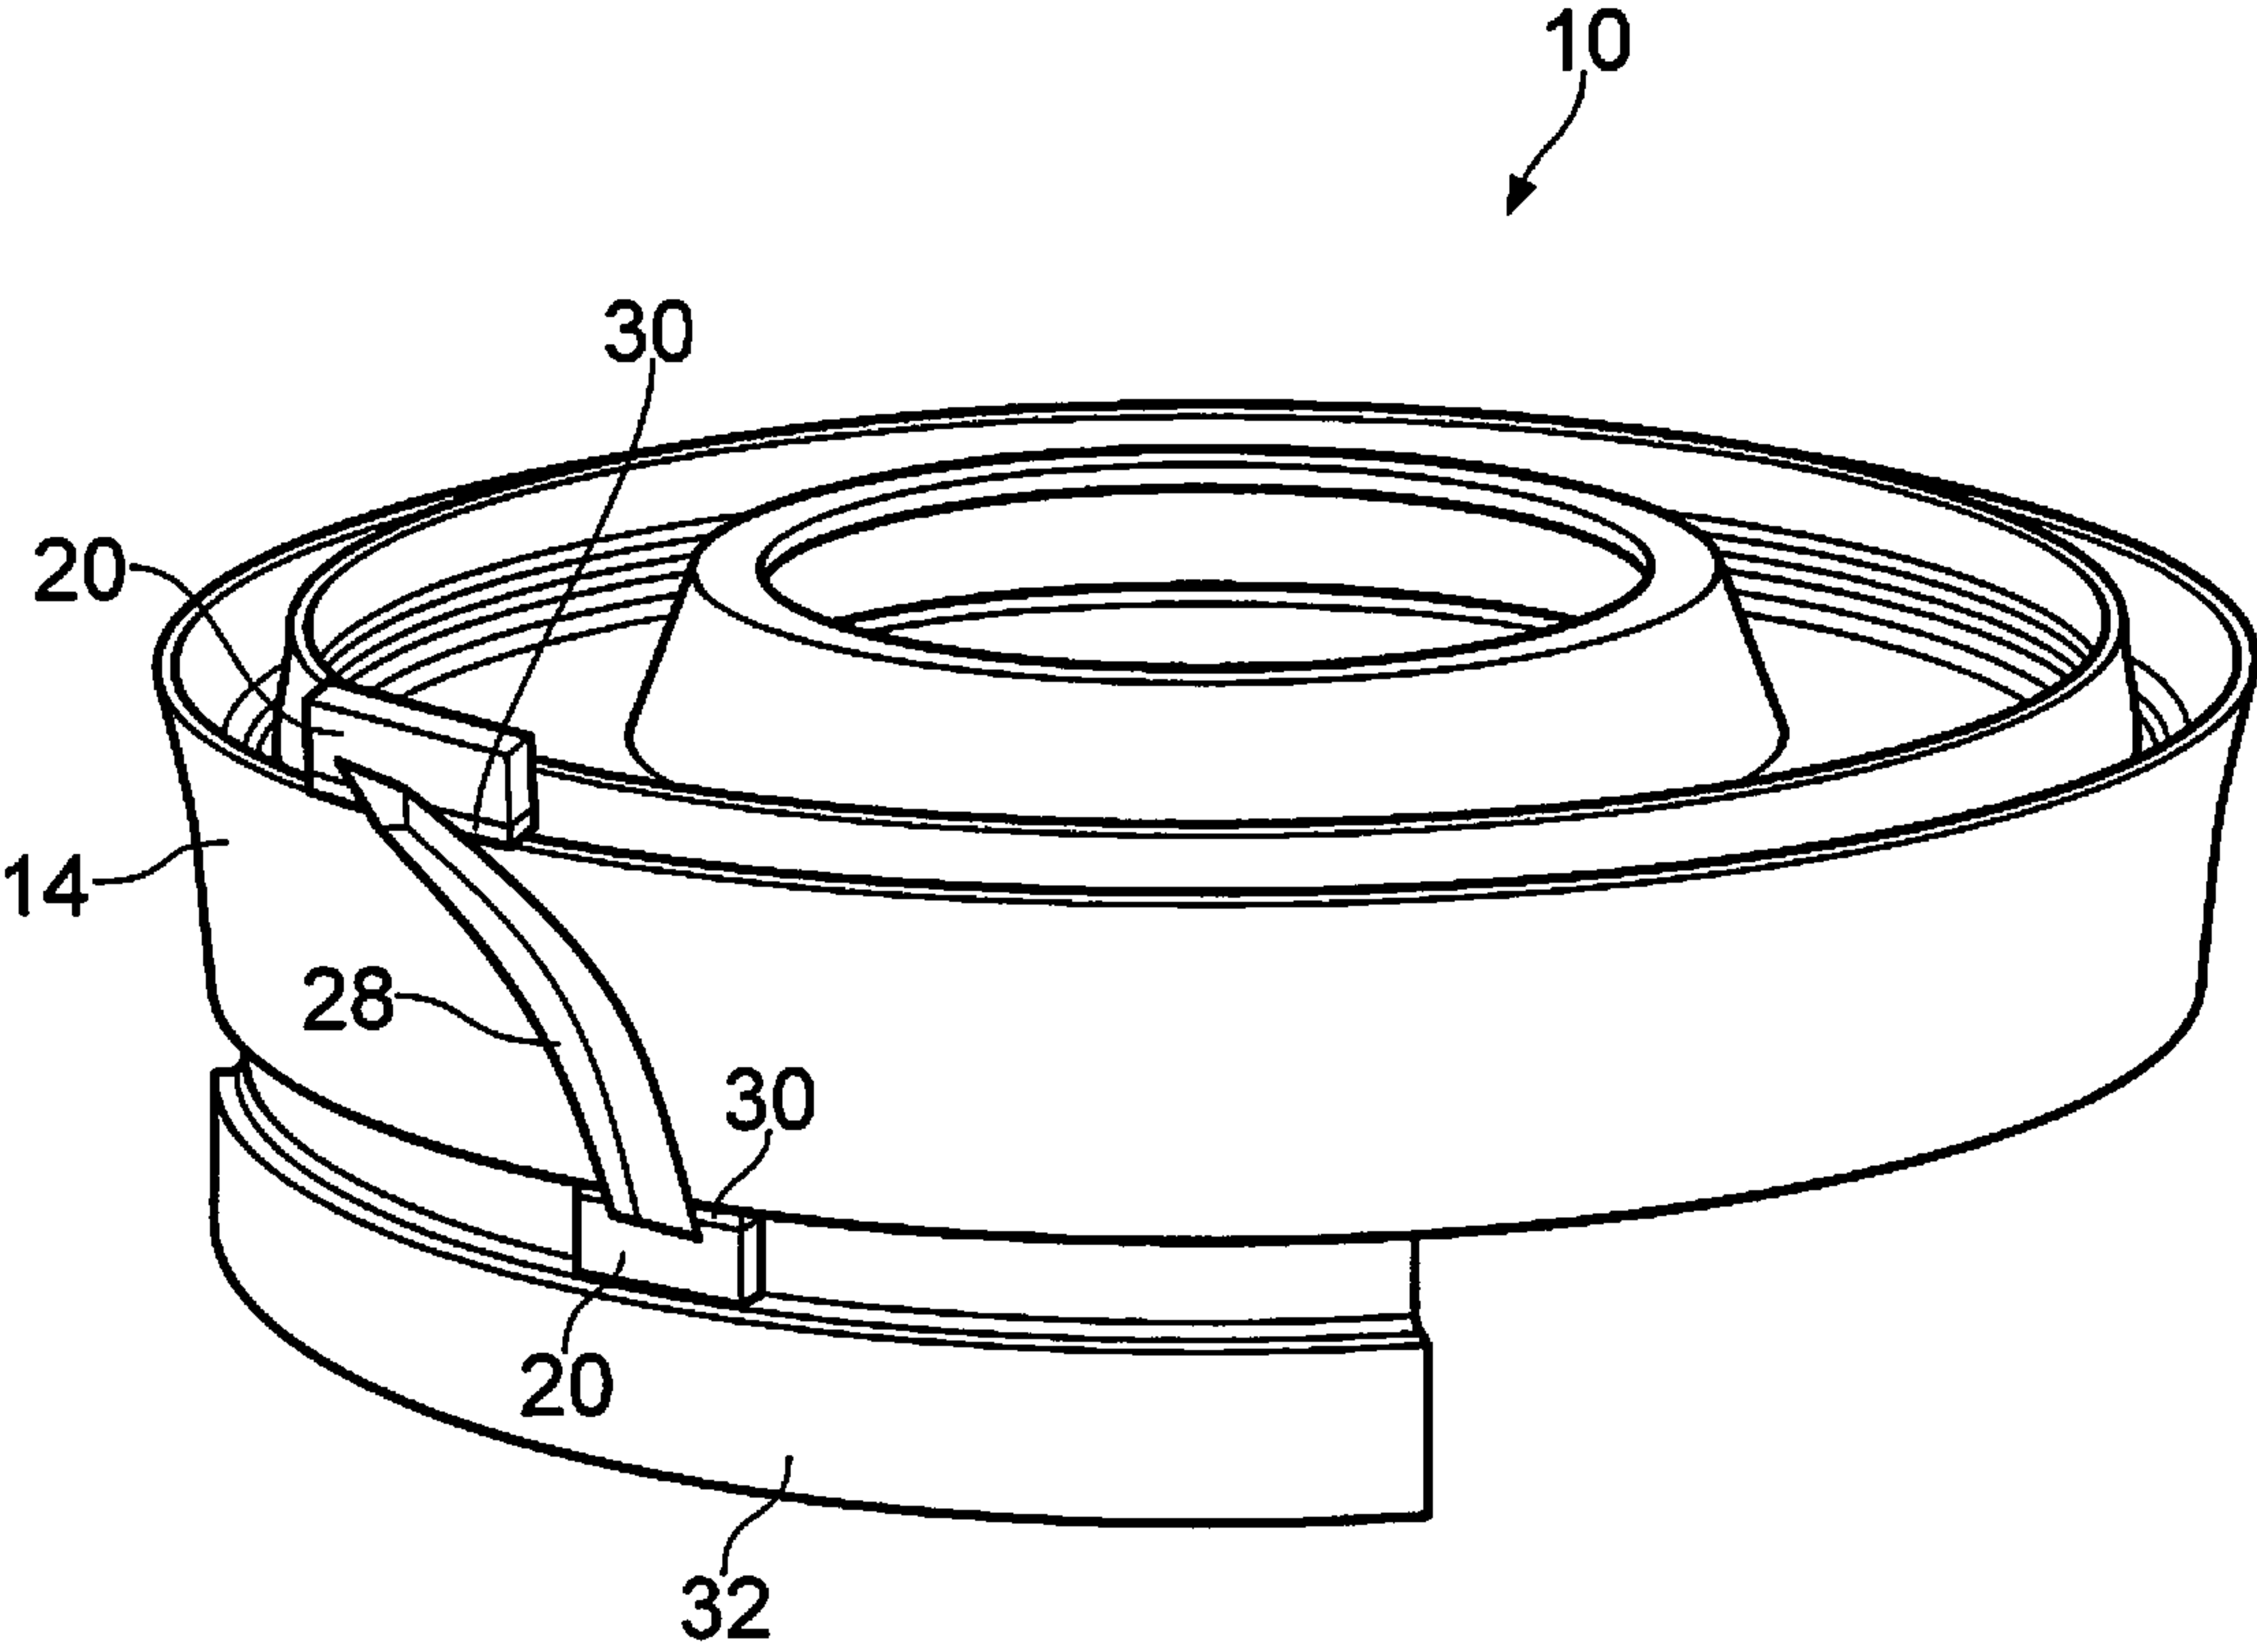
FIG. 3 shows schematically a perspective view of the assembly of FIG. 2(d).

Also shown in FIG. 3 is a tooling 32 which locates beneath one of the sacrificial supports 20. Although not shown, a similar tooling is located on the other side of the assembly 10 beneath the other sacrificial support. The tooling reacts the radial forge load and an axial oscillation load during LFW. Further tooling can be applied at a radially inward portion of the assembly to provide an axial clamp for in-plane load reaction.
