(10) **Patent No.:** **US 9,512,724 B2**
(45) **Date of Patent:** **Dec. 6, 2016**

(54) **METHOD FOR REPAIRING WEAR MARKS ON A ROTOR SUPPORTING THE FAN OF A BYPASS ENGINE**

(71) Applicant: **SNECMA**, Paris (FR)

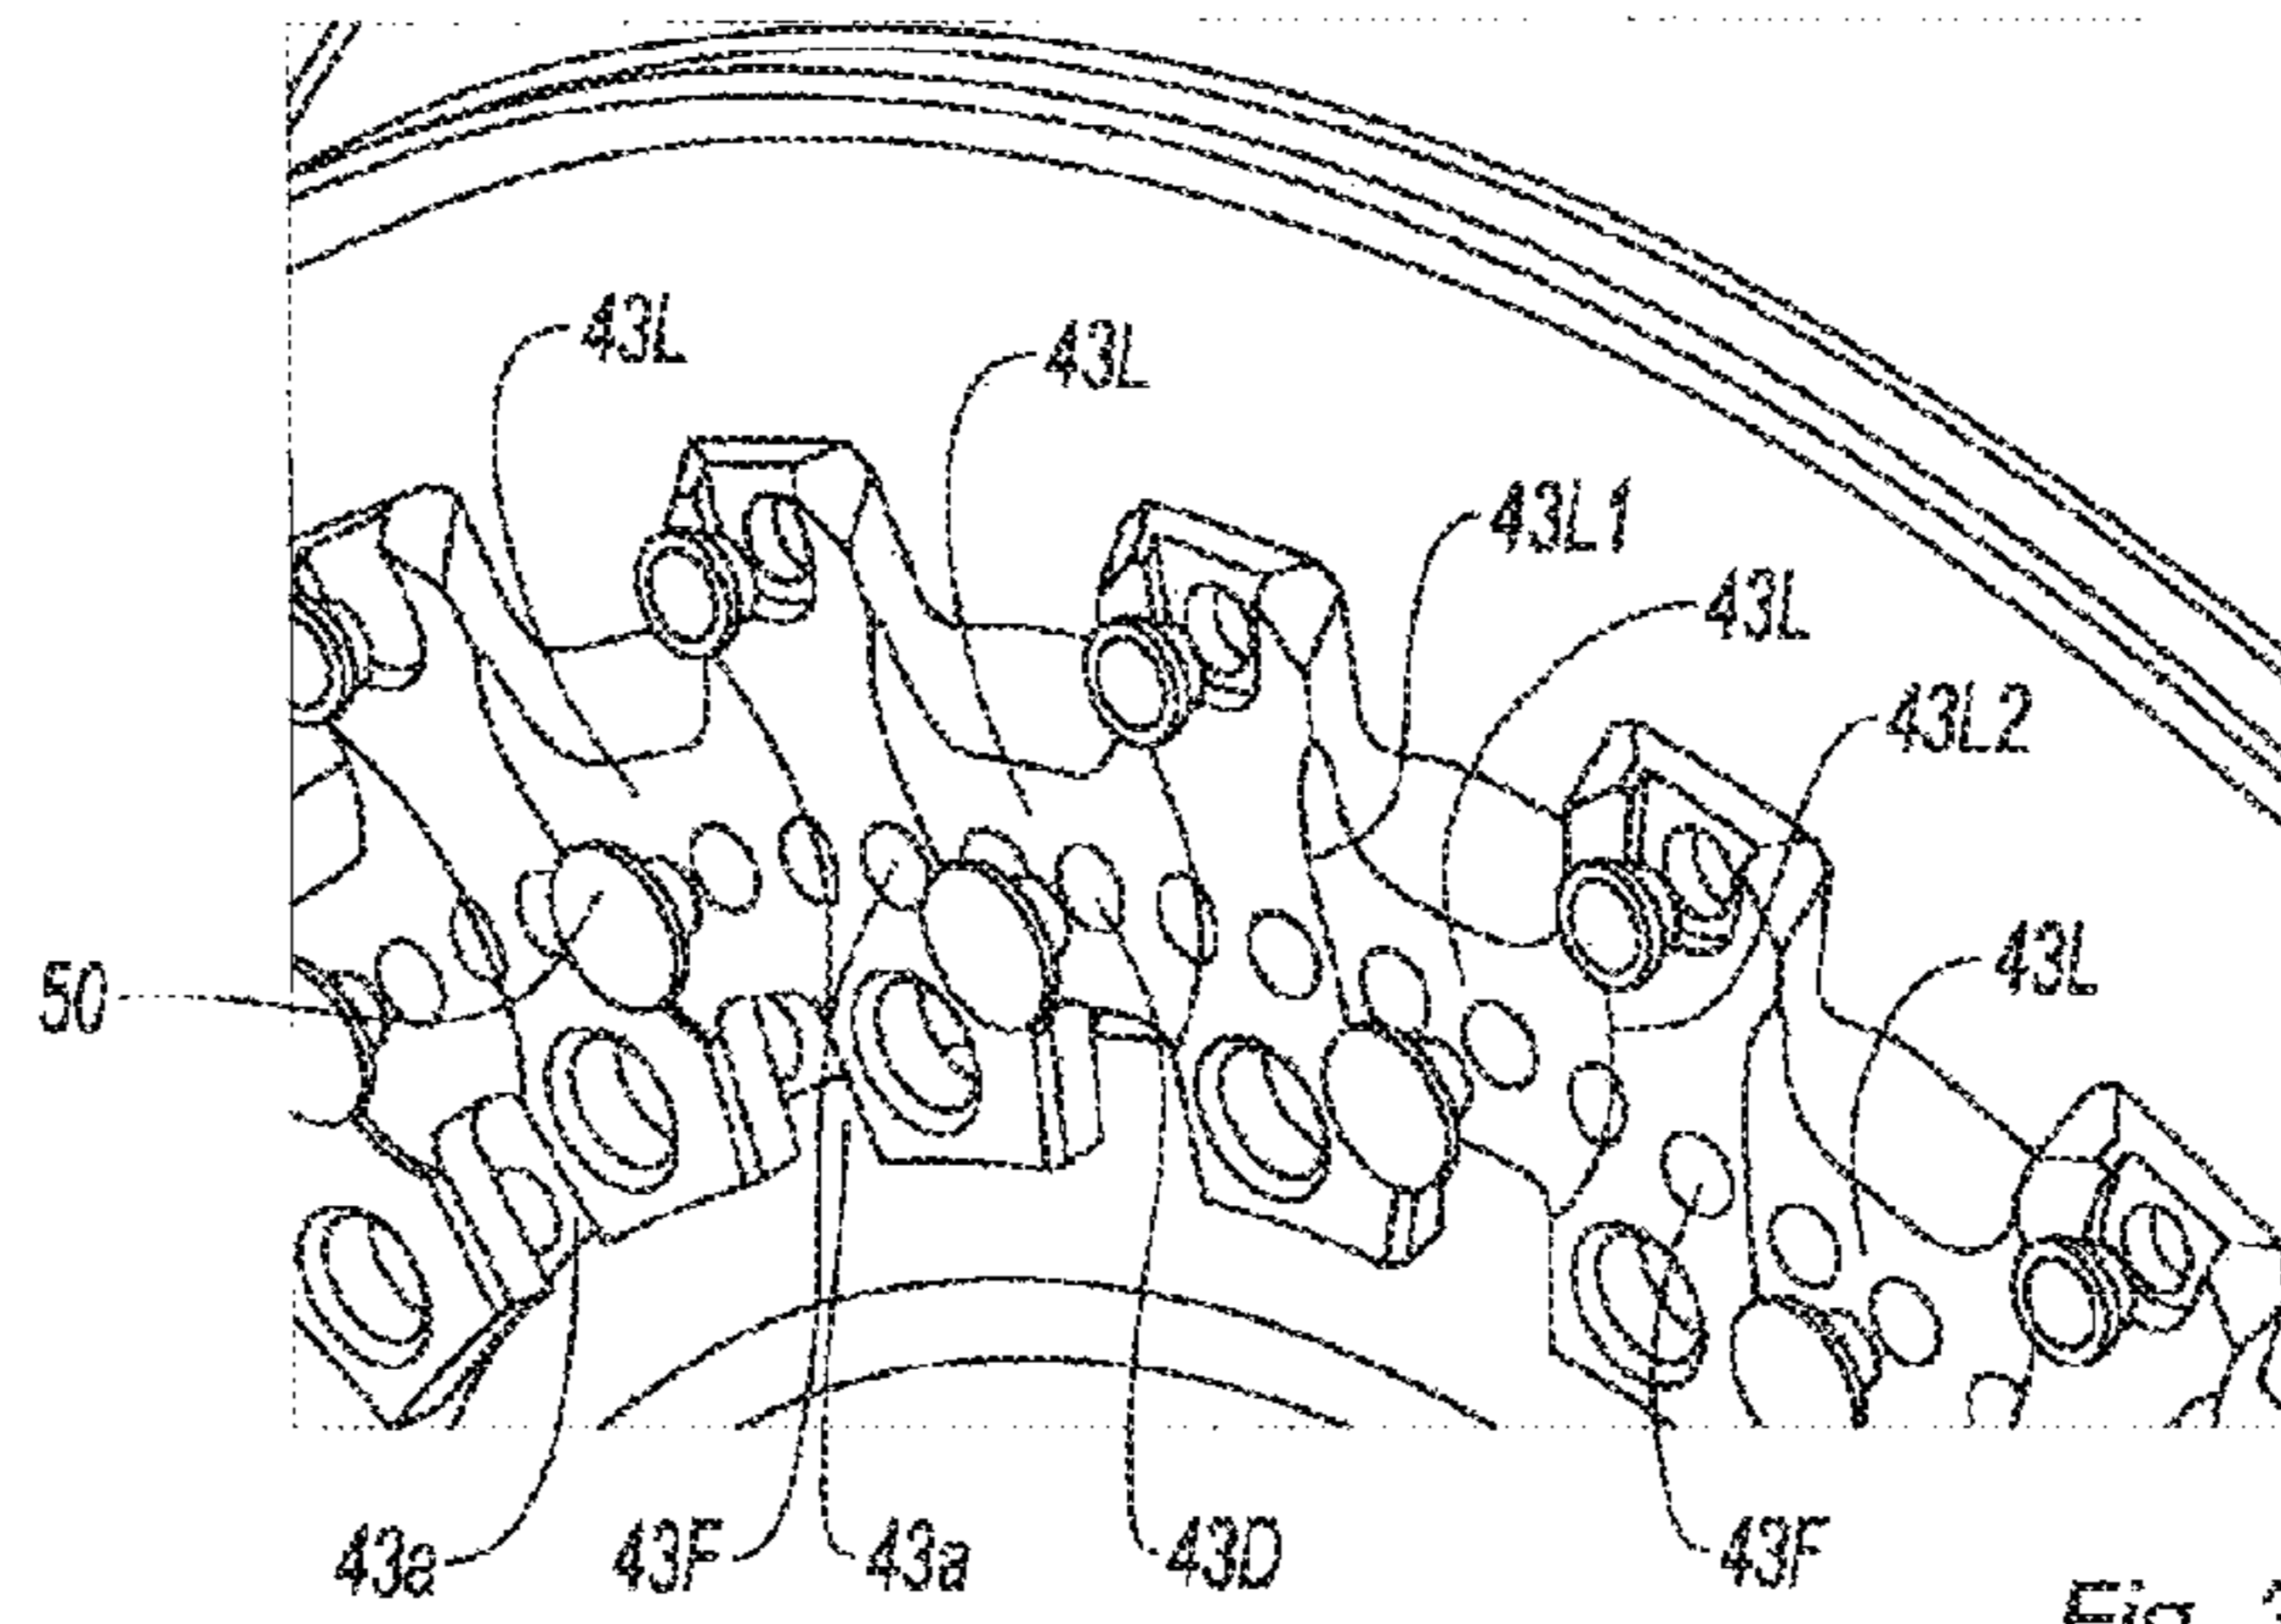
Fig. 3

FIG. 3 shows, in perspective, the upstream flange of the drum of the compressor with spot facing regions;

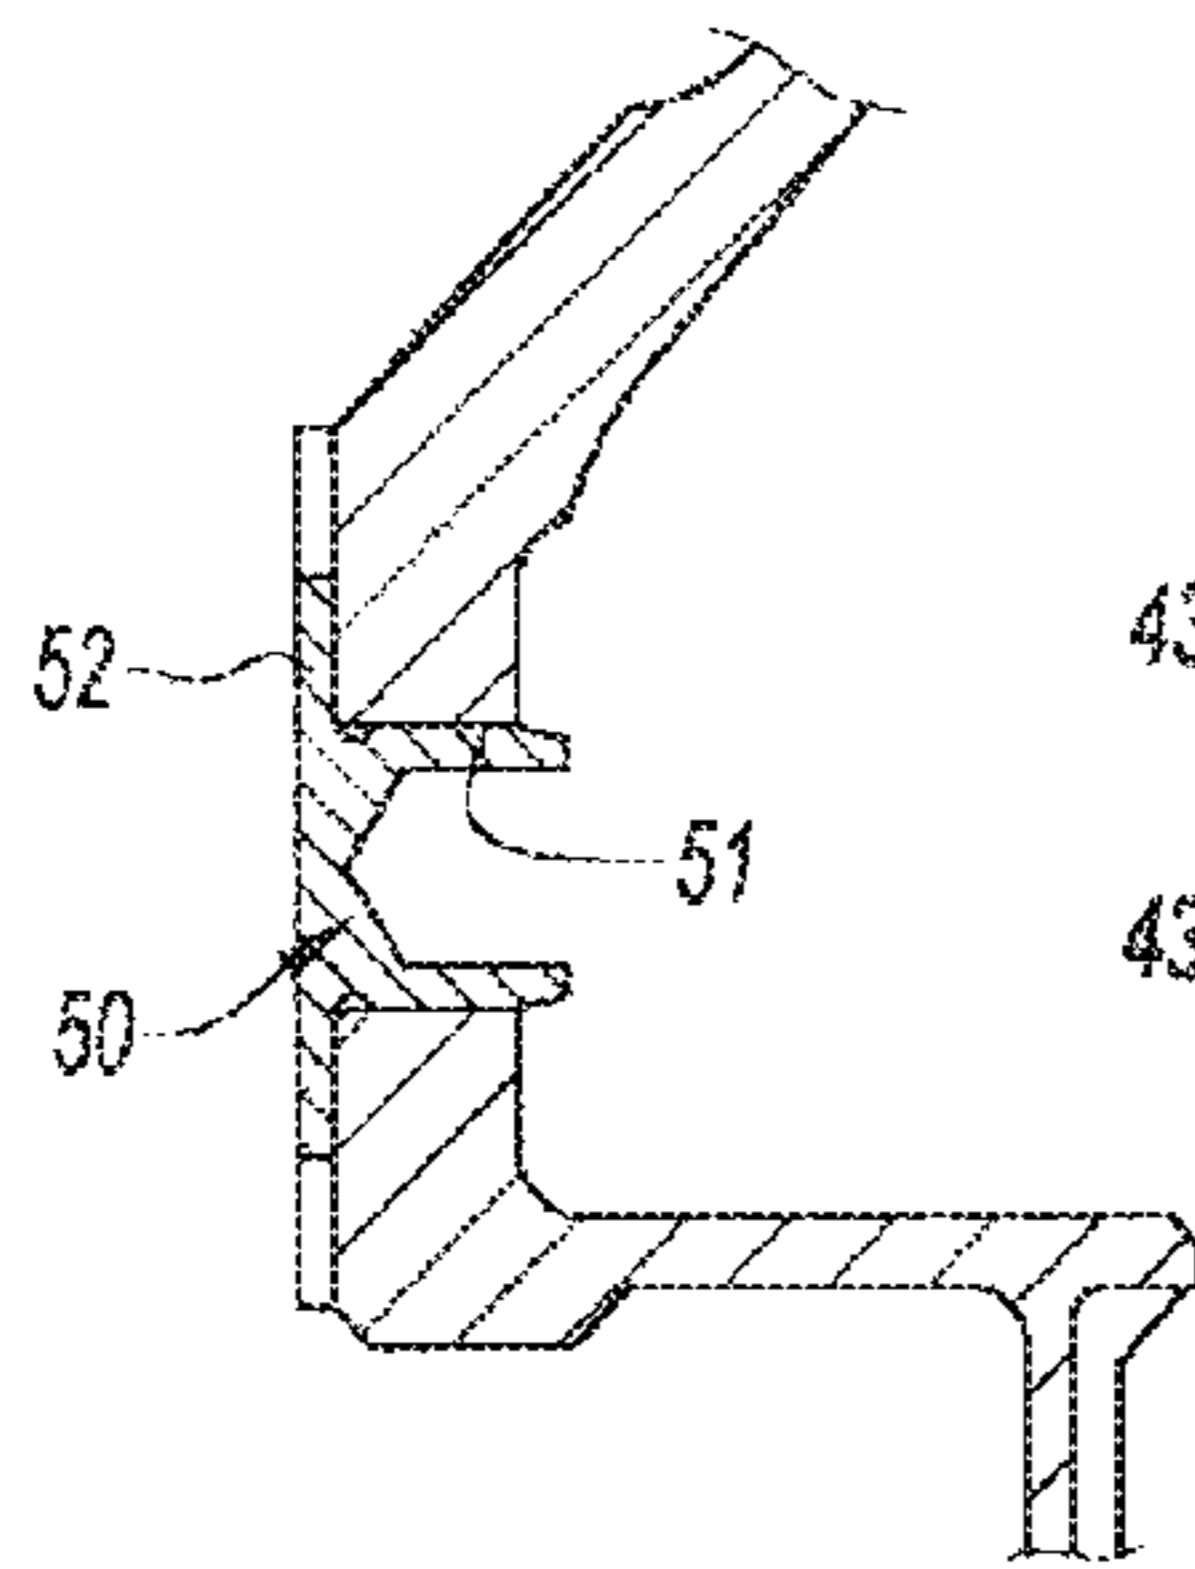
Fig. 4

FIG. 4 shows the flange front on and, in section, the anti-wear peg fitted in a stress-relief hole;

There follows a description of the repair method of the invention. This involves machining an optimized spot face 43L in the region of each wear mark T, see FIG. 4. This spot face 43L is defined by its circumferential extent between two radial borders 43L1 and 43L2, its radial extent and its depth. Once the spot faces have been created, the surface of the flange 43 is reconstituted by putting in place anti-wear pegs 50 in the stress-relief openings 43D opposite the slots of the disk 20. These anti-wear pegs have a stem 51 which is accommodated in the corresponding hole and a collar 52 which presses against the base of the spot face 43L.

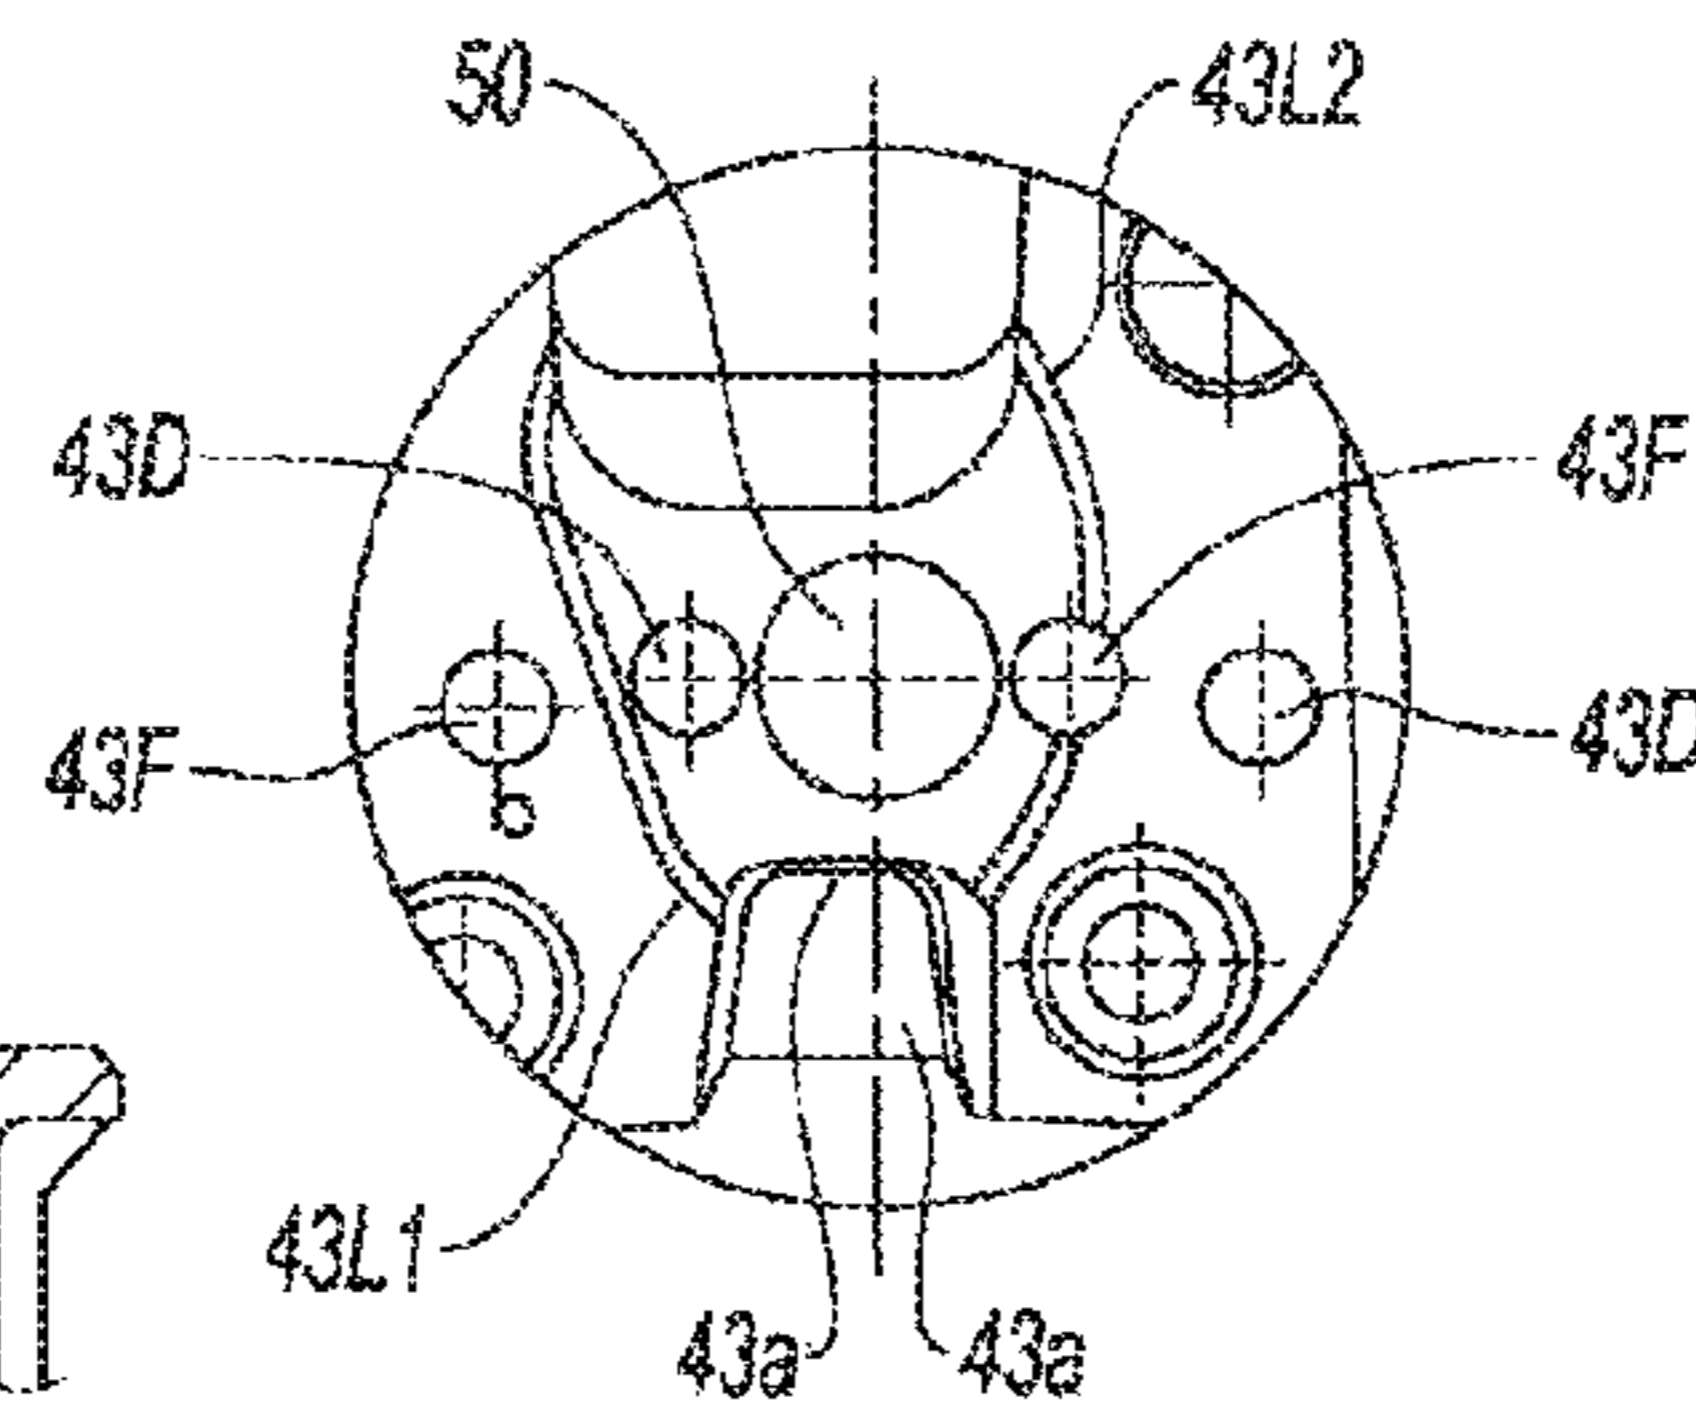
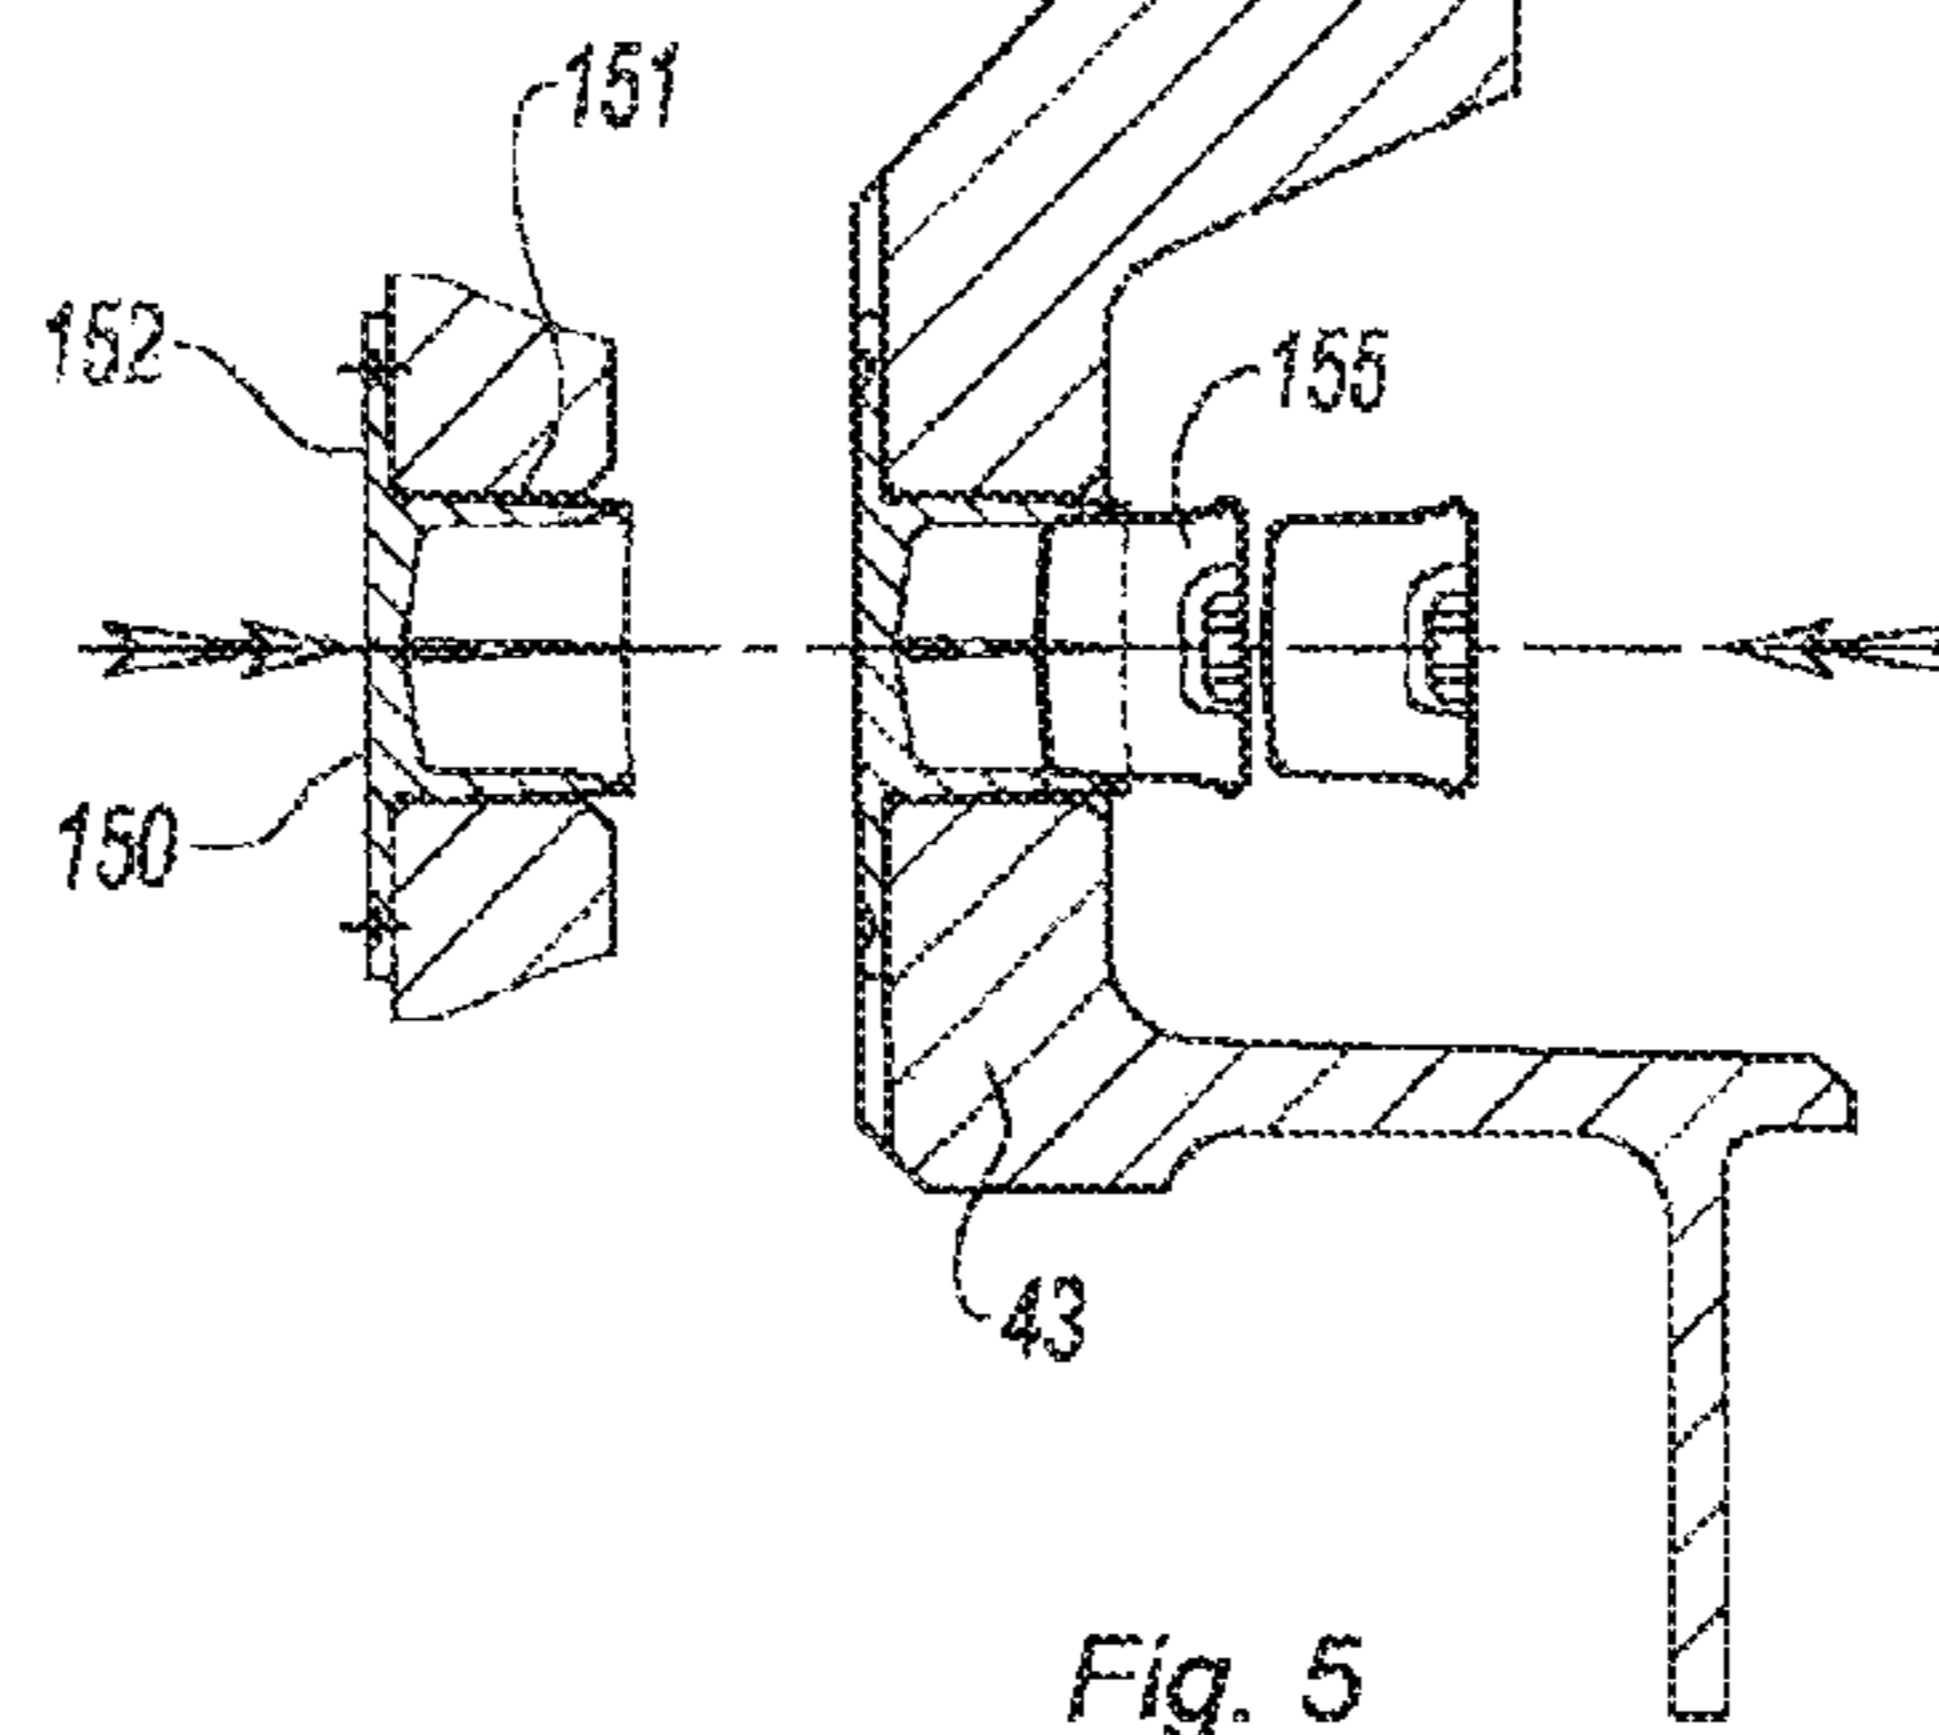
Fig. 5

FIG. 5 shows a variant embodiment of the fitting of the anti-wear pegs with and without male locking element.

FIG. 5, for example, shows a solution for fitting a peg 150 with a stem 151 and a collar 152 which comprises a male element 155 which is placed in the stem by being introduced on the side opposite the collar. The stem is split in the longitudinal direction such that it can stretch in the radial direction. Once in place in the hole, the male element, which is slightly frustoconical, is guided axially in the stem which induces radial forces on the walls of the stem of the peg. Guidance can be obtained by screwing or by force-fitting.
