(54) **METHOD FOR REPAIRING A FLANGE OF A HOUSING**

A method of repairing a flange of a casing, or a casing made of aluminum, for a turbine engine or an airplane turboprop or turbojet, the flange including at least one through hole for passing a bolt for fastening equipment. The method includes: forming a spot face in the flange around the hole for passing the bolt; anodizing the bottom surface of the spot face; placing a washer on the spot face; and fastening the washer to the flange using adhesive.

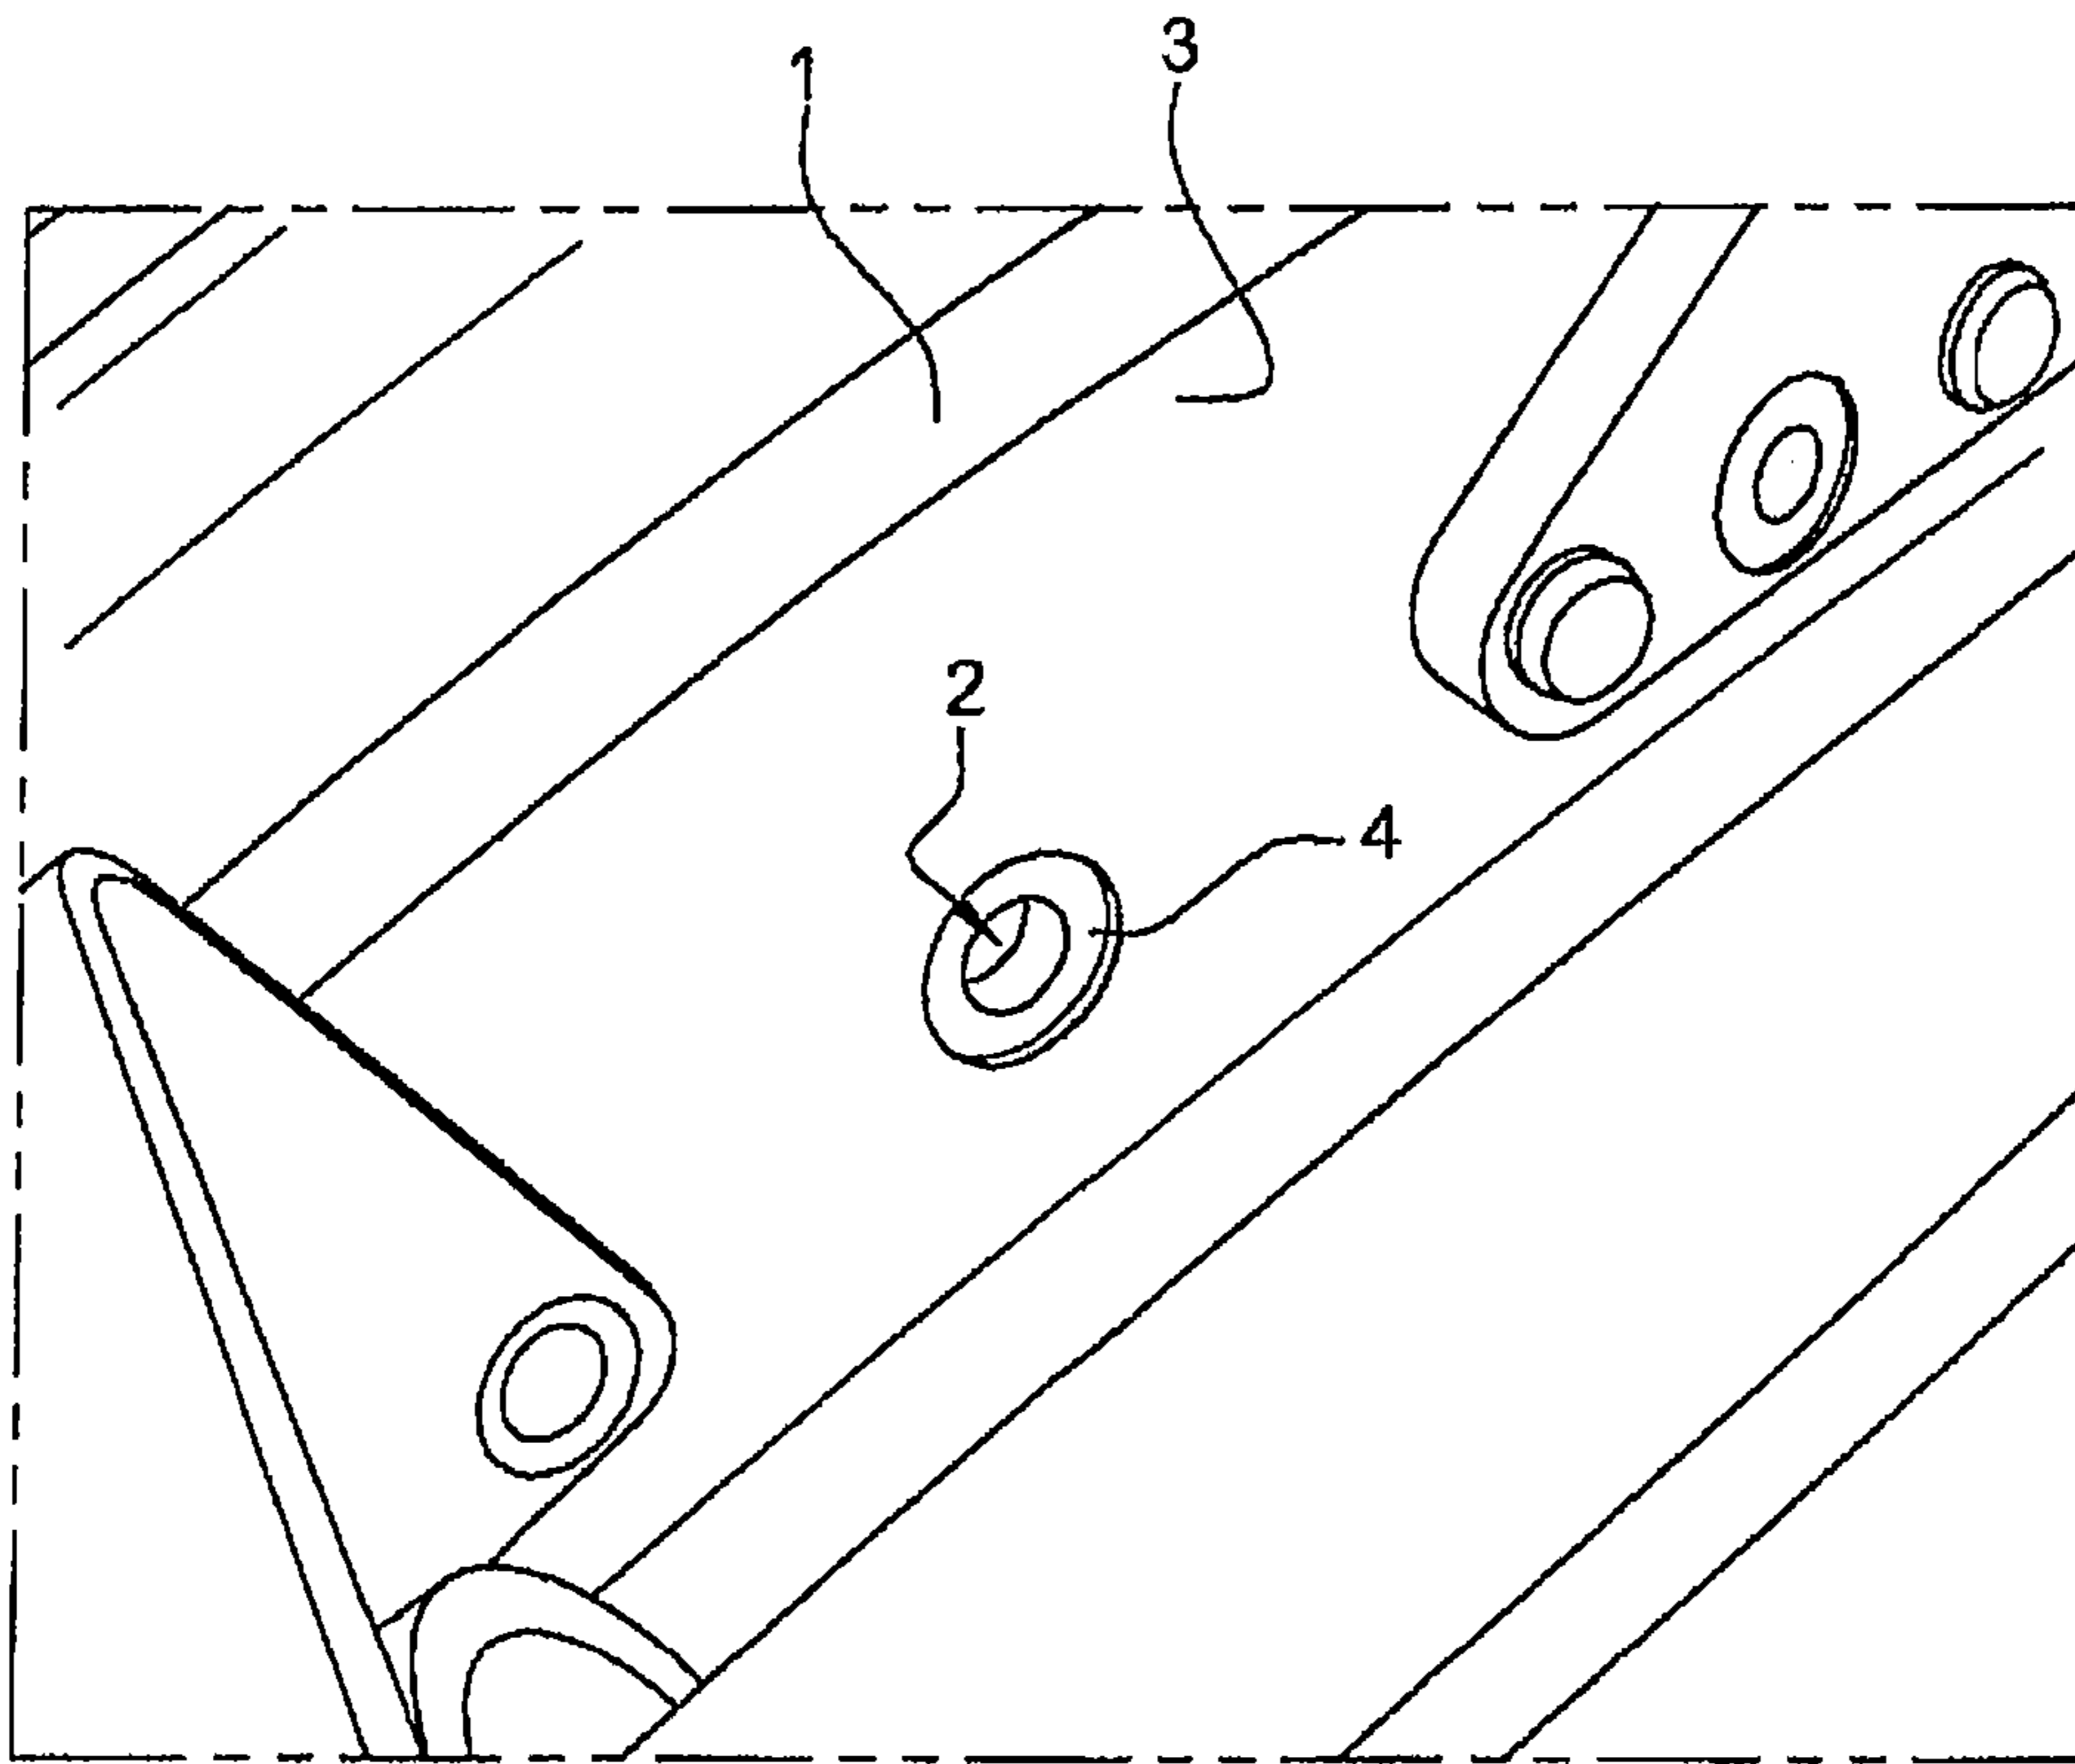
Fig. 1

FIG. 1 is a perspective view of a portion of a damaged flange;

FIGS. 1 and 2 show an annular flange 1 of an aluminum casing of a high-pressure compressor of a turbojet that has been damaged by mechanical stresses generated while the turbojet was in operation.

The flange 1 has holes 2 formed near its circumference and regularly spaced apart from one another, the holes opening out at both ends into annular side surfaces 3. The holes 2 are used for passing bolts, for bolting stiffeners or pieces of equipment. In the example of FIGS. 1 and 2, the equipment (not shown) has a face of circular section that, when in use, bears against the corresponding side face 3 around the bolt-passing hole 2.

In operation, vibration of the casing can give rise to bruising damage 4 of the inside surfaces of the holes 2 and of the side surface 3 of the flange 1. There can thus be seen a localized indentation in the surface 3 of the flange 1 in the zone where contact is made between the flange and the piece of equipment, together with an increase in the diameter of the hole 2 and/or ovalizing of the section of the hole 2. All of these kinds of damage can clearly be seen in FIGS. 1 and 2.

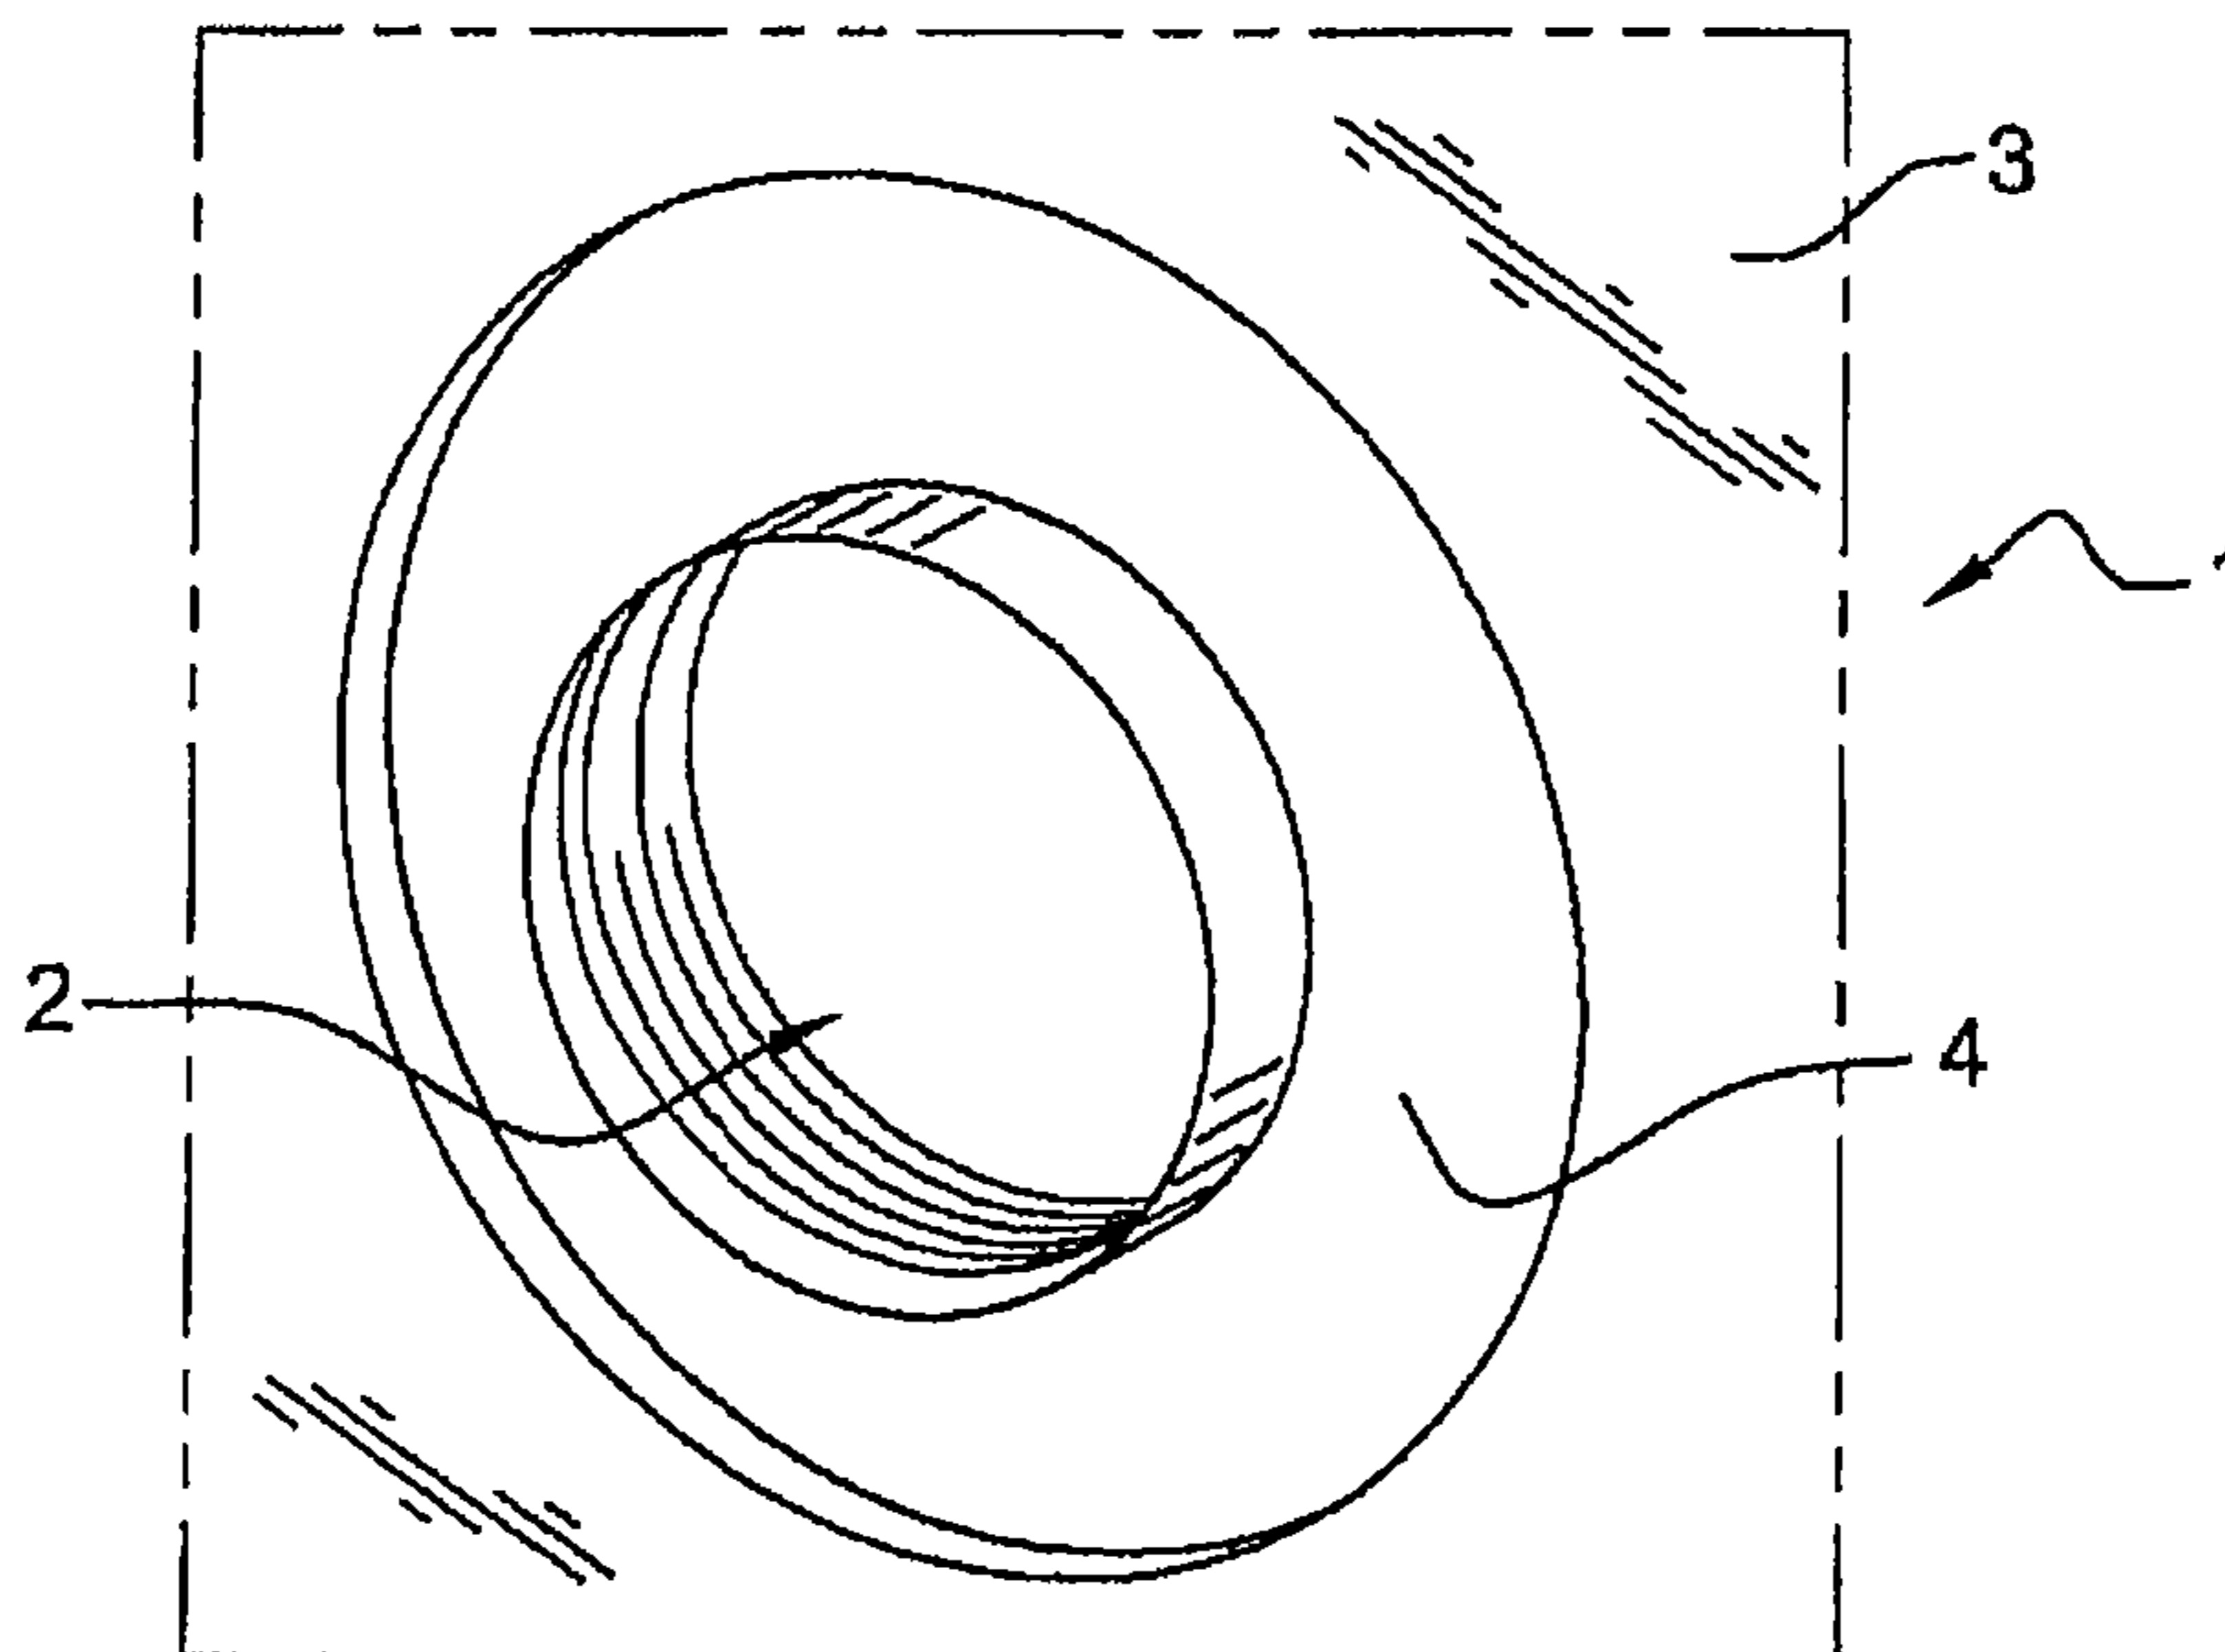
Fig. 2

FIG. 2 is a view on a larger scale of the through hole in the damaged flange;

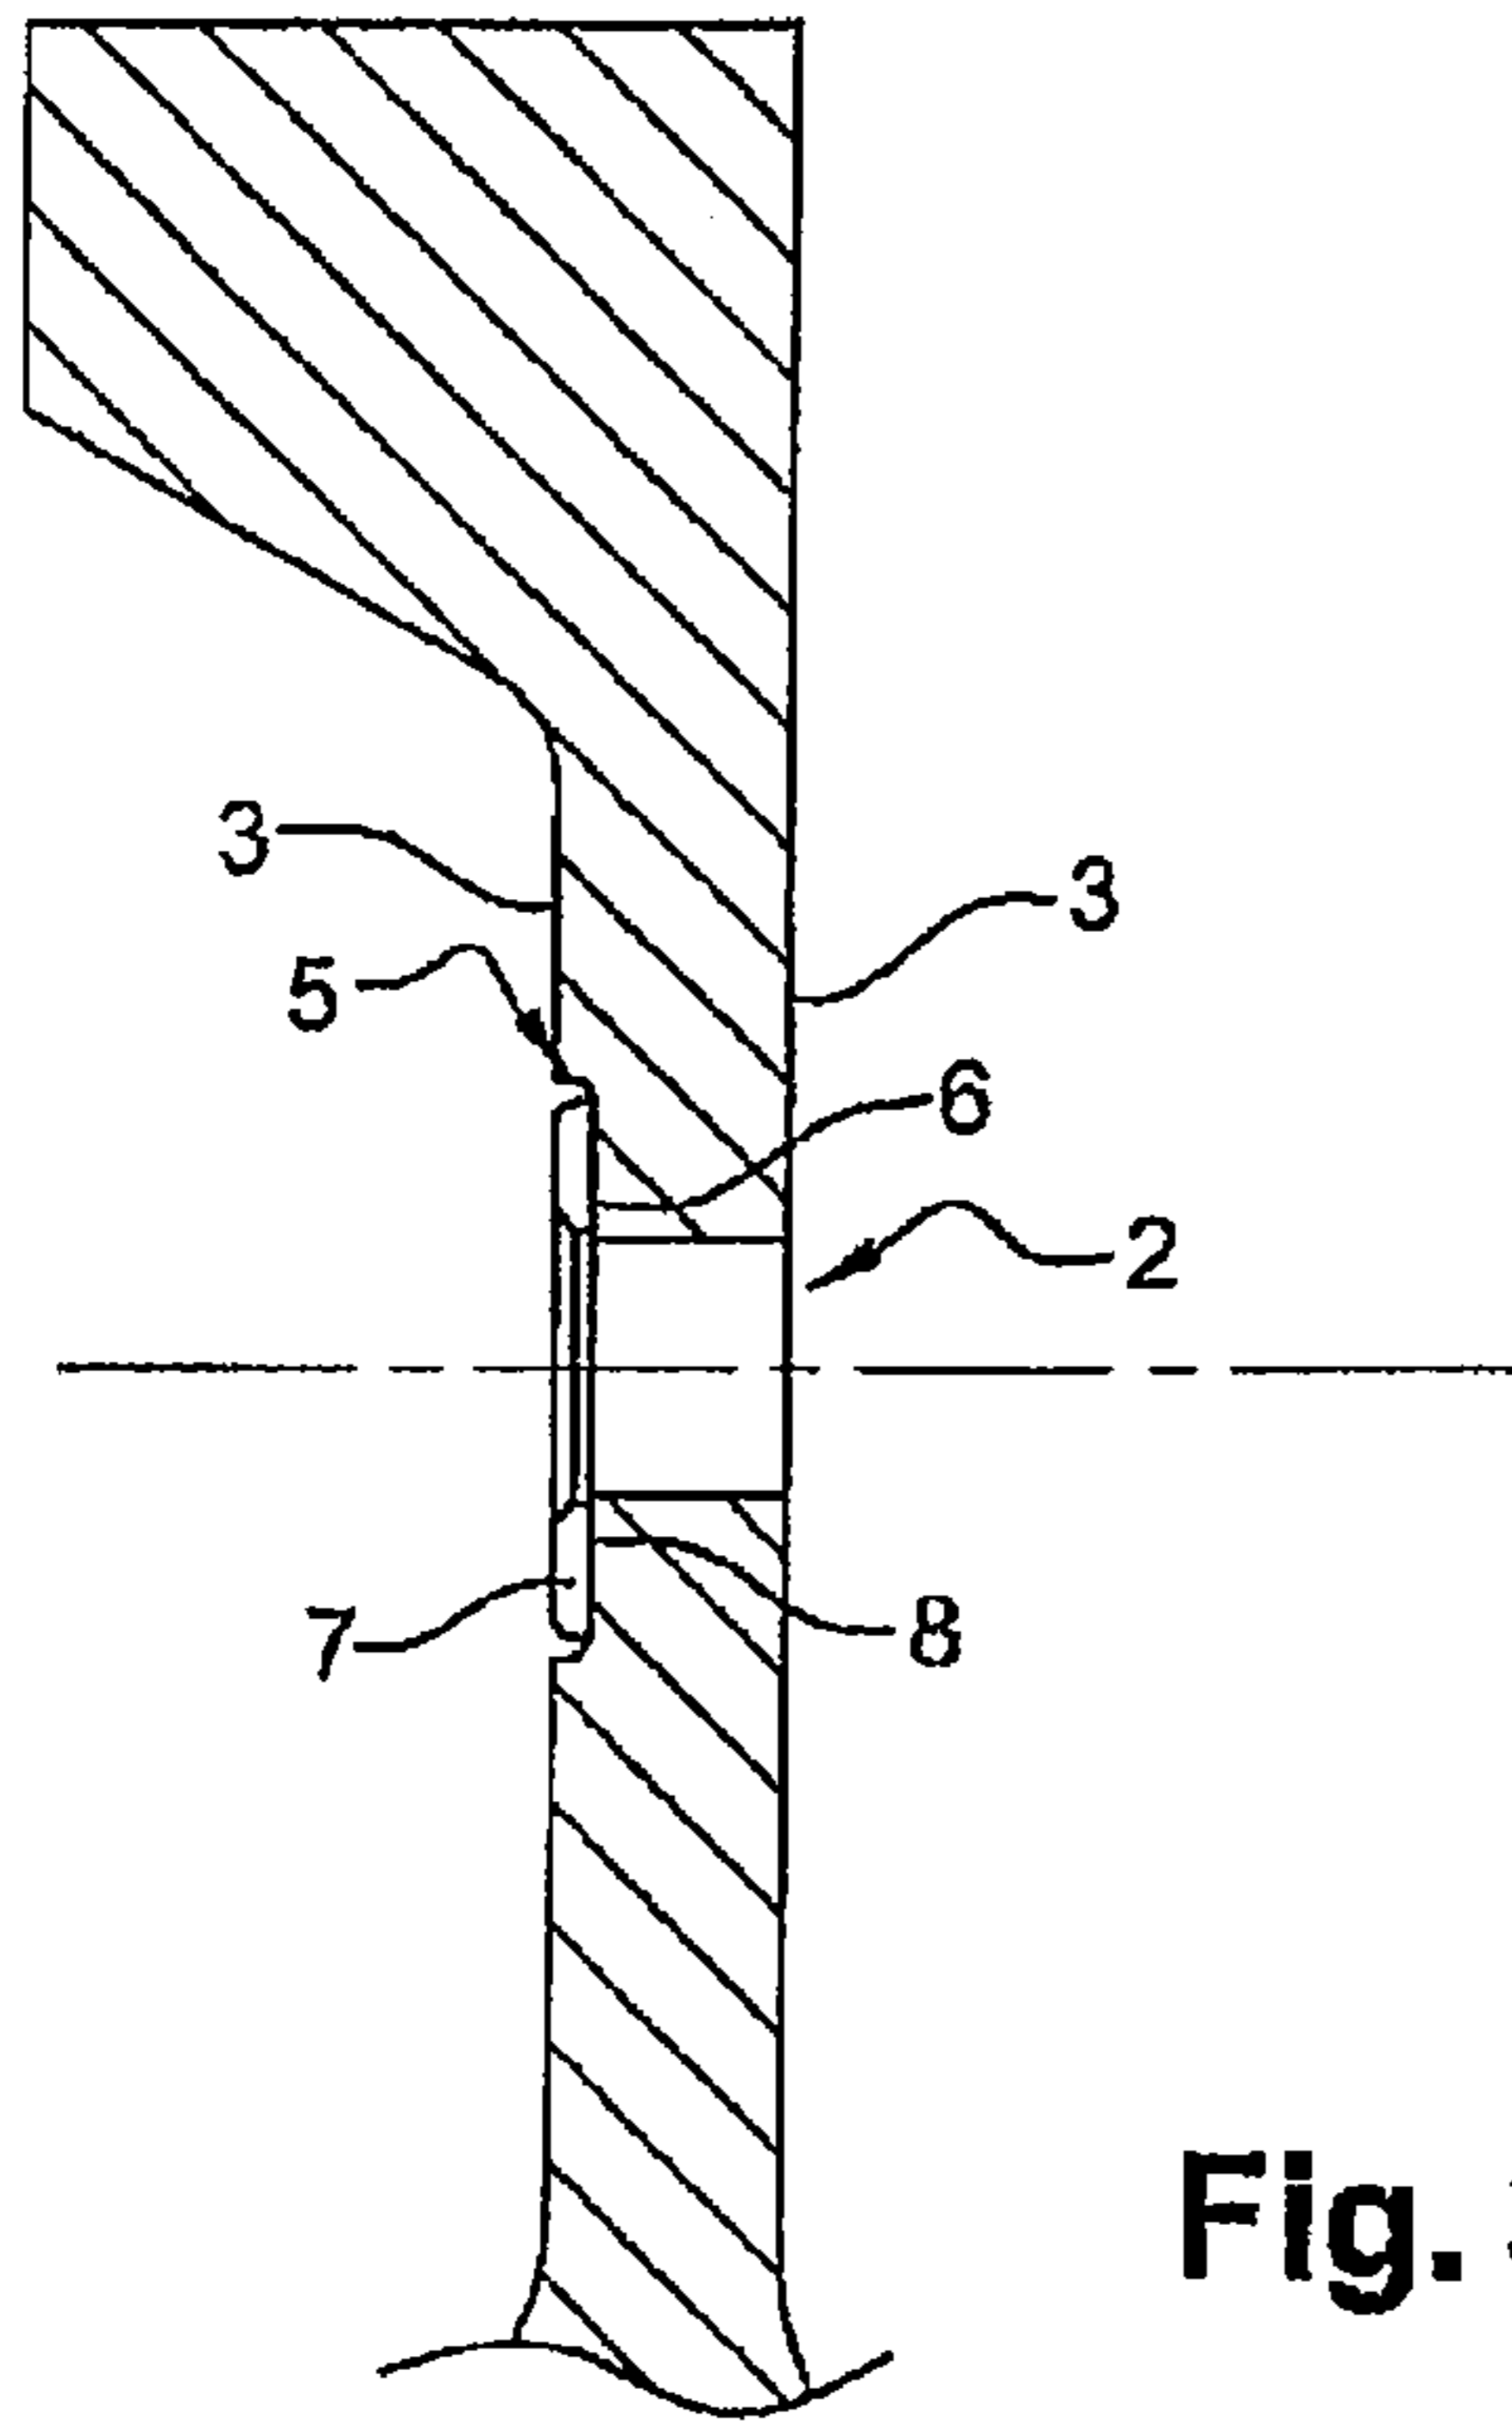
Fig. 3

FIG. 3 is an axial section view through a flange portion that has been repaired by the method of the invention; and

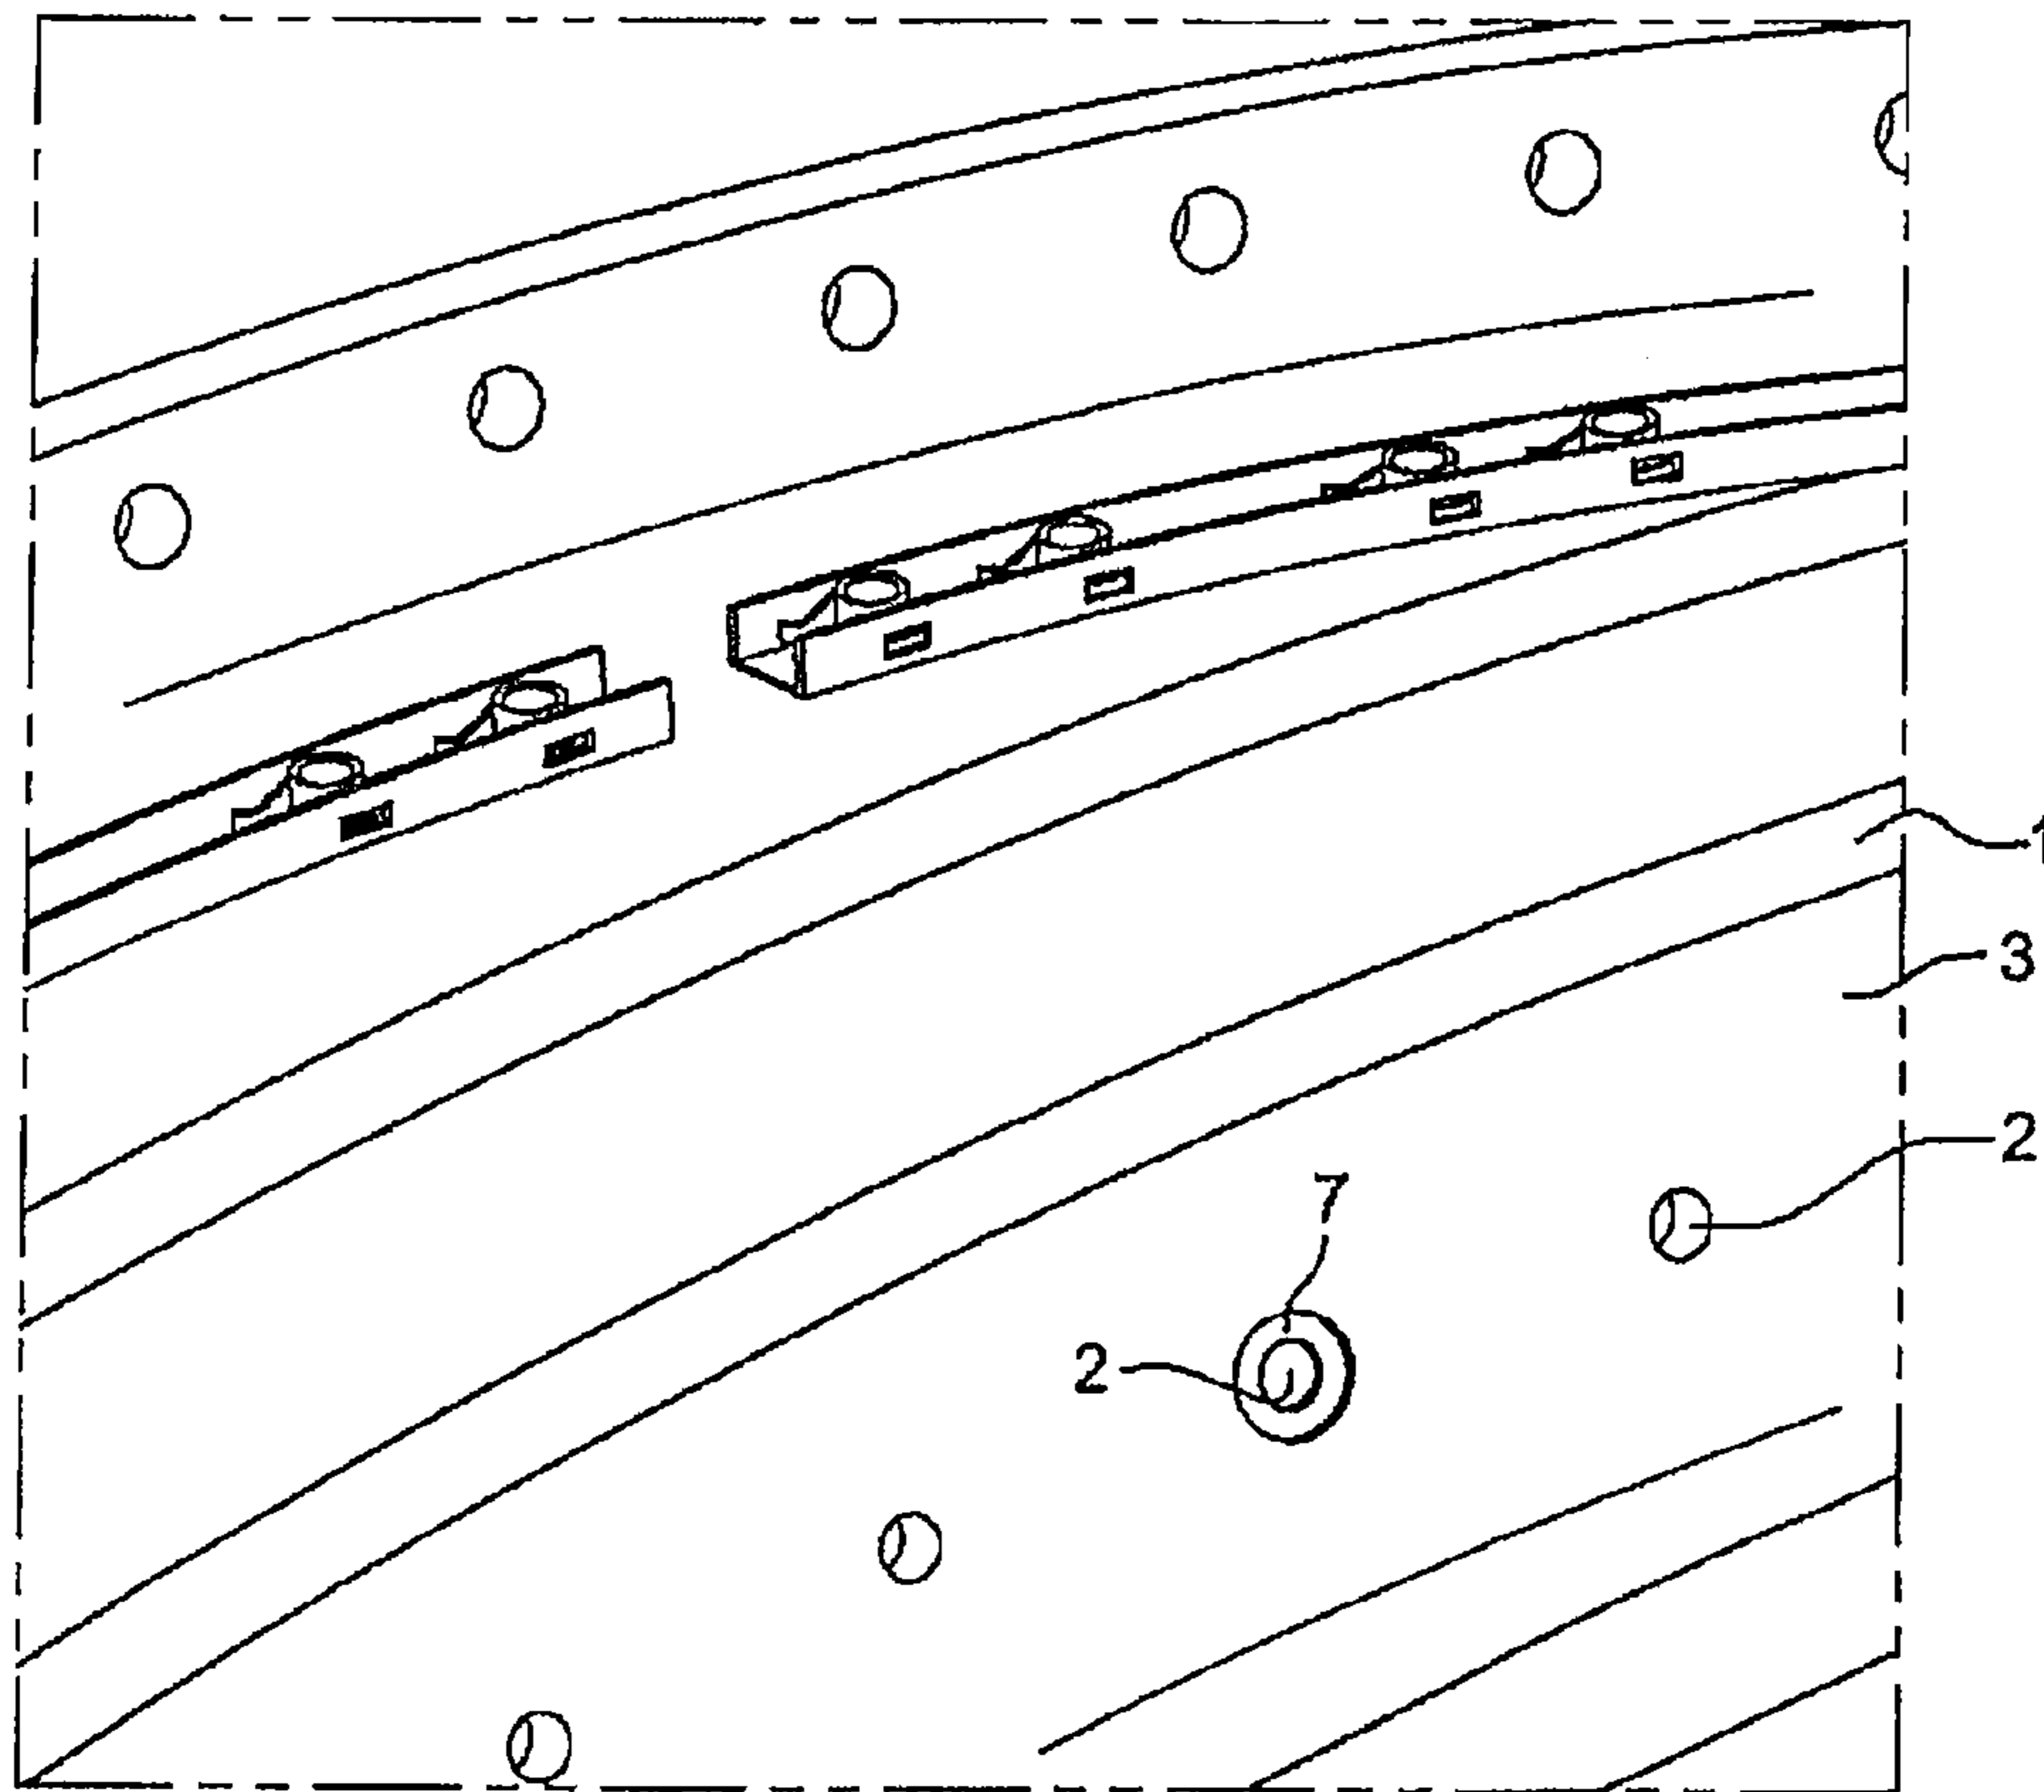
Fig. 4

FIG. 4 is a fragmentary perspective view of the FIG. 3 flange.
