(10) **Patent No.:** **US 9,533,383 B2**
(45) **Date of Patent:** **Jan. 3, 2017**

(54) **METHOD FOR REPAIRING A FLANGE OF A HOUSING**

(73) Assignee: **SNECMA**, Paris (FR)

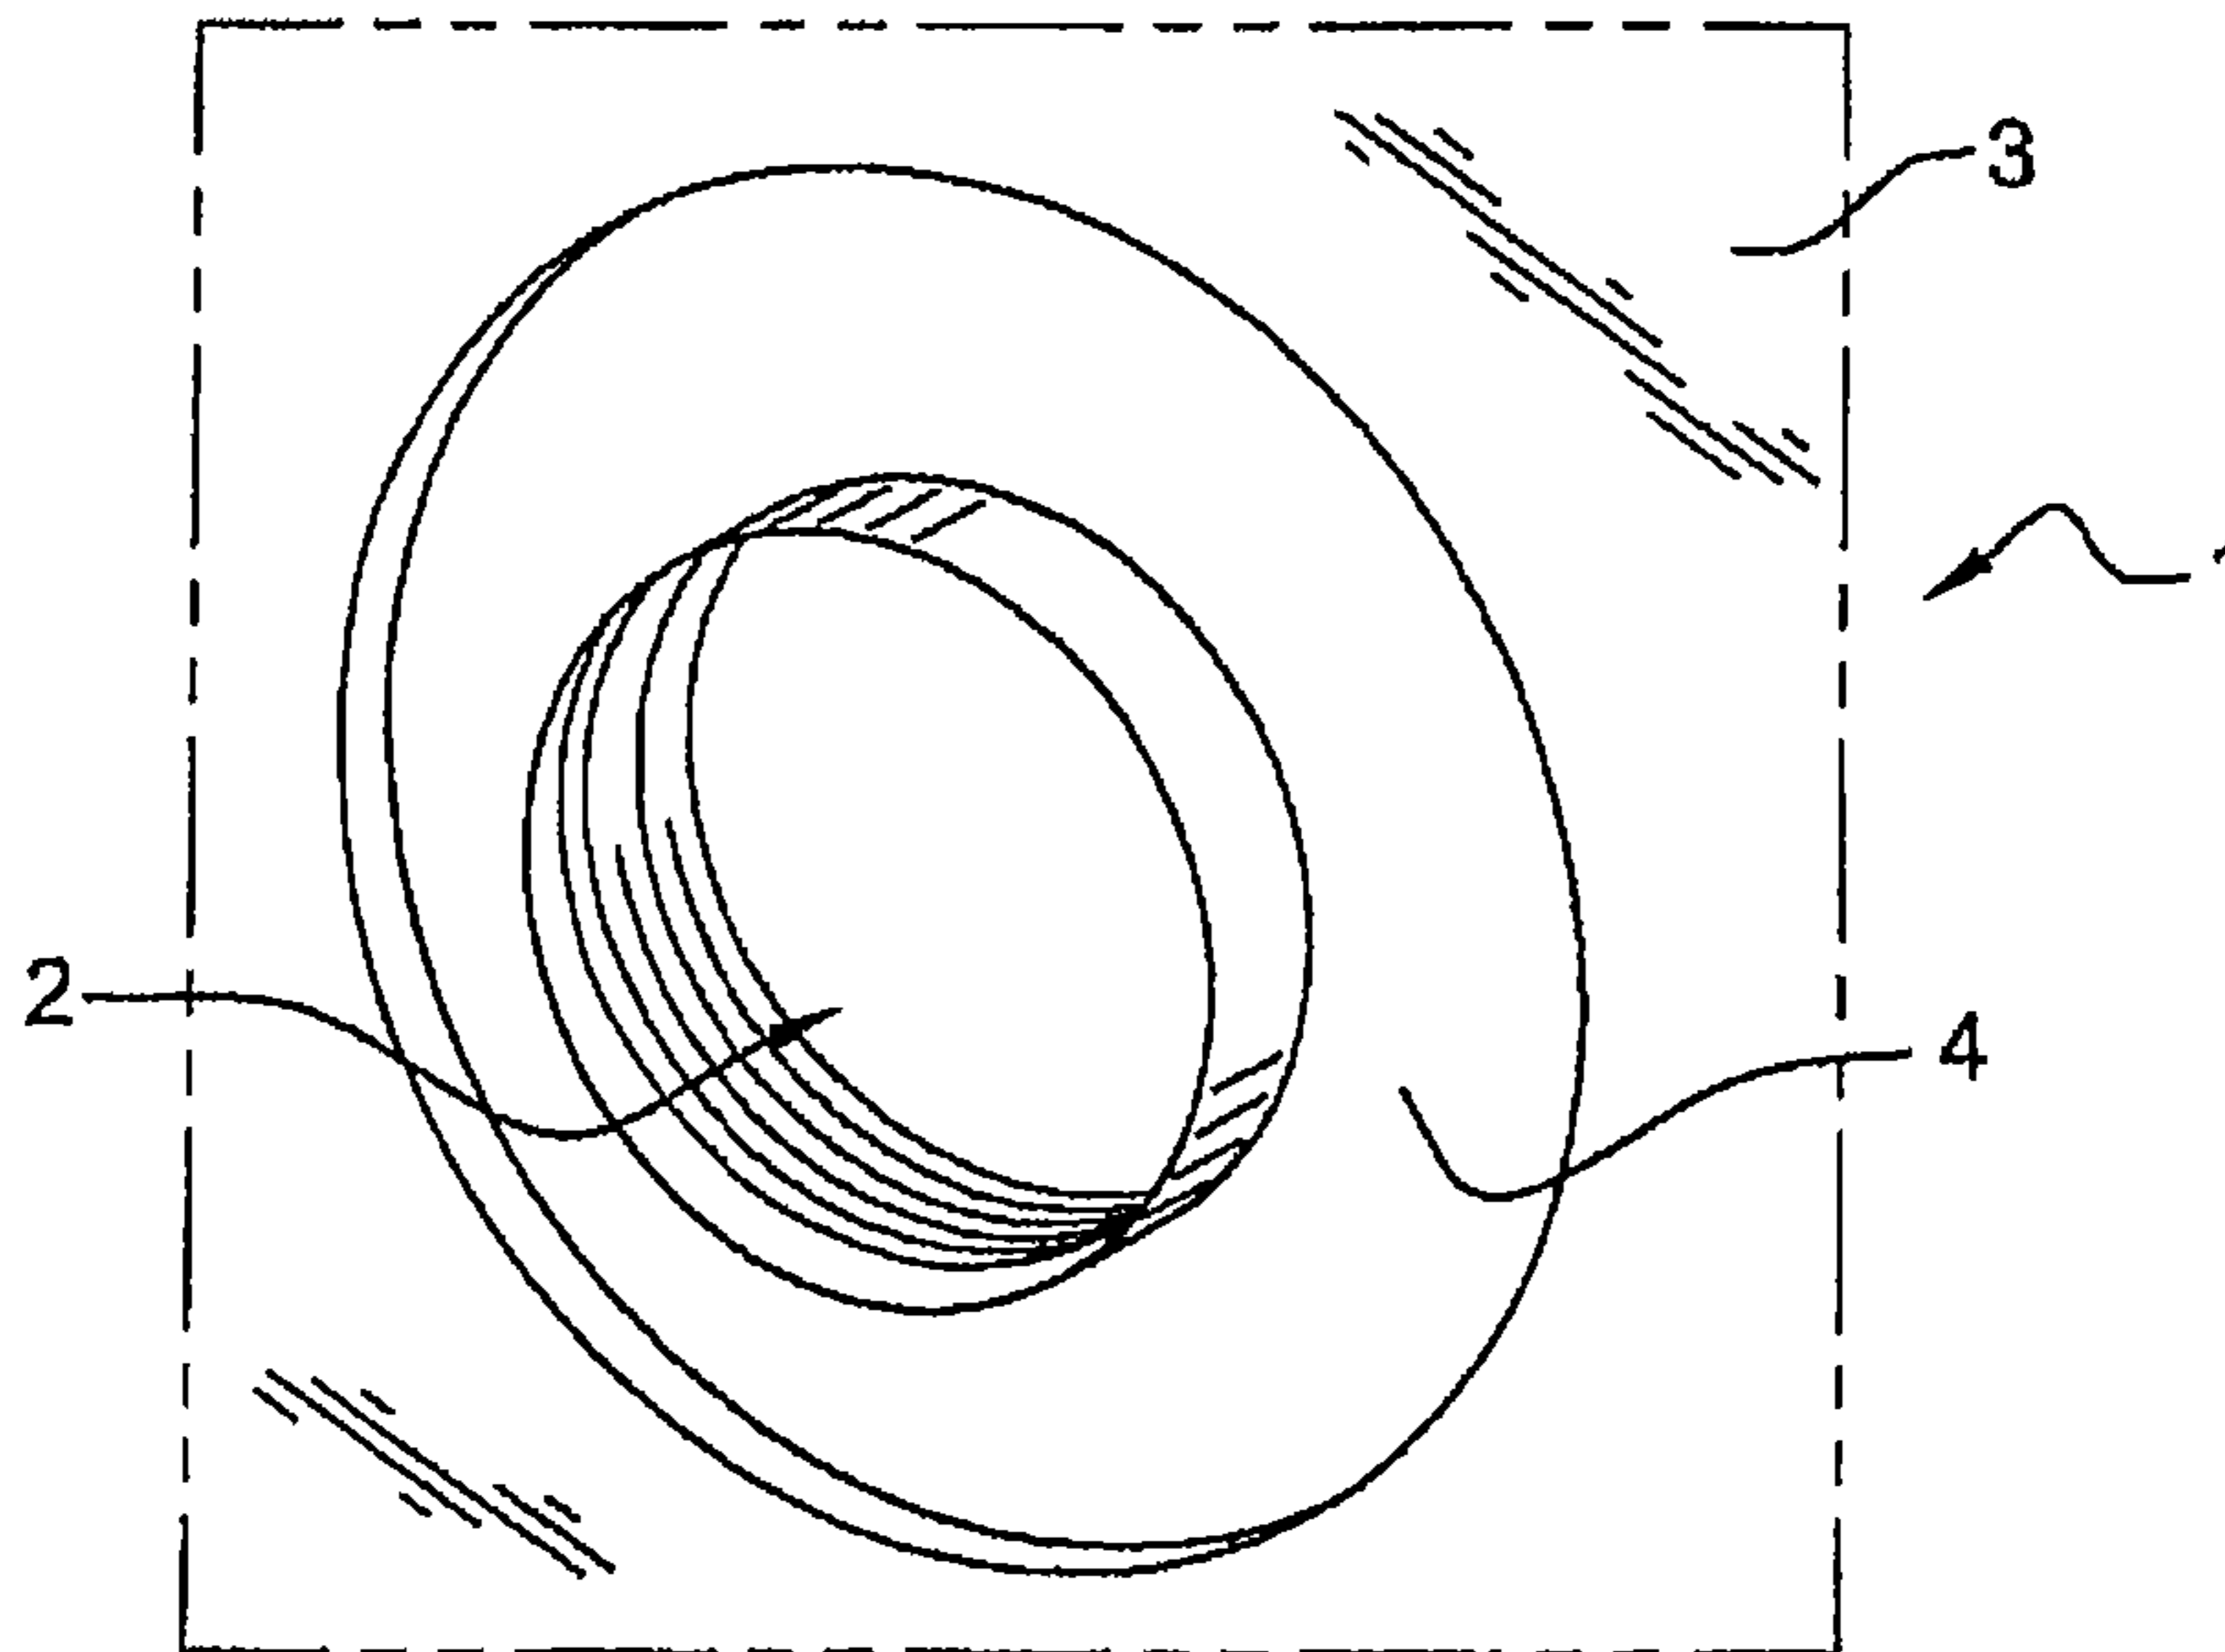
Fig. 2

FIG. 2 is a view on a larger scale of the through hole in the damaged flange;

FIGS. 1 and 2 show an annular flange 1 of an aluminum casing of a high-pressure compressor of a turbojet that has been damaged by mechanical stresses generated while the turbojet was in operation.

In operation, vibration of the casing can give rise to bruising damage 4 of the inside surfaces of the holes 2 and of the side surface 3 of the flange 1. There can thus be seen a localized indentation in the surface 3 of the flange 1 in the zone where contact is made between the flange and the piece of equipment, together with an increase in the diameter of the hole 2 and/or ovalizing of the section of the hole 2. All of these kinds of damage can clearly be seen in FIGS. 1 and 2.

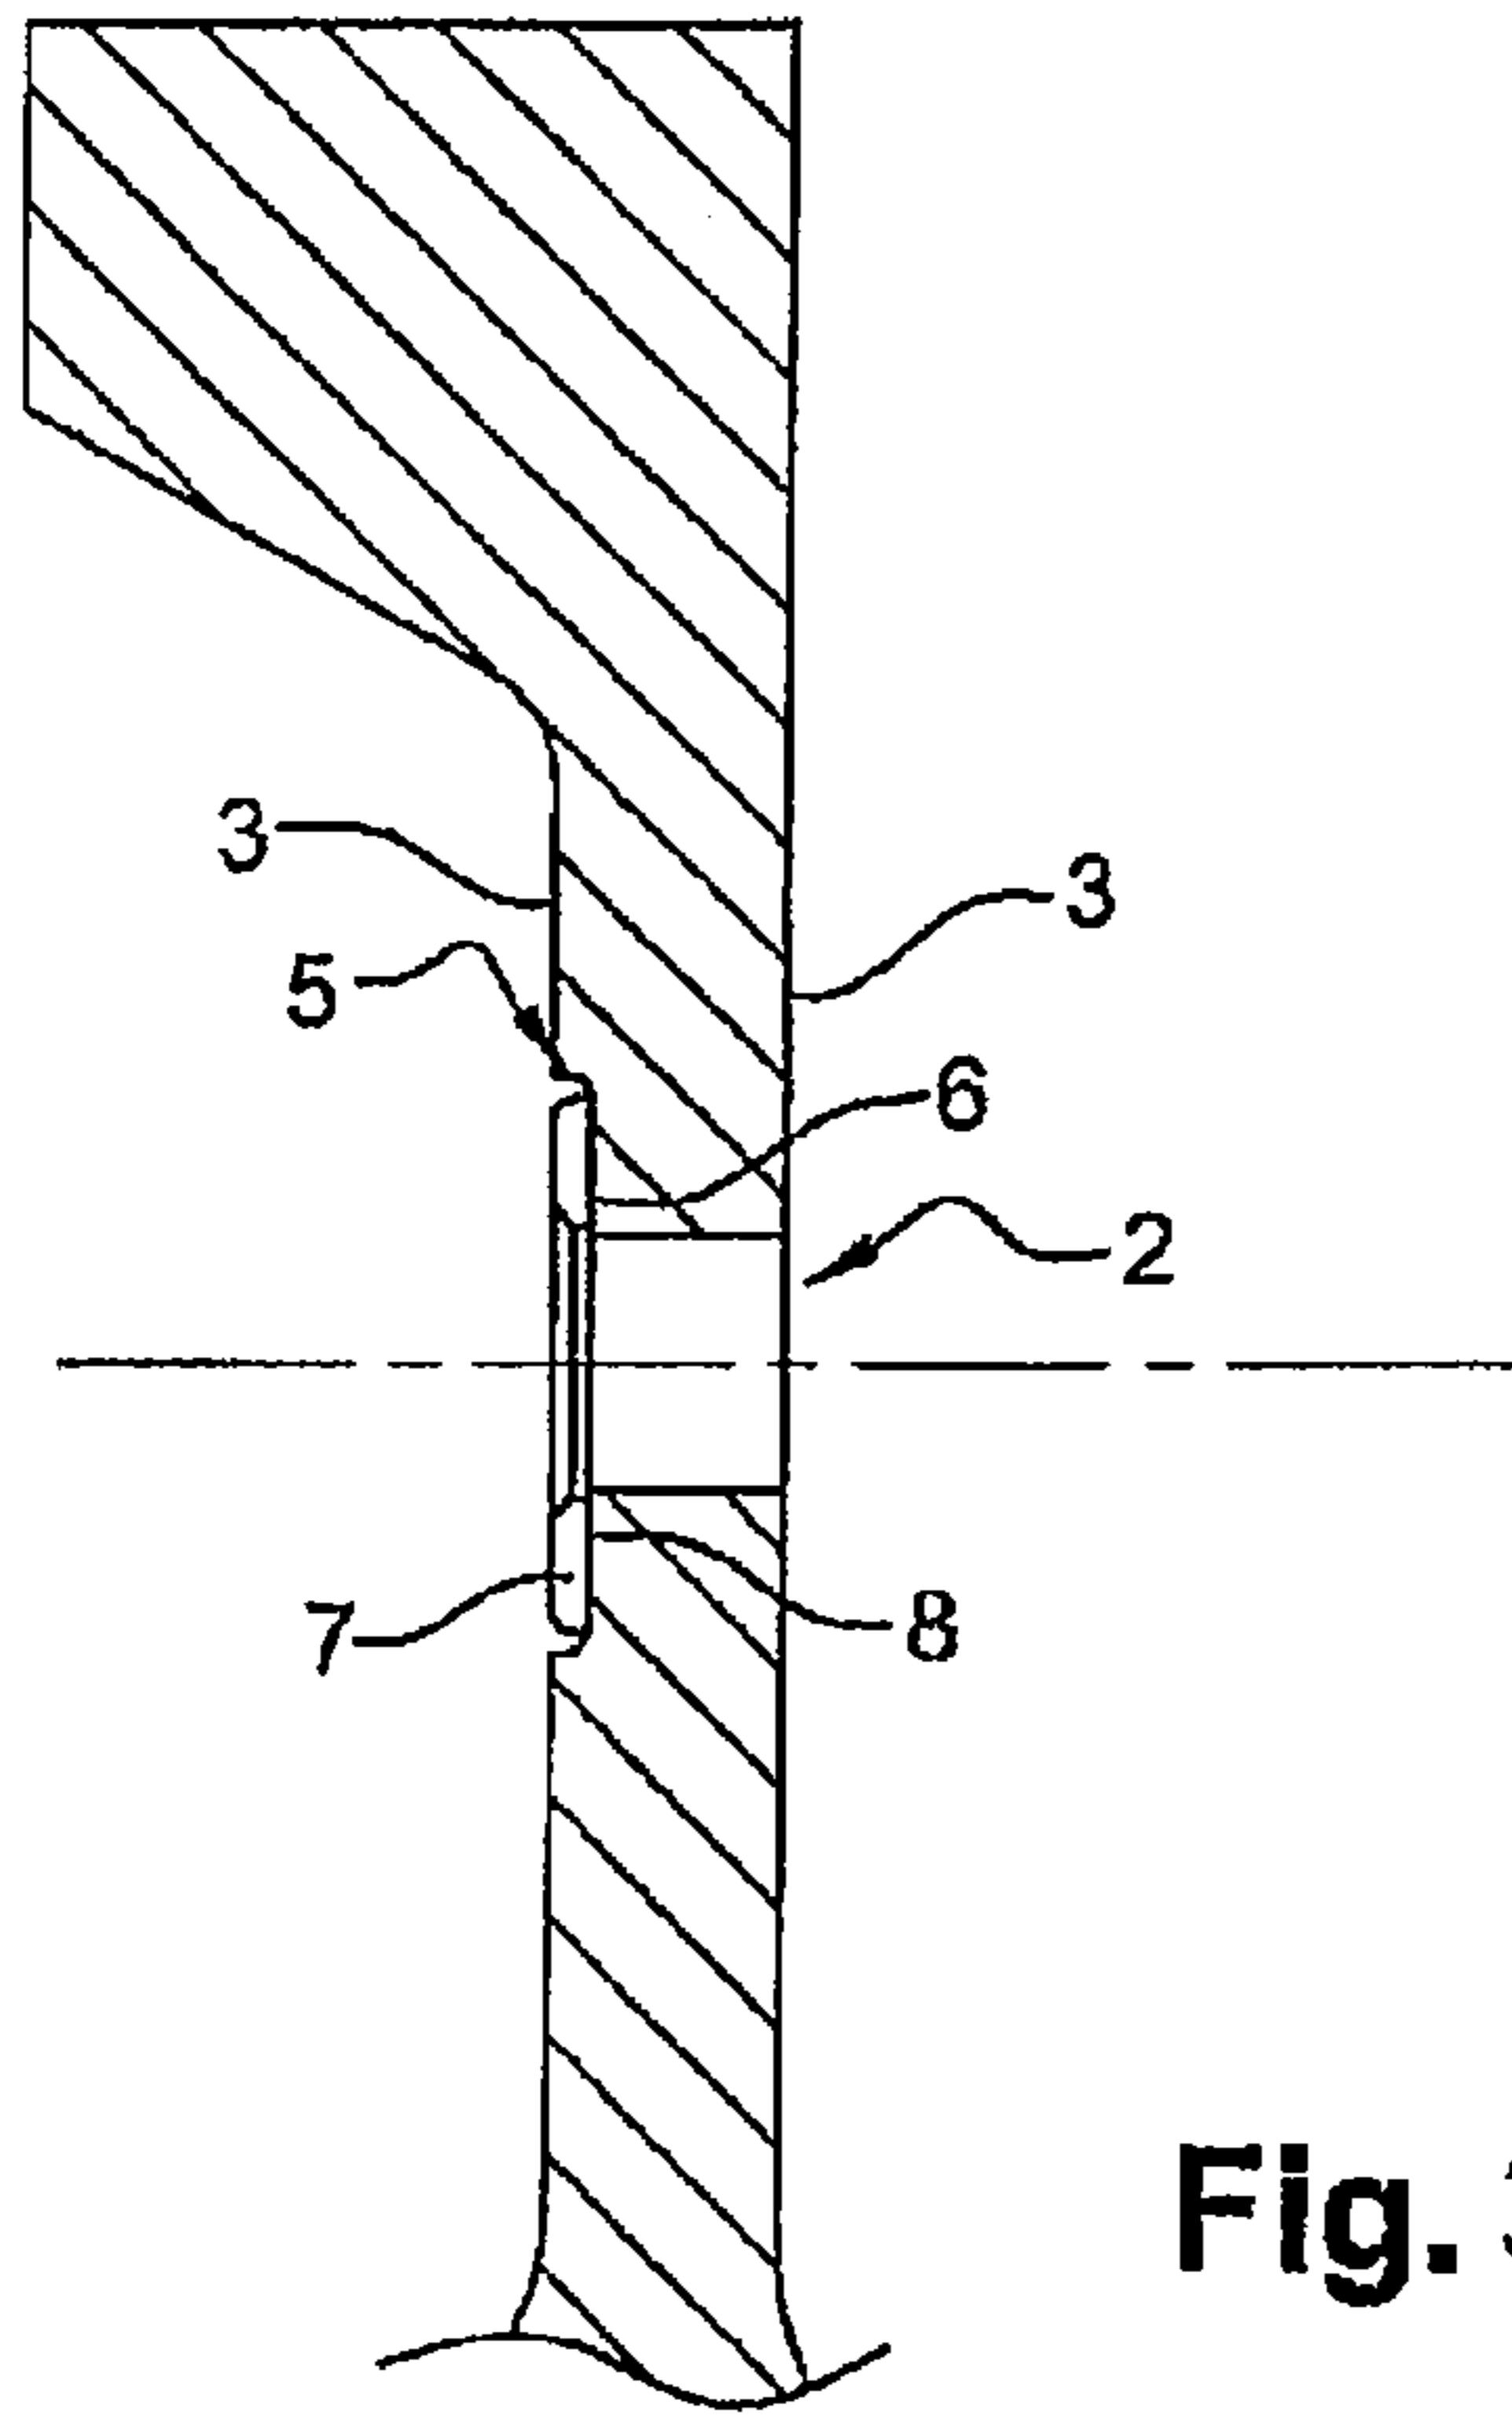
Fig. 3

FIG. 3 is an axial section view through a flange portion that has been repaired by the method of the invention; and
