(12) **United States Patent**
Weiss et al.

(54) **METHOD FOR REPAIRING COMPRESSOR OR TURBINE DRUMS**

(73) Assignee: **Rolls-Royce Deutschland Ltd & Co KG**, Blankerfelde-Mahlow (DE)

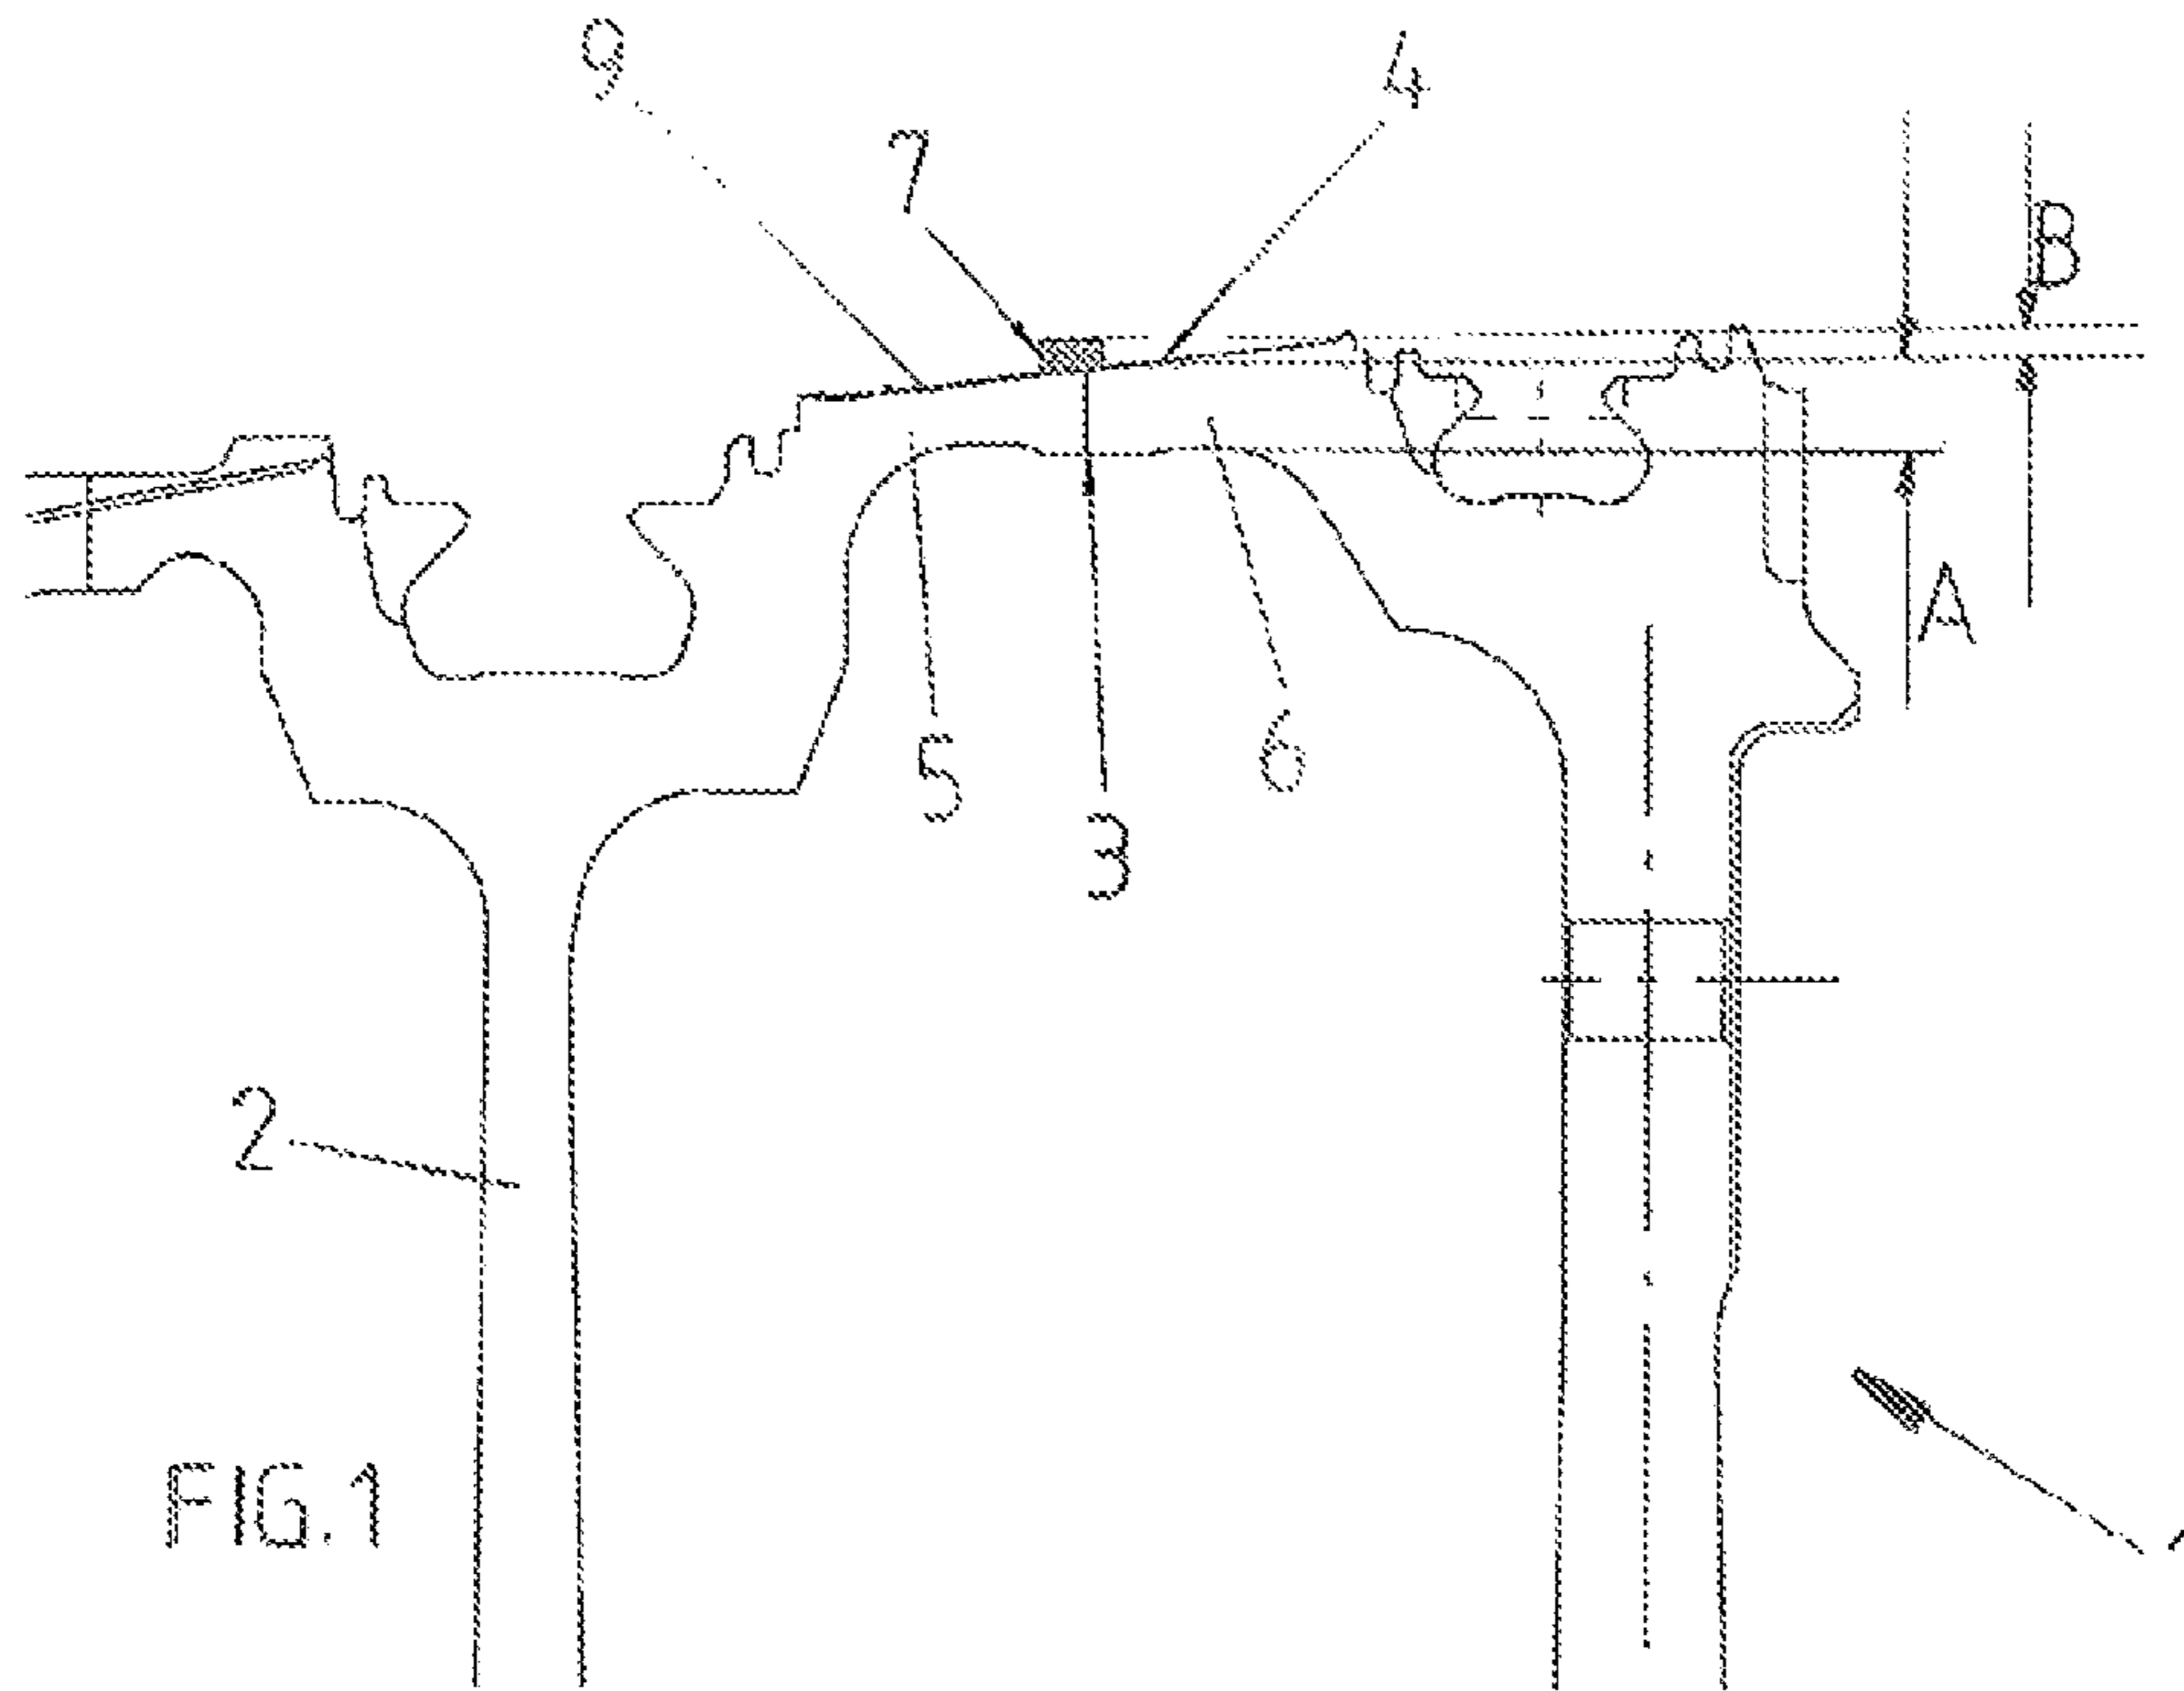
FIG. 1 shows a sectional view of a portion of a welded multi-stage compressor drum before the separation of a worn rotor disk, and

The multi-stage compressor drum 1 shown in FIG. 1 for a gas-turbine engine and designed for separate blading has a defective (worn or damaged) rotor disk 4 connected to an intact rotor disk 2 by a circumferential root face 3. The defective rotor disk 4 should be replaced by a rotor disk 4' already approved (validated) during the original manufacture of the compressor drum 1. Here, the root face 3 has a height A reduced after the machining process.

At the point, of connection between the intact rotor disk 2 and the damaged rotor disk 4, a first and larger material coating 7 extending to both sides beyond the front surface of the root face 3 is applied by means of laser welding—in a first process step—onto the radially outer and machined surface of the two flanges 5, 6 of the rotor disks 2, 4. The height B of the material coating 7 is selected such that the total height (A+B) in the area of the root face 3 attains a value C corresponding to the height of the root face 3' (FIG. 2) during welding of the rotor disks in the new construction before the machining process.

In a second process step, a second and lesser (thinner) material coating 8 is optionally applied by laser welding in the area of the plasma pocket 9 provided on the outer surface of the flange 5 of the rotor disk 2. In the subsequent third process step, the defective rotor disk 4 to be replaced is detached precisely in the root face 3 and through the middle of the first material coating 7 from the intact rotor disk 2 by means of a metal-cutting or alternatively non-metal-cutting separating method.

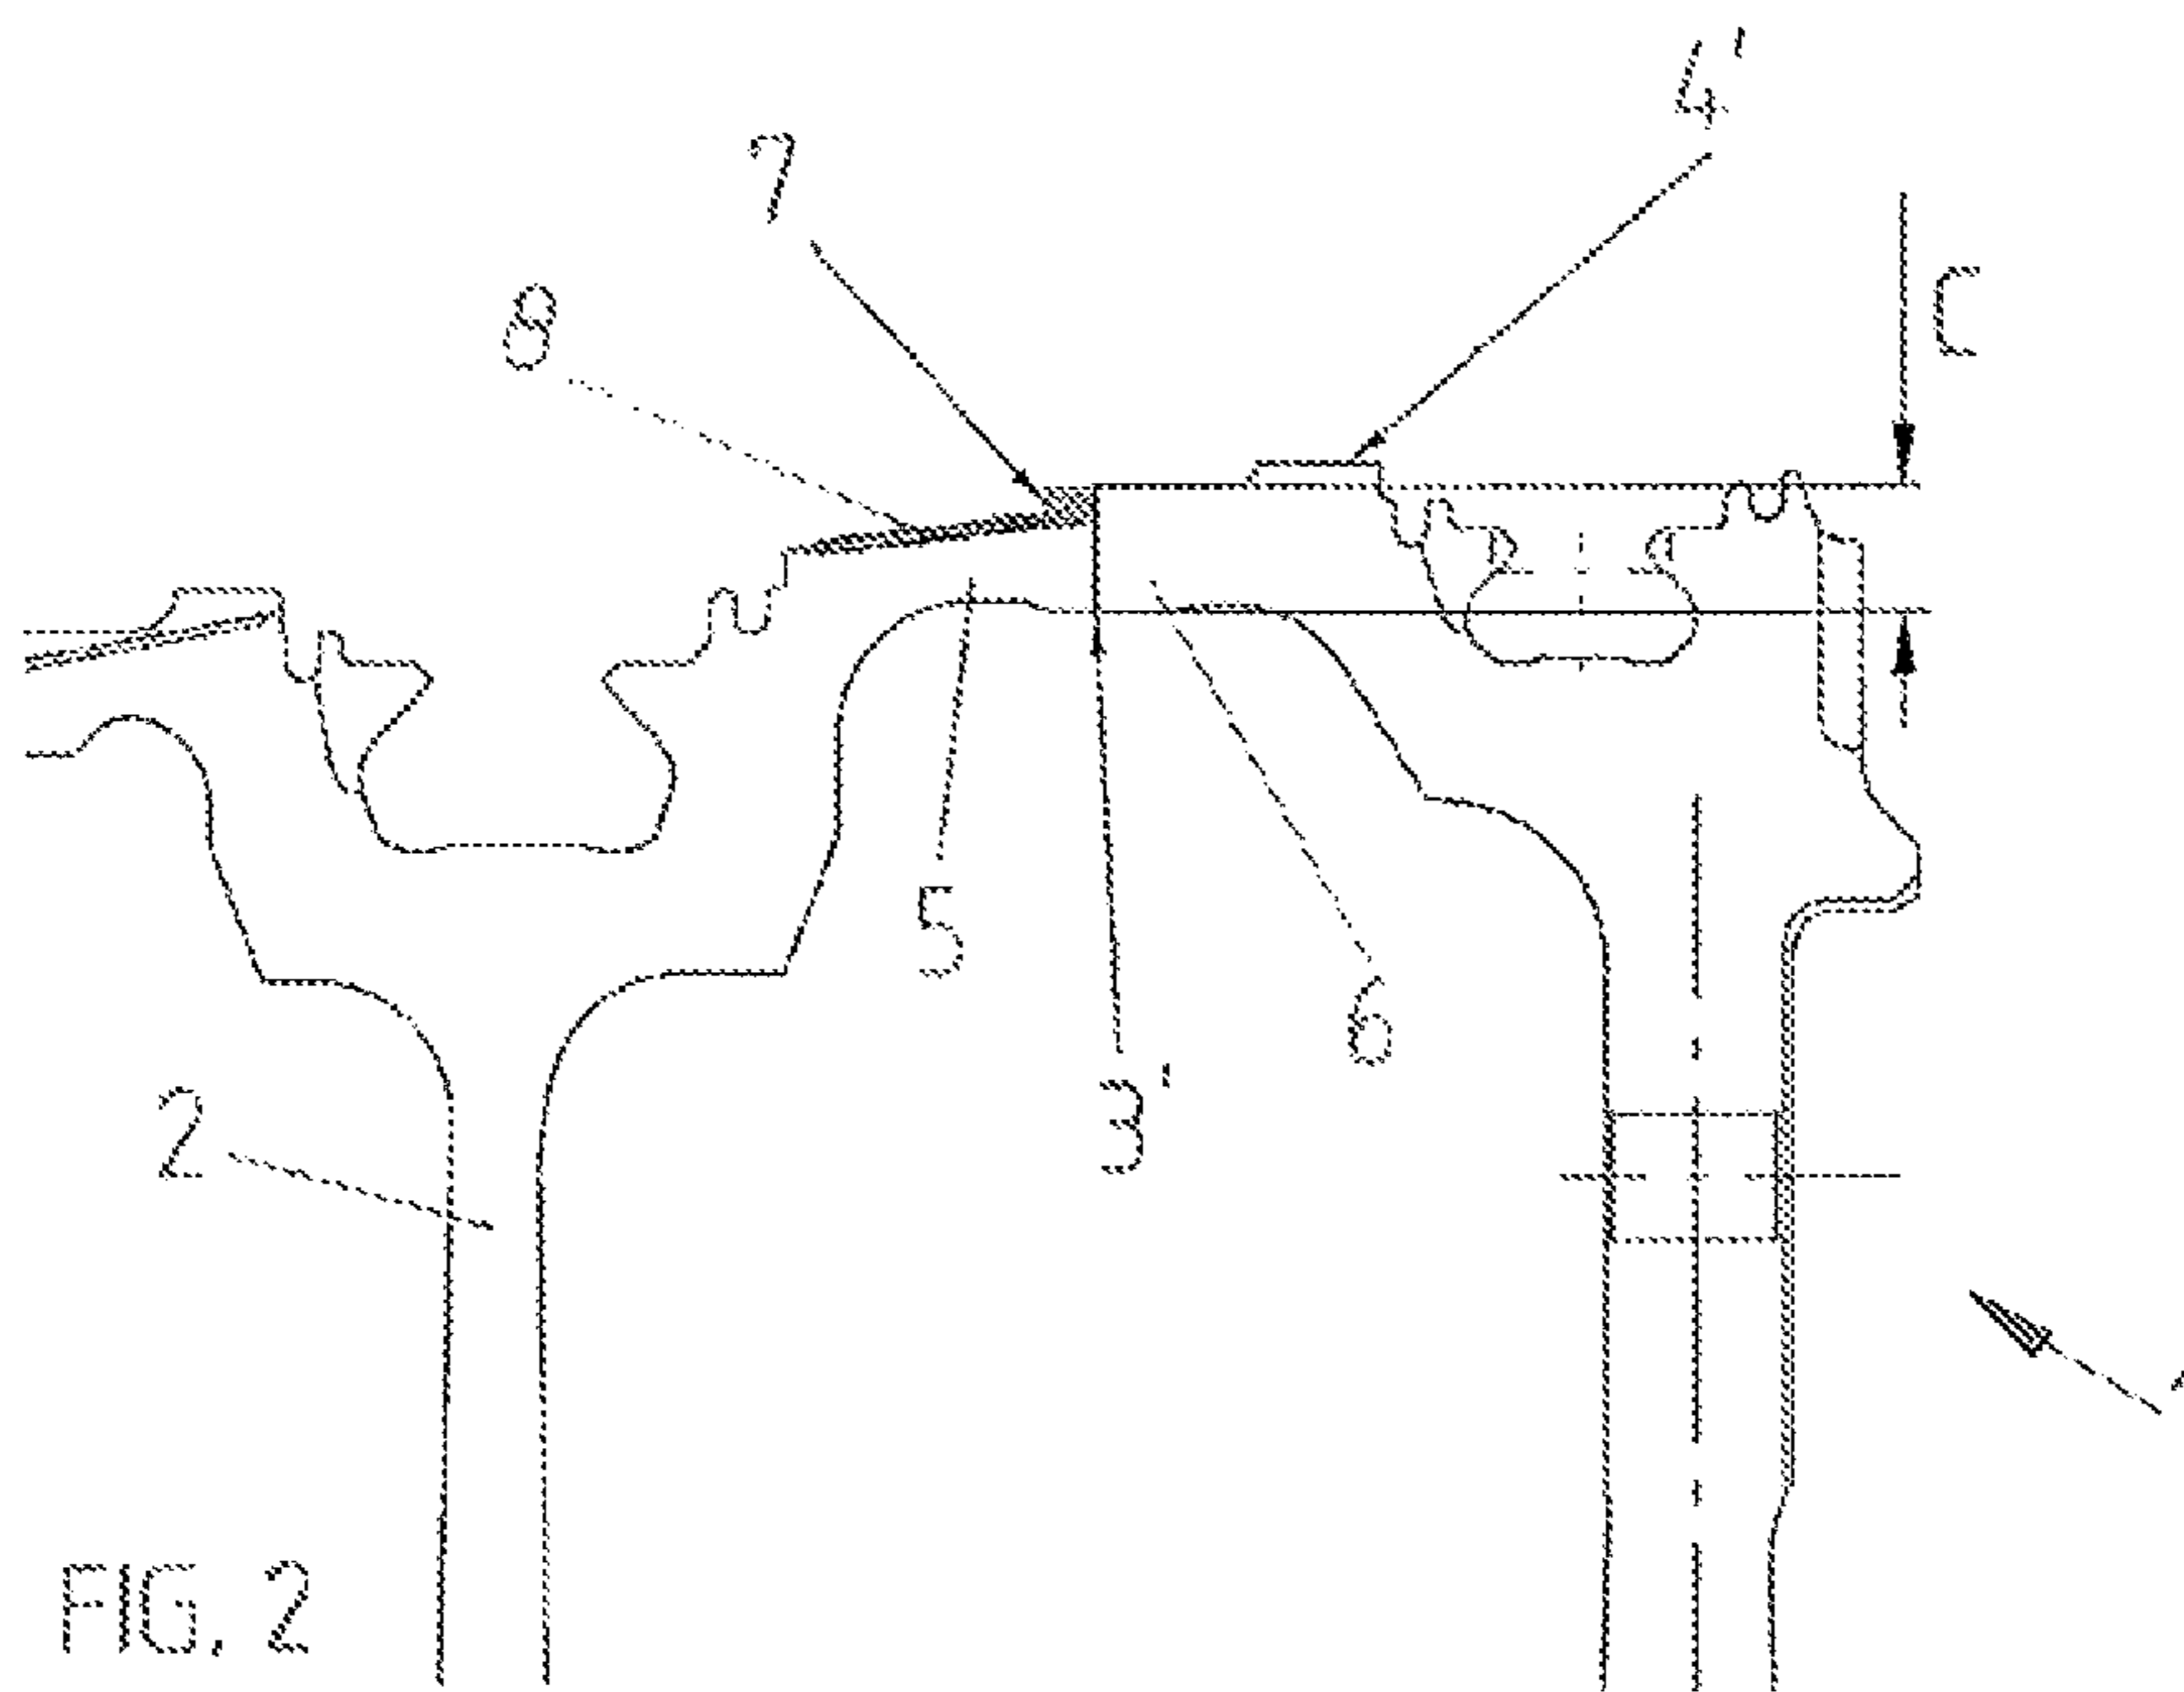
FIG. 2 shows the compressor drum after separation of the worn rotor disk and welding of a new rotor disk.
