(54) **METHOD FOR REPAIRING COMPRESSOR OR TURBINE DRUMS**

(73) Assignee: **Rolls-Royce Deutschland Ltd & Co KG**, Blankerfelde-Mahlow (DE)

This invention relates to a method for repairing two-stage or multi-stage compressor or turbine drums, consisting of rotor disks connected to one another by a root face and having separate or integral blades, by which method a defective rotor disk is separated by metal-cutting and replaced by a new rotor disk.

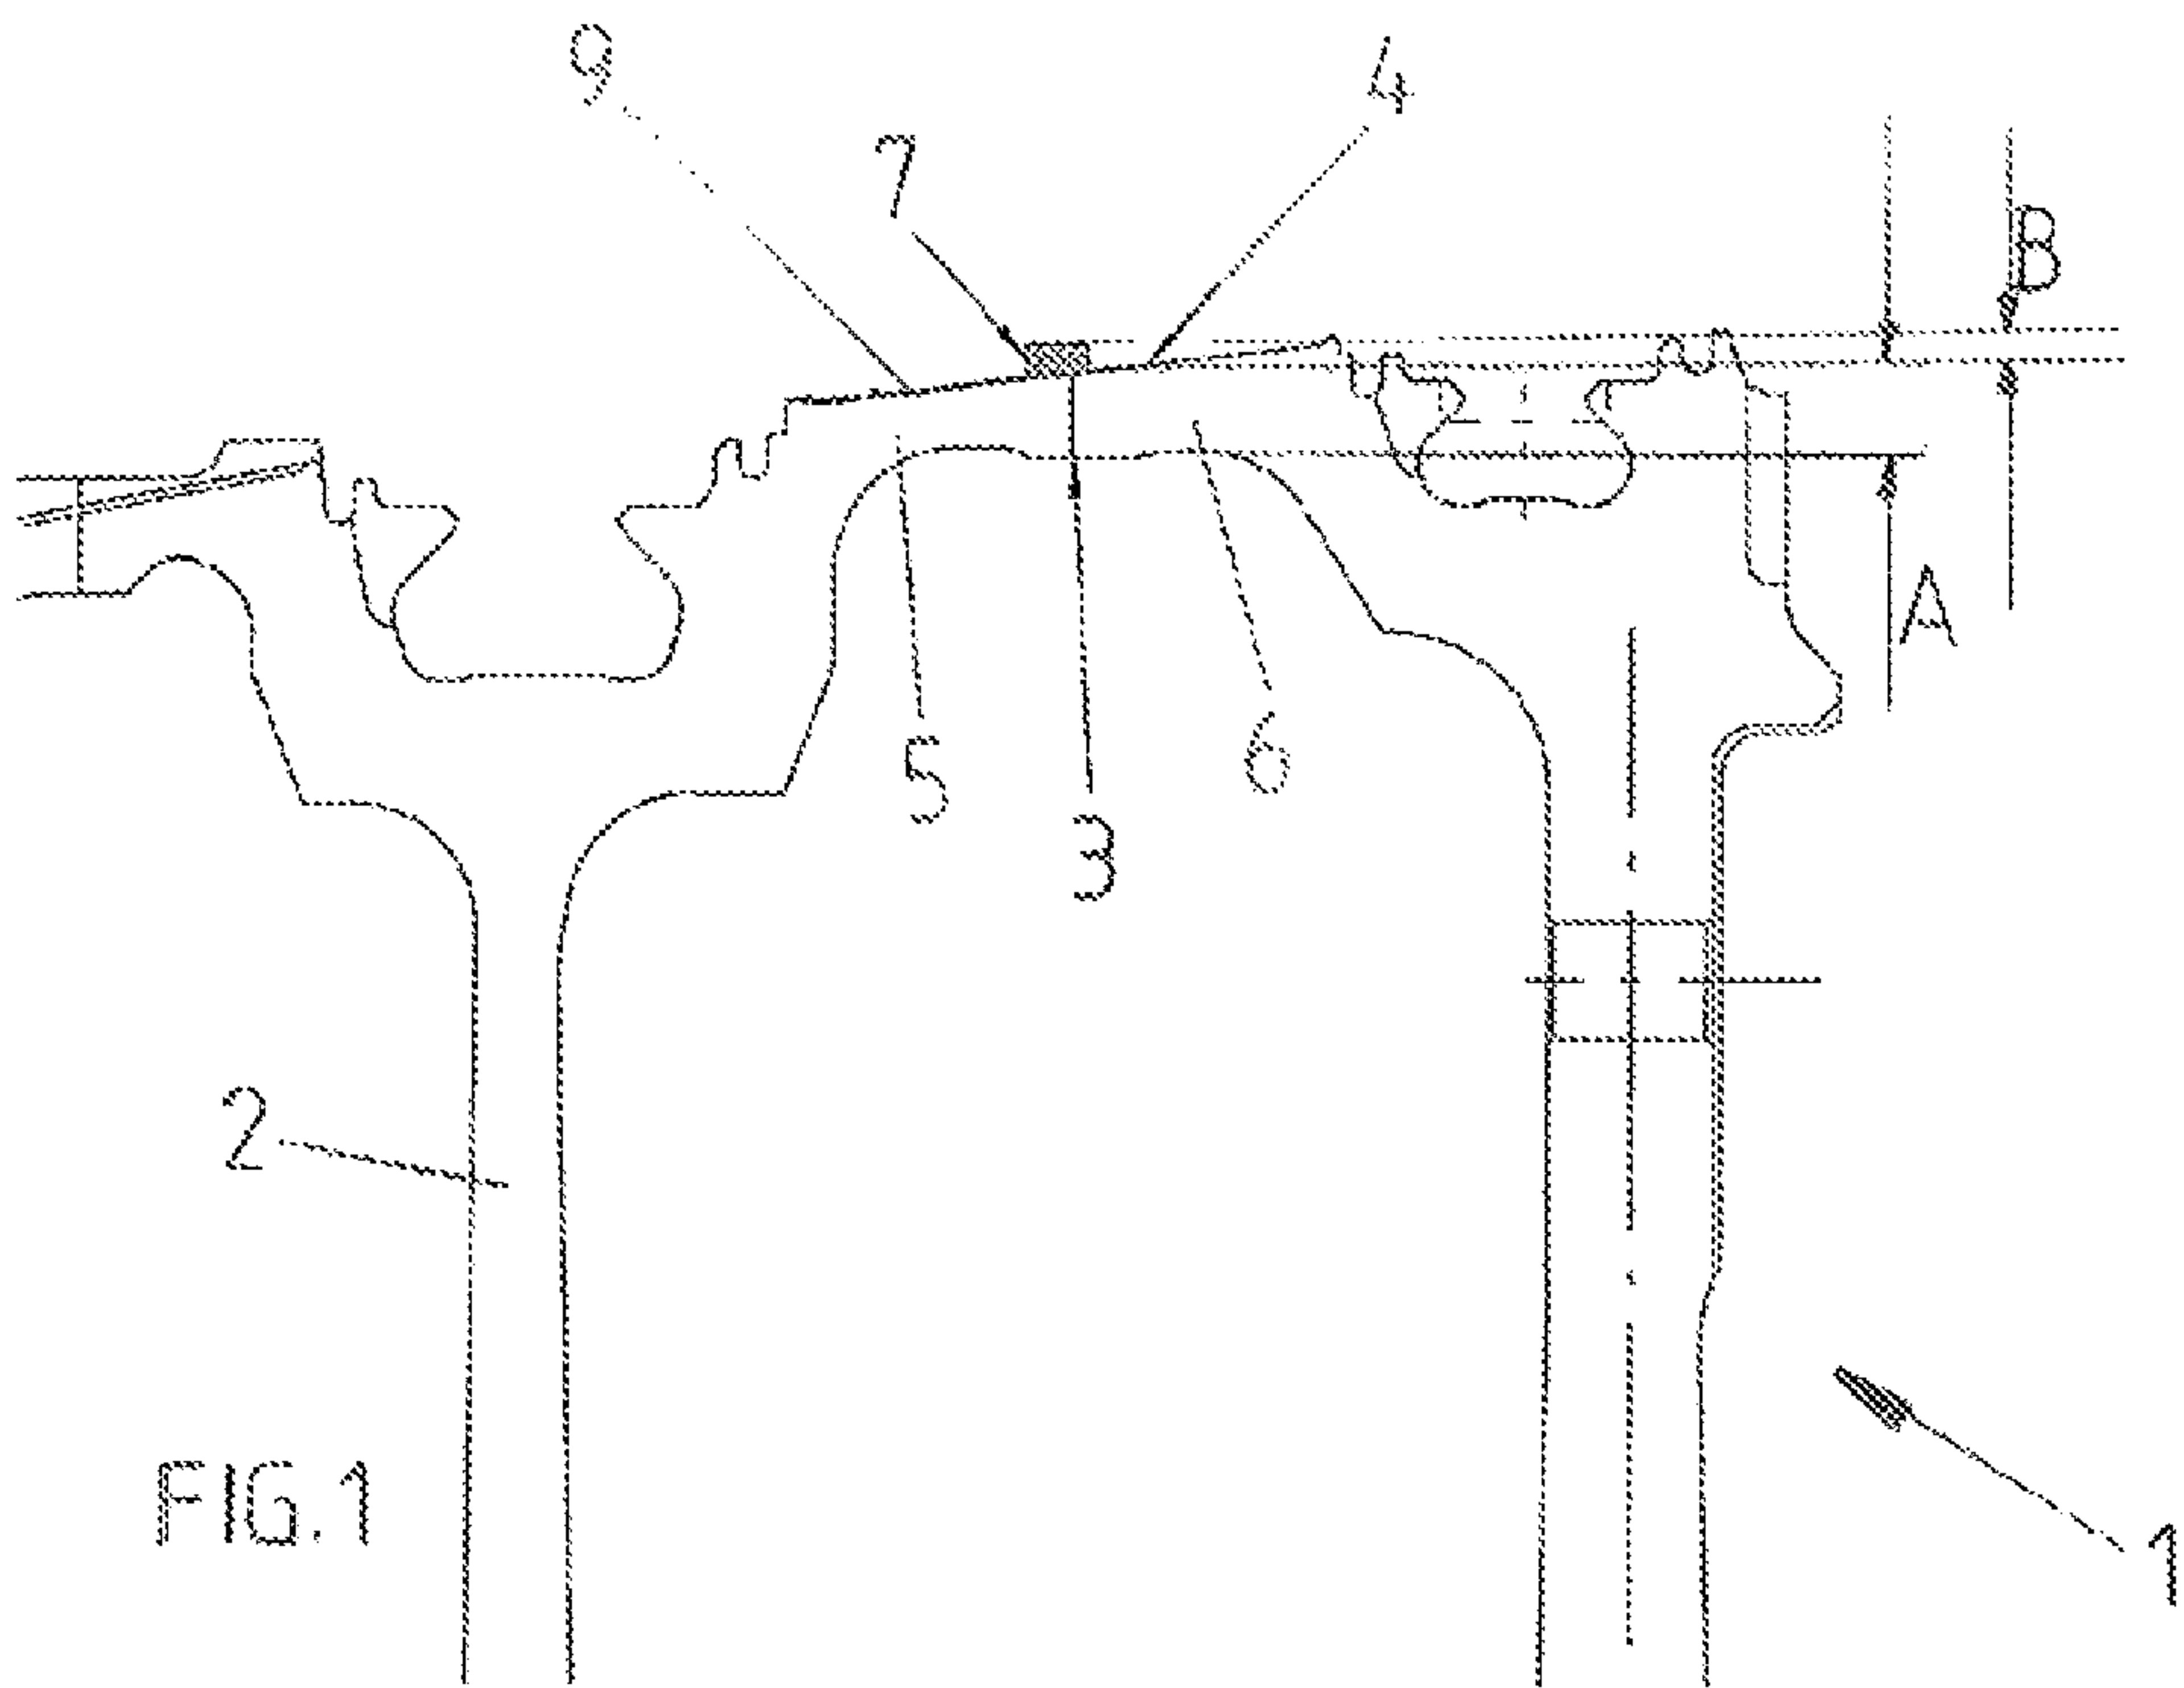
FIG. 1 shows a sectional view of a portion of a welded multi-stage compressor drum before the separation of a worn rotor disk, and

The multi-stage compressor drum 1 shown in FIG. 1 for a gas-turbine engine and designed for separate blading has a defective (worn or damaged) rotor disk 4 connected to an intact rotor disk 2 by a circumferential root face 3. The defective rotor disk 4 should be replaced by a rotor disk 4' already approved (validated) during the original manufacture of the compressor drum 1. Here, the root face 3 has a height A reduced after the machining process.

At the point, of connection between the intact rotor disk 2 and the damaged rotor disk 4, a first and larger material coating 7 extending to both sides beyond the front surface of the root face 3 is applied by means of laser welding—in a first process step—onto the radially outer and machined surface of the two flanges 5, 6 of the rotor disks 2, 4. The height B of the material coating 7 is selected such that the total height (A+B) in the area of the root face 3 attains a value C corresponding to the height of the root face 3' (FIG. 2) during welding of the rotor disks in the new construction before the machining process.

In a second process step, a second and lesser (thinner) material coating 8 is optionally applied by laser welding in the area of the plasma pocket 9 provided on the outer surface of the flange 5 of the rotor disk 2. In the subsequent third process step, the defective rotor disk 4 to be replaced is detached precisely in the root face 3 and through the middle of the first material coating 7 from the intact rotor disk 2 by means of a metal-cutting or alternatively non-metal-cutting separating method.

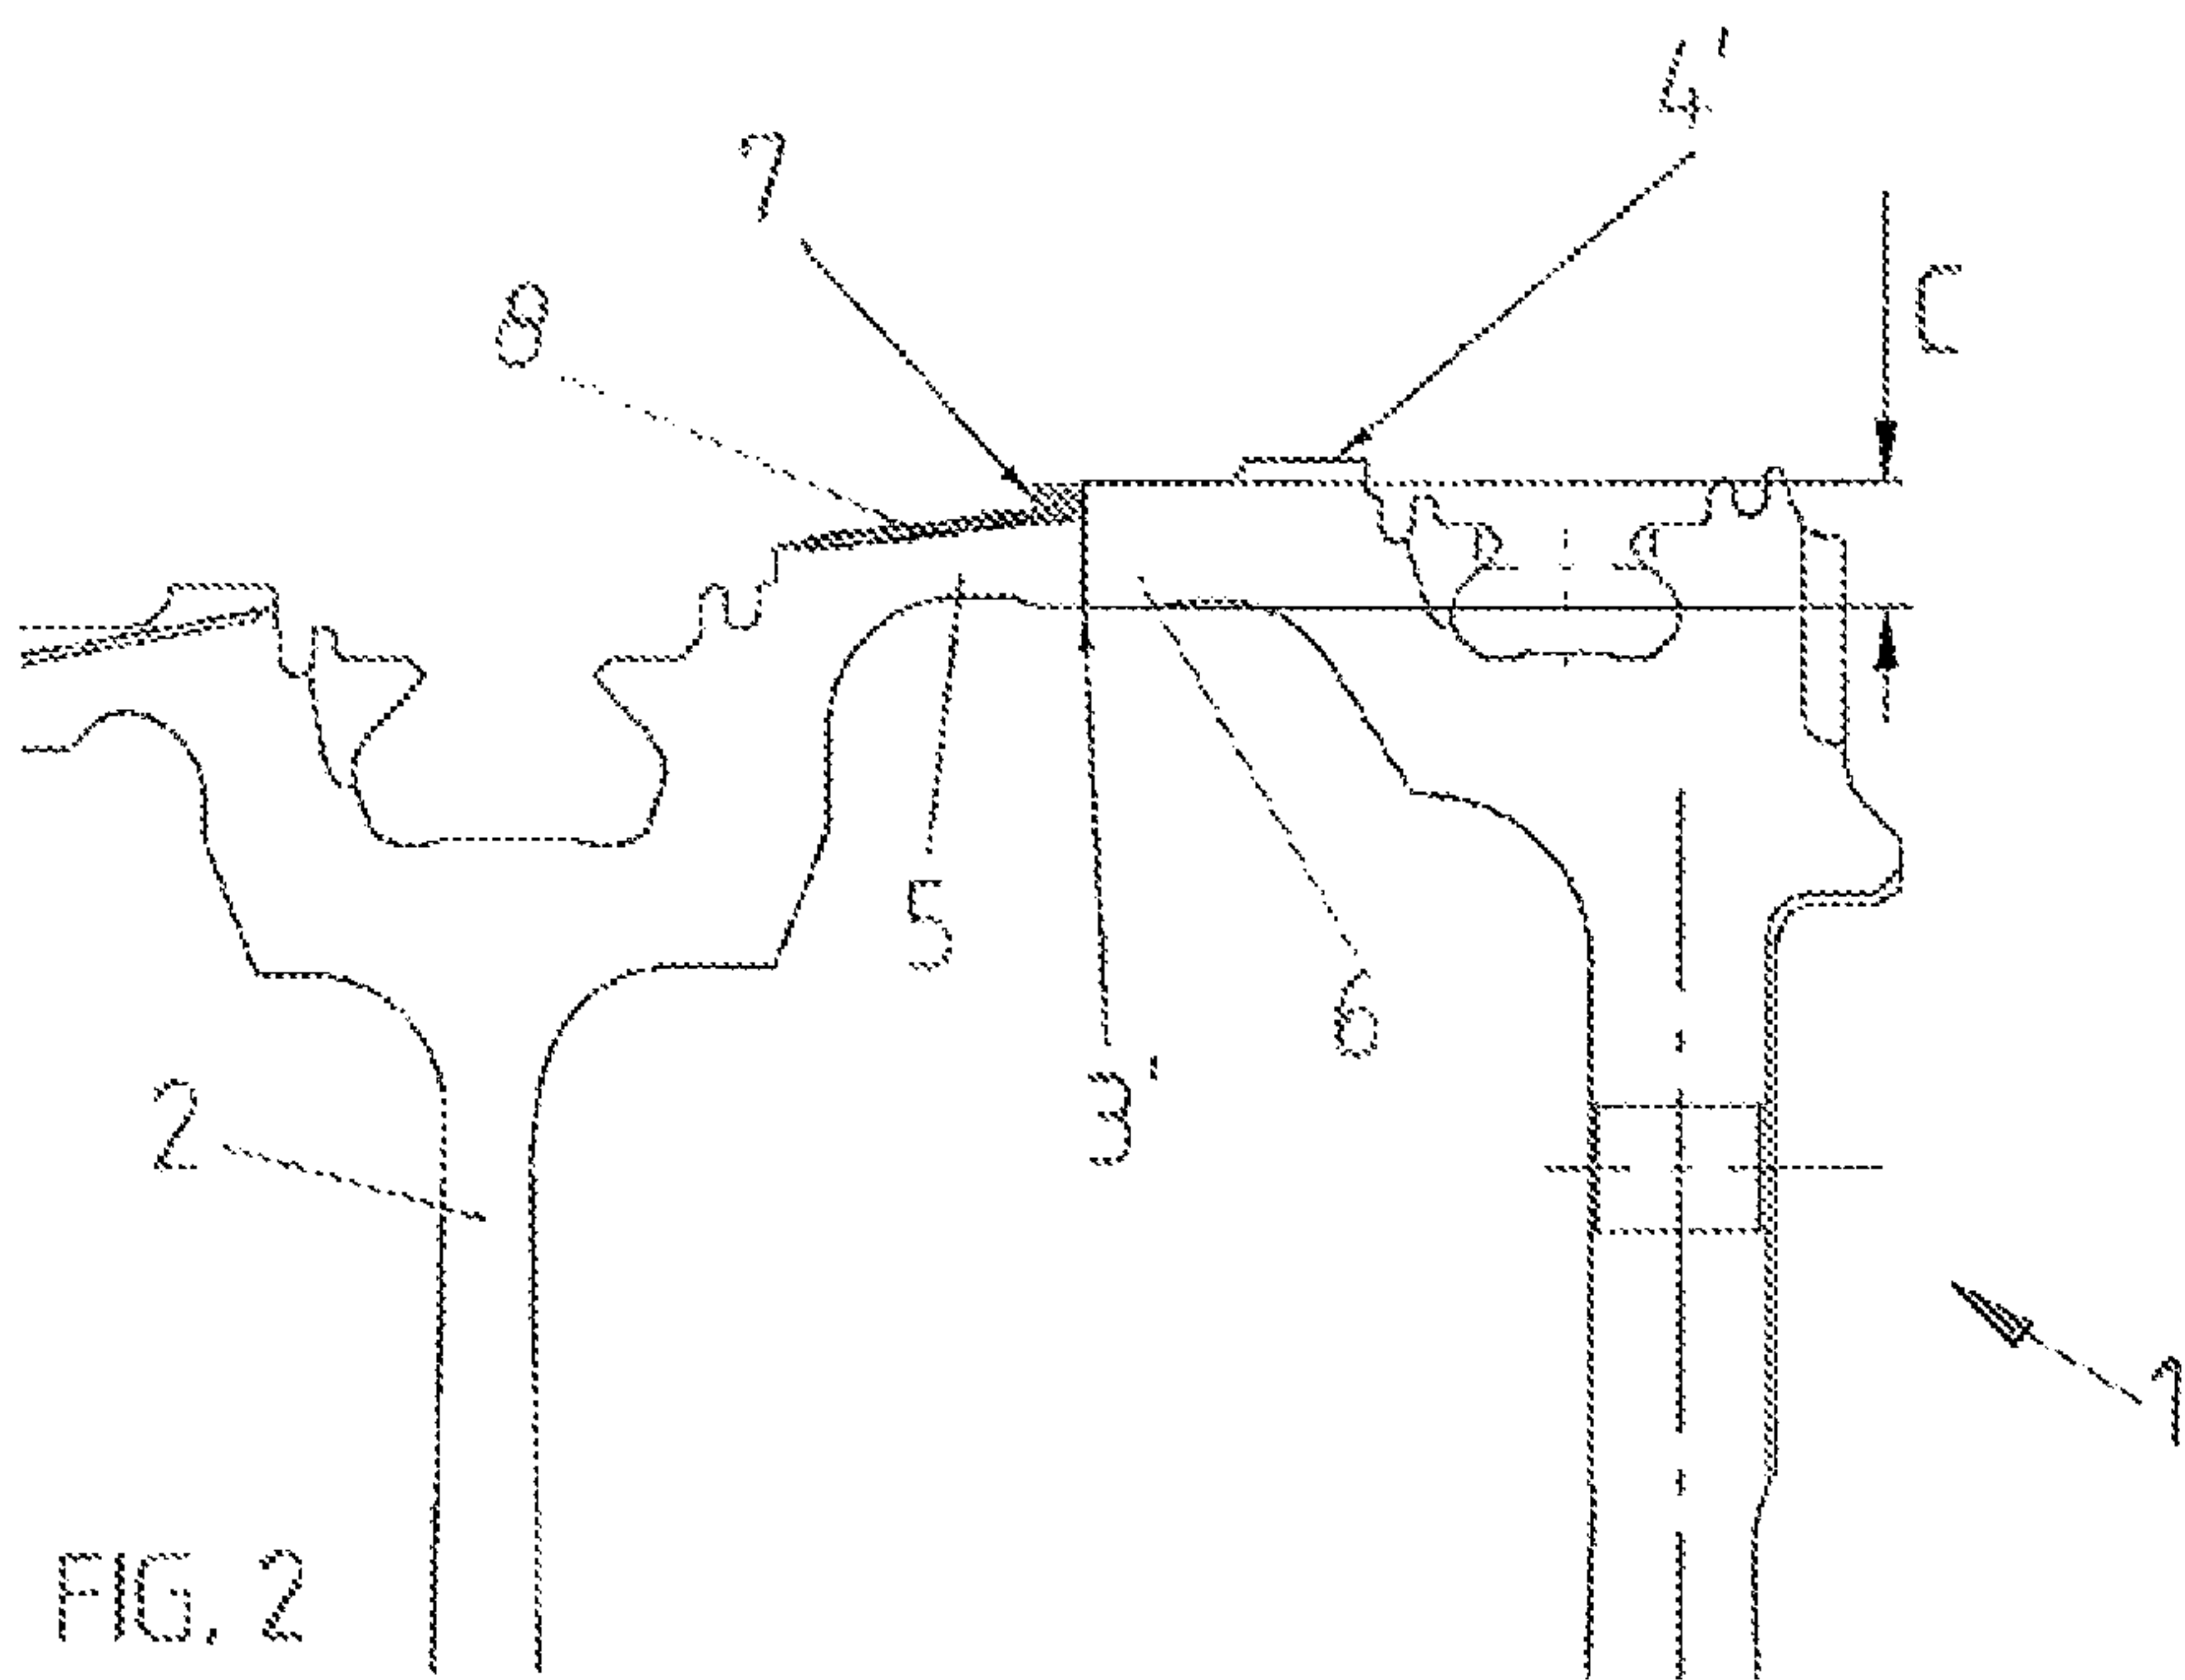
FIG. 2 shows the compressor drum after separation of the worn rotor disk and welding of a new rotor disk.
