(10) **Patent No.:** **US 9,670,793 B2**
(45) **Date of Patent:** **Jun. 6, 2017**

(54) **IR SENSOR/SYSTEM FOR DETECTION OF HEATING ASSOCIATED WITH CRACK PROPAGATION DURING OPERATION OF ROTATING EQUIPMENT**

(71) Applicant: **Siemens Energy, Inc.**, Orlando, FL
(US)

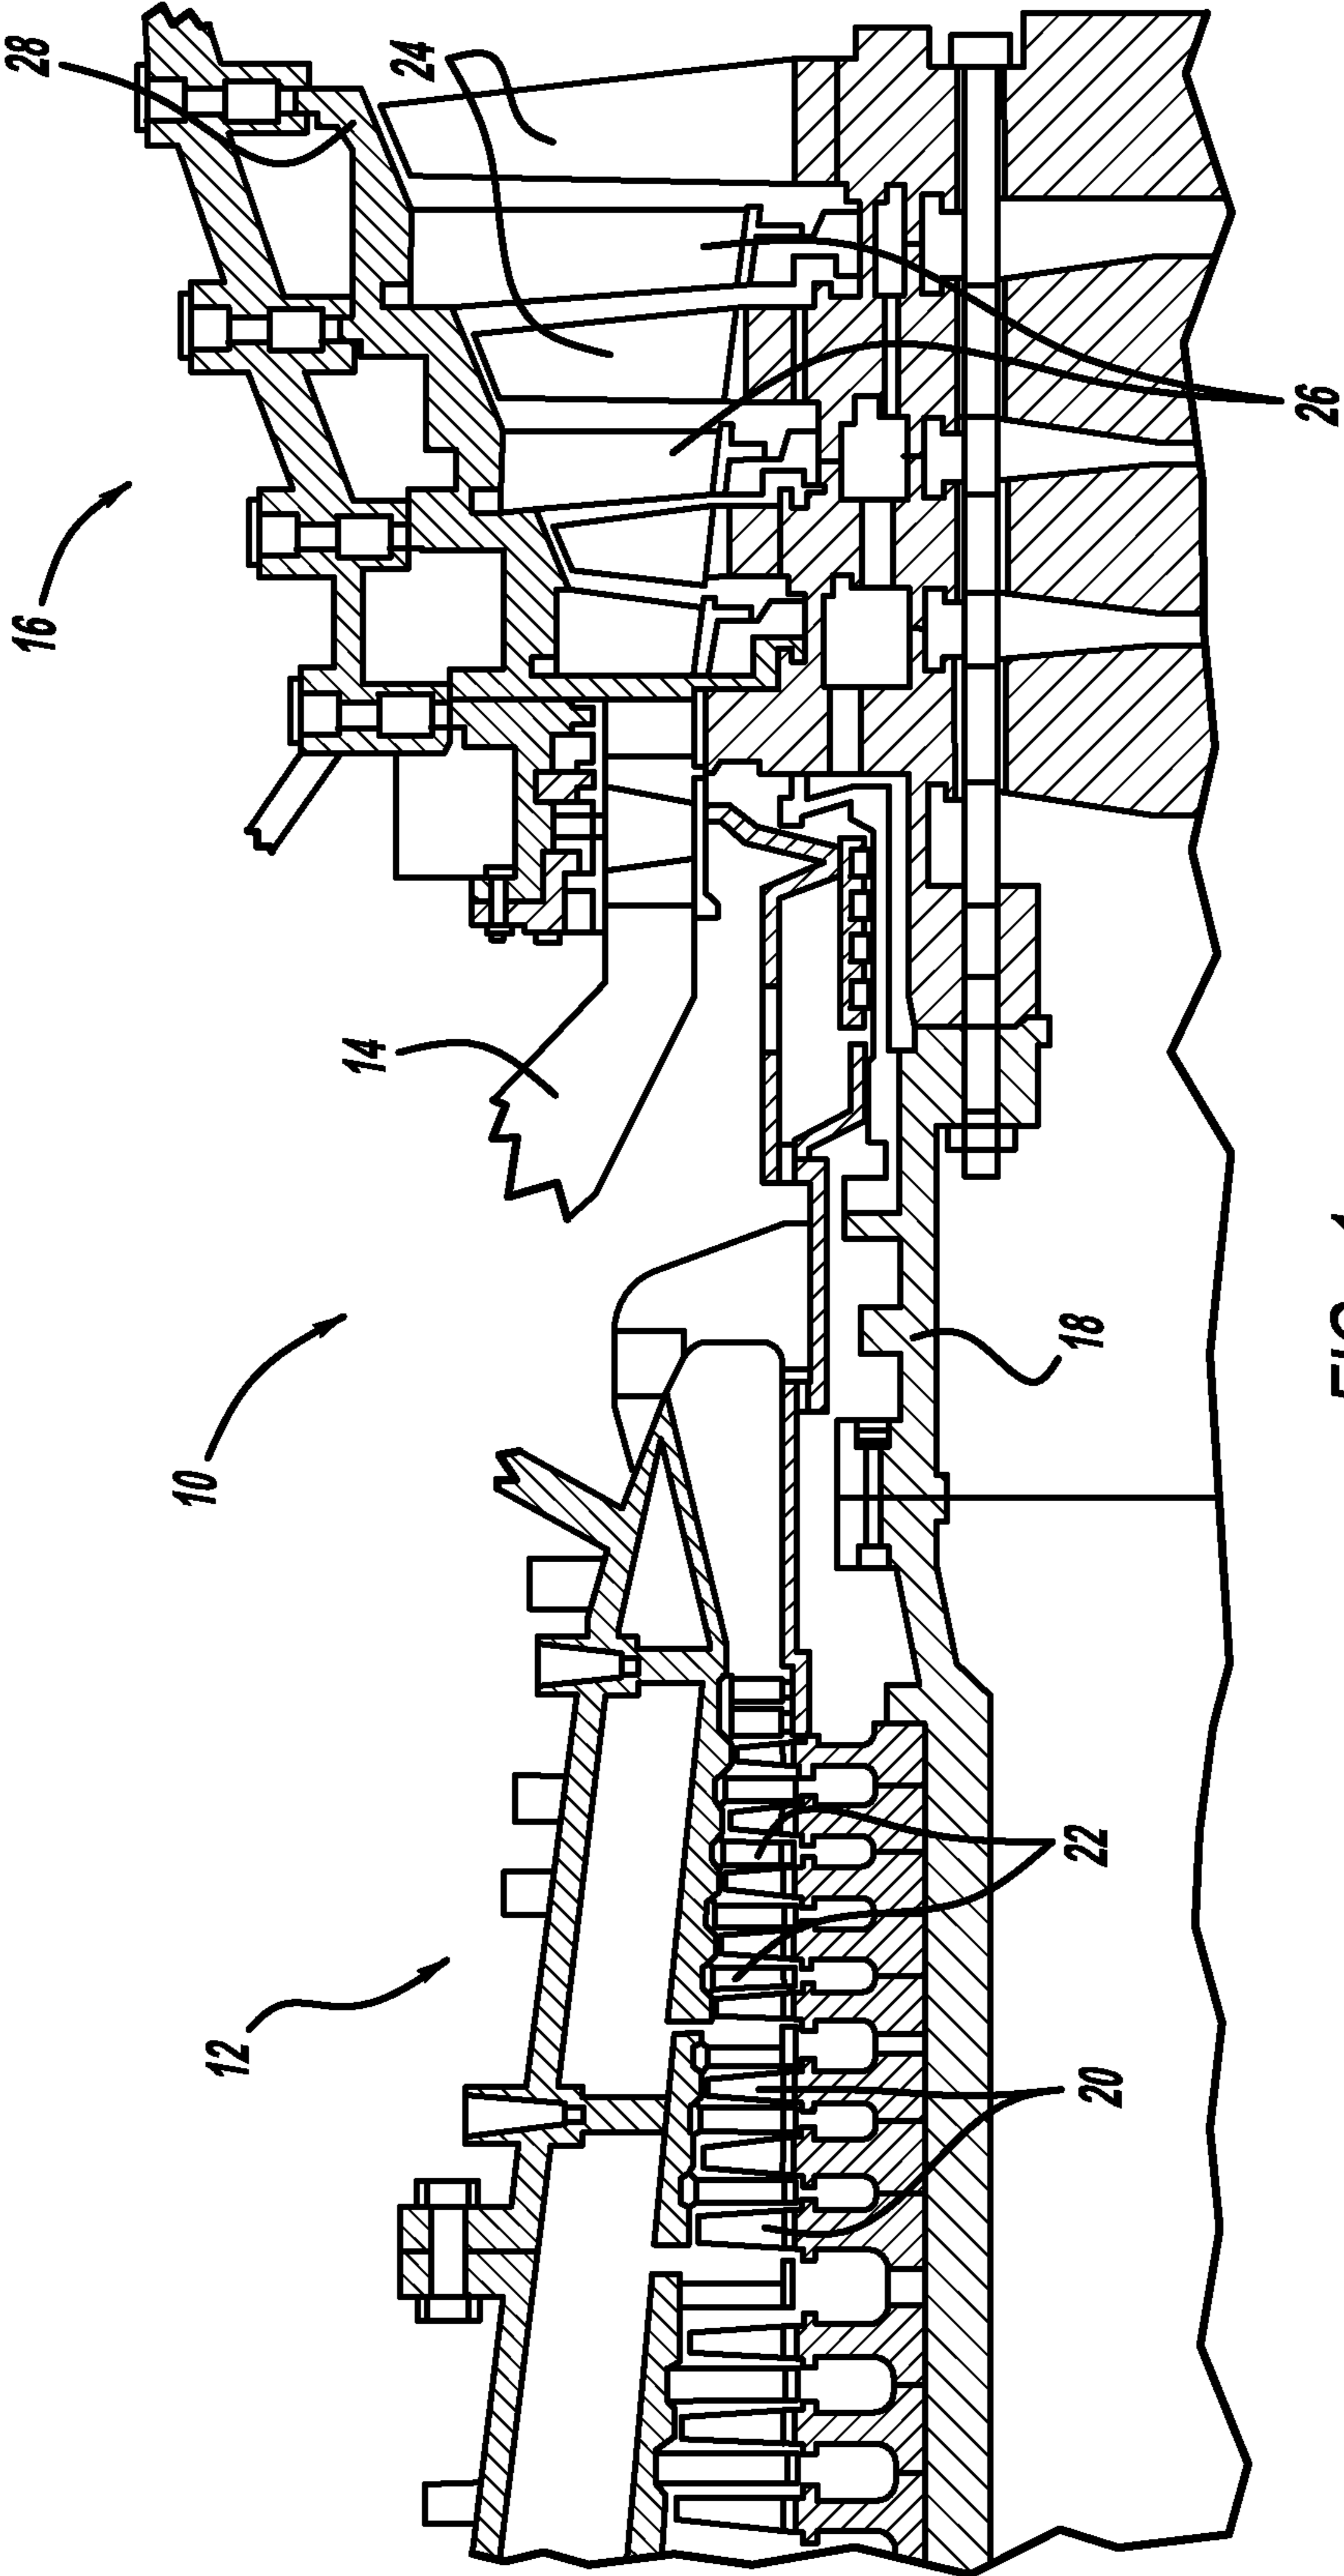
FIG - 1

FIG. 1 is a cut-away, cross-sectional view of a gas turbine engine;

FIG. 1 is a cut-away, cross-sectional view of a portion of a gas turbine engine 10 including a compressor section 12, a combustion section 14 and a turbine section 16, where operation of the engine 10 rotates a shaft 18. Although FIG. 1 is specific to a gas turbine engine, it is intended to be a general representation of many types of turbines, such as steam turbines, including an L-0 steam turbine, that would benefit from the thermal imaging and detection system as discussed herein. As is well understood by those skilled in the art, gas turbine engines of this type have various applications, such as electric generators in a power generating plant, aircraft engines, ship engines, etc.
