US009718416B2

(54) **AUTOMOTIVE HEADLINER LOCATOR TAB FOR SERVICE REPAIR**

(71) Applicant: **FORD GLOBAL TECHNOLOGIES, LLC**, Dearborn, MI (US)

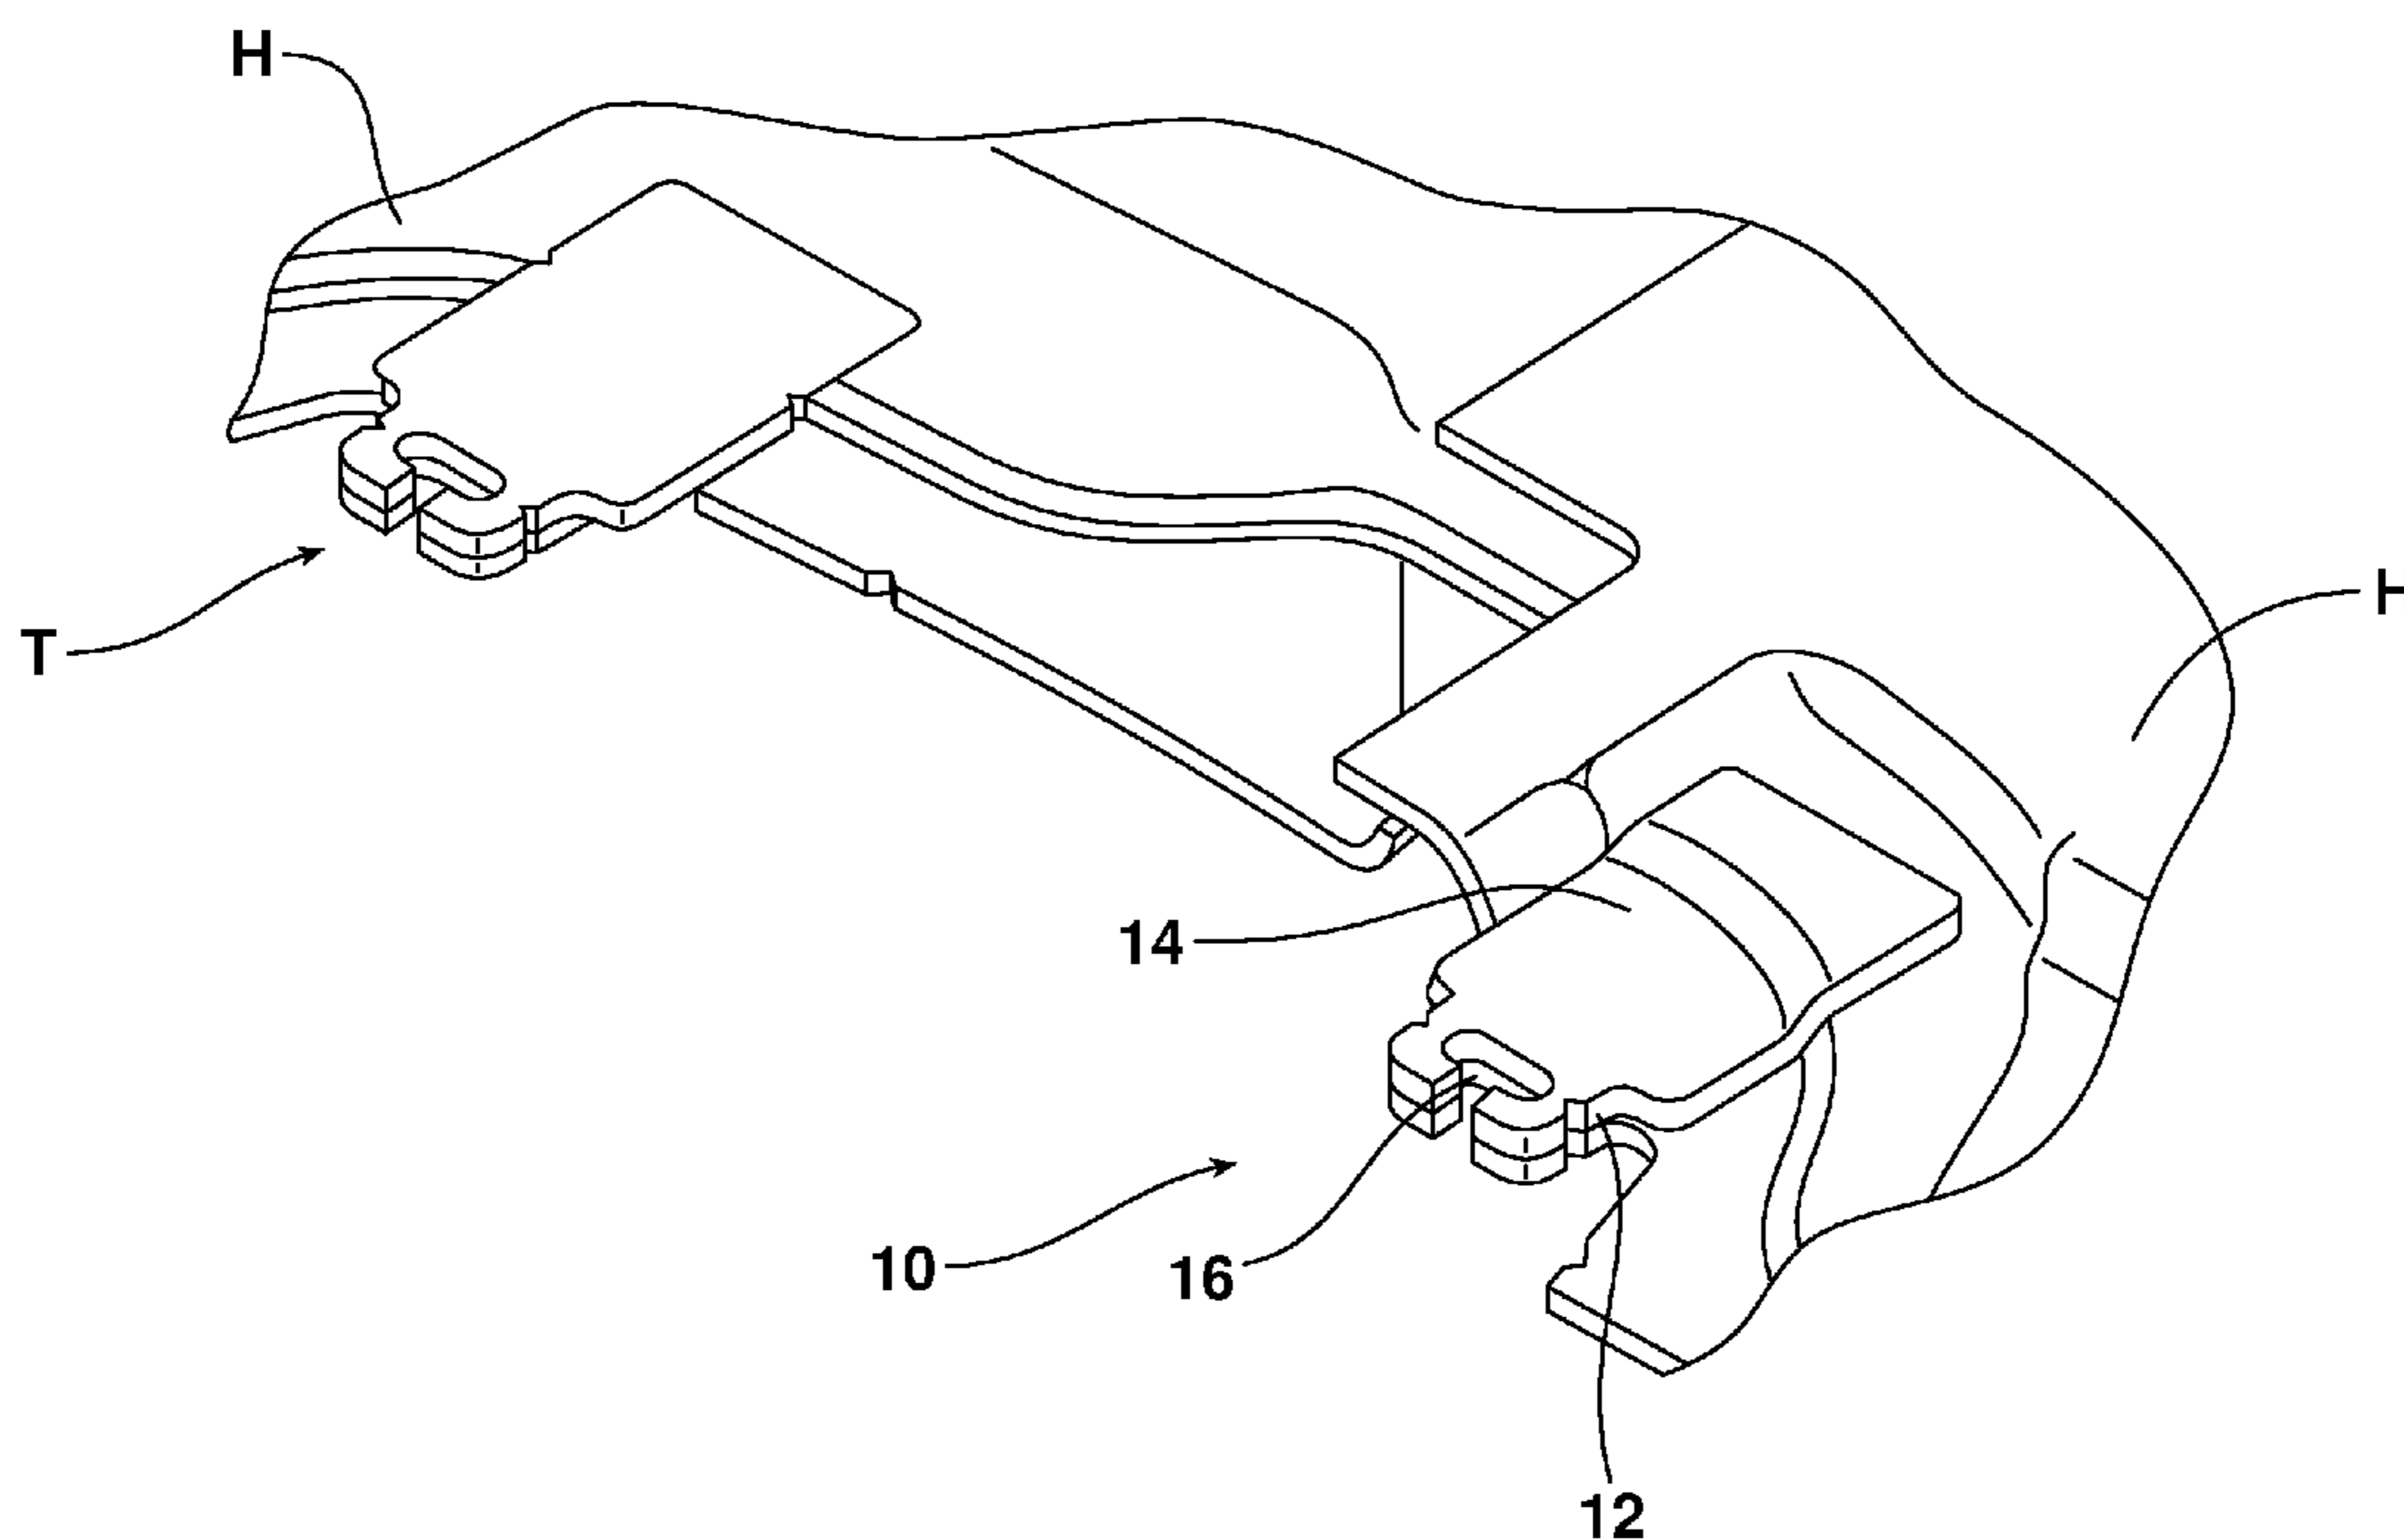
FIG. 1 is a perspective view of a replacement locator tab clearly illustrating the locator portion and the headliner mounting portion.

Reference is now made to FIGS. 1 and 1a illustrating the replacement locator tab 10 which includes a locator portion 12 and a headliner mounting portion 14. As illustrated, the locator portion 12 includes a keyhole opening 16 that is adapted to be secured over a pillar block pin of the motor vehicle in a manner that will be described in greater detail below. A layer of adhesive film 18 is provided on a face 20

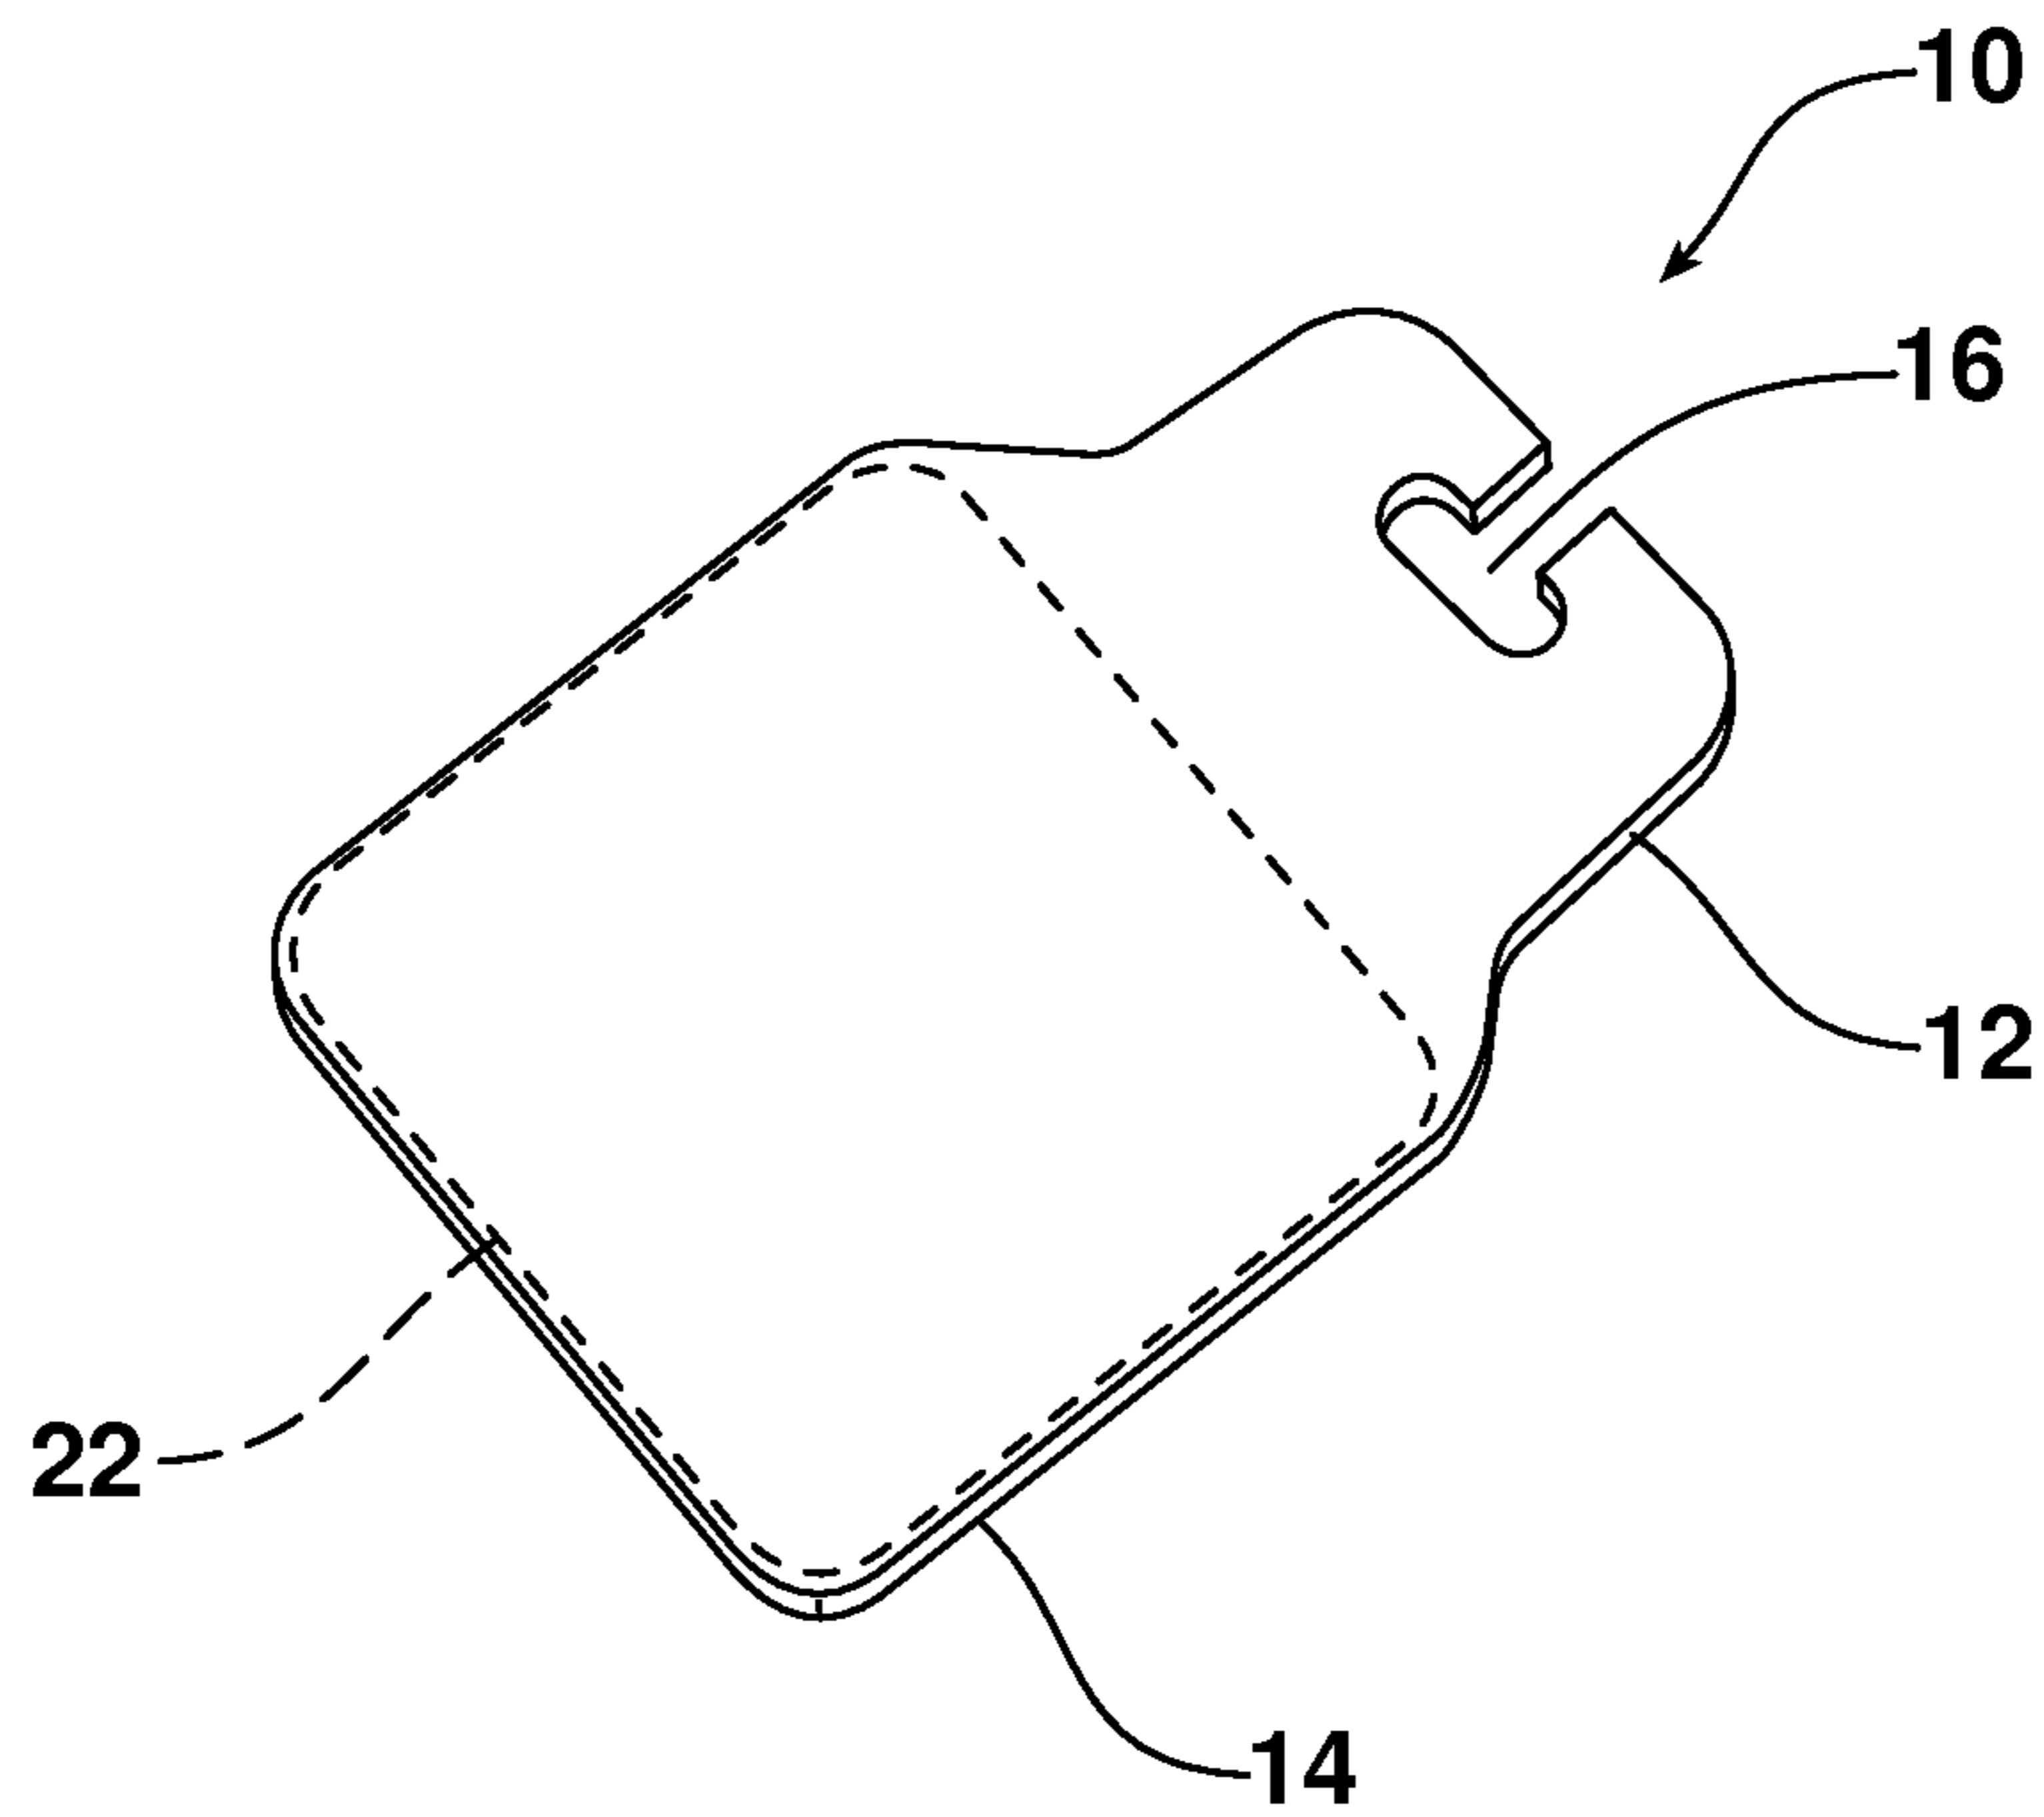
FIG. 1a is a cross-sectional view of the replacement locator tab illustrated in FIG. 1 clearly illustrating the body of the locator tab, the adhesive film on a face of the headliner mounting portion of that locator tab and the protective film overlying that adhesive film.

Next comes the step of connecting the new or replacement locator tab **10** to the headliner H. As best illustrated in FIGS. 1a, 3d and 3e, this is done by removing the protective film **22** from the adhesive film **18** on the face **20** of the headliner mounting portion **14** of the replacement locator tab **10**. With the face **20** pointed downward, the replacement locator tab **10** is carefully positioned behind the headliner H and the locator portion **12** is aligned with the pillar block pin BP so that the pillar block pin is centered in the keyhole opening **16**. The headliner is then gently moved outboard so that the edges are within three to five mm of the body side of the sheet metal. Once the headliner H is aligned in the correct position, one works fingers behind the headliner H and firmly presses the replacement locator tab and headliner together for approximately 15 seconds until good adhesion is achieved between the mounting portion **14** and the headliner.
