(54) METHODS FOR PERFORMING GAS TURBINE ENGINE CASING REPAIRS AND REPAIRED CASES

Methods for repairing gas turbine engine casings and repaired casings are provided. In this regard, a representative method for repairing a gas turbine engine casing includes: removing an annular portion of the engine casing; and attaching an annular replacement portion to the engine casing.

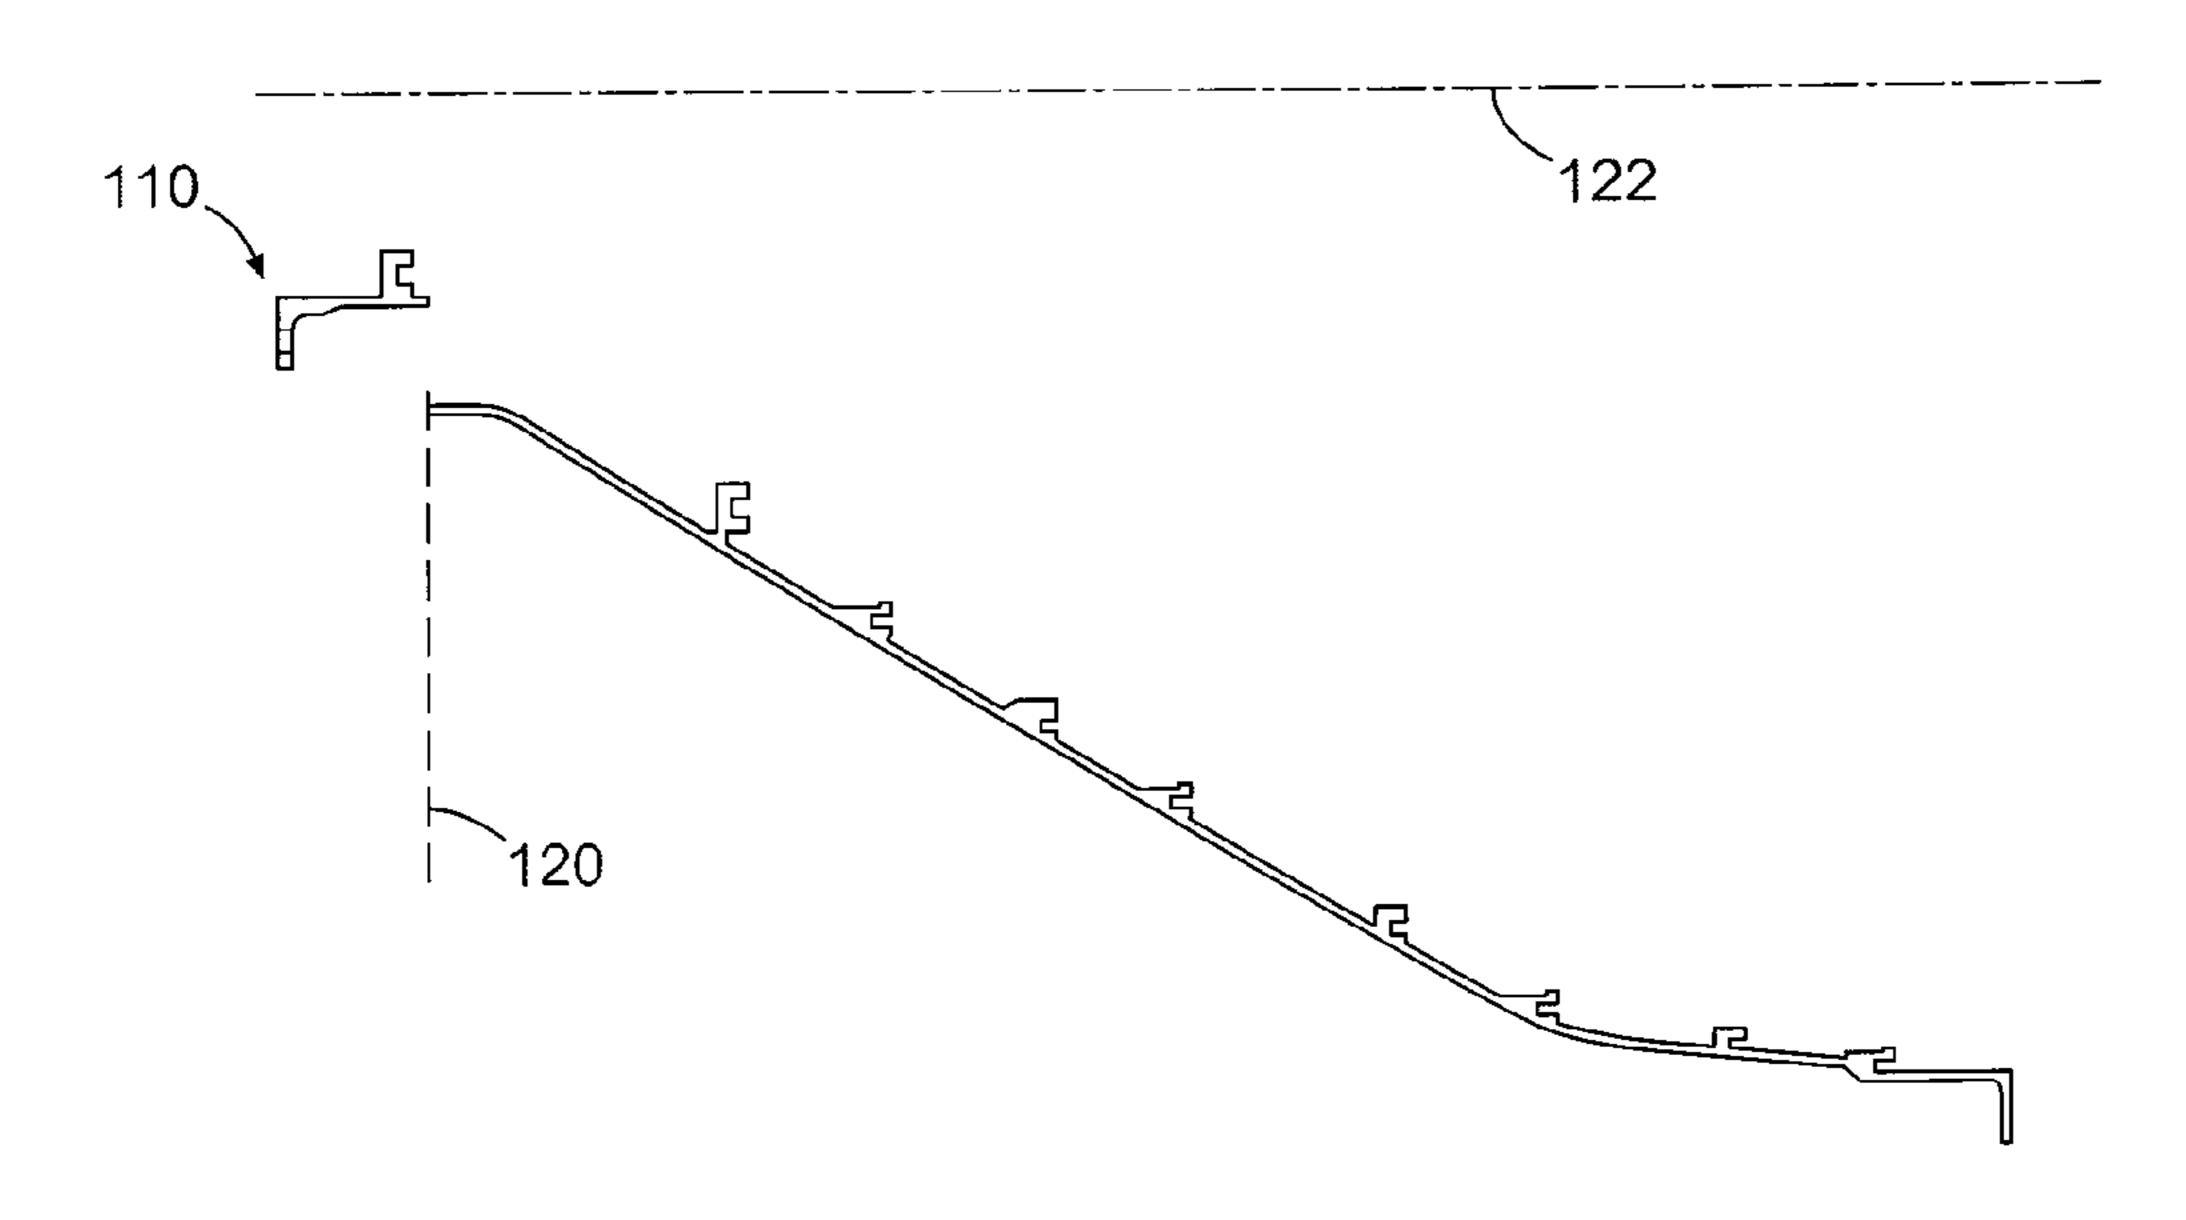
FIG. 2 is a schematic diagram depicting a step of an exemplary embodiment of a method for repairing a gas 55 turbine engine casing.

As shown in FIG. 2, removal of front flange 110 from case is accomplished by cutting the case along the cut plane 120. The cut plane is oriented perpendicular to the longitudinal axis 122 of the casing although other cut plane orientations can be used in other embodiments. Cutting can be accomplished in various manners, such as by machining, turning, milling, sawing, or laser cutting. Notably, the cut plane is located outside of a containment zone of the casing in this embodiment. However, in other embodiments, the cut plane may be associated with a containment zone.

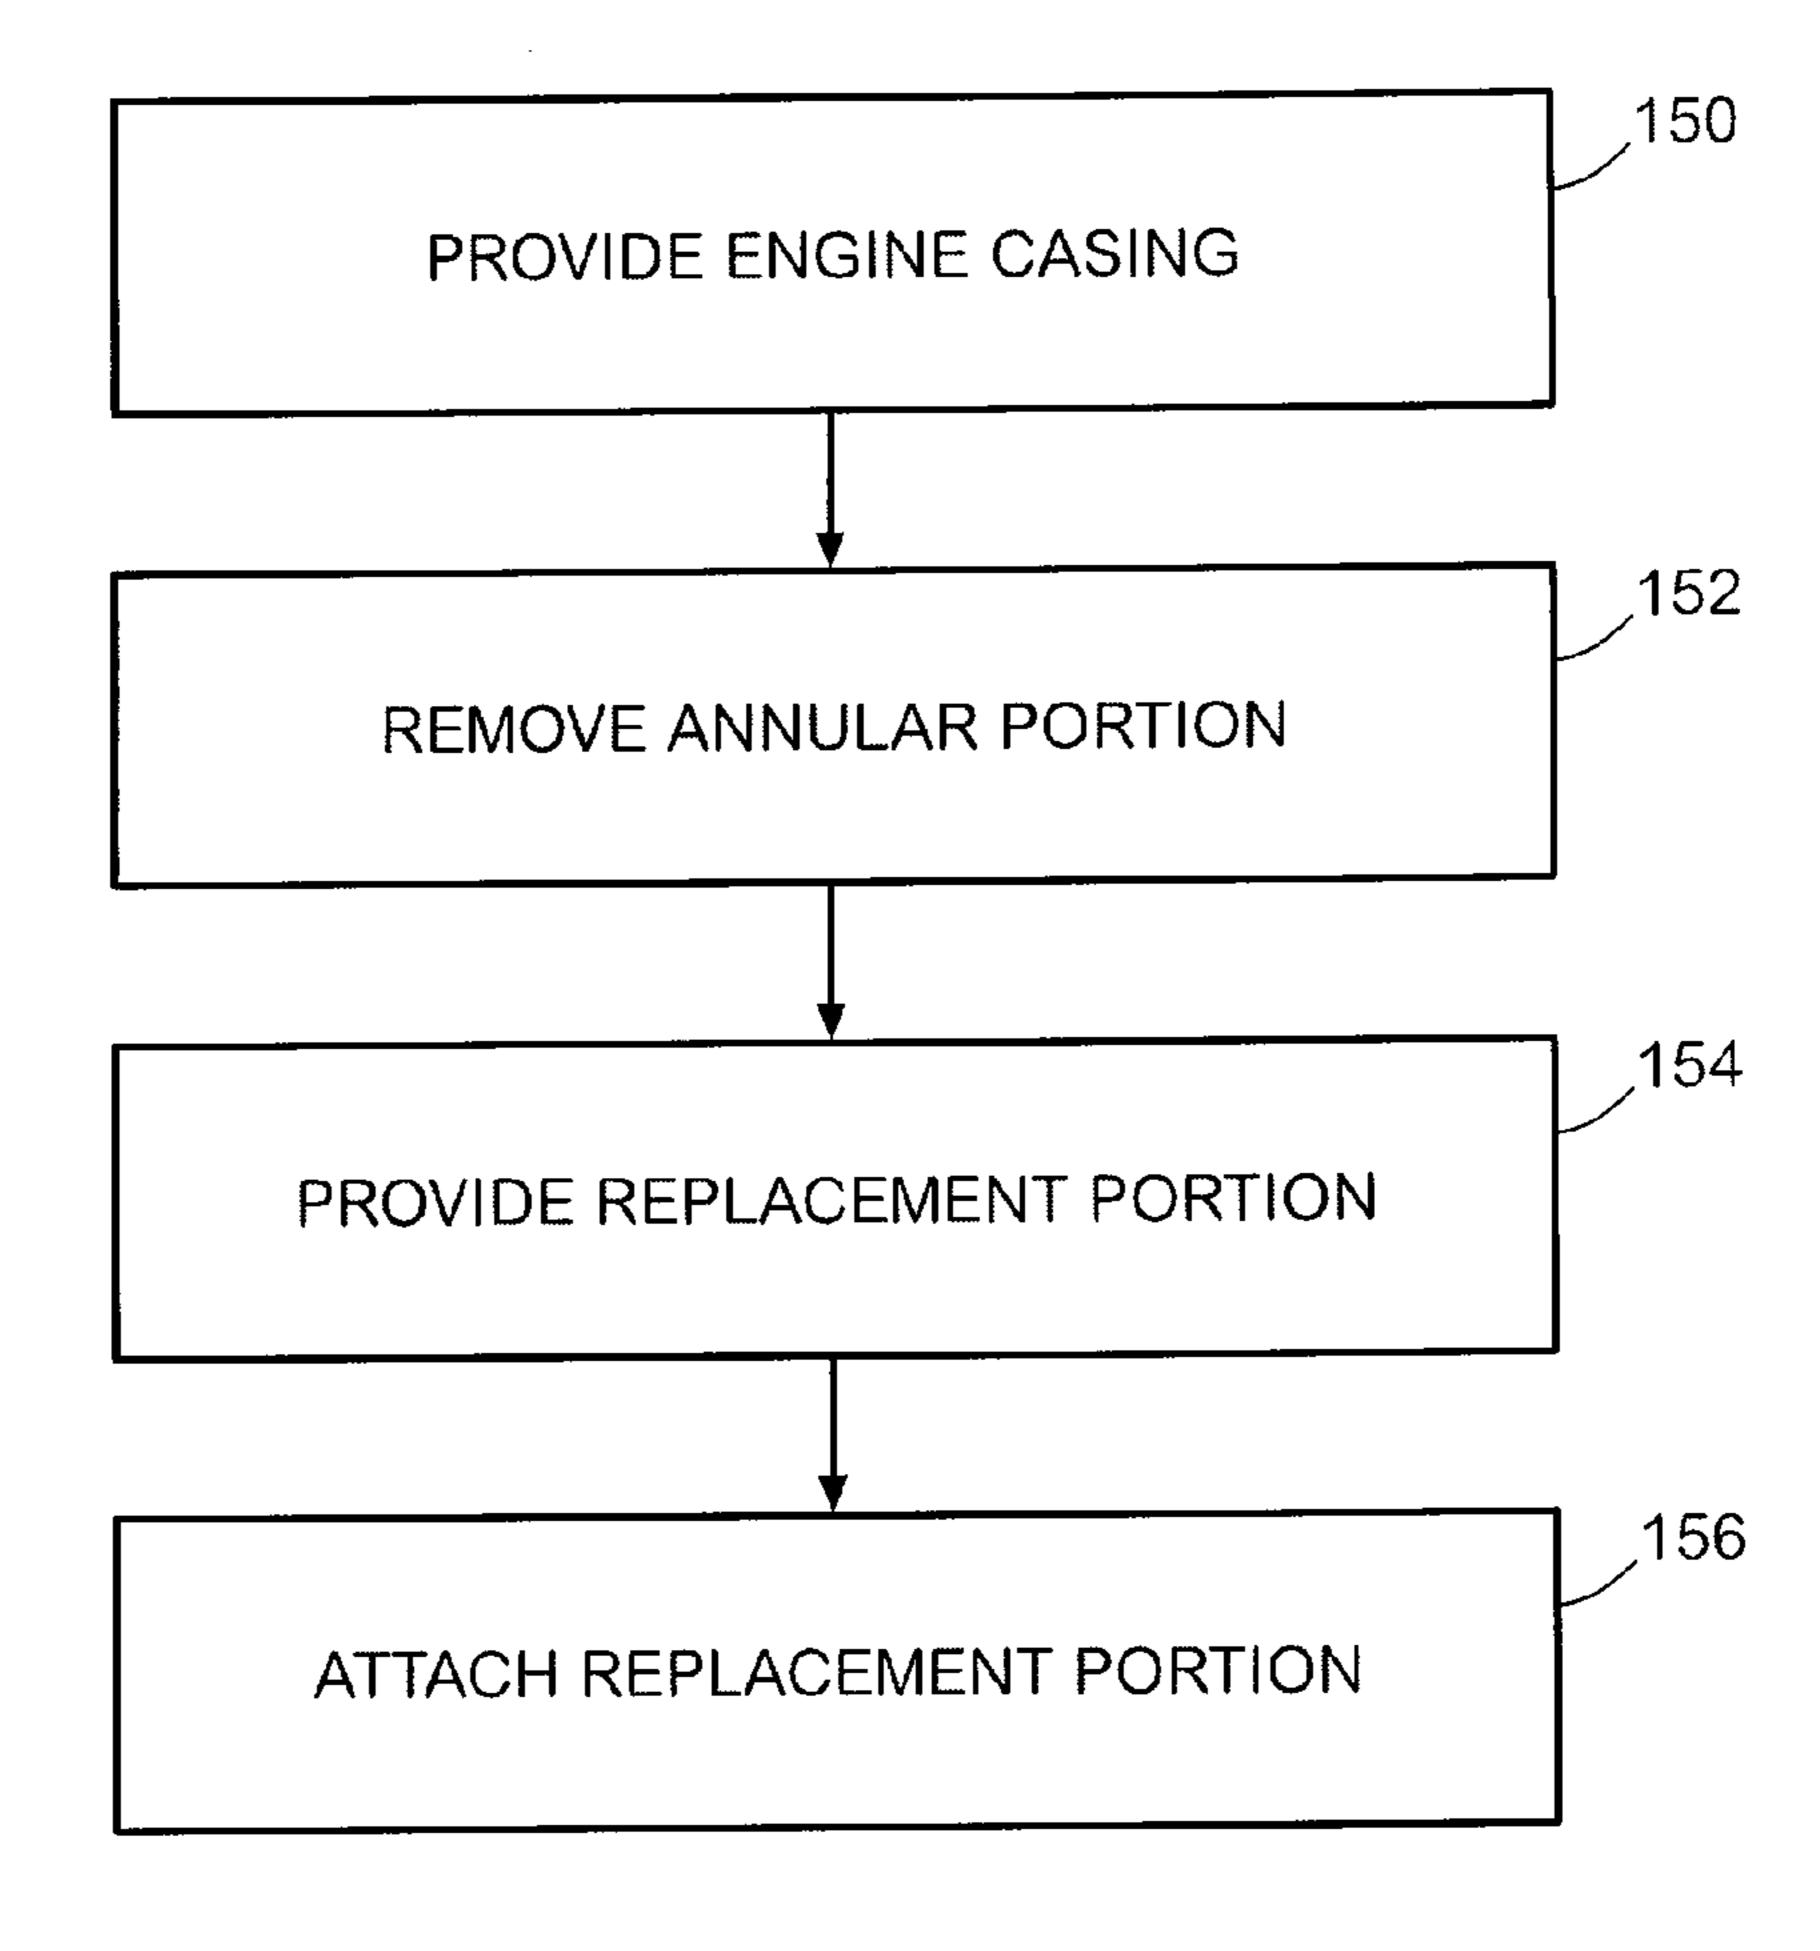
FIG. 4 is a flowchart depicting an embodiment of a method for repairing a gas turbine engine casing.

As shown in FIG. 4 an exemplary embodiment of a method for repairing a gas turbine engine casing includes providing an engine casing (block 150). In block 152, an annular portion of the engine case is removed, and a replacement portion is provided (block 154). In some embodiments, the portion removed is restricted to non-containment portion of the casing. Thereafter, such as depicted in block 156, the replacement portion is attached to the engine casing.

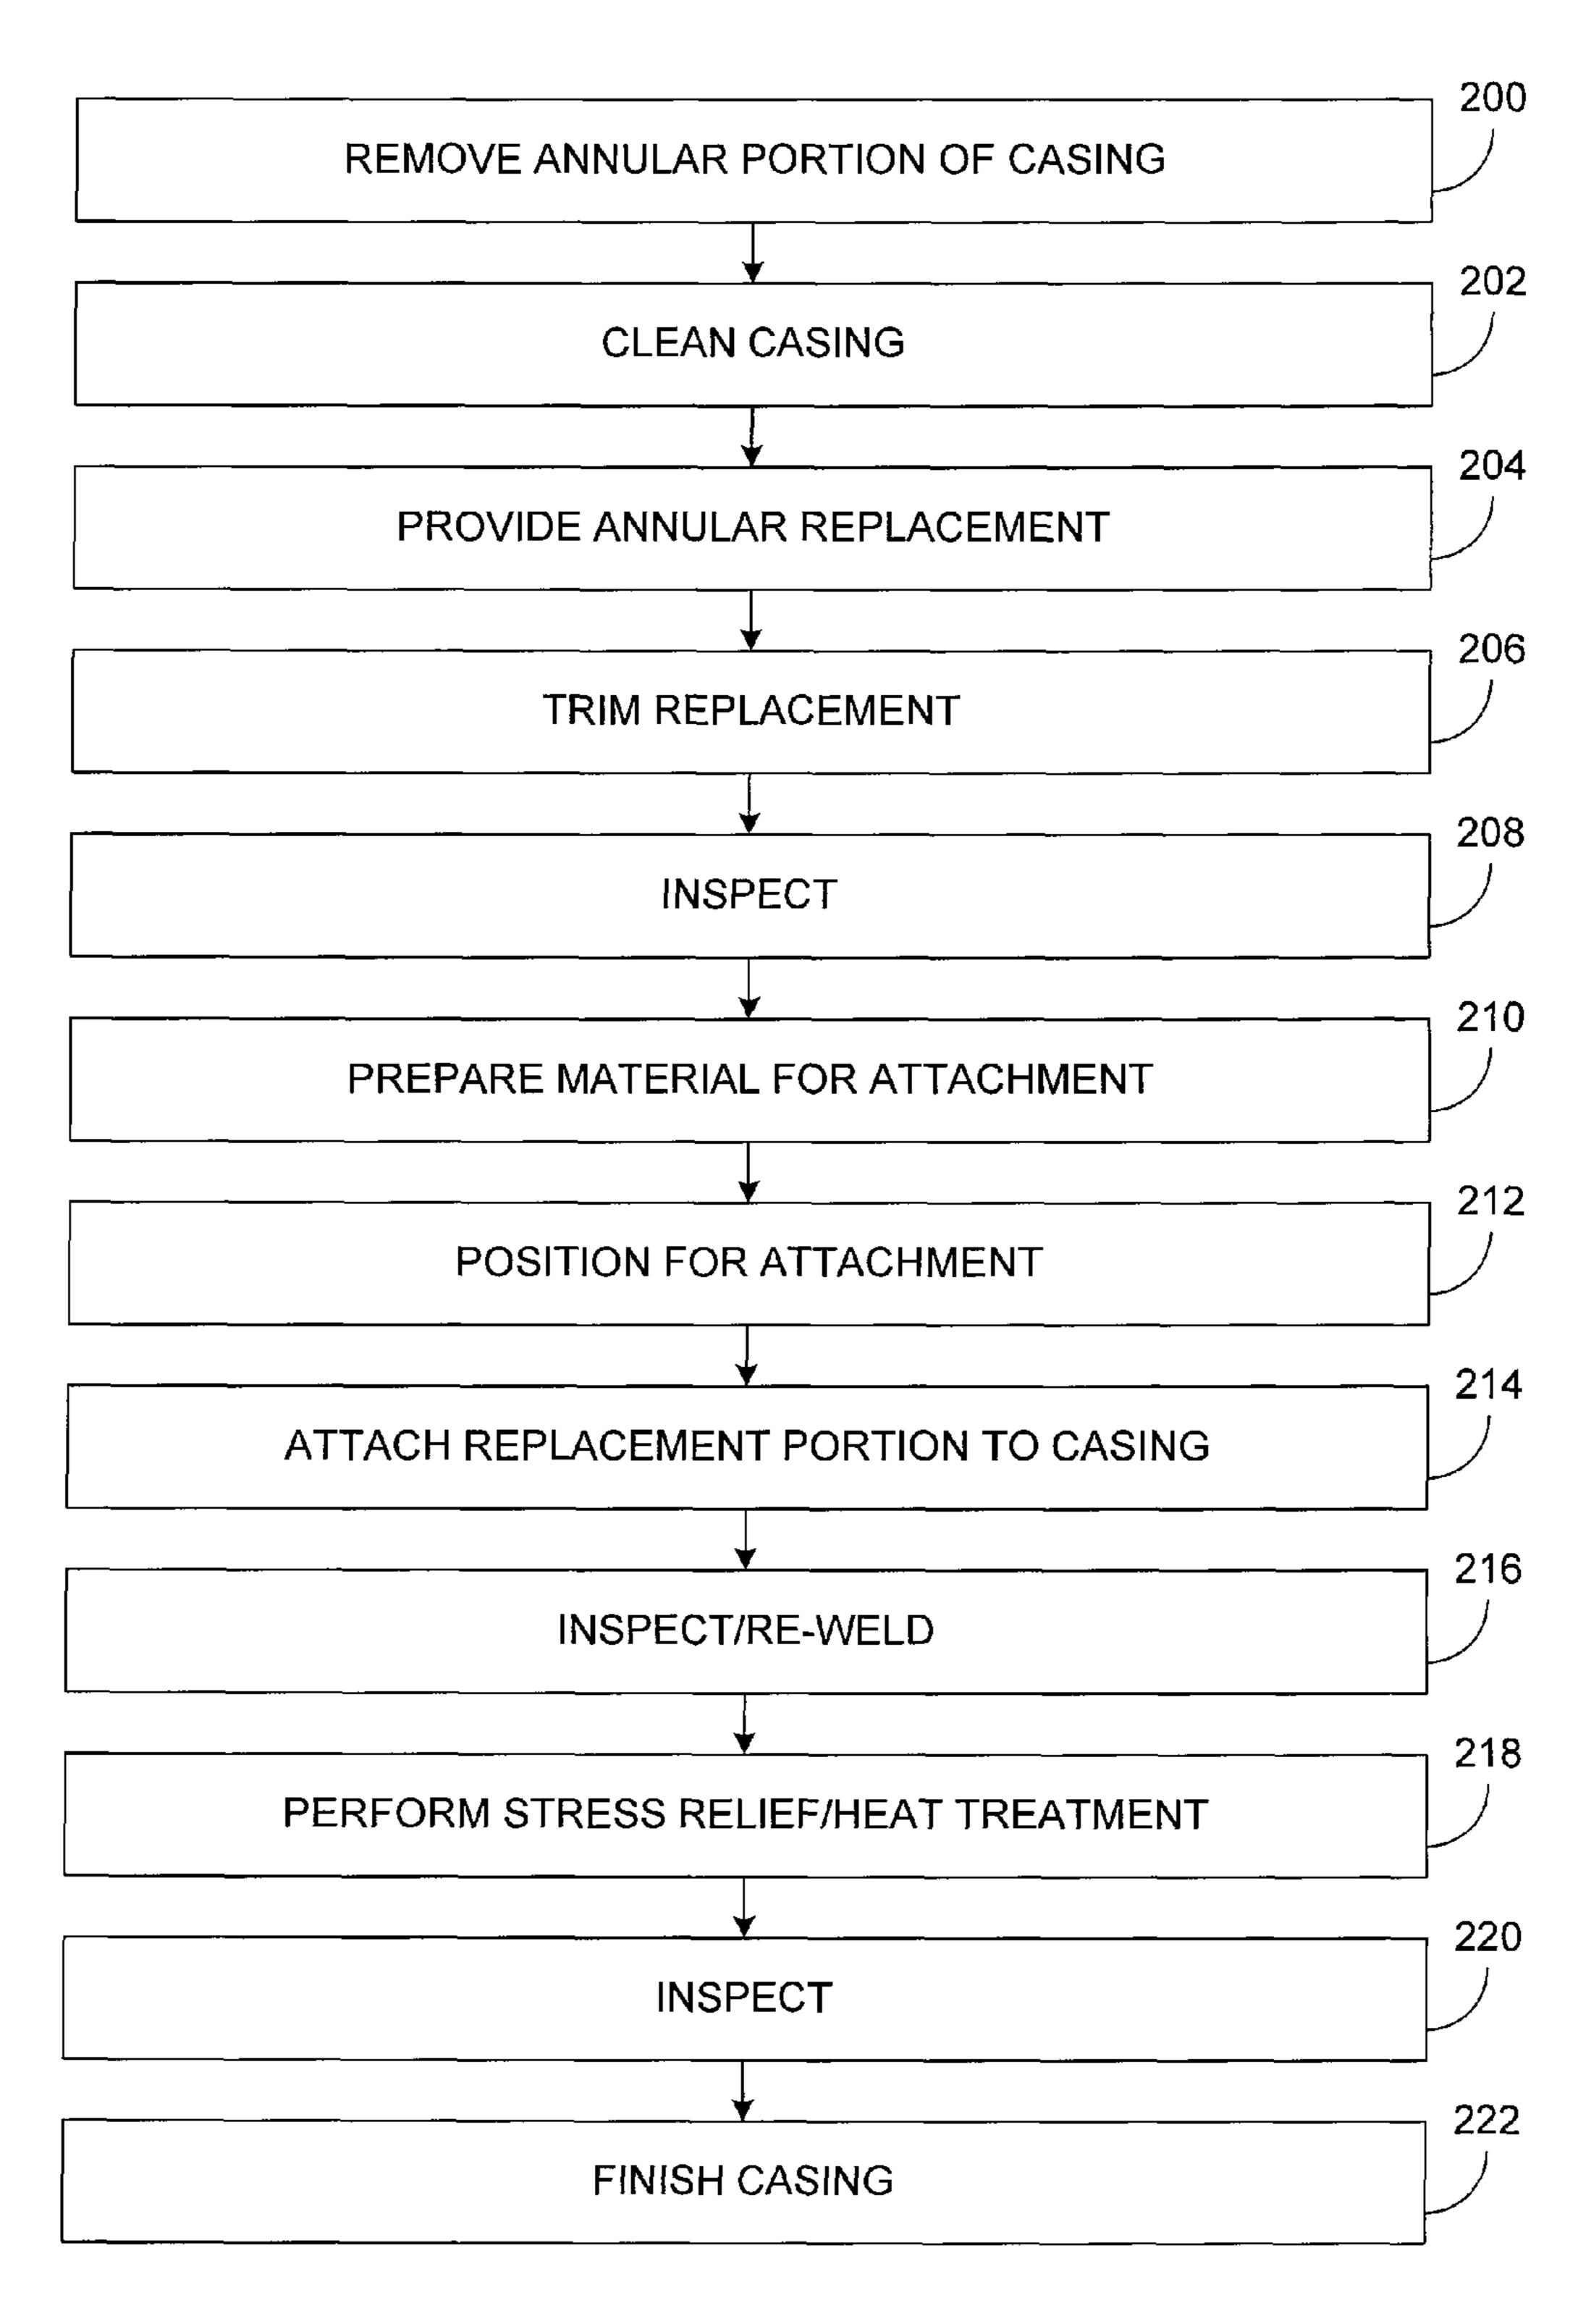
FIG. 5 is a schematic diagram depicting another embodiment of a method for repairing a gas turbine engine casing.

Another exemplary embodiment of a method for repairing a gas turbine engine casing is depicted in the flowchart of FIG. 5. As shown in FIG. 5, the method may be construed as beginning at block 200, in which an annular portion of a gas turbine engine casing is removed. By way of example, the portion can be a front flange portion of a turbine casing. In block 202, the remaining casing can be cleaned.
