(54) **LEAK DETECTION IN COMPOSITE STRUCTURES**

(71) Applicant: **The Boeing Company**, Chicago, IL (US)

A leak through the thickness of a structure is detected from one side of the structure using a leak detection layer. The leak detection layer exhibits visually observable changes when exposed to an air leak.

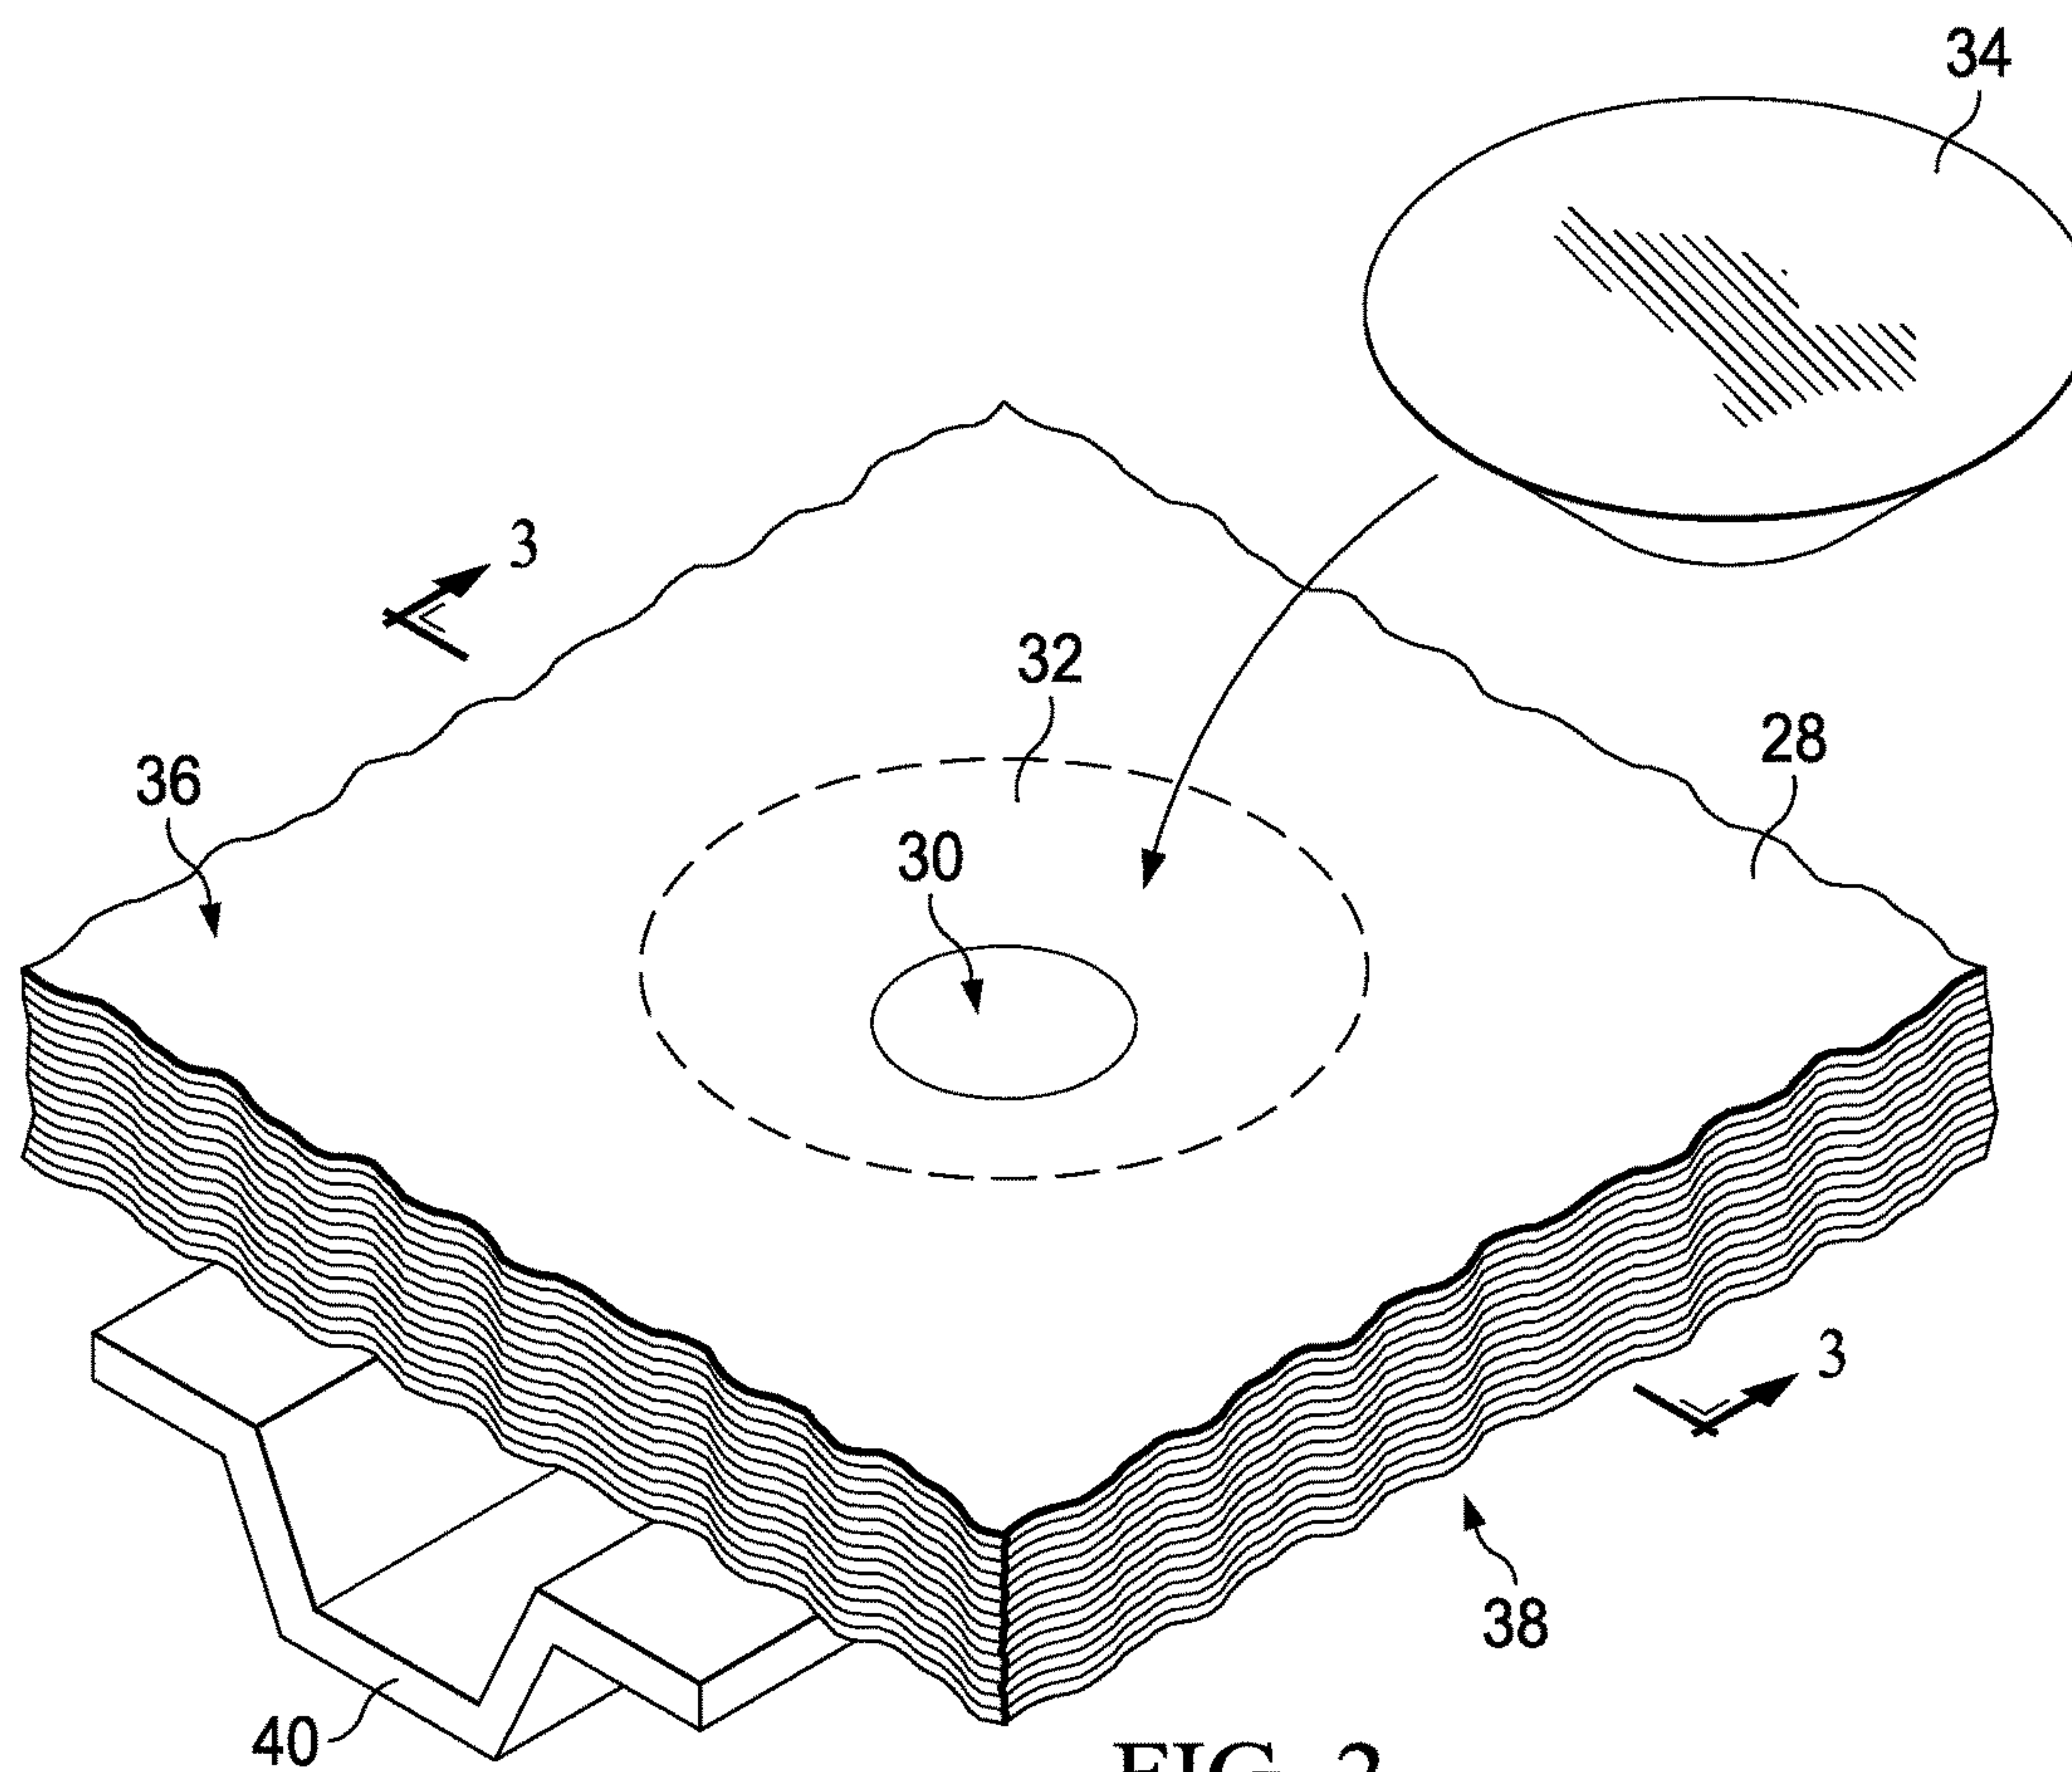
FIG. 2 is an illustration of a perspective view of the area requiring rework shown in FIG. 1, also illustrating an underlying stringer on the backside of the skin.

Referring now also to FIGS. 2 and 3, in the illustrated example, the skin 28 has a frontside 36 and a backside 38, and the non-conformity 30 comprises a dent-like depression in the frontside 36 of the skin. In order to reduce or eliminate the non-conformity 30, an area 32 of the skin 28 containing the non-conformity 30, sometimes referred to hereinafter as a “rework area” 32, may be reworked and restored using a composite laminate rework patch 34 (FIG. 2). As will be discussed later in more detail, this rework process involves removing material from the skin 28 within the rework area 32 and replacing the material that has been removed with the composite patch 34. Depending upon the location of the non-conformities 30 in the skin 28, structure such as the stringer 40 shown in FIG. 2, or other obstructions may be present on the backside 38 of the skin 28, either directly beneath or immediately adjacent to the rework area 32. The presence of a structure such as the stringer 40 beneath the rework area 32 may require that the rework process be performed substantially only from the frontside 36 of the skin 28.

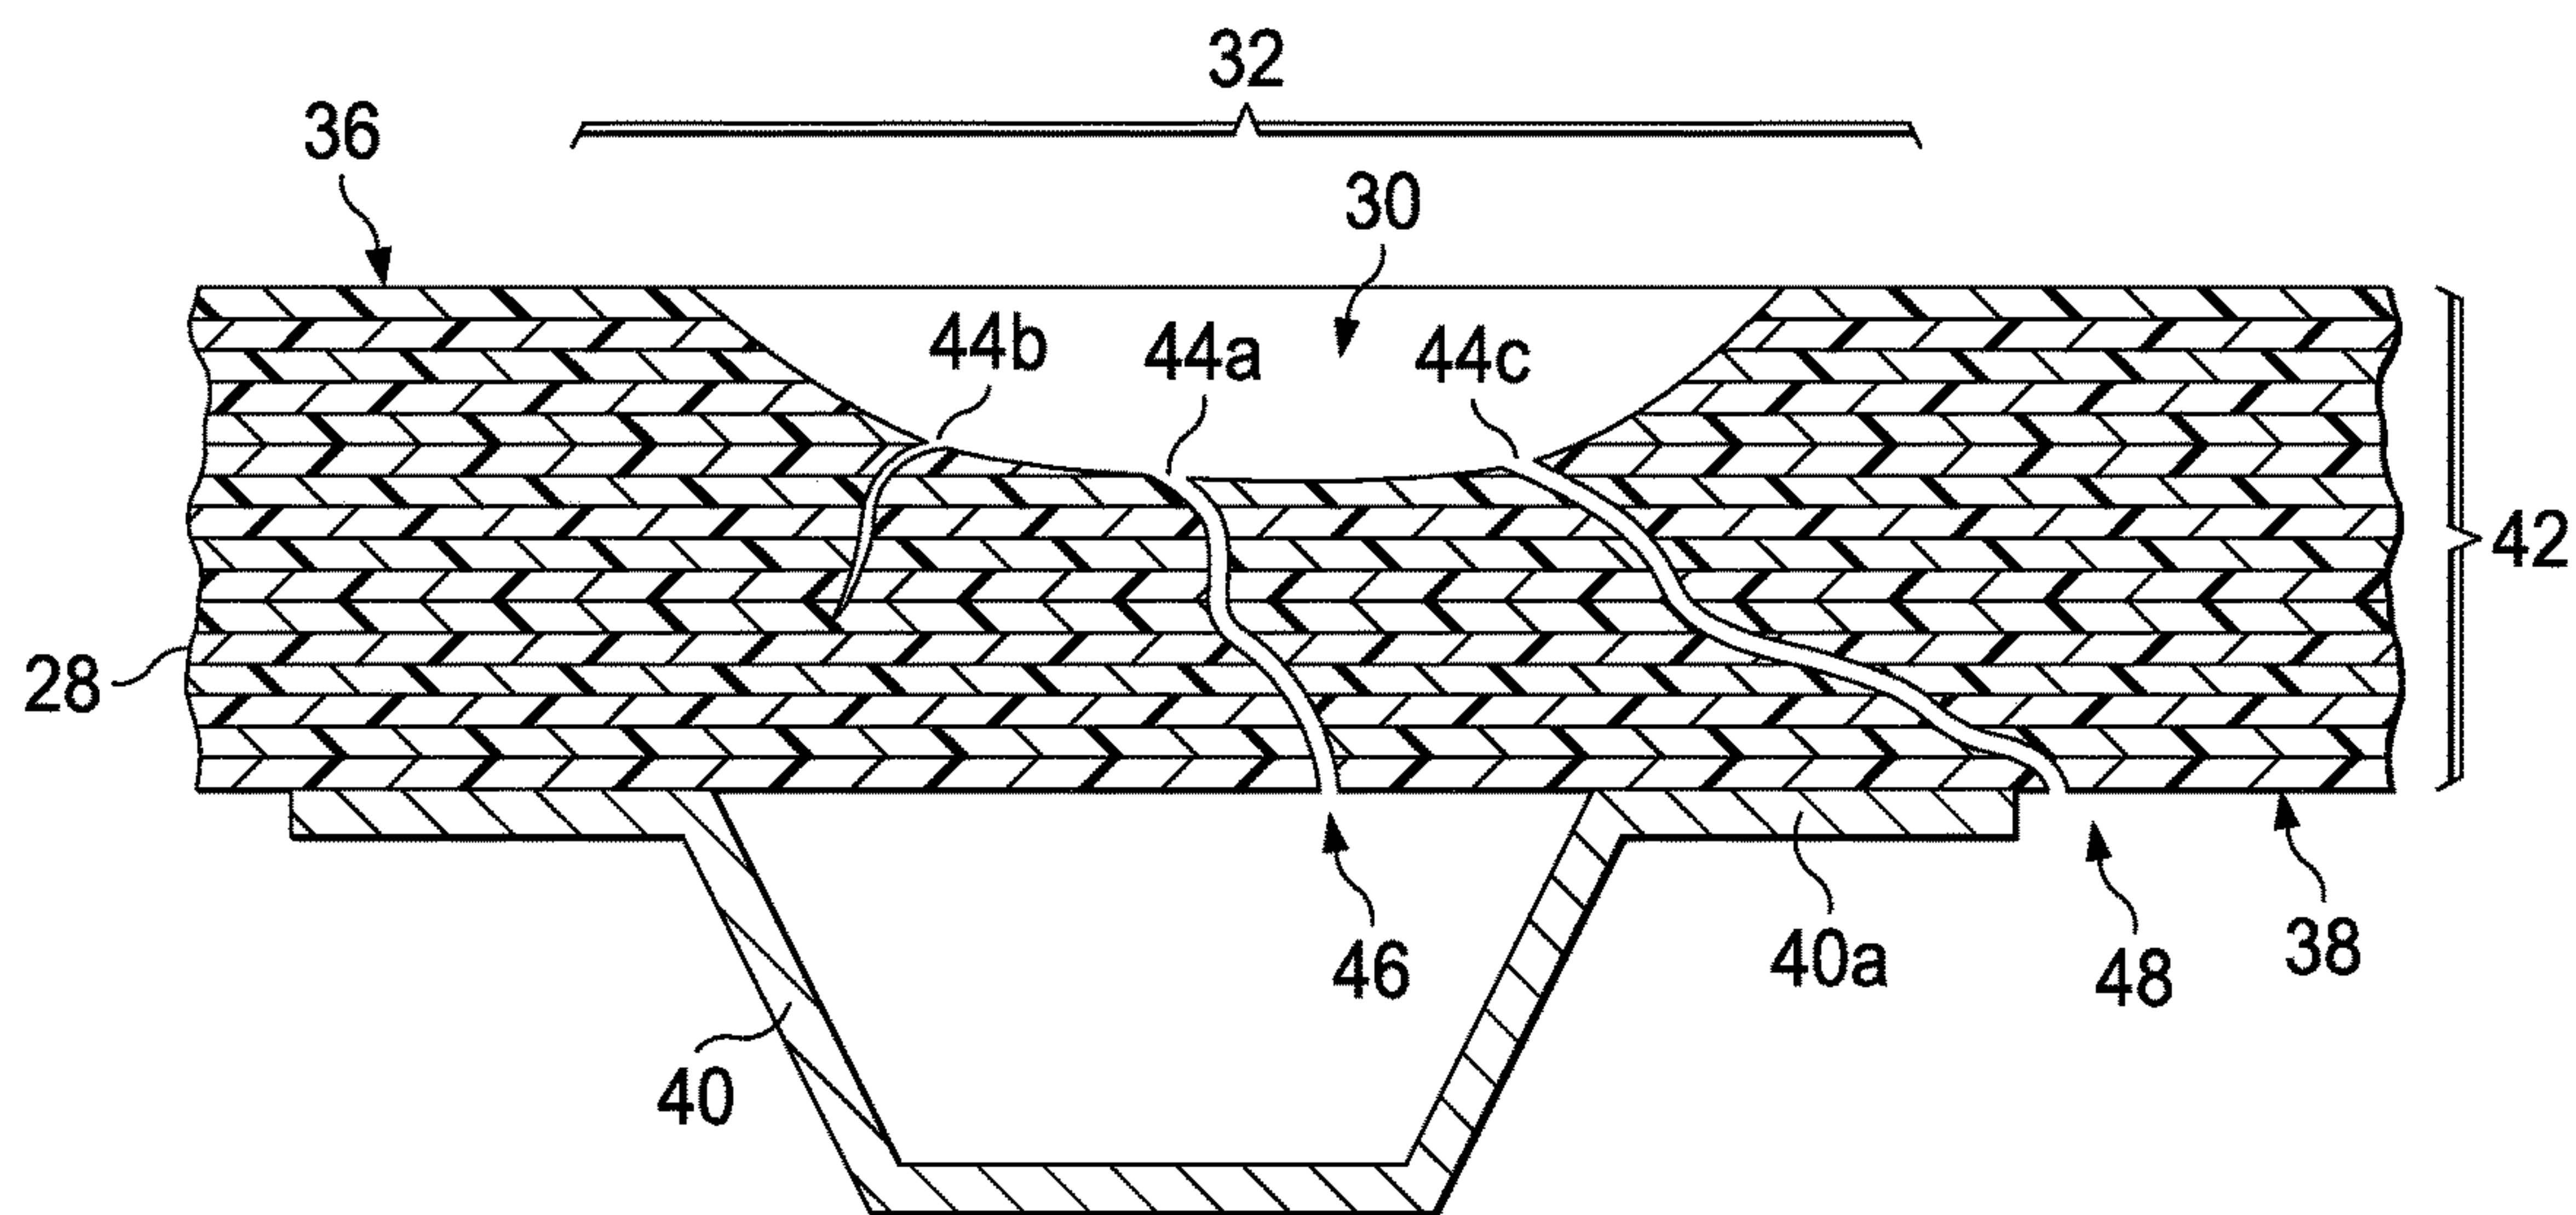
FIG. 3 is an illustration of a sectional view taken along the line 3-3 in FIG. 2.

In some cases, the non-conformity 30 may include voids 44a, 44b, 44c such as cracks or fractures which may or may not extend through the entire thickness 42 of the skin 28. For example, as shown in FIG. 3, one void 44b extends only partially through the thickness 42 of the skin 28, while two additional voids 44a and 44c extend completely through the

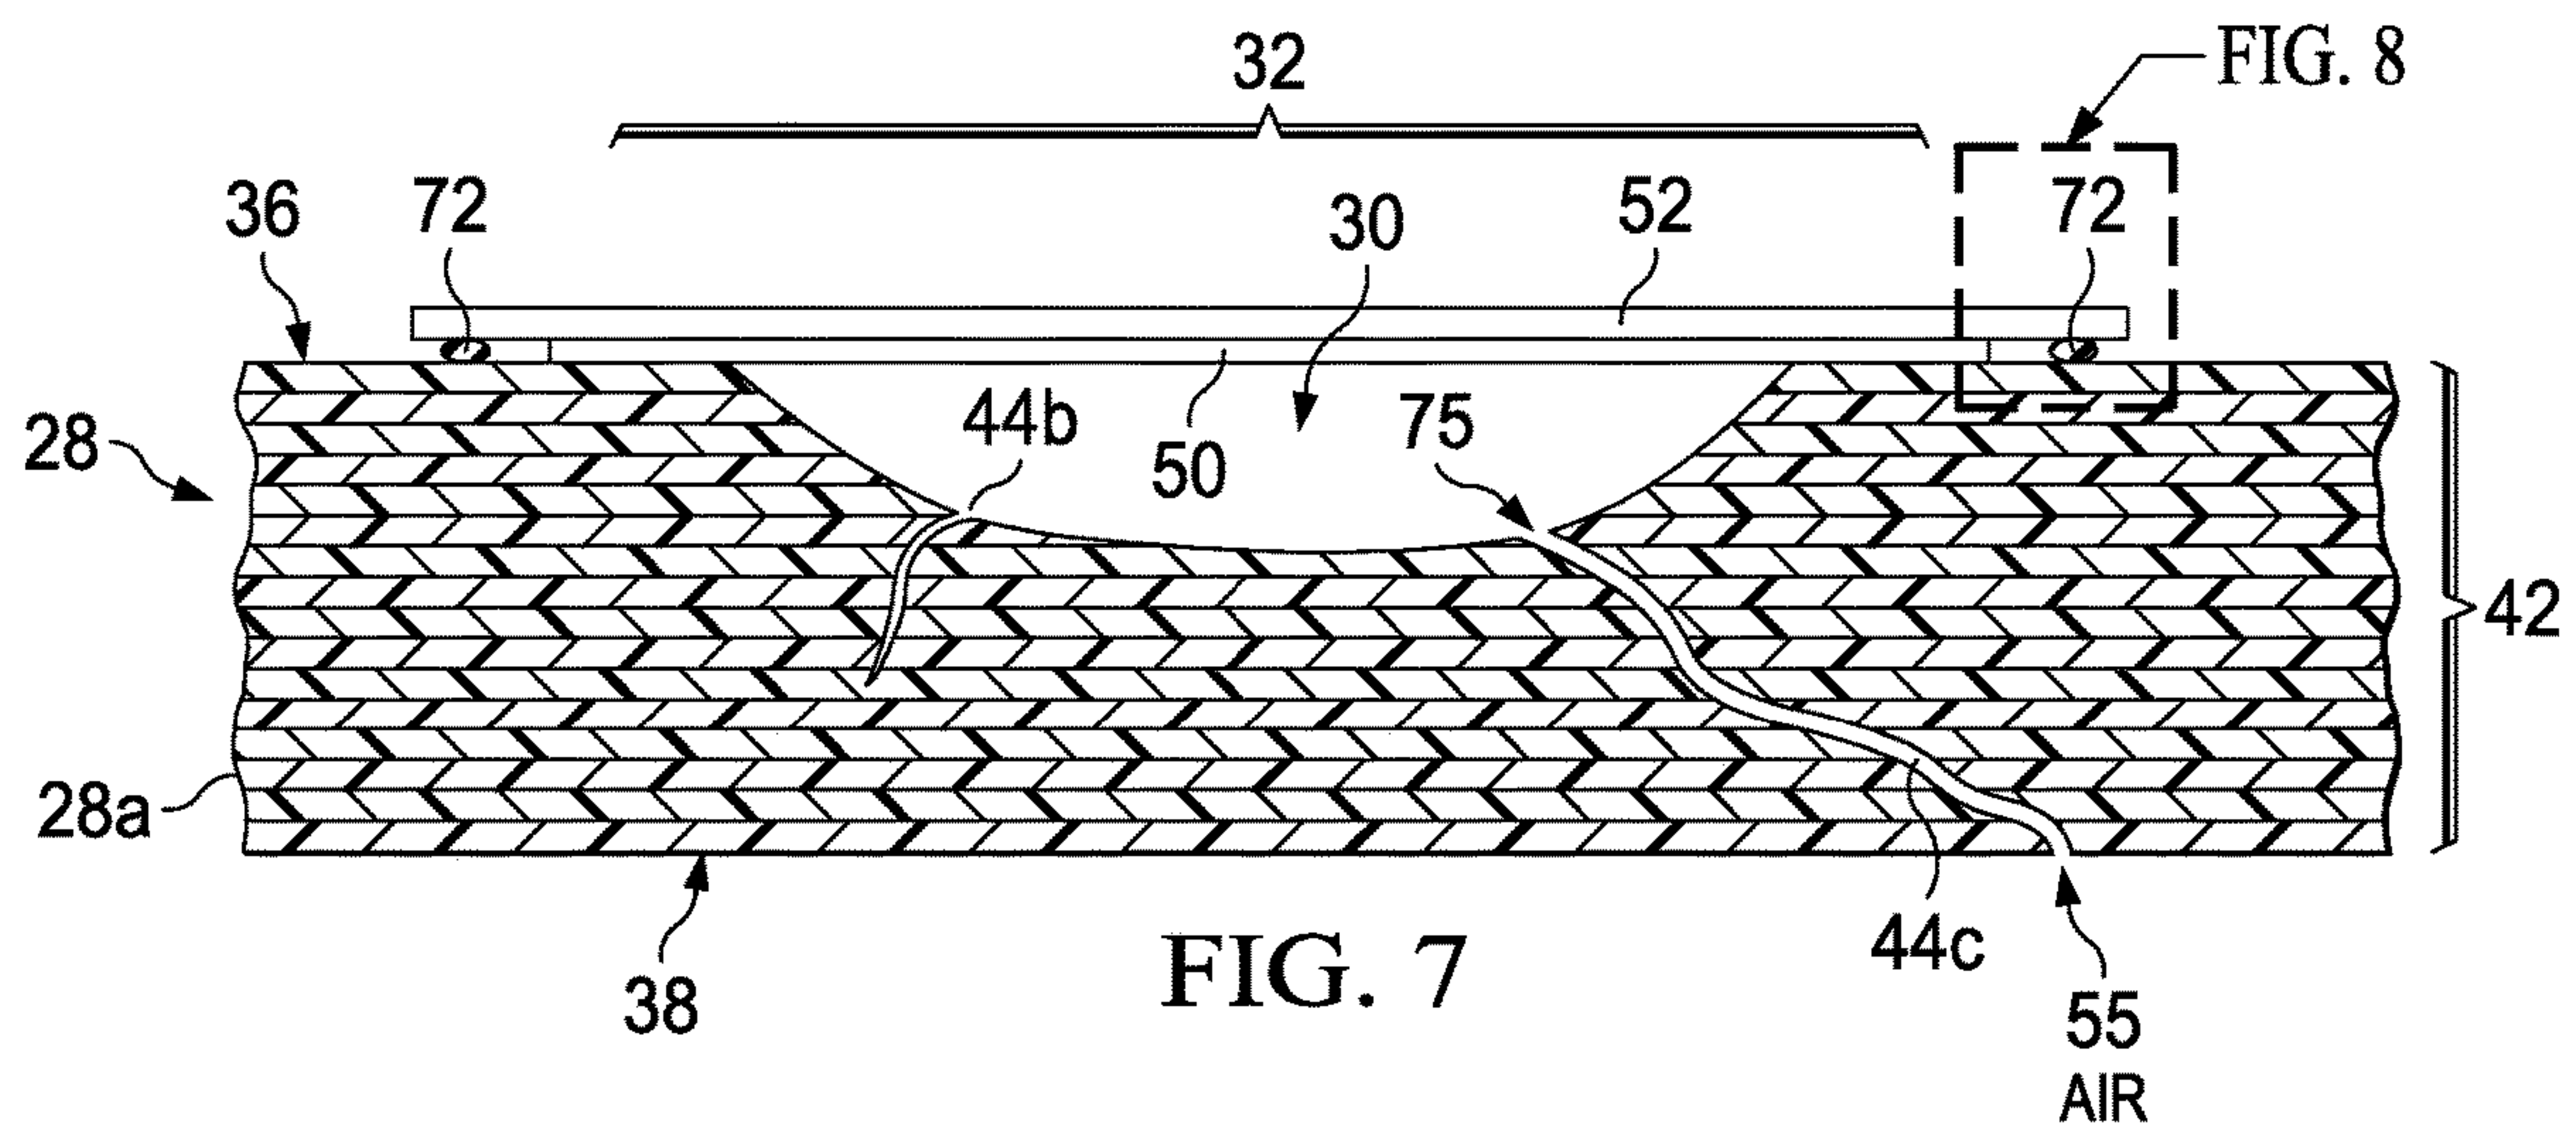
FIG. 7 is an illustration of a sectional view of an area of a composite skin having a void extending through the thickness of thereof, a leak detection layer and vacuum bag having been installed.

Attention is now directed to FIGS. 7-11 which sequentially illustrate the steps of a method of reworking a structure 28, such as the composite skin 28 of the aircraft 20 shown in FIG. 1 in order to eliminate non-conformities in the skin 28. Referring particularly to FIG. 7, an LDL 50 is placed over the frontside 36 of the structure 28 within an area 32 containing a non-conformity 30 which, in the illustrated example, comprises a dent. A vacuum bag 52 is then placed over the LDL 50 and sealed to the frontside 36 using seals 72. The vacuum bag 52 seals-off the LDL 50 from the surrounding, ambient atmosphere. In this example, the structure 28 contains a first void 44b which extends only partially through the thickness 42 of the structure 28, and a second void 44c that extends entirely through the thickness 42 to the backside 38, forming an air leak 75. Evacuation of the vacuum bag 52 draws air 55 in through the void 44c on the backside 38, thereby exposing the LDL to oxygen caused by the air leak 75. As previously discussed, the air leak 75 results in a localized change in the LDL 50 which is visually observable.

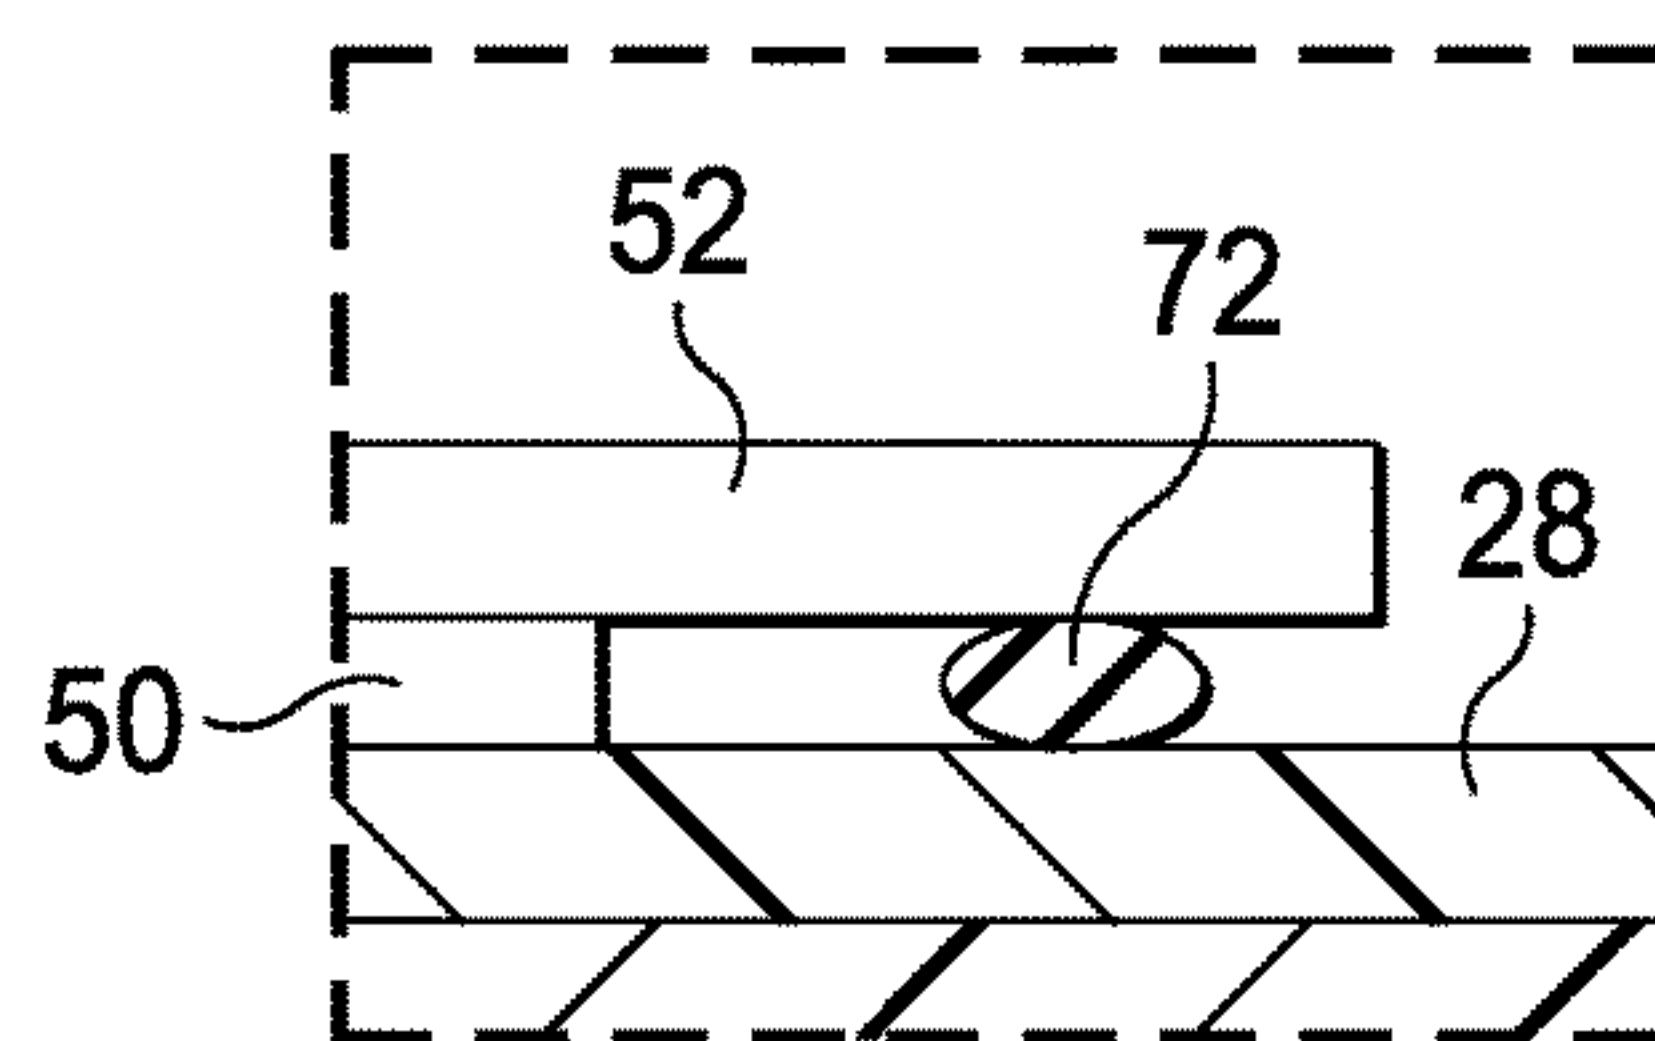
FIG. 8 is an illustration of the area designated as FIG. 8 in FIG. 7.
