(12) **United States Patent**
Maresca, Jr. et al.

(10) **Patent No.:** **US 9,811,900 B2**
(45) **Date of Patent:** ***Nov. 7, 2017**

(54) **AUTOMATIC DETECTION OF DEFECTS IN COMPOSITE STRUCTURES USING NDT METHODS**

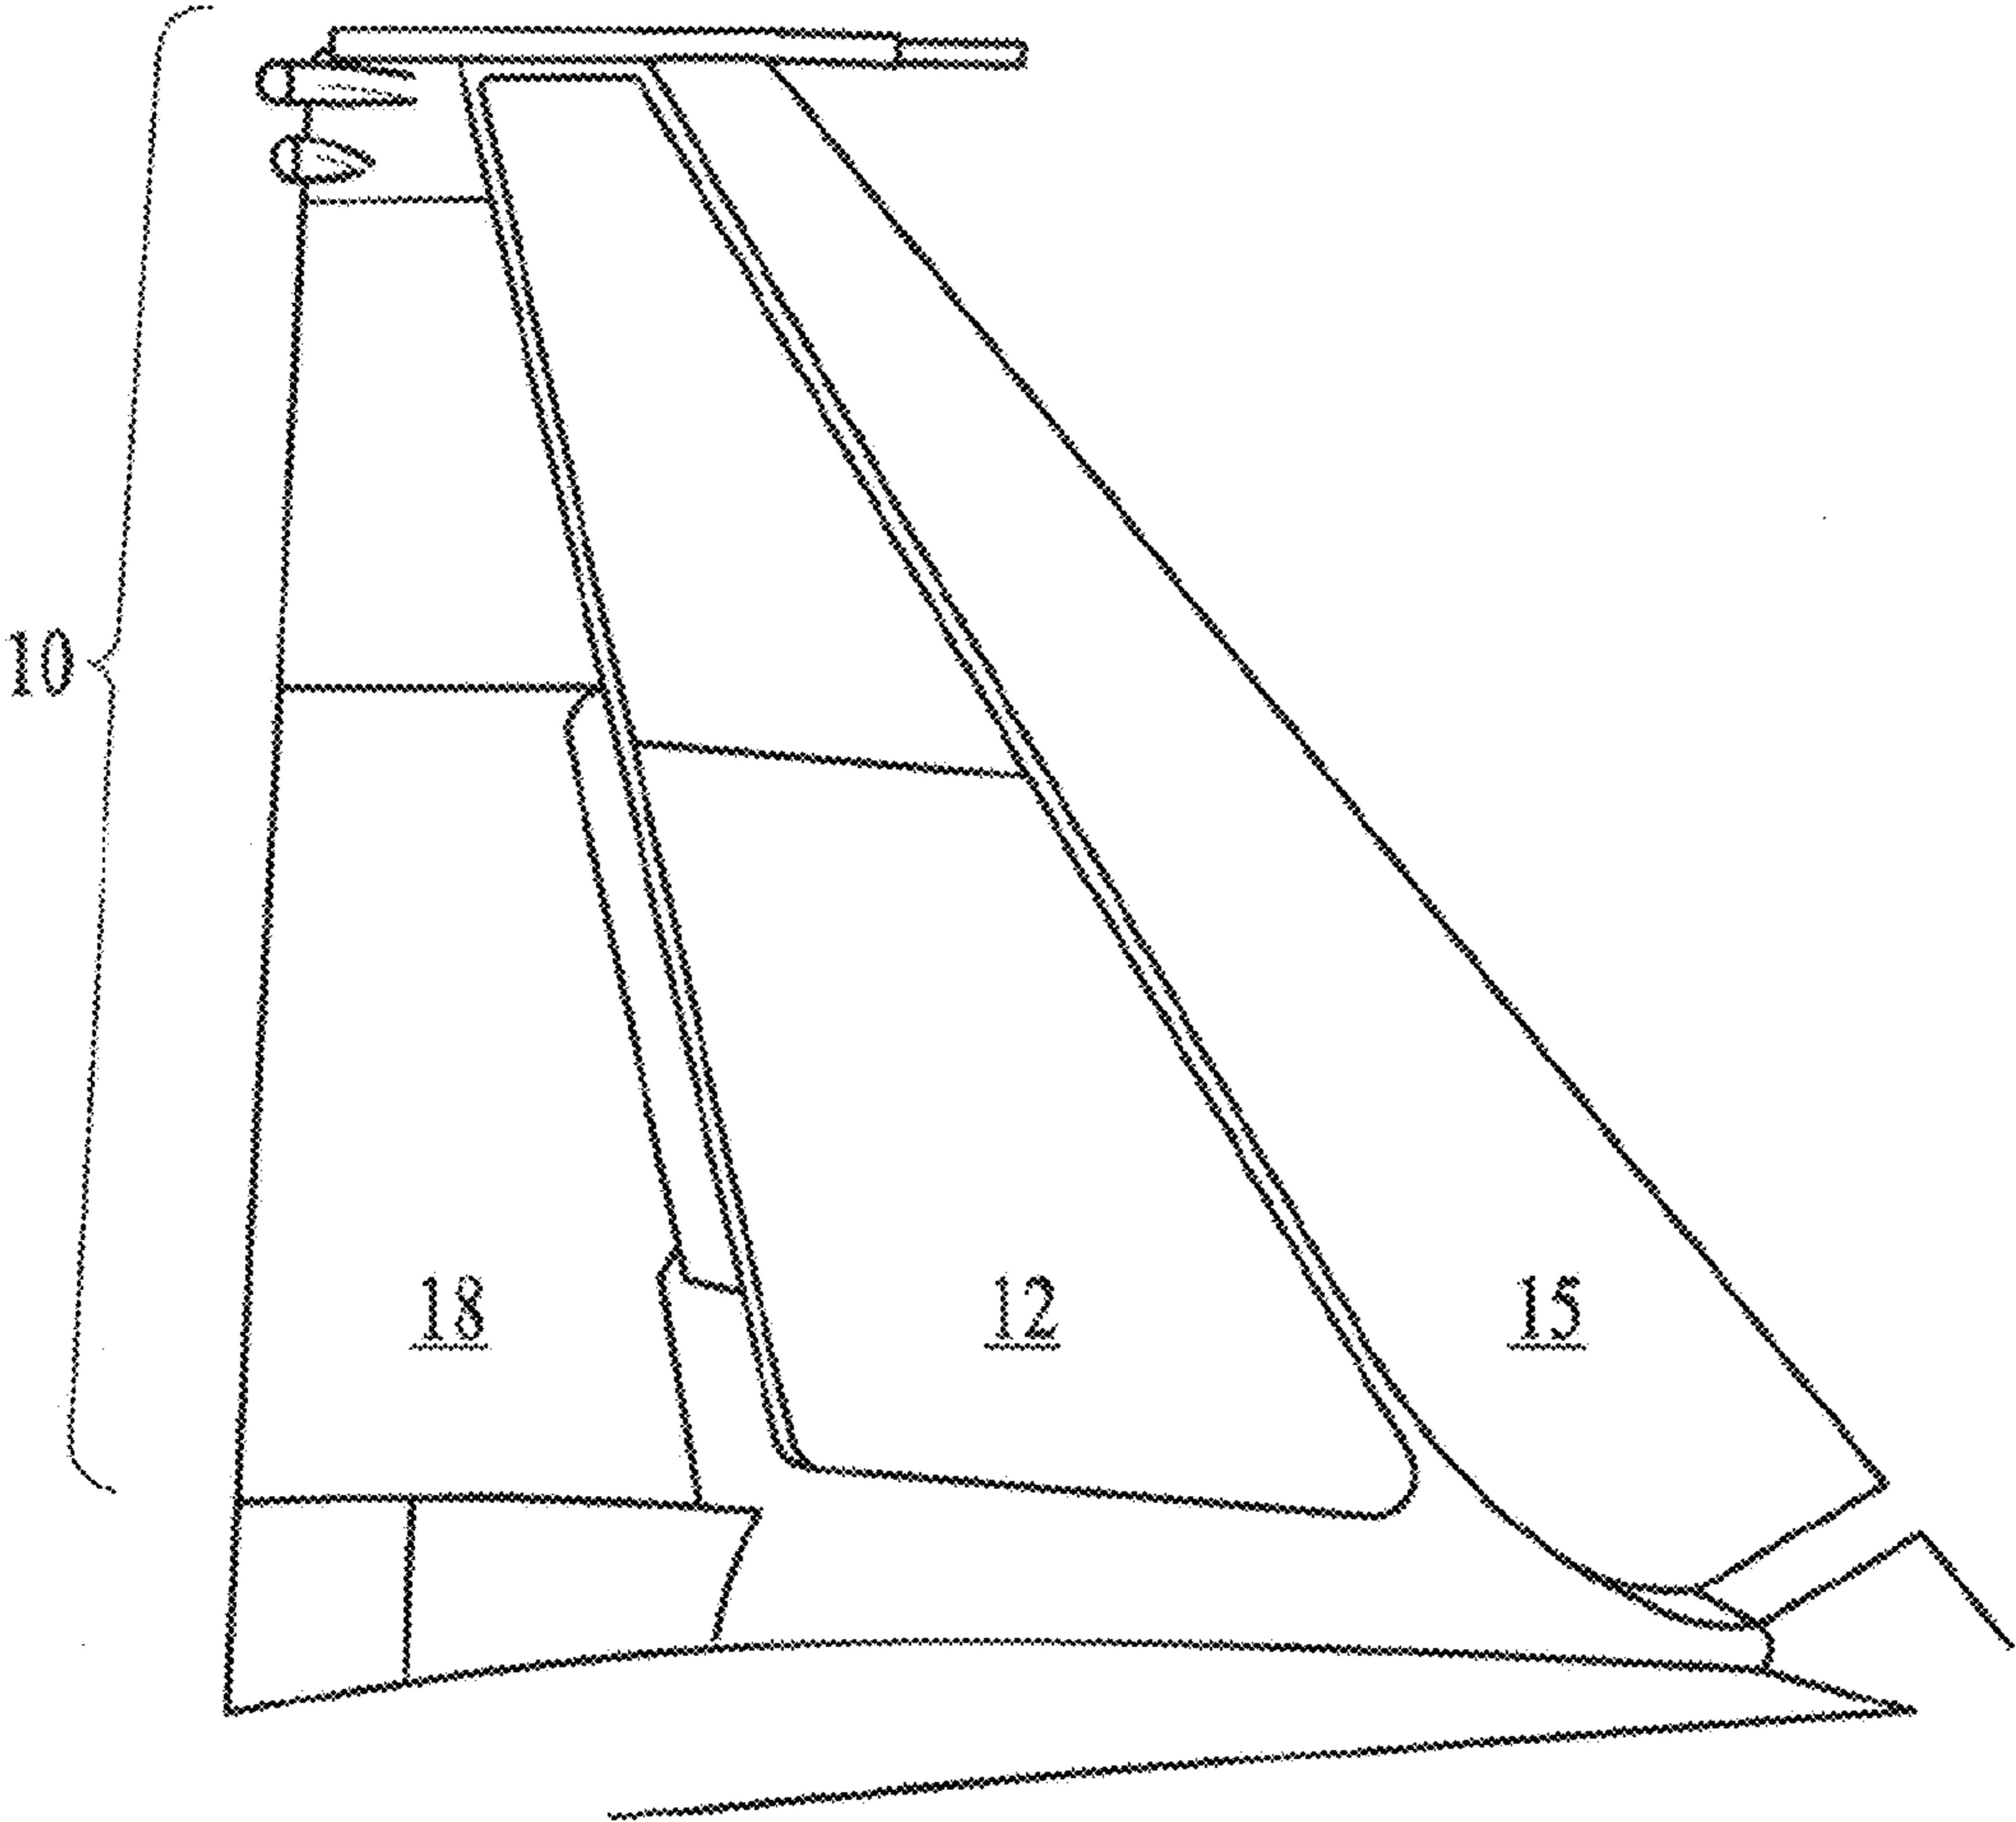
FIG. 1 illustrates the F-15 vertical stabilizer showing the boron composite area and the leading and trailing edge.

FIG. 9 illustrates the output of a raw IR image obtained 30 s after heating the surface of an aircraft honeycomb boron composite used in the vertical stabilizer of the US Air Force (USAF) F-15 jet aircraft shown in FIG. 1. An illustration of a section of the honeycomb boron composite 20 is shown in FIG. 2. The boron composite 26 over the honeycomb 28 and the aluminum skin 24 over the honeycomb is shown. Distinct white spots in the IR image can indicate the presence of a disbond (separation of the boron composite from the aluminum honeycomb) or a delamination (separation between one or more layers of the boron composite). Visual inspection of the IR image indicates many such areas and significant ambiguity. FIG. 10 illustrates the results of the same IR image processed with a computer using a noise cancellation background removal method. One can easily see the disbond along the right edge of the aircraft structure and not be confused by the large area of ambiguous white spots along the left edge and center sections of the composite structure. This simple illustration shows the benefit of signal processing methods over visual interpretation in terms of accuracy and reliability. It minimizes the number of false detections (i.e., false alarms). It is also significant that the computer analysis is done automatically and can be done remotely without having to output the IR image.

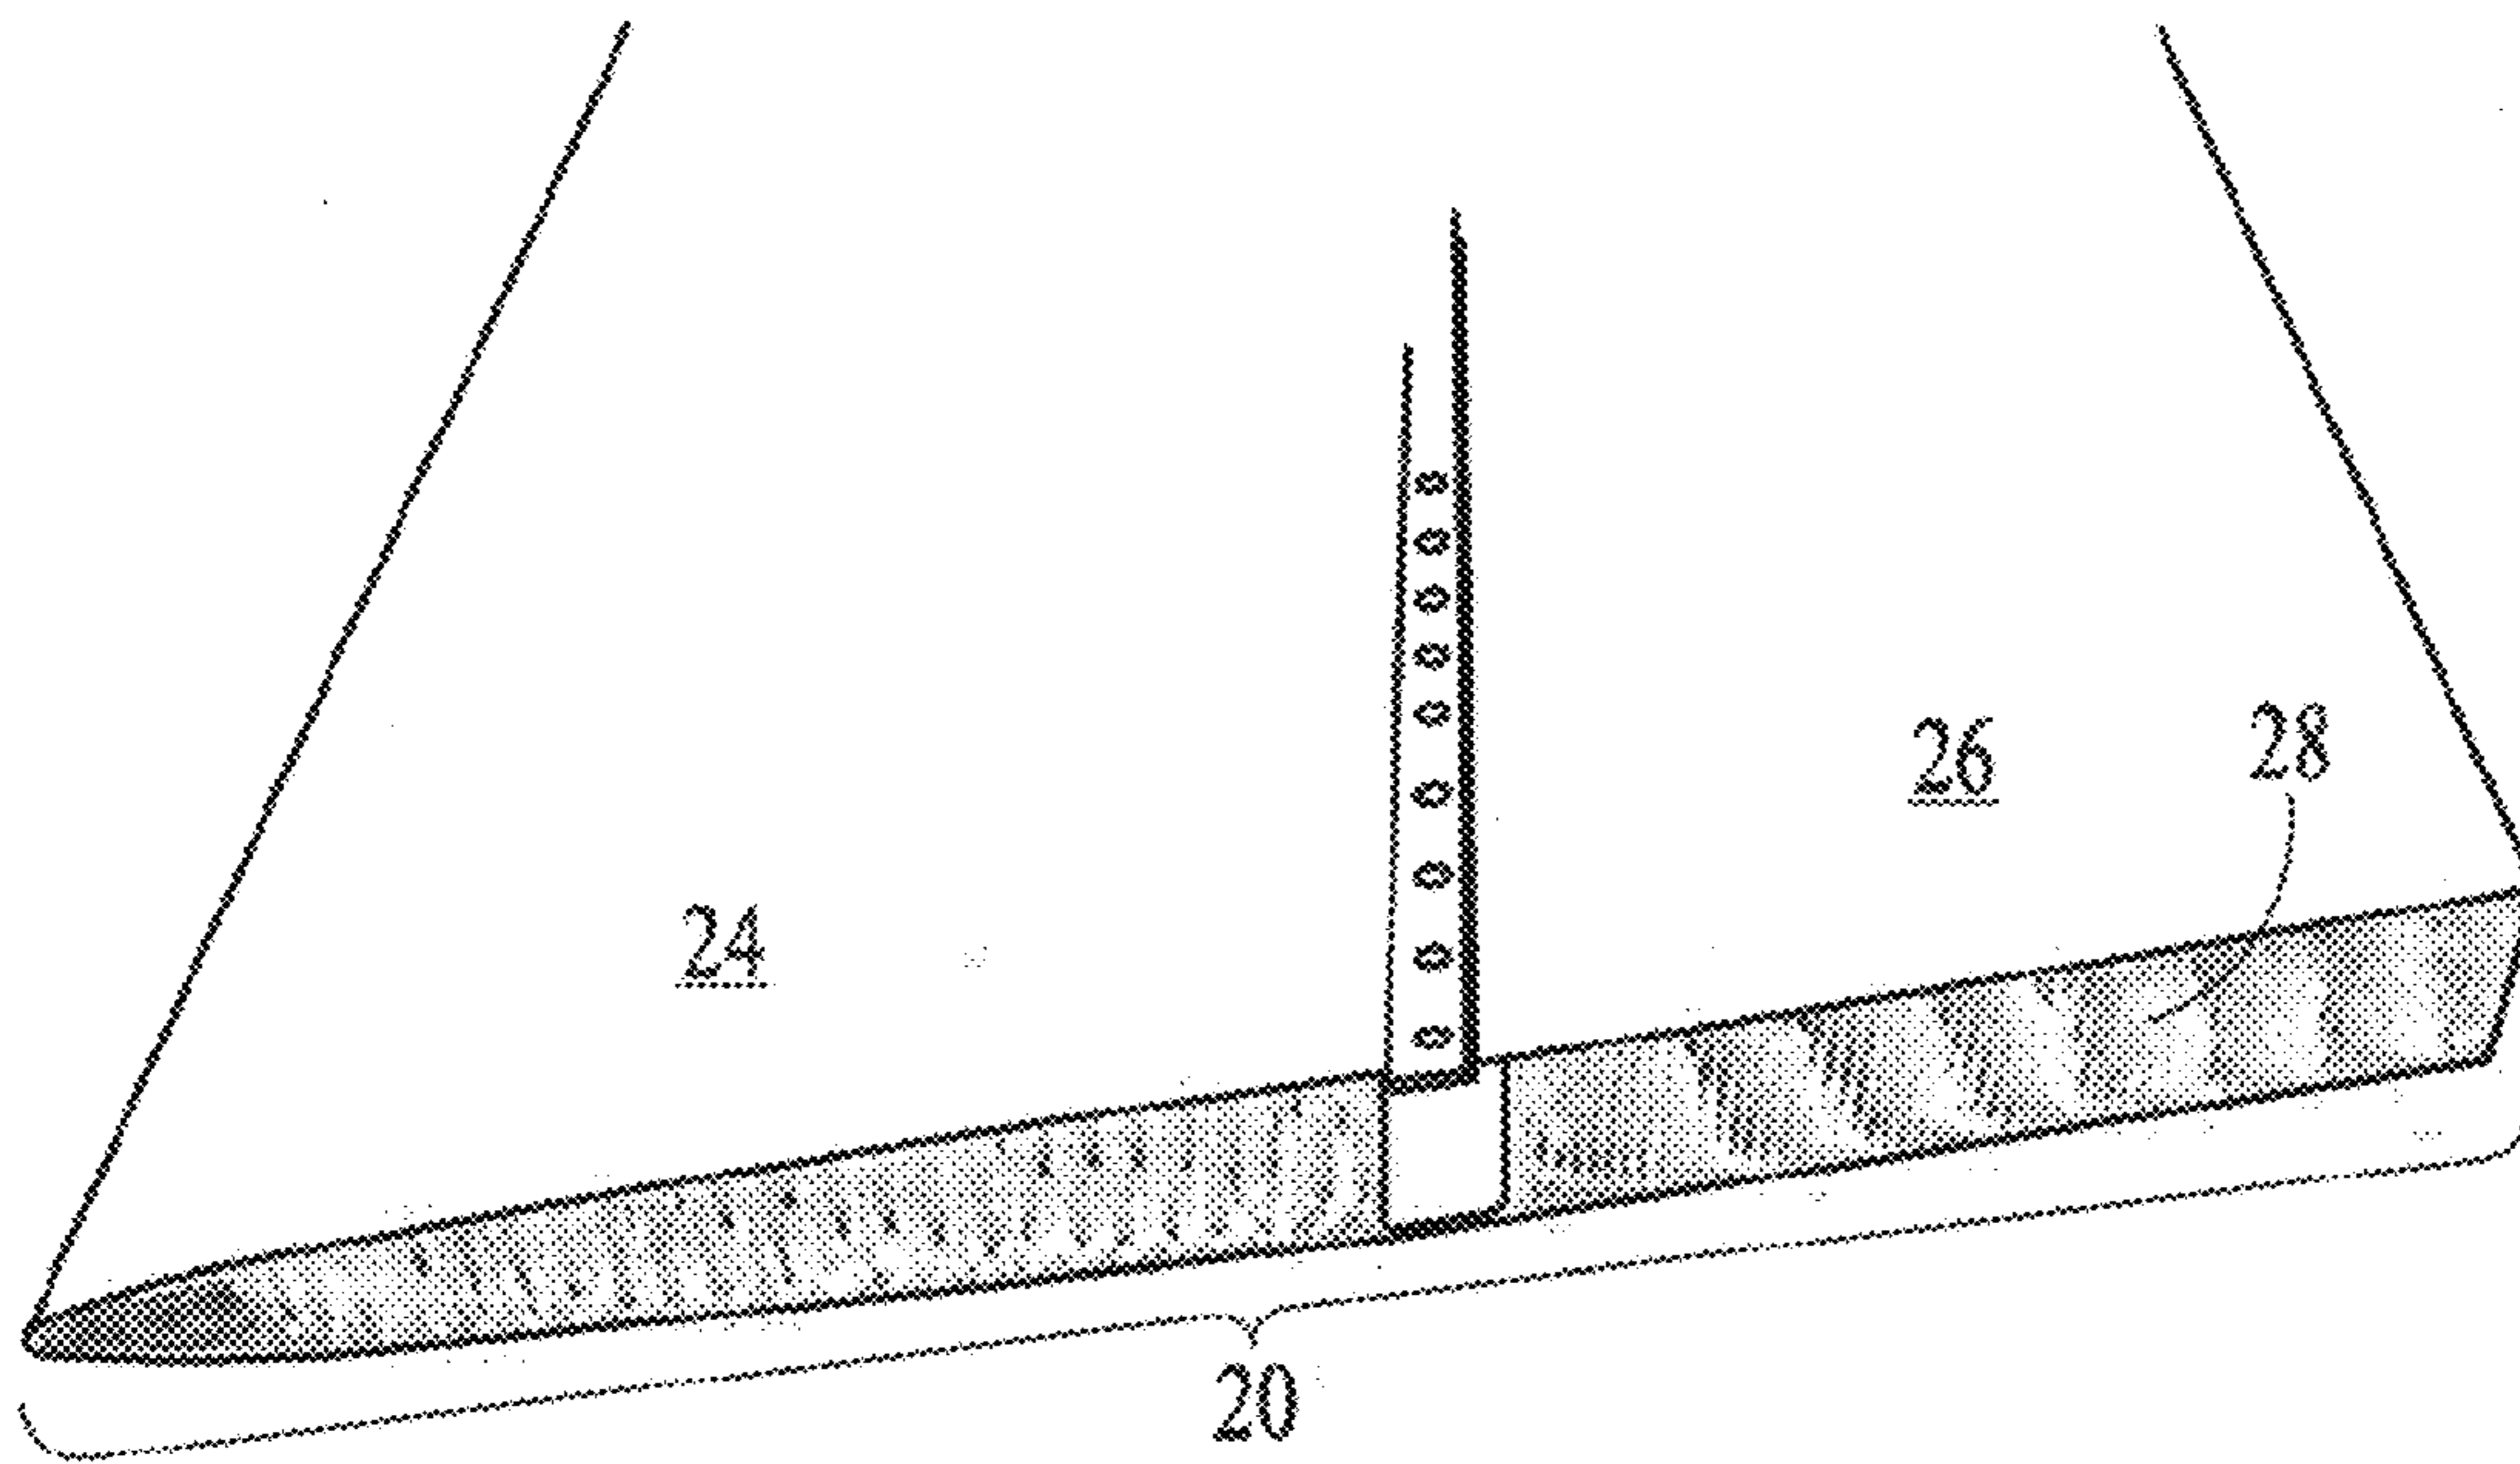
FIG. 2 illustrates the internal structure of an article with a boron composite skin over an internal aluminum honeycomb.

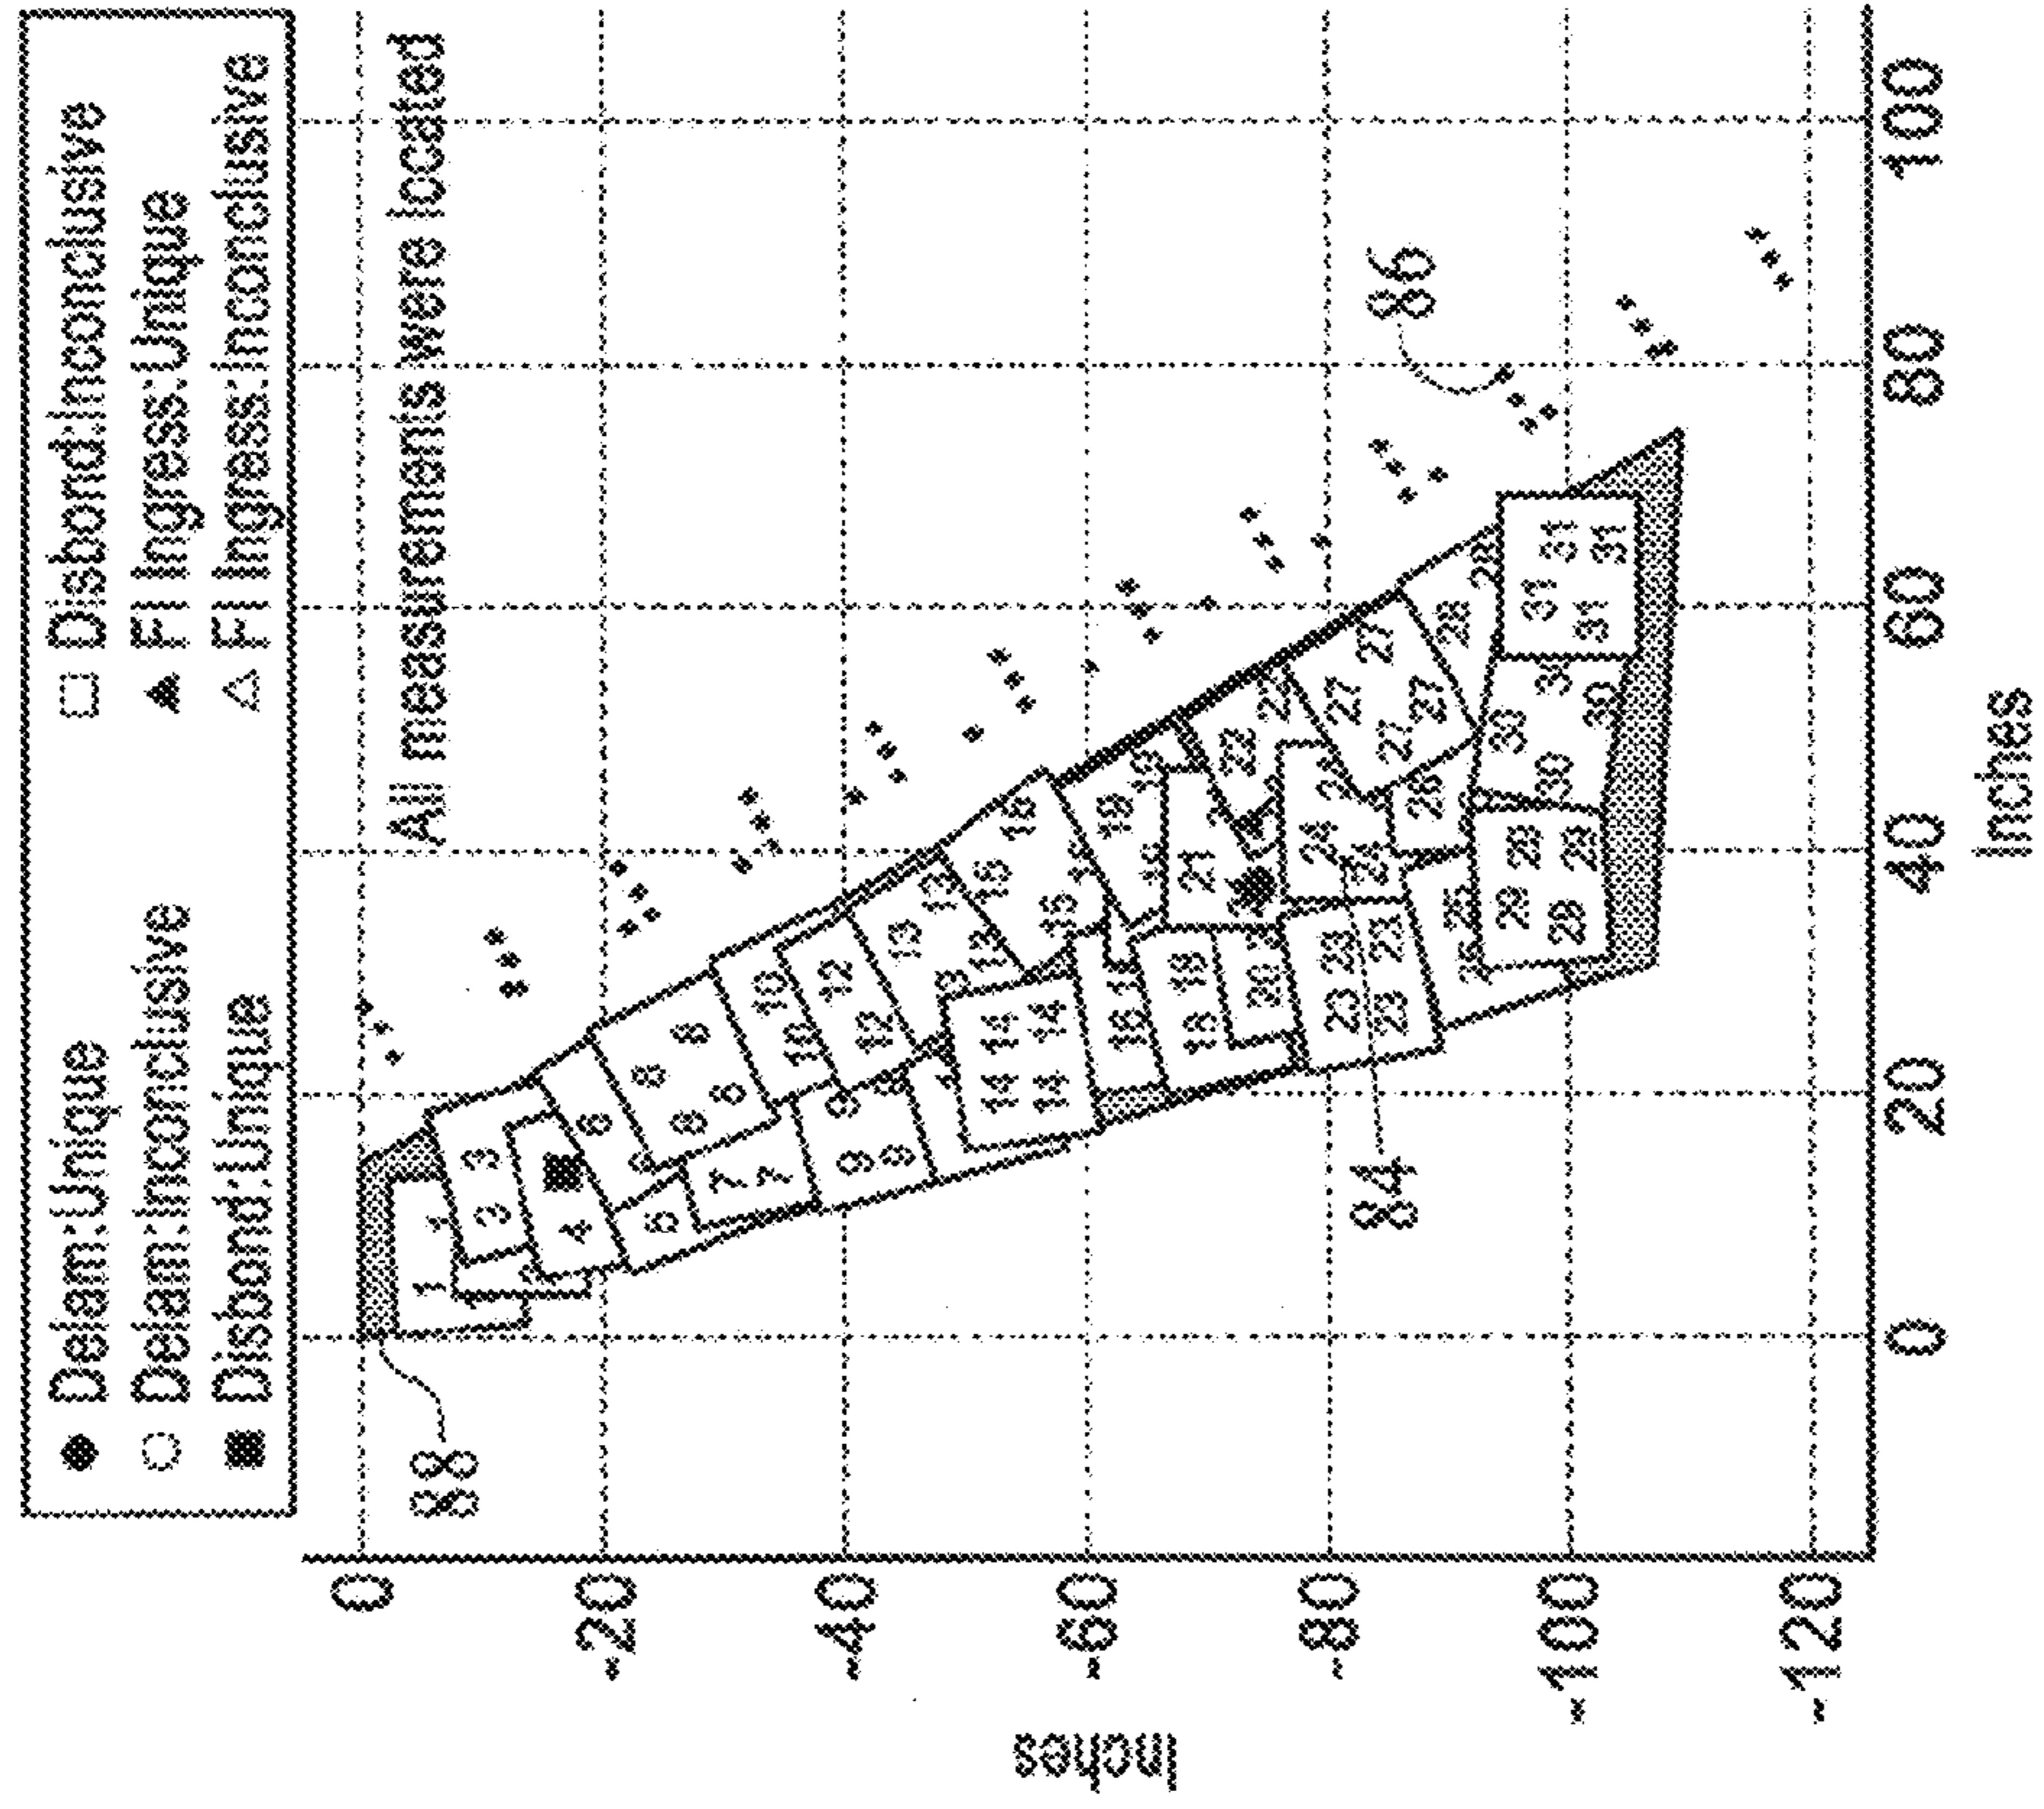
FIG. 3 illustrates the IRIS system in used on an actual F-15 with a defect and image coverage map shown on the right.

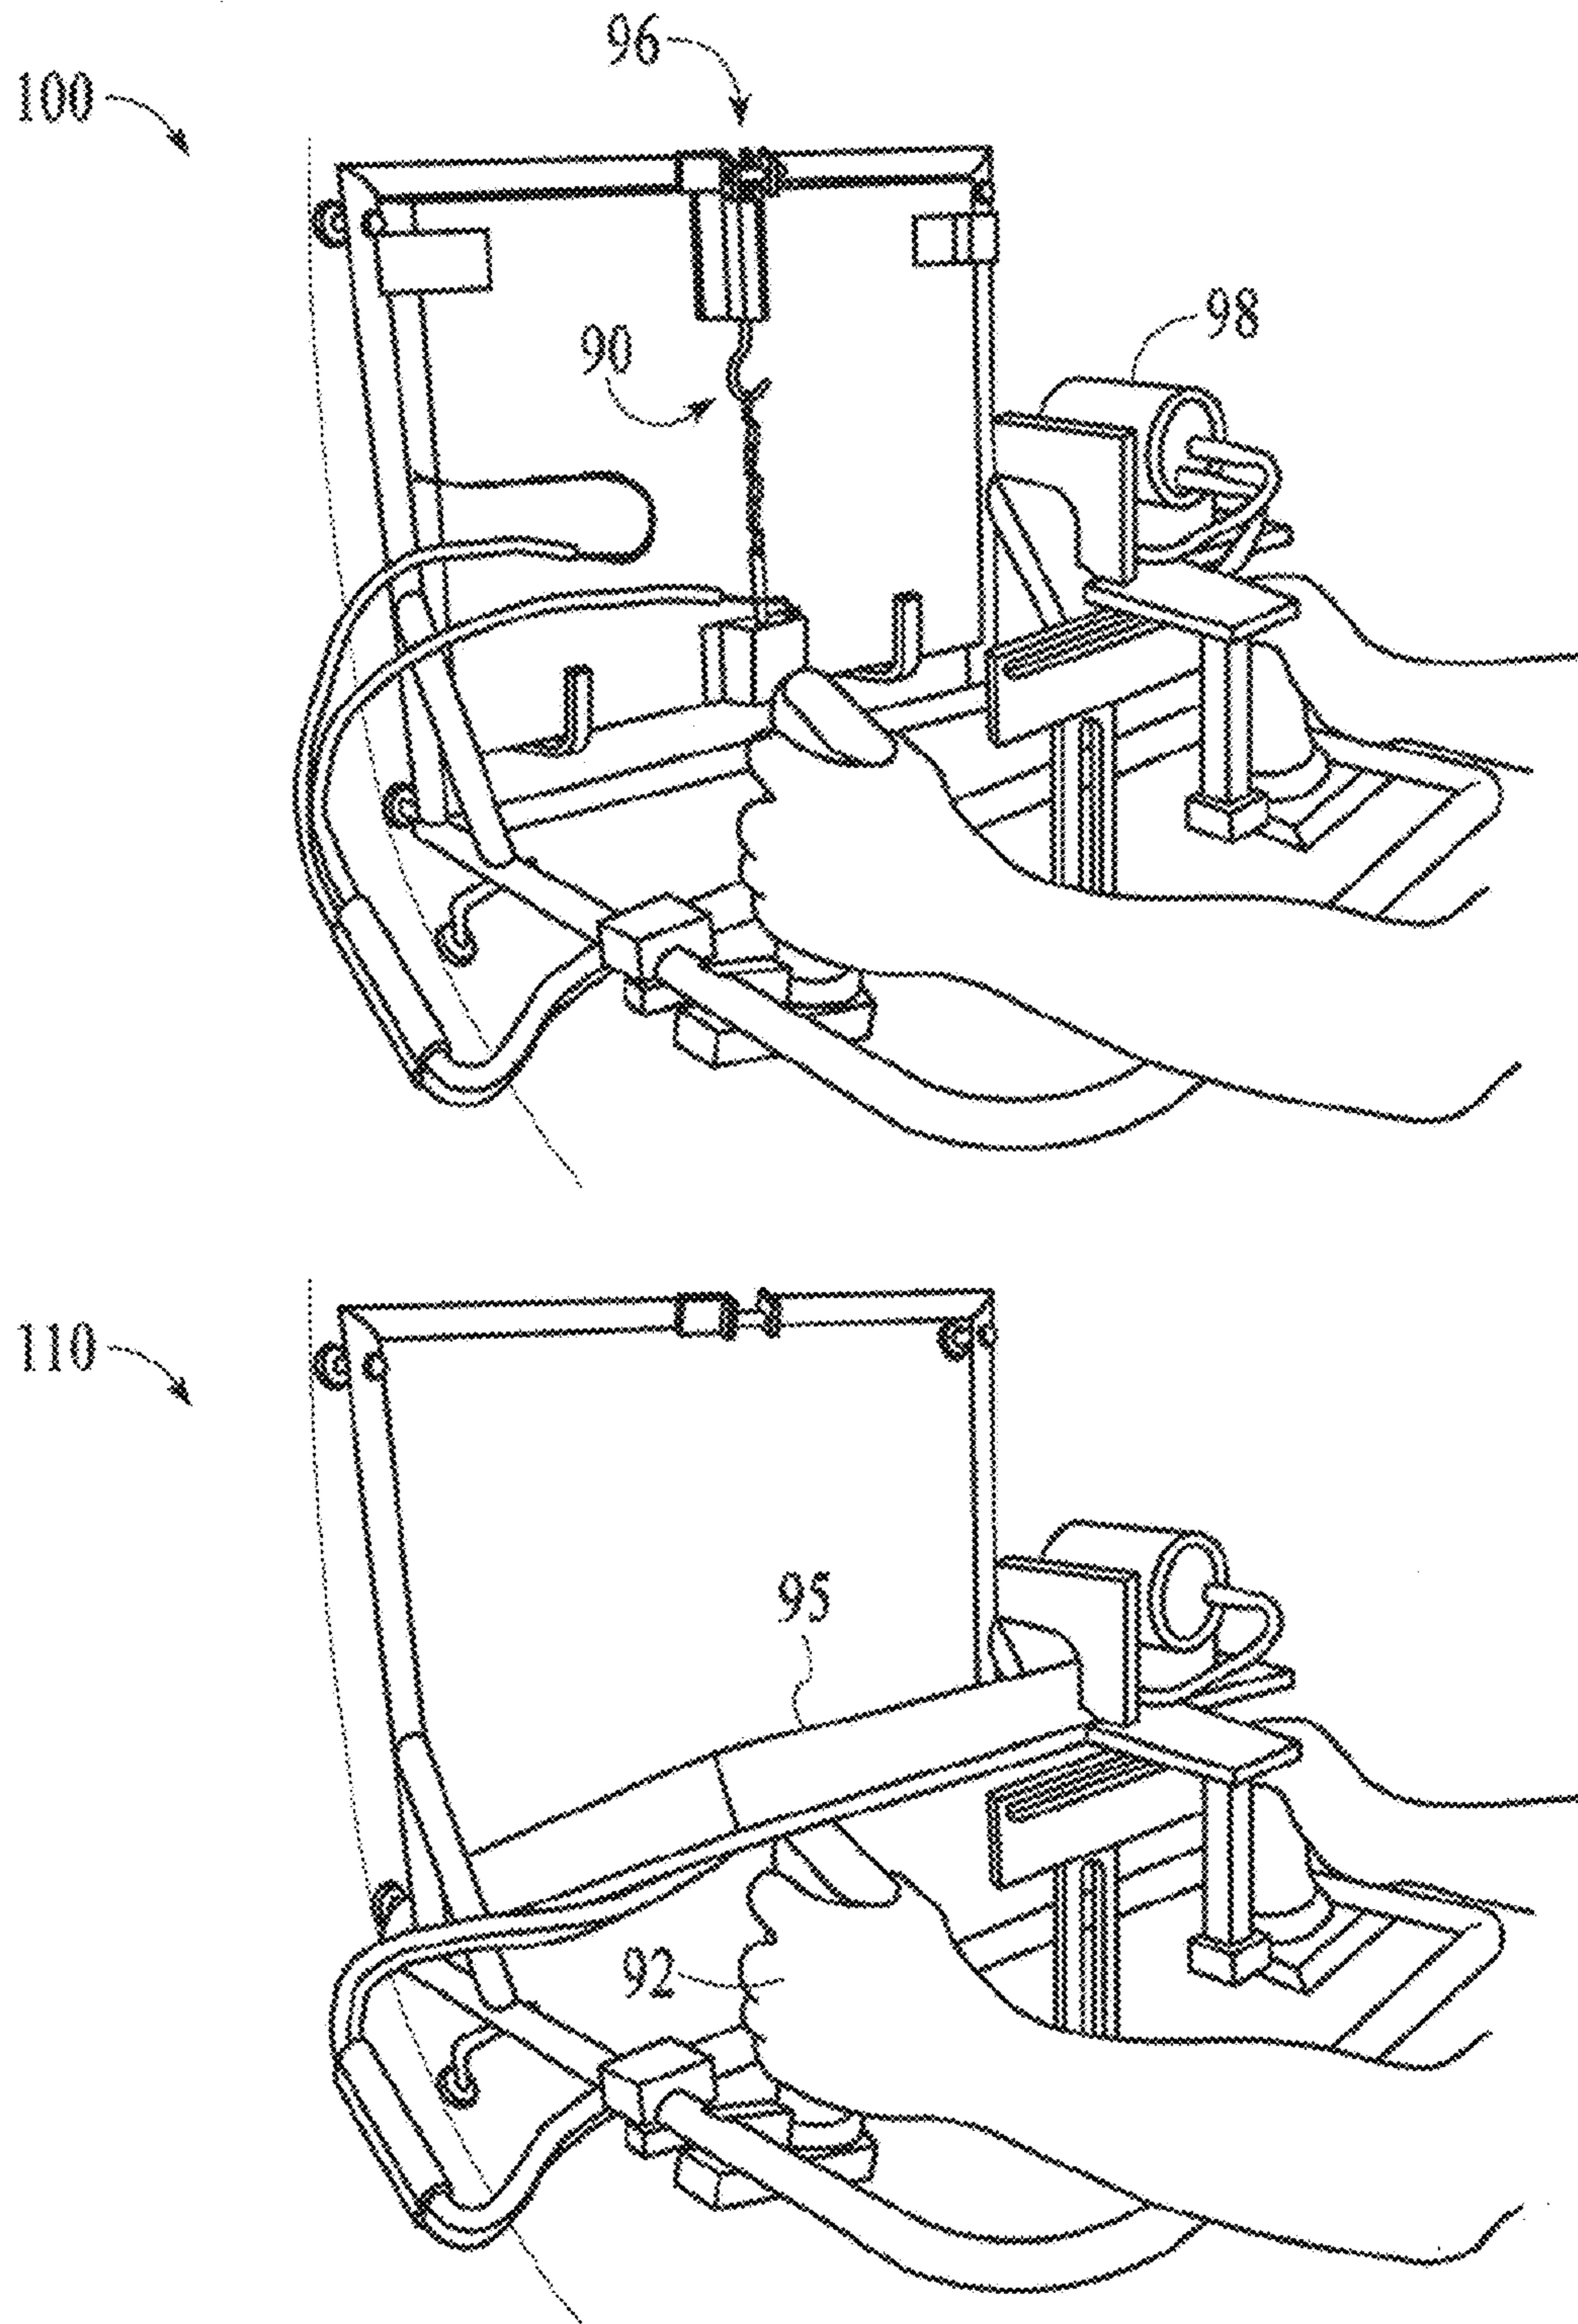
FIG. 4 illustrates the IR inspection method with heat being applied to the surface of the boron honeycomb composite on an F-15 vertical stabilizer in the lab and after the latch was released so that the heating mat fell out of the way of the IR camera and IR measurements of the composite surface could take place.

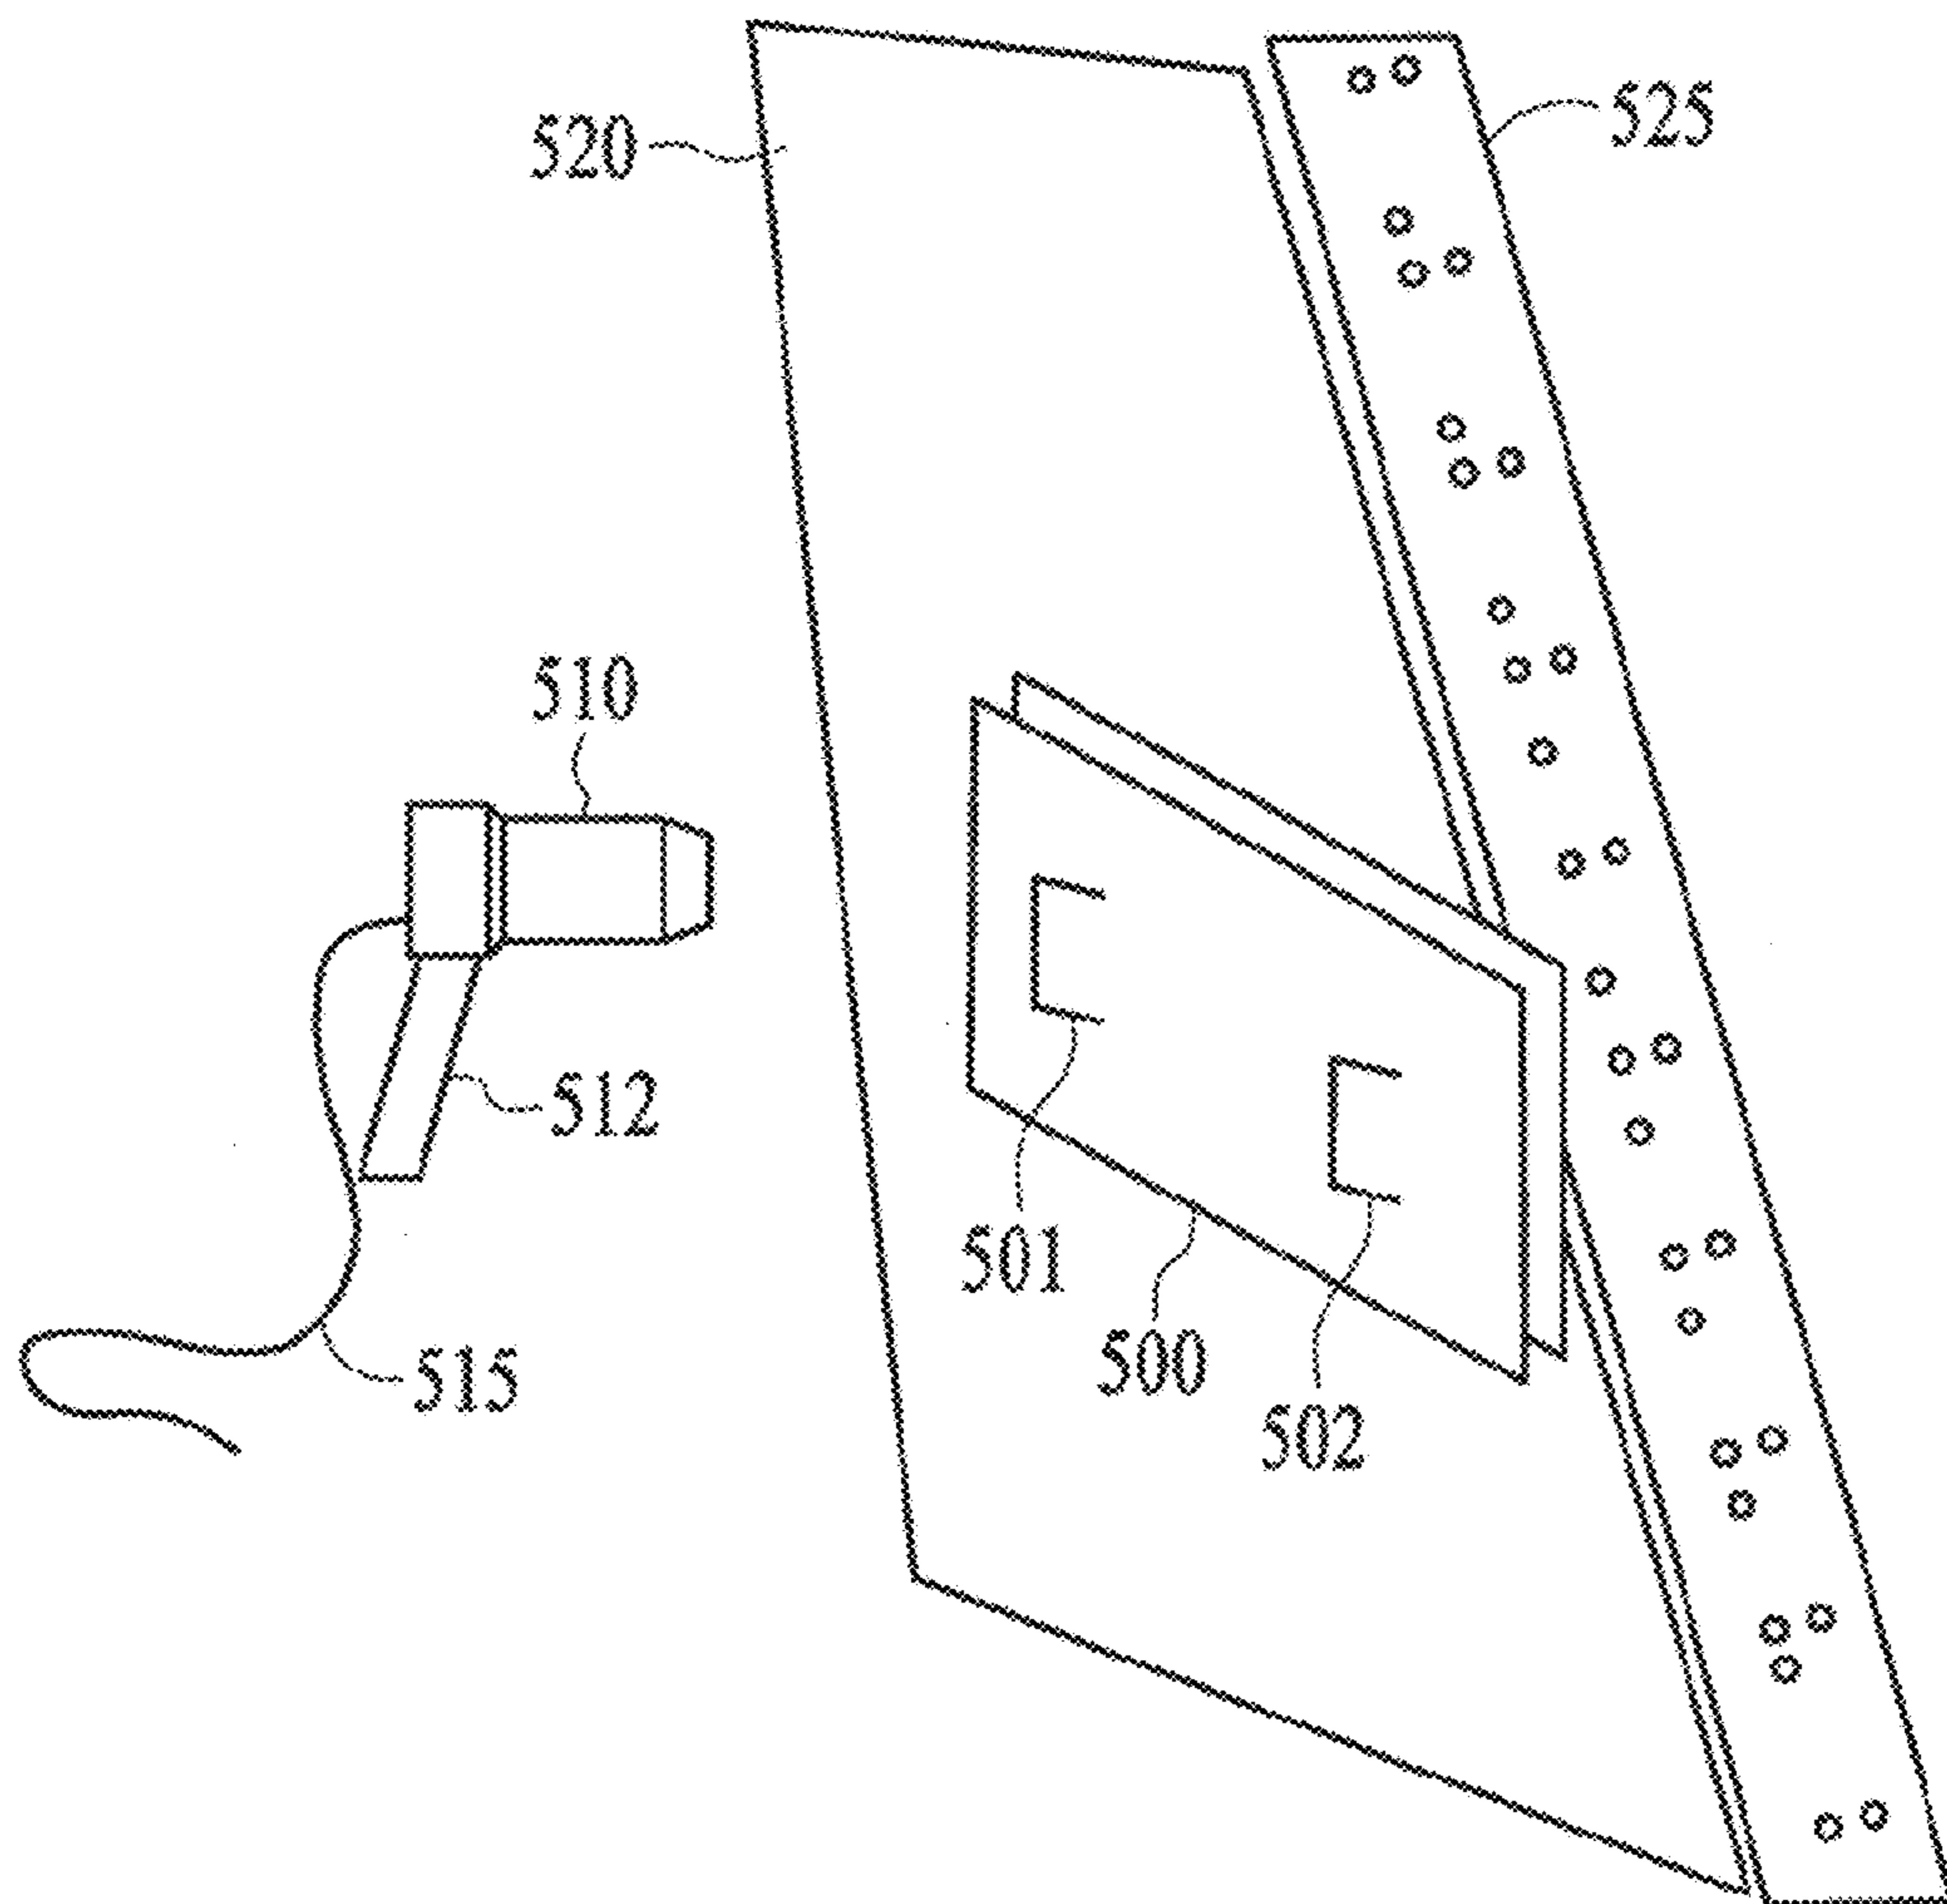
FIG. 5 illustrates a conceptual sketch of a handheld IR inspection system consisting of a handheld camera and manually operated heating mat.

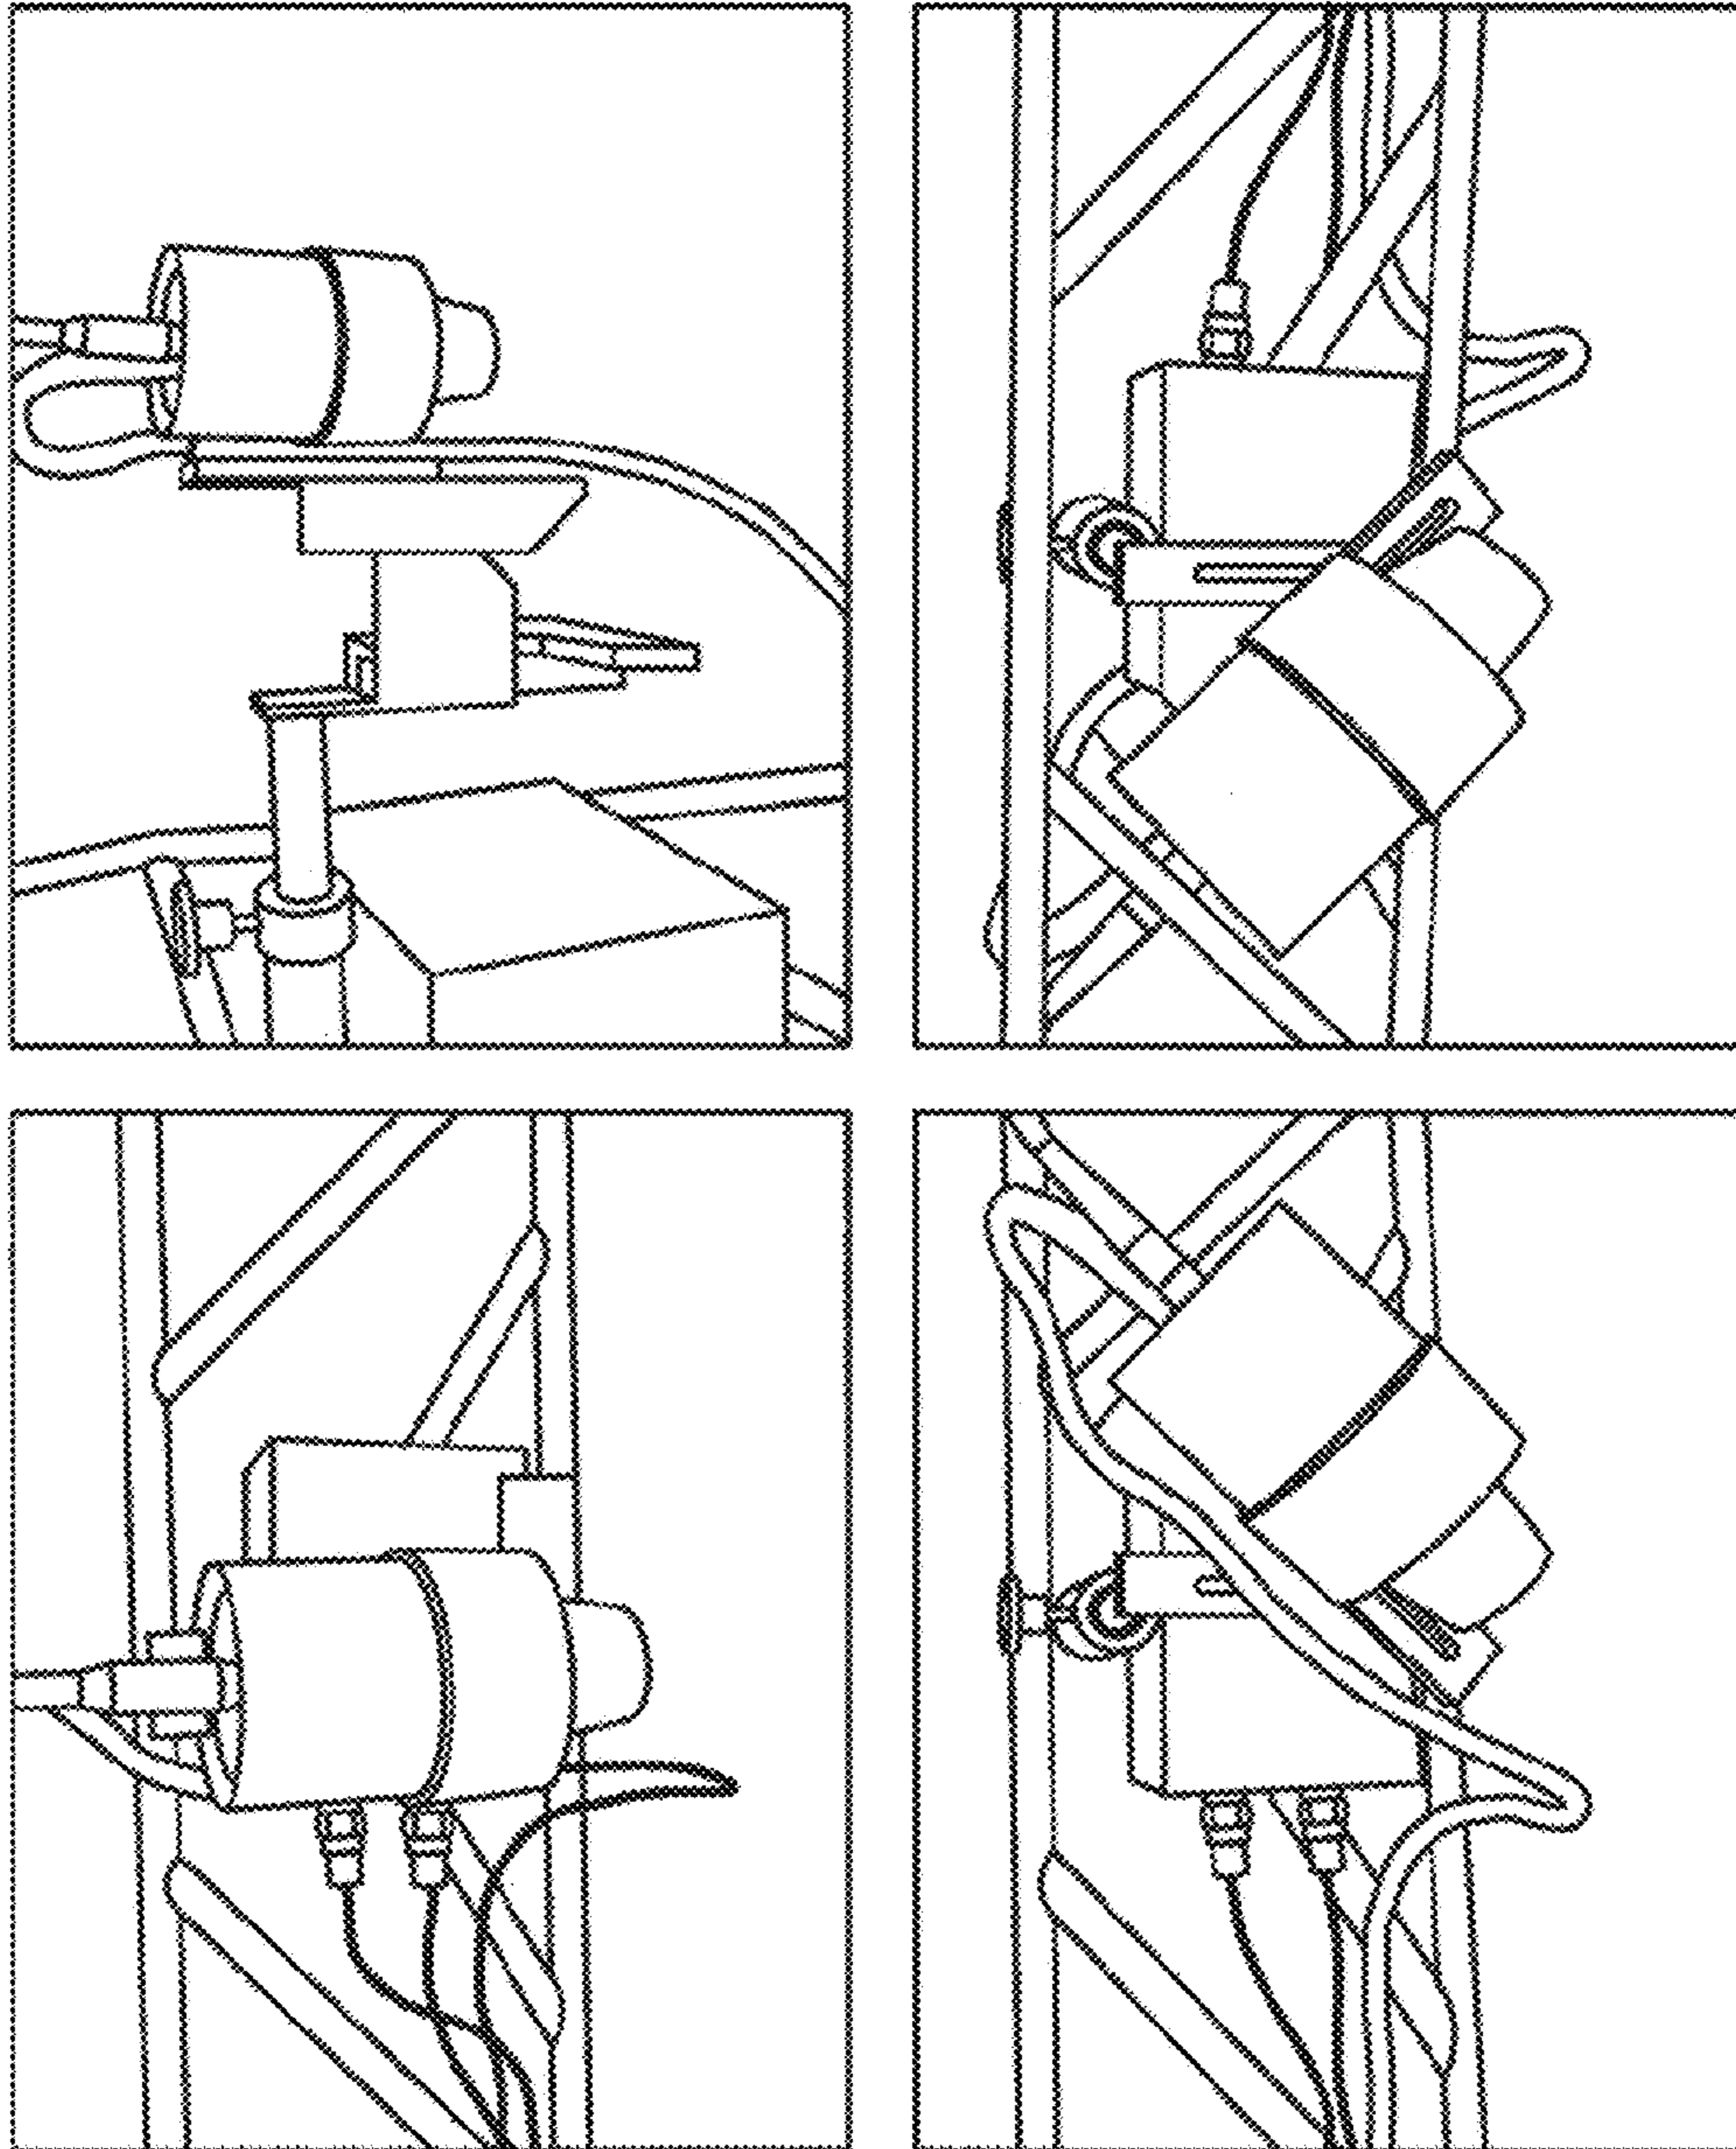
FIG. 6 illustrates the IR camera mount which allows the IR camera to be rotated to the correct position for viewing the IR Ruler. Stops designed in the mount set the rotation without the operator having to measure or align the rotation.
