(12) **United States Patent**
Maresca, Jr. et al.

(10) **Patent No.:** **US 9,811,900 B2**
(45) **Date of Patent:** ***Nov. 7, 2017**

(54) **AUTOMATIC DETECTION OF DEFECTS IN COMPOSITE STRUCTURES USING NDT METHODS**

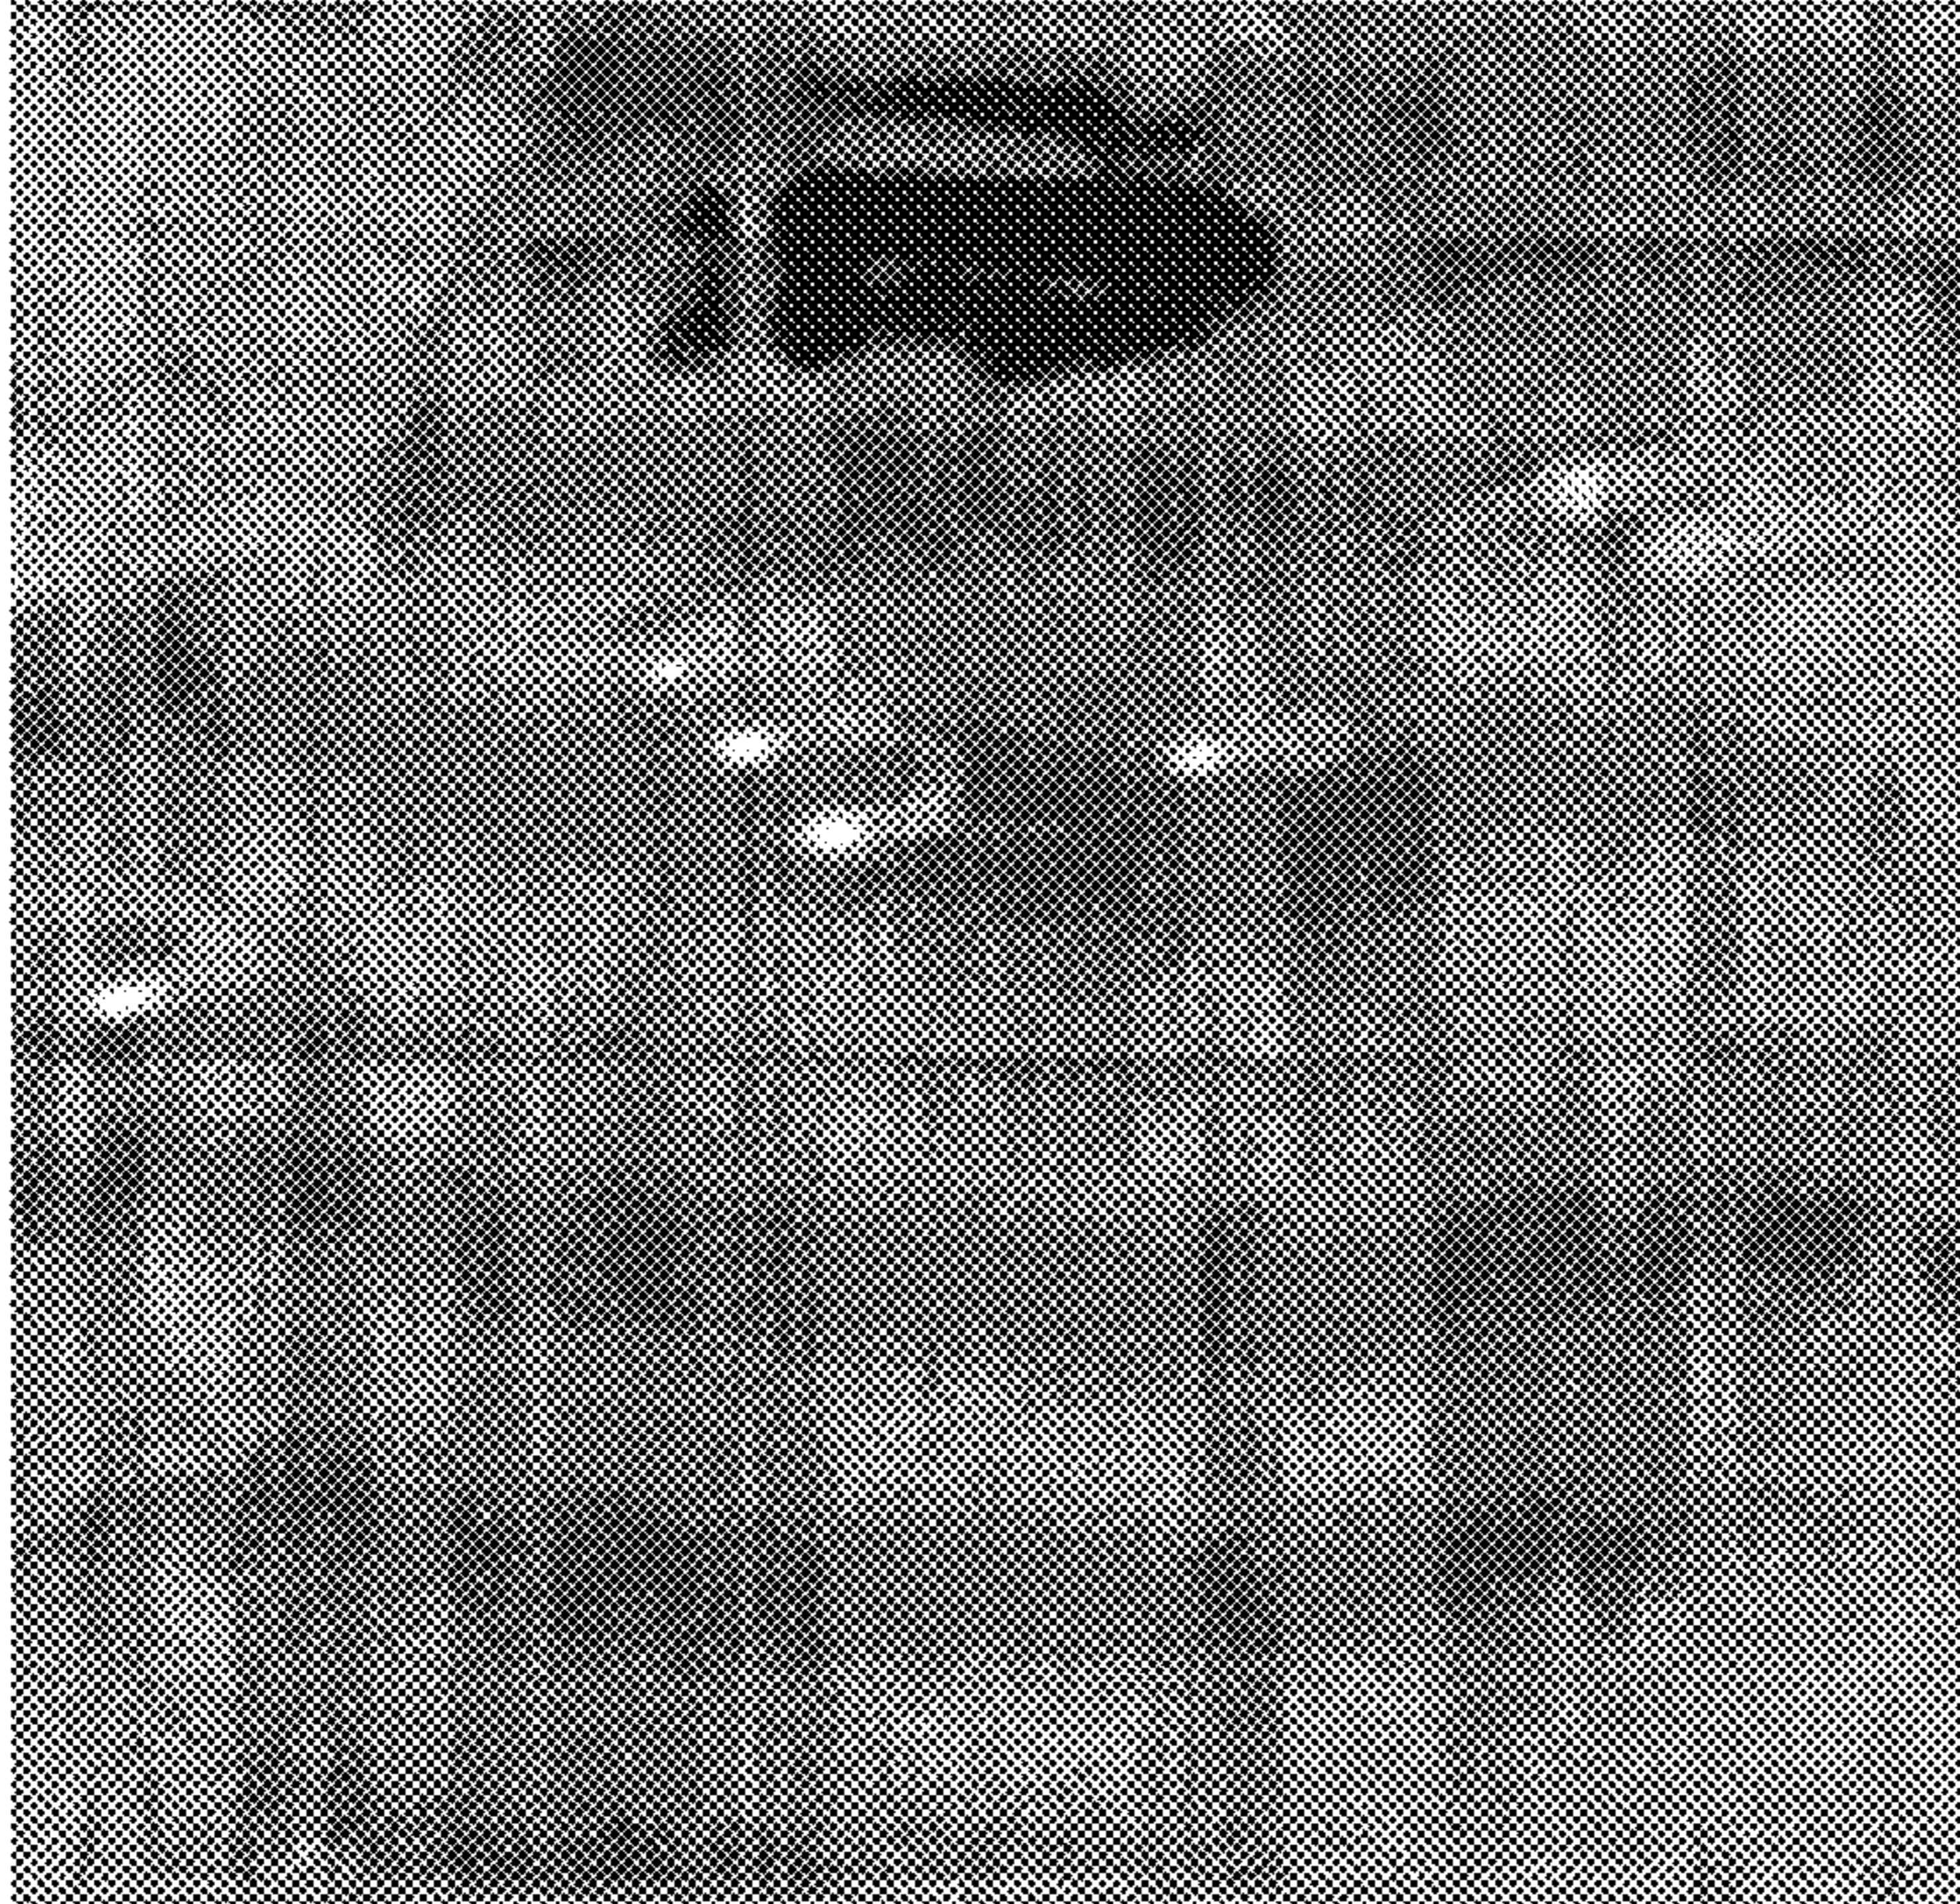
FIG. 7 illustrates the IR Ruler positioned on the vertical stabilizer and the IR image of the IR Ruler recorded during the heating step of a measurement.

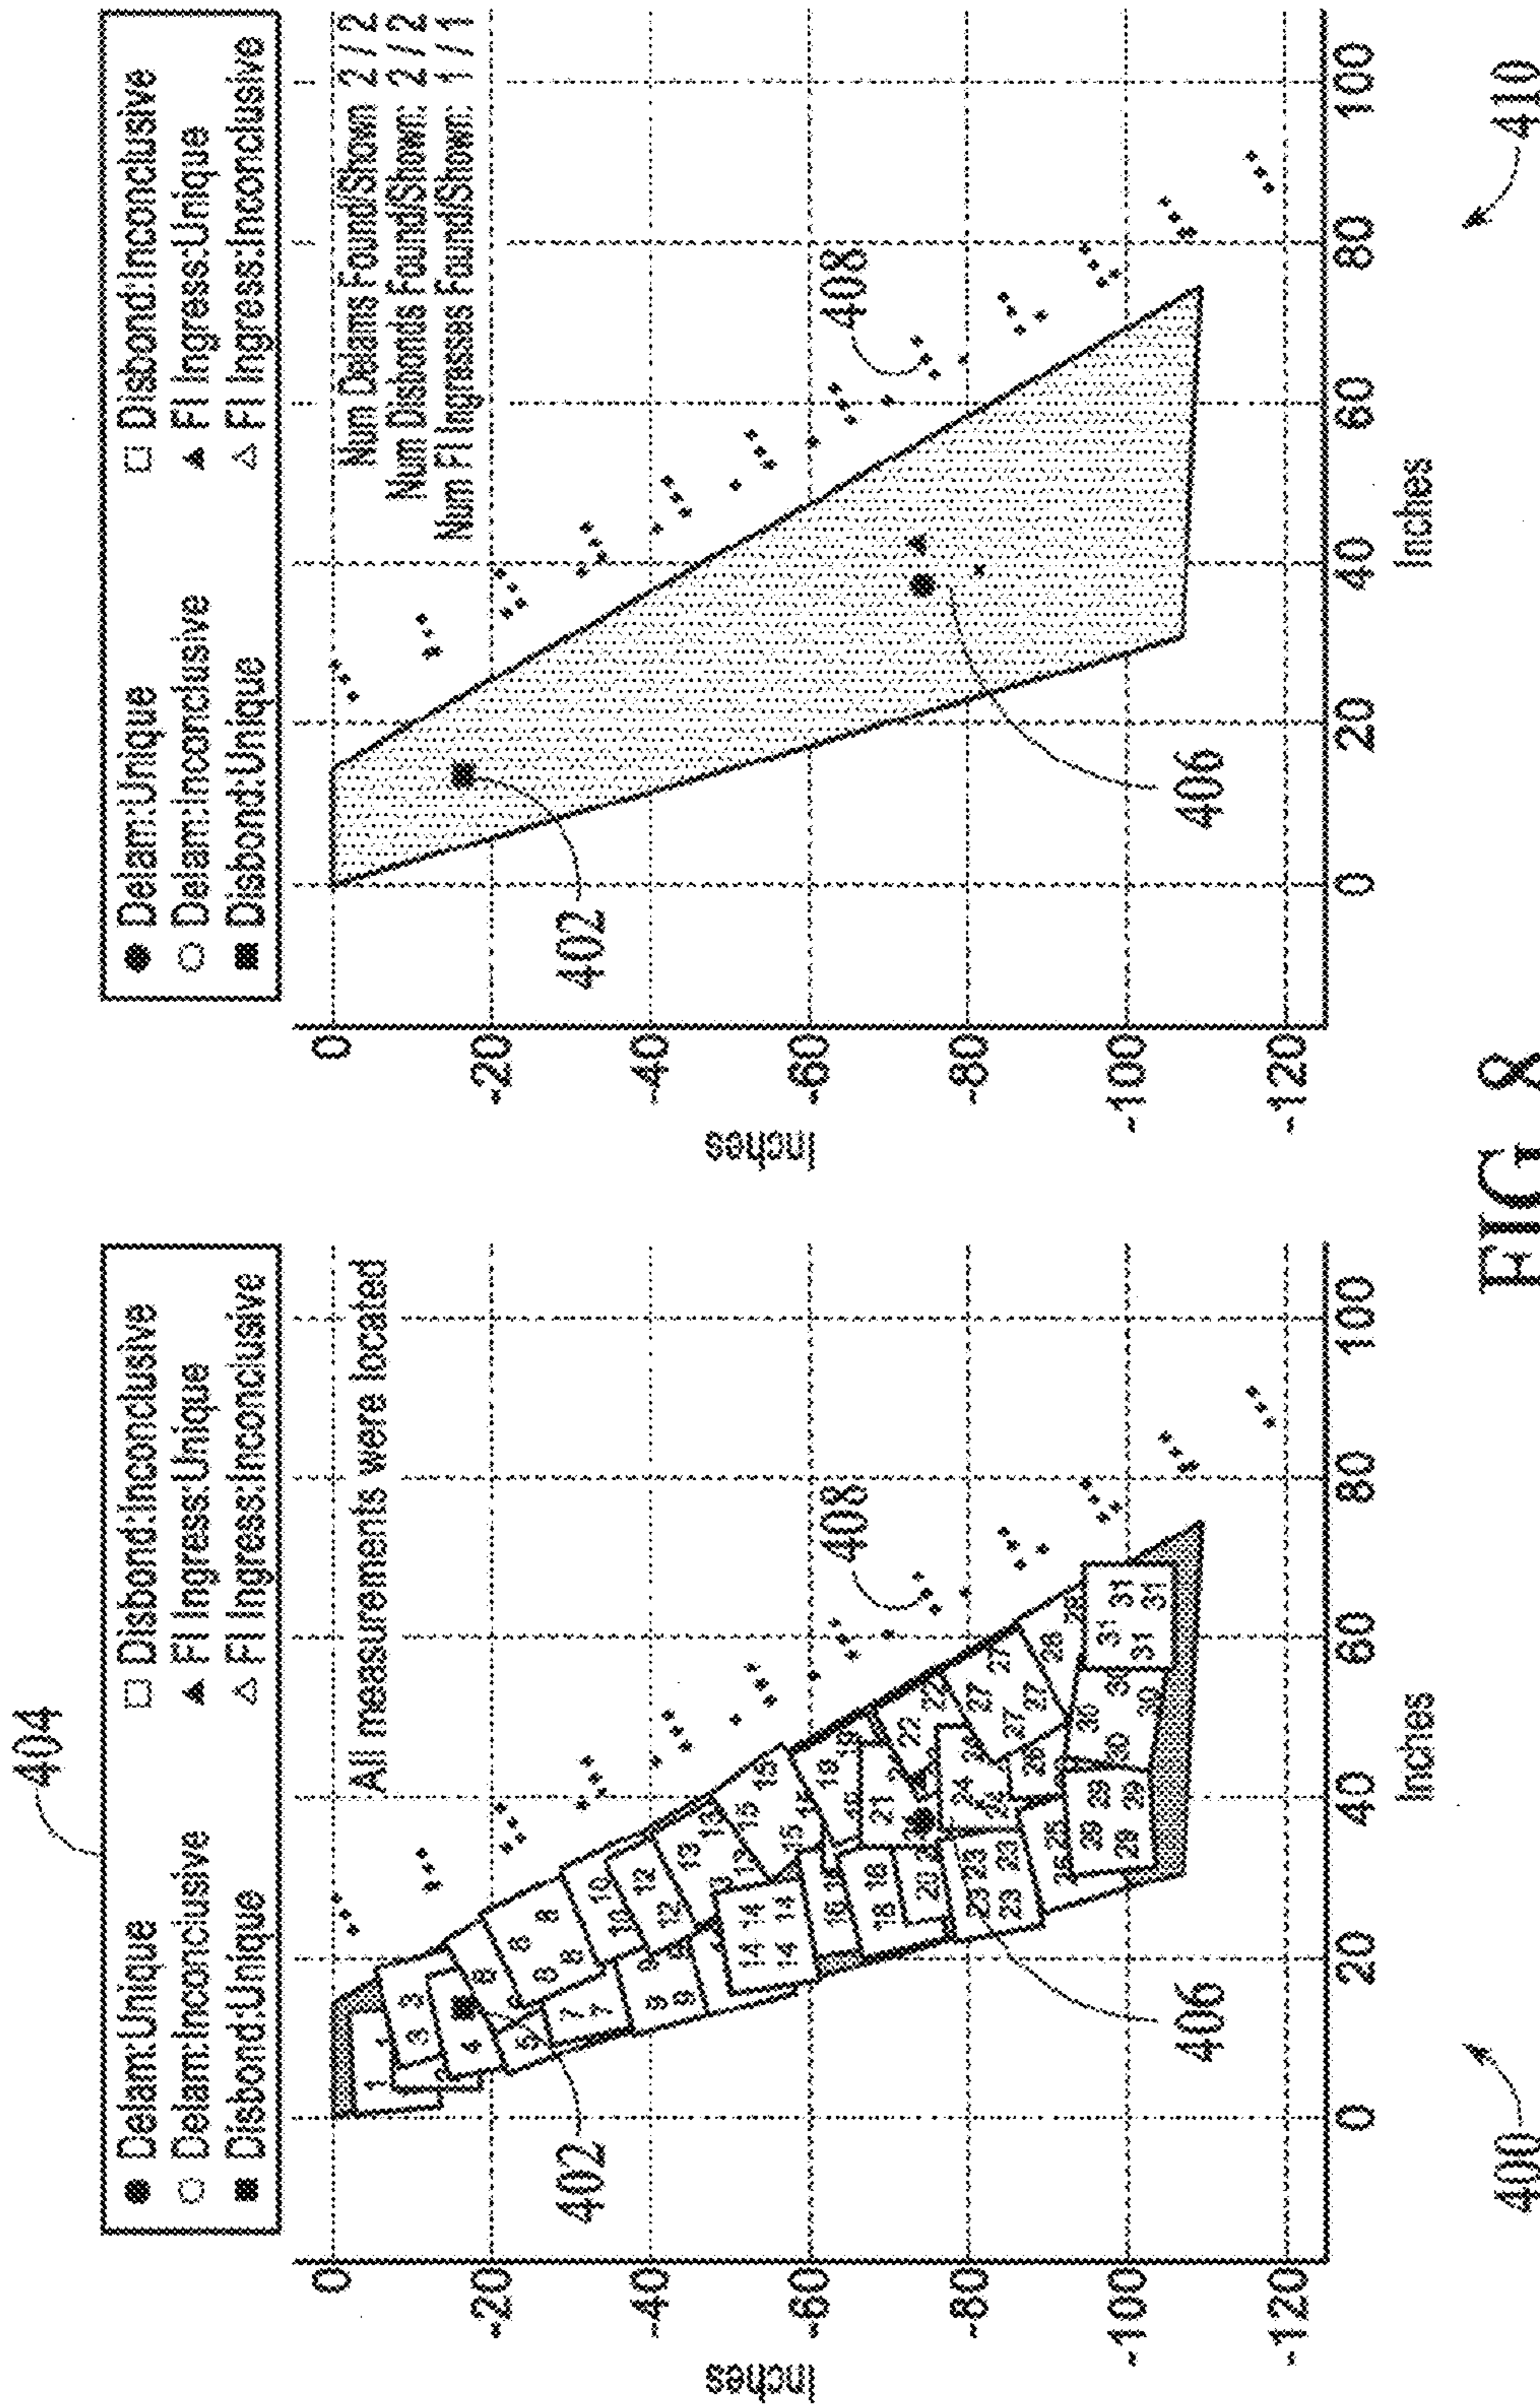
FIG. 8 illustrates the coverage map with measurement numbers and the flaw map that the IRIS creates at the end of an inspection.

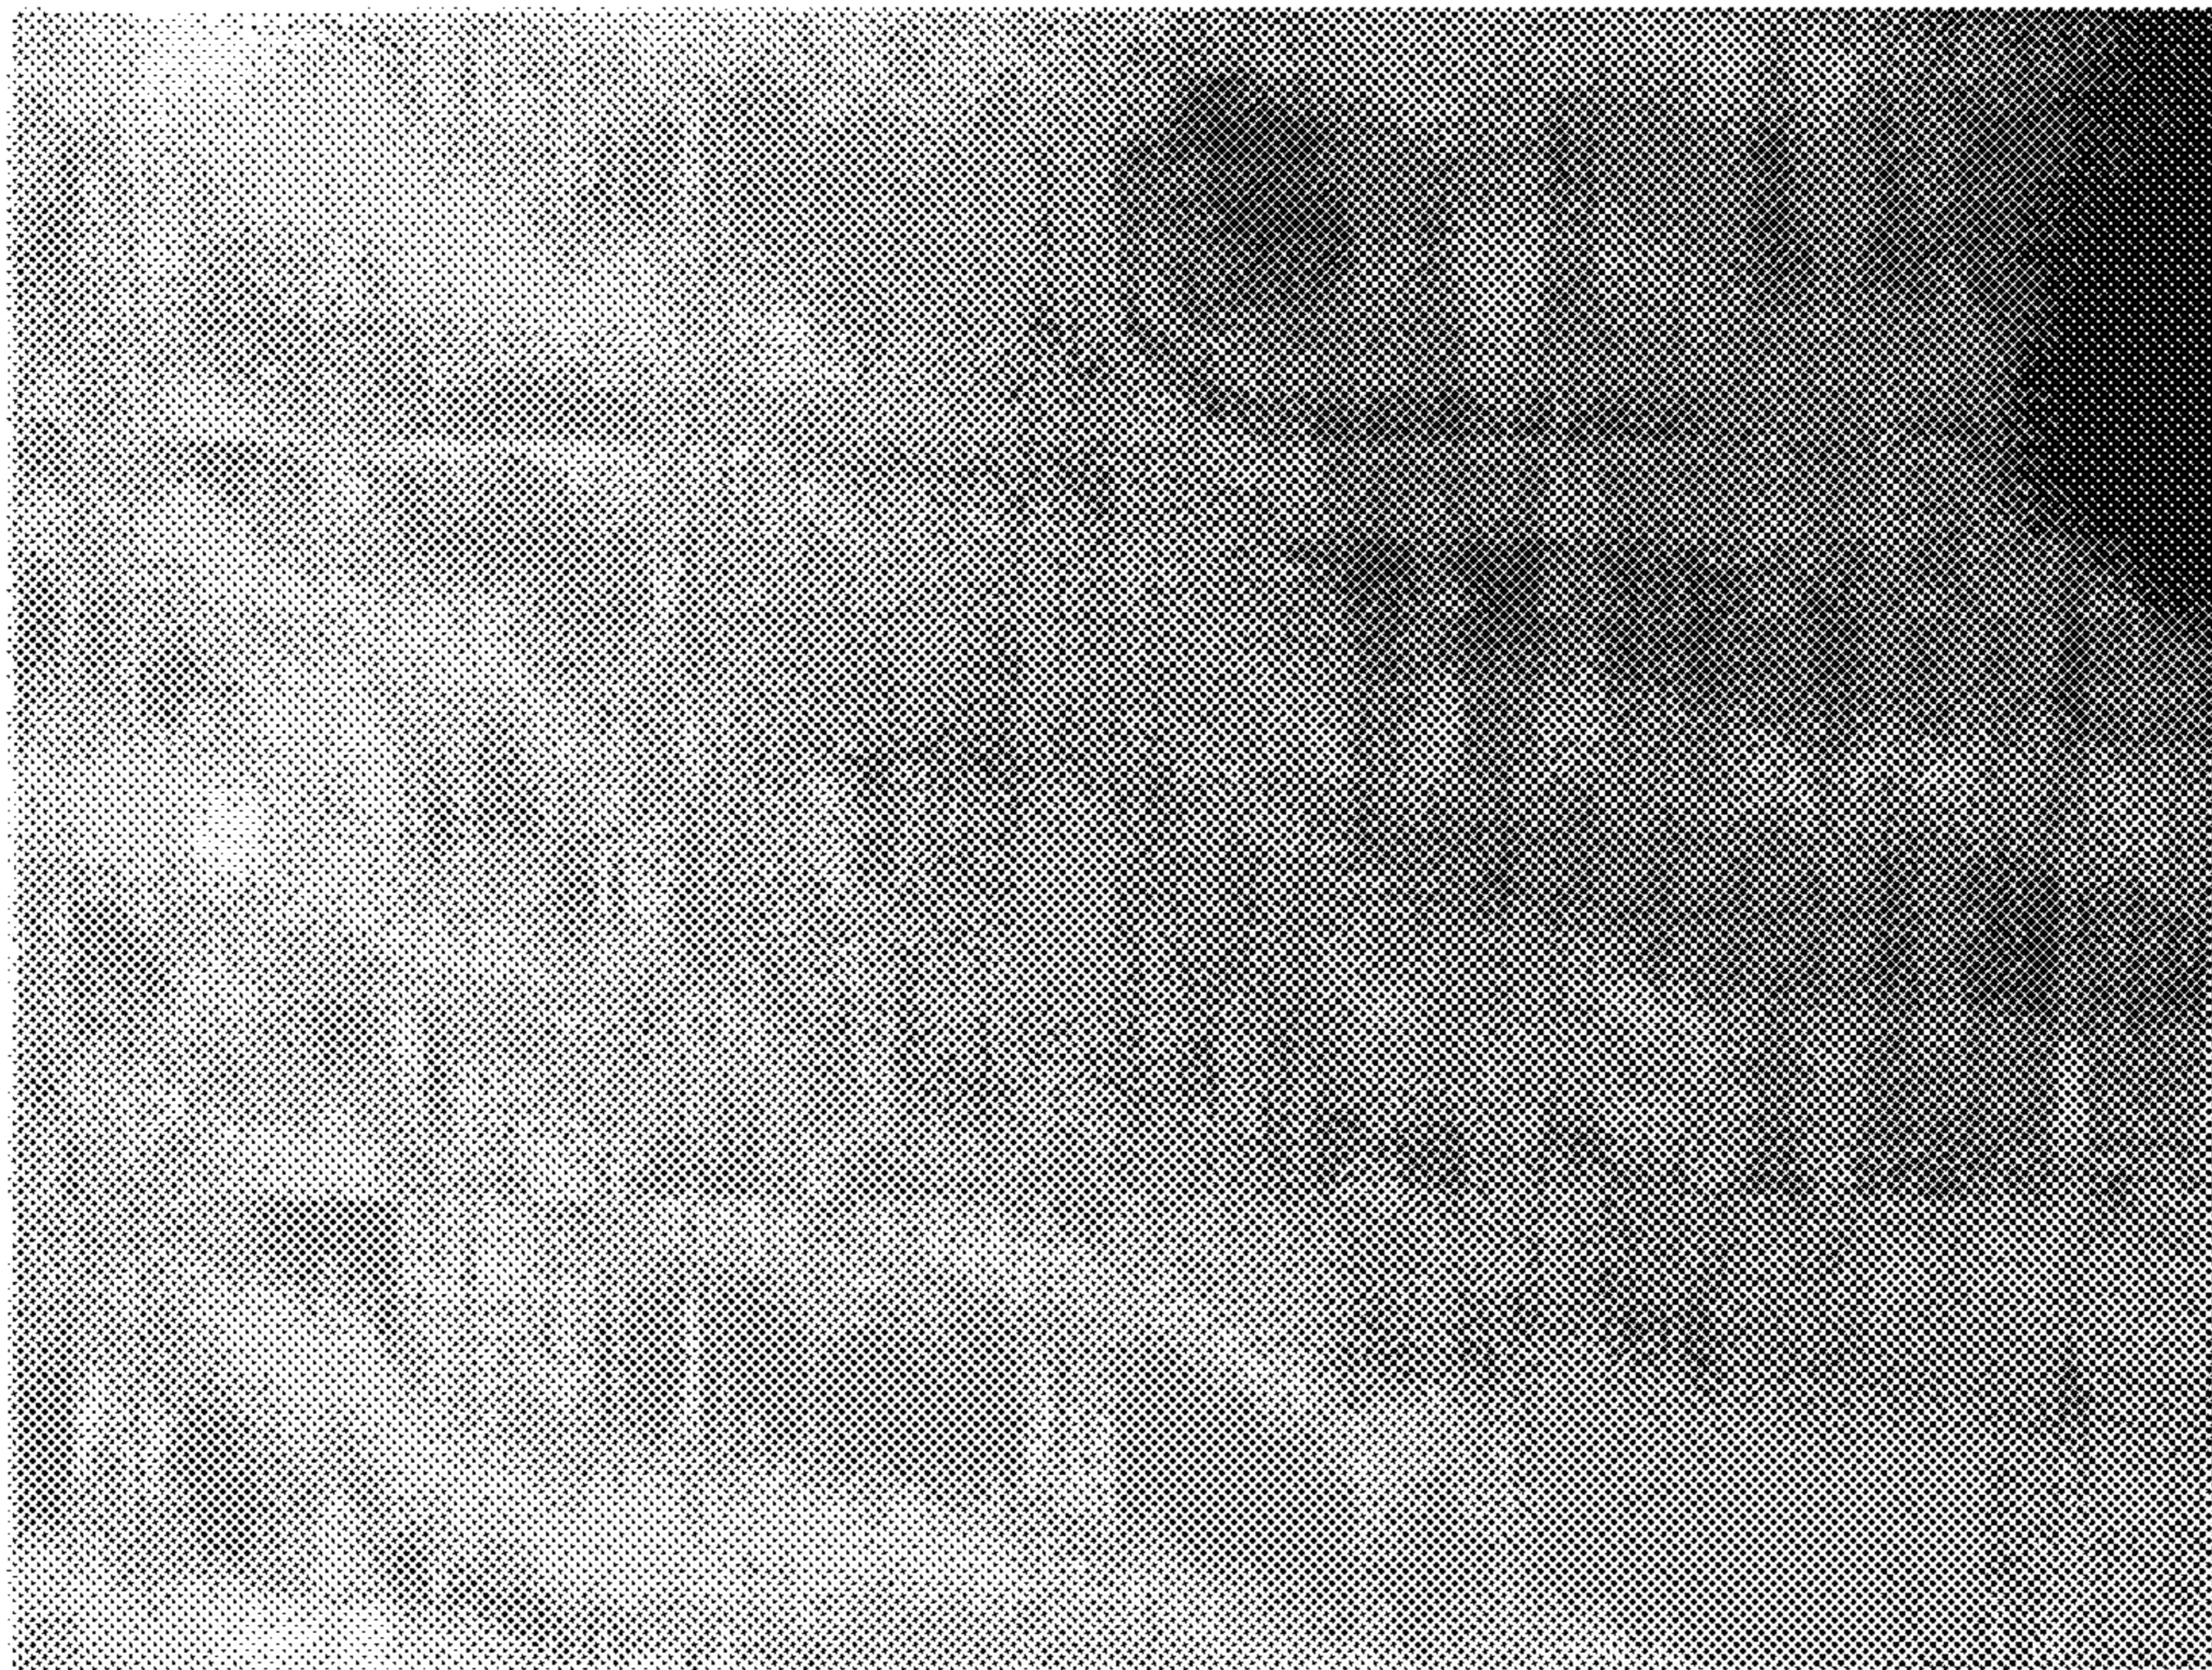
FIG. 9 illustrates a raw IR image collected 30 seconds after removing the heater showing a fluid ingress (darker area) and a disbond (lighter area).

FIG. 9 illustrates the output of a raw IR image obtained 30 s after heating the surface of an aircraft honeycomb boron composite used in the vertical stabilizer of the US Air Force (USAF) F-15 jet aircraft shown in FIG. 1. An illustration of a section of the honeycomb boron composite 20 is shown in FIG. 2. The boron composite 26 over the honeycomb 28 and the aluminum skin 24 over the honeycomb is shown. Distinct white spots in the IR image can indicate the presence of a disbond (separation of the boron composite from the aluminum honeycomb) or a delamination (separation between one or more layers of the boron composite). Visual inspection of the IR image indicates many such areas and significant ambiguity. FIG. 10 illustrates the results of the same IR image processed with a computer using a noise cancellation background removal method. One can easily see the disbond along the right edge of the aircraft structure and not be confused by the large area of ambiguous white spots along the left edge and center sections of the composite structure. This simple illustration shows the benefit of signal processing methods over visual interpretation in terms of accuracy and reliability. It minimizes the number of false detections (i.e., false alarms). It is also significant that the computer analysis is done automatically and can be done remotely without having to output the IR image.

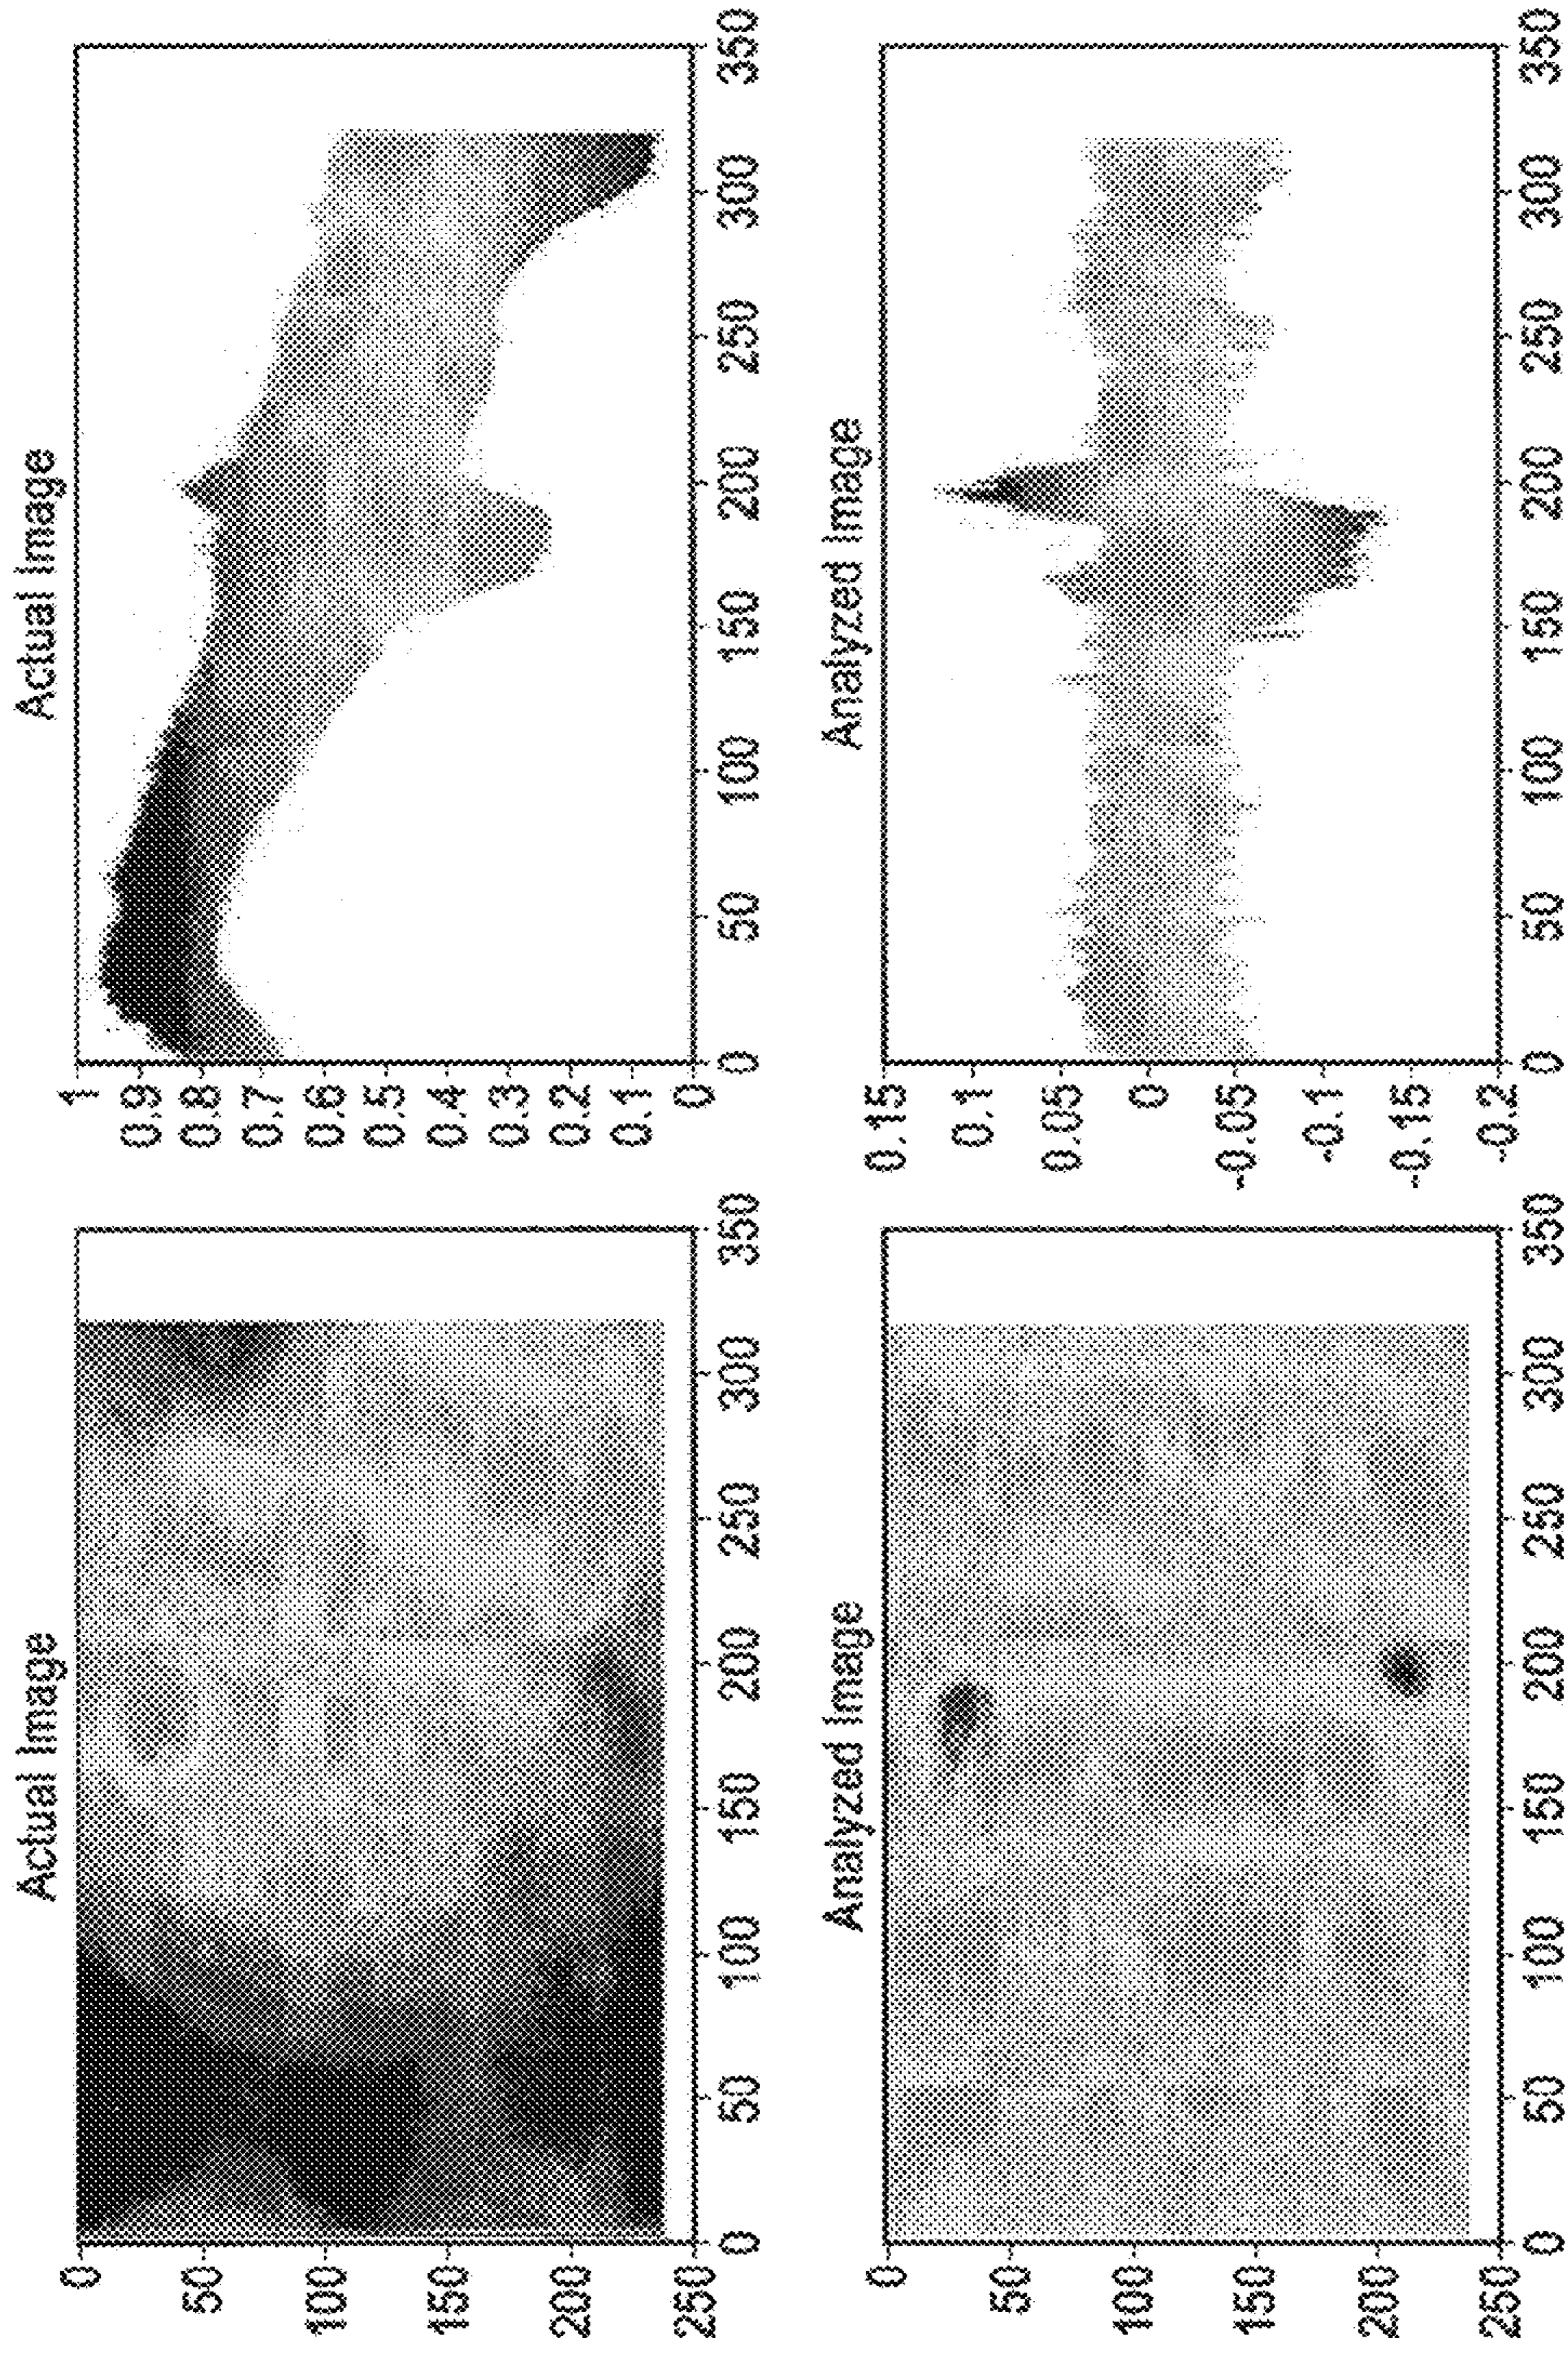
FIG. 10 illustrates the results of the noise cancelling algorithms applied to a raw IR image.

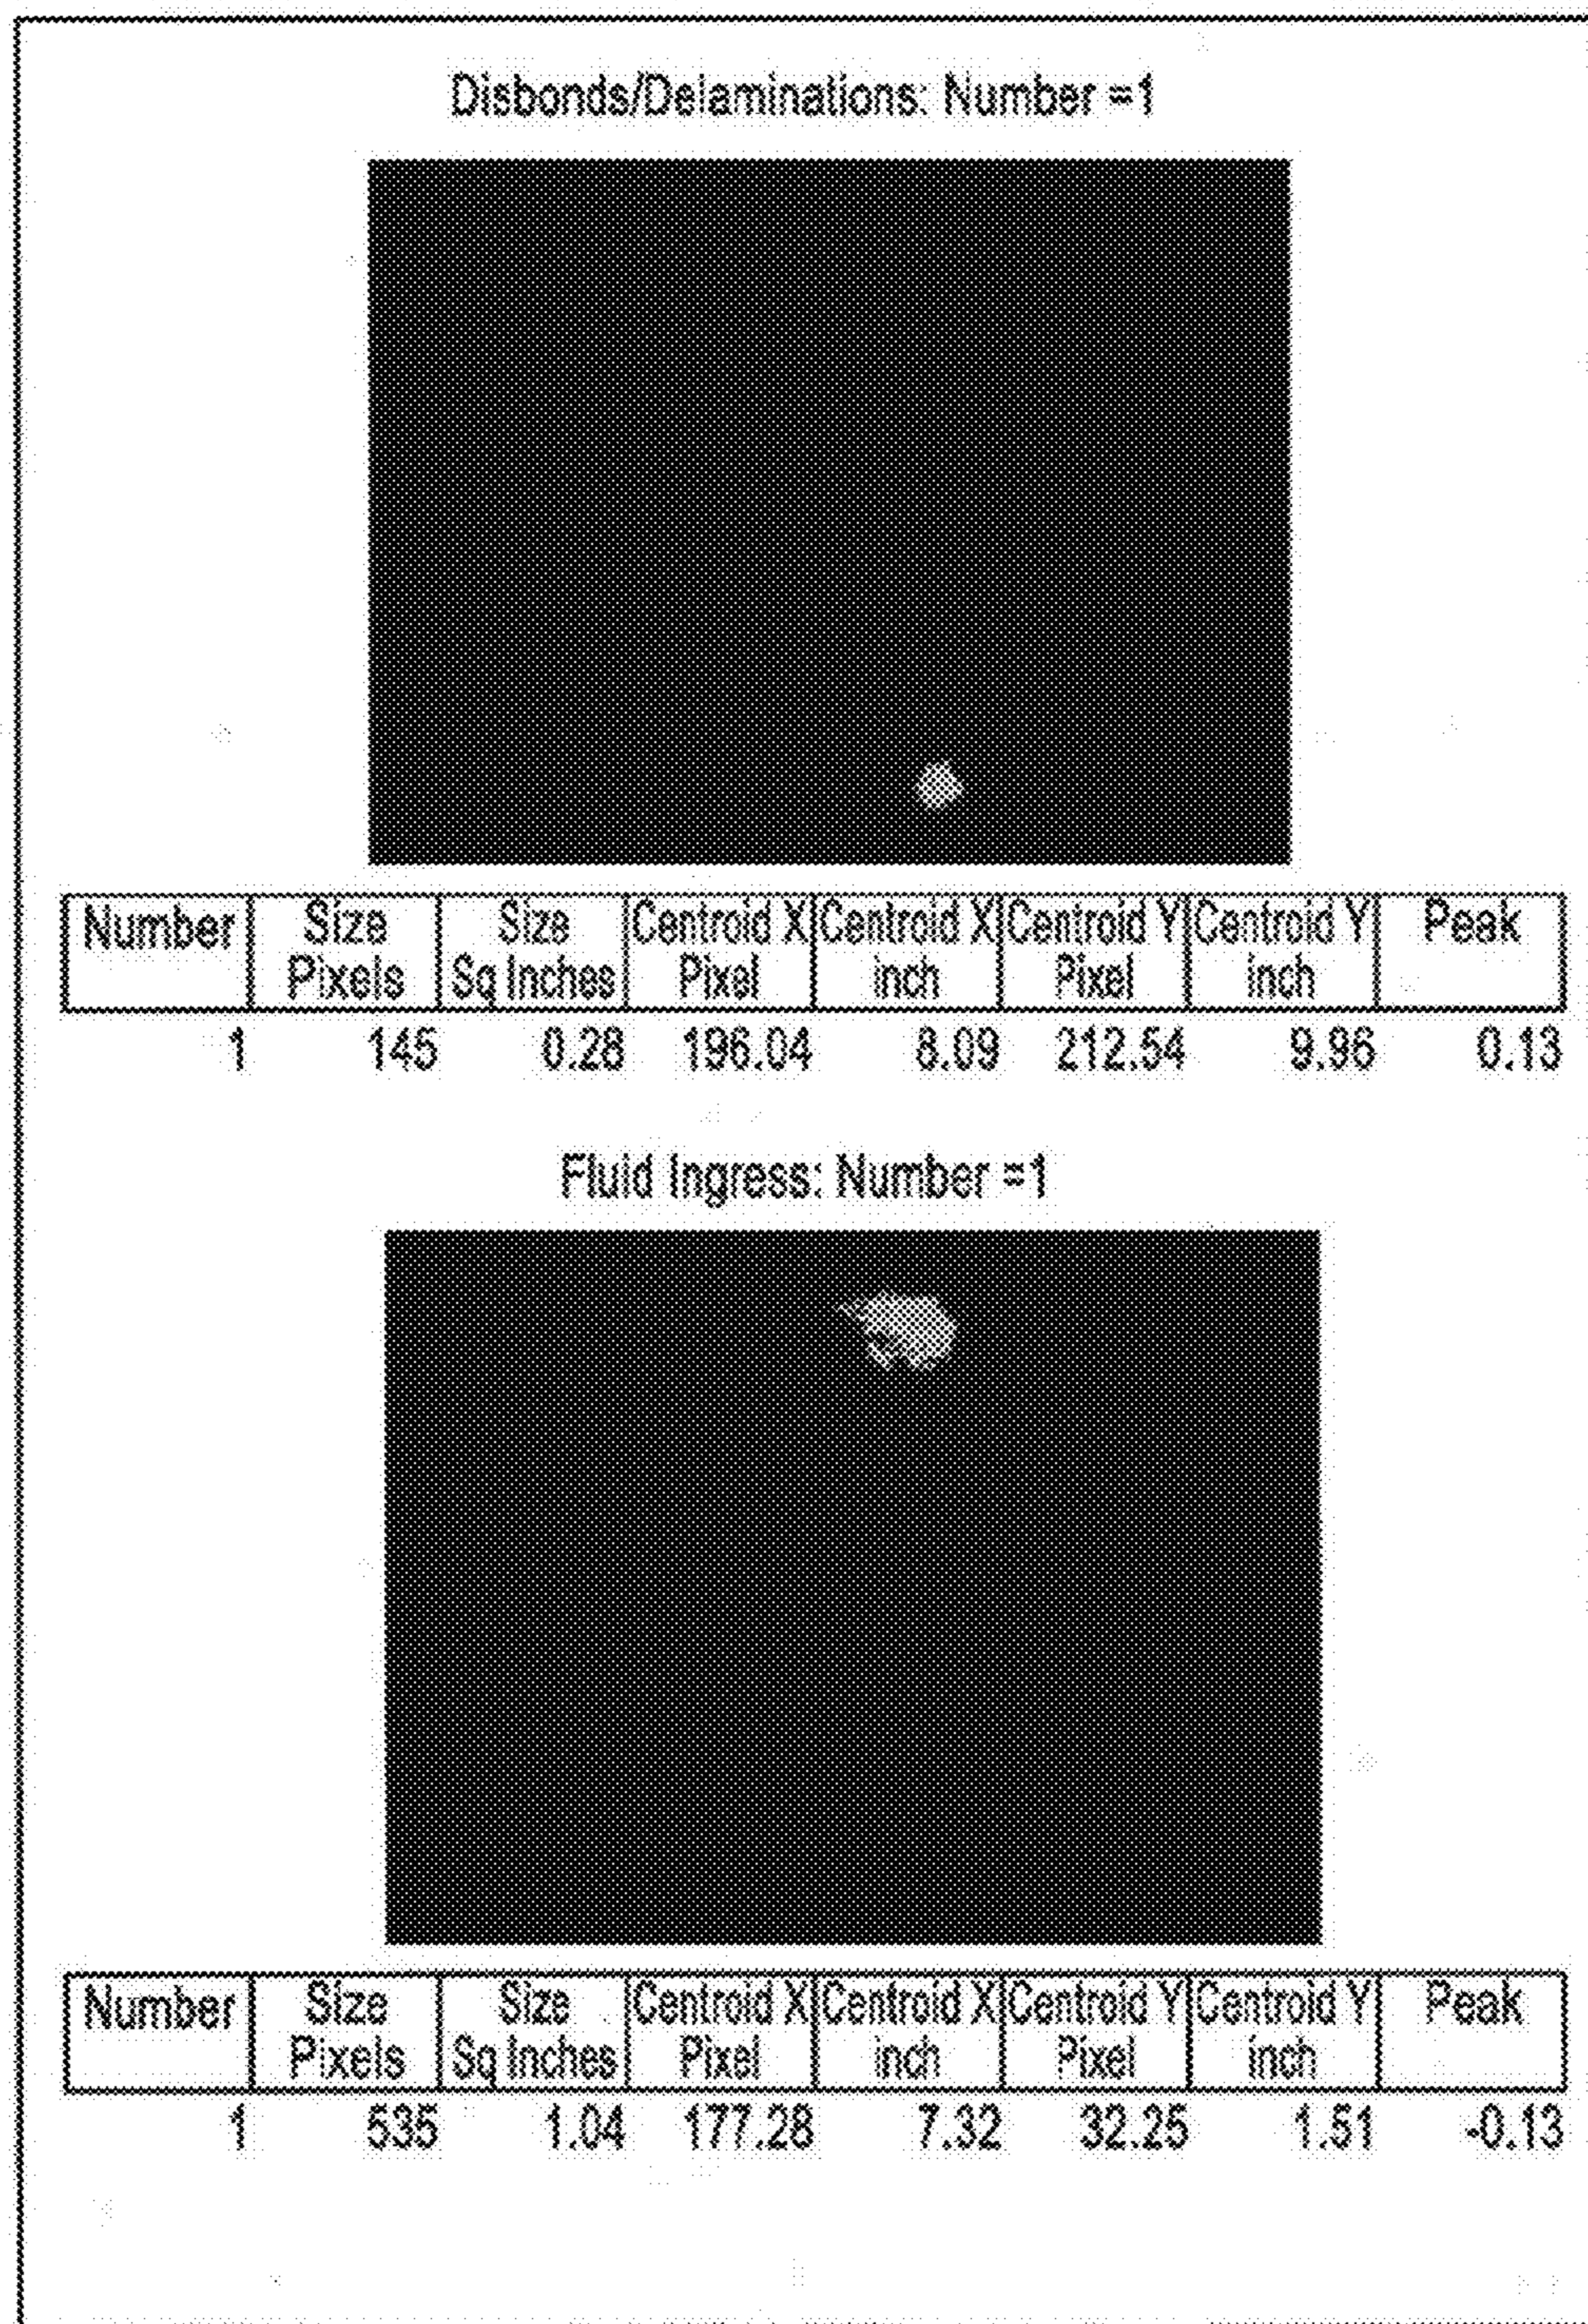
FIG. 11 illustrates the cluster maps of the fluid ingress and disbond detected with the IRIS system.

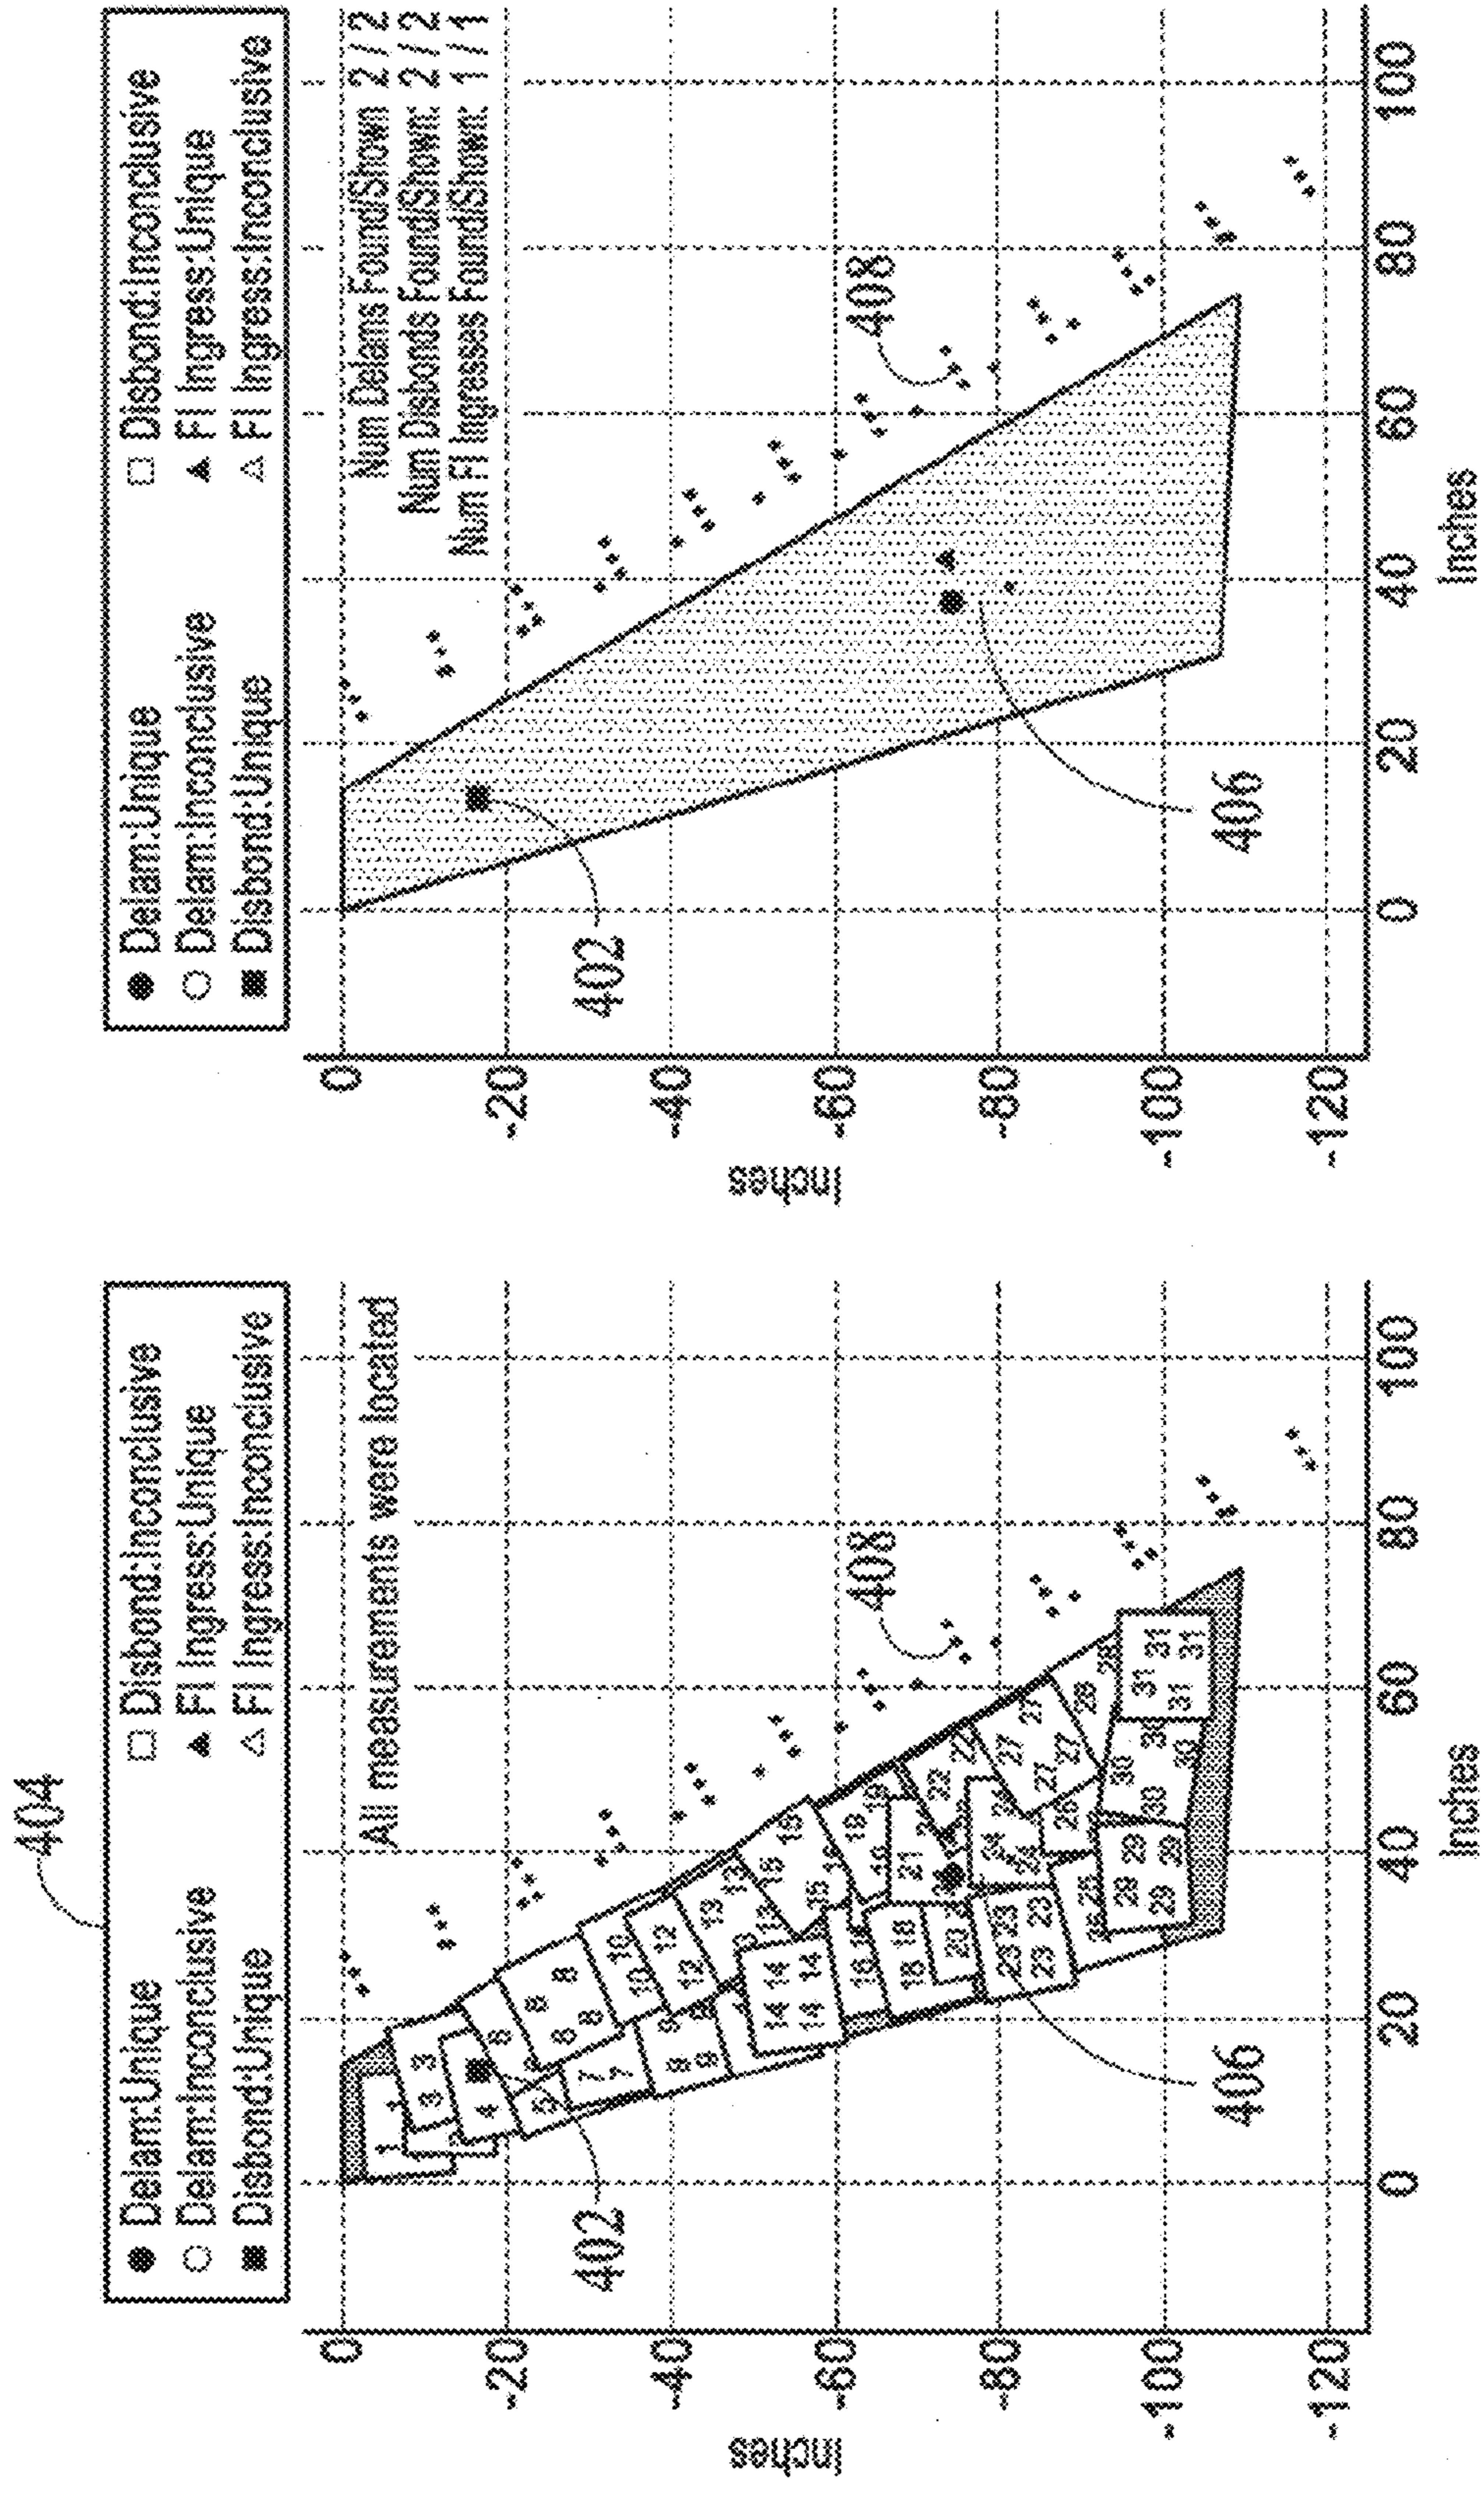
FIG. 12 illustrates the coverage map with measurement numbers and the flaw map that the IRIS creates at the end of an inspection.
