(12) **United States Patent**
Maresca, Jr. et al.

(10) **Patent No.:** **US 9,811,900 B2**
(45) **Date of Patent:** ***Nov. 7, 2017**

(54) **AUTOMATIC DETECTION OF DEFECTS IN COMPOSITE STRUCTURES USING NDT METHODS**

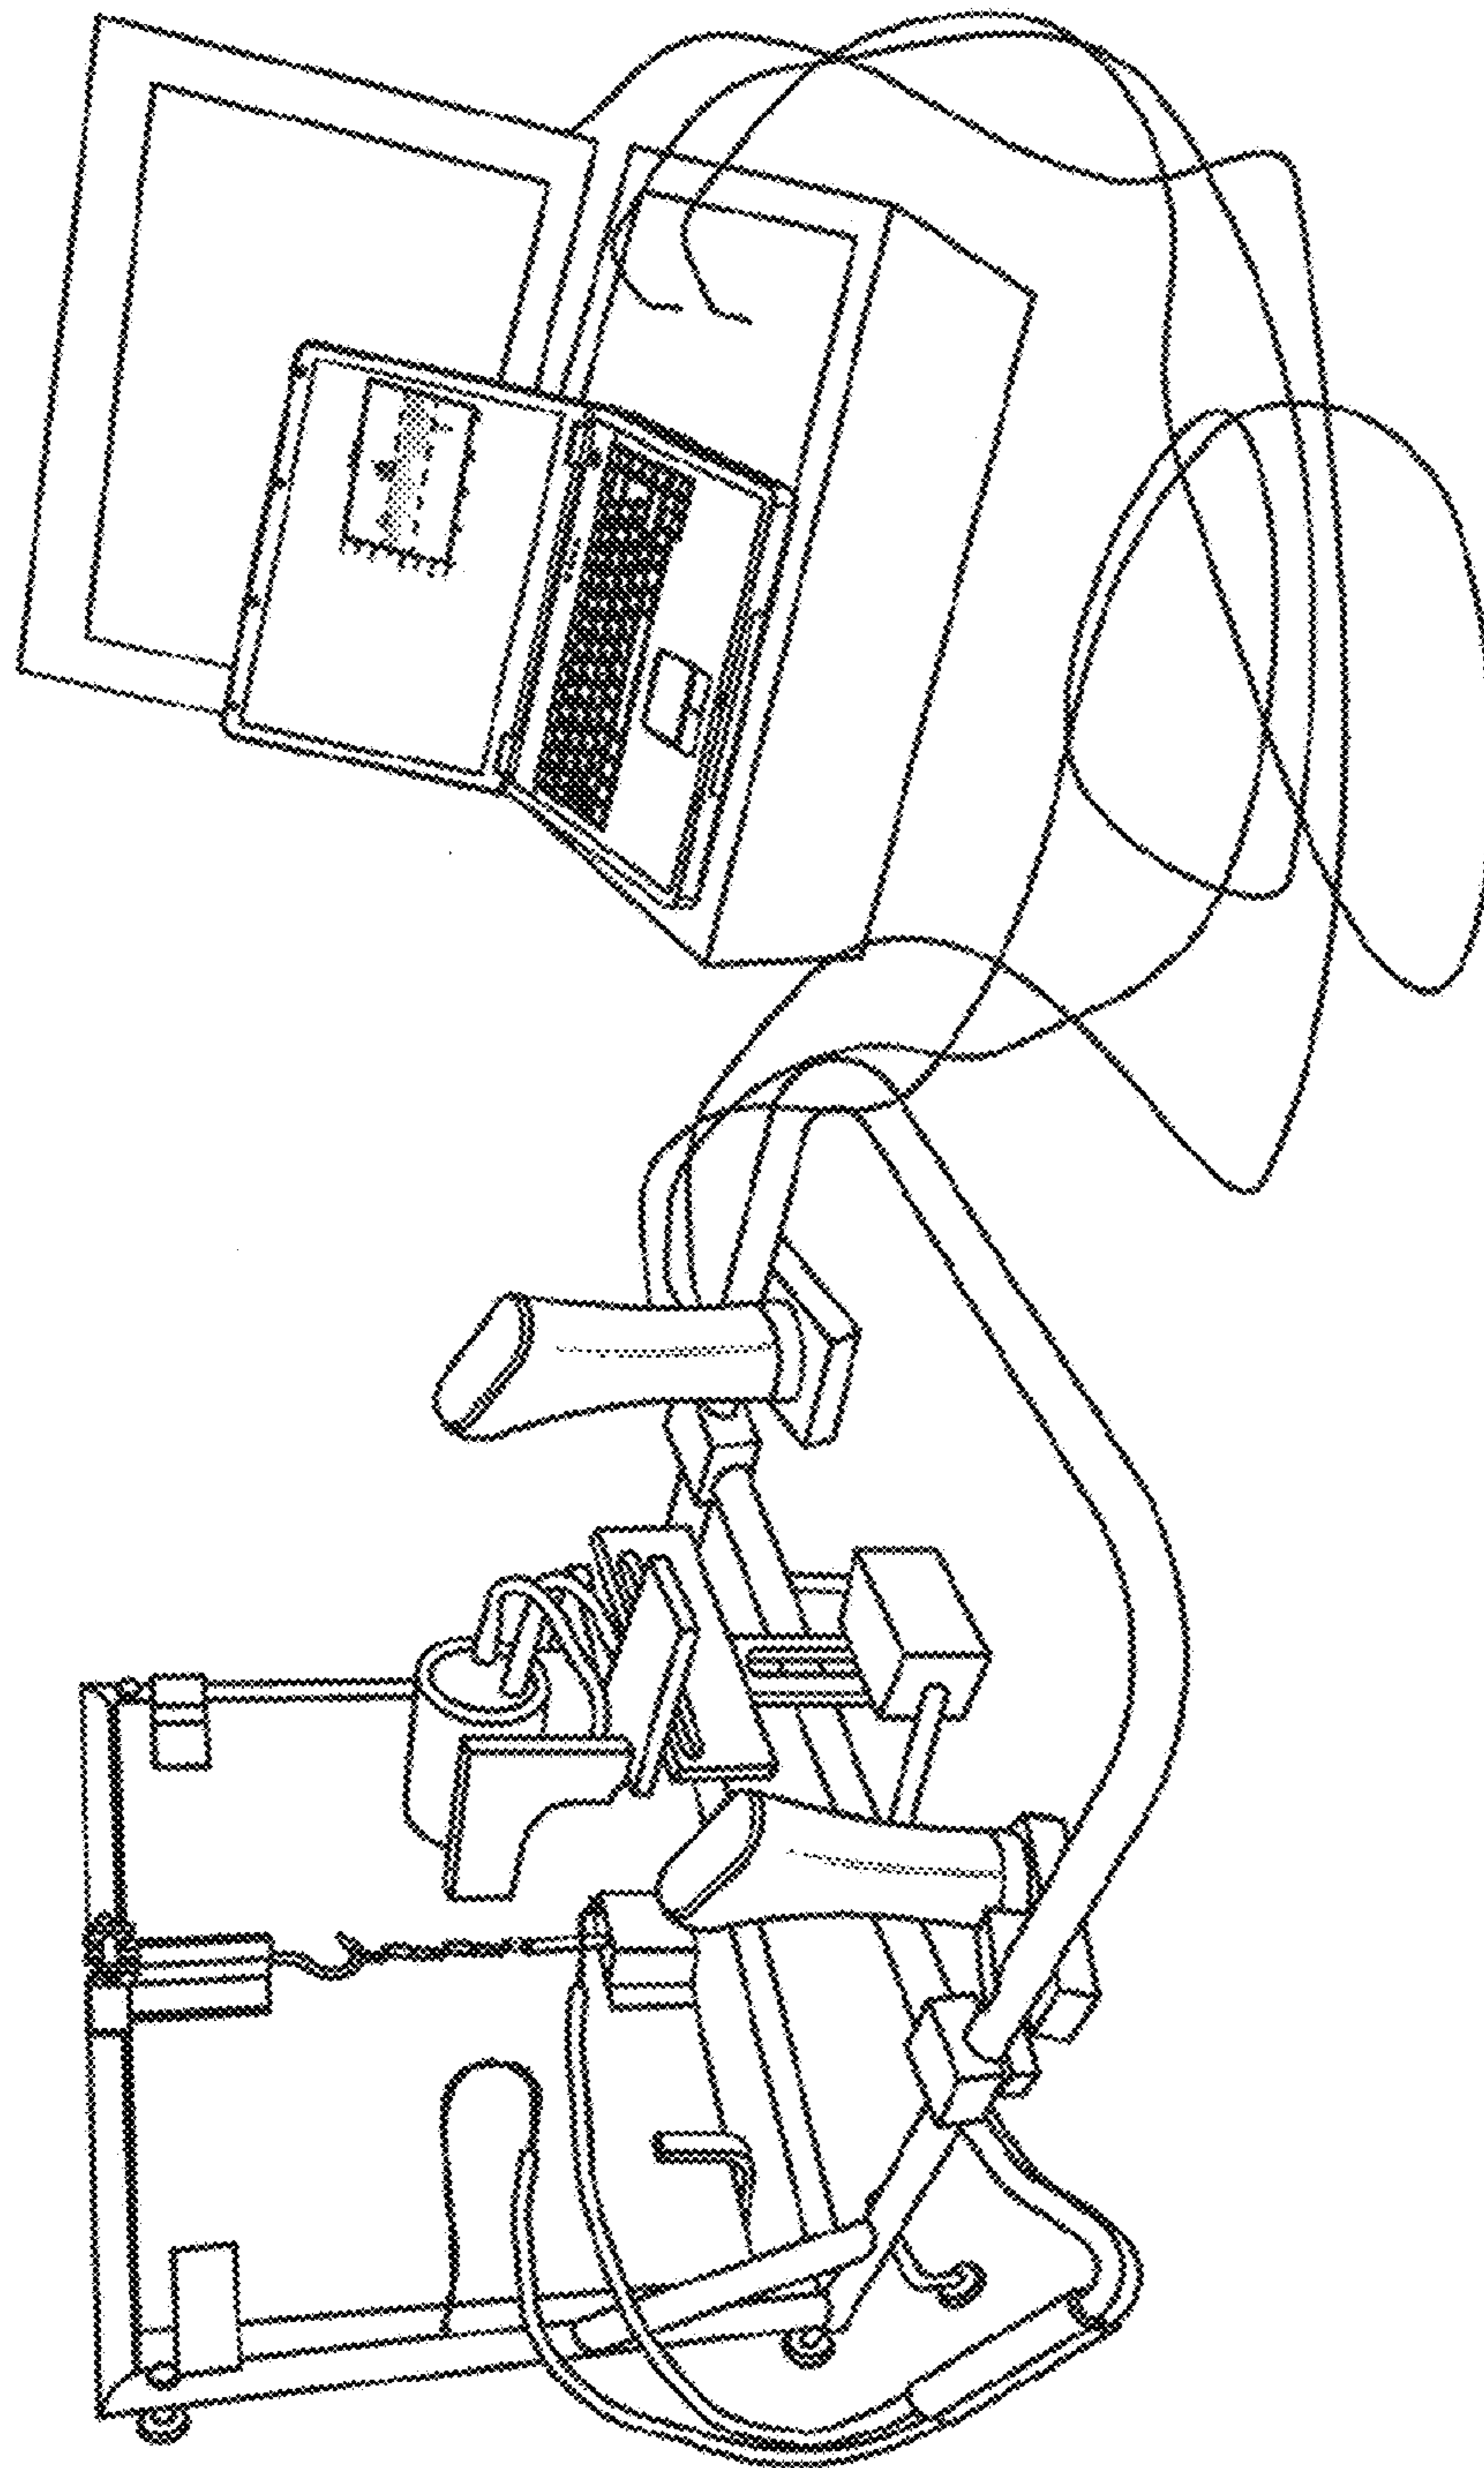
FIG. 13 illustrates the complete IRIS system including the frame with heater and IR camera, control box with notebook computer, and cabling.

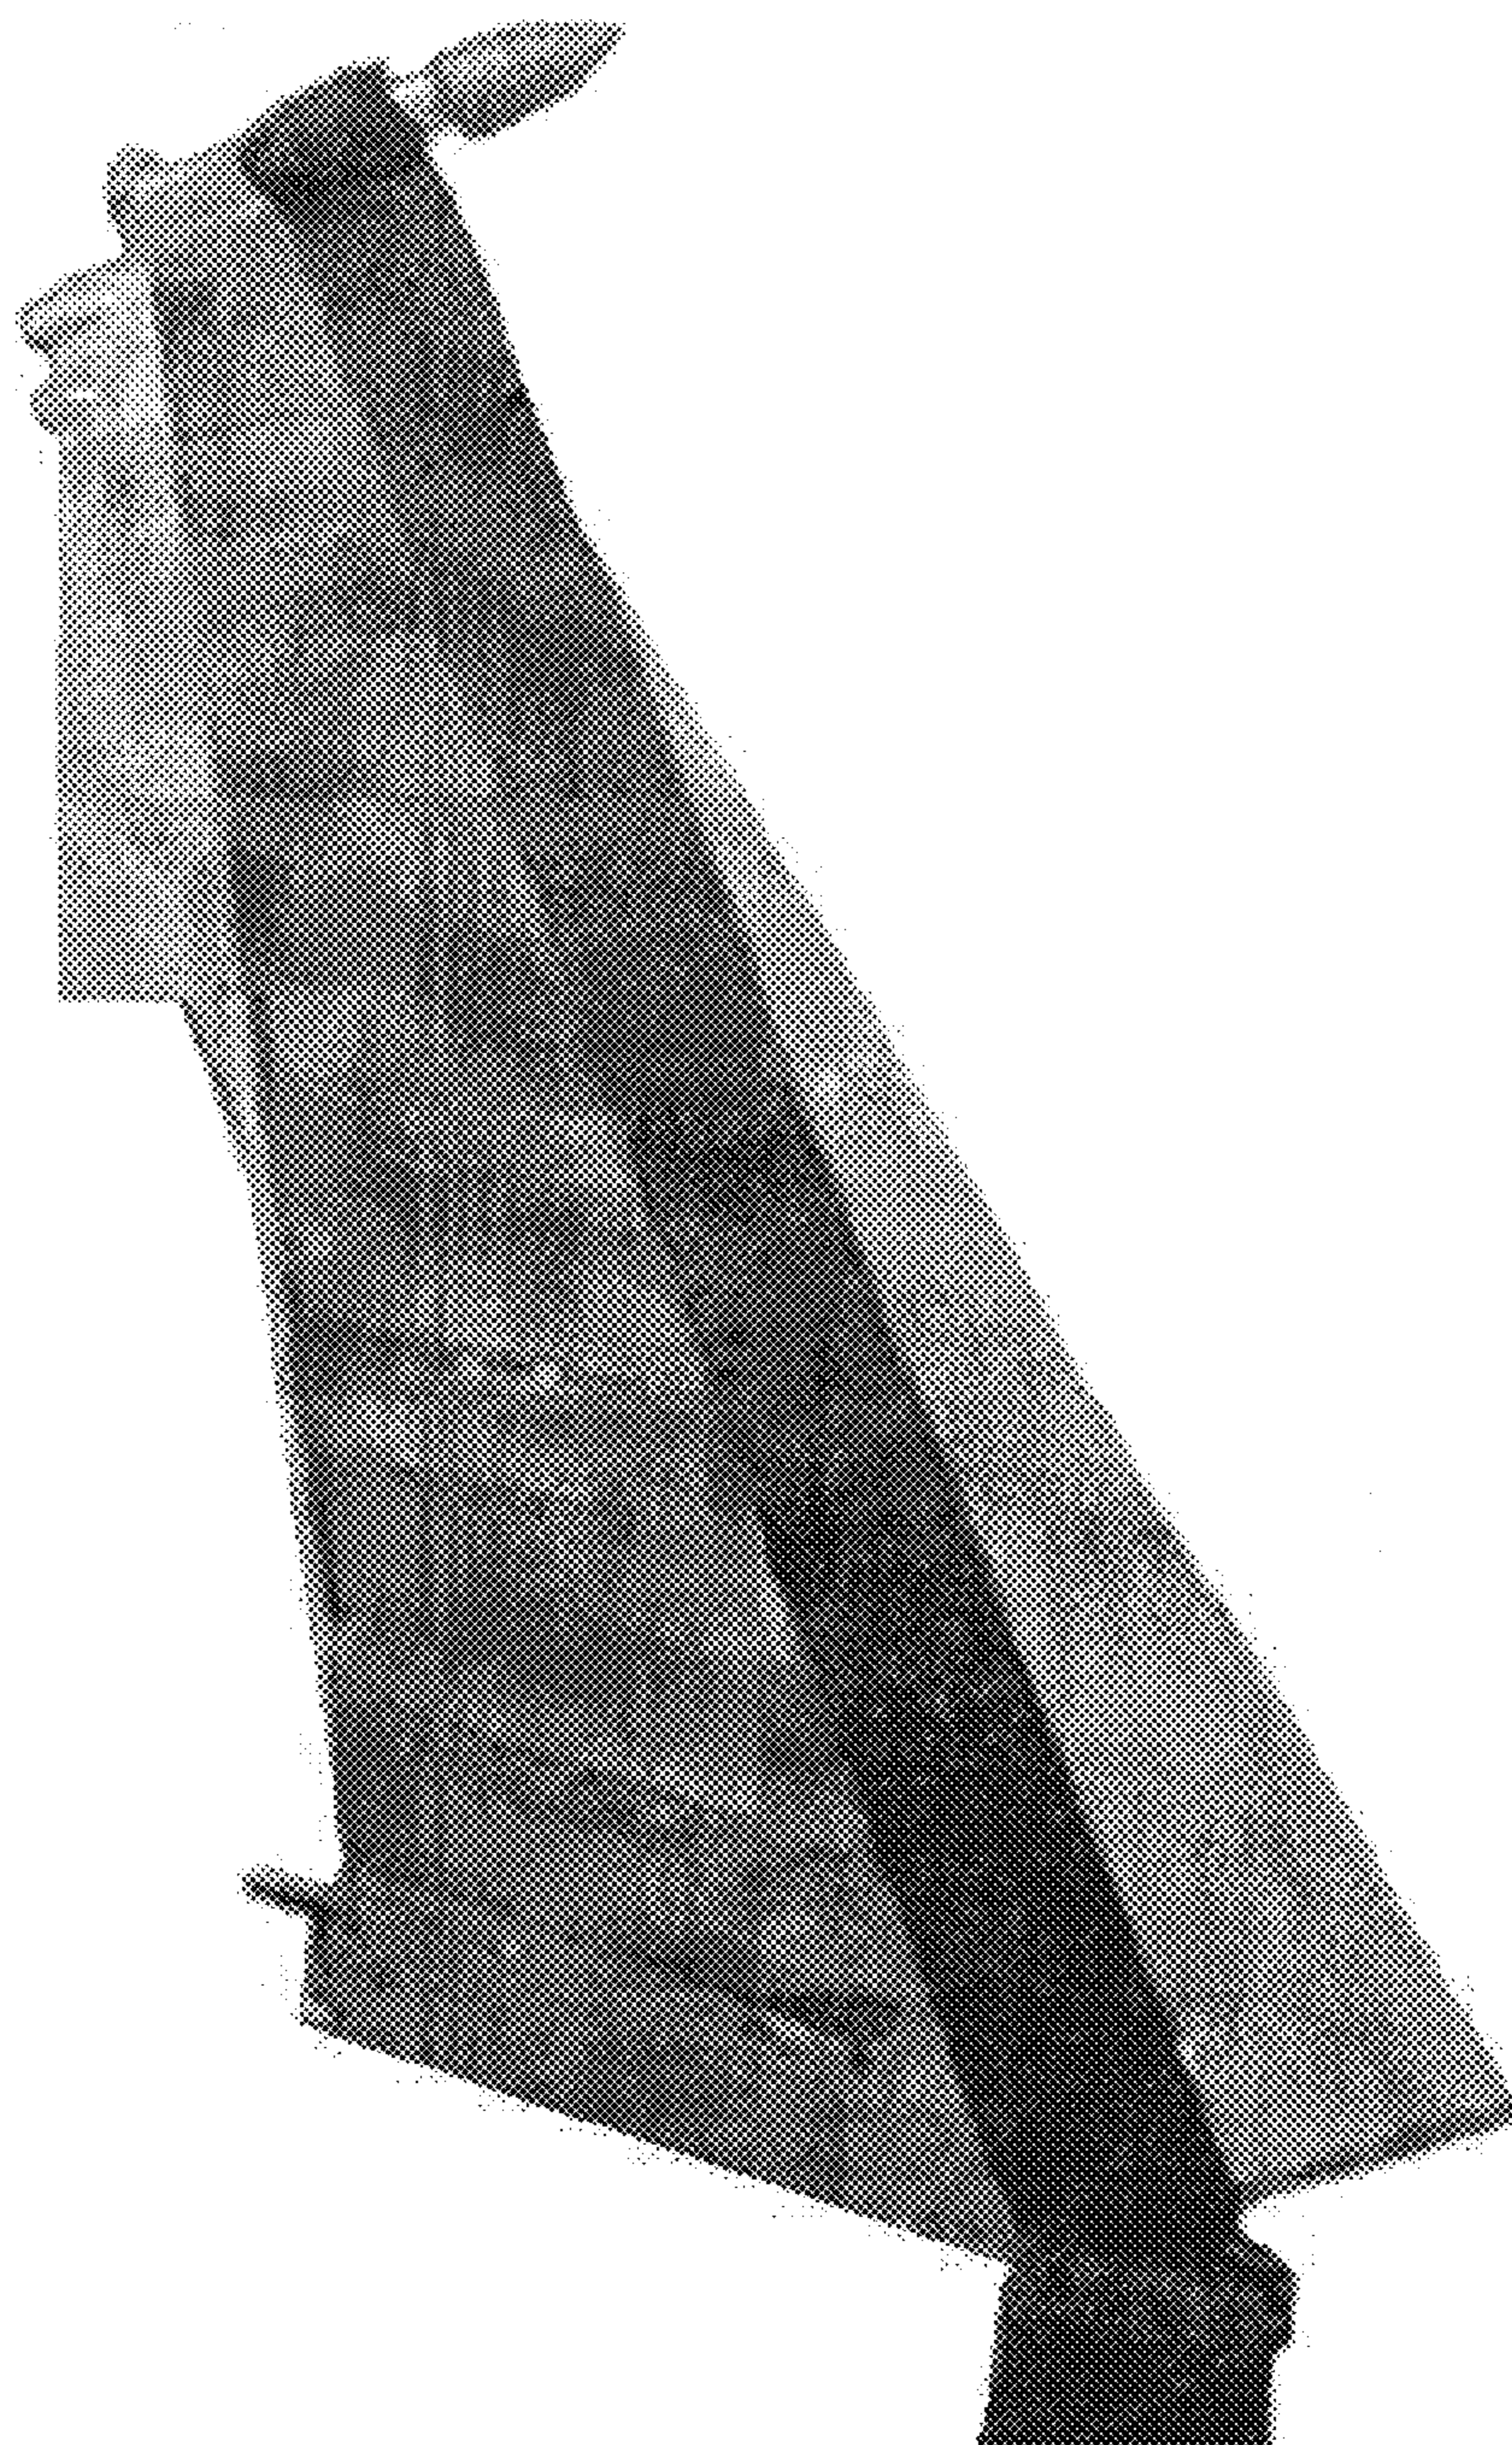
FIG. 14 illustrates an F-15 vertical stabilizer with the IR Ruler placed along the leading edge.

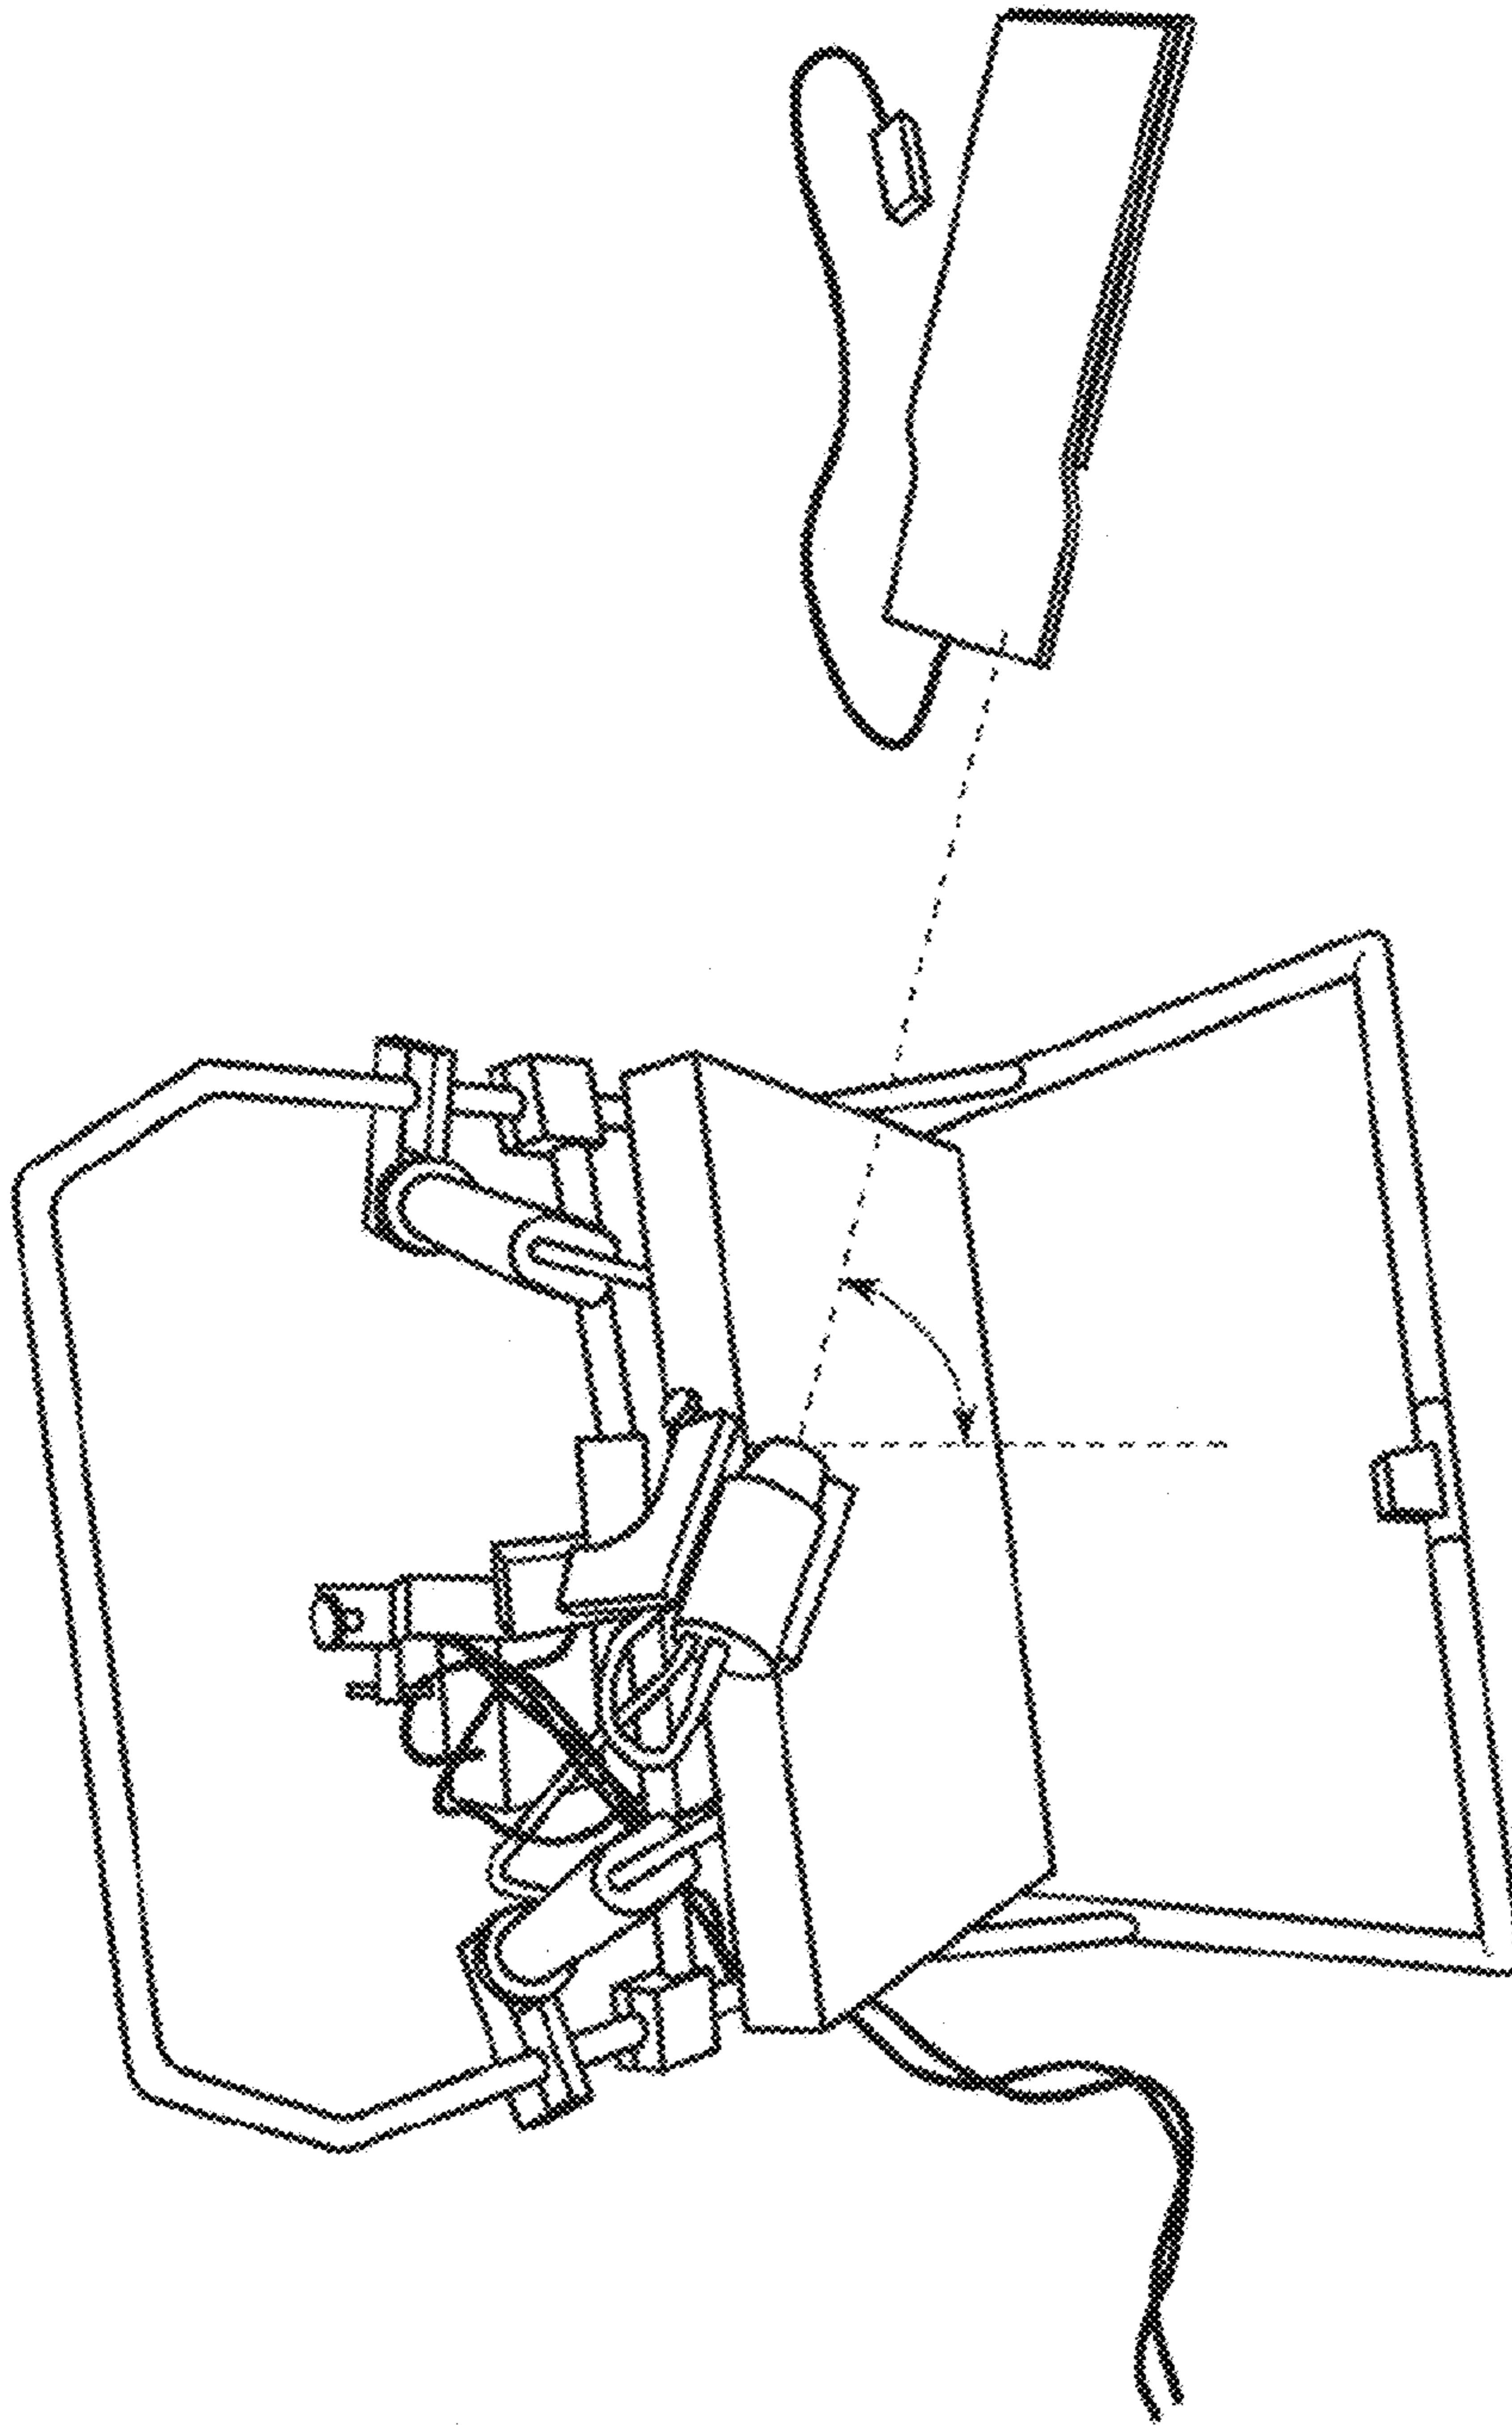
FIG. 15 illustrates the IRIS frame placed in the calibration jig which is used to confirm the placement of the camera and determine the calibration factors for the location algorithms.

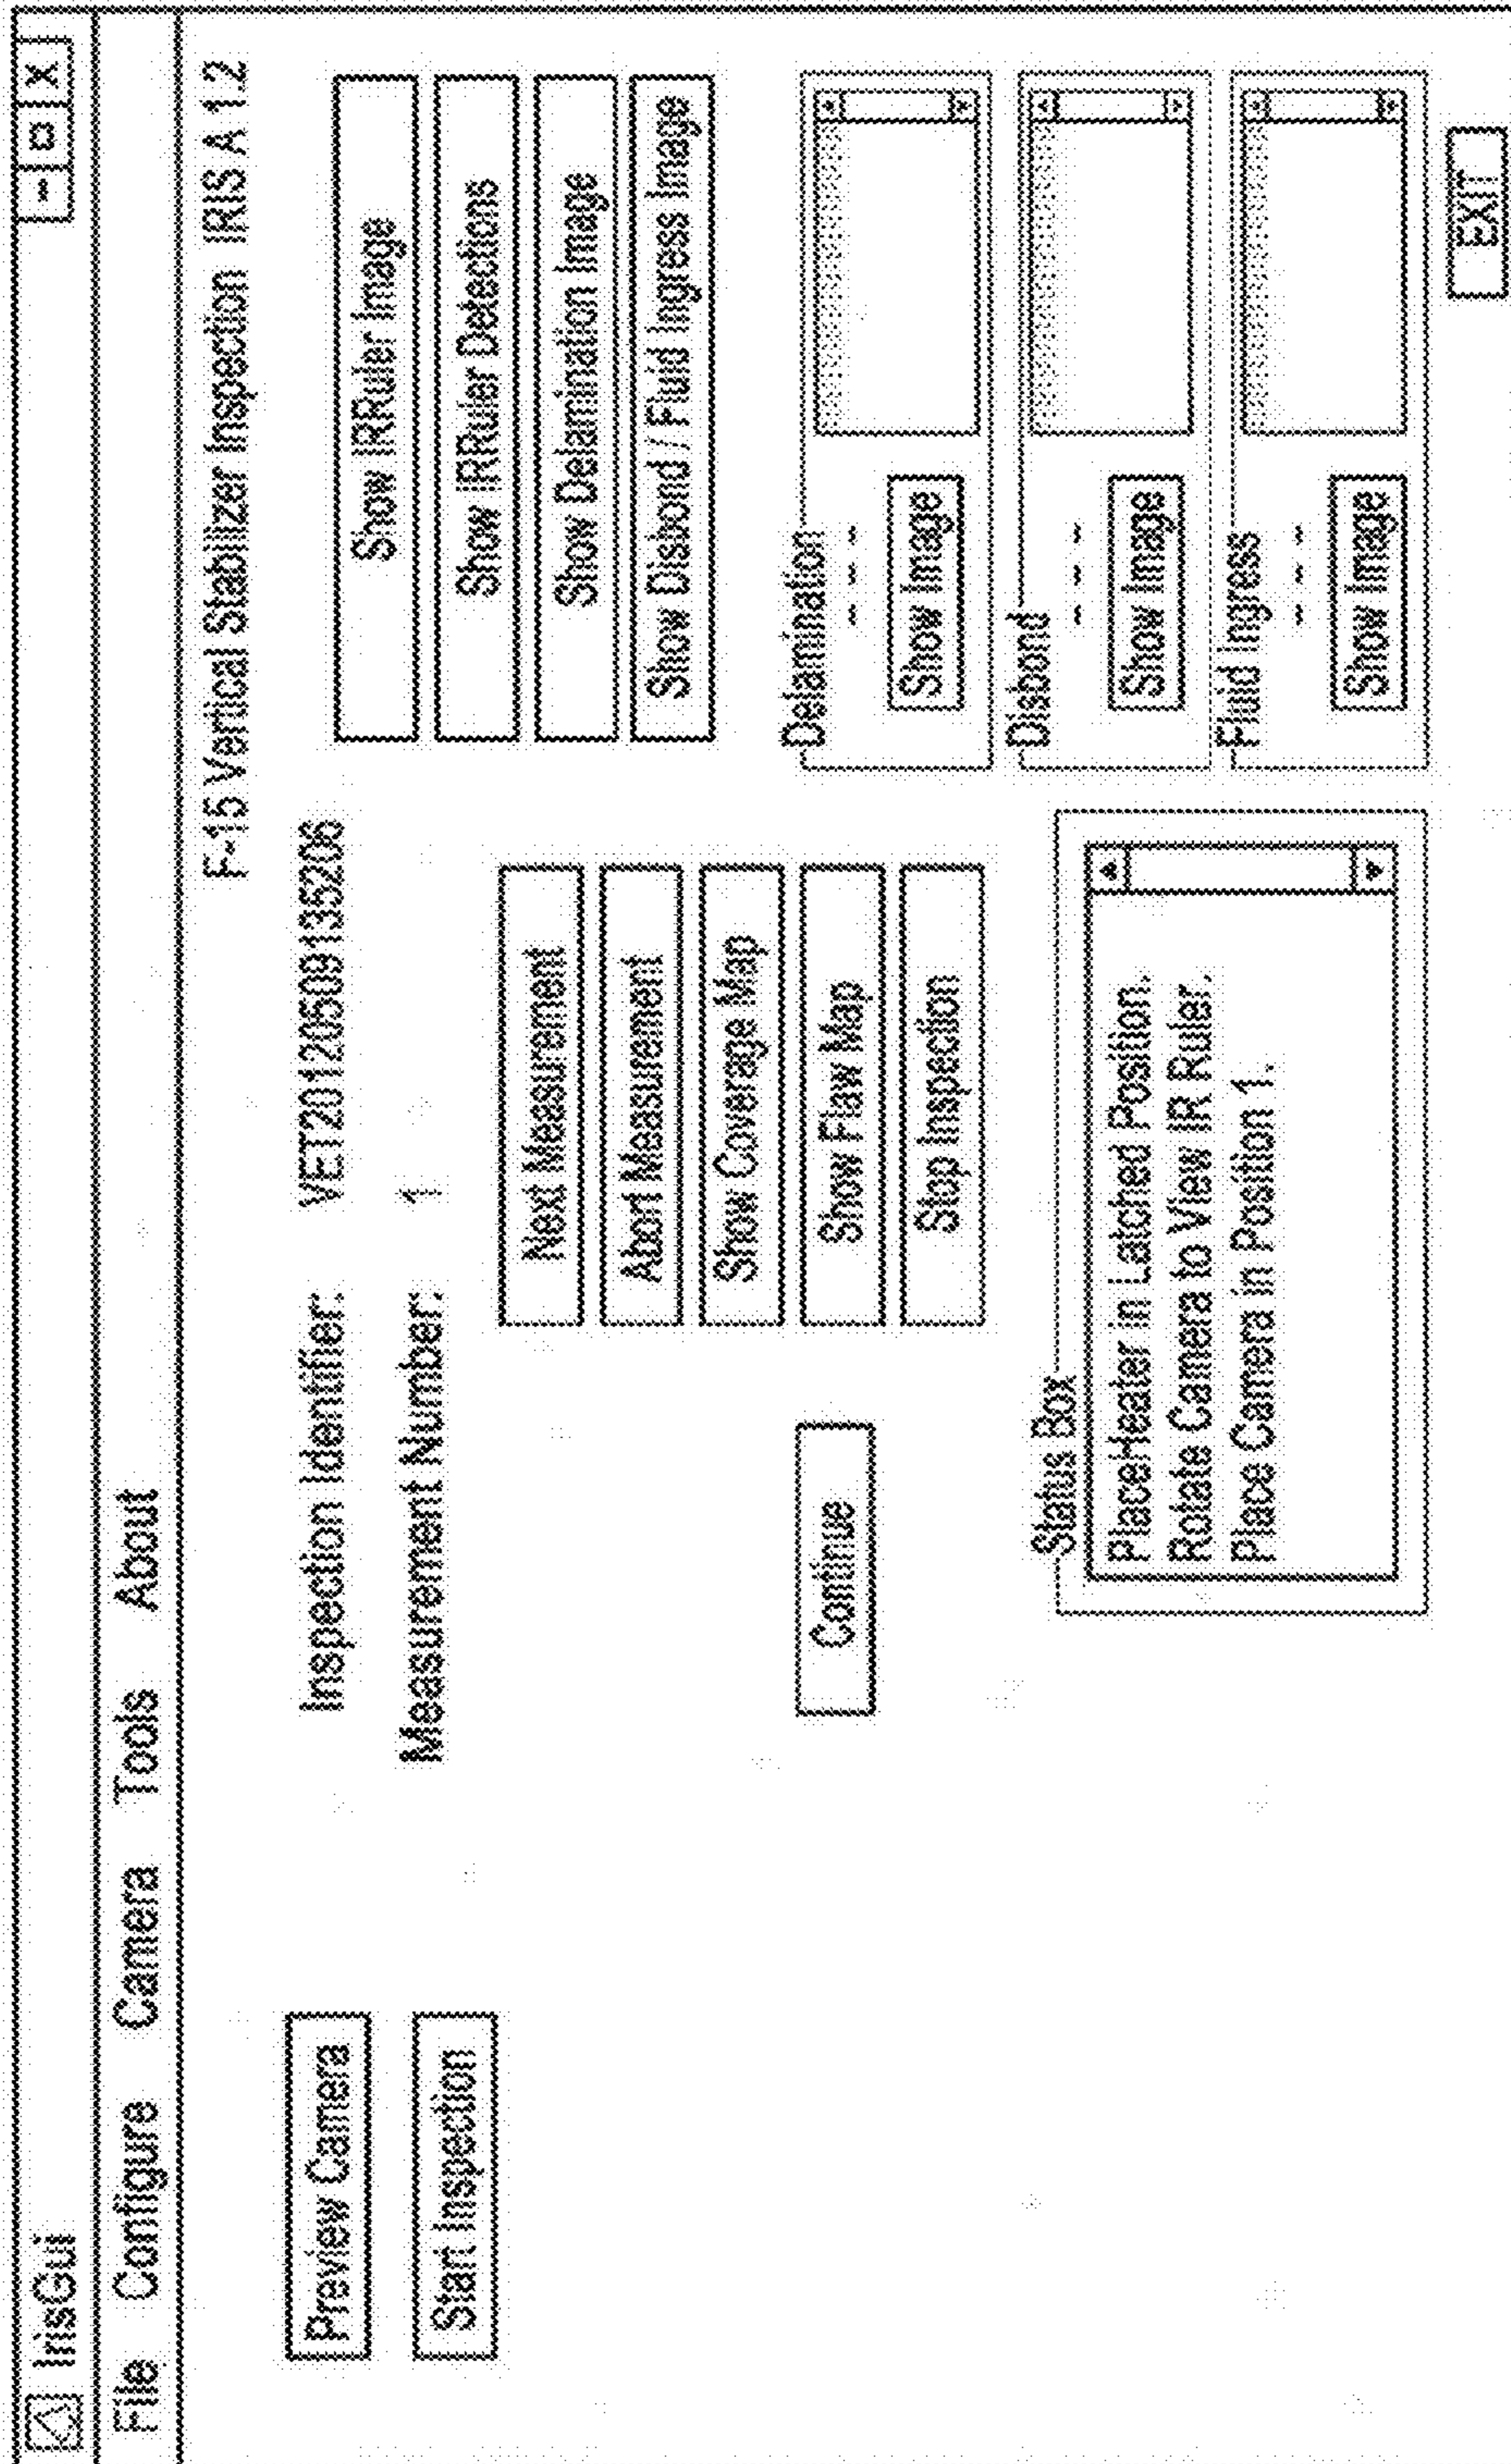
FIG. 17 illustrates the Main Screen of the IRIS graphical user interface.

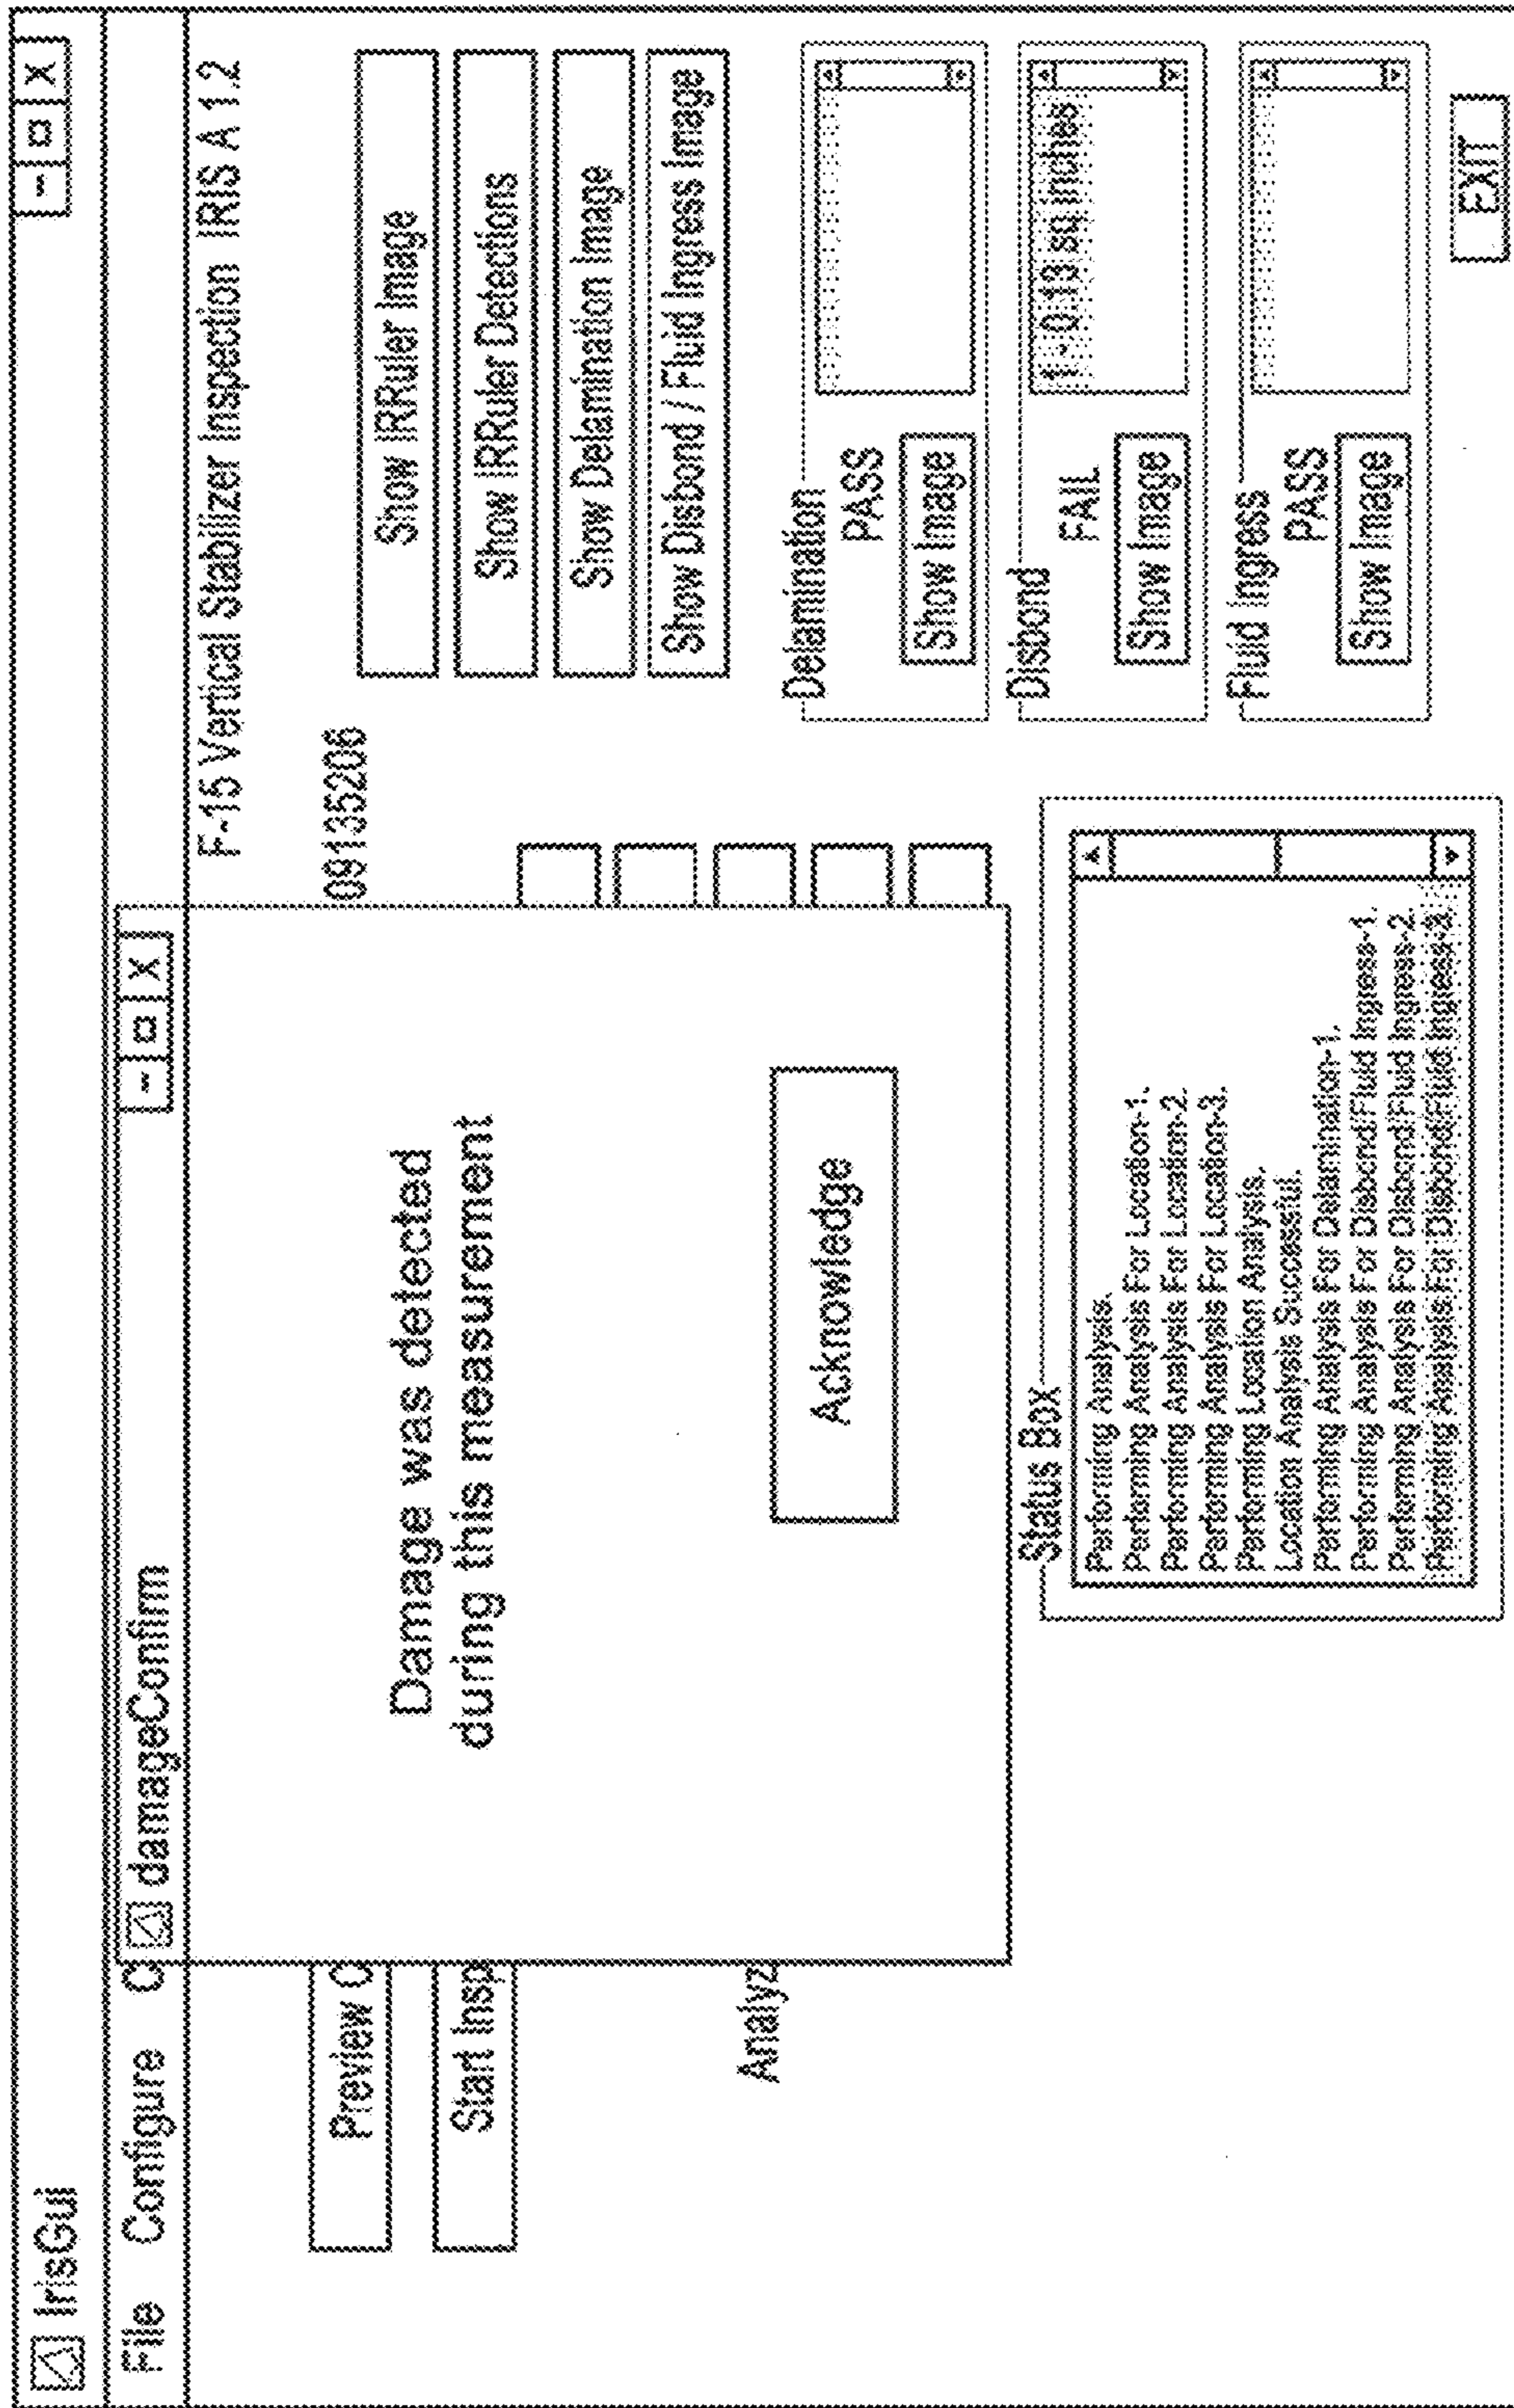
FIG. 18 illustrates the Main Screen of the IRIS graphical user interface while conducting an inspection.

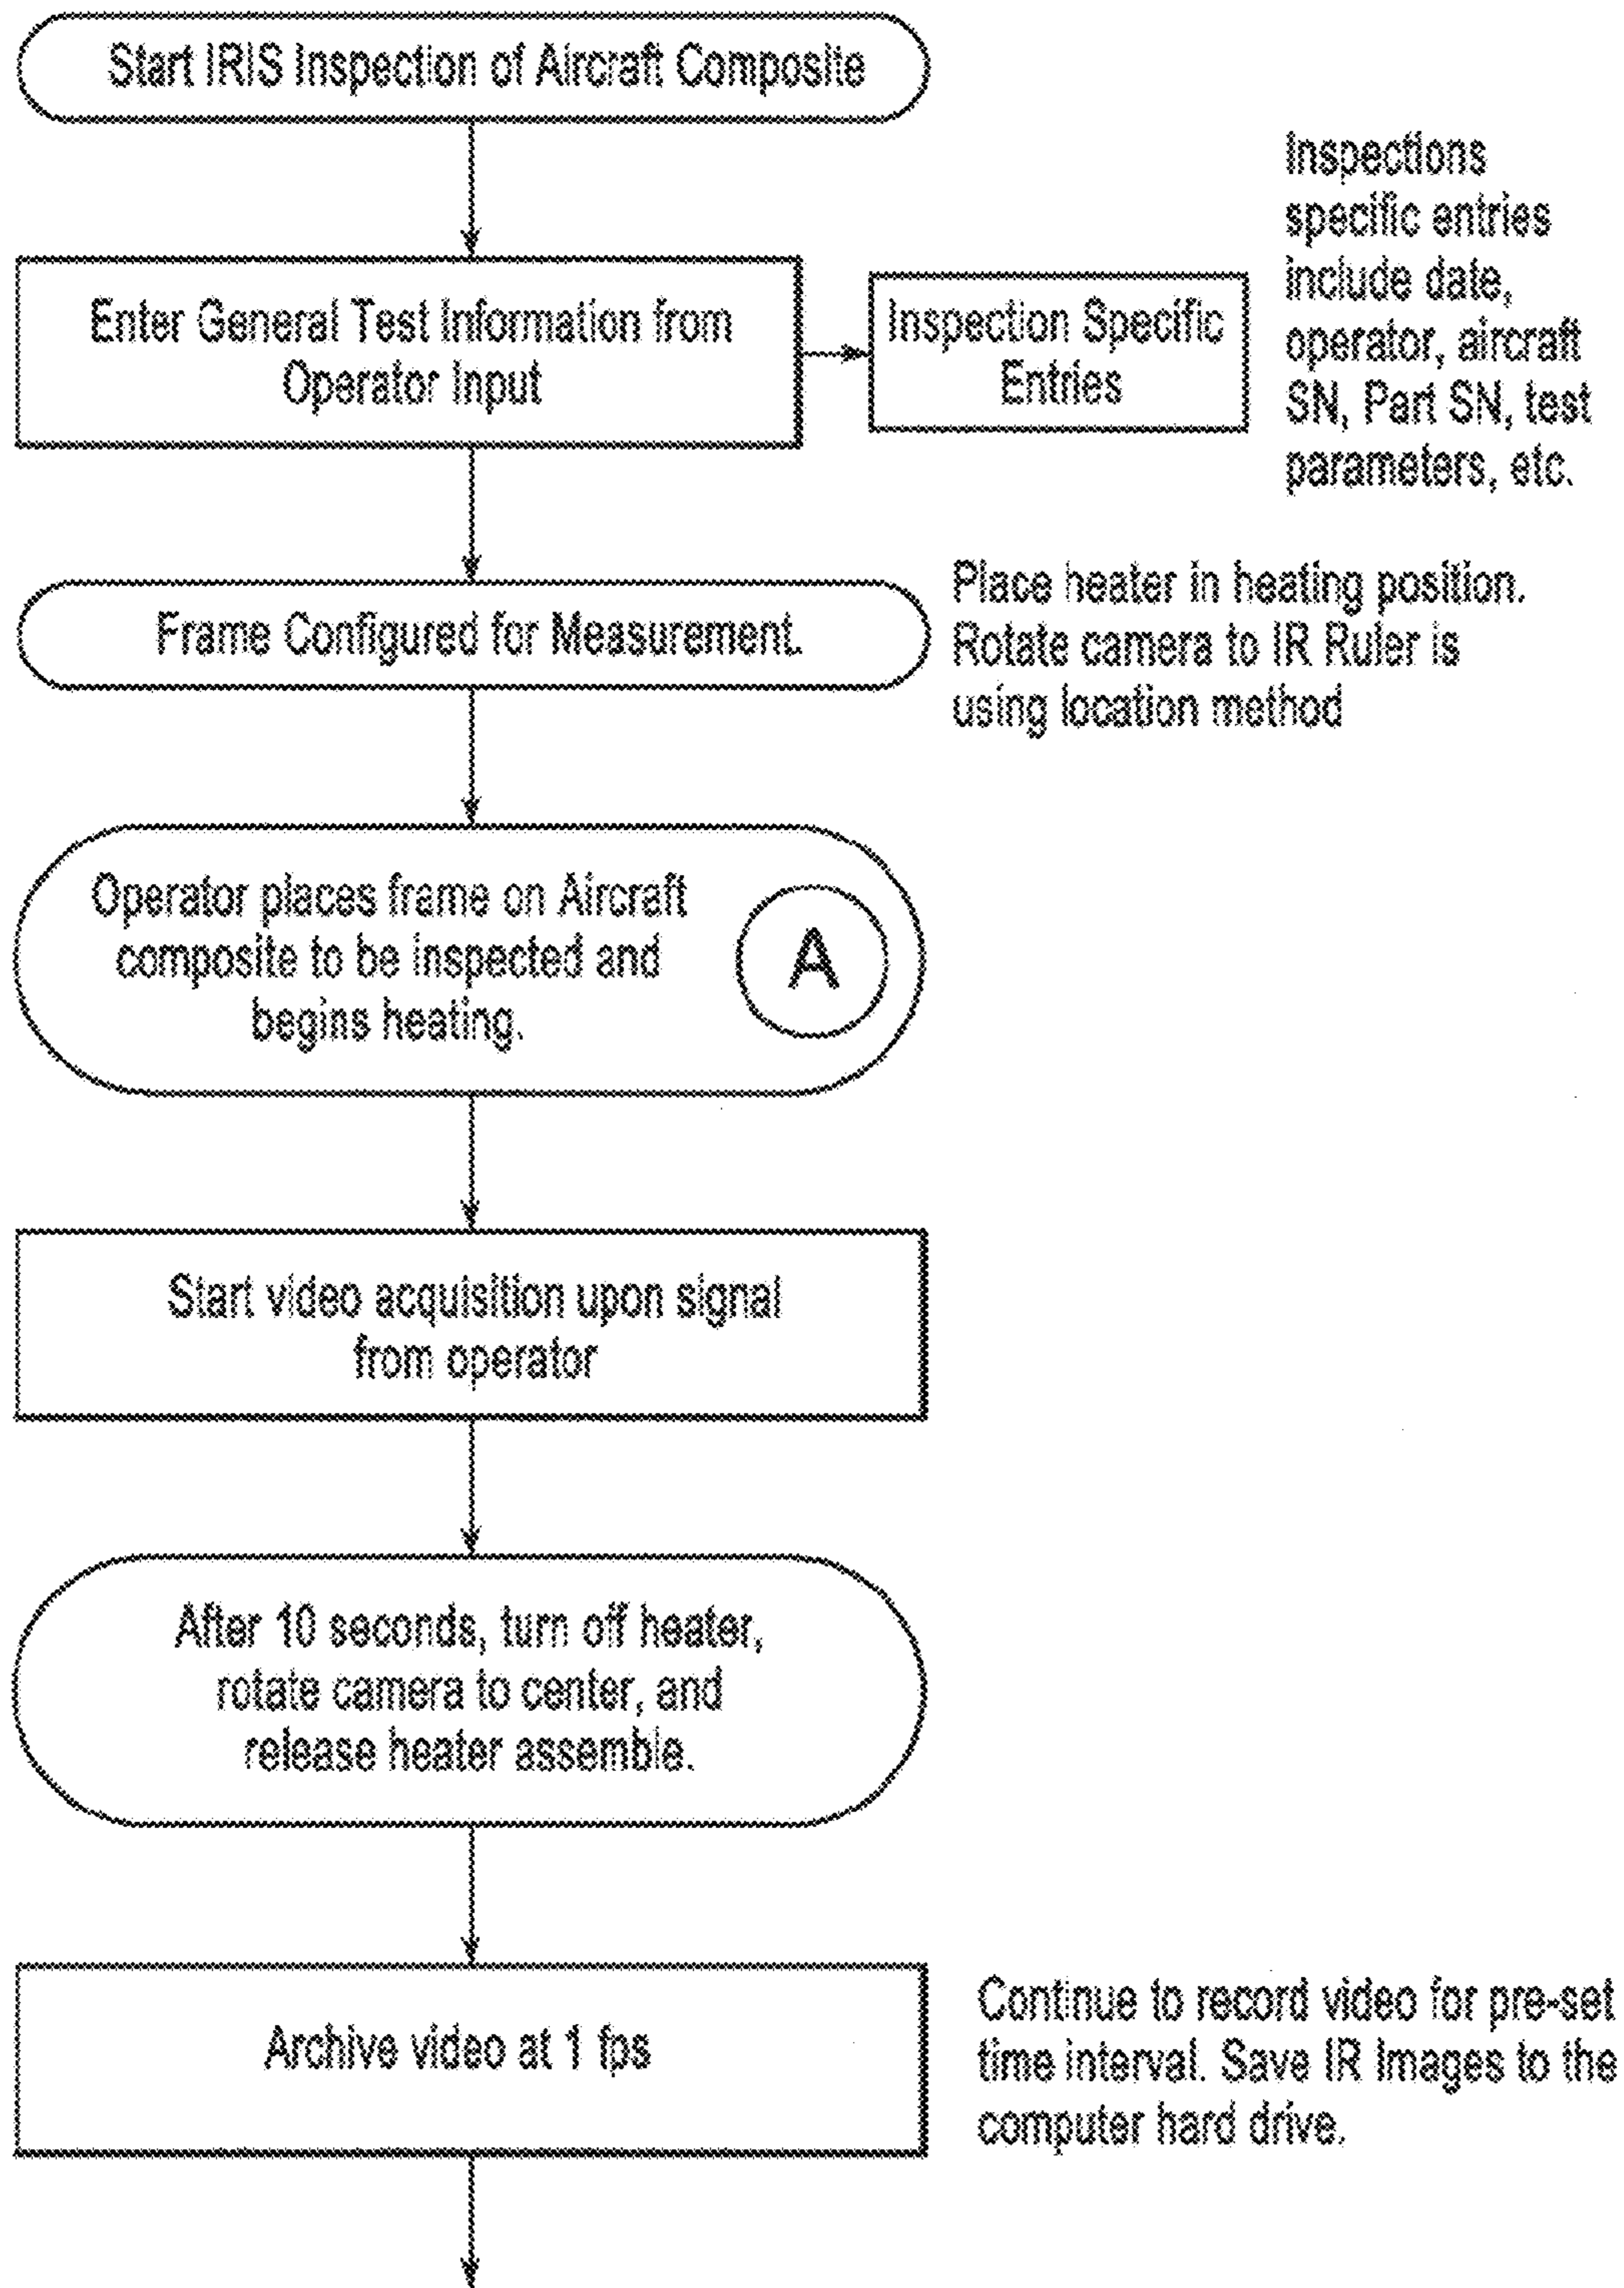
FIG. 20 illustrates the process flow of the image acquisition portion of the IRIS software.
