(12) **United States Patent**
Maresca, Jr. et al.

(10) **Patent No.:** **US 9,811,900 B2**
(45) **Date of Patent:** ***Nov. 7, 2017**

(54) **AUTOMATIC DETECTION OF DEFECTS IN COMPOSITE STRUCTURES USING NDT METHODS**

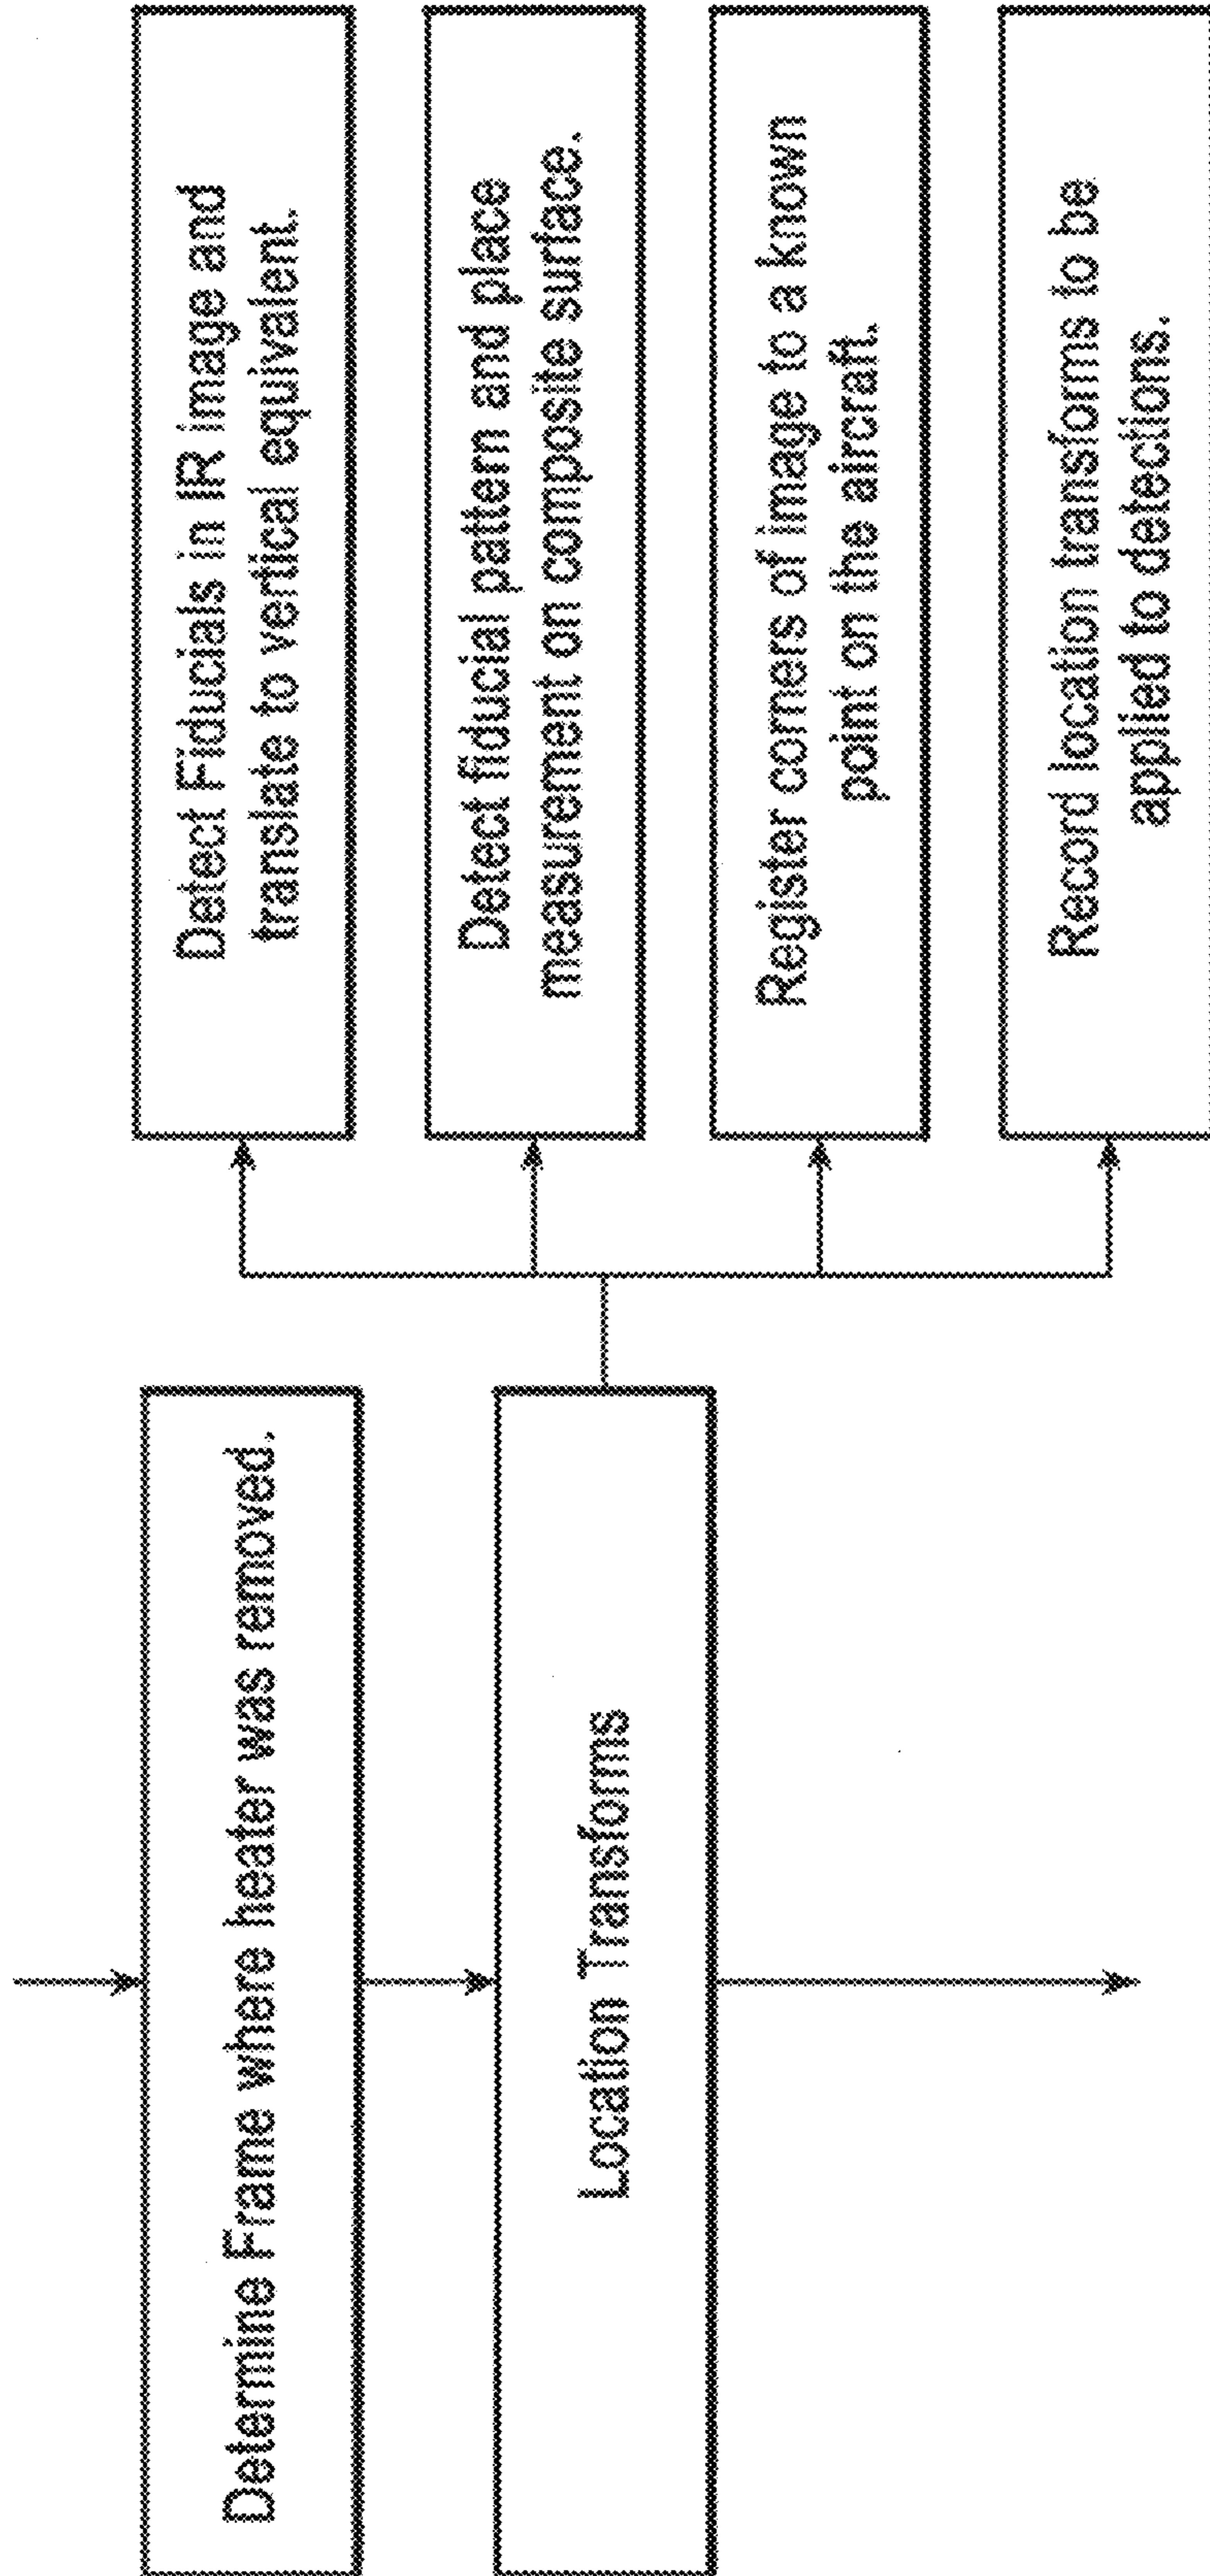
FIG. 21 illustrates the process flow for the location algorithms of the IRIS software.

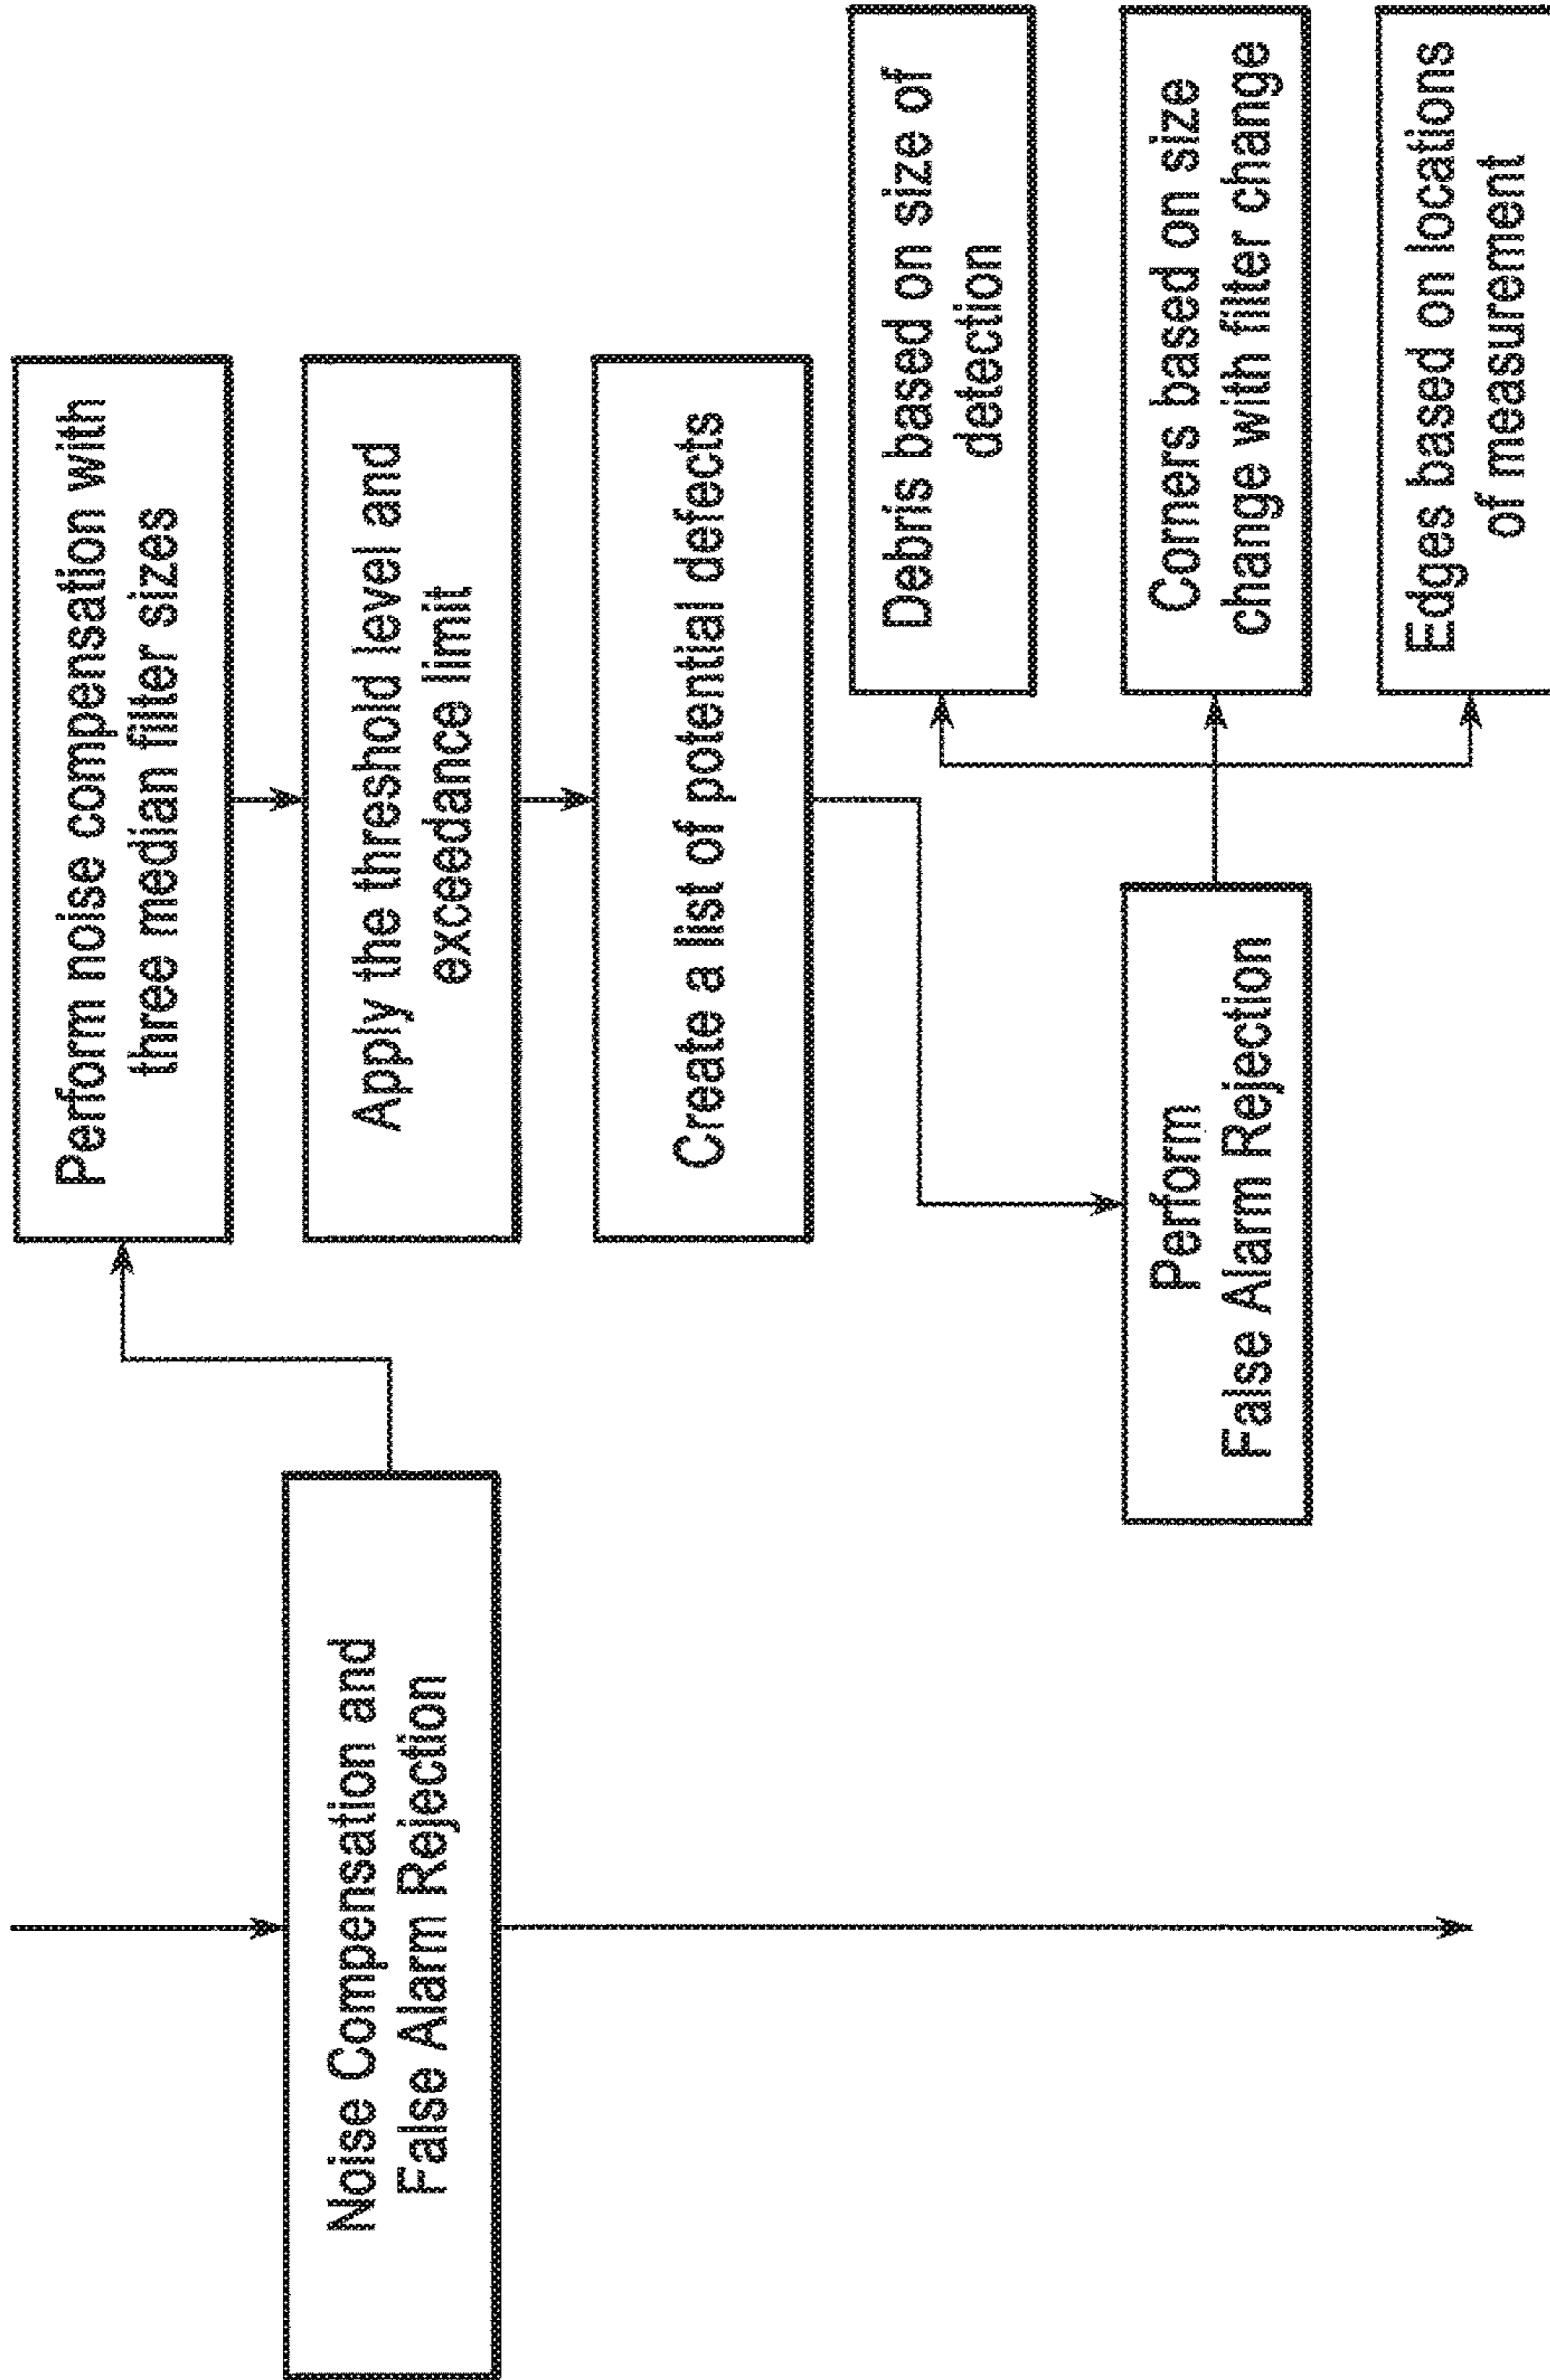
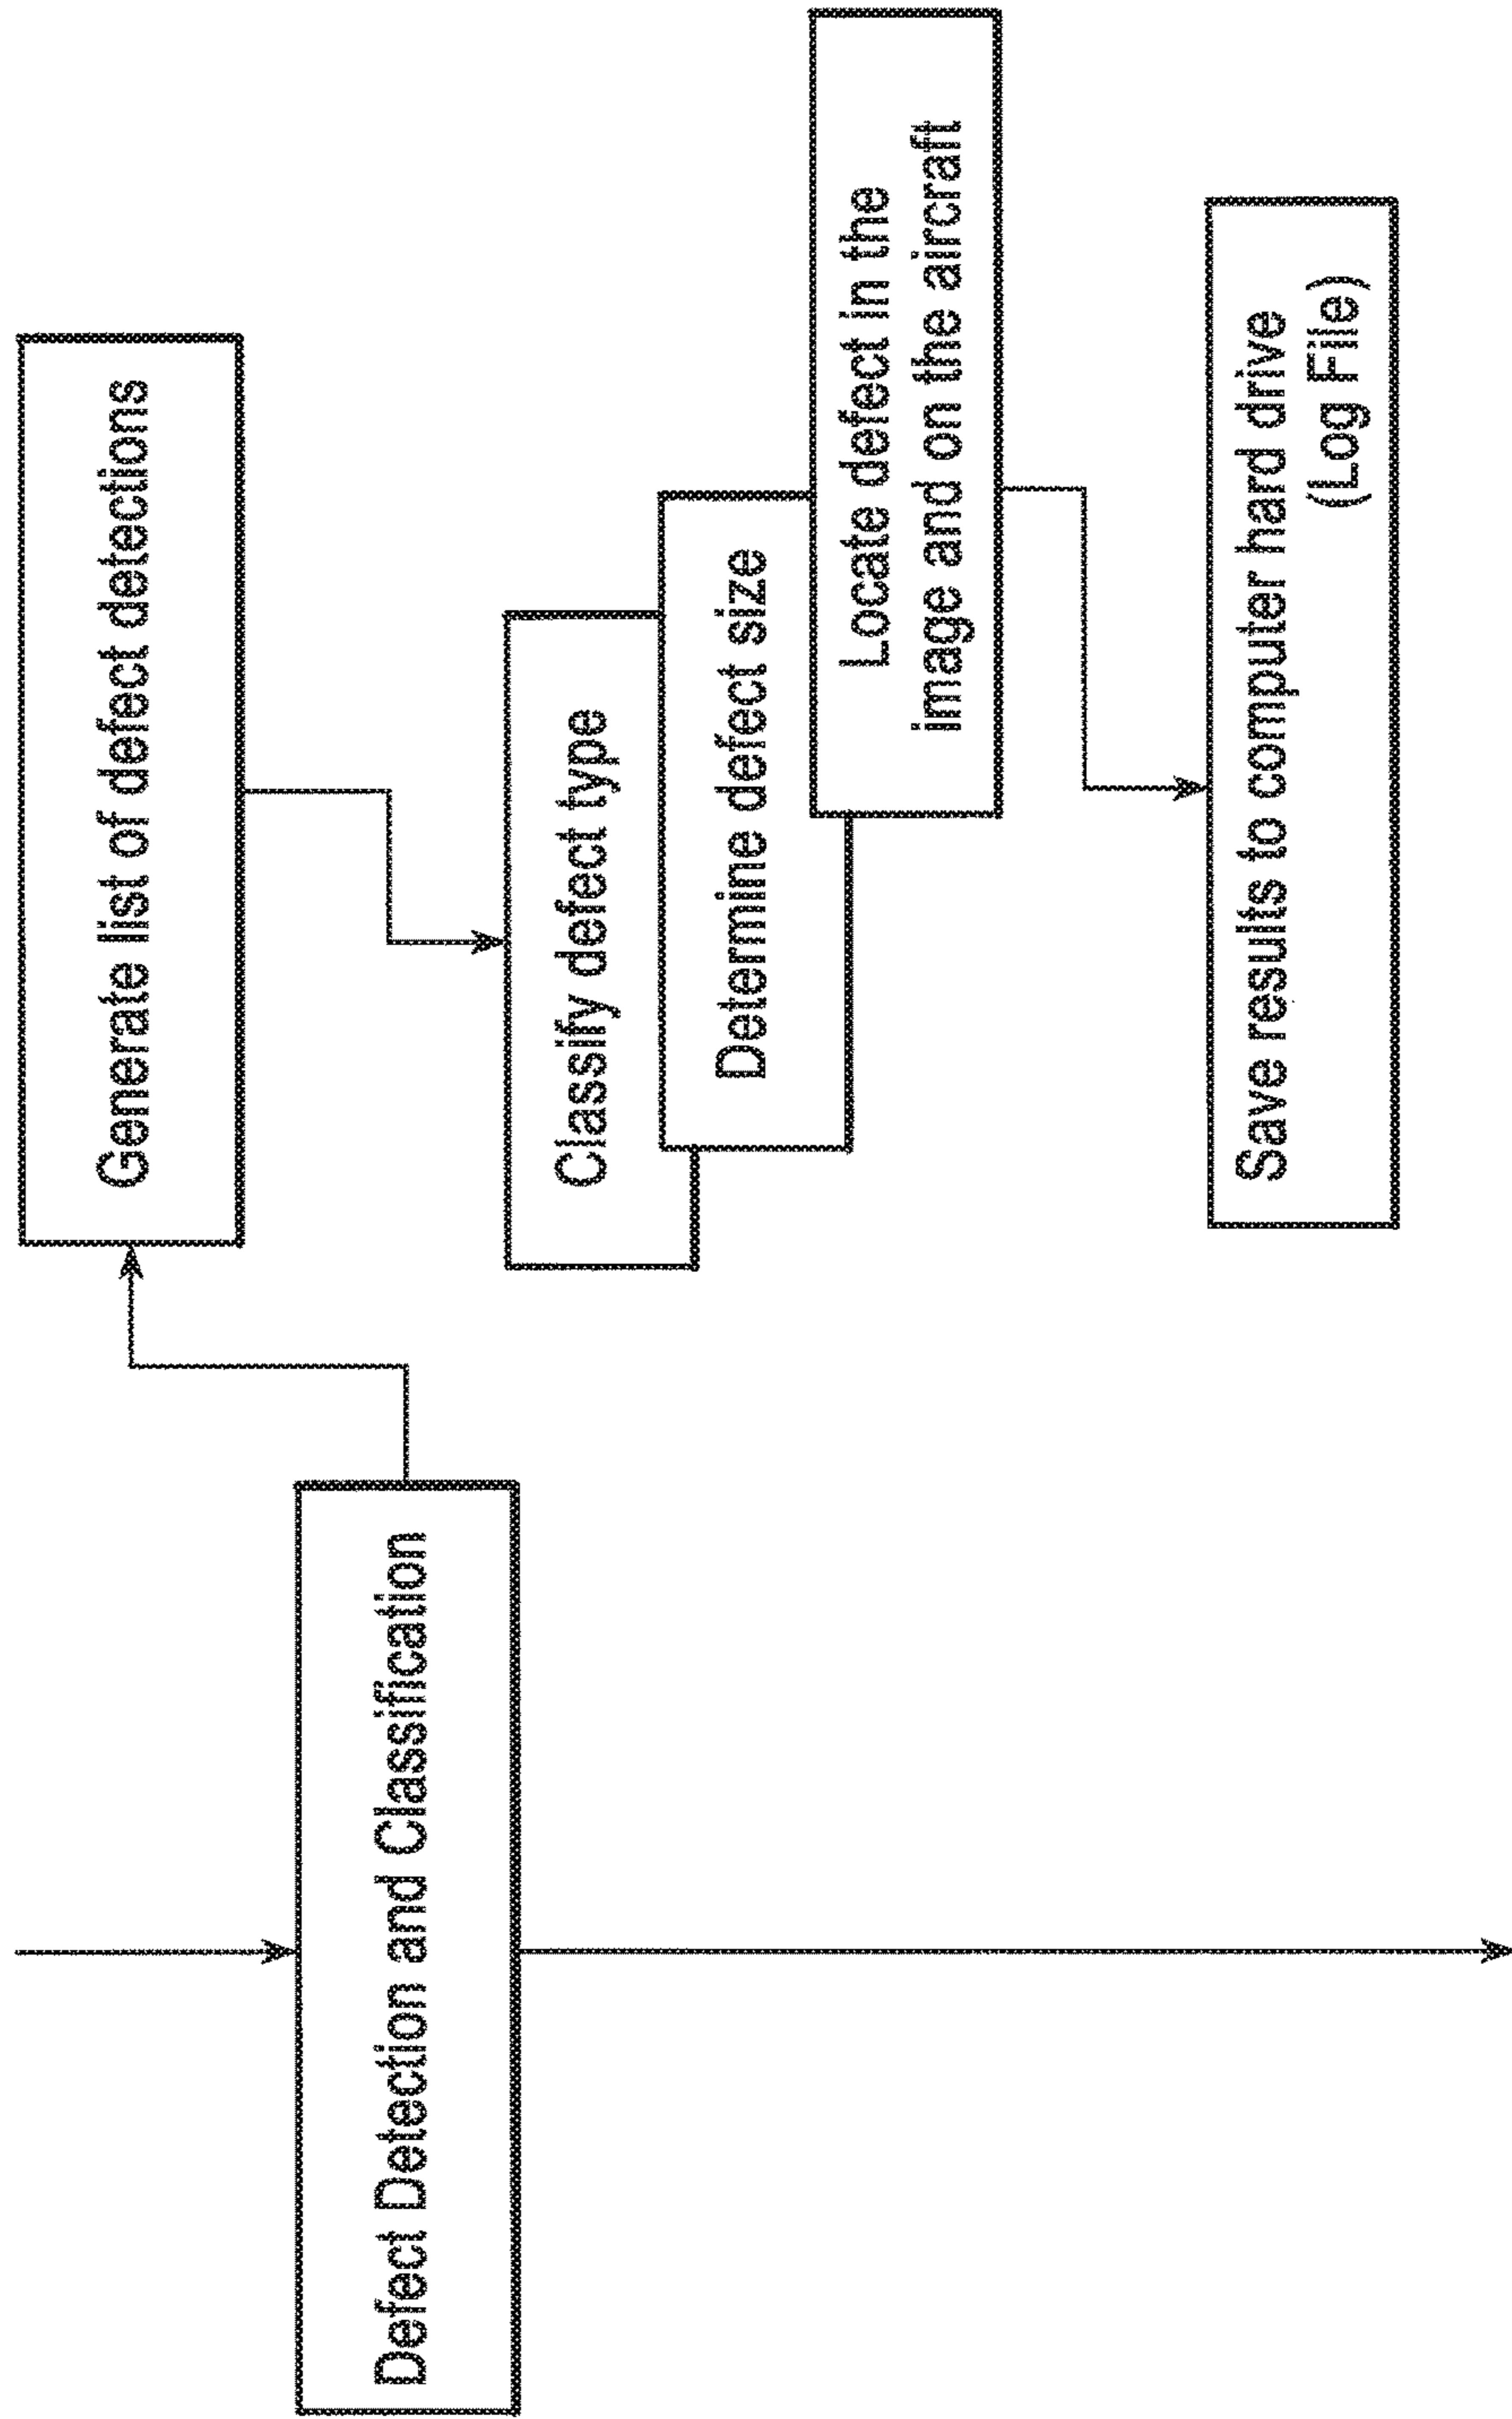
FIG. 22 illustrates the process flow of the false alarm mitigation and detection portion of the IRIS software.

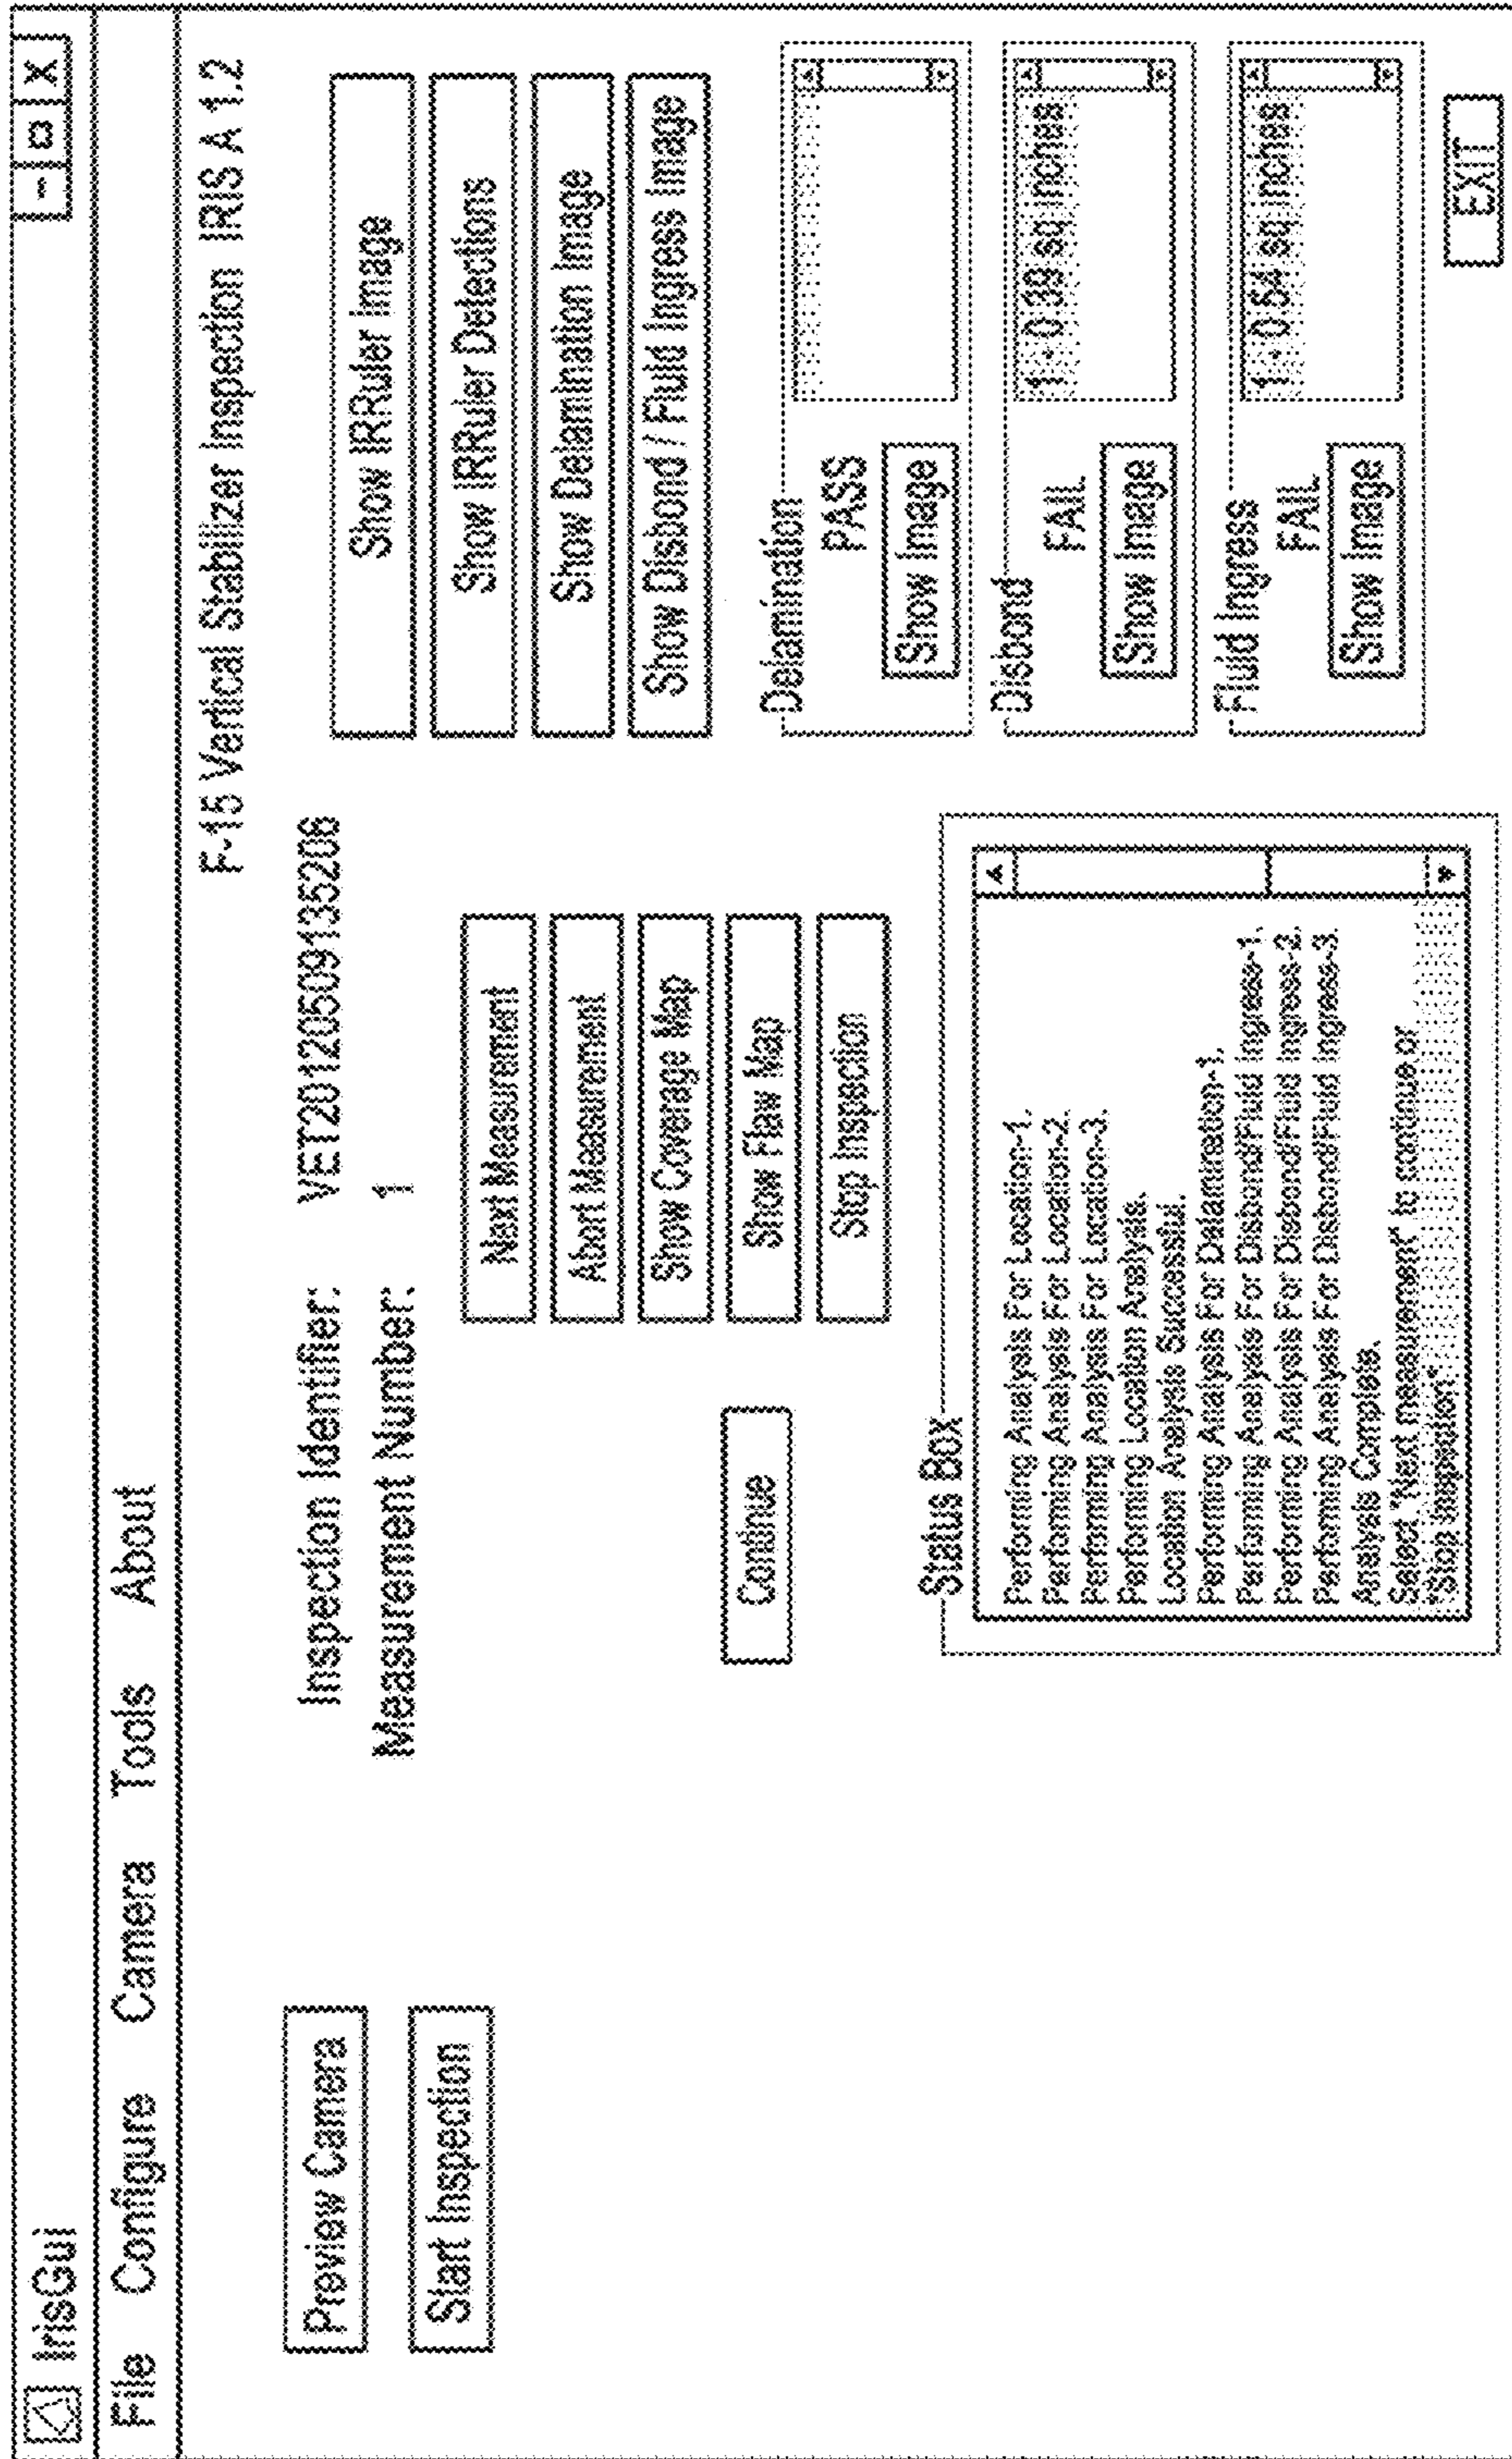
FIG. 23 illustrates the IRIS graphical user interface main screen showing the results of an individual measurement.
