US009816905B2

(54) **METHOD FOR ANALYSING A FRACTURE  
FACE OF A PART OF A TURBINE ENGINE**

## METHOD FOR ANALYSING A FRACTURE FACE OF A PART OF A TURBINE ENGINE

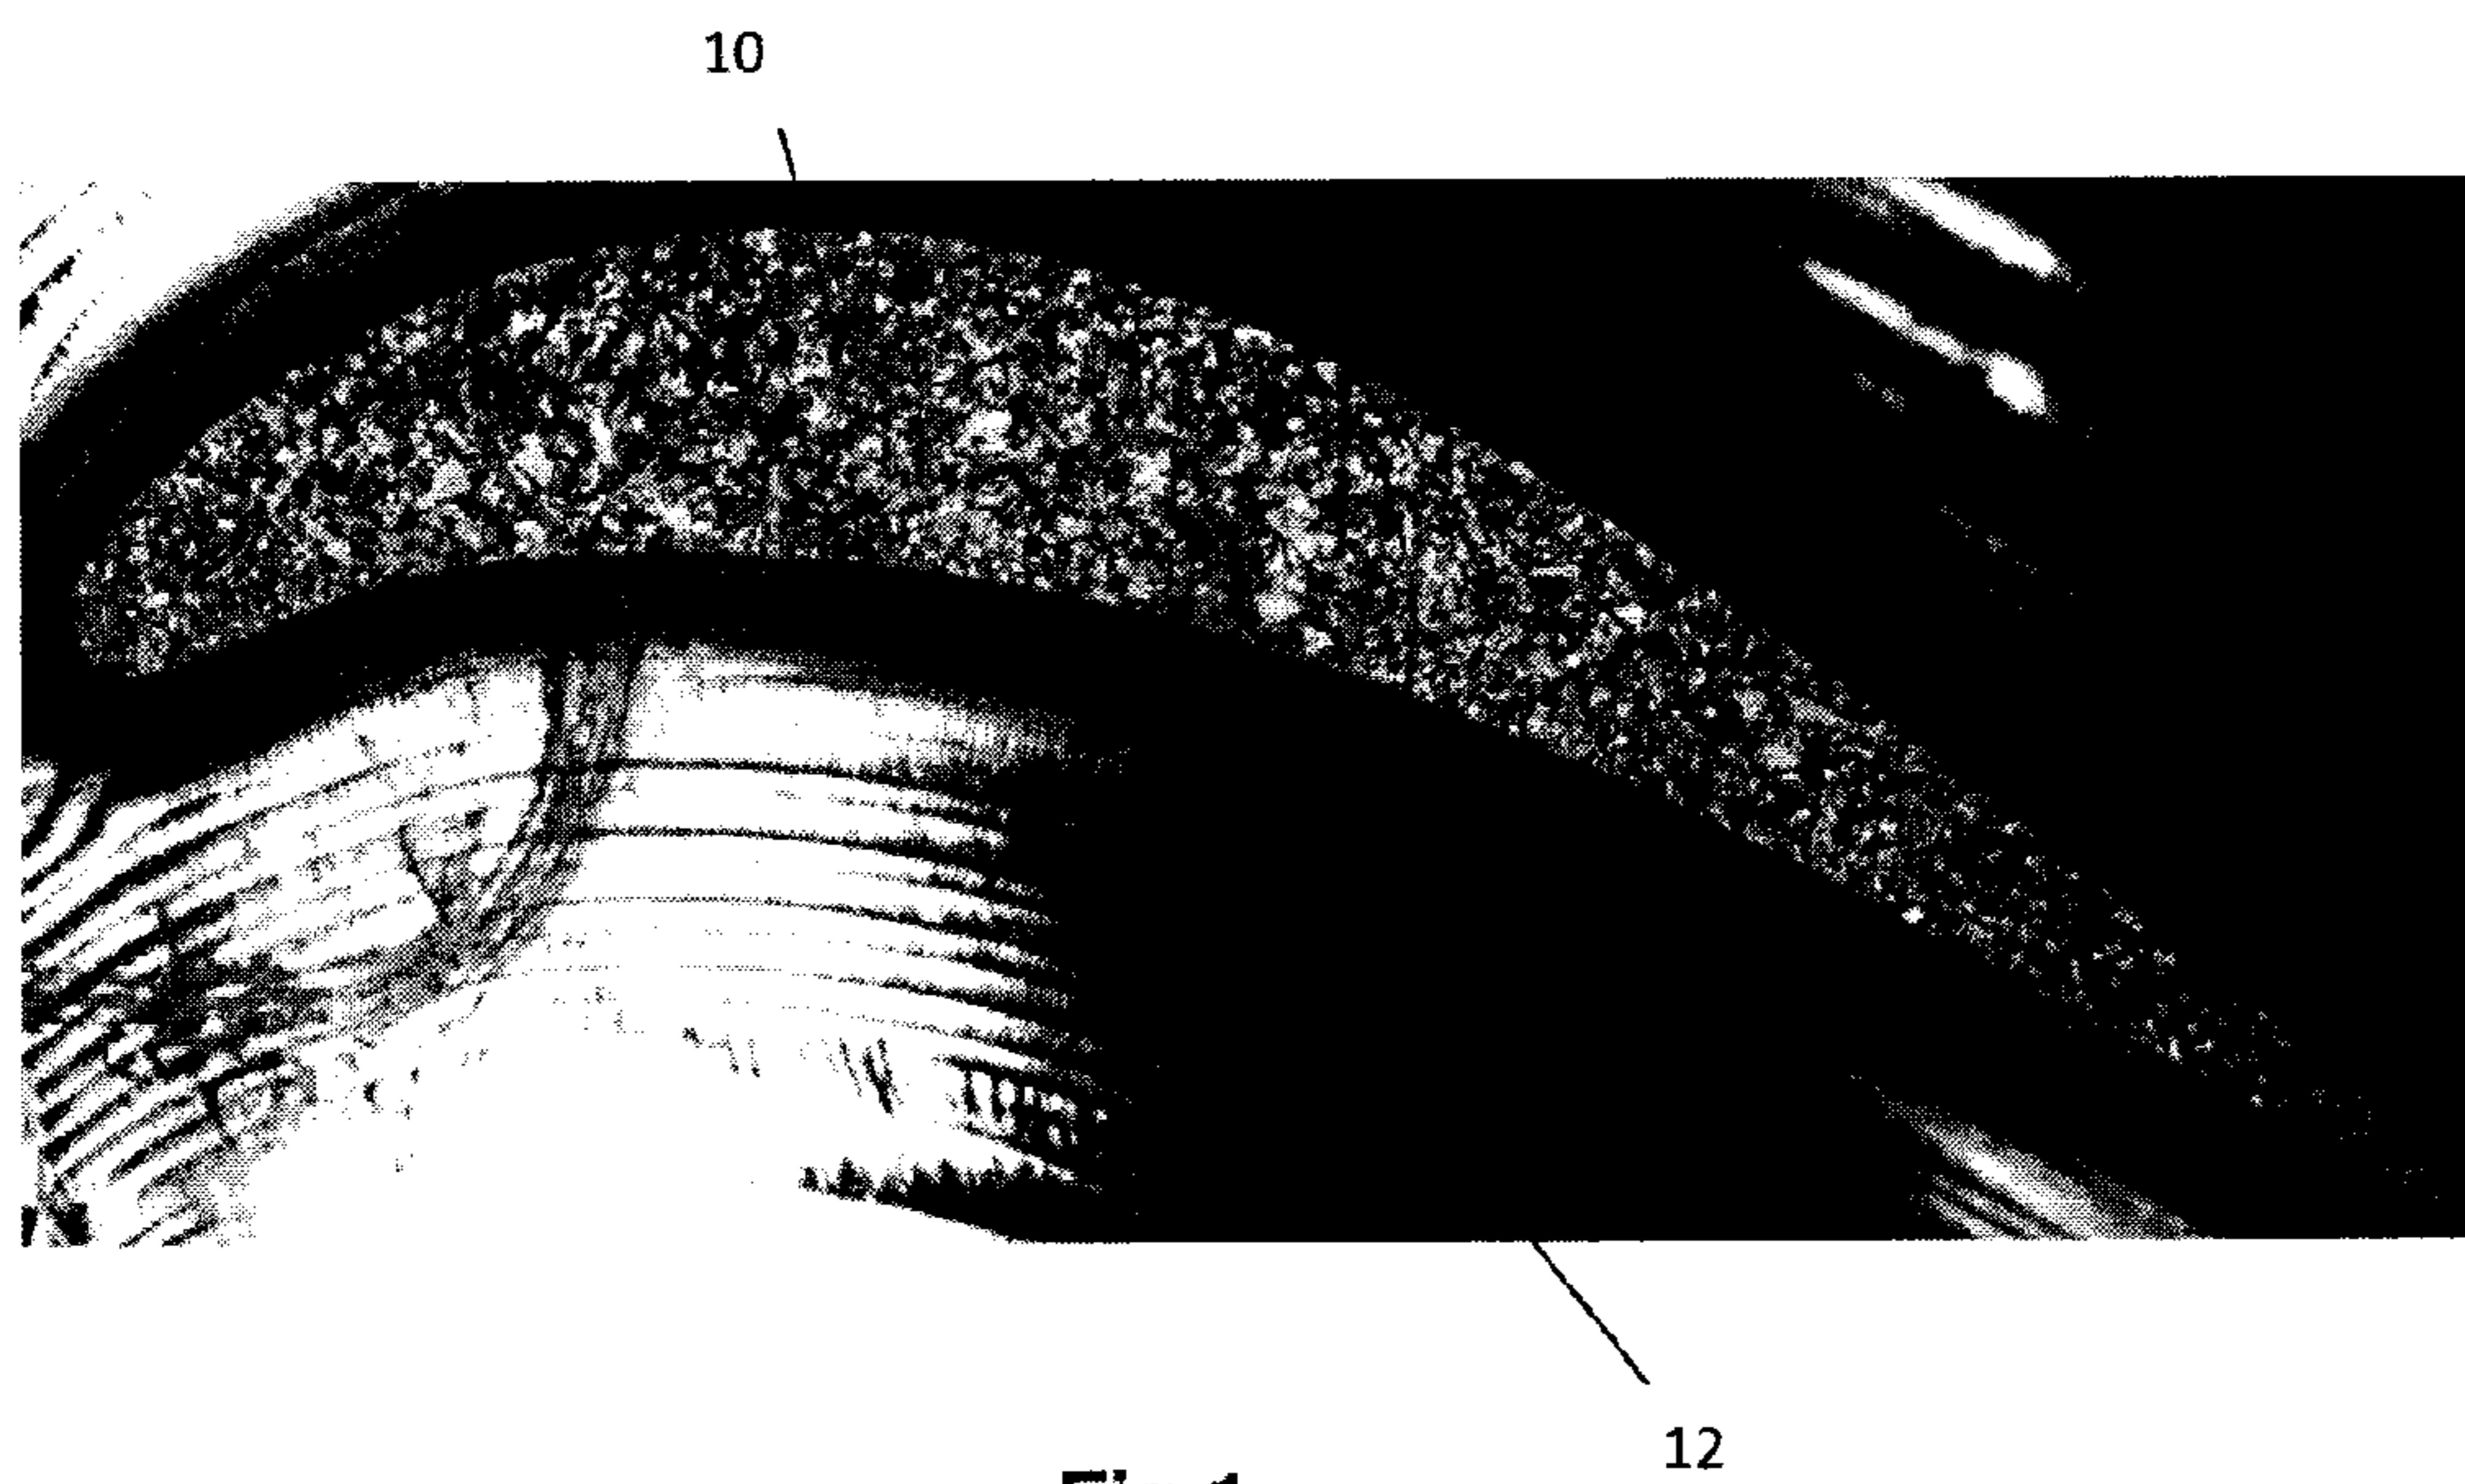
Fig.1

FIG. 1 is a binocular loupe image of a fracture face of a TiAl turbine engine blade,

Reference is firstly made to FIG. 1, which is a binocular loupe image of a fracture face 10 of a TiAl blade 12 of a turbine engine turbine. The fracture face 10 extends in a plane which in this case is transverse to the leaf of the blade.

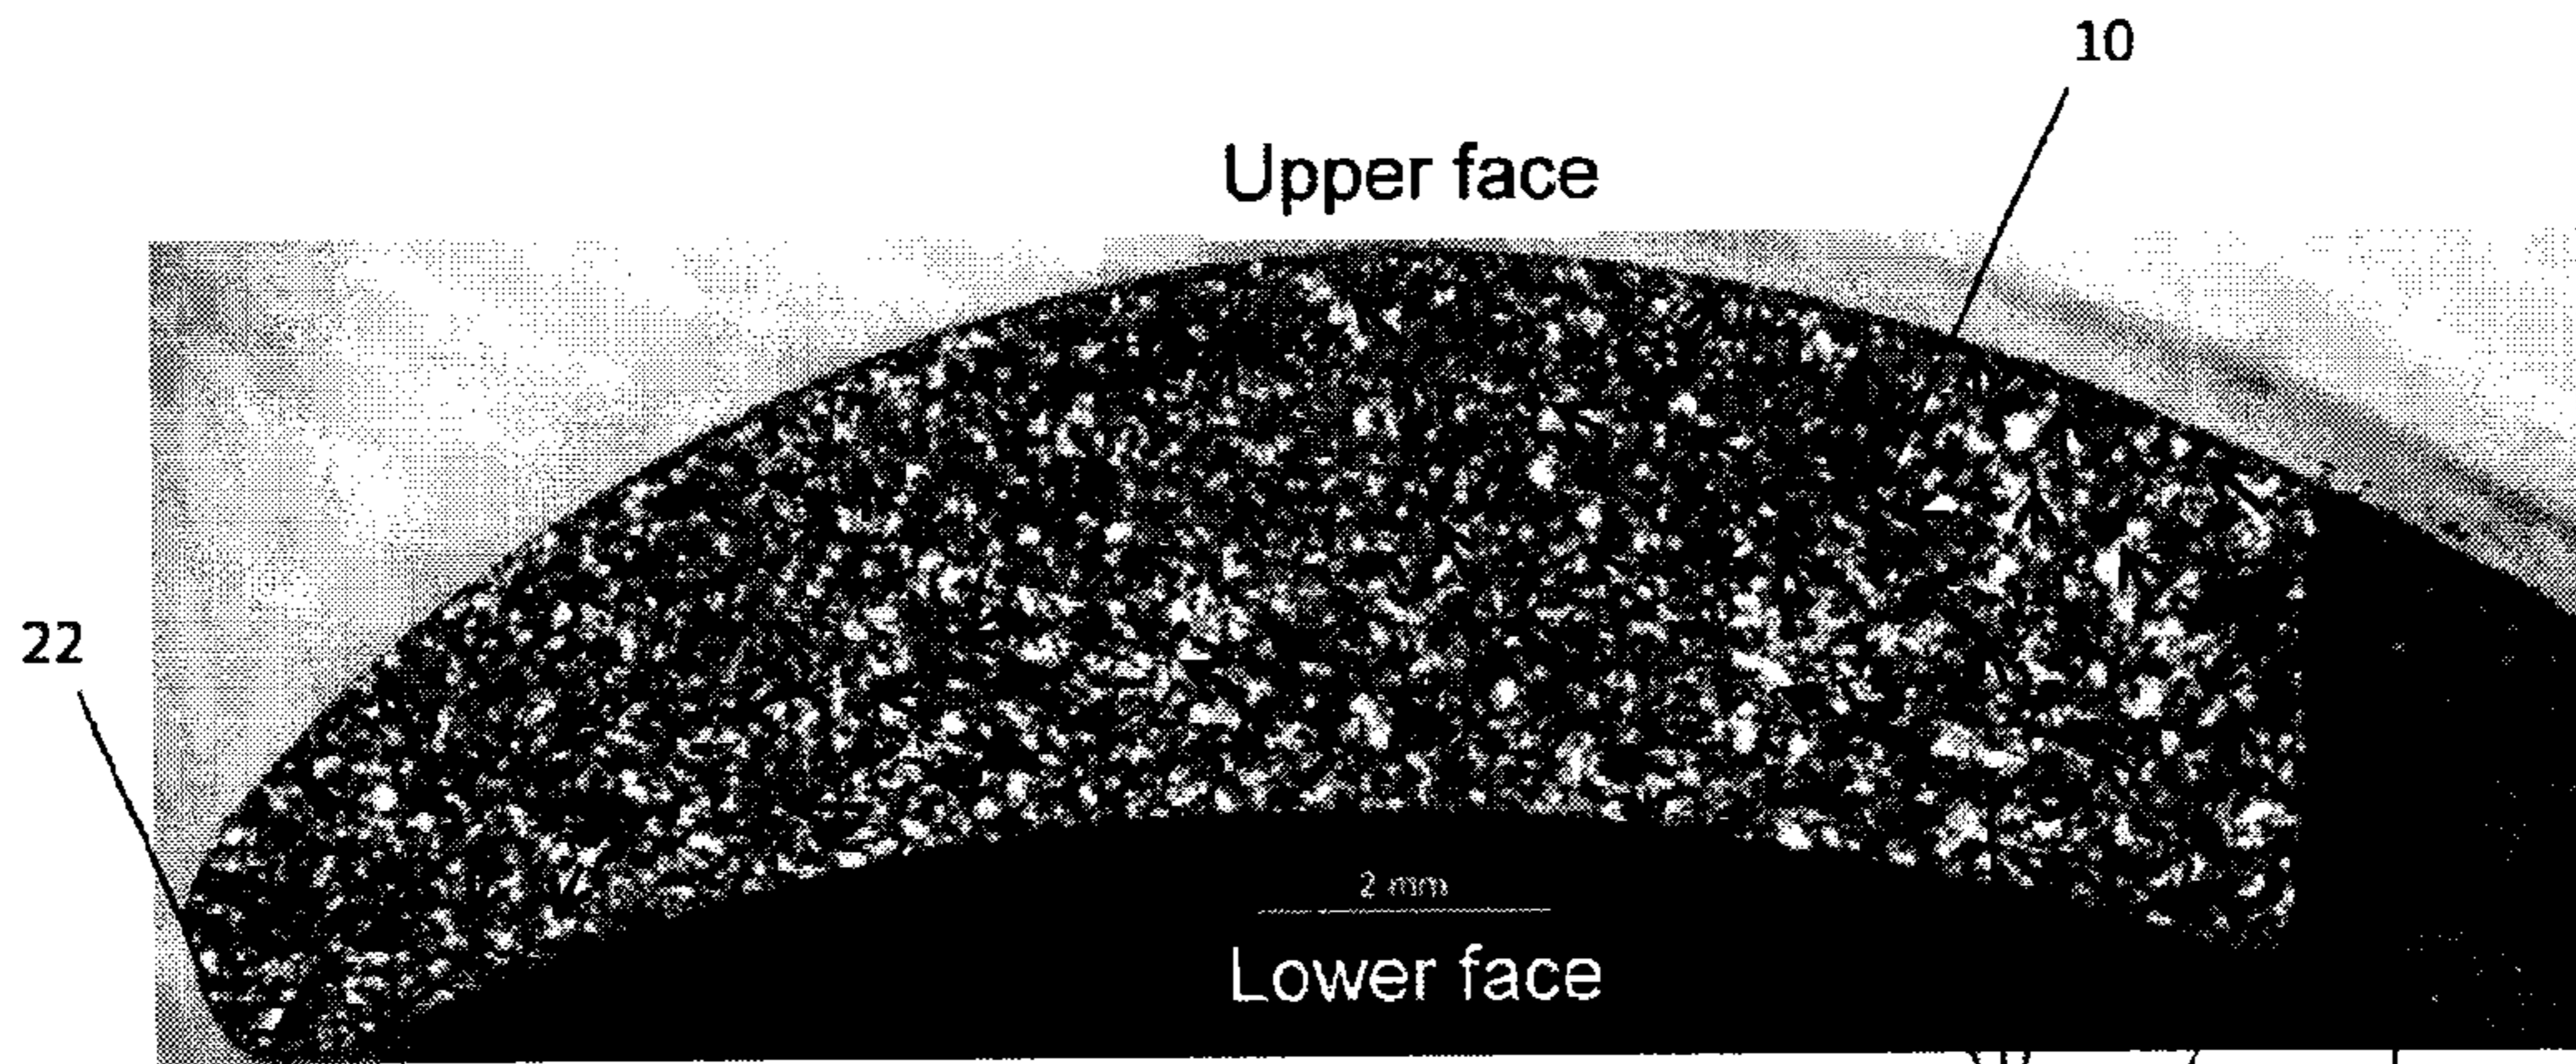
Fig. 4

FIG. 4 is a binocular loupe image of another fracture face of a TiAl blade,

FIG. 4 is an image obtained using a binocular loupe and processed using a computer so as to add arrows which show the position and the orientation of the cleavage facets 16. FIG. 5 is a larger-scale SEM image of a part from FIG. 4. The fracture of the blade from FIG. 4 was obtained by producing a notch 18 in the trailing edge of the blade leaf, then by subjecting the blade to a brutal fracture experiment induced in a laboratory according to a method of bending, from the lower face towards the upper face.

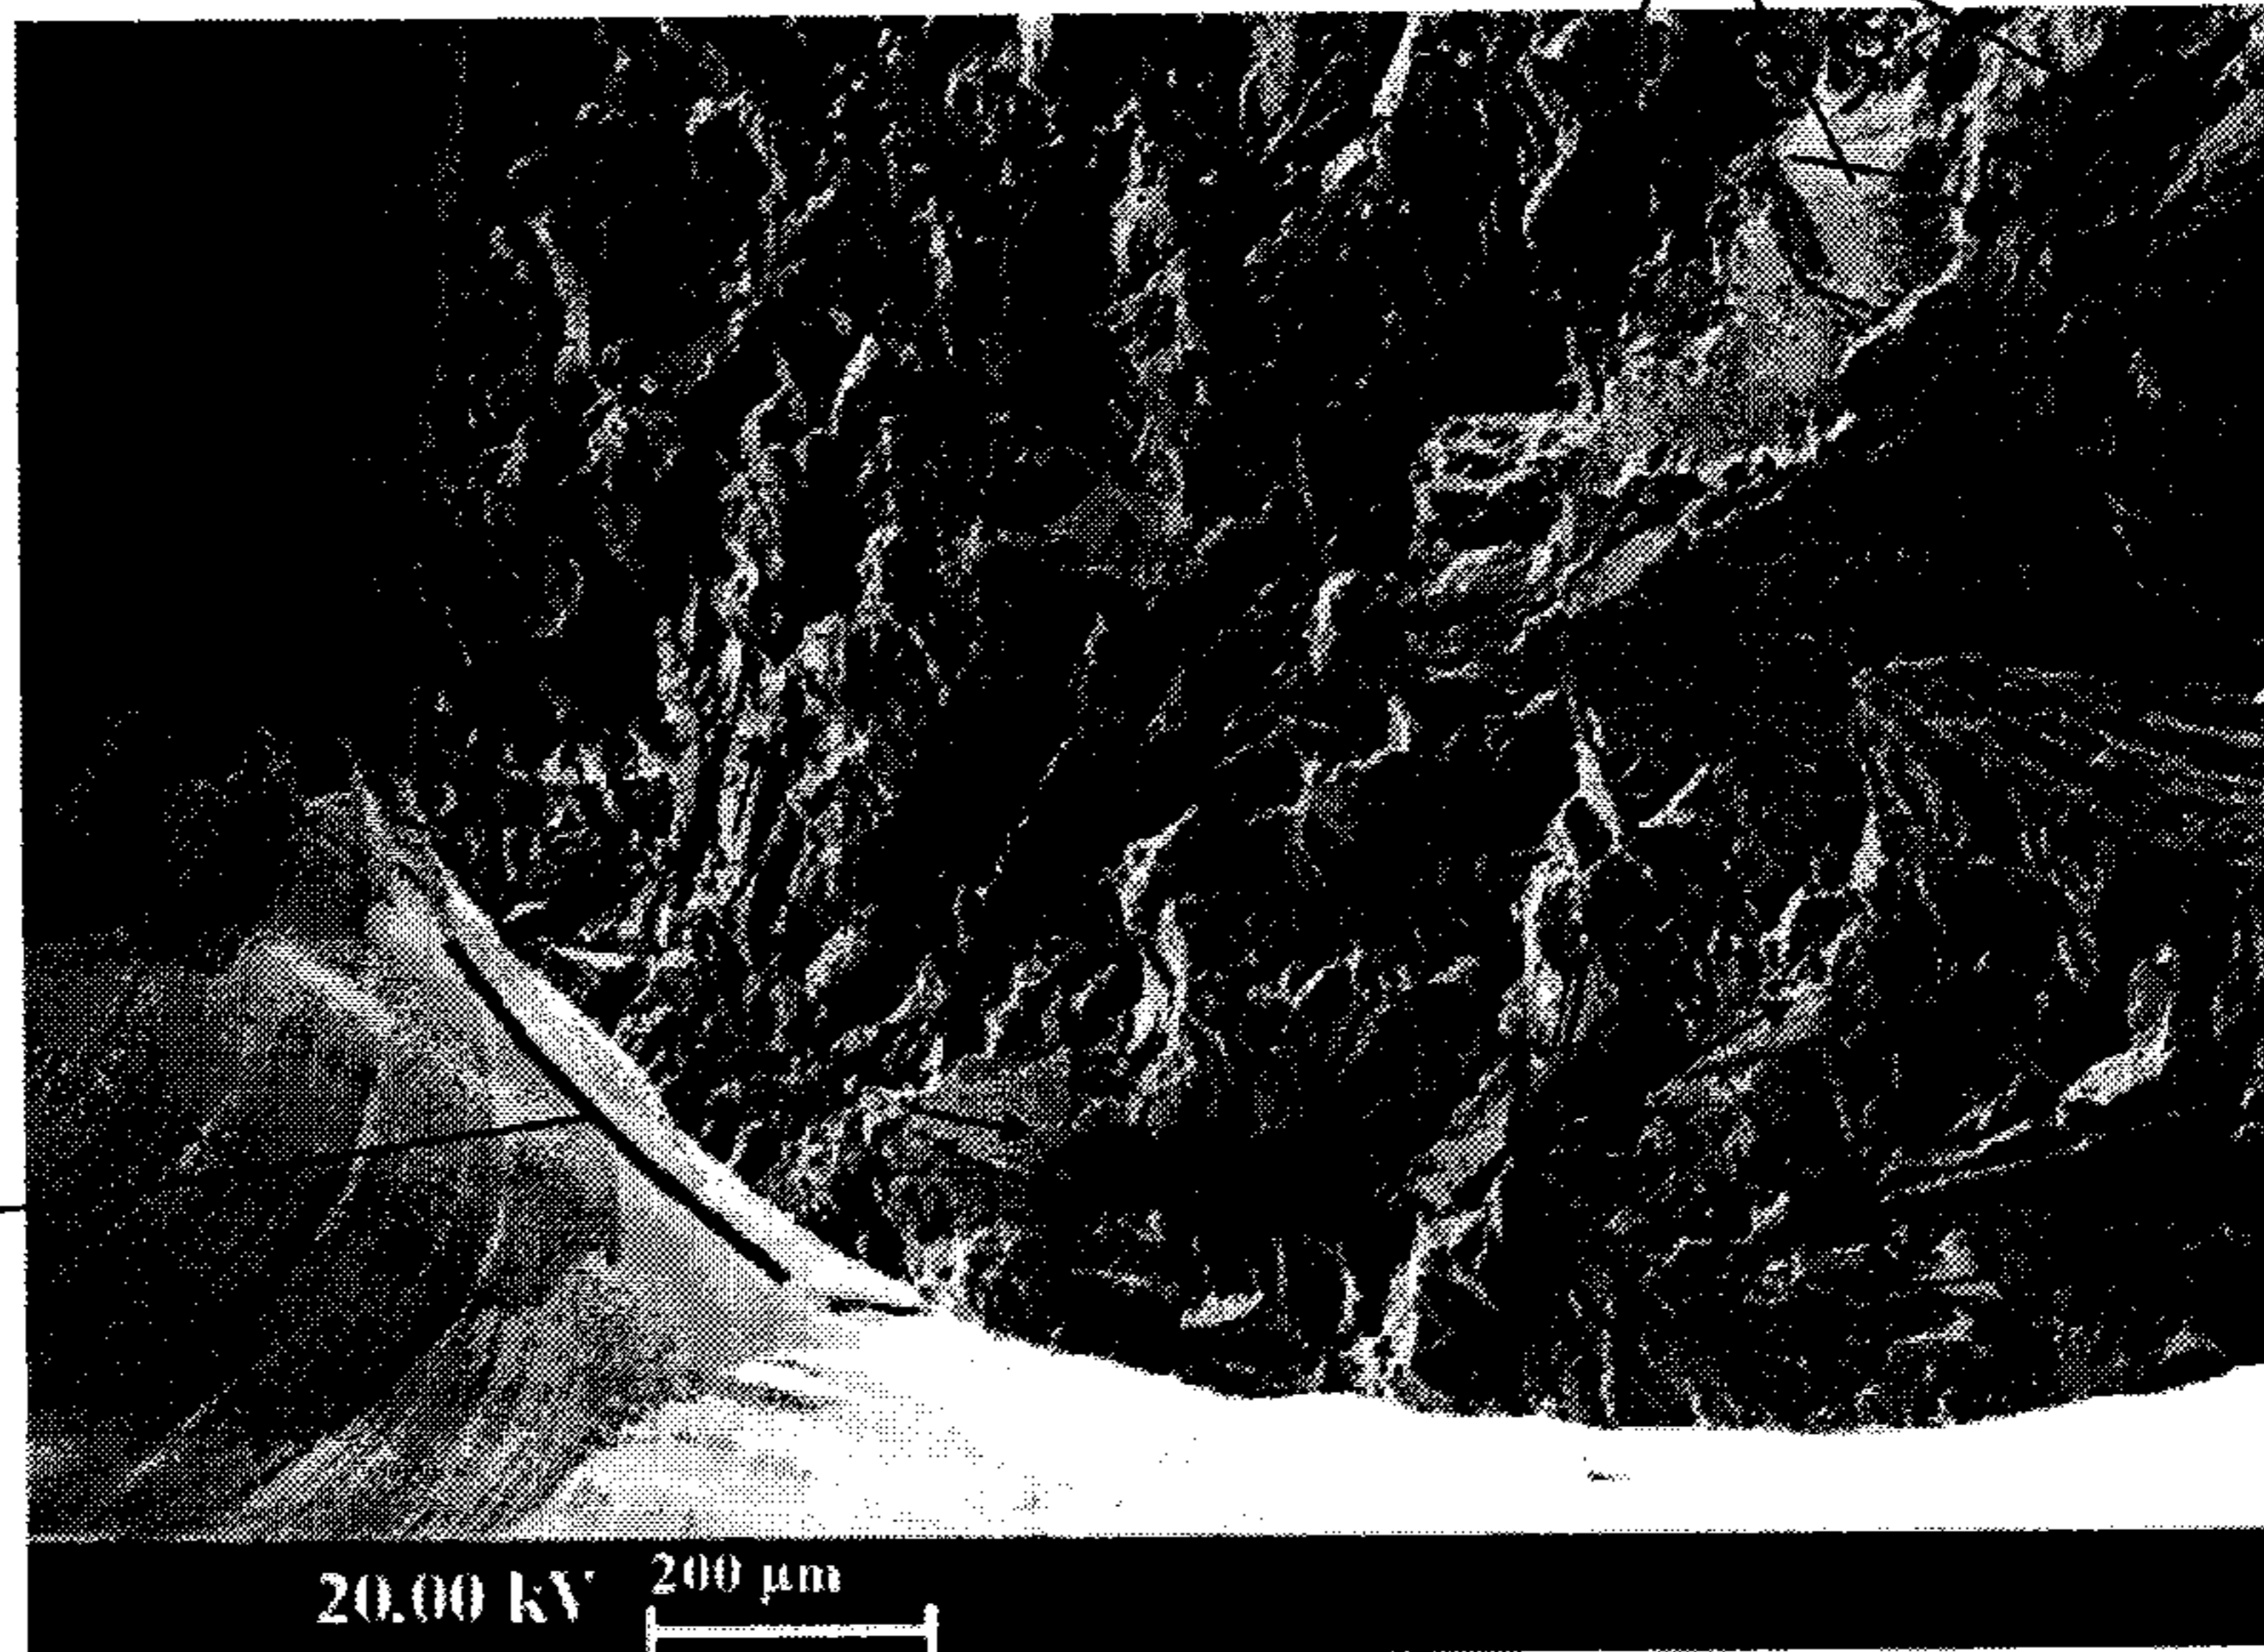
Fig. 6

FIG. 6 is a partial SEM image of another fracture face of a TiAl blade,

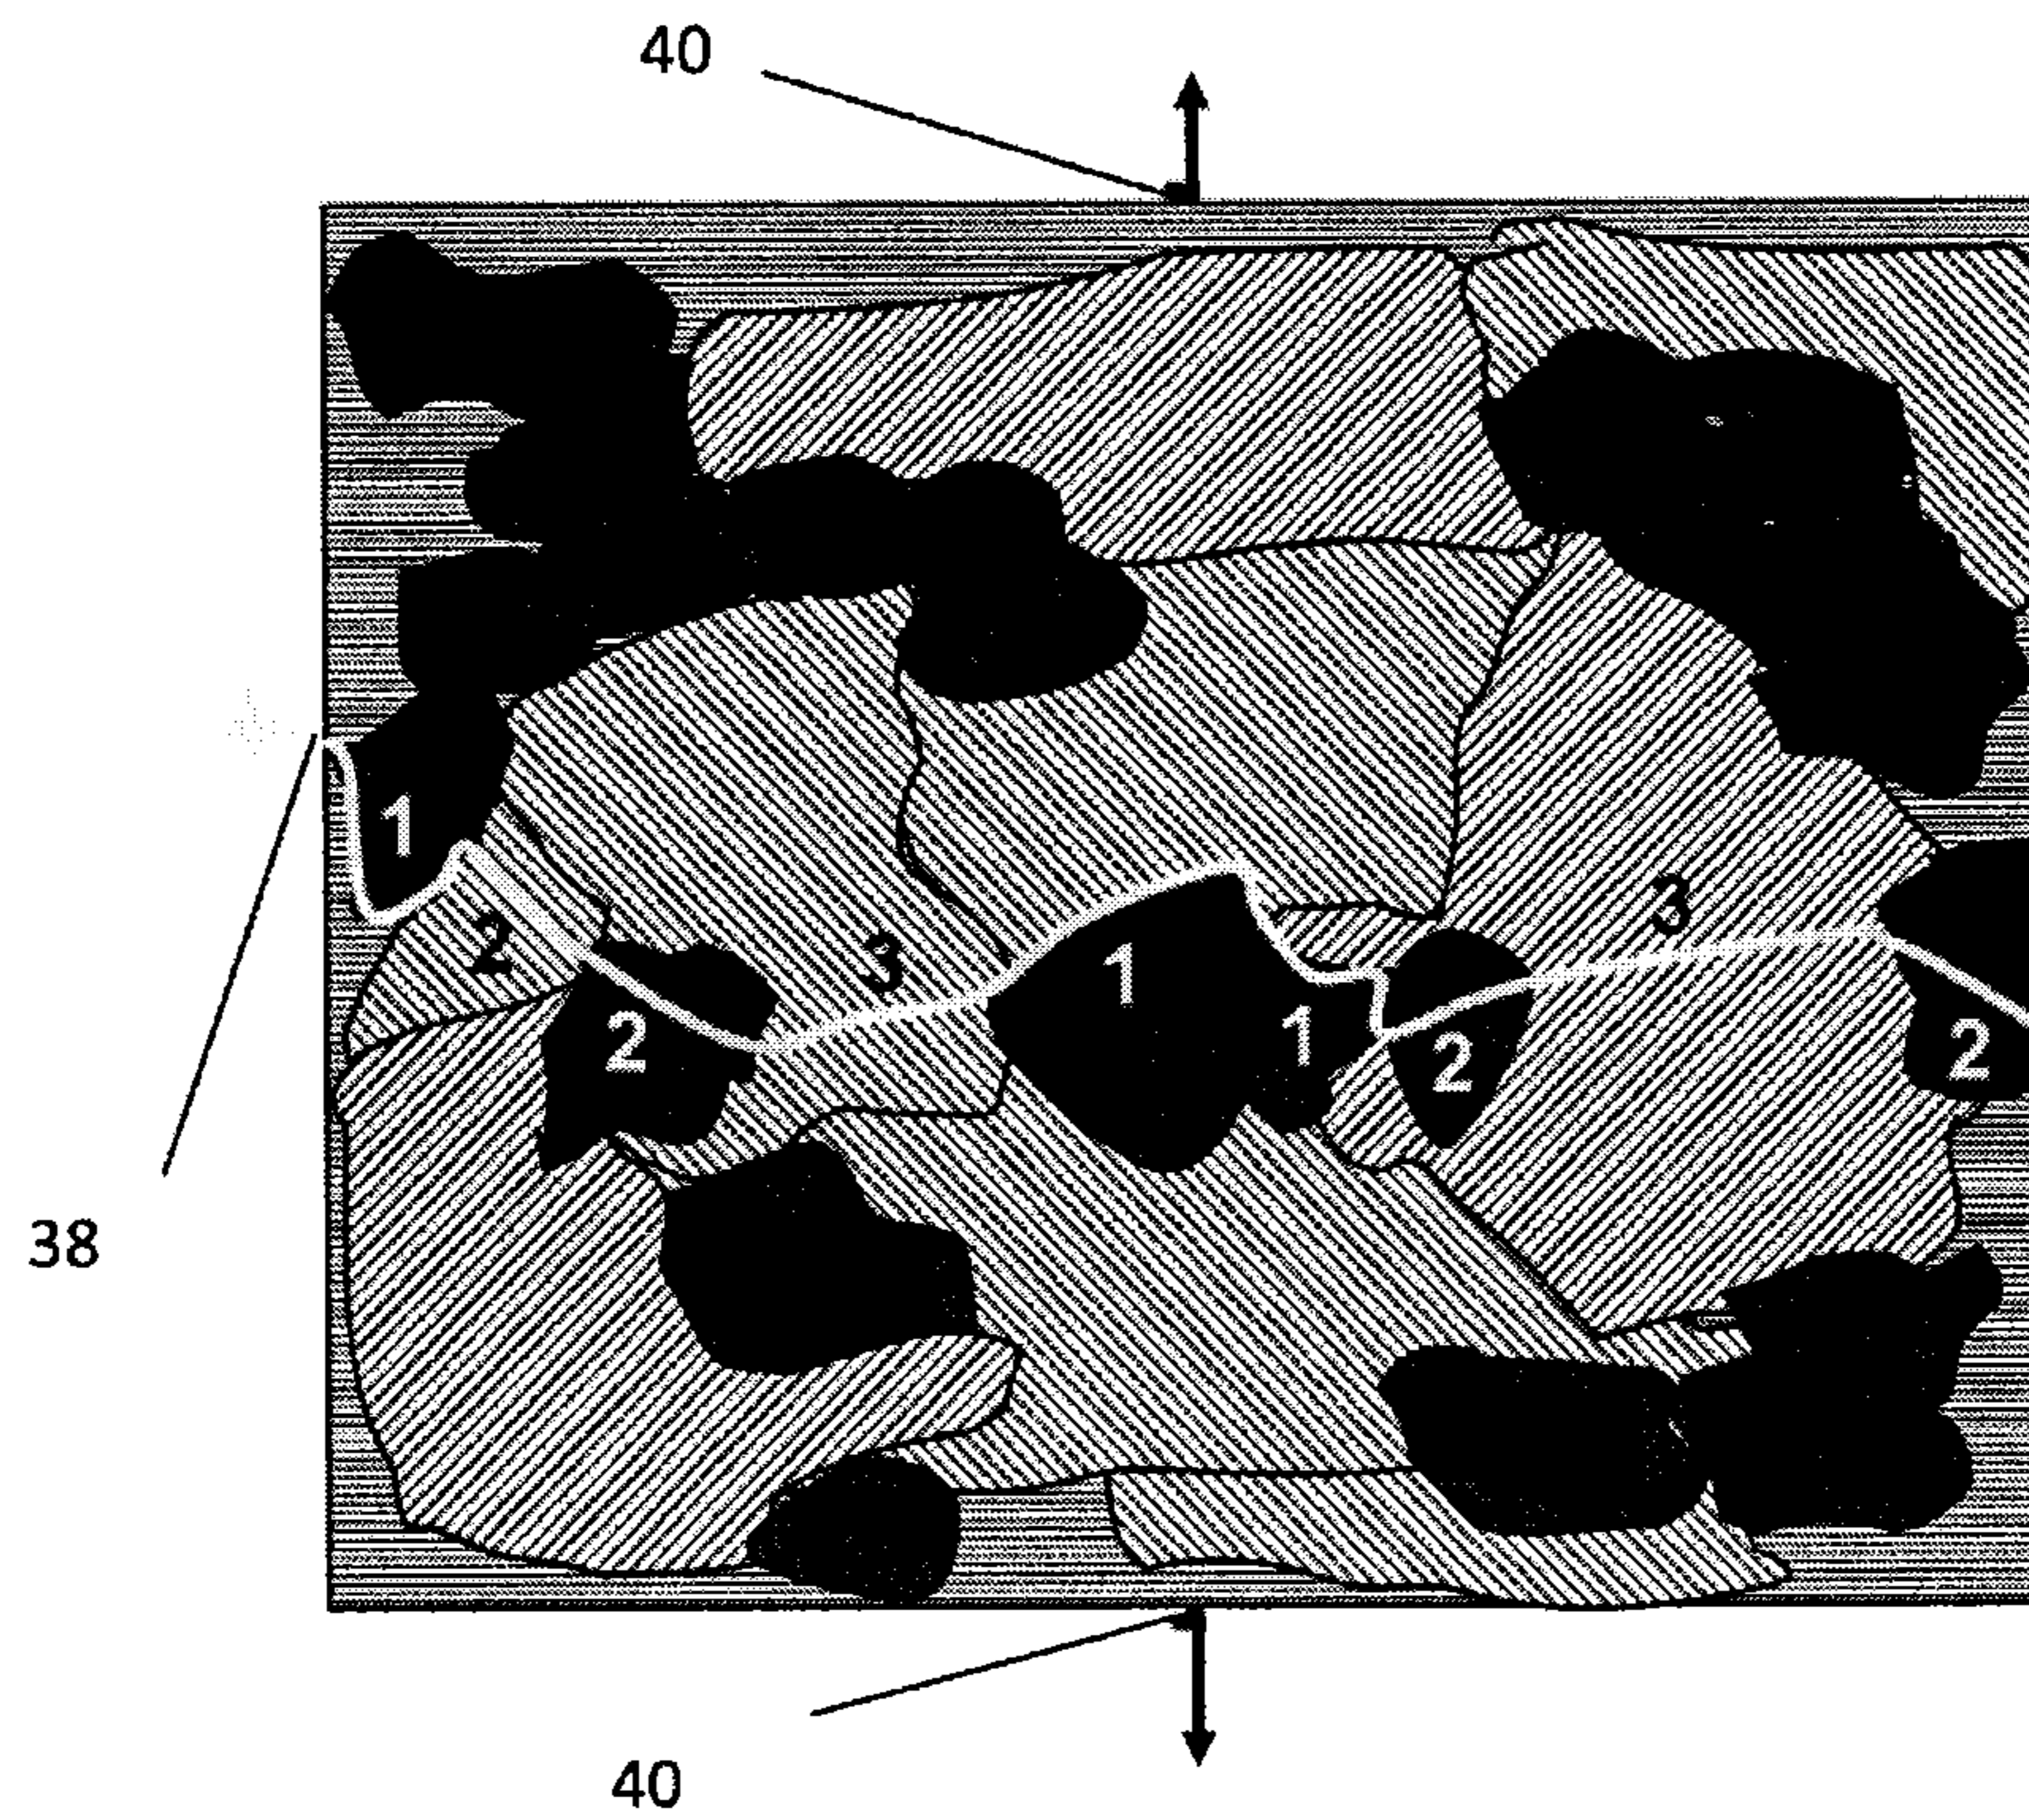
Fig. 7

FIG. 7 is a very schematic sectional view of a TiAl part, and shows the progression of a crack through granular regions of the part,

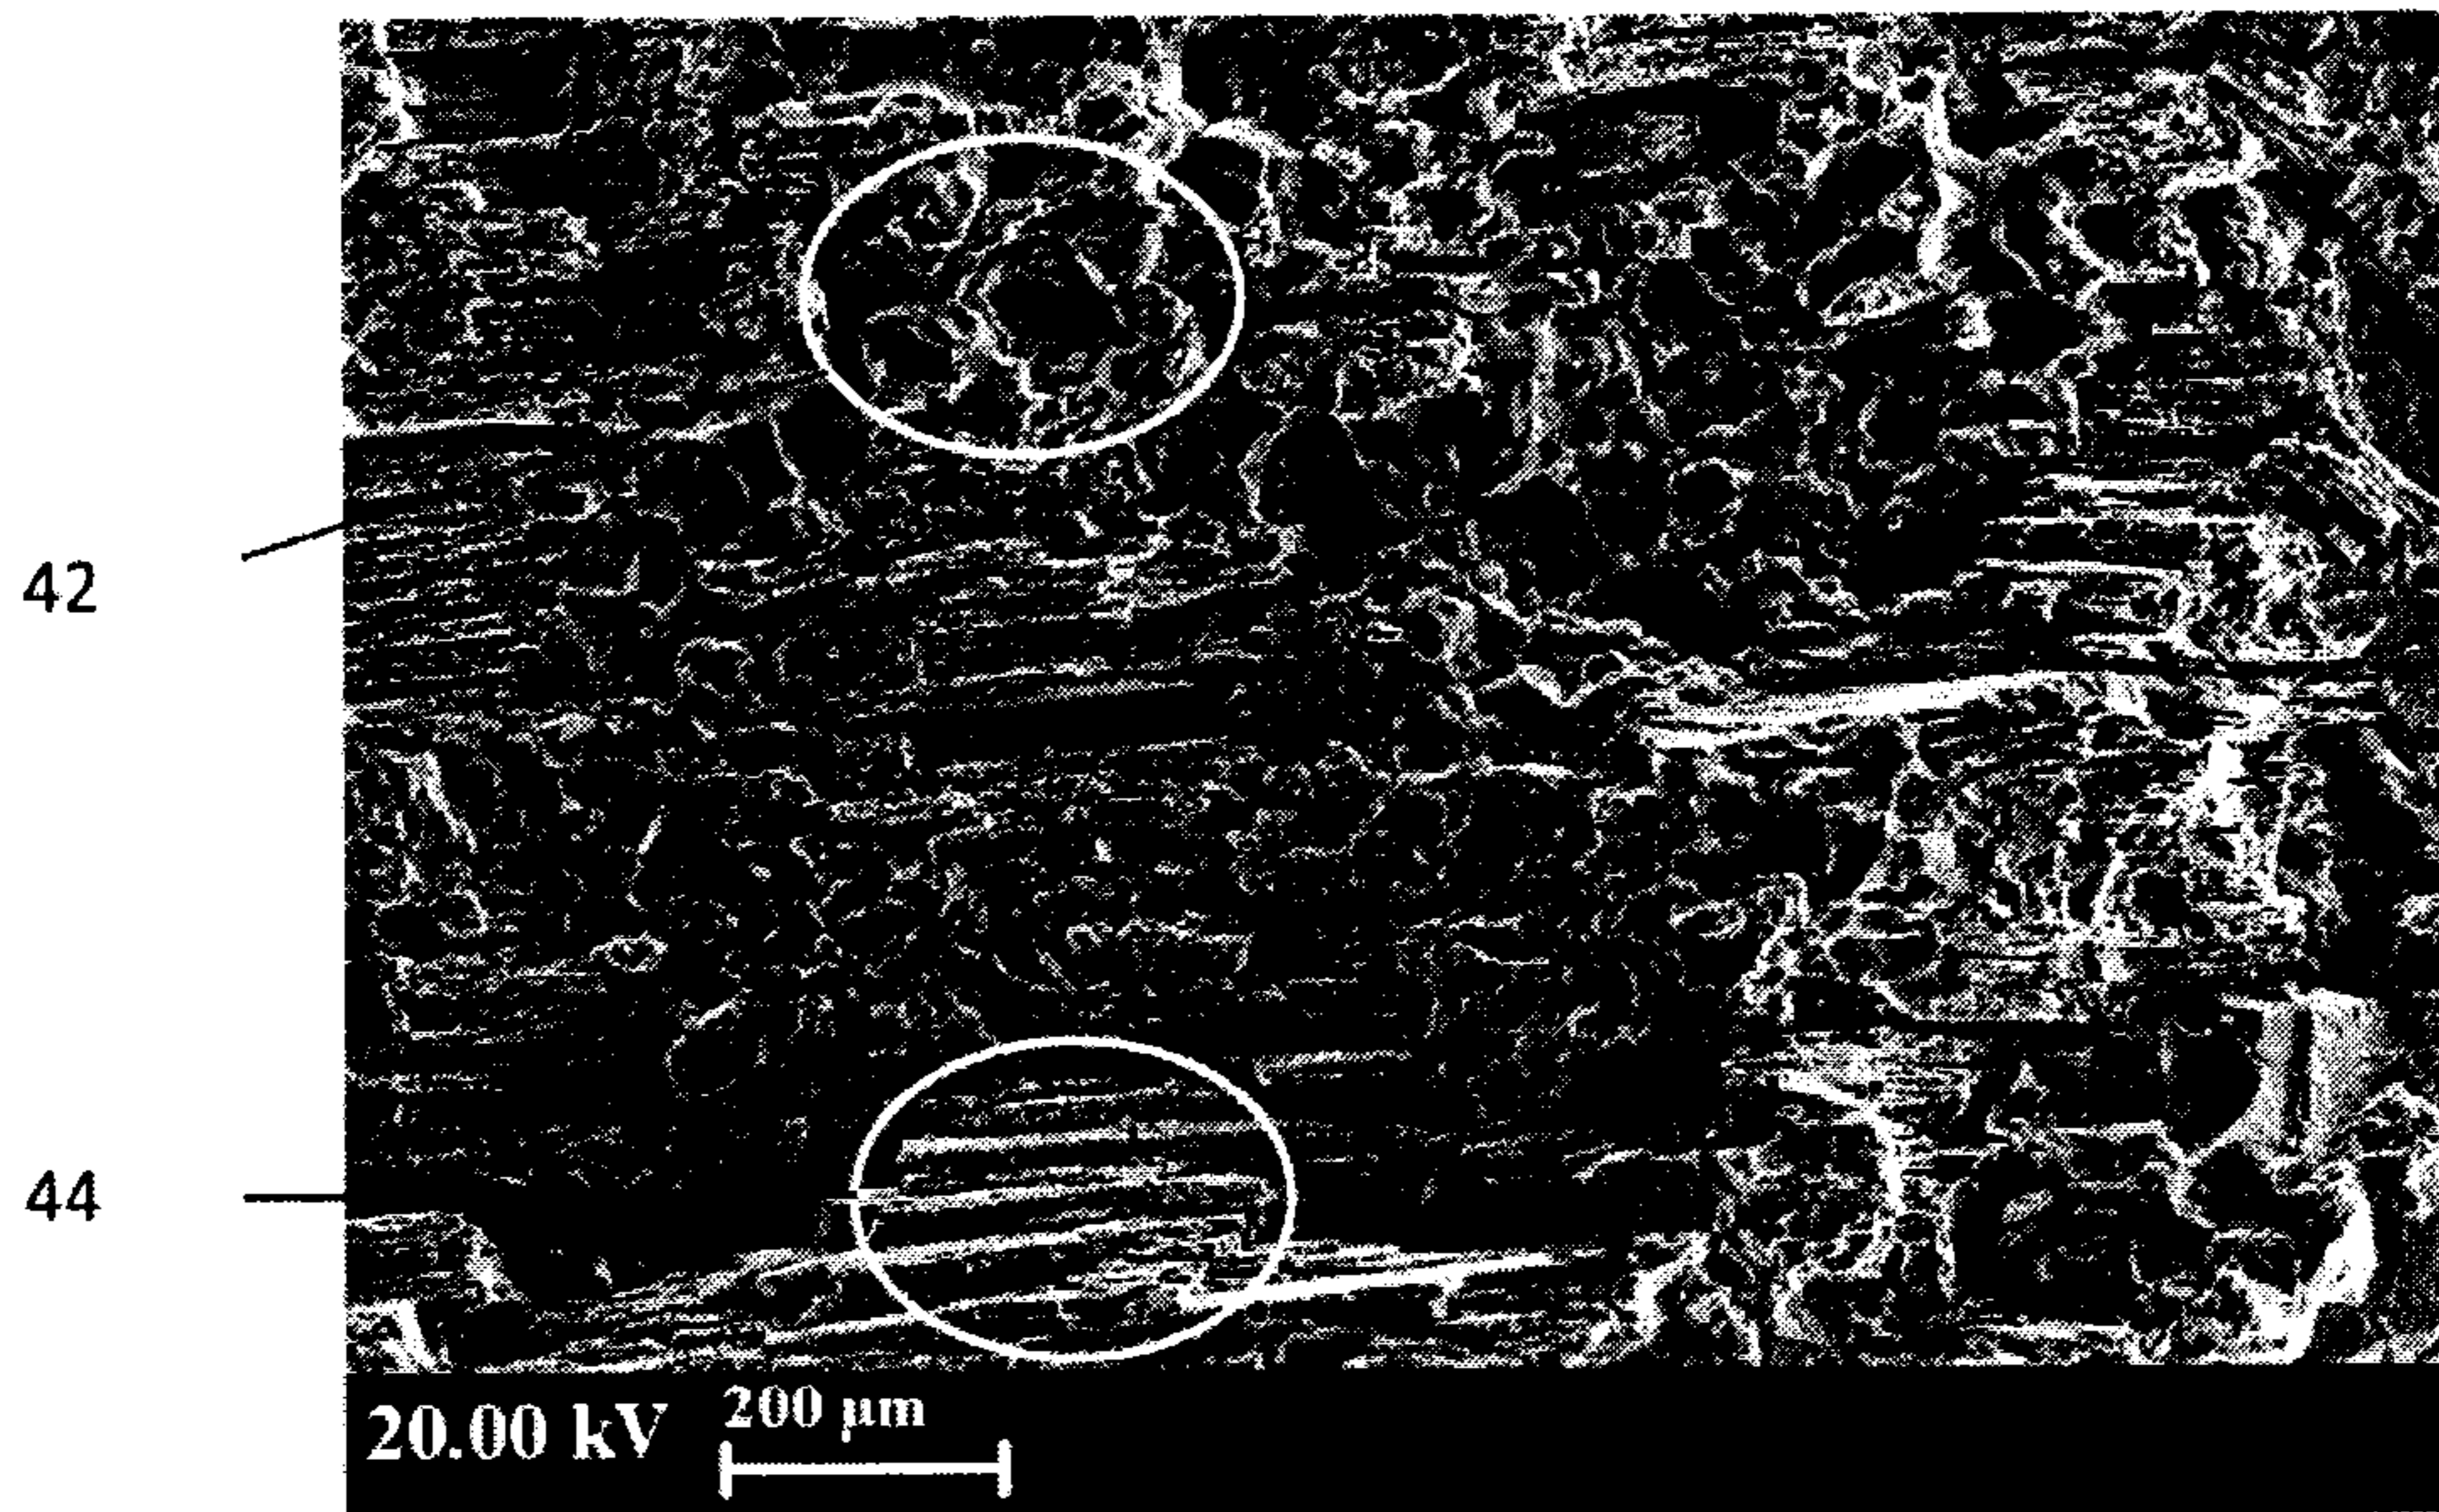
Fig. 8

FIG. 8 is a partial SEM image of another fracture face of a TiAl blade, and shows equiaxed grains and lamellar grains,

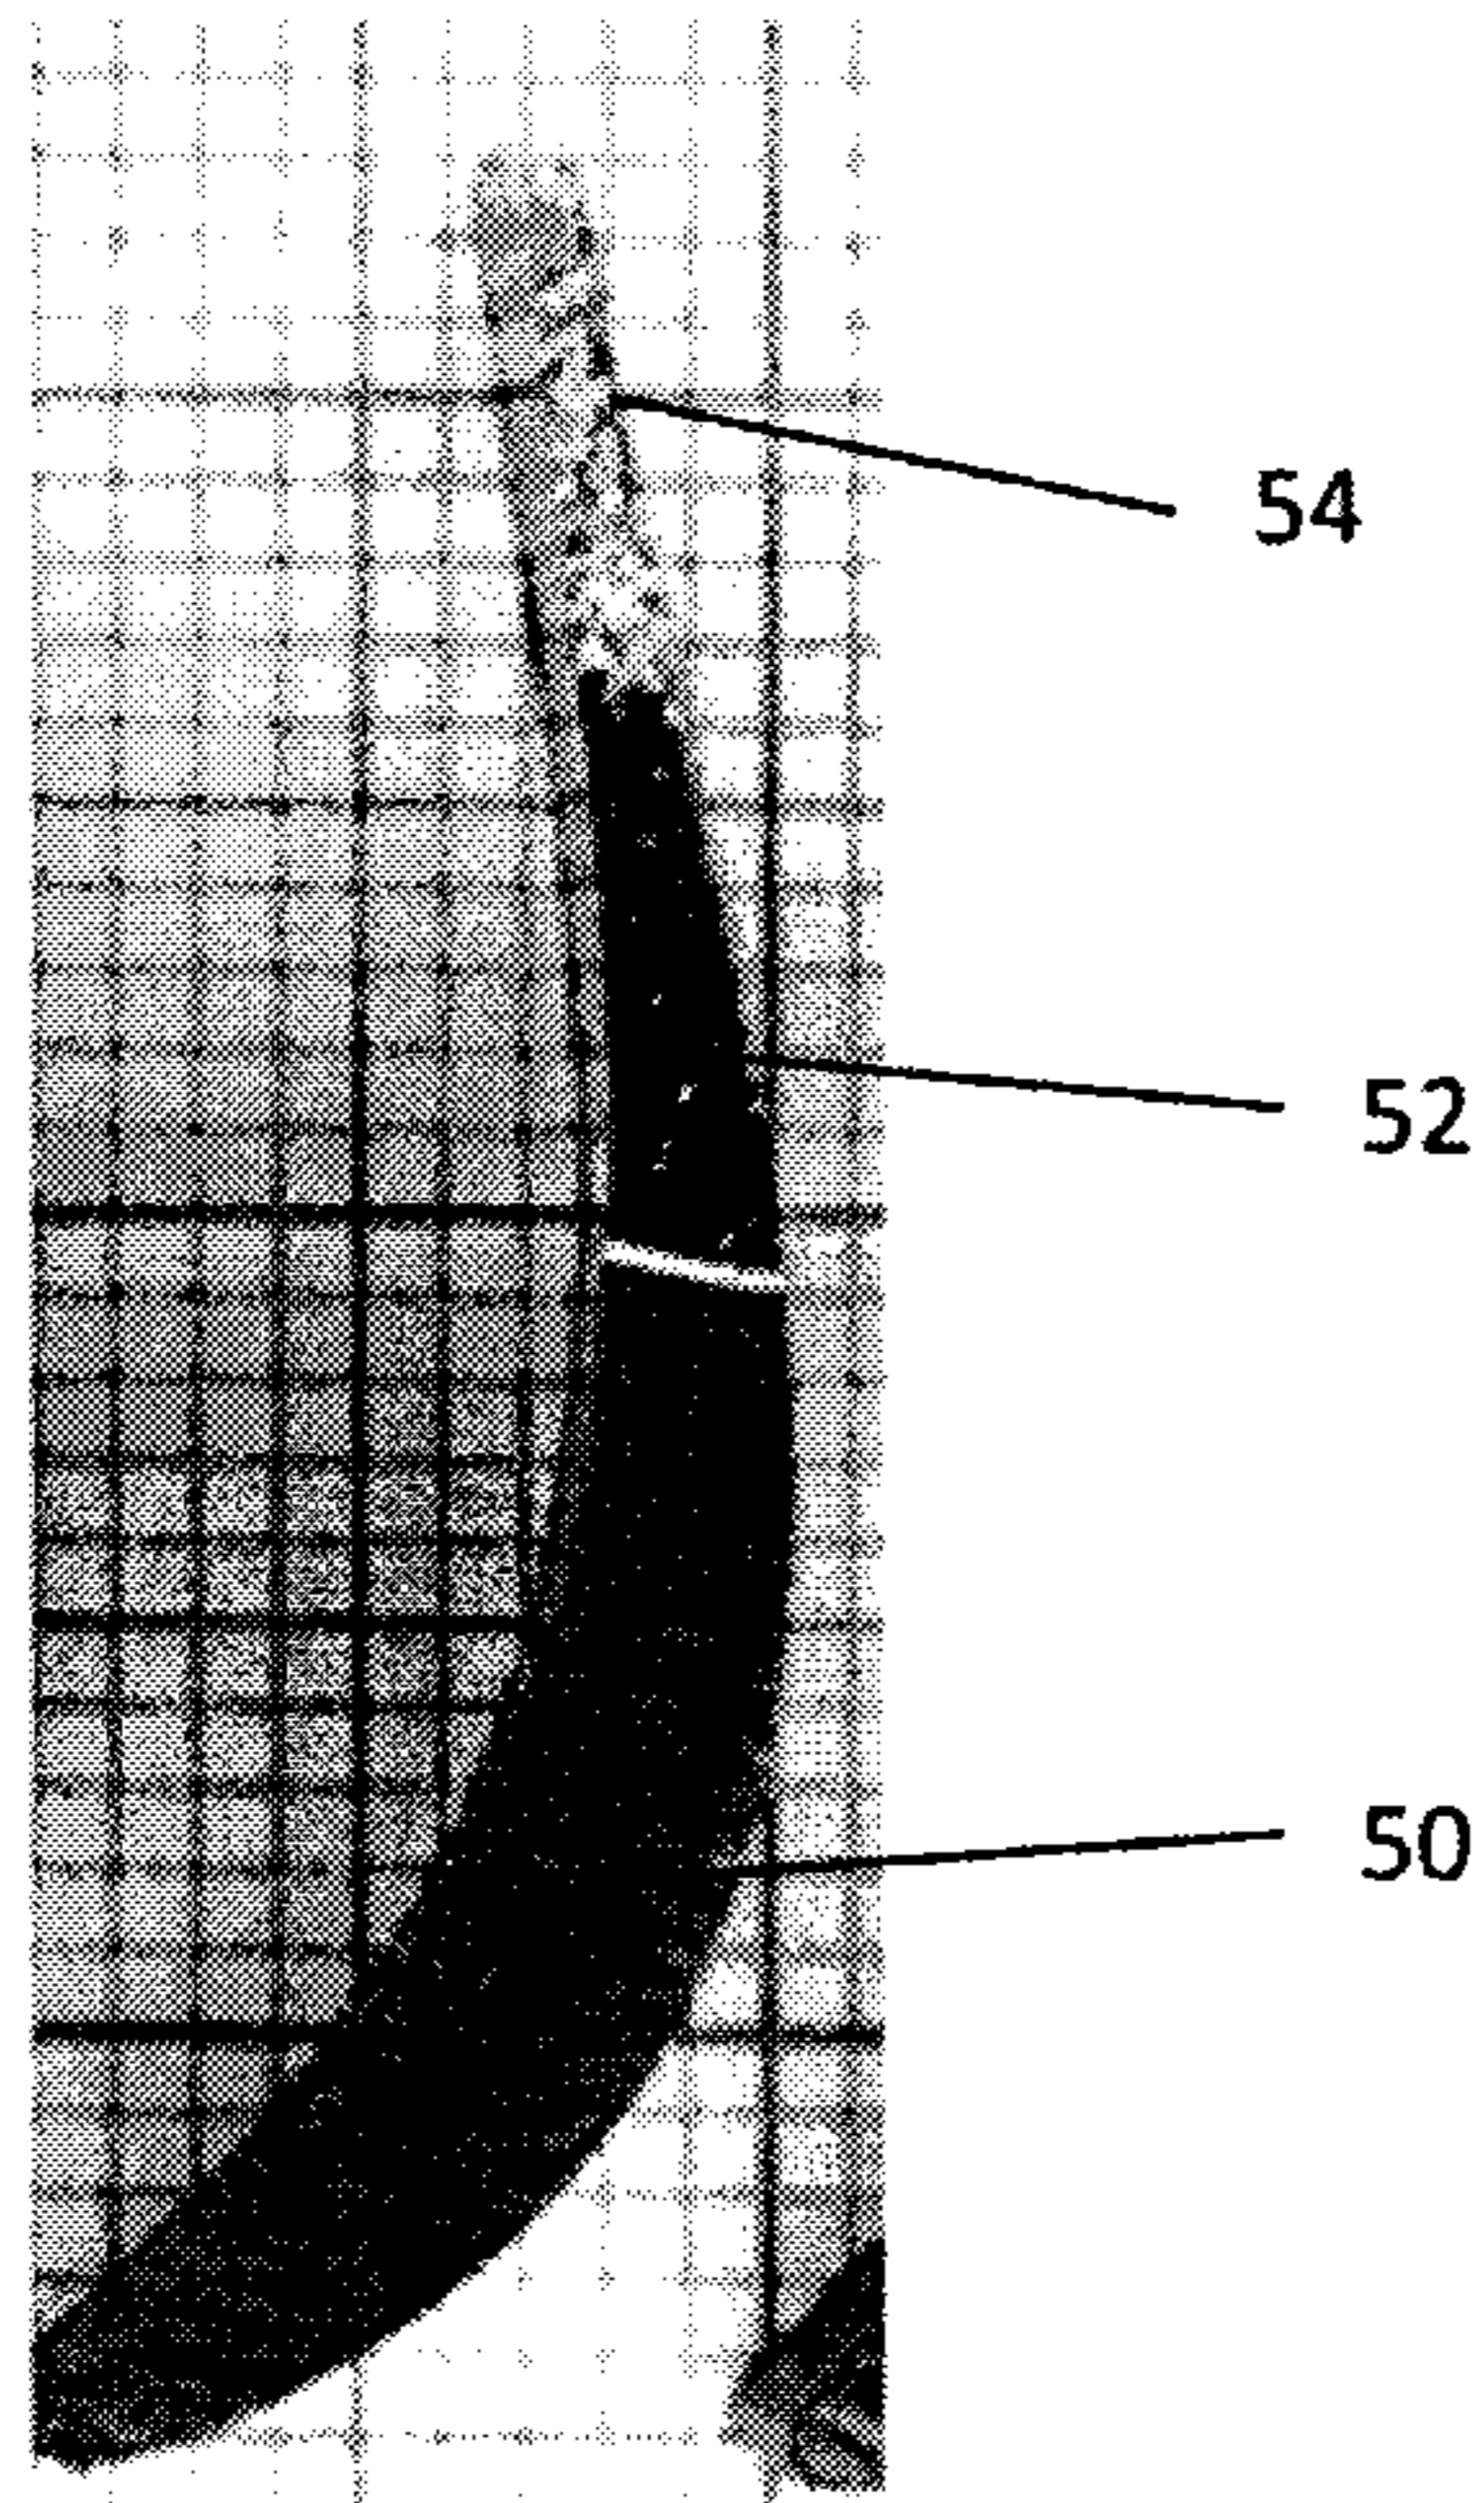
Fig. 9

FIG. 9 is a video image of the face of a TiAl blade which has been subjected to an oxidising heat treatment,
