US009816905B2

(54) **METHOD FOR ANALYSING A FRACTURE  
FACE OF A PART OF A TURBINE ENGINE**

## METHOD FOR ANALYSING A FRACTURE FACE OF A PART OF A TURBINE ENGINE

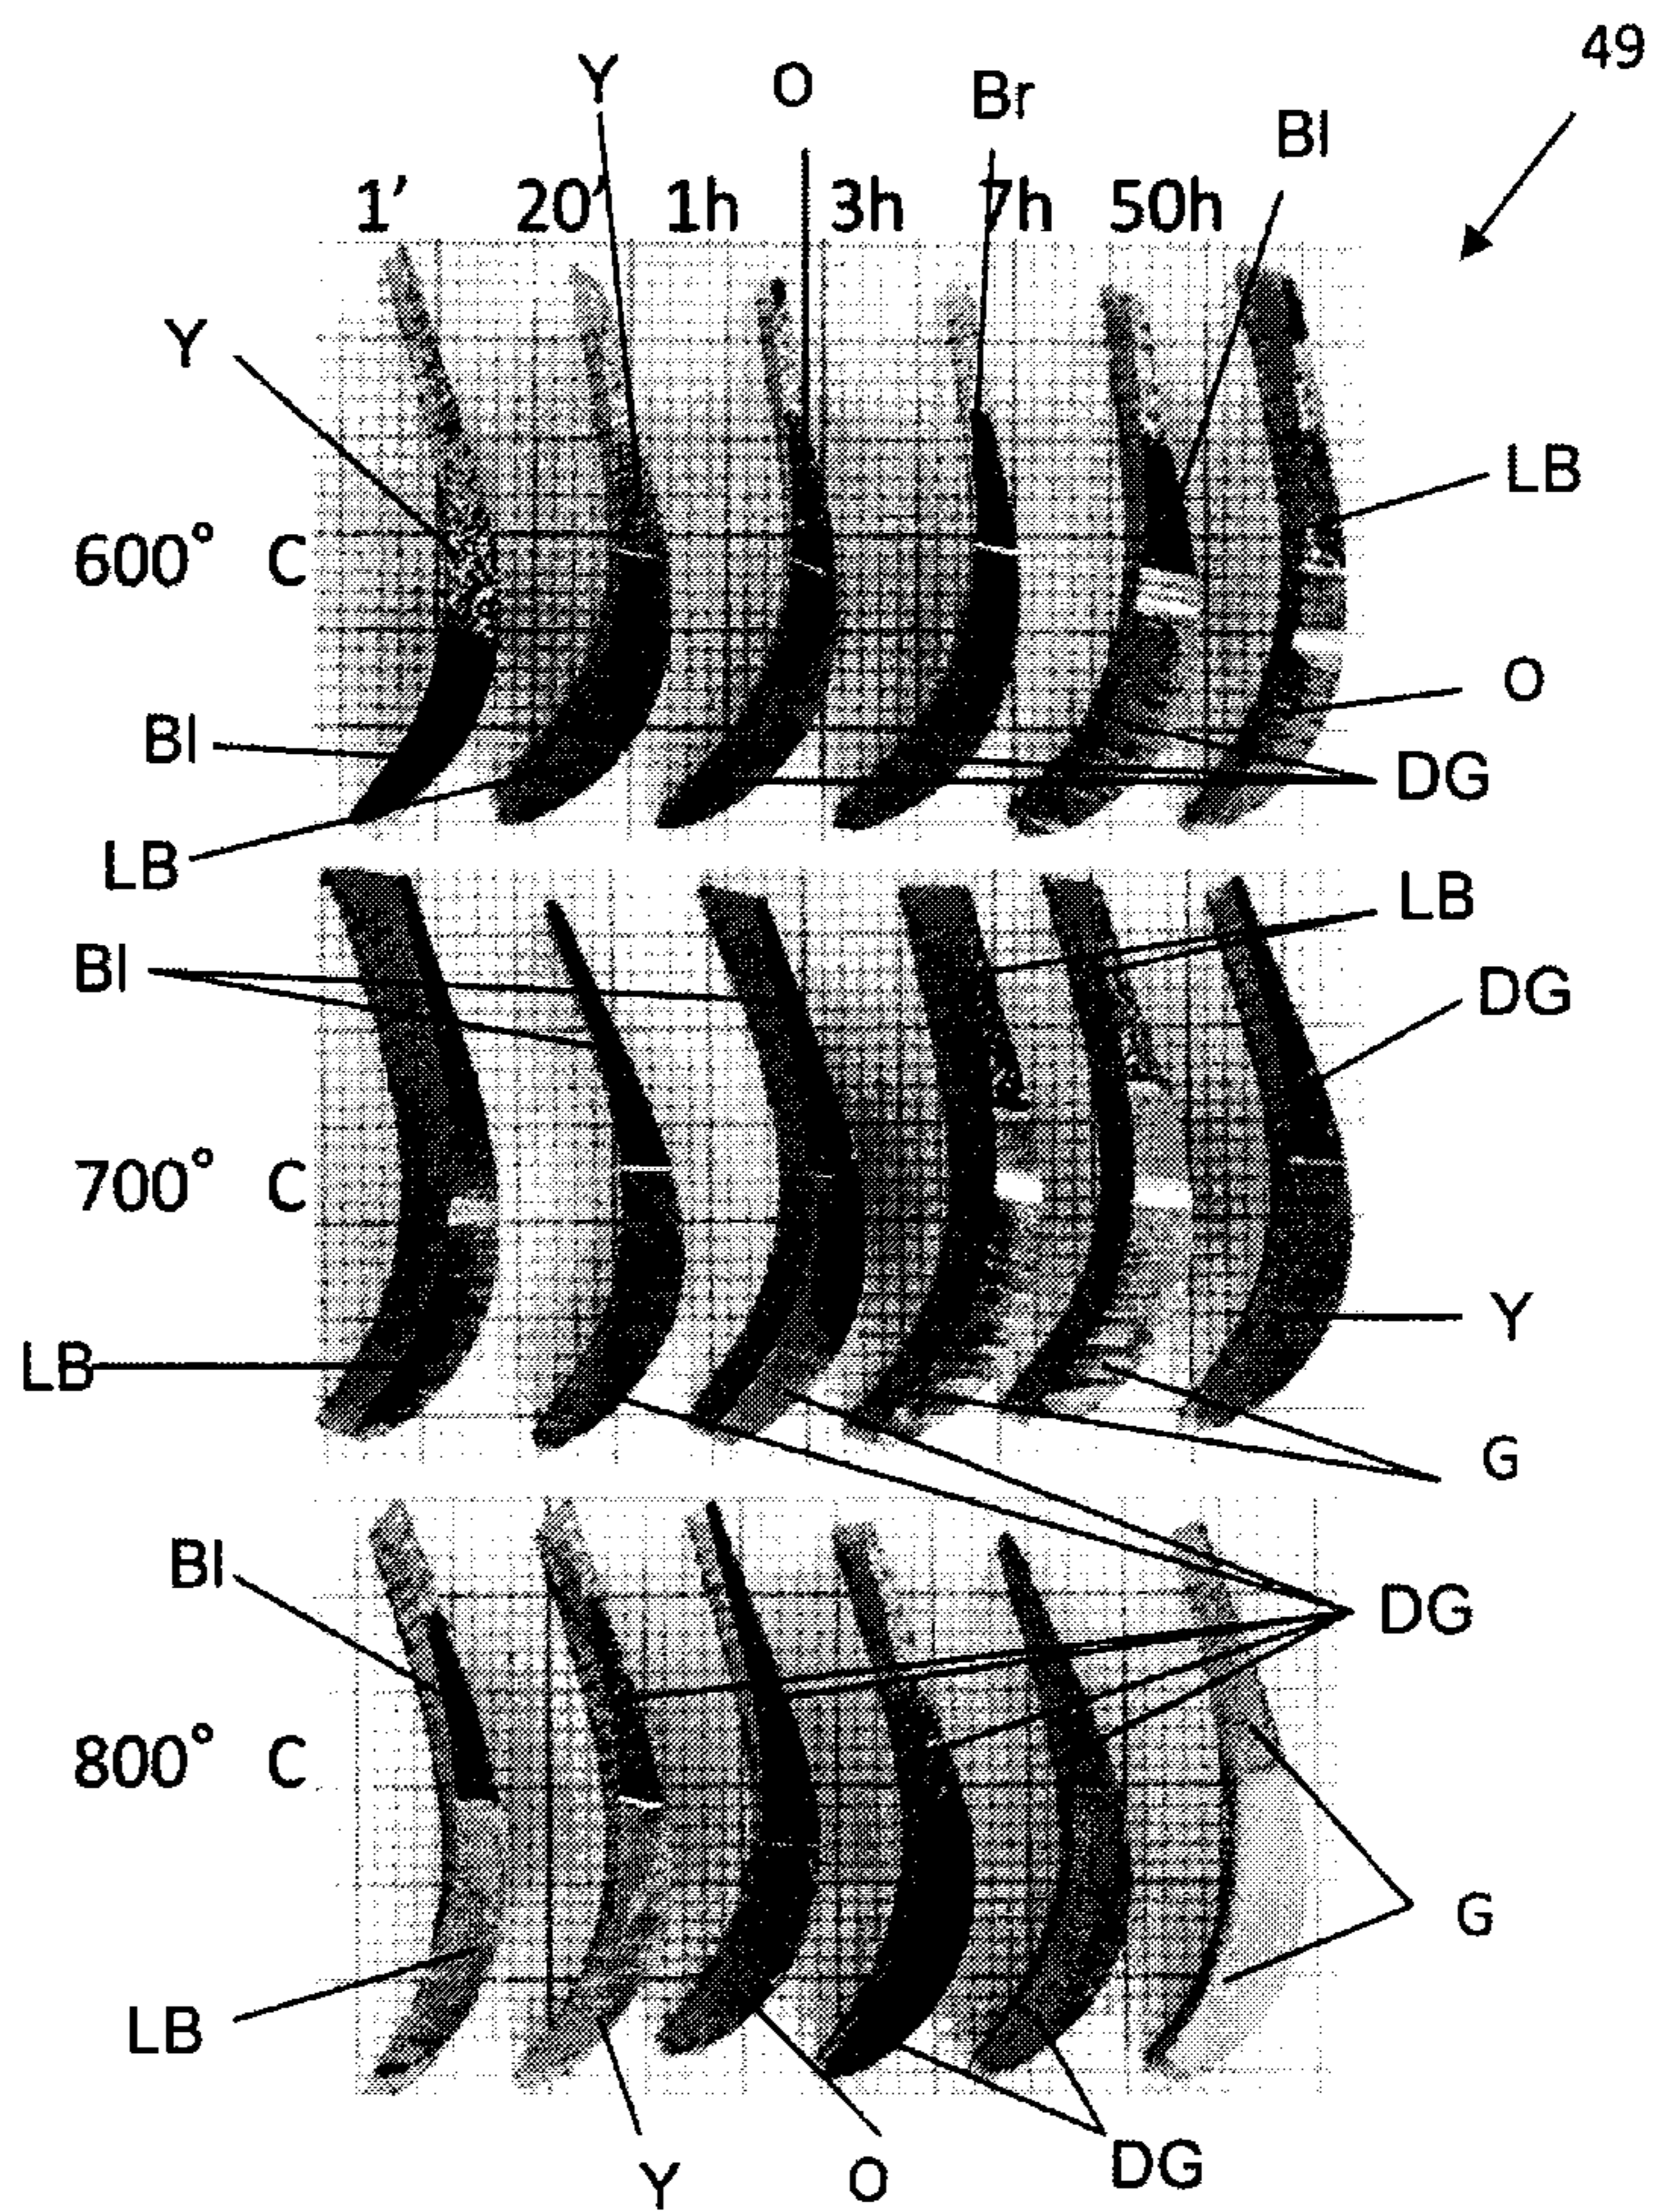
Fig. 10

FIG. 10 is a video image of a heat tint colour chart,
