(12) **United States Patent**
Colladon

(10) **Patent No.:** **US 9,816,905 B2**
(45) **Date of Patent:** **Nov. 14, 2017**

(54) **METHOD FOR ANALYSING A FRACTURE
FACE OF A PART OF A TURBINE ENGINE**

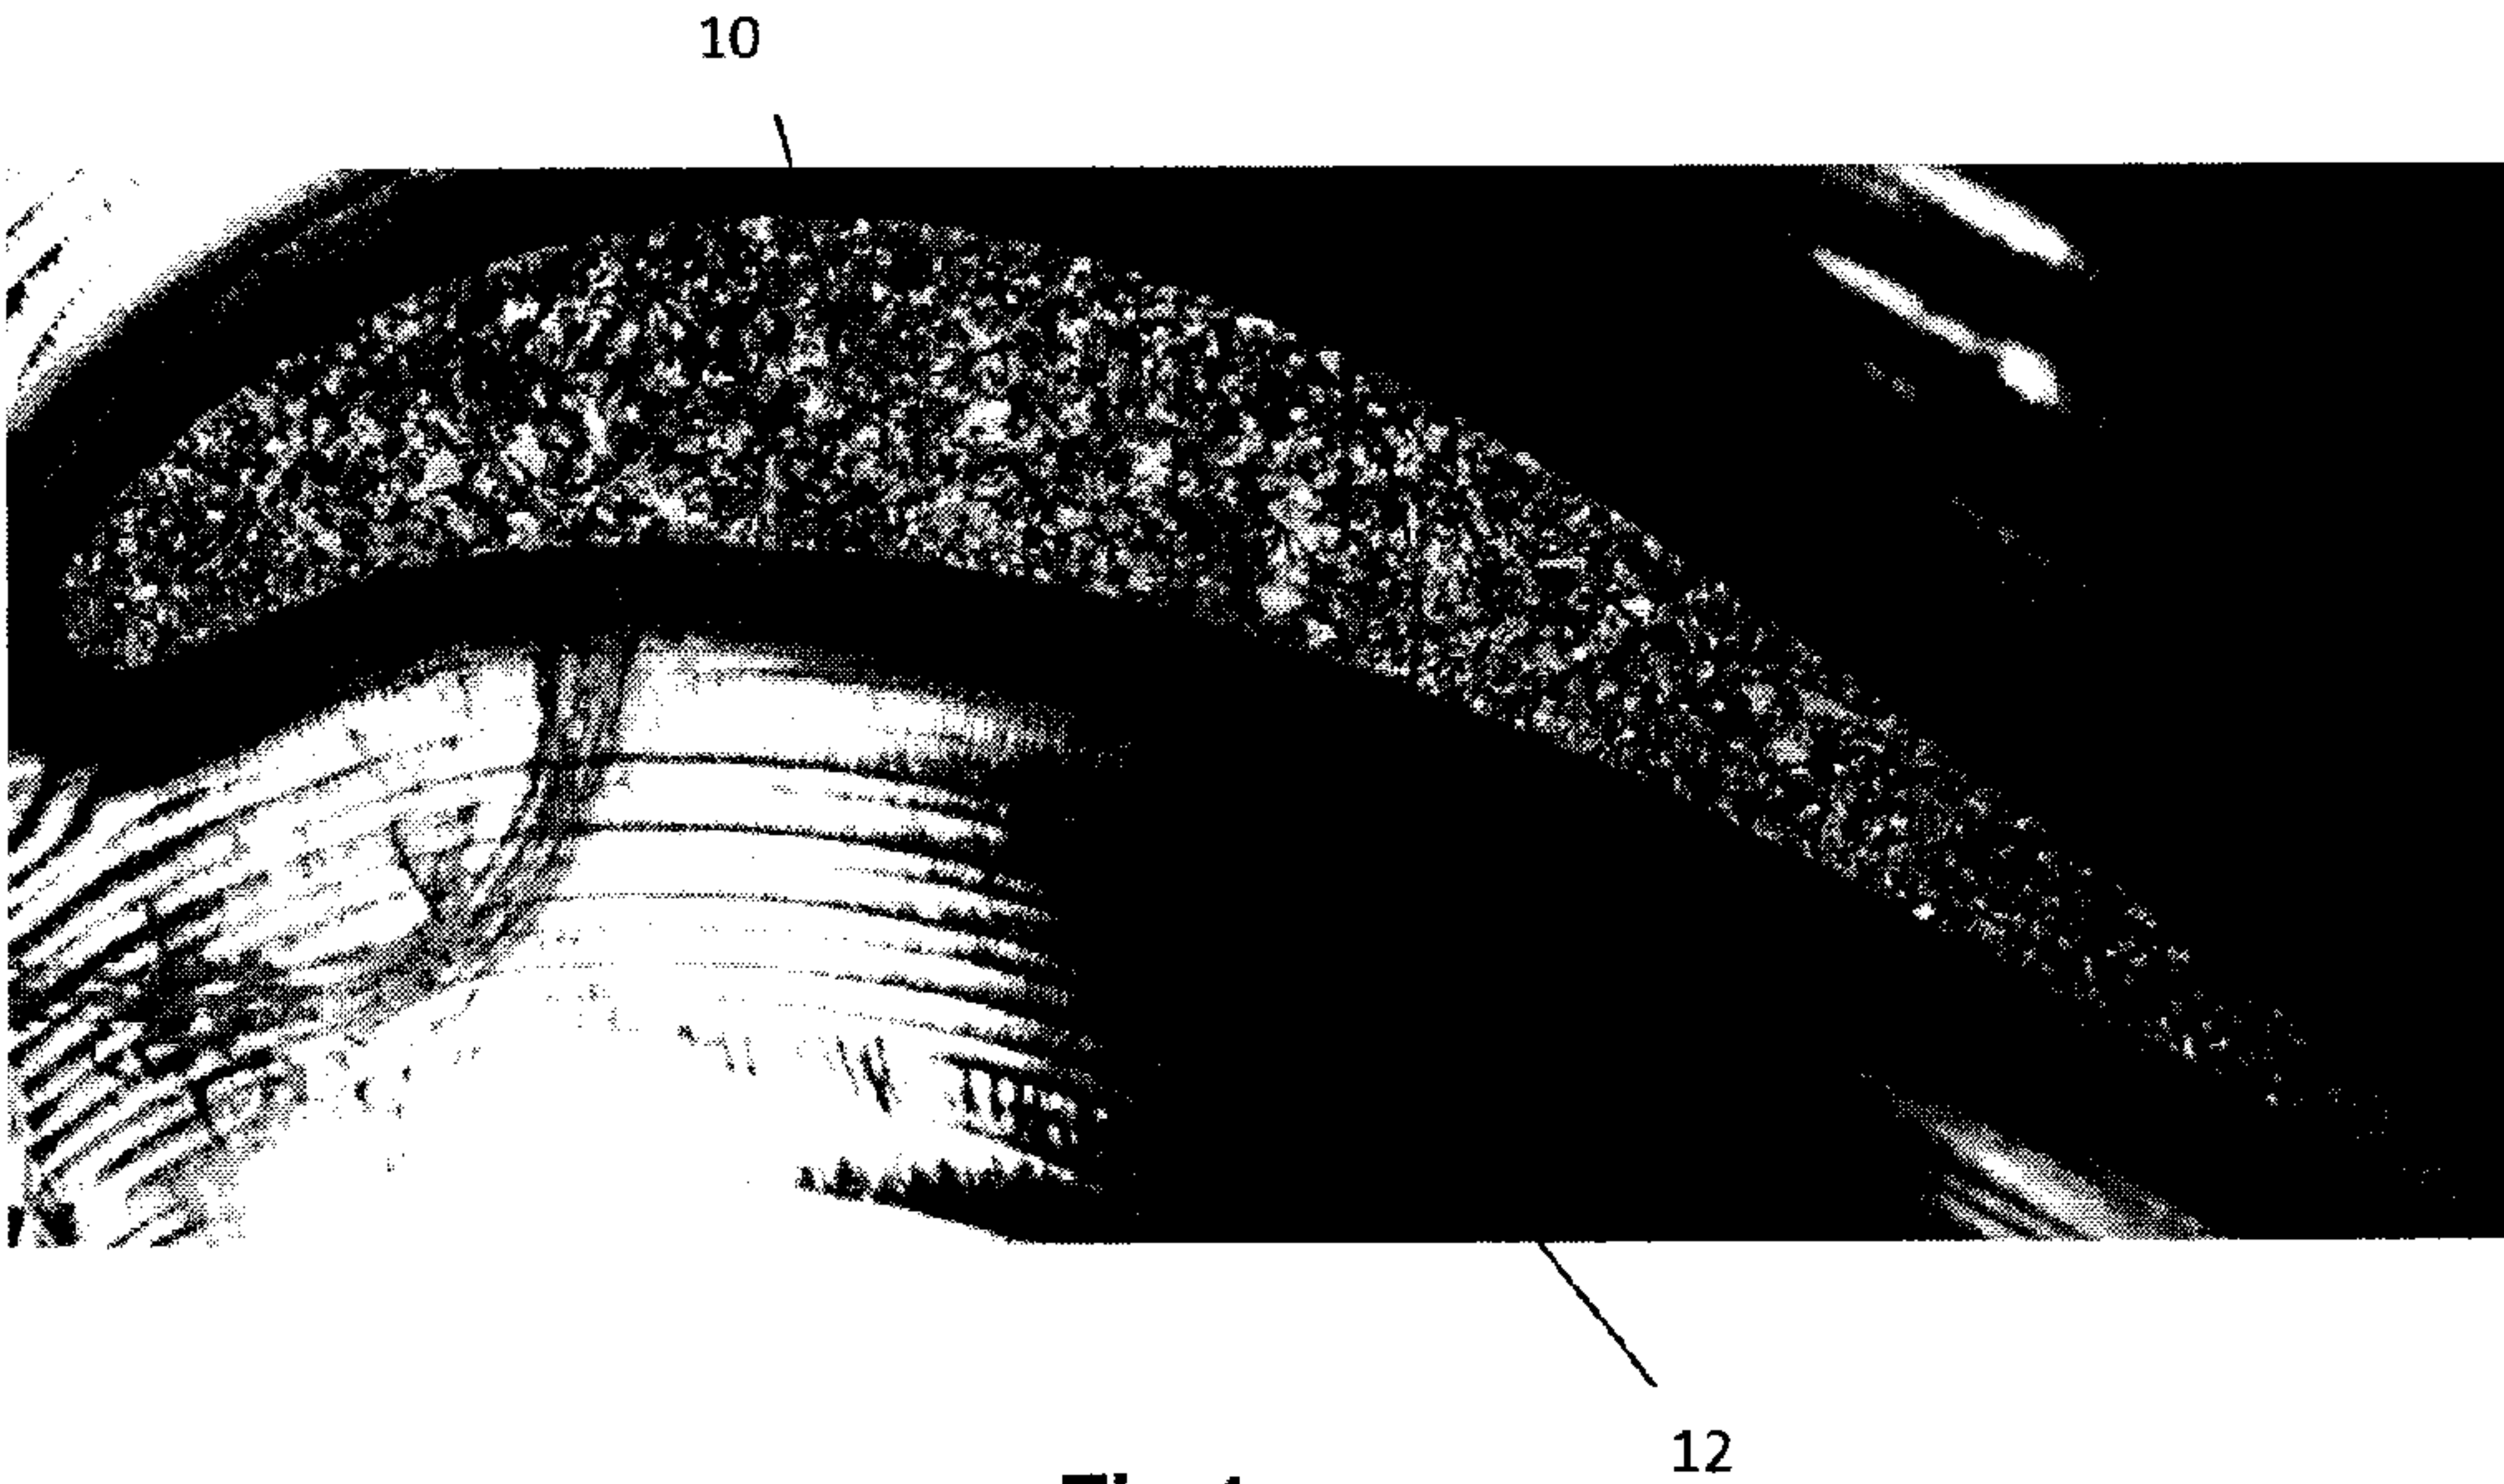
Fig.1

FIG. 1 is a binocular loupe image of a fracture face of a TiAl turbine engine blade,

Reference is firstly made to FIG. 1, which is a binocular loupe image of a fracture face 10 of a TiAl blade 12 of a turbine engine turbine. The fracture face 10 extends in a plane which in this case is transverse to the leaf of the blade.

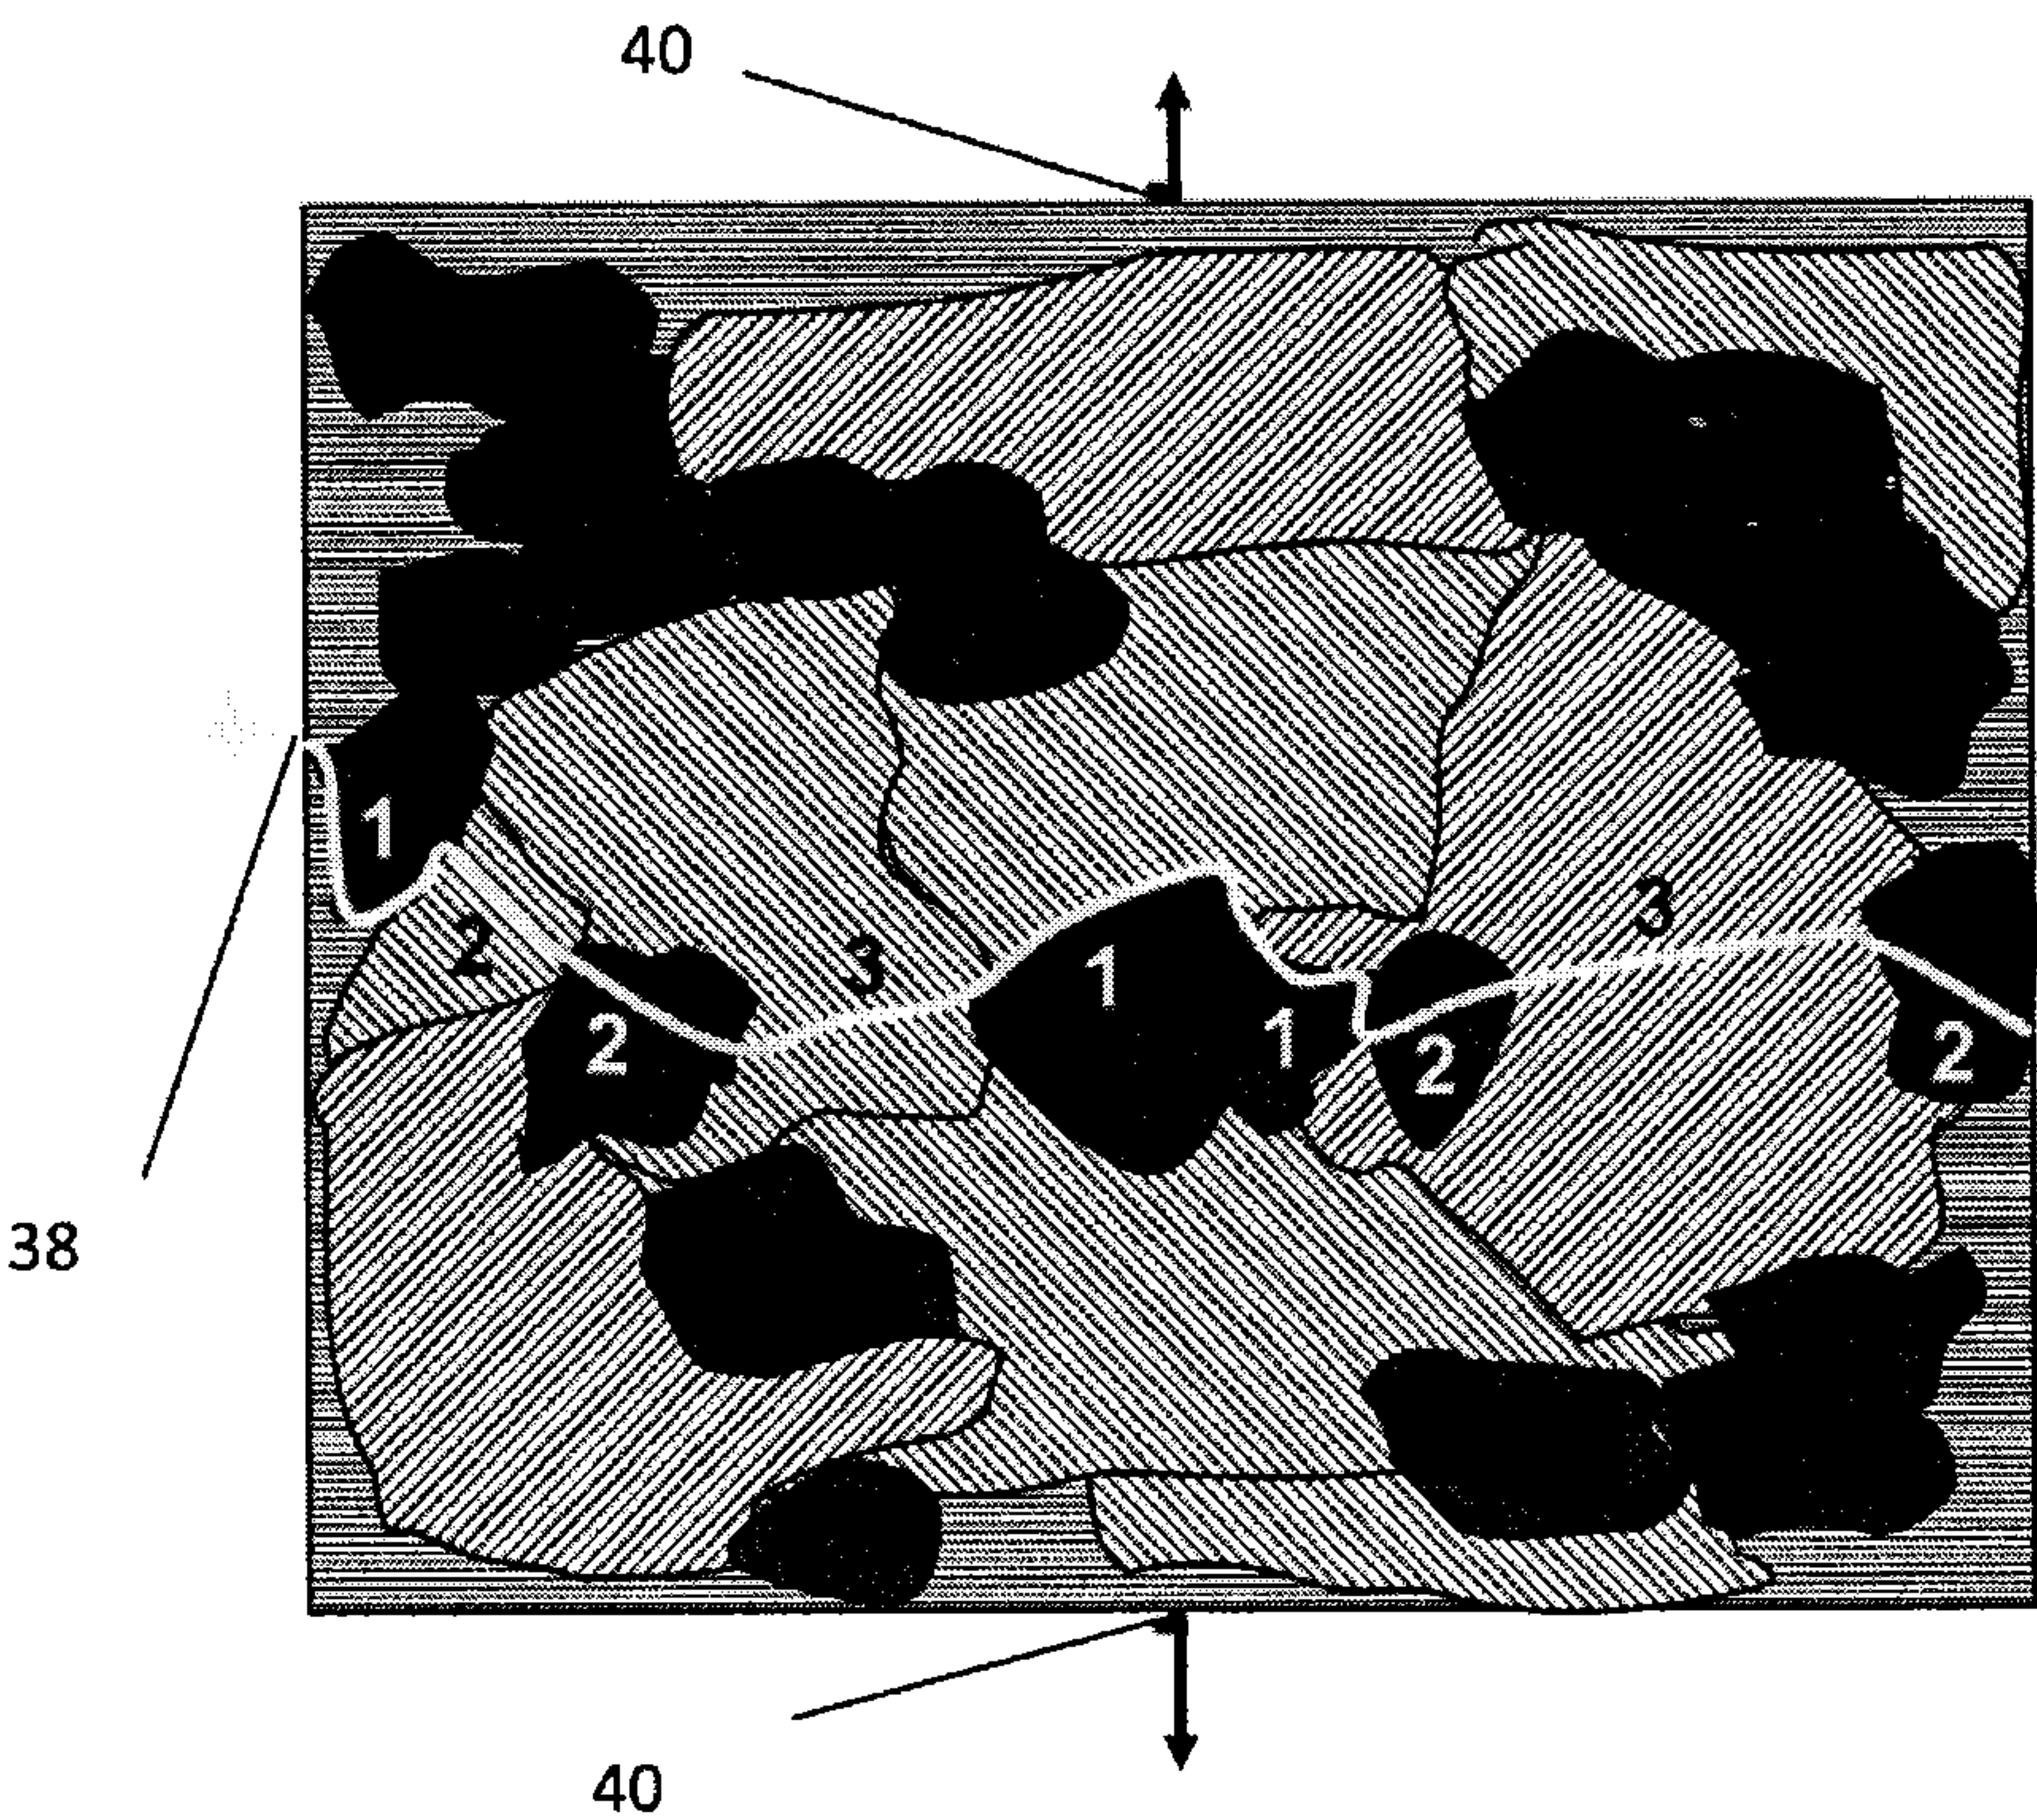
Fig. 7

FIG. 7 is a very schematic sectional view of a TiAl part, and shows the progression of a crack through granular regions of the part,

FIG. 7 is a very schematic sectional view of a TiAl part in which a crack has propagated, the progression of which is indicated by reference numeral 38. Said crack was generated by a pulling experiment (arrows 40) in the sectional plane of the drawing. In this schematic drawing, each region delimited by a continuous line defines a region in which a particular type of grain is present. The grey regions comprise equiaxed grains γ and the cross-hatched regions comprise lamellar grains $\gamma+\alpha_2$. The part thus has a duplex microstructure. In addition, the number “1” indicates that the crack has passed around the lamellar grains, which manifests as the presence of intergranular patterns in the surface of the crack face, the number “2” indicates that the crack passes through equiaxed or lamellar grains, which manifests as the presence of cleavage patterns in the surface of the face (the crack propagates in parallel with the lamellae in the case of the lamellar grains), and the number “3” indicates that the crack passes through lamellar grains in a direction which is not in parallel with the lamellae. The propagation of the crack through equiaxed or lamellar grains (reference numerals 2 and 3) leads to the appearance of cleavage facets on the fracture face. The same results are obtained when the part is subjected to a vibratory fatigue experiment at high frequency (HCF) or to an oligocyclic fatigue experiment at low frequency (LCF). Different results were nevertheless obtained according to the temperature of the heat treatment of the part. The equiaxed grains are absent from the fracture surfaces when the part is not exposed to heat. Said grains start to appear above 500° C., and the density thereof increases as the temperature to which the part is exposed increases. A part which is subjected to a heat treatment at 700° C. and is broken at this temperature comprises two to three times more equiaxed grains than a broken part which is subjected to a heat treatment at 500° C. The analysis of the density of equiaxed grains on a fracture or crack face thus also makes it possible to evaluate the temperature experienced by the part.

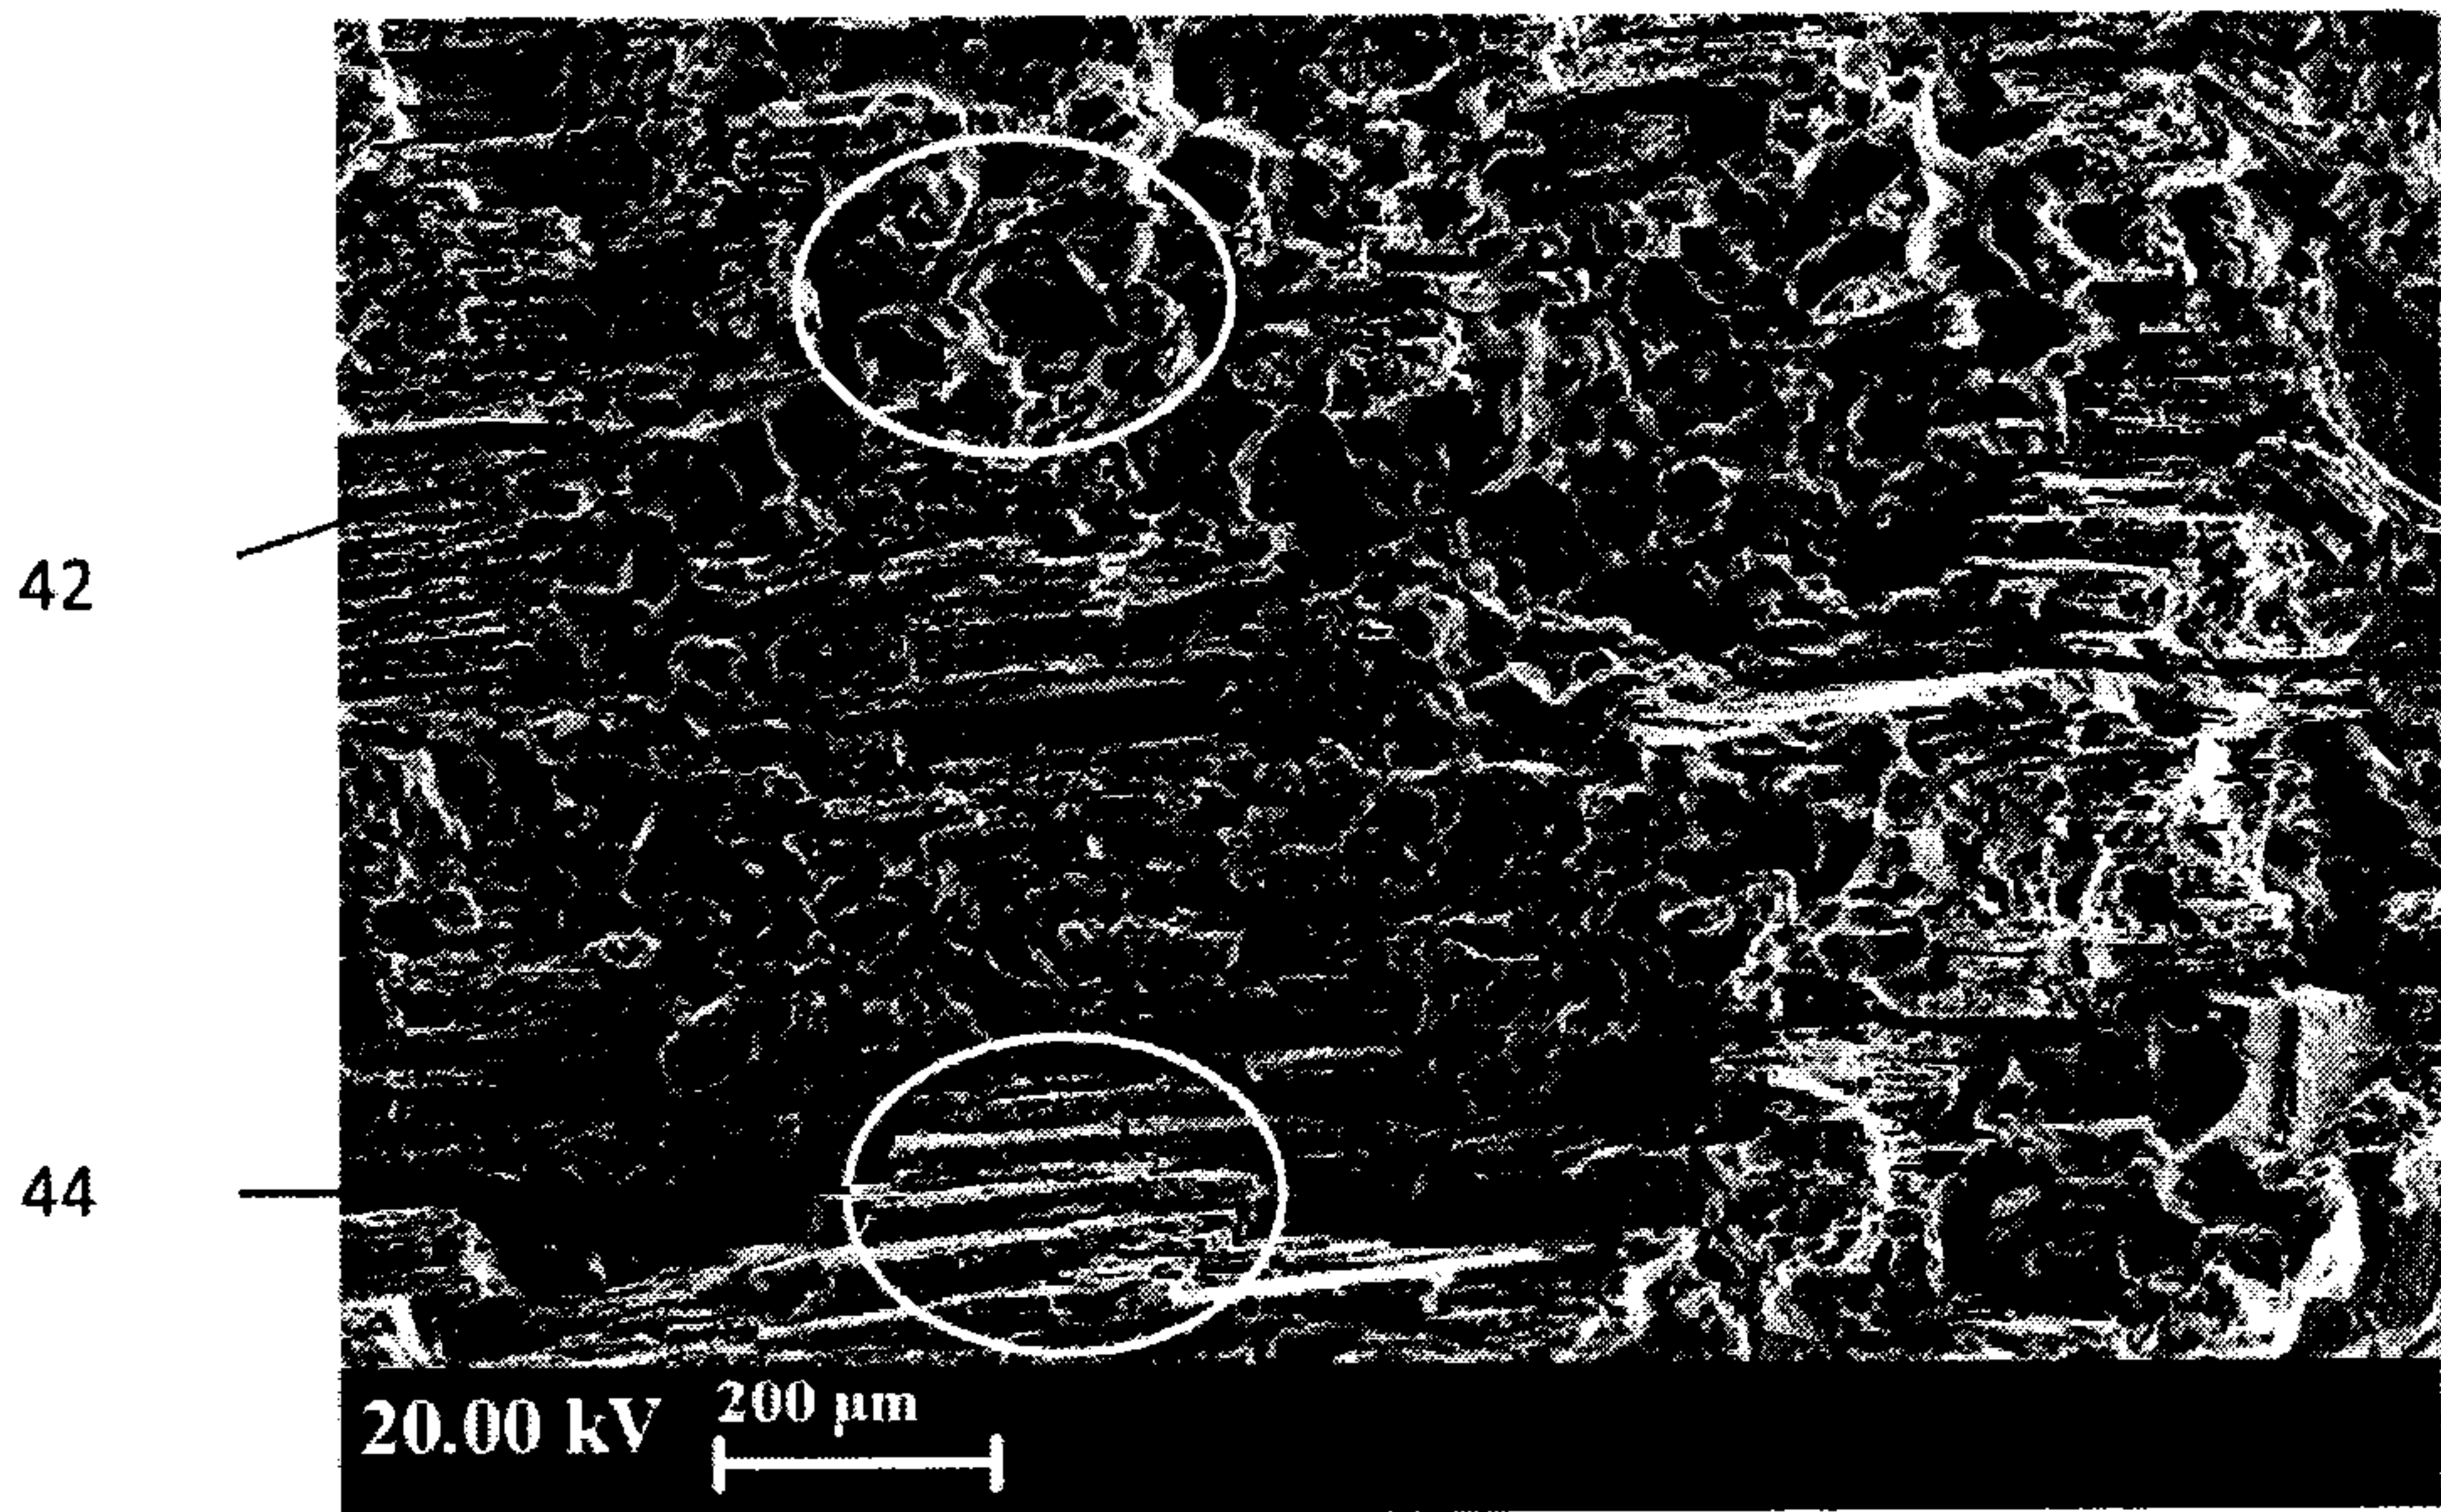
Fig. 8

FIG. 8 is a partial SEM image of another fracture face of a TiAl blade, and shows equiaxed grains and lamellar grains,

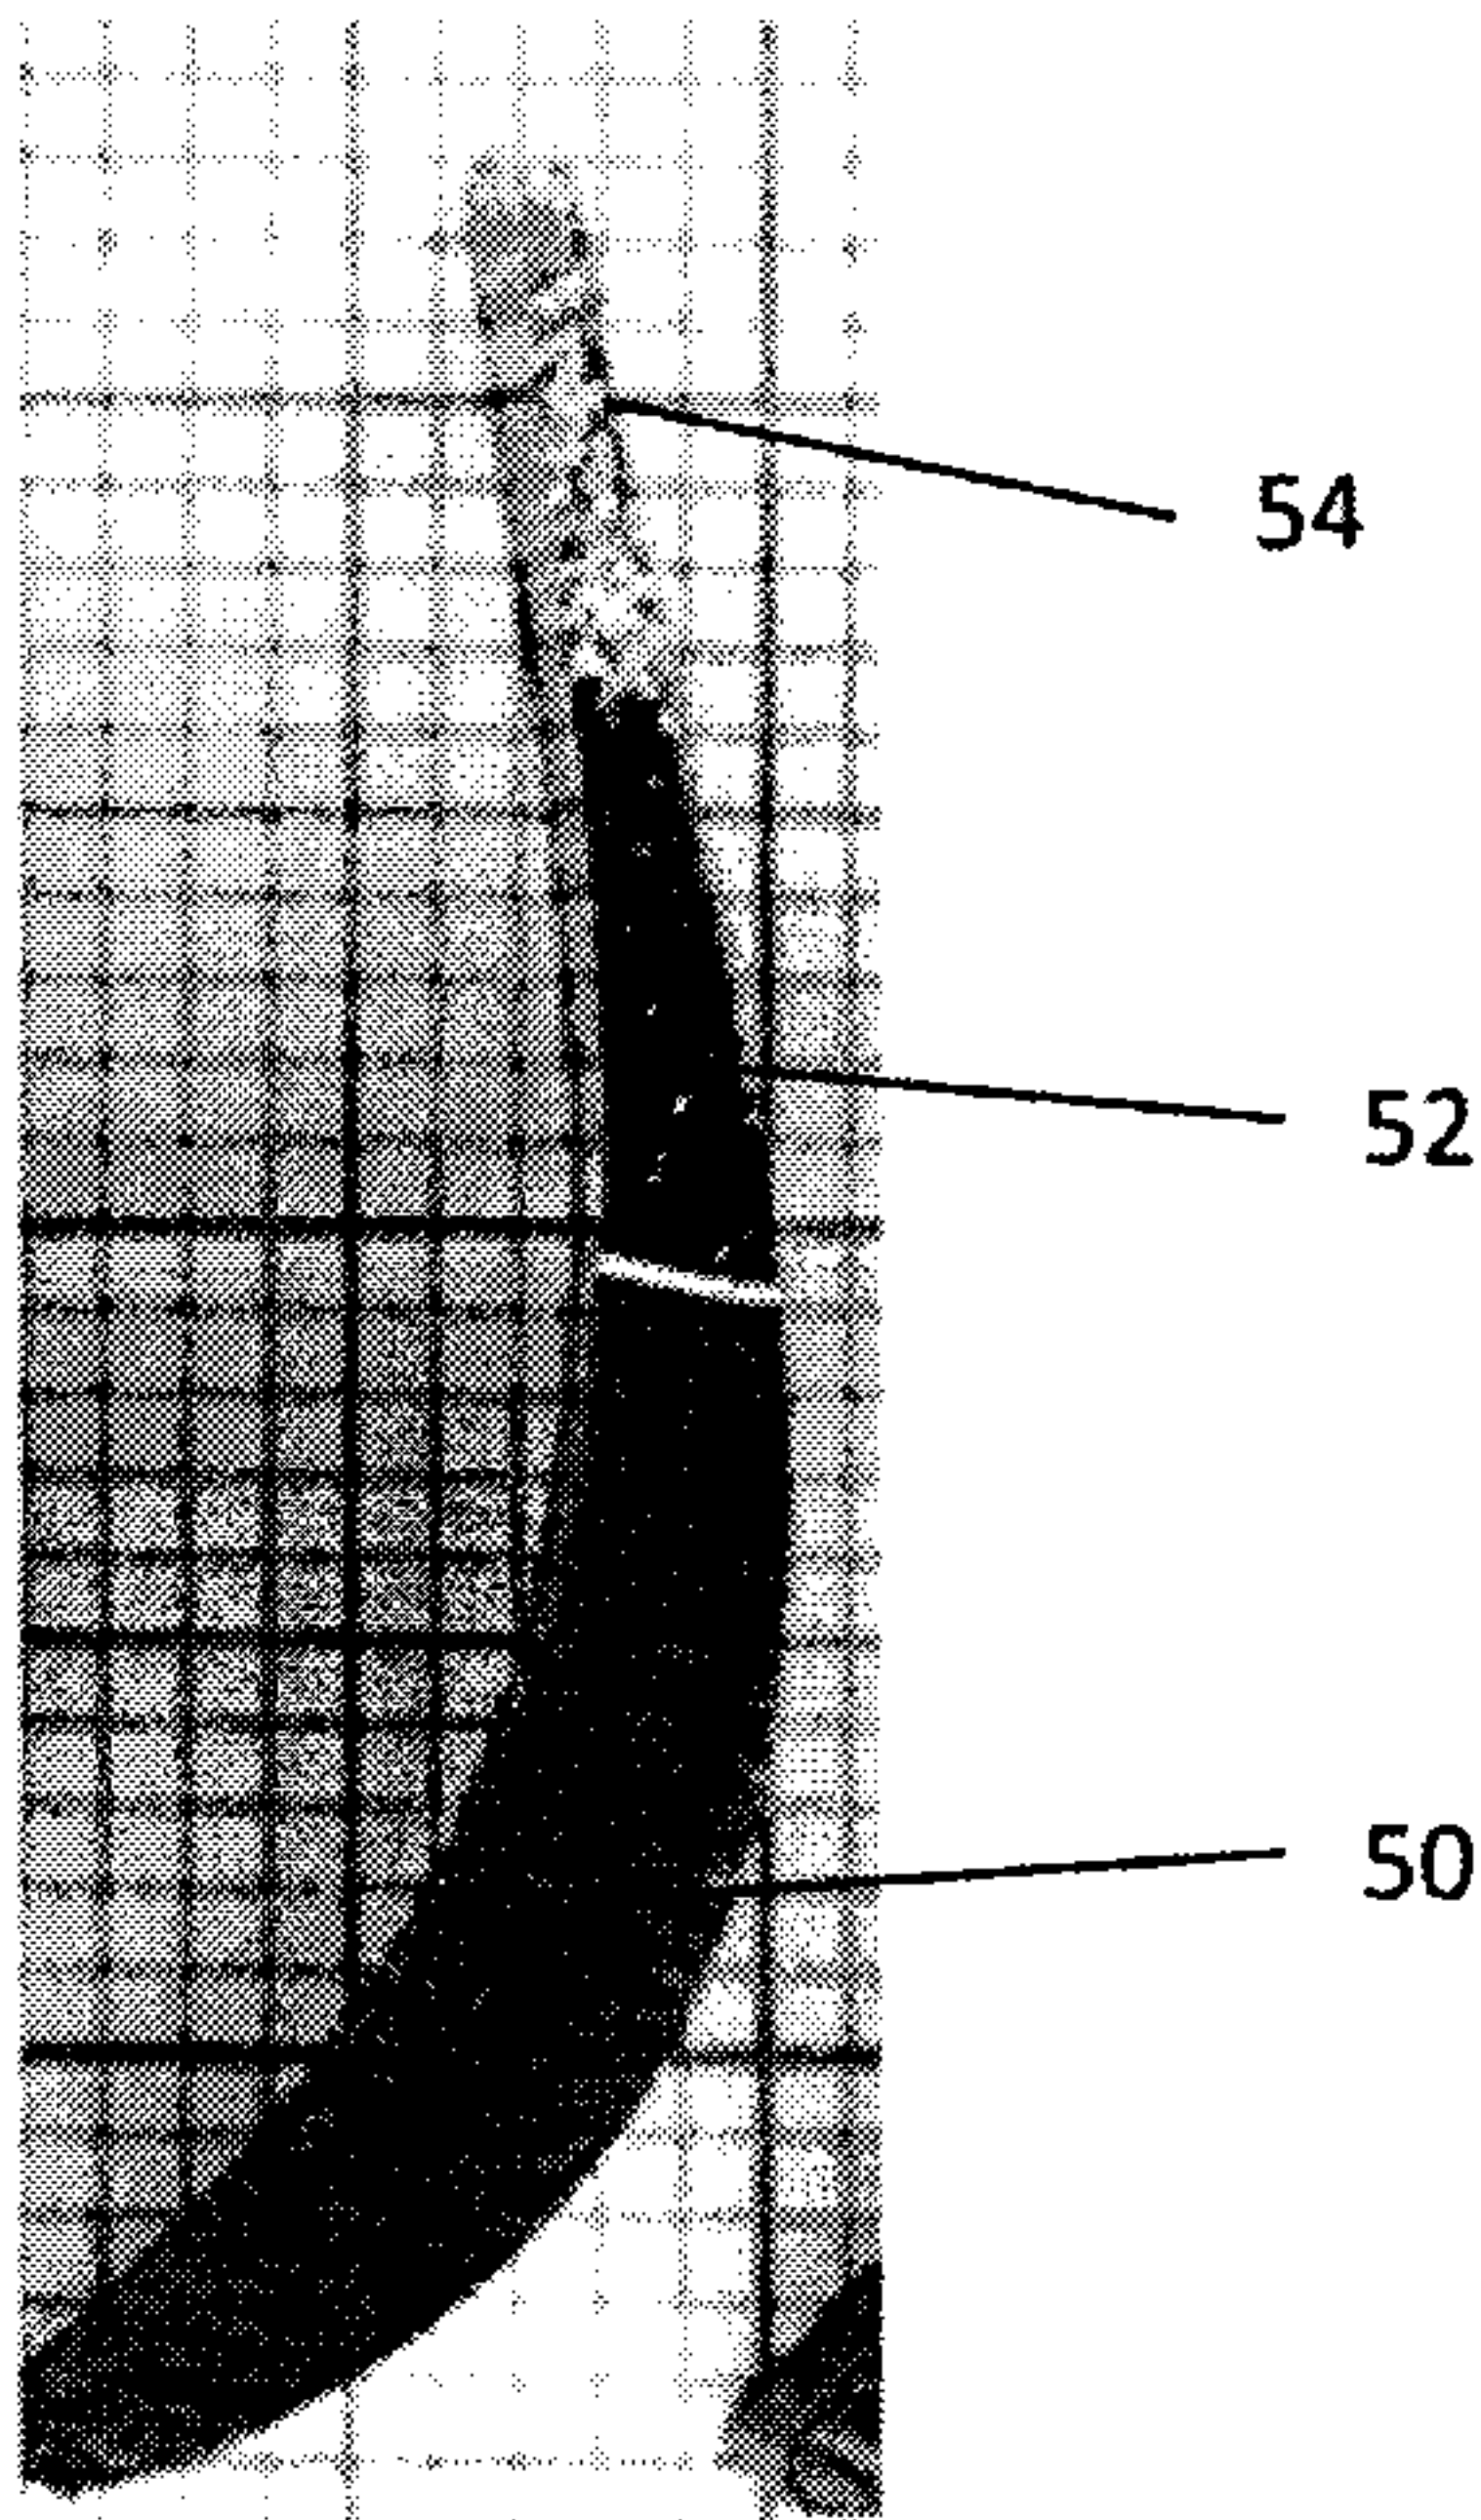
Fig. 10

FIG. 10 is a video image of a heat tint colour chart,

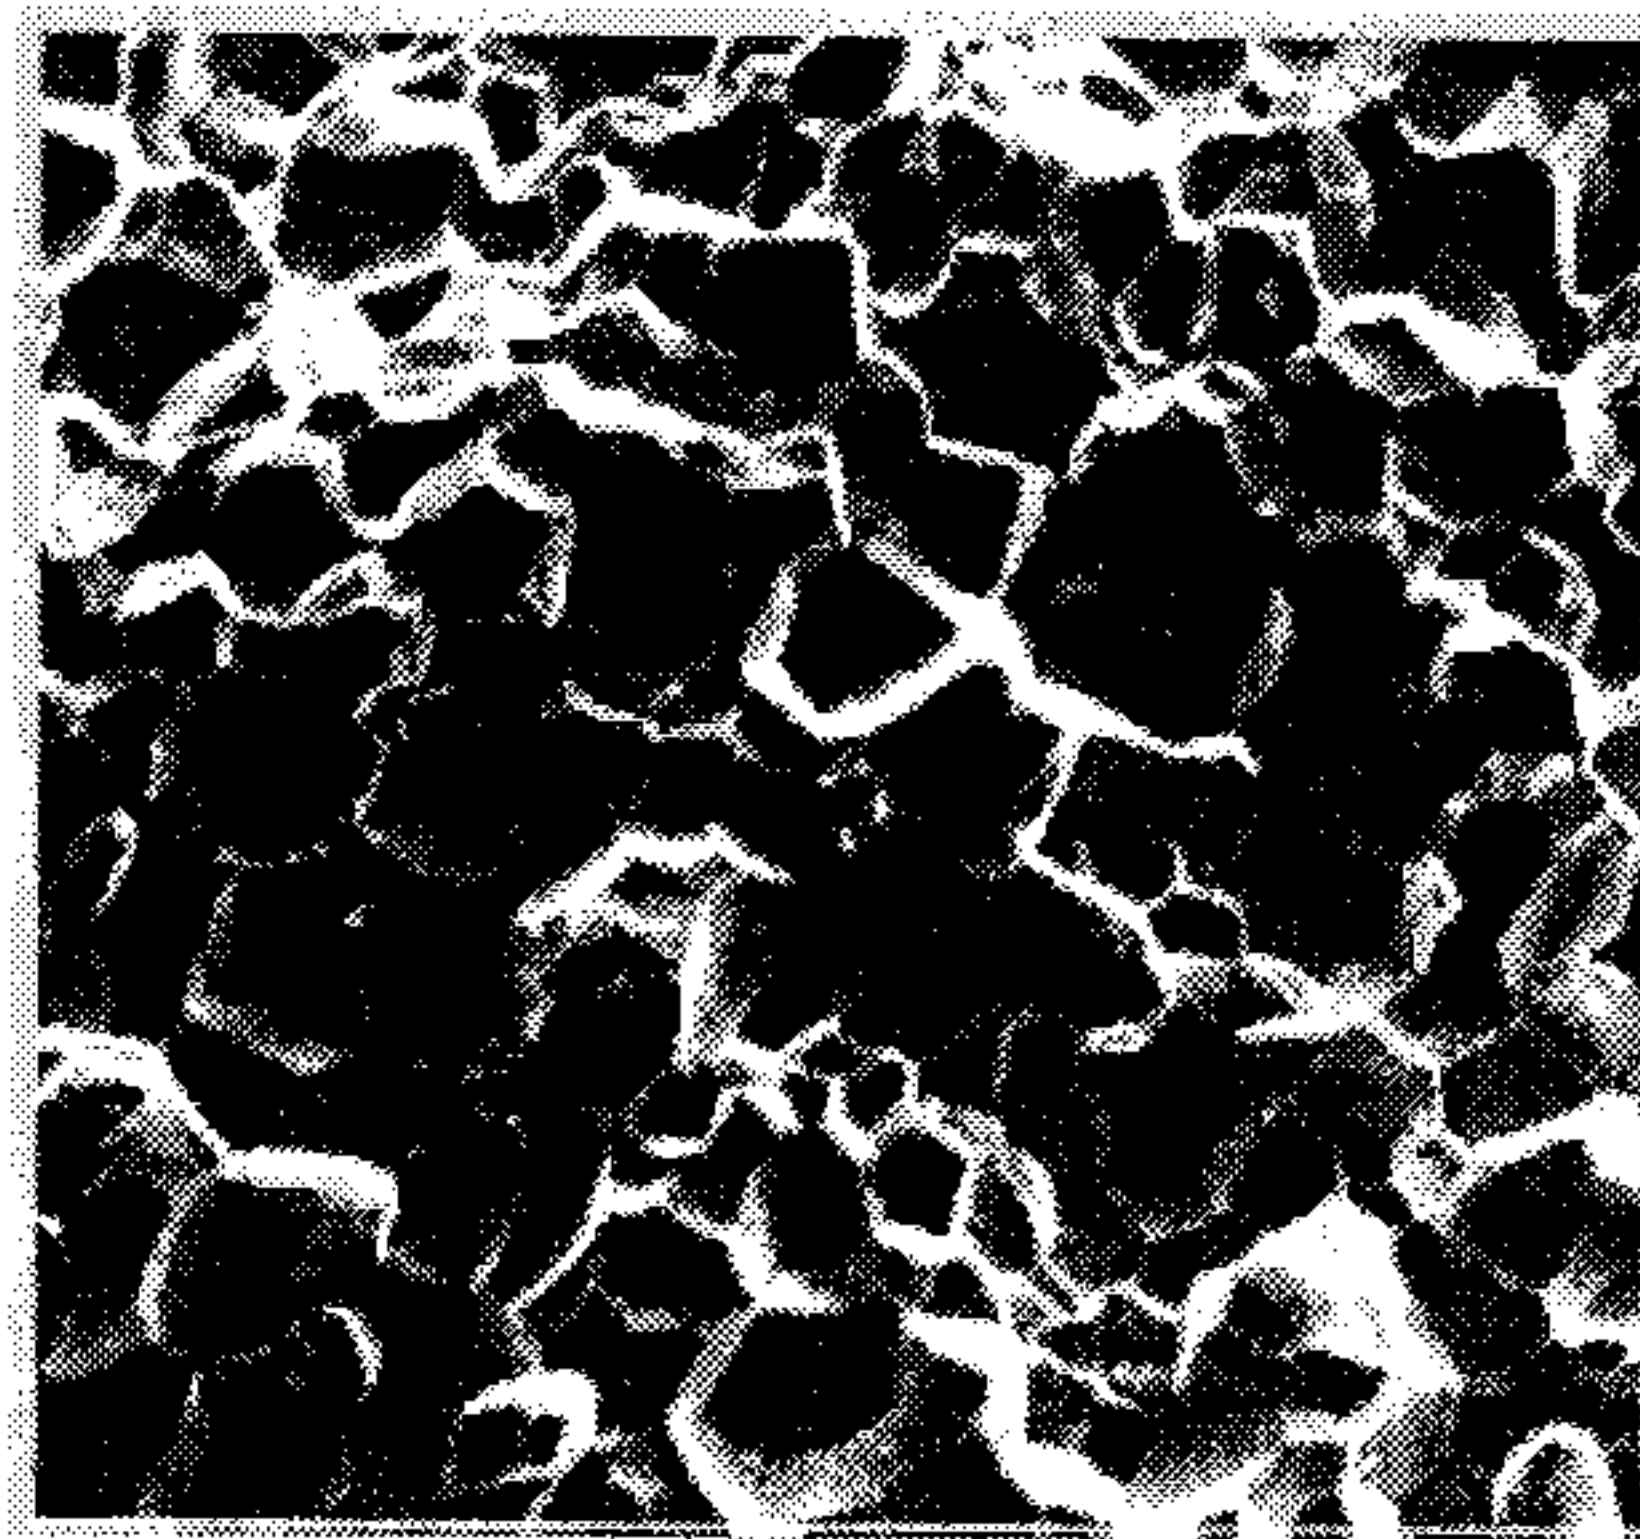
FIGS. 12 to 14 are SEM images of a fracture face showing cleavage facets, equiaxed grains and ductile dimples respectively.
