(54) **REPAIR ARTICLE OF A GAS TURBINE ENGINE**

A repaired article includes a body extending between a first side and a second side. The body has a repair section with an associated thickness between the first side and the second side. The repair section includes regions of plastic deformation distributed through the thickness. A gas turbine engine including the body is also disclosed.

## REPAIR ARTICLE OF A GAS TURBINE ENGINE

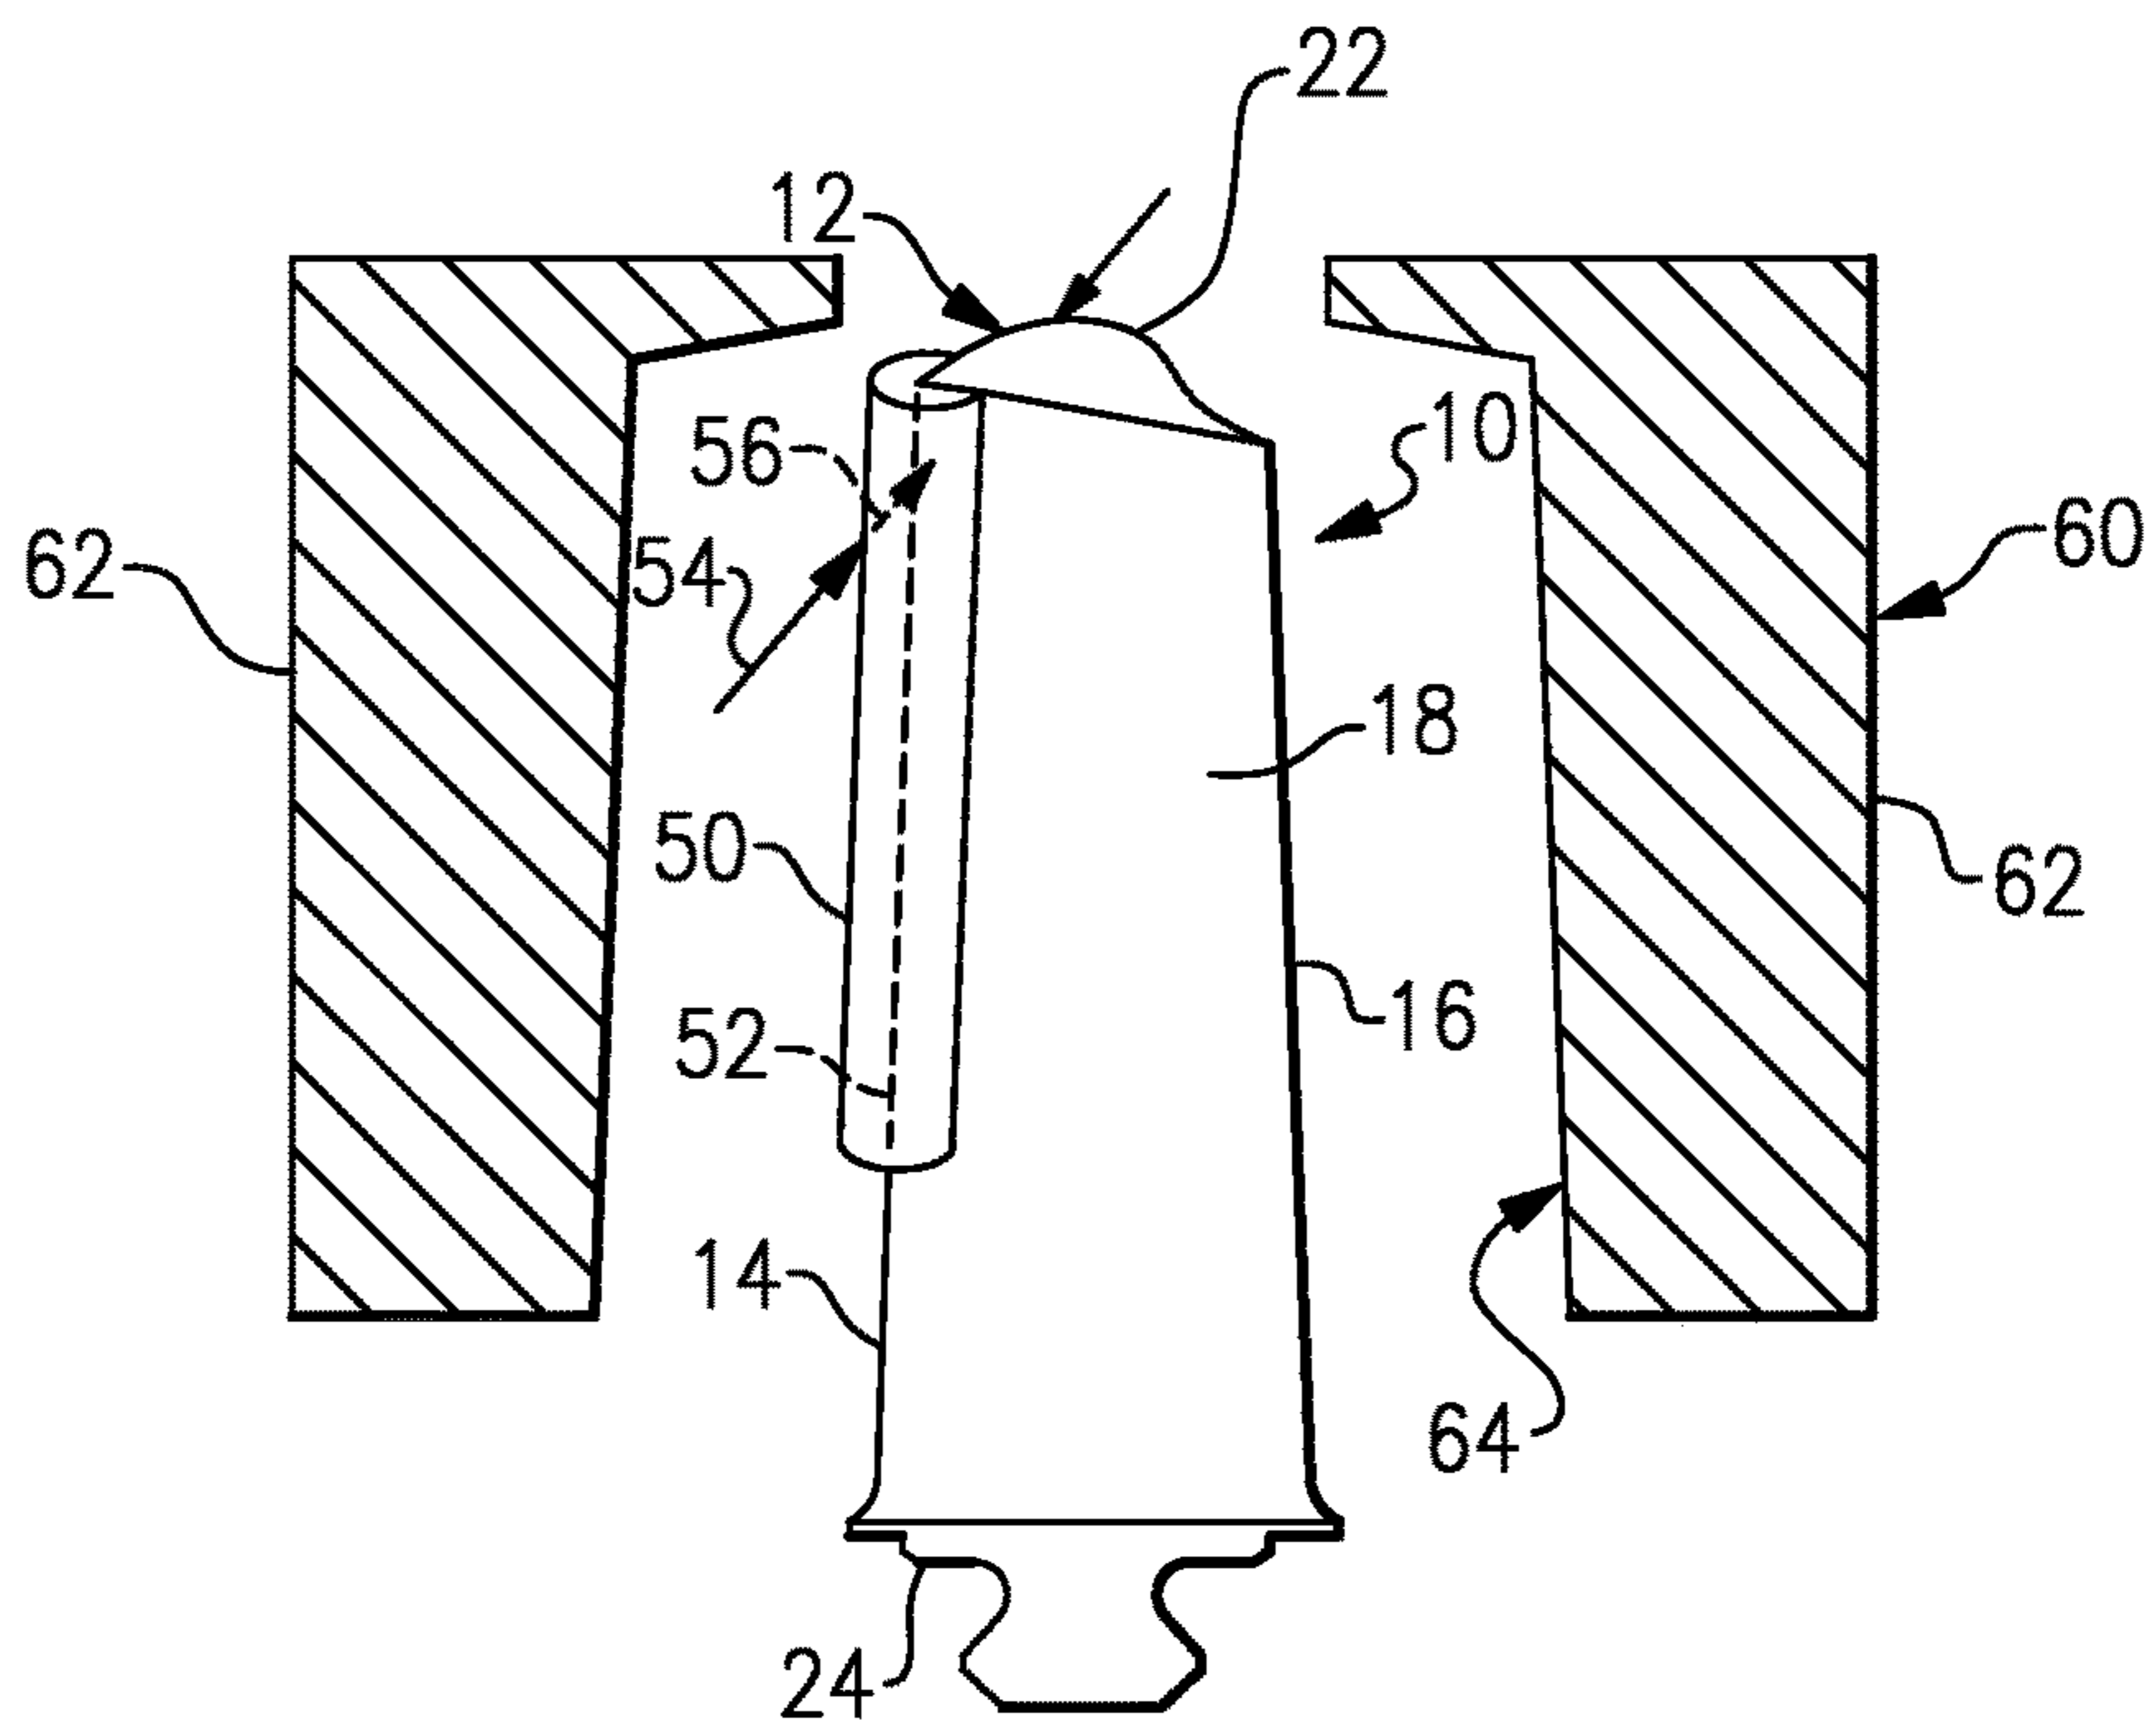
**FIG. 4**

FIG. 4 illustrates an example implementation of an attaching step and a mechanical working step of a repair method.

Referring to FIG. 4, a repair section 50 is then attached to the article 10 in the location of the void 48. The repair section 50 may nominally have the same composition as the alloy of the article 10. In one example, the repair section includes about 50-55 wt % nickel, about 17-21 wt % chromium, about 0.65-1.15 wt % titanium, about 0.2-0.8 wt % aluminum, about 4.75-5.5 wt % columbium, about 0-1 wt % cobalt, about 2.8-3.3 wt % molybdenum, and a balance of iron.

The die 60 includes a pair of die halves 62 that define a cavity 64 that is contoured to the shape of the original article 10. The cavity 64 may enclose the entire article 10 (airfoil 12 and base platform 24), only the airfoil 12, only the repair section 50, or the repair section with some overlap of the airfoil 12 (e.g., to facilitate fixturing). The die halves 62 compress and plastically deform the repair section 50 to reduce the cross-sectional area 54 down to no less than the cross-sectional area 56 of the original geometry of the article 10. The die halves 62 are then opened, and the article 10 is removed. Any flash material from the repair section 50 may then be trimmed, leaving the article 10 and repair section 50 having a geometry that is substantially equal to the original geometry as illustrated in FIG. 5.

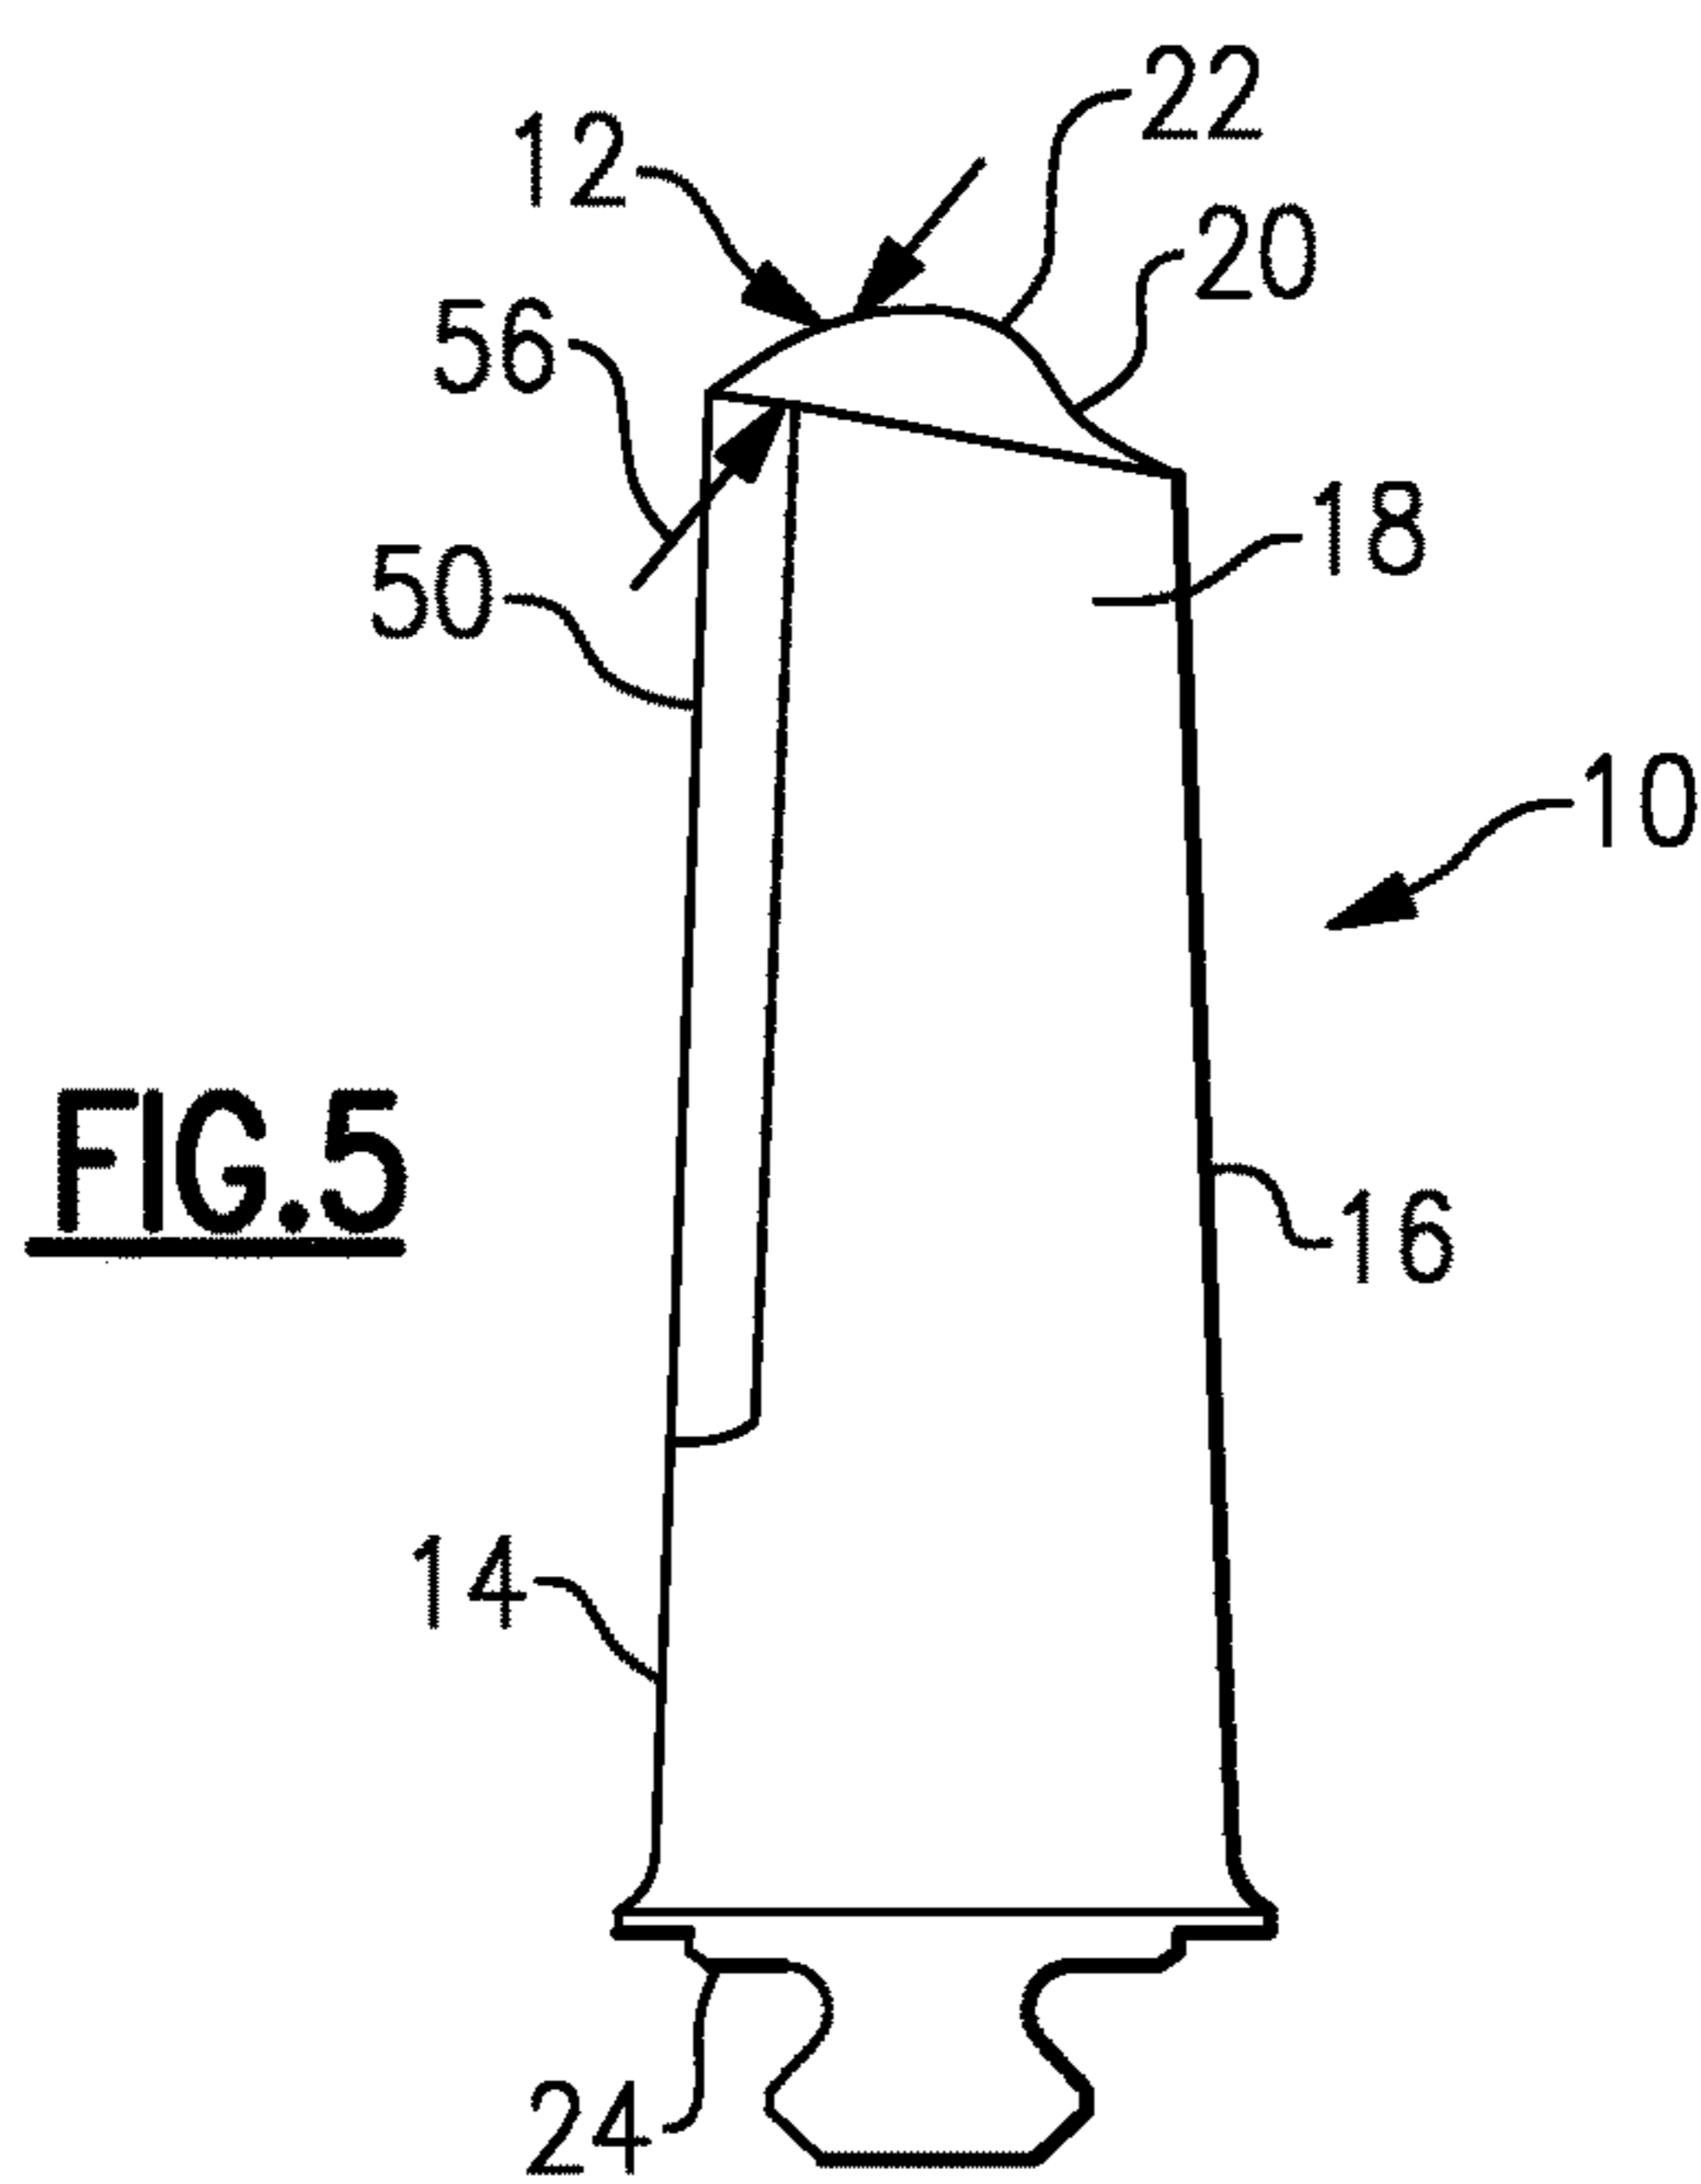
**FIG. 5**

FIG. 5 illustrates an example of the article after being repaired.

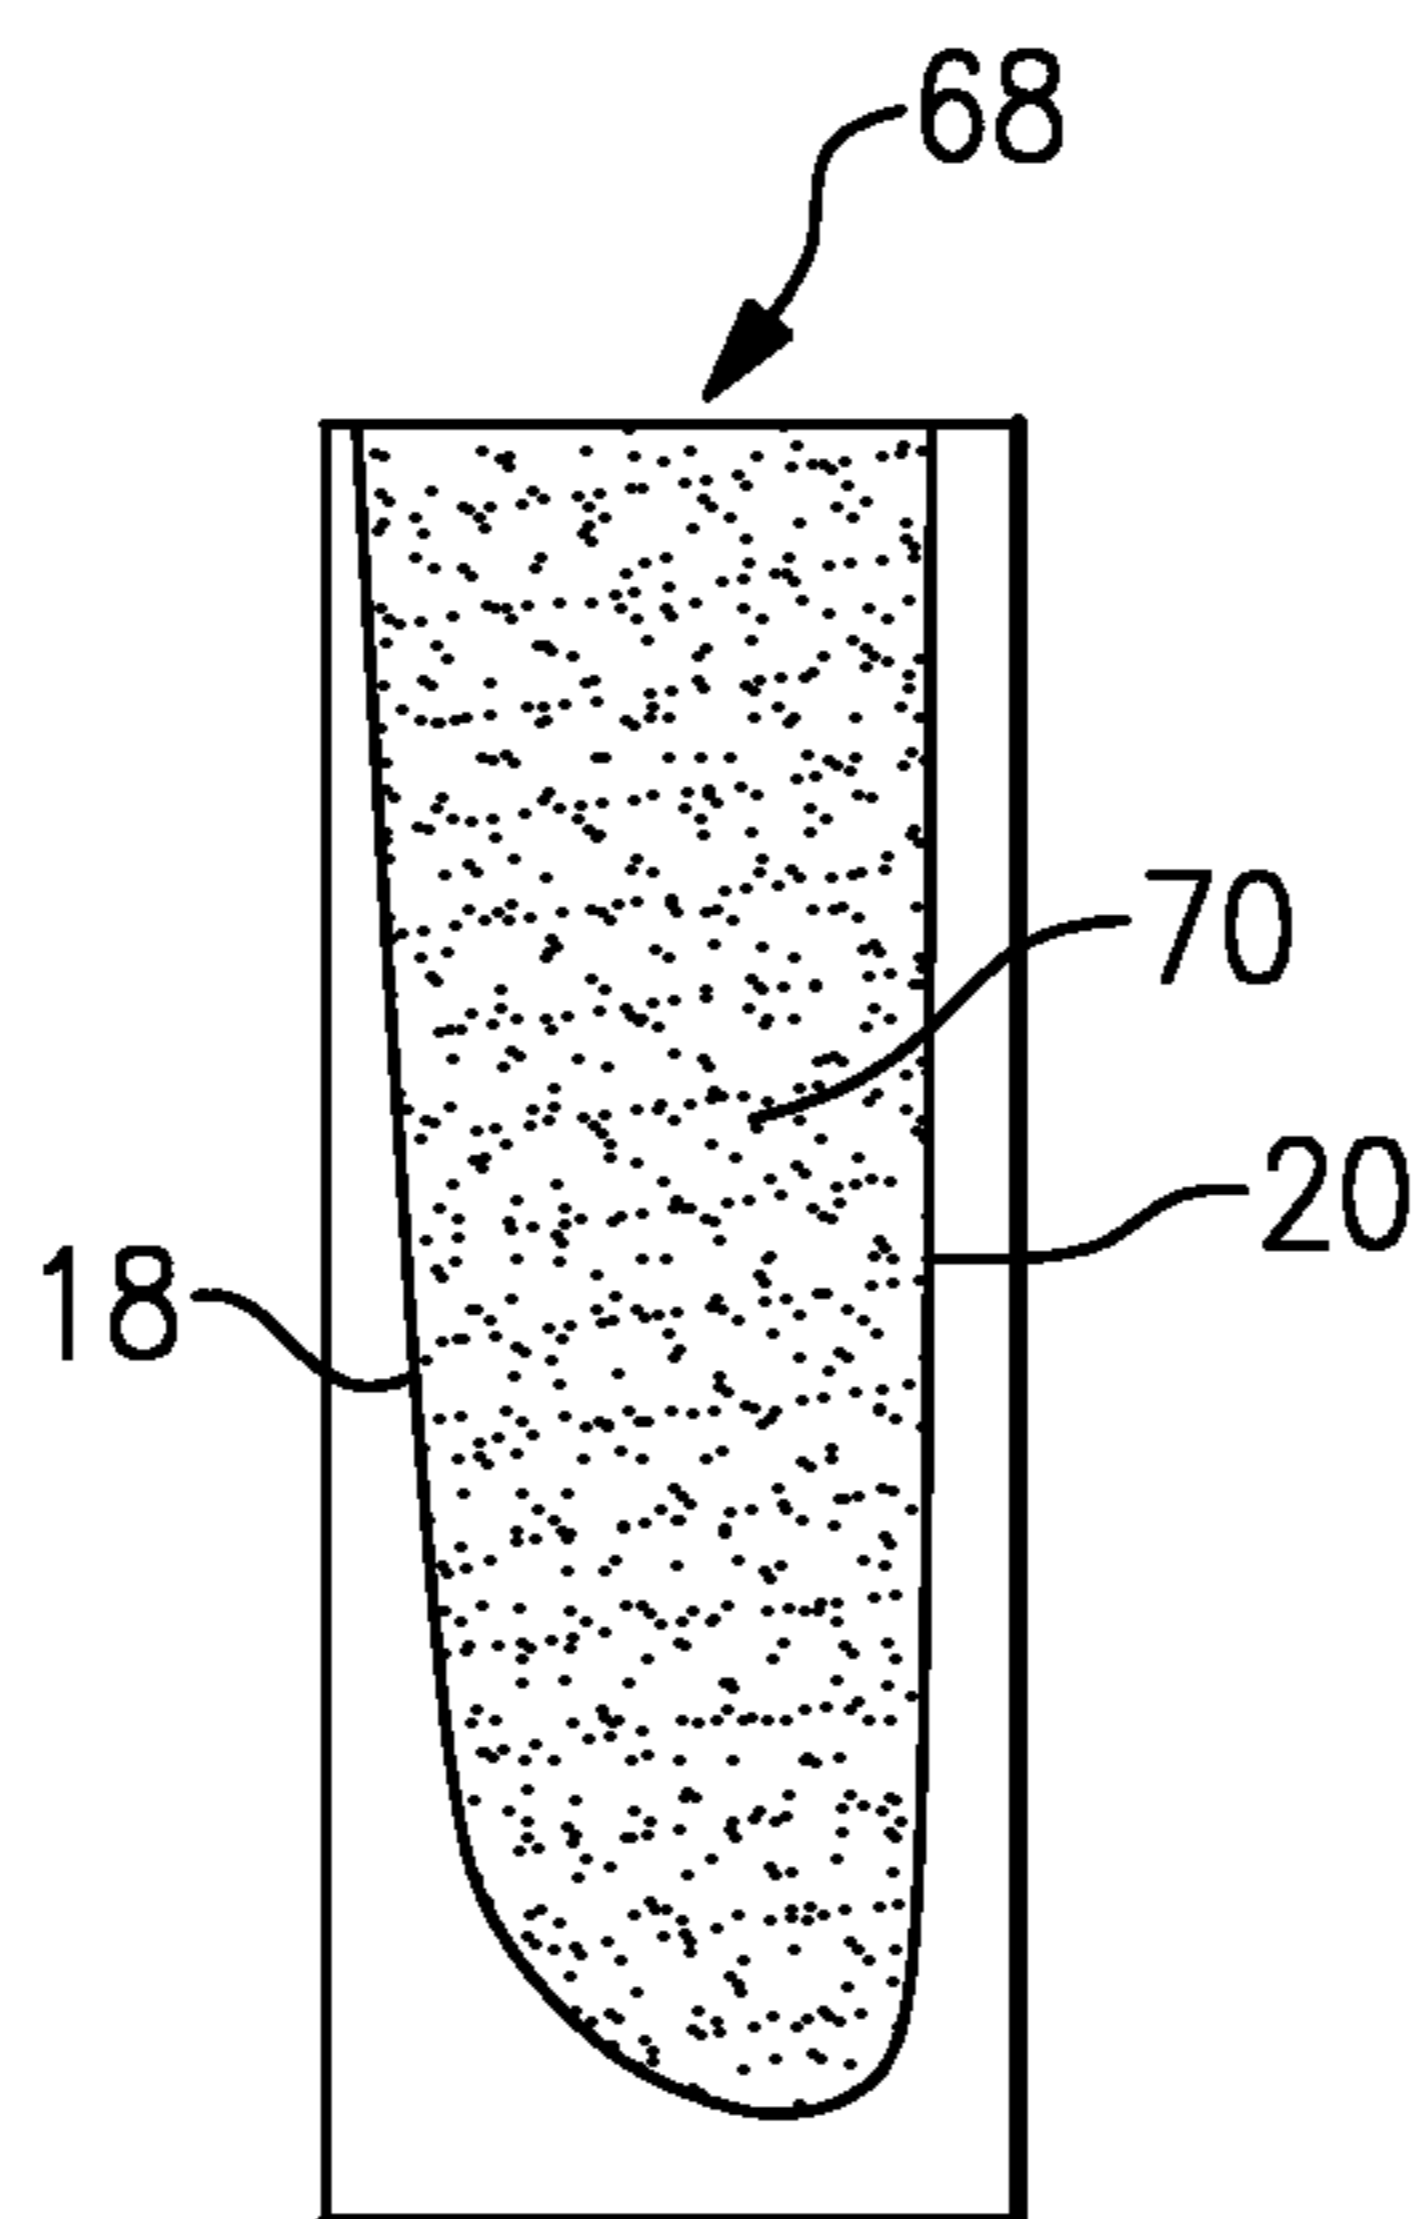
**FIG. 8**

FIG. 8 schematically illustrates an image of a repair section having regions of plastic deformation.

FIG. 8 illustrates an example schematic image 68 using scanning electron microscope electron back-scatter diffraction patterns (Orientation Imaging Microscopy). In this

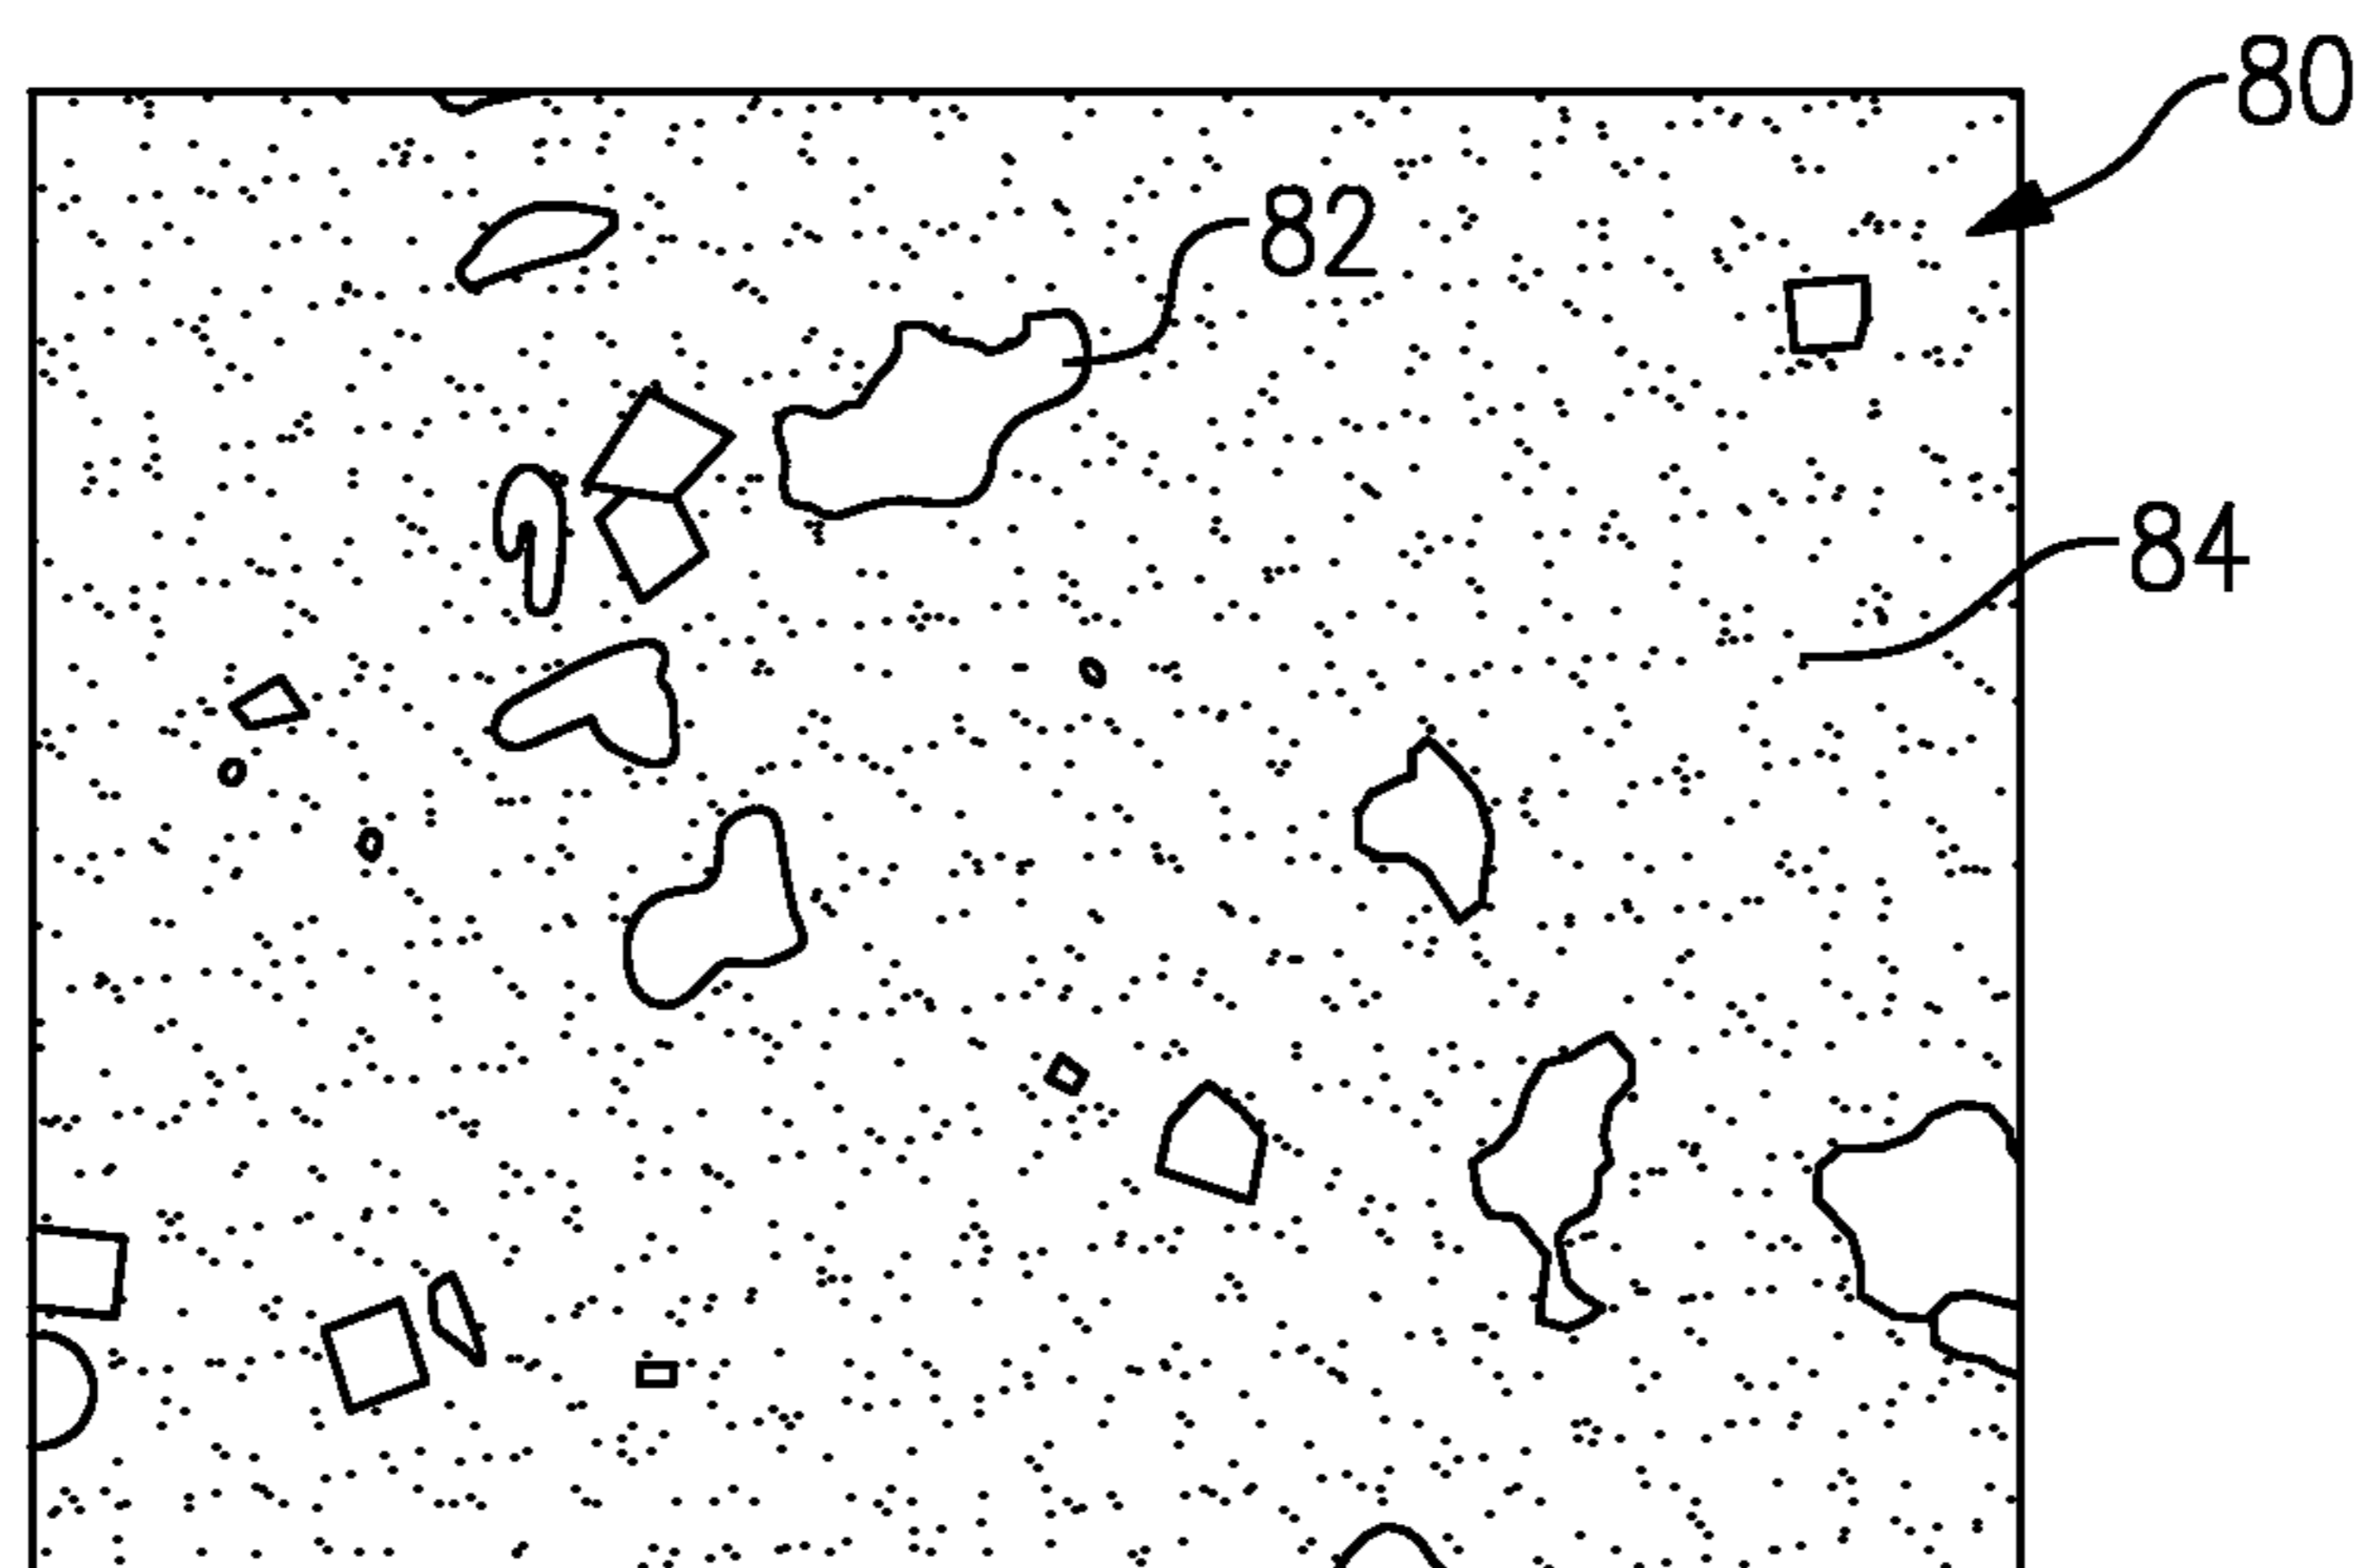
**FIG. 9**

FIG. 9 illustrates an example microstructure that is substantially free of a delta phase.

Referring to FIG. 9, the method 40 may also be used to achieve a desirable microstructure 80. For example, the microstructure 80 includes regions of Laves phase 82 distributed within a matrix 84 of the alloy composition. In this example, the microstructure 80 is substantially free from, and in some examples entirely free of, orthorhombic delta phase regions of  $\text{Ni}_3\text{Cb}$ , which is a needle-shaped phase that is known to degrade physical properties (e.g., fatigue strength). For instance, the disclosed method 40 may be used to avoid a solution heat treating step that typically results in the formation of the delta phase. In some repair processes, an article having a repair section may be heat treated at 1750° F. or higher to homogenously solutionize elements within the alloy, and then be aged at approximately 1150-1350° F. (621-732° C.) to precipitation strengthen the alloy. The heat treating typically contributes to the formation of the delta phase. However, using the disclosed method 40, the solution heat treating step can be eliminated because the plastic deformation and dislocations from the mechanical working contribute to improving fatigue strength and thereby lessen the need for heat treating. Therefore, at least the heat treating step may be eliminated, although it still may be desirable to utilize the aging process to achieve a degree of precipitation strengthening.
