(54) **REPAIR ARTICLE OF A GAS TURBINE ENGINE**

A repaired article includes a body extending between a first side and a second side. The body has a repair section with an associated thickness between the first side and the second side. The repair section includes regions of plastic deformation distributed through the thickness. A gas turbine engine including the body is also disclosed.

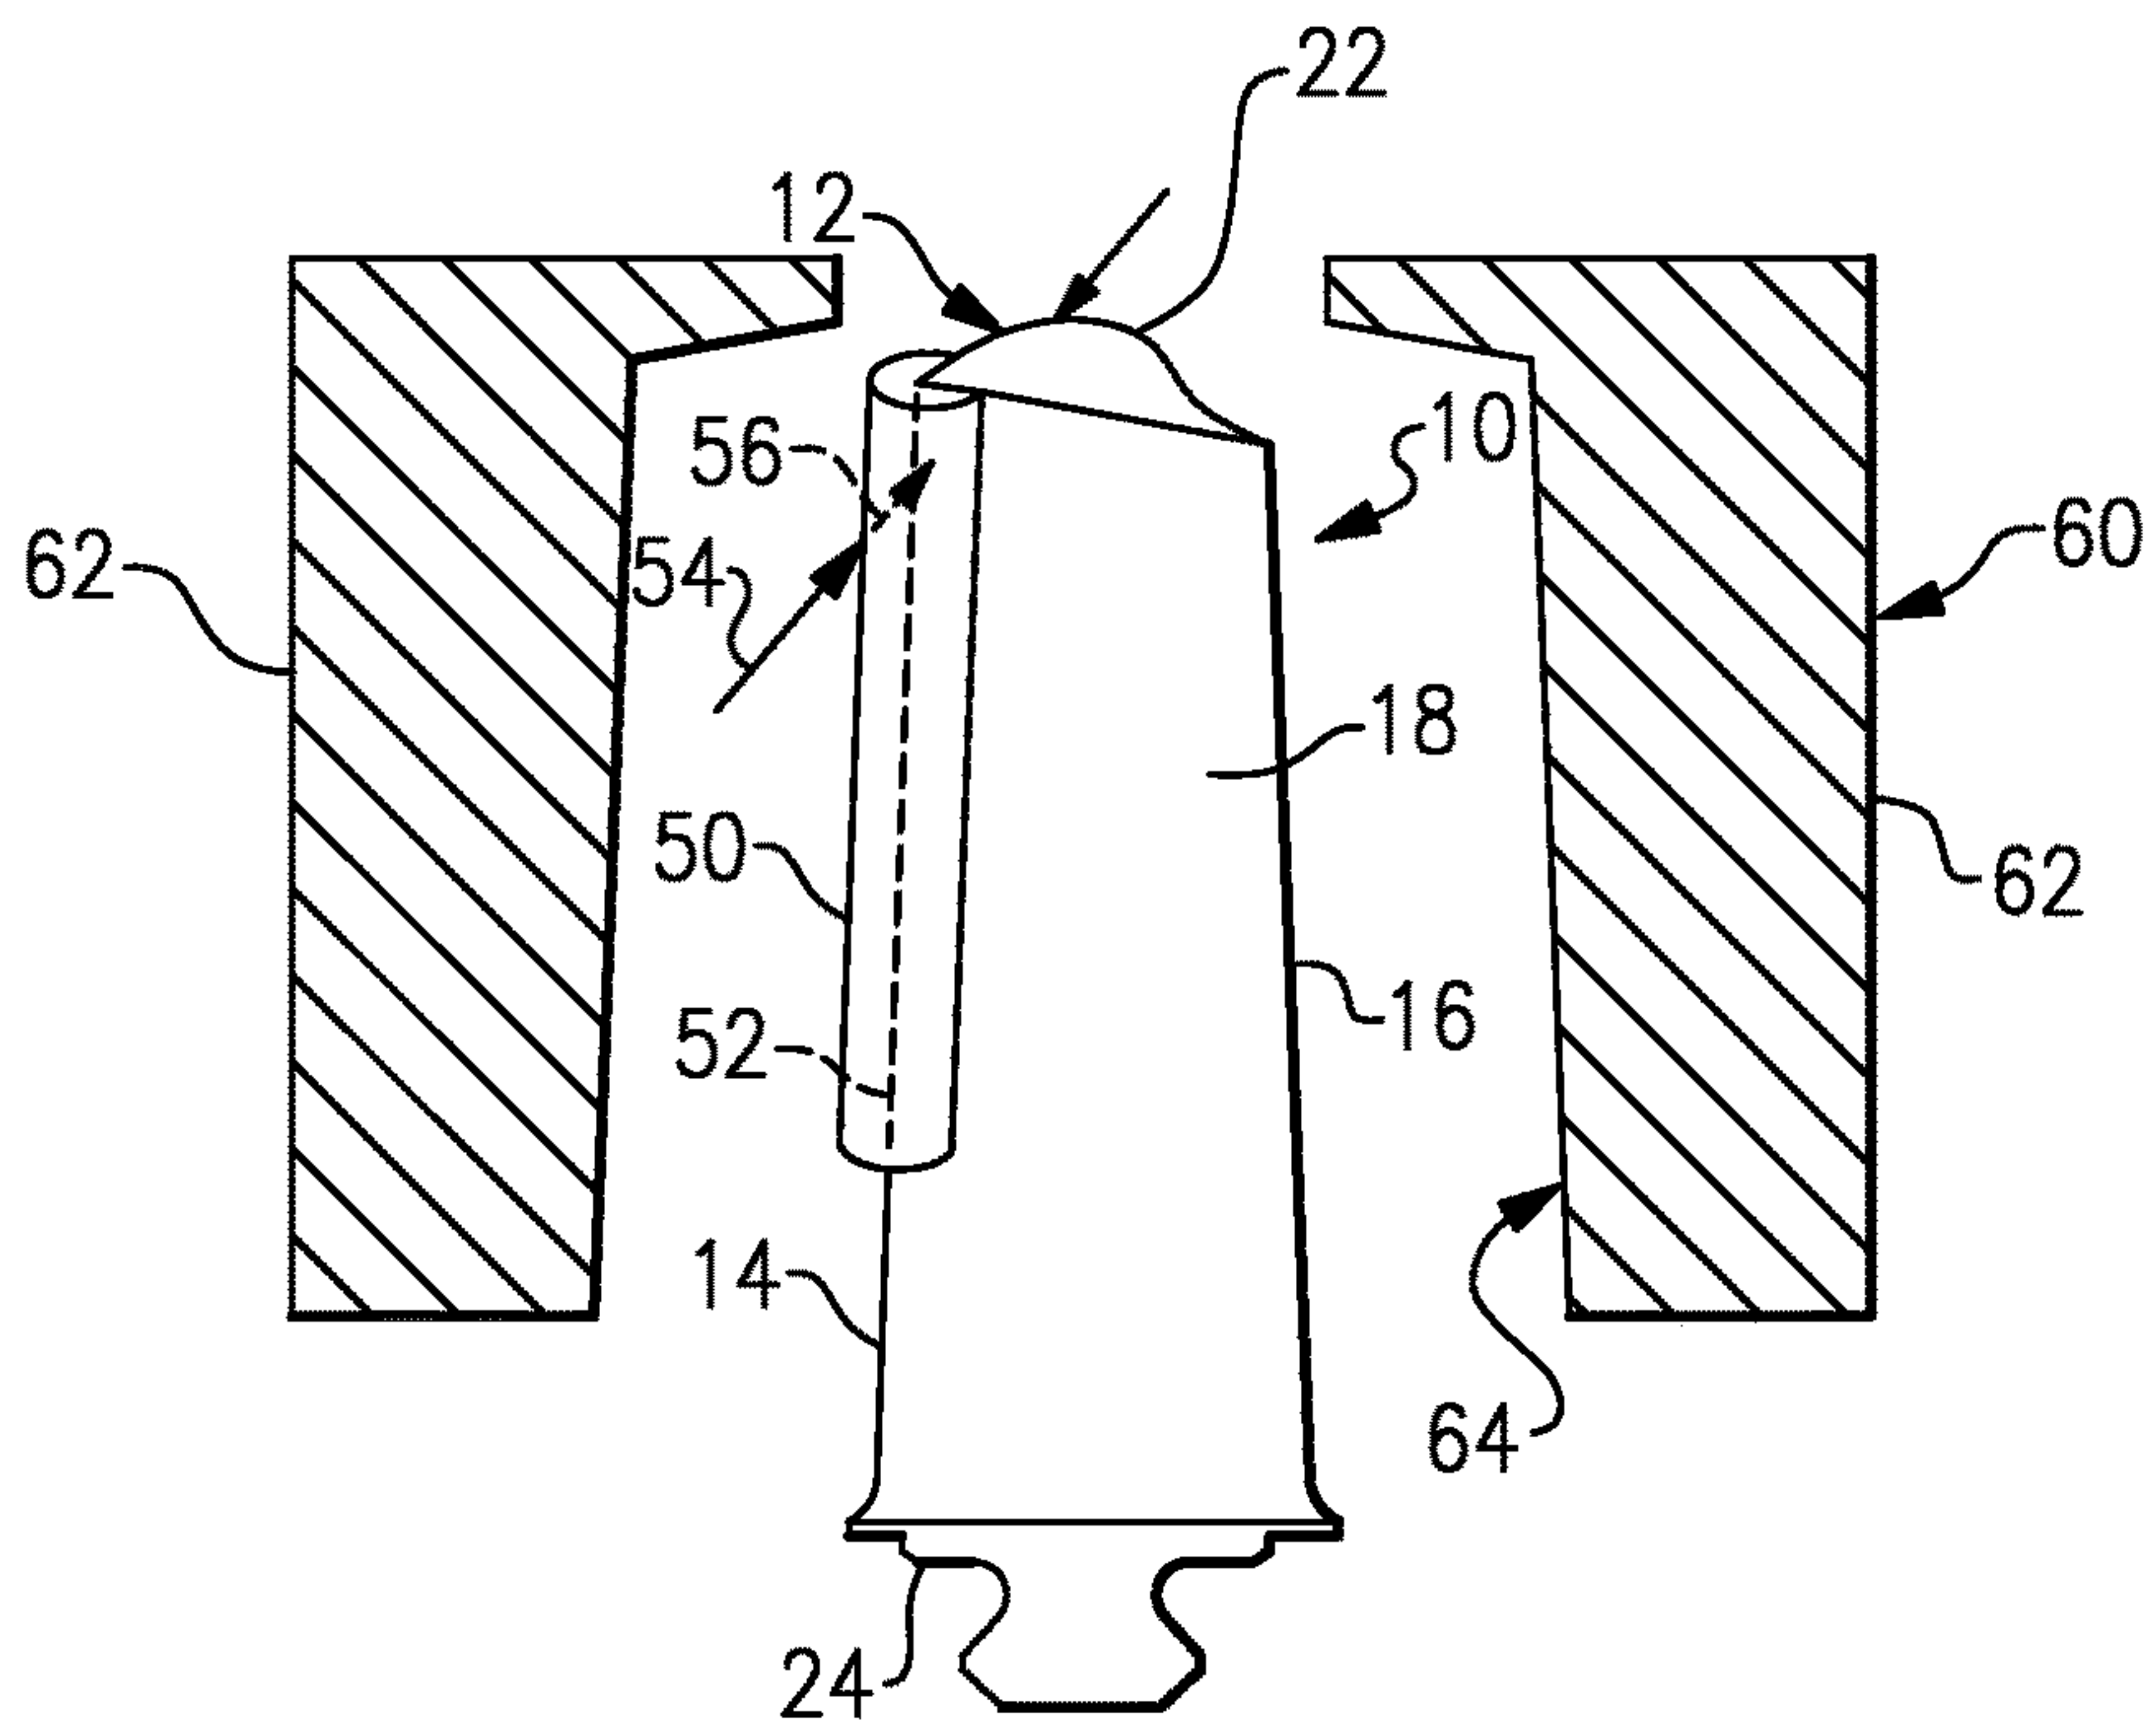
FIG. 4 illustrates an example implementation of an attaching step and a mechanical working step of a repair method.

Referring to FIG. 4, a repair section 50 is then attached to the article 10 in the location of the void 48. The repair section 50 may nominally have the same composition as the alloy of the article 10. In one example, the repair section includes about 50-55 wt % nickel, about 17-21 wt % chromium, about 0.65-1.15 wt % titanium, about 0.2-0.8 wt % aluminum, about 4.75-5.5 wt % columbium, about 0-1 wt % cobalt, about 2.8-3.3 wt % molybdenum, and a balance of iron.

The die 60 includes a pair of die halves 62 that define a cavity 64 that is contoured to the shape of the original article 10. The cavity 64 may enclose the entire article 10 (airfoil 12 and base platform 24), only the airfoil 12, only the repair section 50, or the repair section with some overlap of the airfoil 12 (e.g., to facilitate fixturing). The die halves 62 compress and plastically deform the repair section 50 to reduce the cross-sectional area 54 down to no less than the cross-sectional area 56 of the original geometry of the article 10. The die halves 62 are then opened, and the article 10 is removed. Any flash material from the repair section 50 may then be trimmed, leaving the article 10 and repair section 50 having a geometry that is substantially equal to the original geometry as illustrated in FIG. 5.

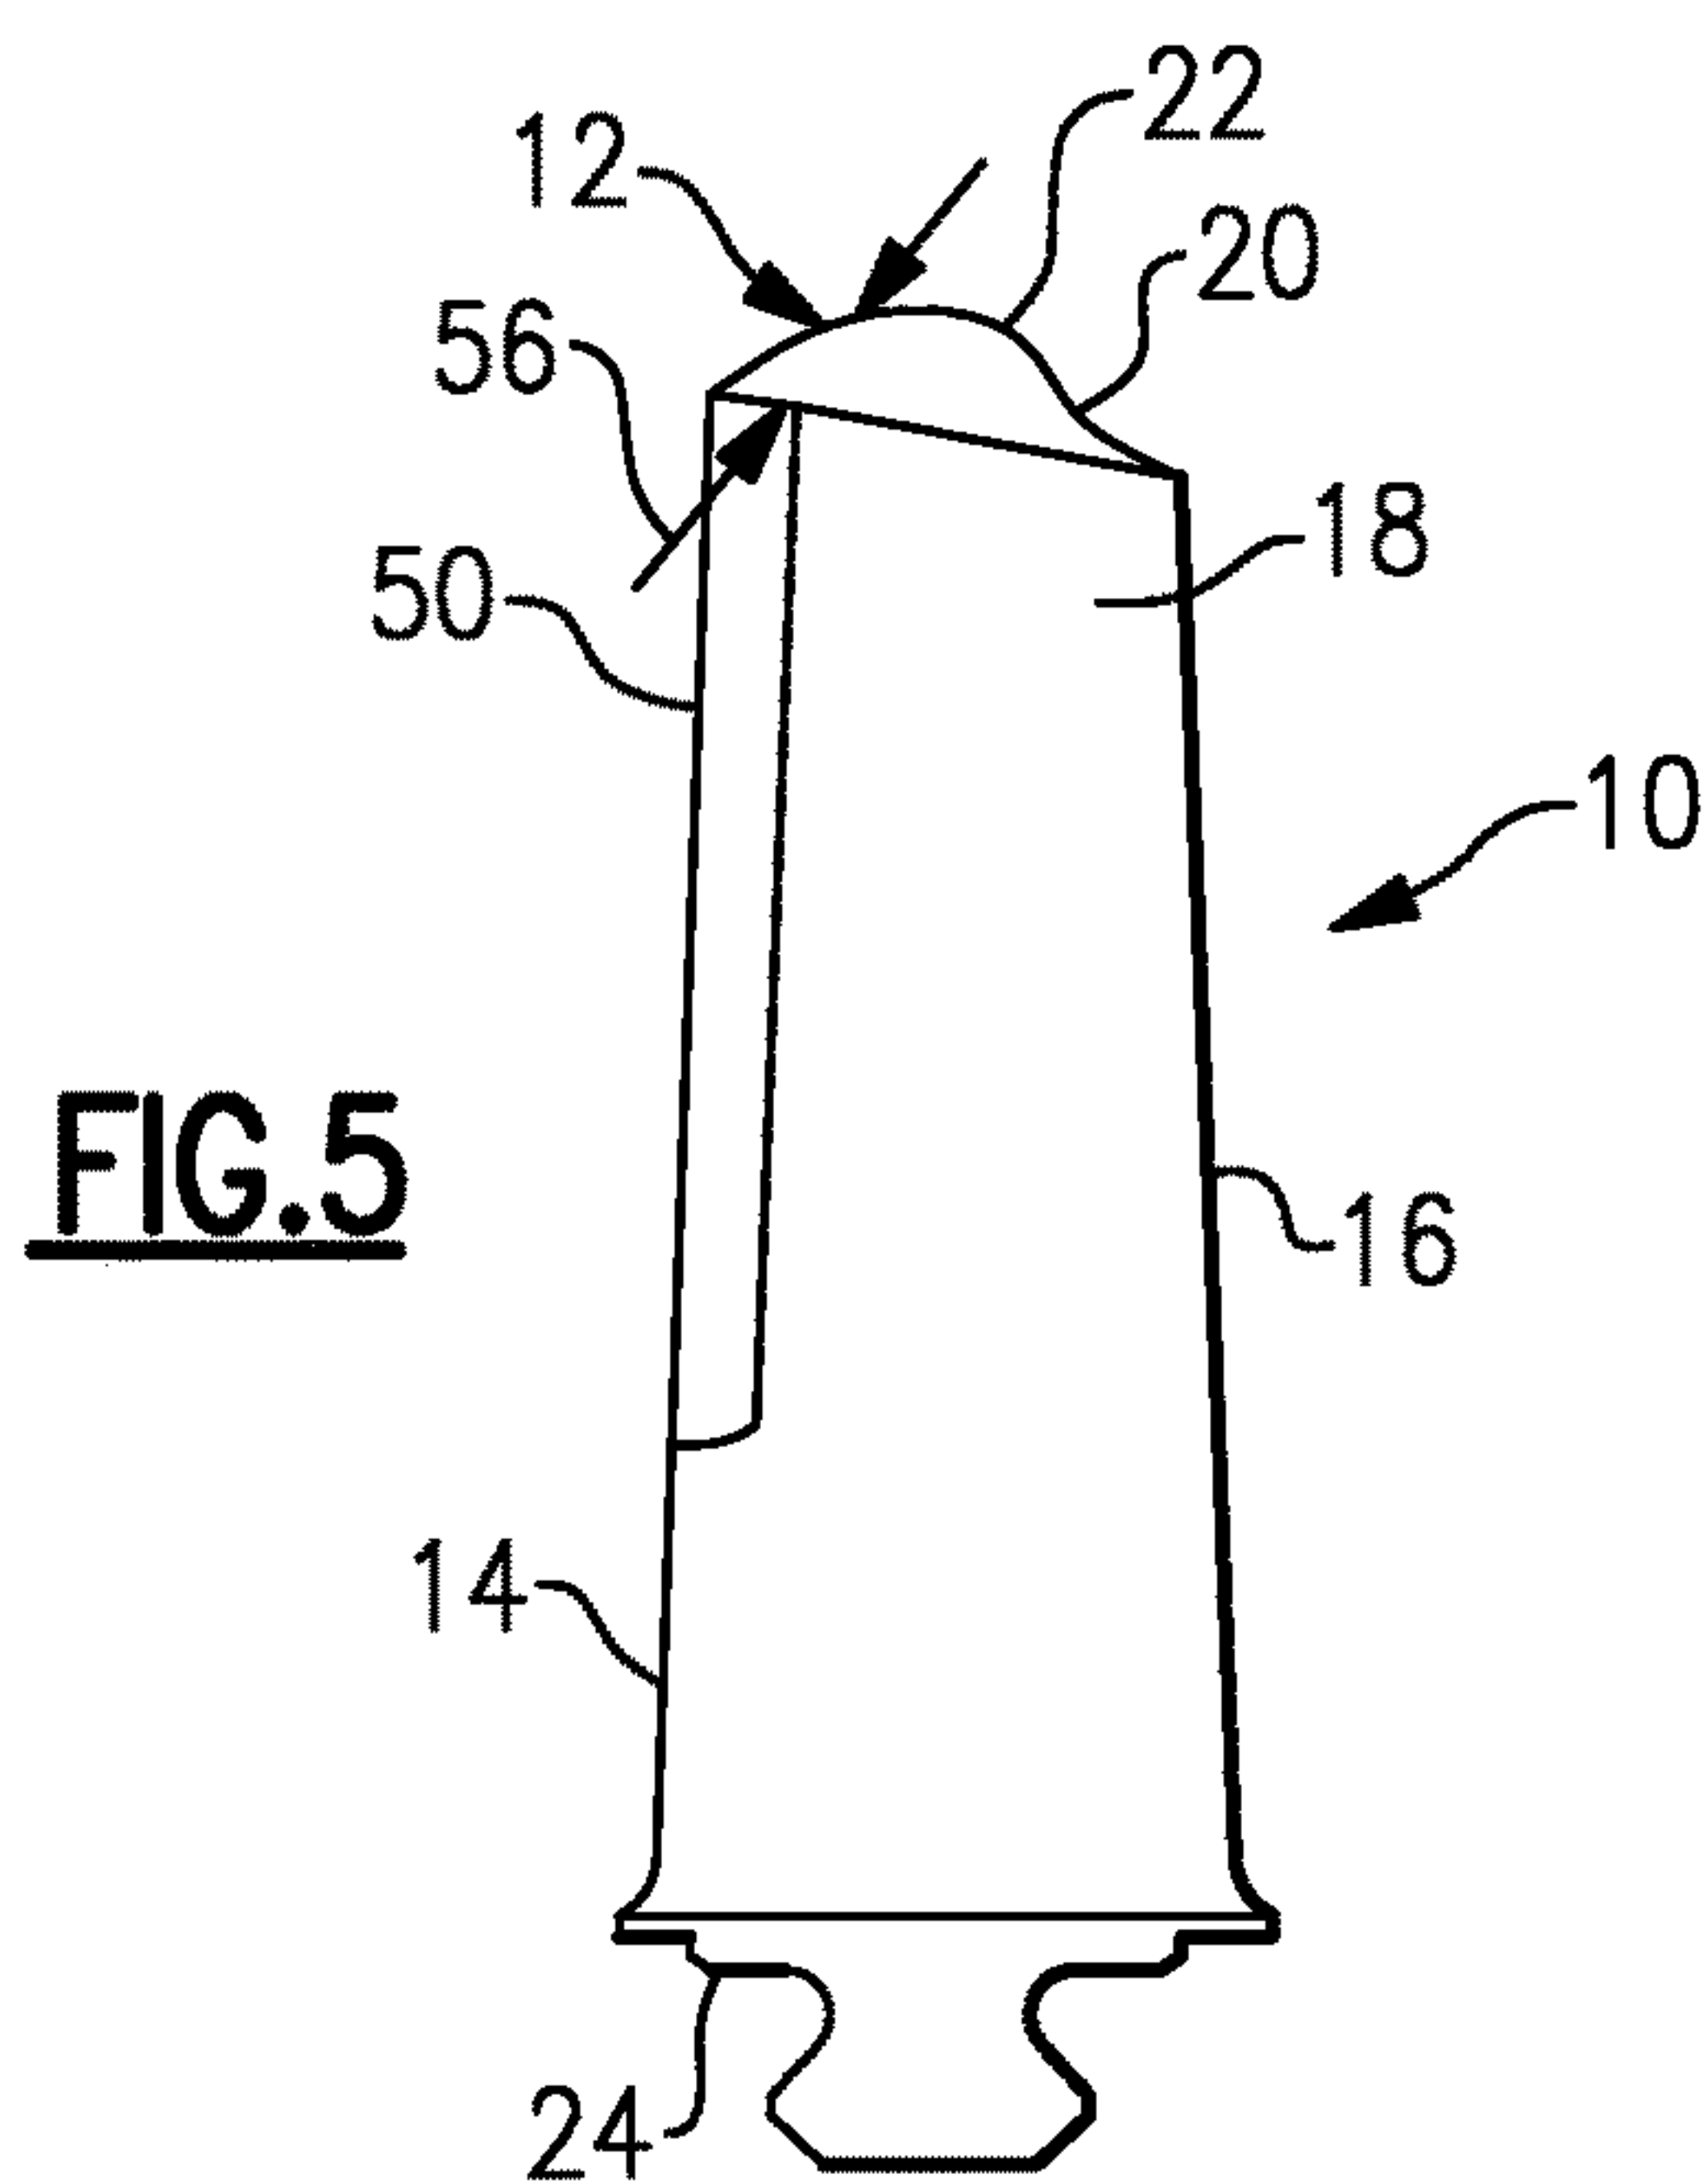
FIG. 5 illustrates an example of the article after being repaired.

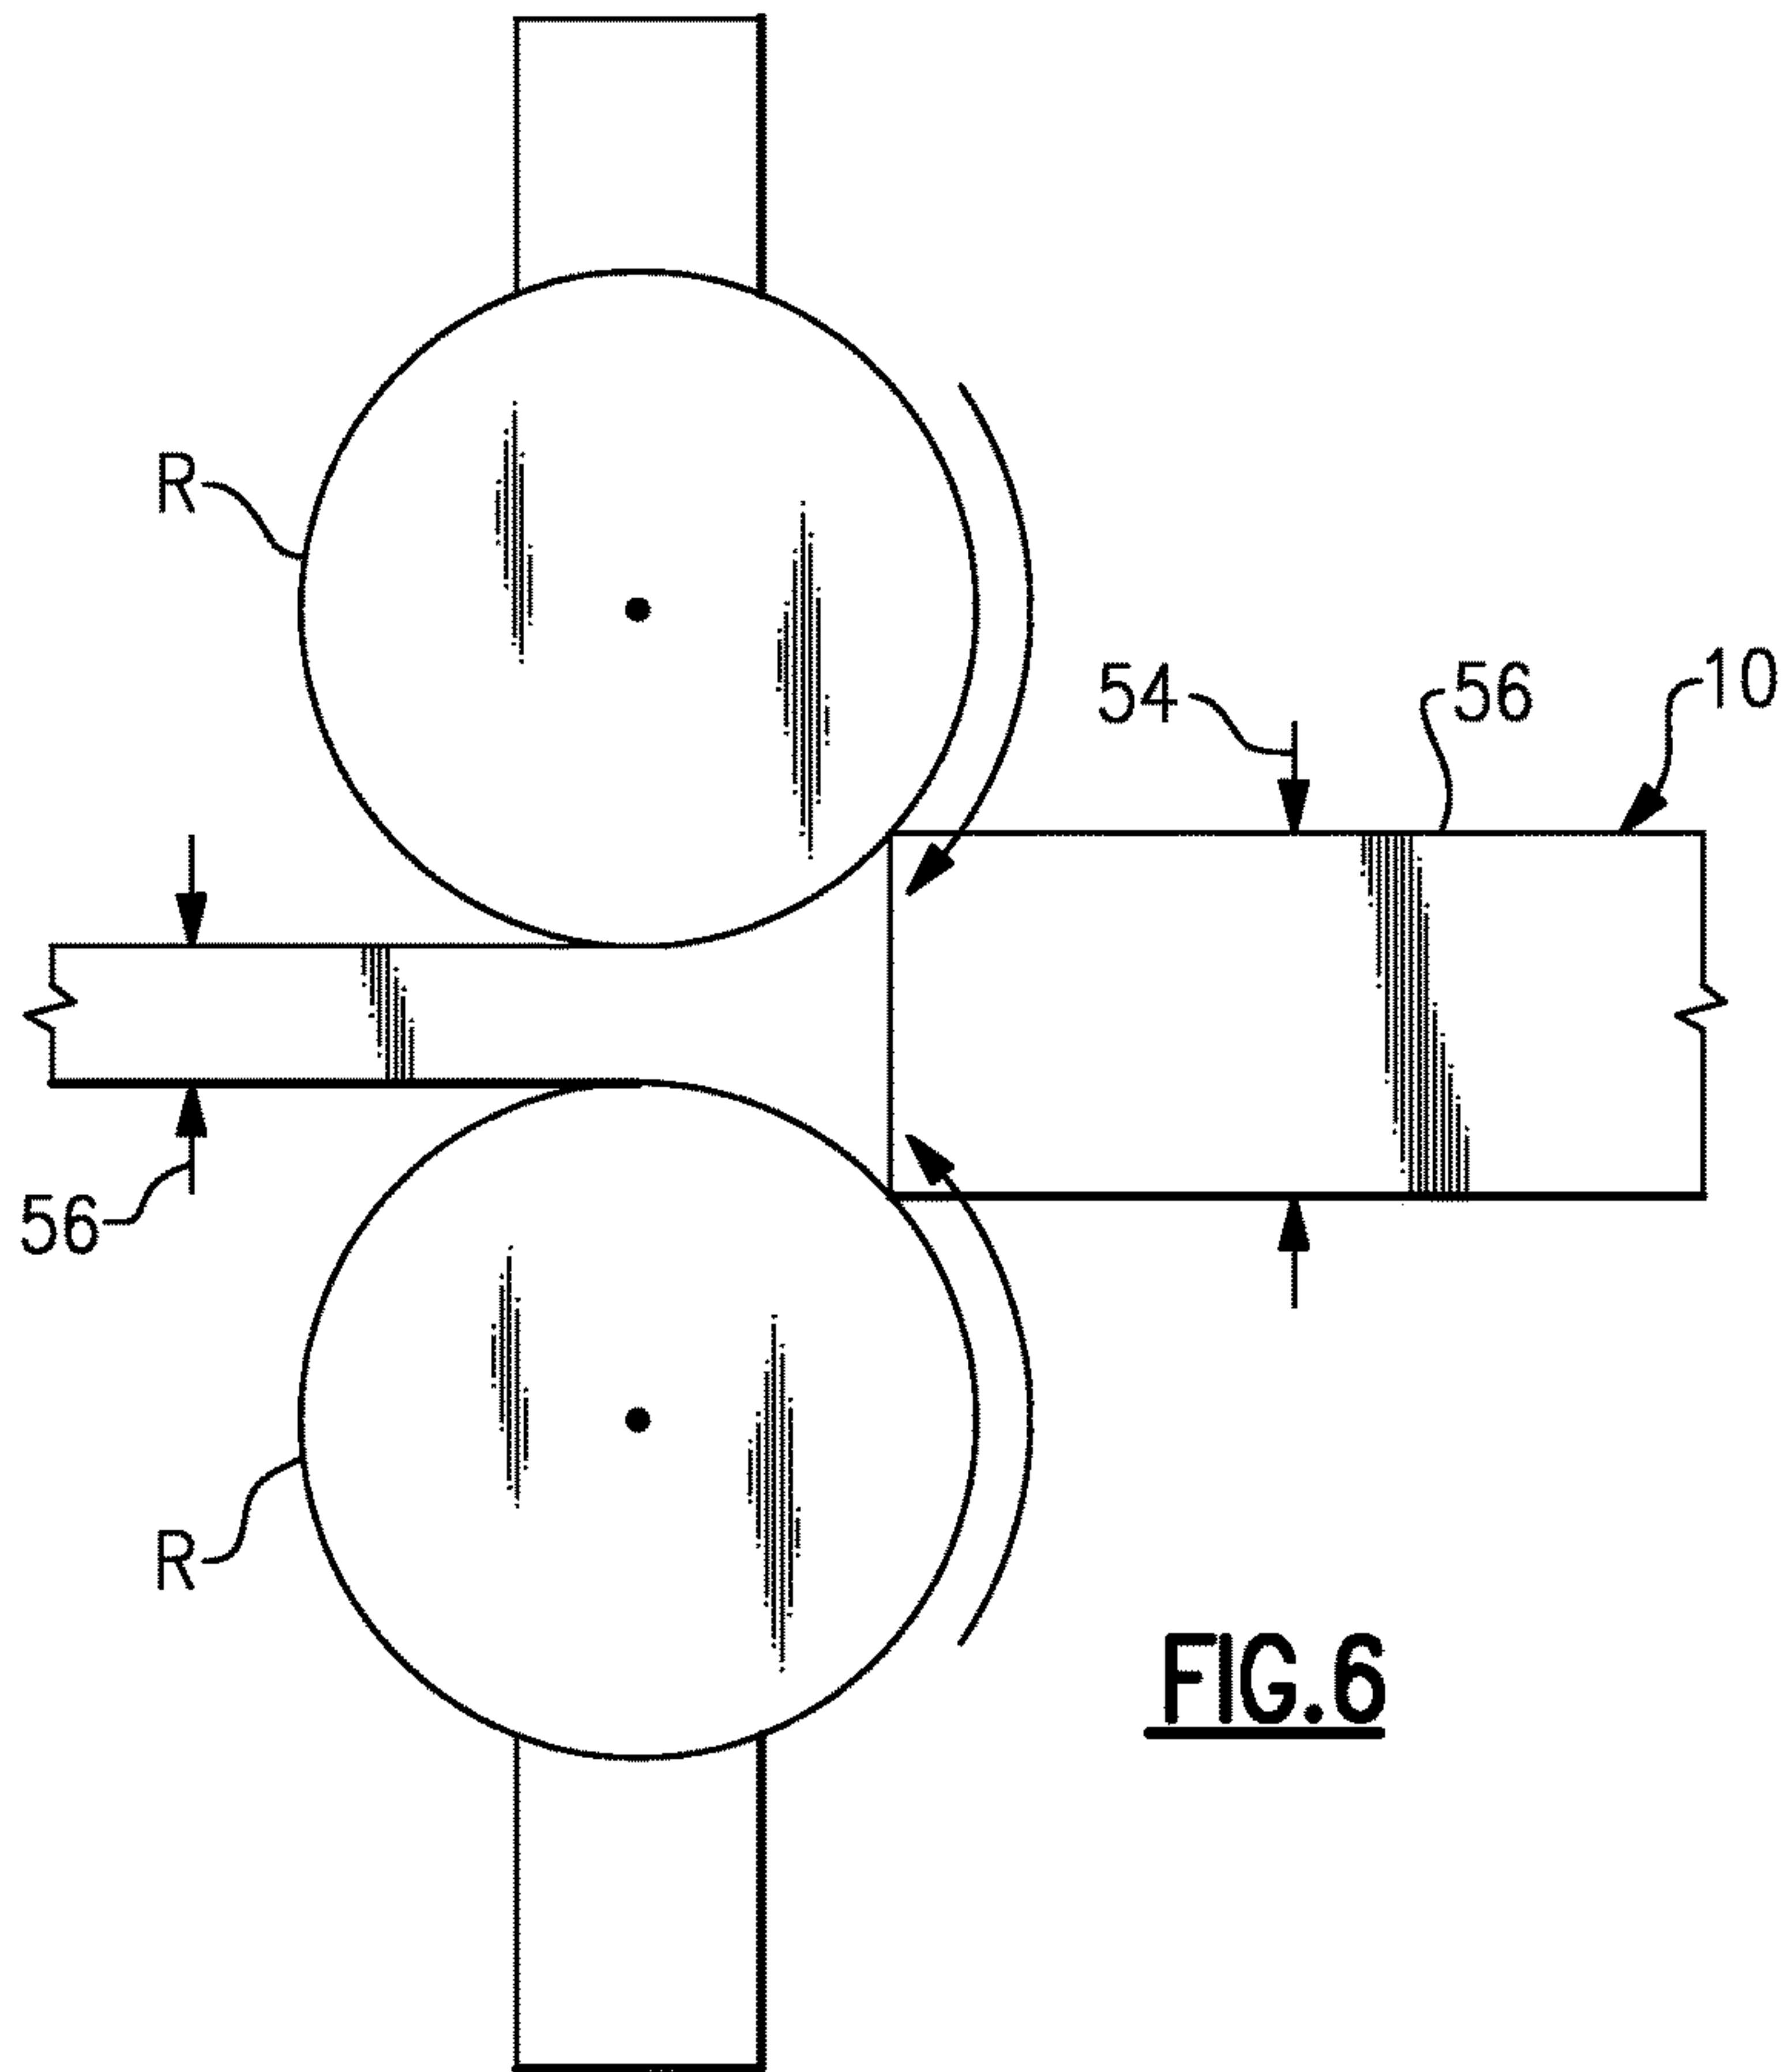
FIG. 6 illustrates an example mechanical working step that includes roll planishing.

As an alternative to forging, or in addition to forging, the mechanical working step 46 may include planishing. As illustrated in FIG. 6, the planishing may be roll planishing where the repair section 50 is rolled between rollers R to reduce the cross-sectional area 54 down to no less than the cross-sectional area 56 of the original geometry of the article 10. As illustrated in FIG. 7, the planishing may be hammer planishing where the repair section 50 is hammered between a reciprocating hammer 57a and a planish stake 57b to reduce the cross-sectional area 54 down to no less than the cross-sectional area 56 of the original geometry of the article 10. The planishing may be conducted manually or using an automated or semi-automated planishing machine.

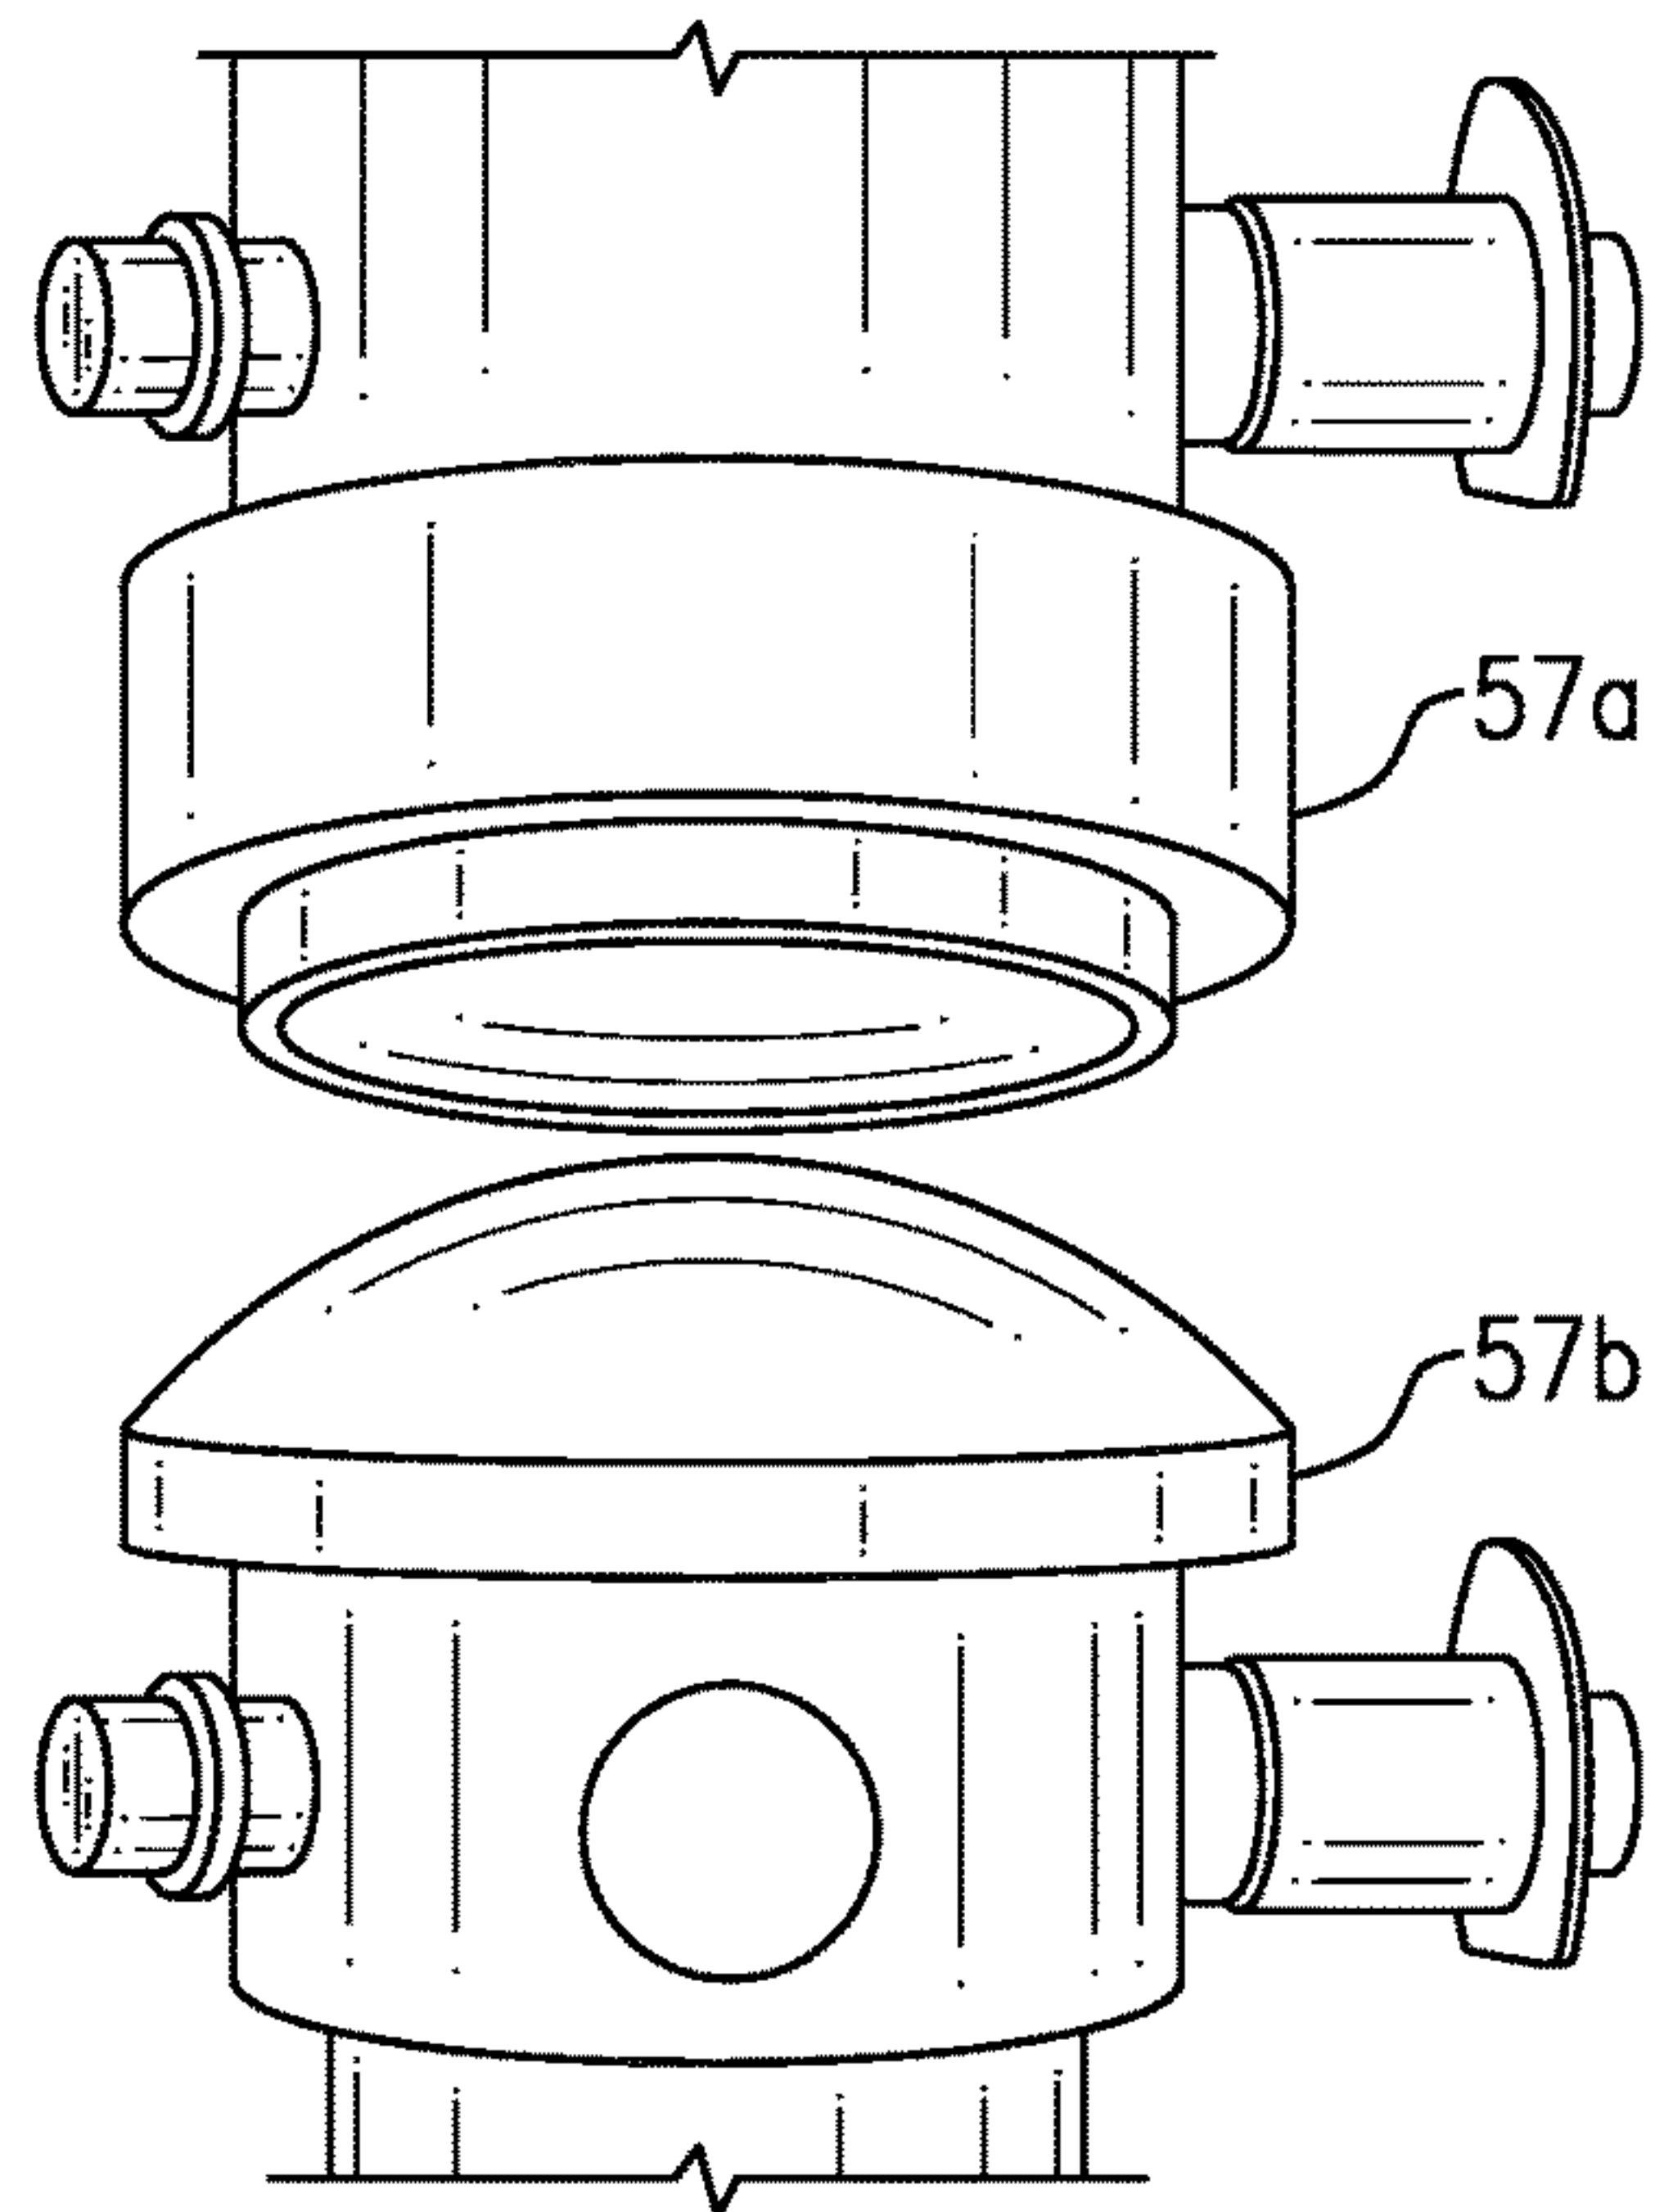
FIG. 7 illustrates an example mechanical working step that includes hammer planishing.

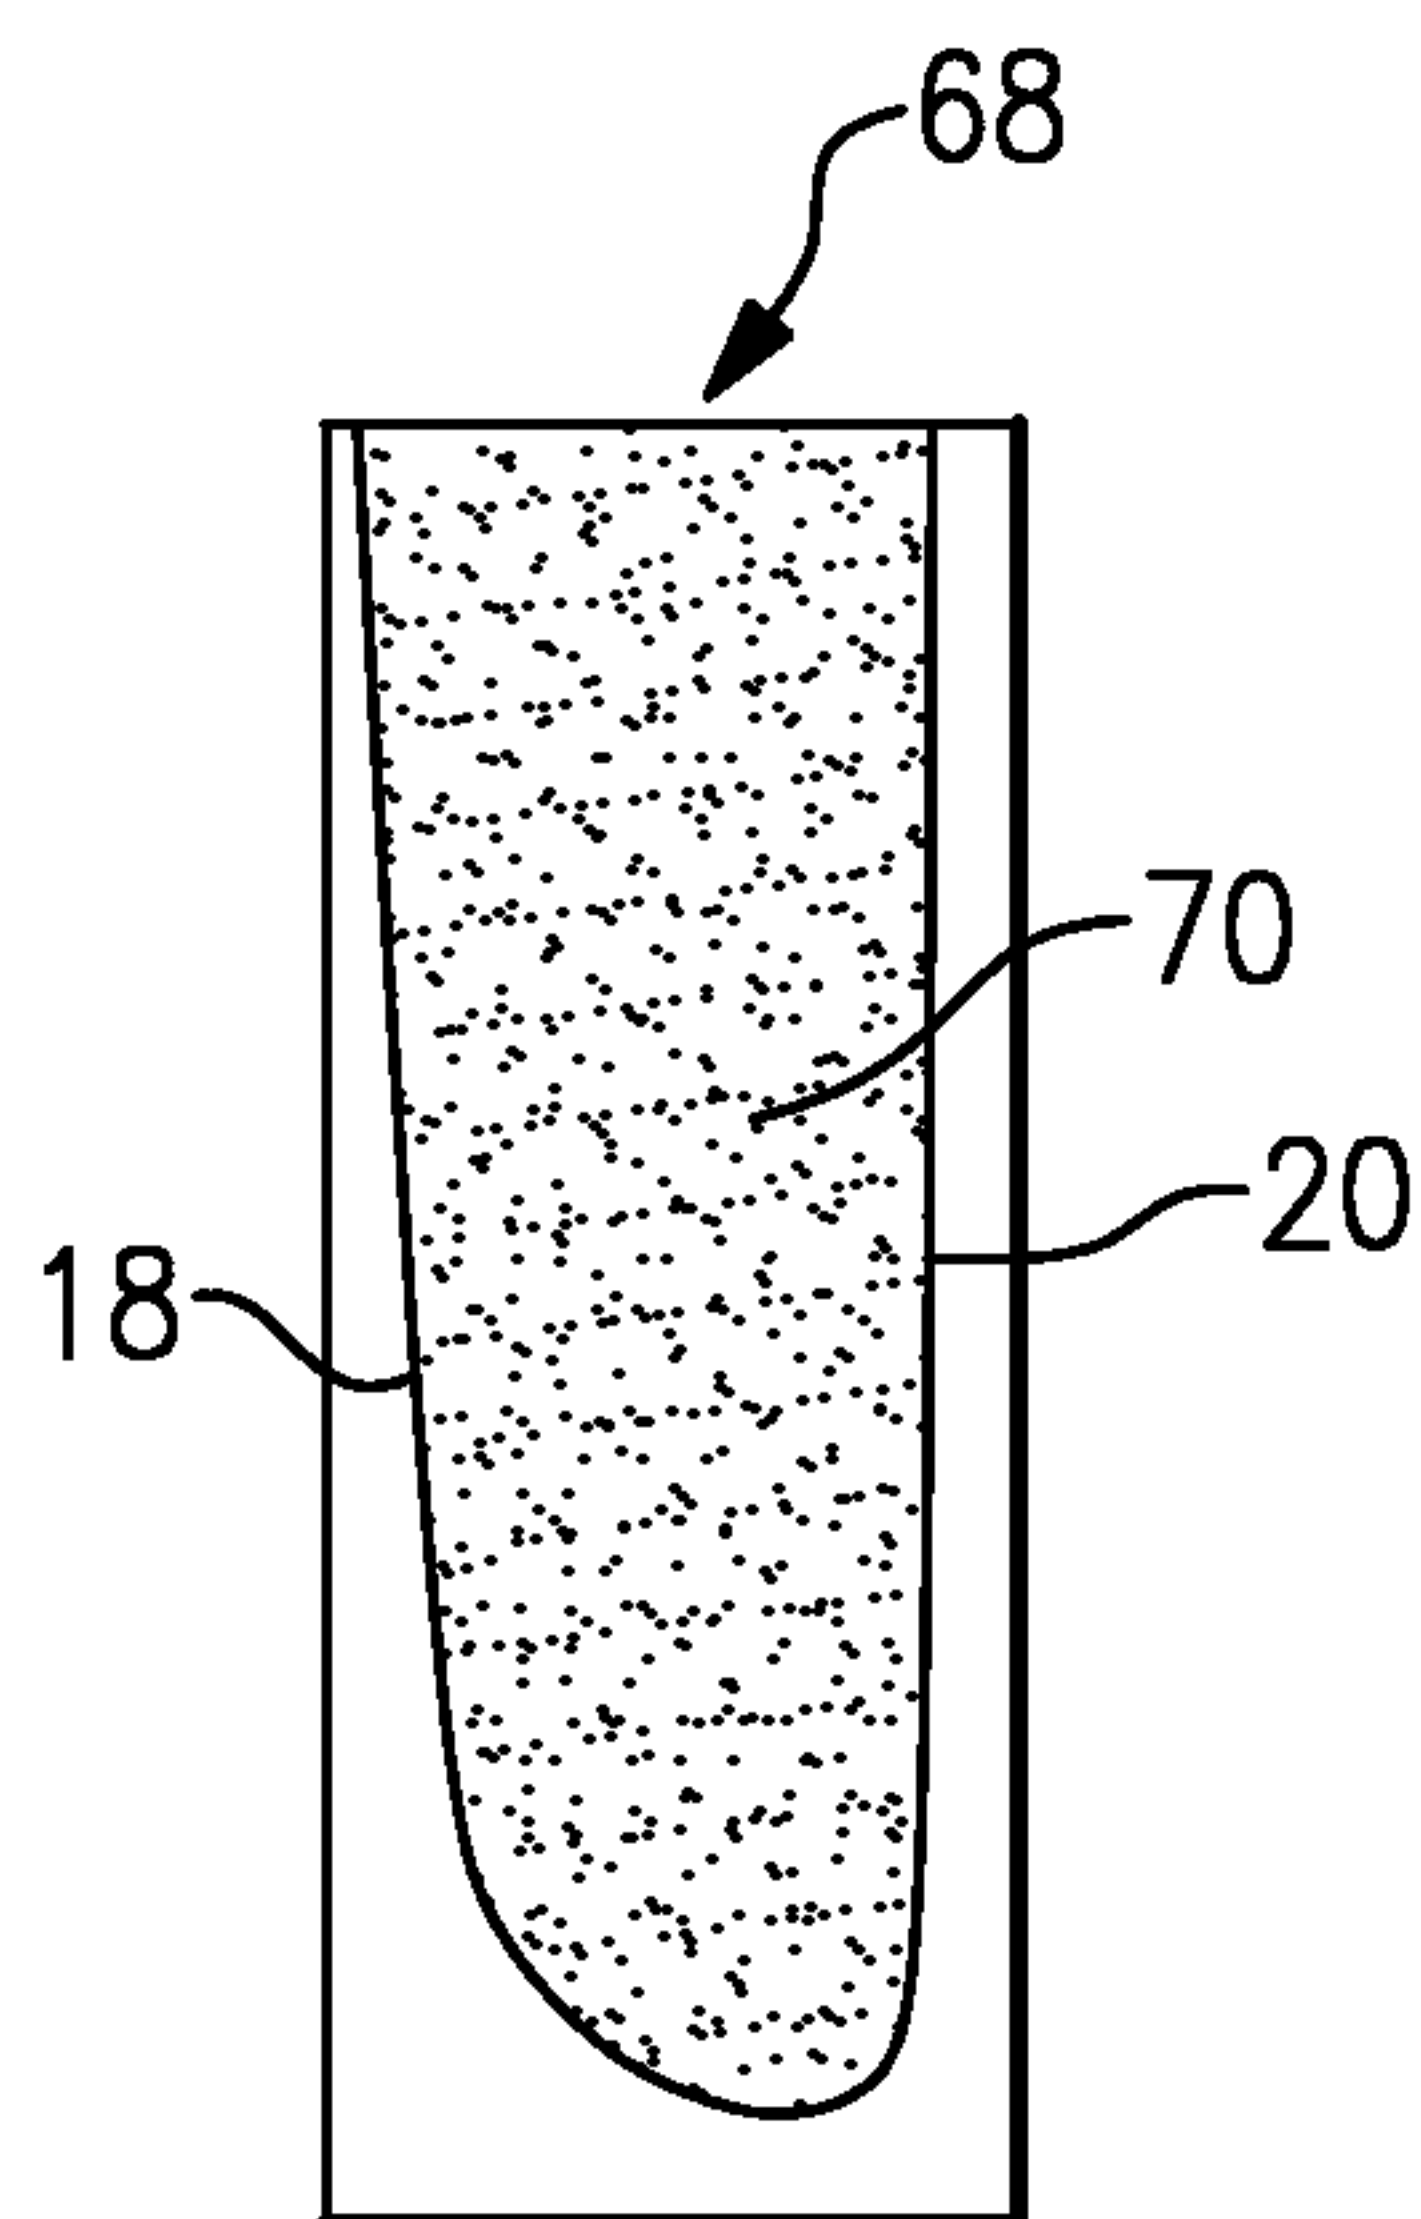
FIG. 8 schematically illustrates an image of a repair section having regions of plastic deformation.

FIG. 8 illustrates an example schematic image 68 using scanning electron microscope electron back-scatter diffraction patterns (Orientation Imaging Microscopy). In this

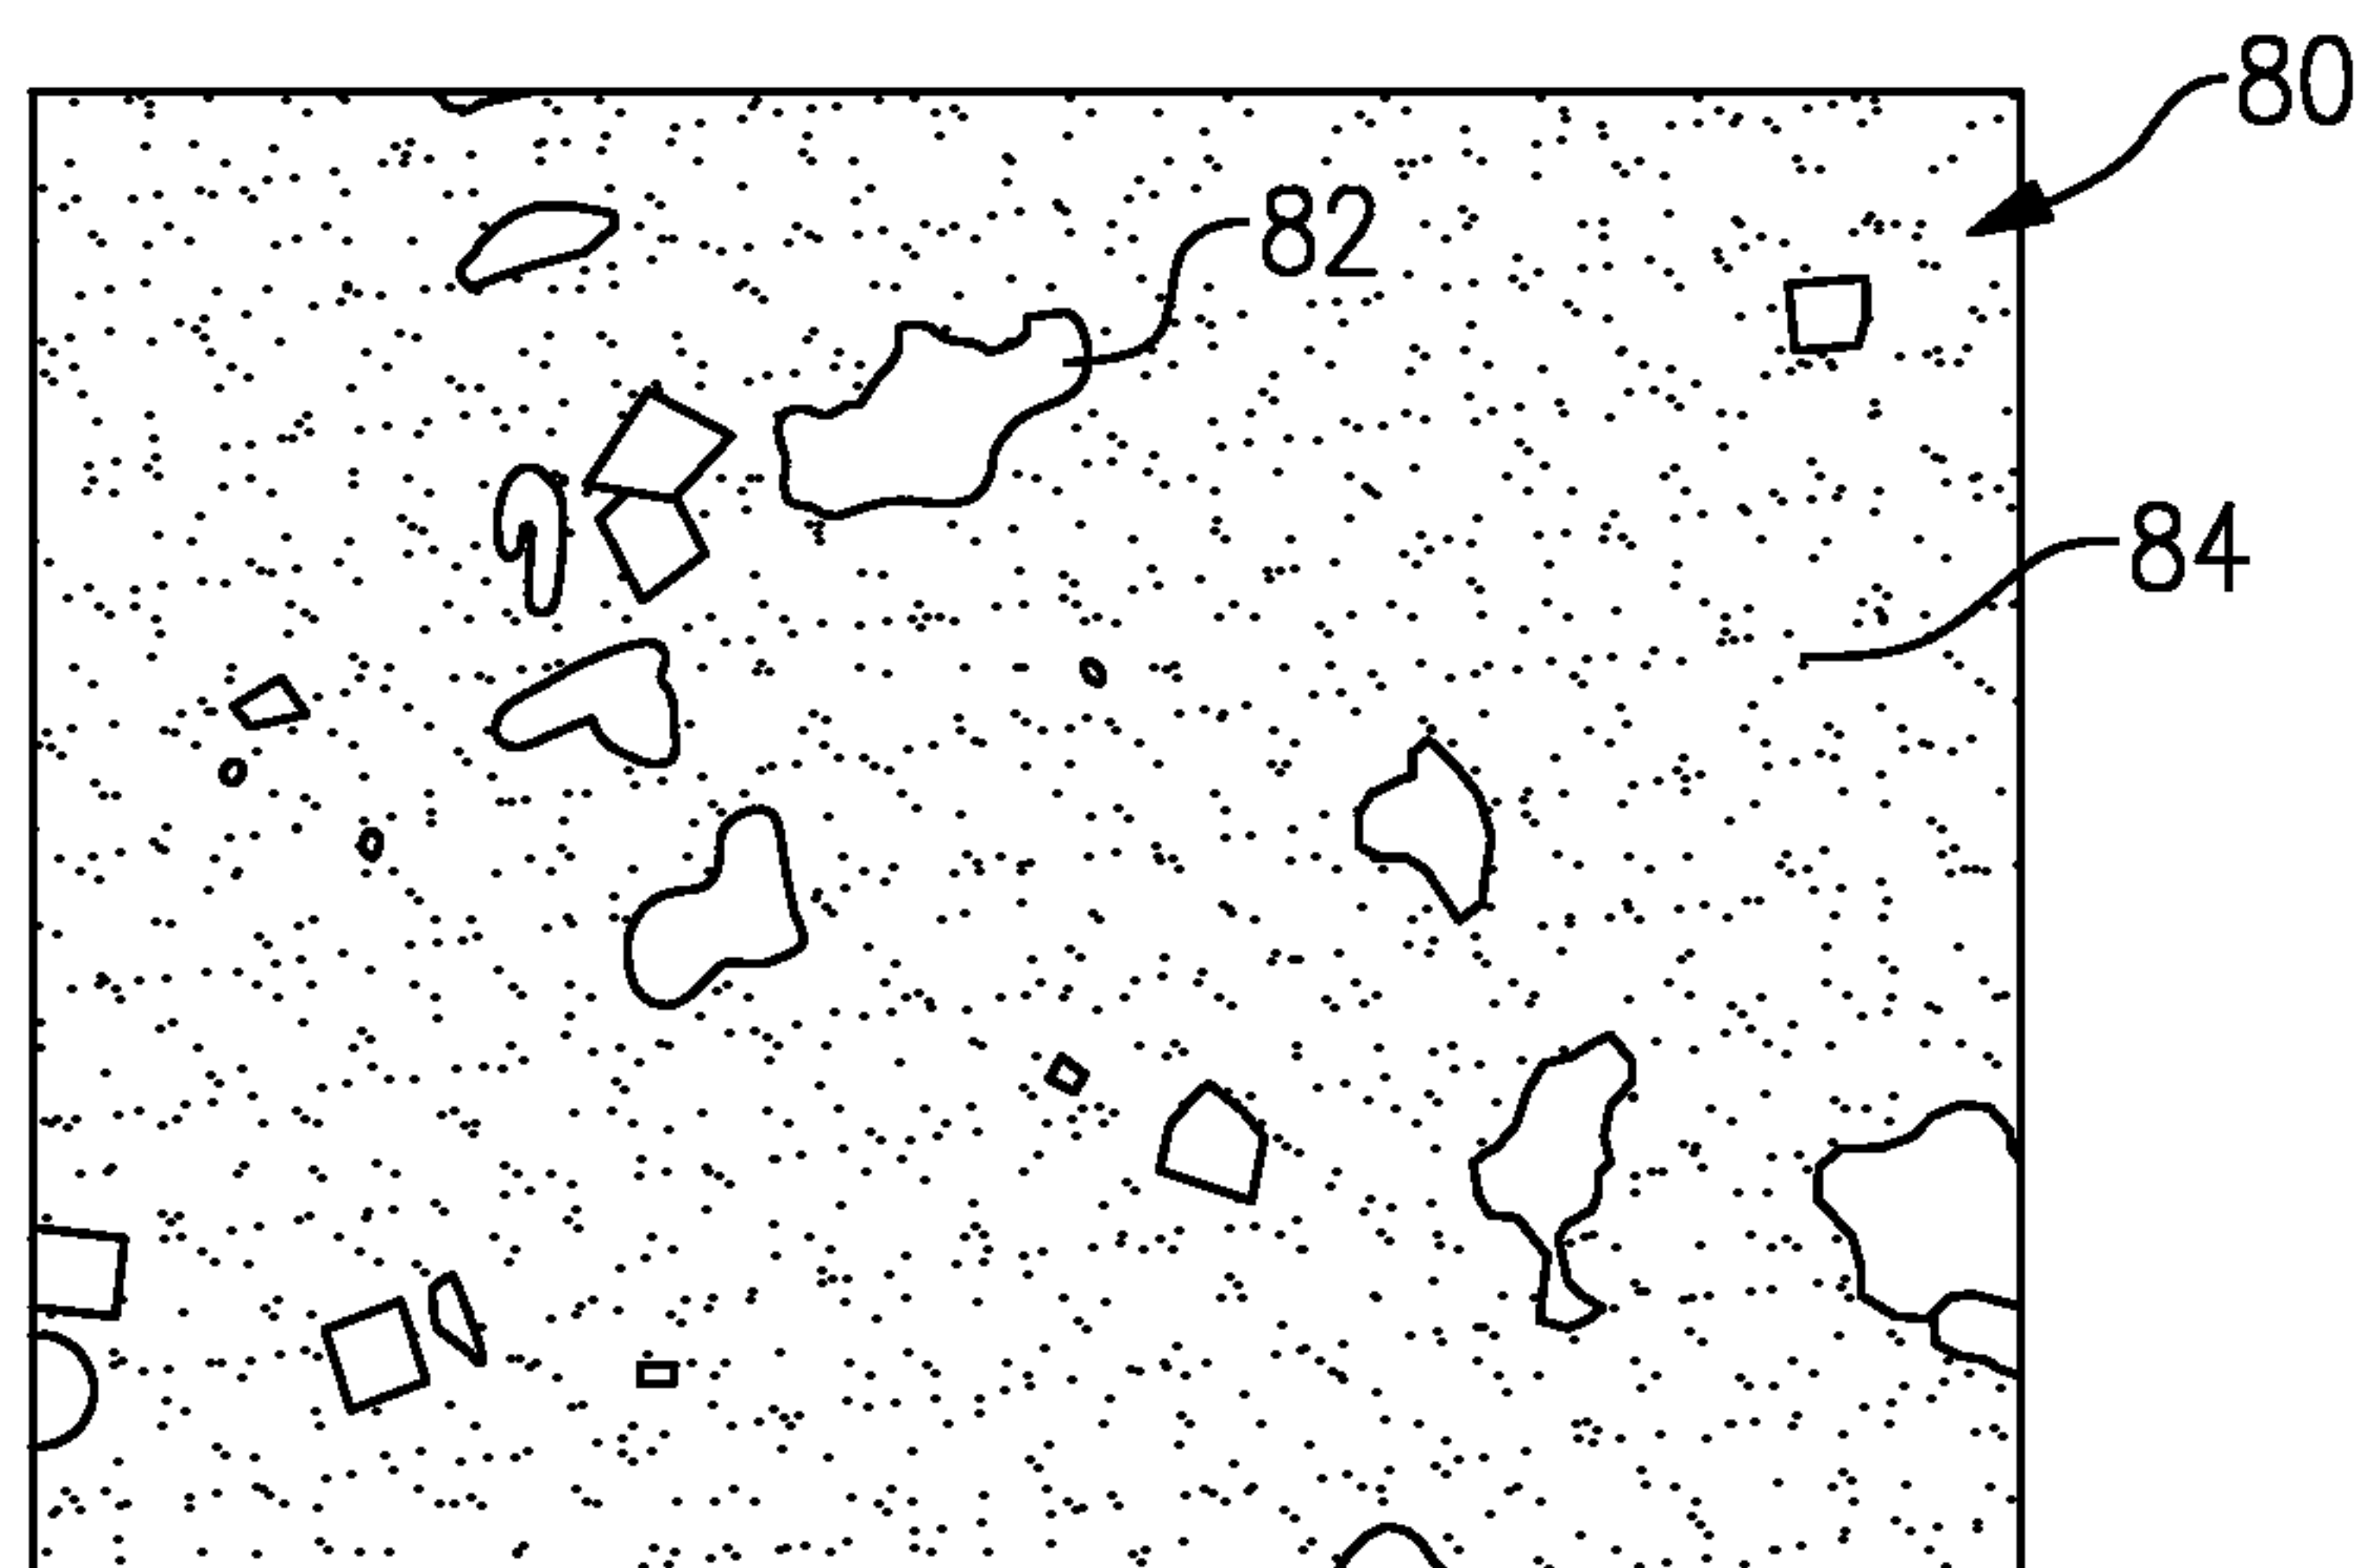
FIG. 9 illustrates an example microstructure that is substantially free of a delta phase.

Referring to FIG. 9, the method 40 may also be used to achieve a desirable microstructure 80. For example, the microstructure 80 includes regions of Laves phase 82 distributed within a matrix 84 of the alloy composition. In this example, the microstructure 80 is substantially free from, and in some examples entirely free of, orthorhombic delta phase regions of Ni_3Cb , which is a needle-shaped phase that is known to degrade physical properties (e.g., fatigue strength). For instance, the disclosed method 40 may be used to avoid a solution heat treating step that typically results in the formation of the delta phase. In some repair processes, an article having a repair section may be heat treated at 1750° F. or higher to homogenously solutionize elements within the alloy, and then be aged at approximately 1150-1350° F. (621-732° C.) to precipitation strengthen the alloy. The heat treating typically contributes to the formation of the delta phase. However, using the disclosed method 40, the solution heat treating step can be eliminated because the plastic deformation and dislocations from the mechanical working contribute to improving fatigue strength and thereby lessen the need for heat treating. Therefore, at least the heat treating step may be eliminated, although it still may be desirable to utilize the aging process to achieve a degree of precipitation strengthening.
