**DEFECT INSPECTION METHOD AND  
APPARATUS THEREFOR****CROSS-REFERENCE TO RELATED  
APPLICATION**

The present invention relates to a defect inspection method and an apparatus therefor, for inspecting whether or not a defect exists on an object to be photographed by irradiating the object to be photographed with striped illumination.

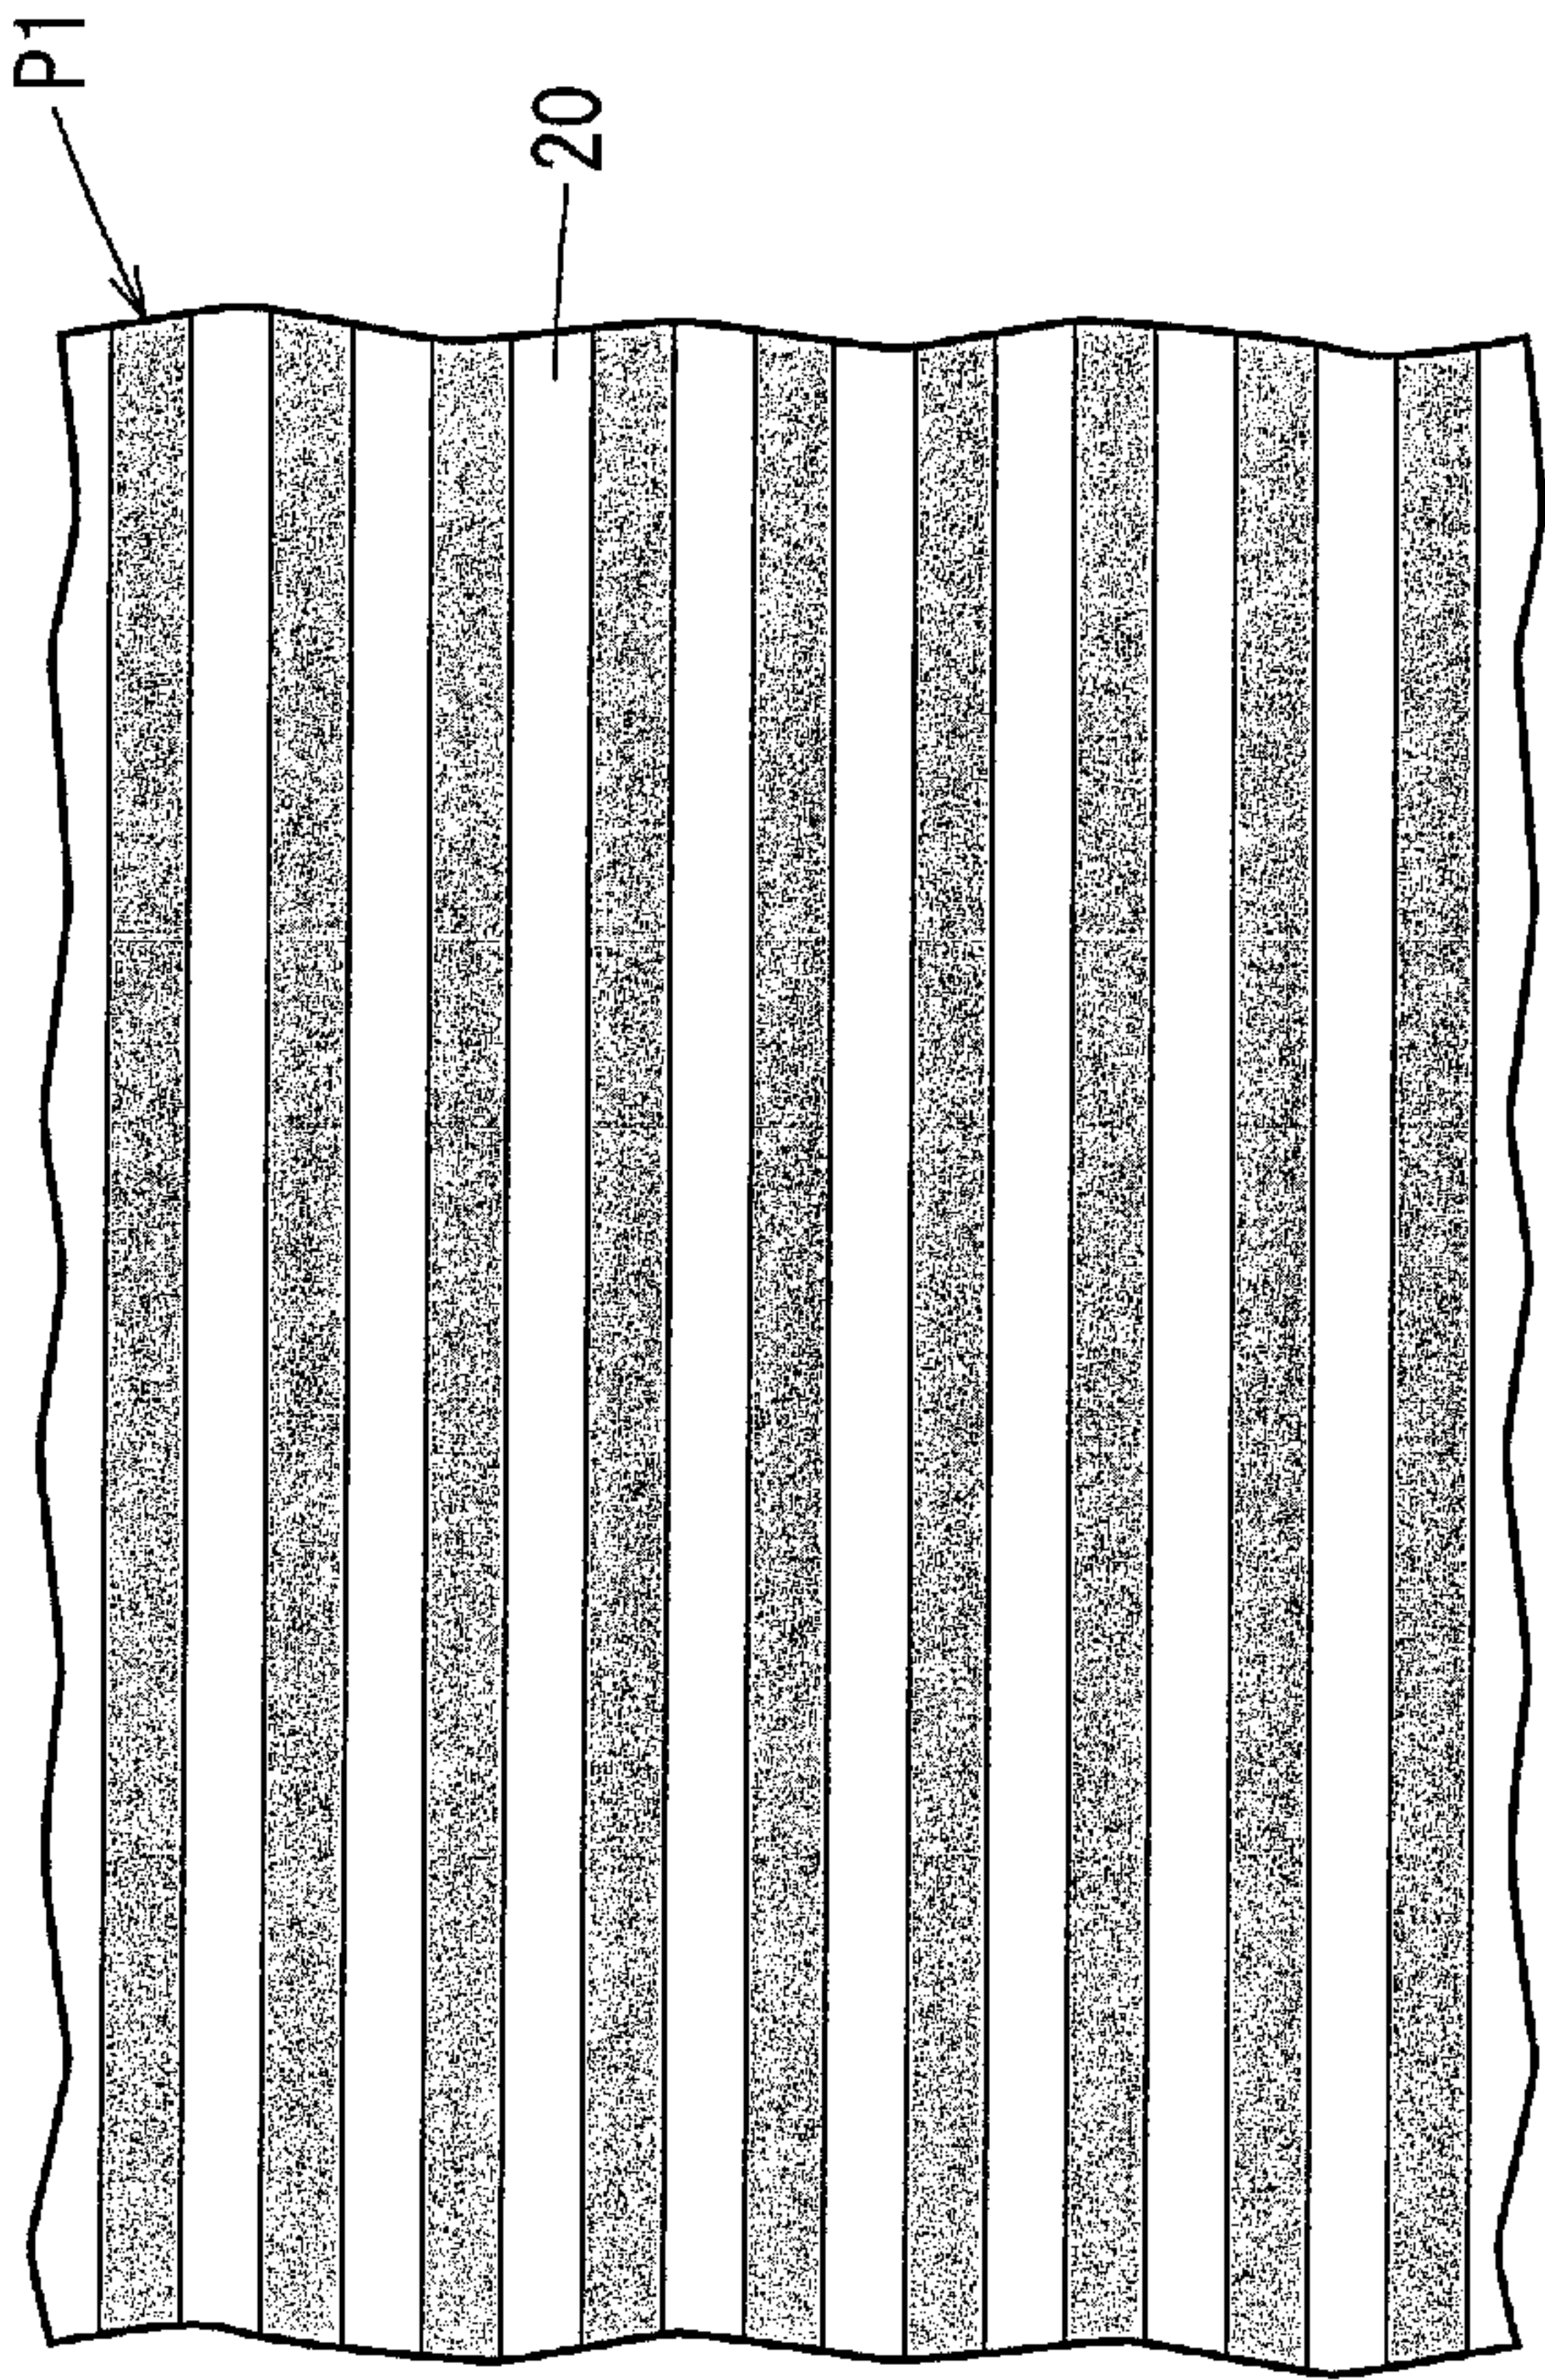
FIG. 3 is a plan view showing a striped shaped light and dark pattern that is formed on an automobile body as an object to be photographed; and

Consequently, the stripe shaped light and dark pattern P1 is formed without interruption on the automobile body 20, as shown in FIG. 3.

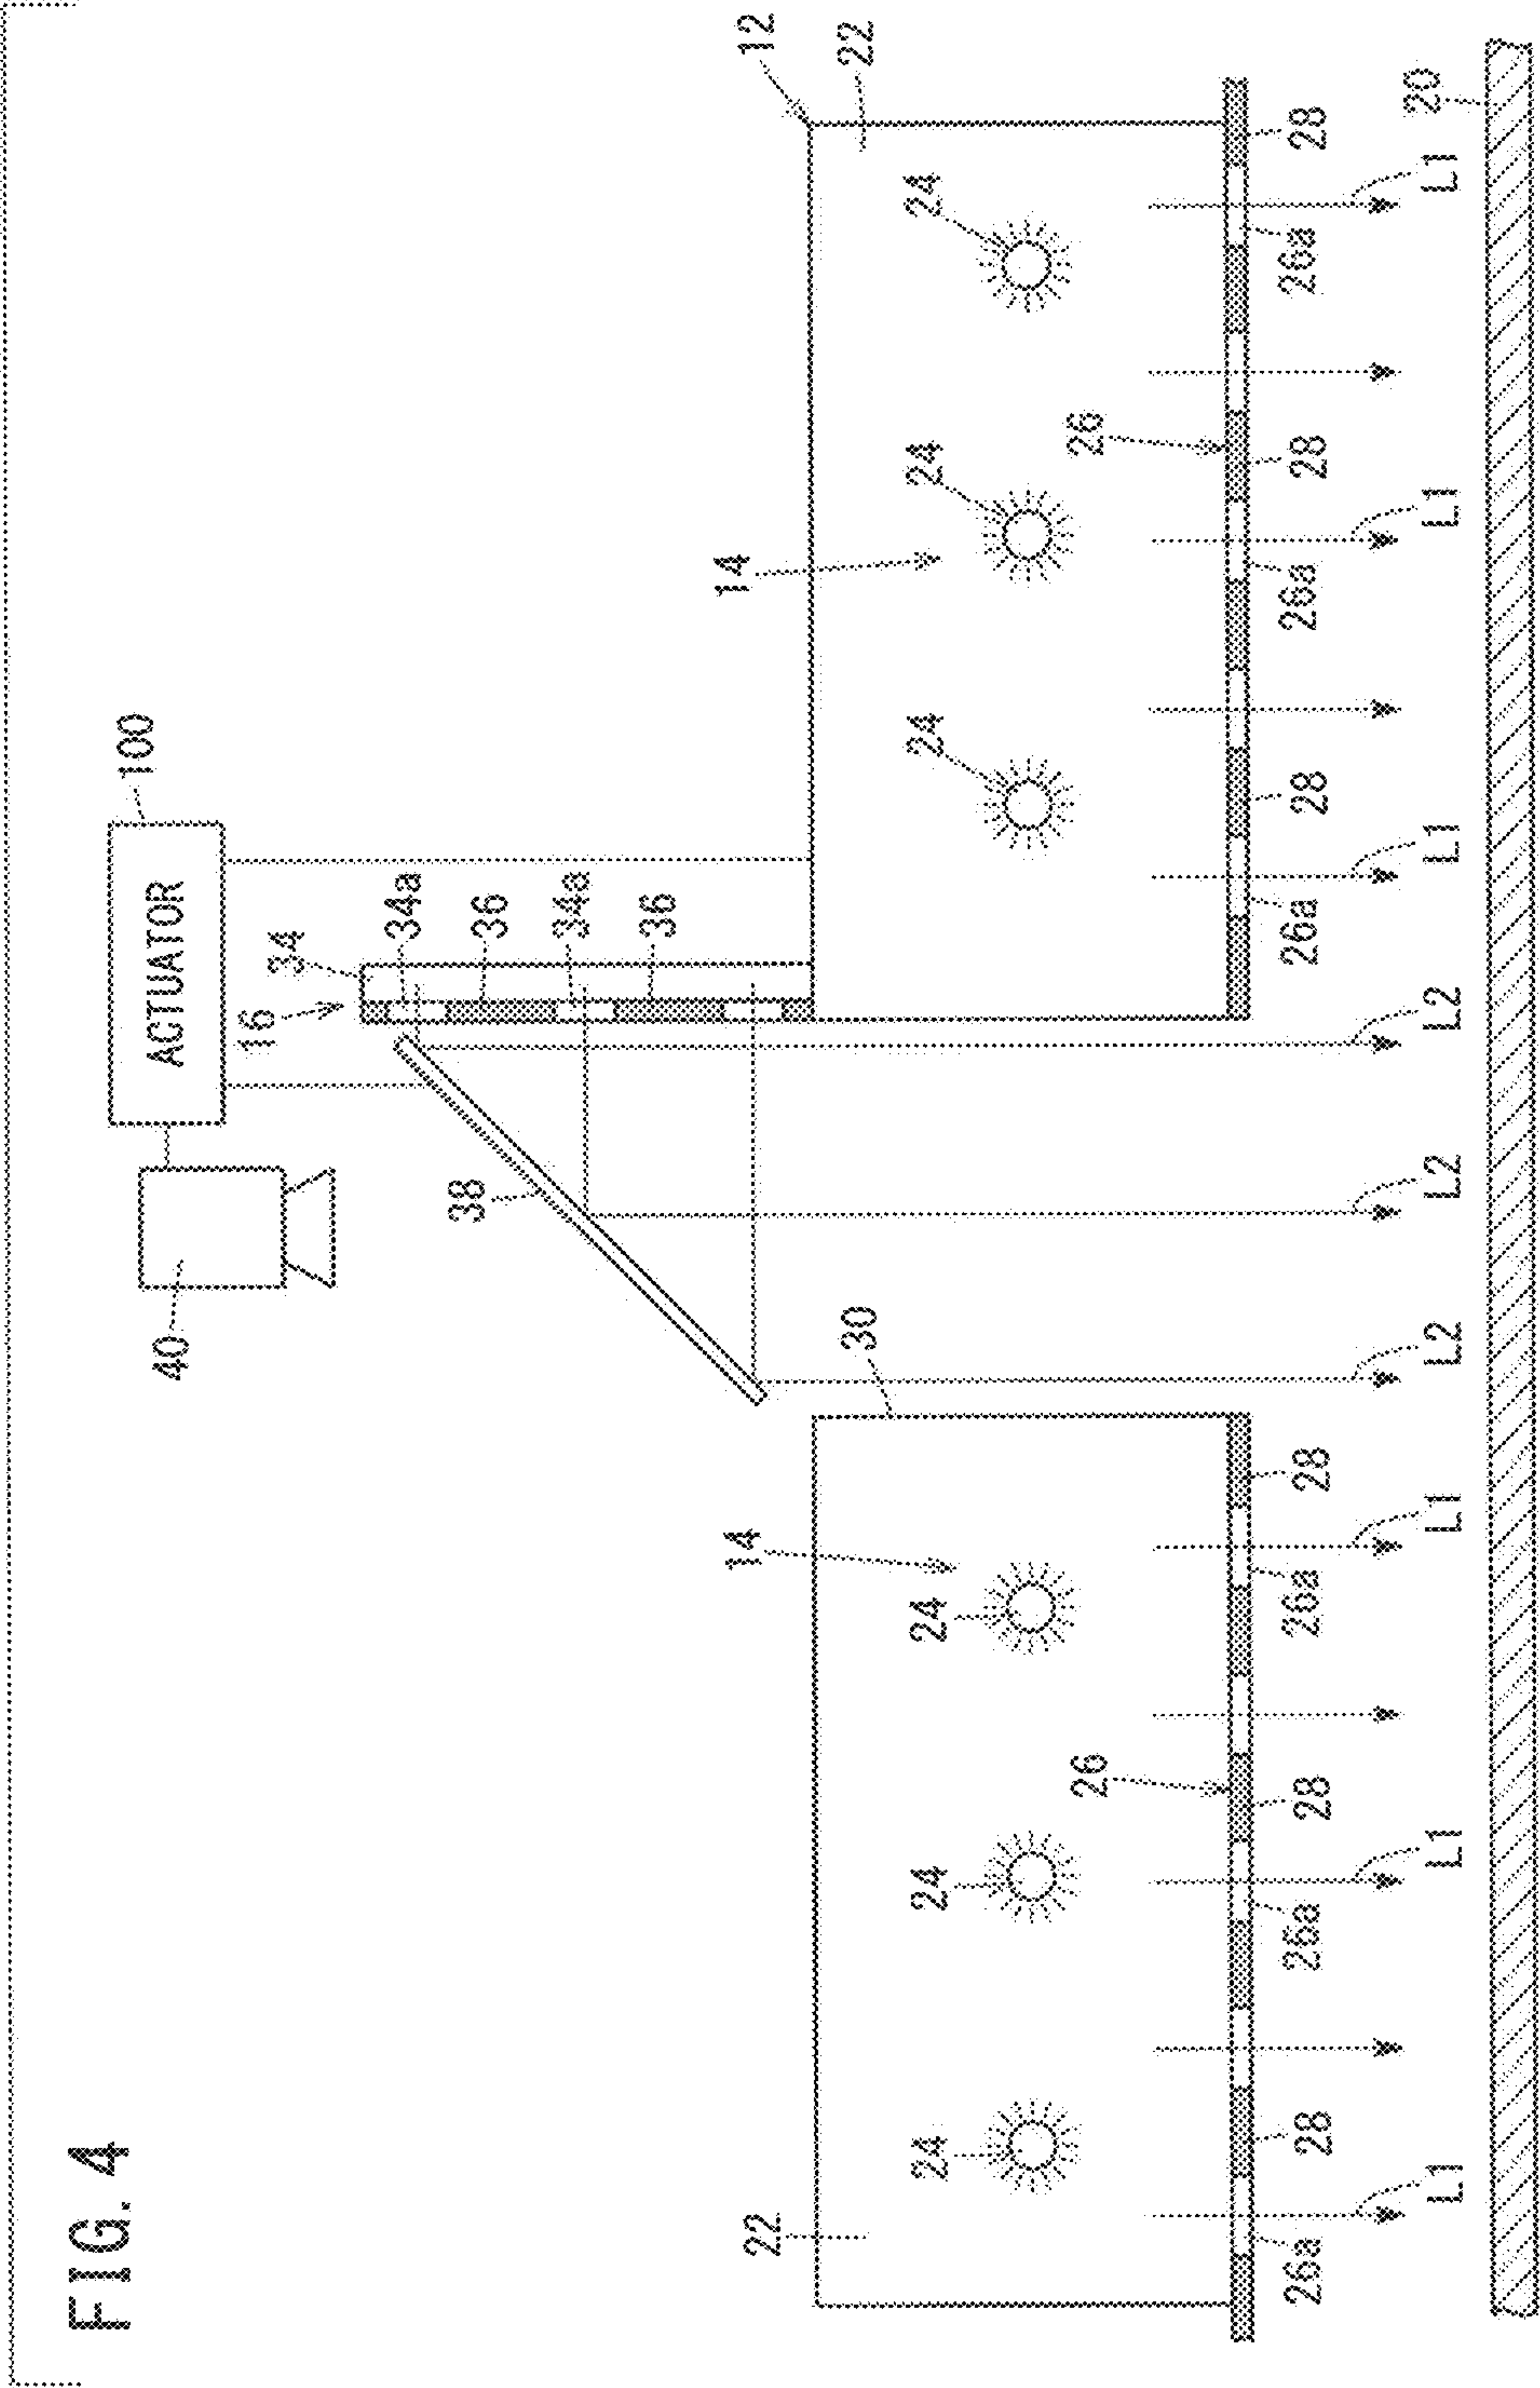
FIG. 4 is a schematic vertical cross-sectional view of principal parts of a defect inspection apparatus in which a half mirror and a second slit light source are disposed above a through hole.

For example, the arrangement locations of the second slit light source 16 and the half mirror 38 are not limited to being in the interior of the through hole 30, and they may be disposed at the positions shown in FIG. 4. For example, the second slit light source 16 is disposed in the vicinity of the upper opening of the through hole 30, and the half mirror 38 is arranged upwardly of the through hole 30. In this case as well, the second slit light L2 from the second slit light source 16 first proceeds in a horizontal direction. Thereafter, the second slit light L2 is refracted by the half mirror 38 and proceeds in a vertical downward direction, whereupon the second slit light L2 is made incident on the automobile body 20. Consequently, the same inspection results are obtained as in the case shown in FIG. 2.
