(54) **FIRESHIELD FASTENER HOOD**

(57) **ABSTRACT**
A fireshield fastener hood and method of bonding a cover to a substrate therefor.

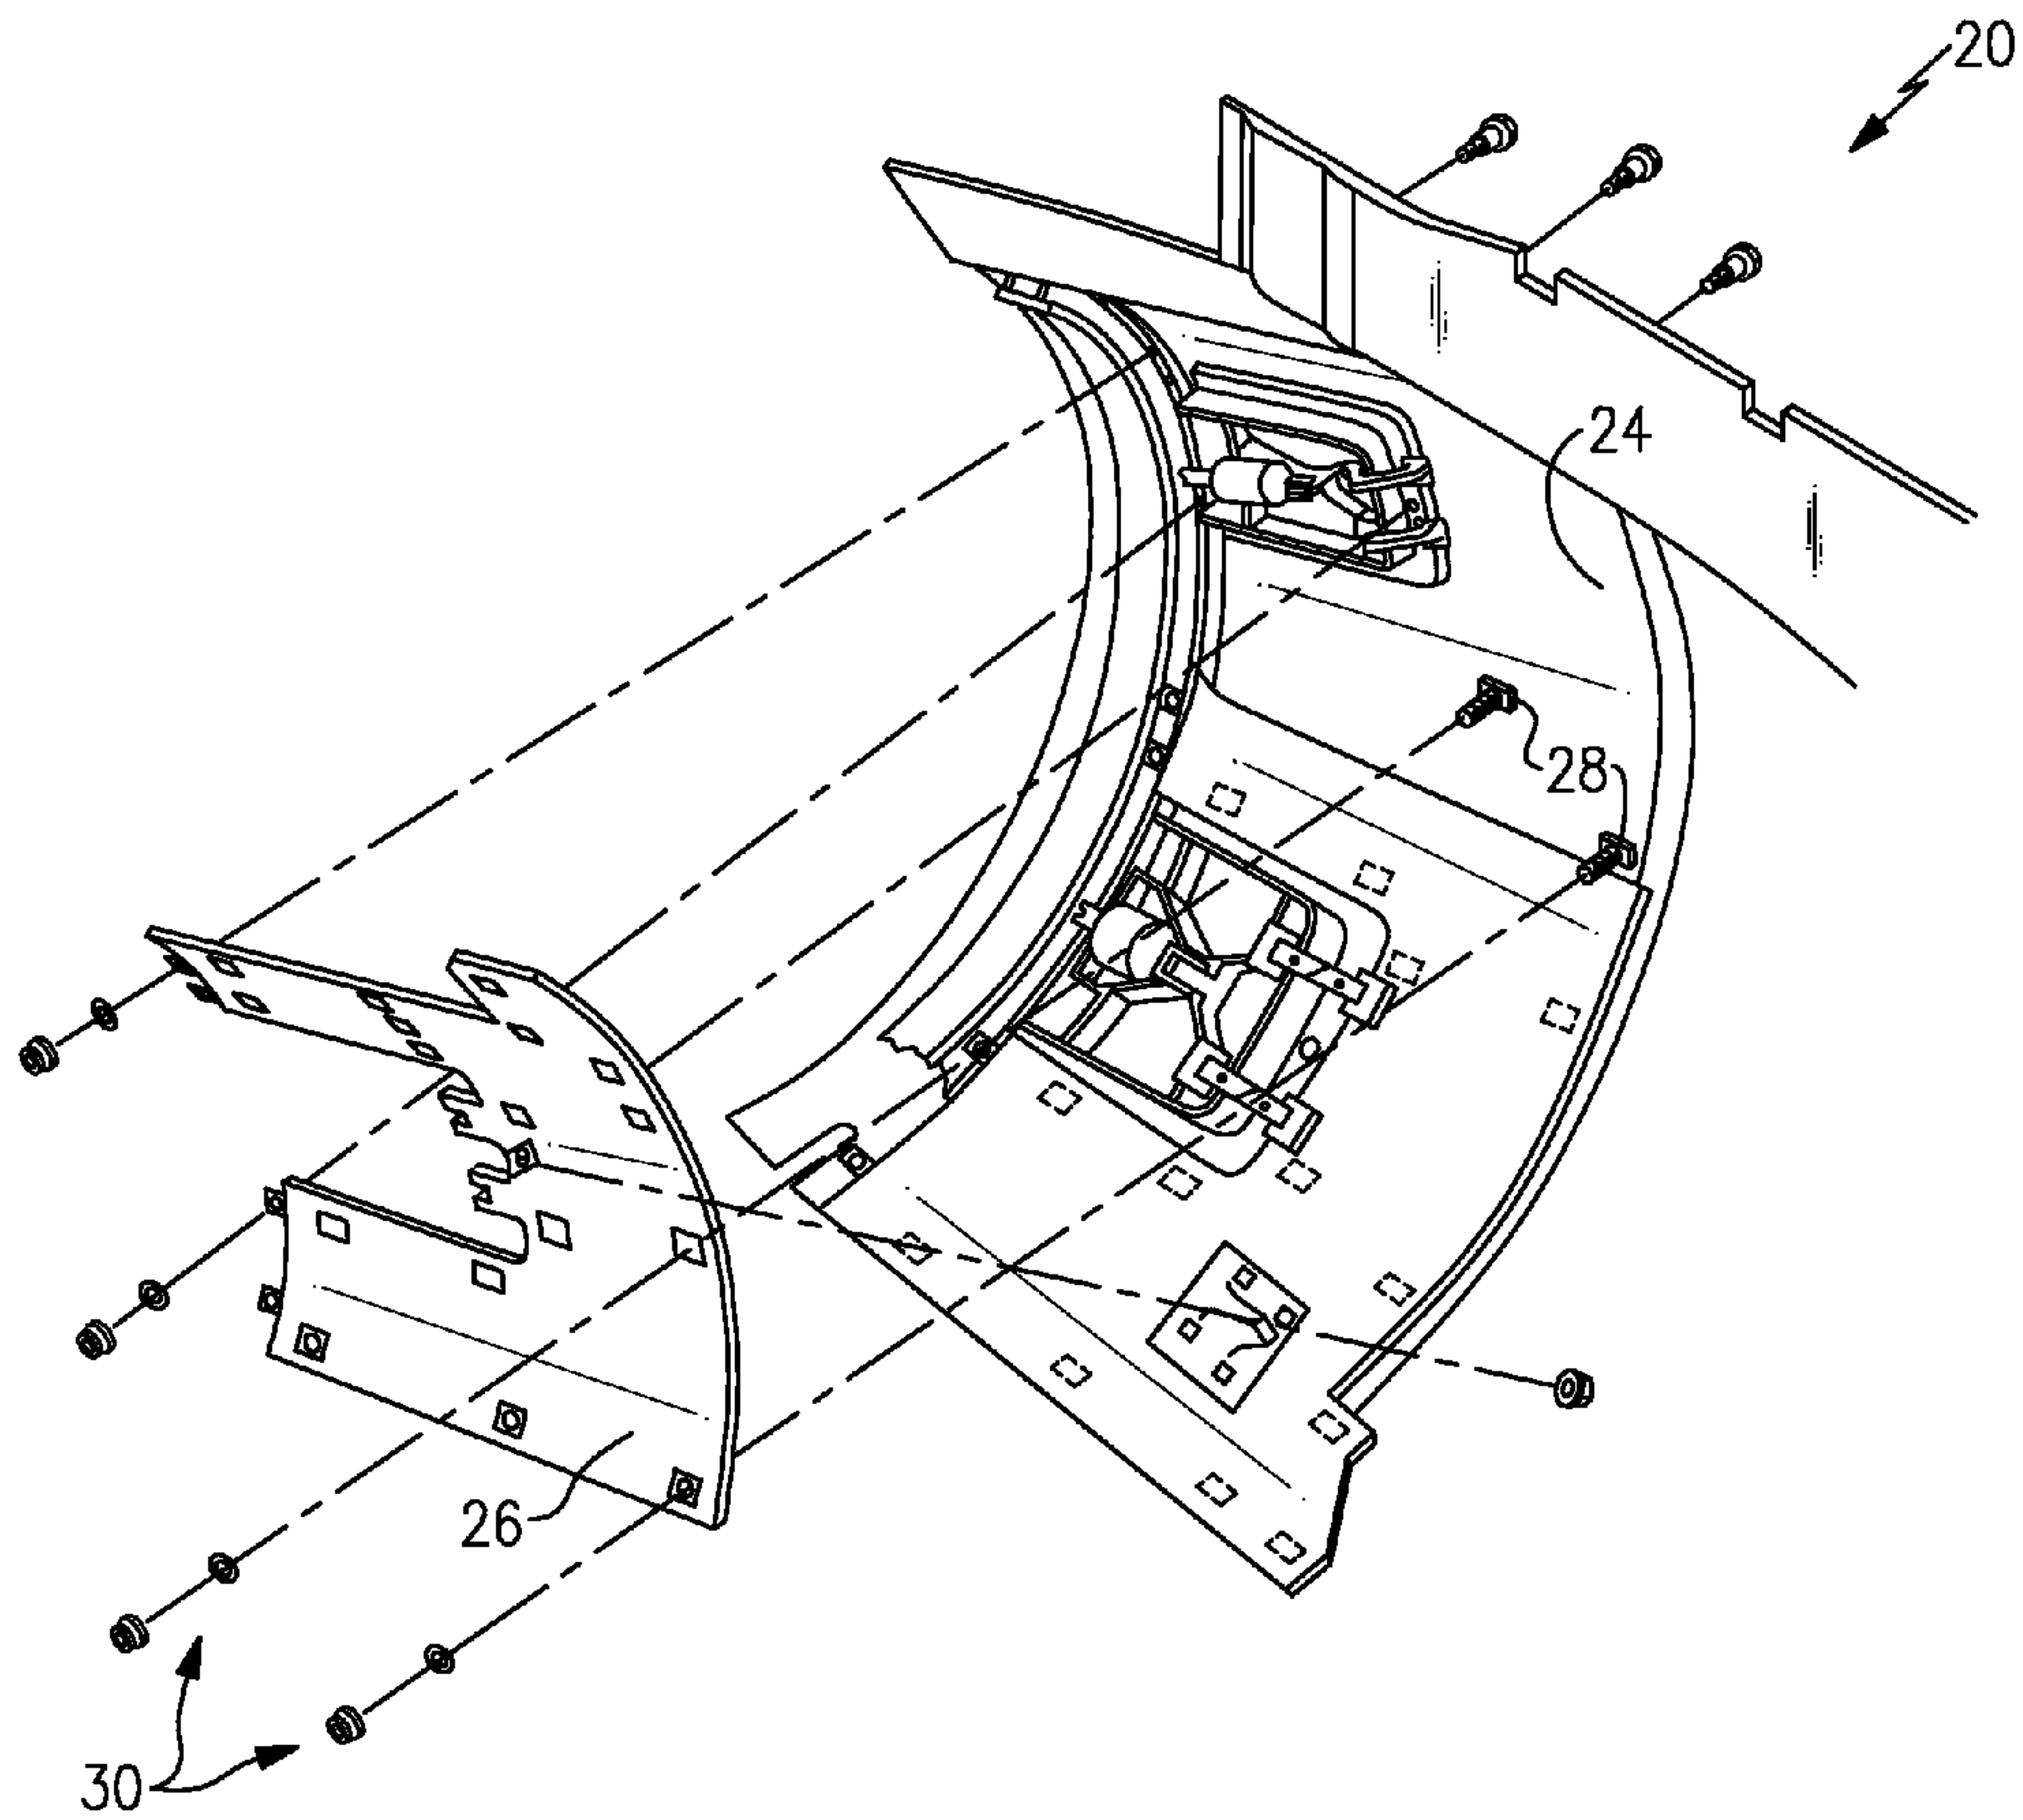
FIG.2

FIG. 2 is an exploded view of a fireshield of the nacelle structure of FIG. 1;

With reference to FIG. 2, the nacelle structure 20 generally includes an inner cowl section 24 onto which is mounted a fireshield 26. The cowl section 24 is typically manufactured from a carbon fiber or light weight metallic material such as an aluminum alloy which may require the thermal protection of the fireshield 26 during normal service or in the abnormal event of a fire in that compartment.

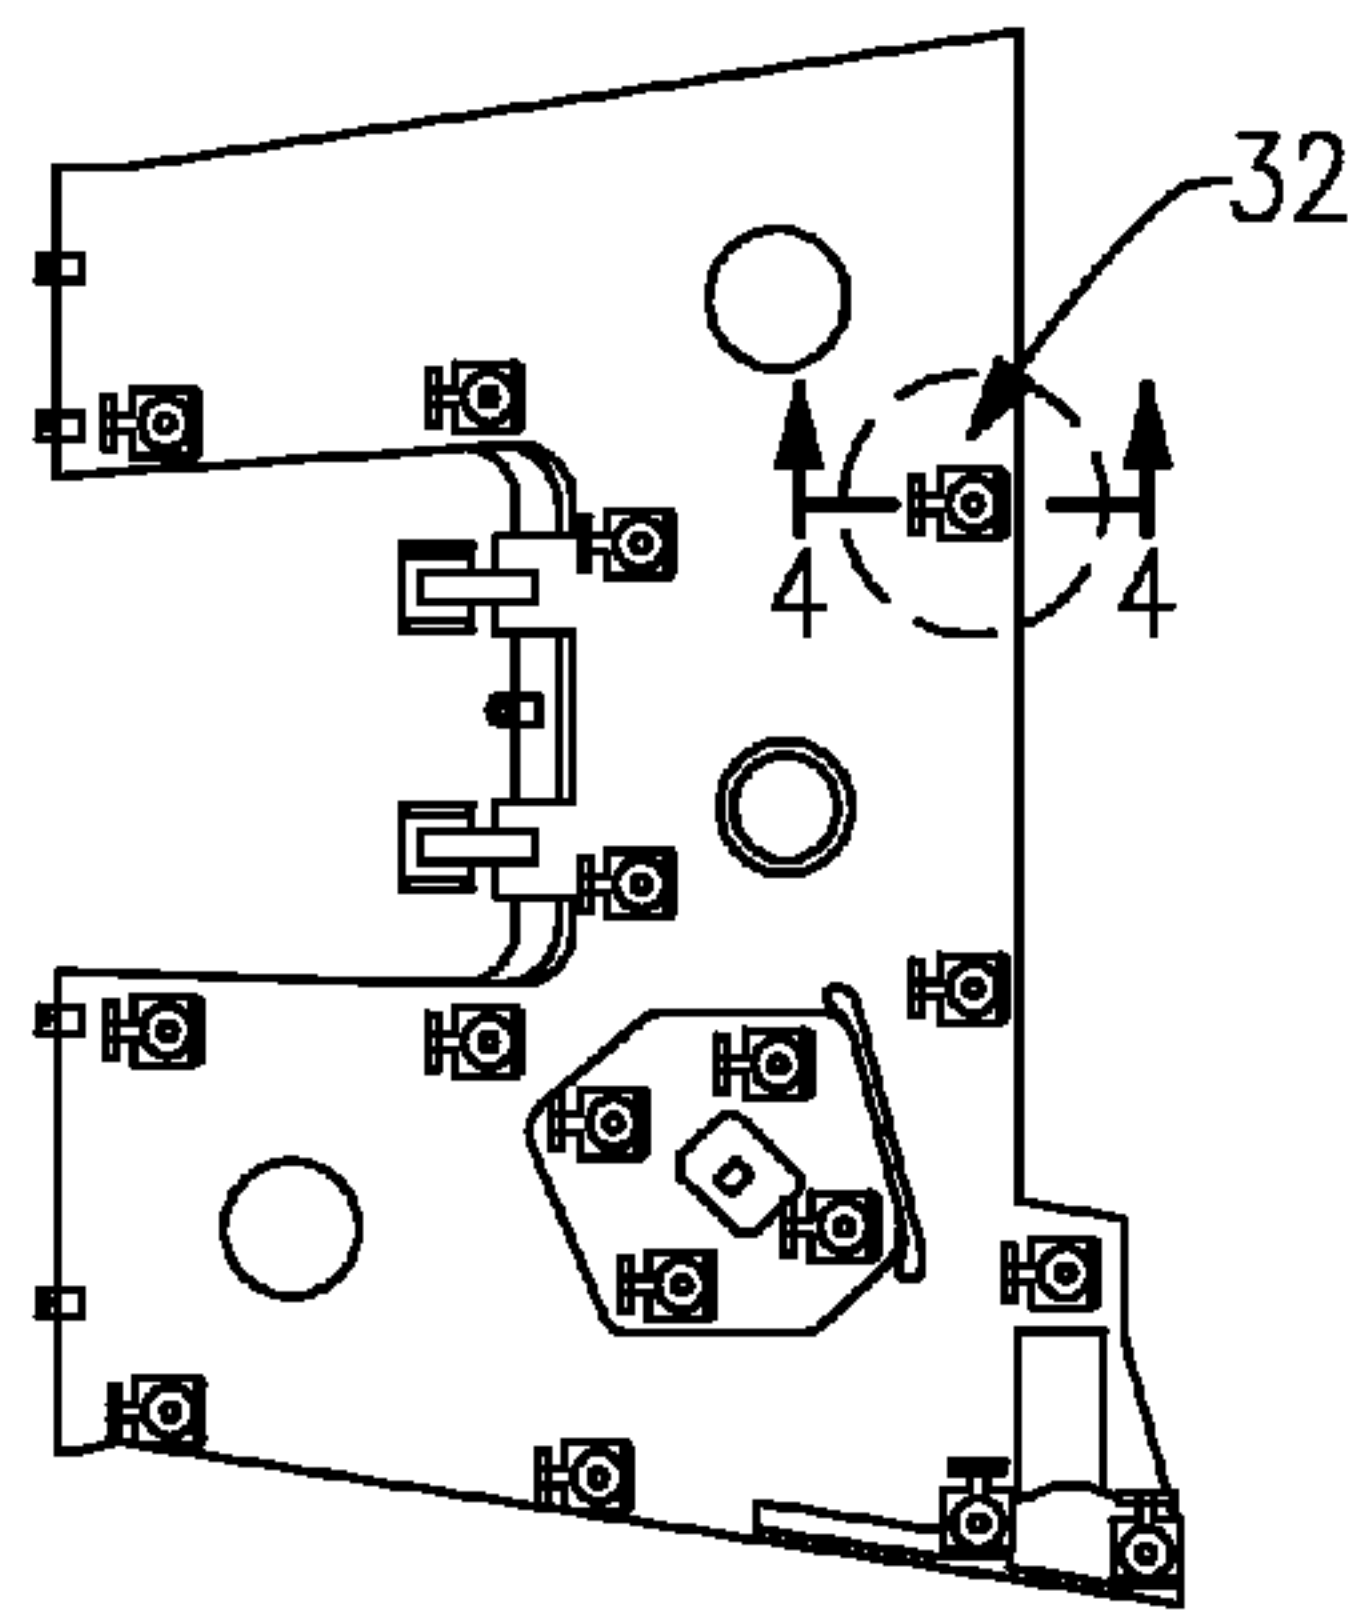
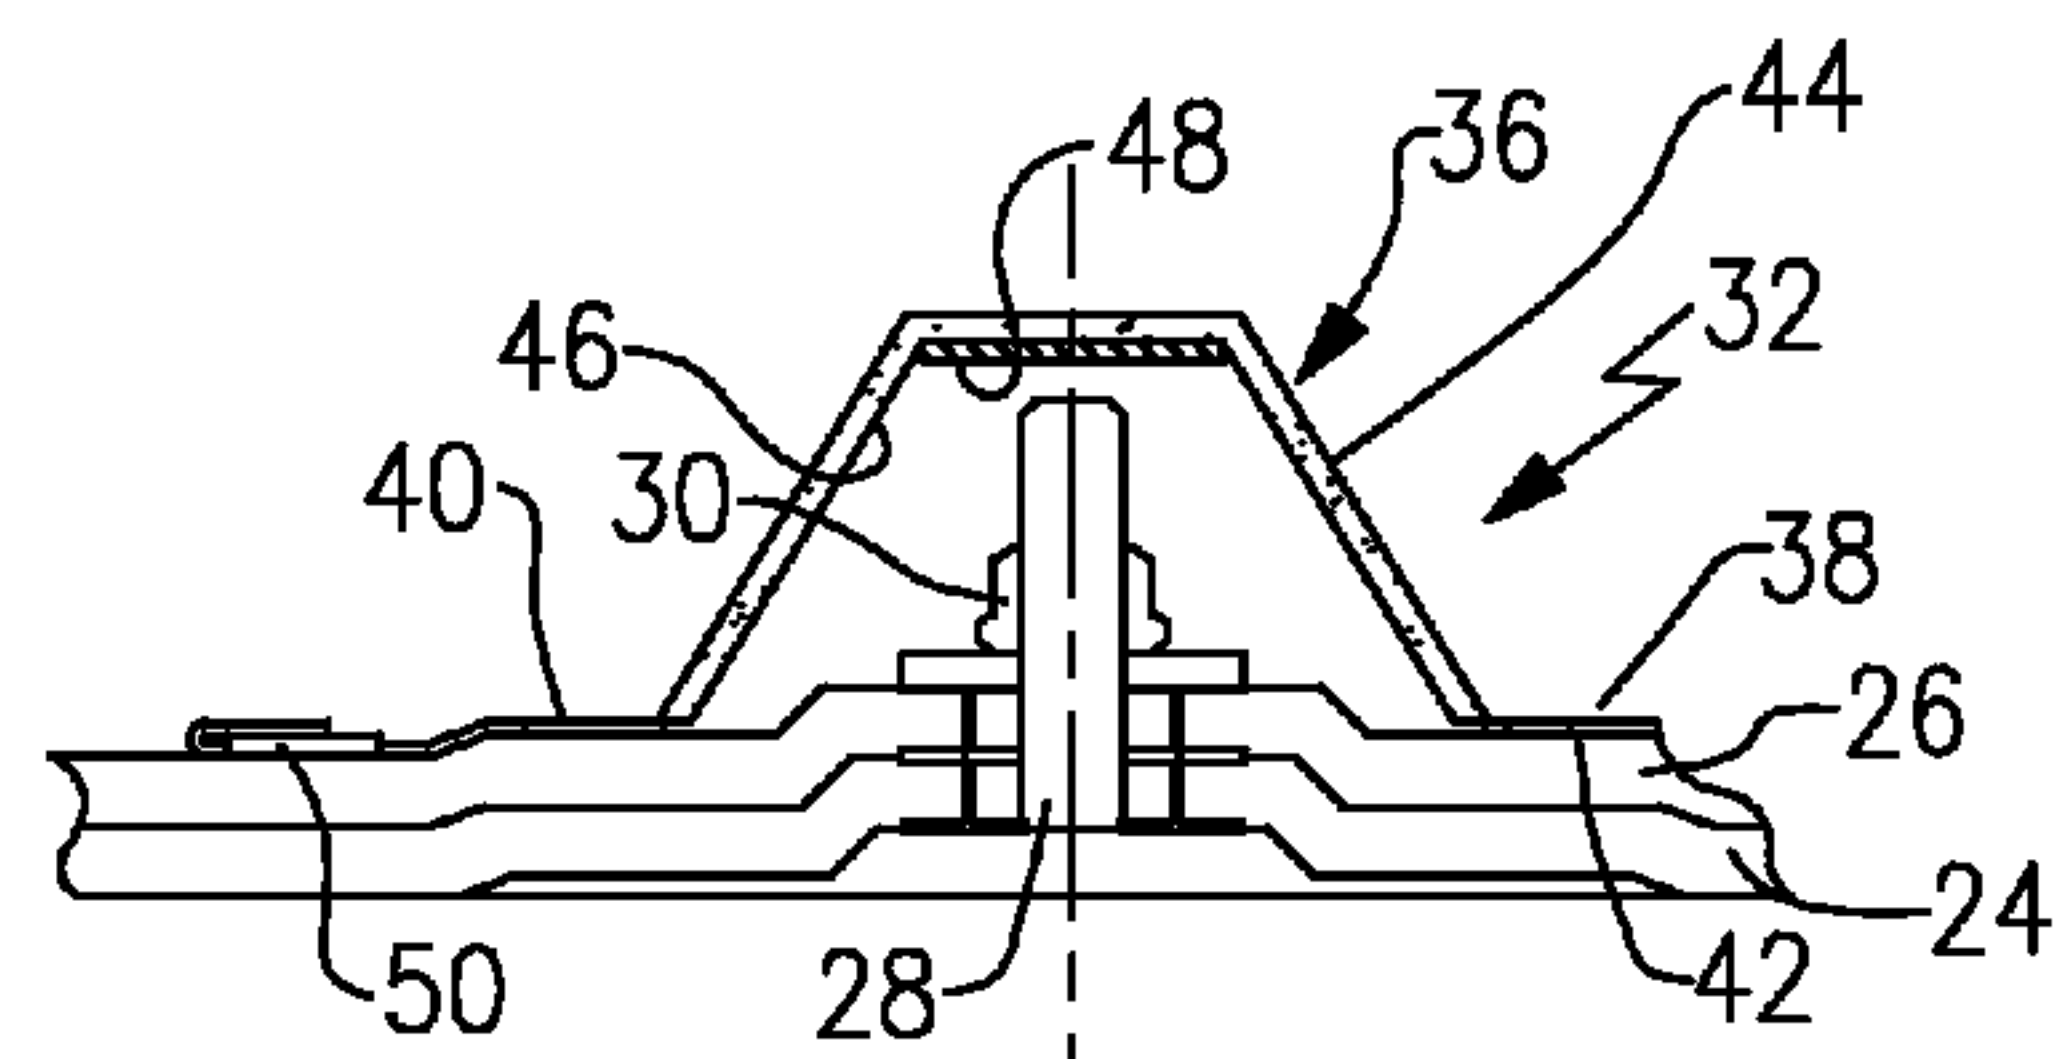
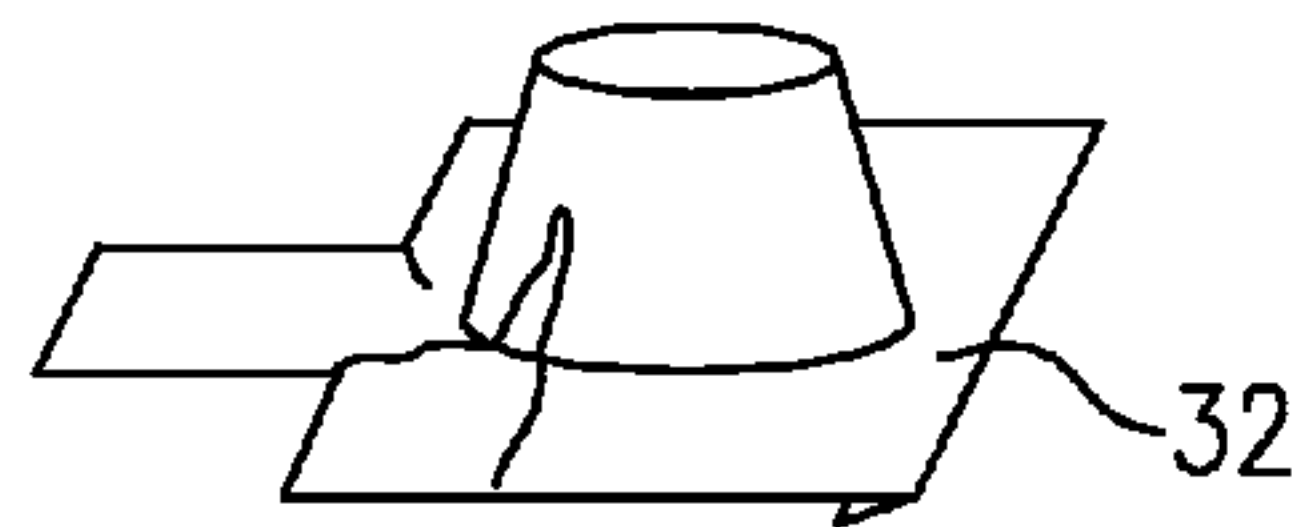
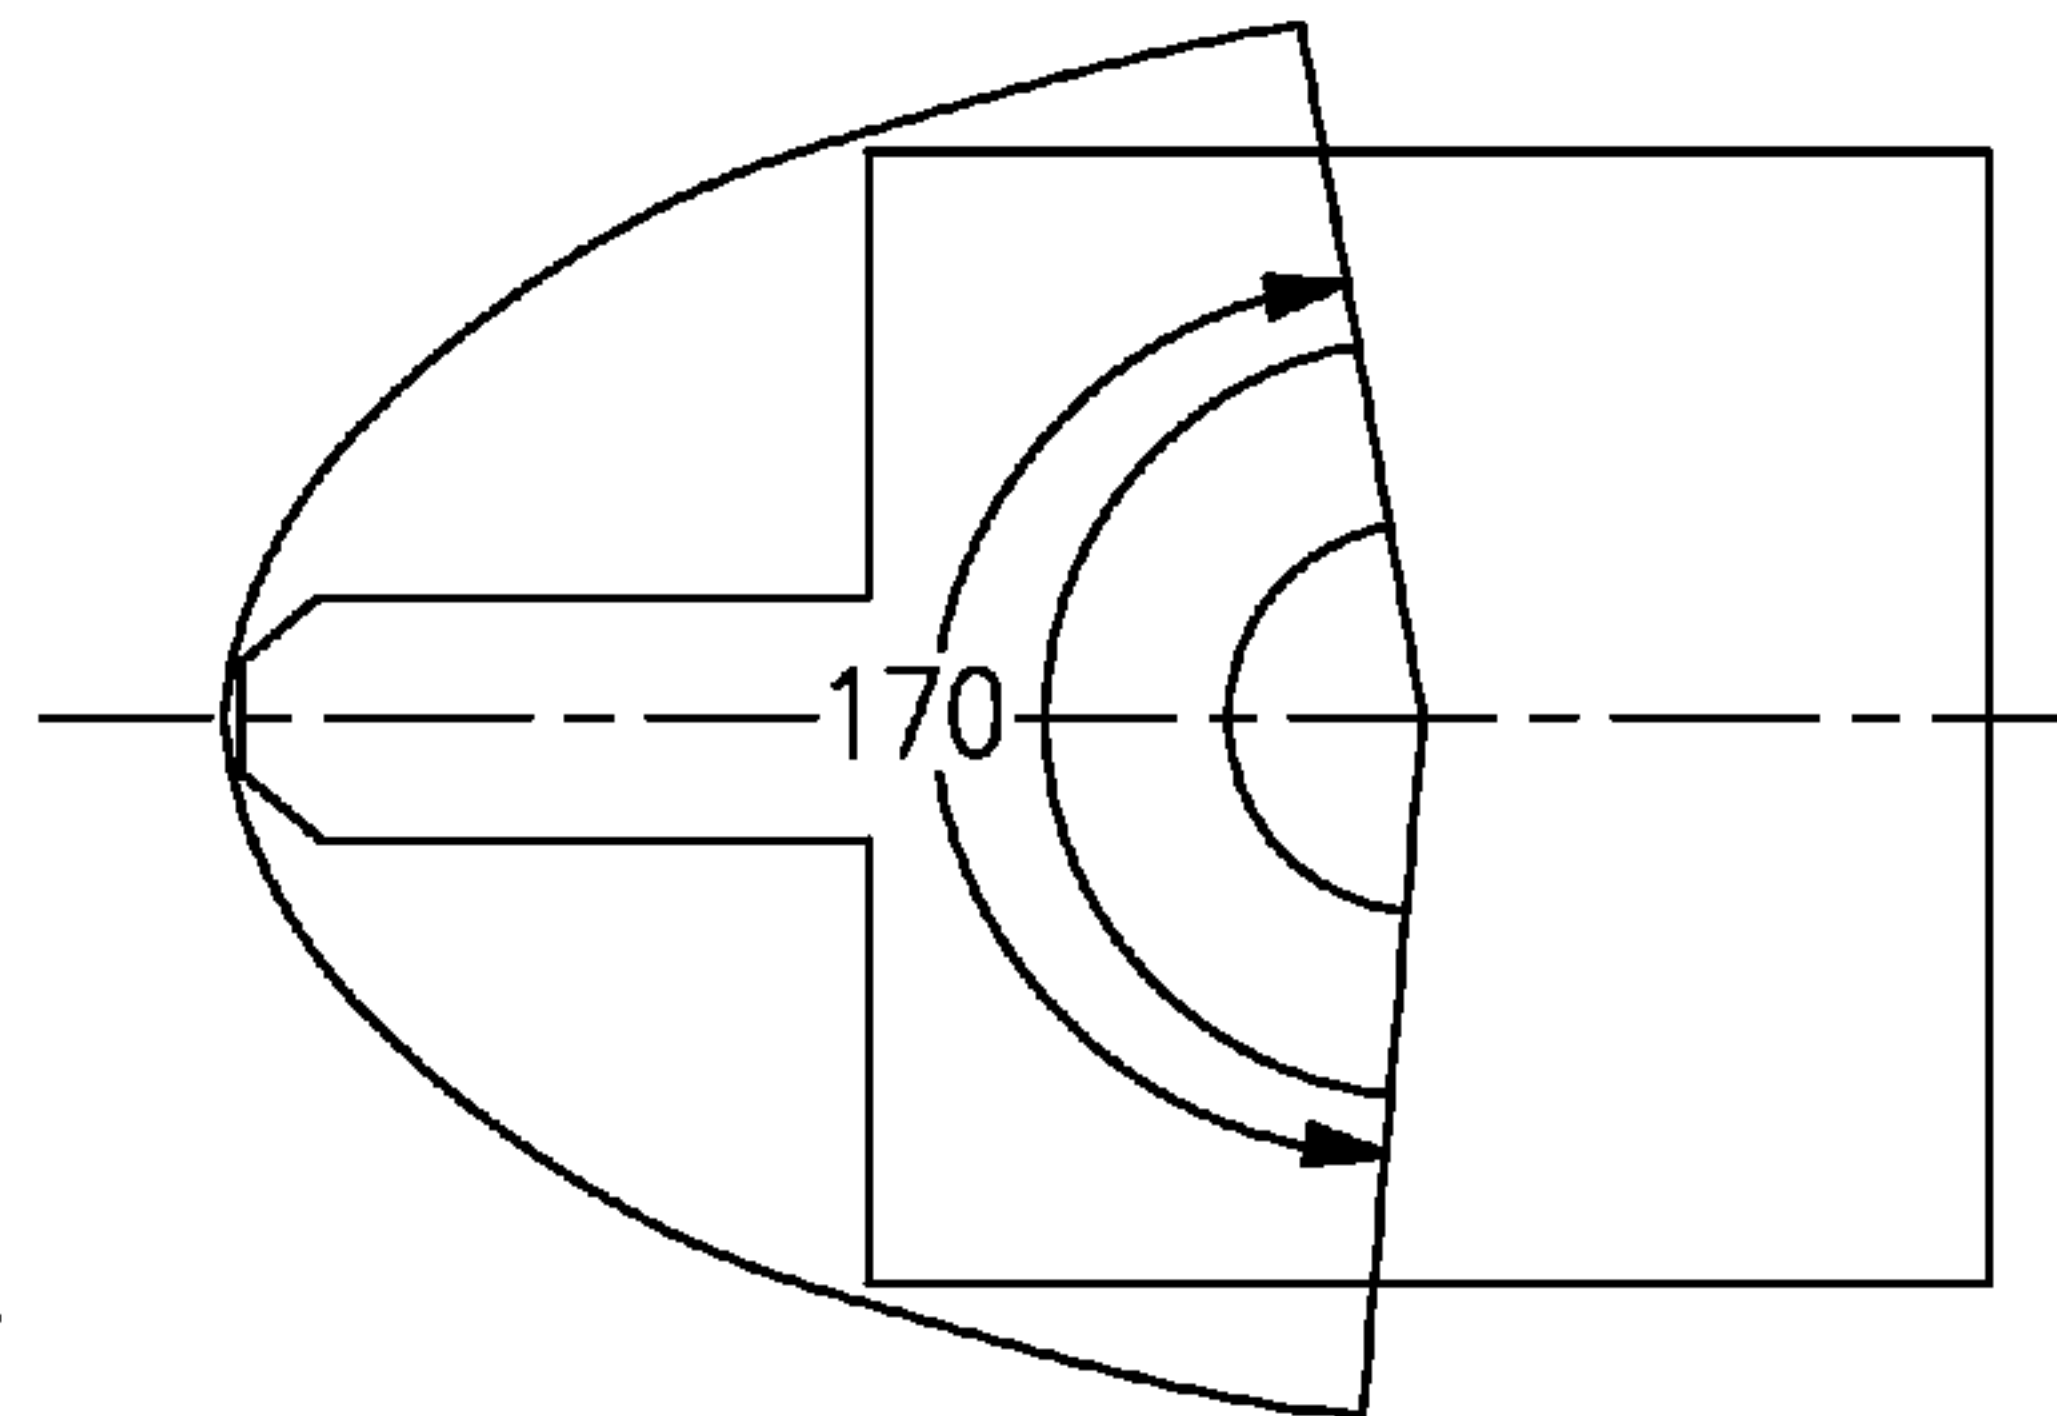
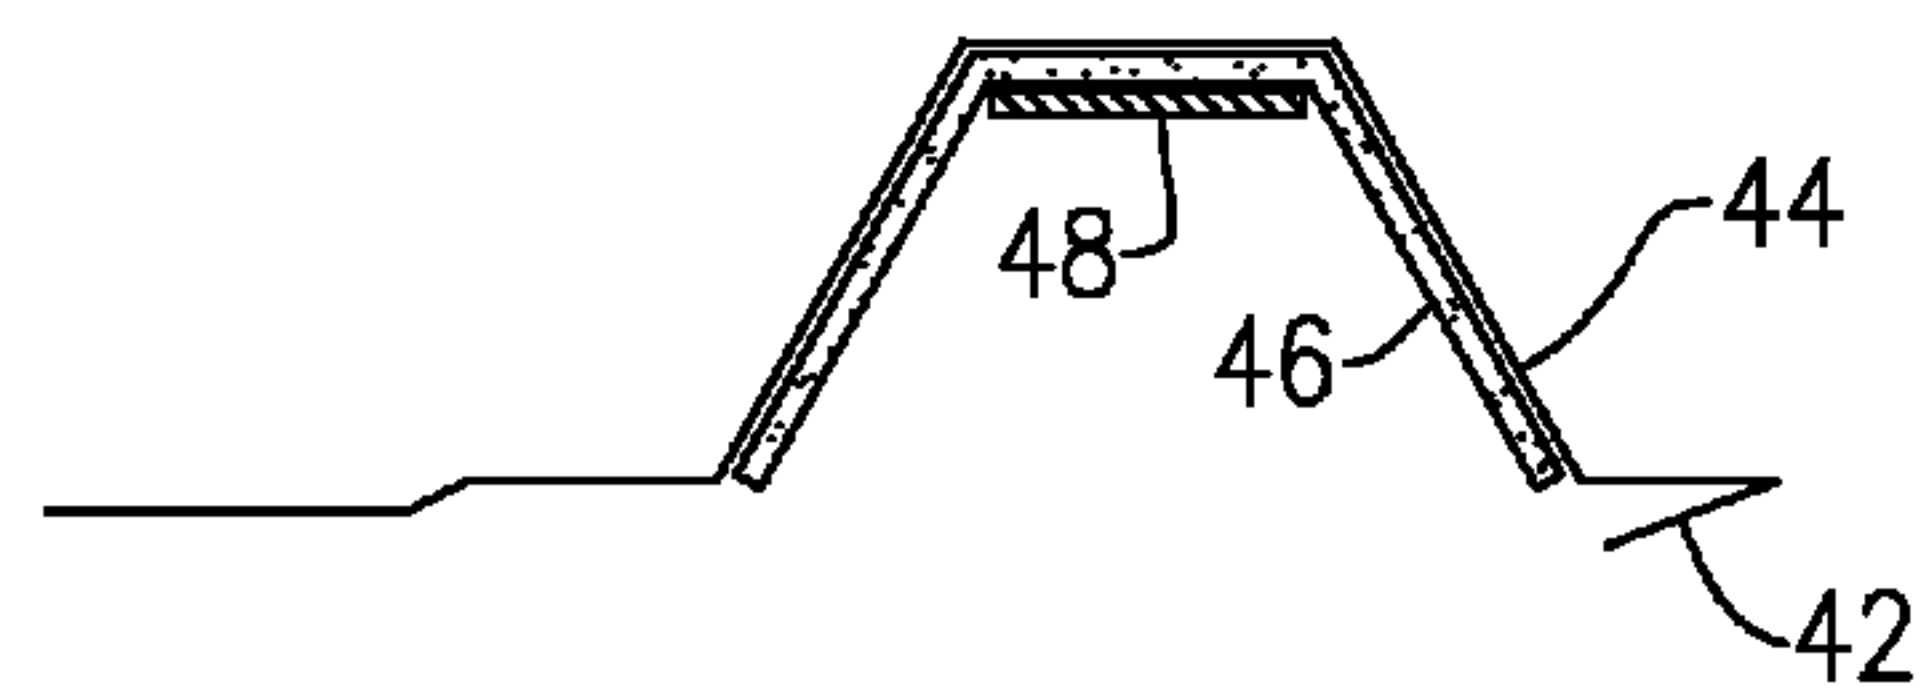
FIG.8

- 100 CLEAN A REPAIR AREA OF A SUBSTRATE.
- 102 TRIM OFF A TAB FROM THE SUBSTRATE.
- 104 FORM THE COVER TO MATCH THE CONTOUR OF A SUBSTRATE. LEAVE ENOUGH TO FOR THE NEW TAB. THE COVER SHOULD OVERLAY THE CONTOURED HOOD AND PLATFORM OF THE SUBSTRATE.

- 106 VISUALLY INSPECT THE COVER. FOLDS AND WRINKLES ARE PERMITTED, BUT THE COVER MUST NOT HAVE ANY CRACKS OR TEARS.
- 108 TRIM THE COVER TO COVER THE ENTIRE HOOD EXCEPT THE HINGE. TRIM COVER EXCEPT AT THE HINGE AND TAB.

- 122 CURE SEALANT.
- 124 INSPECT THE COVER FOR SEALING.
- 126 ENGAGE THE TAB WITH THE RETAINER.

FIG. 8 is a method of repair steps for the fireshield fastener hood;

With Reference to FIG. 8, step 100 of a manufacture or repair to the fireshield fastener hood 32 includes cleaning the repair area of the fireshield fastener hood 32. The cleaning

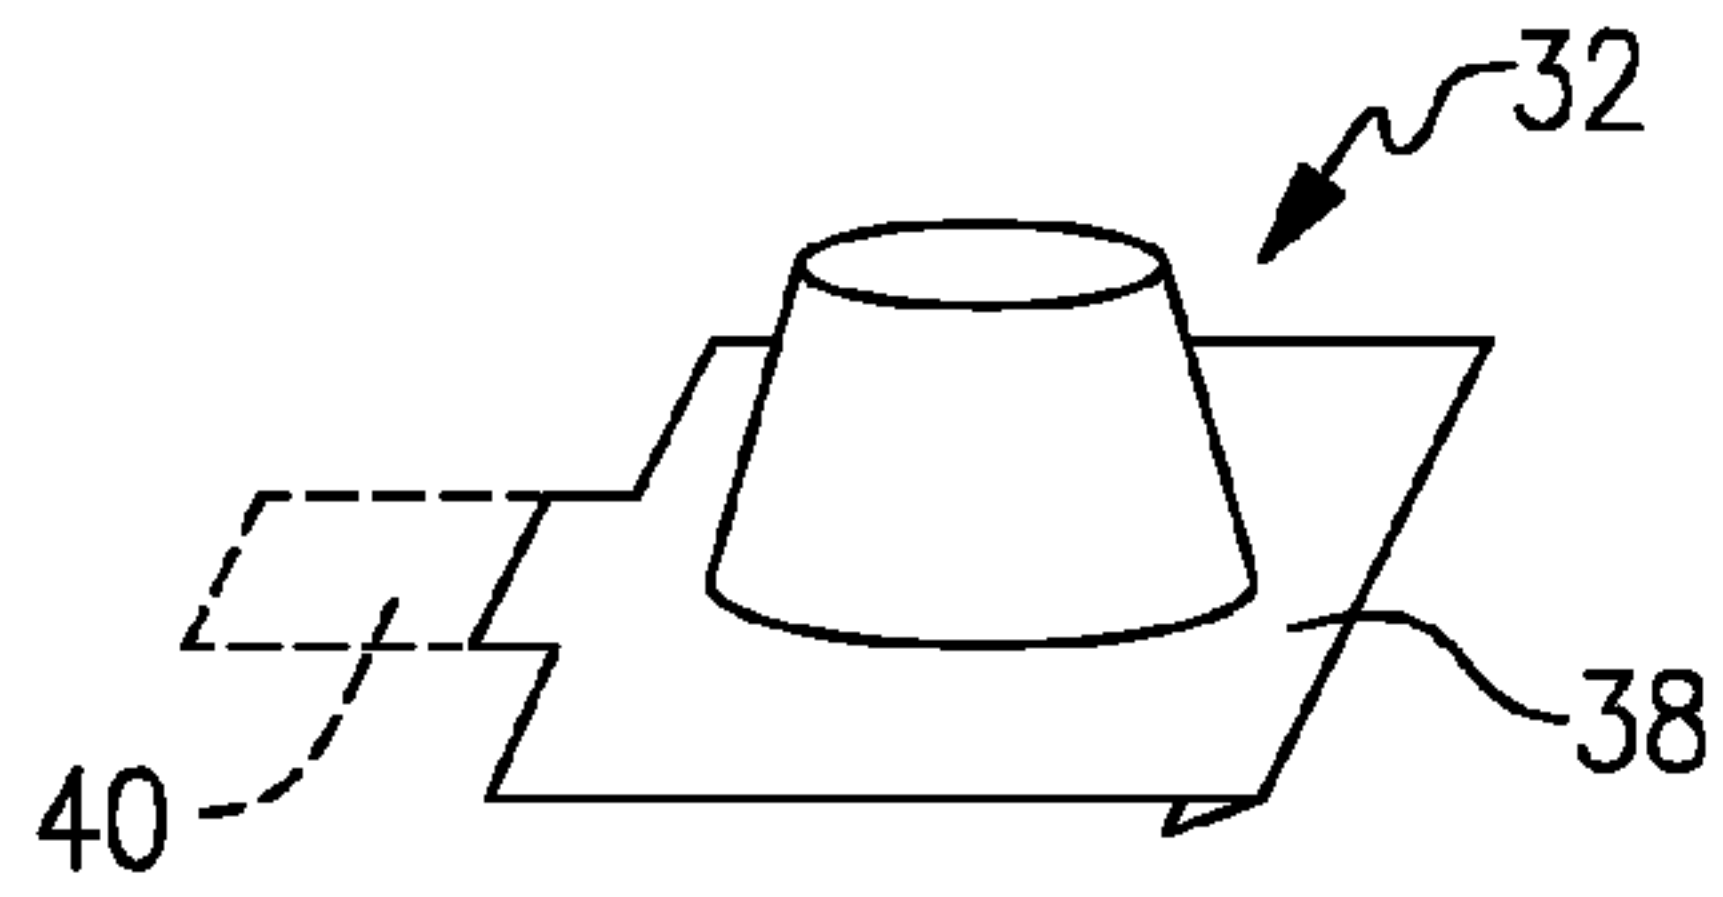
FIG. 9 is a perspective view of the fireshield fastener hood with a tab cut off;

Step **102** of the repair may include removal of the tab **40** (FIGS. 9 and 10). The tab **40** may be trimmed to be from 0 to 0.3 inches (0-8 mm) from the platform **38**. The tab removal may only be necessary where an extra thick tab **40** will not fit under retainer **50** or when tab **40** is damaged.

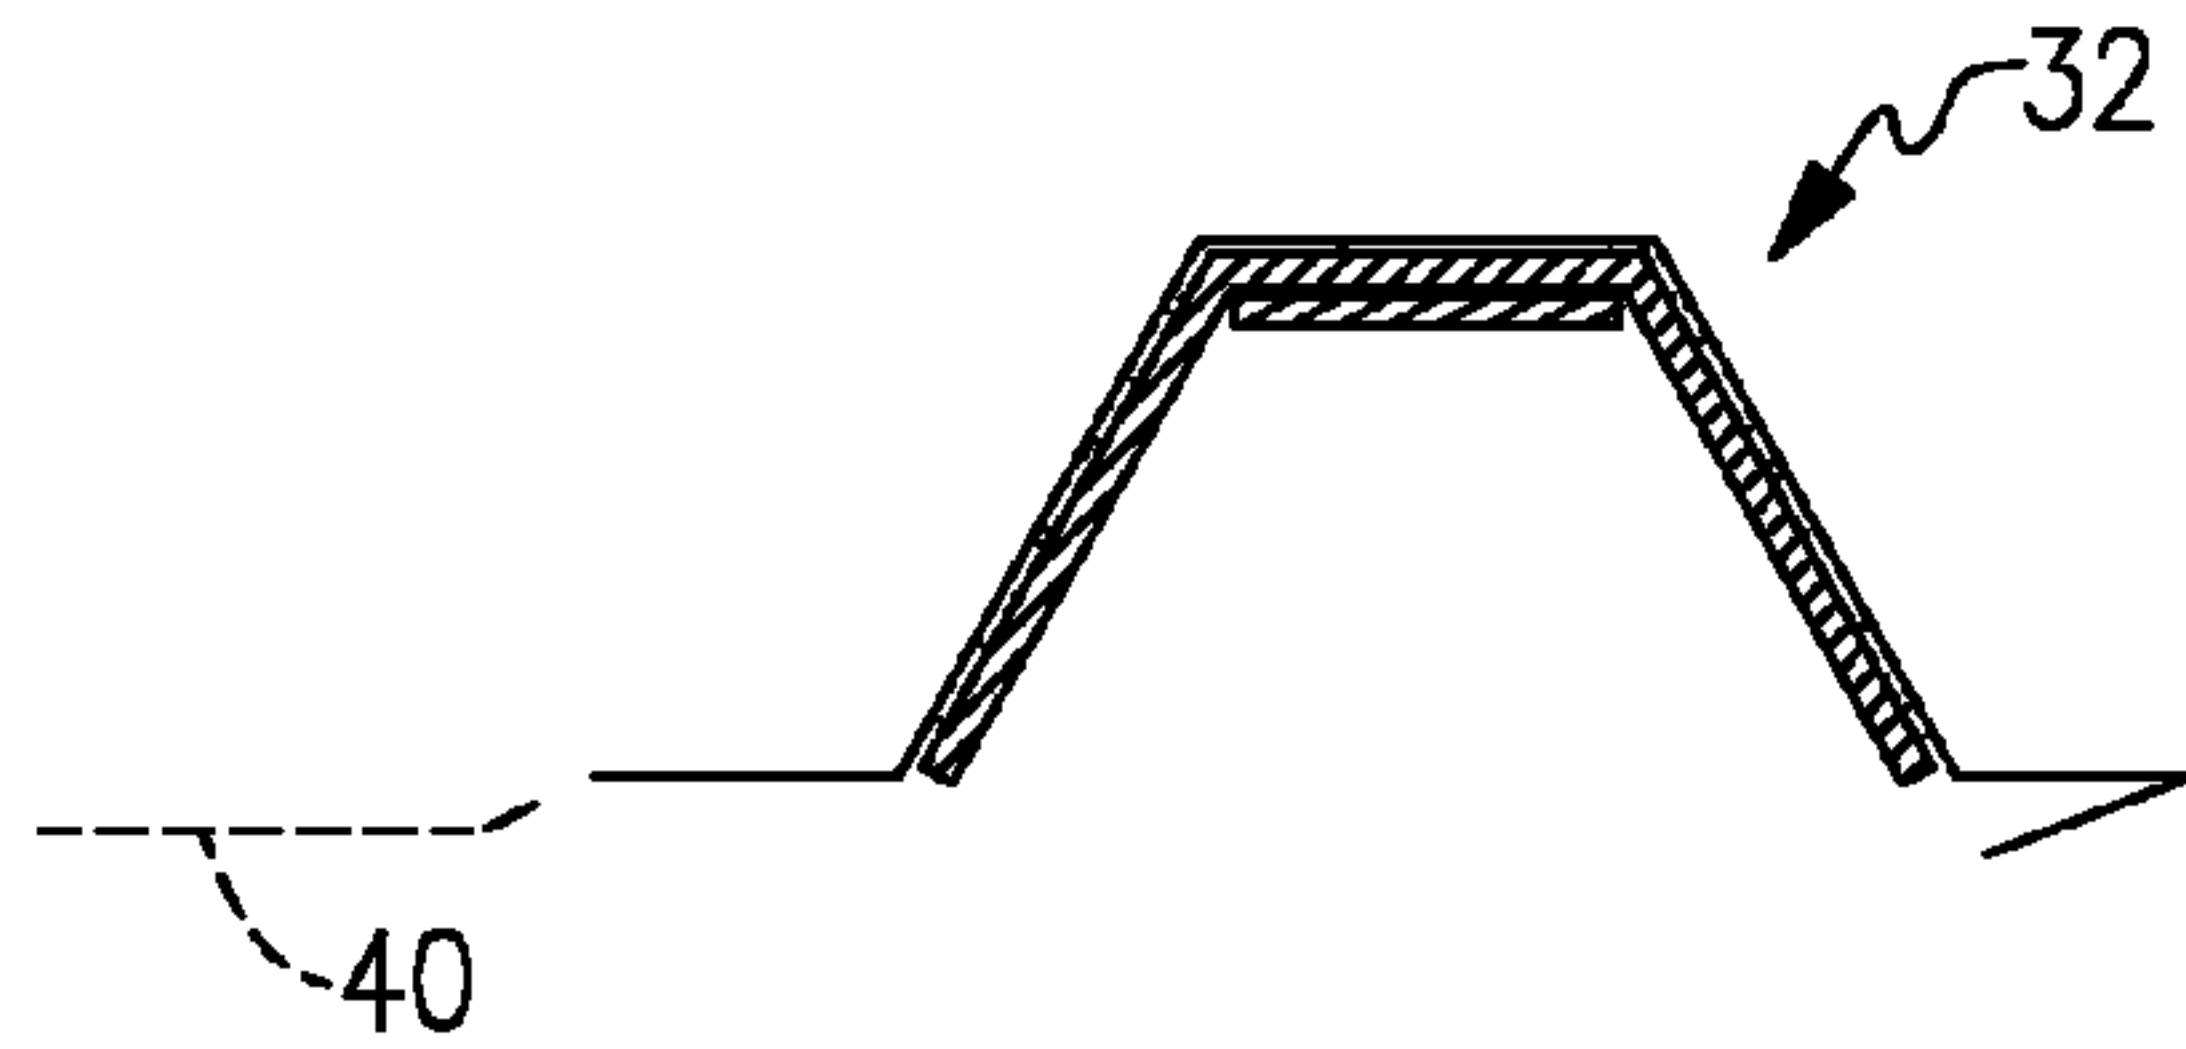
FIG. 10 is a sectional view of the fireshield fastener hood with the tab cut off;

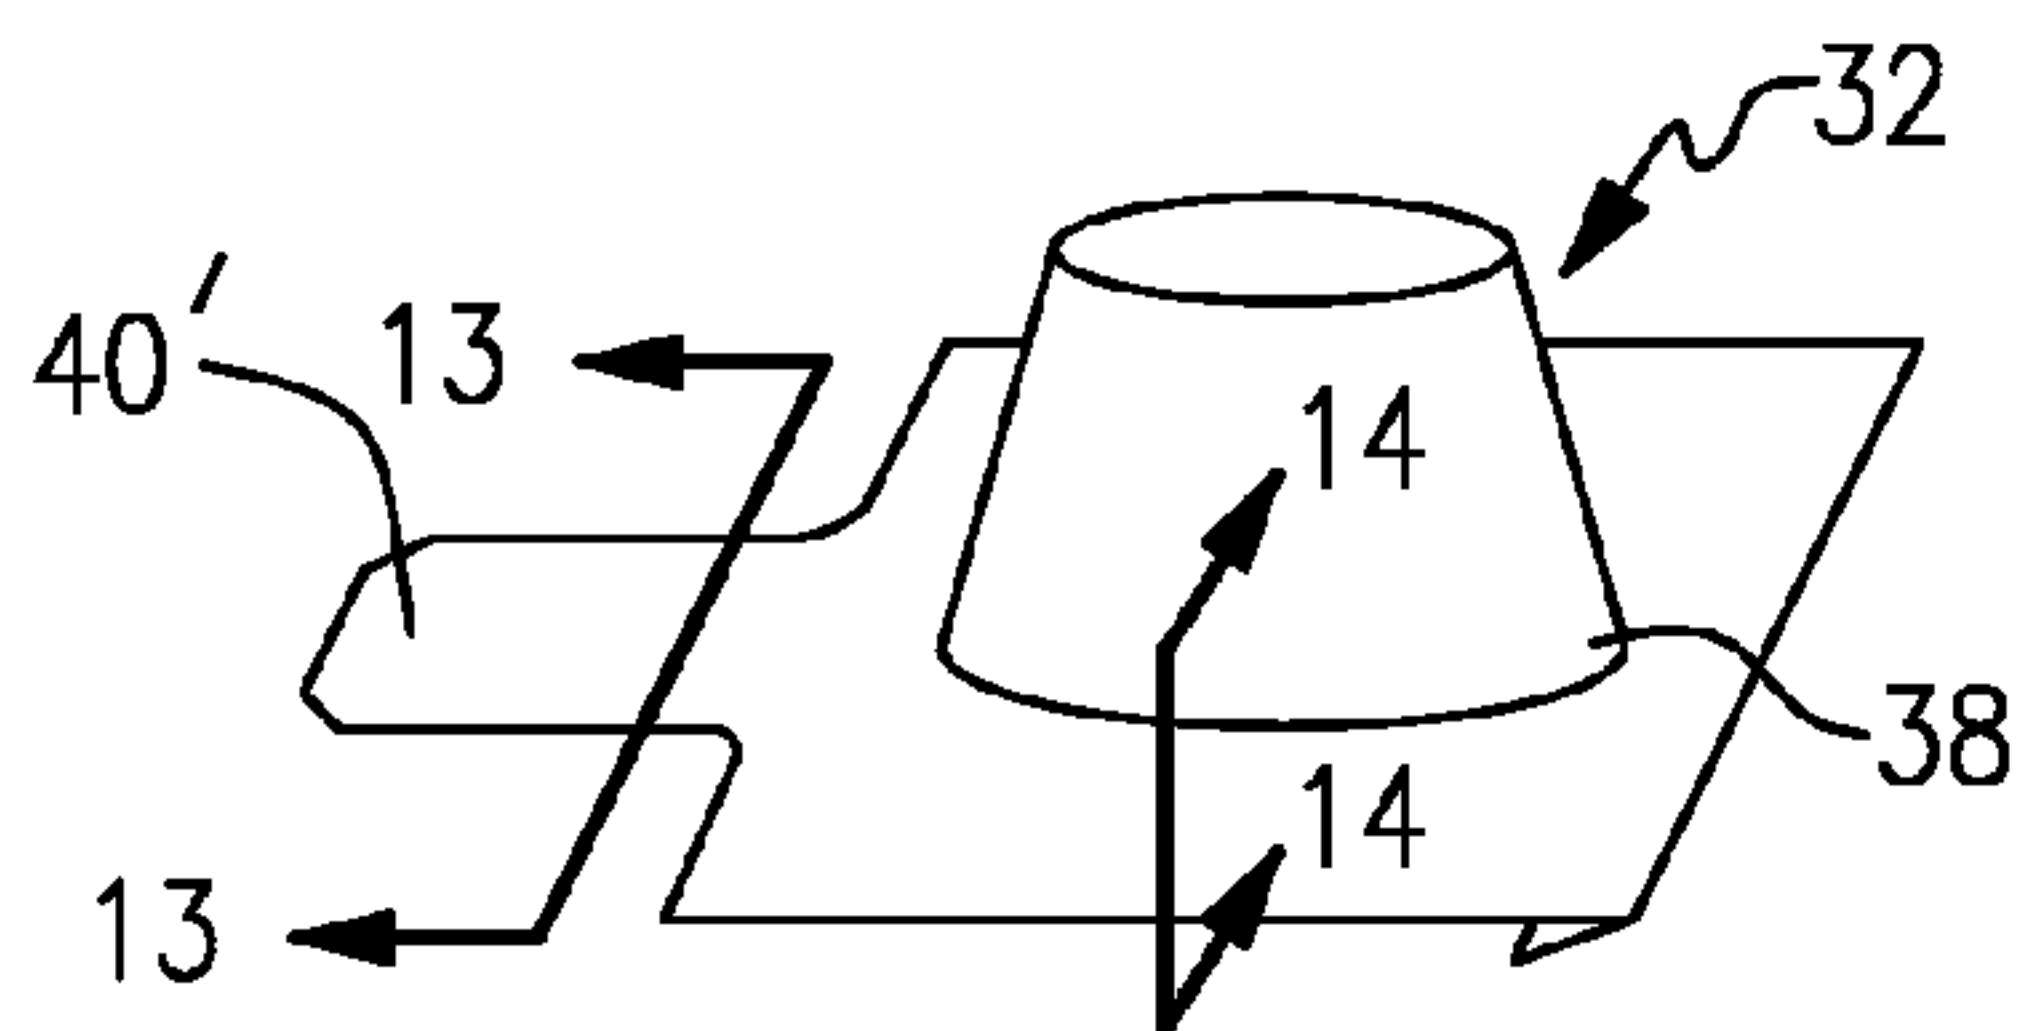
FIG. 11 is a perspective view of the fireshield fastener hood with a cover mounted thereon;

With Reference to FIG. 11, a cover **52** is formed to match the contour of the substrate **44**, hood **36** and platform **38** (Step **104**). The cover **52** may be formed over a rigid tool which is generally of the contour of the hood **36** and the platform **38**. It should be understood that a kit to perform the repair may include a preformed cover **52**. The cover **52** should cover the entire contoured hood surface with sufficient material to allow trim. Folds and wrinkles are permitted, but the cover **52** must not have any cracks or tears.

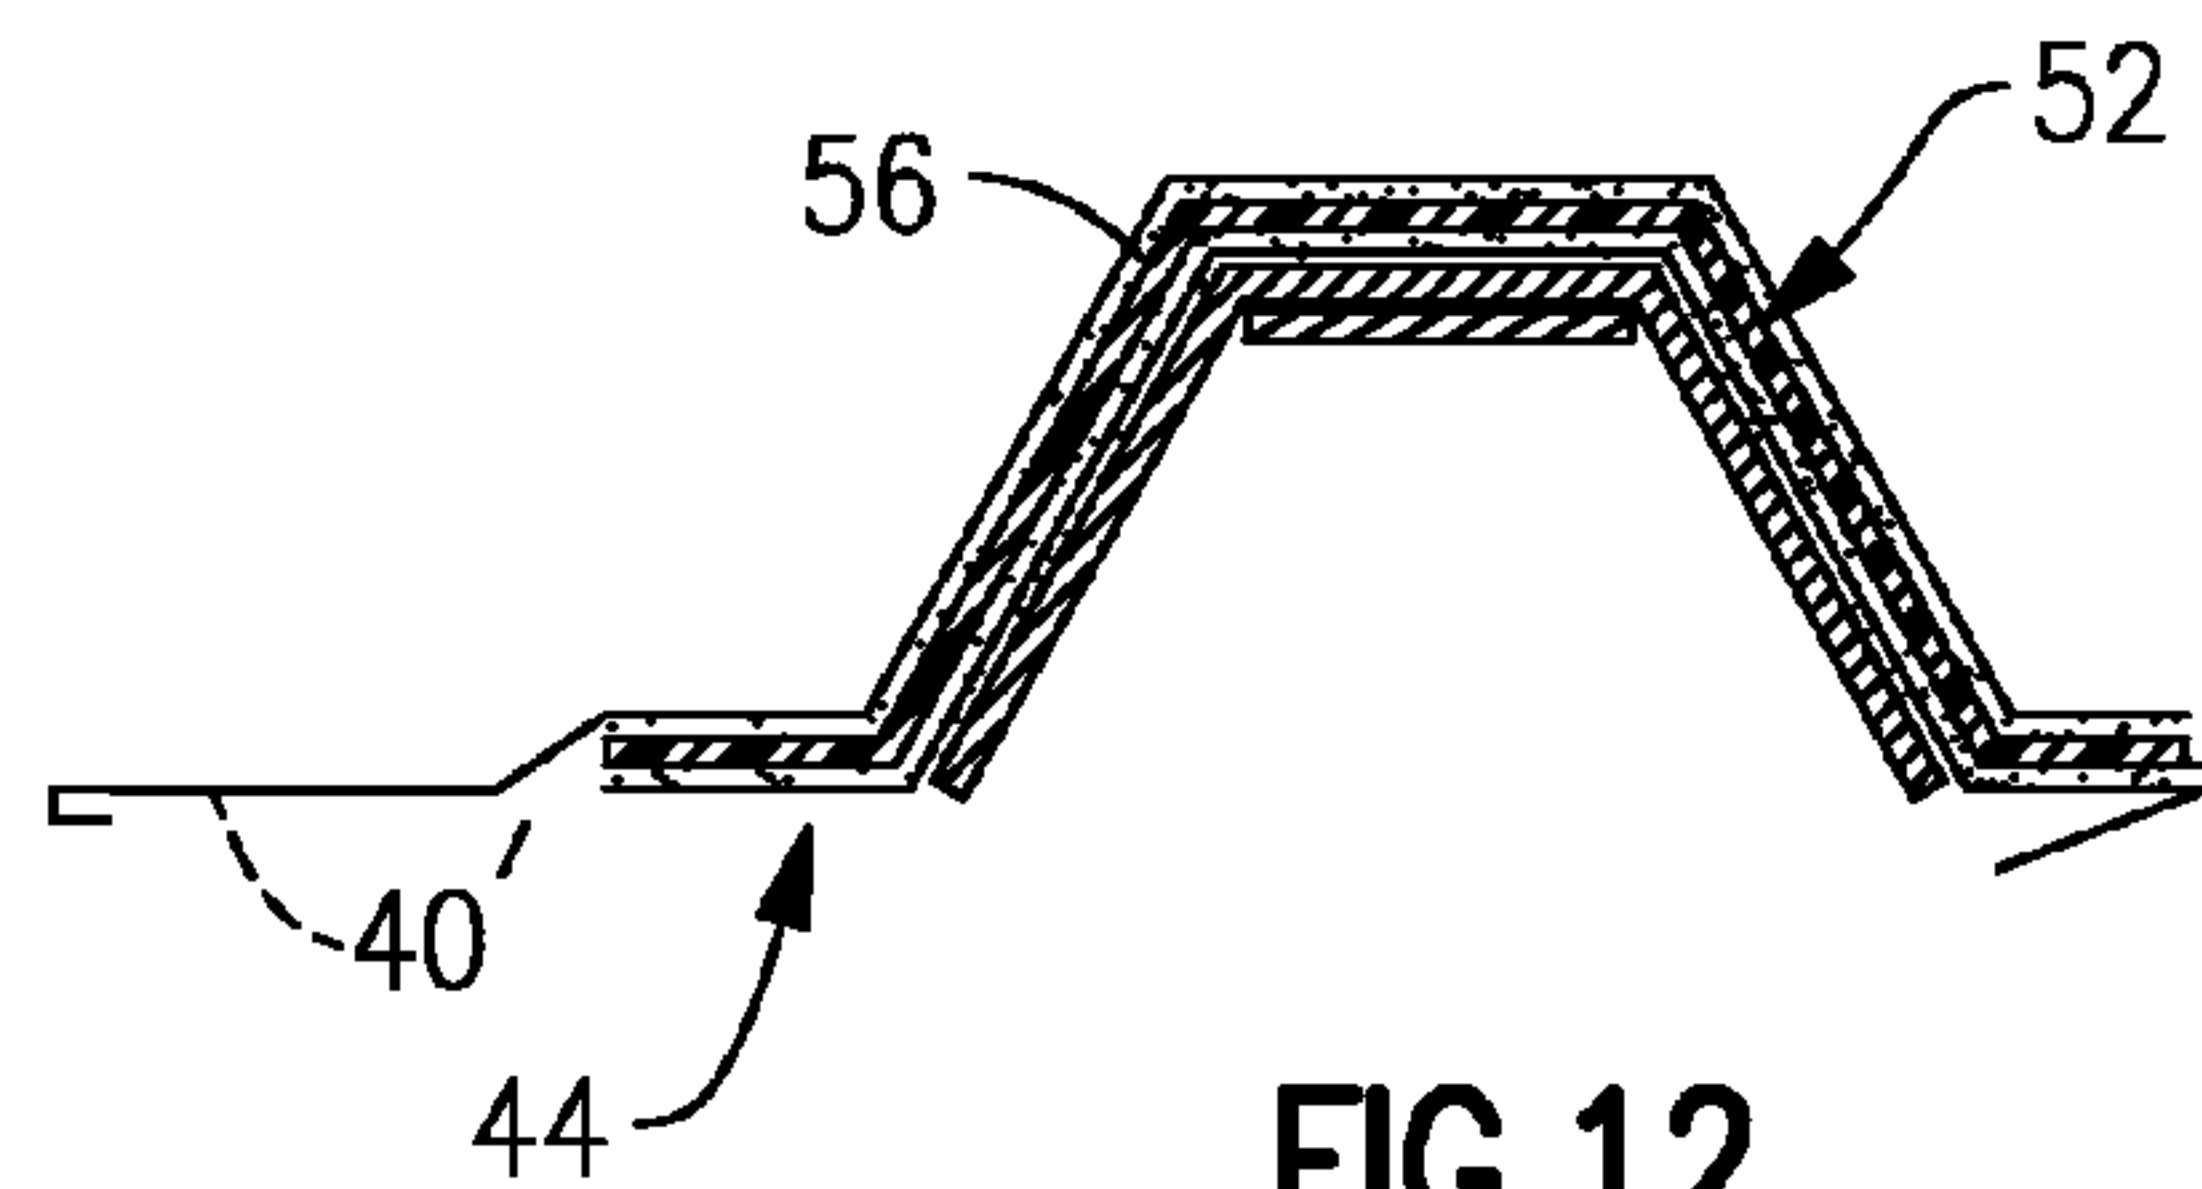
FIG. 12 is a sectional view of the fireshield fastener hood with a cover mounted thereon;

With reference to FIG. 12, in step **114**, a layer of sealant **56** is applied to the mating surface of the cover **52**, and the substrate **44**. The sealant **56** may be a thixotropic silicone paste firewall sealant such as DAPCO 18-4F manufactured by D Aircraft Products Inc. of California, USA.

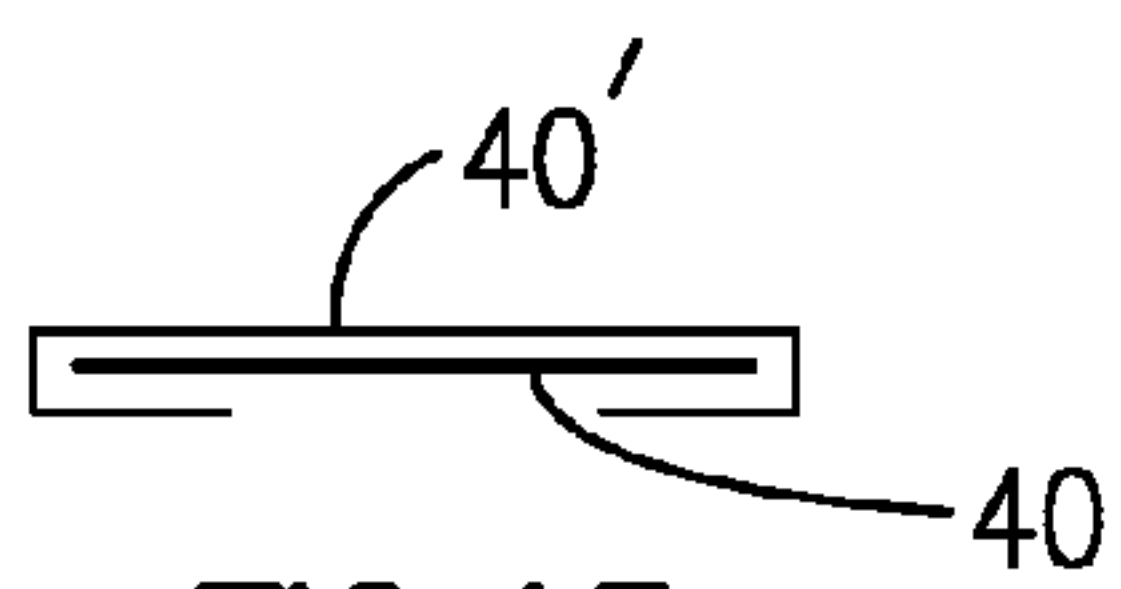
FIG. 13 is a sectional view of a replacement tab taken along line 13-13 in FIG. 11;

The cover **52** may be manufactured of an AISI 300 Series Stainless Steel alloy which is approximately the same thickness as the hood **32**. That is, the cover **52** may be manufactured from a similar material as the substrate **44**. The cover **52** may also form a replacement tab **40'**. That is, the cover **52** forms a double layer of material over the hood **36** and the platform **38** but a single layer to define the replacement tab **40'** as only a single layer thickness would fit within the retainer **50** (FIG. 12). The section of the cover **52** which forms the replacement tab **40'** should be doubled over a minimum of 0.08 inches (2 mm) along the length of the replacement tab **40** to increase the strength to the replacement tab **40'** (FIG. 13).
