(54) **FIRESHIELD FASTENER HOOD**

(57) **ABSTRACT**
A fireshield fastener hood and method of bonding a cover to a substrate therefor.

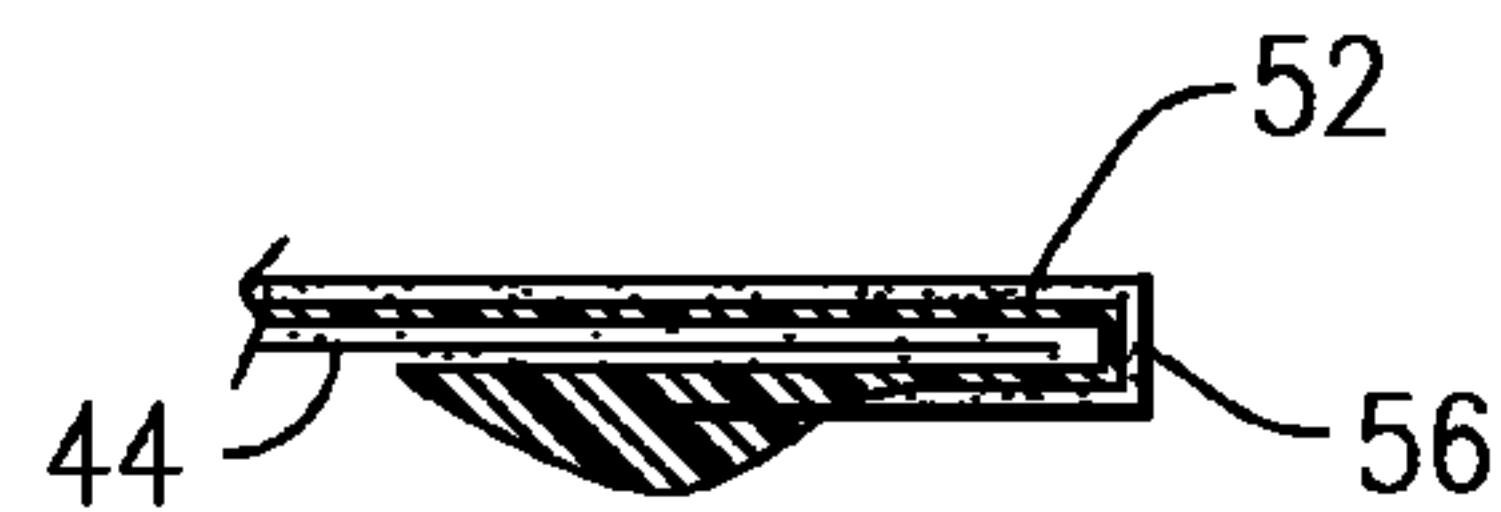
FIG. 14 is an edge view of the fireshield fastener hood with a cover along line 14-14 in FIG. 11; and

Step **108** of the repair includes trimming the cover **52** to cover the substrate except the hinge **42**. The trimming should include additional material to wrap around the edges. (FIG. 14). The cover **52** may be a maximum of 0.060 inches (10 mm) of the edge (FIG. 14). It is permissible to trim the replacement tab **40'** of the cover **52** to width and length after bonding.

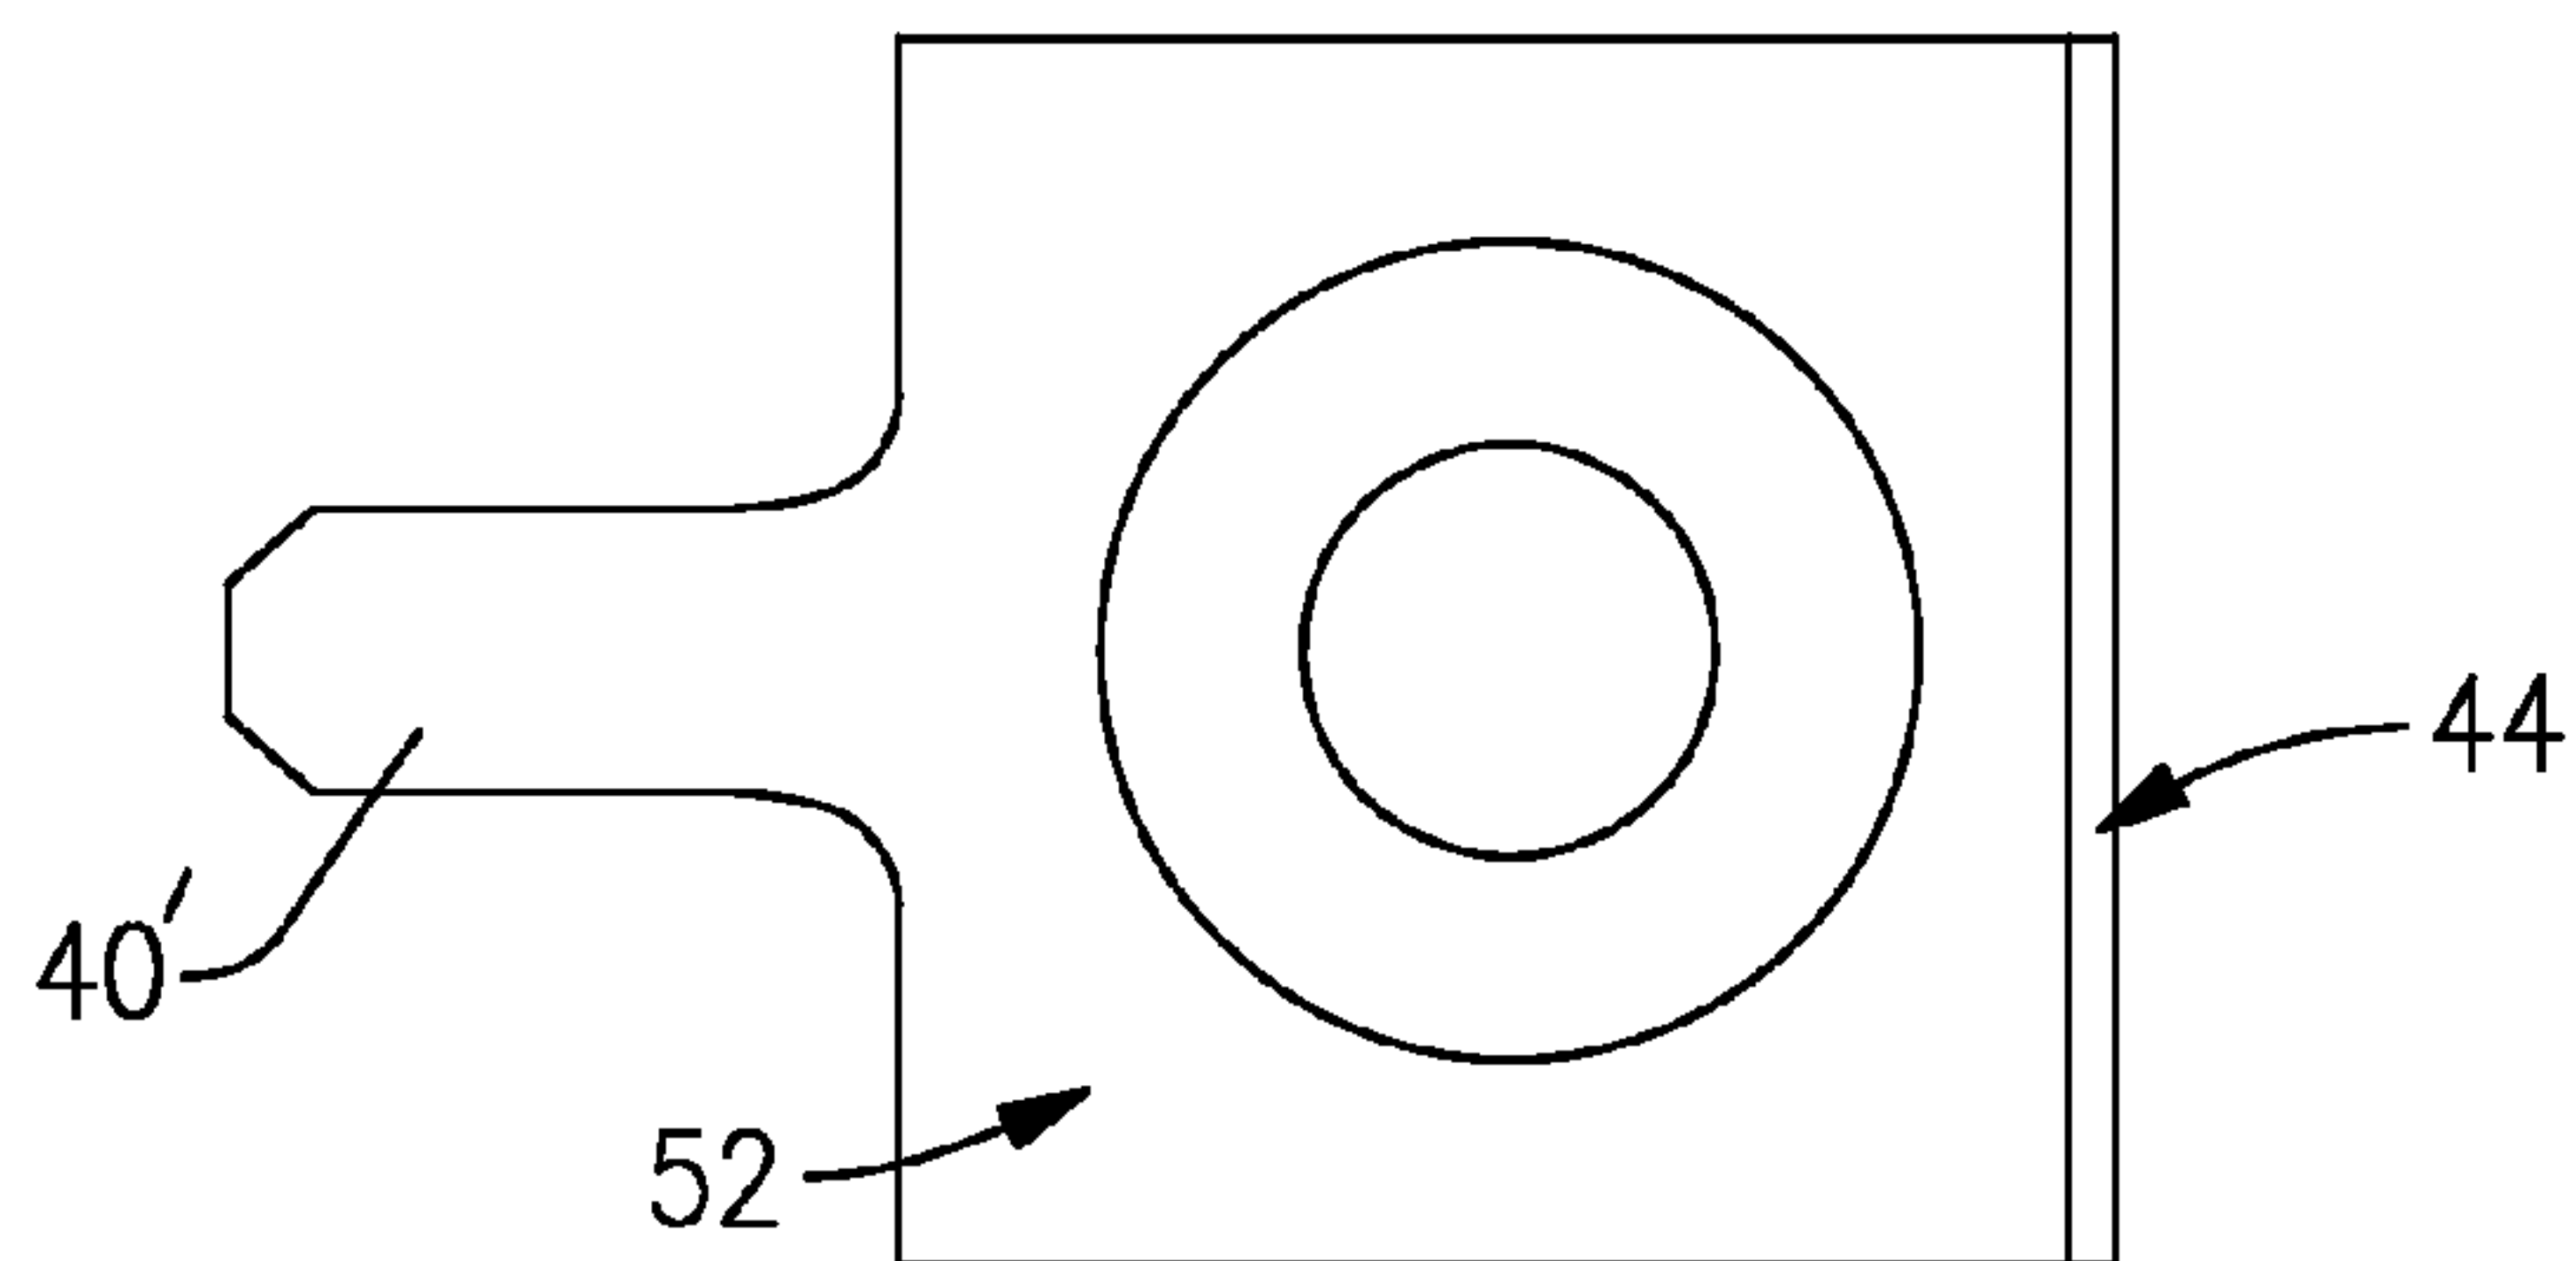
FIG. 15 is a top view of the fireshield fastener hood with the cover.
