US010024028B2

(54) **METHOD FOR REPAIRING BUCKETS**

(71) Applicant: **Minetec S.A.**, Santiago (CL)

A method for repairing a bucket of a piece of earthwork equipment is provided, the method being specifically applicable to the repair of electric shovel buckets.

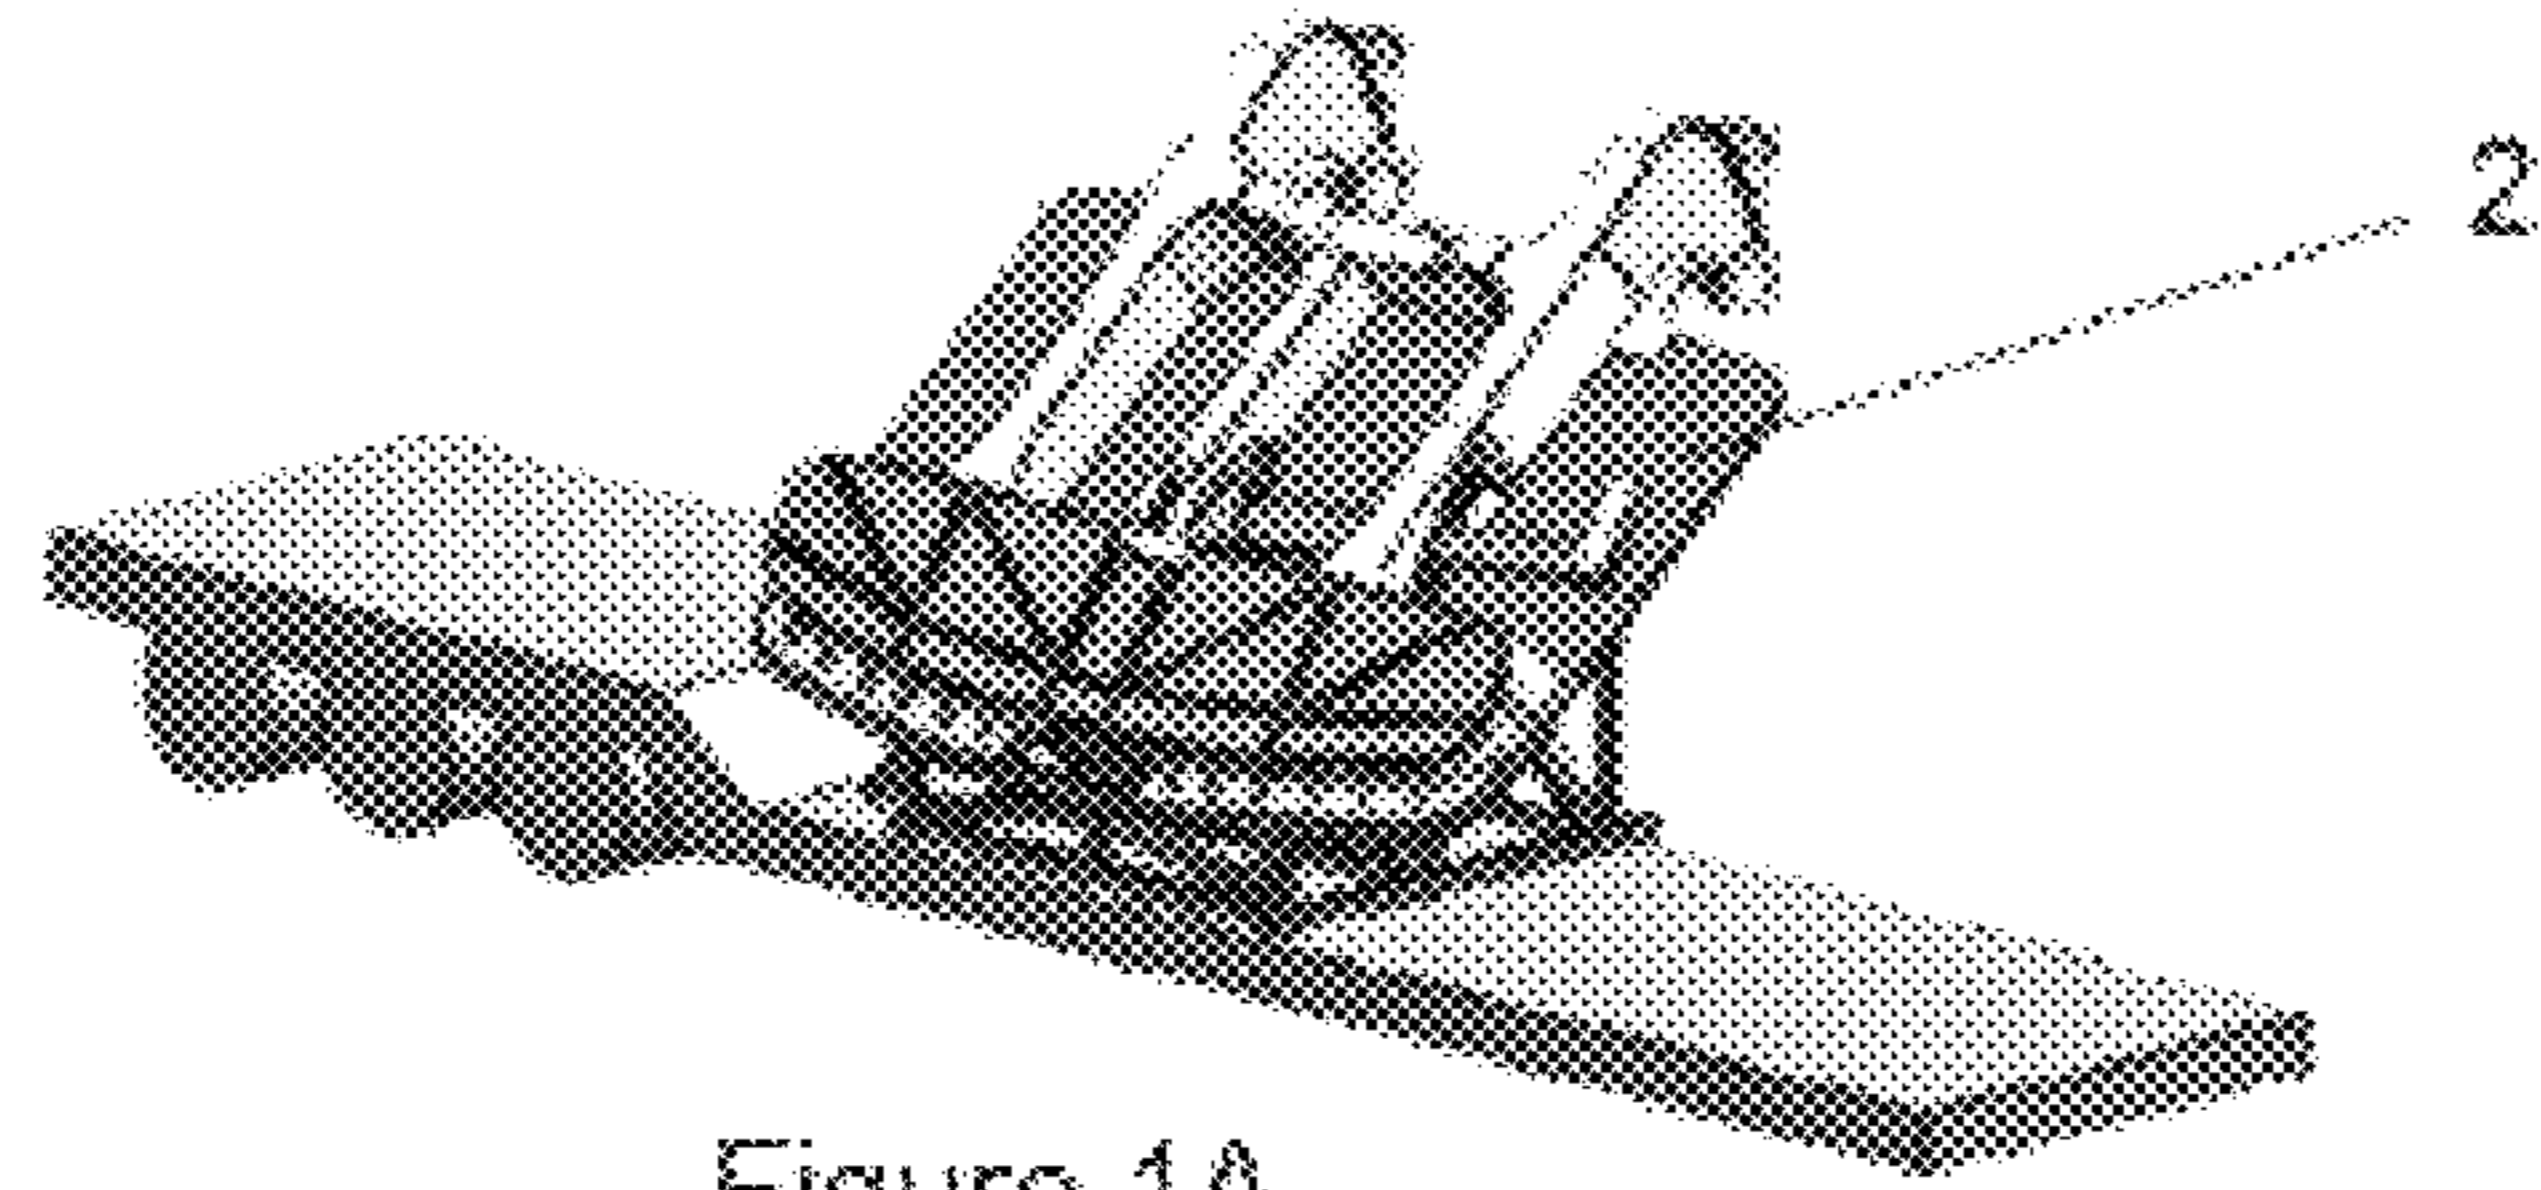
Figure 1A

FIG. 1A shows the arrival of a door for maintenance task.

In the prior art, the door comes disassembled from the bucket and is transported separately as shown in FIG. 1A, each of these components follows a separate maintenance line.

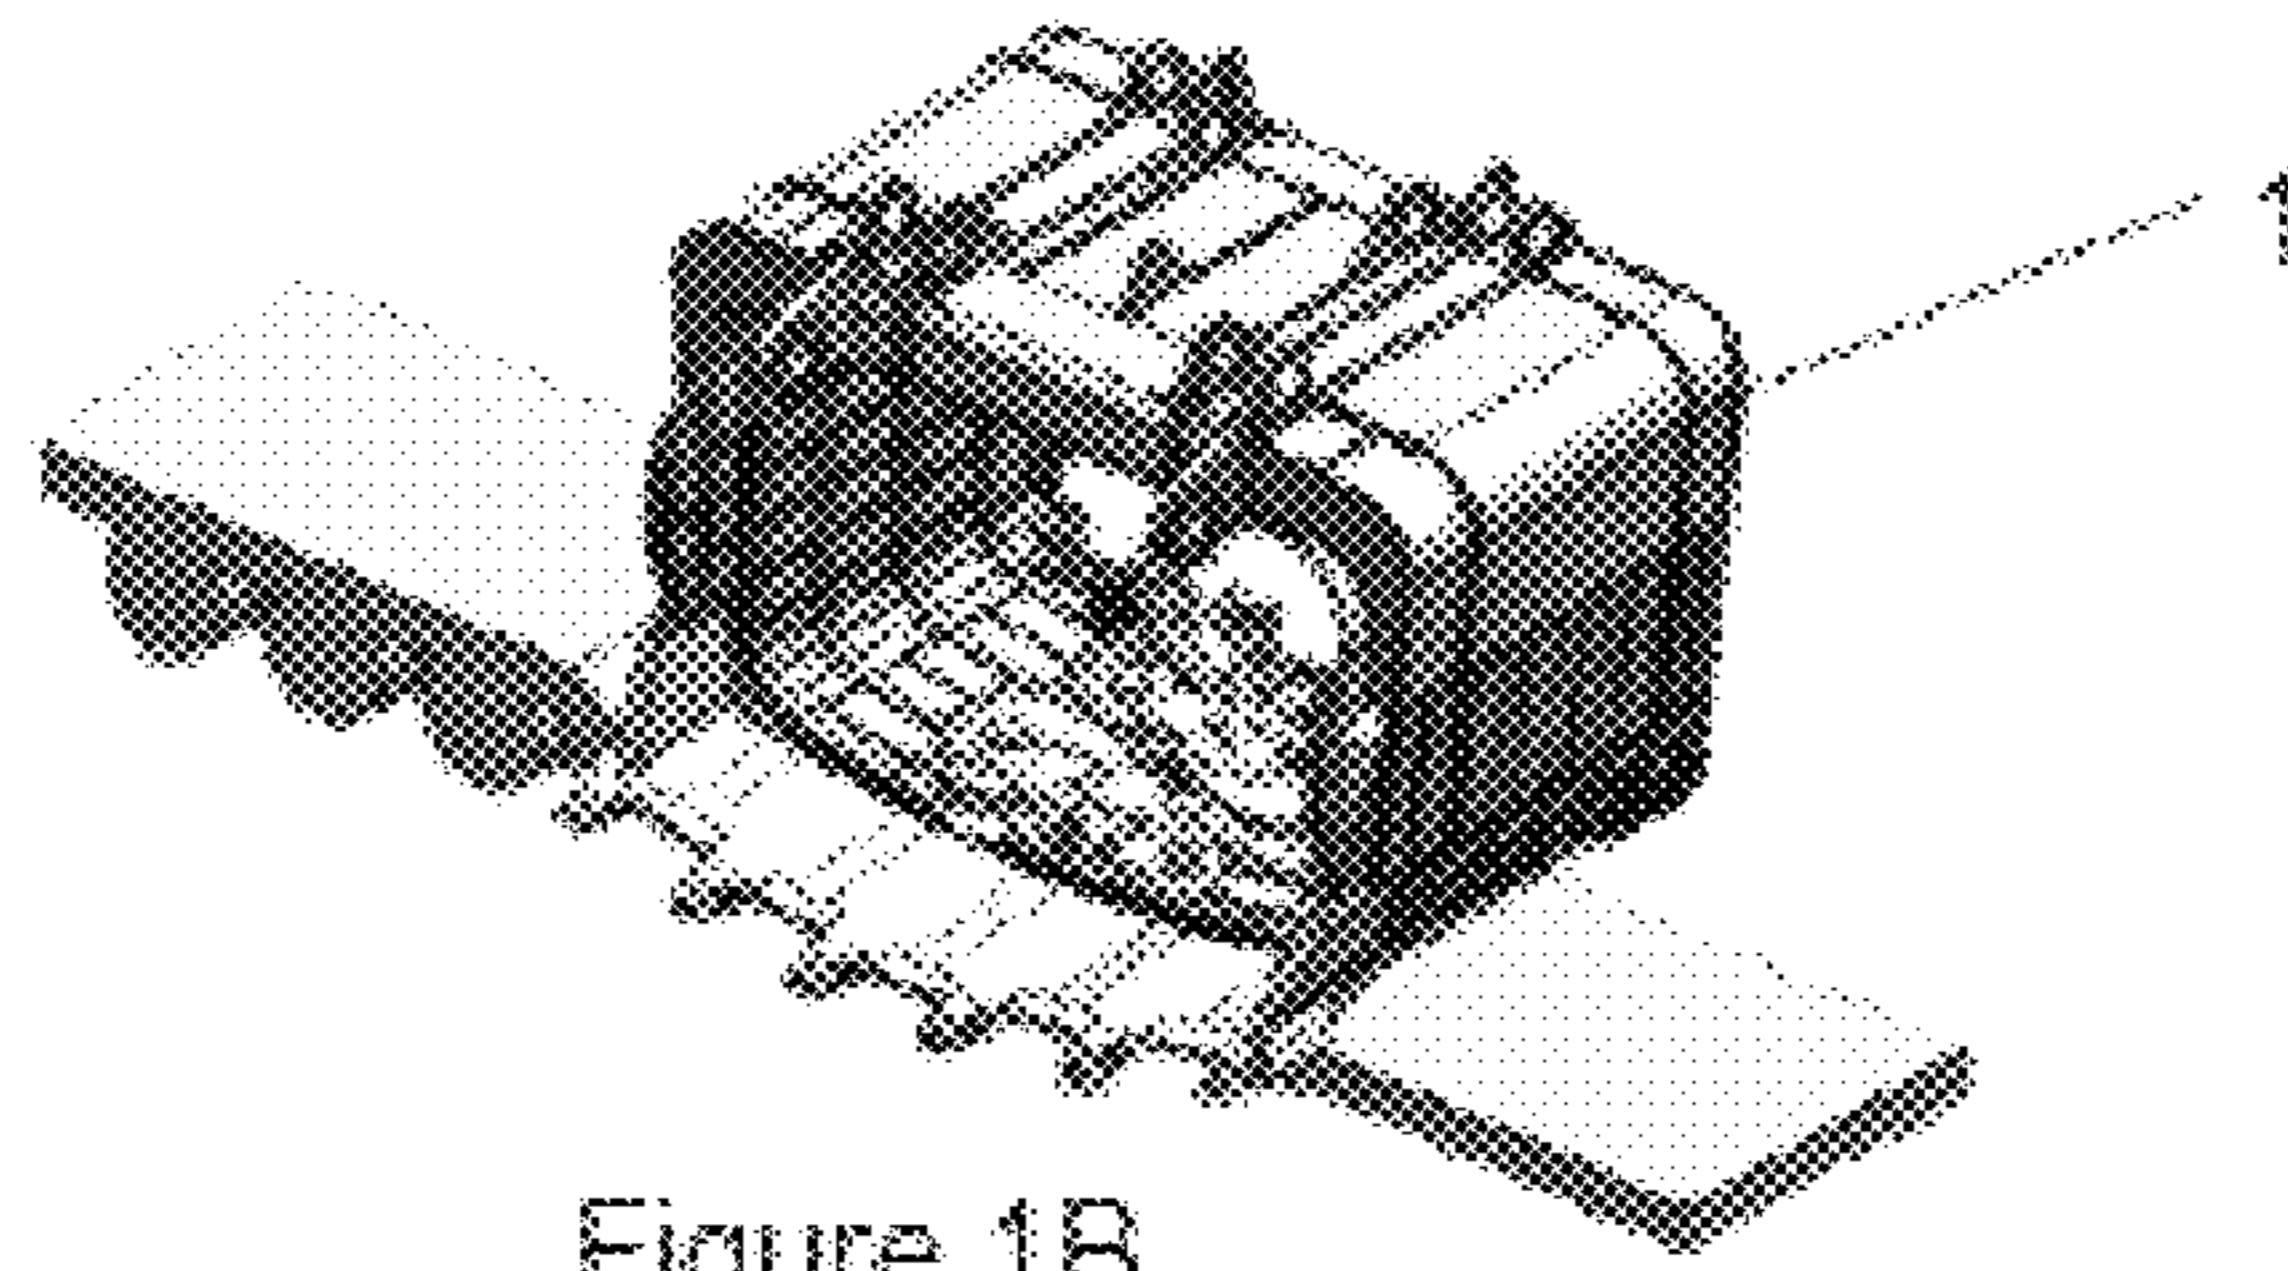
Figure 1B

FIG. 1B shows the arrival of a bucket with the door disassembled for maintenance.

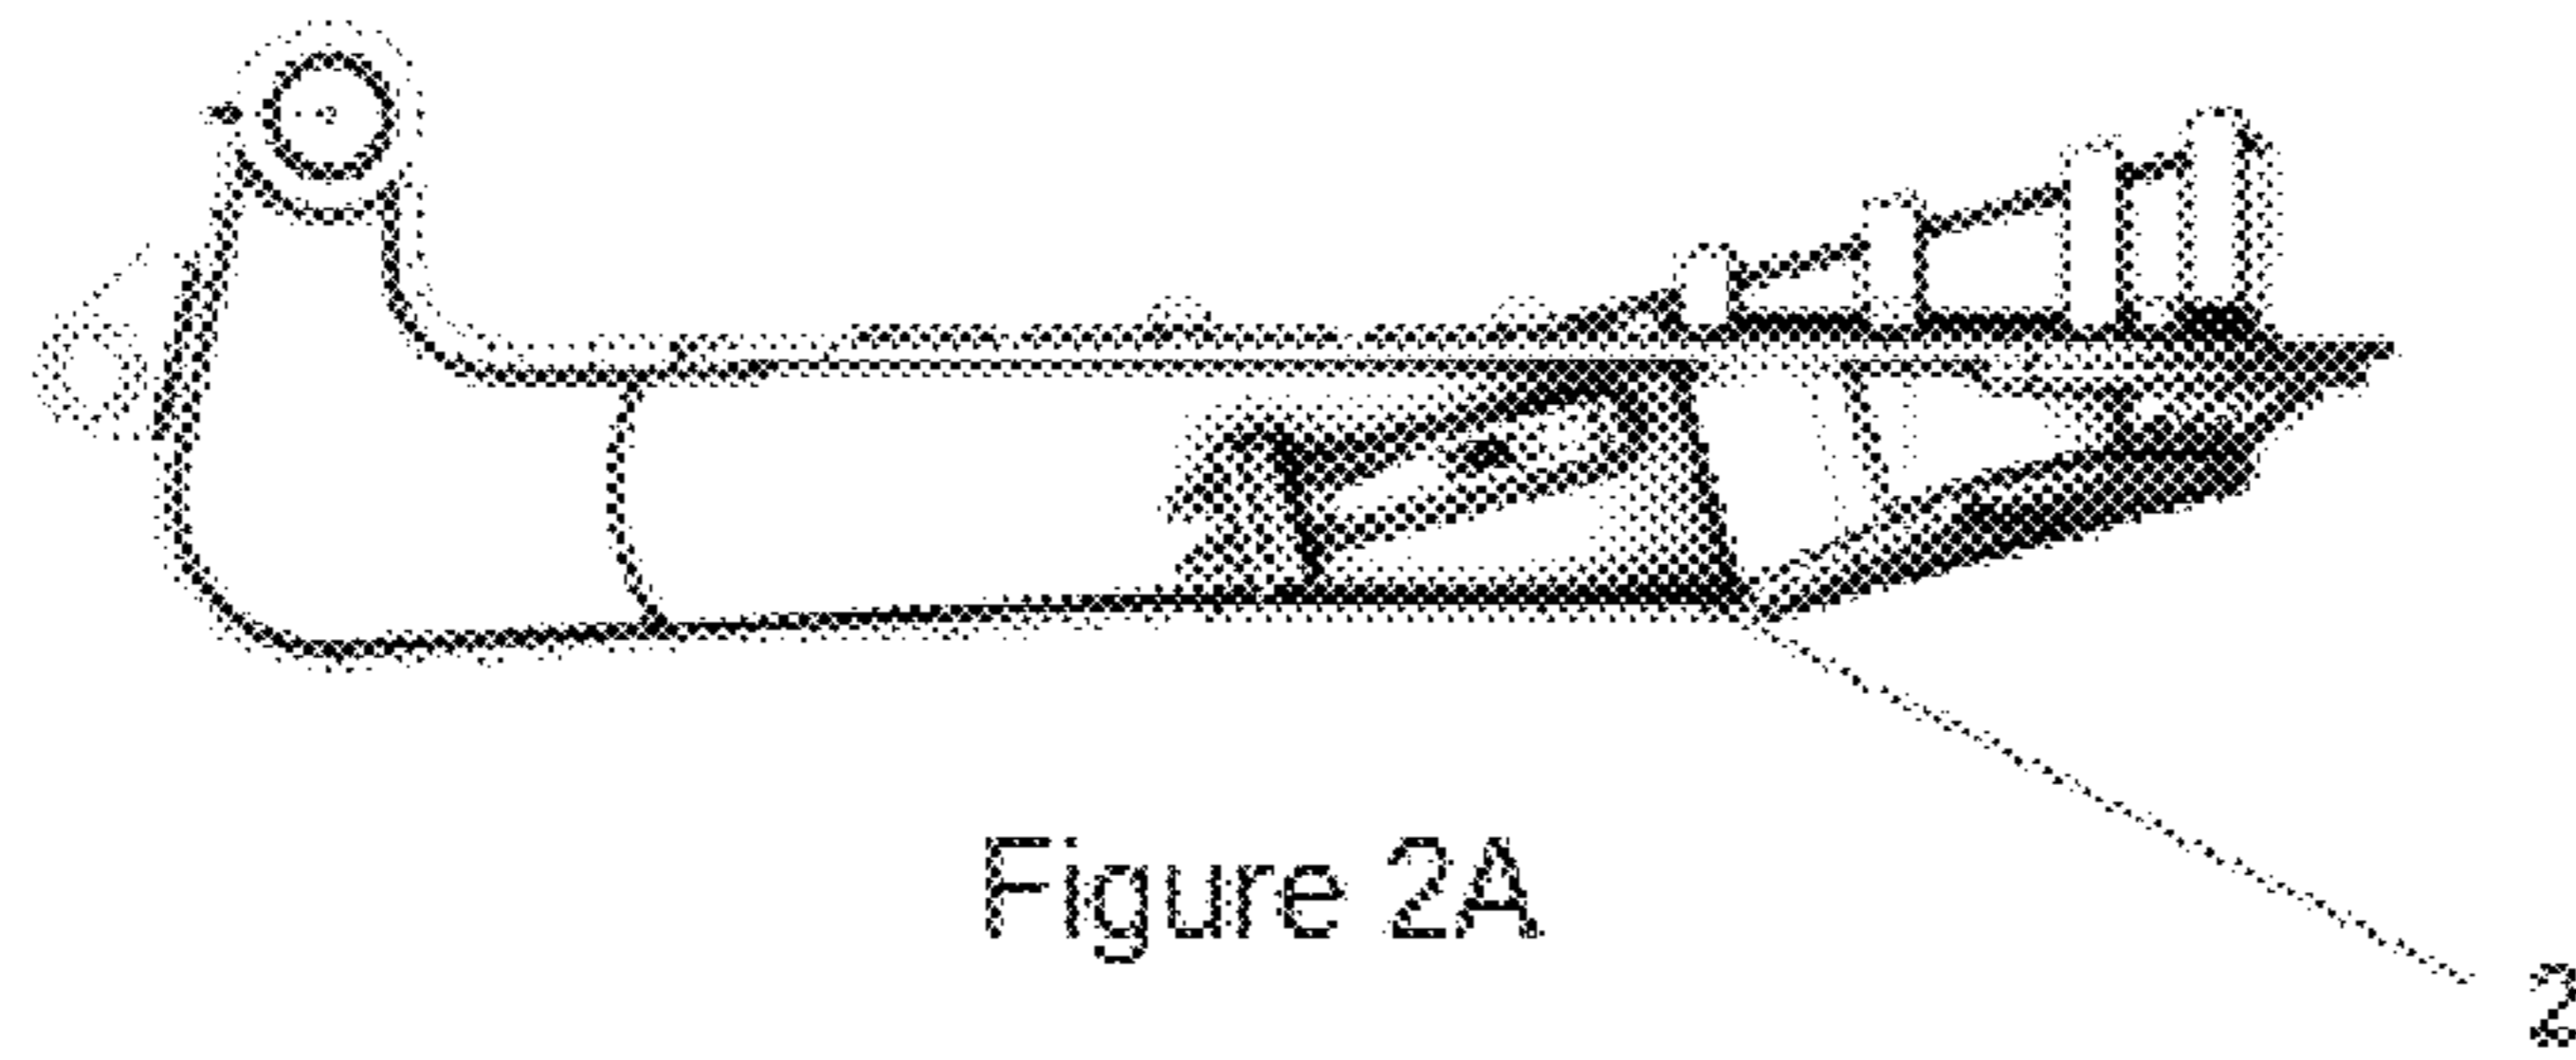
Figure 2A

FIG. 2A shows the door once unloaded from the truck in a first position to repair its inner part (upper area).

All damaged or worn elements are repaired on their inner side and the area of connection of the door with the bucket (FIG. 2A).

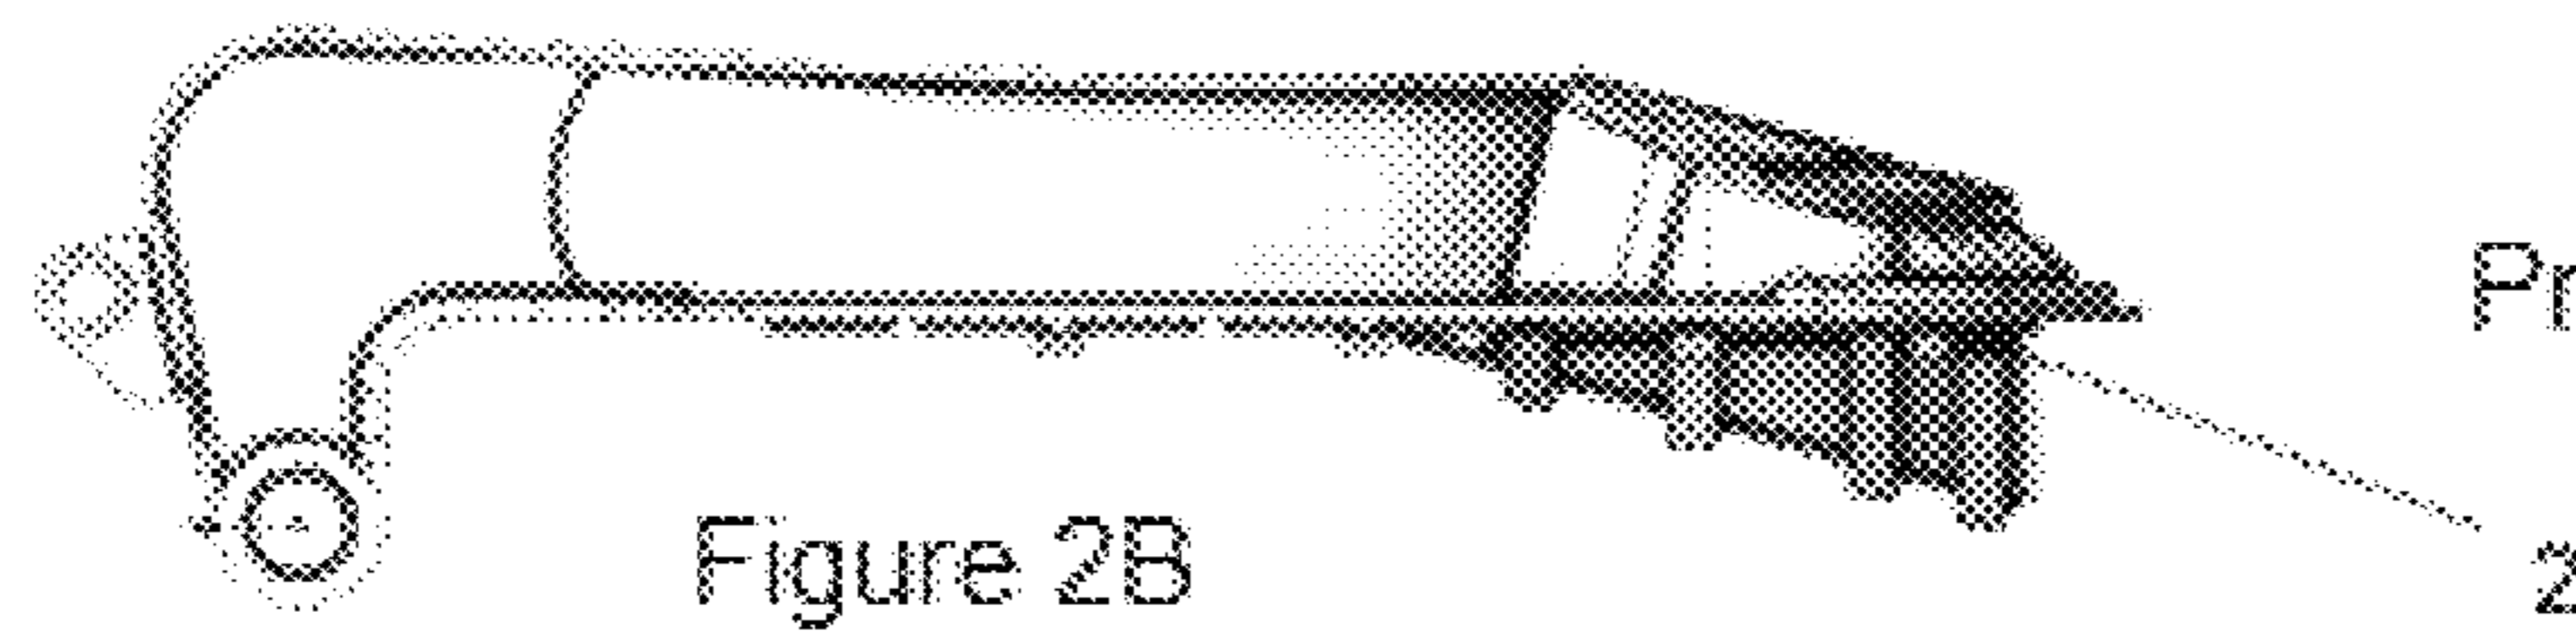
Figure 2B

FIG. 2B shows the door once unloaded from the truck in a second inverted position to repair the outer part (upper area).

The door is rotated 180 degrees to repair damaged or worn elements (FIG. 2B).

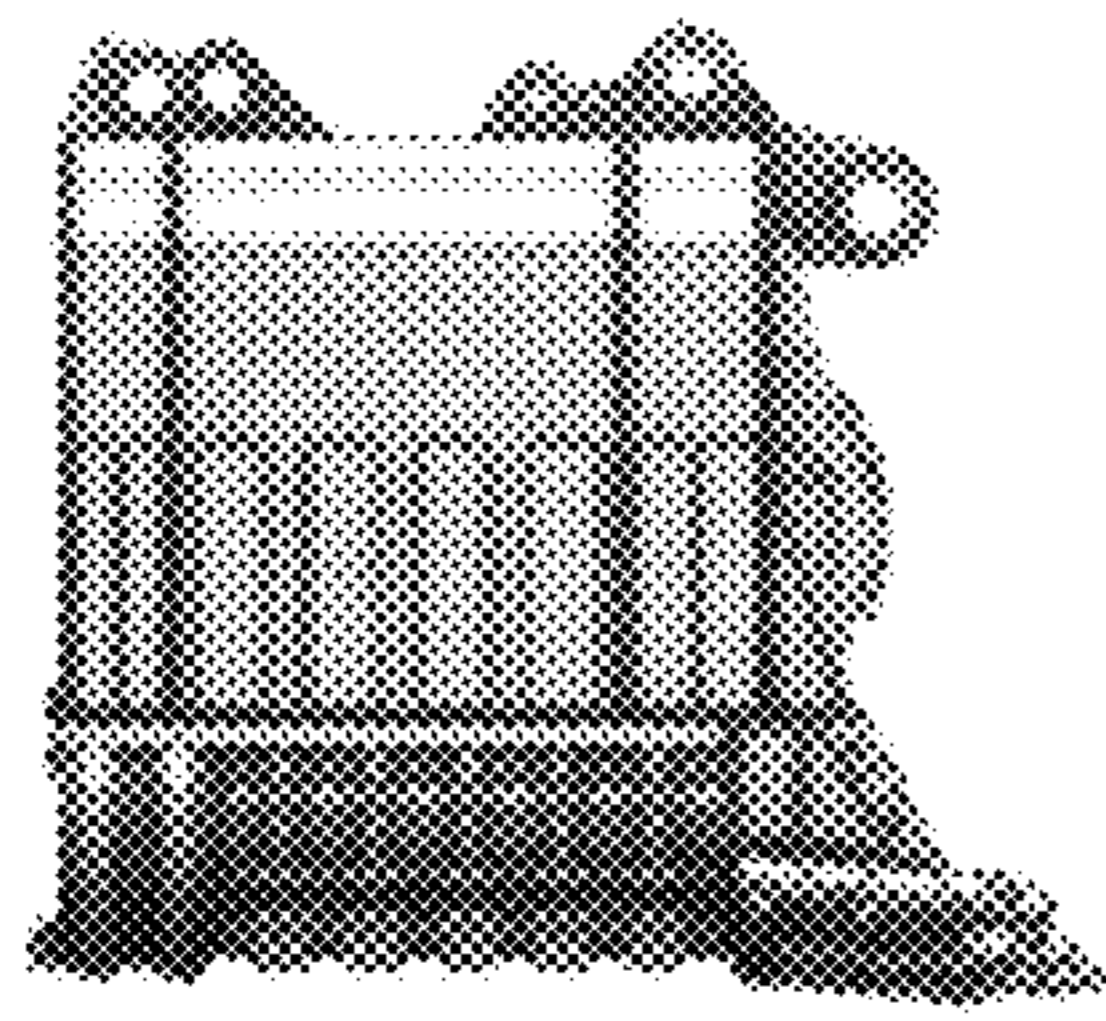
Figure 3A

FIG. 3A shows a first position to repair the inner and outer areas of the bucket.

First position (FIG. 3A), repair of inner and outer area, according to practice it requires 5 welders for 23 days, 1 boiler operator for 7 days, and 1 assistant for 23 days.

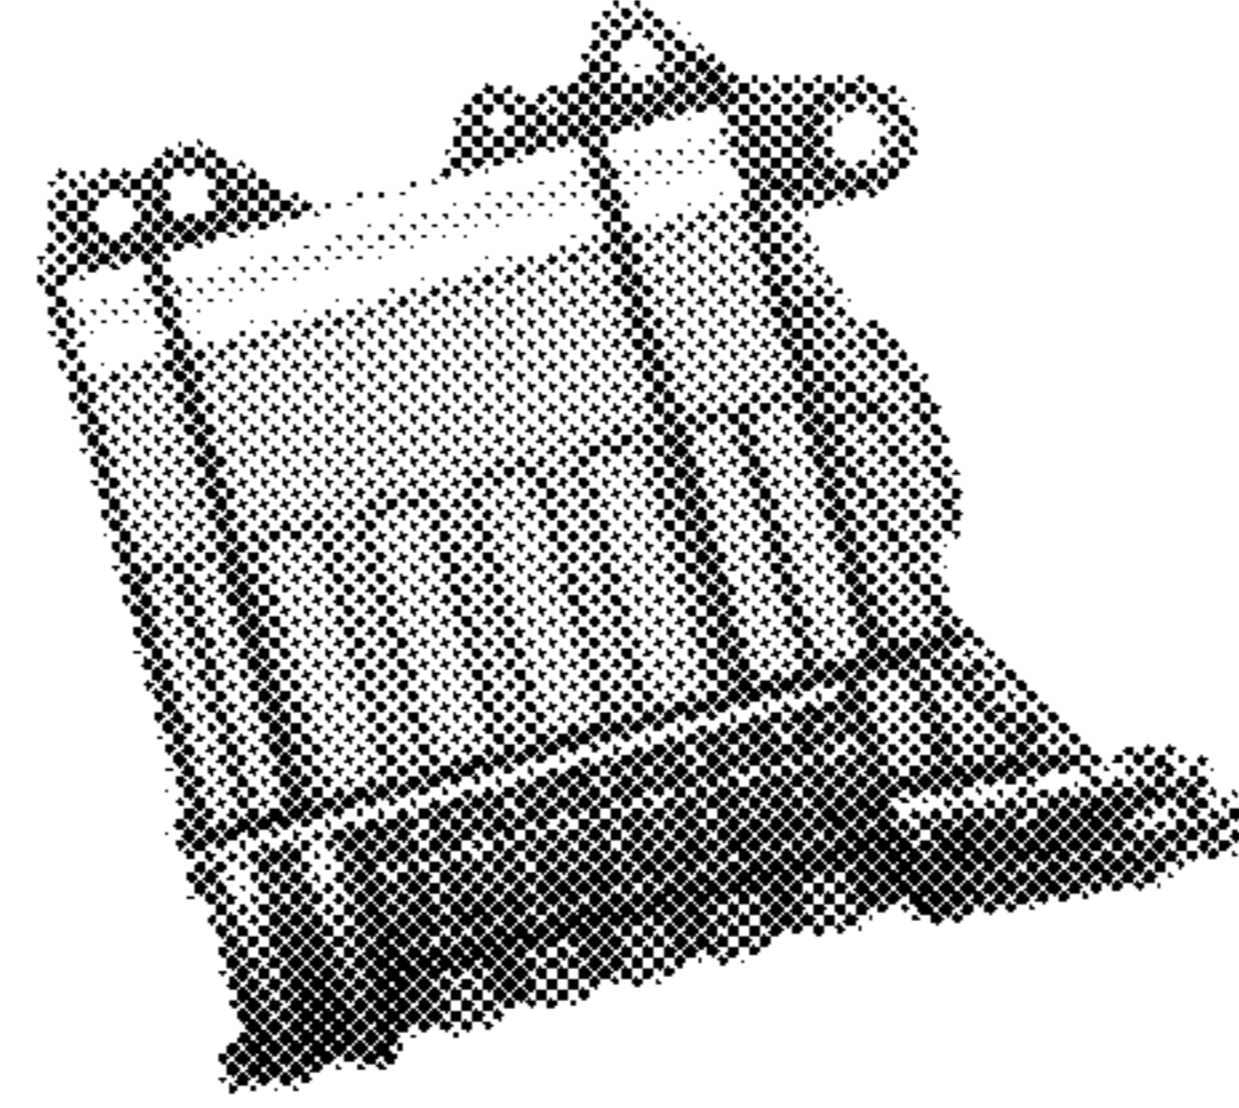
Figure 3B

FIG. 3B shows a second position to repair the external sides and lip of the bucket.

Second position (FIG. 3B), front door is raised and outer sides and lip are repaired, according to practice it requires 5 welders for 10 days, 1 boiler operator for 7 days, and 1 assistant for 10 days.

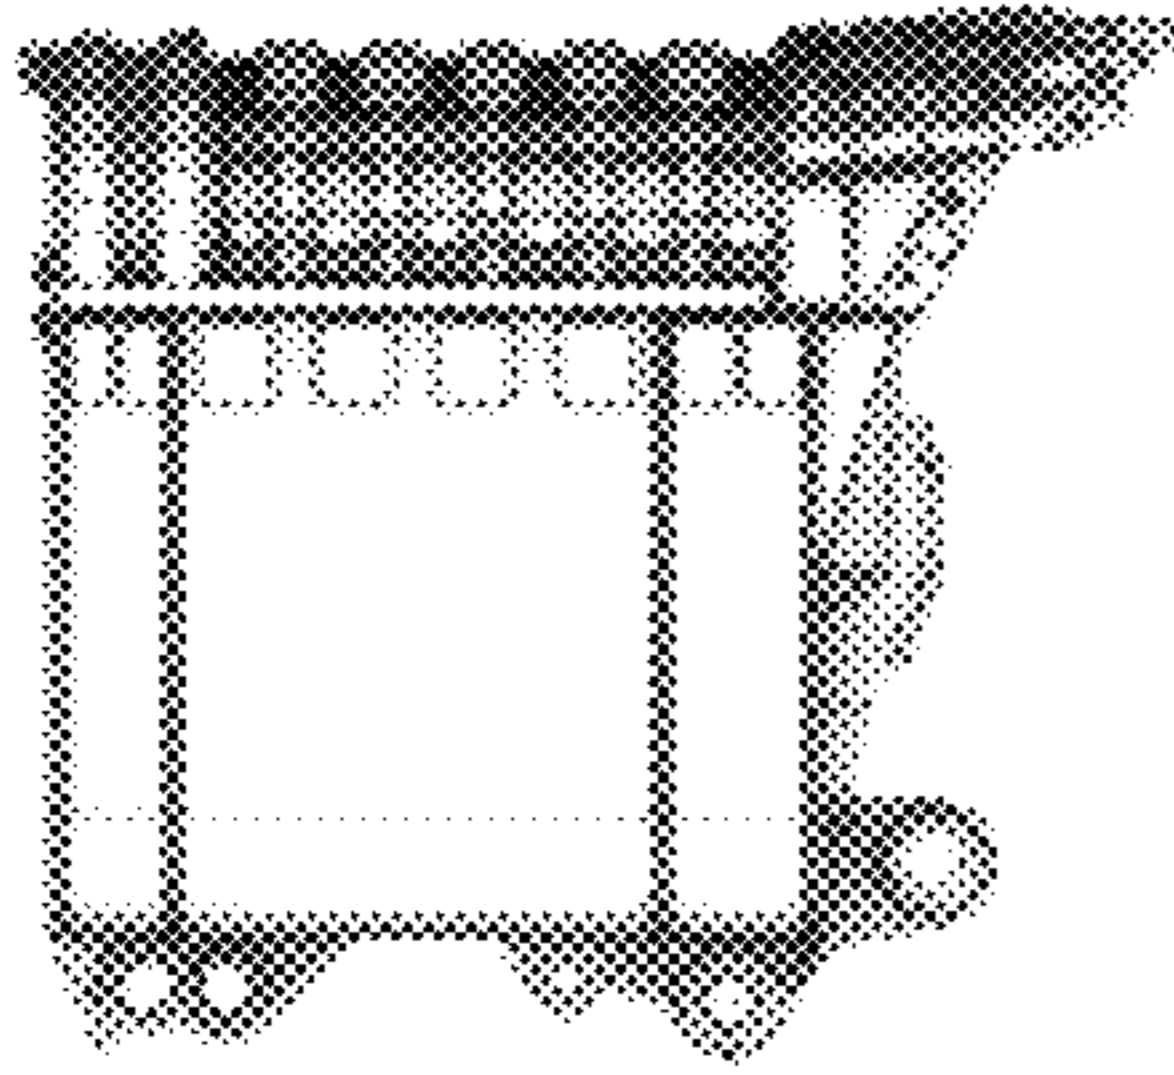
Figure 3C

FIG. 3C shows a third position in which the bucket is reversed to repair the outer floor.

The bucket is rotated 180 degrees (FIG. 3C) and the outer floor is repaired, for which it requires 3 welders for 15 days, one boiler operator for 7 days, and 1 assistant for 15 days.

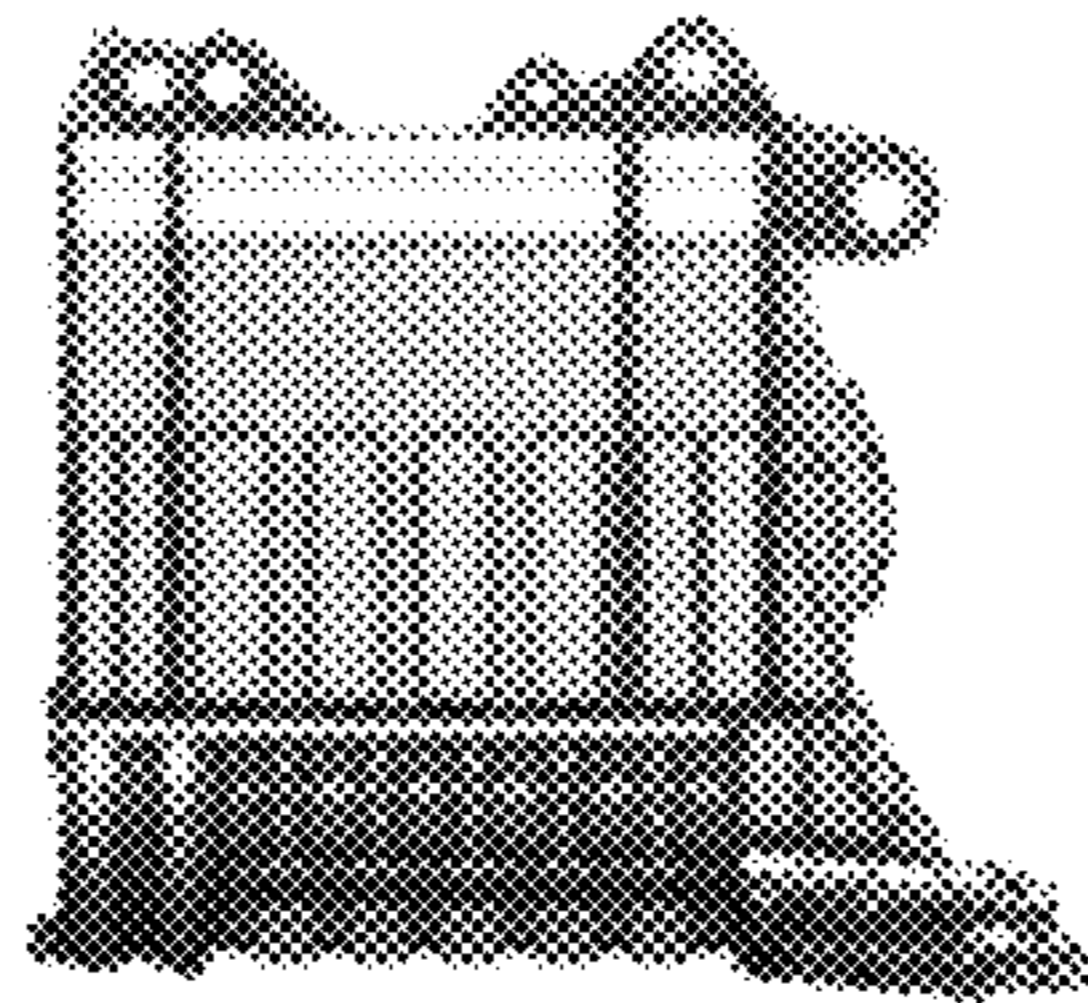
Figure 3D

FIG. 3D shows a new reversion of the bucket to repair the connection area.

The bucket is rotated again 180 degrees (FIG. 3D) and the connection area is repaired, it requires 3 welders for 10 days, 3 turners for 7 days, and 1 assistant for 10 days.

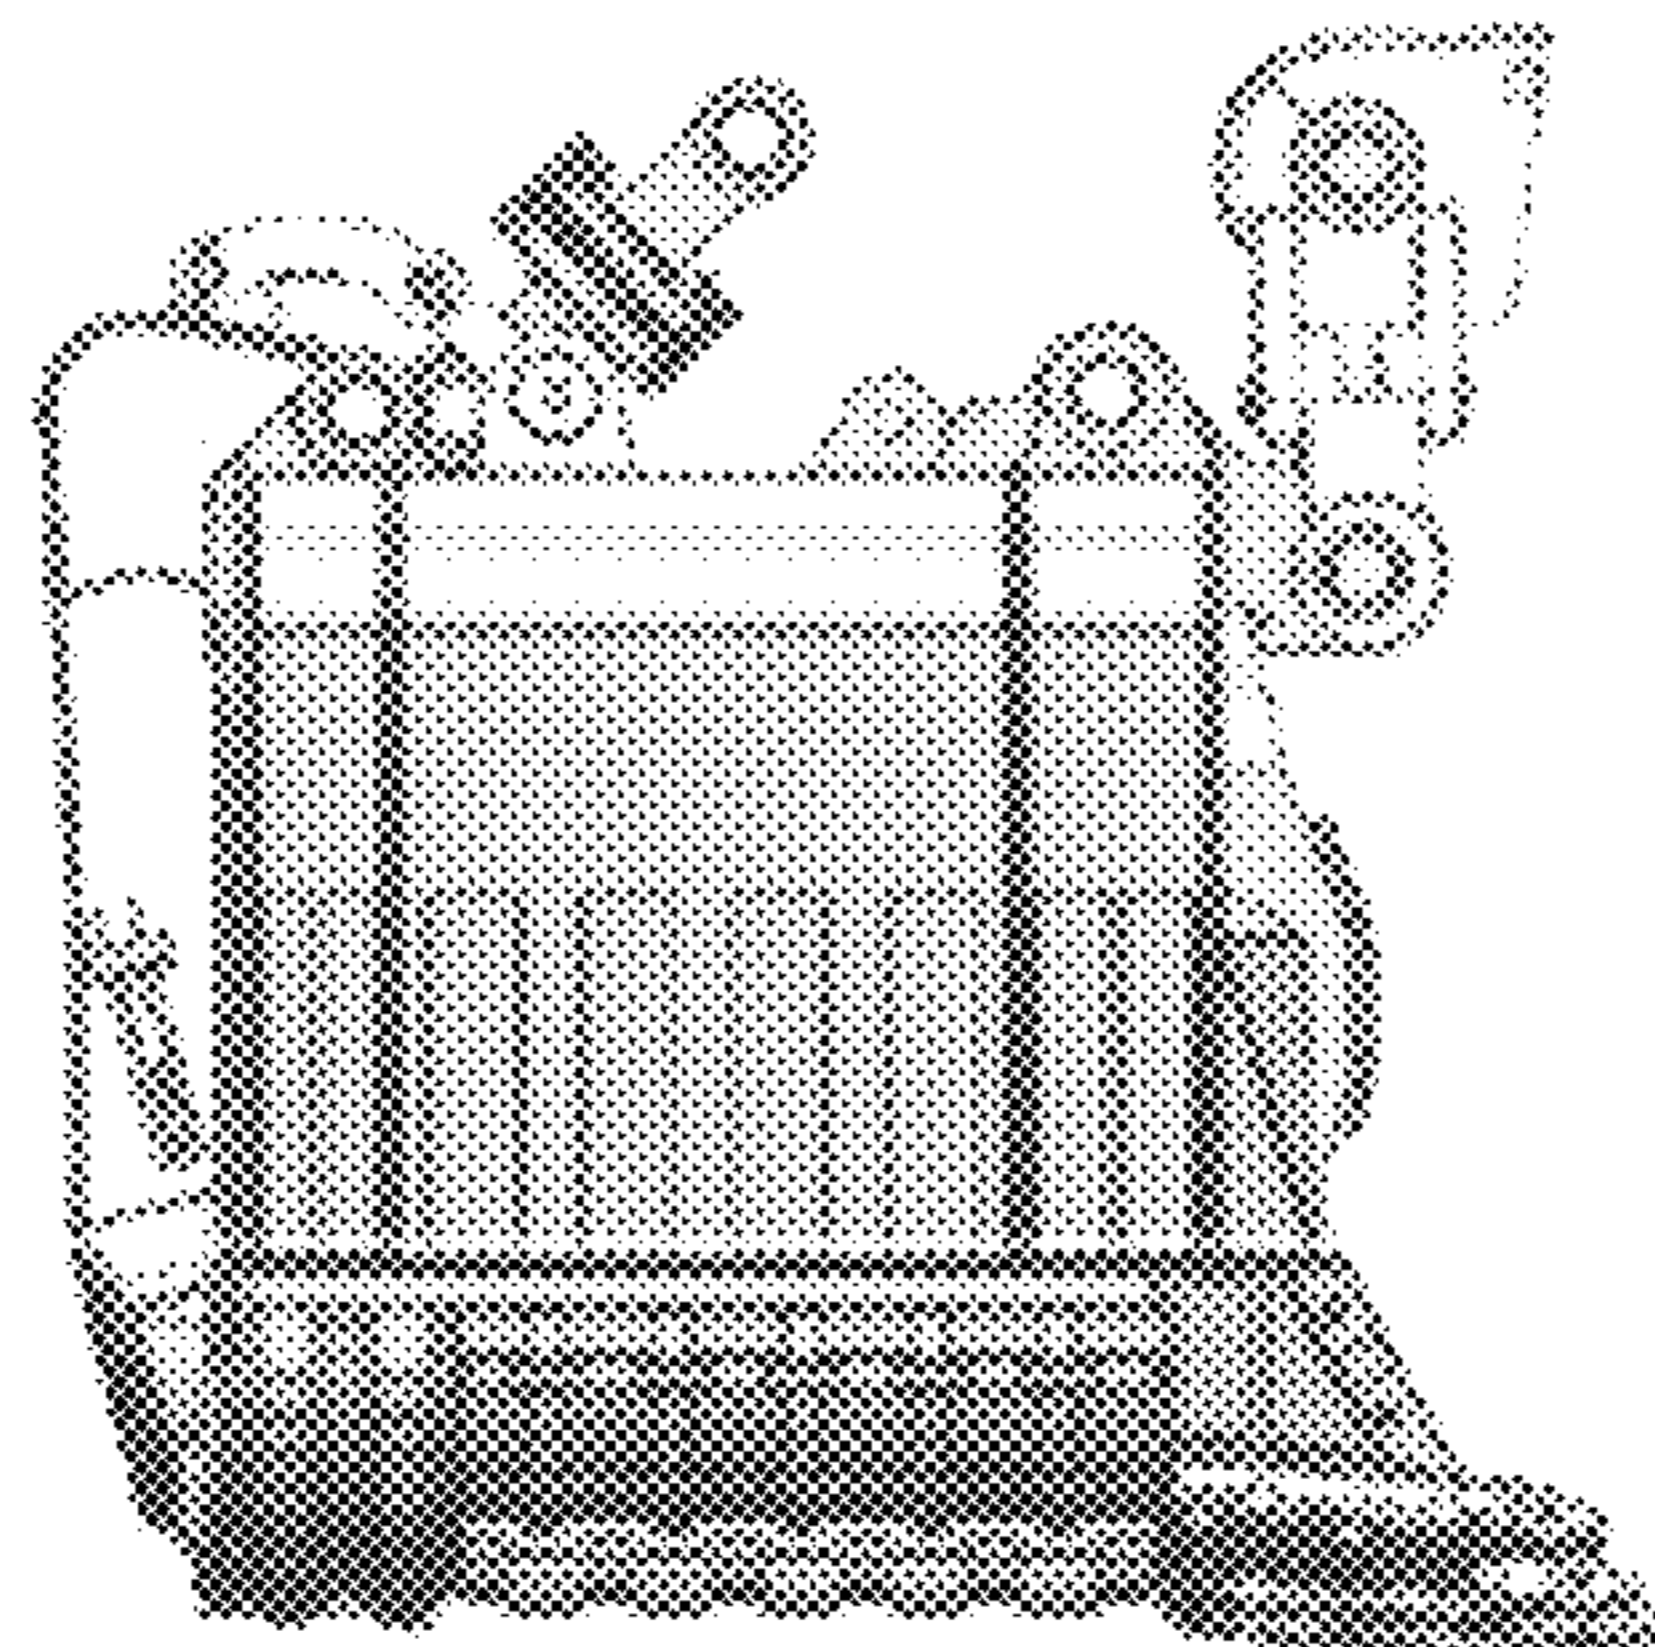
Figure 4

FIG. 4 shows a finished bucket for the process with all its accessories.
